MISSOURI DEPARTMENT OF NATURAL RESOURCES  
STATE HISTORIC PRESERVATION OFFICE, P.O. Box 176, Jefferson City, MO 65102  
**ARCHITECTURAL/HISTORIC INVENTORY FORM**

1. SURVEY NO. LI-AS-001-001		2. SURVEY NAME: Marceline Survey	
3. COUNTY: Linn		4. ADDRESS (STREET NO.) 275	STREET (NAME) West Broadway
5. CITY: Marceline	VICINITY: <input type="checkbox"/>	6. UTM: / /	7. TOWNSHIP/RANGE/SECTION: T: R: S:

8. HISTORIC NAME (IF KNOWN): Walt Disney's Childhood Home		9. PRESENT/OTHER NAME (IF KNOWN): Walt Disney's Childhood Home	
10. OWNERSHIP: <input checked="" type="checkbox"/> PRIVATE <input type="checkbox"/> PUBLIC		11A. HISTORIC USE (IF KNOWN): Single Dwelling	11B. CURRENT USE: Single Dwelling
<b>HISTORICAL INFORMATION</b>

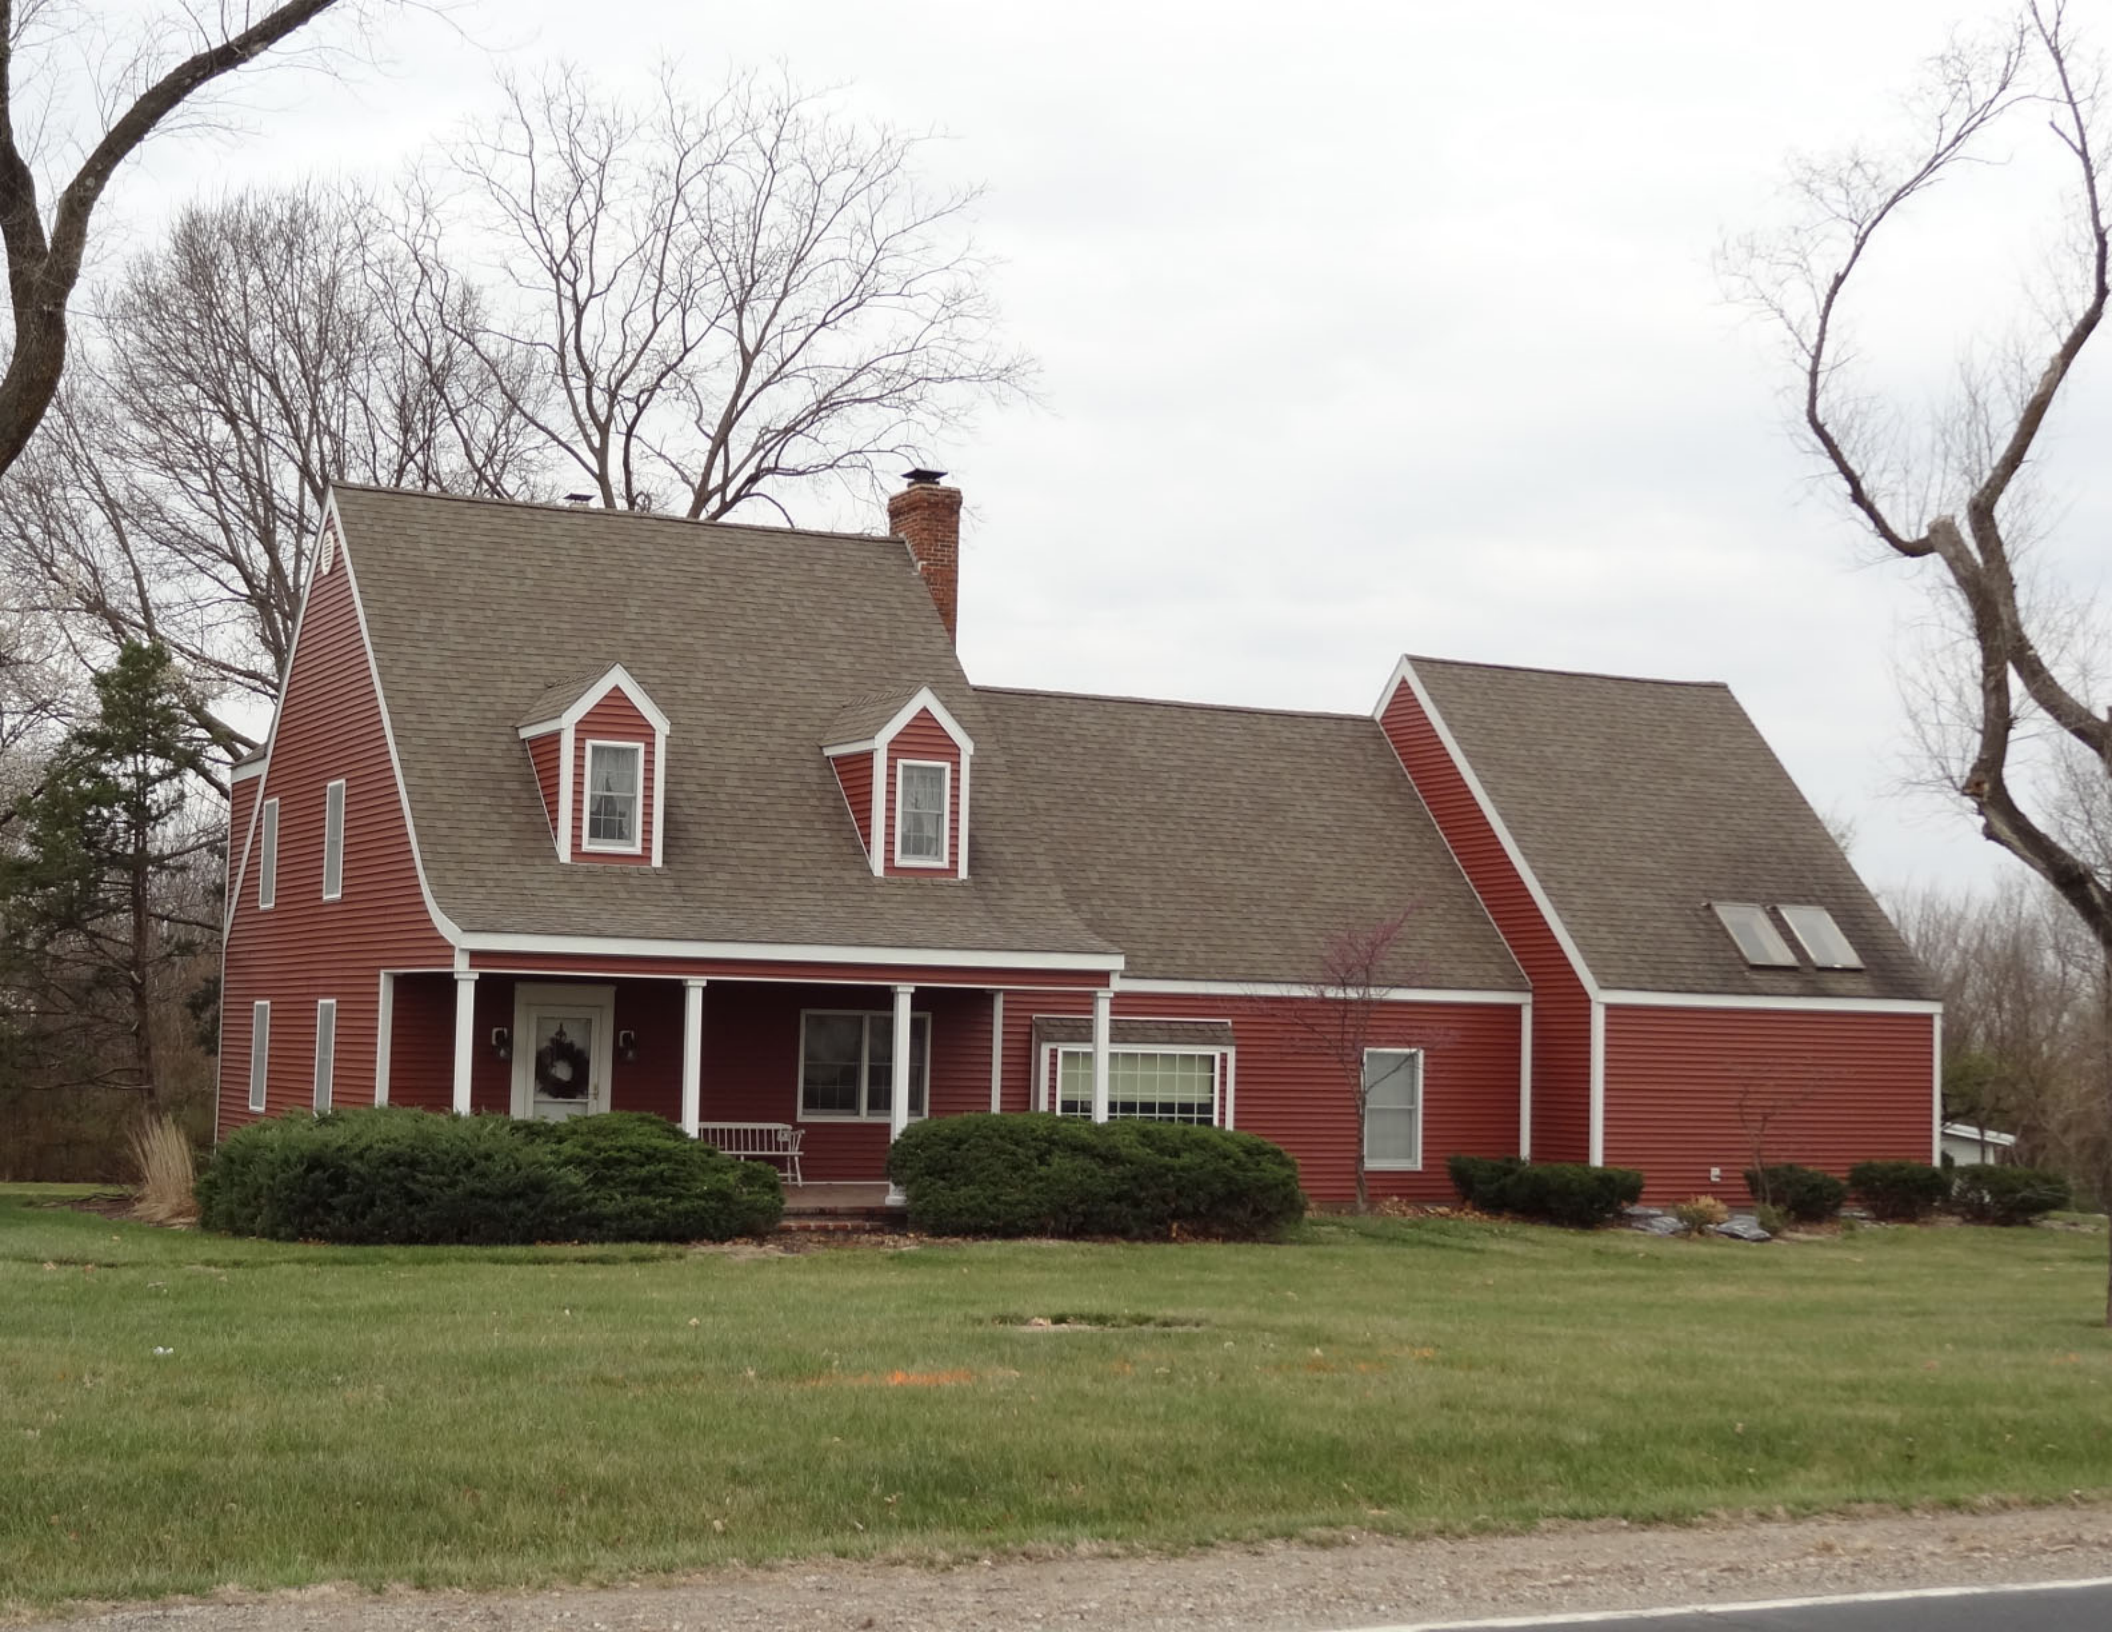
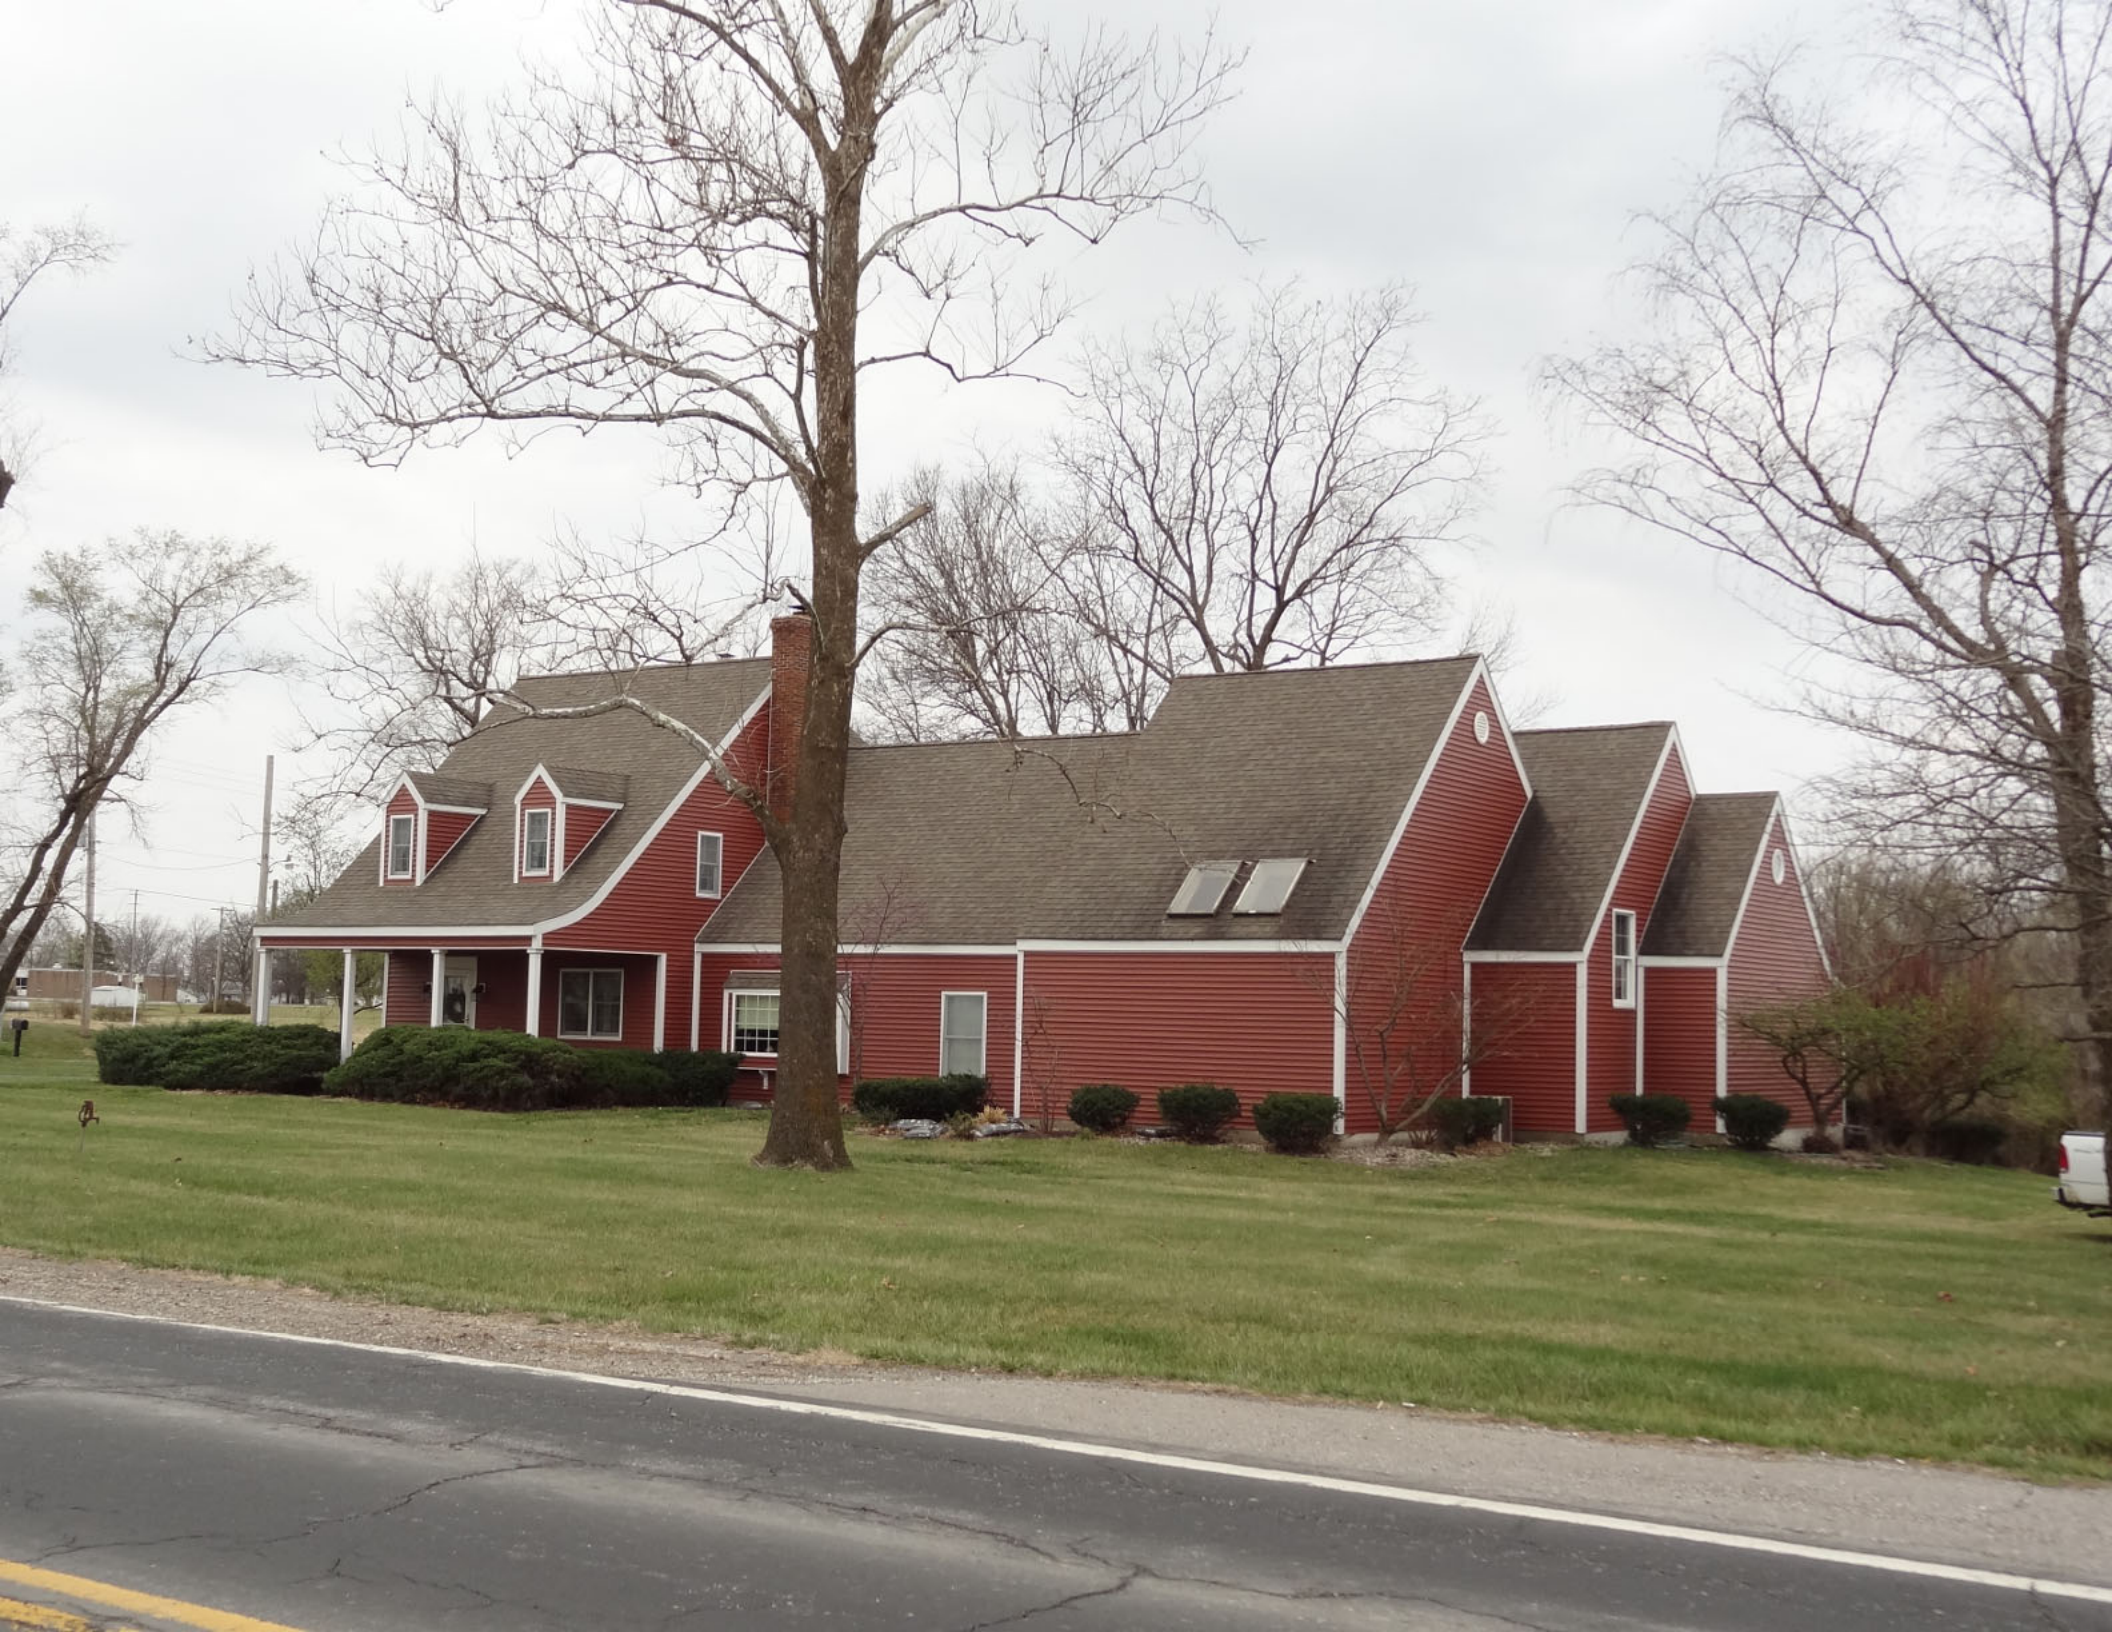
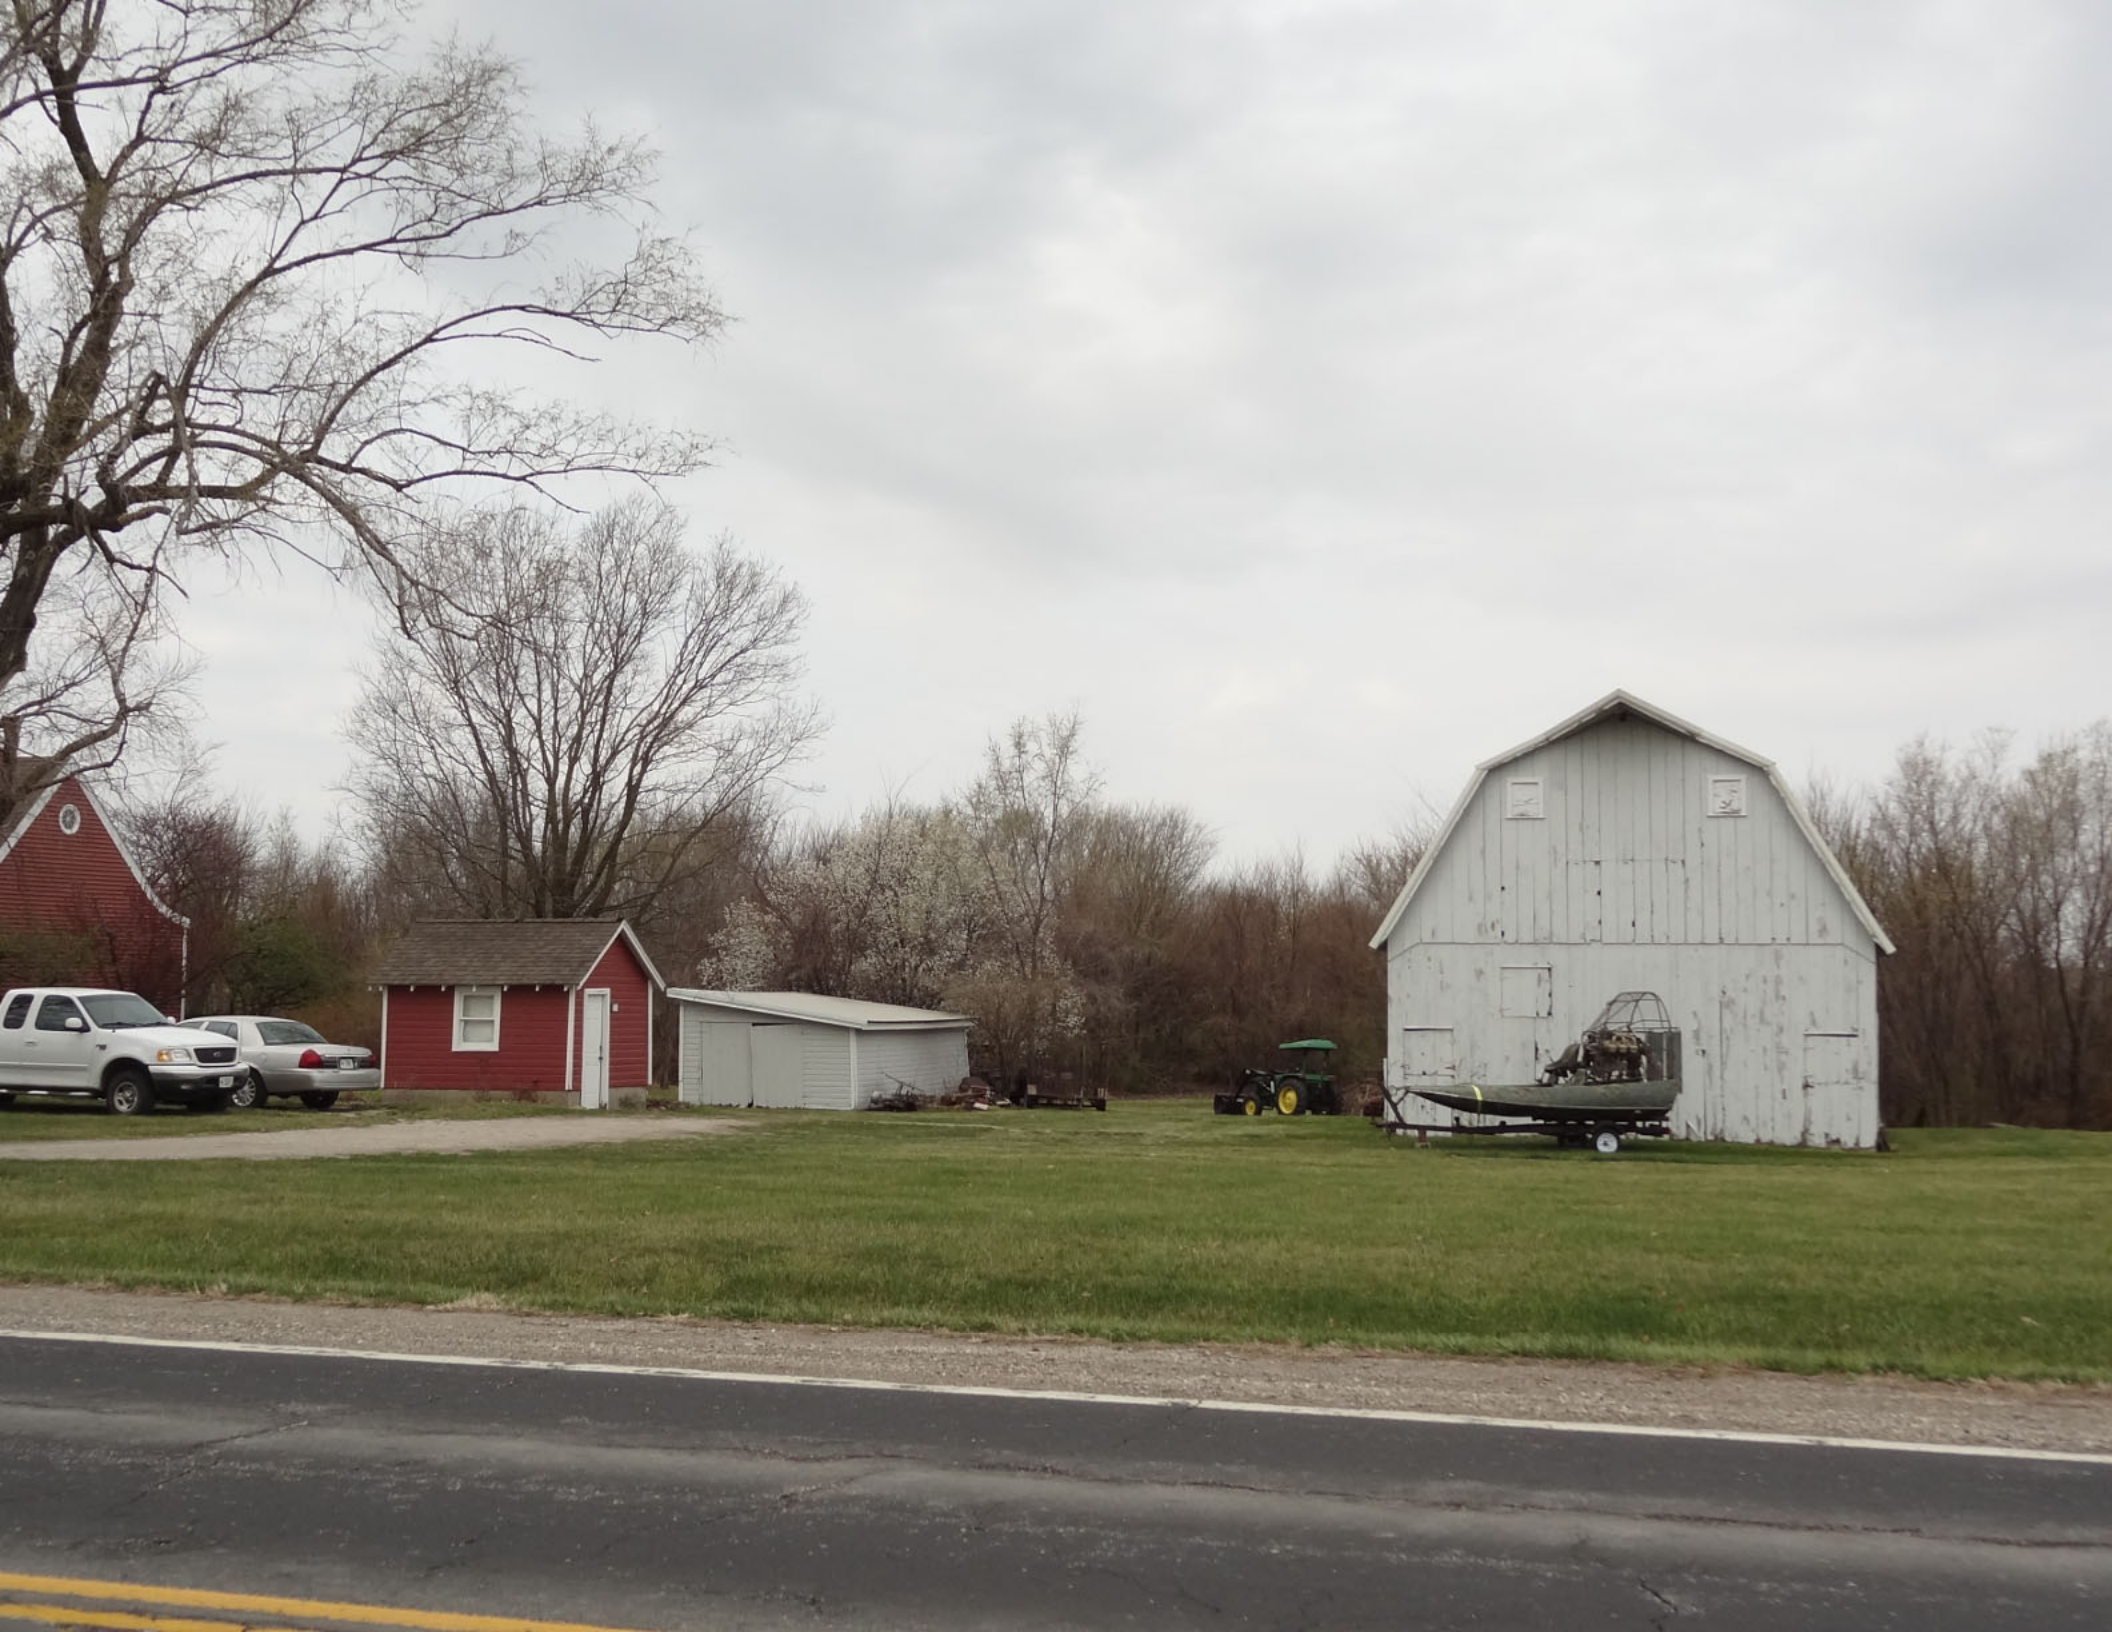
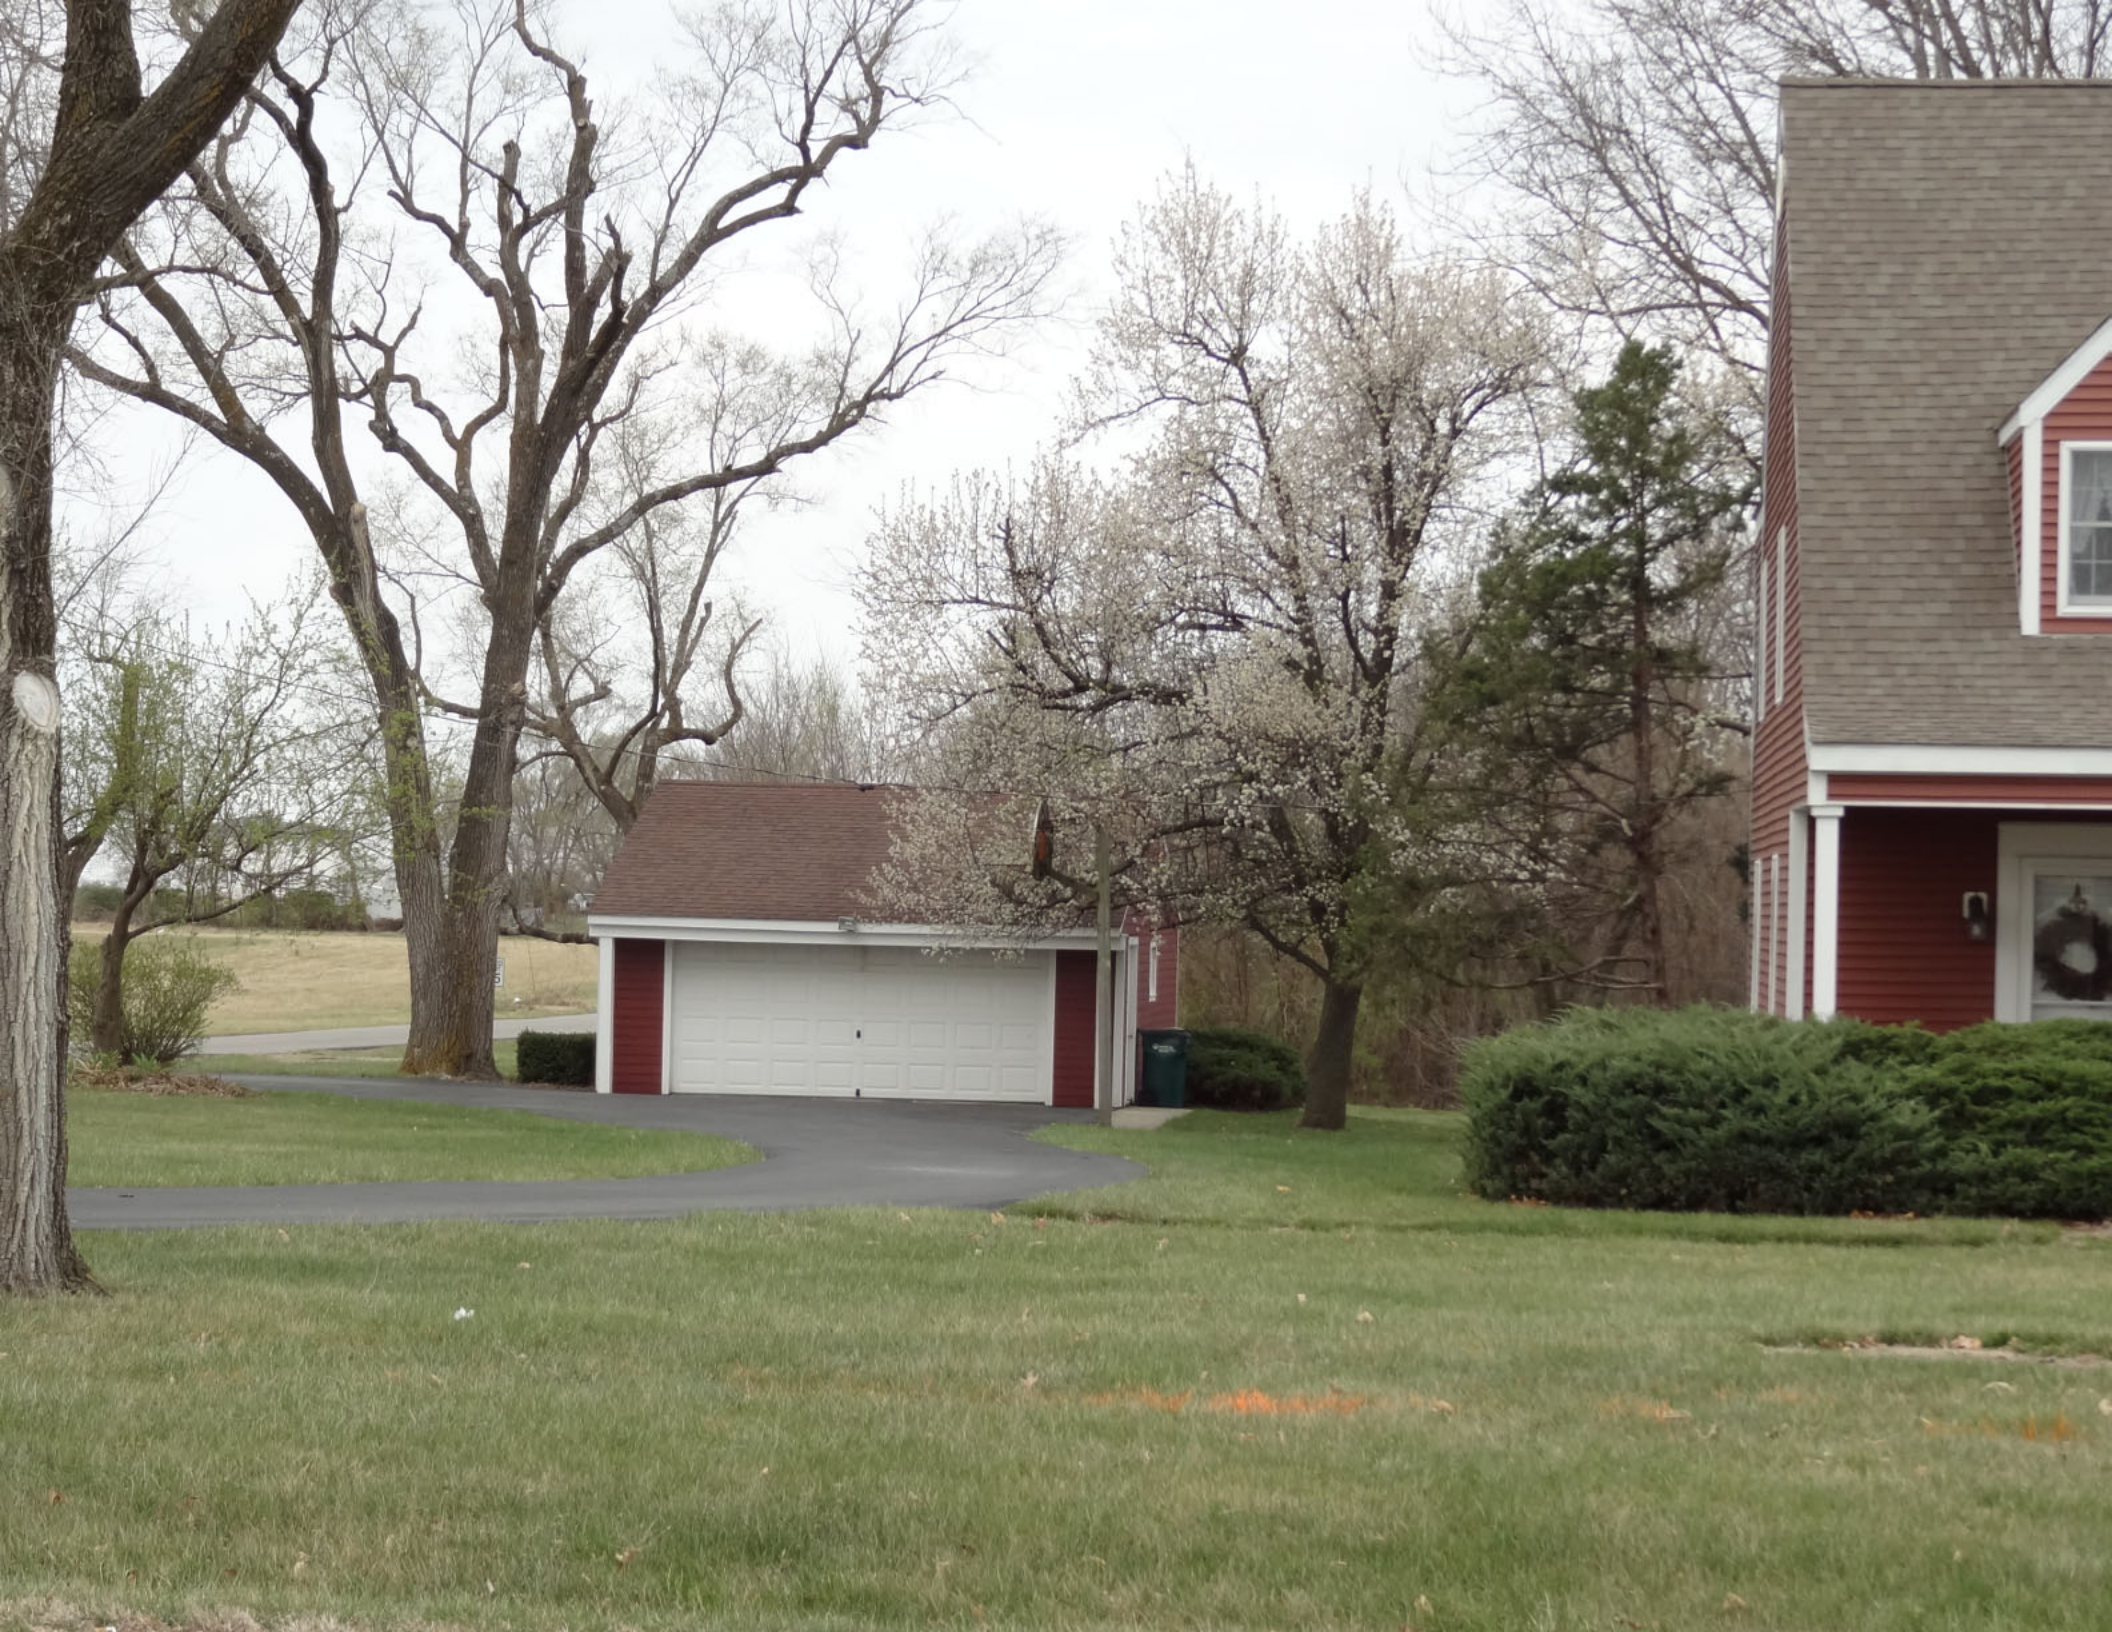
The house has a side gable and has five sections that appear to be constructed at different times. Starting from the south the first and second bays are under the flared porch. The first bay has a single door moving north there is a pair of large six-over-six vinyl hung windows. The next bay is in a recessed portion. The third bay is a projecting window with a multi pane window, moving north there is a single six-over-six vinyl window. Moving north there is a projecting bay that has no openings. Moving north there are two more bays both of which were blank walls without ornamentation.

The southern most bays have two dormers each with six-over-six vinyl windows. There is also a chimney on the end of this bay. There in the portion over the fifth bay has a pair of skylights in the side gable roof.

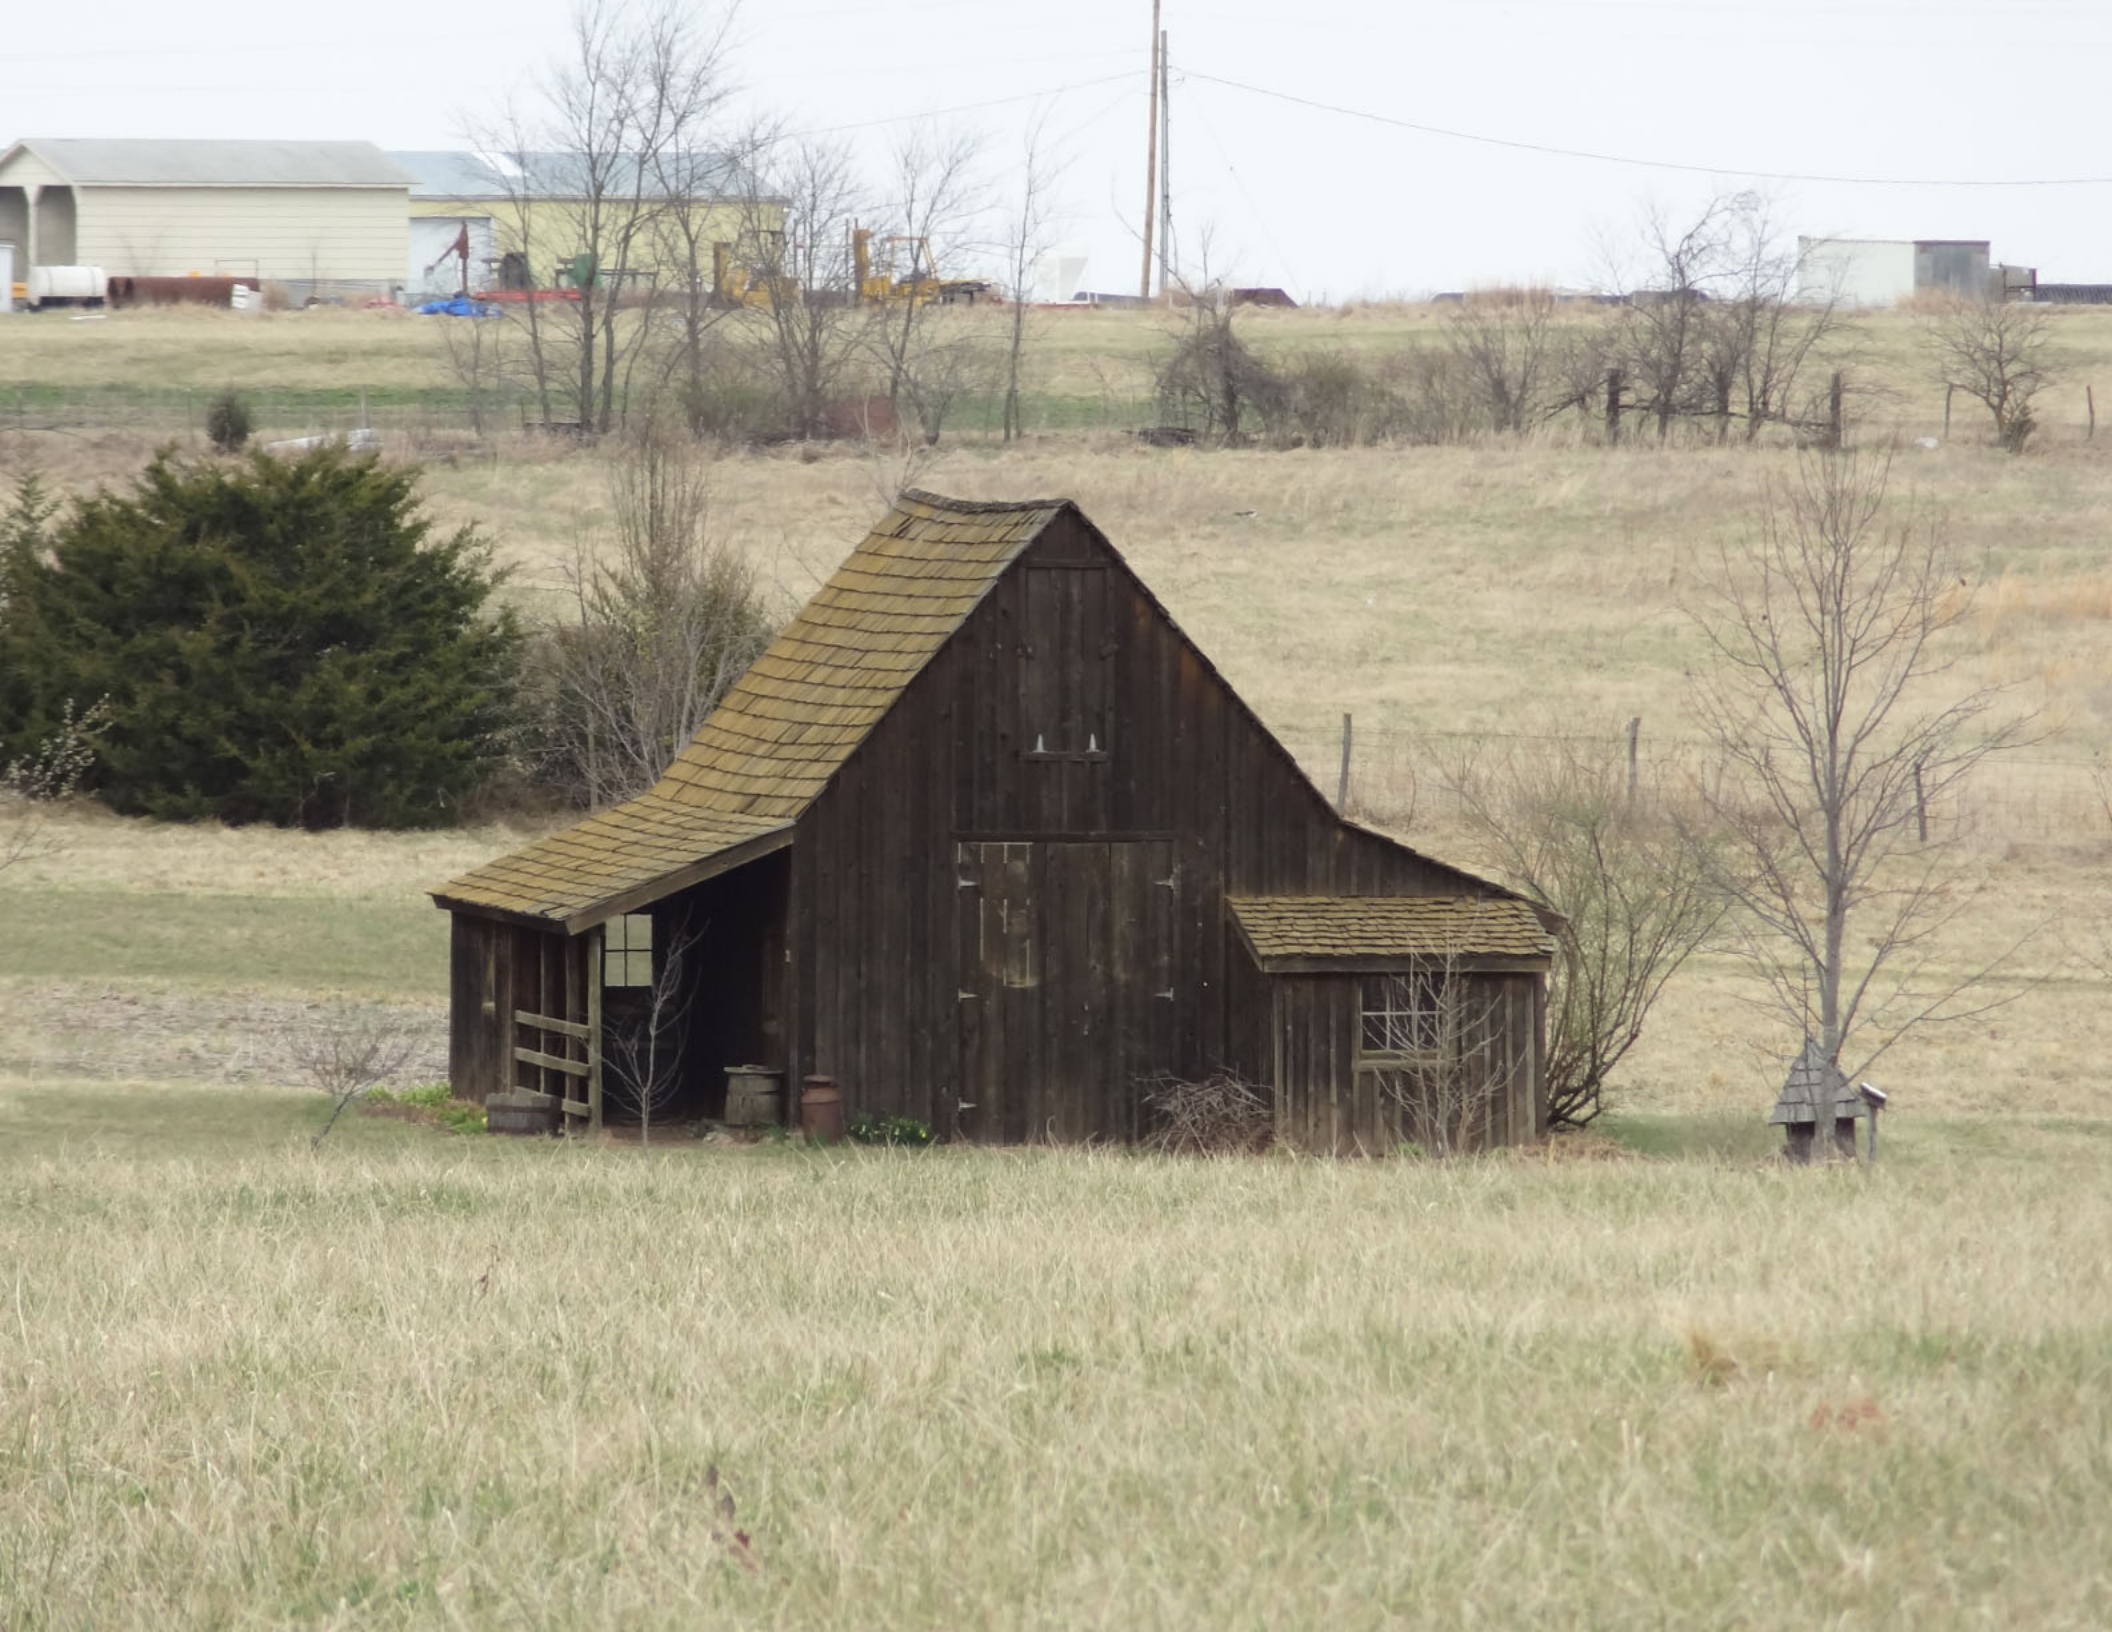
The barn faces west. There appears to be three bays. There is a porch on the south elevation that leads into the main barn the porch has a shed roof that meets up with the main side gabled porch. The central bay has a pair of double board and batten wood doors. Moving north there is shed roof portion on the north elevation and attached to that it s a small shed roofed portion with a small fixed six pane window in this portion. There is a small opening in the upper portion of the central portion of the barn.

The barn is used primarily as a commemorative space. Visitors are encouraged to sign the interior of the building.
