MISSOURI DEPARTMENT OF NATURAL RESOURCES  
STATE HISTORIC PRESERVATION OFFICE, P.O. Box 176, Jefferson City, MO 65102  
**ARCHITECTURAL/HISTORIC INVENTORY FORM**

1. SURVEY NO. LI-AS-001-001		2. SURVEY NAME: Marceline Survey	
3. COUNTY: Linn		4. ADDRESS (STREET NO.) 275	STREET (NAME) West Broadway
5. CITY: Marceline	VICINITY: <input type="checkbox"/>	6. UTM: / /	7. TOWNSHIP/RANGE/SECTION: T: R: S:

8. HISTORIC NAME (IF KNOWN): Walt Disney's Childhood Home		9. PRESENT/OTHER NAME (IF KNOWN): Walt Disney's Childhood Home	
10. OWNERSHIP: <input checked="" type="checkbox"/> PRIVATE <input type="checkbox"/> PUBLIC		11A. HISTORIC USE (IF KNOWN): Single Dwelling	11B. CURRENT USE: Single Dwelling
<b>HISTORICAL INFORMATION</b>

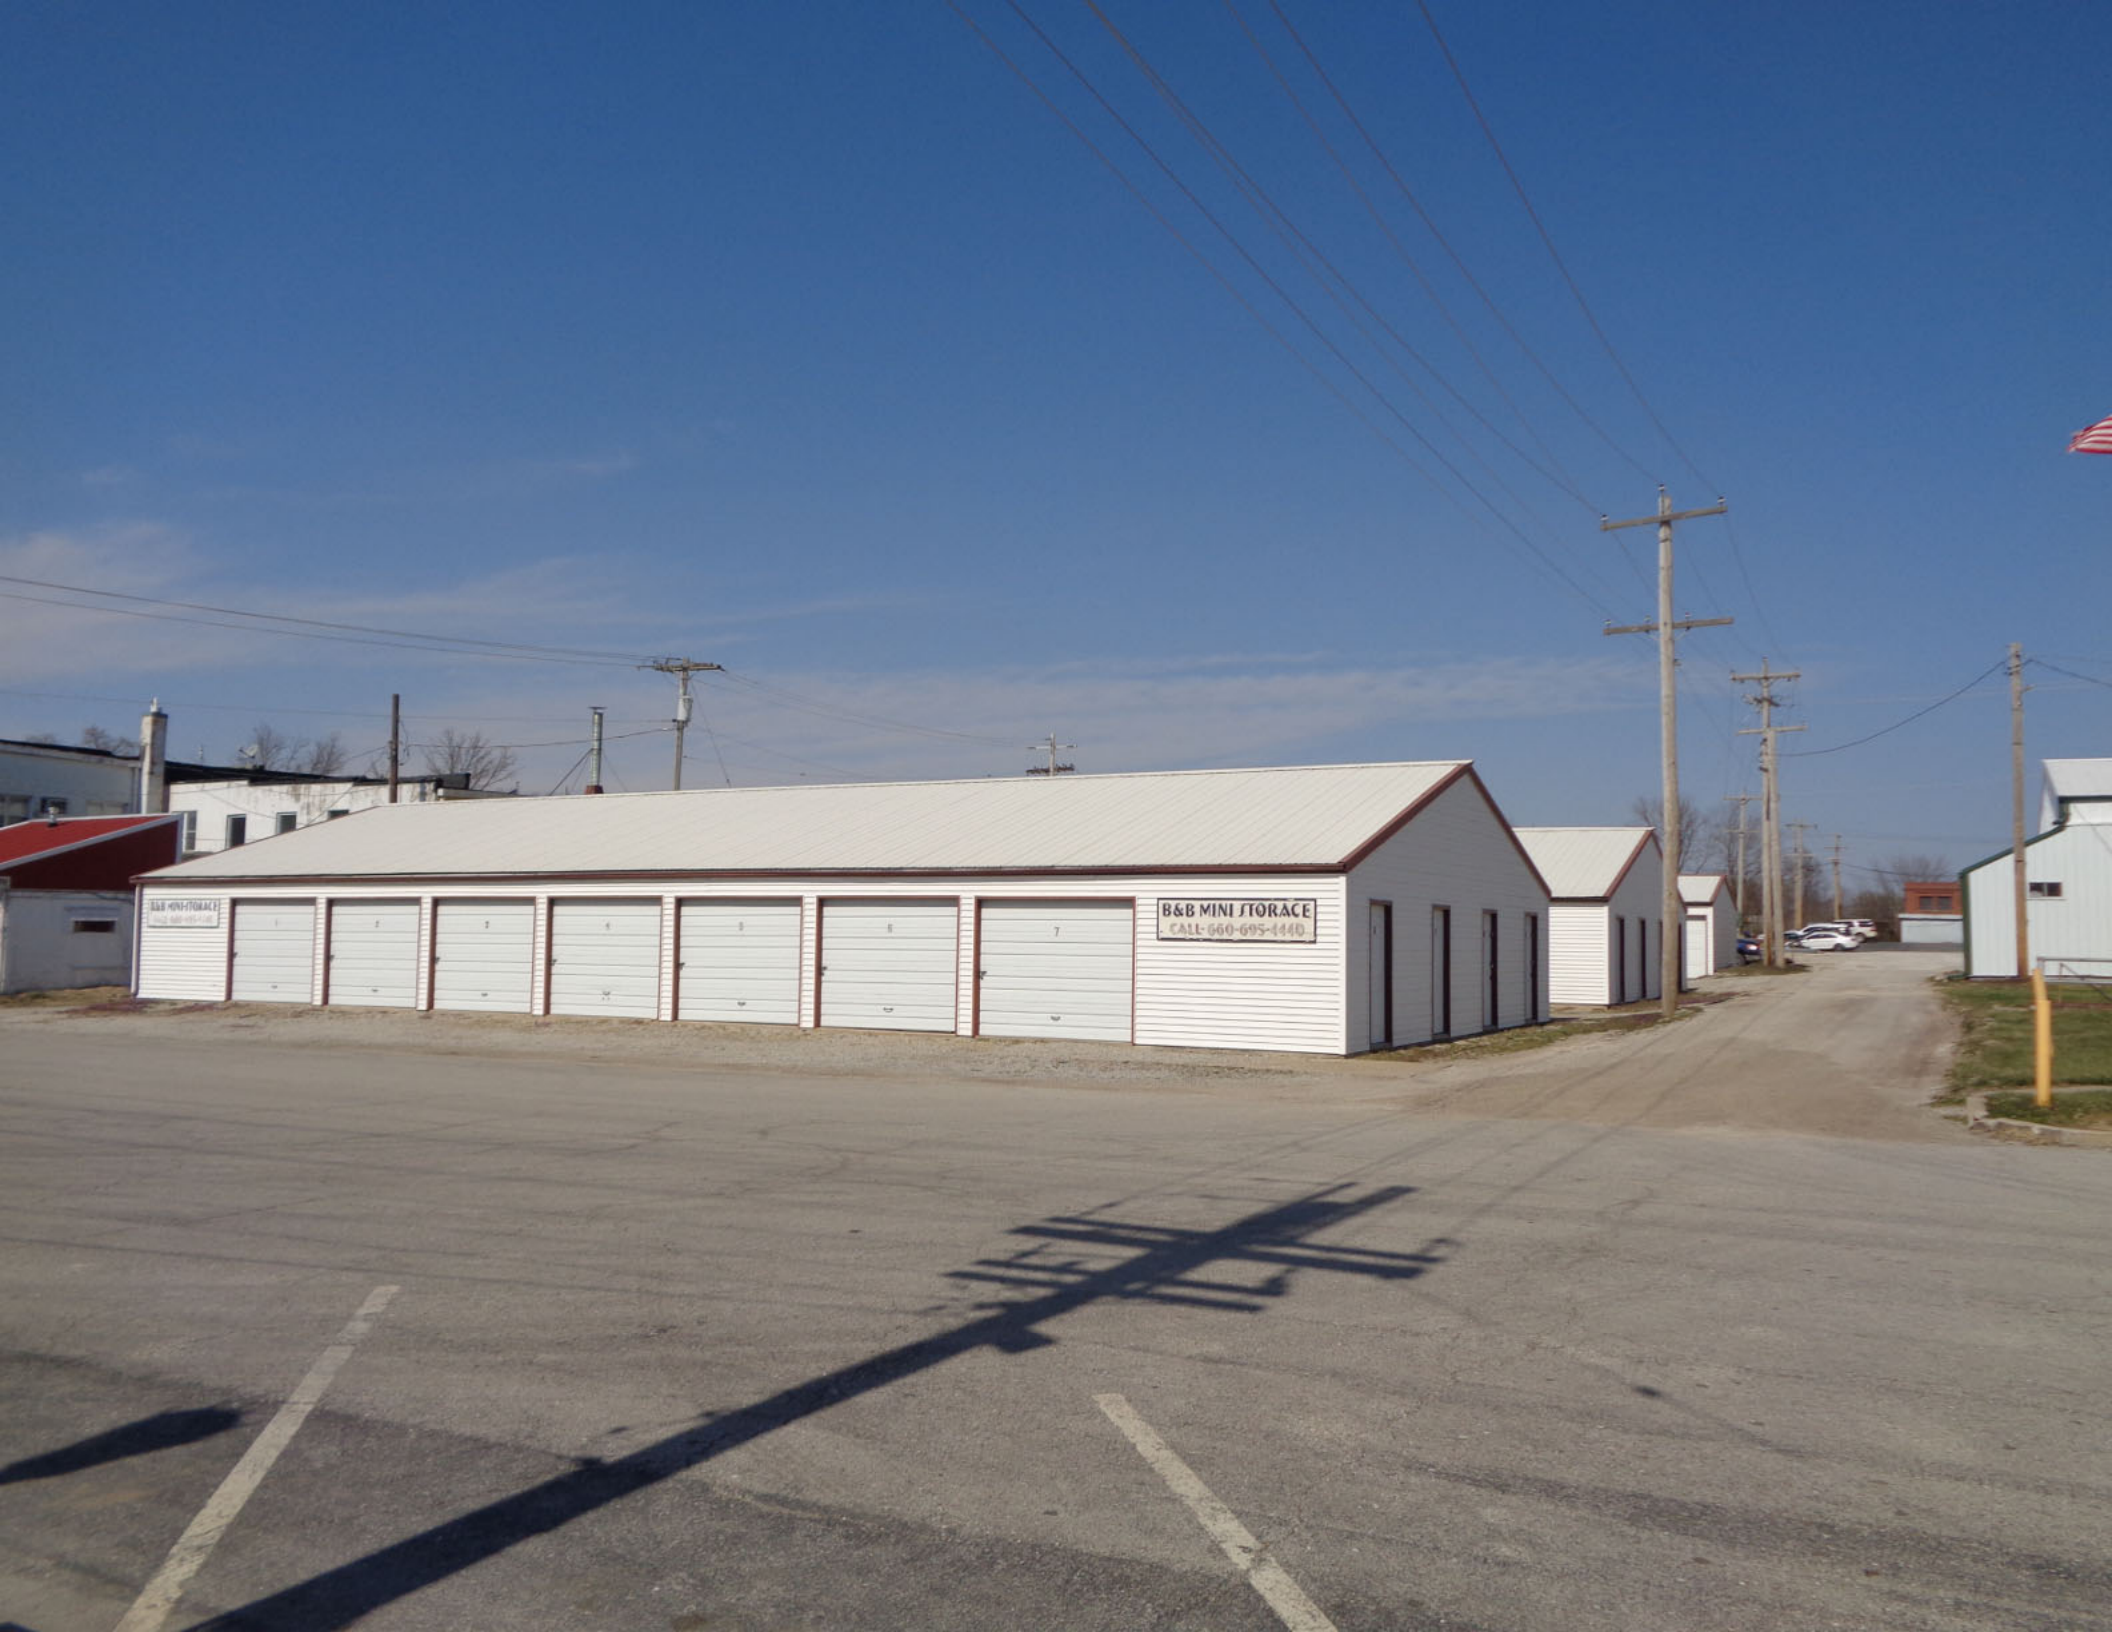
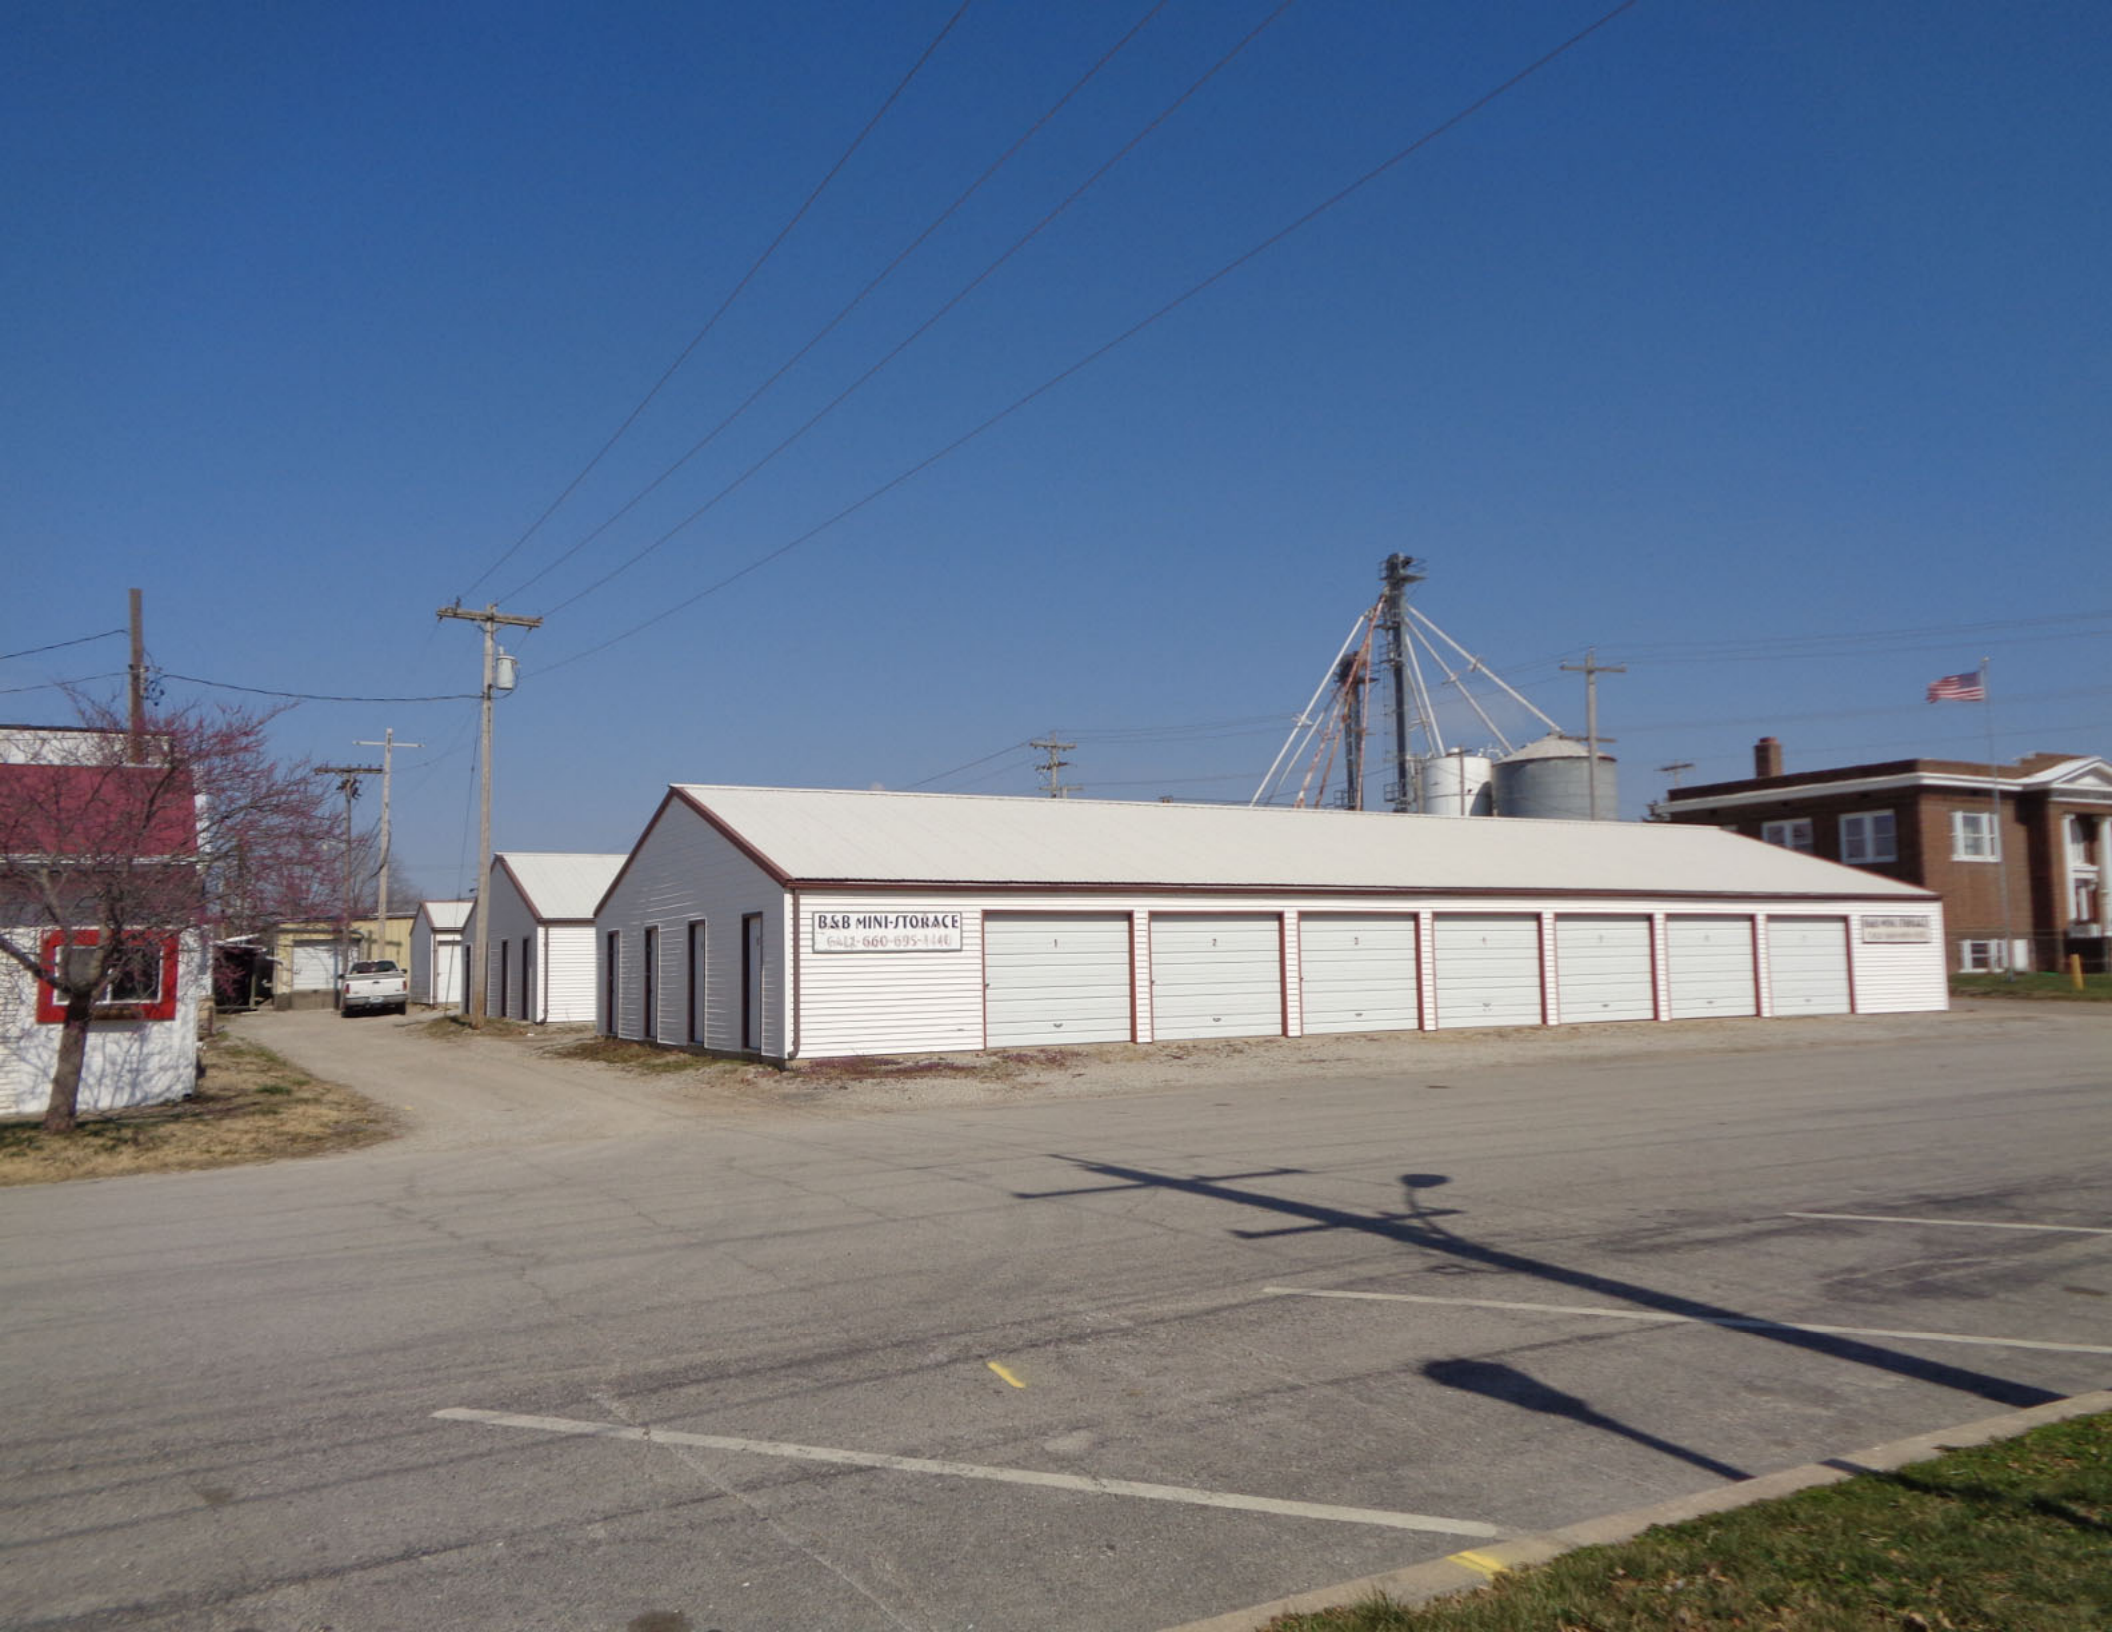
This is a group of three storage buildings. The first building on the south has seven overhead garage doors numbered with each unit on the primary elevation and the northern elevation with four smaller units on the east and west elevations. The second or middle building has a similar arrangement. The northern most building has seven overhead garage doors only on the southern elevation and no other storage units.

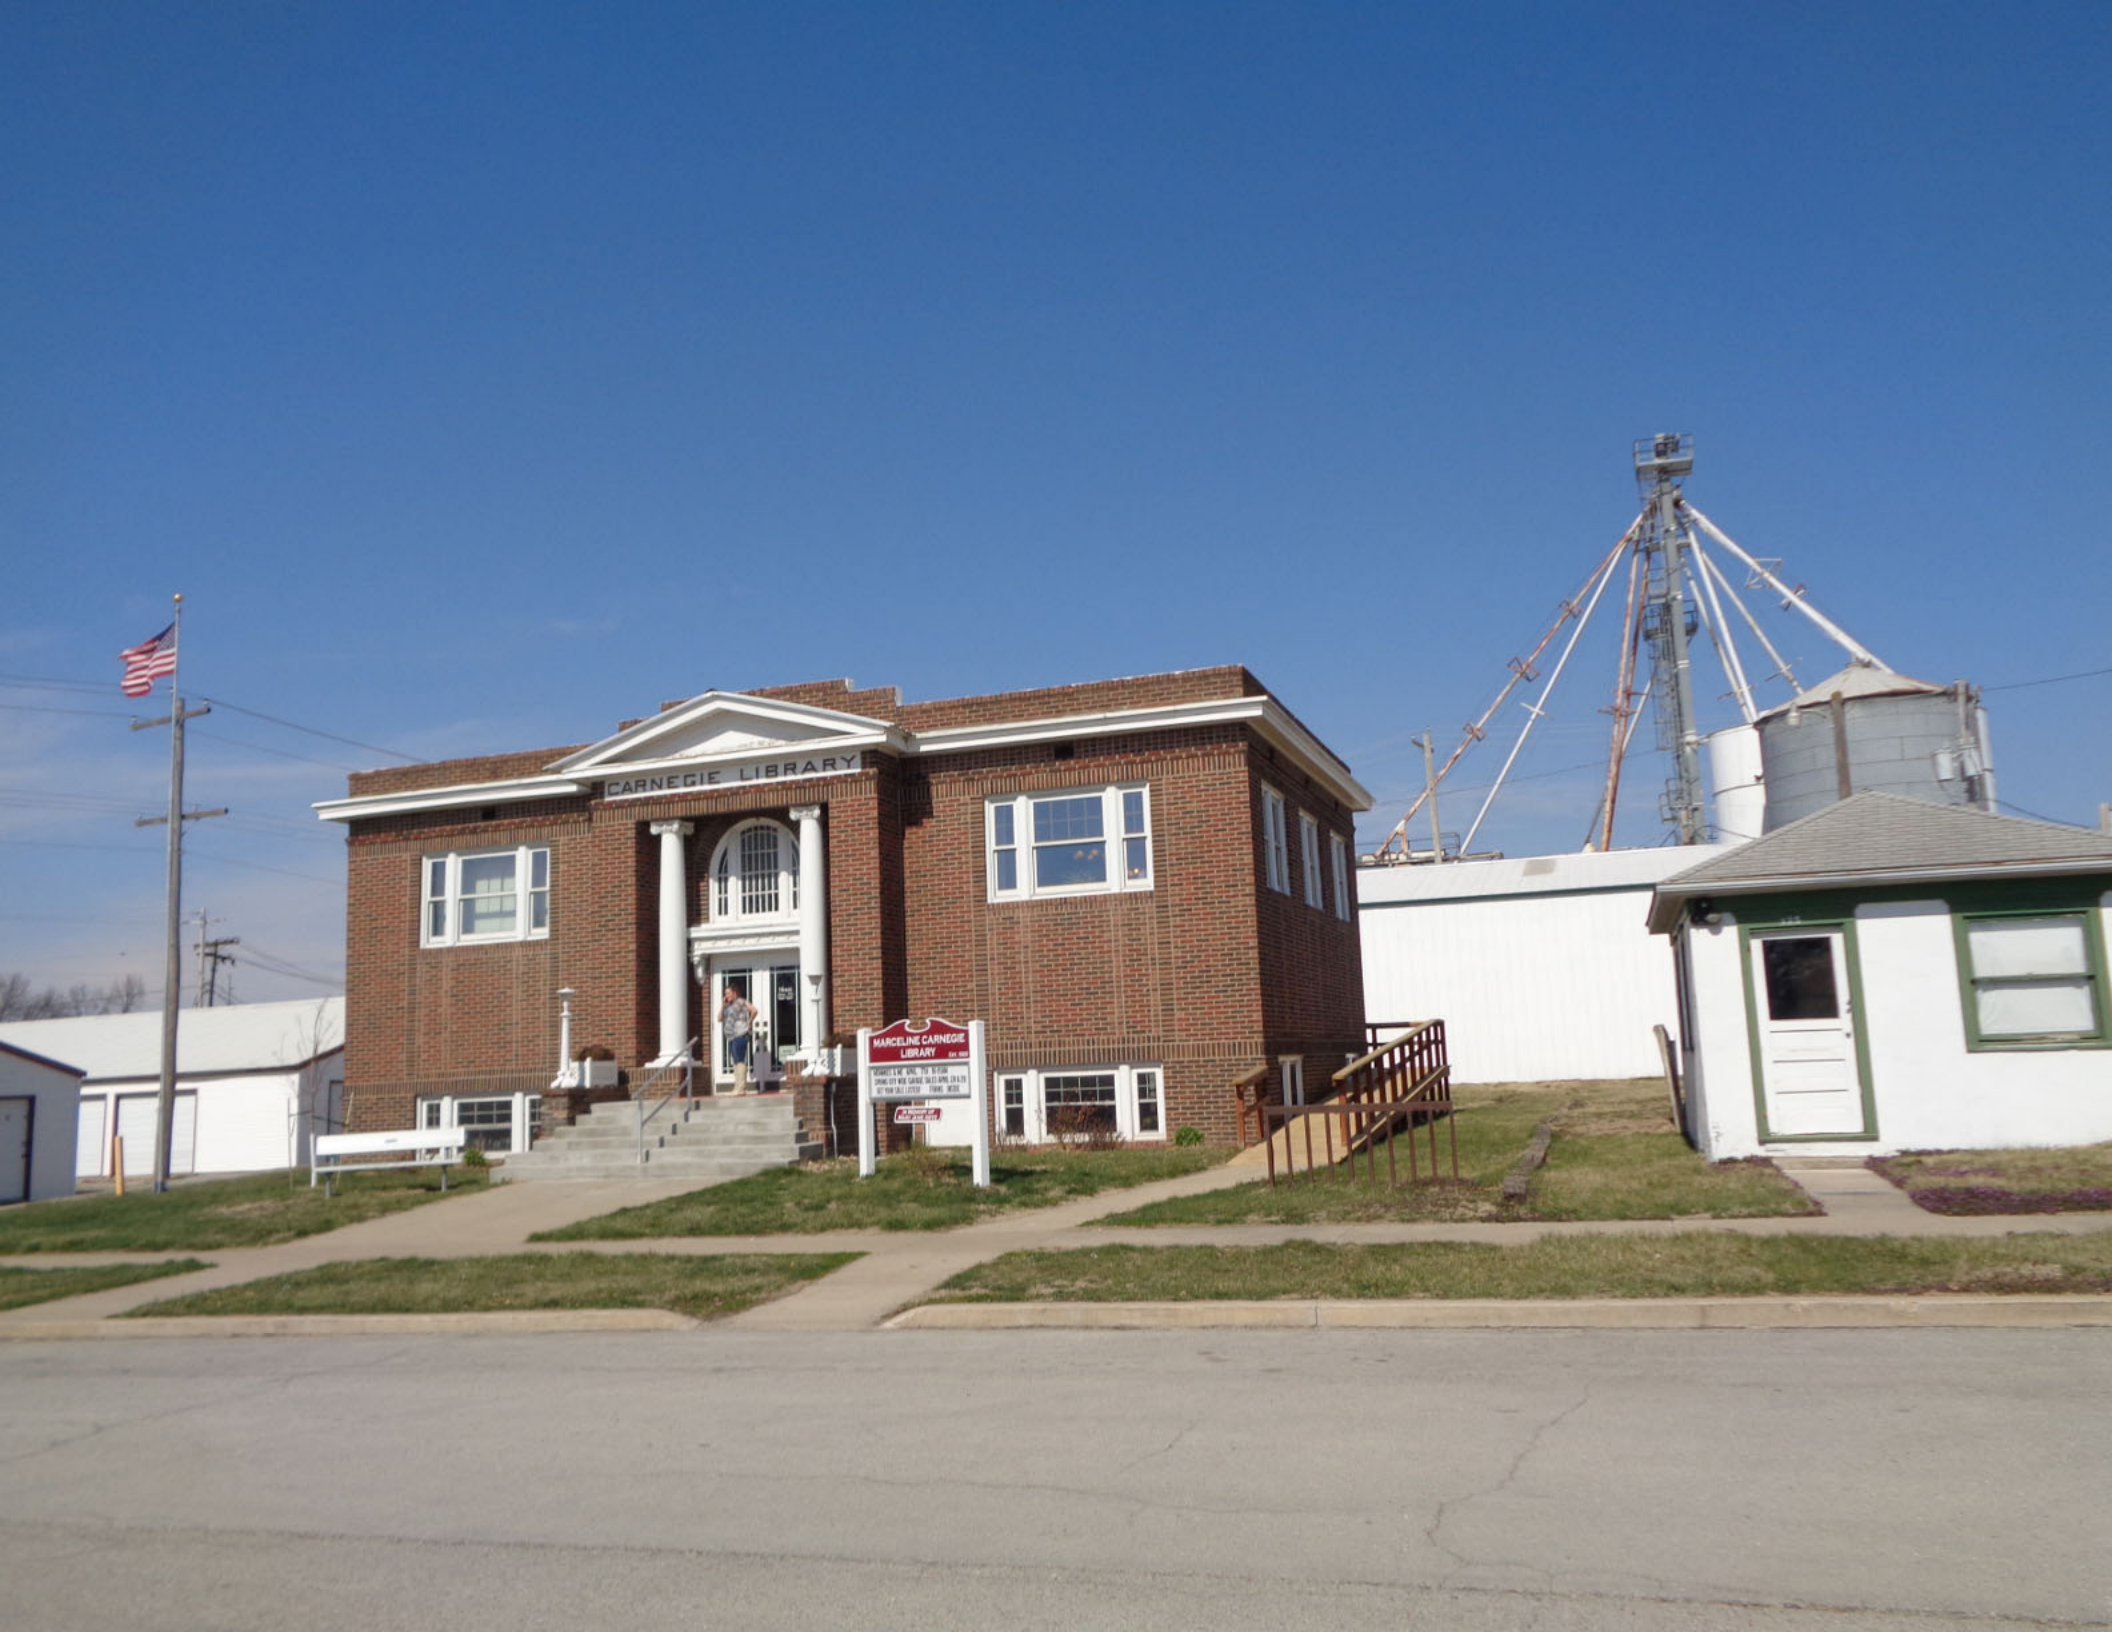
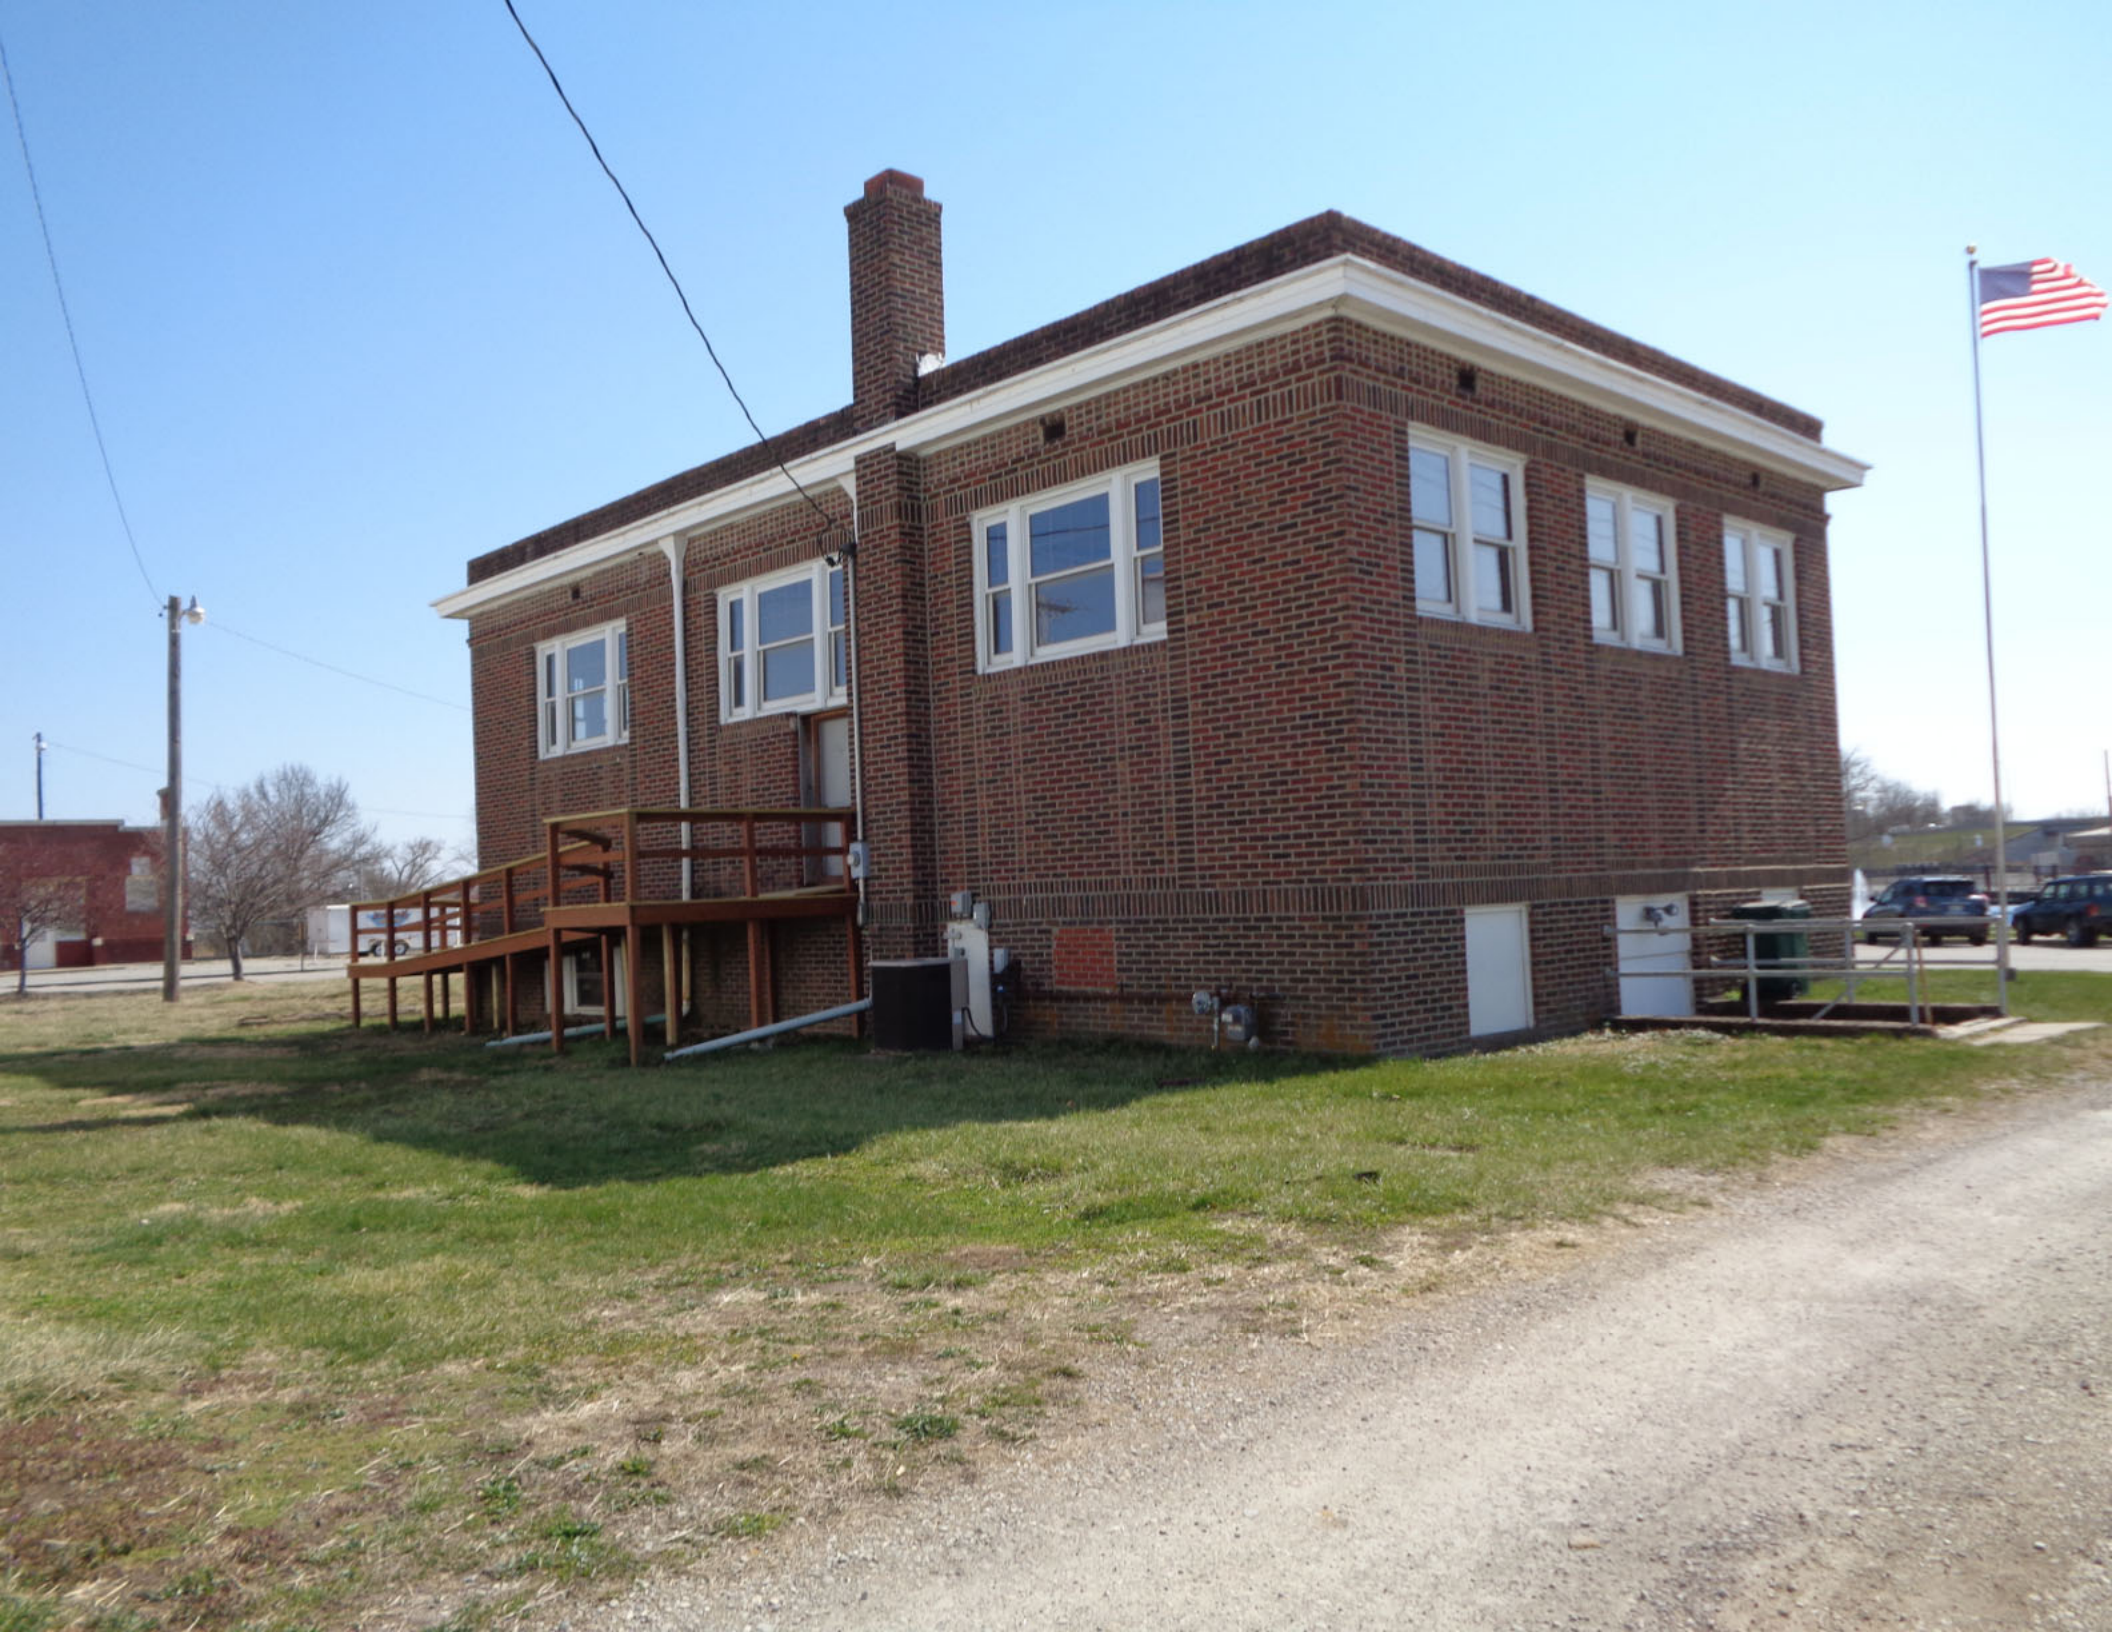
The Carnegie Library has a symmetrical facade. Starting from the east there is a grouping of three windows in the upper portion of the main elevation. There are two small four-over-one windows with a larger eight-over-one window in the center. Moving west is the main entrance to the building. The entrance is accessible via a rise of concrete steps the entrance is slightly recessed set of double wood doors with large windows in the doors. There is an ionic column on either side of the door that extends the full height of the building. Above the door is a small decorative canopy. Above the door is a wood multi-paned arched window that appears original. The western bay has a grouping of three windows with four-over-one windows on each side of a larger eight-over-one window. The building has a raised parapet around the roofline and a small pedimented portion over the main entrance with a sign "CARNEGIE LIBRARY" below the pediment. The windows in the raised basement mimic those on the main level above. Most windows may be replacements but they match the original configuration.

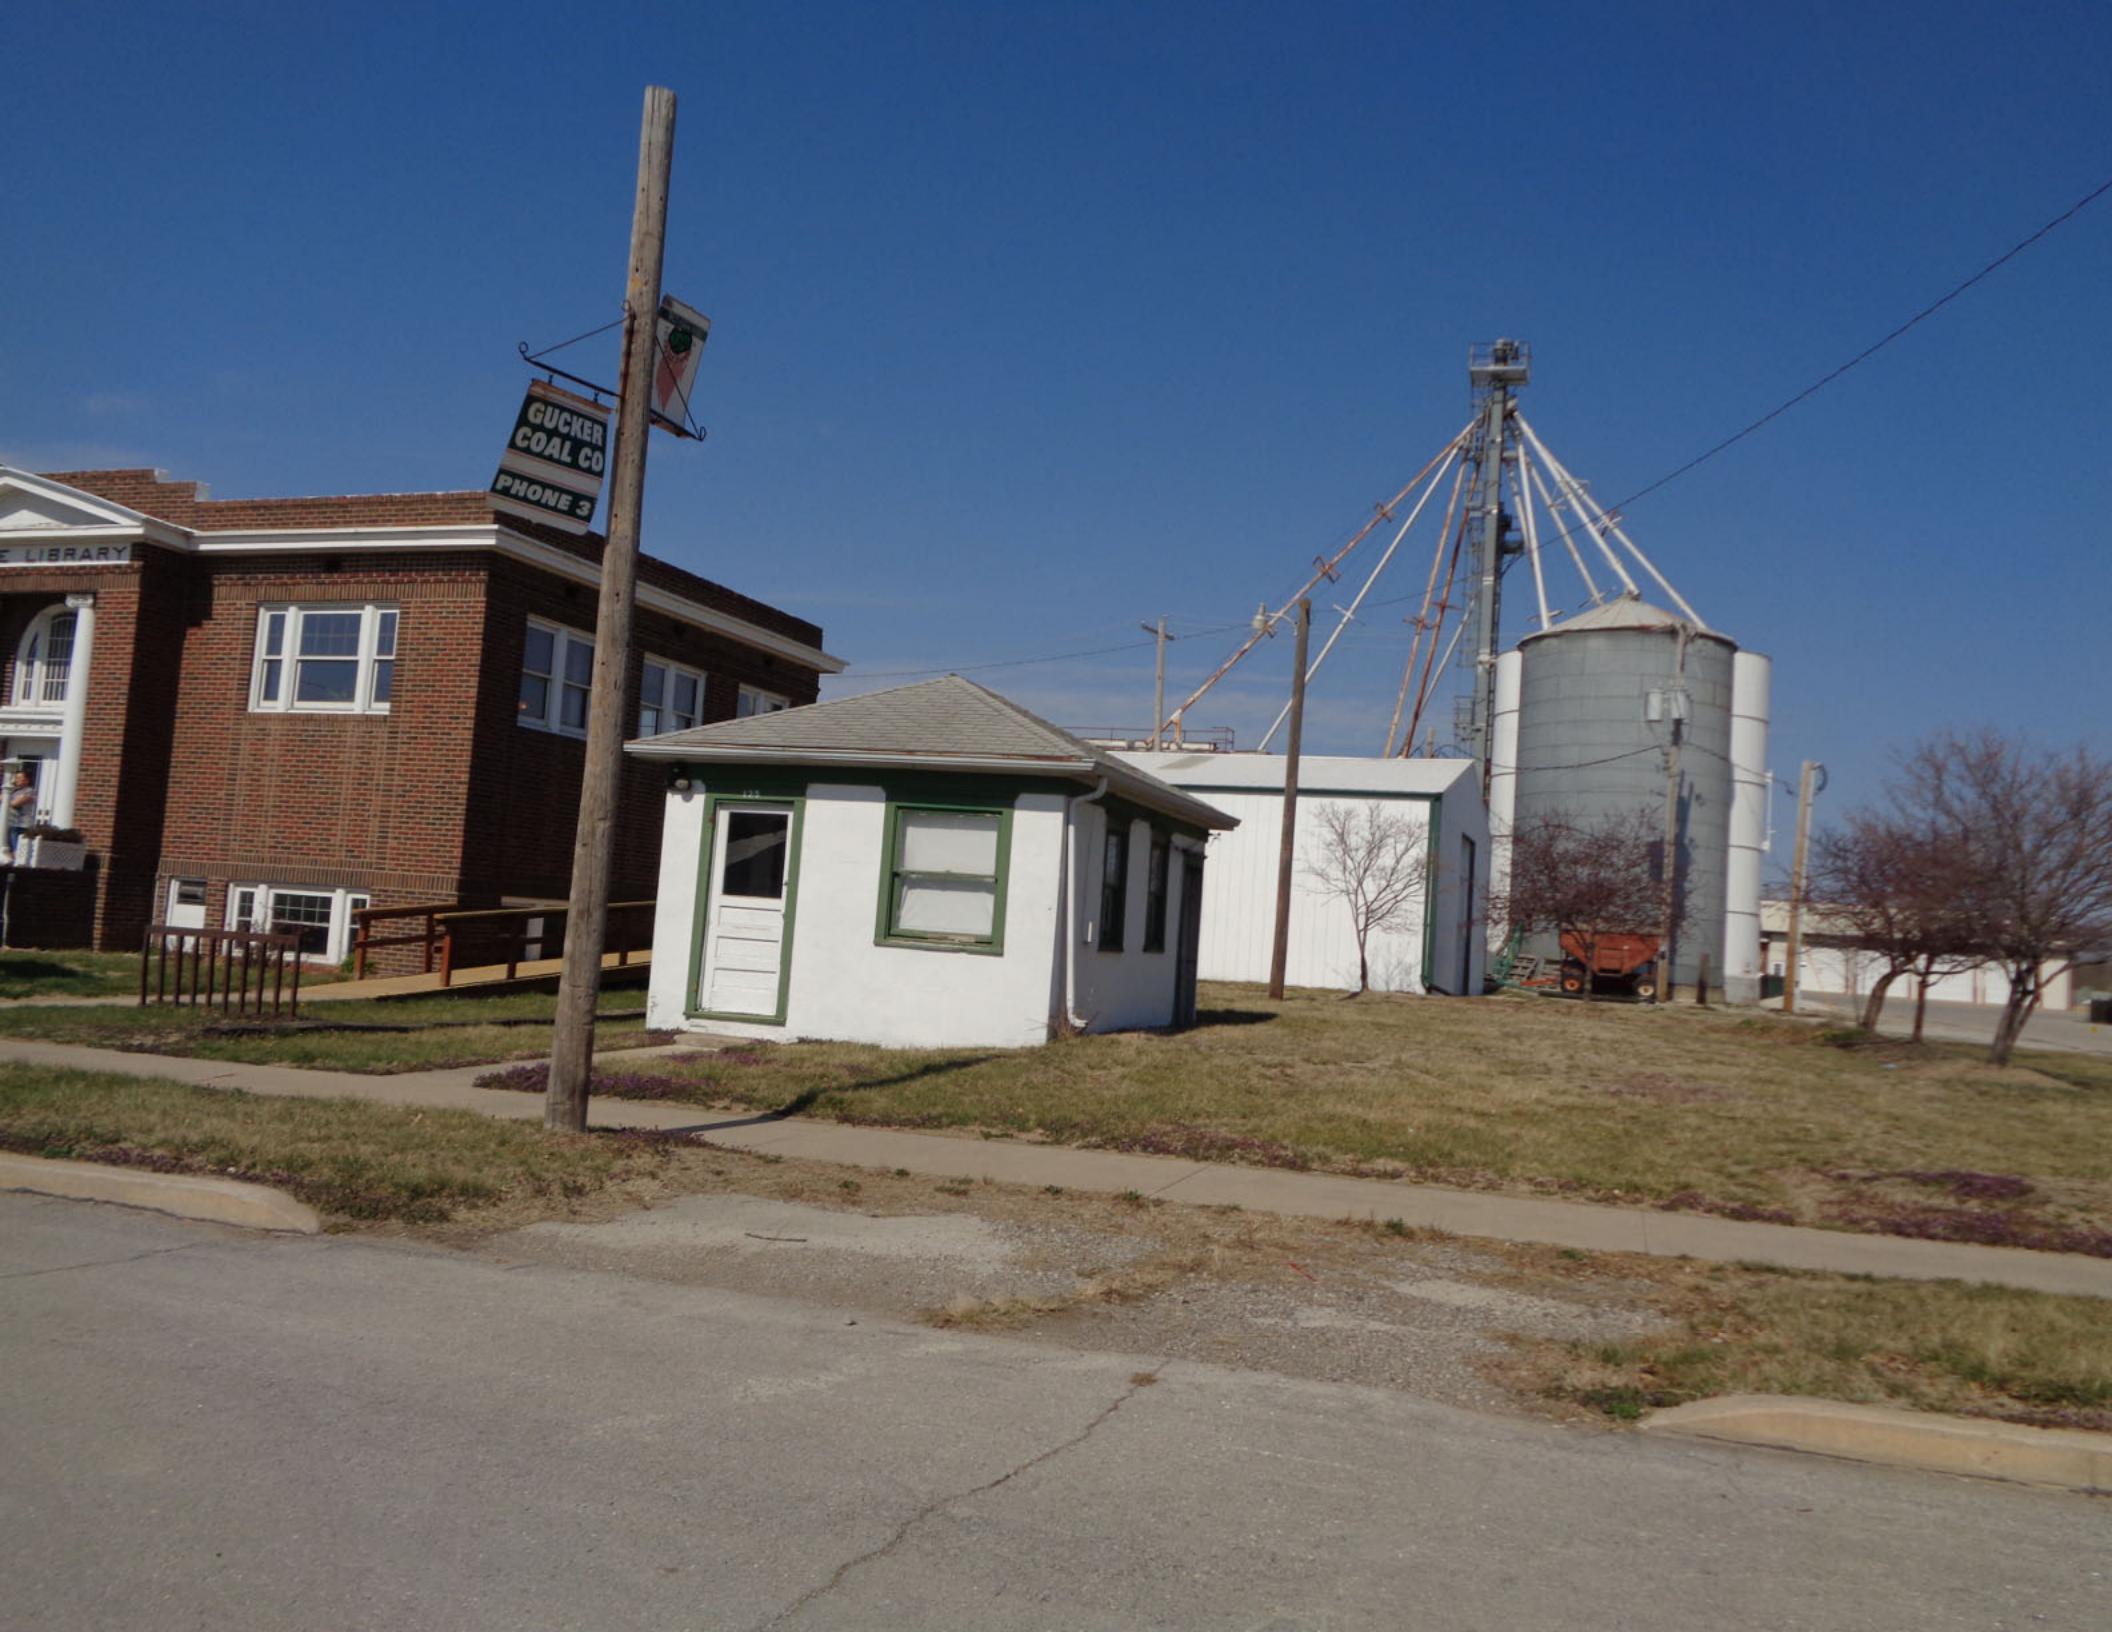
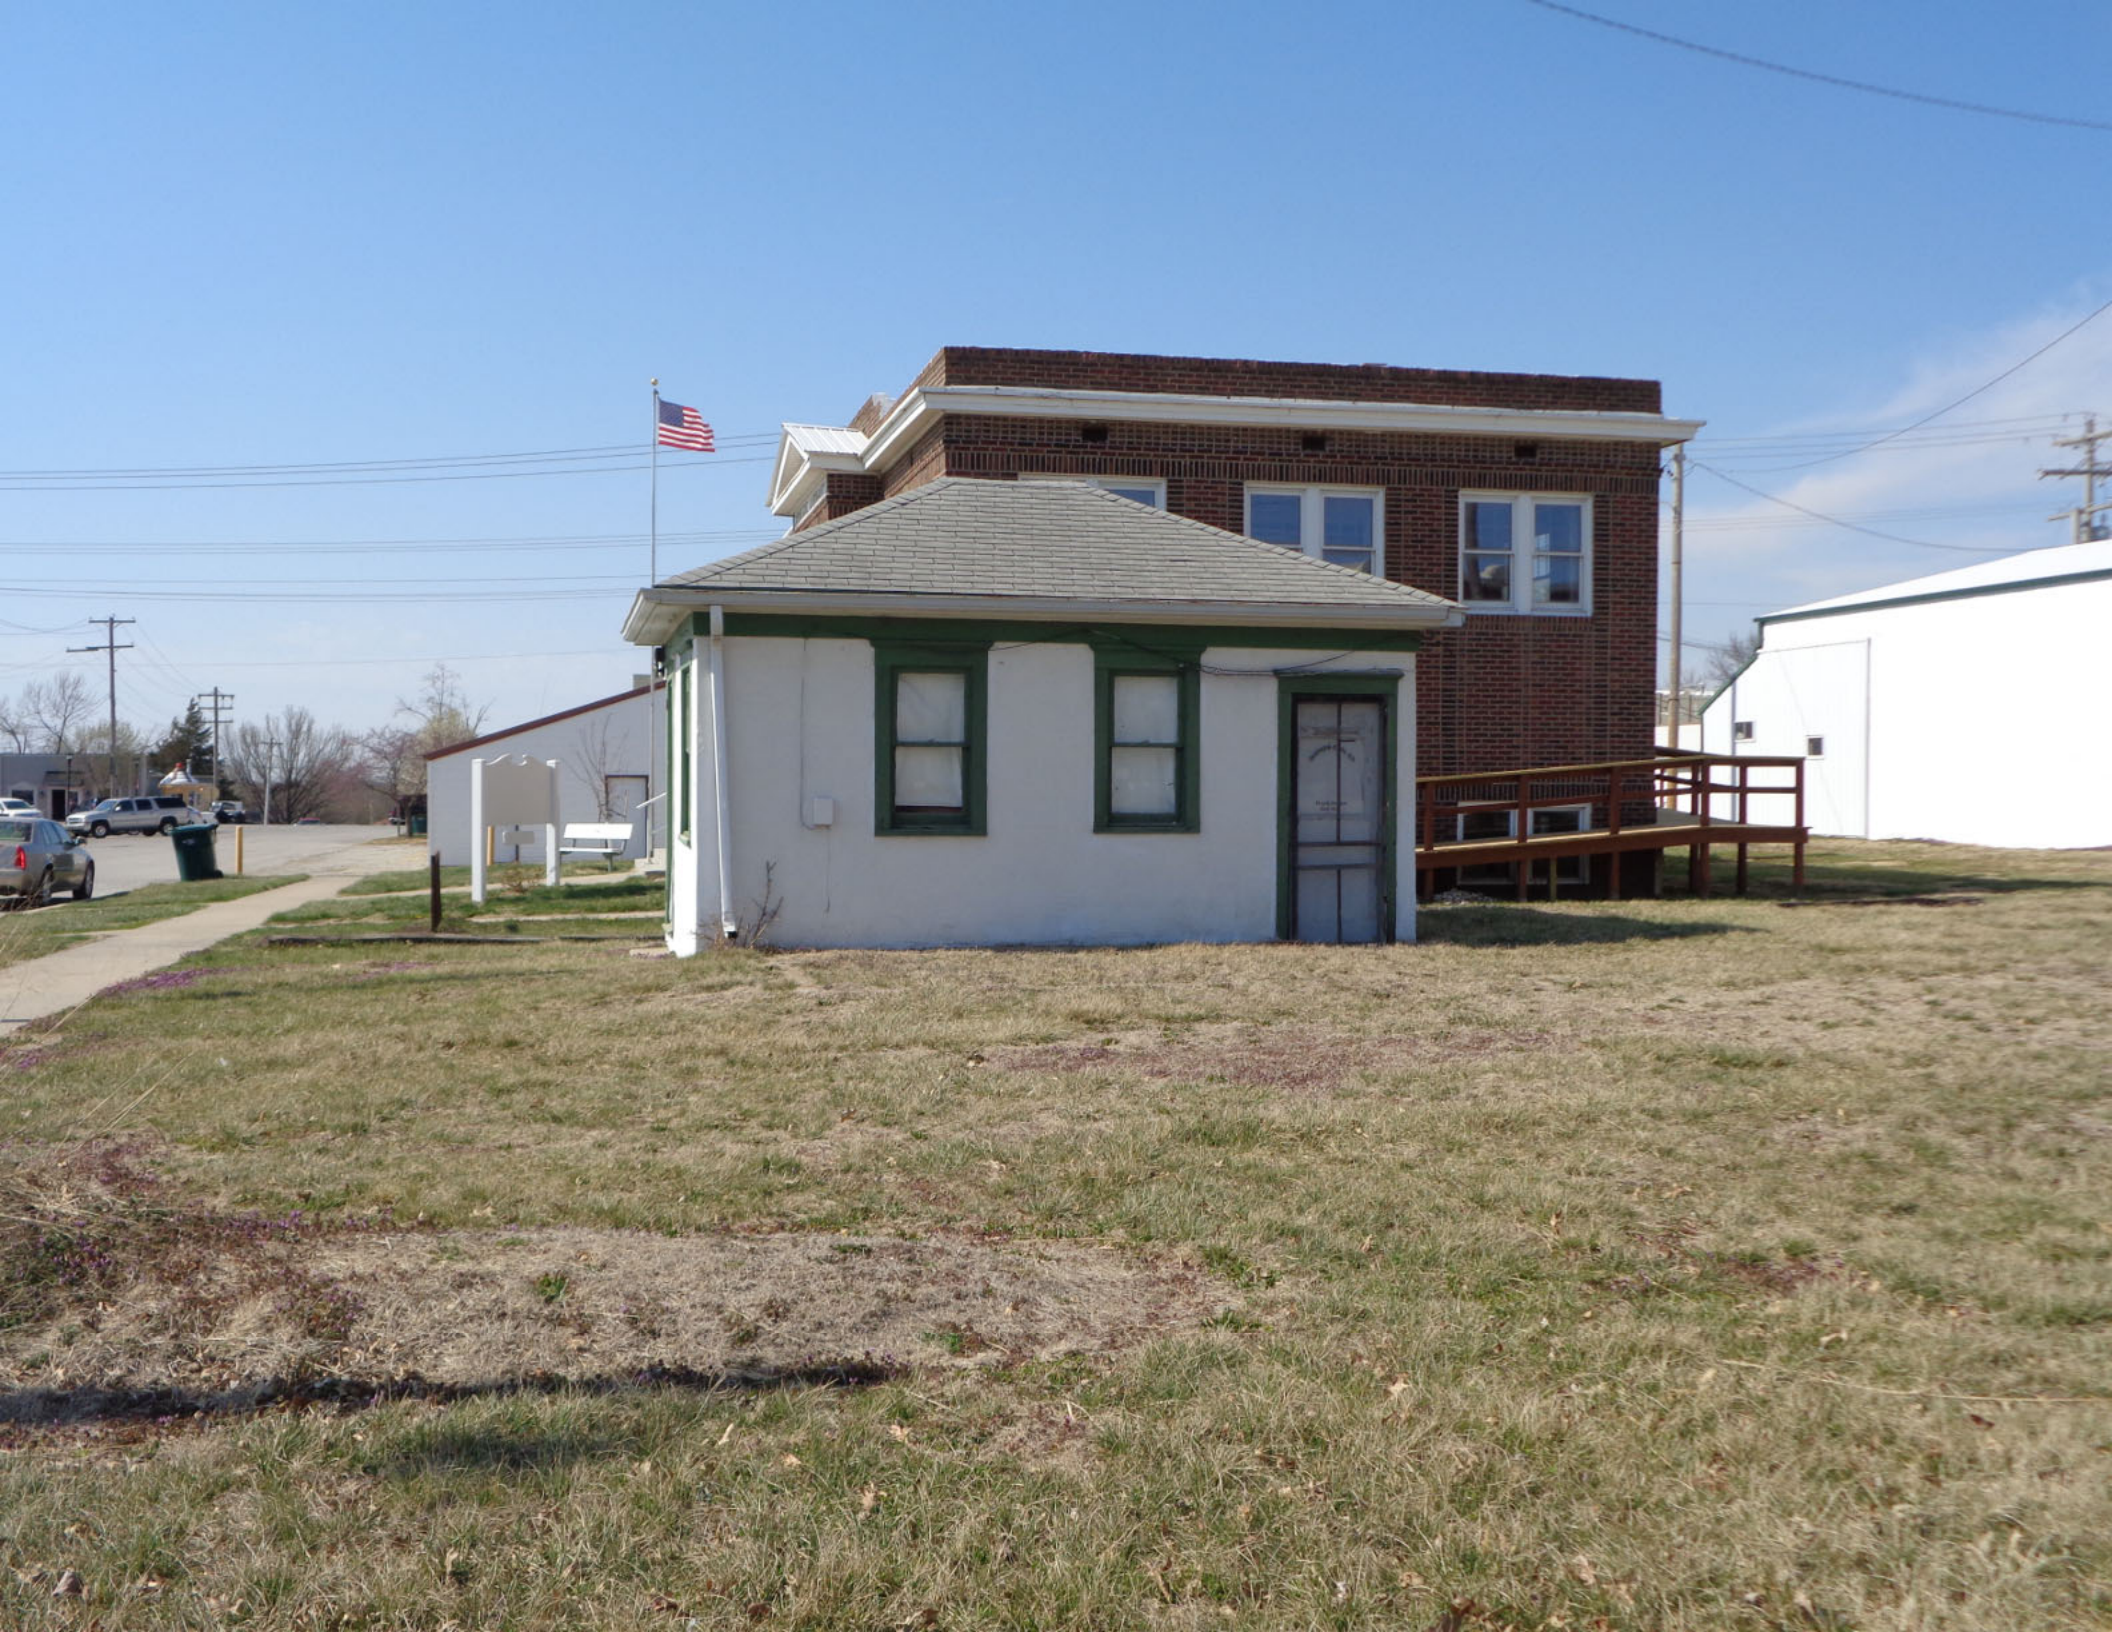
This is a small building with two bays the first bay is the entrance is located in the western bay and it is a simple wooden door with a window. The next bay is a single one-over-one wood hung wood window. Both the window and the door appear original. There is a concrete sidewalk that approaches the building from the main sidewalk on California. The building has a hipped roof that has asphalt shingles.
