MISSOURI DEPARTMENT OF NATURAL RESOURCES  
STATE HISTORIC PRESERVATION OFFICE, P.O. Box 176, Jefferson City, MO 65102  
**ARCHITECTURAL/HISTORIC INVENTORY FORM**

1. SURVEY NO. LI-AS-001-001		2. SURVEY NAME: Marceline Survey	
3. COUNTY: Linn		4. ADDRESS (STREET NO.) 275	STREET (NAME) West Broadway
5. CITY: Marceline	VICINITY: <input type="checkbox"/>	6. UTM: / /	7. TOWNSHIP/RANGE/SECTION: T: R: S:

8. HISTORIC NAME (IF KNOWN): Walt Disney's Childhood Home		9. PRESENT/OTHER NAME (IF KNOWN): Walt Disney's Childhood Home	
10. OWNERSHIP: <input checked="" type="checkbox"/> PRIVATE <input type="checkbox"/> PUBLIC		11A. HISTORIC USE (IF KNOWN): Single Dwelling	11B. CURRENT USE: Single Dwelling
<b>HISTORICAL INFORMATION</b>

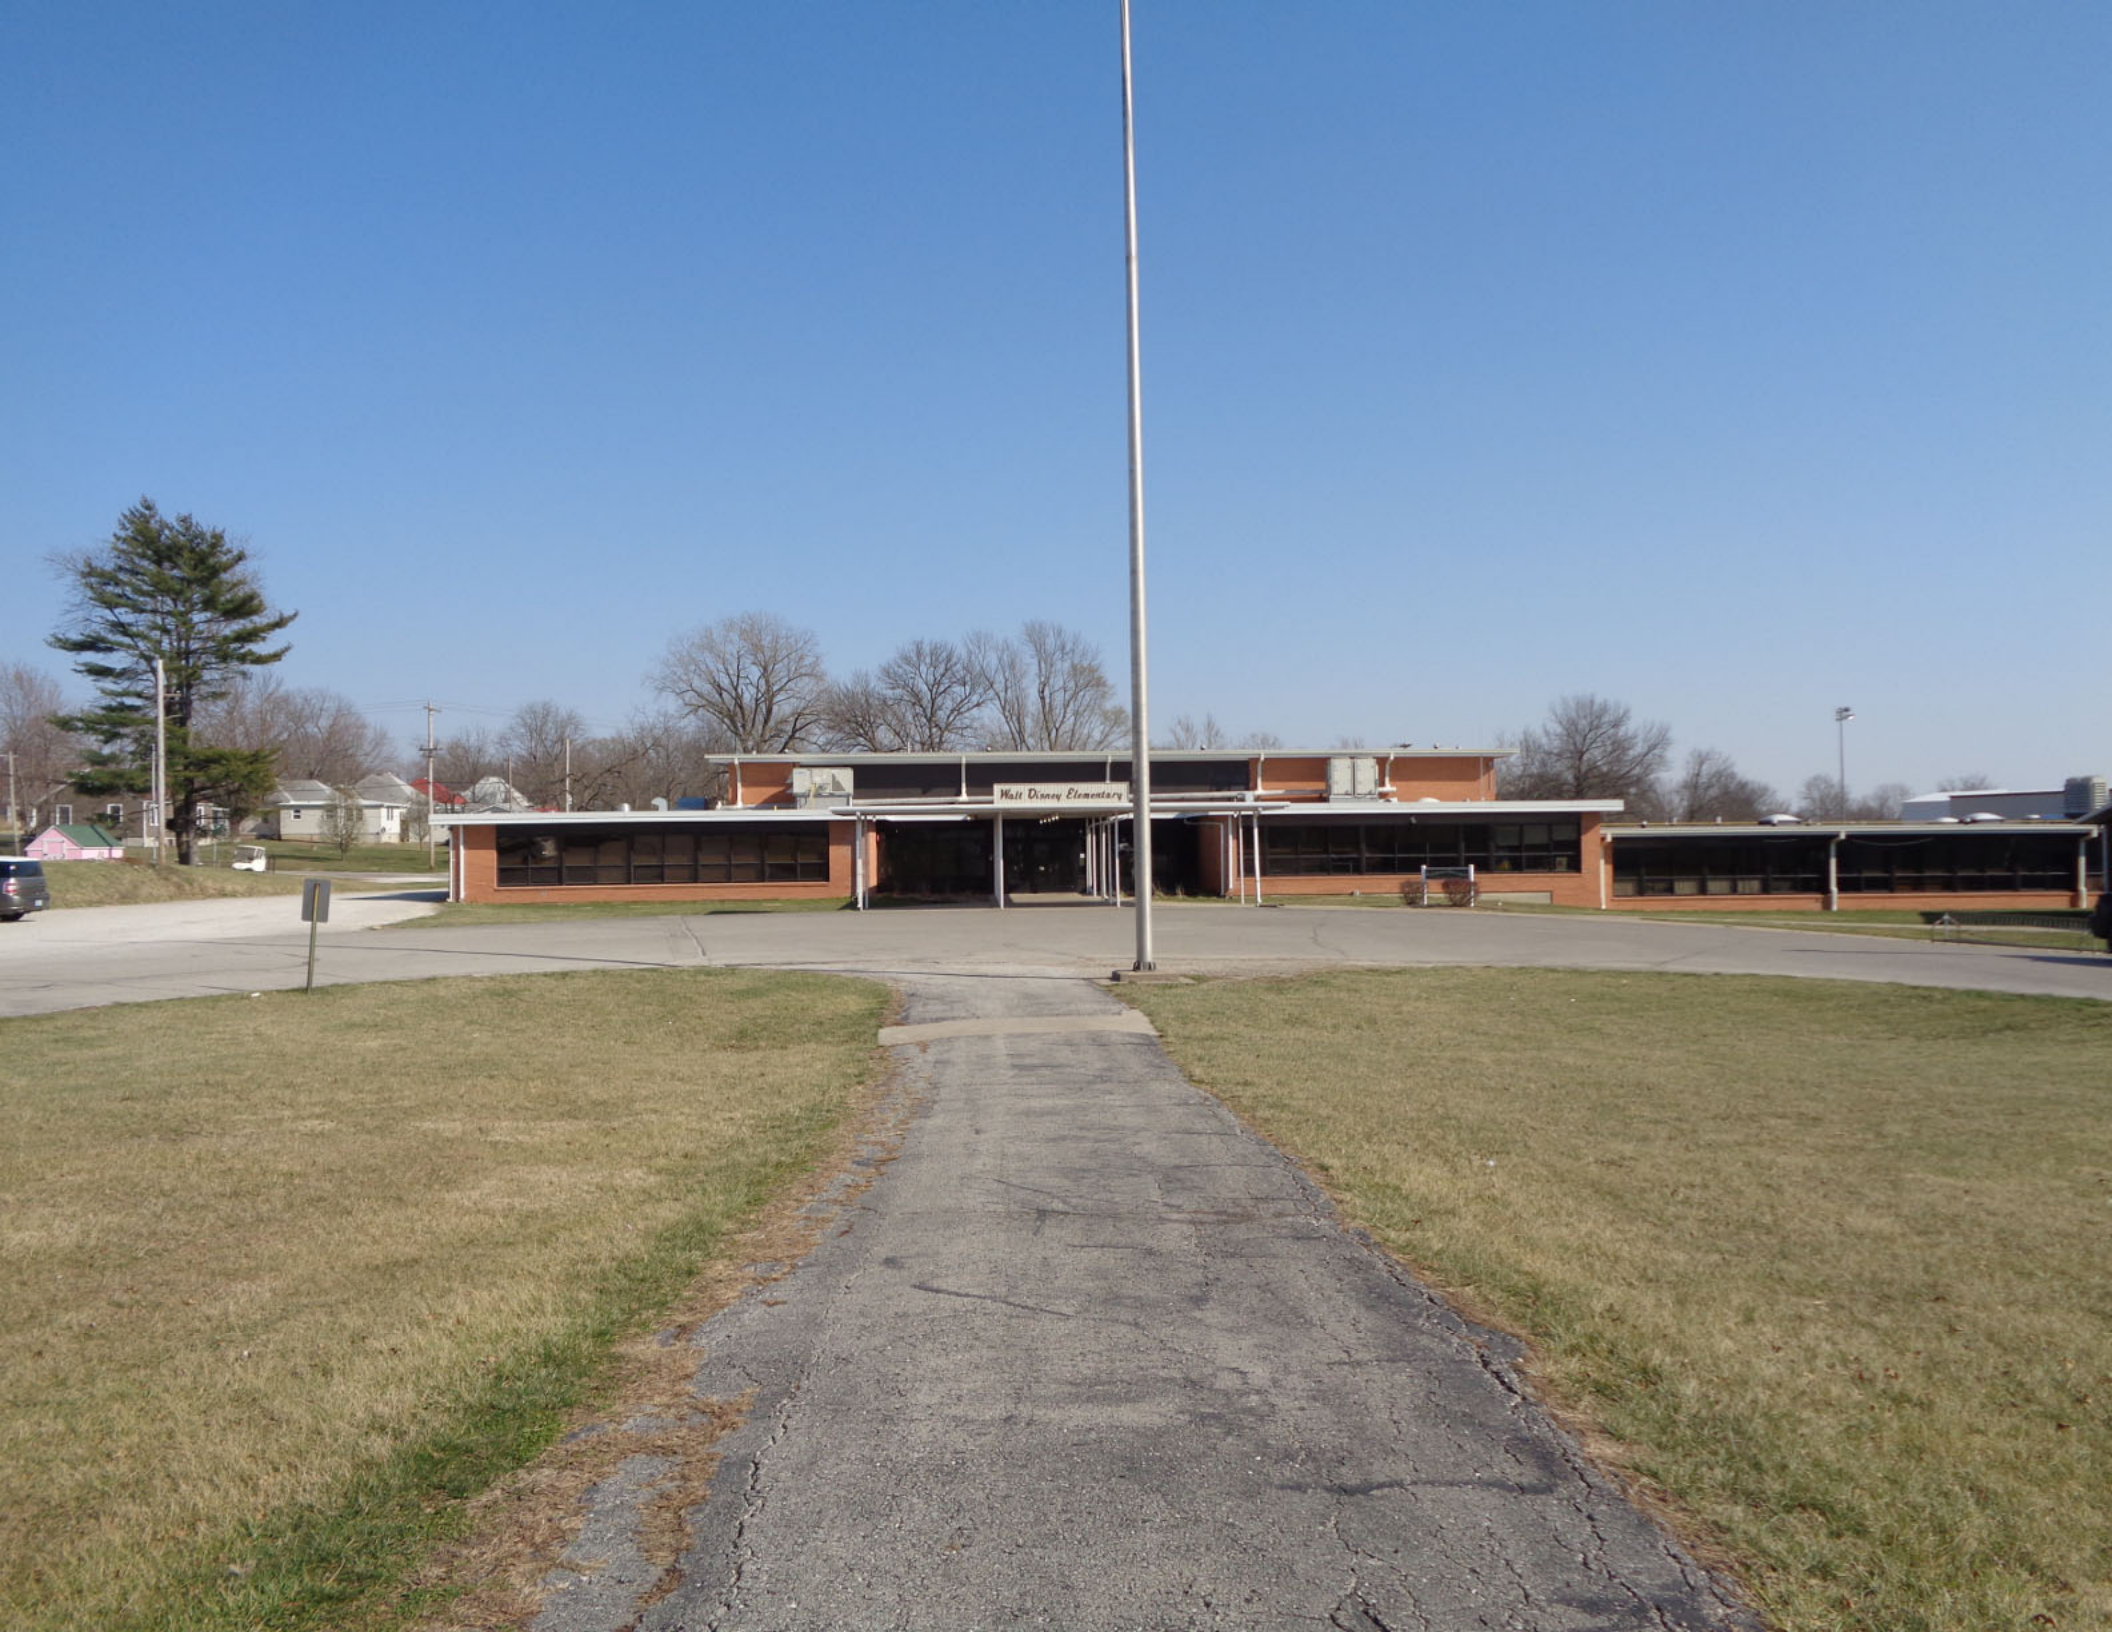
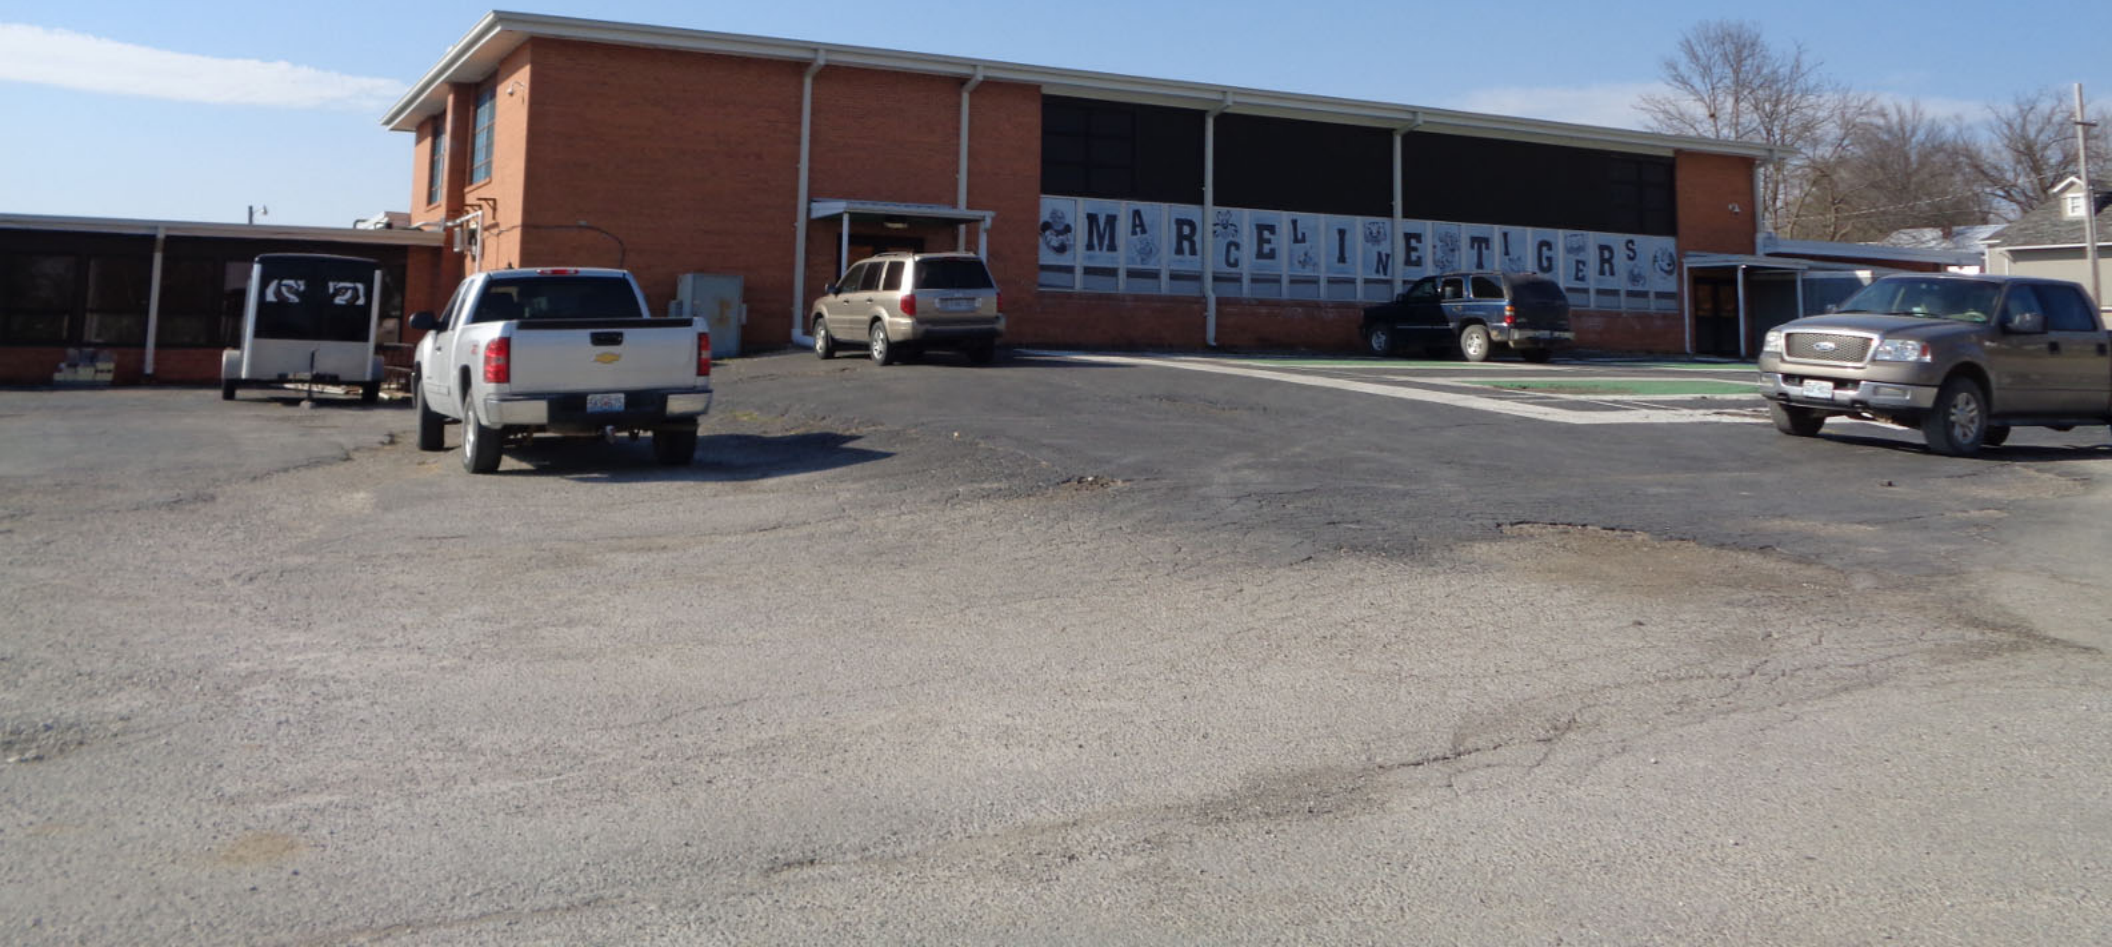
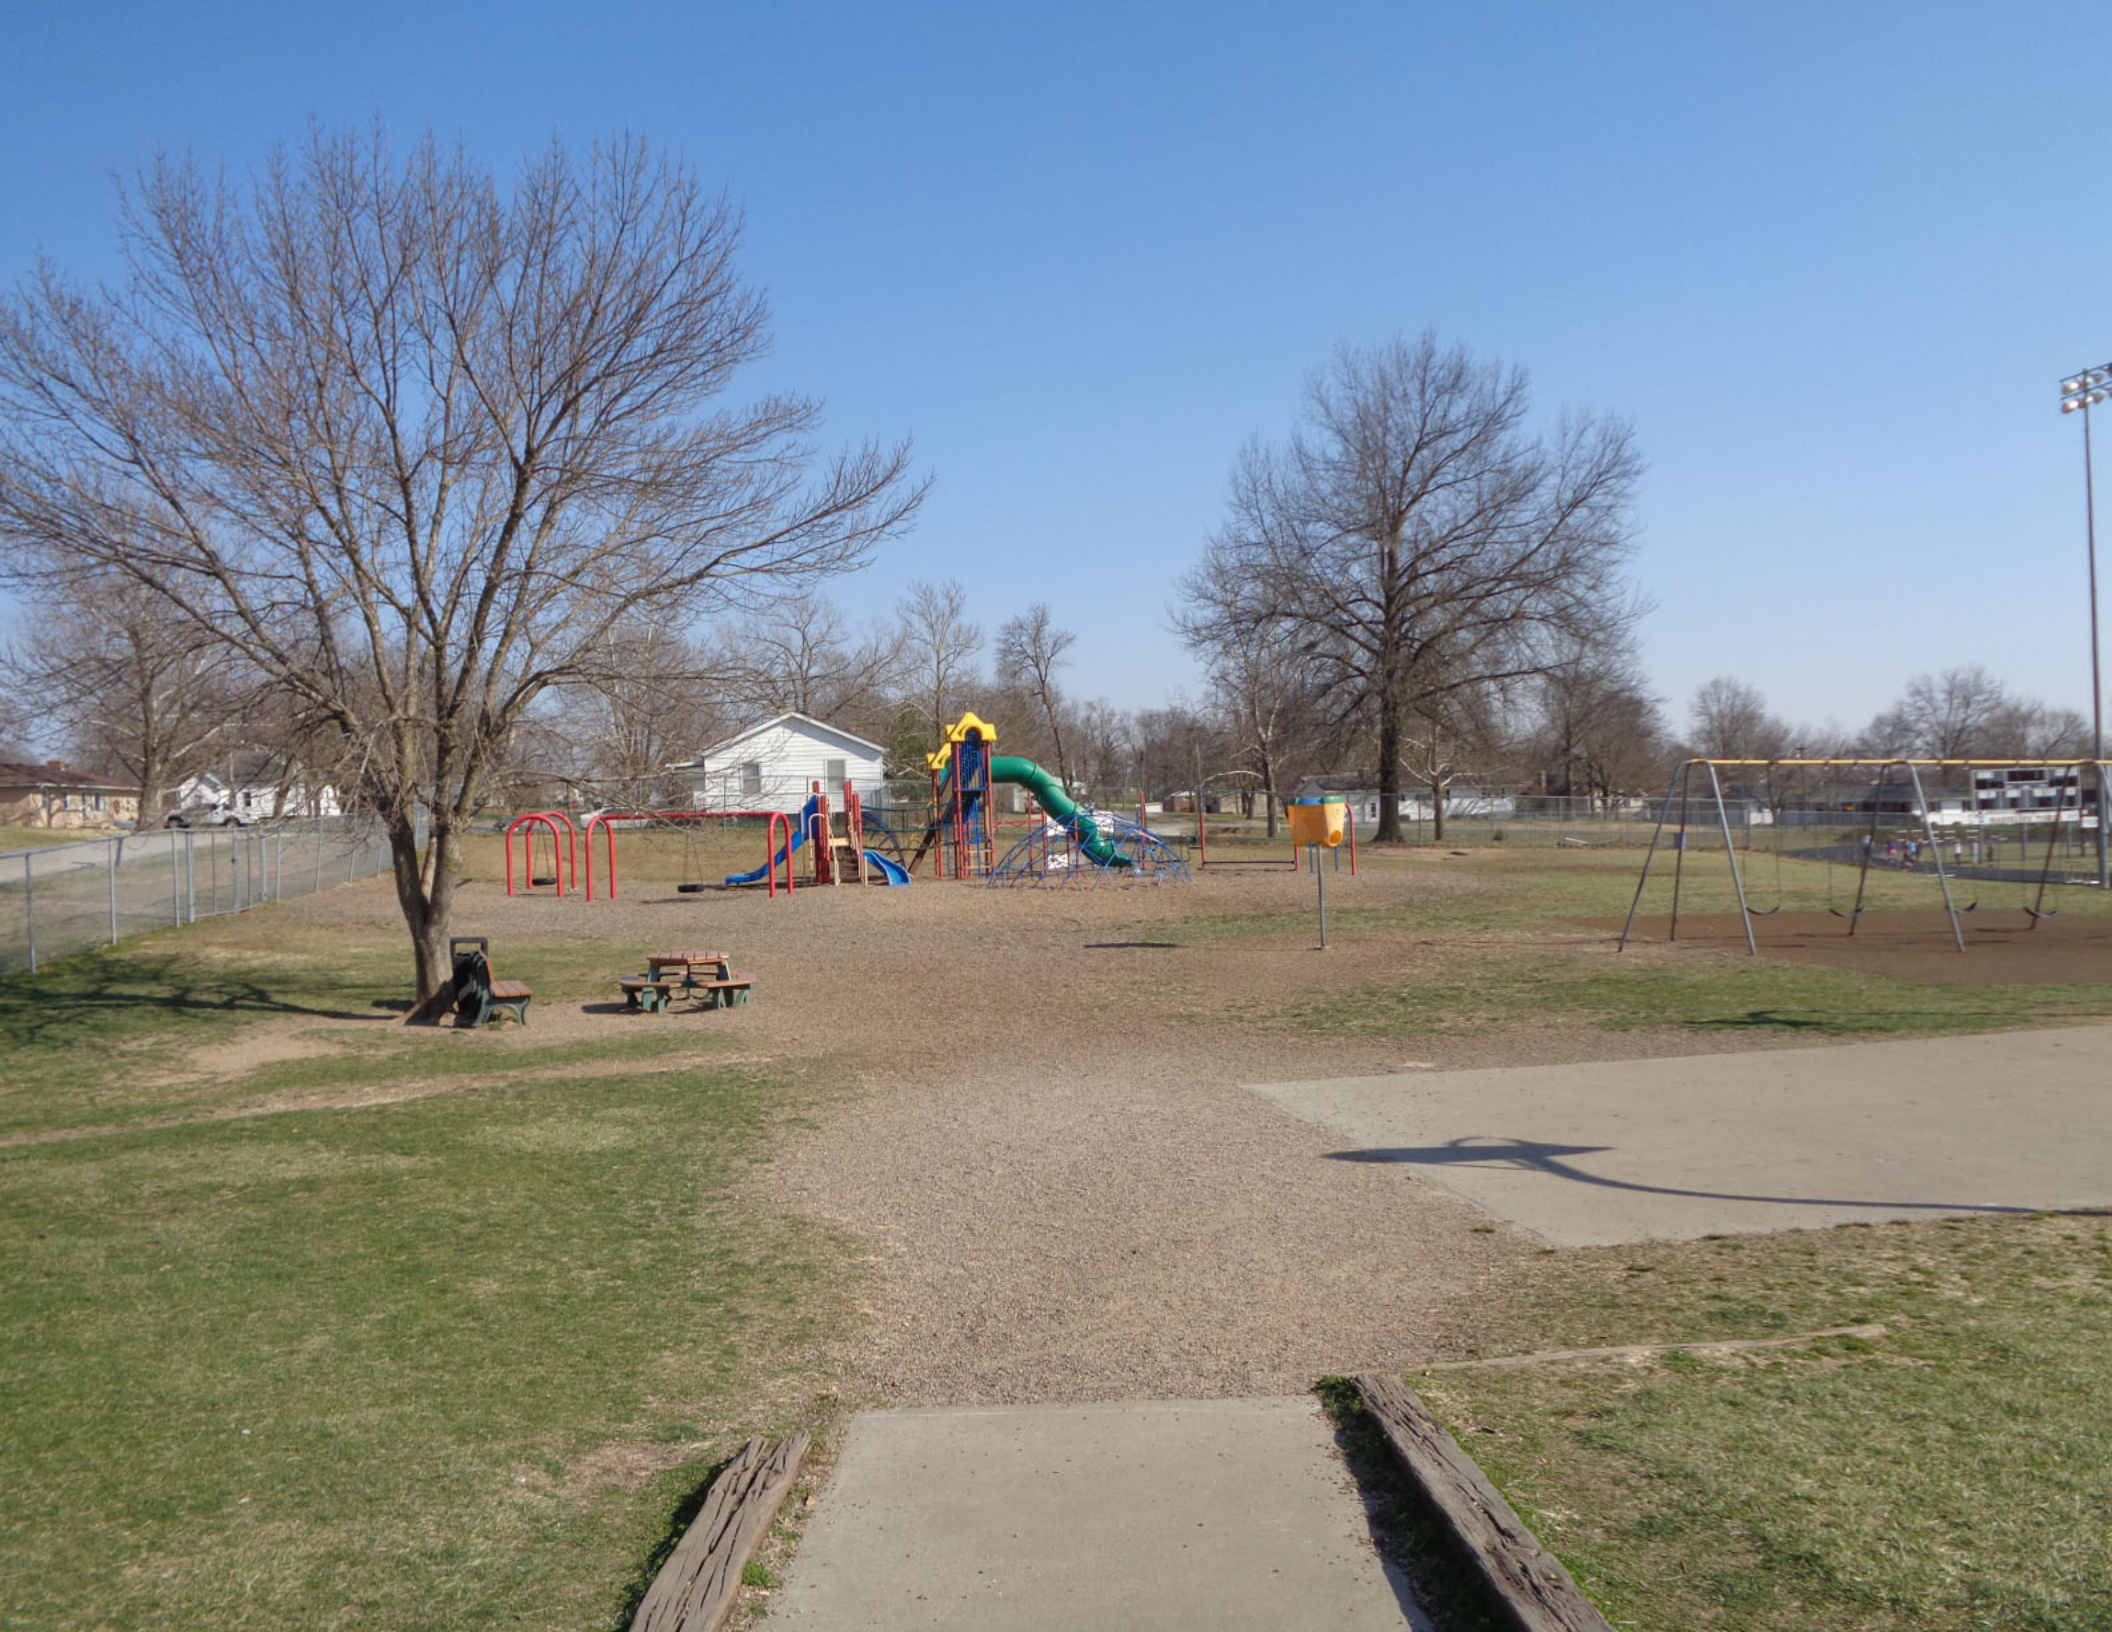
This is a sprawling, flat-roofed brick mid-century modern building with wide overhanging eaves and an irregular footprint. The primary facade, which faces northwest, has four visible bays. All except the second are made up of large expanses of windows. The windows appear to have been replaced c. 2015 and have much darker tinting and muntins than the original windows. What is likely a fifth bay of windows is obscured by a large metal building which abuts but does not appear to be attached to the original elementary building. The second bay holds a recessed double door entry that is also surrounded by dark windows. Extending out from this entrance is a covered walkway. Behind the facade the two story gymnasium is visible.
