MISSOURI DEPARTMENT OF NATURAL RESOURCES  
STATE HISTORIC PRESERVATION OFFICE, P.O. Box 176, Jefferson City, MO 65102  
**ARCHITECTURAL/HISTORIC INVENTORY FORM**

1. SURVEY NO. LI-AS-001-001		2. SURVEY NAME: Marceline Survey	
3. COUNTY: Linn		4. ADDRESS (STREET NO.) 275	STREET (NAME) West Broadway
5. CITY: Marceline	VICINITY: <input type="checkbox"/>	6. UTM: / /	7. TOWNSHIP/RANGE/SECTION: T: R: S:

8. HISTORIC NAME (IF KNOWN): Walt Disney's Childhood Home		9. PRESENT/OTHER NAME (IF KNOWN): Walt Disney's Childhood Home	
10. OWNERSHIP: <input checked="" type="checkbox"/> PRIVATE <input type="checkbox"/> PUBLIC		11A. HISTORIC USE (IF KNOWN): Single Dwelling	11B. CURRENT USE: Single Dwelling
<b>HISTORICAL INFORMATION</b>

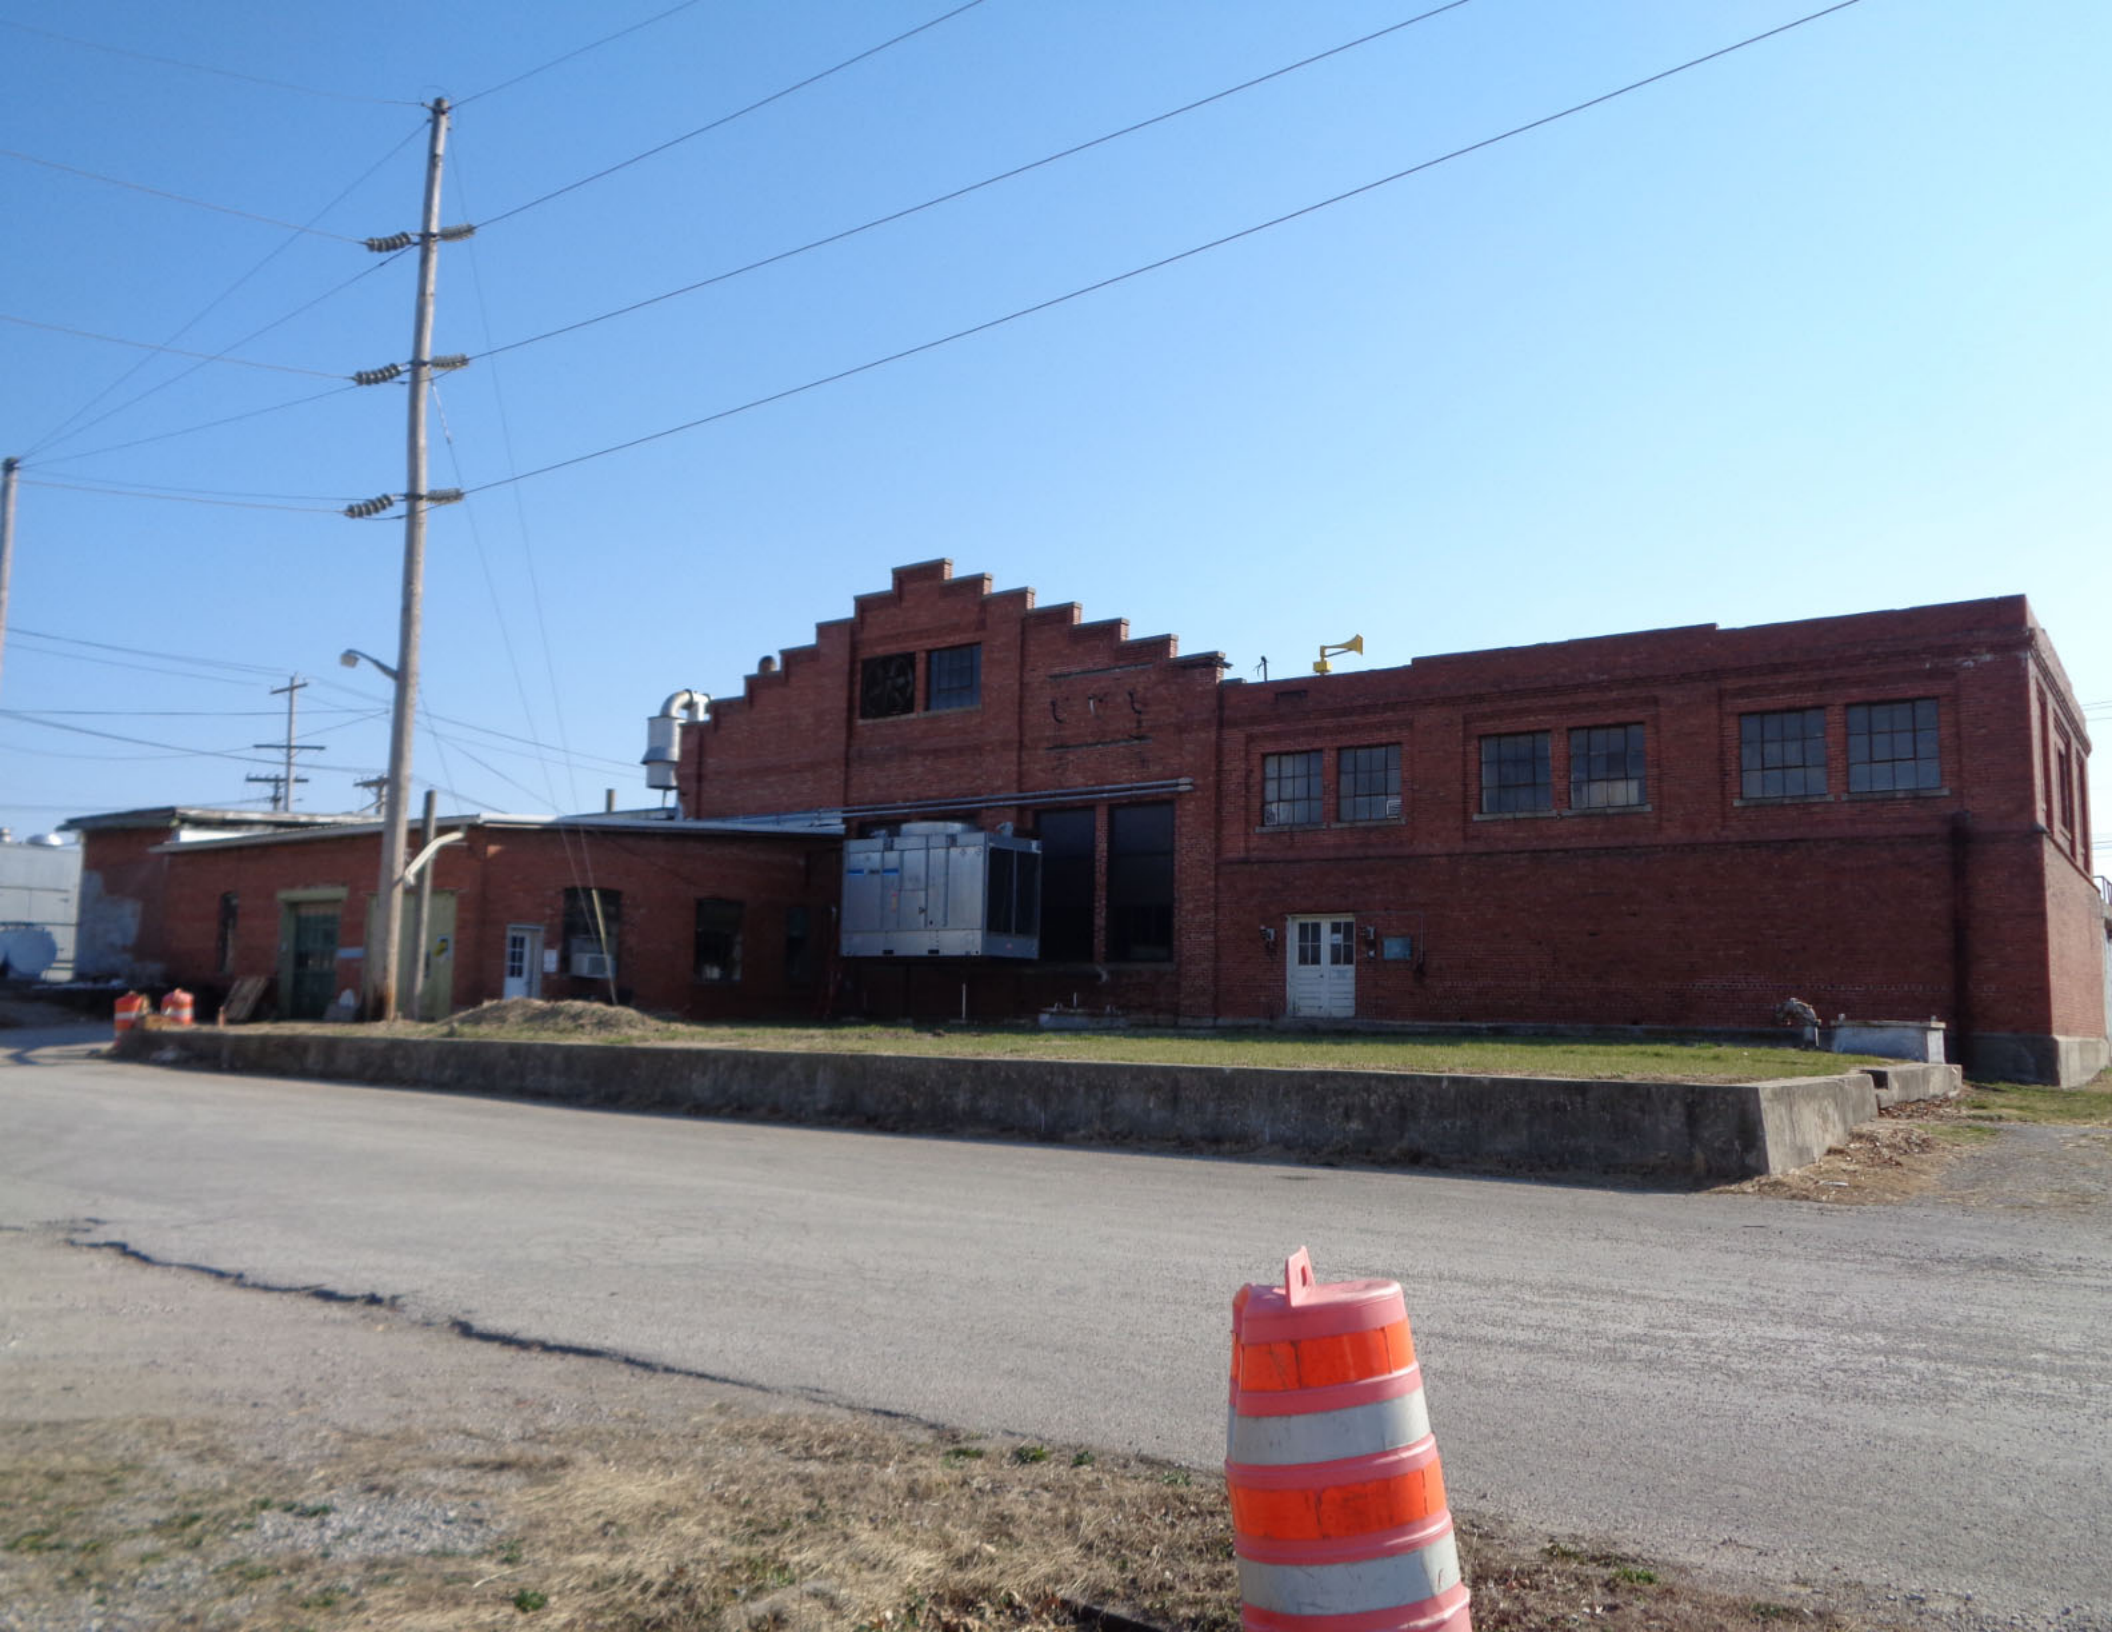
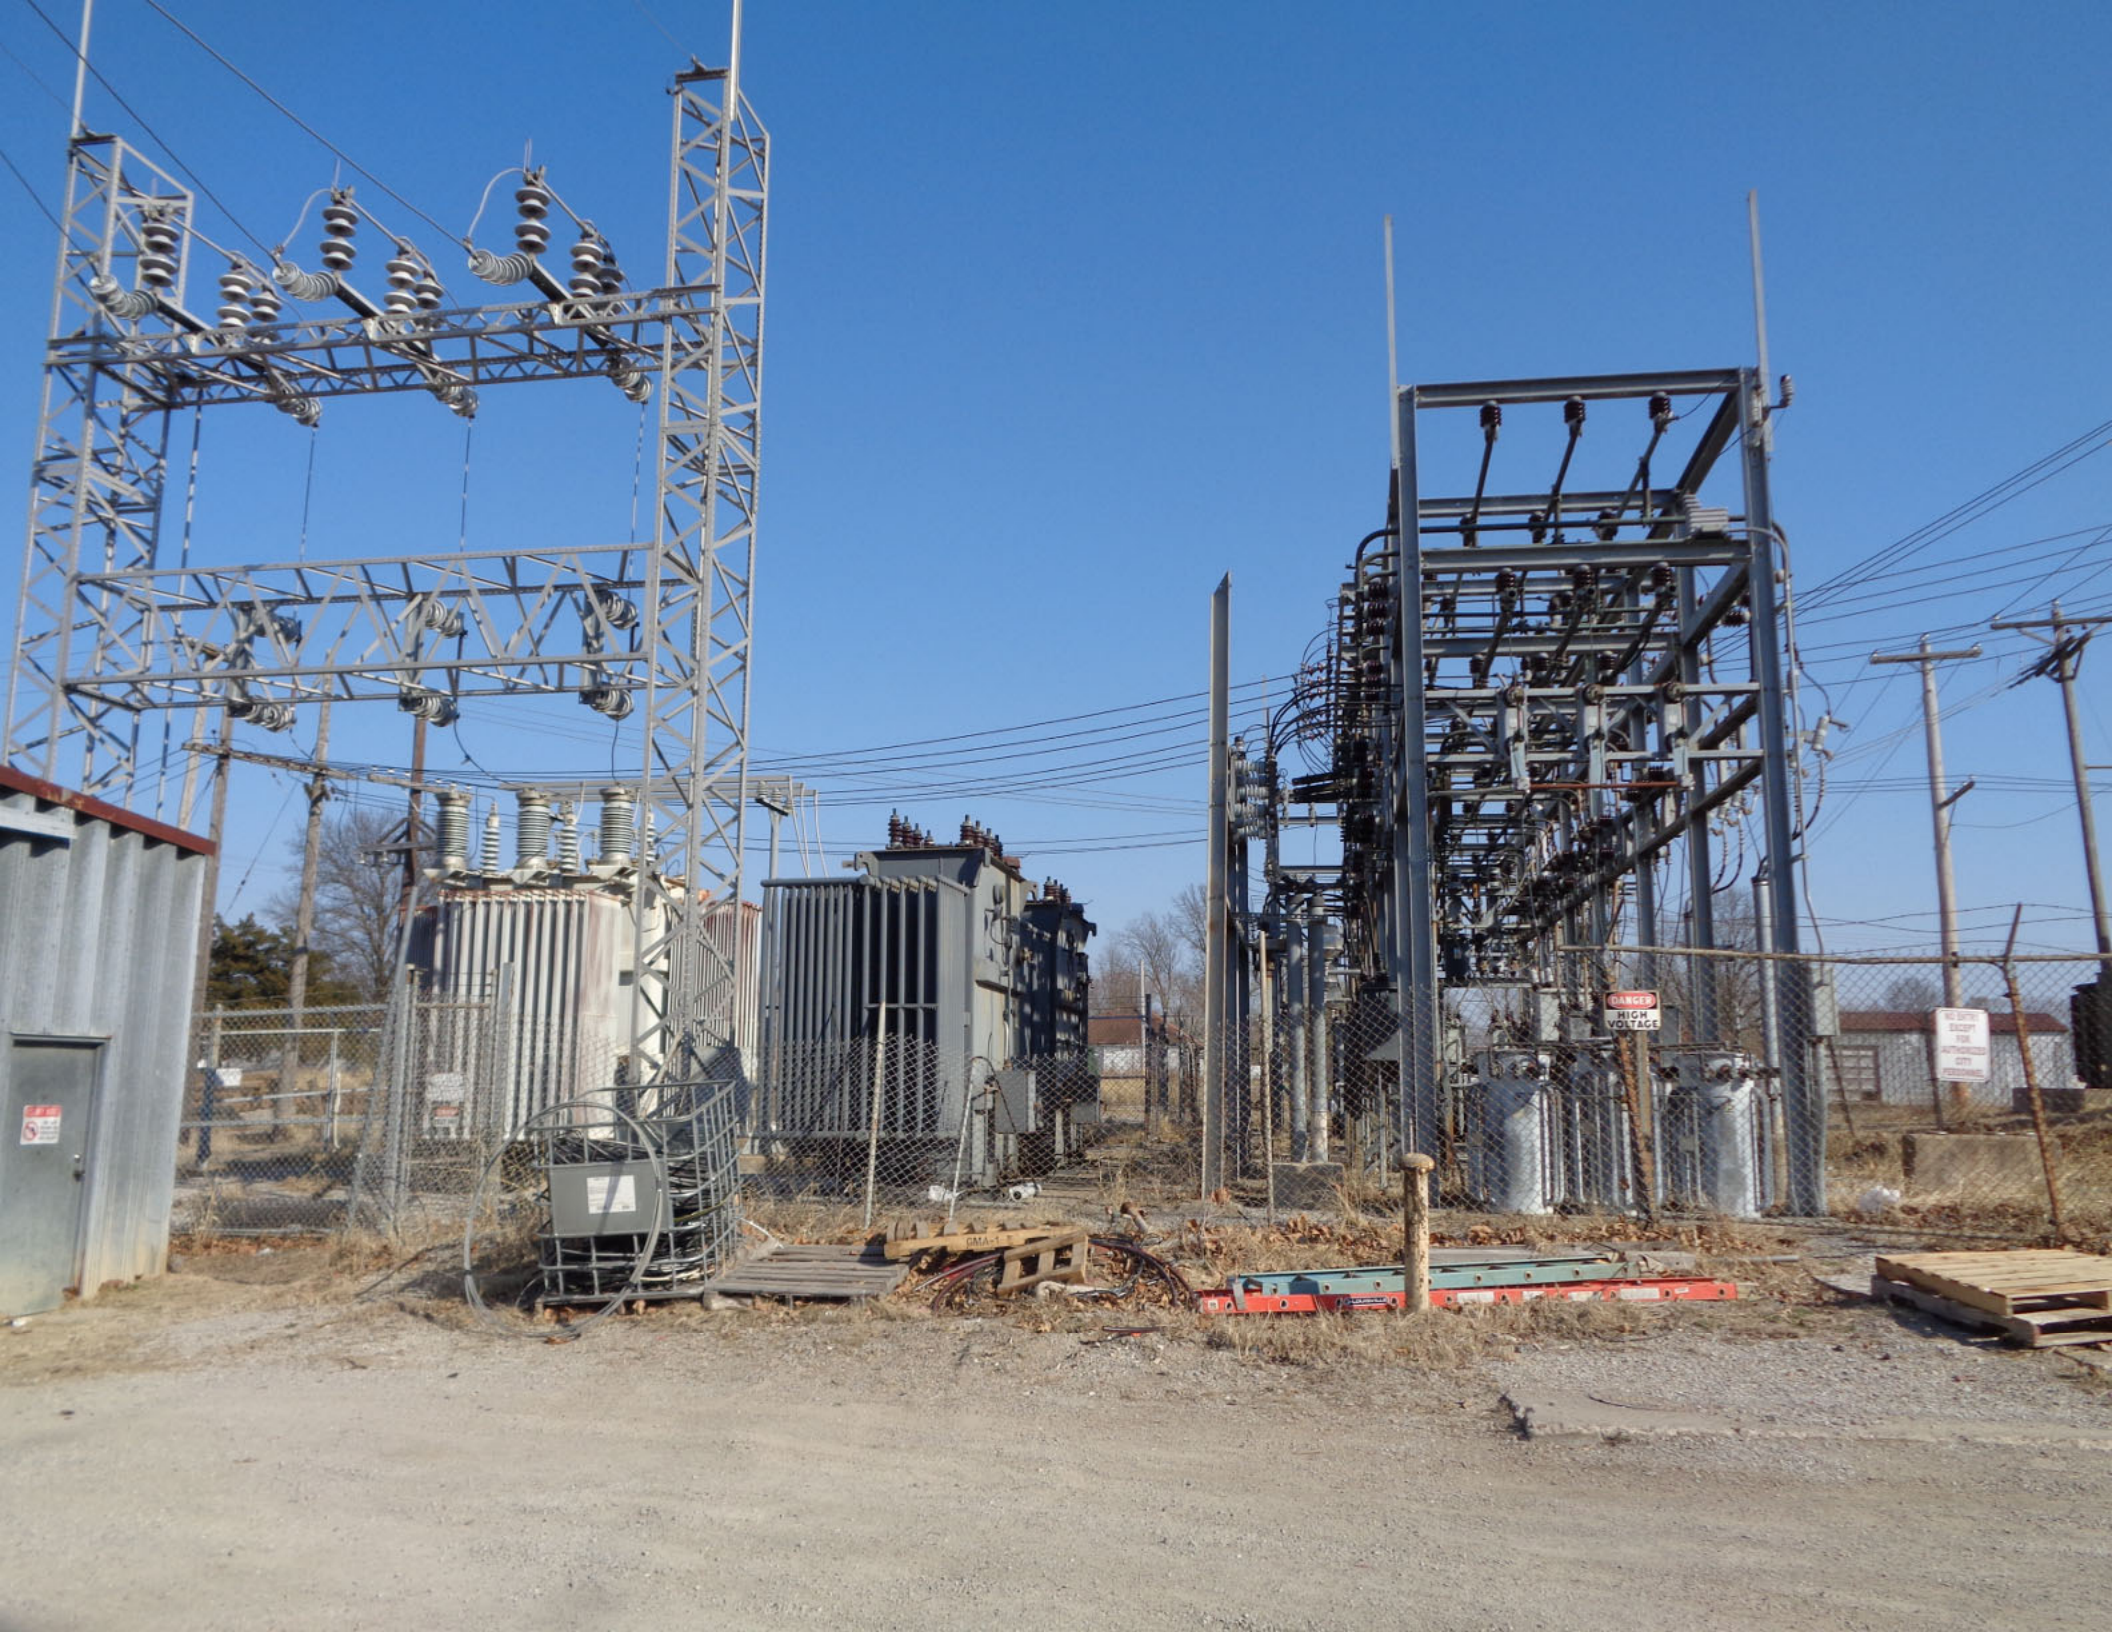
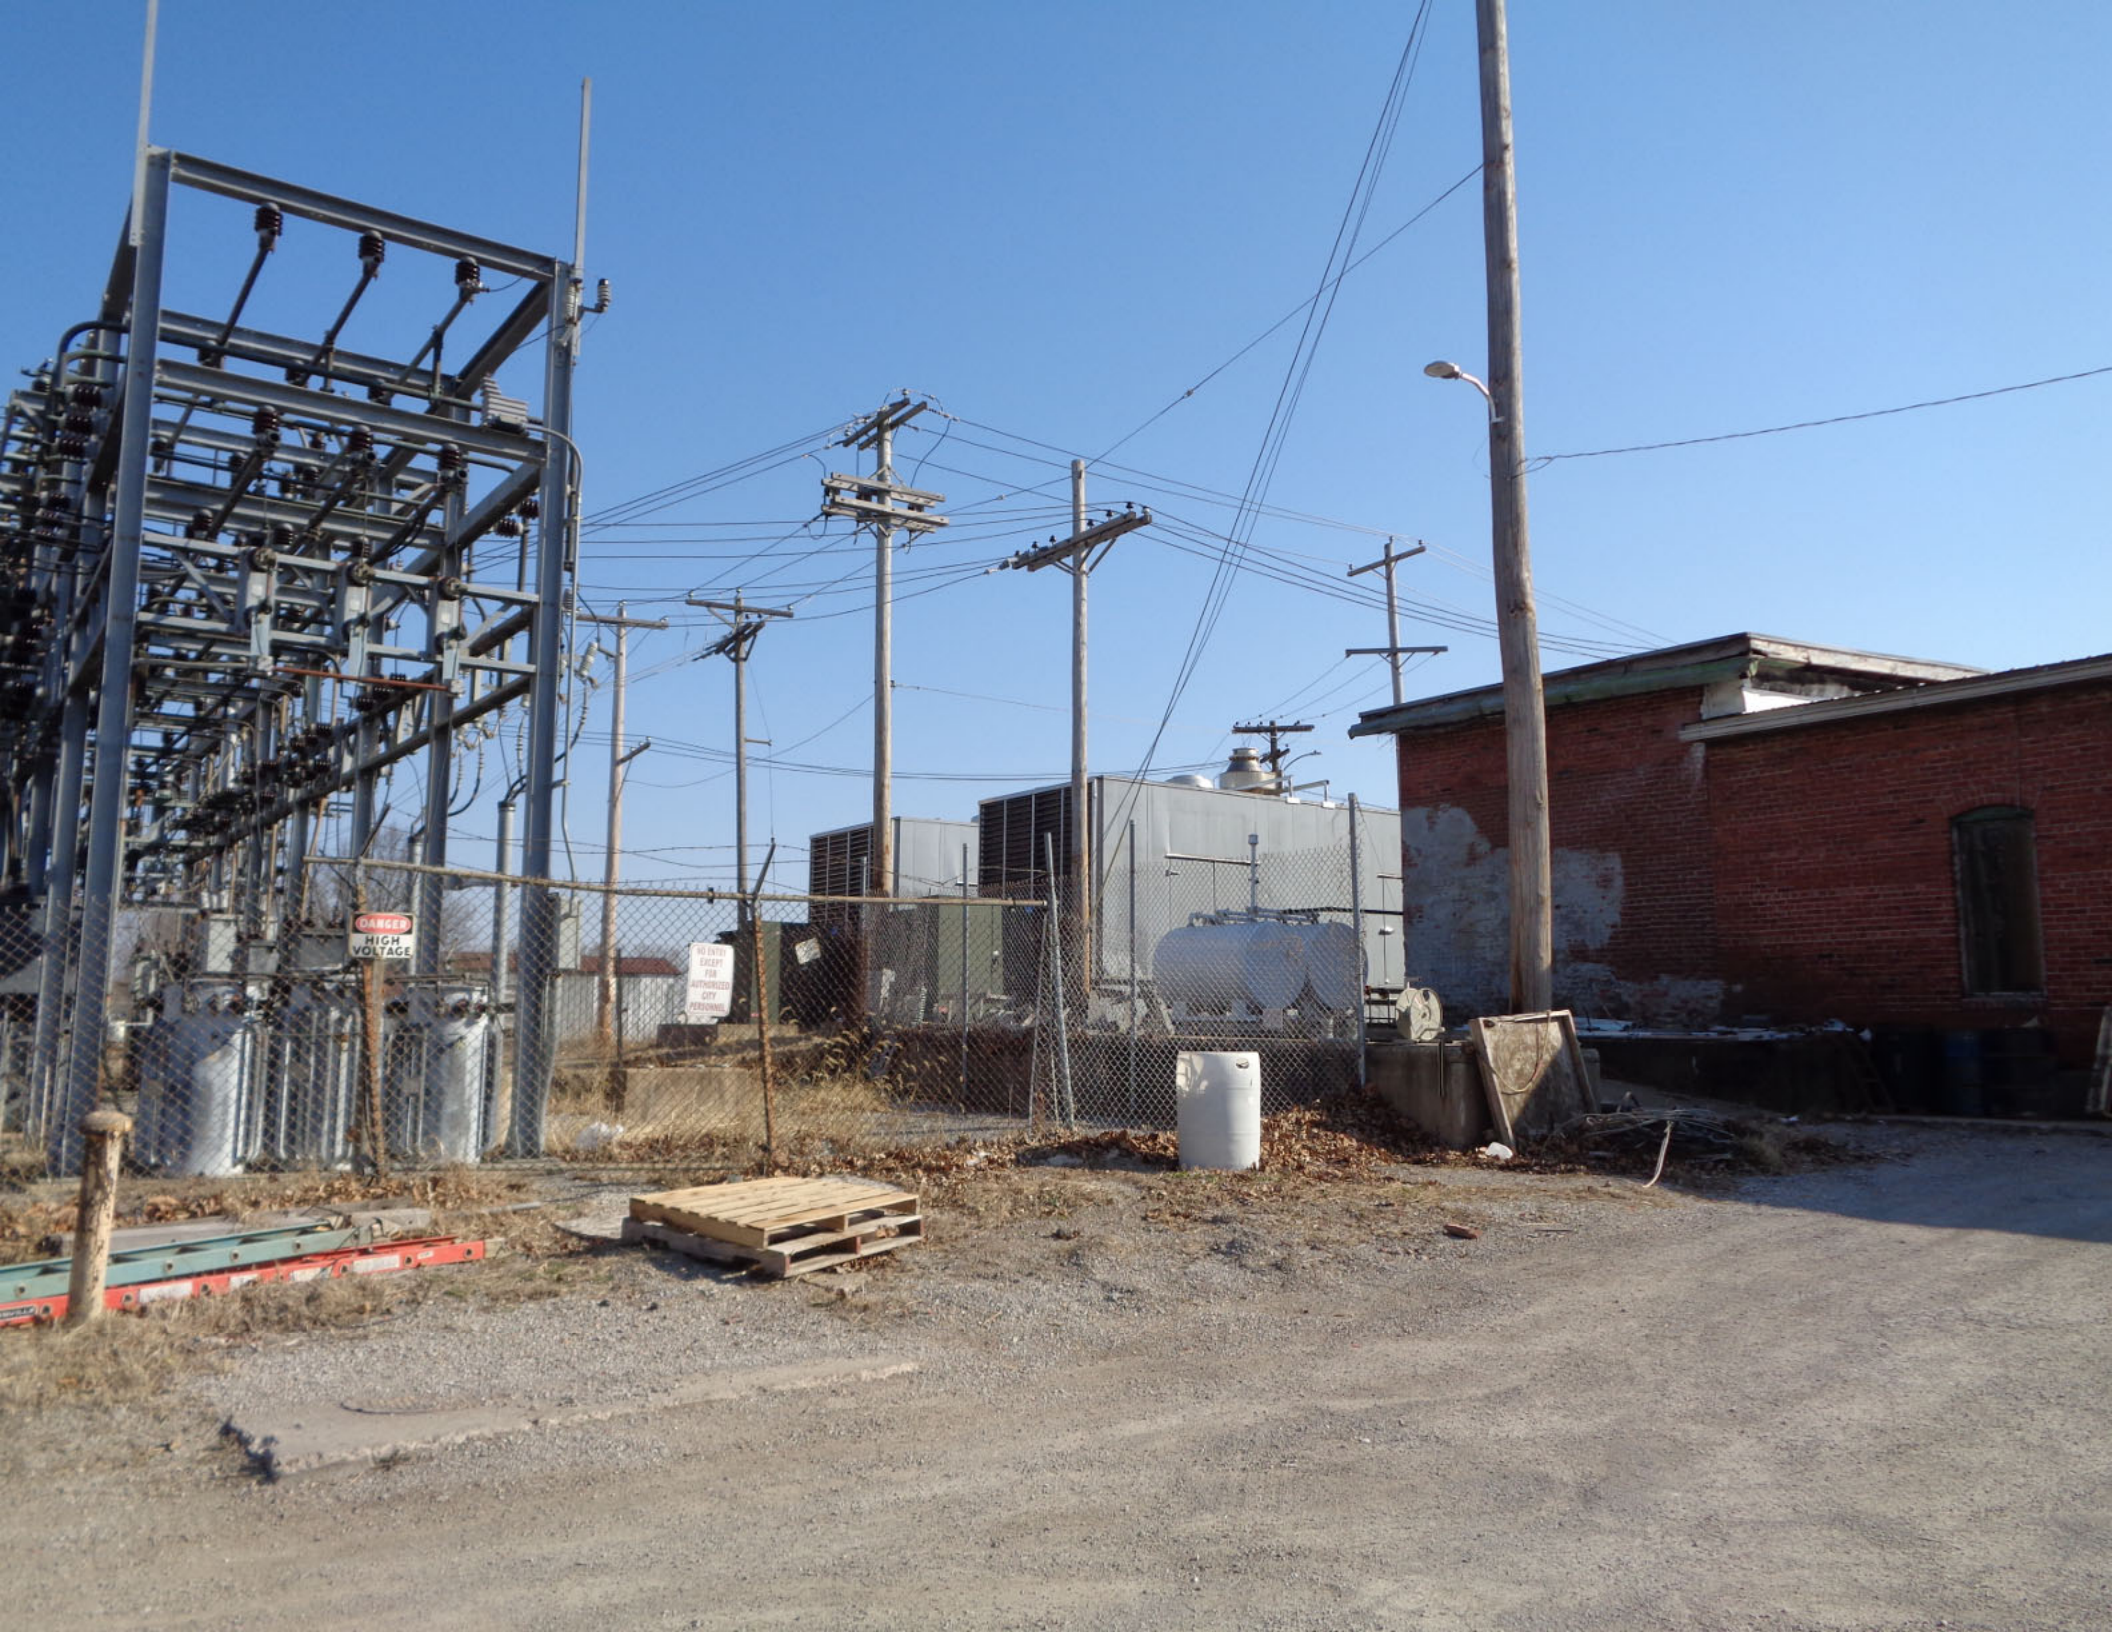
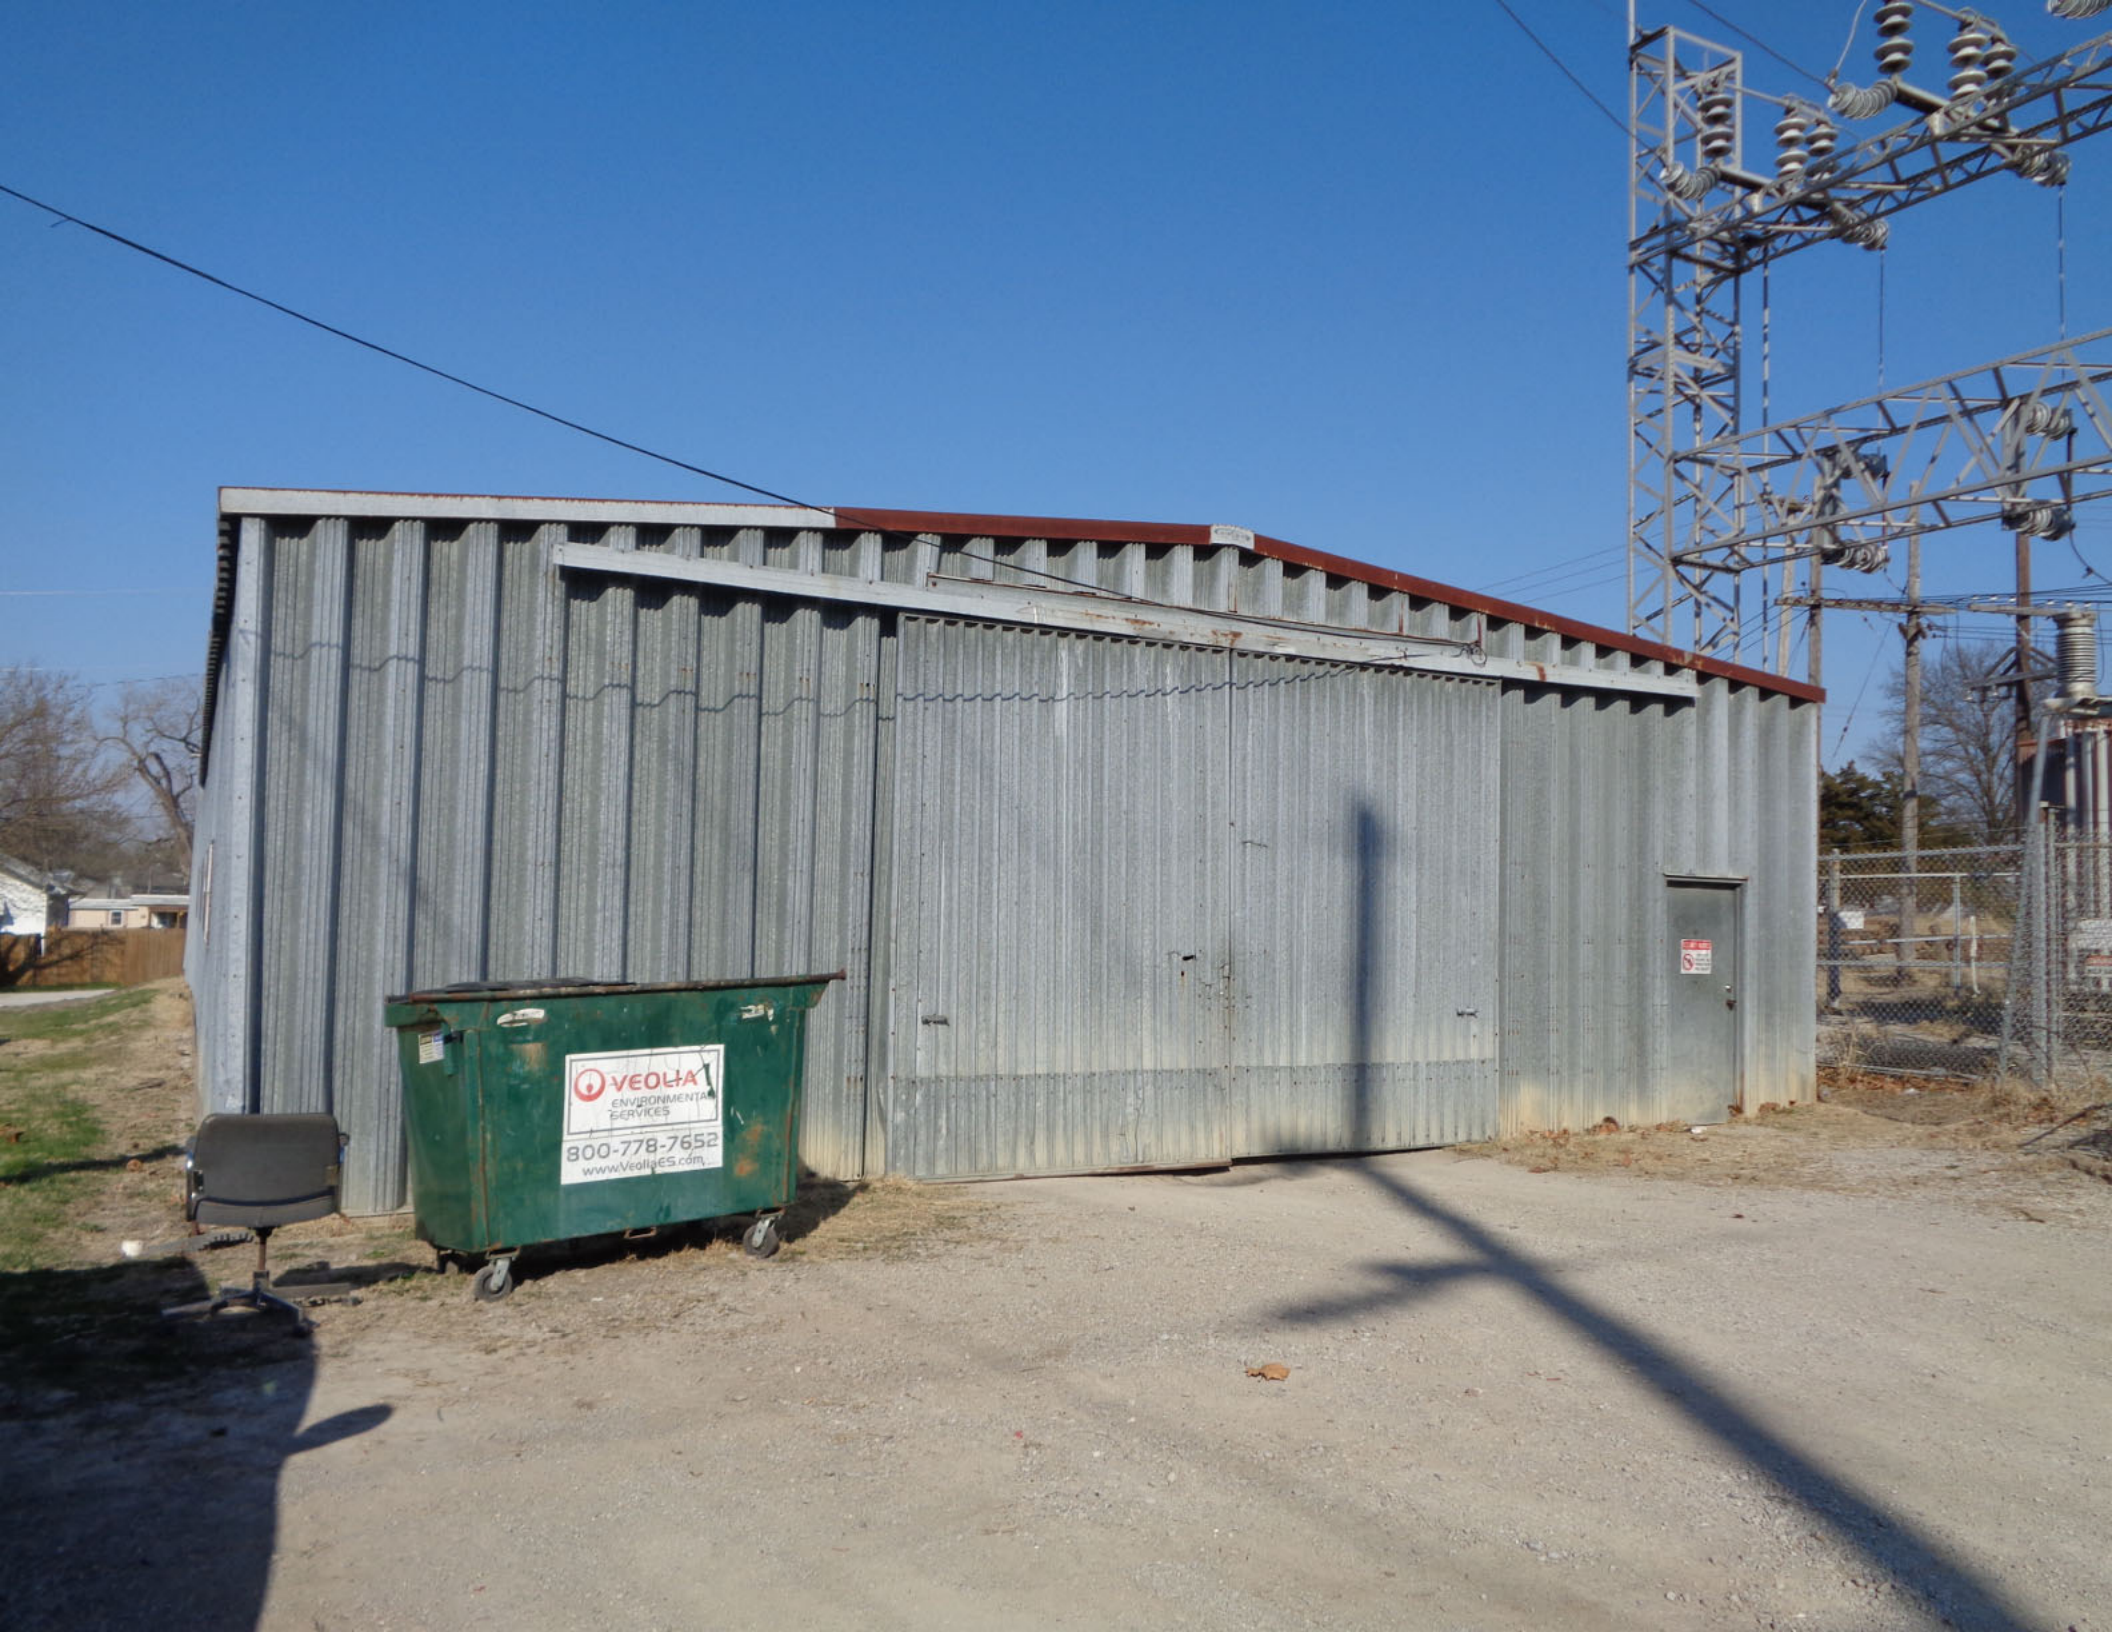
The facade of this brick building faces northeast. The eastern half of the building is 1 story and projects out from the 2 story facade. What appears to be an original portion of the building is visible towards the east; it has no openings and is slightly taller than the next 1 story portion of the building, which is likely an addition c. 1930. This addition has 3 bays. The 1st holds an early single window with a slightly arched cornice with 2 rows of rowlock brick; it also has a rowlock brick sill. The next bay holds a wooden garage door; while the door looks historic it appears to have altered an original opening that also had an arched cornice of rowlock brick. The 3rd bay appears to have also held a garage door but it has since been infilled with a metal panel. On the west side of the 1 story portion of the facade there are 2 more windows openings with arched cornices. The 2 story portion of the building then houses a large piece of equipment behind which are 4 large multi-paned awning windows. There is then a pair of early double doors. The 1st (eastern) half of the 2nd story has increasingly tall stepped parapet behind which is a medium gabled roof. Centered in the stepped parapet are 2 historic openings with concrete sills: one holds a large fan and the other 12 panes in metal frames. The western flat-roofed portion of the 2nd story houses 3 pairs of original 12-paned windows with concrete sills sitting in squares of slightly recessed brick. The western elevation is visible from Chicago and houses 4 more of these windows. The rear of the building has a similar configuration, particularly on the 2nd floor.
