MISSOURI DEPARTMENT OF NATURAL RESOURCES  
STATE HISTORIC PRESERVATION OFFICE, P.O. Box 176, Jefferson City, MO 65102  
**ARCHITECTURAL/HISTORIC INVENTORY FORM**

1. SURVEY NO. LI-AS-001-001		2. SURVEY NAME: Marceline Survey	
3. COUNTY: Linn		4. ADDRESS (STREET NO.) 275	STREET (NAME) West Broadway
5. CITY: Marceline	VICINITY: <input type="checkbox"/>	6. UTM: / /	7. TOWNSHIP/RANGE/SECTION: T: R: S:

8. HISTORIC NAME (IF KNOWN): Walt Disney's Childhood Home		9. PRESENT/OTHER NAME (IF KNOWN): Walt Disney's Childhood Home	
10. OWNERSHIP: <input checked="" type="checkbox"/> PRIVATE <input type="checkbox"/> PUBLIC		11A. HISTORIC USE (IF KNOWN): Single Dwelling	11B. CURRENT USE: Single Dwelling
<b>HISTORICAL INFORMATION</b>

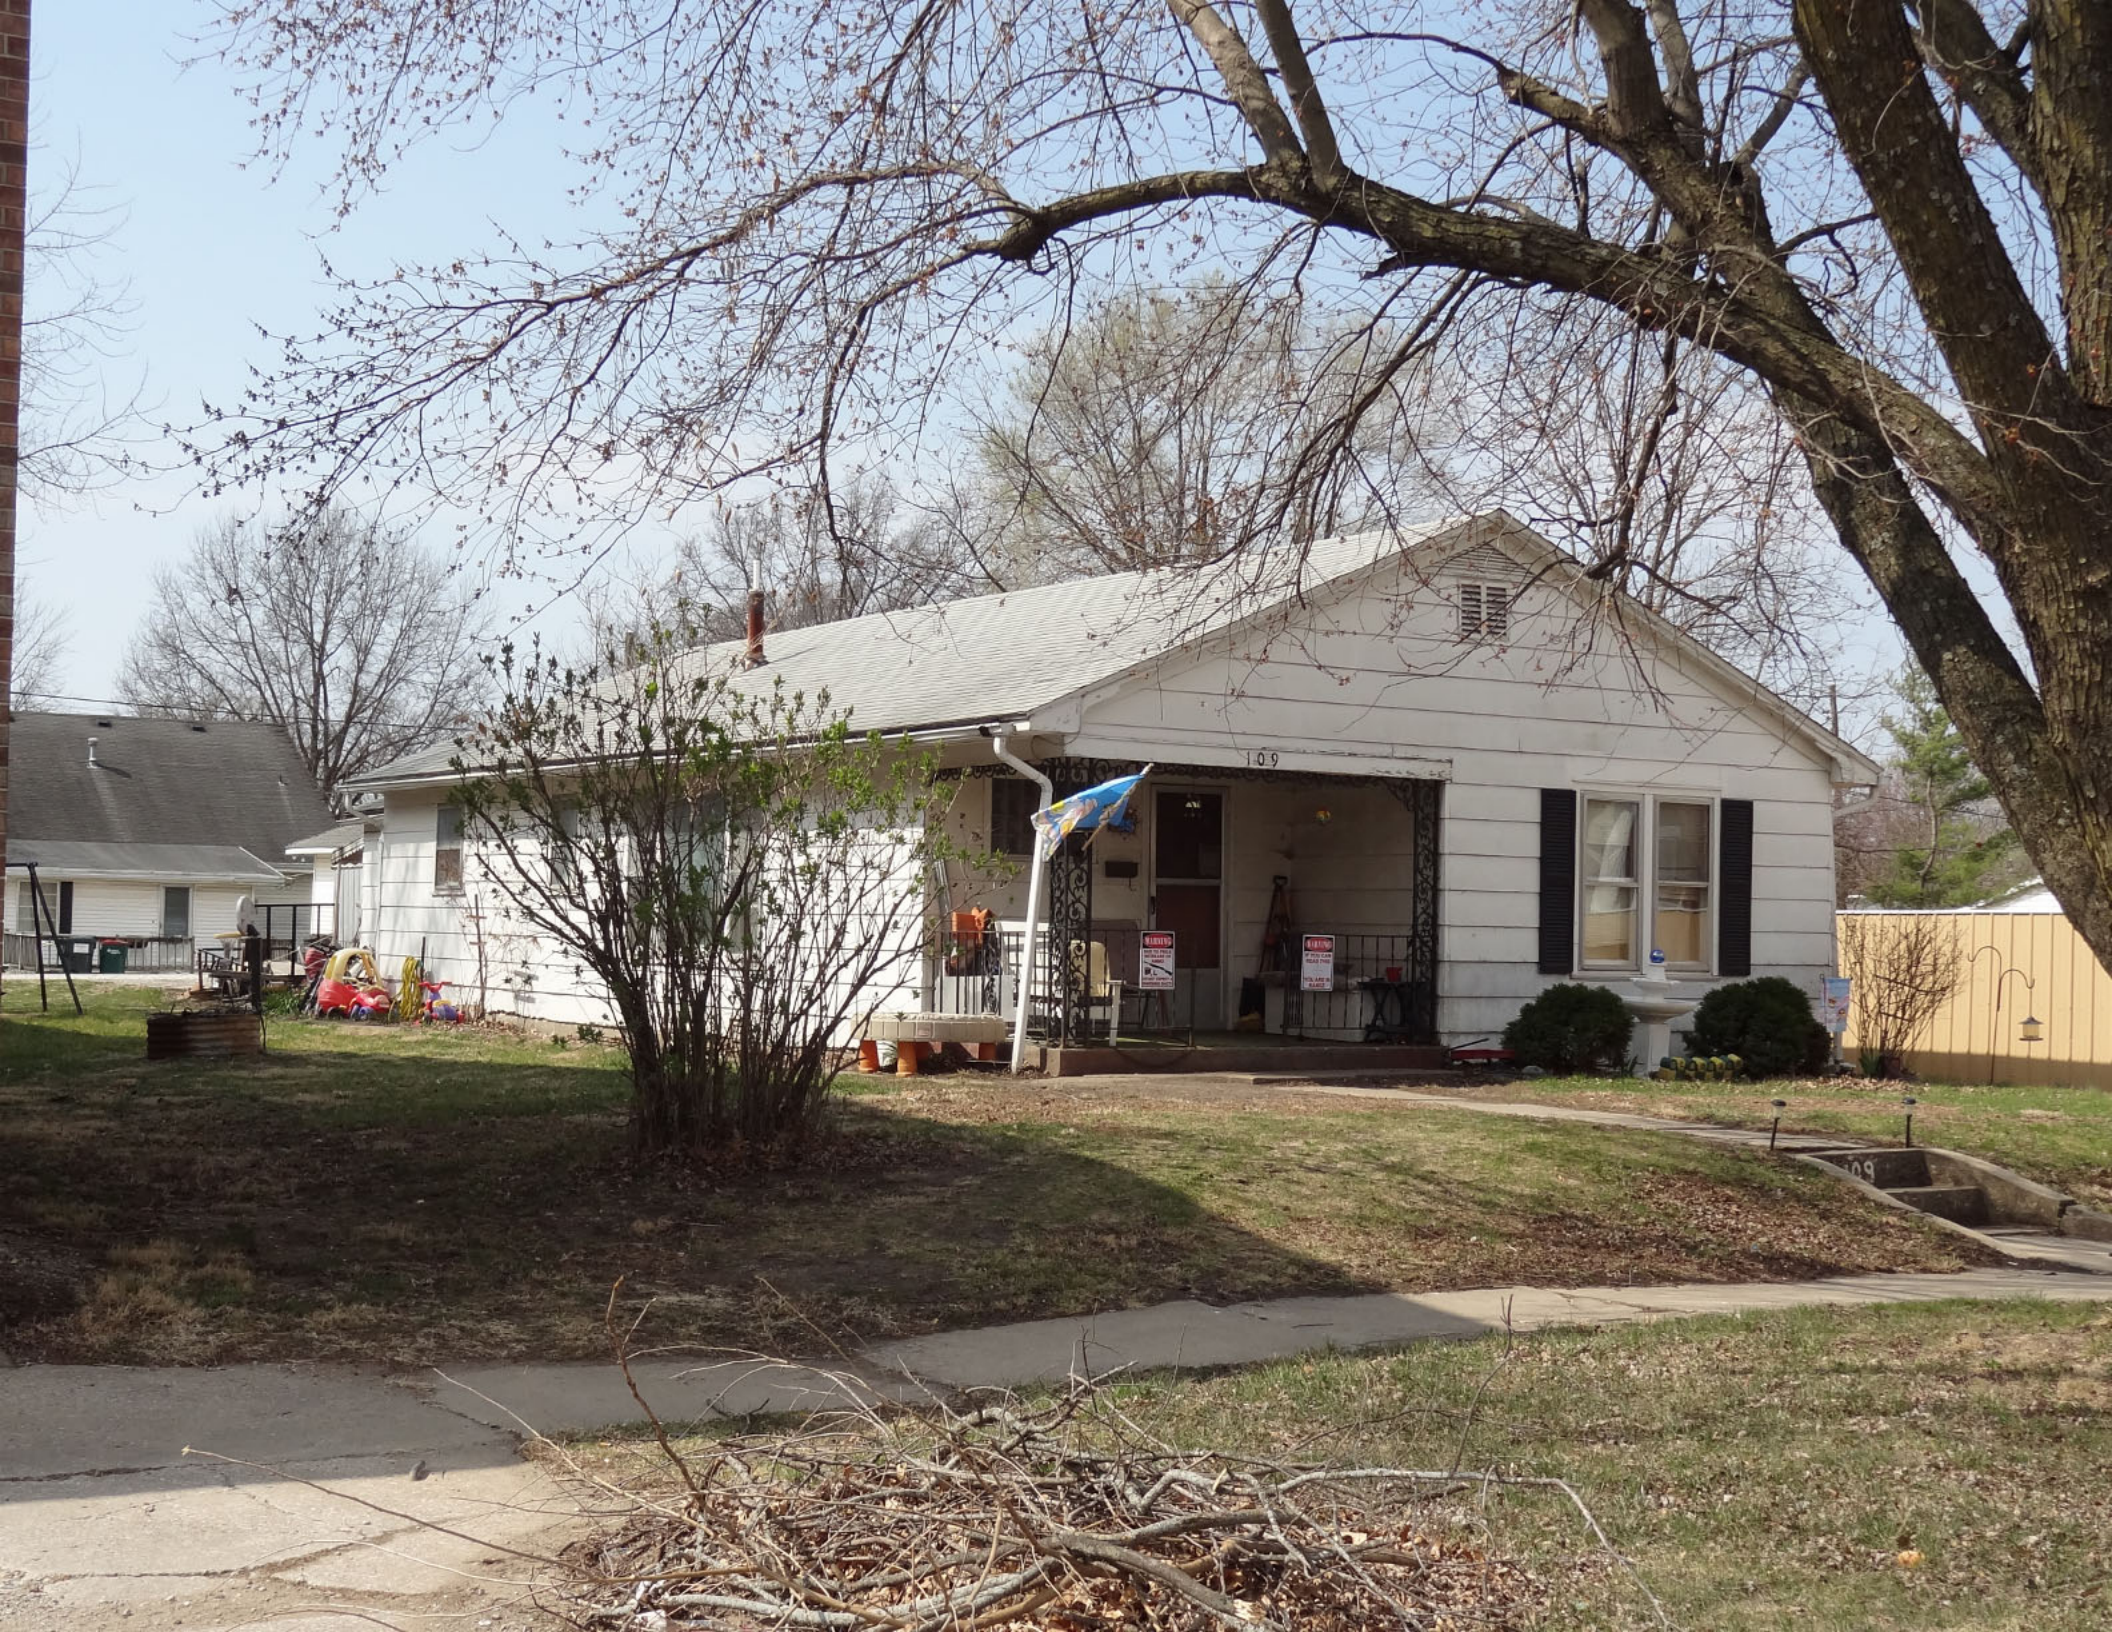
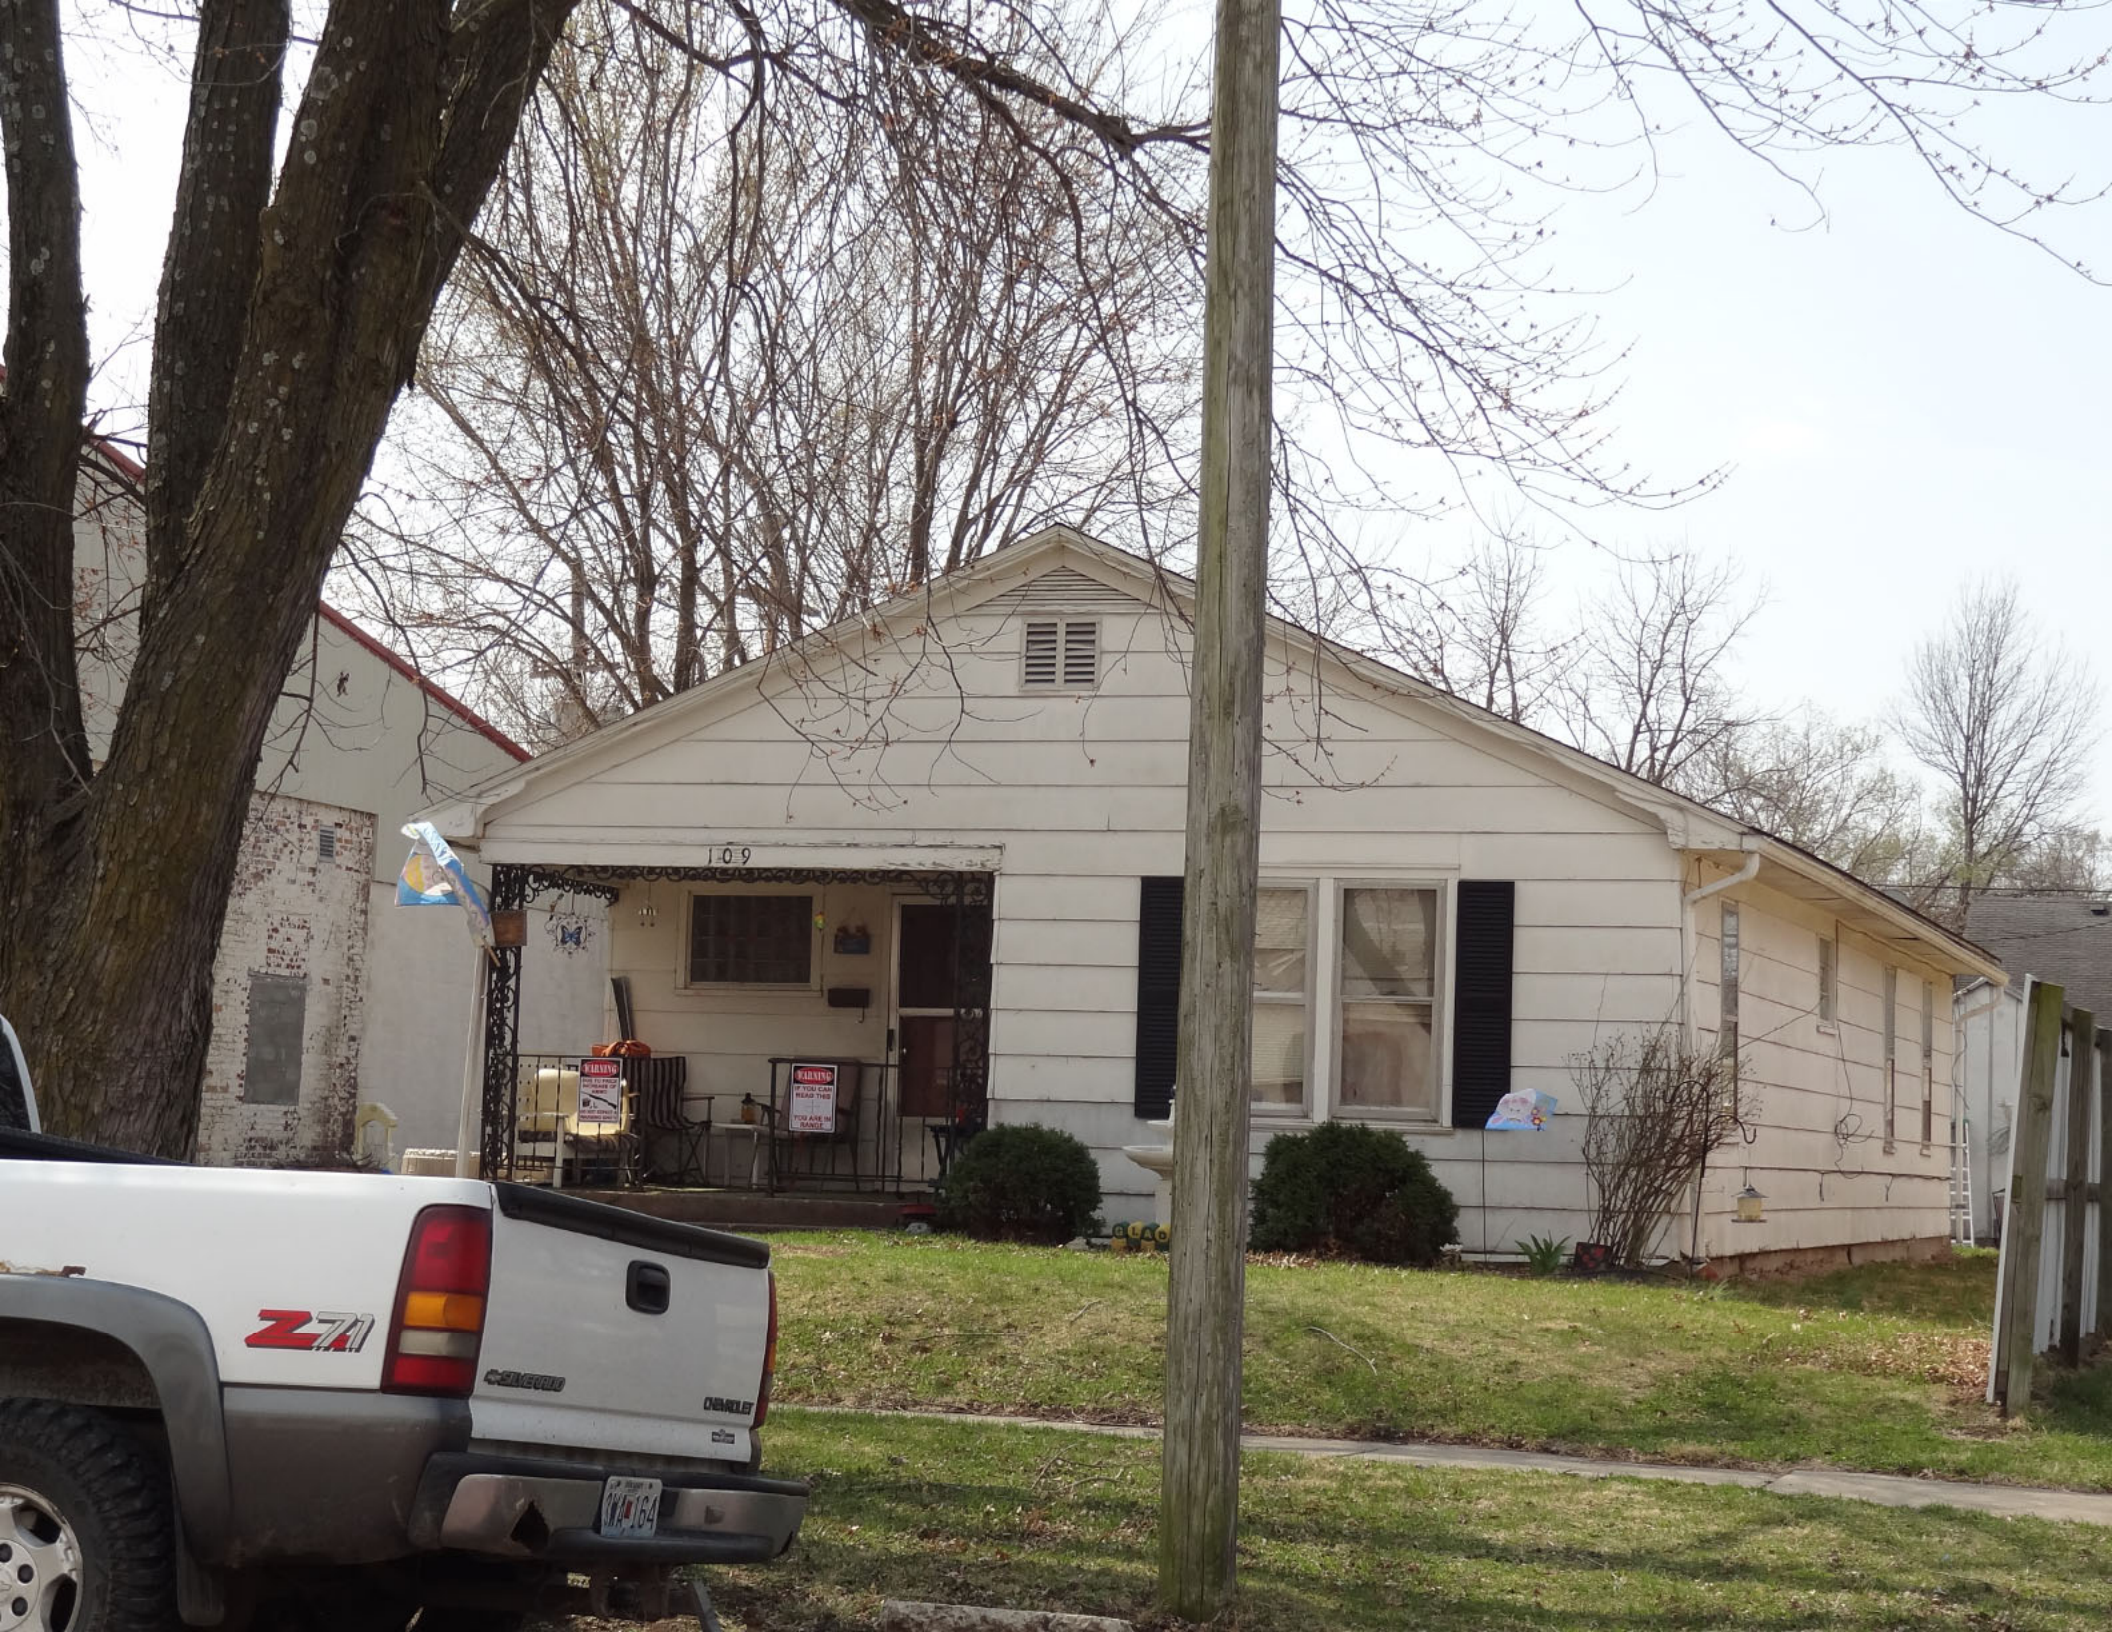
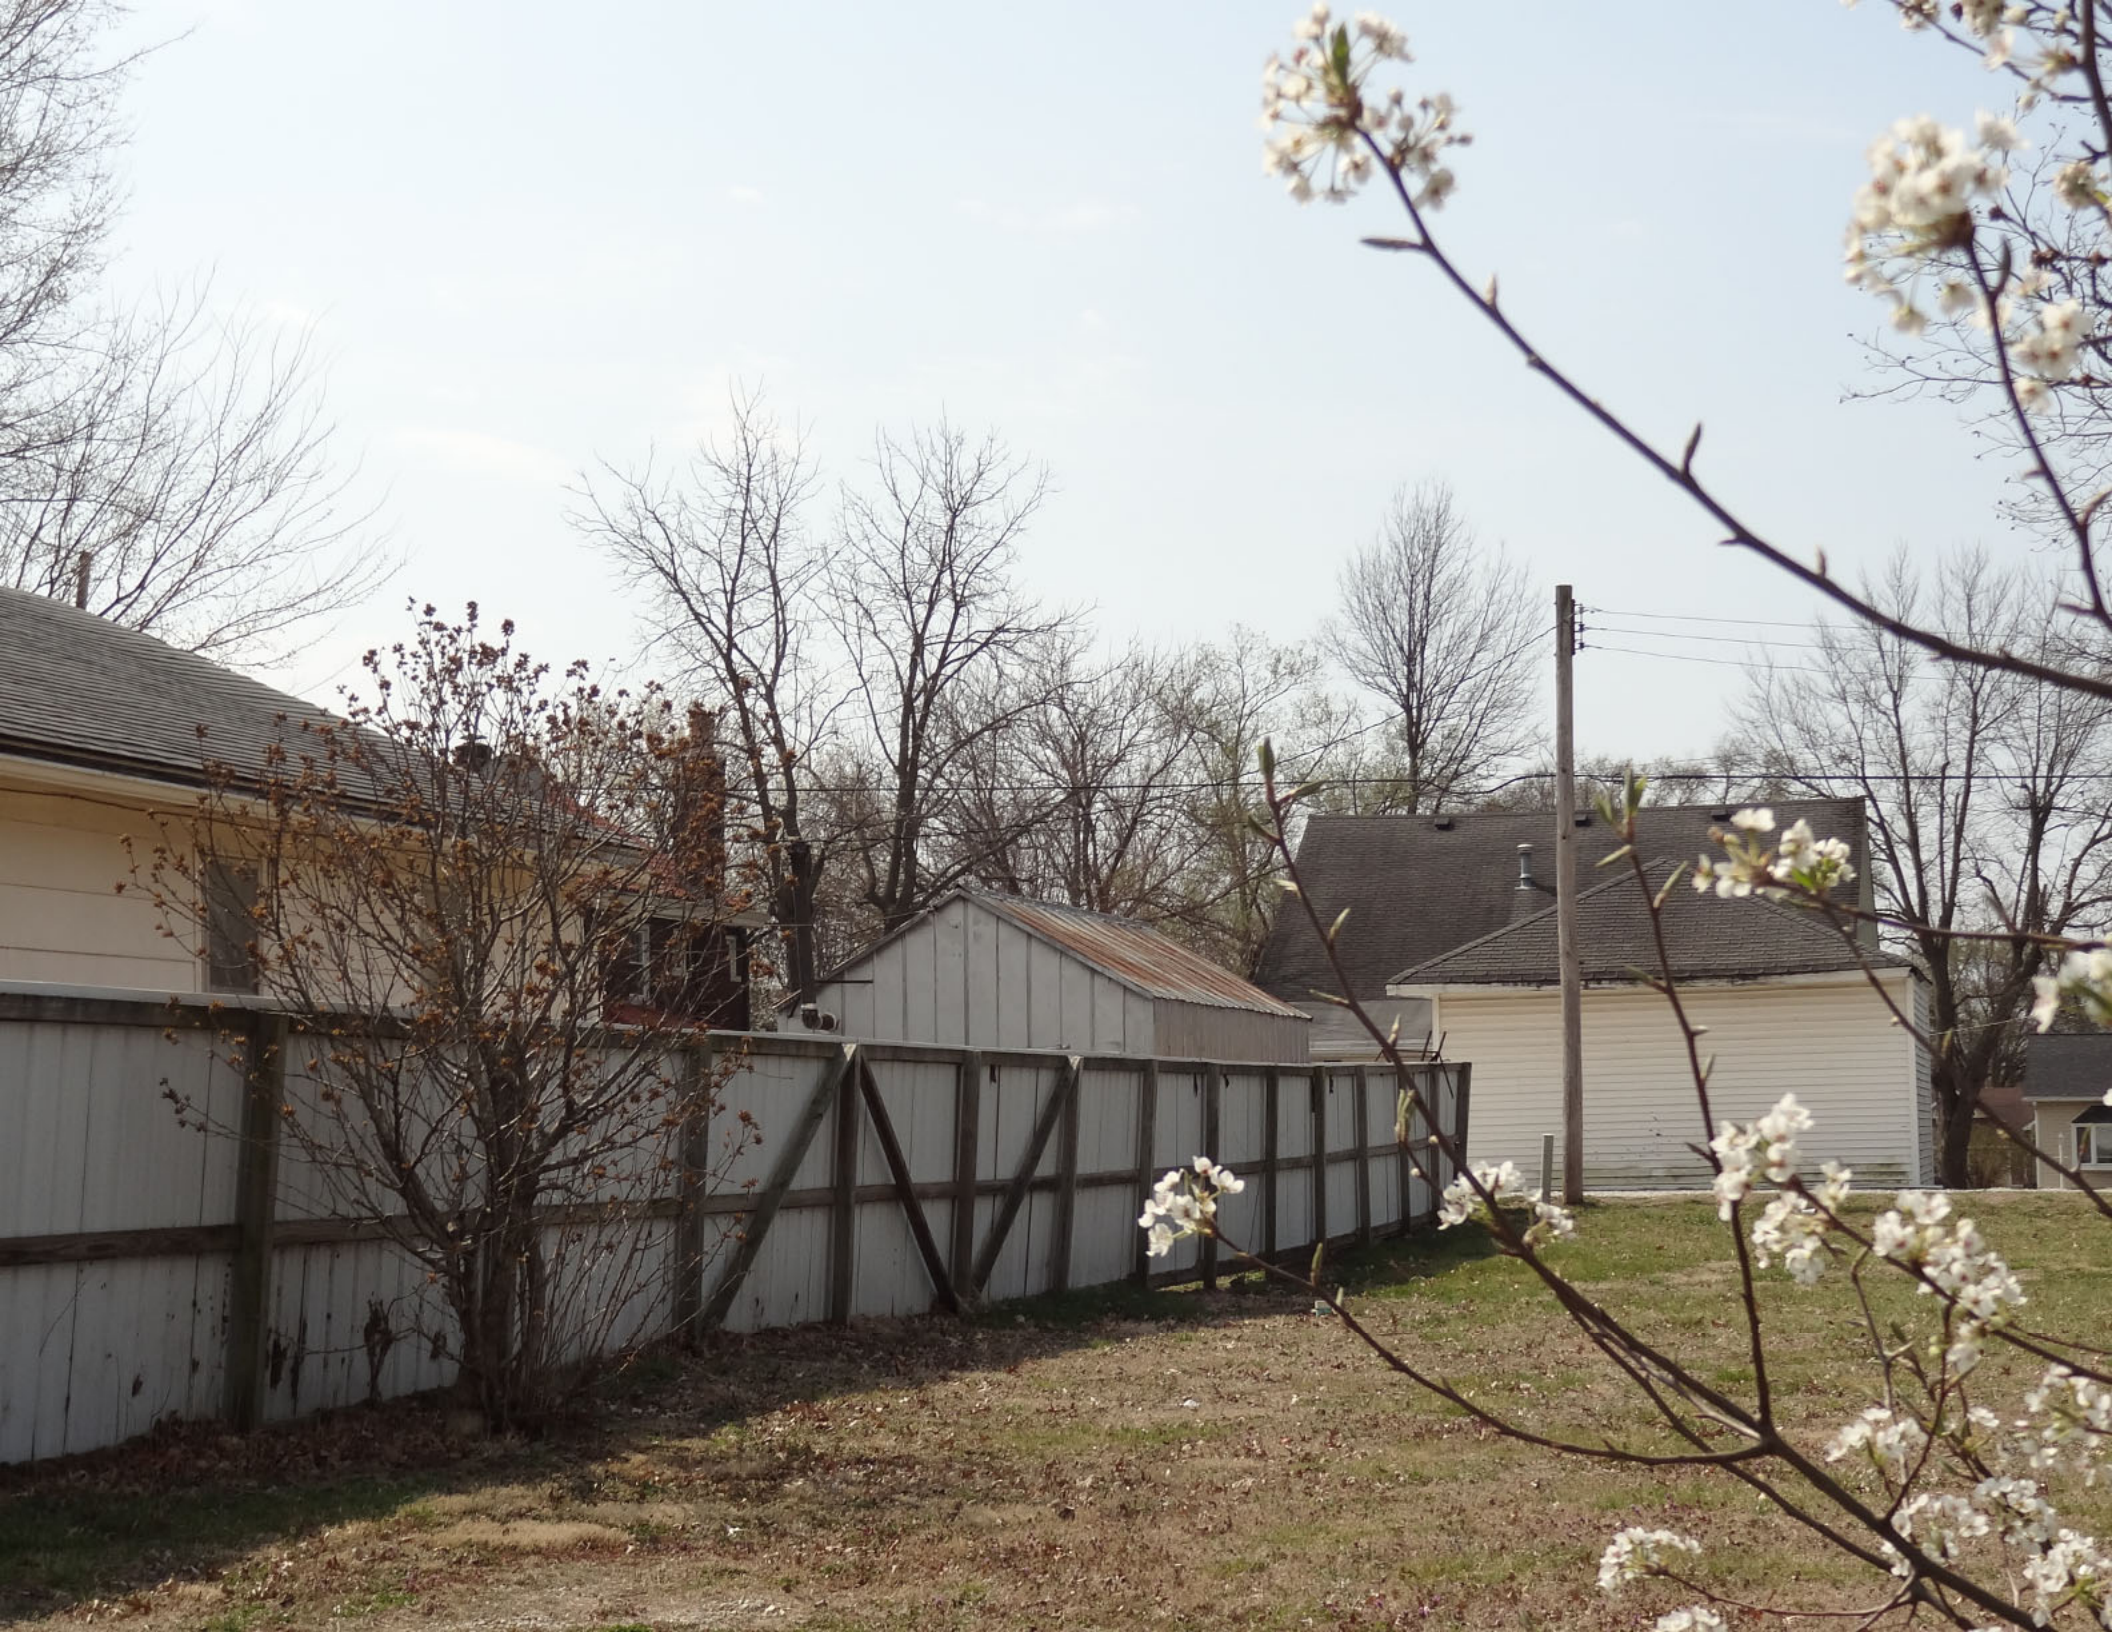
There is a small gabled outbuilding that is constructed of pressed metal there appears to be a large chimney potentially for a wood burning stove.

This is a one story ranch house. This building appears to have been reclad with large metal siding and replacement windows. There are three bays on the facade. From the east moving west the first two bays are under the porch awning. The first bay is a single fixed window. The next bay has the main entrance, with a solid door with a metal screen door. In the third bay there is a pair of metal one-over-one hung windows. These windows have vinyl shutters on either side. There is a small square attic vent above. The porch there are metal supports and railings around the porch.

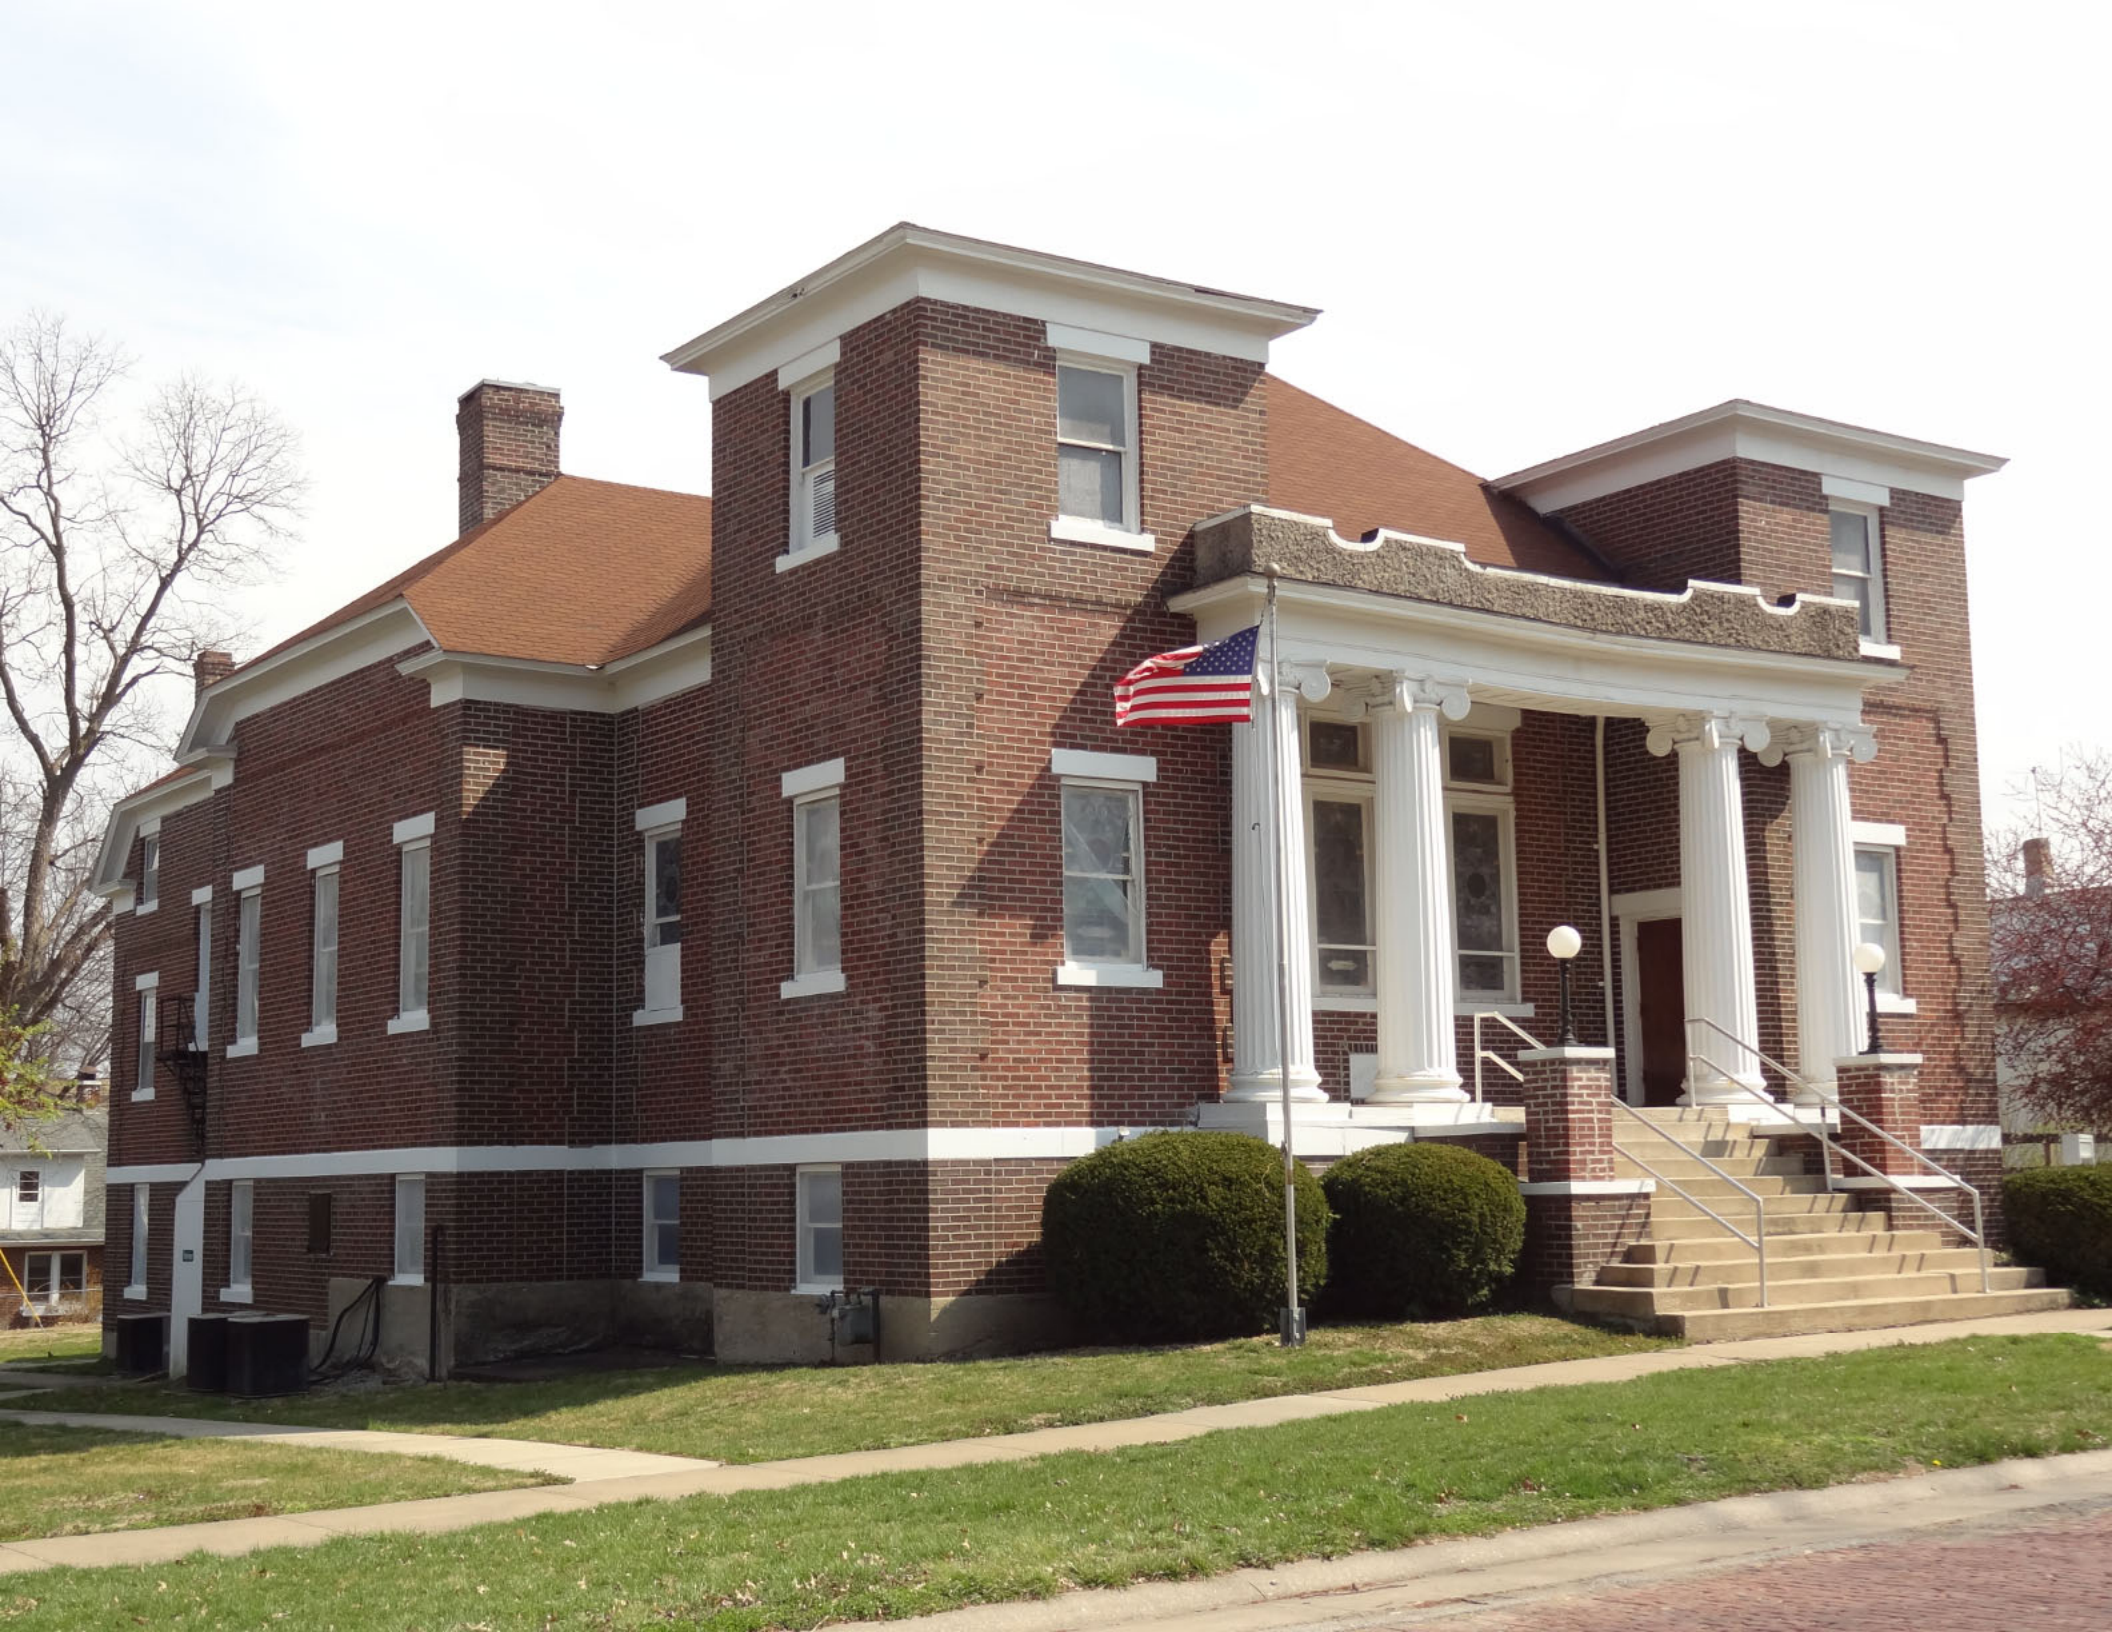
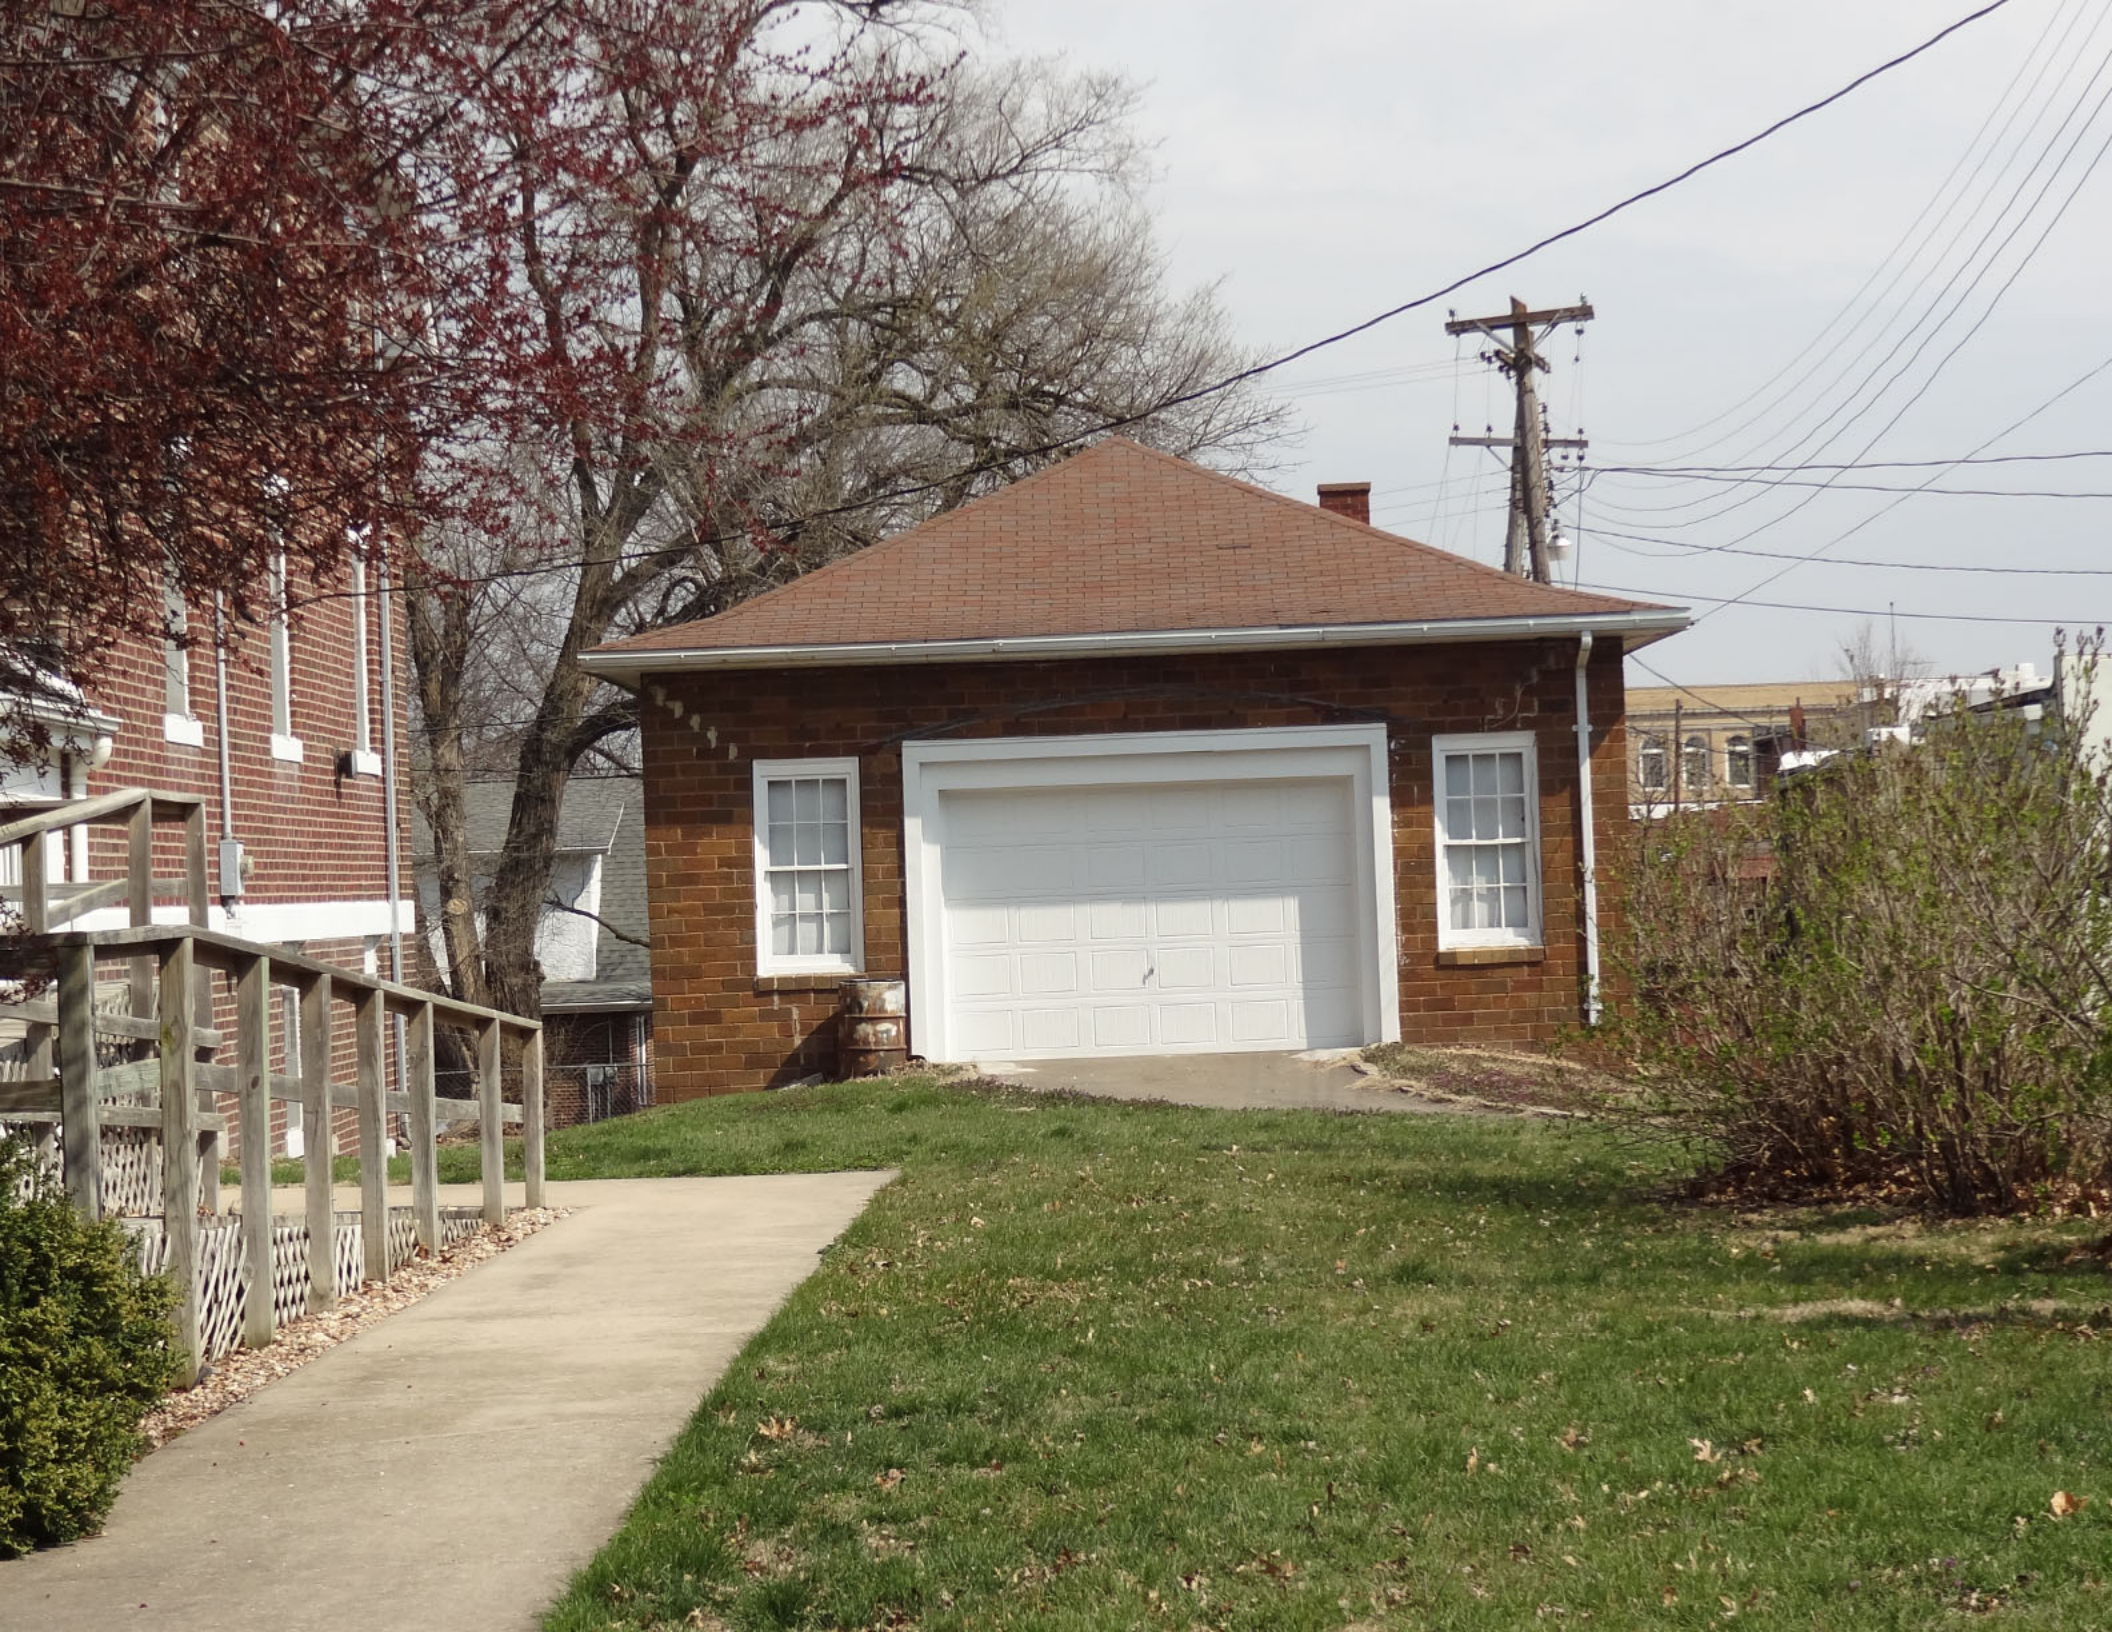
This is a two story brick church building. The church has a hipped asphalt shingle roof with two two-story towers with flat roof with wide eaves that project from each side of the facade. On the first floor of each tower there is a single one-over-one stained glass window with a concrete sill and lintel. These towers also have decorative brick quoining that is a slightly different color brick as the area that surrounds the windows. The second story of each tower also has a single one-over-one wood window with concrete sills and lintels. The central bay is located under a large porch area that is supported by four ionic columns two on each side of the porch. The columns support a wood entablature that has a stucco parapet above the wood. The porch is accessed via a tall rise of concrete stairs that lead to the large porch area. At both the east and the west walls of the recessed porch area there are single doors that lead into the building. The rear or north wall of the central bay there is a grouping of windows. There are four large fixed stained glass windows with stained glass transom above, the windows are protected by solid glass storm windows. Below this row of windows is the date stone with information about the construction of the church.

The church building has a raised basement with windows. A portion of the rear of the building was used for a Sunday school according to the Sanborn Maps and may have been constructed at a later date.
