MISSOURI DEPARTMENT OF NATURAL RESOURCES  
STATE HISTORIC PRESERVATION OFFICE, P.O. Box 176, Jefferson City, MO 65102  
**ARCHITECTURAL/HISTORIC INVENTORY FORM**

1. SURVEY NO. LI-AS-001-001		2. SURVEY NAME: Marceline Survey	
3. COUNTY: Linn		4. ADDRESS (STREET NO.) 275	STREET (NAME) West Broadway
5. CITY: Marceline	VICINITY: <input type="checkbox"/>	6. UTM: / /	7. TOWNSHIP/RANGE/SECTION: T: R: S:

8. HISTORIC NAME (IF KNOWN): Walt Disney's Childhood Home		9. PRESENT/OTHER NAME (IF KNOWN): Walt Disney's Childhood Home	
10. OWNERSHIP: <input checked="" type="checkbox"/> PRIVATE <input type="checkbox"/> PUBLIC		11A. HISTORIC USE (IF KNOWN): Single Dwelling	11B. CURRENT USE: Single Dwelling
<b>HISTORICAL INFORMATION</b>

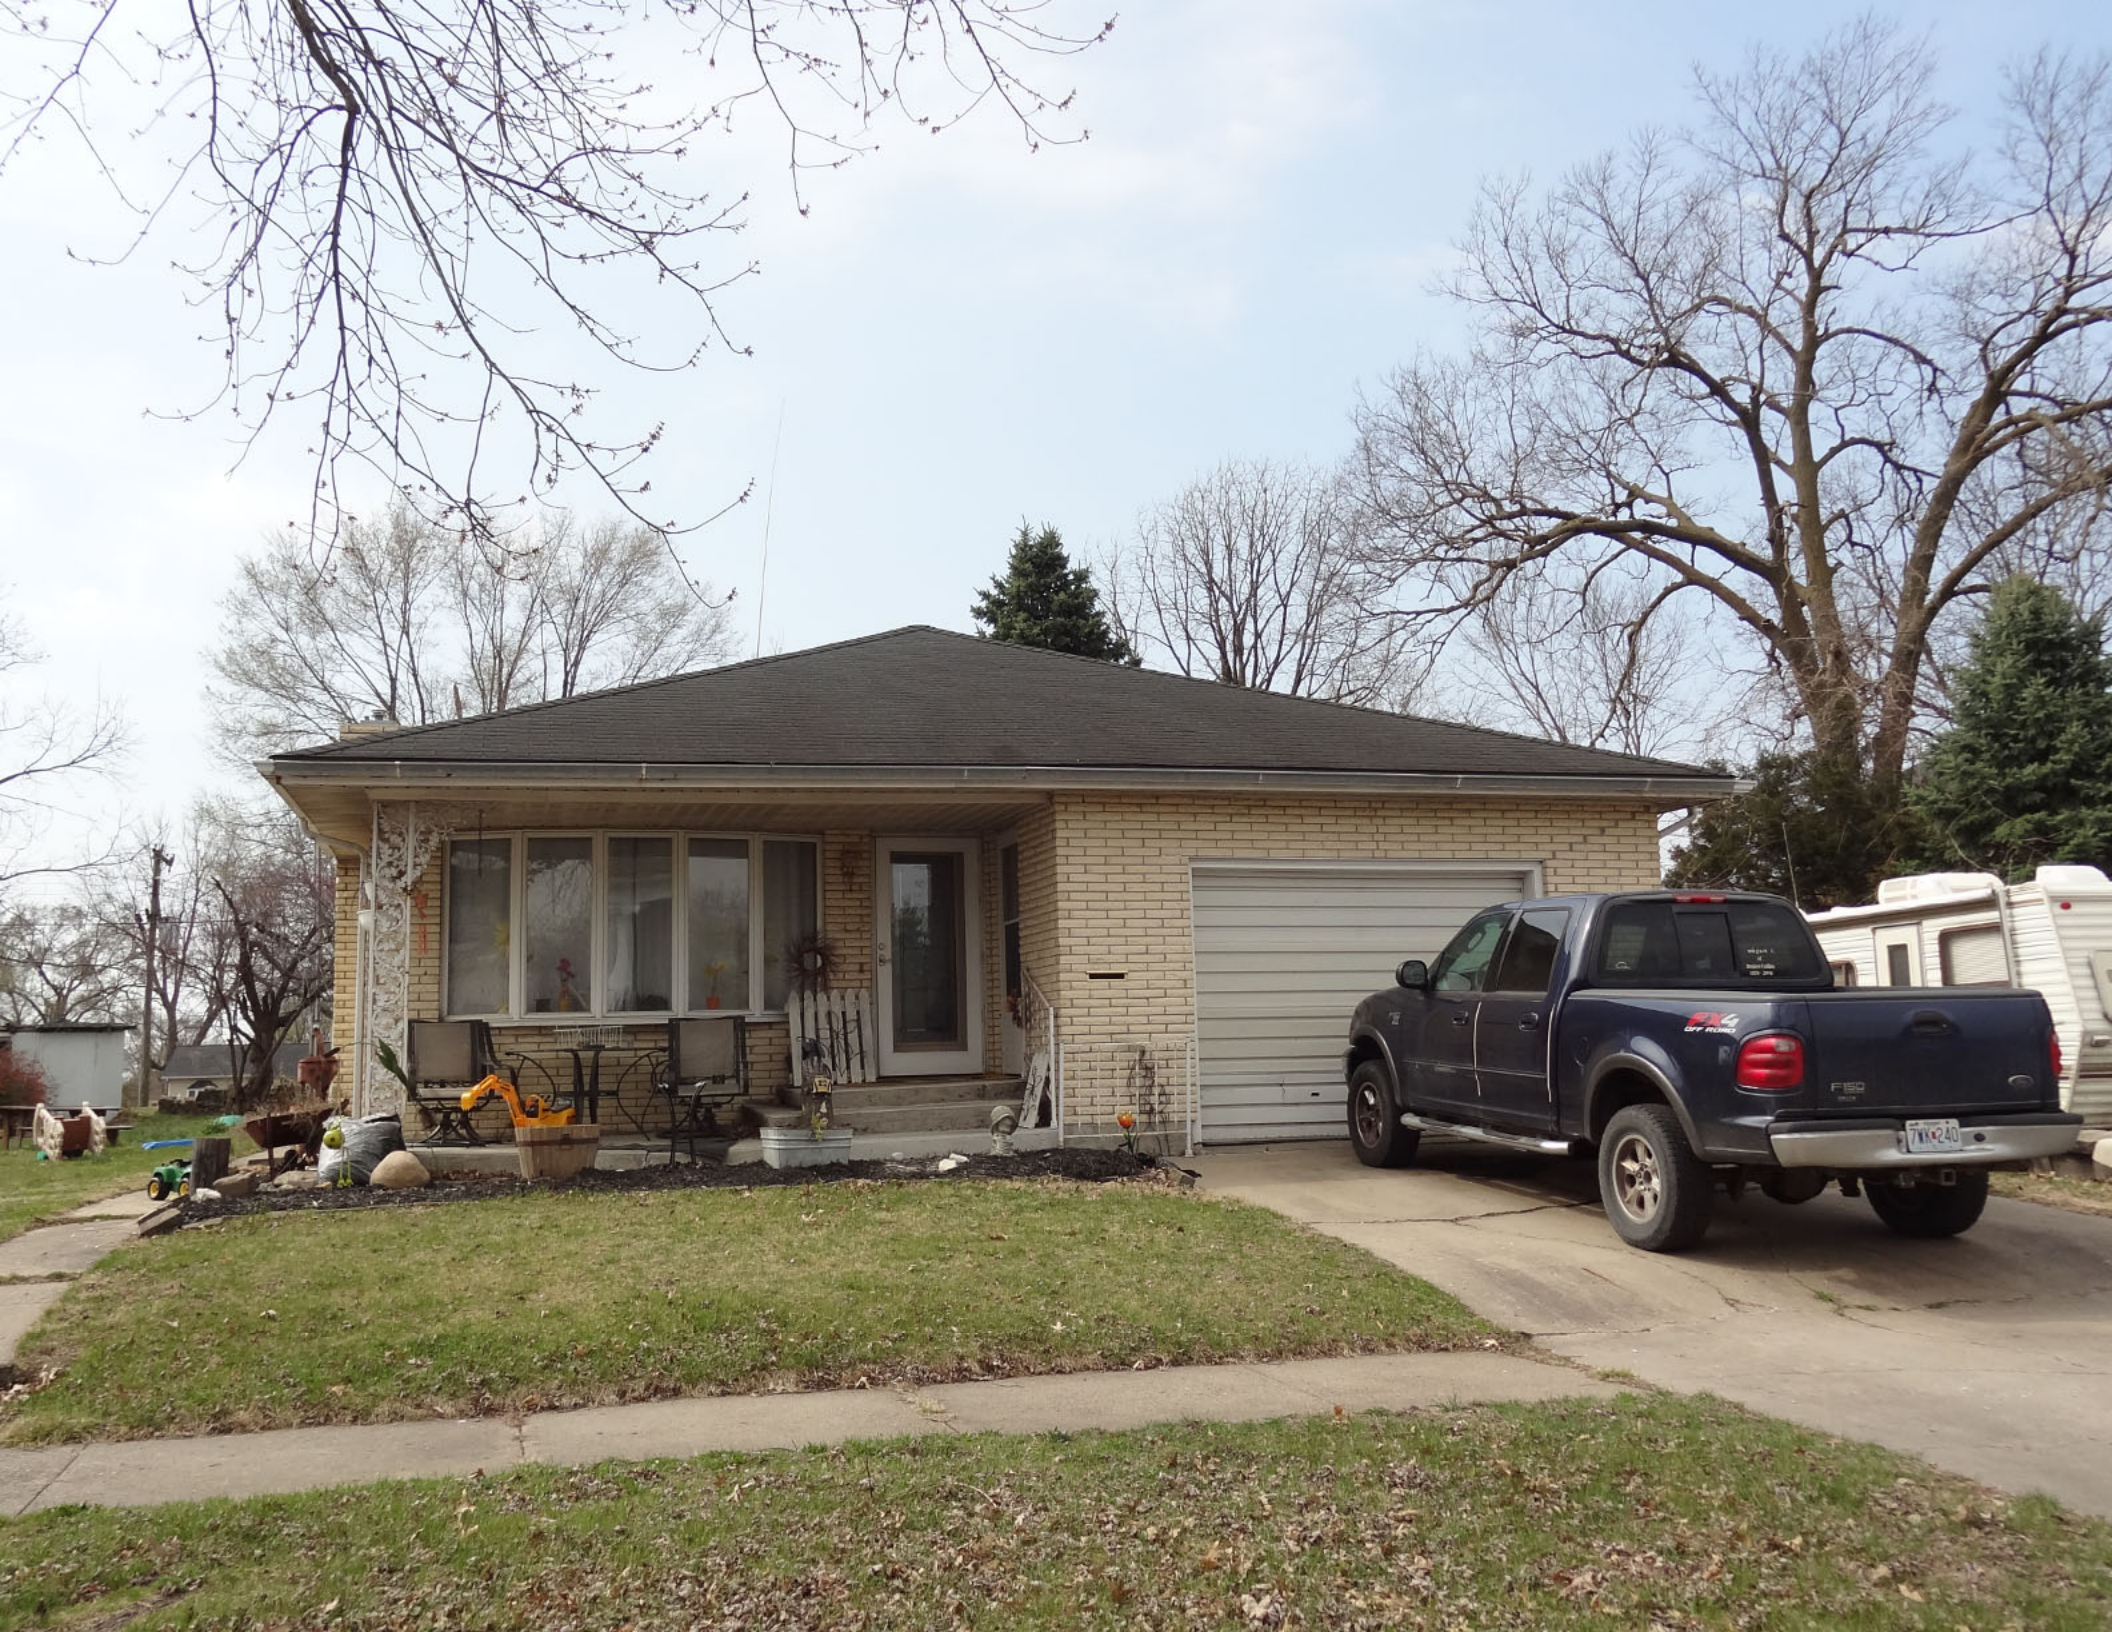
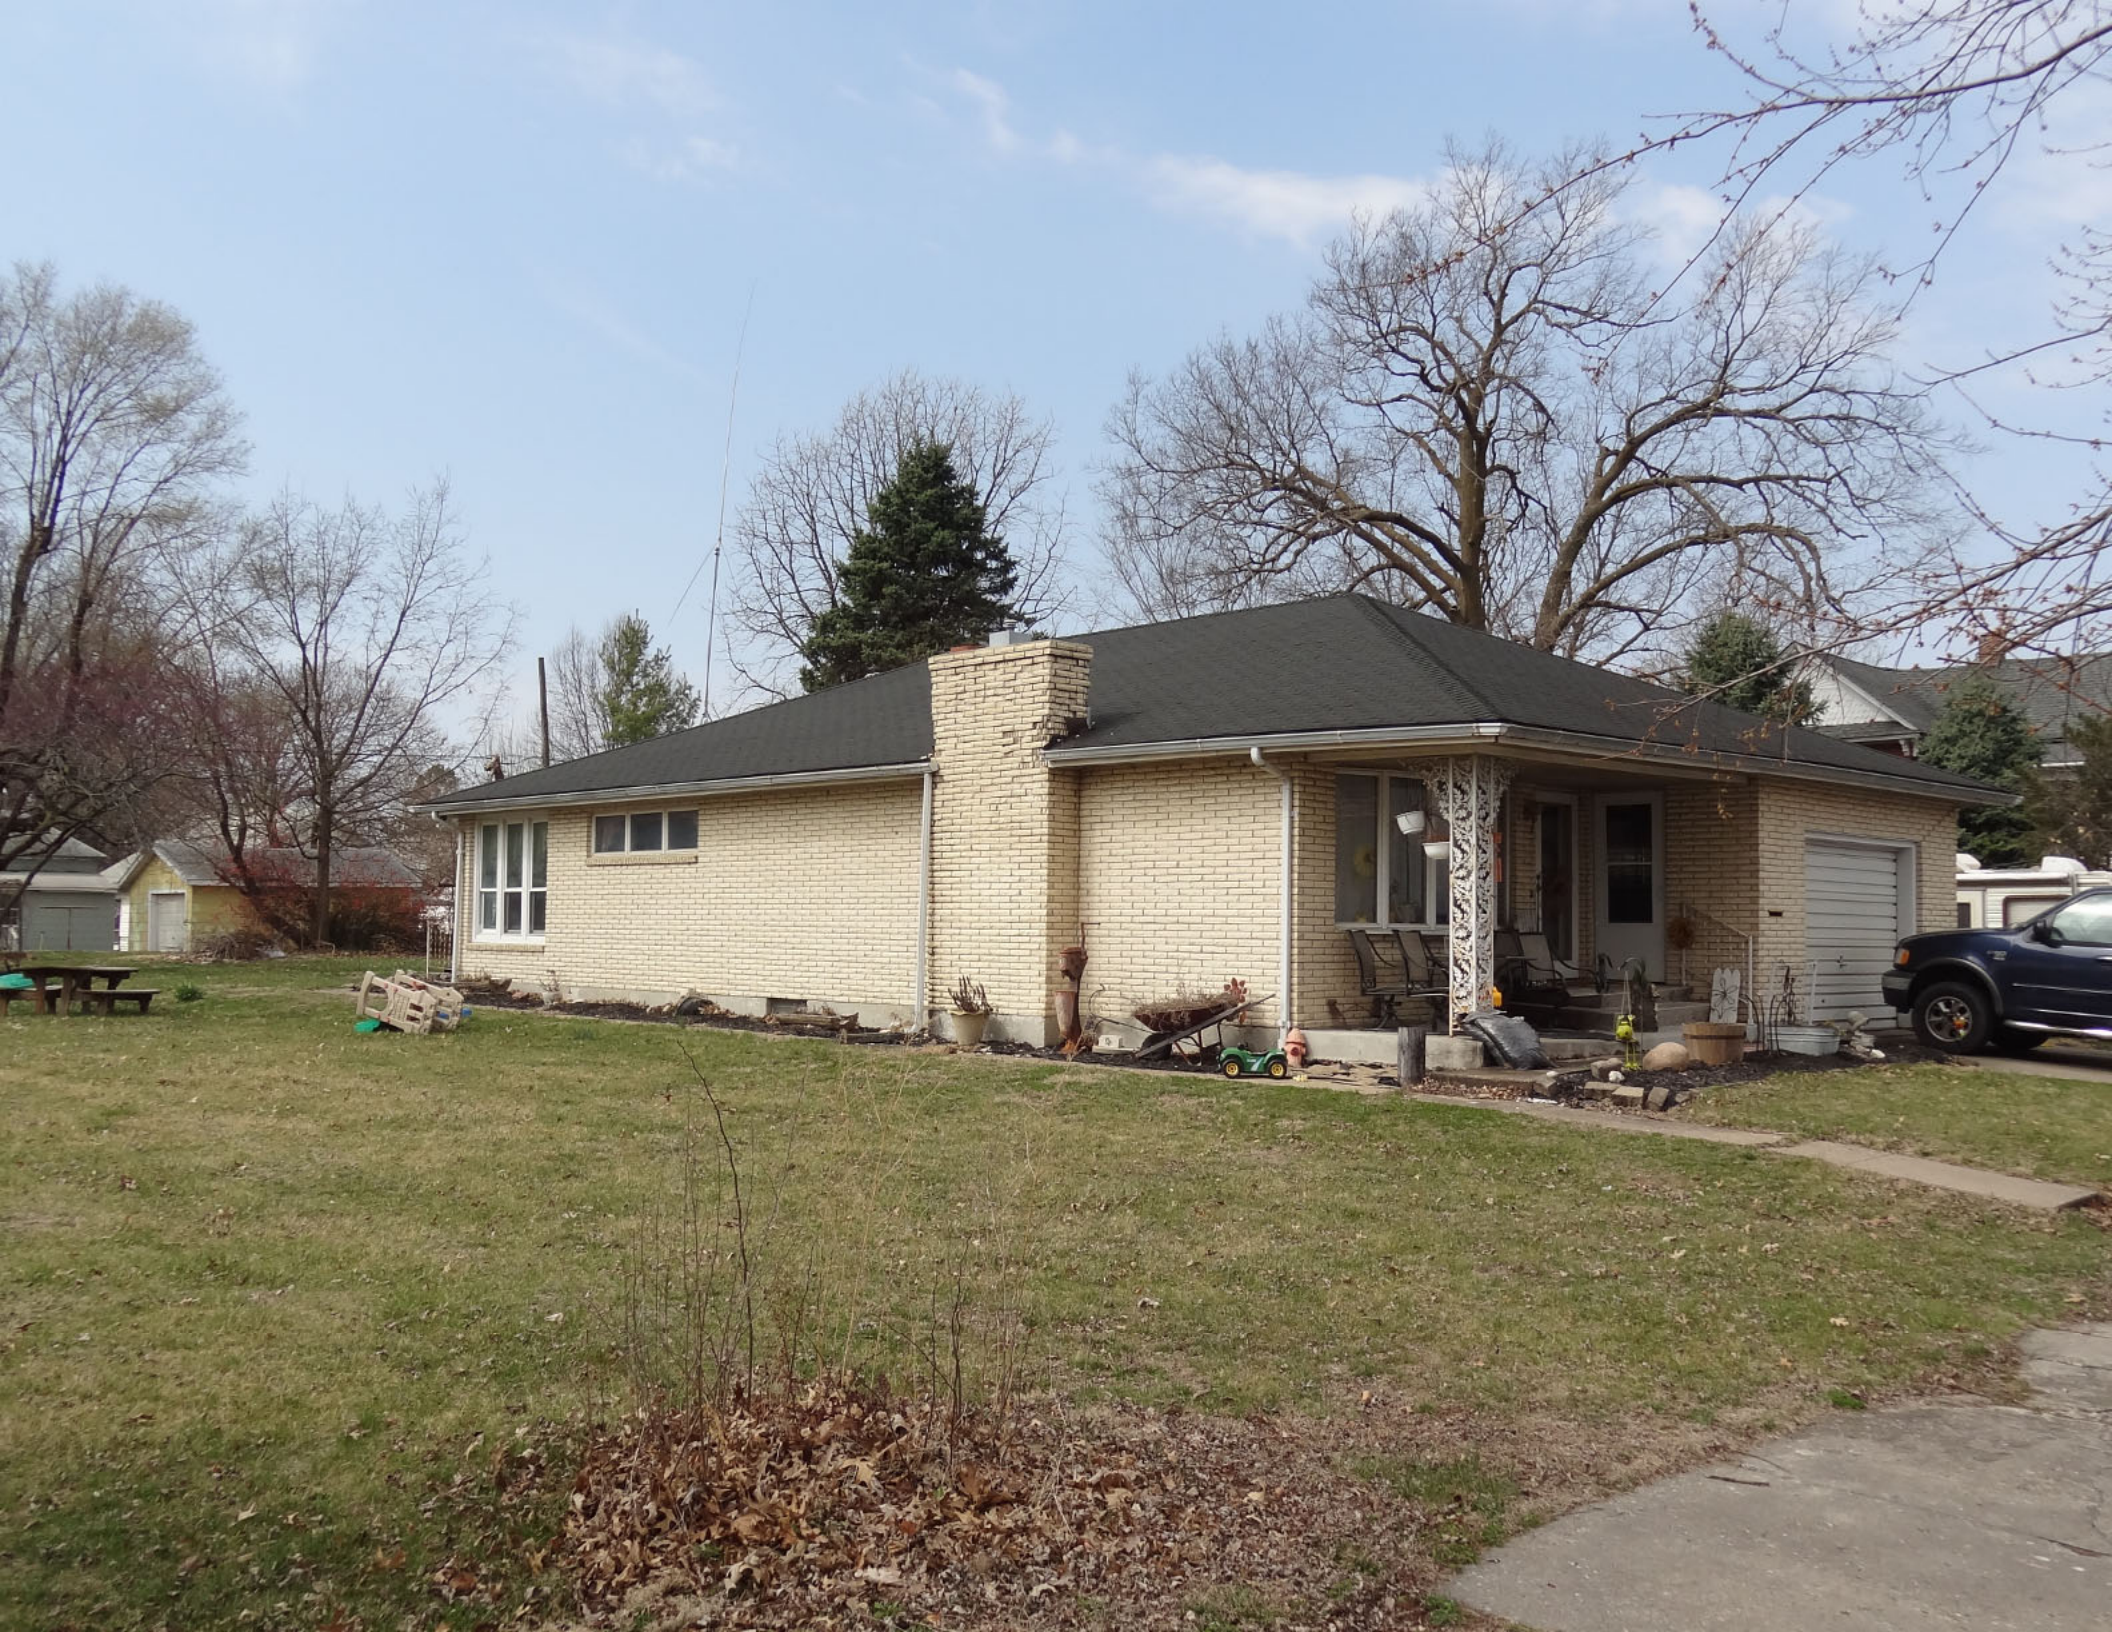
The porch is supported by a single decorative metal support on the left side. There is also a metal mail slot on the bay with the garage door.

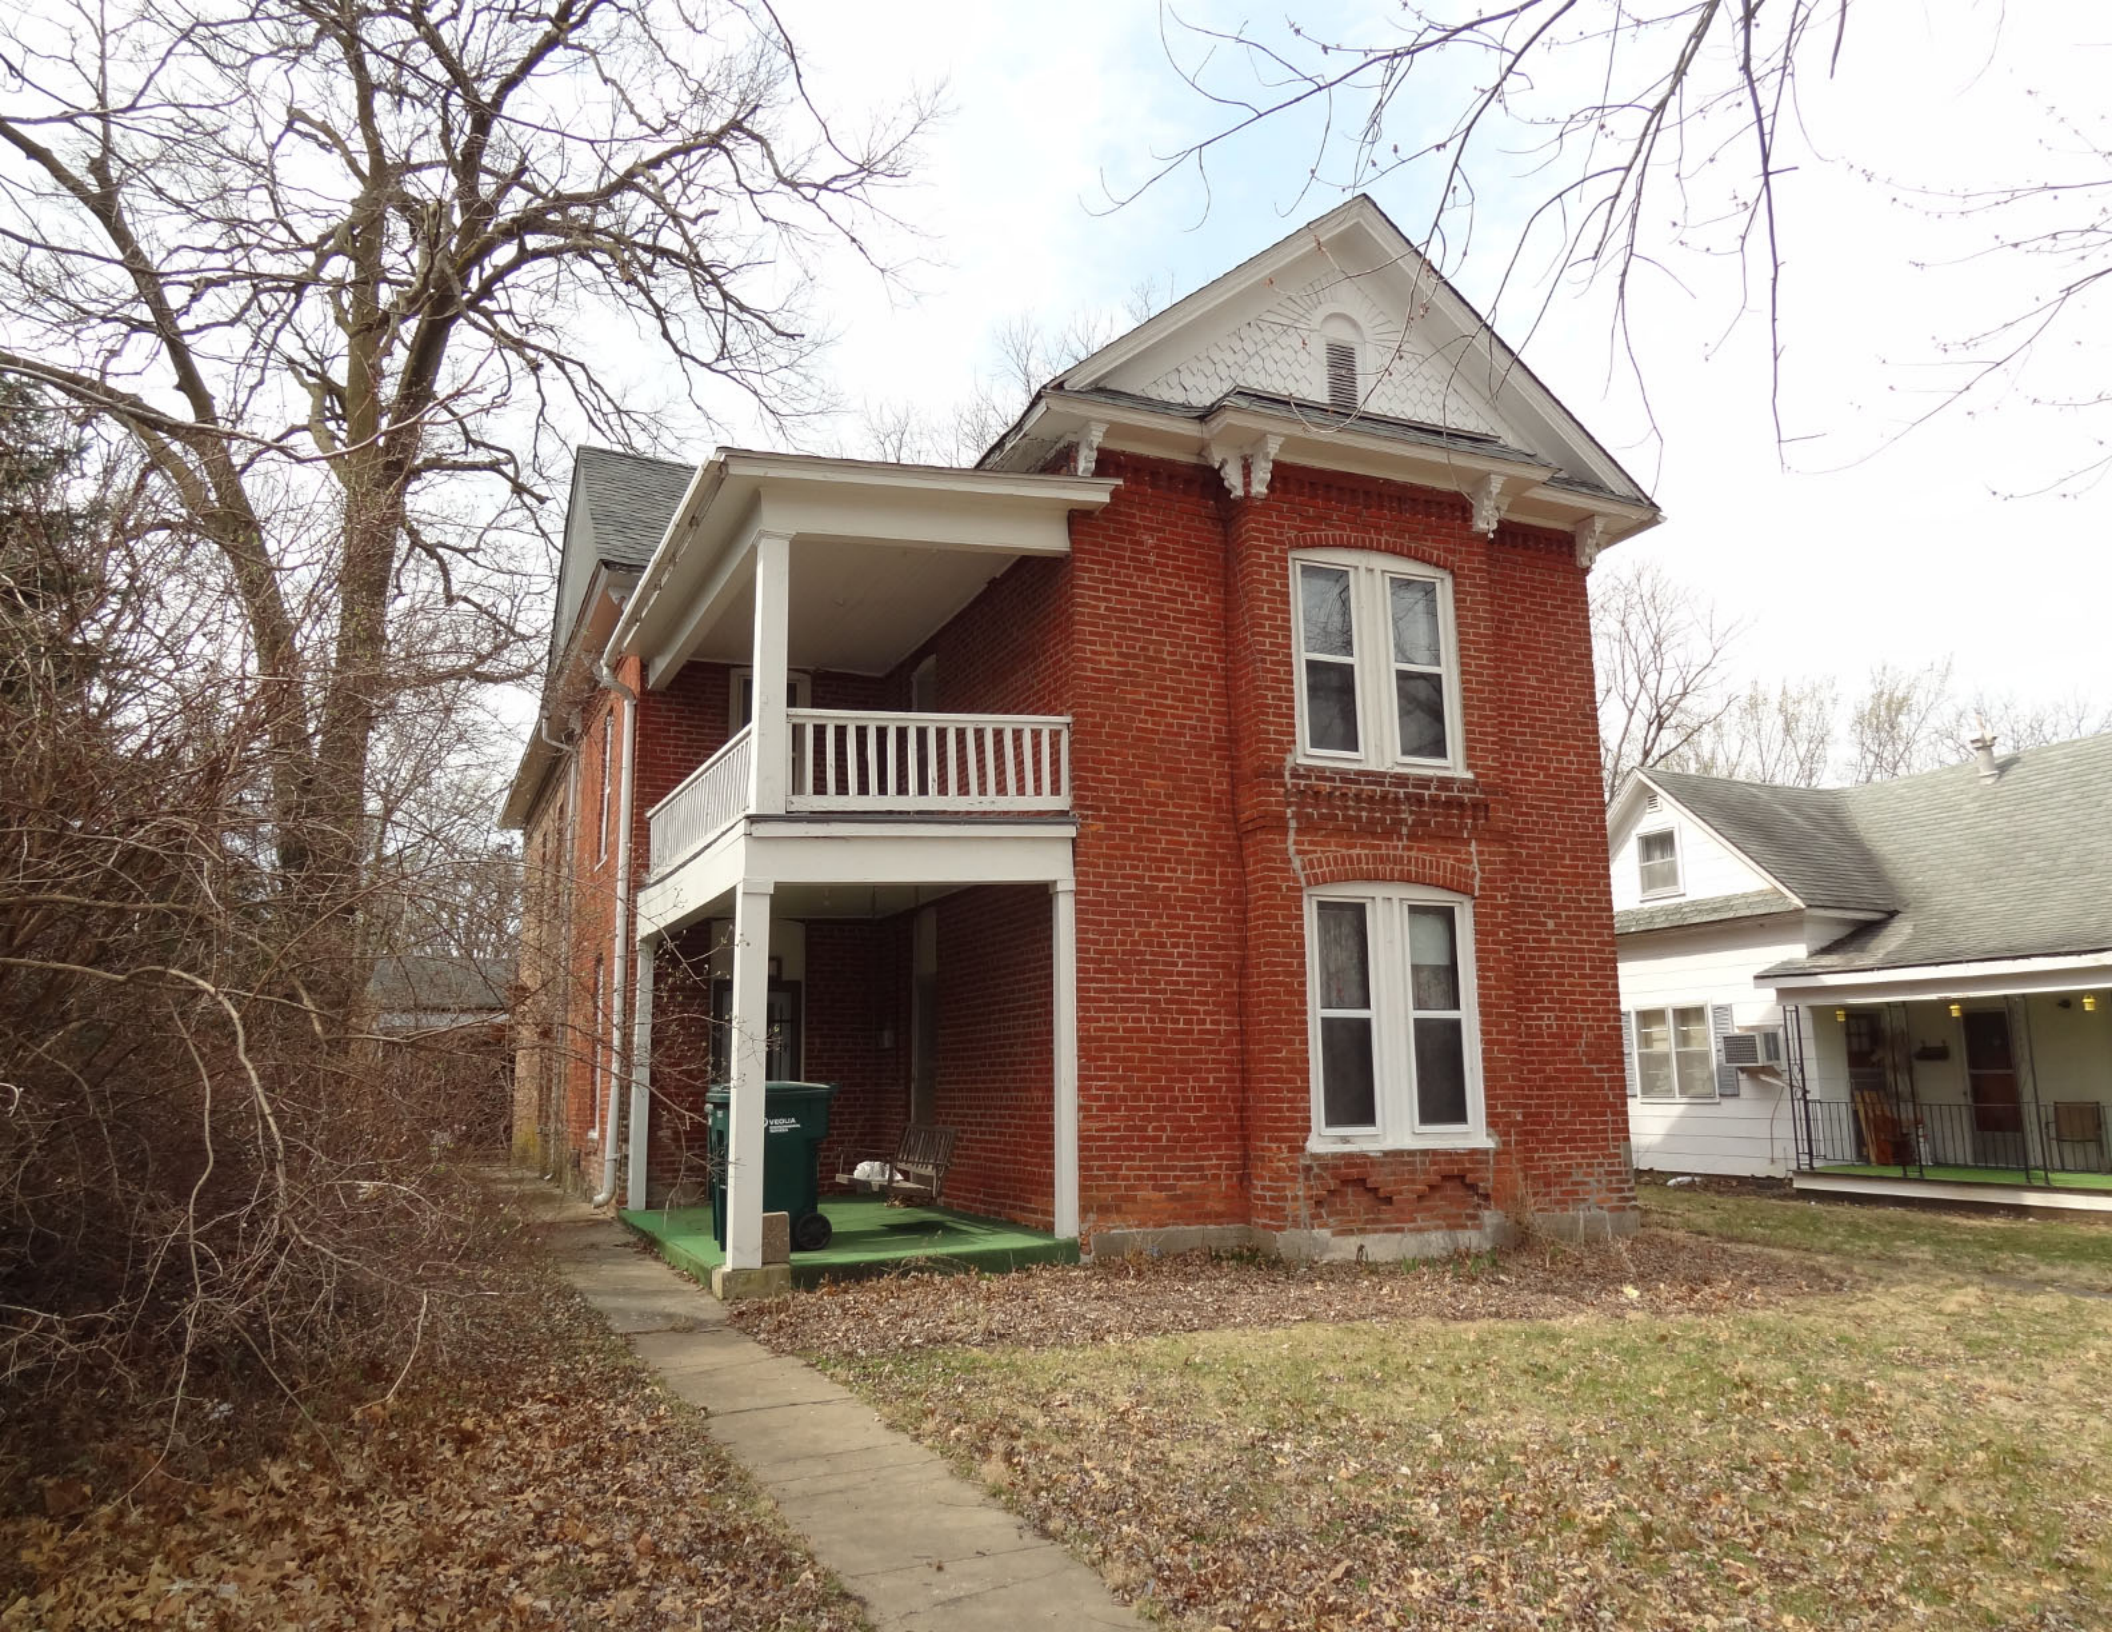
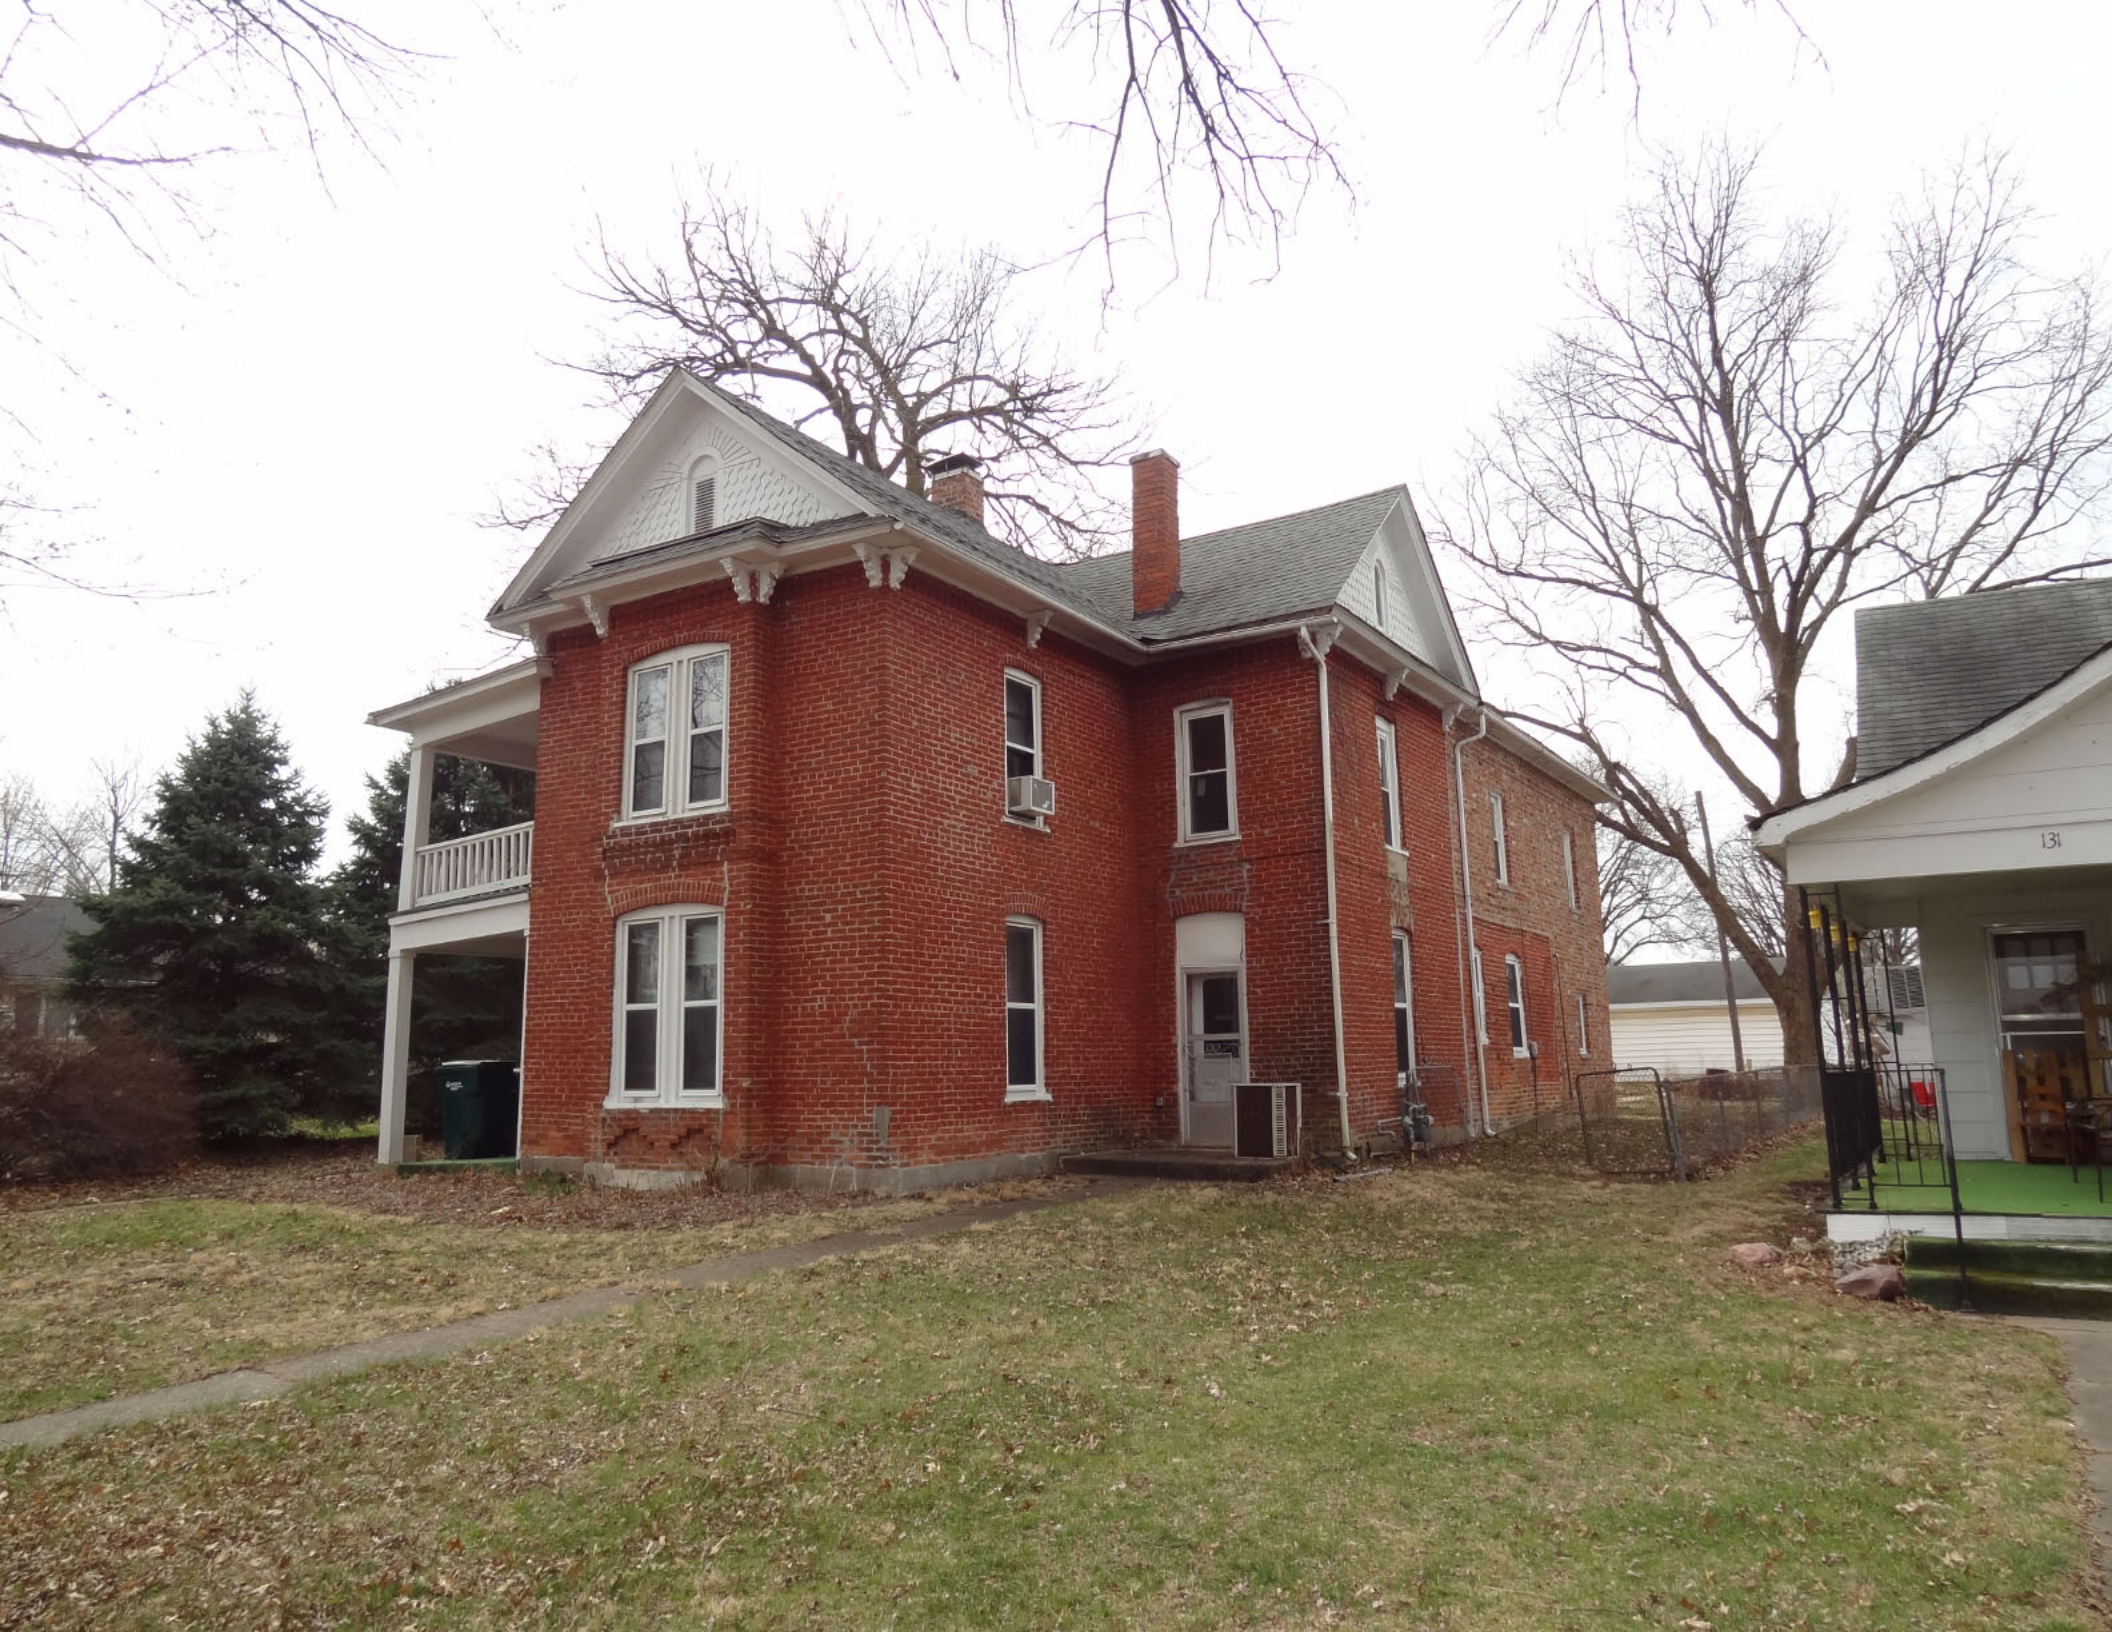
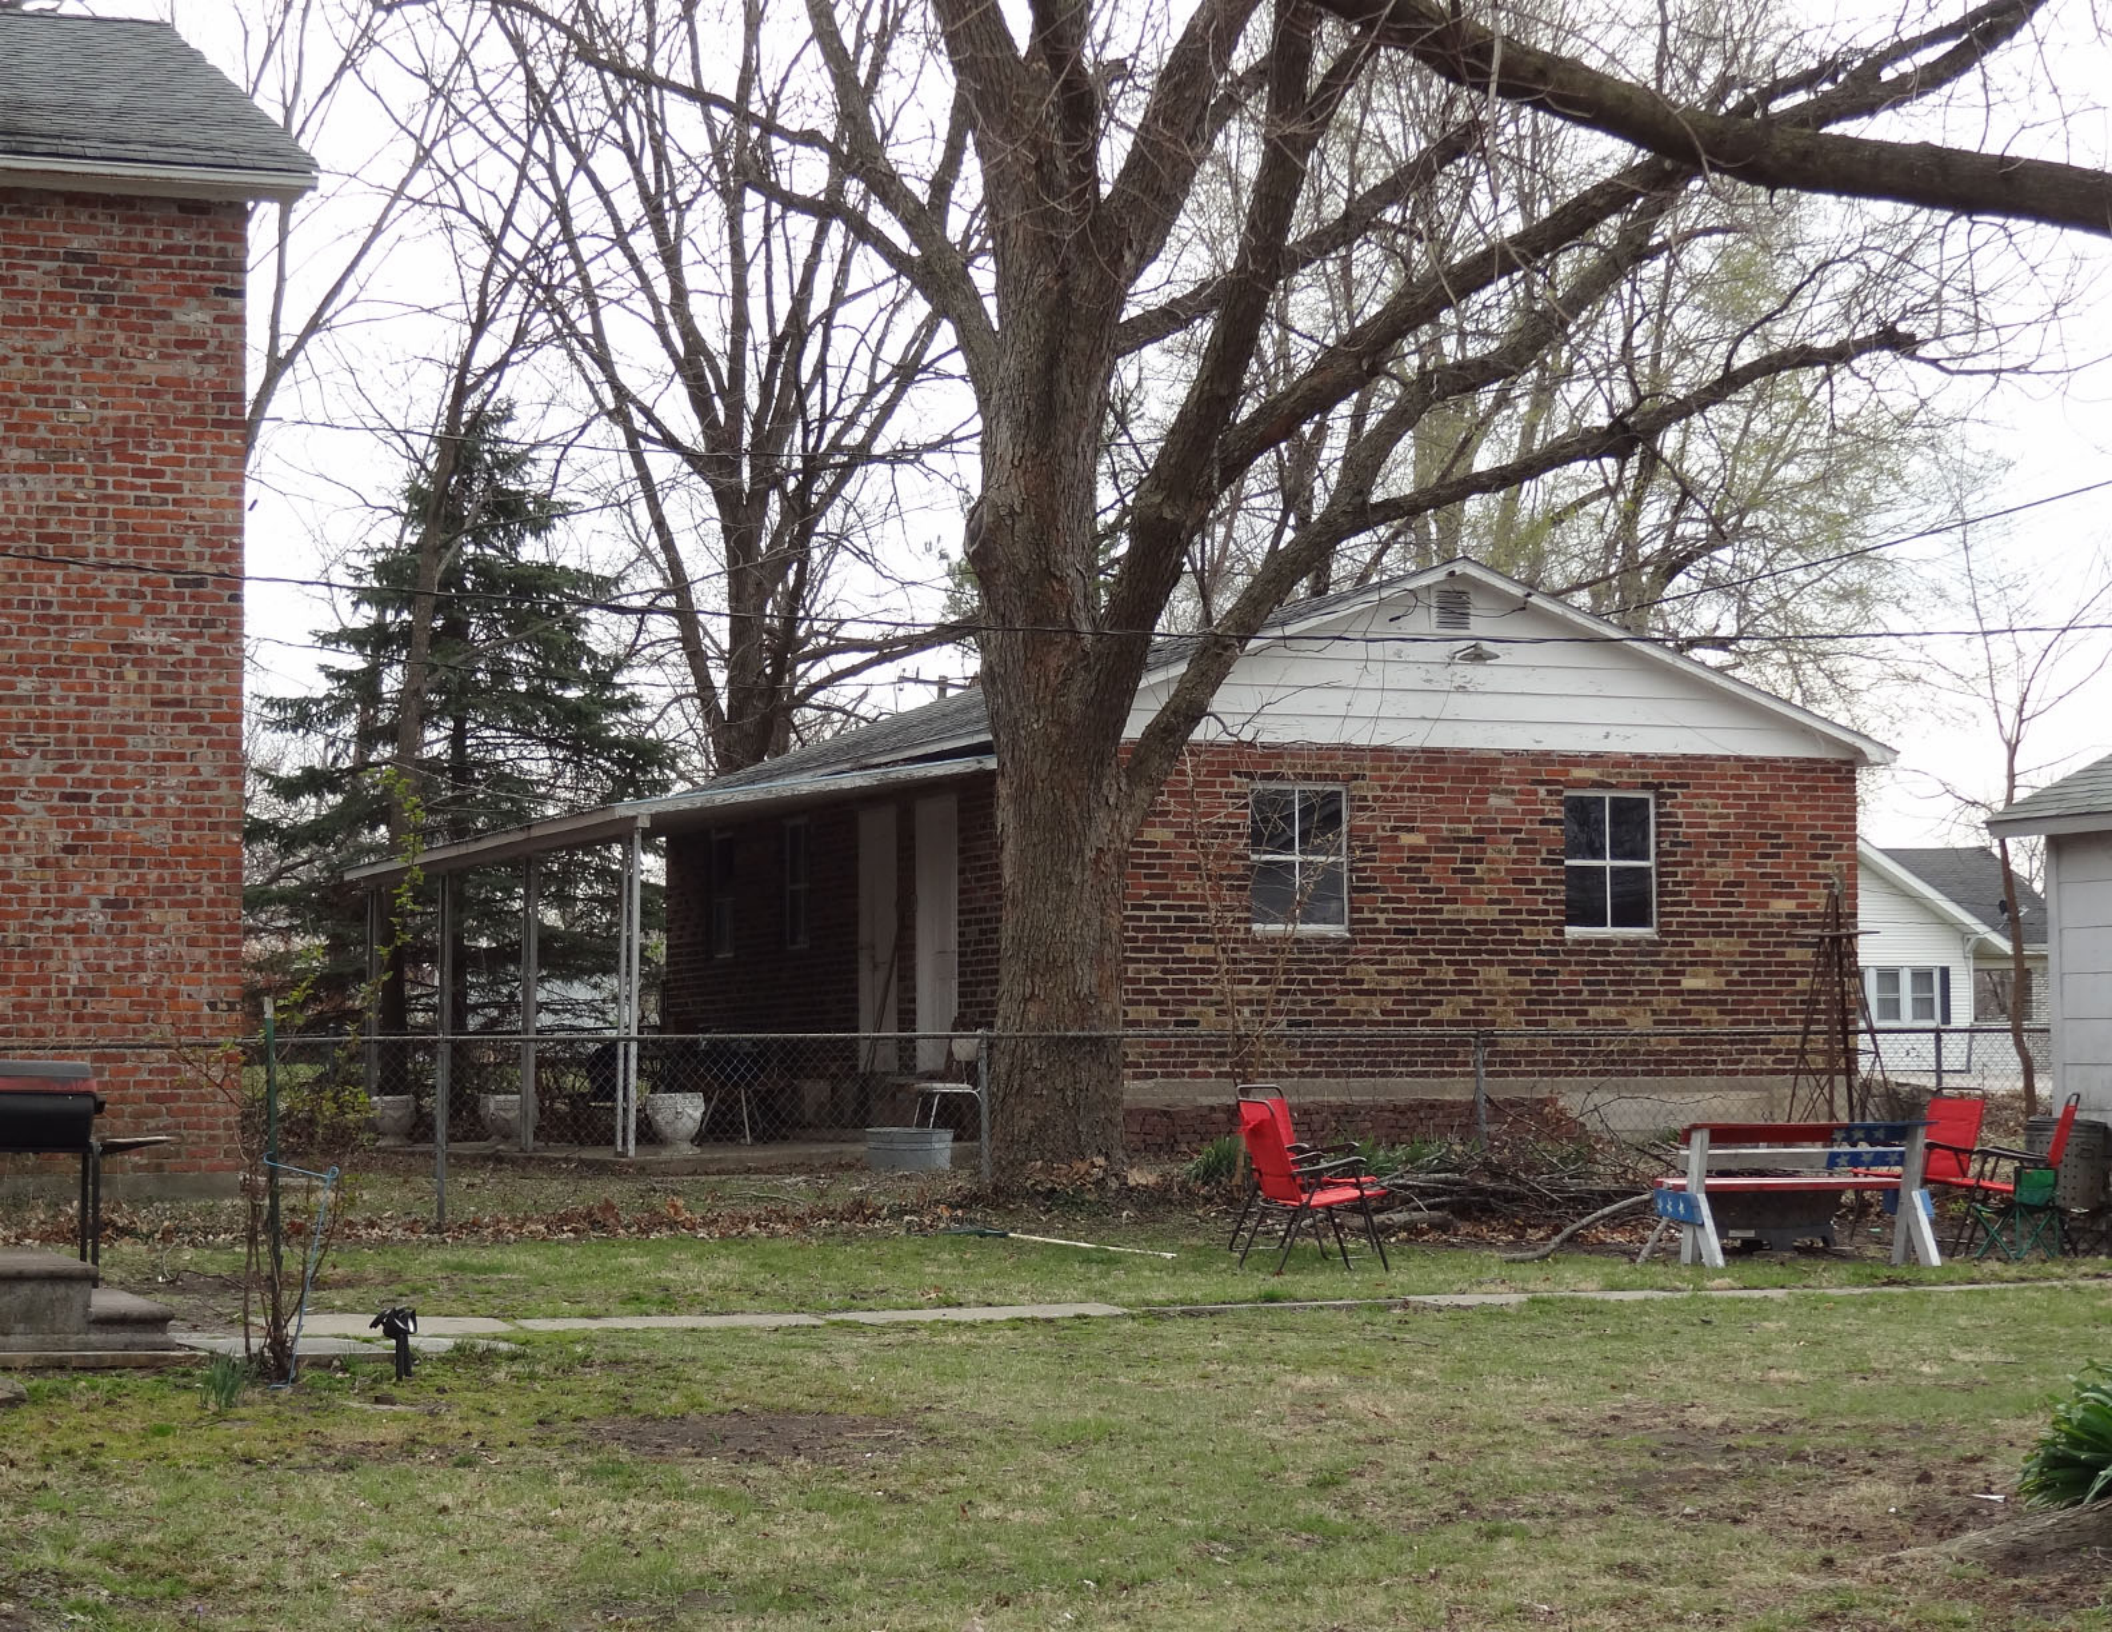
This a two story Italianate house that was constructed of brick the original house has a seven to one common bond brick pattern. The house has a two story shed roof porch on the east elevation. The porch is supported by square wood columns and has a wood railing on the second story. Under the porch is are two entrances to the house. The first entrance is on the north elevation and is wood door with a heavy metal screen door over the primary door. The second entrance is on the east wall and is difficult to see from the street but appear to have a metal screen door. The primary facade of the house has three bays that is organized symmetrically the center bay is slightly projecting and has an arched window opening with two one-over-one vinyl replacement windows and the bays to either side are blank brick walls. Moving west there is a projecting gable that has a single wood door in the north wall with a metal screen. The pattern repeats on the second story. In the front gable end there is an arched attic vent with a fanlight patter that is surrounded by fishlap singles the roof is supported by decorative brackets and there is decorative brickwork elements. The house does have a large modern brick addition to the rear that is constructed of a different color of brick and has modern one-over-one vinyl windows throughout. It is clear the addition added a second story to a portion of the historic property in addition to a new two story portion.
