MISSOURI DEPARTMENT OF NATURAL RESOURCES  
STATE HISTORIC PRESERVATION OFFICE, P.O. Box 176, Jefferson City, MO 65102  
**ARCHITECTURAL/HISTORIC INVENTORY FORM**

1. SURVEY NO. LI-AS-001-001		2. SURVEY NAME: Marceline Survey	
3. COUNTY: Linn		4. ADDRESS (STREET NO.) 275	STREET (NAME) West Broadway
5. CITY: Marceline	VICINITY: <input type="checkbox"/>	6. UTM: / /	7. TOWNSHIP/RANGE/SECTION: T: R: S:

8. HISTORIC NAME (IF KNOWN): Walt Disney's Childhood Home		9. PRESENT/OTHER NAME (IF KNOWN): Walt Disney's Childhood Home	
10. OWNERSHIP: <input checked="" type="checkbox"/> PRIVATE <input type="checkbox"/> PUBLIC		11A. HISTORIC USE (IF KNOWN): Single Dwelling	11B. CURRENT USE: Single Dwelling
<b>HISTORICAL INFORMATION</b>

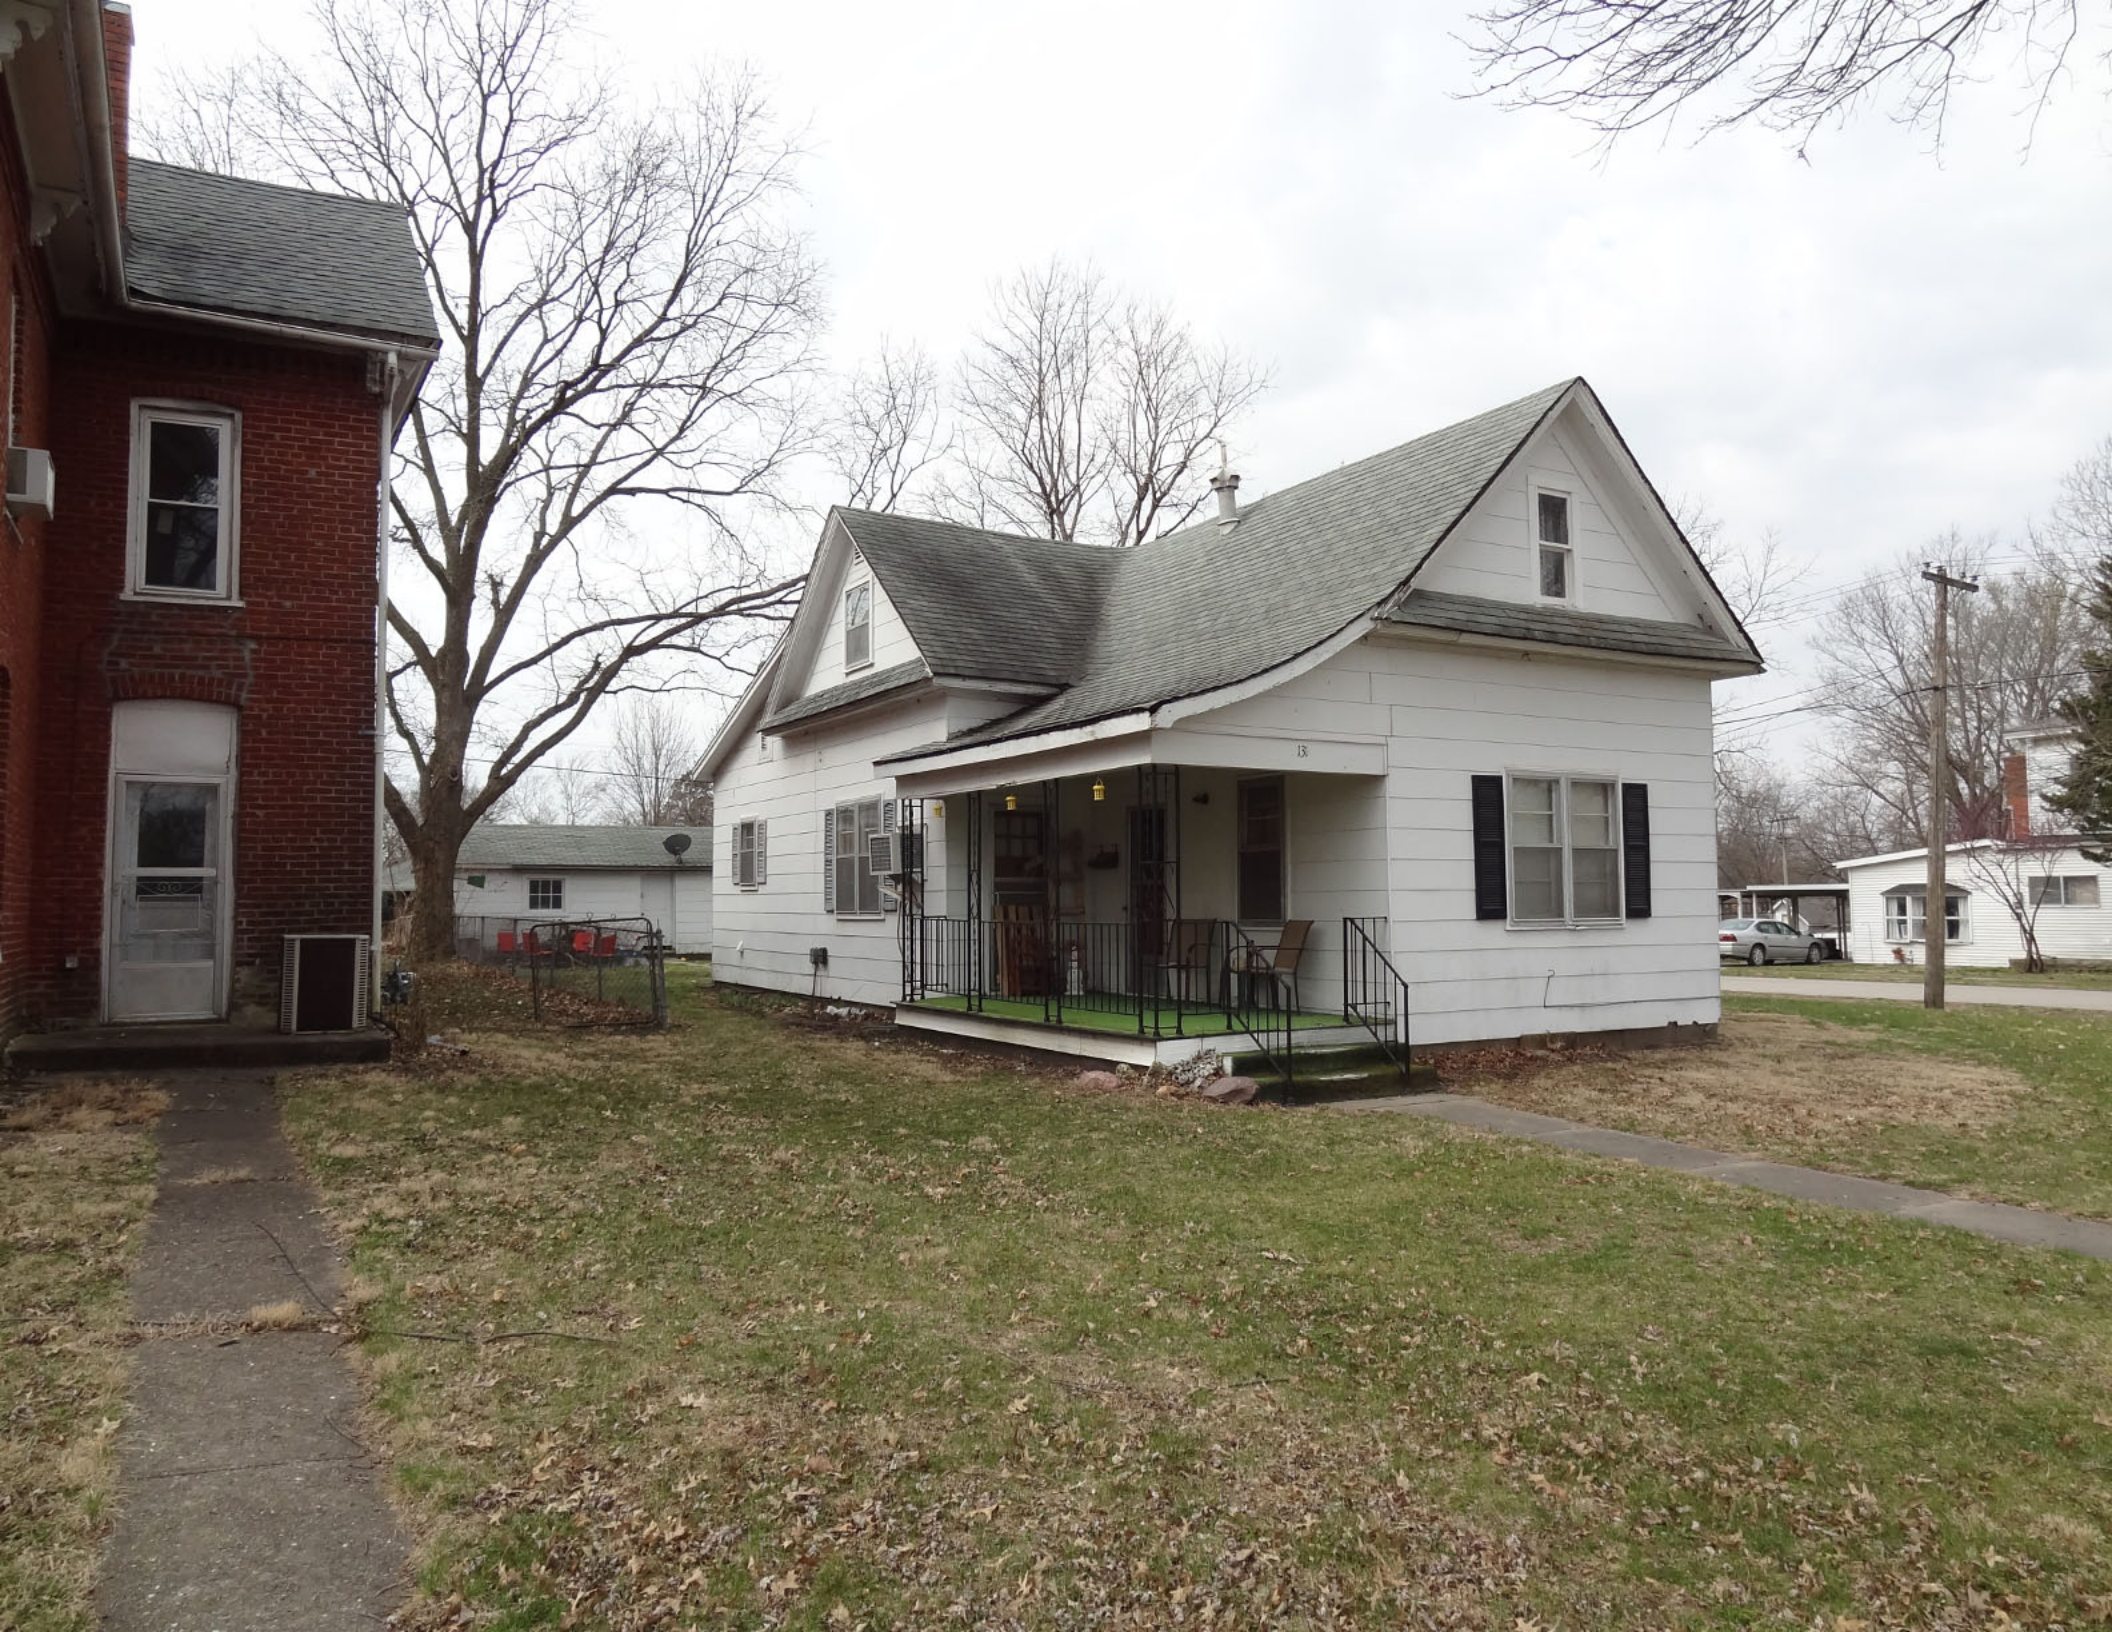
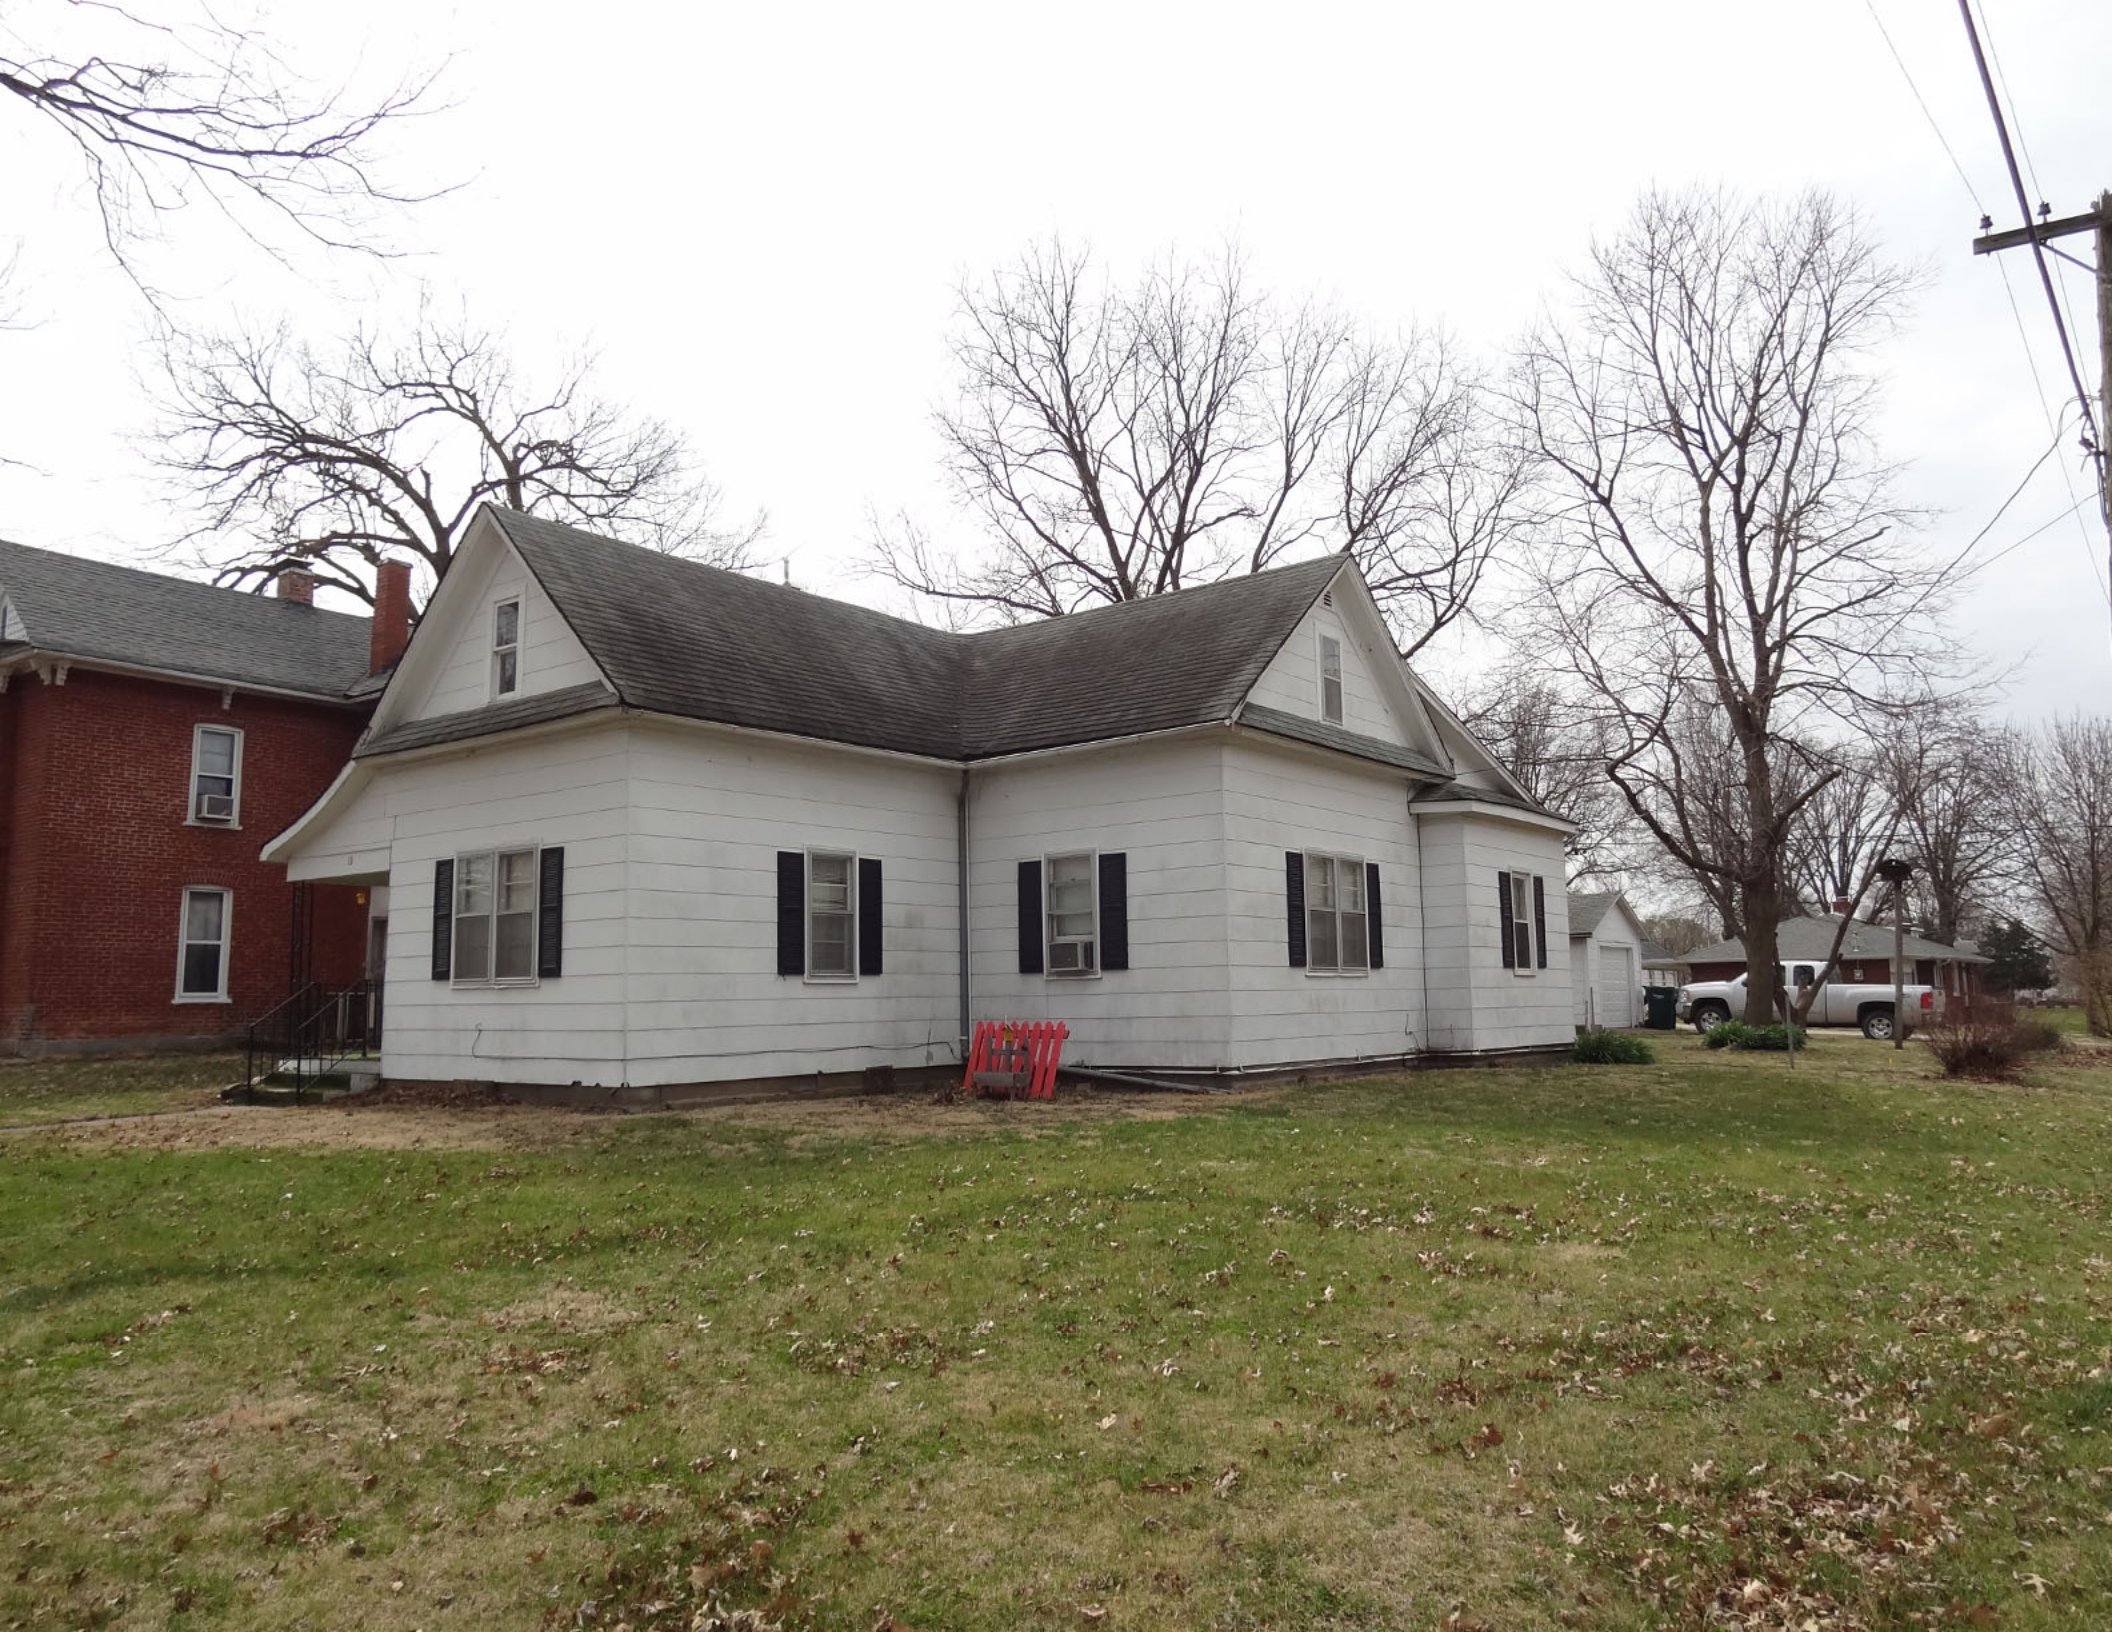
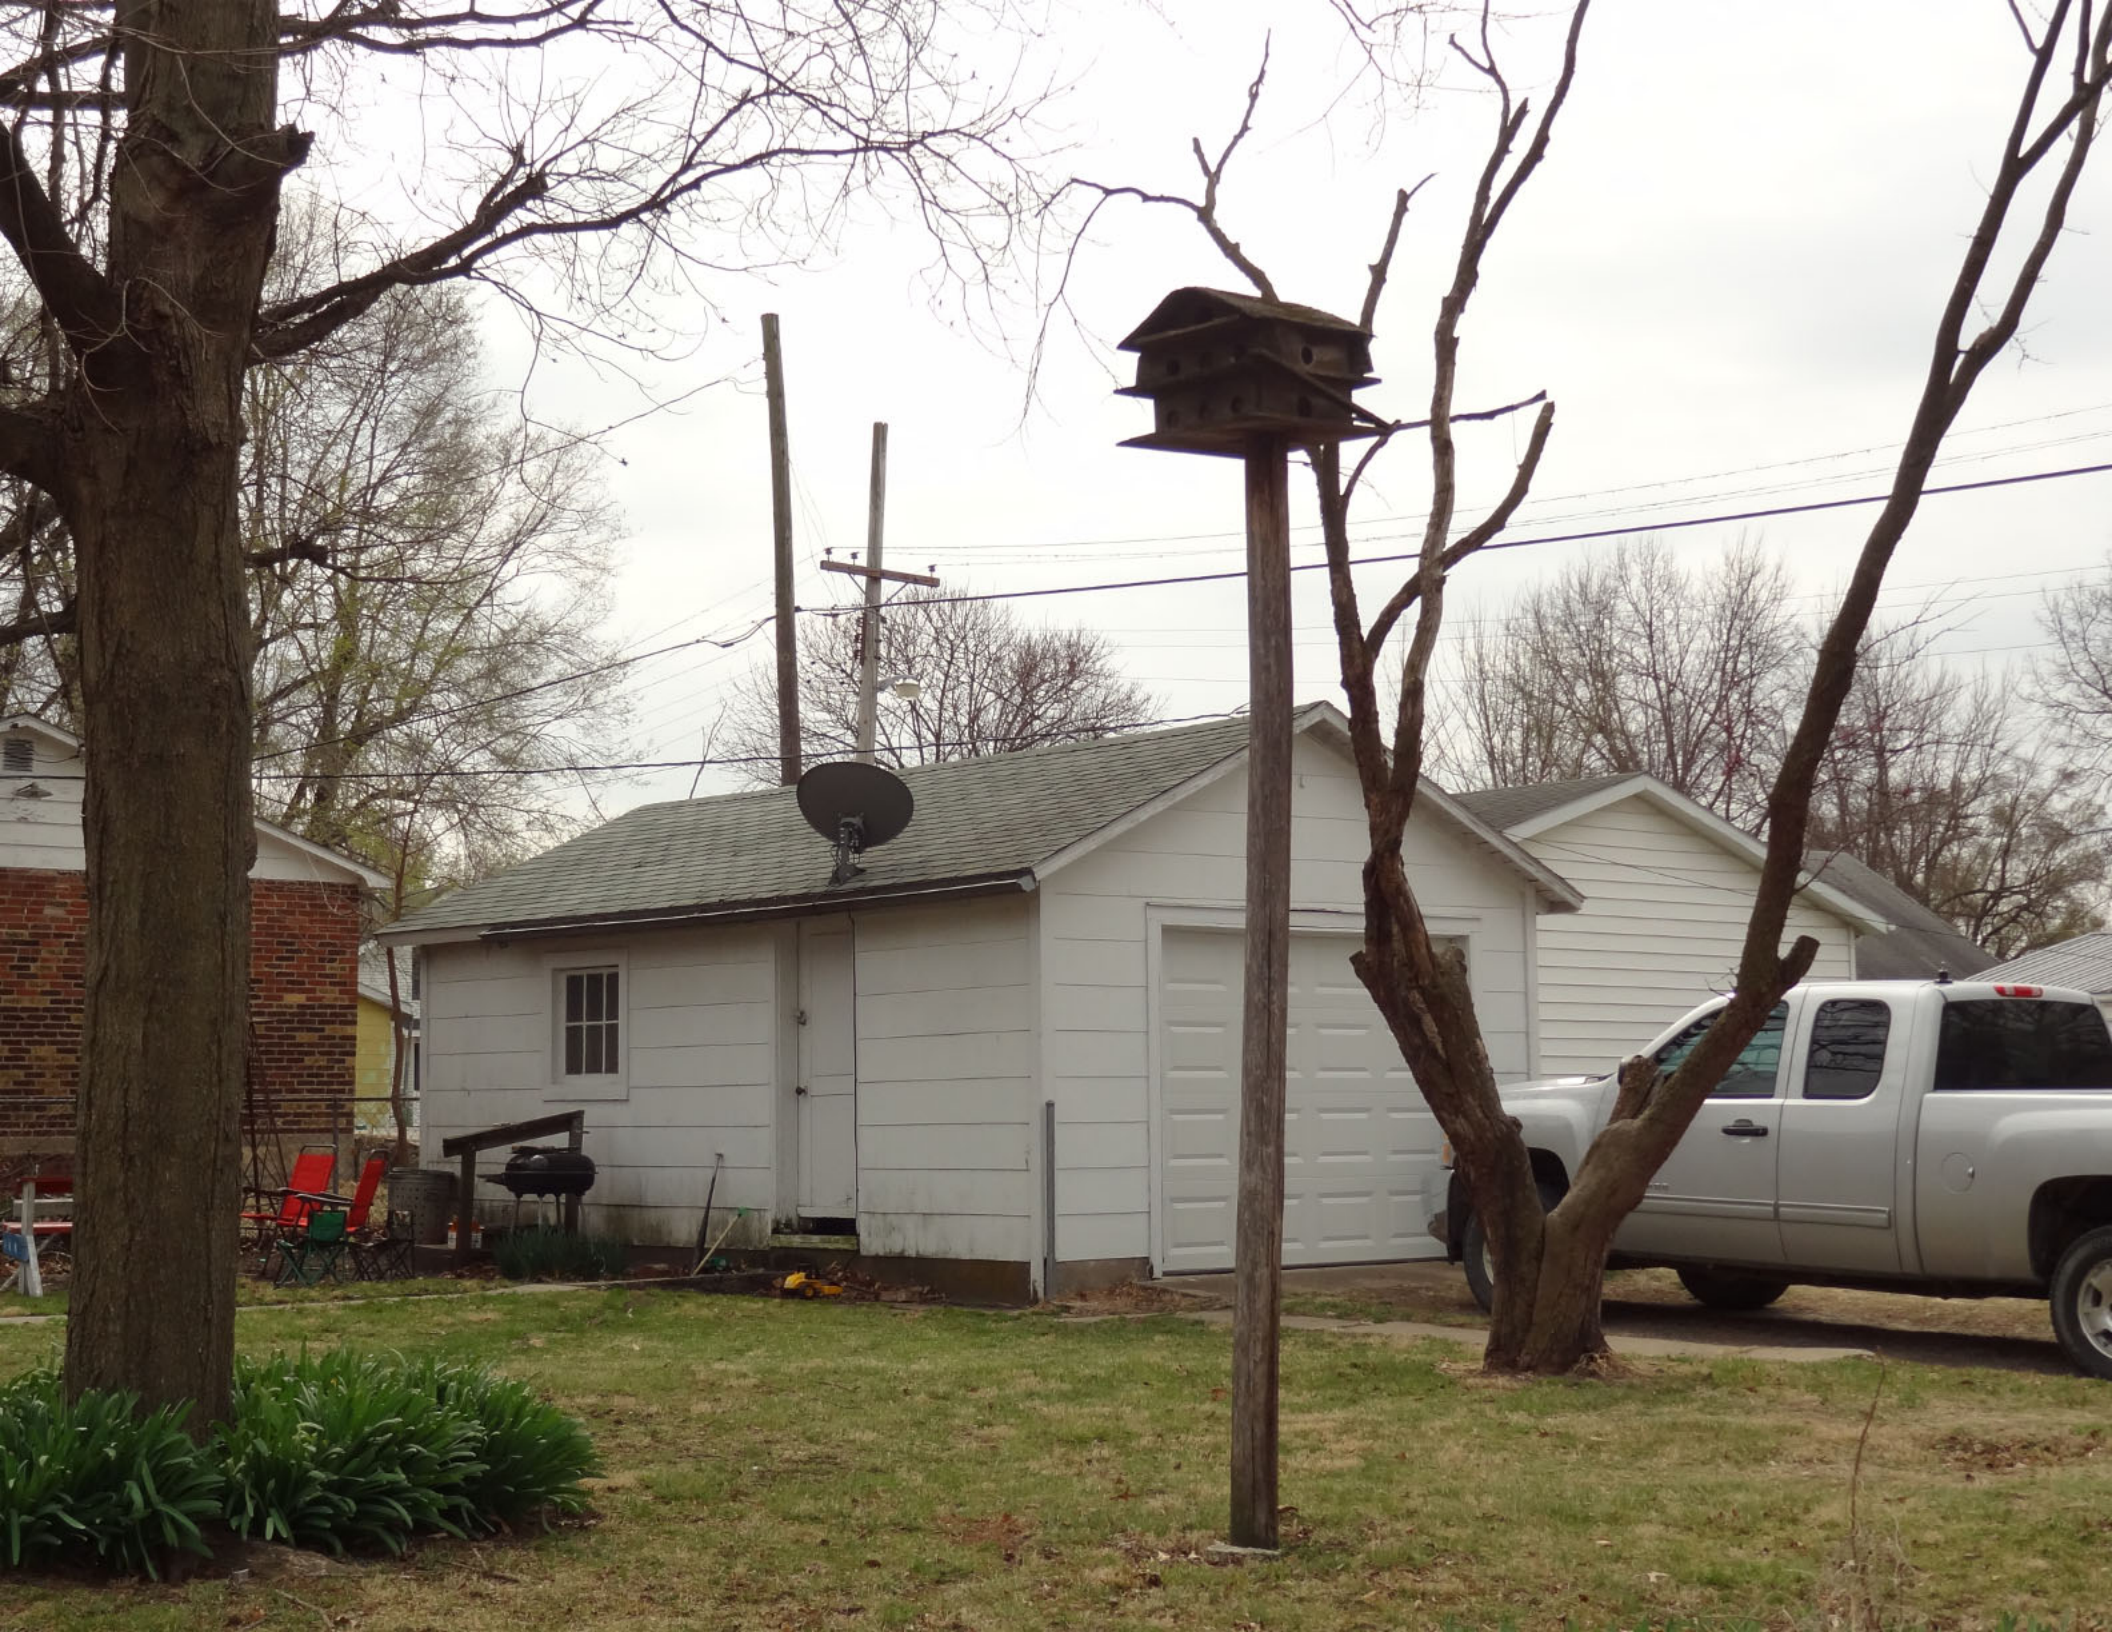
The roof is cross-gabled. In the front gable end of the house has a small one-over-one wood window.

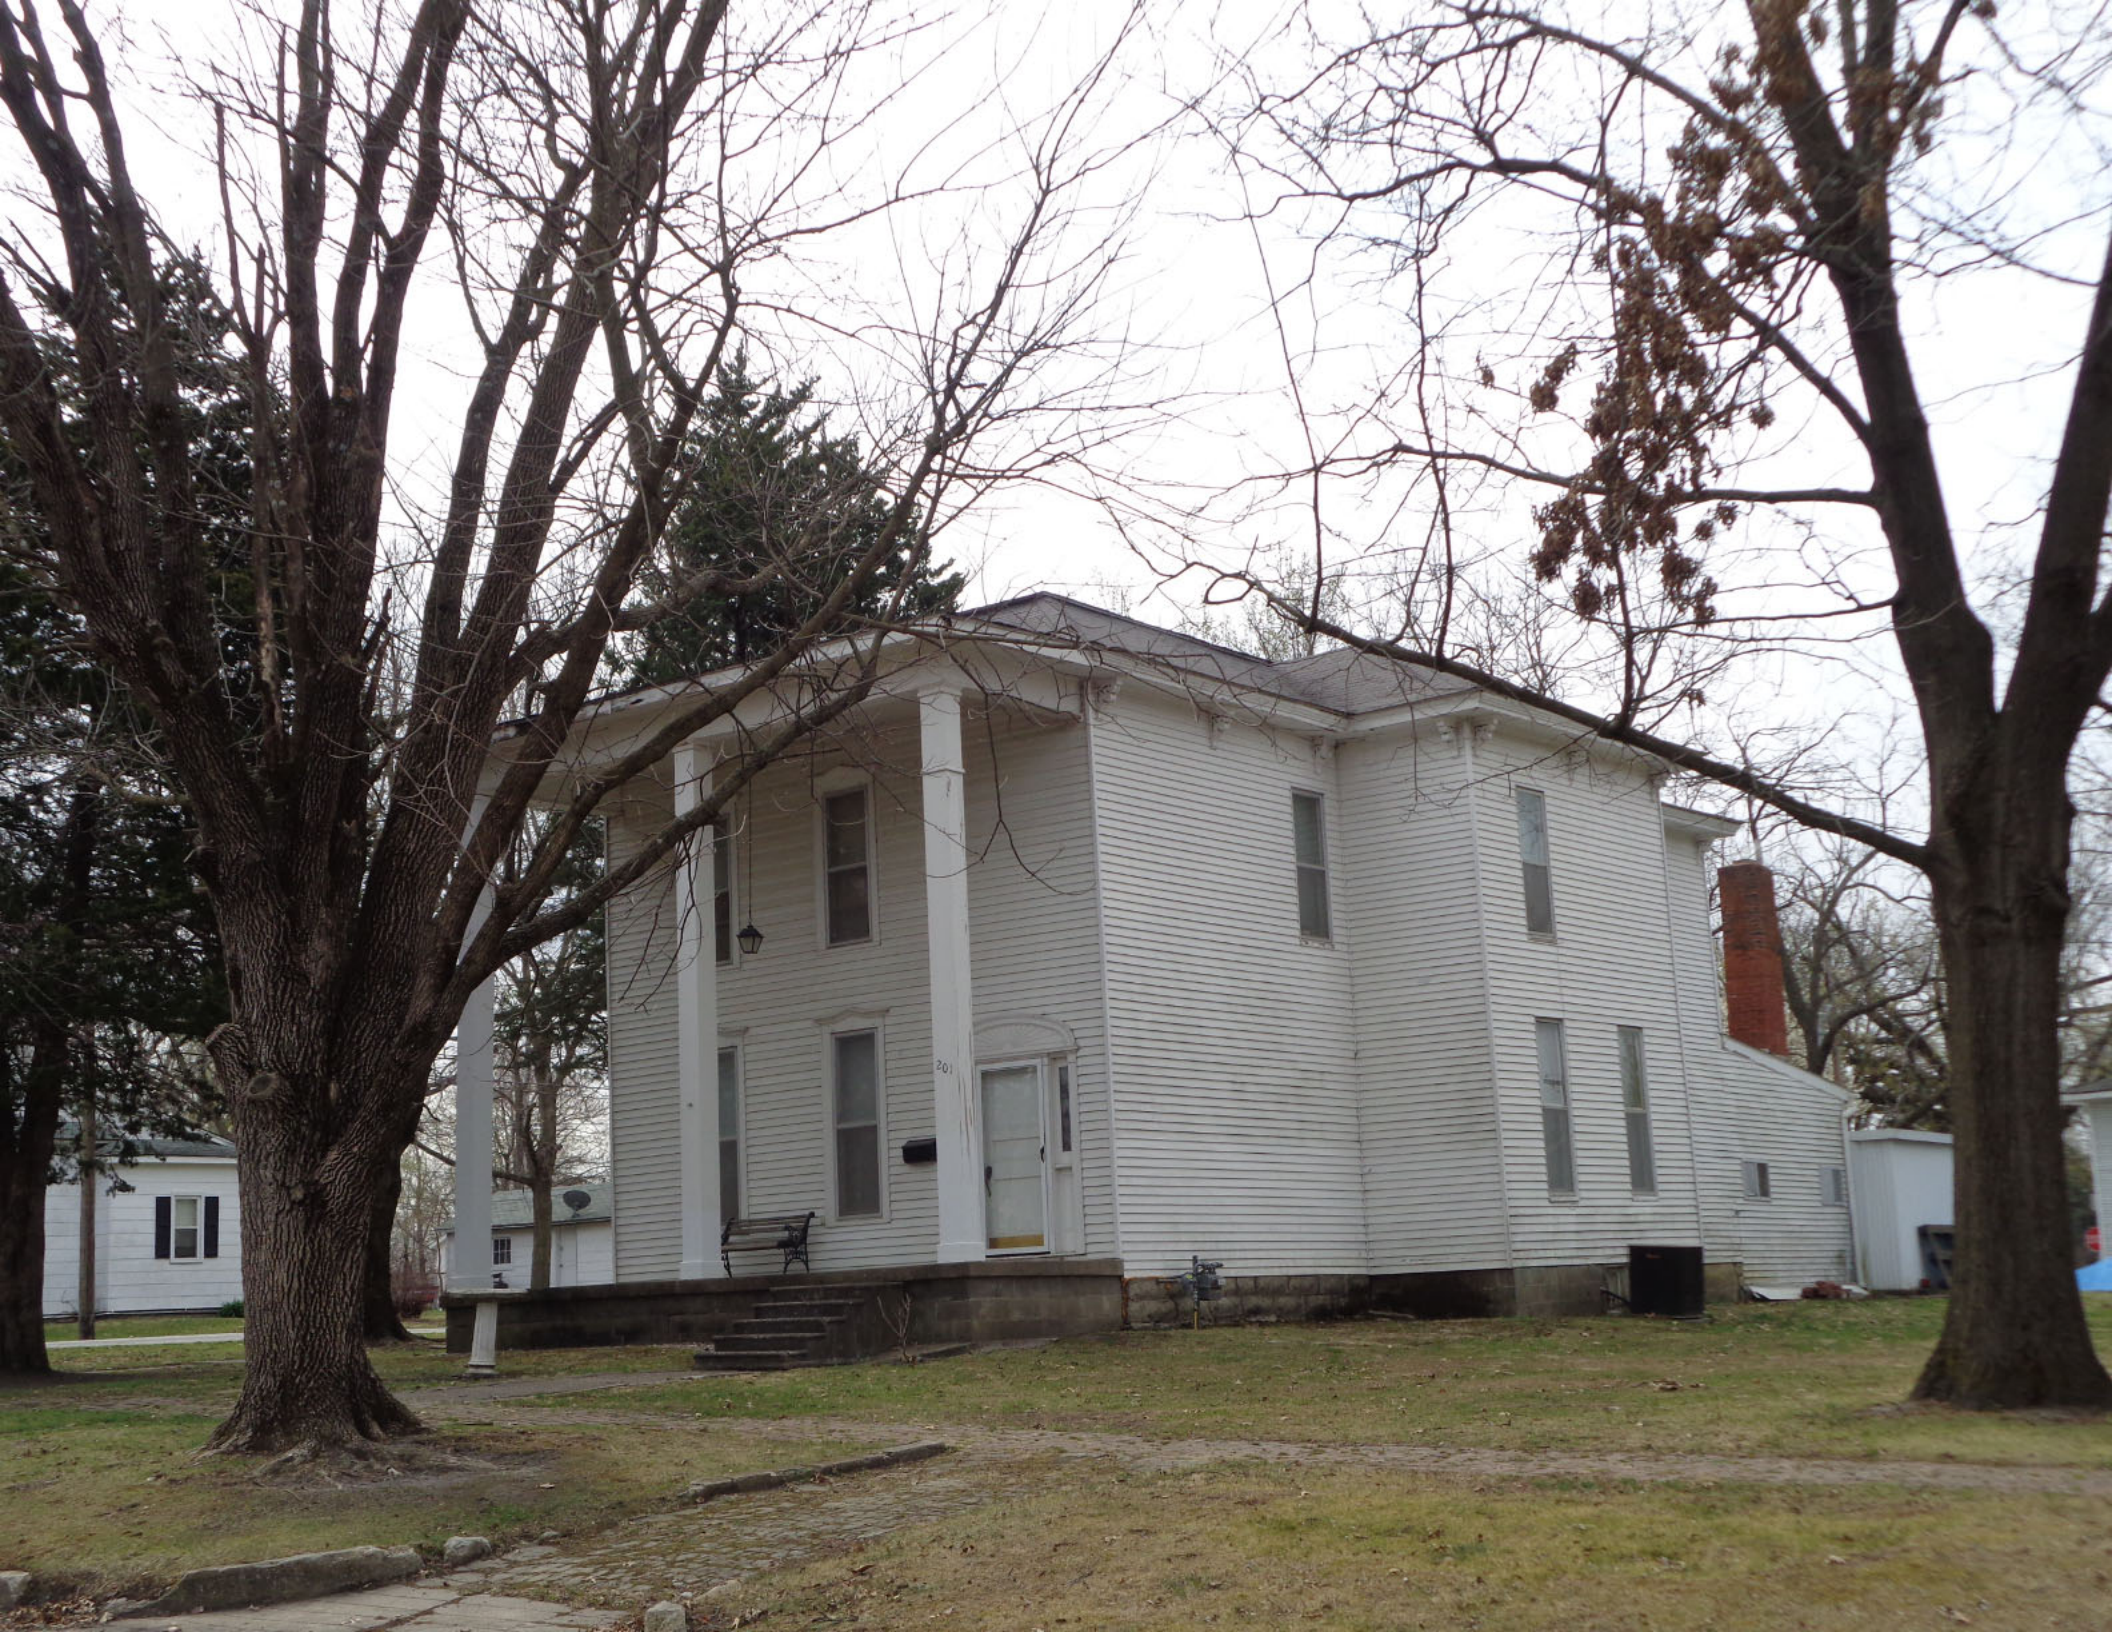
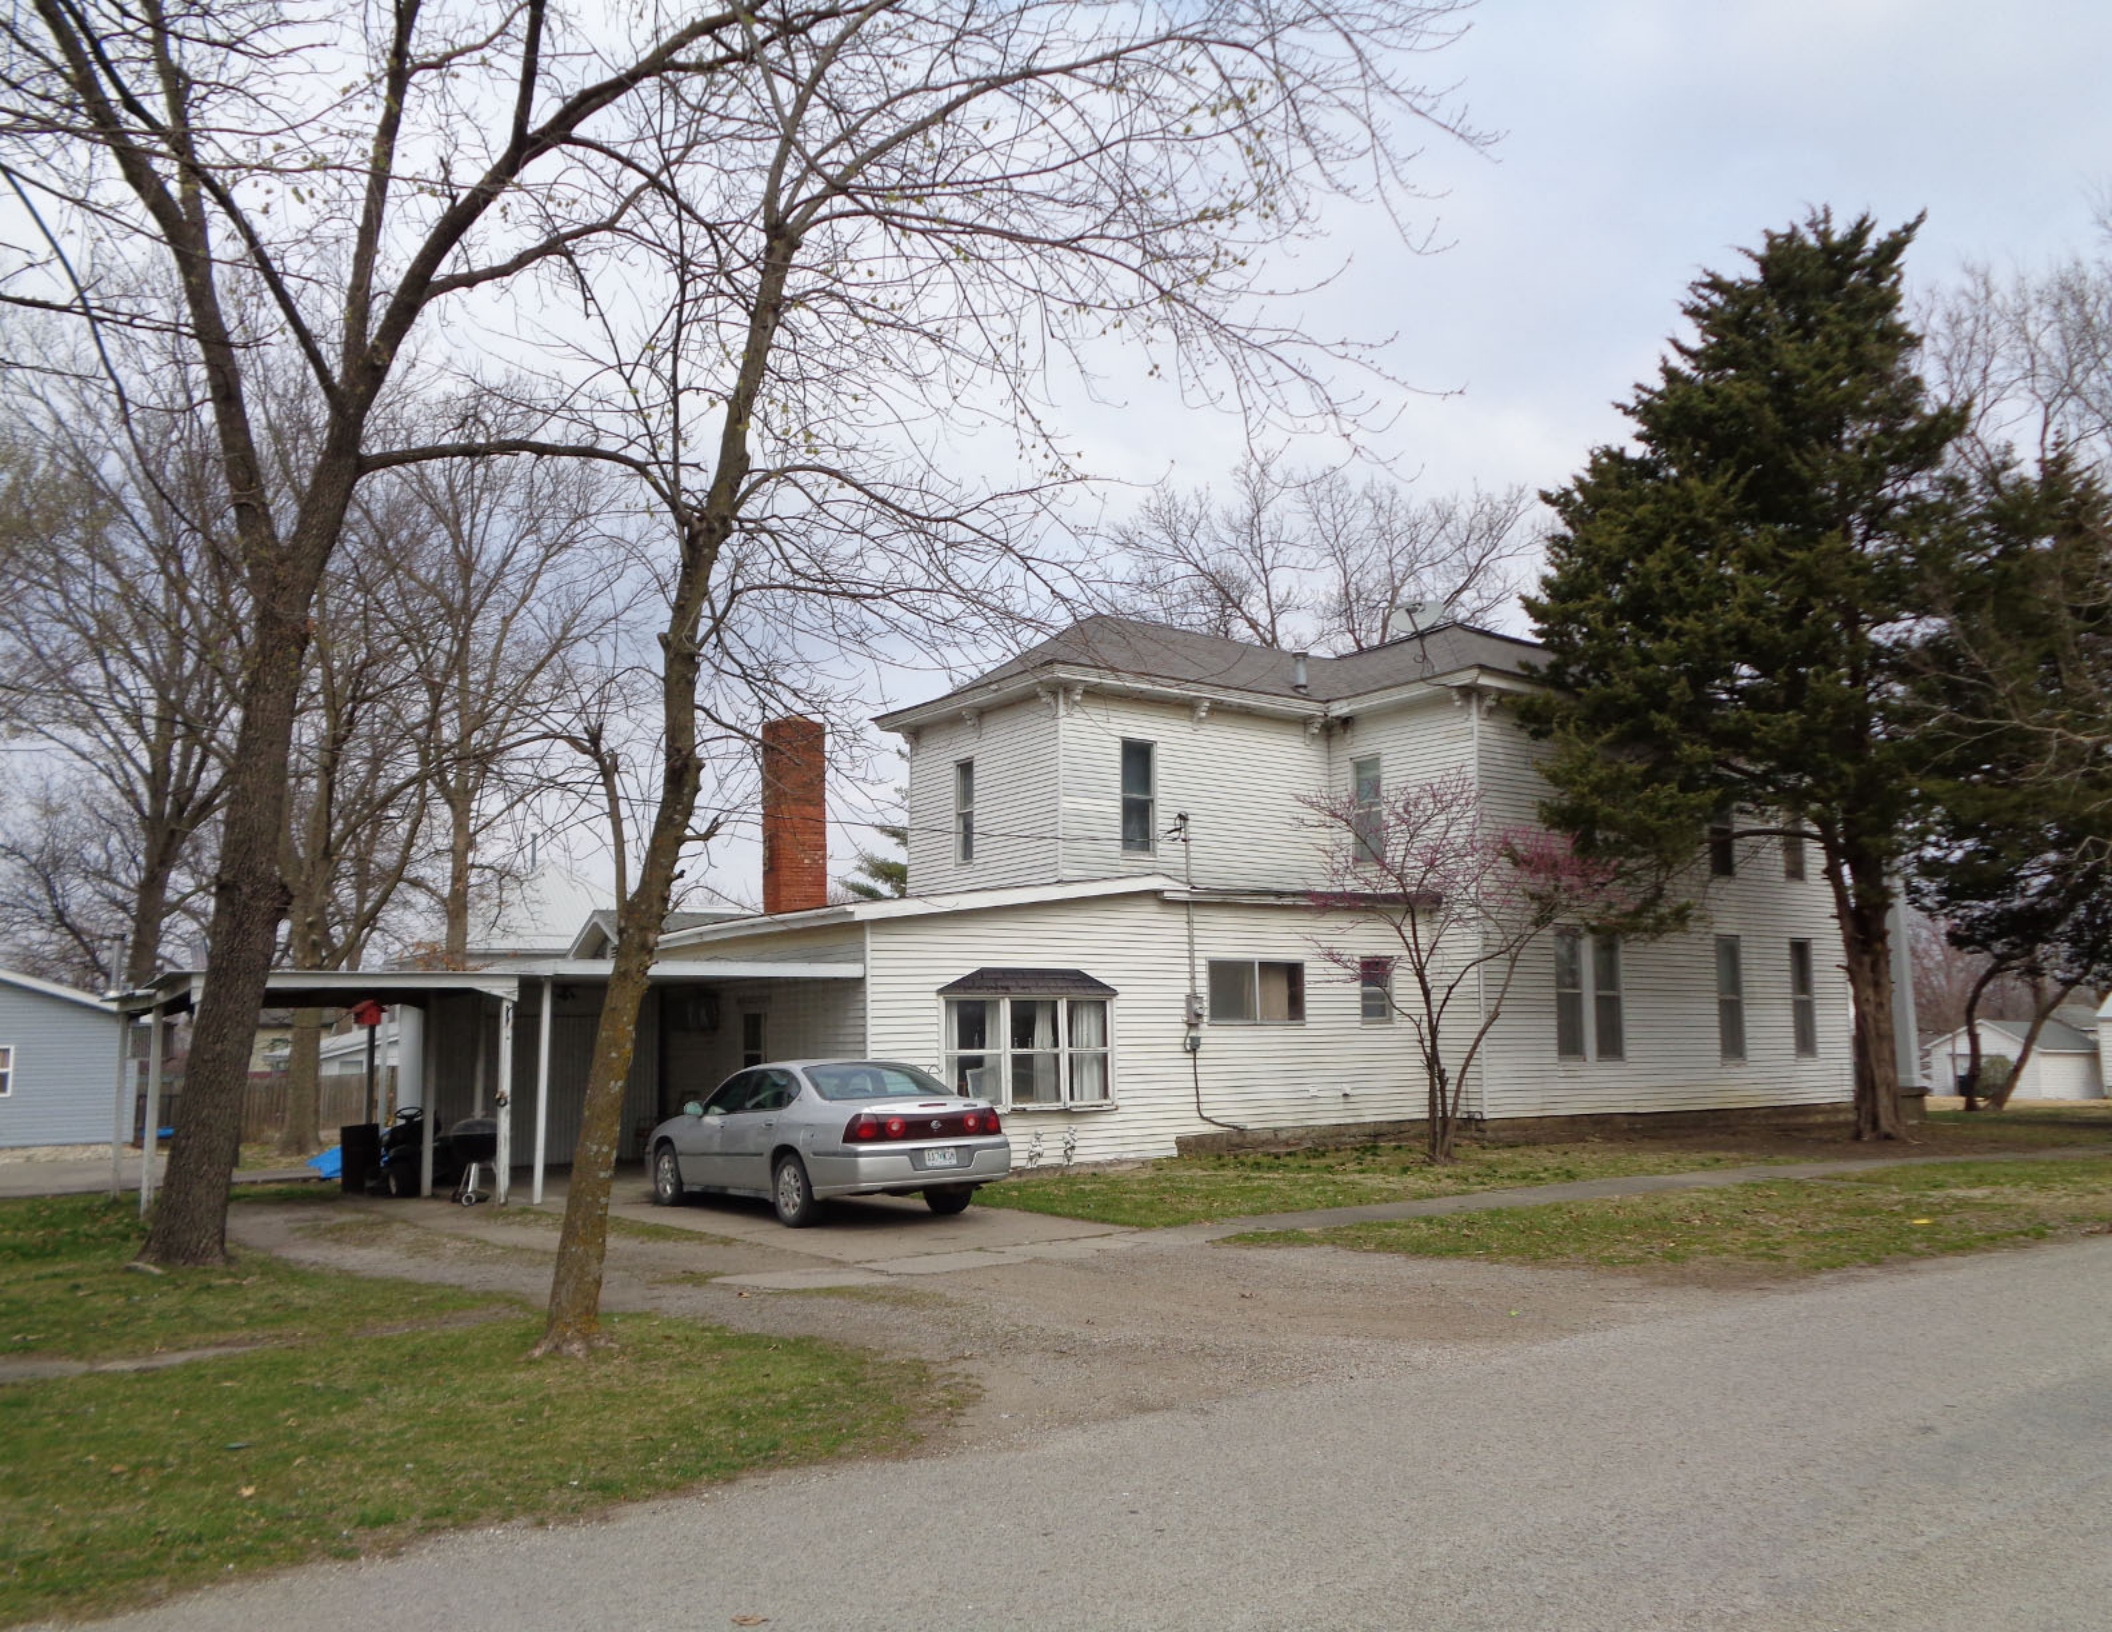
This is a two-story building with elements of the Neoclassical style. The facade has a large two-story full-width porch with three square support columns. The primary entrance is located in the western most bay; the solid door is flanked by side-lights and has a fan over the door. To the east is a single one-over-one metal replacement window with a decorative window crown. The next bay to the east has an identical window. The second level of the facade has two windows placed over the windows on the lower level. The western most bay in the second story is blank. The elements of Greek Revival styling appear to have been added later, the Sanborn Maps from 1911-1939 illustrate a single story porch. The house also has decorative roof brackets. The house has two additions. The first is a small addition on the east side of the rear of the building, this was a one-story porch that was infilled. The porch appears to have been constructed early in the history of building and appears on the 1911 sanborn map. A second addition was added later to the rear of the property; it is estimated this addition took place c. 1980. The addition is small and has a shed roof and bay window and the chimney is located in this addition. Two carports are also attached to the rear of the building.
