MISSOURI DEPARTMENT OF NATURAL RESOURCES  
STATE HISTORIC PRESERVATION OFFICE, P.O. Box 176, Jefferson City, MO 65102  
**ARCHITECTURAL/HISTORIC INVENTORY FORM**

1. SURVEY NO. LI-AS-001-001		2. SURVEY NAME: Marceline Survey	
3. COUNTY: Linn		4. ADDRESS (STREET NO.) 275	STREET (NAME) West Broadway
5. CITY: Marceline	VICINITY: <input type="checkbox"/>	6. UTM: / /	7. TOWNSHIP/RANGE/SECTION: T: R: S:

8. HISTORIC NAME (IF KNOWN): Walt Disney's Childhood Home		9. PRESENT/OTHER NAME (IF KNOWN): Walt Disney's Childhood Home	
10. OWNERSHIP: <input checked="" type="checkbox"/> PRIVATE <input type="checkbox"/> PUBLIC		11A. HISTORIC USE (IF KNOWN): Single Dwelling	11B. CURRENT USE: Single Dwelling
<b>HISTORICAL INFORMATION</b>

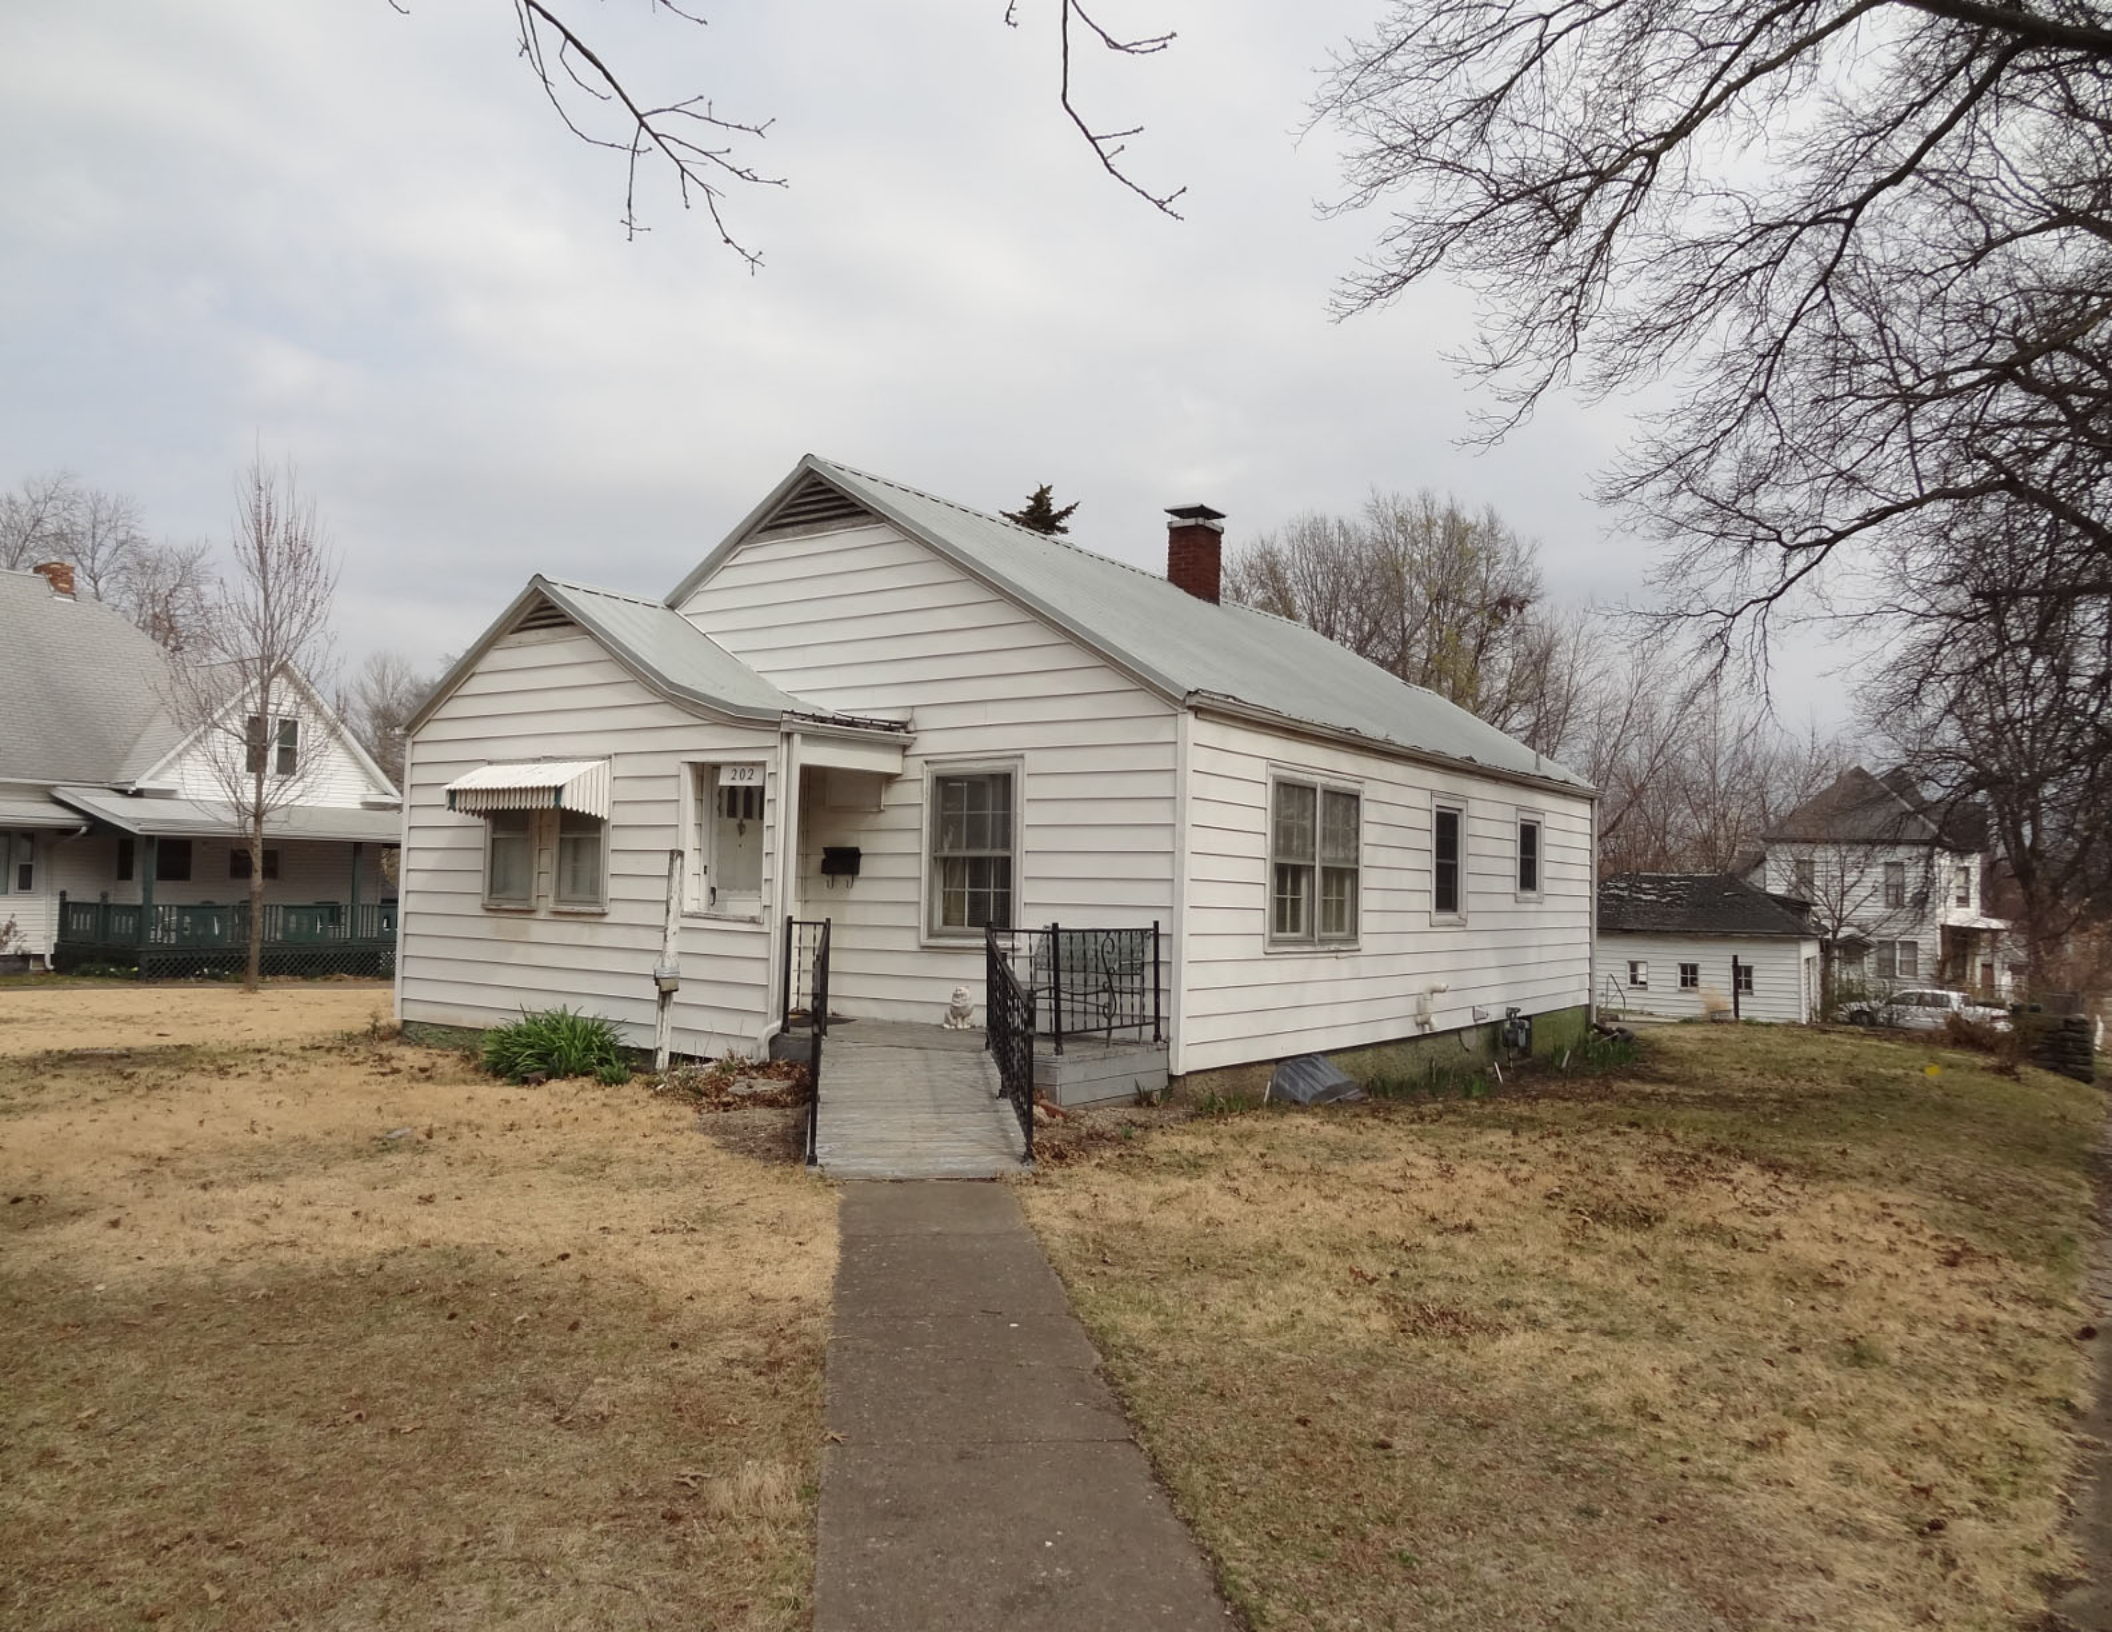
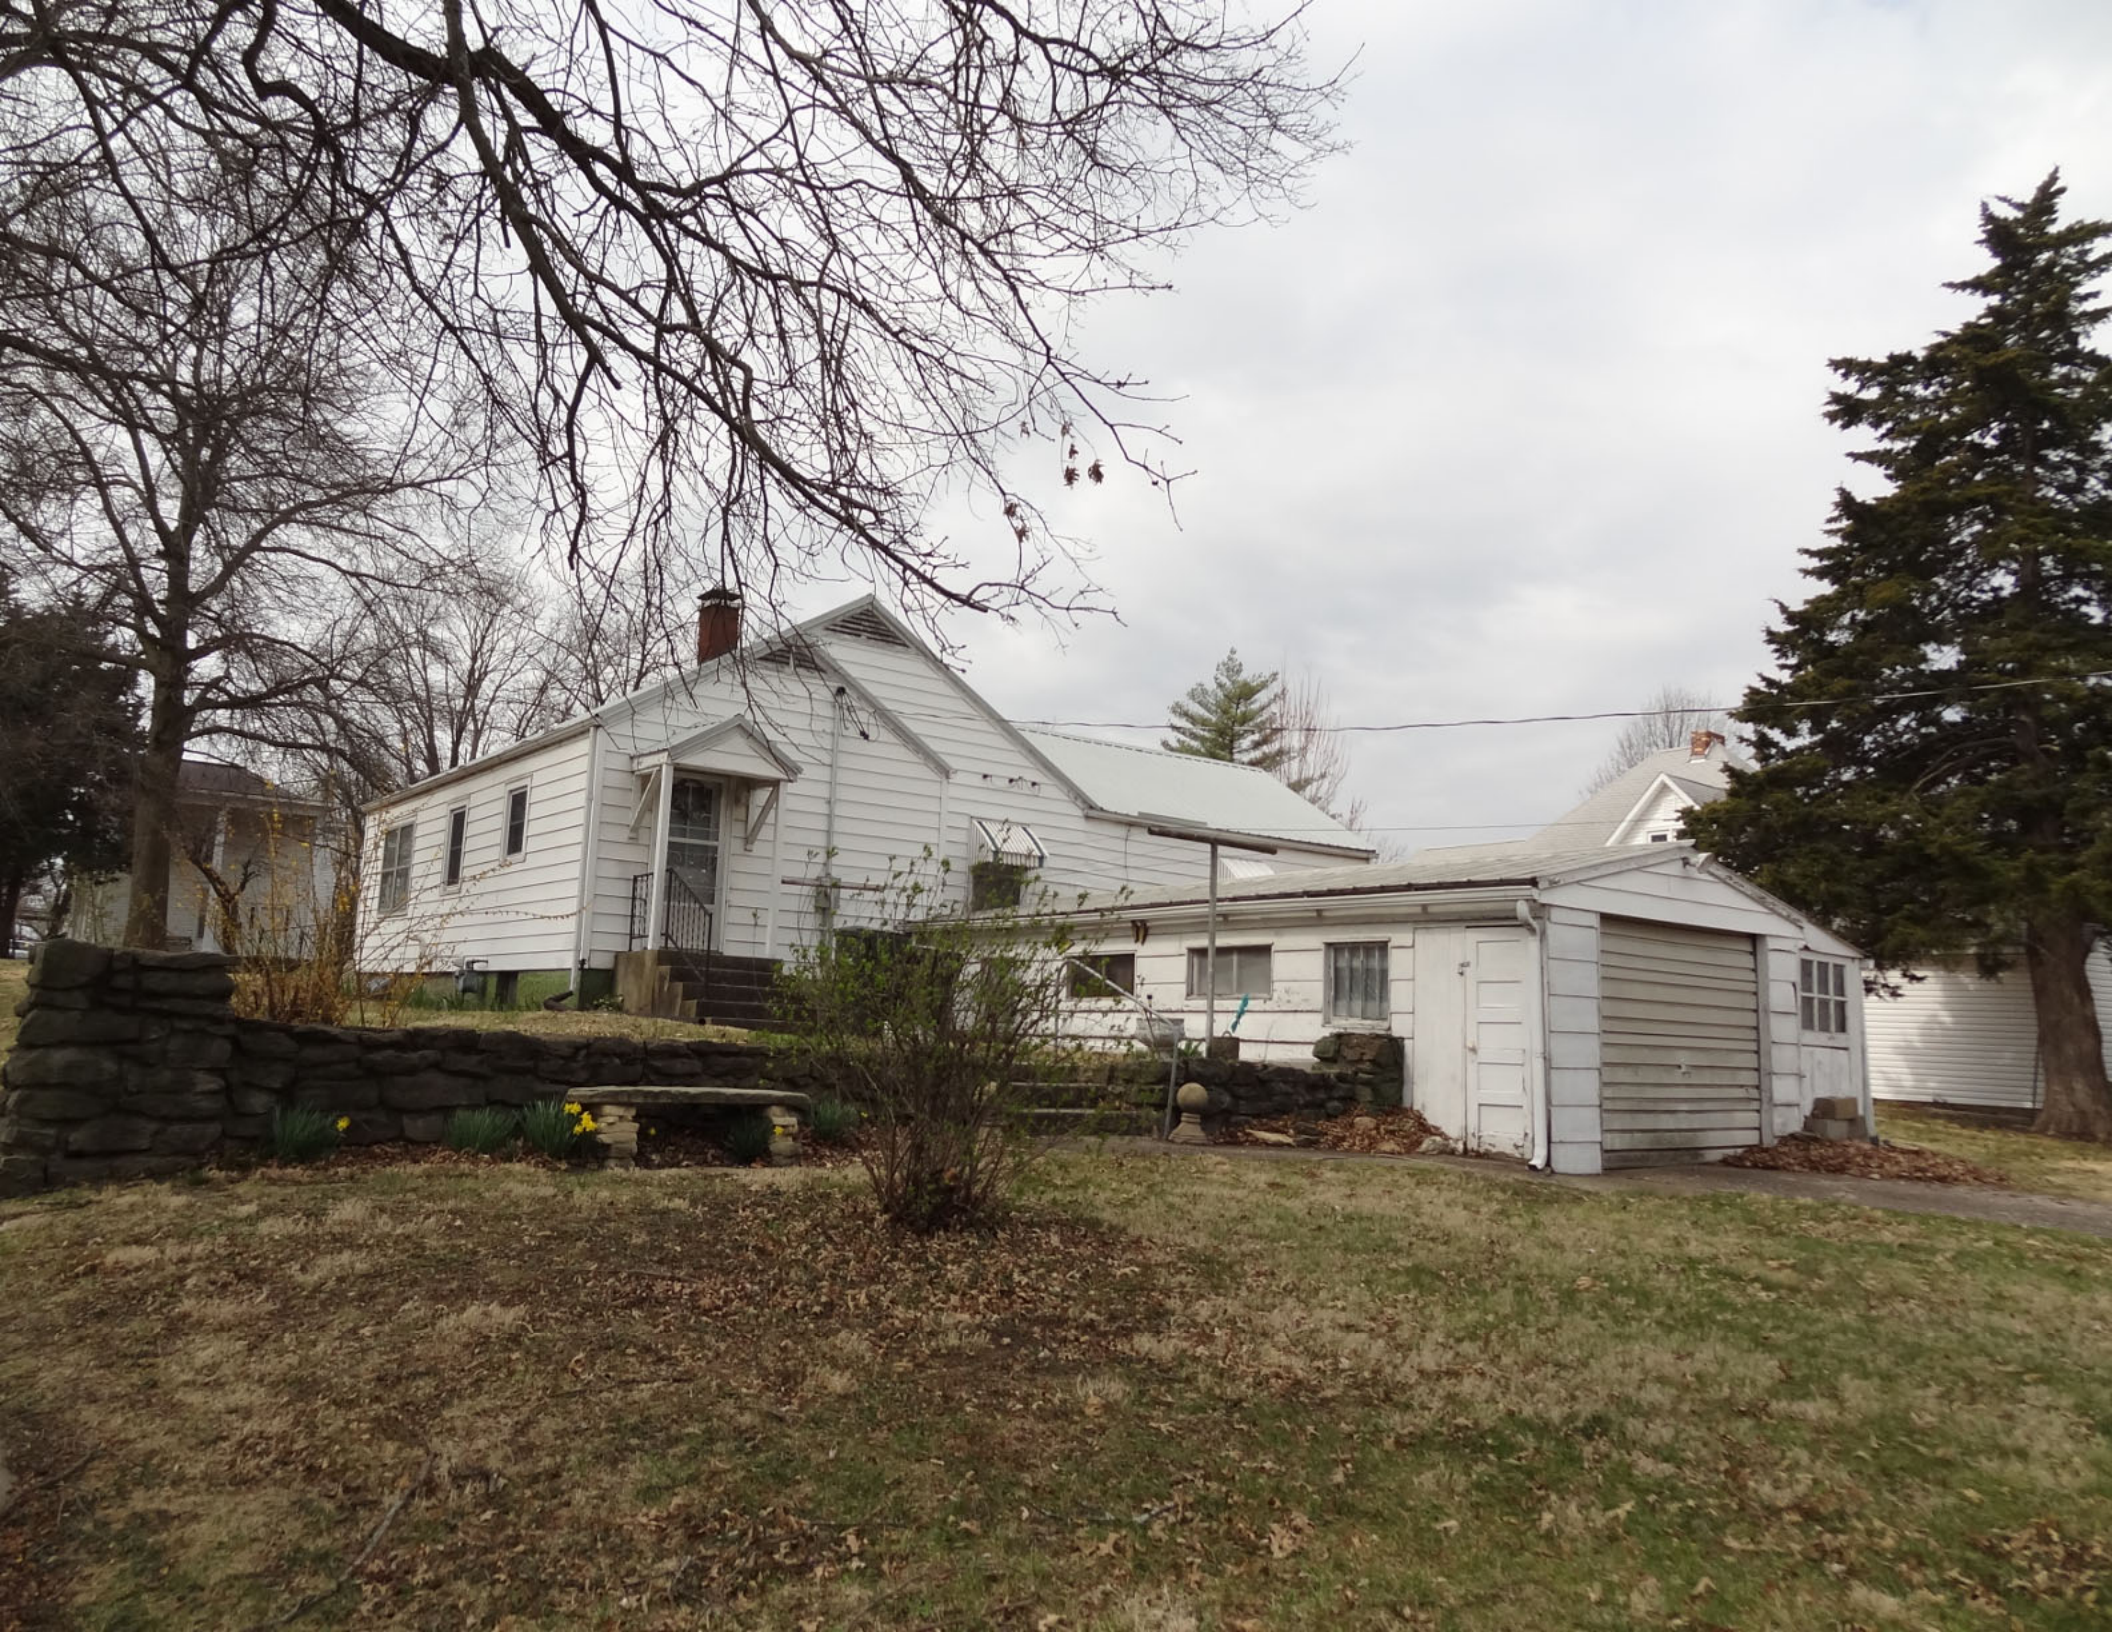
This is a simple 1 story front-gabled home with asbestos siding and a metal roof. Windows are sash. A front-gabled bump out on the western half of the facade has two 4 over 4 windows with an awning. The east facing side of the bump out houses the entrance with several small lights and a door knocker visible behind a storm door. The bump out roof extends out slightly to shelter the entrance which opens onto a platform stoop with a wood ramp and black metal railings. East of the bump out is a 6 over 6 window. The windows appear historic. The site slopes down slightly towards the rear, exposing more of the concrete foundation towards the back of the property and allowing the post 1939 garage addition at the back of the home to be situated at a lower grade. The rear of the home also has a bump out with a small covered stoop with concrete steps and a single metal railing. Another set of concrete steps lead to a sidewalk level with the garage addition. The garage has what look like historic doors and windows of various configurations. What appears to be another addition (post 1939) extends out to the west of the main home as a wing.

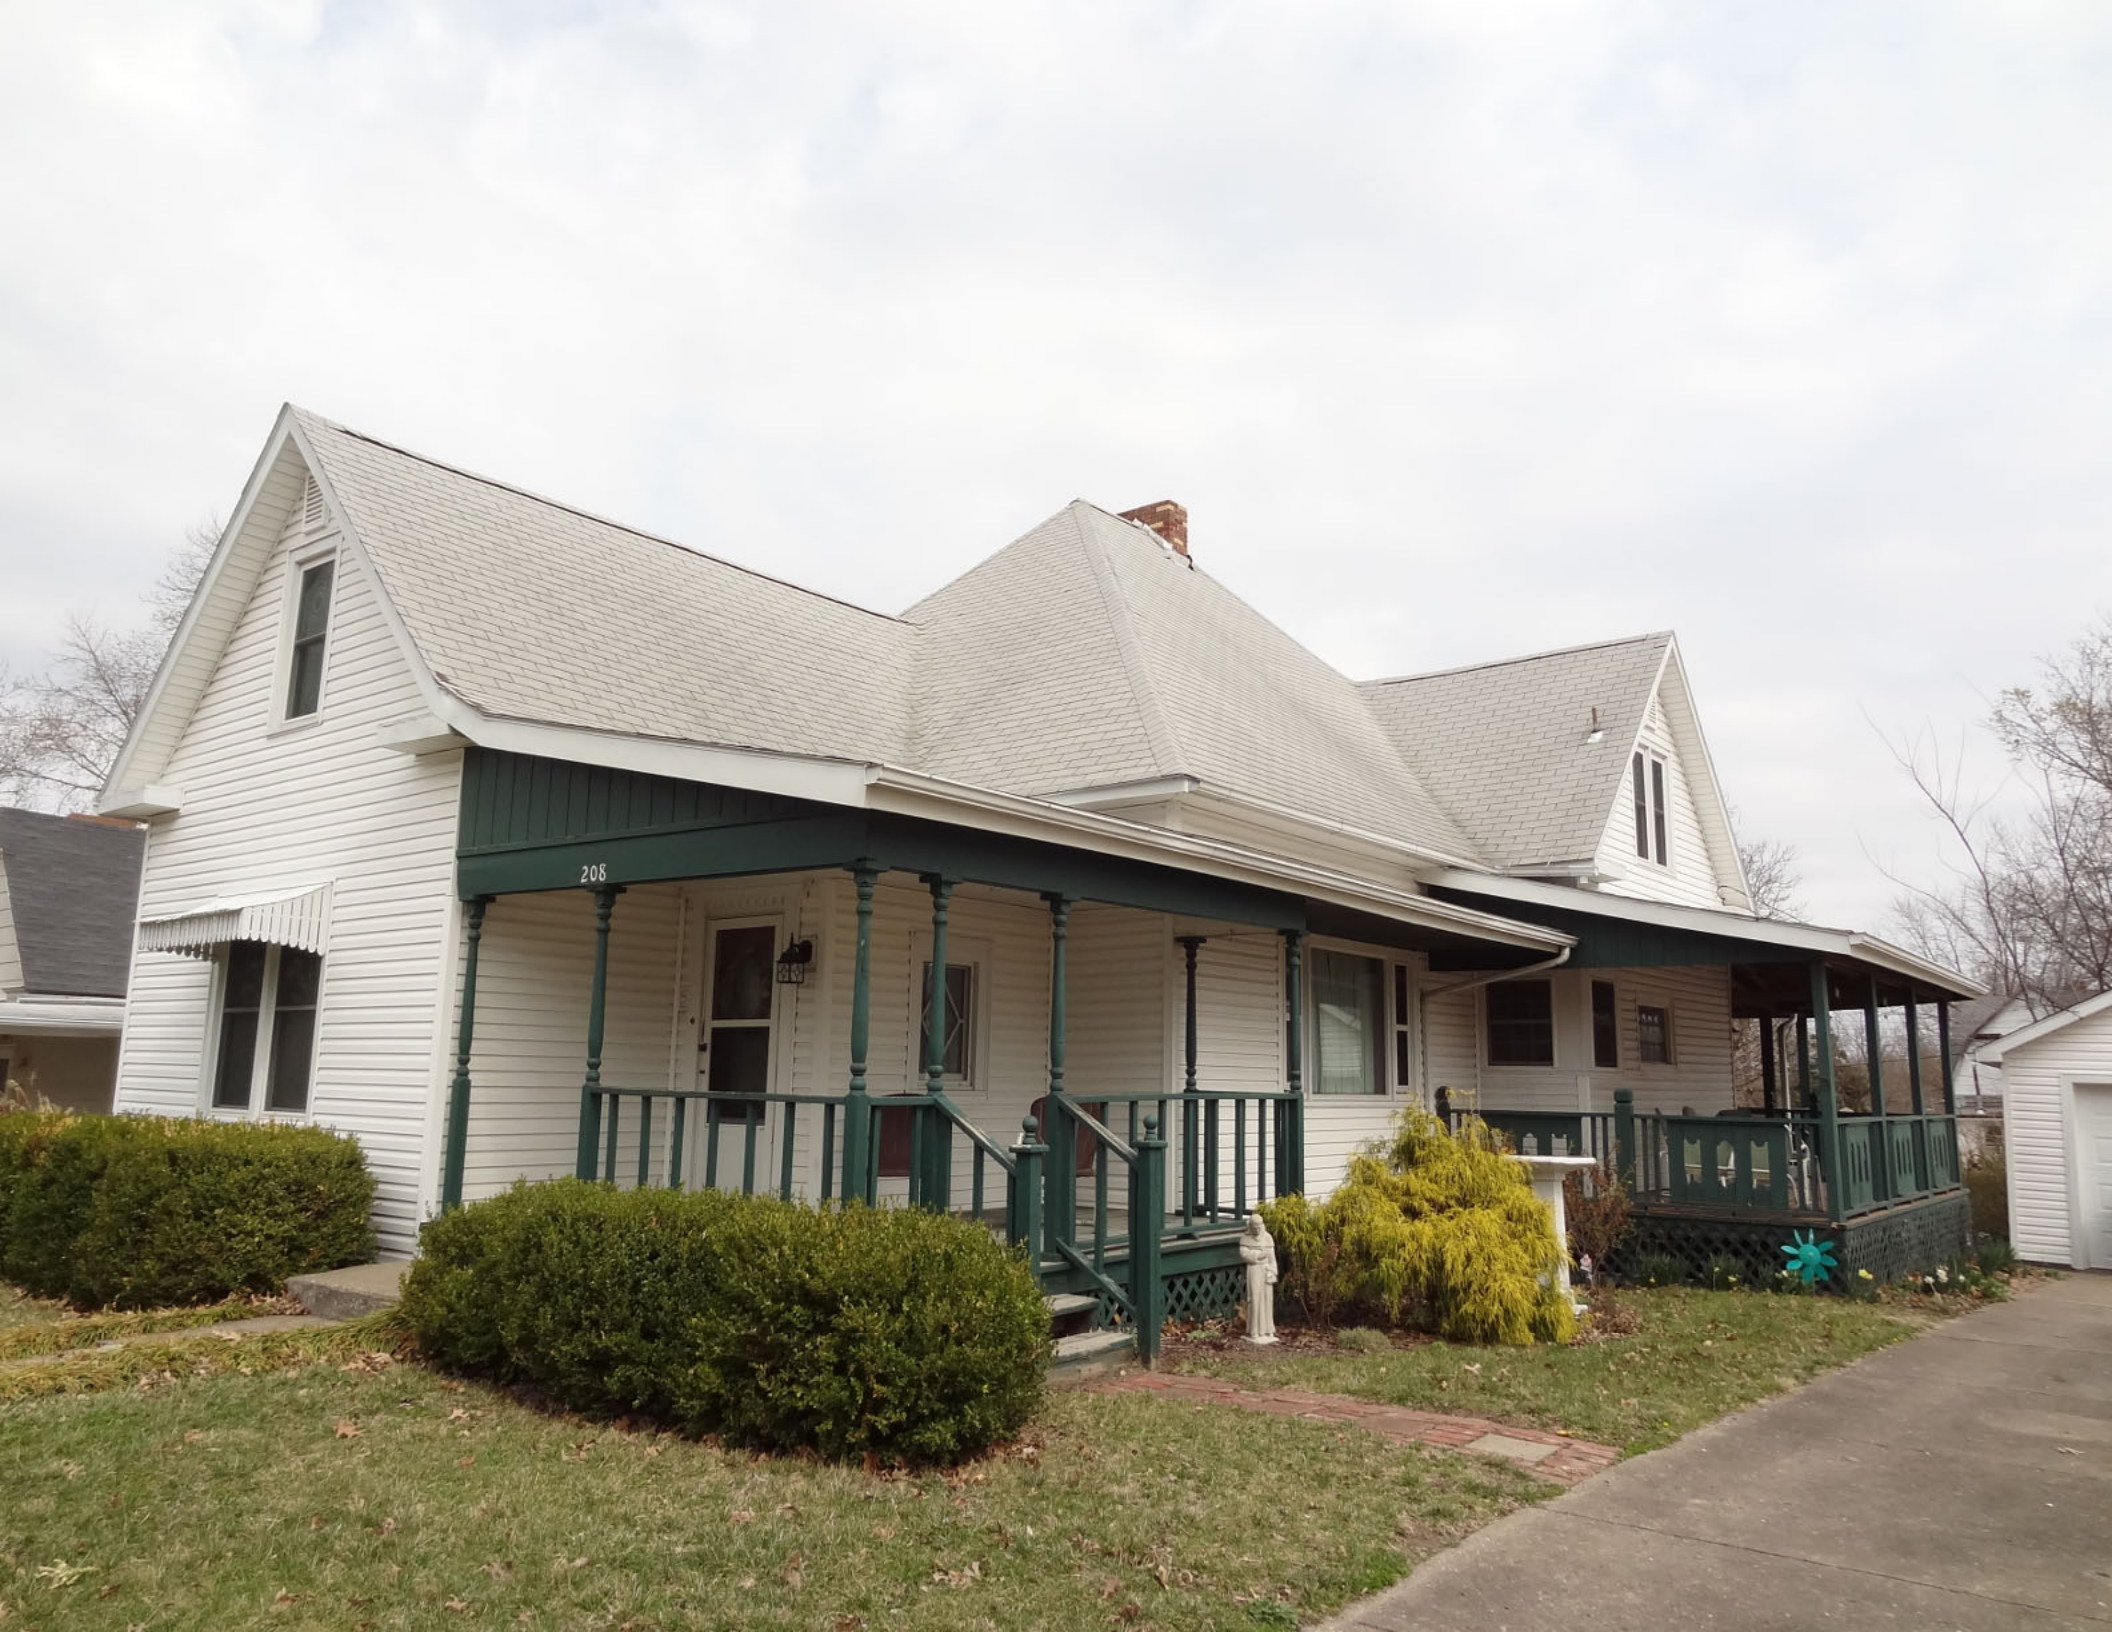
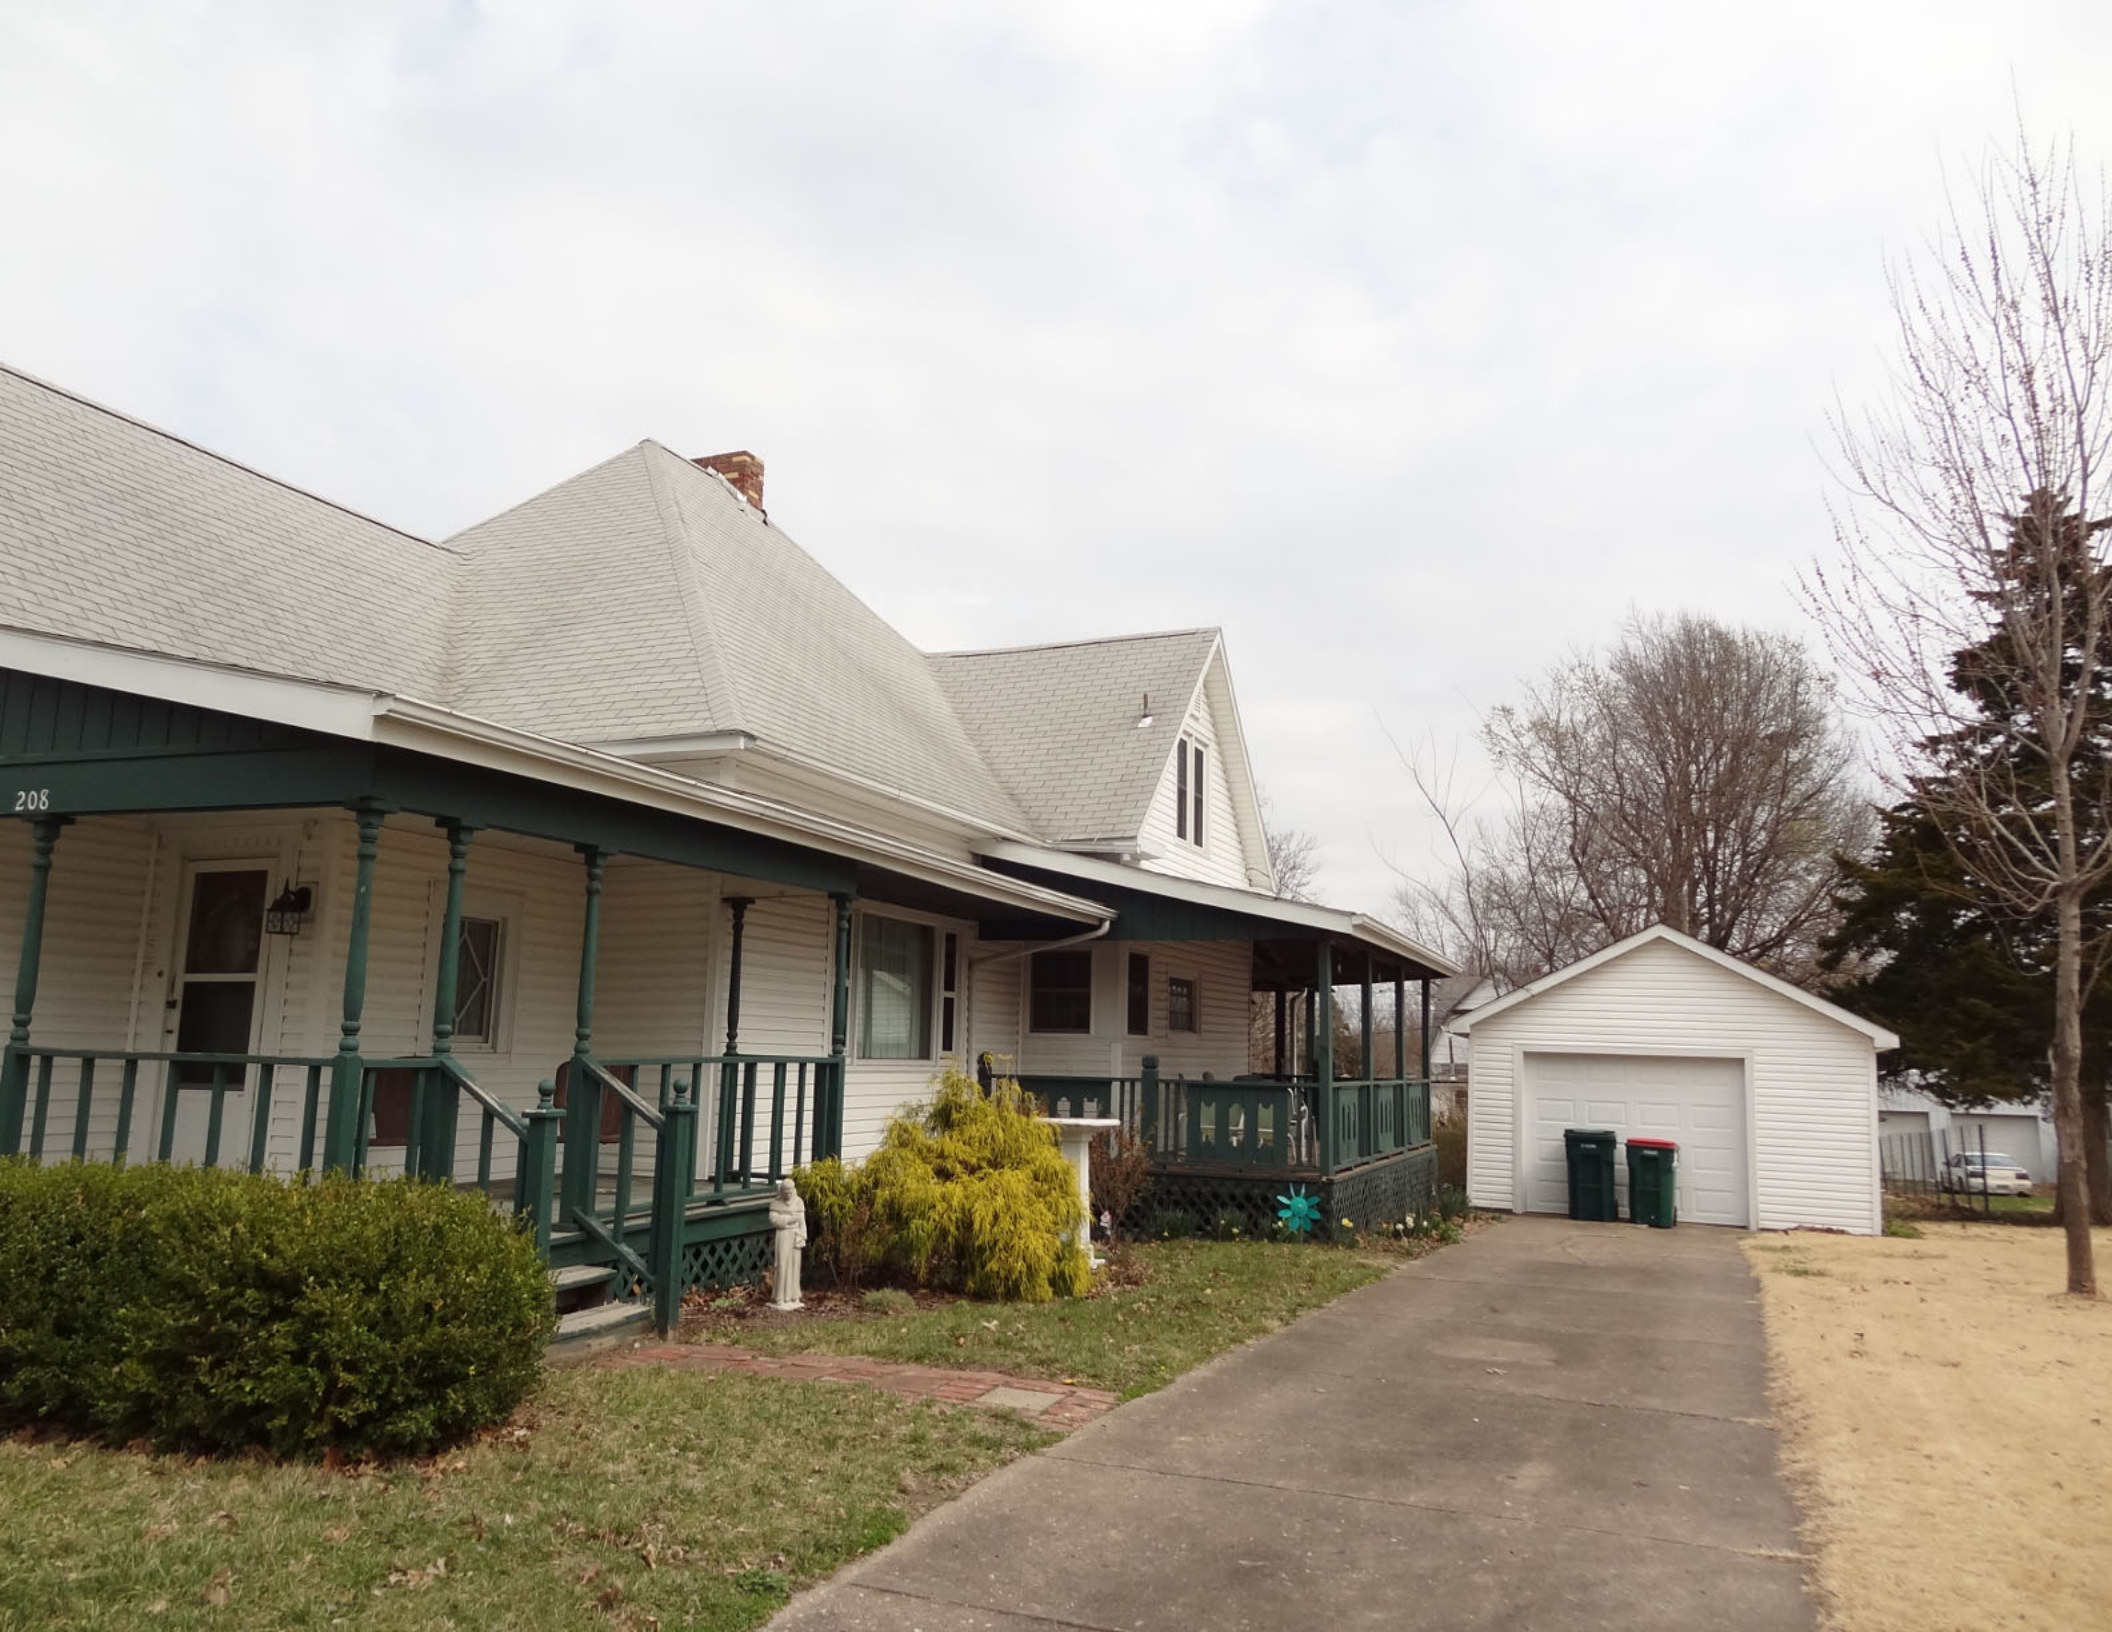
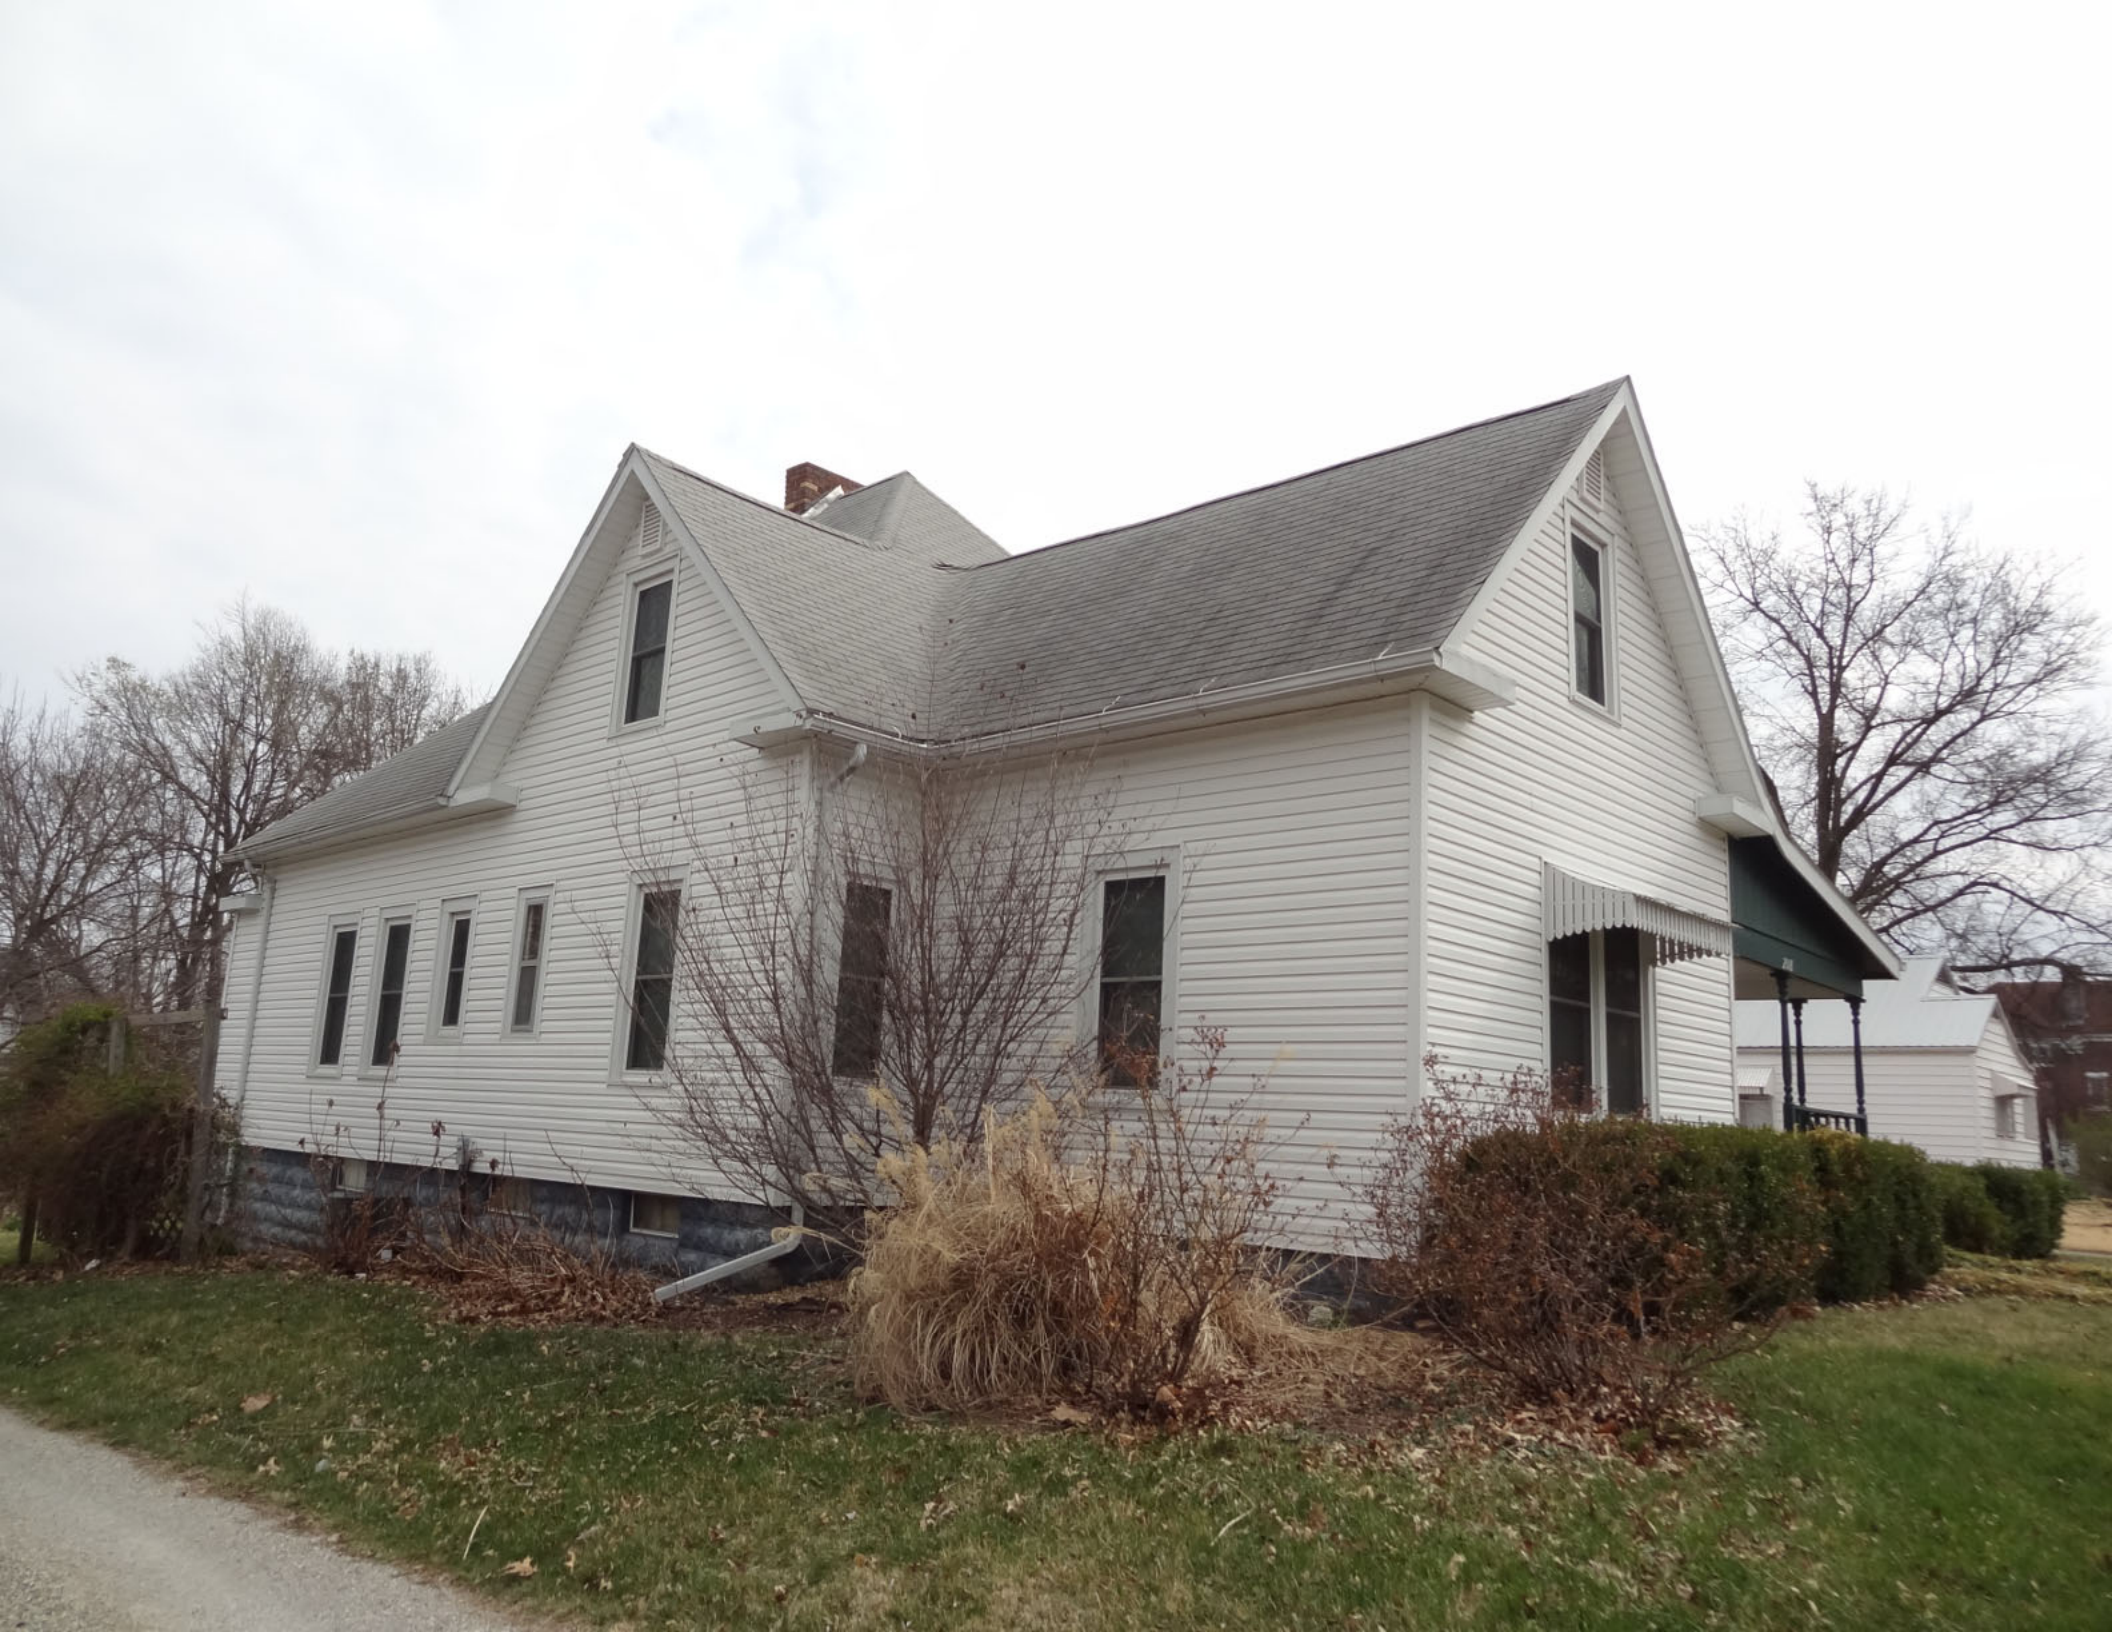
This 2 story home, covered in vinyl, has an irregular footprint with a hipped roof and gables on each side. The front partial-width wraparound porch is painted green and appears original, with Queen Anne style posts. Square columns support the side porch that wraps around the back; this porch may have been added later, after 1939. Denticulated detailing is visible above the front door and a small historic looking lamp is immediately east of the door. In the front gable are two 1 over 1 windows with an awning. Above them in the second story is another 1 over 1 window. Recessed from this front gable and under the cover of the front porch is the front door. It is not easily visible due to the presence of a storm door. Windows, most of which are sash, may be historic. One window on the east side towards the rear has glass blocks. Another window, near the front door but facing east, has muntins in a diamond pattern. Another window facing east is a bay window with one large central pane and two smaller panes on either side.
