MISSOURI DEPARTMENT OF NATURAL RESOURCES  
STATE HISTORIC PRESERVATION OFFICE, P.O. Box 176, Jefferson City, MO 65102  
**ARCHITECTURAL/HISTORIC INVENTORY FORM**

1. SURVEY NO. LI-AS-001-001		2. SURVEY NAME: Marceline Survey	
3. COUNTY: Linn		4. ADDRESS (STREET NO.) 275	STREET (NAME) West Broadway
5. CITY: Marceline	VICINITY: <input type="checkbox"/>	6. UTM: / /	7. TOWNSHIP/RANGE/SECTION: T: R: S:

8. HISTORIC NAME (IF KNOWN): Walt Disney's Childhood Home		9. PRESENT/OTHER NAME (IF KNOWN): Walt Disney's Childhood Home	
10. OWNERSHIP: <input checked="" type="checkbox"/> PRIVATE <input type="checkbox"/> PUBLIC		11A. HISTORIC USE (IF KNOWN): Single Dwelling	11B. CURRENT USE: Single Dwelling
<b>HISTORICAL INFORMATION</b>

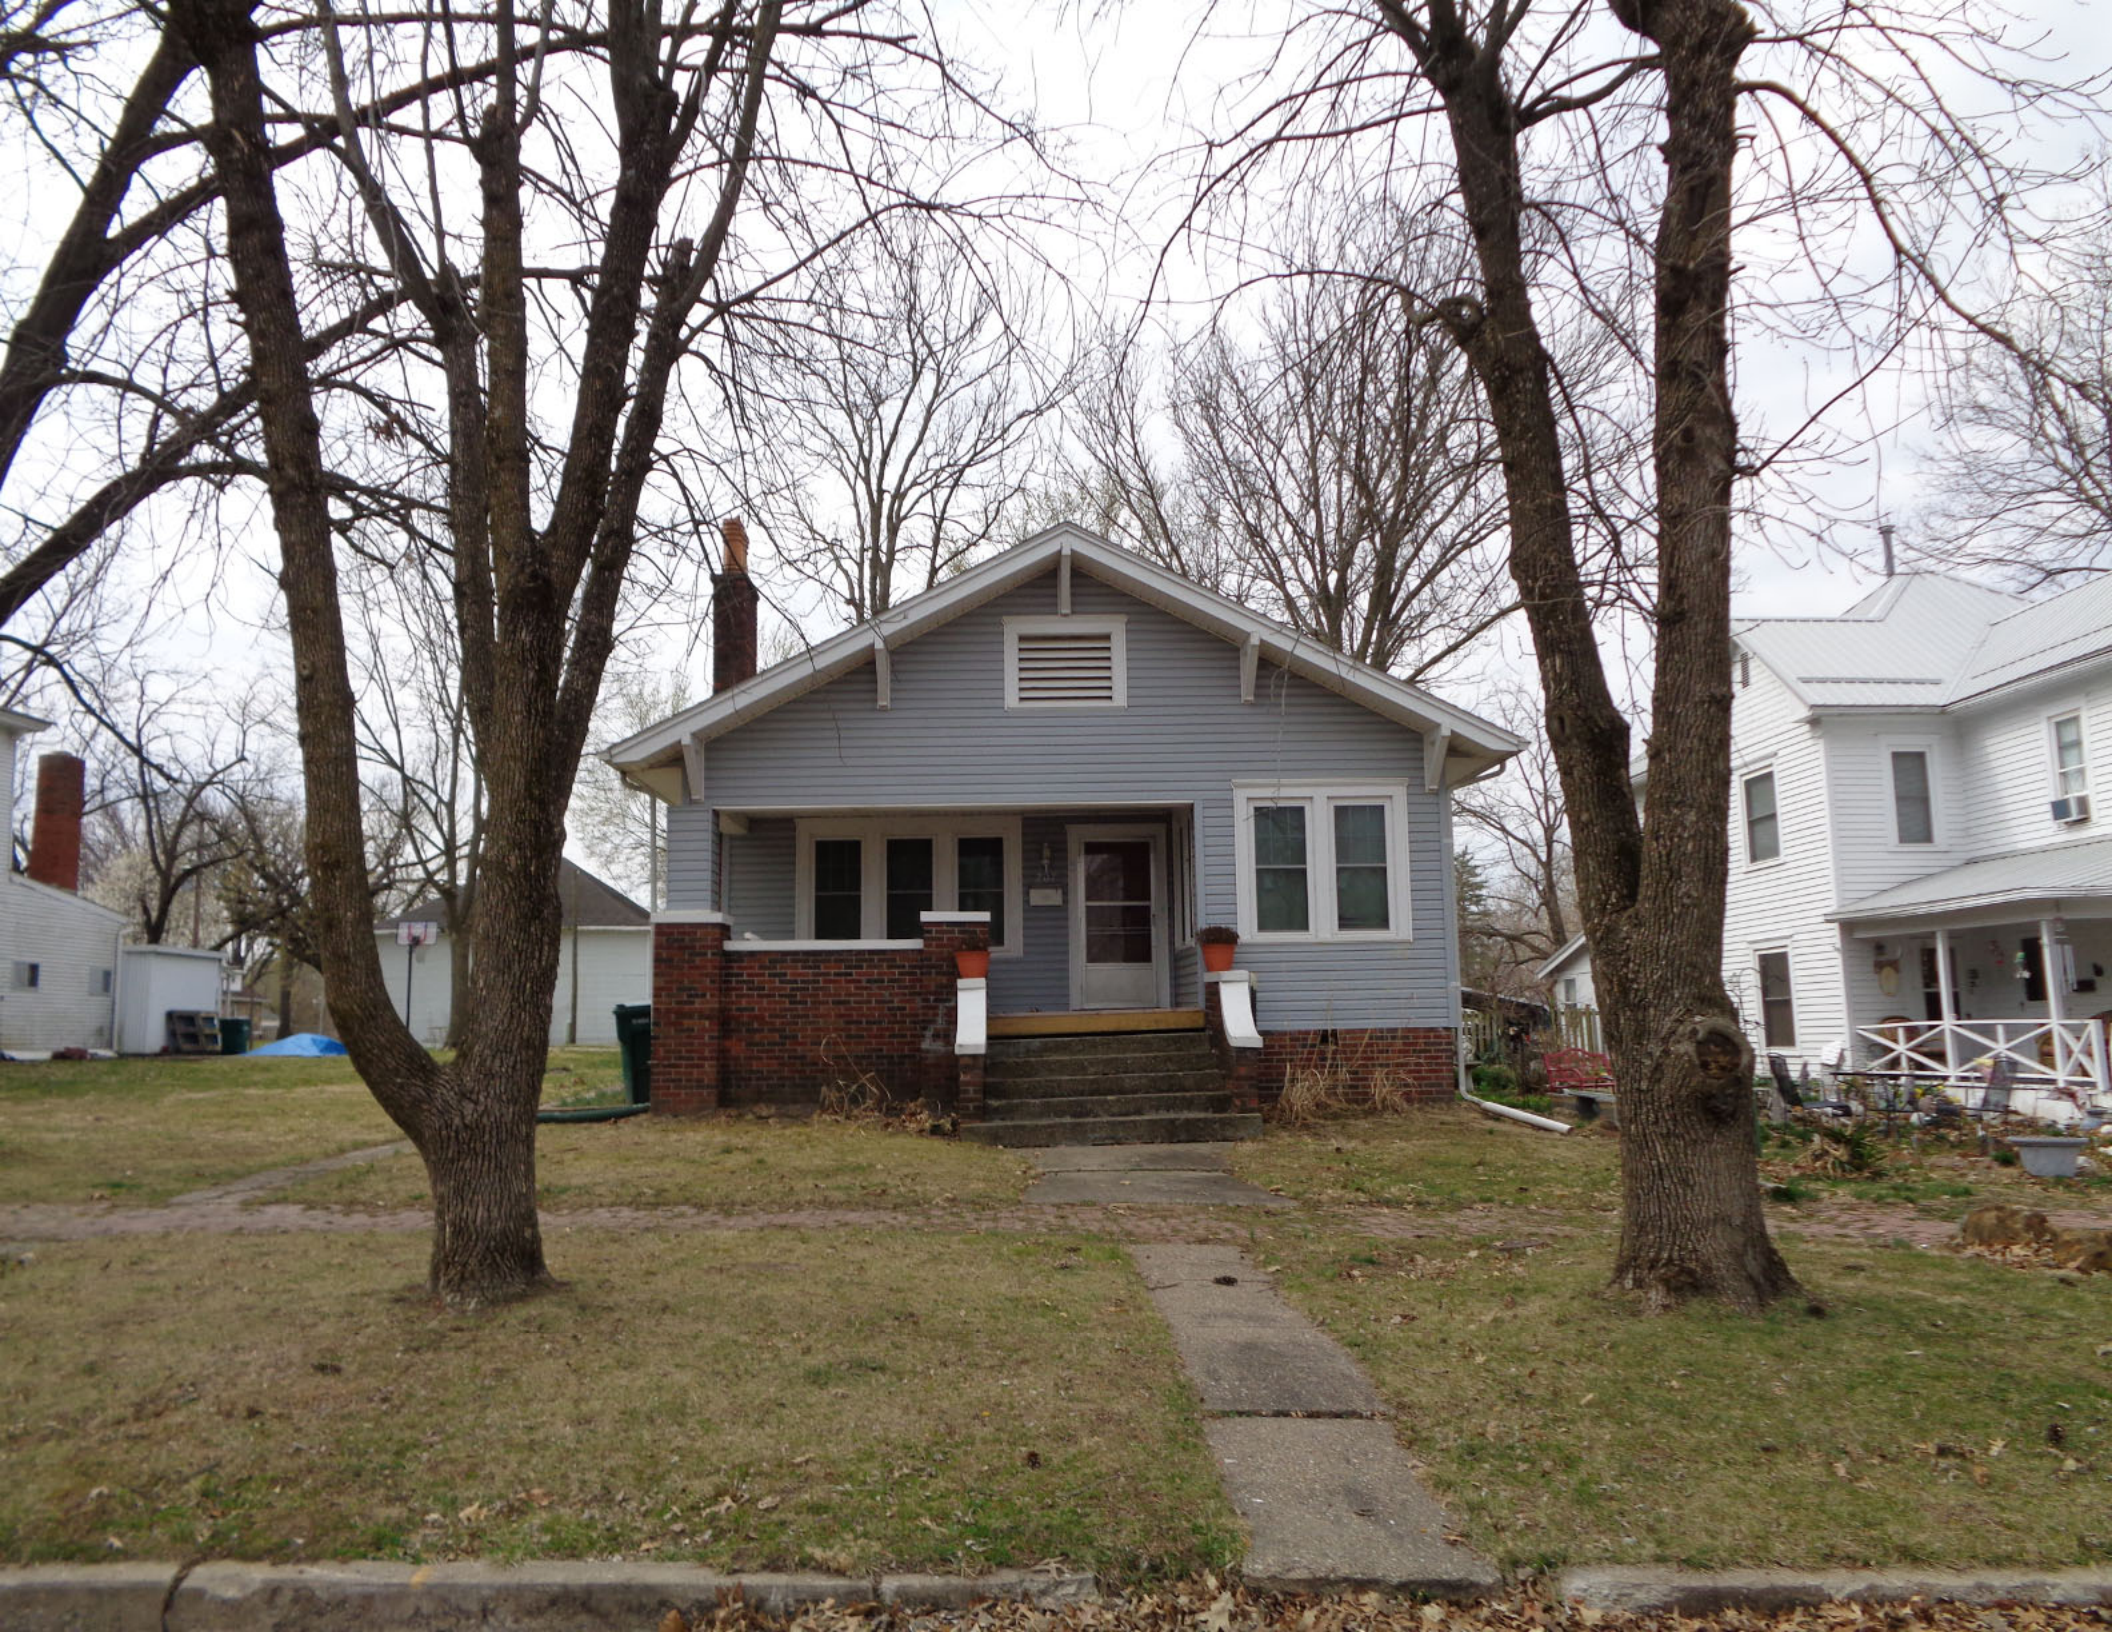
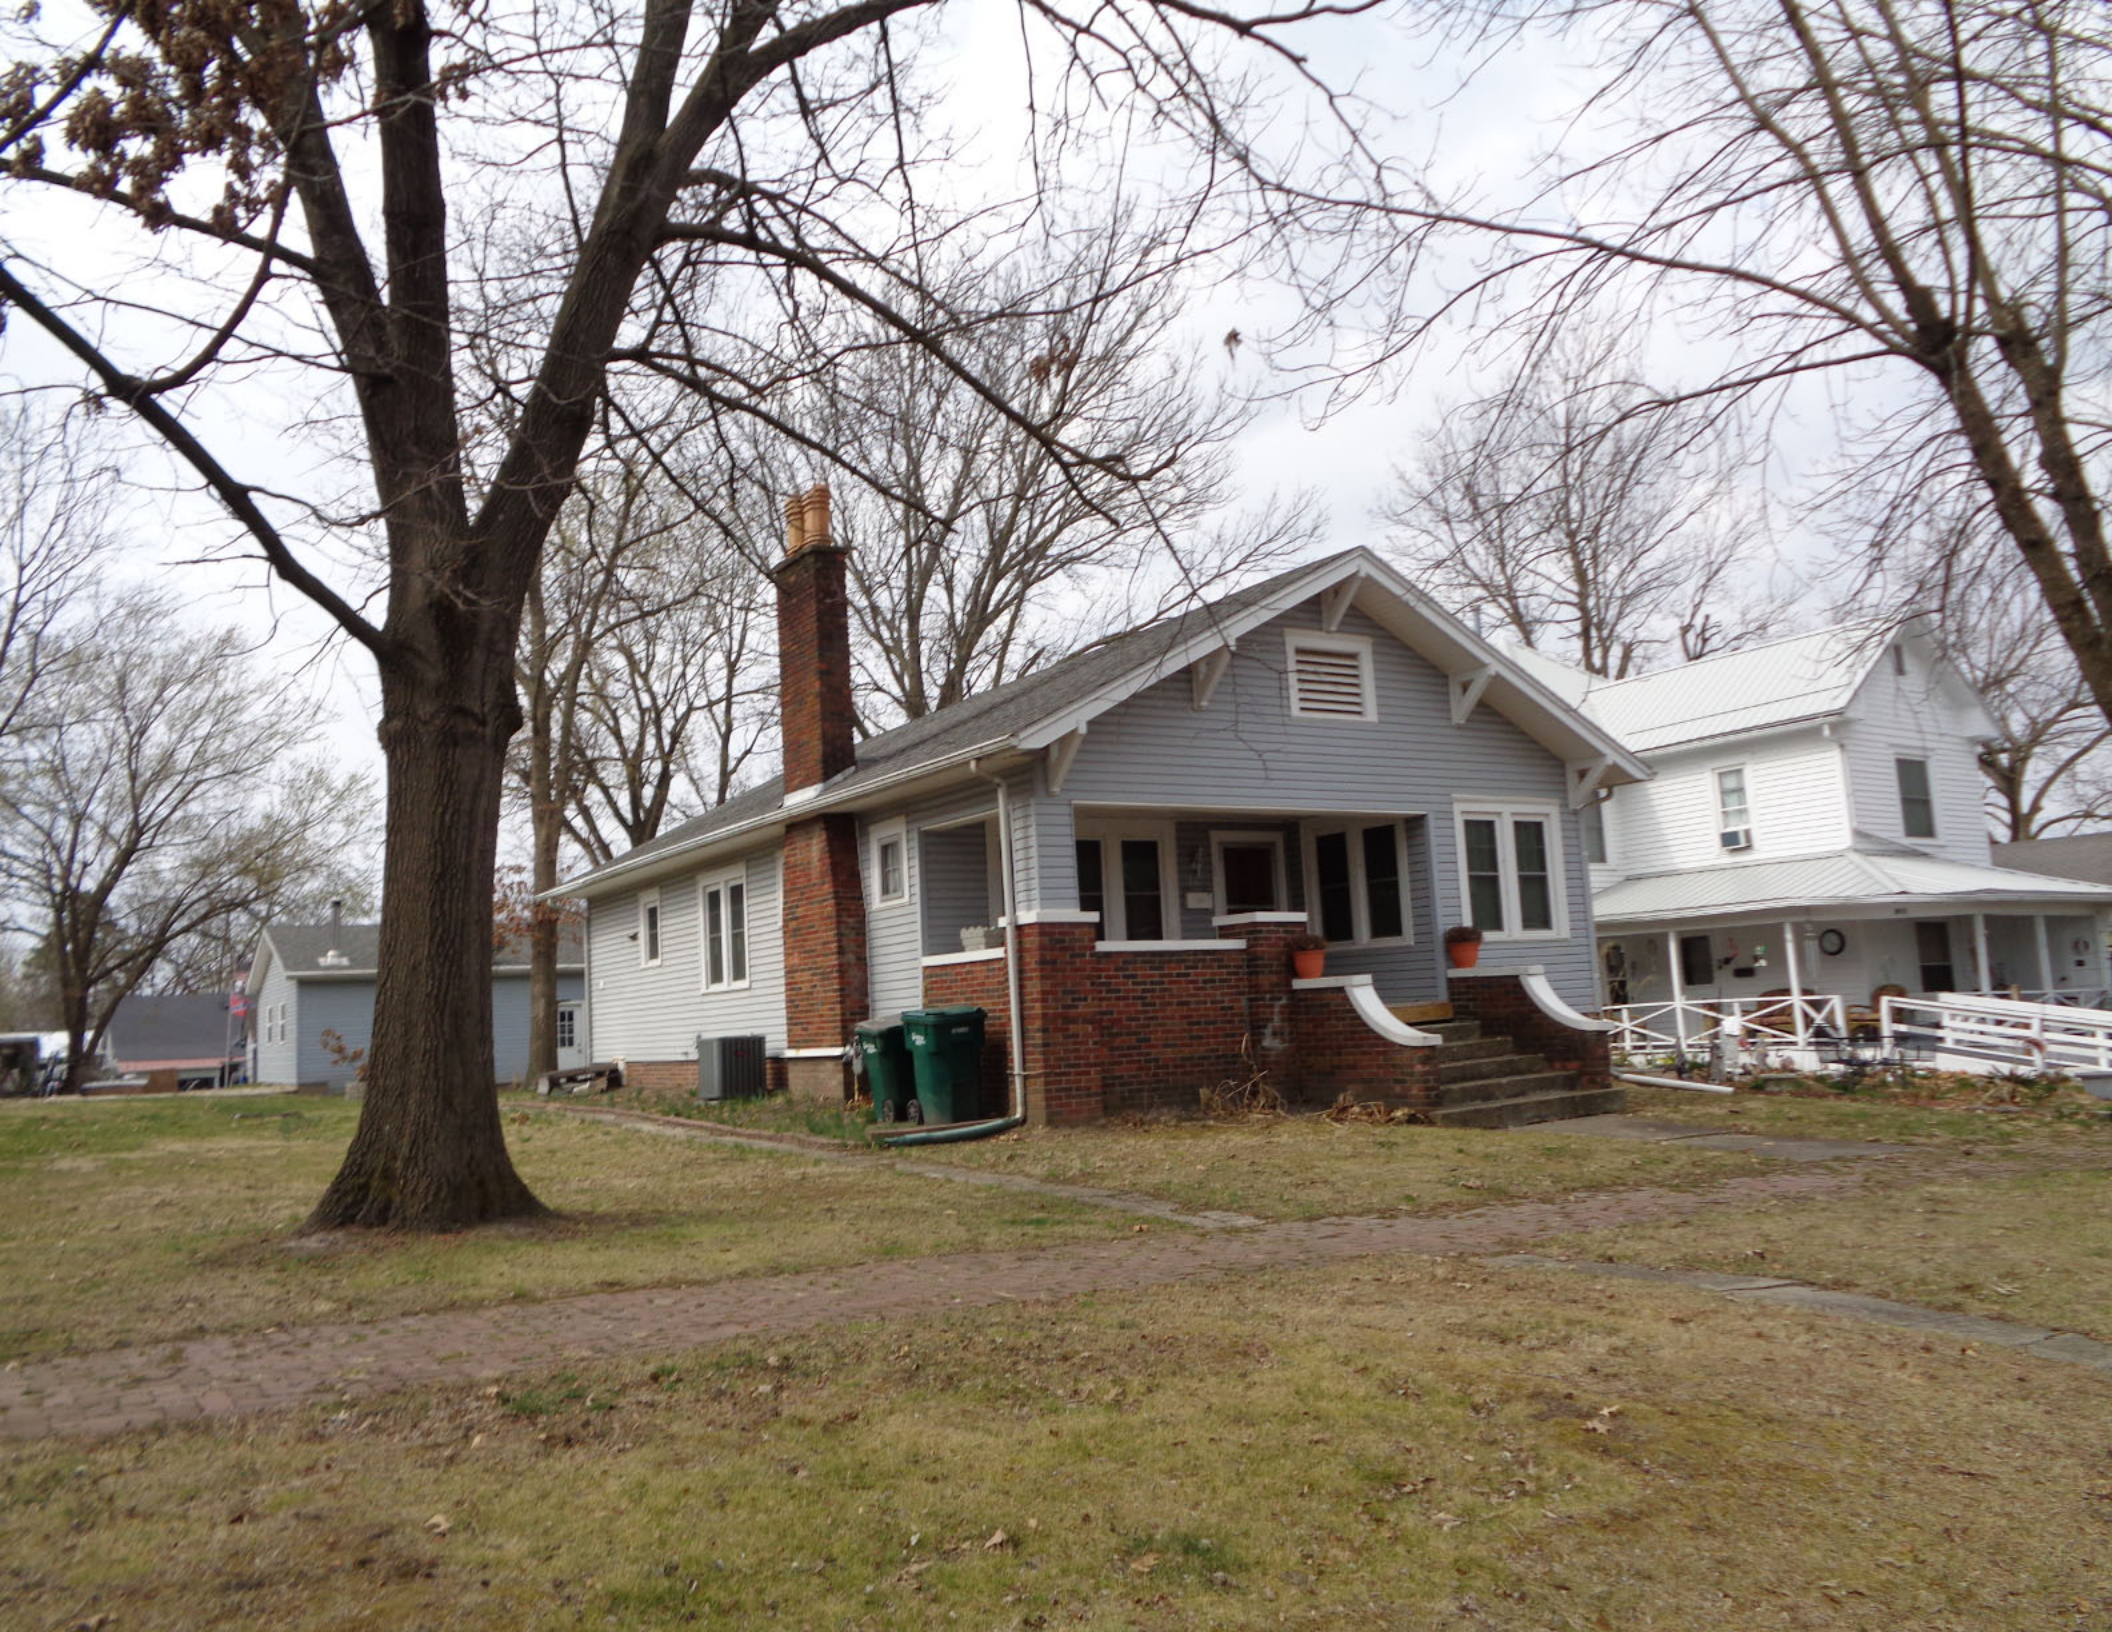
This is a single story residence that is constructed with Craftsman elements. The main elevation has a recessed porch on the eastern two-thirds of the facade. The porch is constructed of brick and is accessed via a rise of concrete steps. Under the recessed porch there are two bays the eastern most has three vinyl replacement six-over-one windows. The next bay has a single door that has an aluminum storm door. There are two vinyl replacement six-over-one windows in the corner wall creating the end to the recessed porch. The third and final bay on the facade has a pair of vinyl six-over-one replacement windows. The exterior is covered in vinyl siding. The roof eave extends and has simple but decorative rafter brackets. There is also a large attic vent in the gable end. There is a chimney located on the eastern slope of the roof, it has decorative chimney pots.

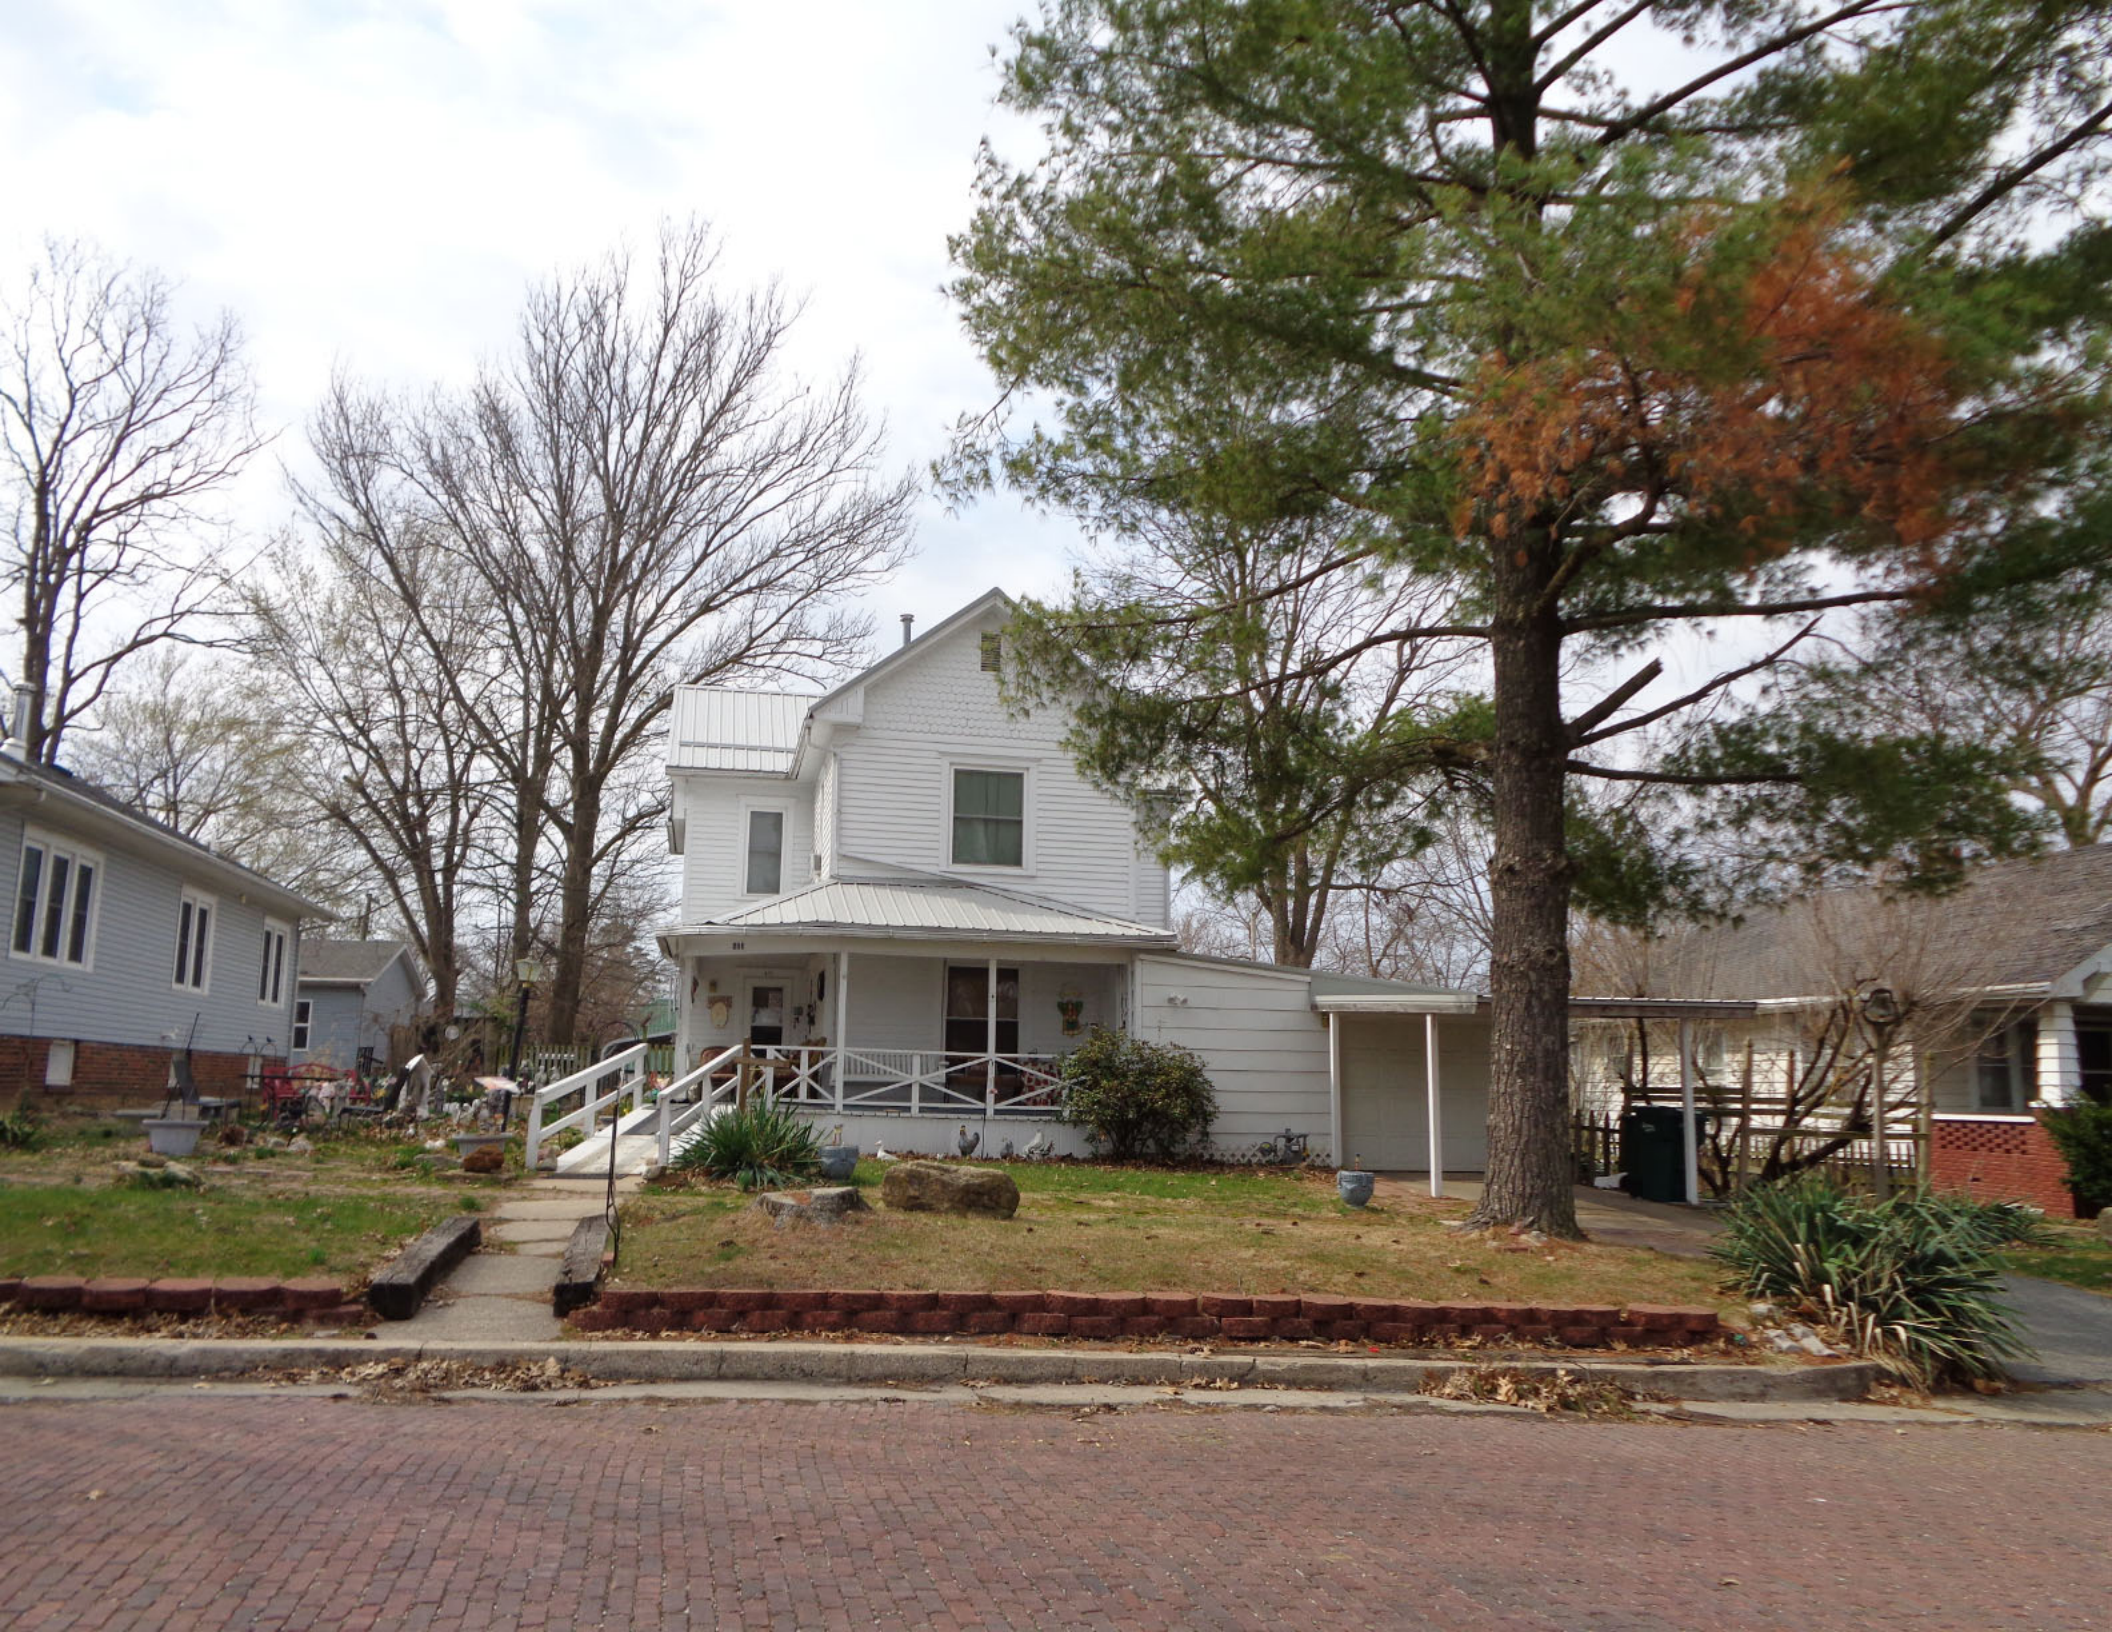
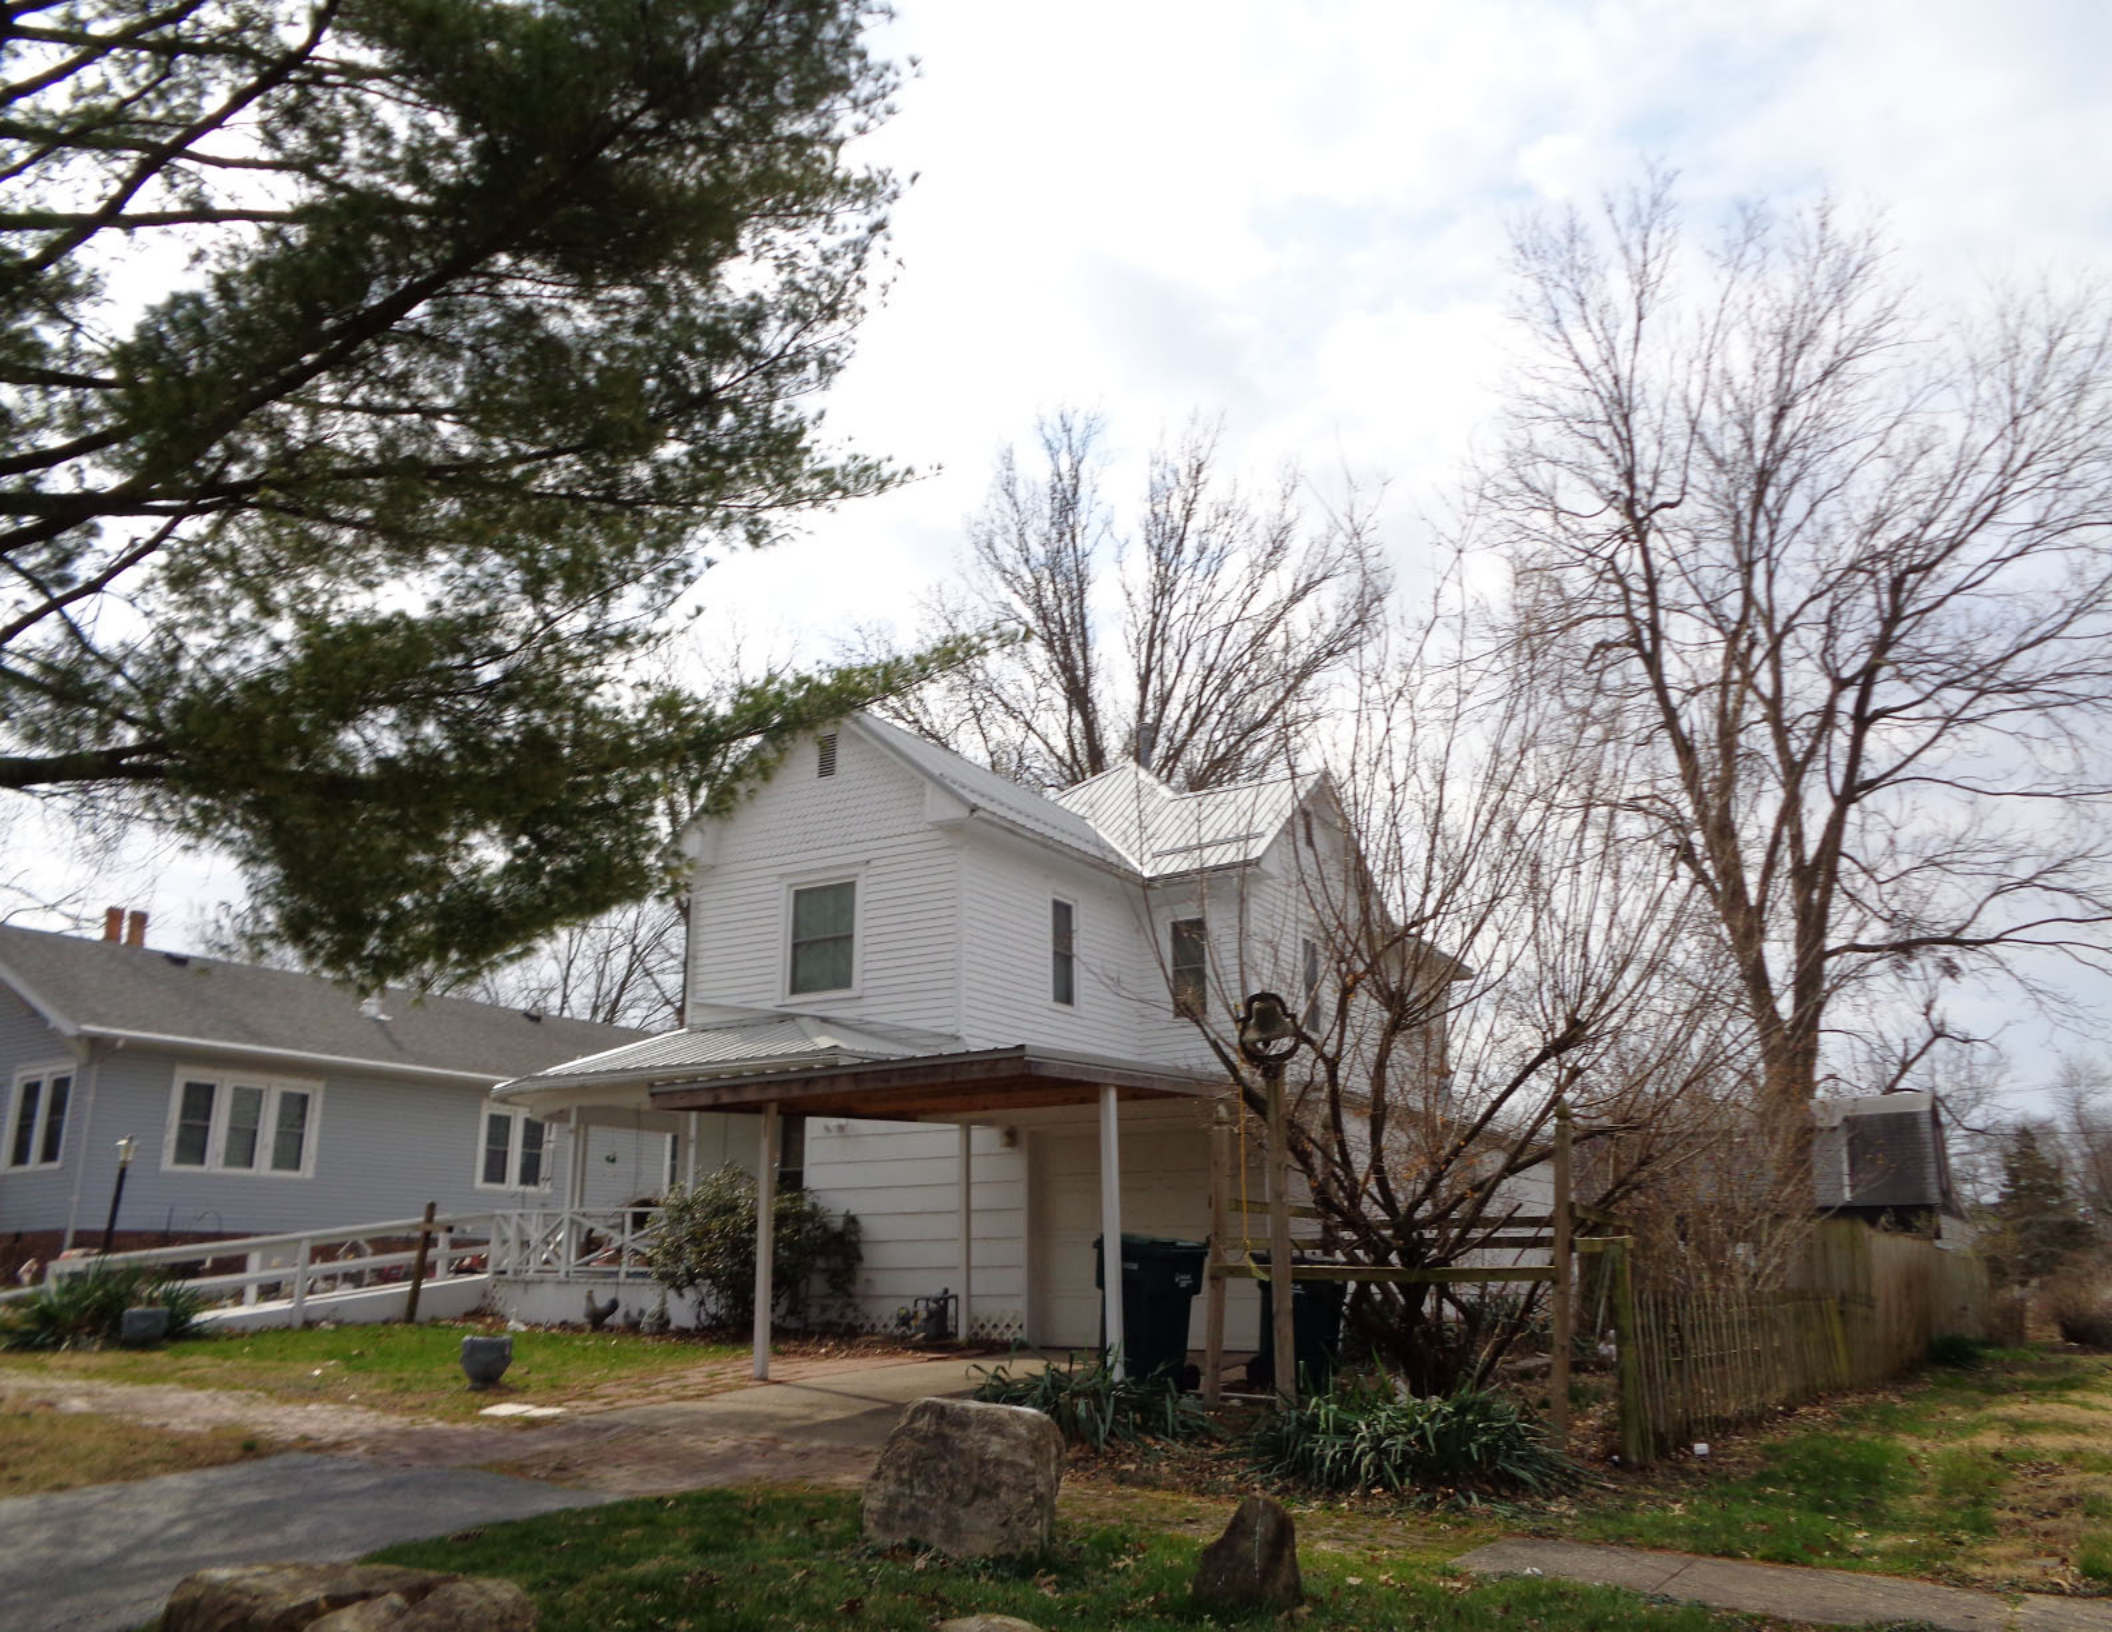
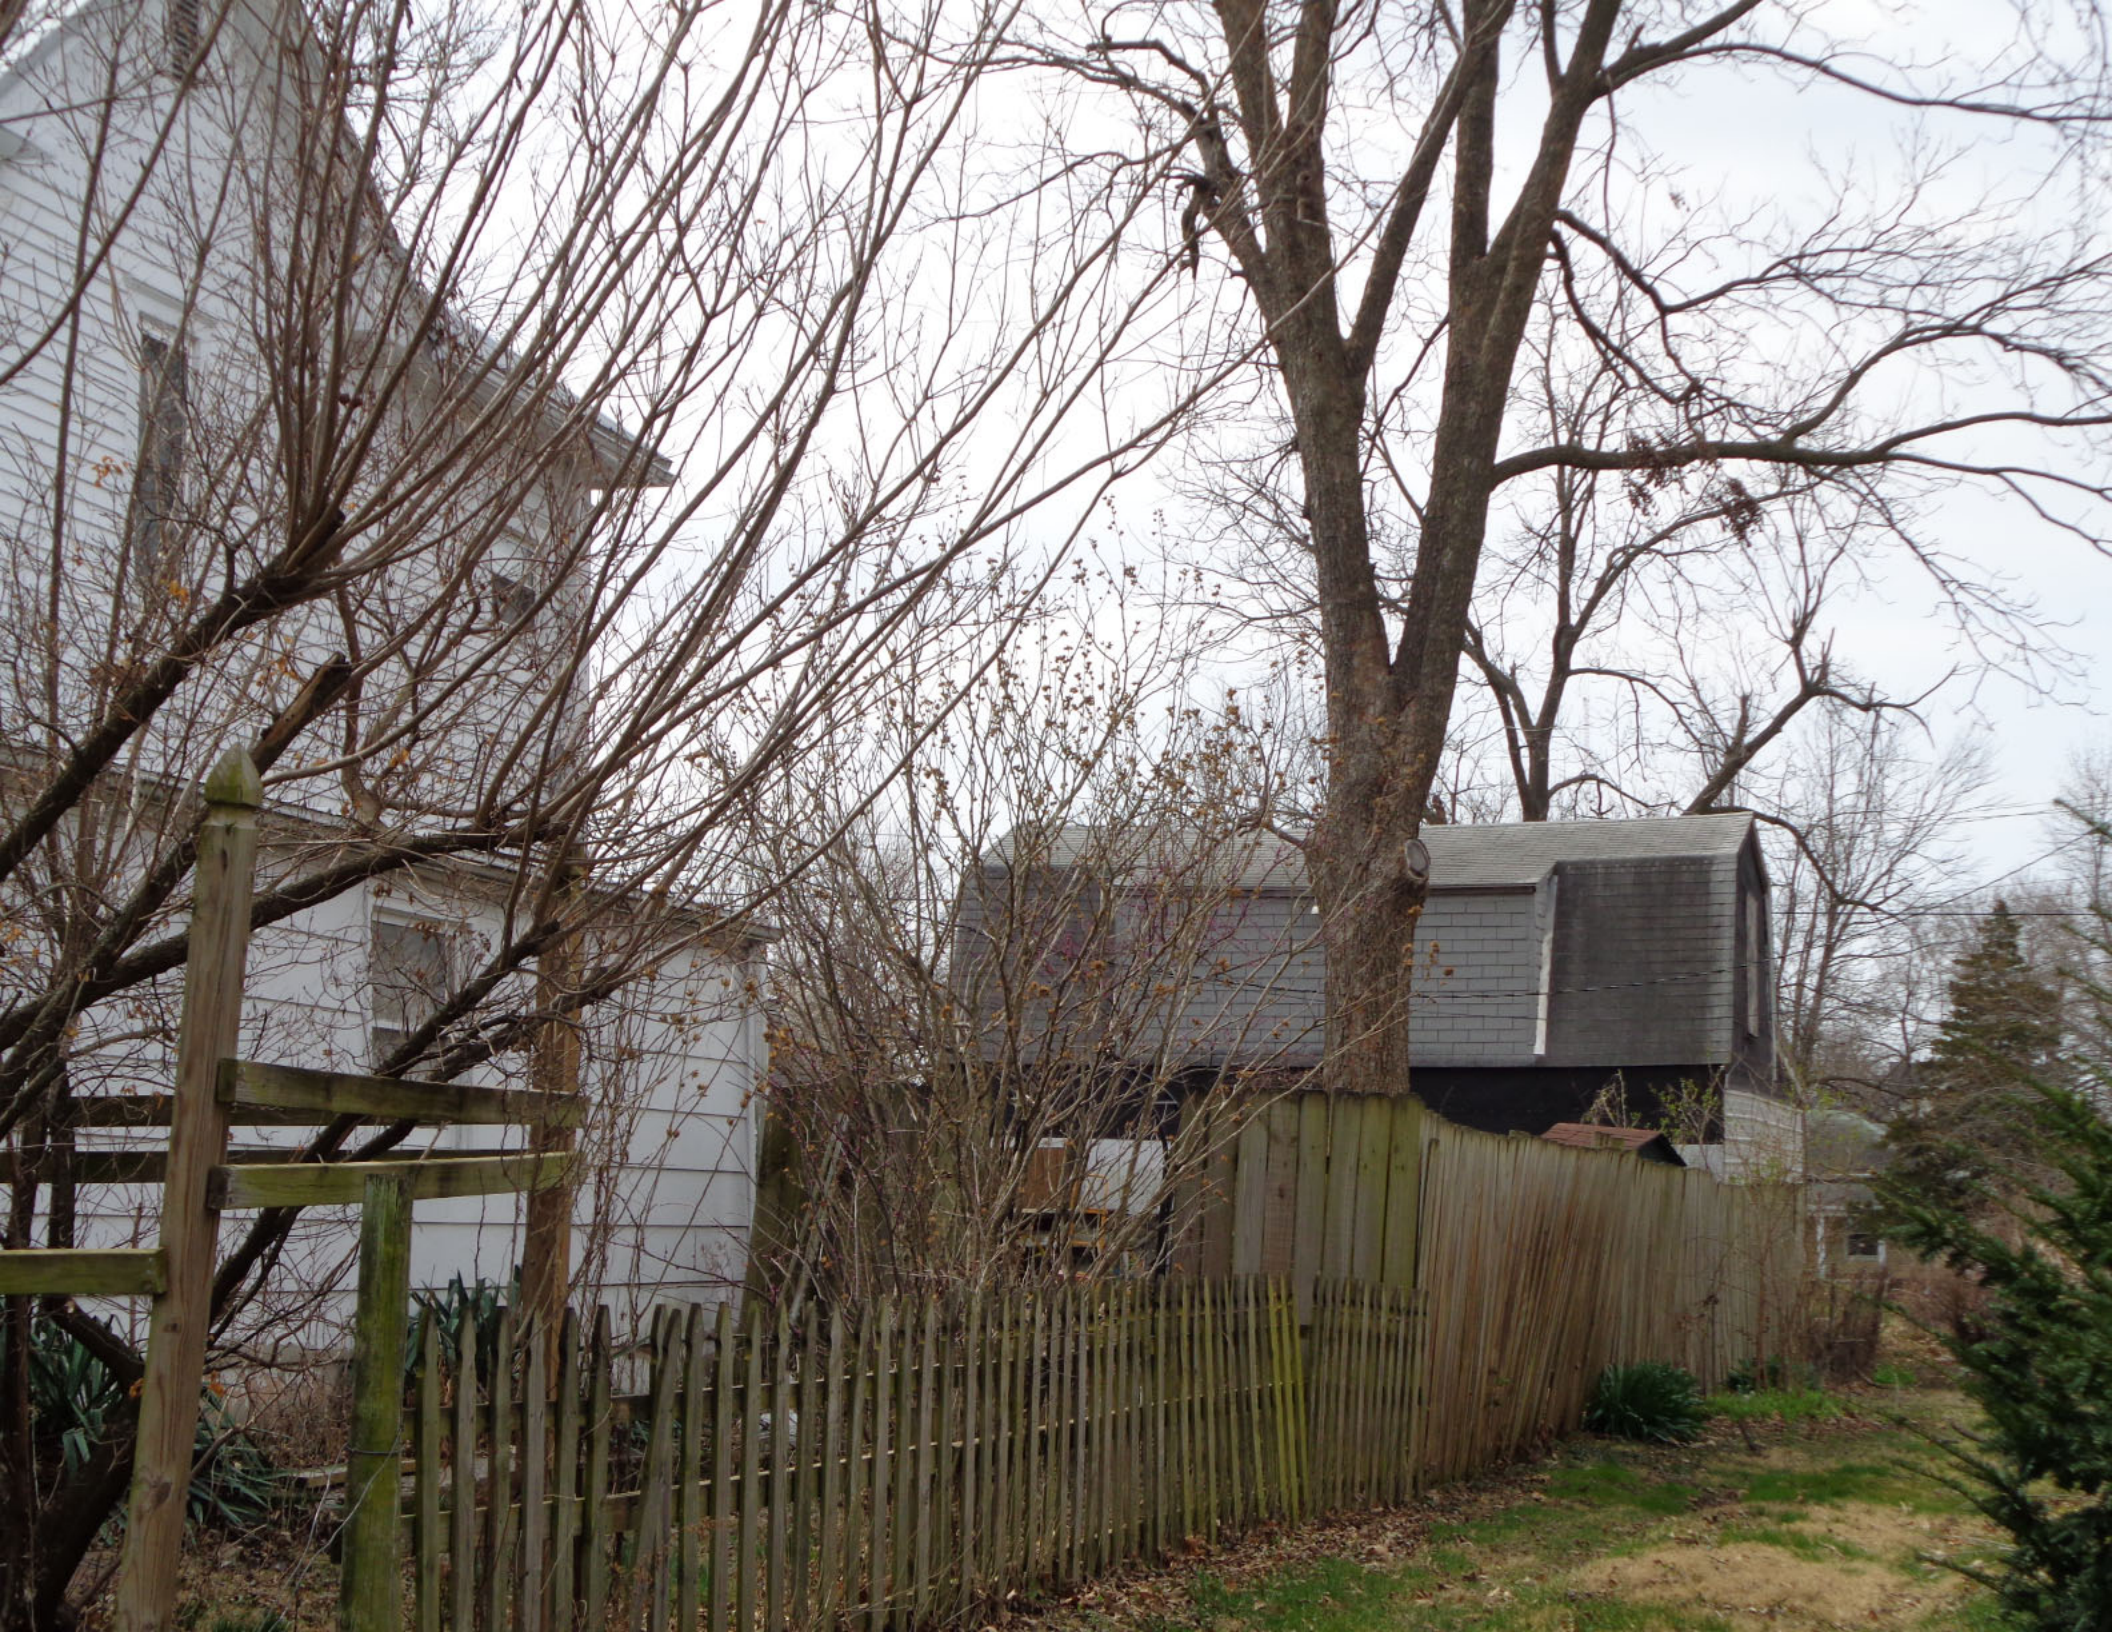
This is a two story house with Queen Anne elements the house is clad in wood siding that appears to be original. The porch appears to be recently modified to include a ramp for wheel chair accessibility. The porch wraps around the corner of the primary facade with single post supports and has a simple wood pattern railing. Under the porch, in the eastern most bay there is a single door that has a modern screen door over. Moving west there is another single door in the eastern wall this door has a modern metal screen door in place. The second bay is on the northern wall and there is a large one-over-one metal window. Moving eastward there is an addition with metal siding connected to the screened in porch. This is a small shed roof addition with a metal overhead garage door a metal carport extends in front of this addition. Starting on the east side of the second story there is a single one-over-one metal window, moving east there is a similar single window in the east wall, on the north wall there is a large single one-over-one wood window moving west the windows arrangement mimics that of the opposite wall. There is decorative fishlap siding in the gable ends on the east, north and west elevations each has a small attic vent.
