MISSOURI DEPARTMENT OF NATURAL RESOURCES  
STATE HISTORIC PRESERVATION OFFICE, P.O. Box 176, Jefferson City, MO 65102  
**ARCHITECTURAL/HISTORIC INVENTORY FORM**

1. SURVEY NO. LI-AS-001-001		2. SURVEY NAME: Marceline Survey	
3. COUNTY: Linn		4. ADDRESS (STREET NO.) 275	STREET (NAME) West Broadway
5. CITY: Marceline	VICINITY: <input type="checkbox"/>	6. UTM: / /	7. TOWNSHIP/RANGE/SECTION: T: R: S:

8. HISTORIC NAME (IF KNOWN): Walt Disney's Childhood Home		9. PRESENT/OTHER NAME (IF KNOWN): Walt Disney's Childhood Home	
10. OWNERSHIP: <input checked="" type="checkbox"/> PRIVATE <input type="checkbox"/> PUBLIC		11A. HISTORIC USE (IF KNOWN): Single Dwelling	11B. CURRENT USE: Single Dwelling
<b>HISTORICAL INFORMATION</b>

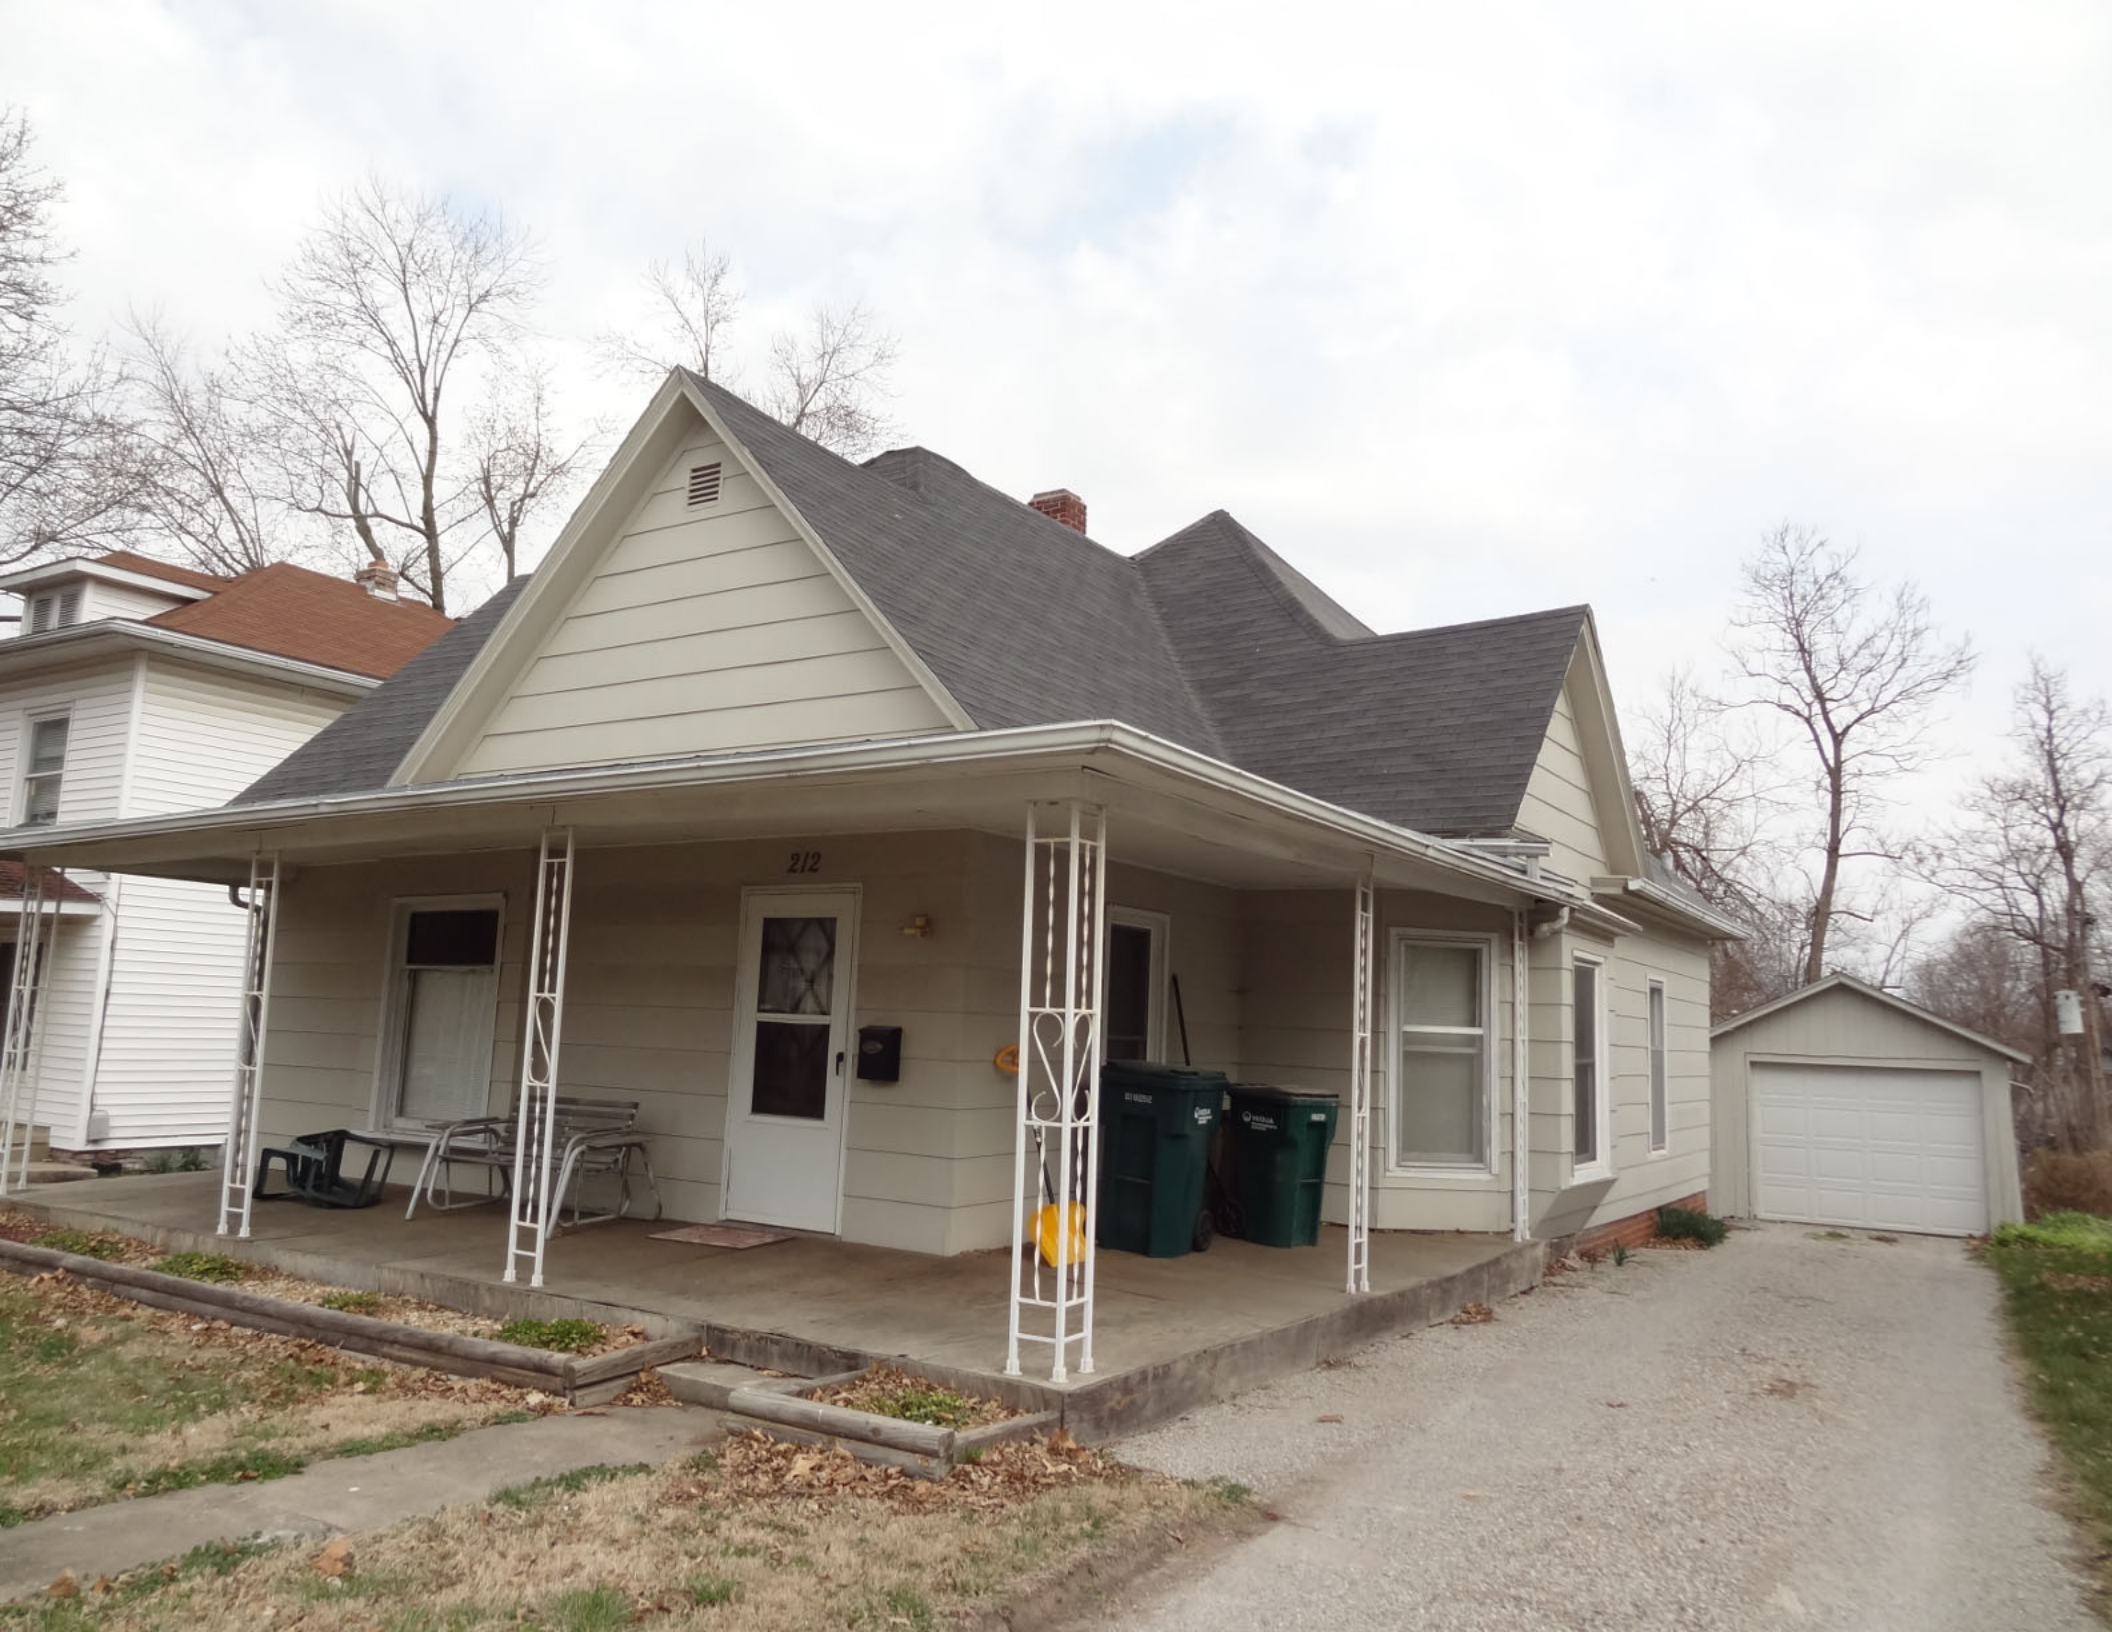
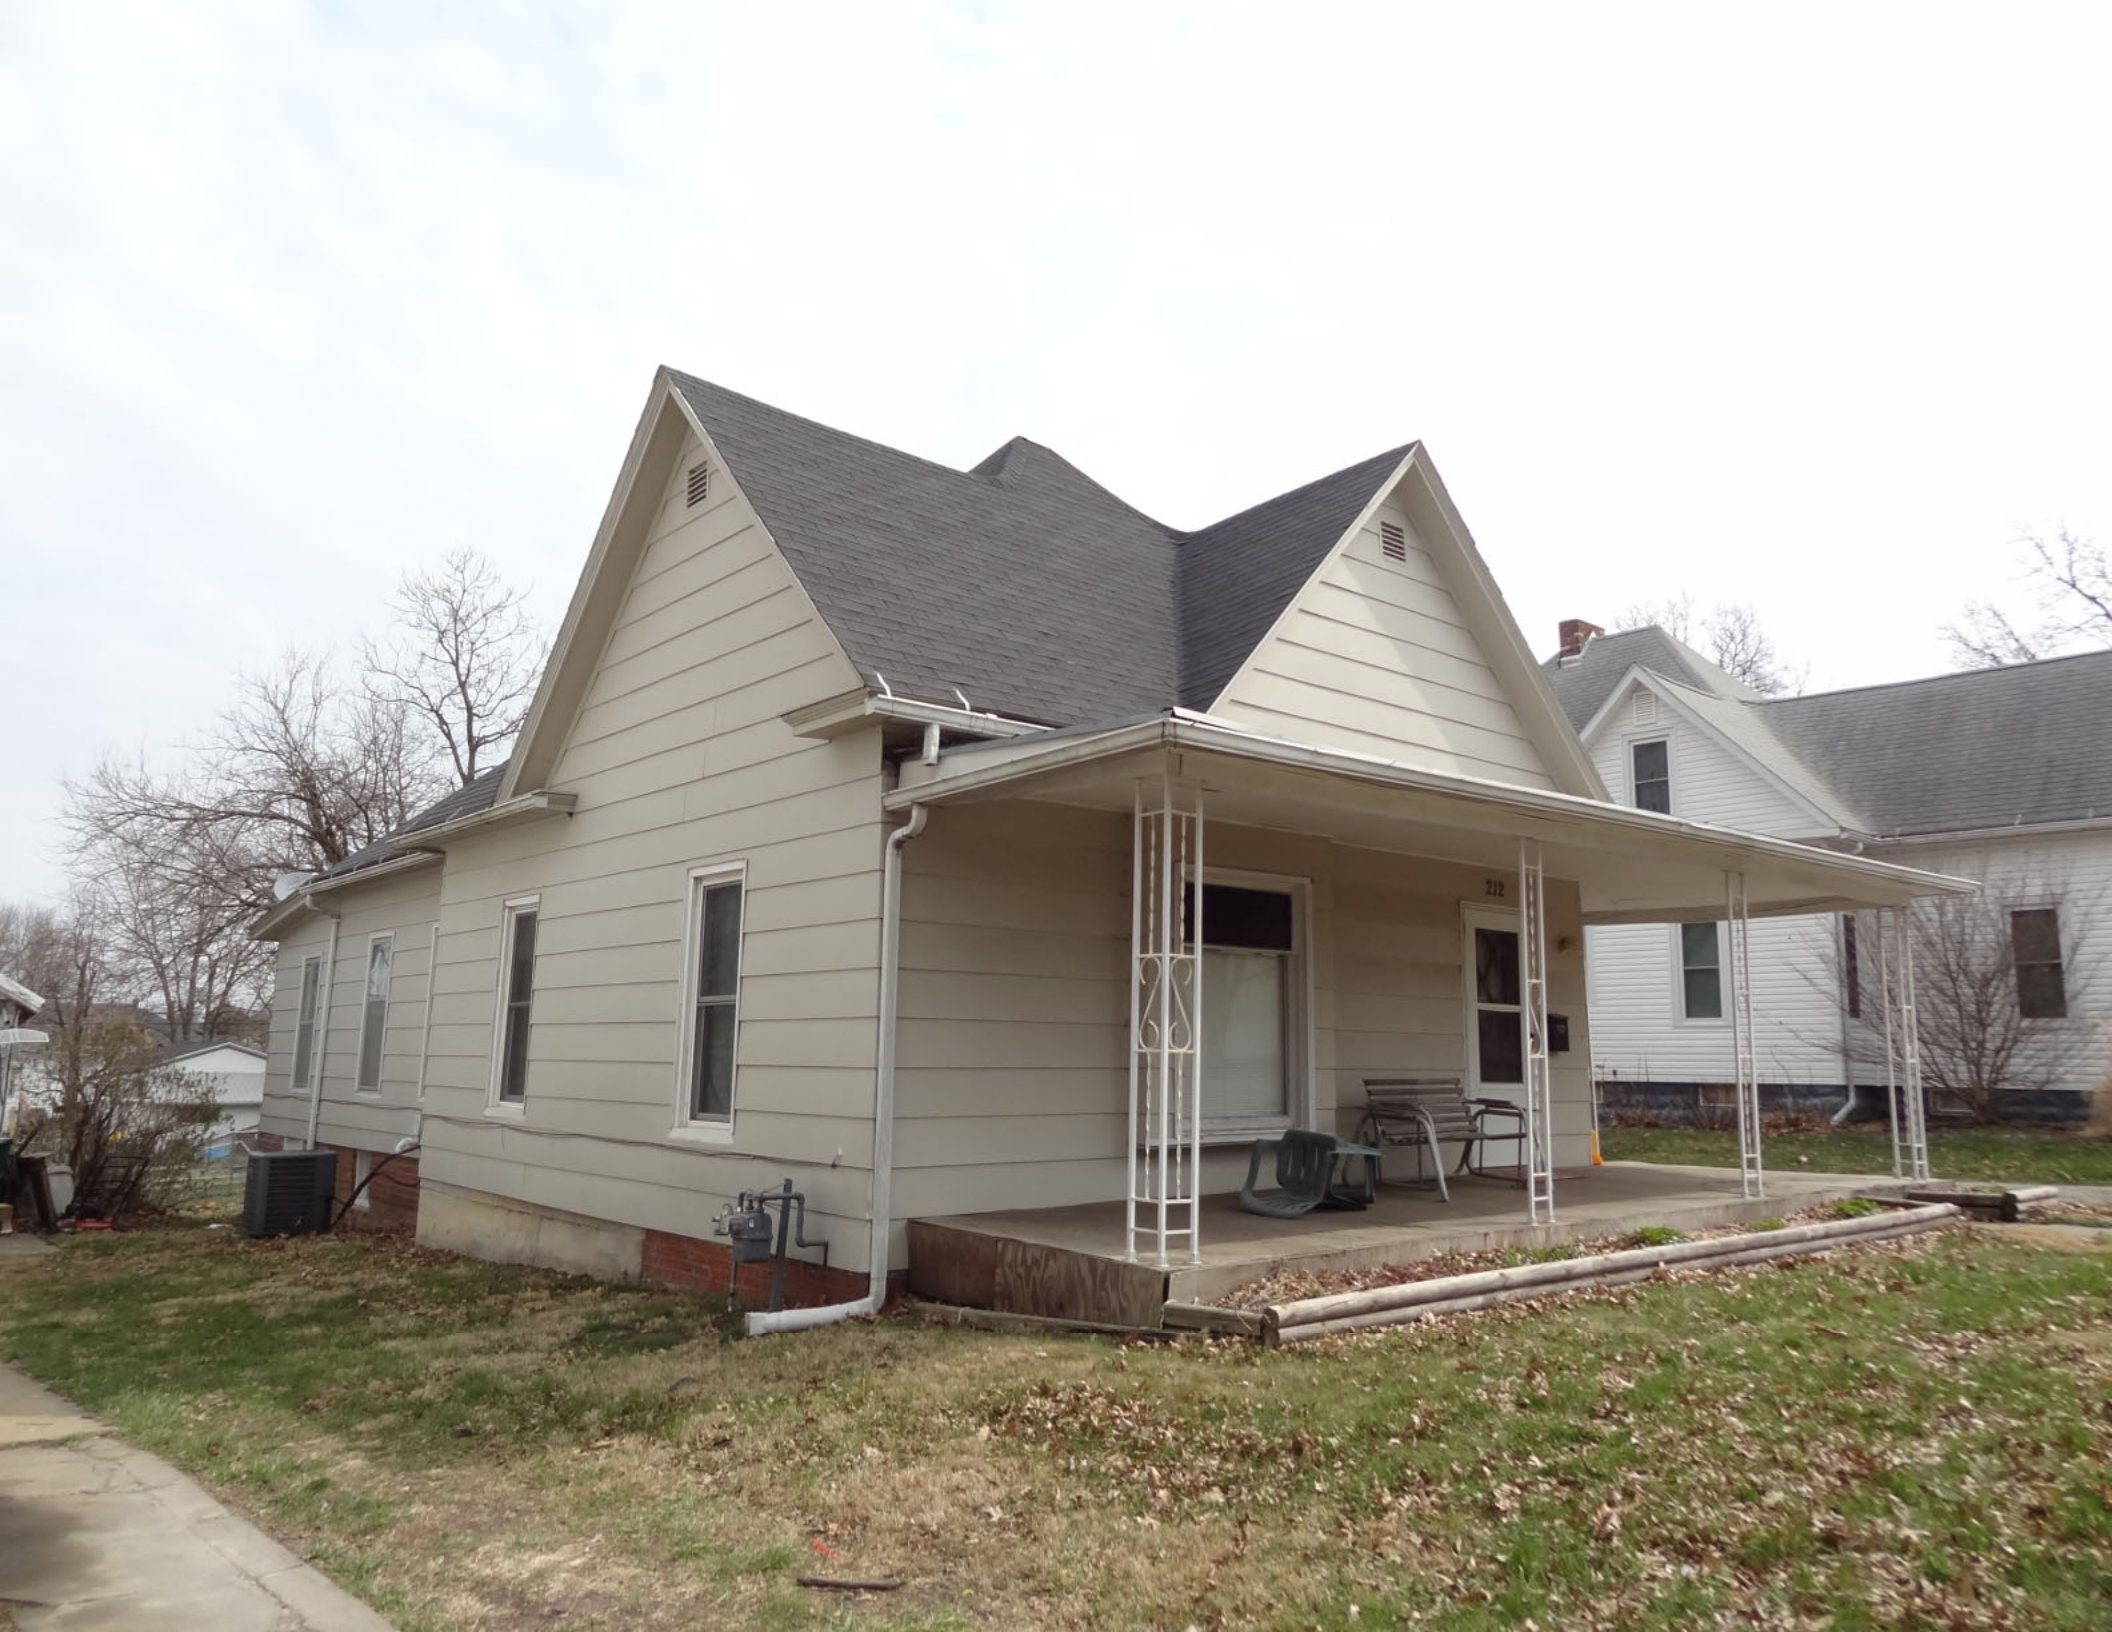
This hipped roof, single story, cross gabled home has asbestos siding and a brick foundation with what looks to be a full basement. The full width wrap around porch has concrete flooring and six decorative metal posts. A chimney straddles the hipped roof but gables front the facade and east and west sides of the home. Most windows are sash and appear to be 1 over 1 replacements. There are two bays on the facade under the porch. One is a historic window with a small screen at the top and one large pane at the bottom. The second bay holds a storm door concealing what might be a historic front door. Then there is a recess where the porch wraps around and another window faces east. Another window is then situated at a diagonal.

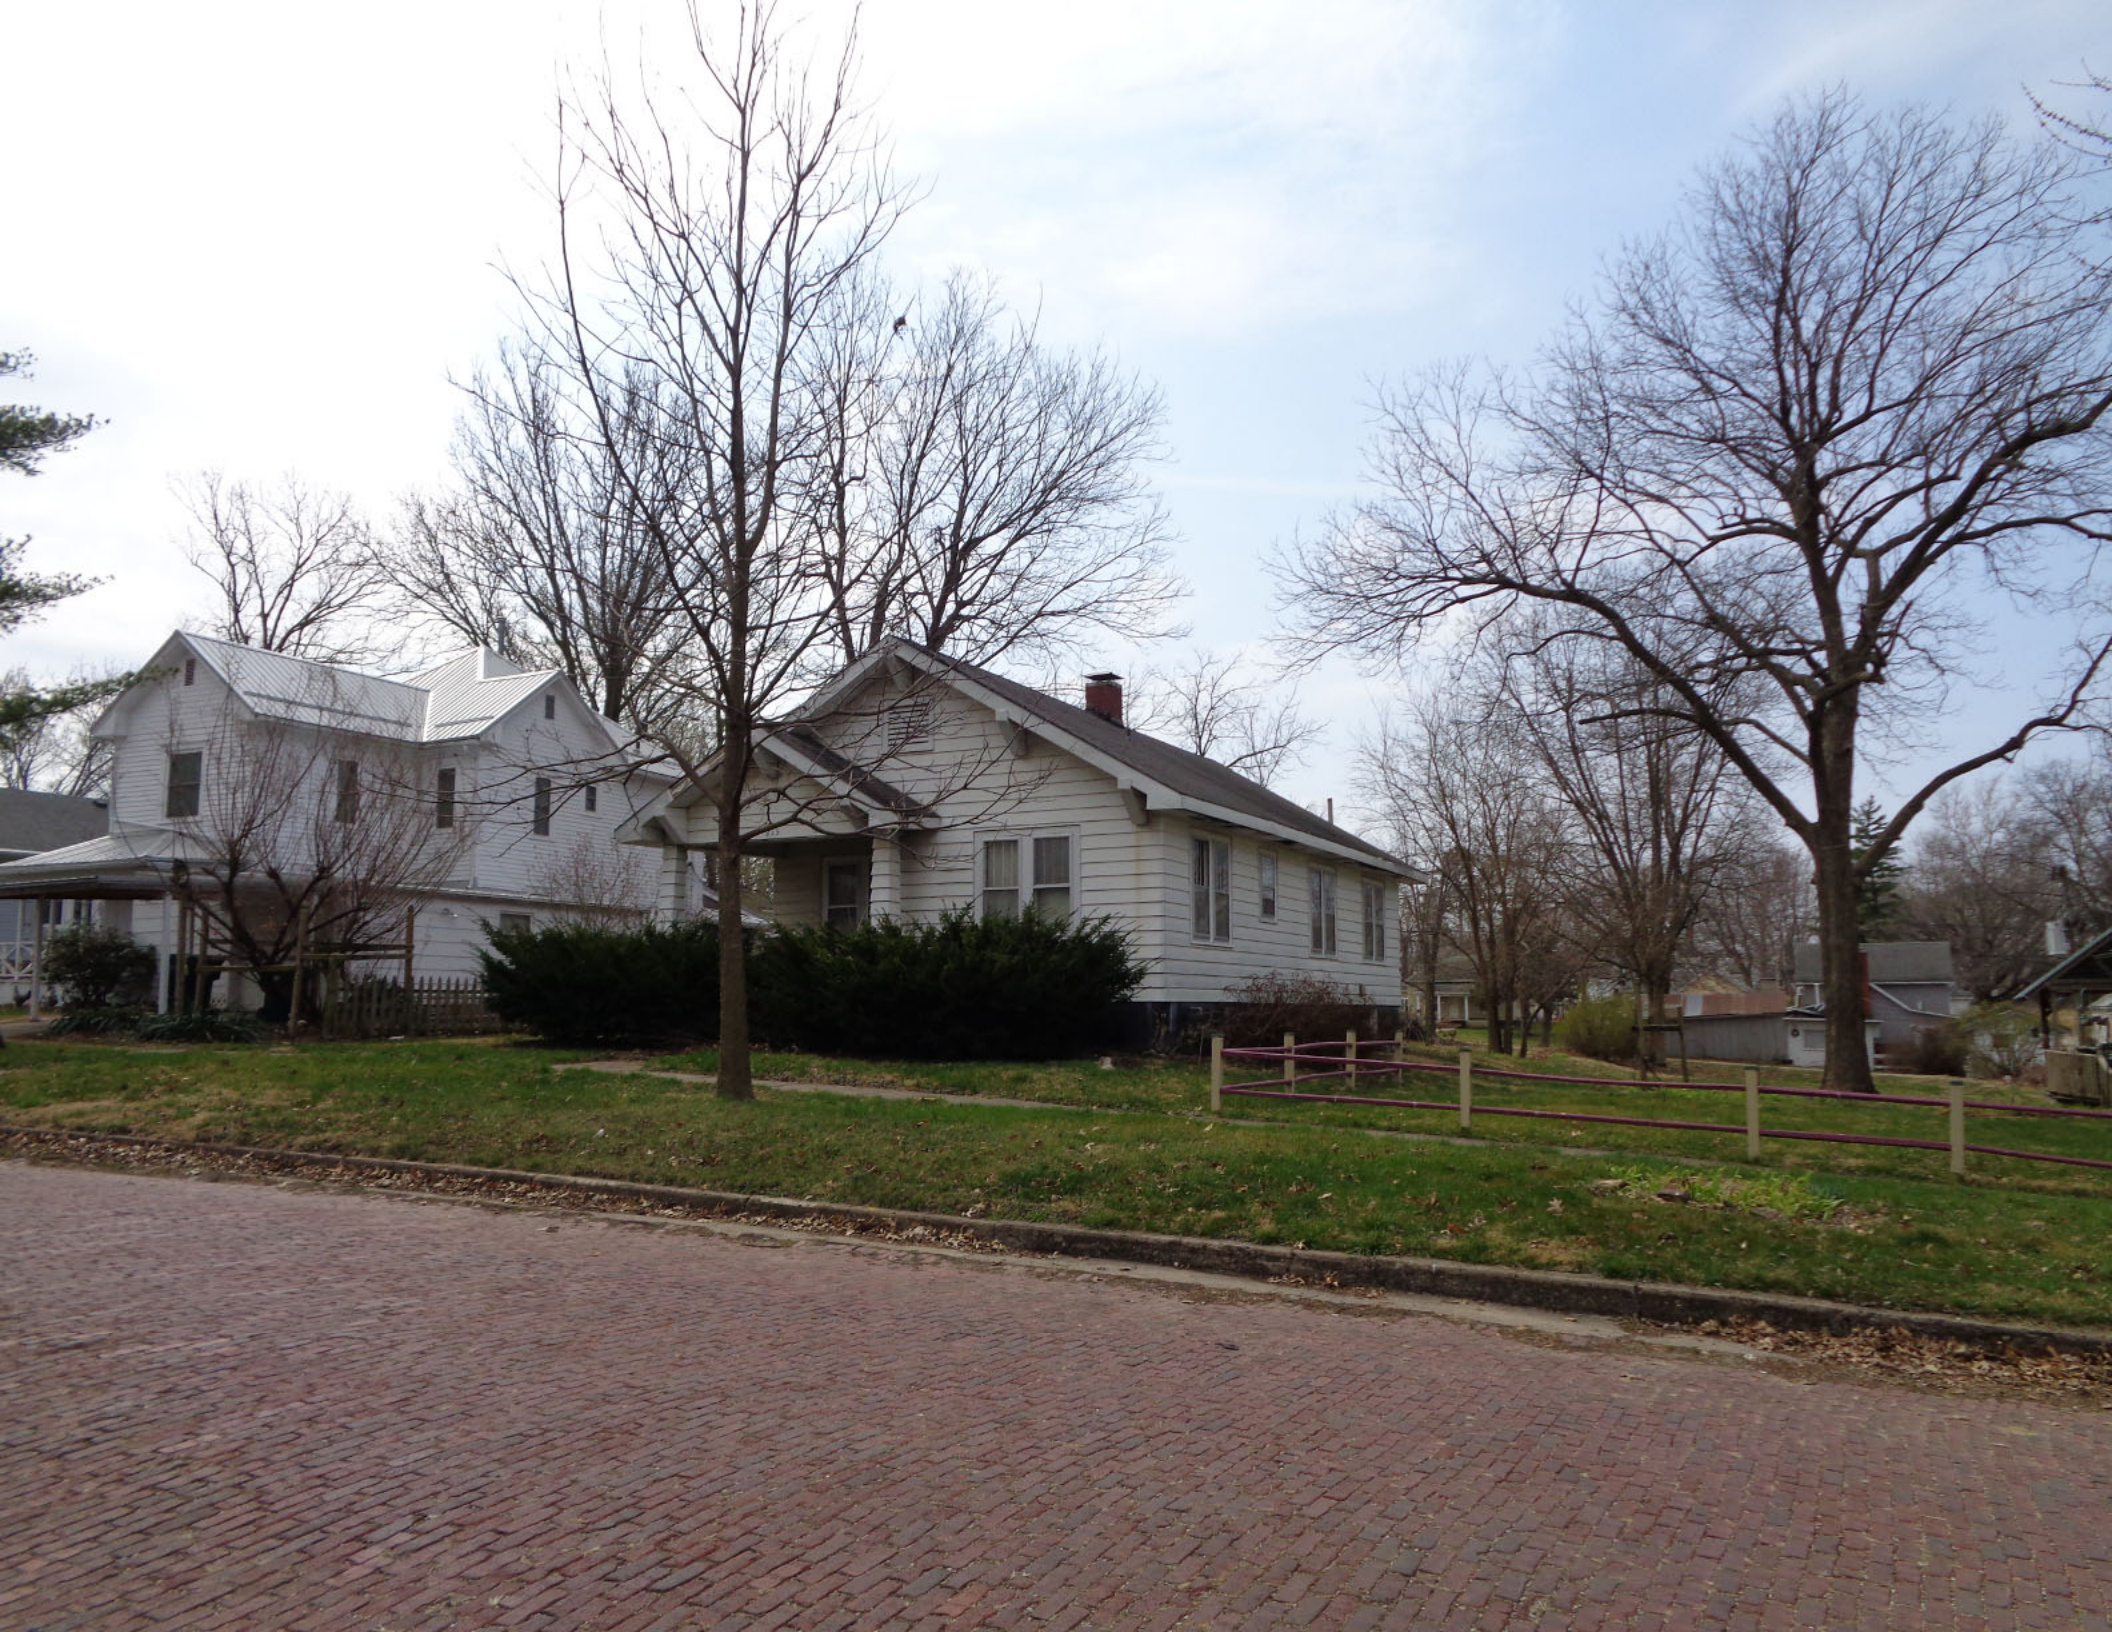
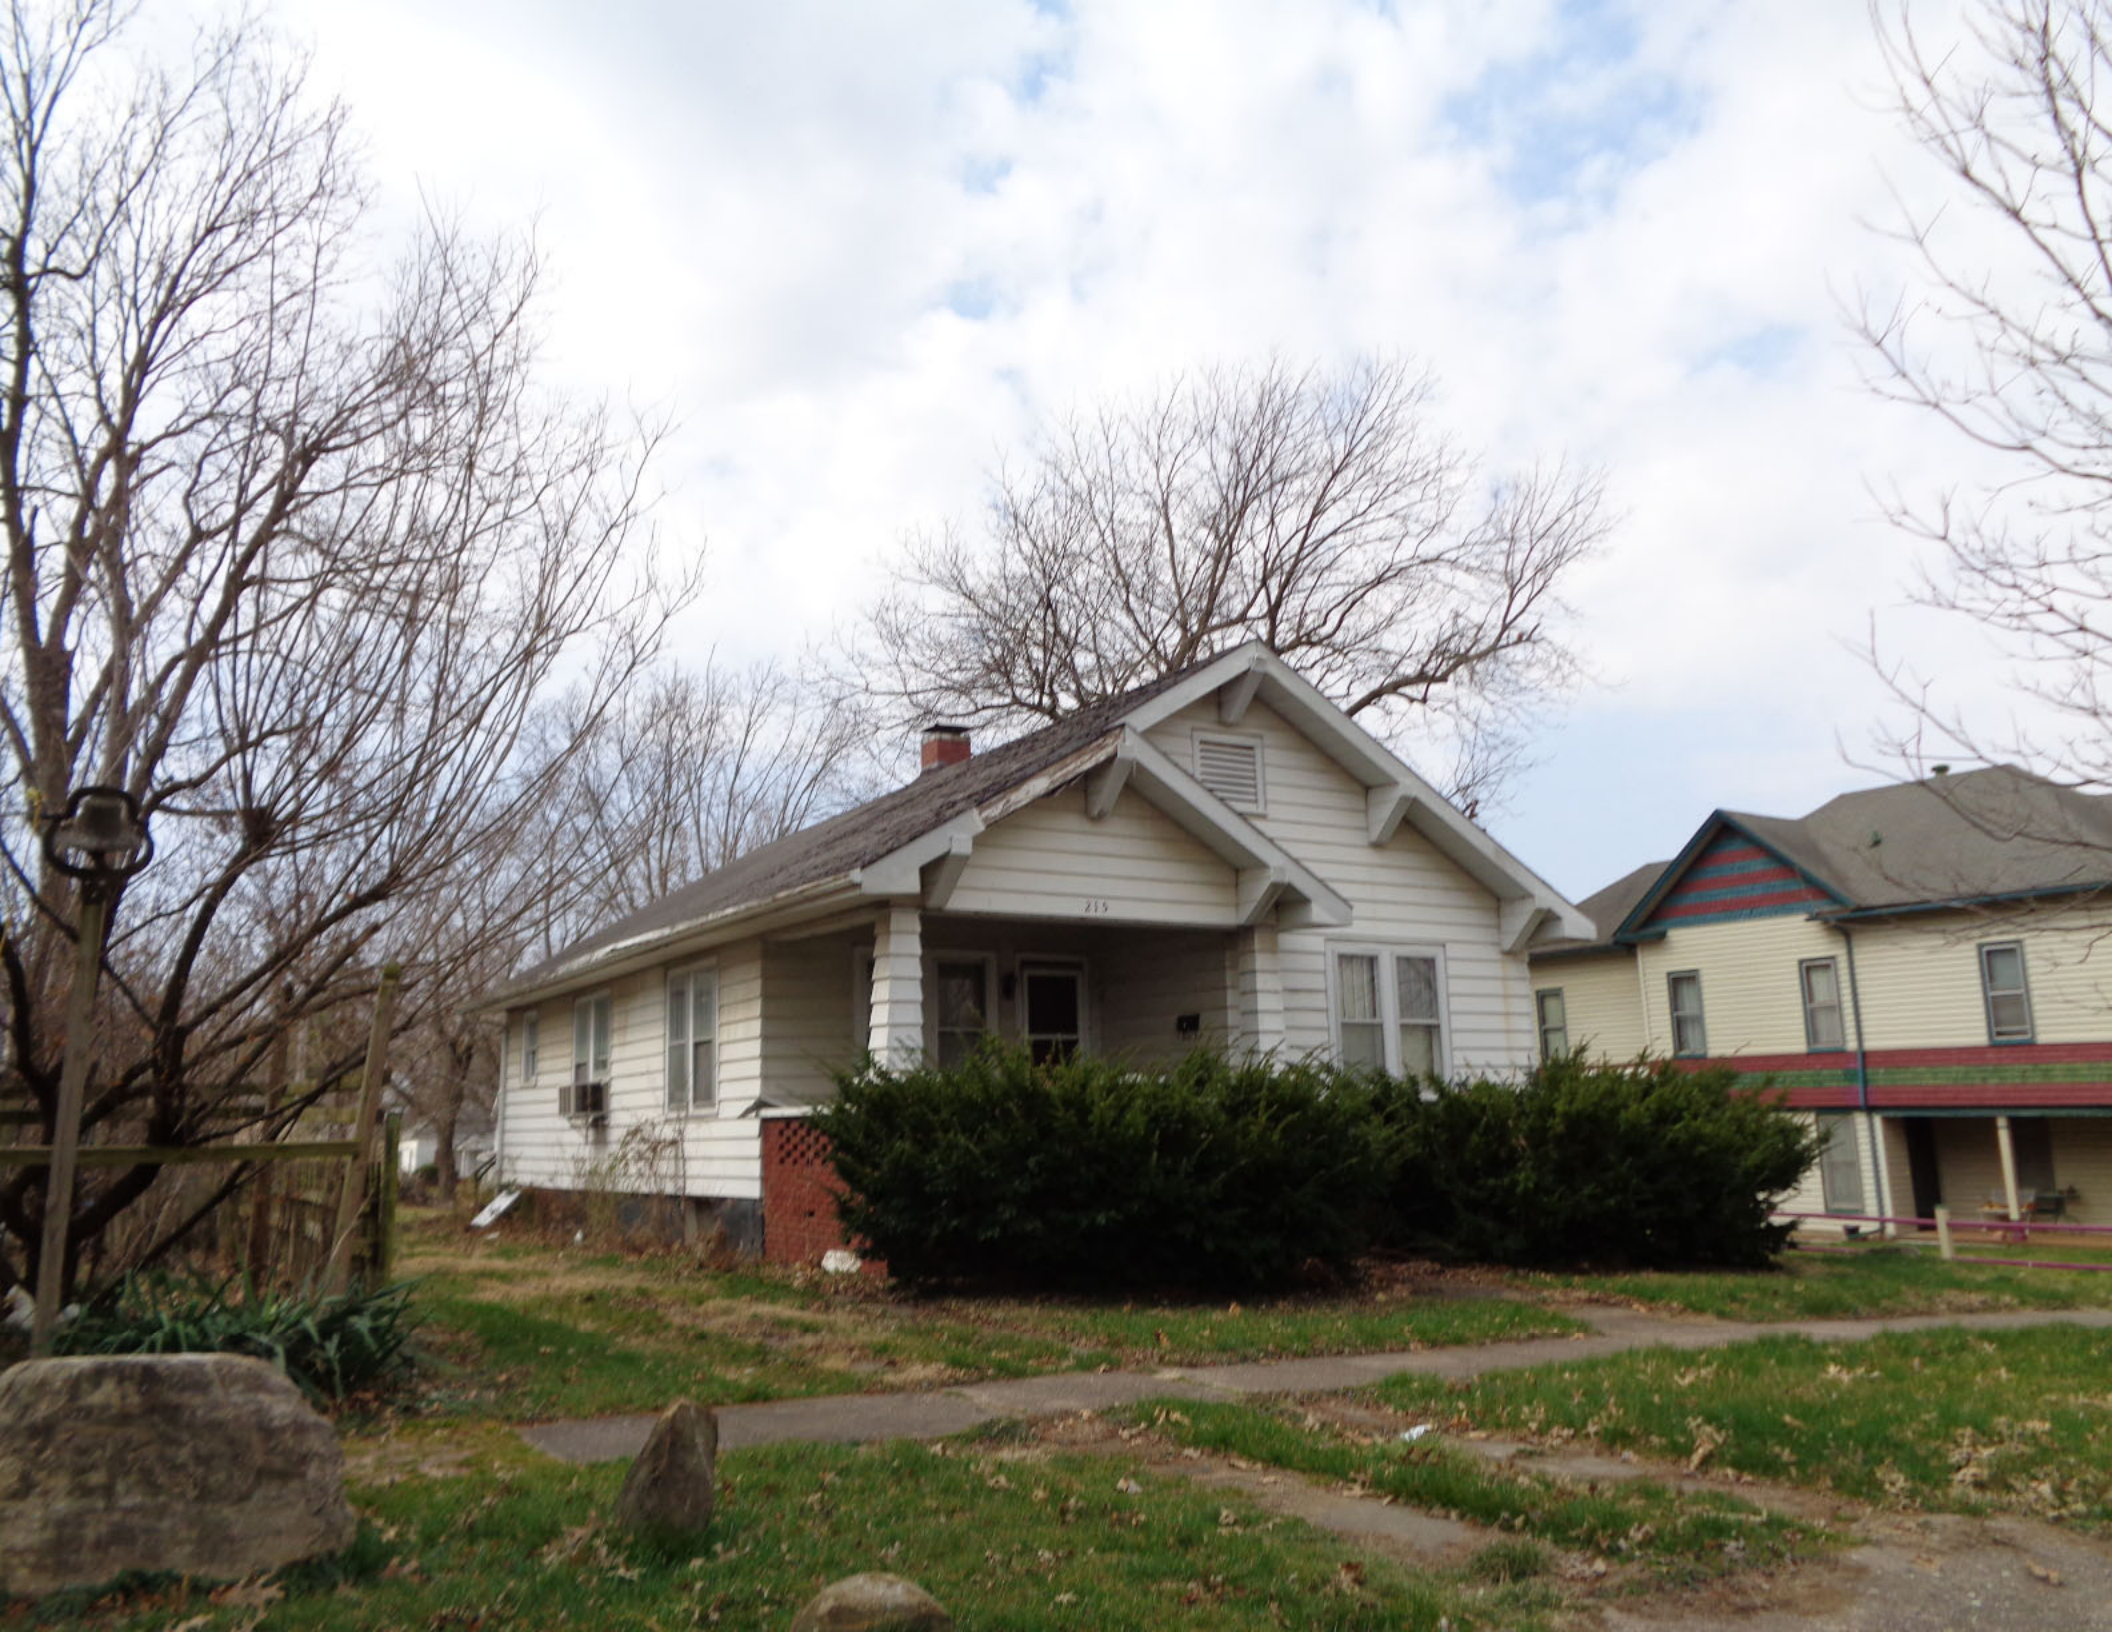
This one story bungalow building was constructed with craftsman elements. The house has been resided with aluminum siding that covers the whole building including the rafter brackets. Starting from the east there is a small brick porch recessed in the east part of the facade. The porch has a small gable roof over the porch creating a double front gable. The first bay to the east has a pair of original wood four-over-one windows, followed by a single entrance with a storm door. The final bay on the west side of the facade has a pair windows the same as those previously described. There is a square attic vent in the front gable. There is also a centrally located brick chimney.

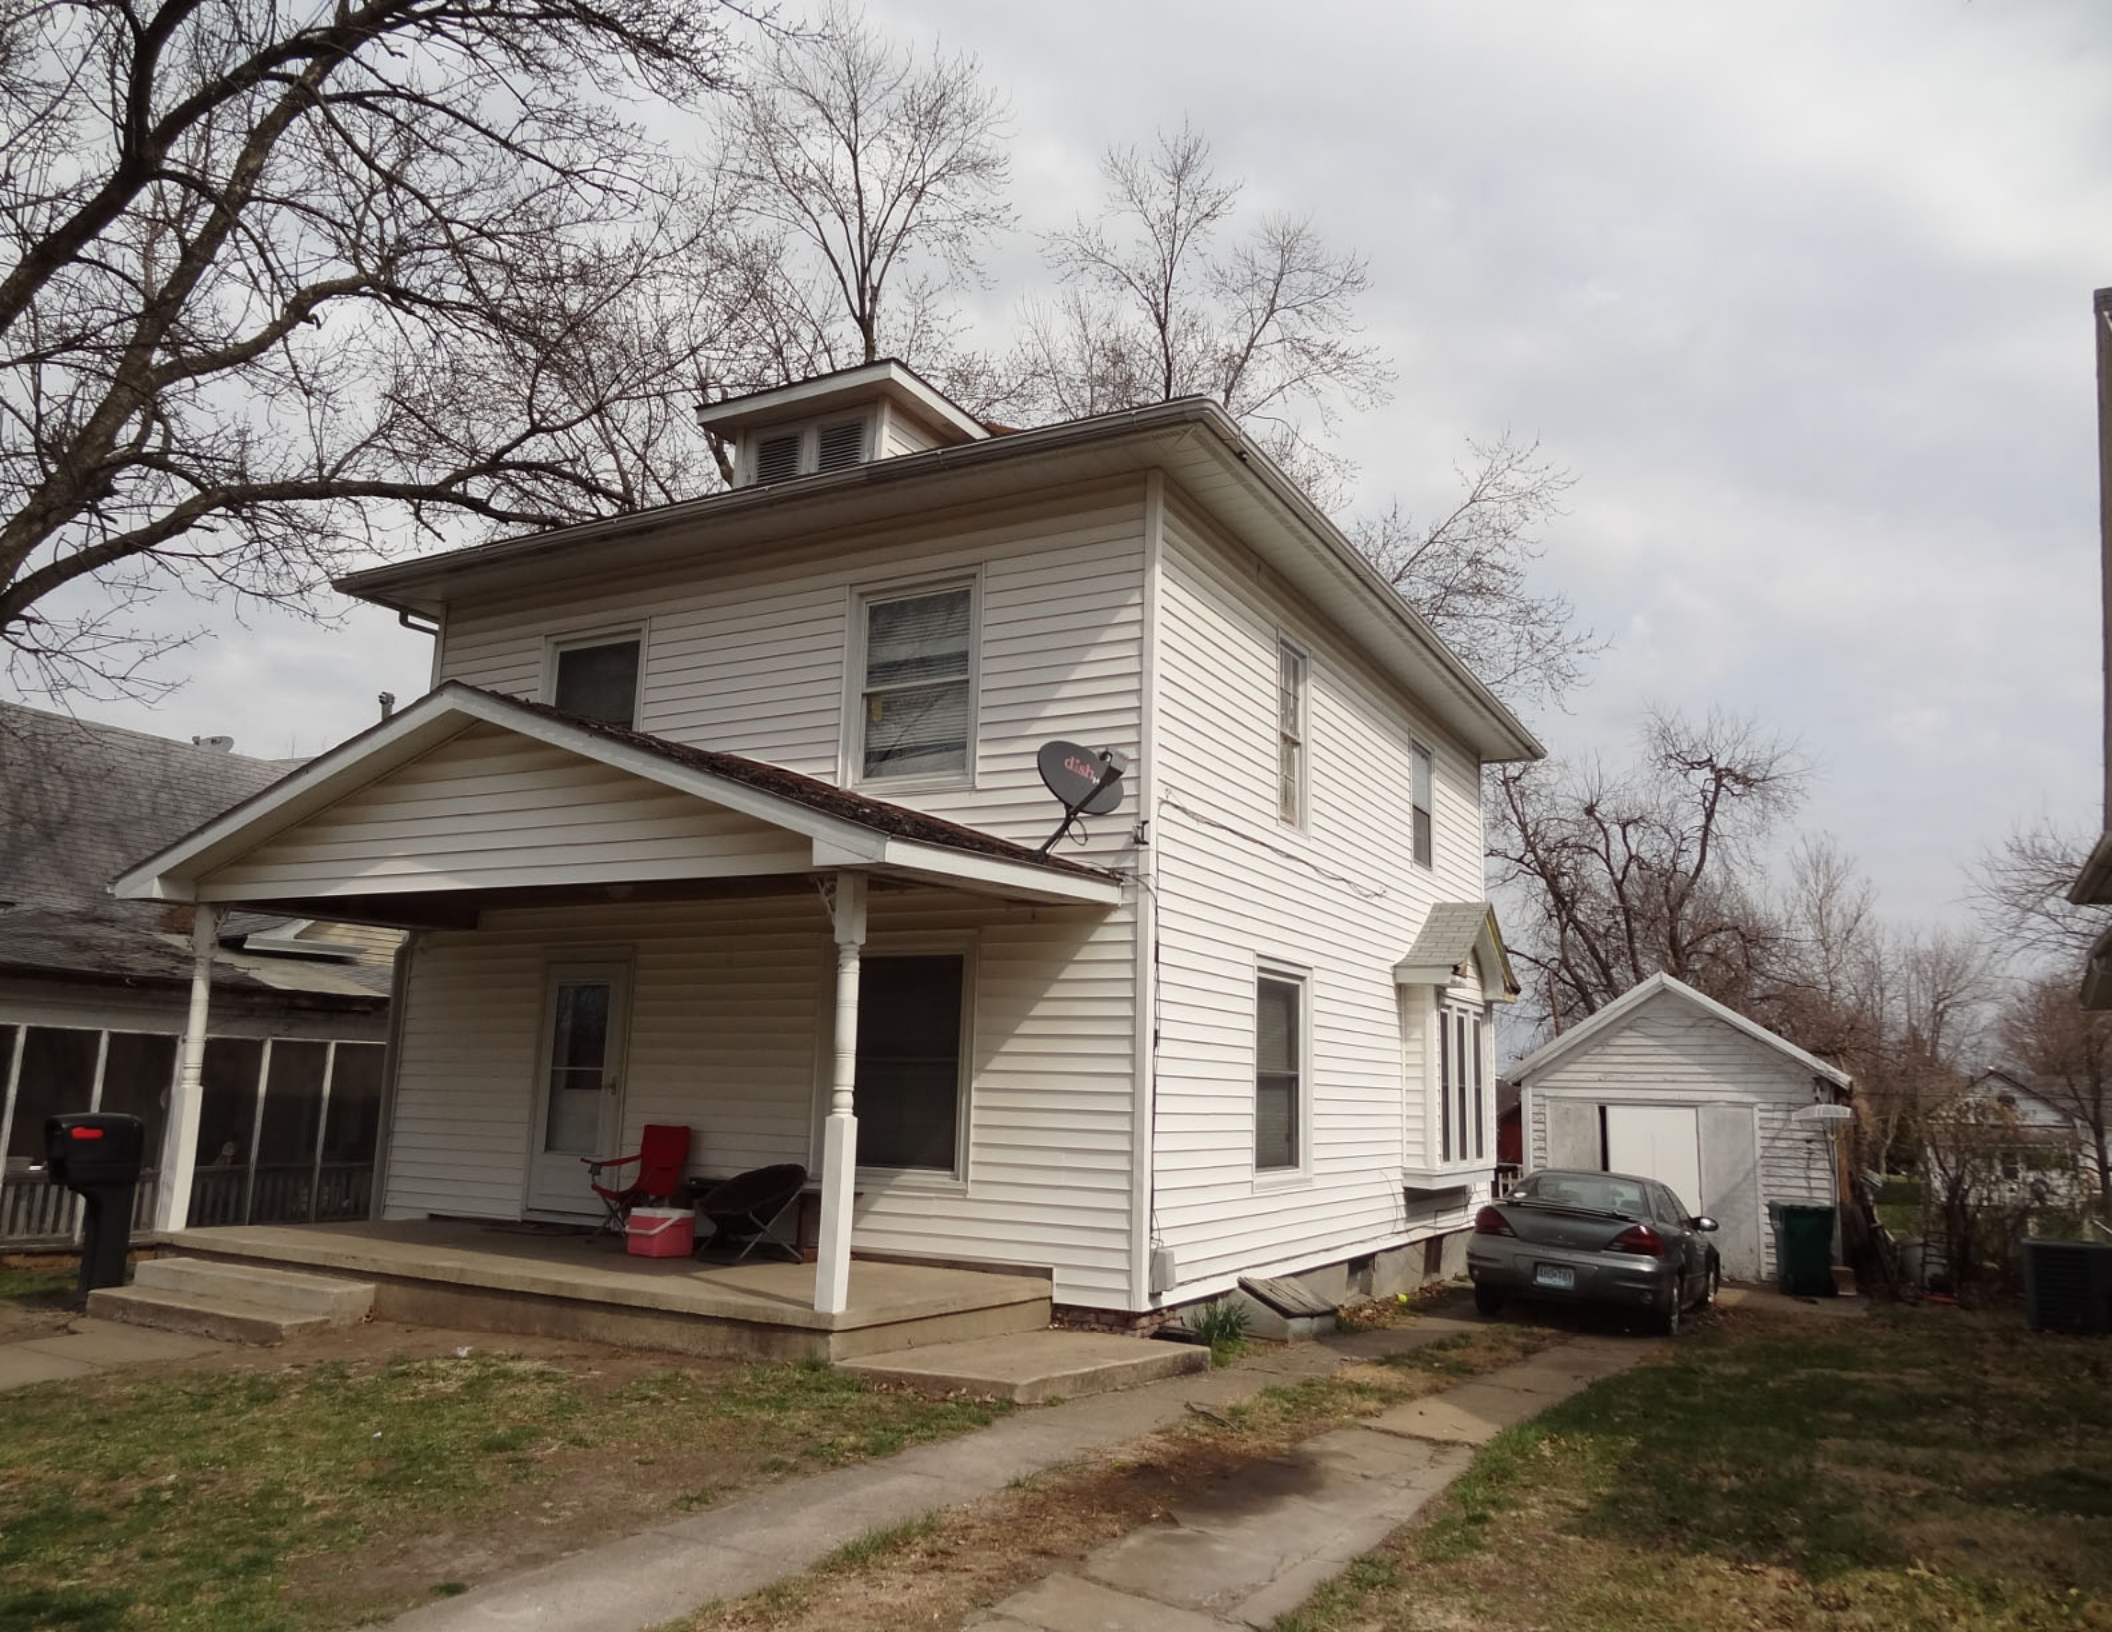
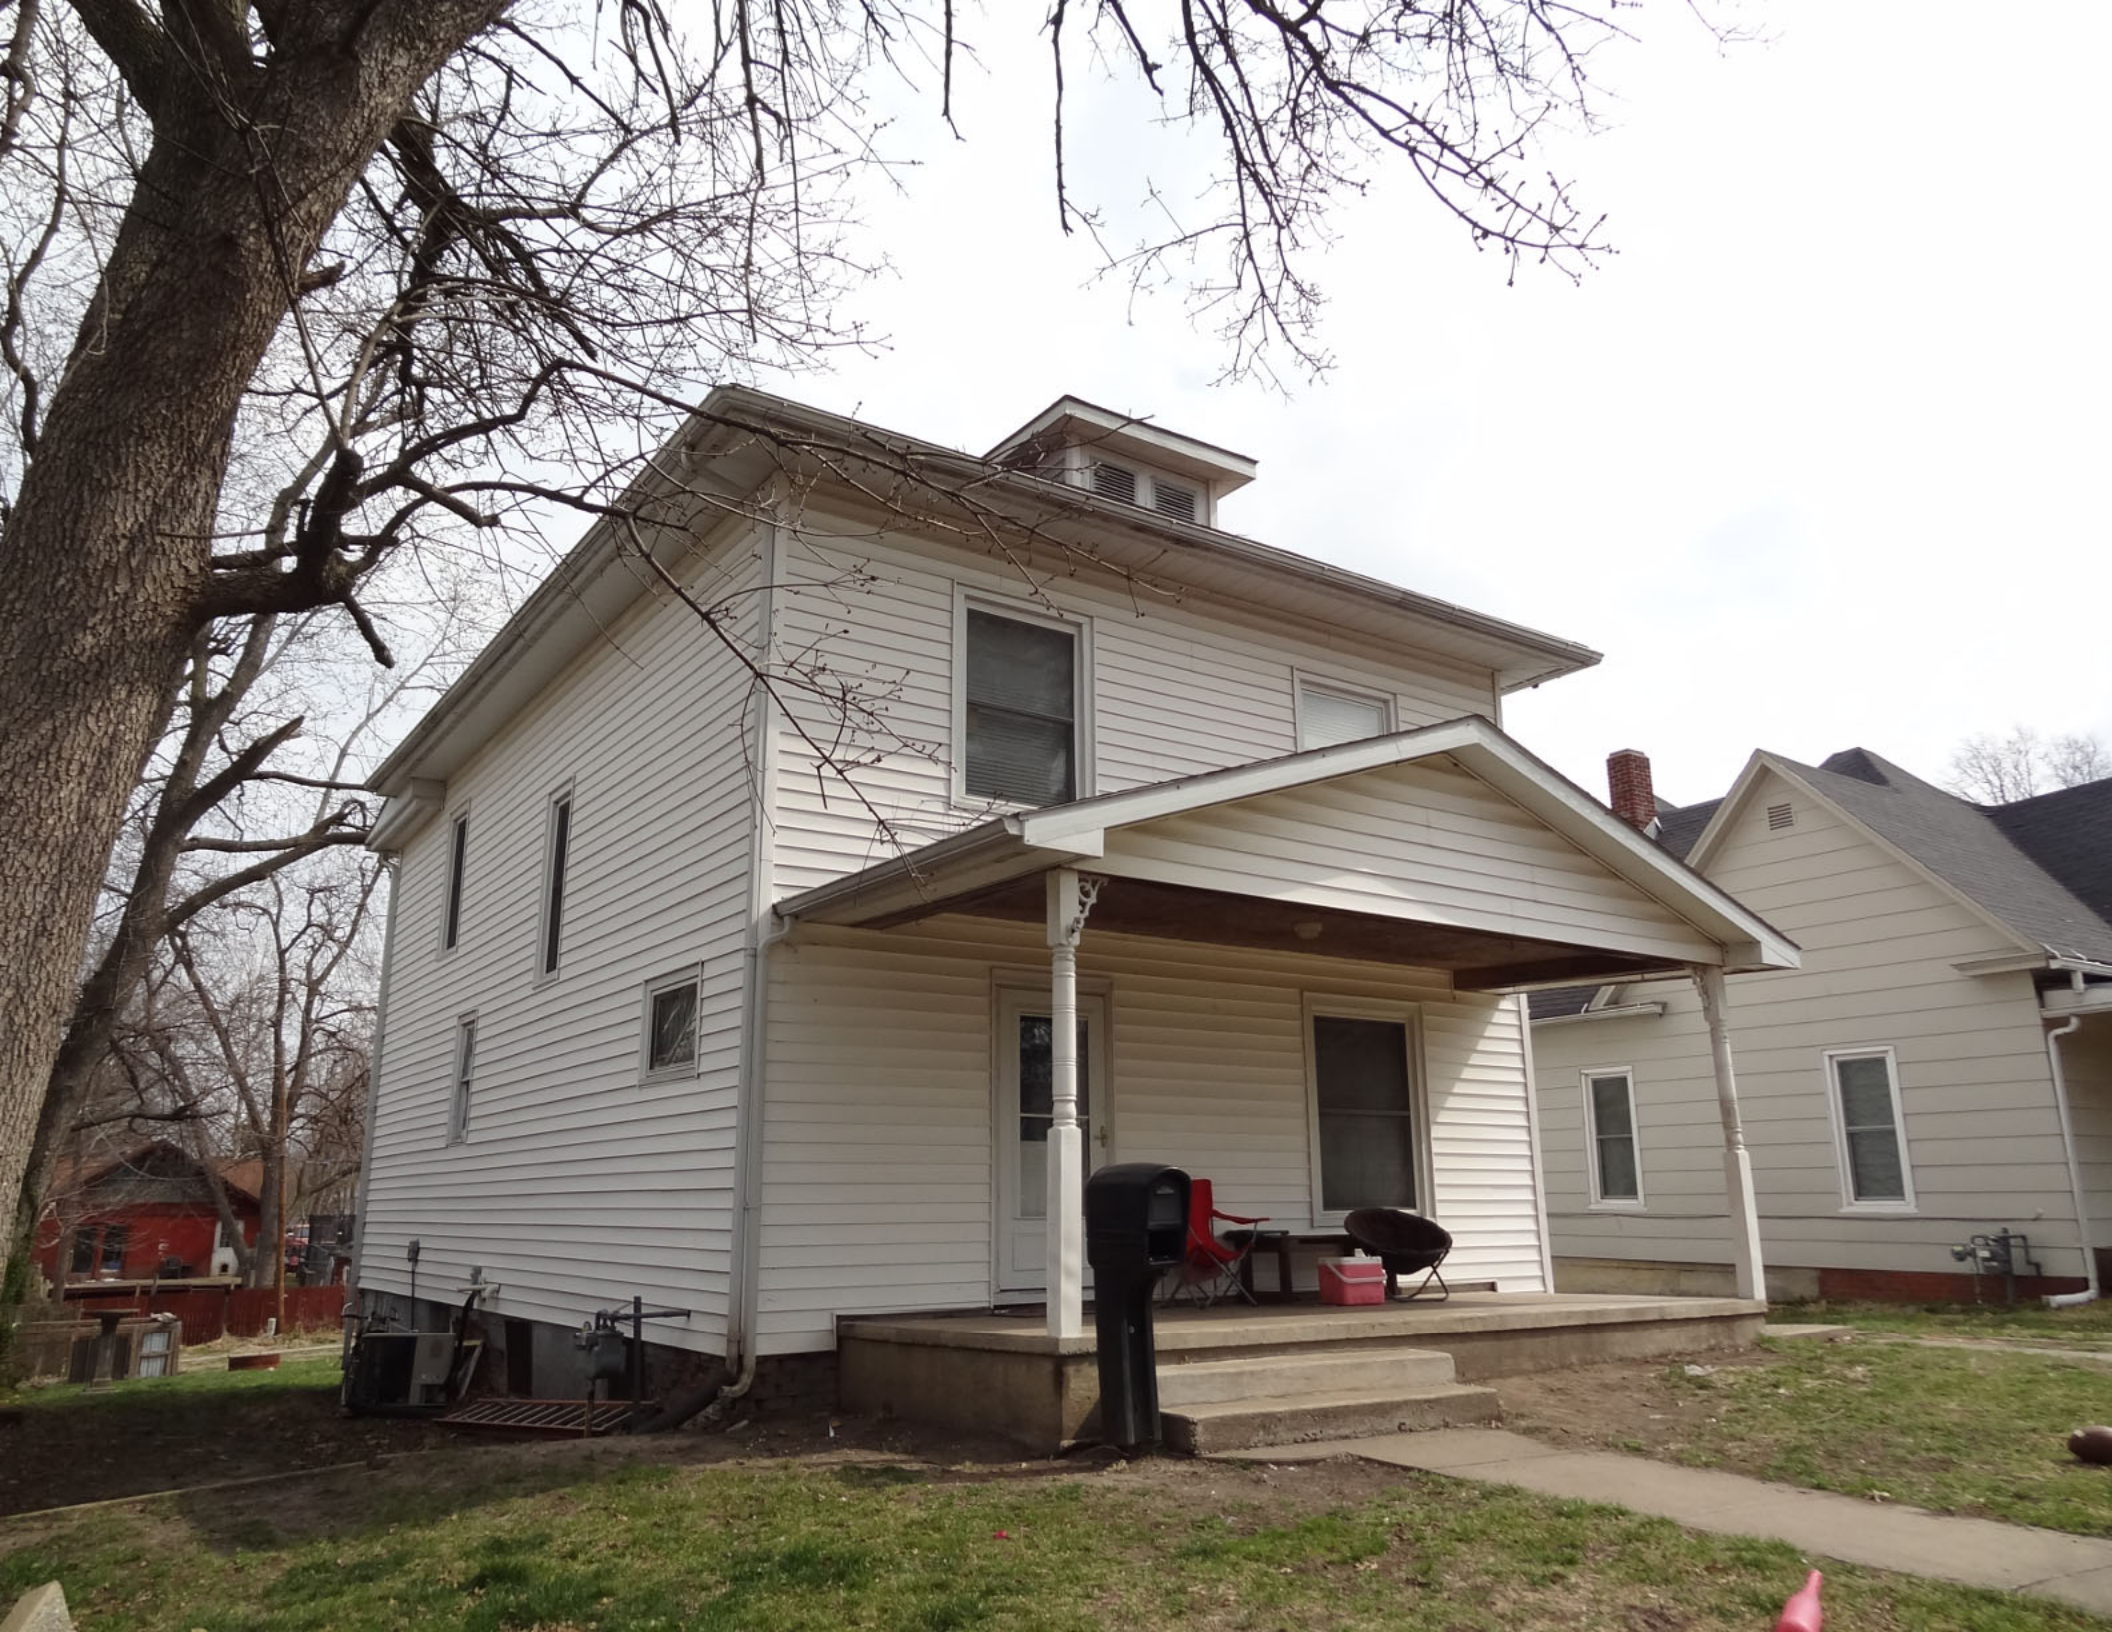
This classic foursquare home has a low hipped roof with a single hipped dormer. The dormer has two vents. The home has asphalt shingles and has been re-clad in vinyl. It has wide overhanging eaves. The full-width front porch is front gabled and has a concrete flooring reached by two concrete steps on the west end of the south facade and a concrete slab on the porch's east side. Two posts with Queen Anne detailing support the porch. Likely constructed with Prairie inspiration, alterations have likely obscured some of this style's detailing. There are two bays. The first is the front door covered by a storm door. The second is a 1 over 1 window. Above the porch are two 1 over 1 windows in line with the bays below. All the 1 over 1 windows are likely replacement. A single 6 over 6 window in the second story of the east elevation is likely historic. All windows are sash except for on the west elevation where there is one small casement window that could be historic. There is also a small bump out window on the east elevation (north end, first story). It has three 1 over 1 windows and a front gabled roof.
