MISSOURI DEPARTMENT OF NATURAL RESOURCES  
STATE HISTORIC PRESERVATION OFFICE, P.O. Box 176, Jefferson City, MO 65102  
**ARCHITECTURAL/HISTORIC INVENTORY FORM**

1. SURVEY NO. LI-AS-001-001		2. SURVEY NAME: Marceline Survey	
3. COUNTY: Linn		4. ADDRESS (STREET NO.) 275	STREET (NAME) West Broadway
5. CITY: Marceline	VICINITY: <input type="checkbox"/>	6. UTM: / /	7. TOWNSHIP/RANGE/SECTION: T: R: S:

8. HISTORIC NAME (IF KNOWN): Walt Disney's Childhood Home		9. PRESENT/OTHER NAME (IF KNOWN): Walt Disney's Childhood Home	
10. OWNERSHIP: <input checked="" type="checkbox"/> PRIVATE <input type="checkbox"/> PUBLIC		11A. HISTORIC USE (IF KNOWN): Single Dwelling	11B. CURRENT USE: Single Dwelling
<b>HISTORICAL INFORMATION</b>

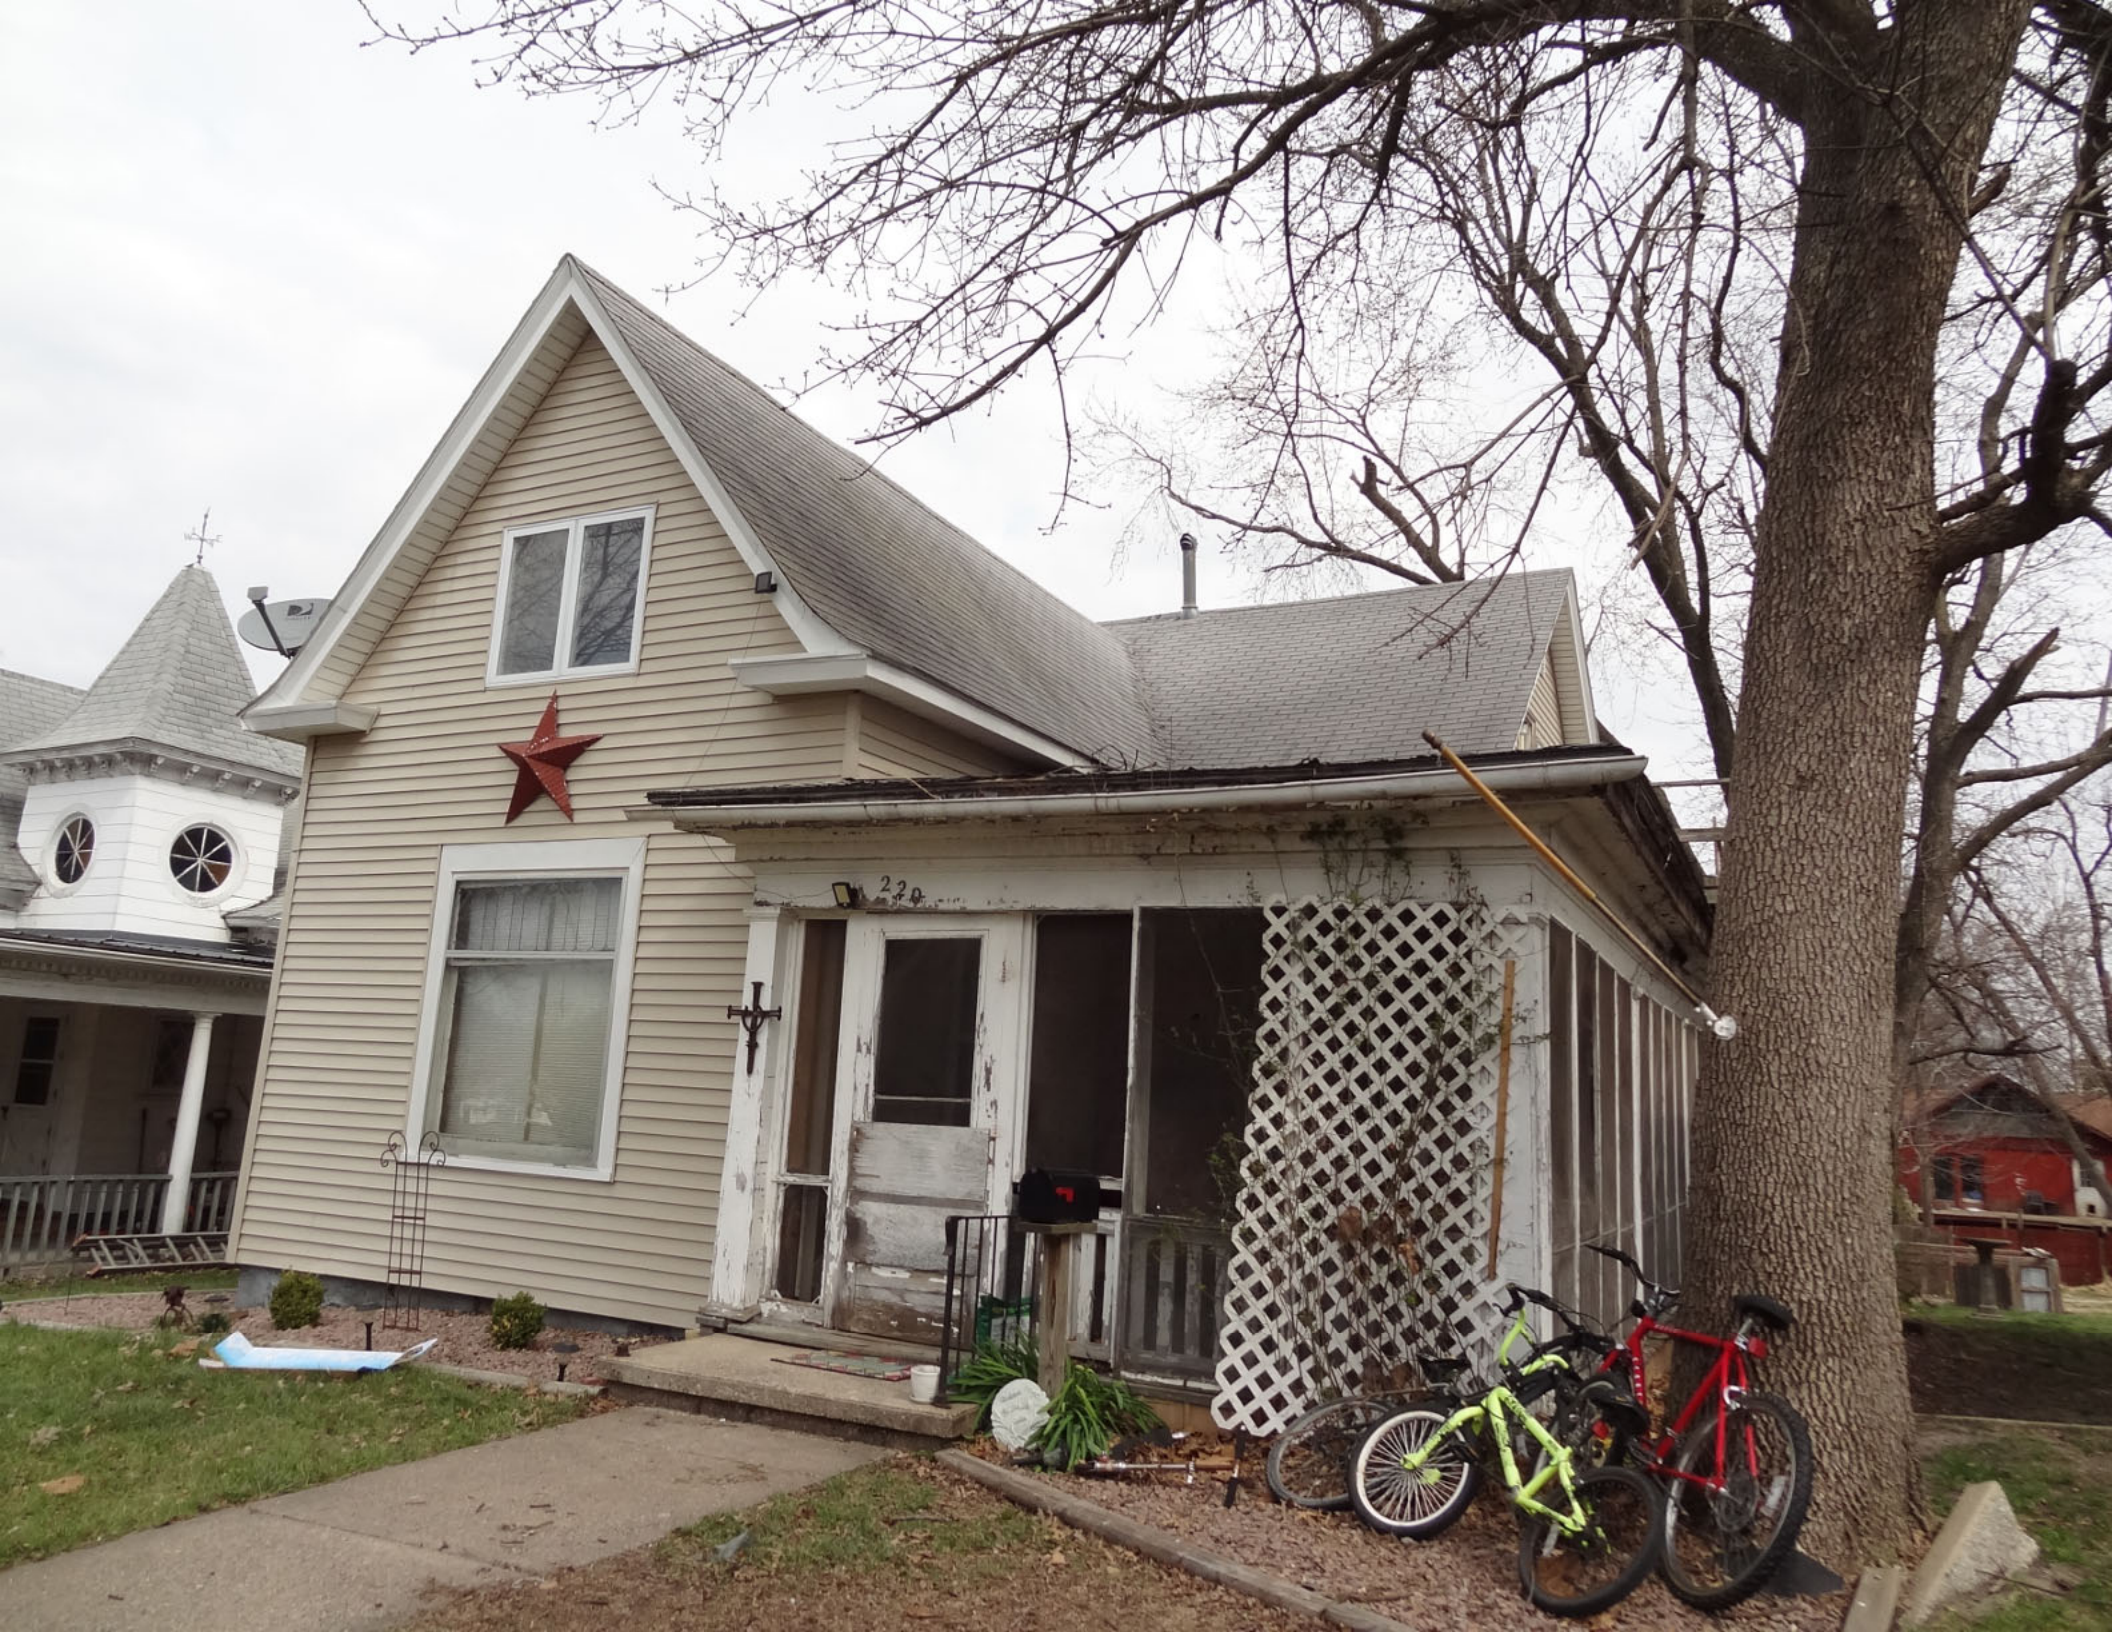
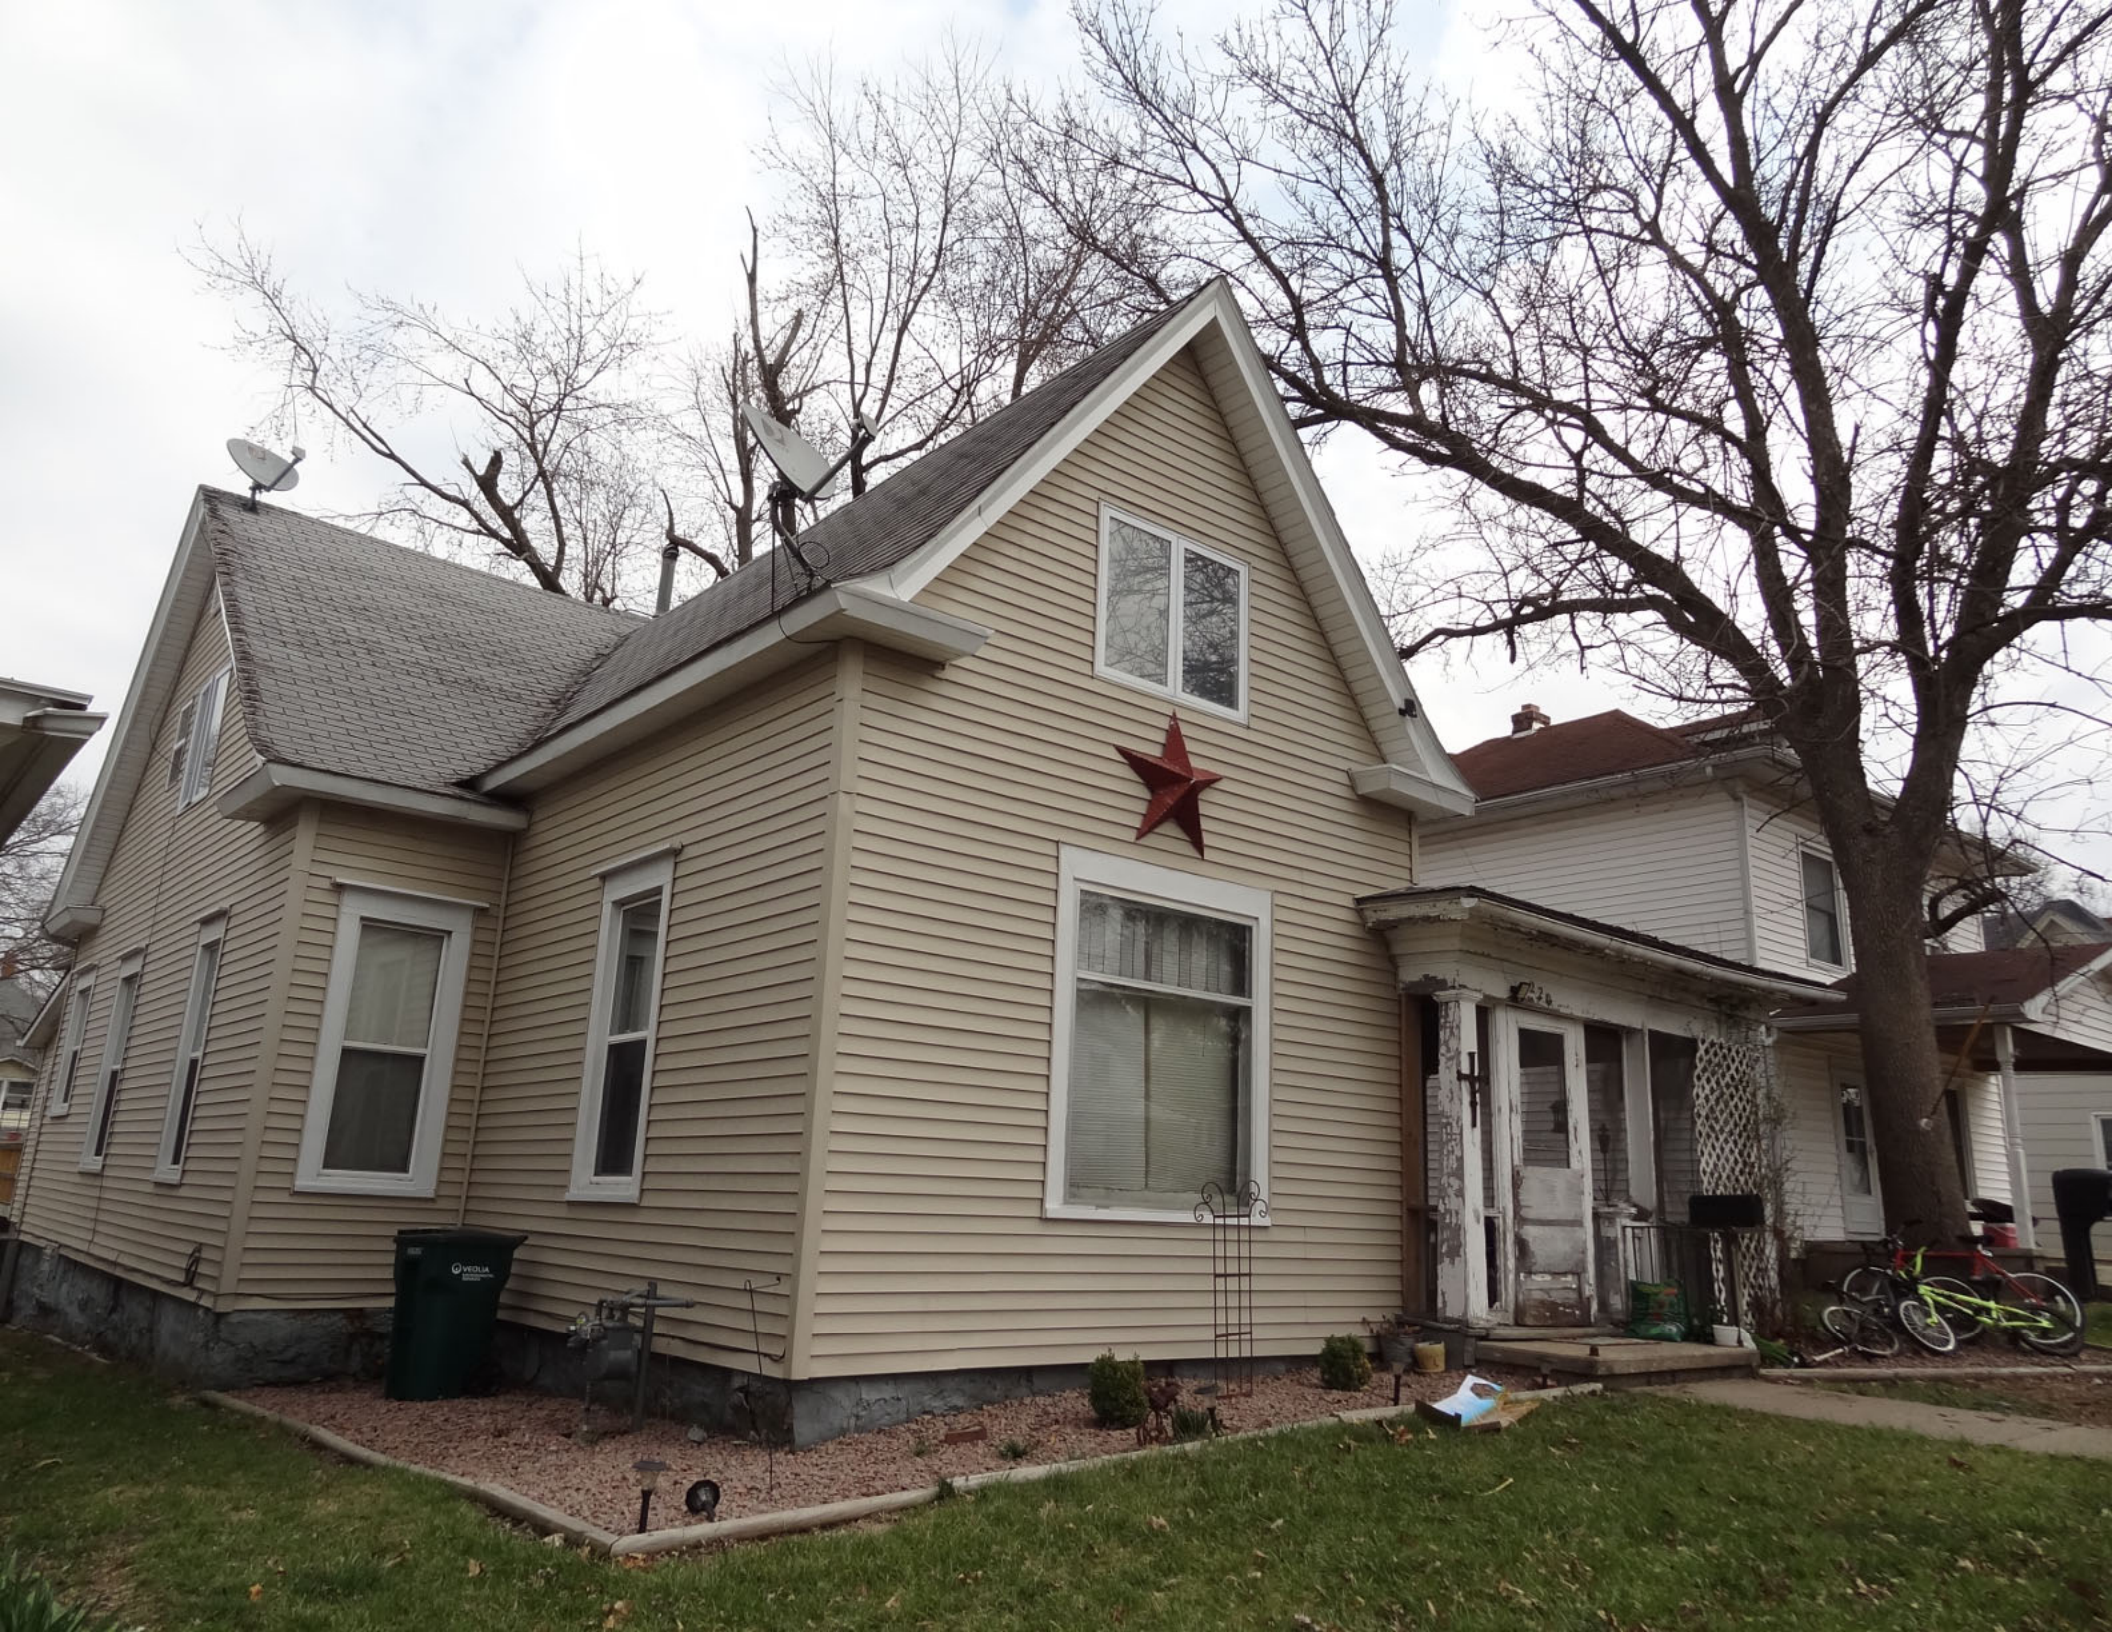
This two story cross gabled home has been re-clad in vinyl. It likely had Queen Anne detailing when first built, like the two similar properties to its immediate east, but those details have since been lost due to alterations that include new siding (installed post 2008) and perhaps an enclosing of the porch, though this likely would have occurred early. It has asphalt shingles and a stone foundation though it appears the foundation was originally covered in plaster that is now crumbling. Most windows are one over one replacement, sash. An exception is visible in the first bay of the facade which houses a large historic window with a single large bottom pane and a smaller upper pane that has metal wire detailing. This window appears original. Above this window is a single nonhistoric casement window with two panes. The porch marks the second bay, but its enclosure obscures any detailing on this side of the home except for a wood railing inside of the screen. The porch is recessed from the first bay and extends down most of the east side of the home. It is wood, painted white, though the paint is peeling. Replacement windows visible on the west side of the home have simple cornices. In the east gable above the porch is a doorway that opens onto a small wooden platform with steps leading down to the back of the home.

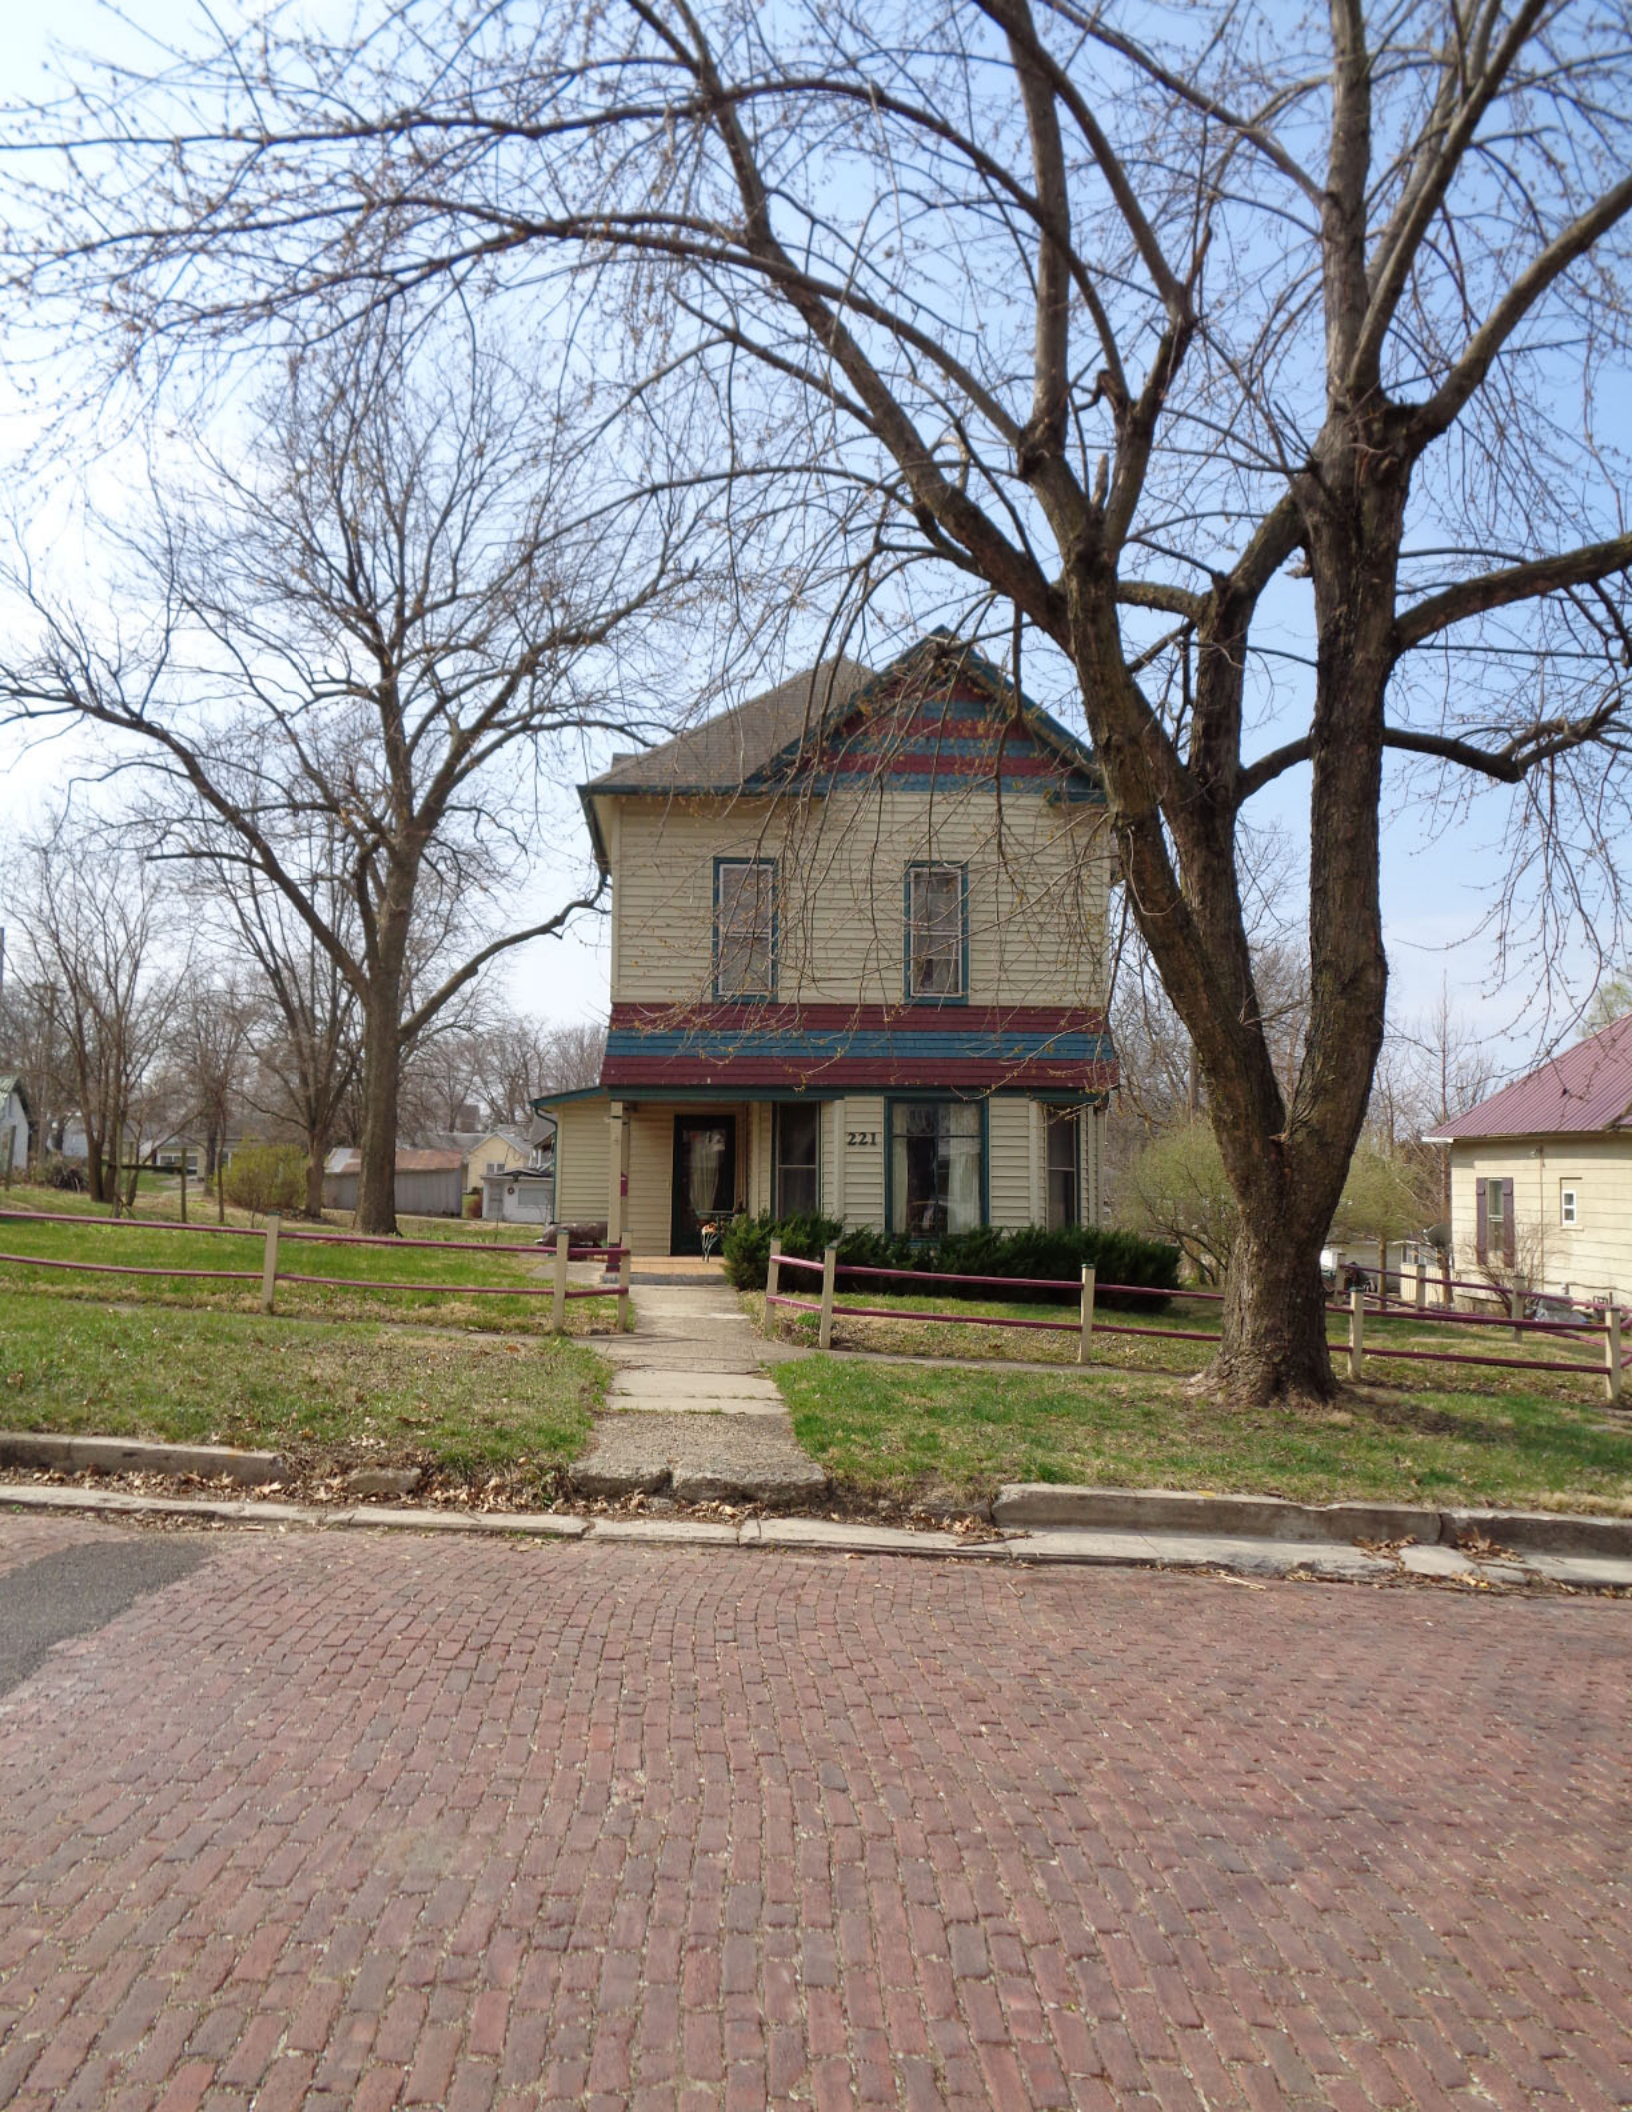
This two story vinyl sided house has elements of Queen Anne styling. The majority of the windows have been replaced. There are four bays on the first floor of the facade. The eastern most bay is recessed under the second story creating a small porch area, in the north wall there is a single door that appears original. Moving eastward there is one-over-one replacement window in the east wall of the recessed area. Moving east back to the north wall the remaining three bays create a three sided bay type area (two cantered windows flanking a larger centered window). The central portion has an original window that has two large panes of glass on the bottom and two small panes in the top; in the top panes there is some leaded detailing. On each side of this window there are one-over-one replacement windows. The area between the first and second levels is clad with multi-colored asphalt shingles. This area protrudes over the front gable creating a cutaway bay window. The second story of the facade has two evenly spaced one-over-one single windows. There is a gable end on the front facade that has multi-colored fishlap shingles.

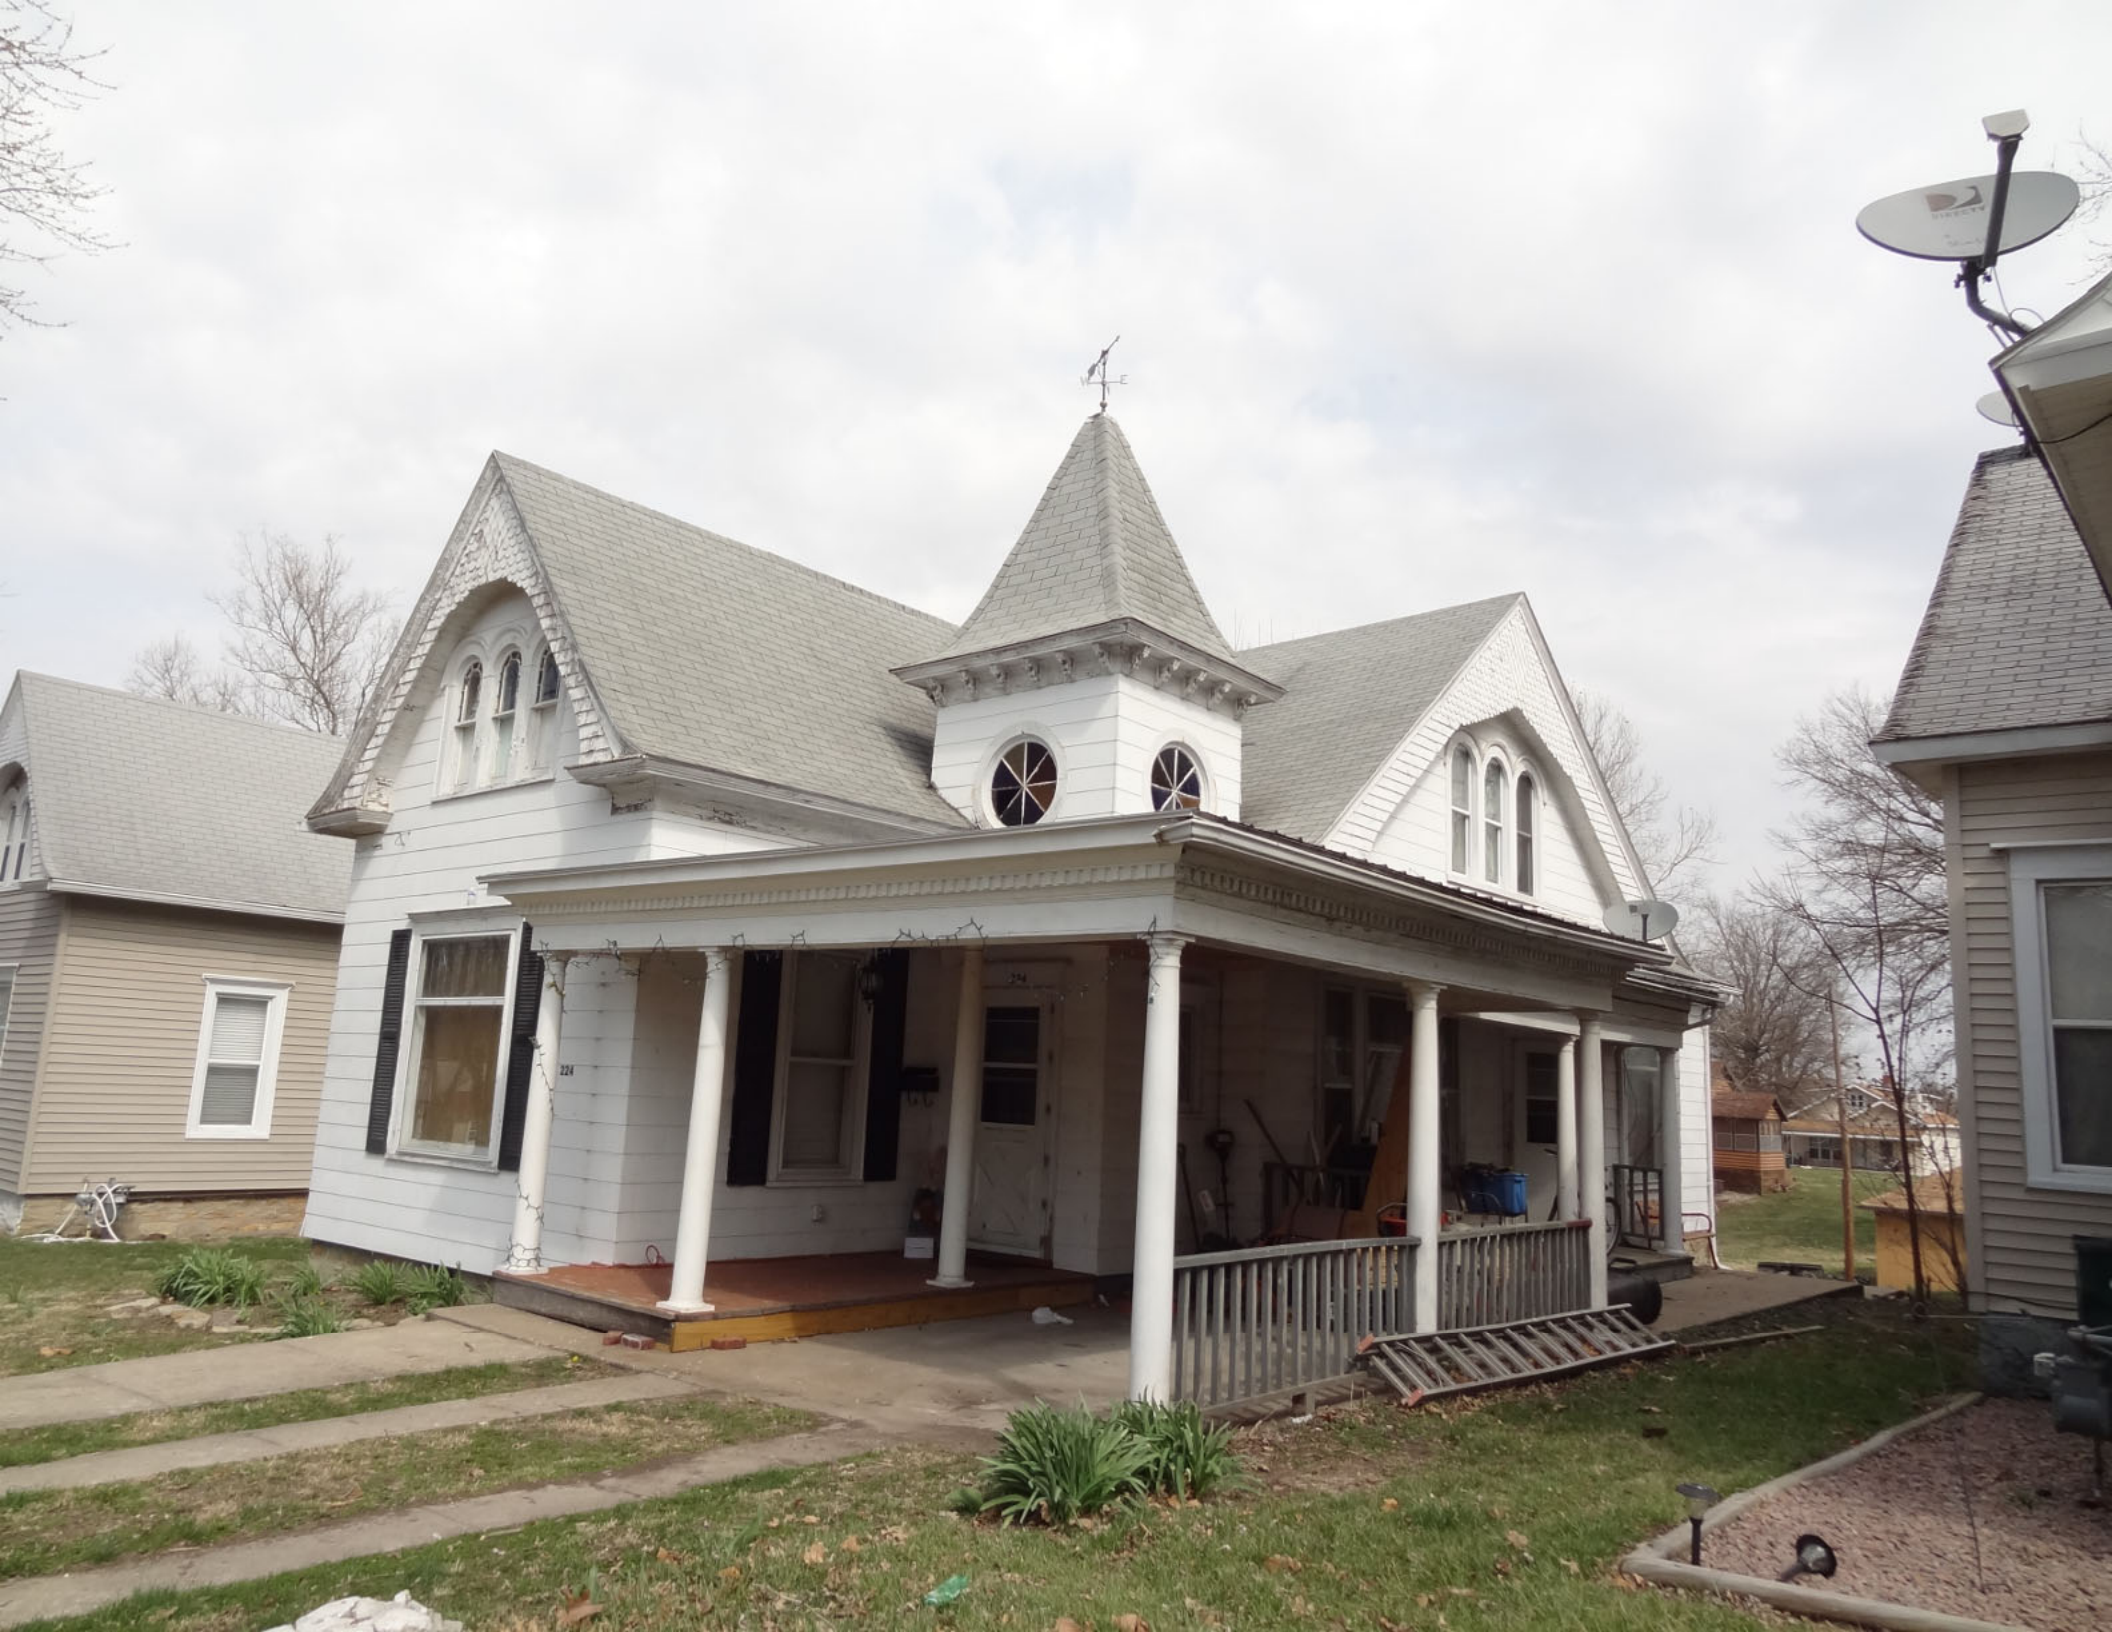
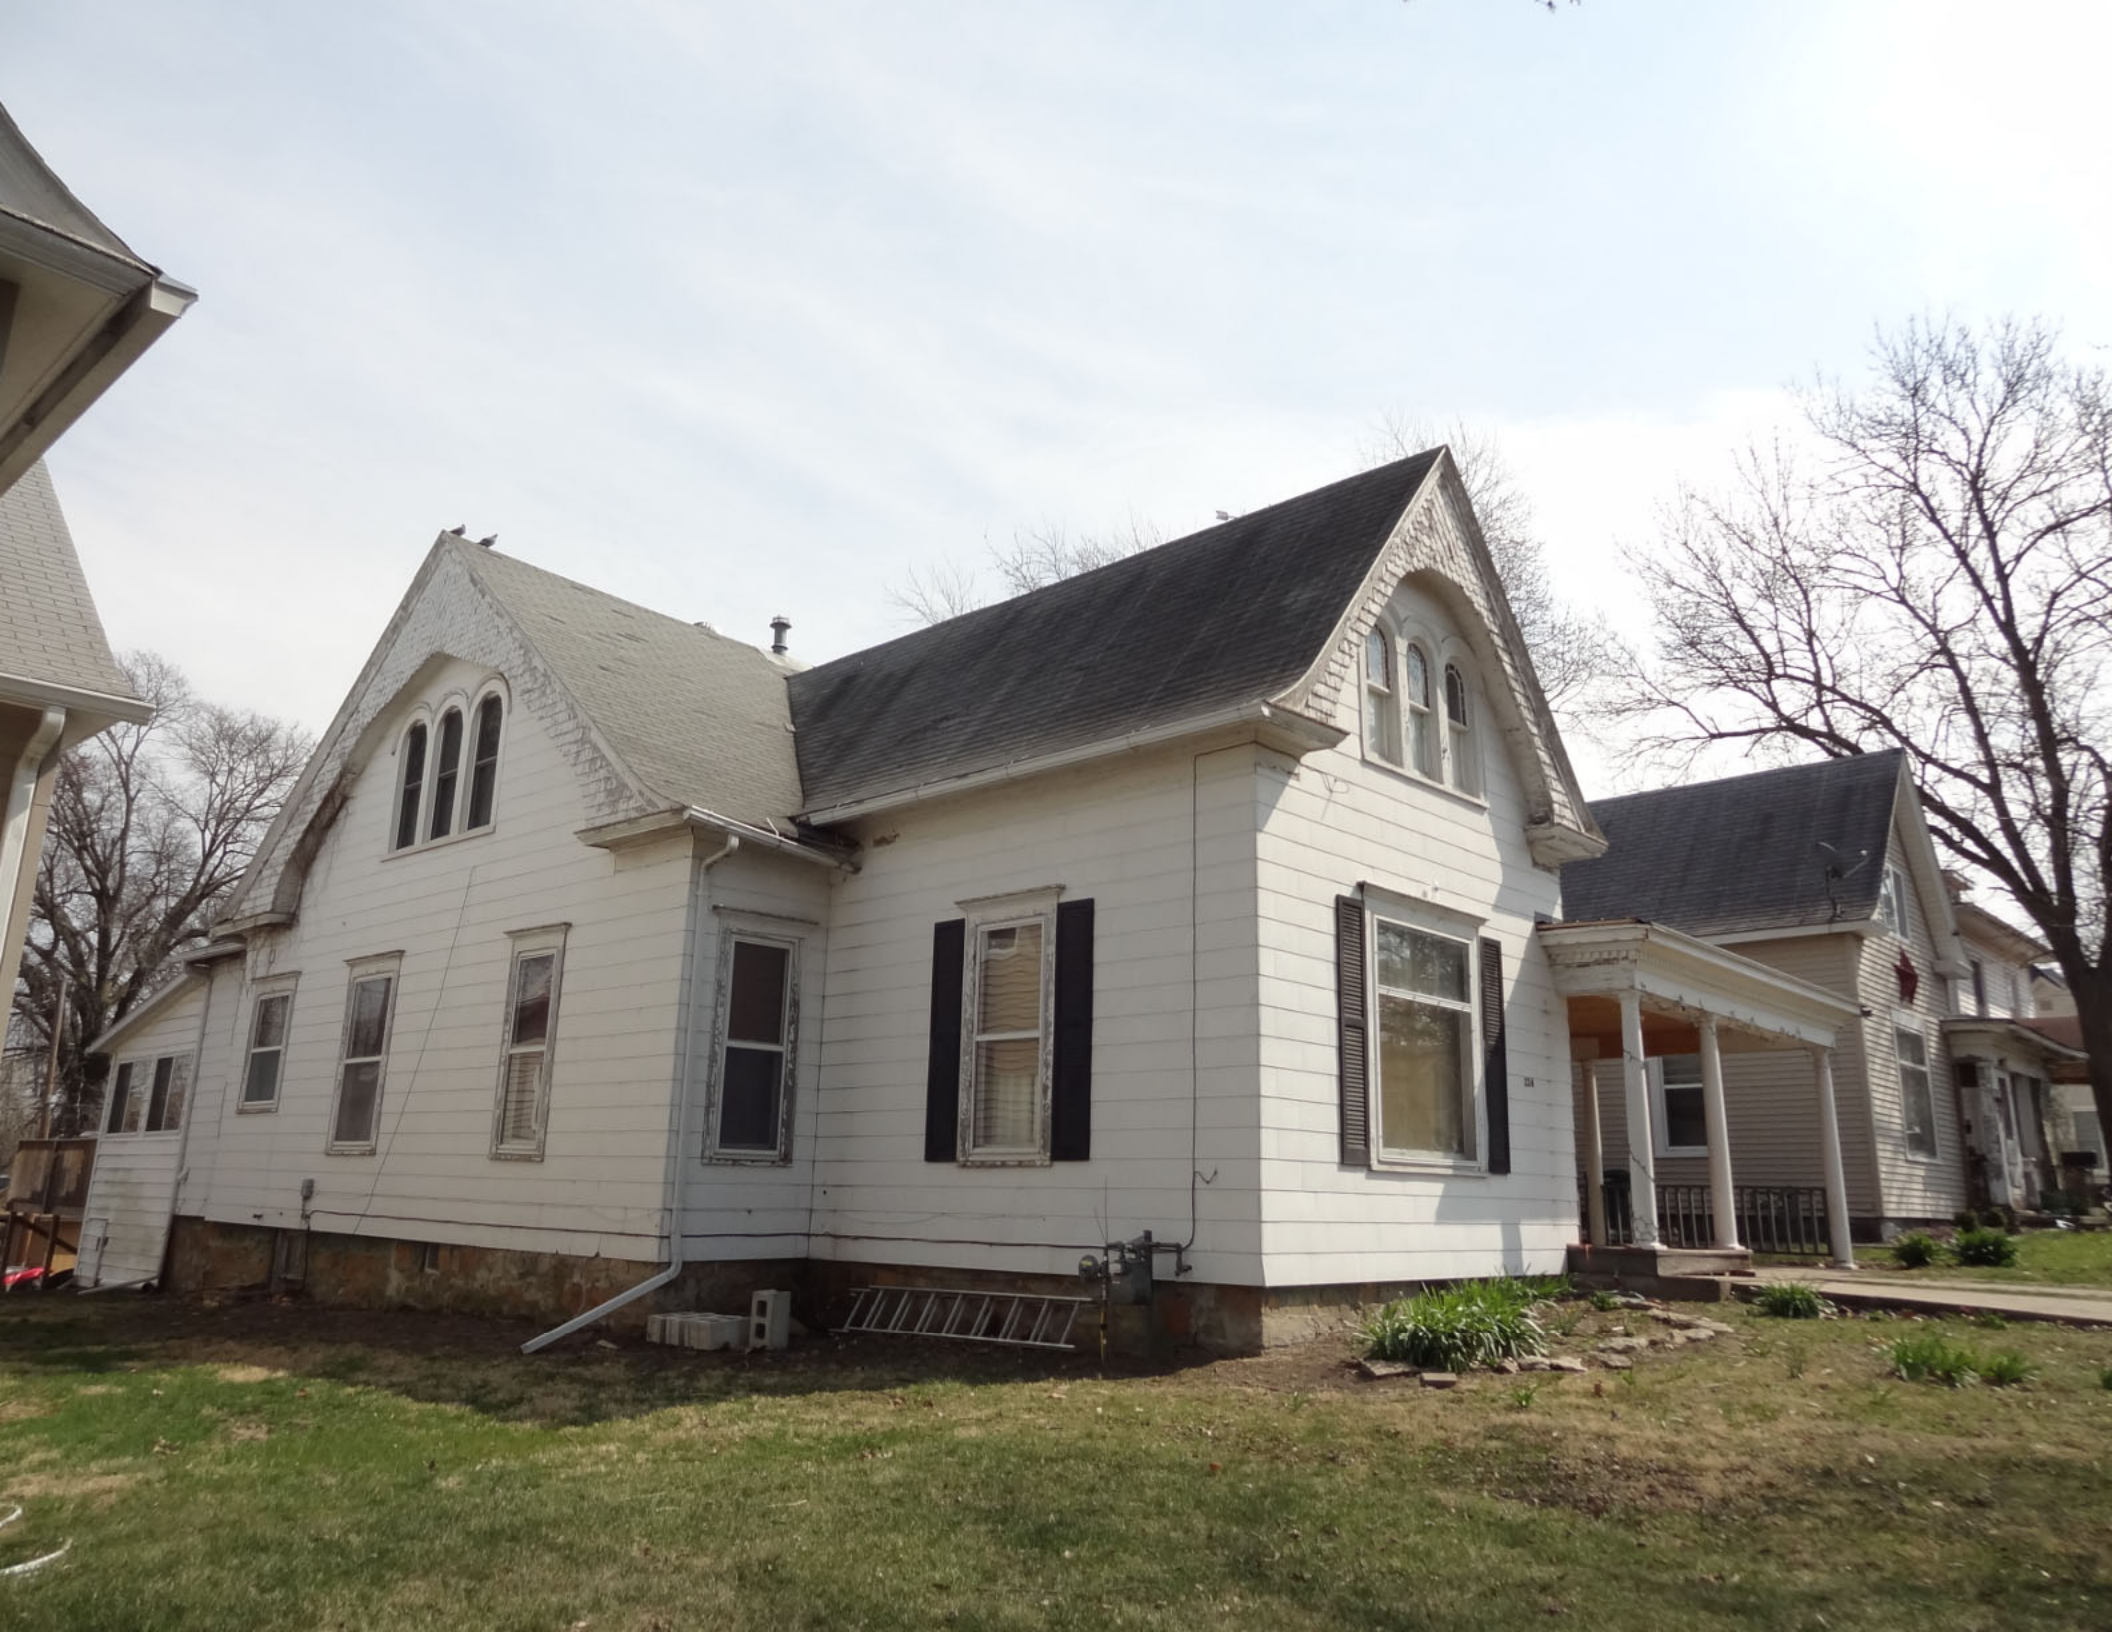
This is a 2 story cross gabled home with asbestos siding and Queen Anne detailing. A flat roofed, partial width open porch wraps the southeast corner of the home. It is supported by 8 doric columns and has denticulated detailing under the roof line. Windows are primarily sash and appear historic. The first bay projects out: it houses a large window with 1 large bottom pane and a smaller top pane that has metal wire detailing on the inside. Above, in the second story are 3 narrow arched windows grouped together. They have muntins that mimic their curve and others that radiate out from the curved muntins. Along the edges of the front gable extending down to the rake are wood shingles. They are fish scale in styling while those in the peak of the gable, surrounded by the fish scaling, are diamond shaped in a diamond pattern. The gables on the east and west side of the home have similar detailing. The windows on the front and side of the projecting bay on the first floor have black shutters. A single 1/1 window faces east on the east side of the projecting bay. The next bay is recessed and sheltered by the porch. It houses a door; the door and the lamp by the door appear historic. The next bay is recessed further under the porch and has a single 1/1 window. Above the porch is a square tower with dentils under its steeply pitched roof (topped by a metal weather vane) and round stain glass windows with pie cut muntins.
