MISSOURI DEPARTMENT OF NATURAL RESOURCES  
STATE HISTORIC PRESERVATION OFFICE, P.O. Box 176, Jefferson City, MO 65102  
**ARCHITECTURAL/HISTORIC INVENTORY FORM**

1. SURVEY NO. LI-AS-001-001		2. SURVEY NAME: Marceline Survey	
3. COUNTY: Linn		4. ADDRESS (STREET NO.) 275	STREET (NAME) West Broadway
5. CITY: Marceline	VICINITY: <input type="checkbox"/>	6. UTM: / /	7. TOWNSHIP/RANGE/SECTION: T: R: S:

8. HISTORIC NAME (IF KNOWN): Walt Disney's Childhood Home		9. PRESENT/OTHER NAME (IF KNOWN): Walt Disney's Childhood Home	
10. OWNERSHIP: <input checked="" type="checkbox"/> PRIVATE <input type="checkbox"/> PUBLIC		11A. HISTORIC USE (IF KNOWN): Single Dwelling	11B. CURRENT USE: Single Dwelling
<b>HISTORICAL INFORMATION</b>

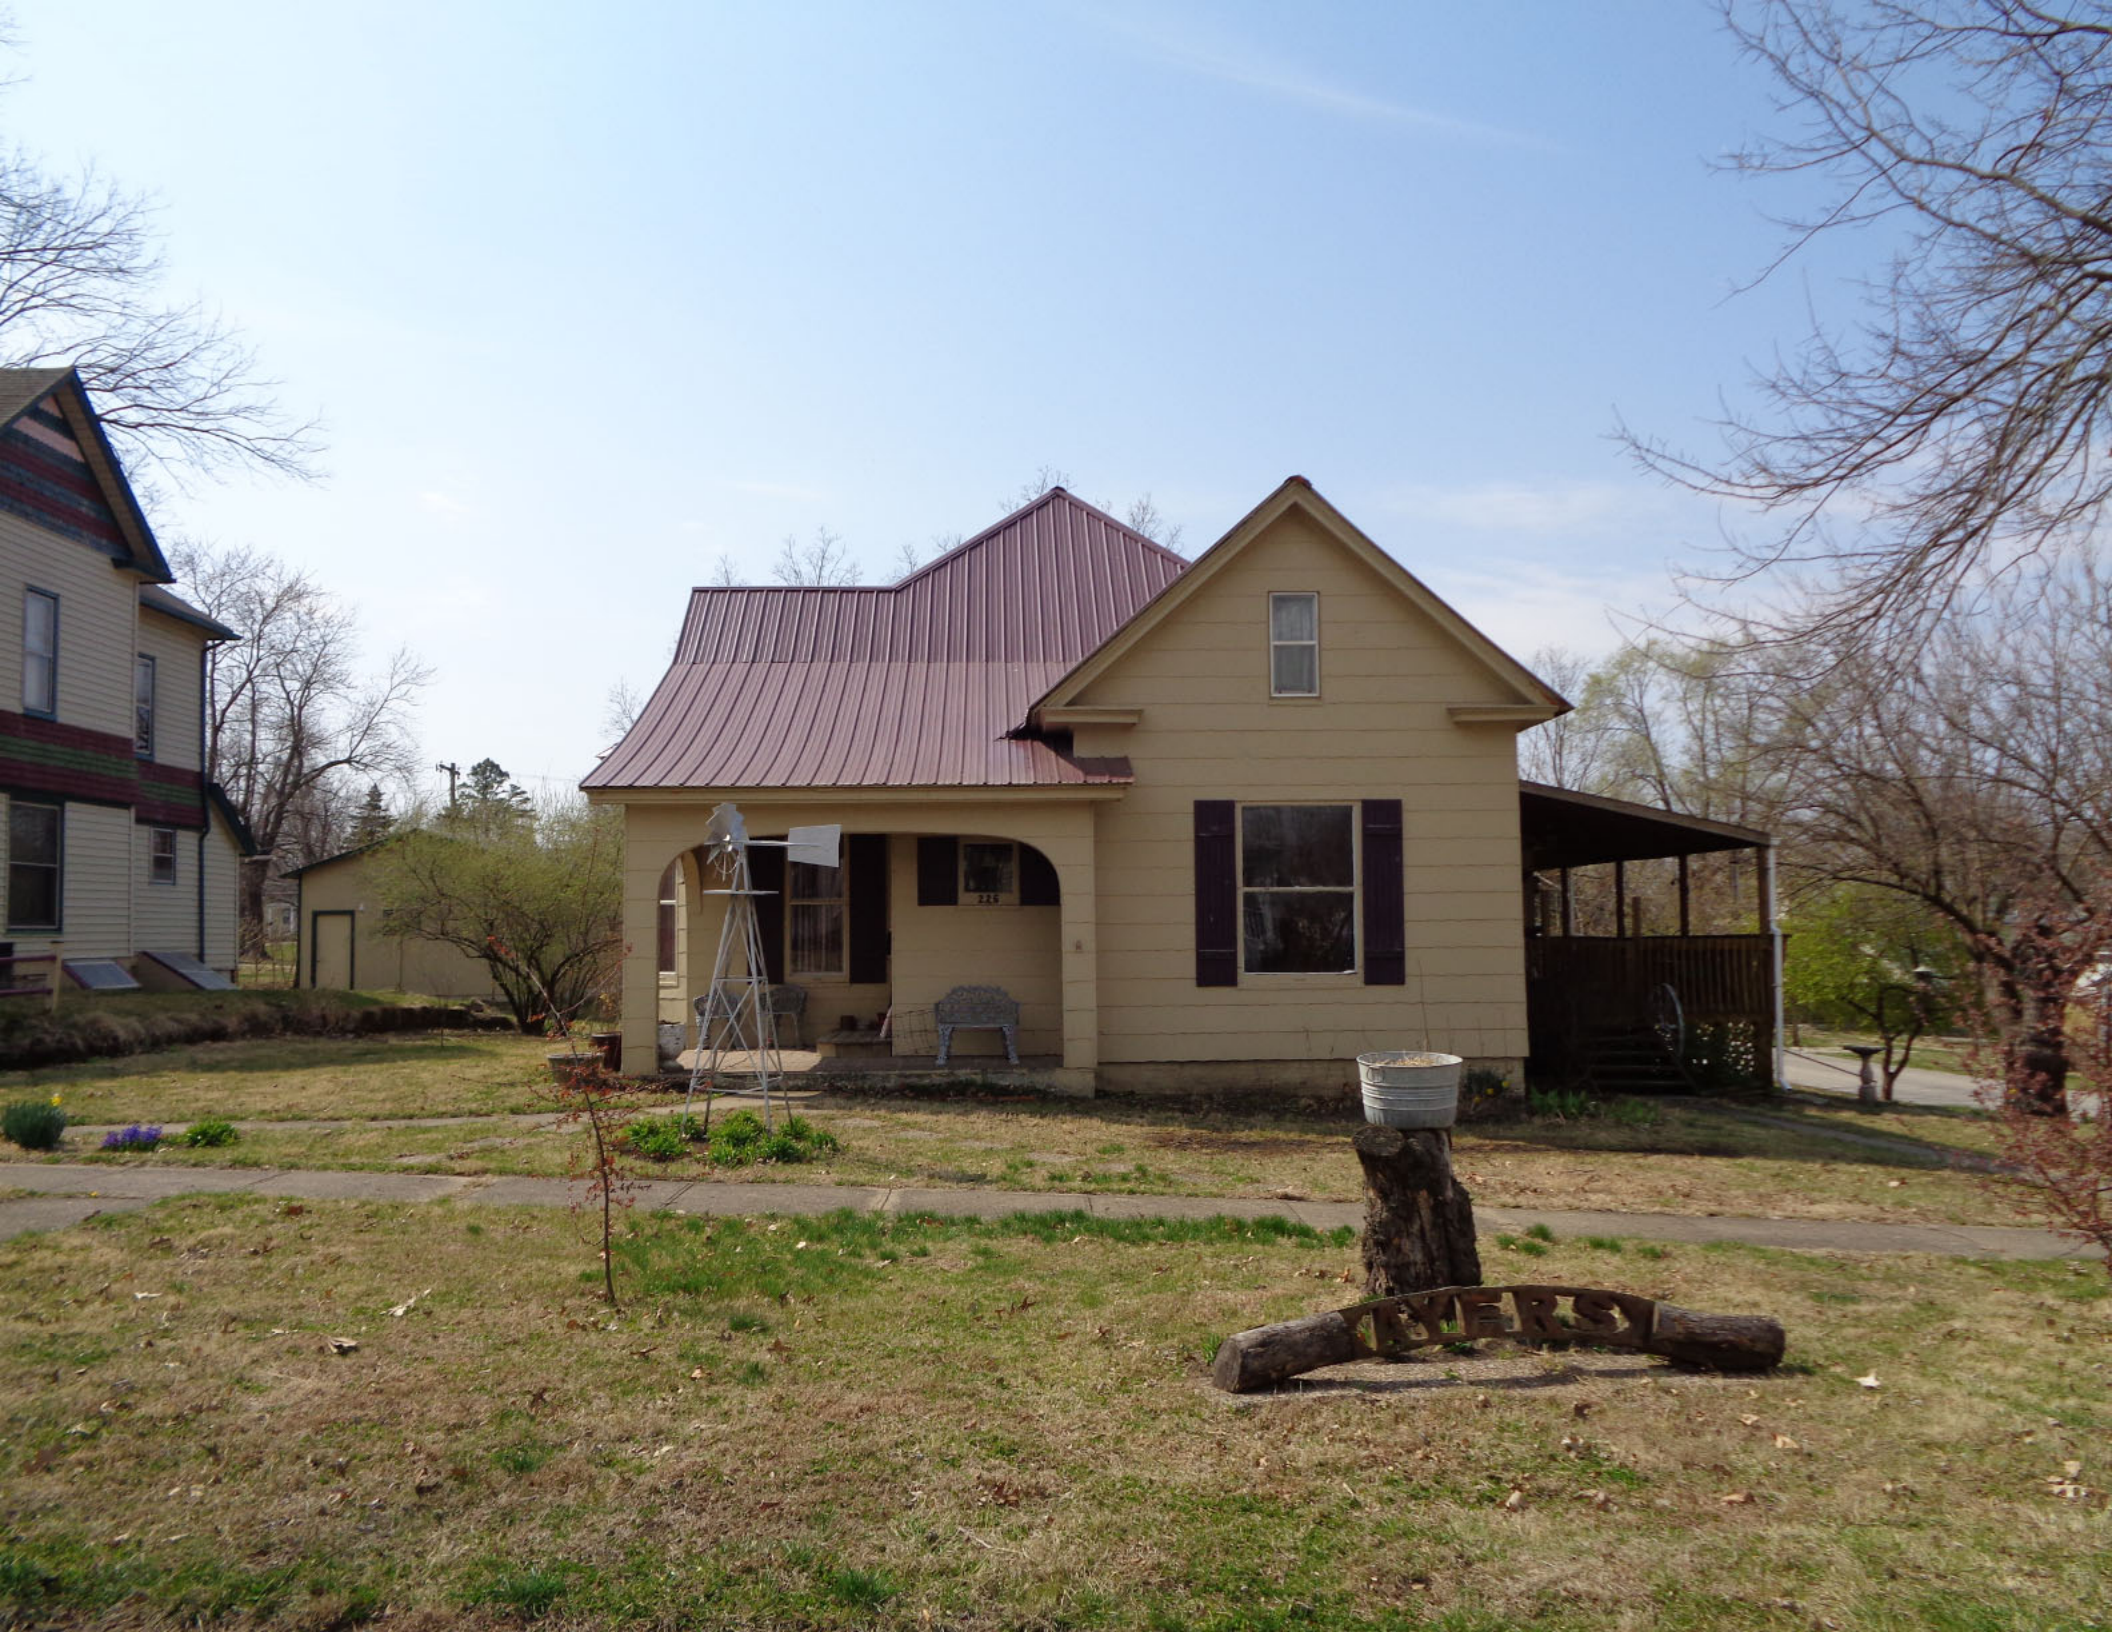
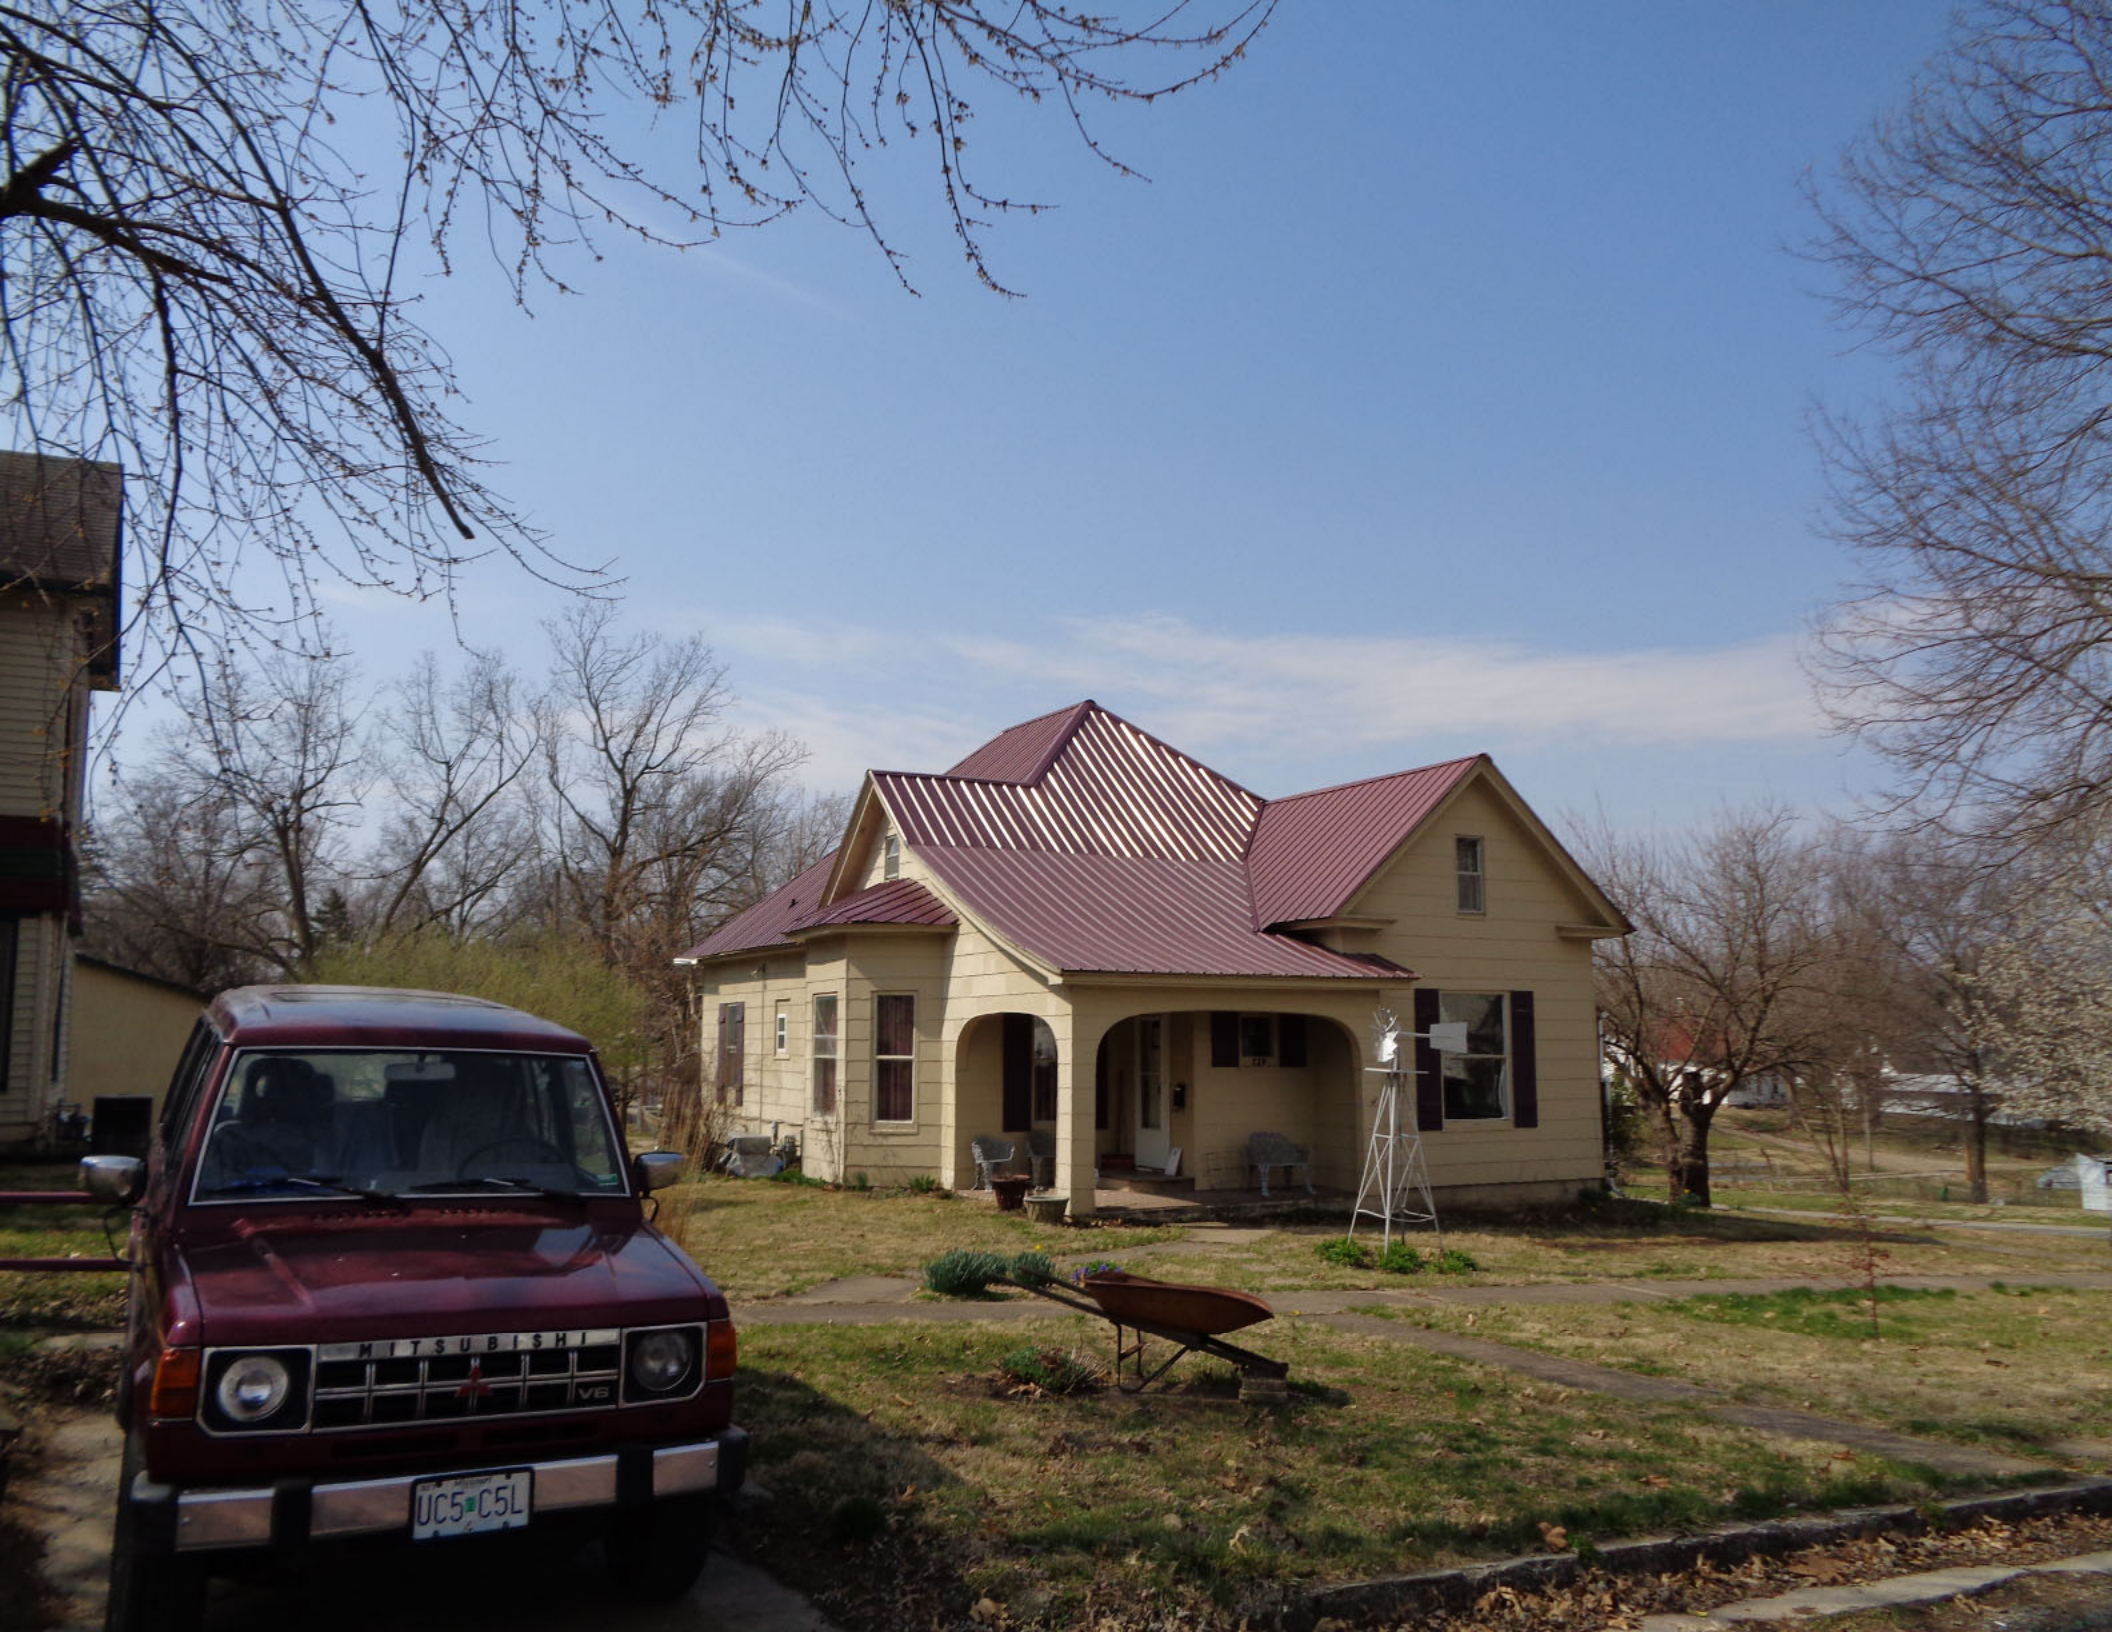
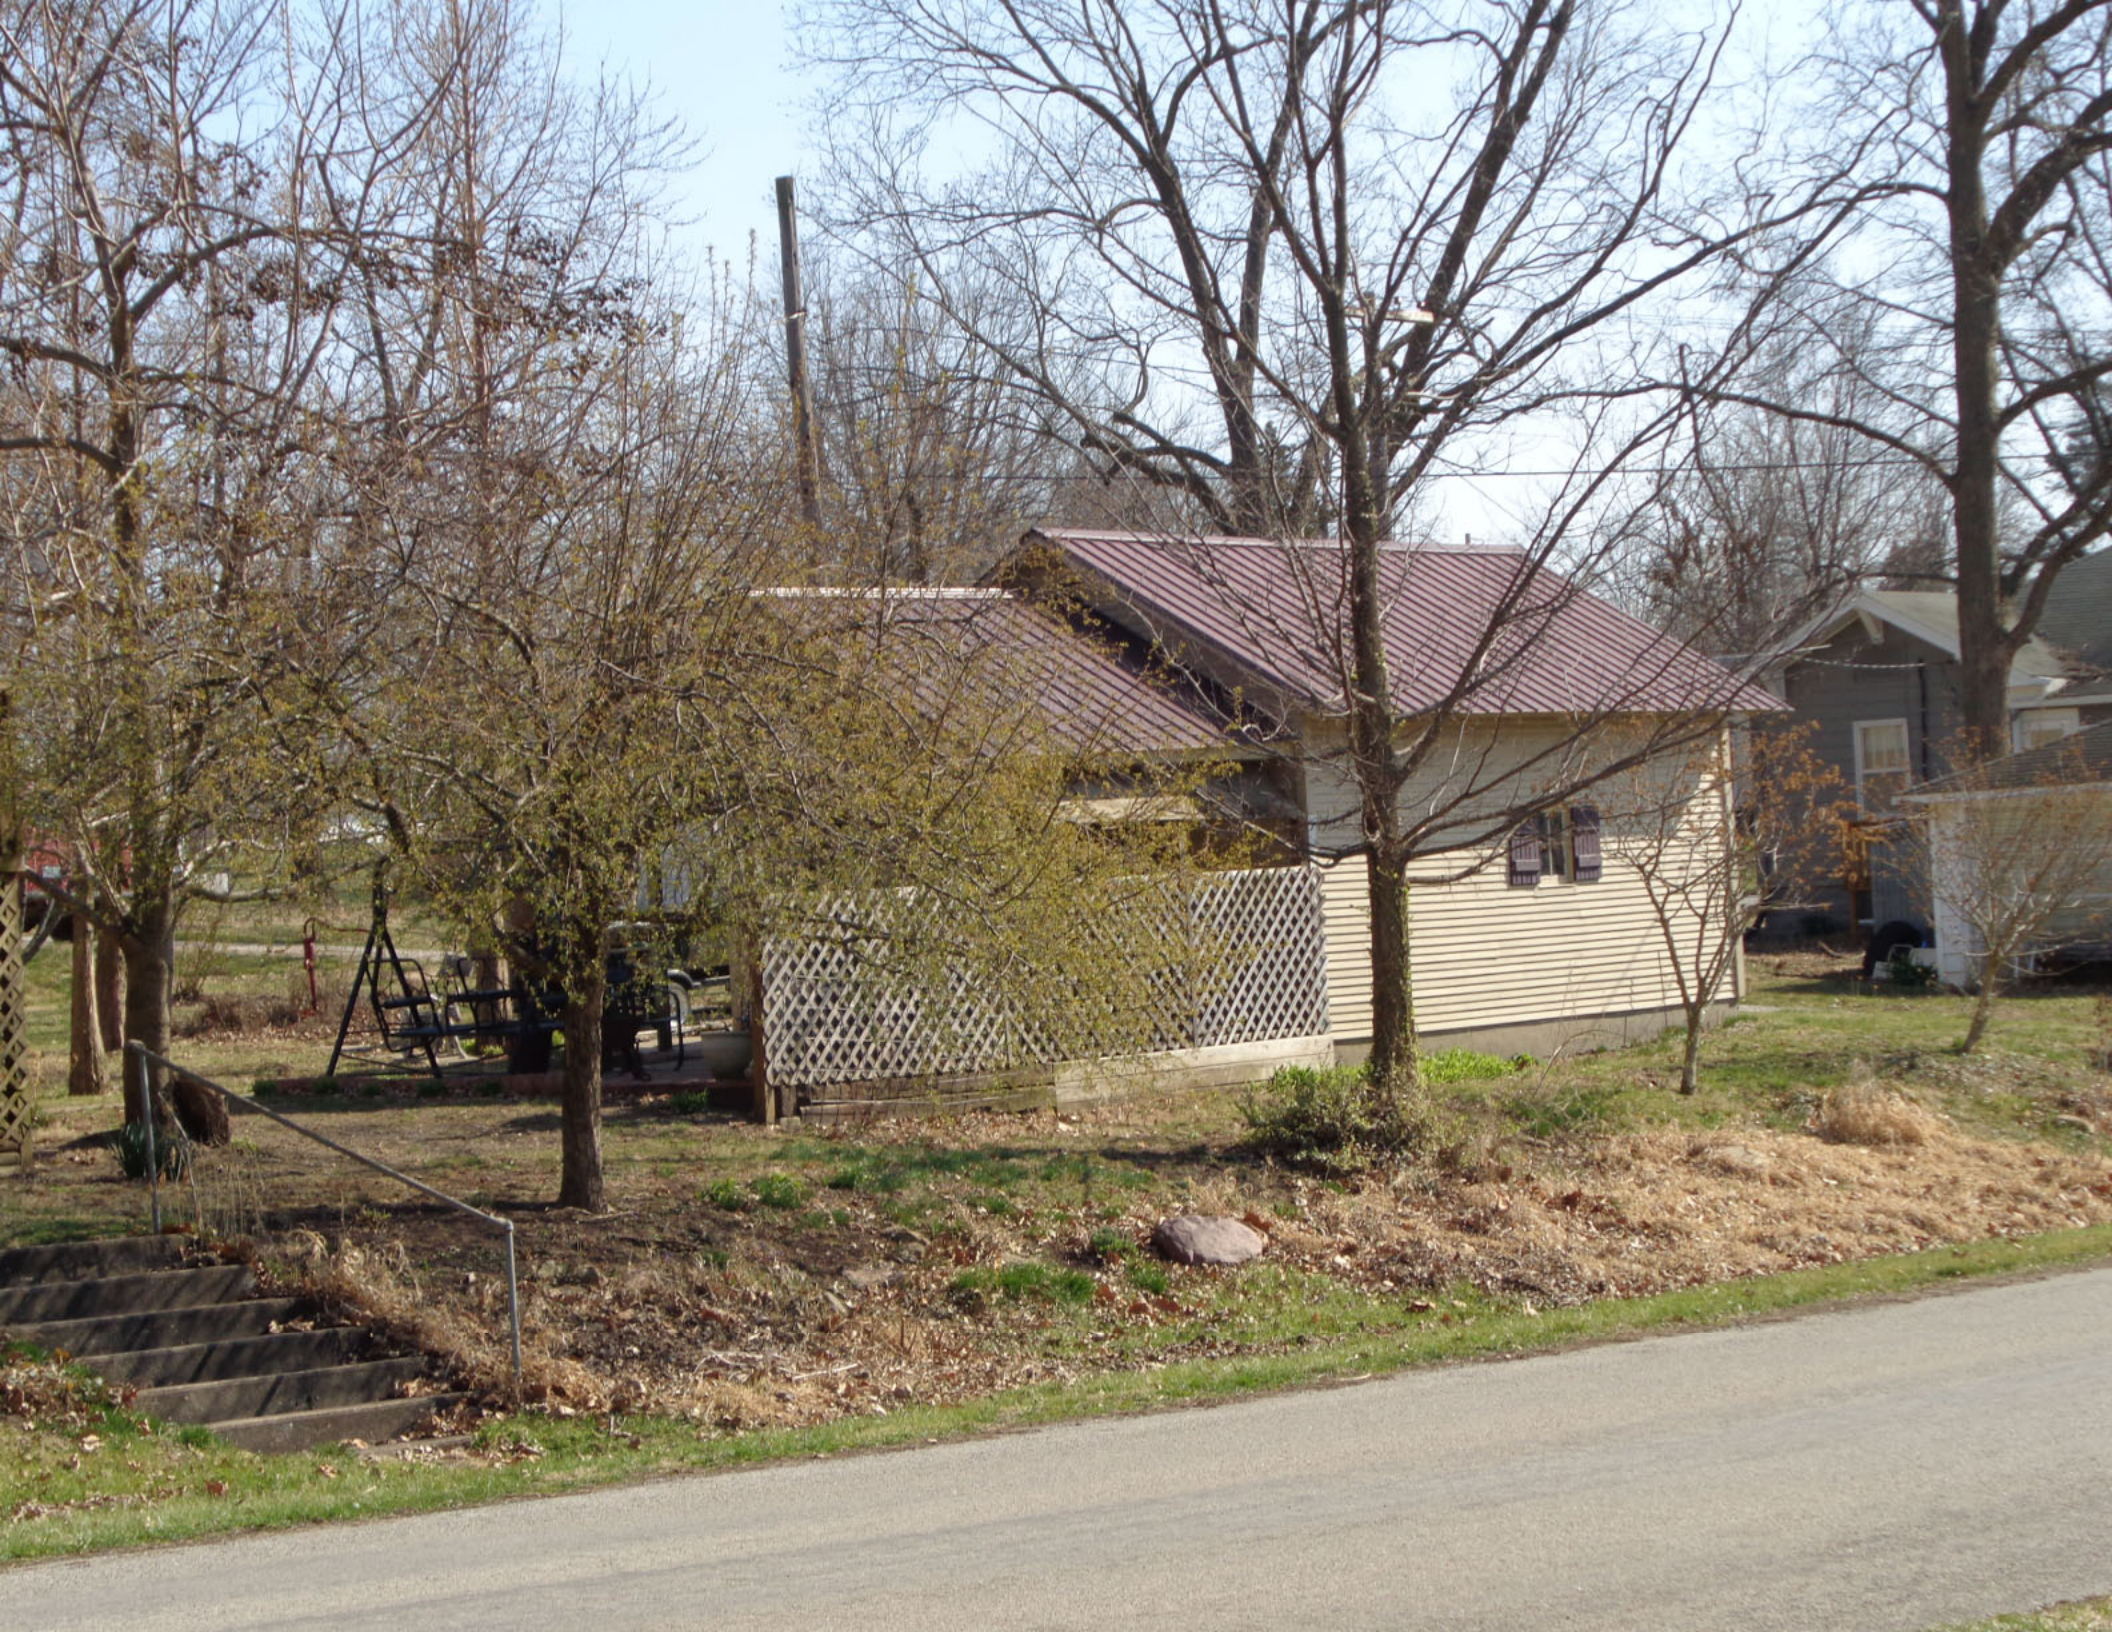
This is a one and a half story house clad in asbestos siding. The house has a small recessed porch on the east side. From the east there is a one-over-one wood window in the eastern most bay. There is a single door on the east wall, moving east on the north side of the bay there is a small high set one-over-one single window. In the western most bay there is a large single one-over-one wood window that is centrally located in the bay. The window is surrounded by shutters. In the western most bay there is a gable end, their are gable returns at this point and there is a small metal one-over-one window. There is an addition to the west of the building, it is surrounded by a porch.

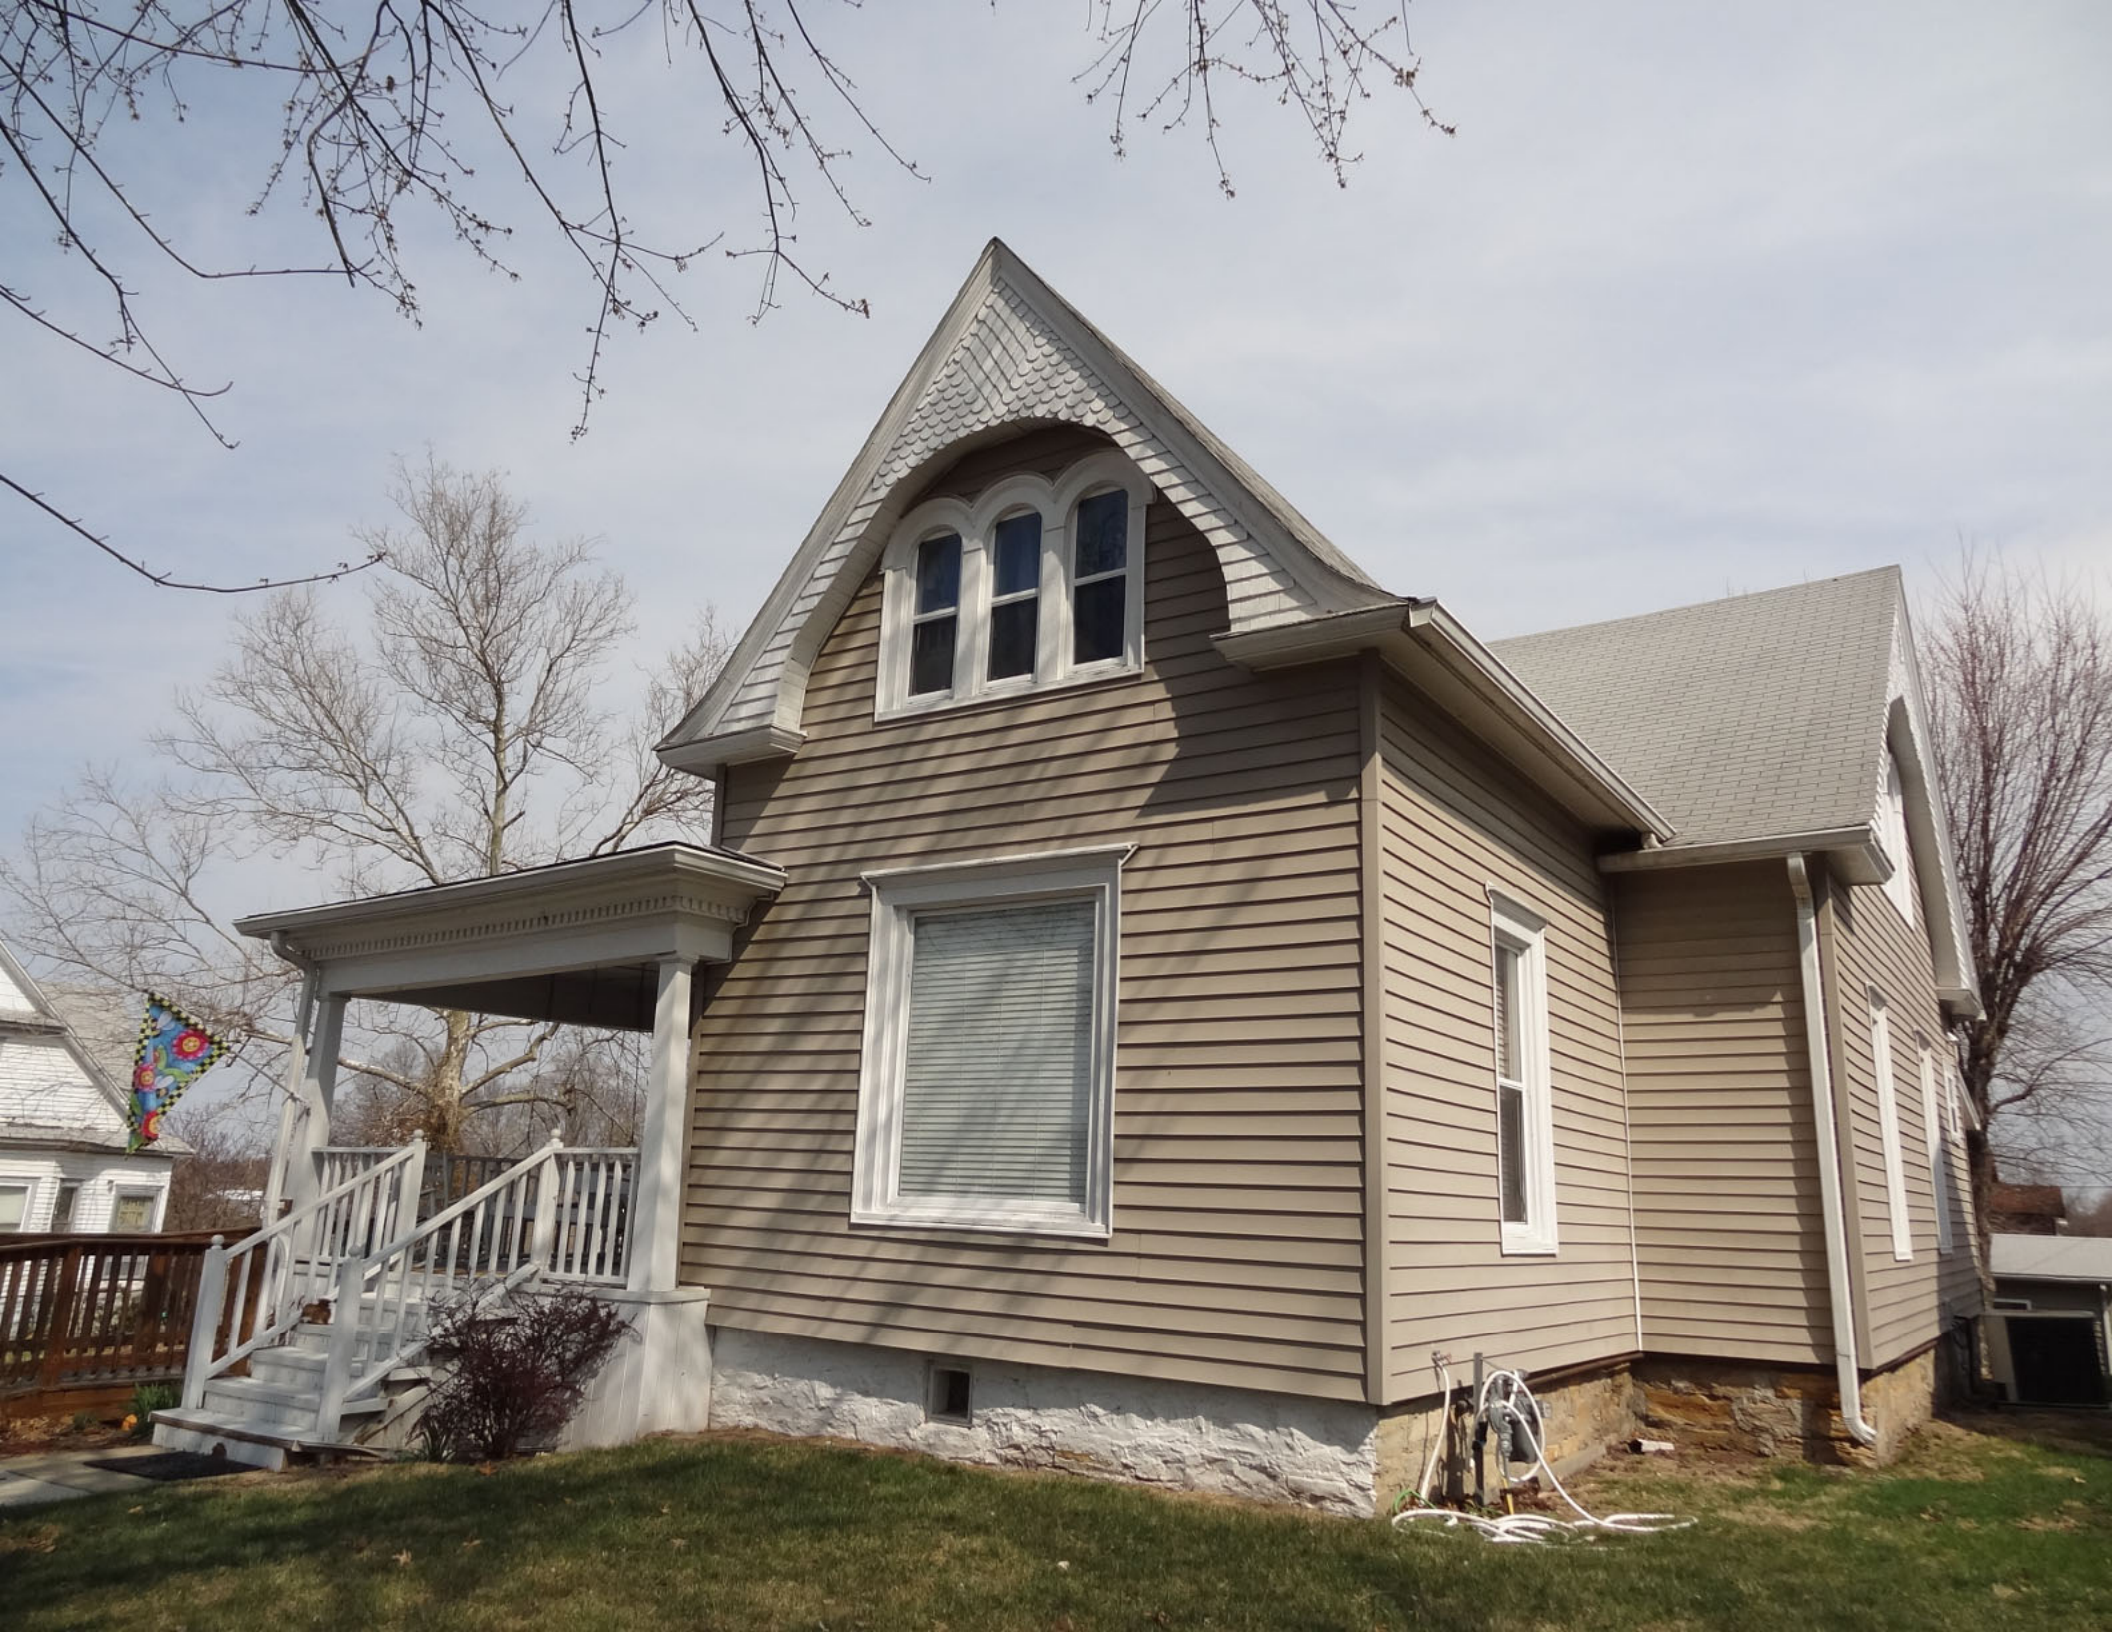
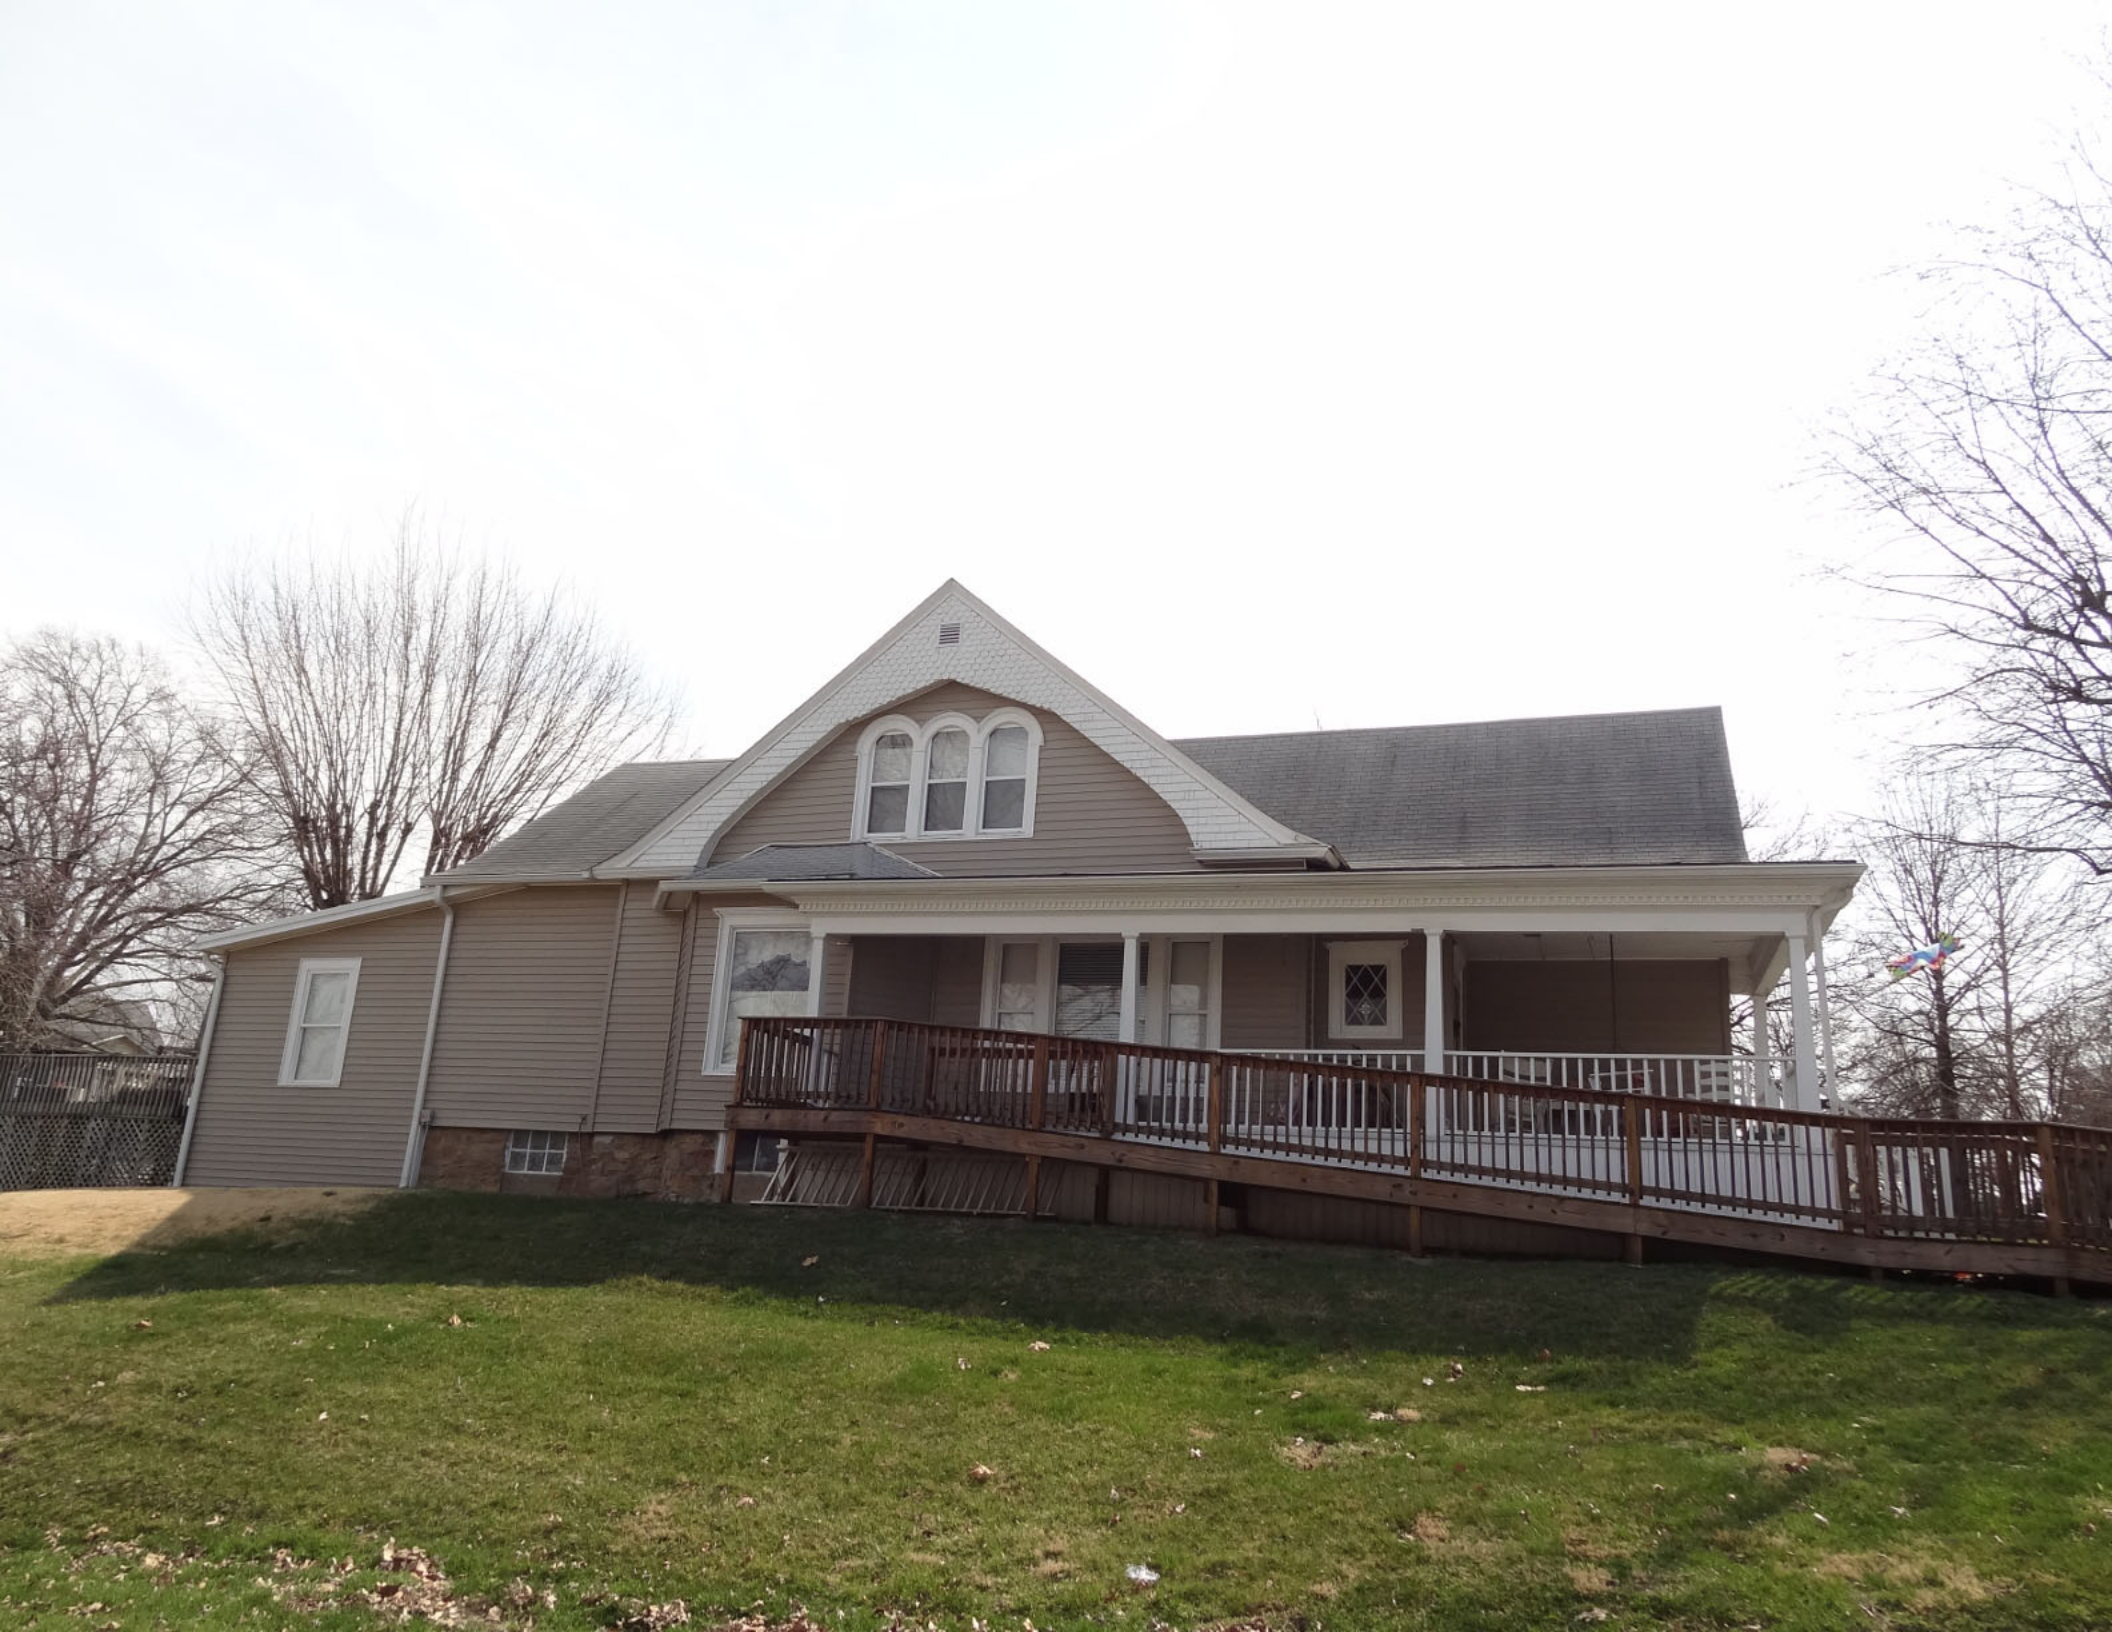
This 2 story cross-gabled home has been re-clad in vinyl. The foundation is stone covered in plaster. The porch is partial width, wrapping around the southwest corner of the home and extending down 2/3rds of the west elevation. It has a flat roof with wide overhanging eaves and an entablature with dentils in the frieze. Reached by 6 wooden stairs, it has simple square columns and a balustrade. Added to the west of the porch after 2008 is a long wooden ramp with balustrade. All windows and doors appear to be replacement except perhaps one on the west elevation that has diamond patterned muntins. Windows have simple cornices. Most windows are 1/1, sash. There are two front bays. The first is the front door, recessed under the porch. The second is a large single pane window in the projecting front gable. Along the edges of the front gable extending down to the rake are wood shingles. Above the second story windows they are fish scale in styling while those in the upper center of the gable, surrounded by the fish scaling, are diamond shaped in a diamond pattern. The gables on the east and west side of the home have similar detailing. This shingling is likely historic as it matches the detailing on the home next door, 224 Gracia. There are 3 arched window openings in the front gable, but the windows have been replaced with small square 1/1 windows (the arches above them remain). An addition appears to have been added to the rear after 1939.
