MISSOURI DEPARTMENT OF NATURAL RESOURCES  
STATE HISTORIC PRESERVATION OFFICE, P.O. Box 176, Jefferson City, MO 65102  
**ARCHITECTURAL/HISTORIC INVENTORY FORM**

1. SURVEY NO. LI-AS-001-001		2. SURVEY NAME: Marceline Survey	
3. COUNTY: Linn		4. ADDRESS (STREET NO.) 275	STREET (NAME) West Broadway
5. CITY: Marceline	VICINITY: <input type="checkbox"/>	6. UTM: / /	7. TOWNSHIP/RANGE/SECTION: T: R: S:

8. HISTORIC NAME (IF KNOWN): Walt Disney's Childhood Home		9. PRESENT/OTHER NAME (IF KNOWN): Walt Disney's Childhood Home	
10. OWNERSHIP: <input checked="" type="checkbox"/> PRIVATE <input type="checkbox"/> PUBLIC		11A. HISTORIC USE (IF KNOWN): Single Dwelling	11B. CURRENT USE: Single Dwelling
<b>HISTORICAL INFORMATION</b>

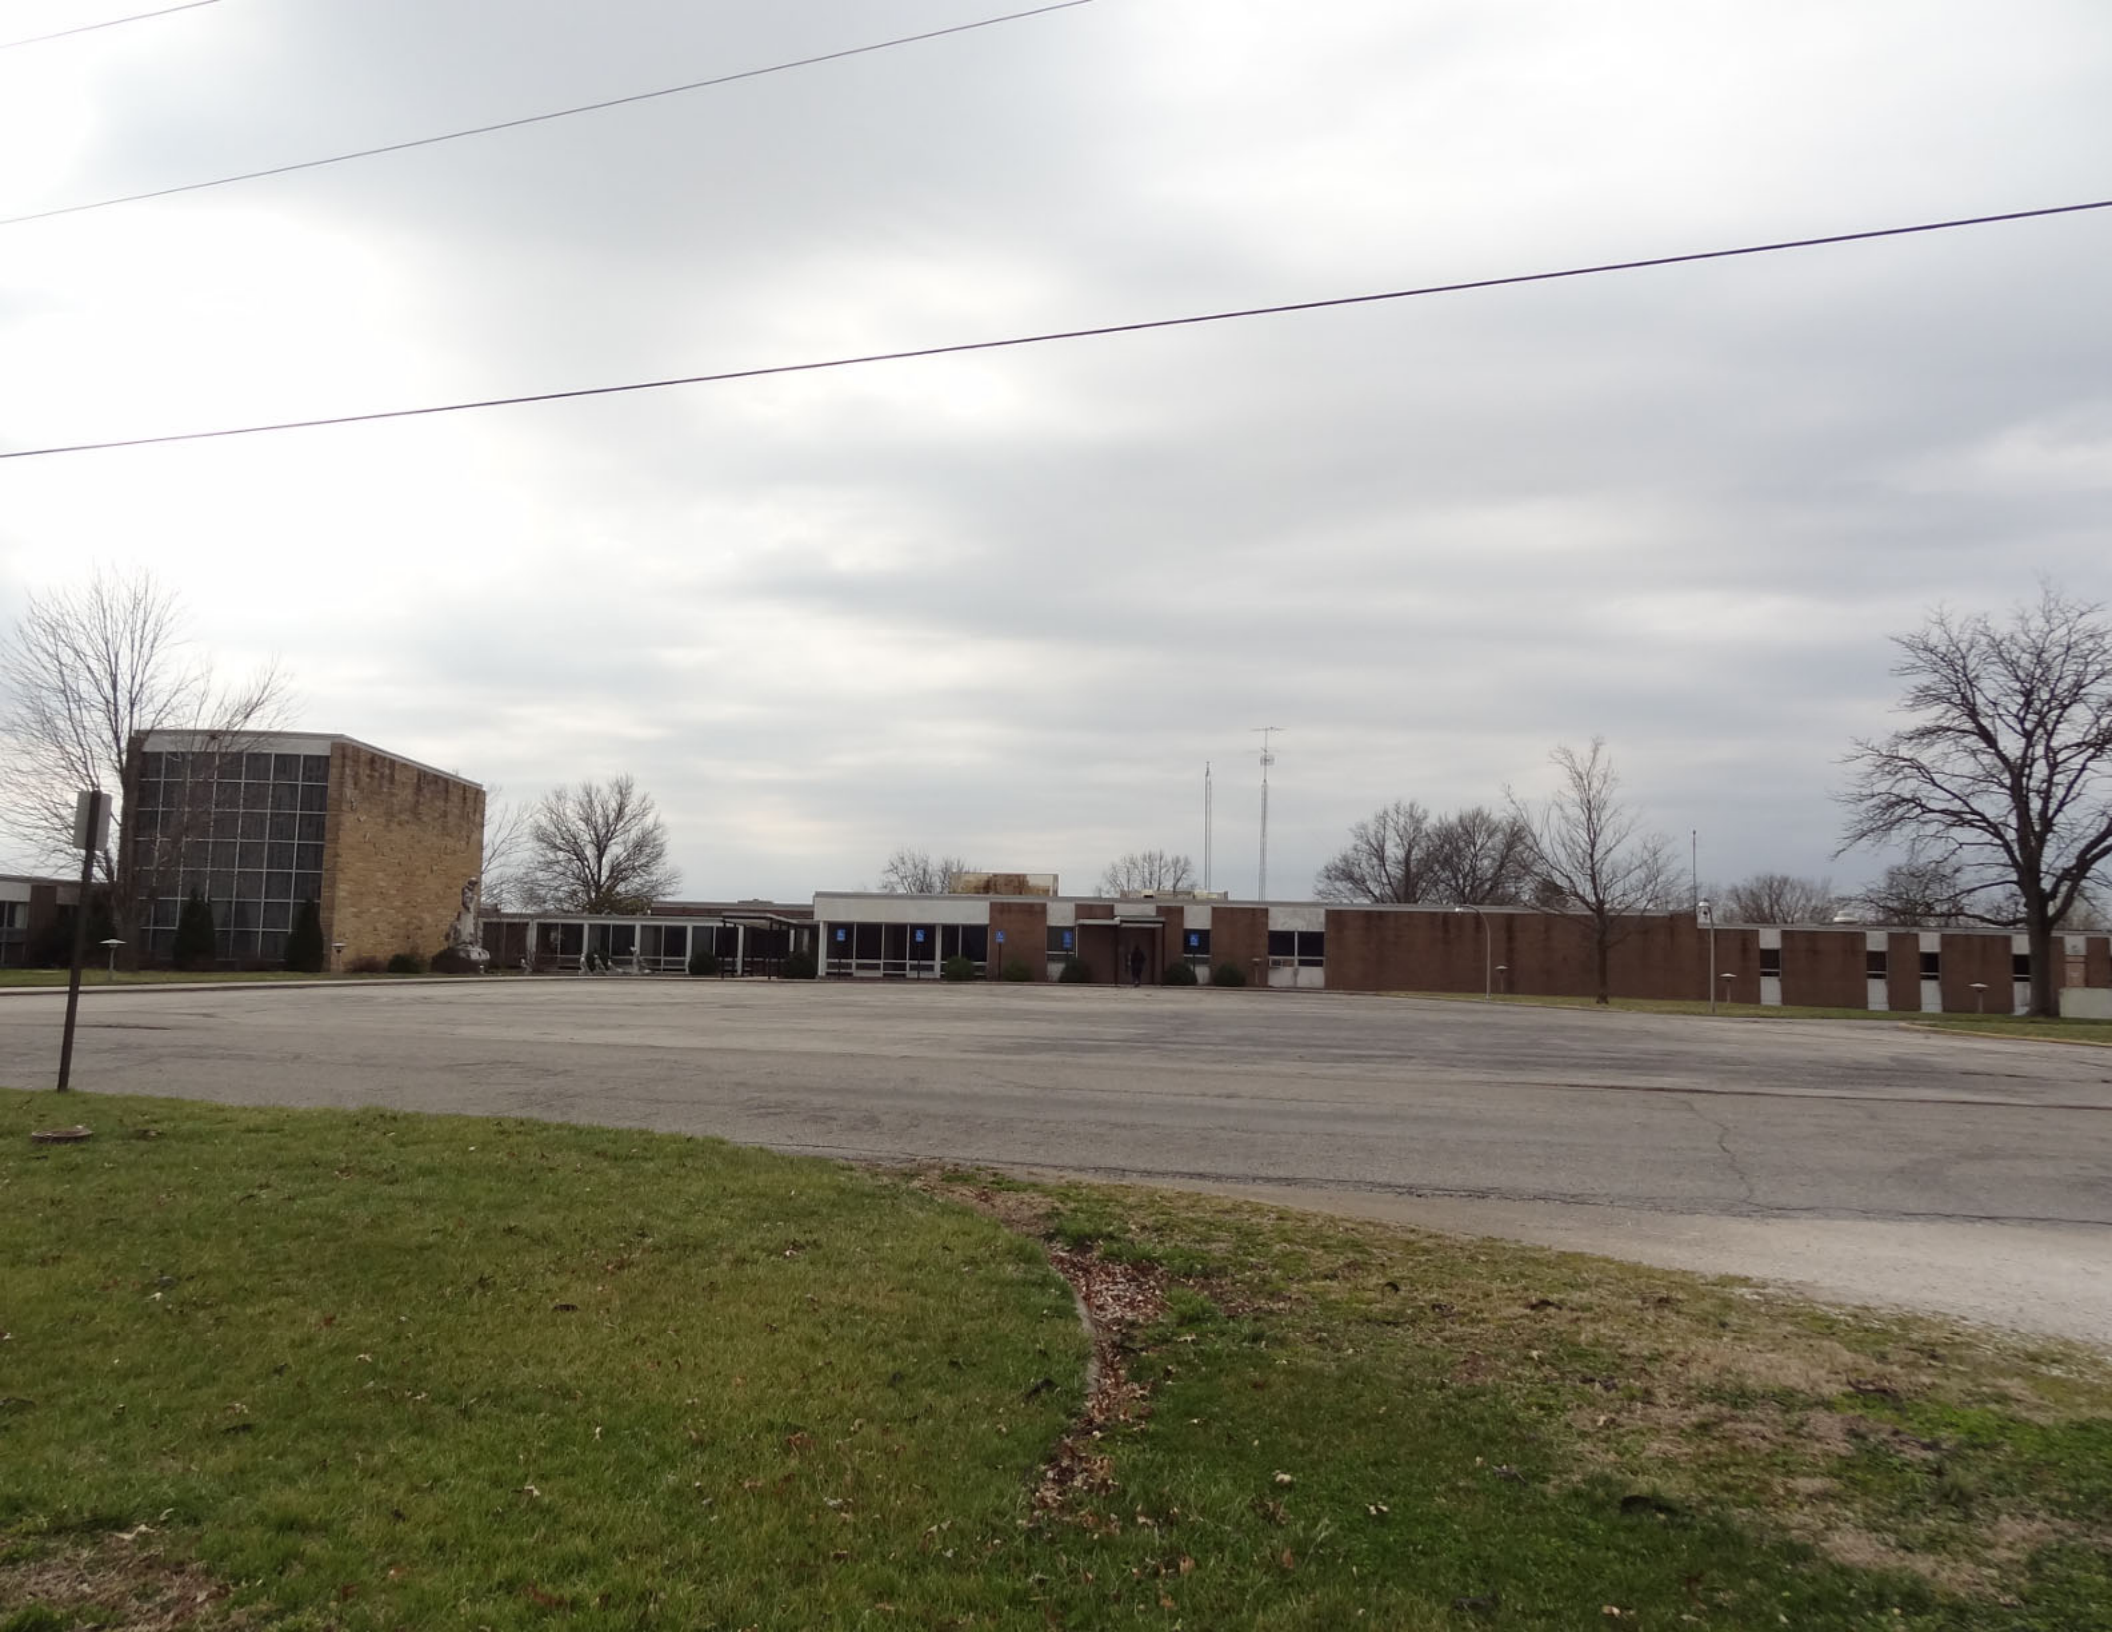
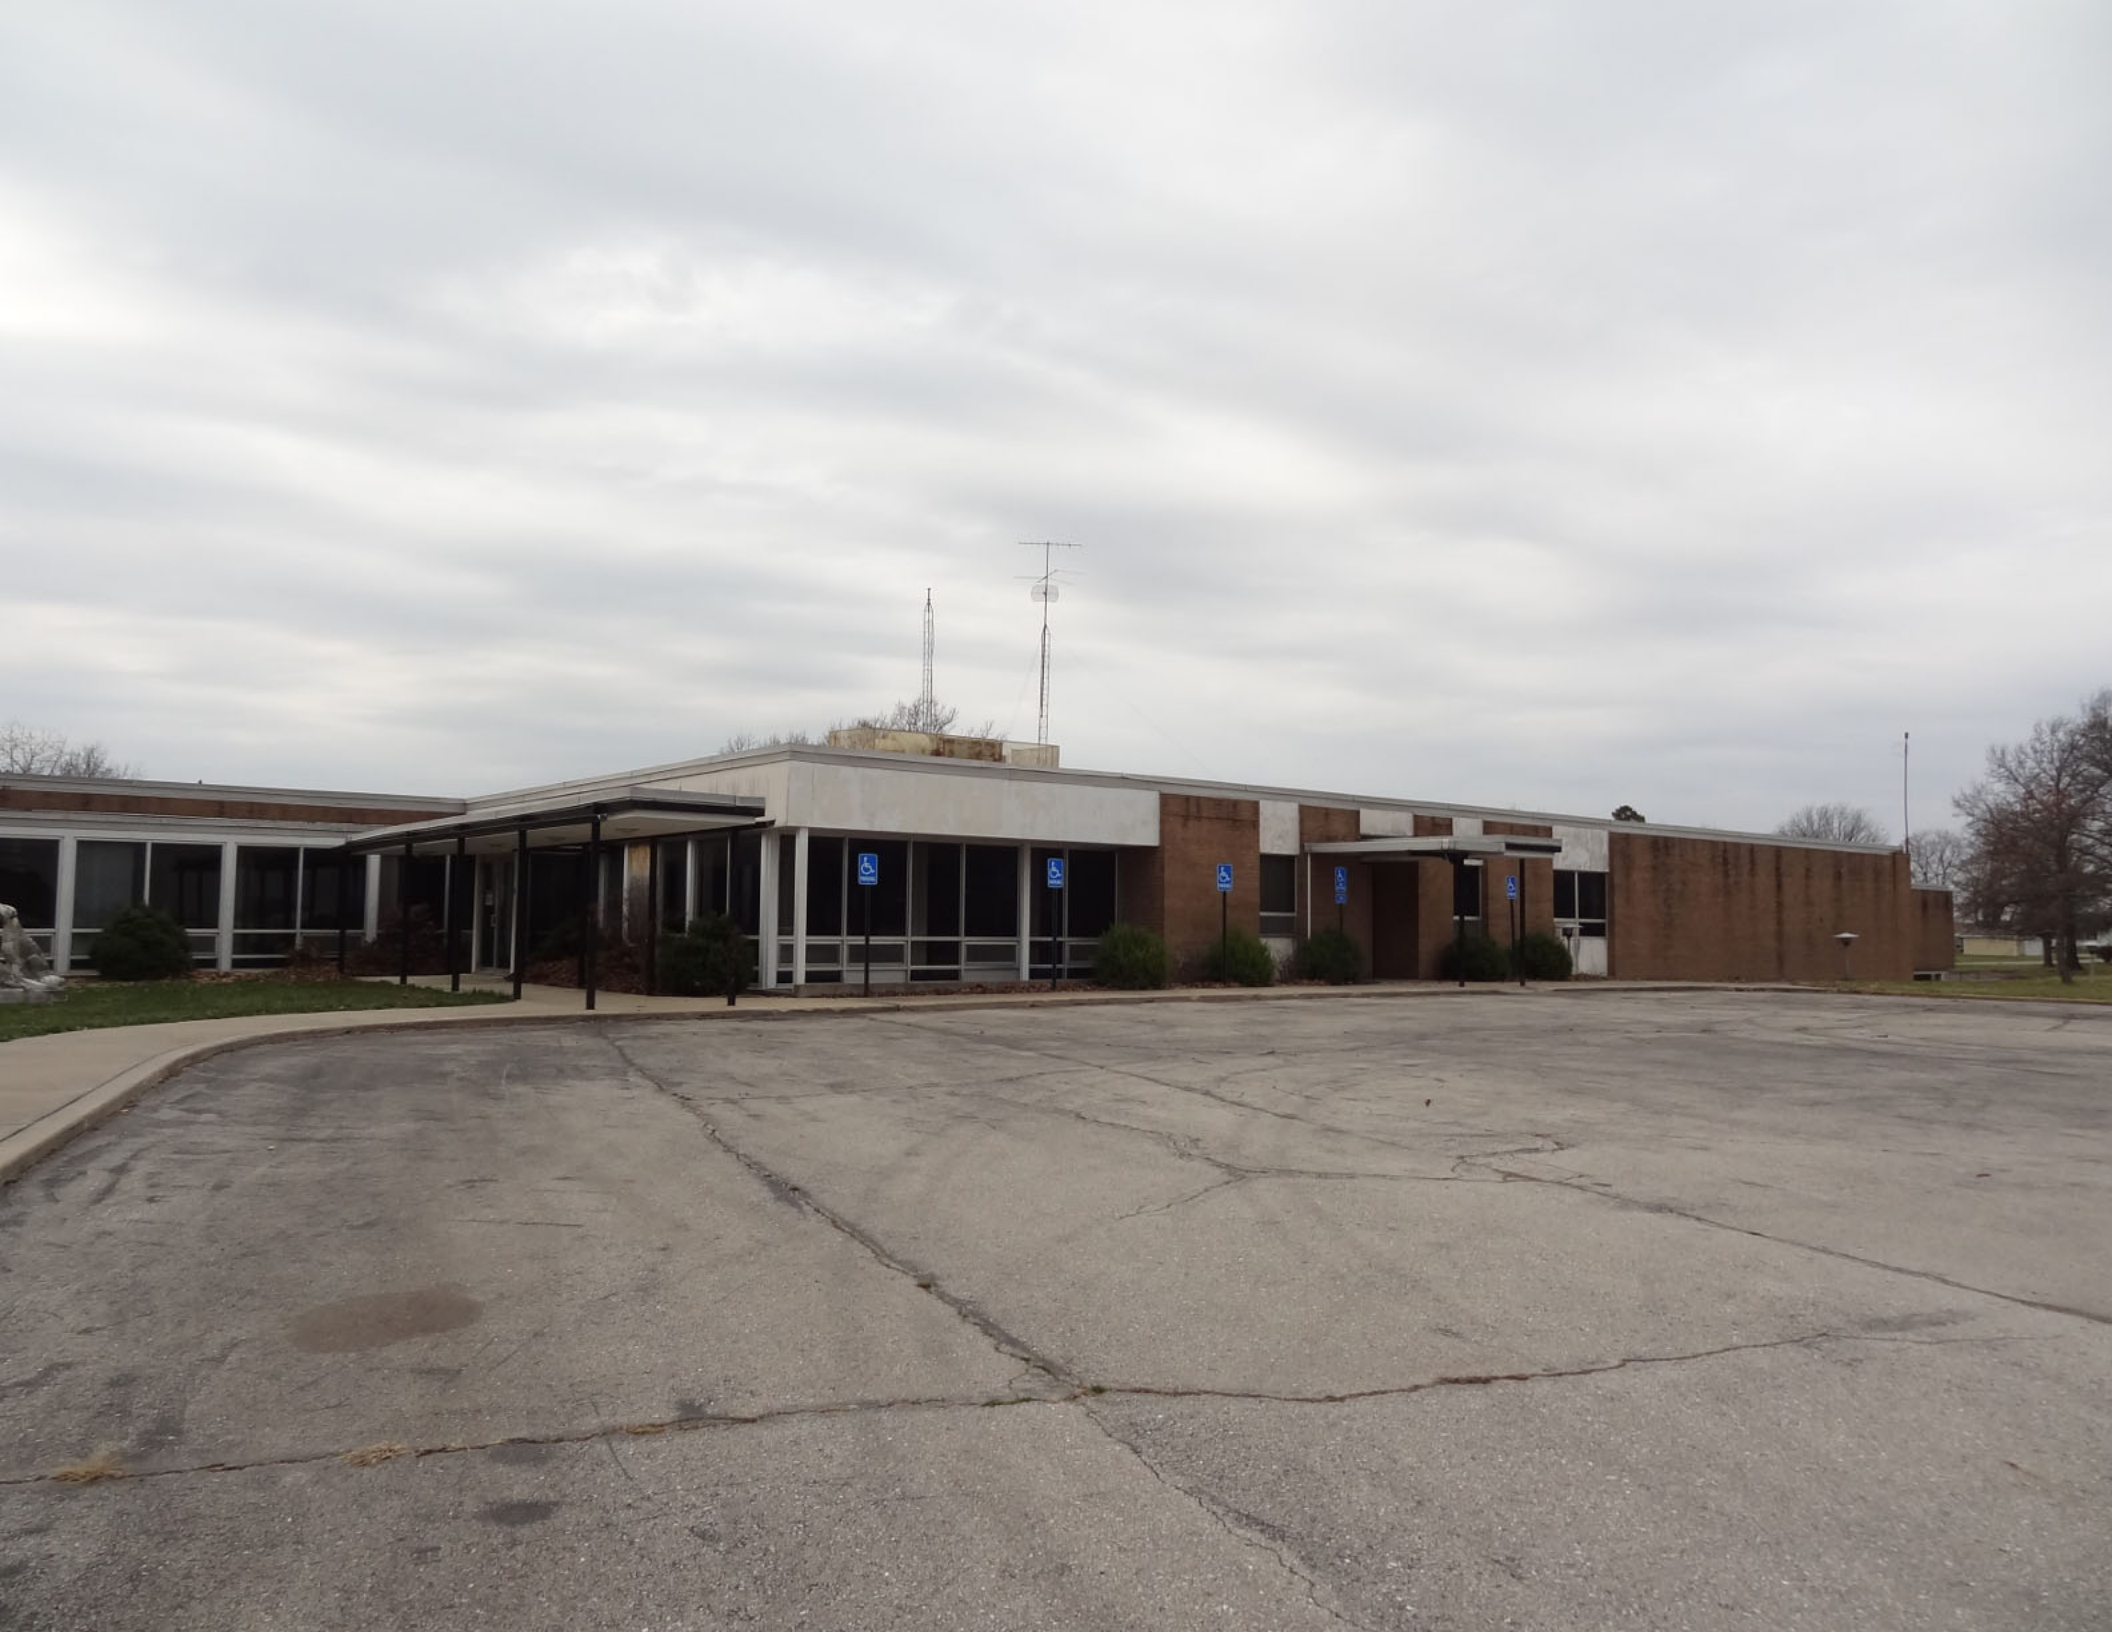
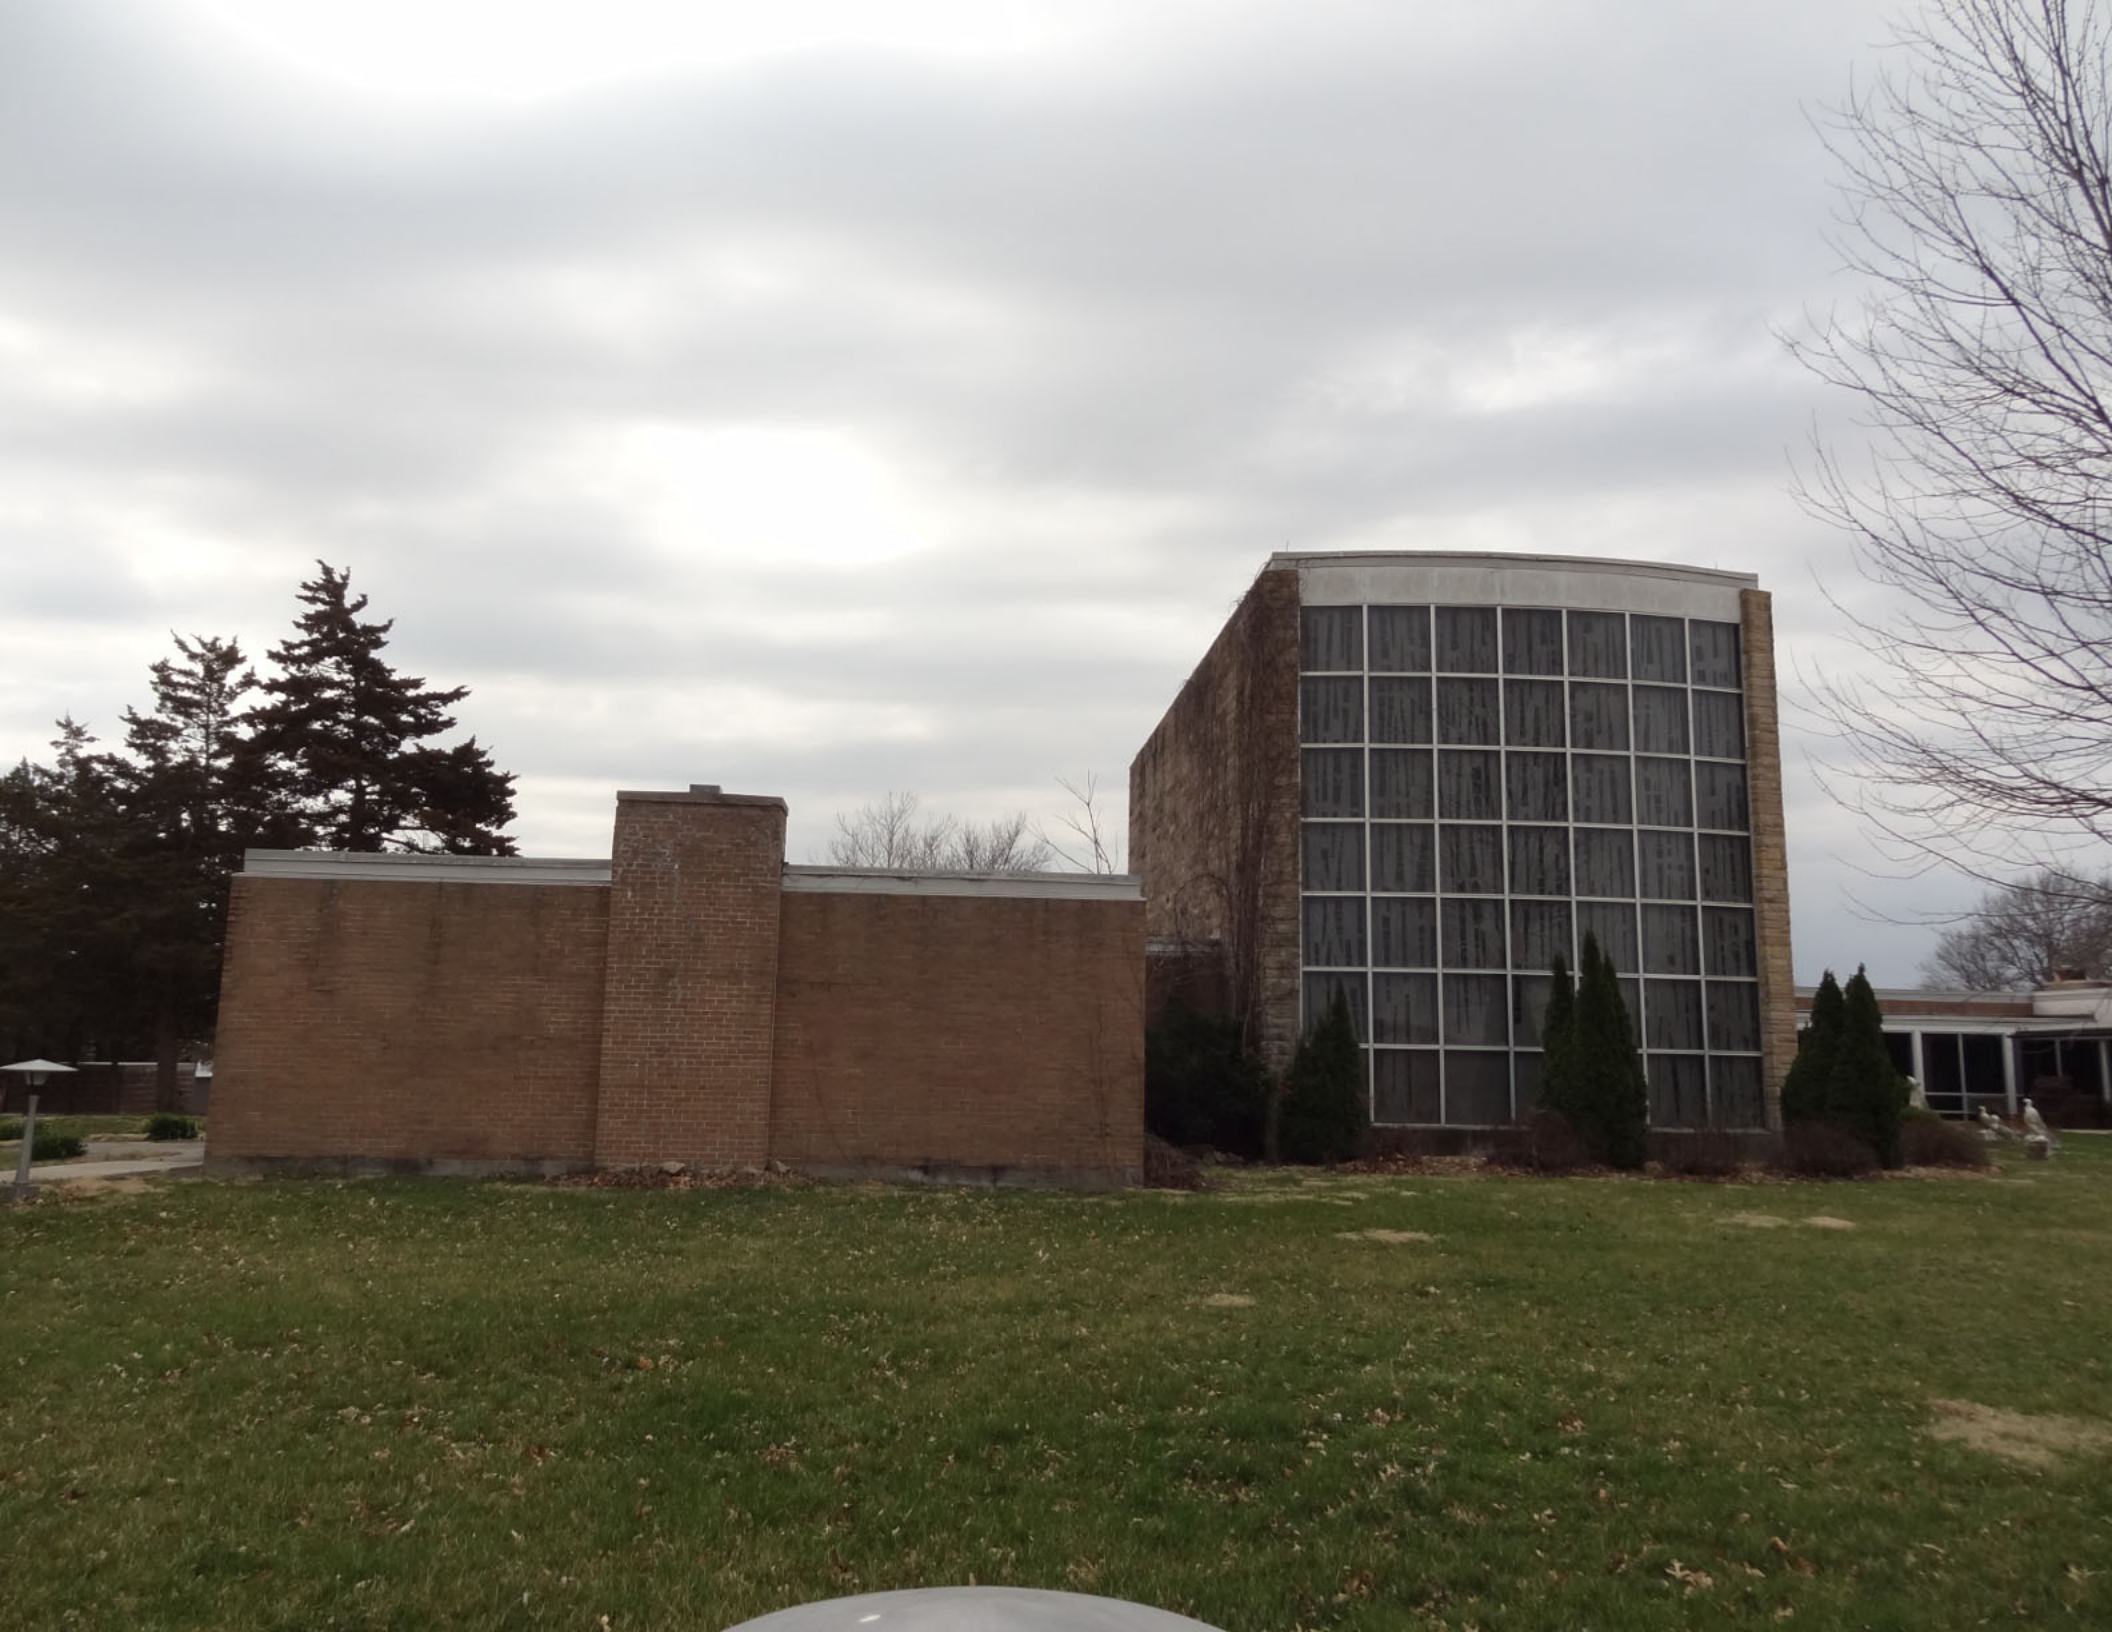
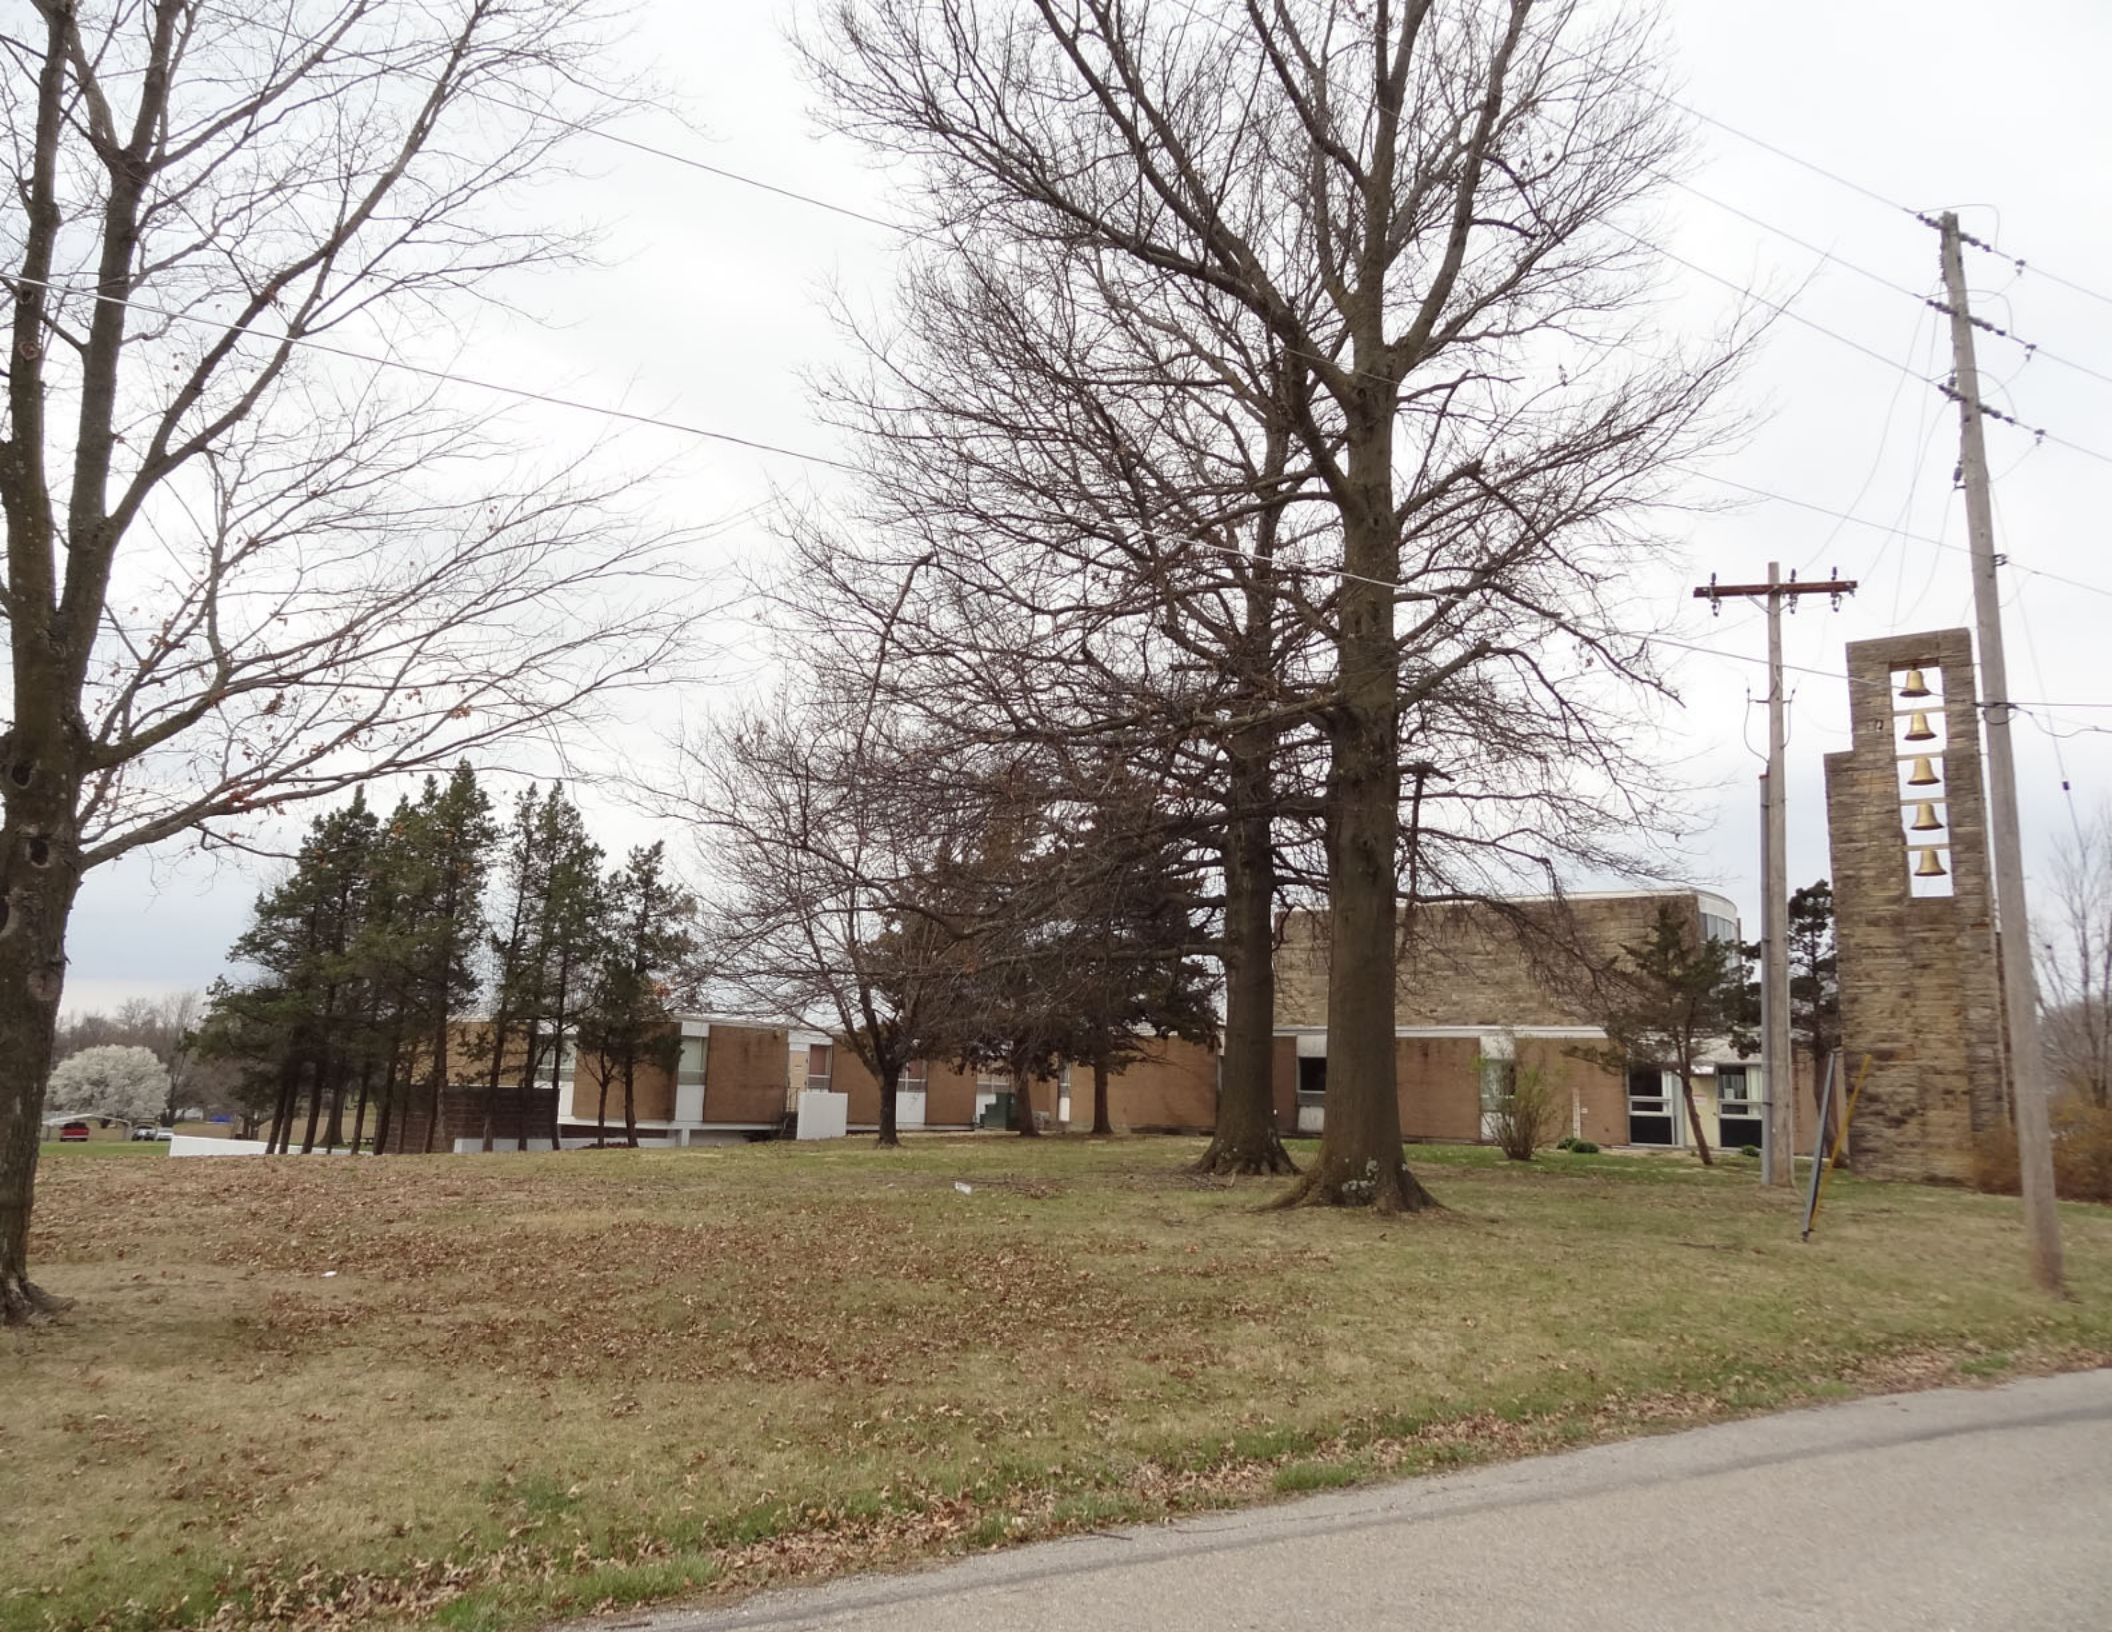
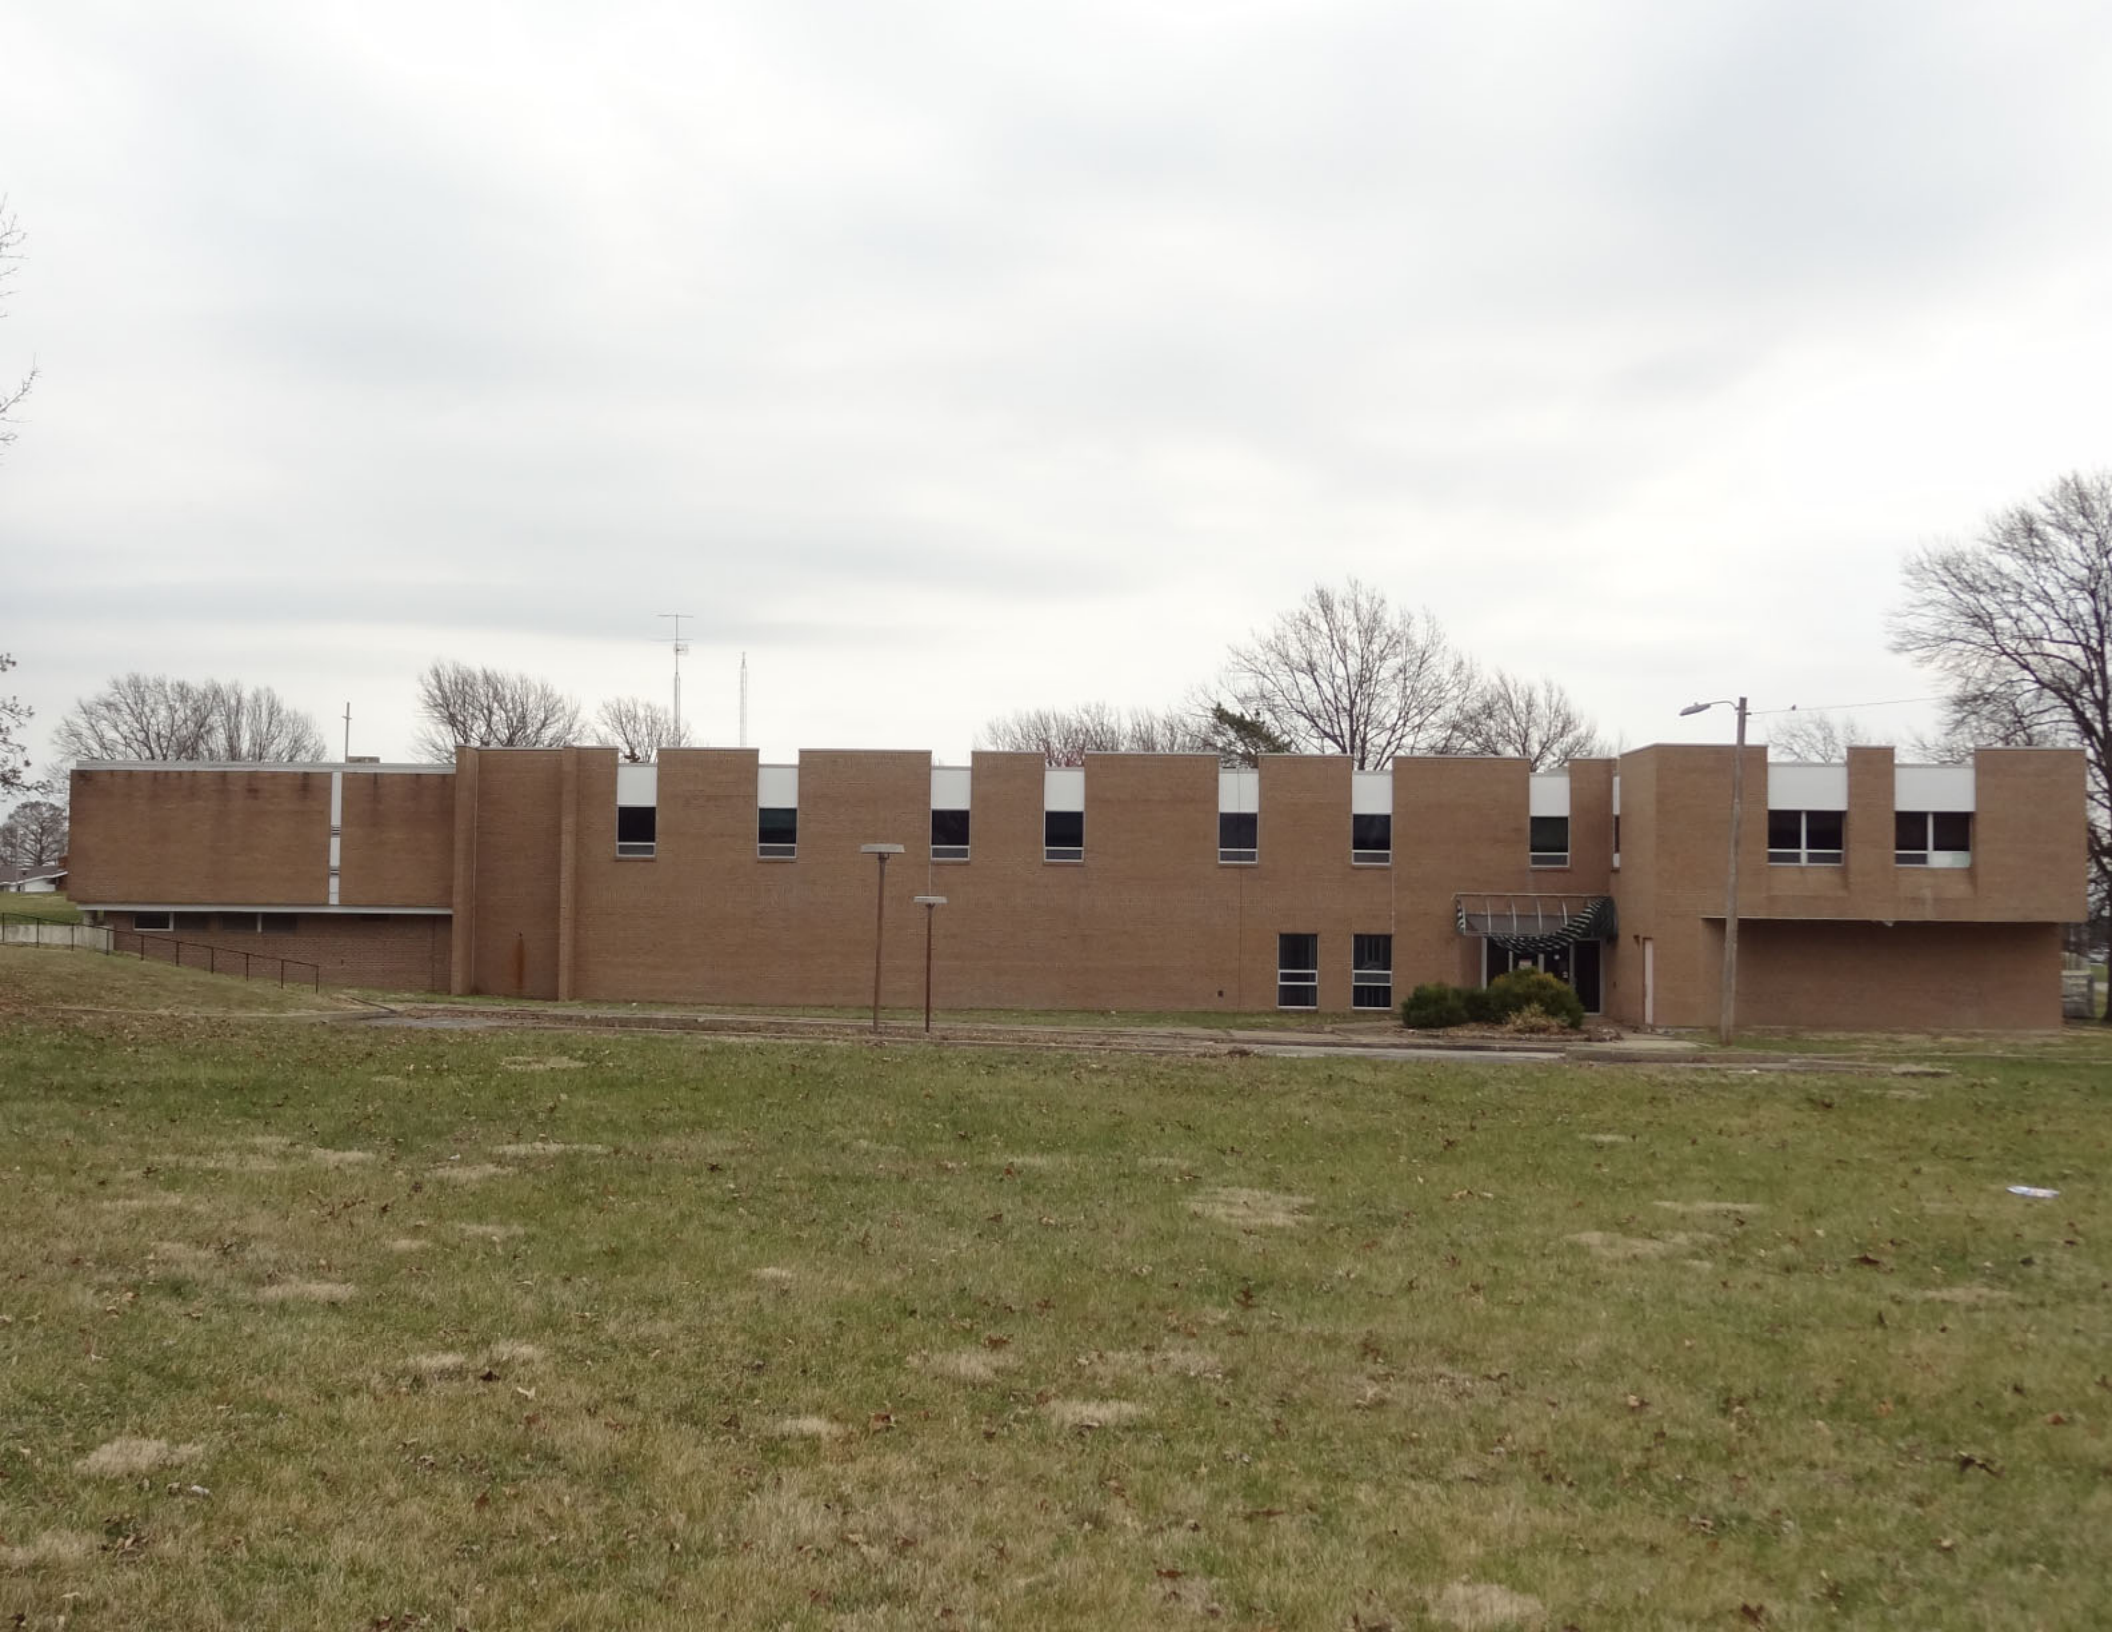
This is a large hospital complex that has an irregular plan starting from the east there is a wing constructed of brick with a central chimney. Moving east there is a wing that was used as a chapel that has full wall of multi-pane windows, this wing was also constructed of stone while the remainder of the building uses brick. These two wings protrude from a rear wing that has the primary entrance. In the space between these buildings there is a garden with statuary of St. Francis and multiple animals. The wing to the rear is low-lying each bay is filled with windows. Each bay has two large windows above and two smaller windows on the bottom. There is a metal awning that leads from the parking lot to the main entrance. (The entrance is recessed toward the interior of the building). Moving east there is a large wing that extends to the west. Starting at the east part of the wing, there are six fixed windows with large panes on the top and smaller panes on the bottom, followed by a brick wall. Next is a single window followed by a pair of solid metal doors. The next bay is another single window followed by a solid brick wall, Moving east there is a pair of windows the remainder of this wing has a solid brick wall without ornamentation. The westernmost wing is two story with a raised basement. The upper story follows a similar pattern of single windows that are irregularly spaced between brick solid brick walls. Please see the images on pages 52 and 76 for information about the pattern/layout of the building.
