MISSOURI DEPARTMENT OF NATURAL RESOURCES  
STATE HISTORIC PRESERVATION OFFICE, P.O. Box 176, Jefferson City, MO 65102  
**ARCHITECTURAL/HISTORIC INVENTORY FORM**

1. SURVEY NO. LI-AS-001-001		2. SURVEY NAME: Marceline Survey	
3. COUNTY: Linn		4. ADDRESS (STREET NO.) 275	STREET (NAME) West Broadway
5. CITY: Marceline	VICINITY: <input type="checkbox"/>	6. UTM: / /	7. TOWNSHIP/RANGE/SECTION: T: R: S:

8. HISTORIC NAME (IF KNOWN): Walt Disney's Childhood Home		9. PRESENT/OTHER NAME (IF KNOWN): Walt Disney's Childhood Home	
10. OWNERSHIP: <input checked="" type="checkbox"/> PRIVATE <input type="checkbox"/> PUBLIC		11A. HISTORIC USE (IF KNOWN): Single Dwelling	11B. CURRENT USE: Single Dwelling
<b>HISTORICAL INFORMATION</b>

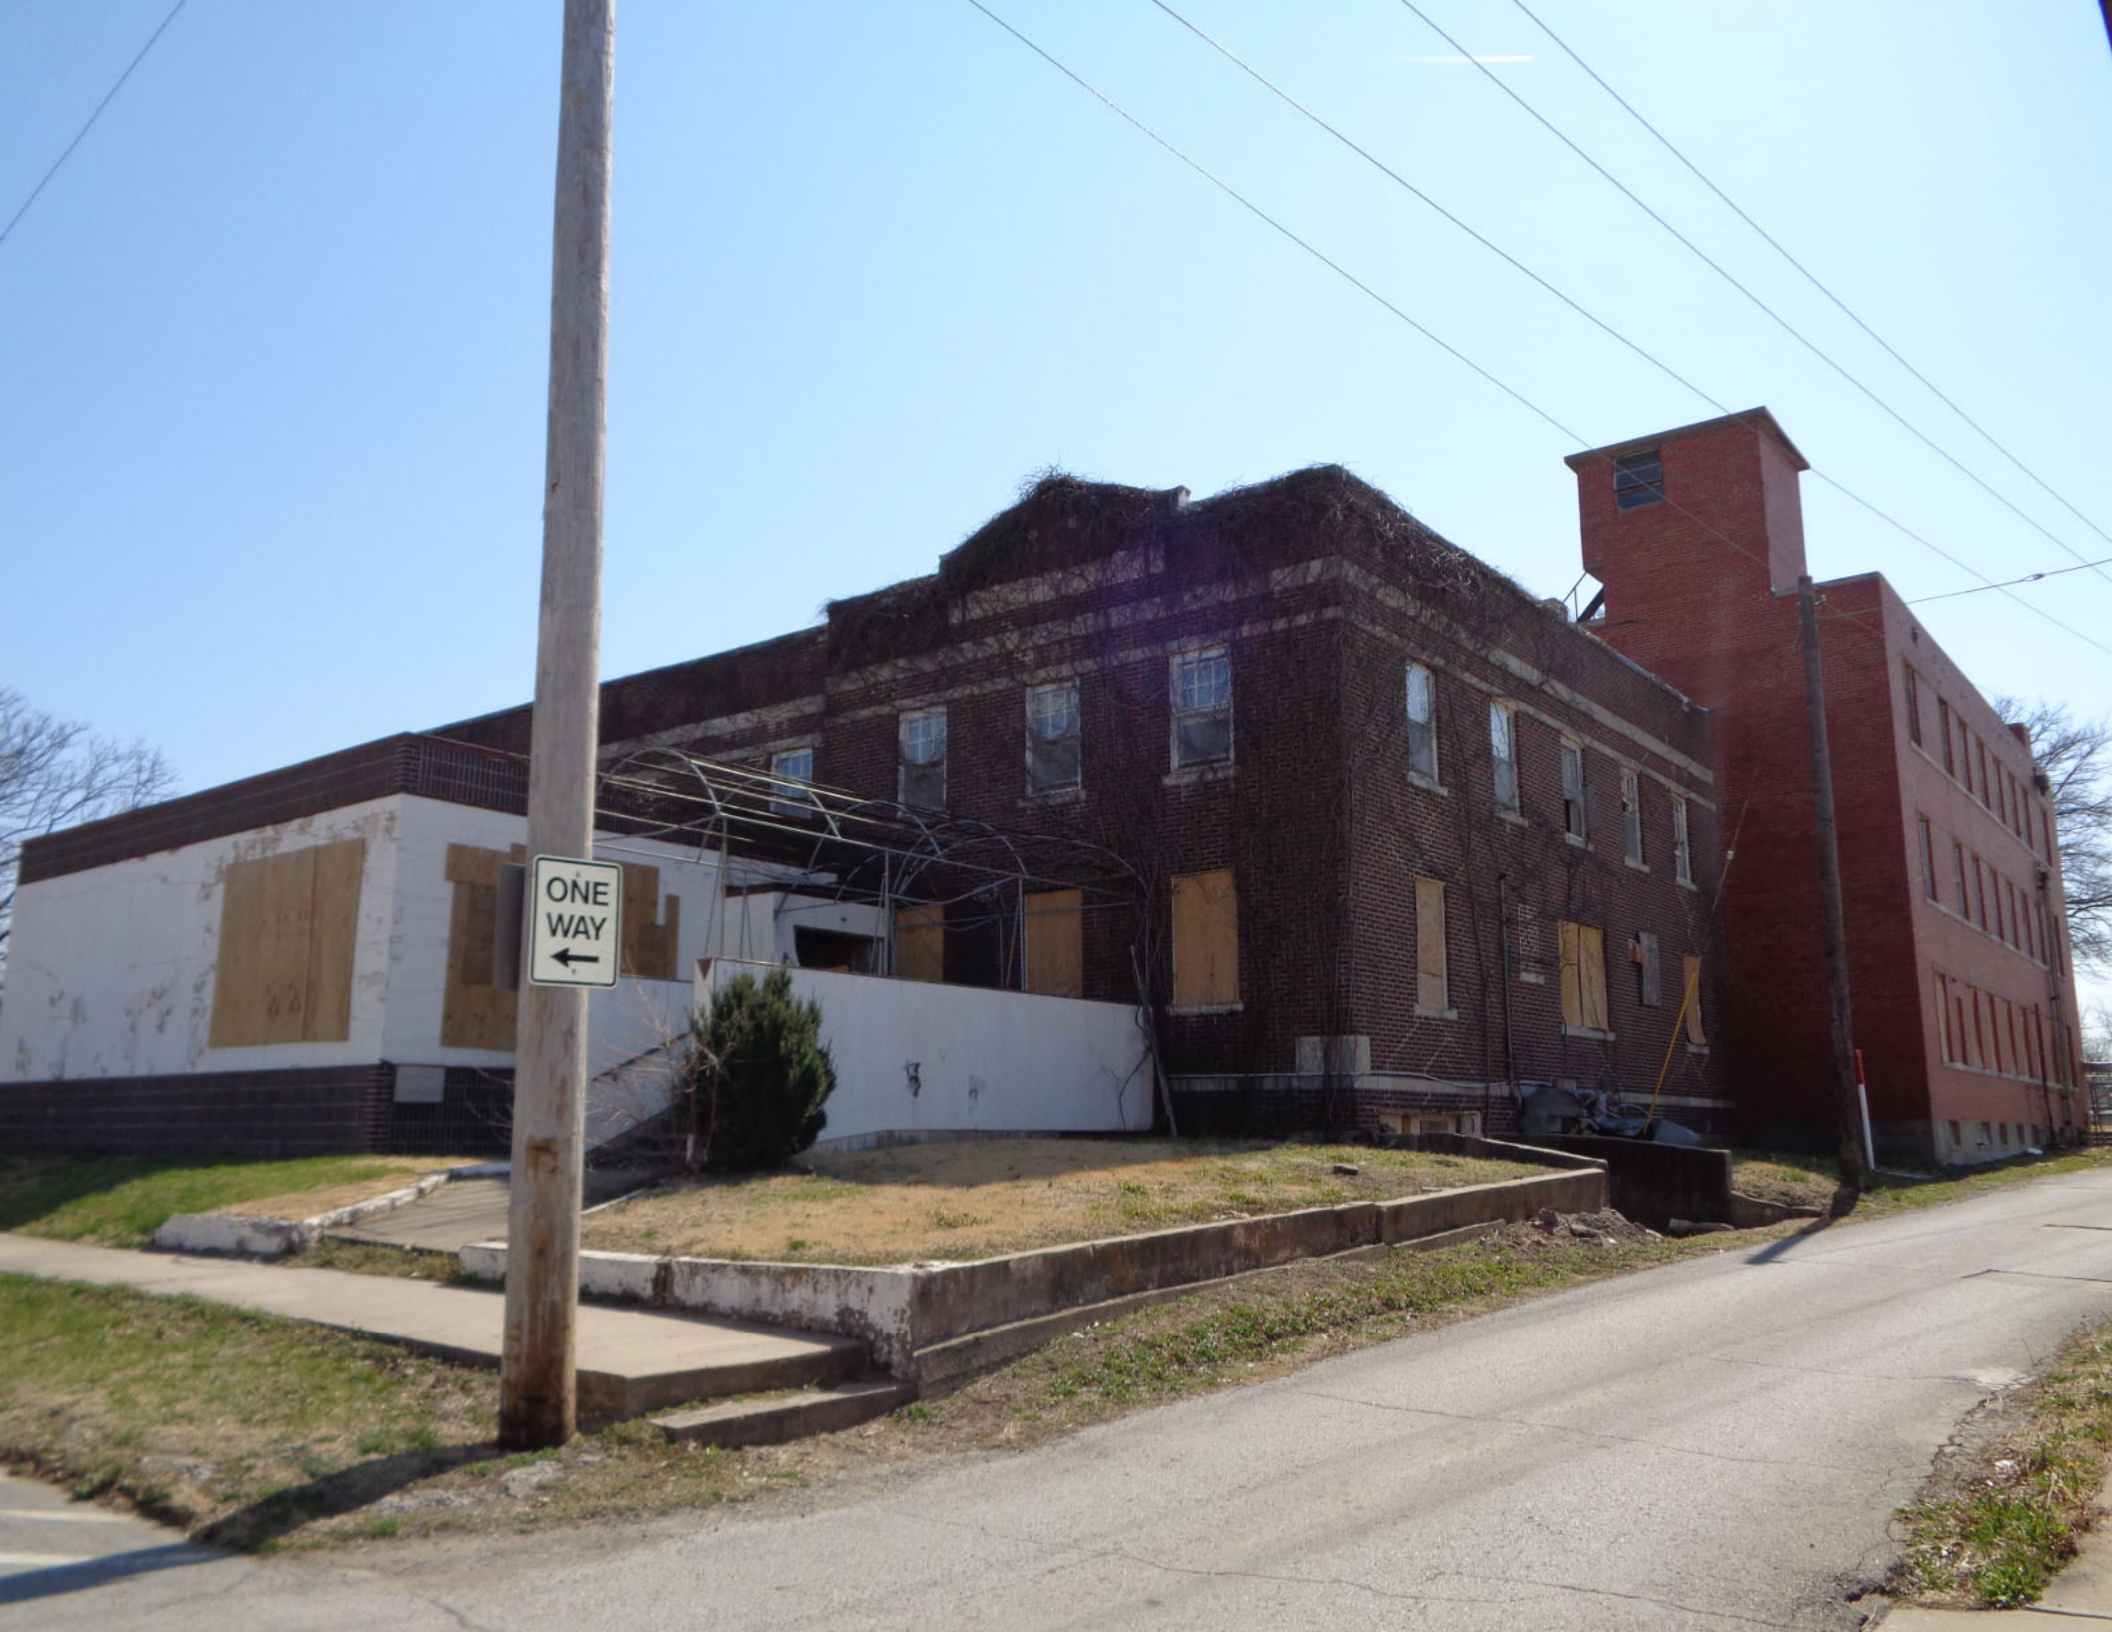
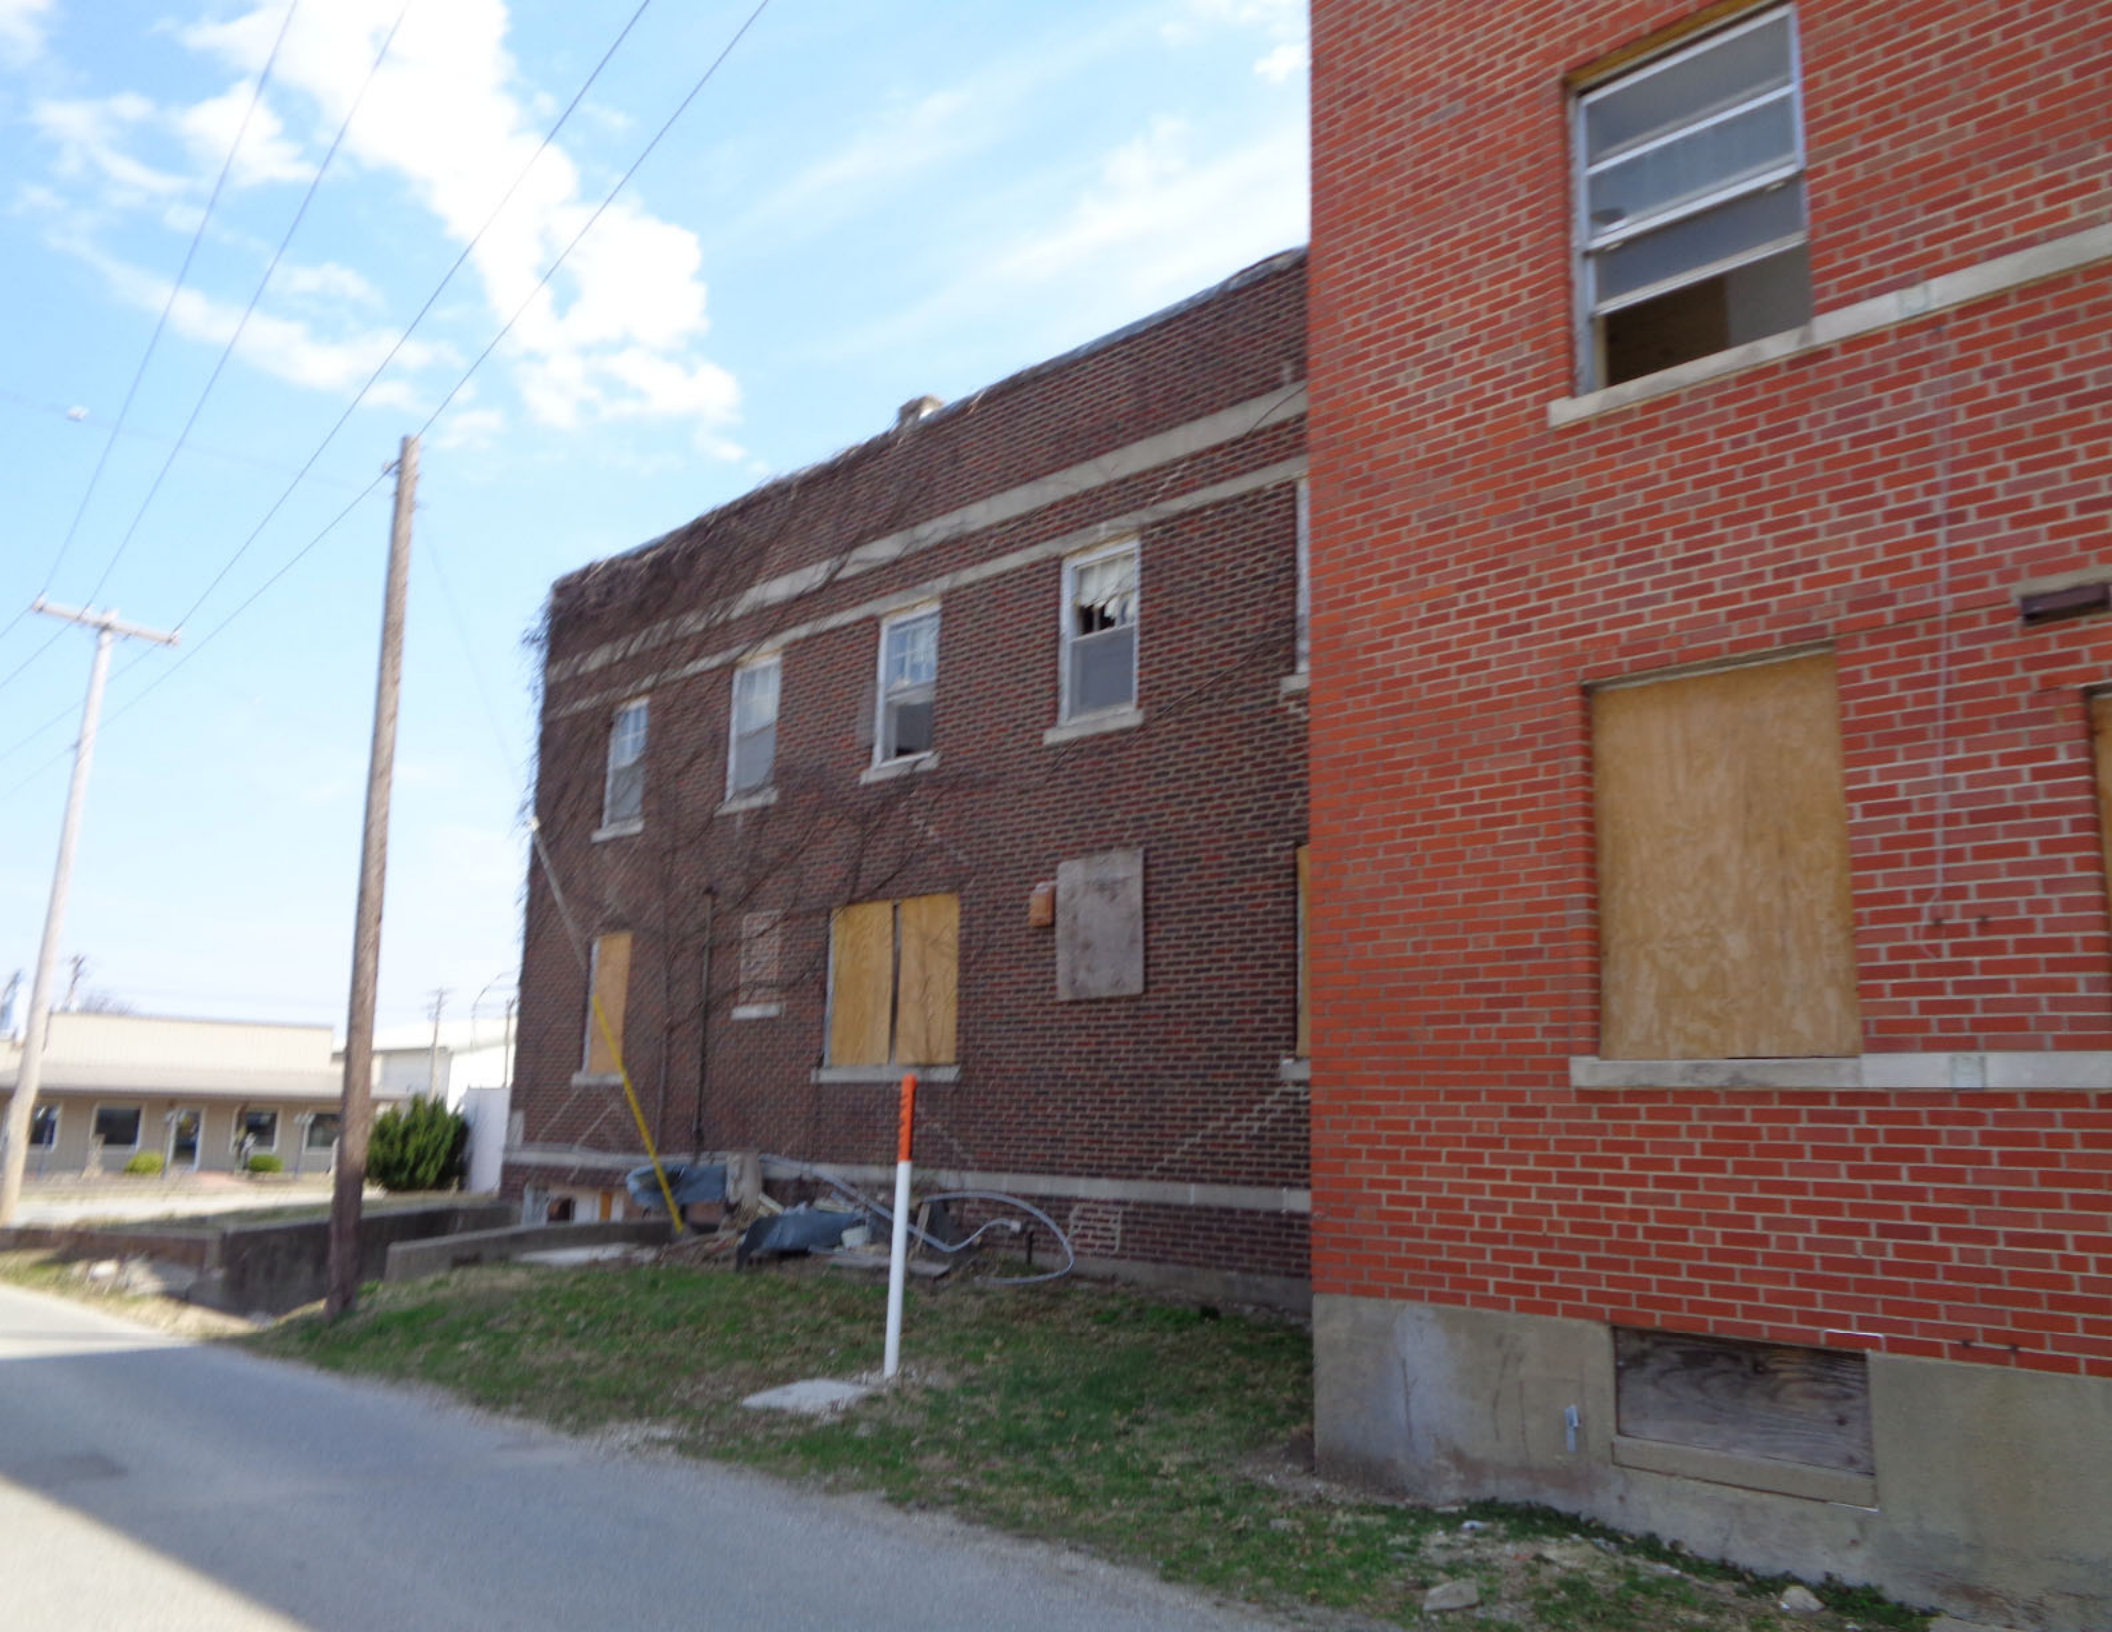
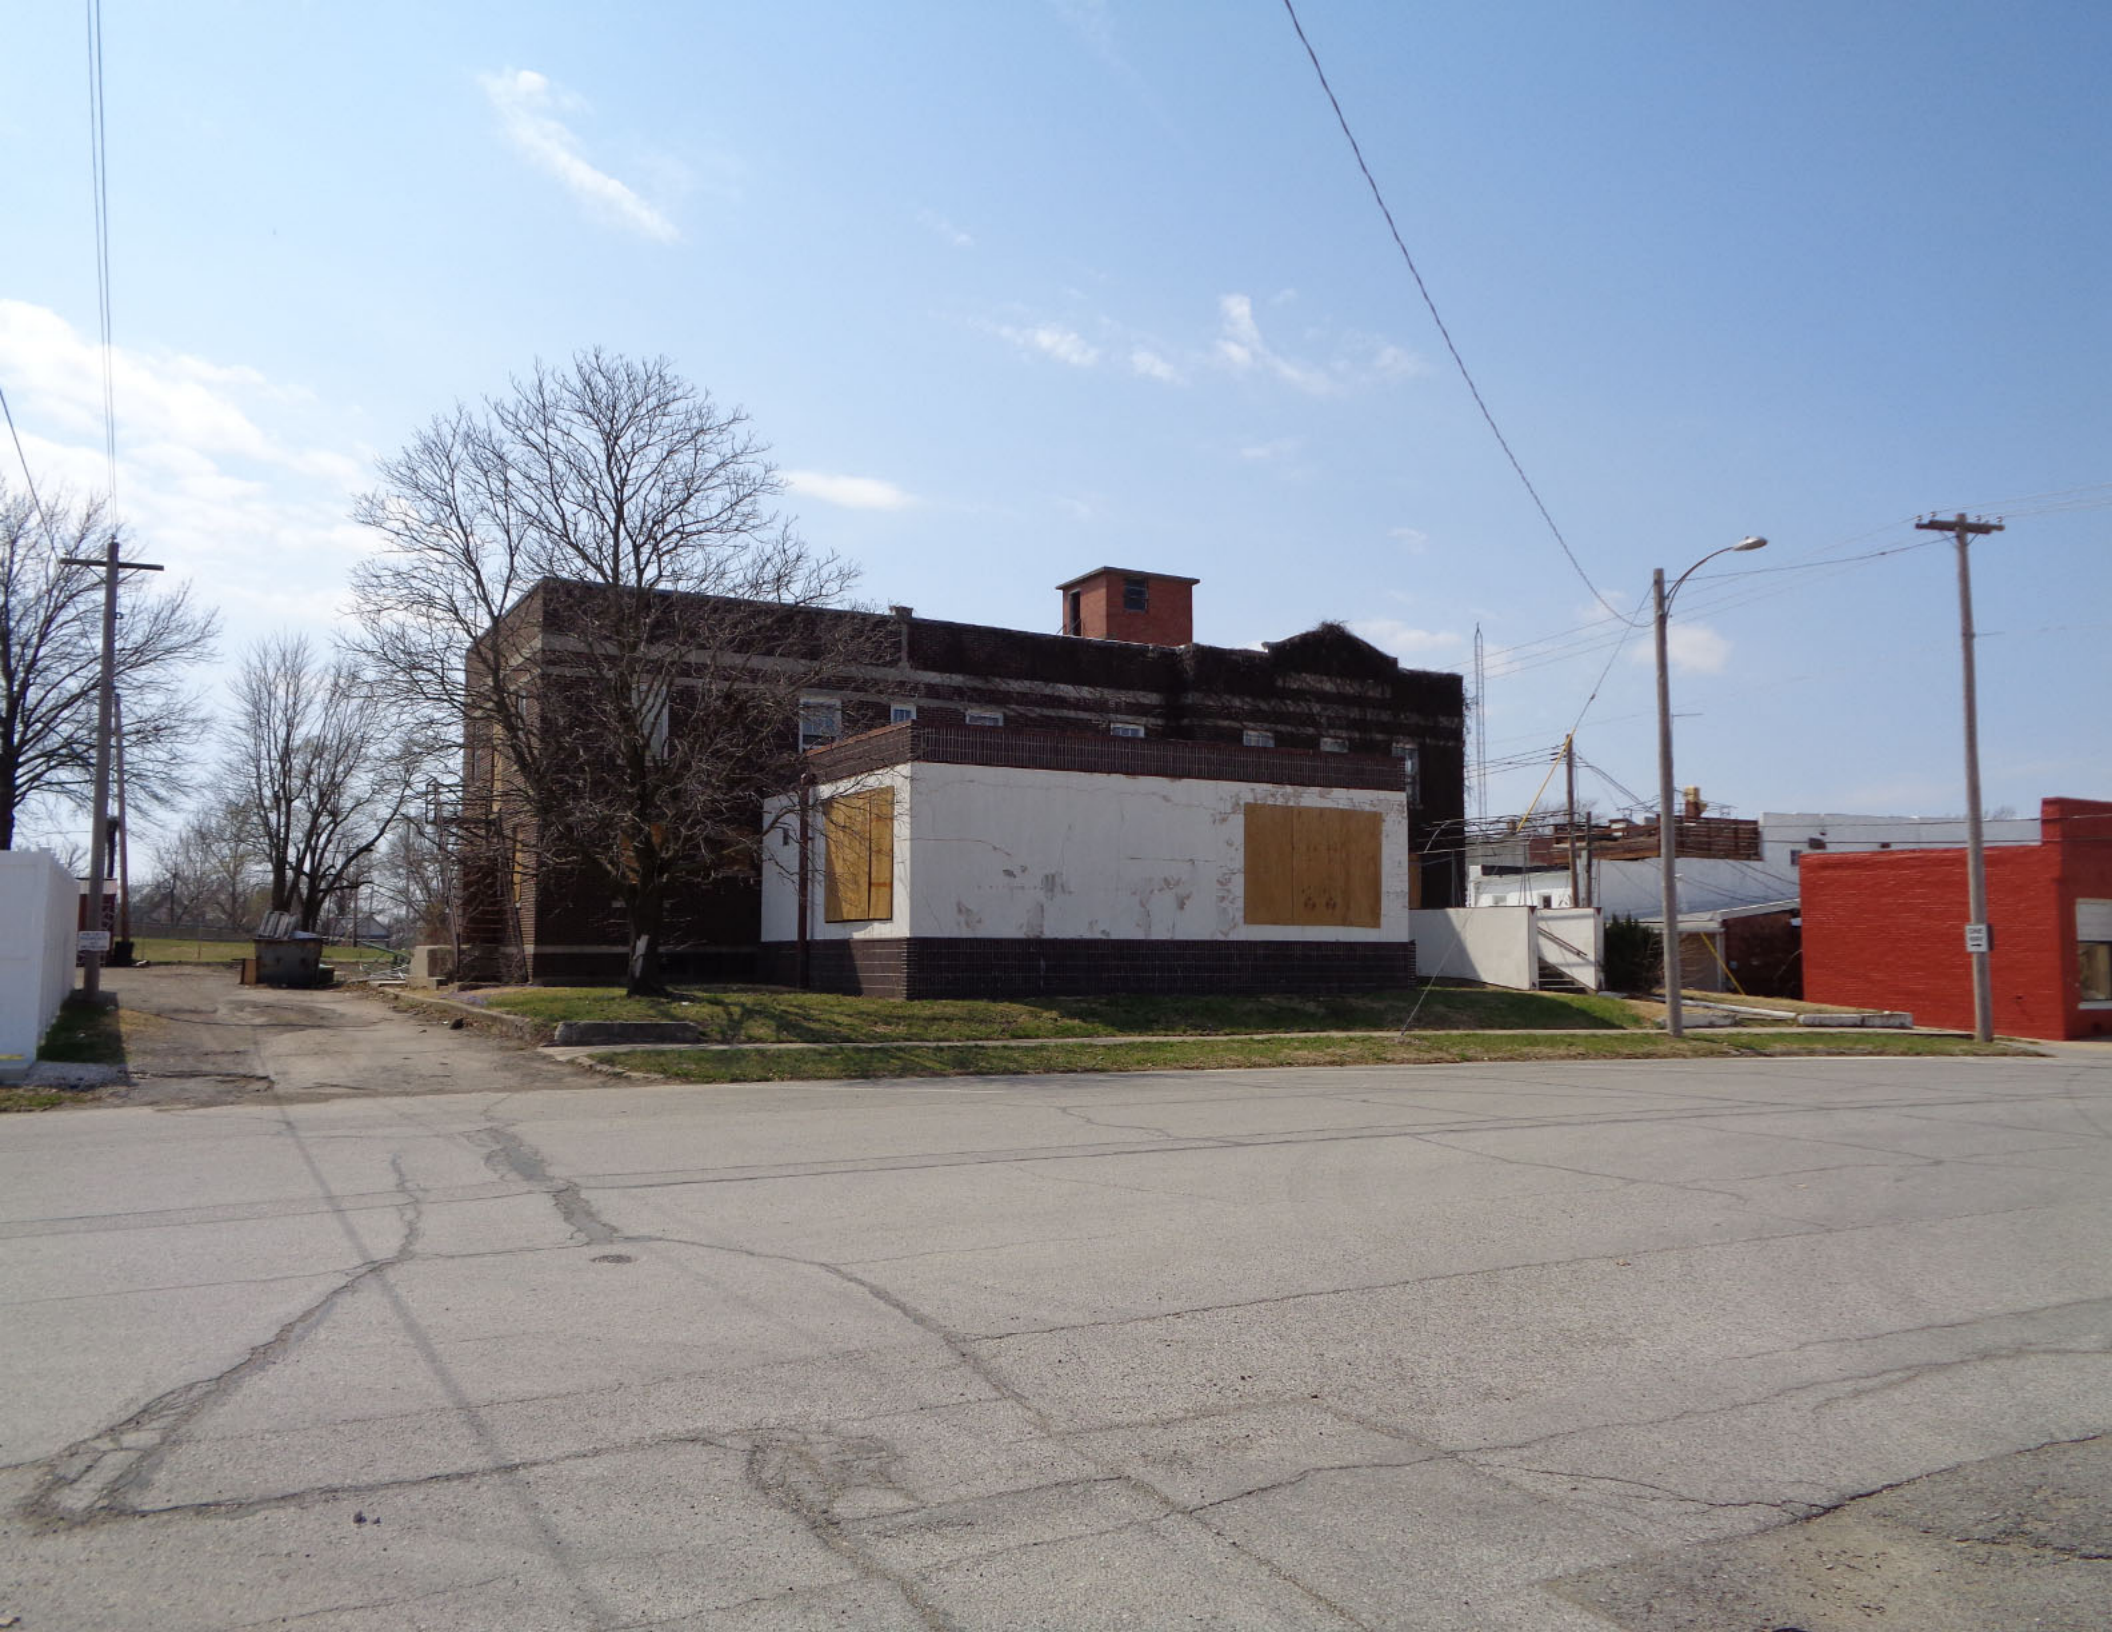
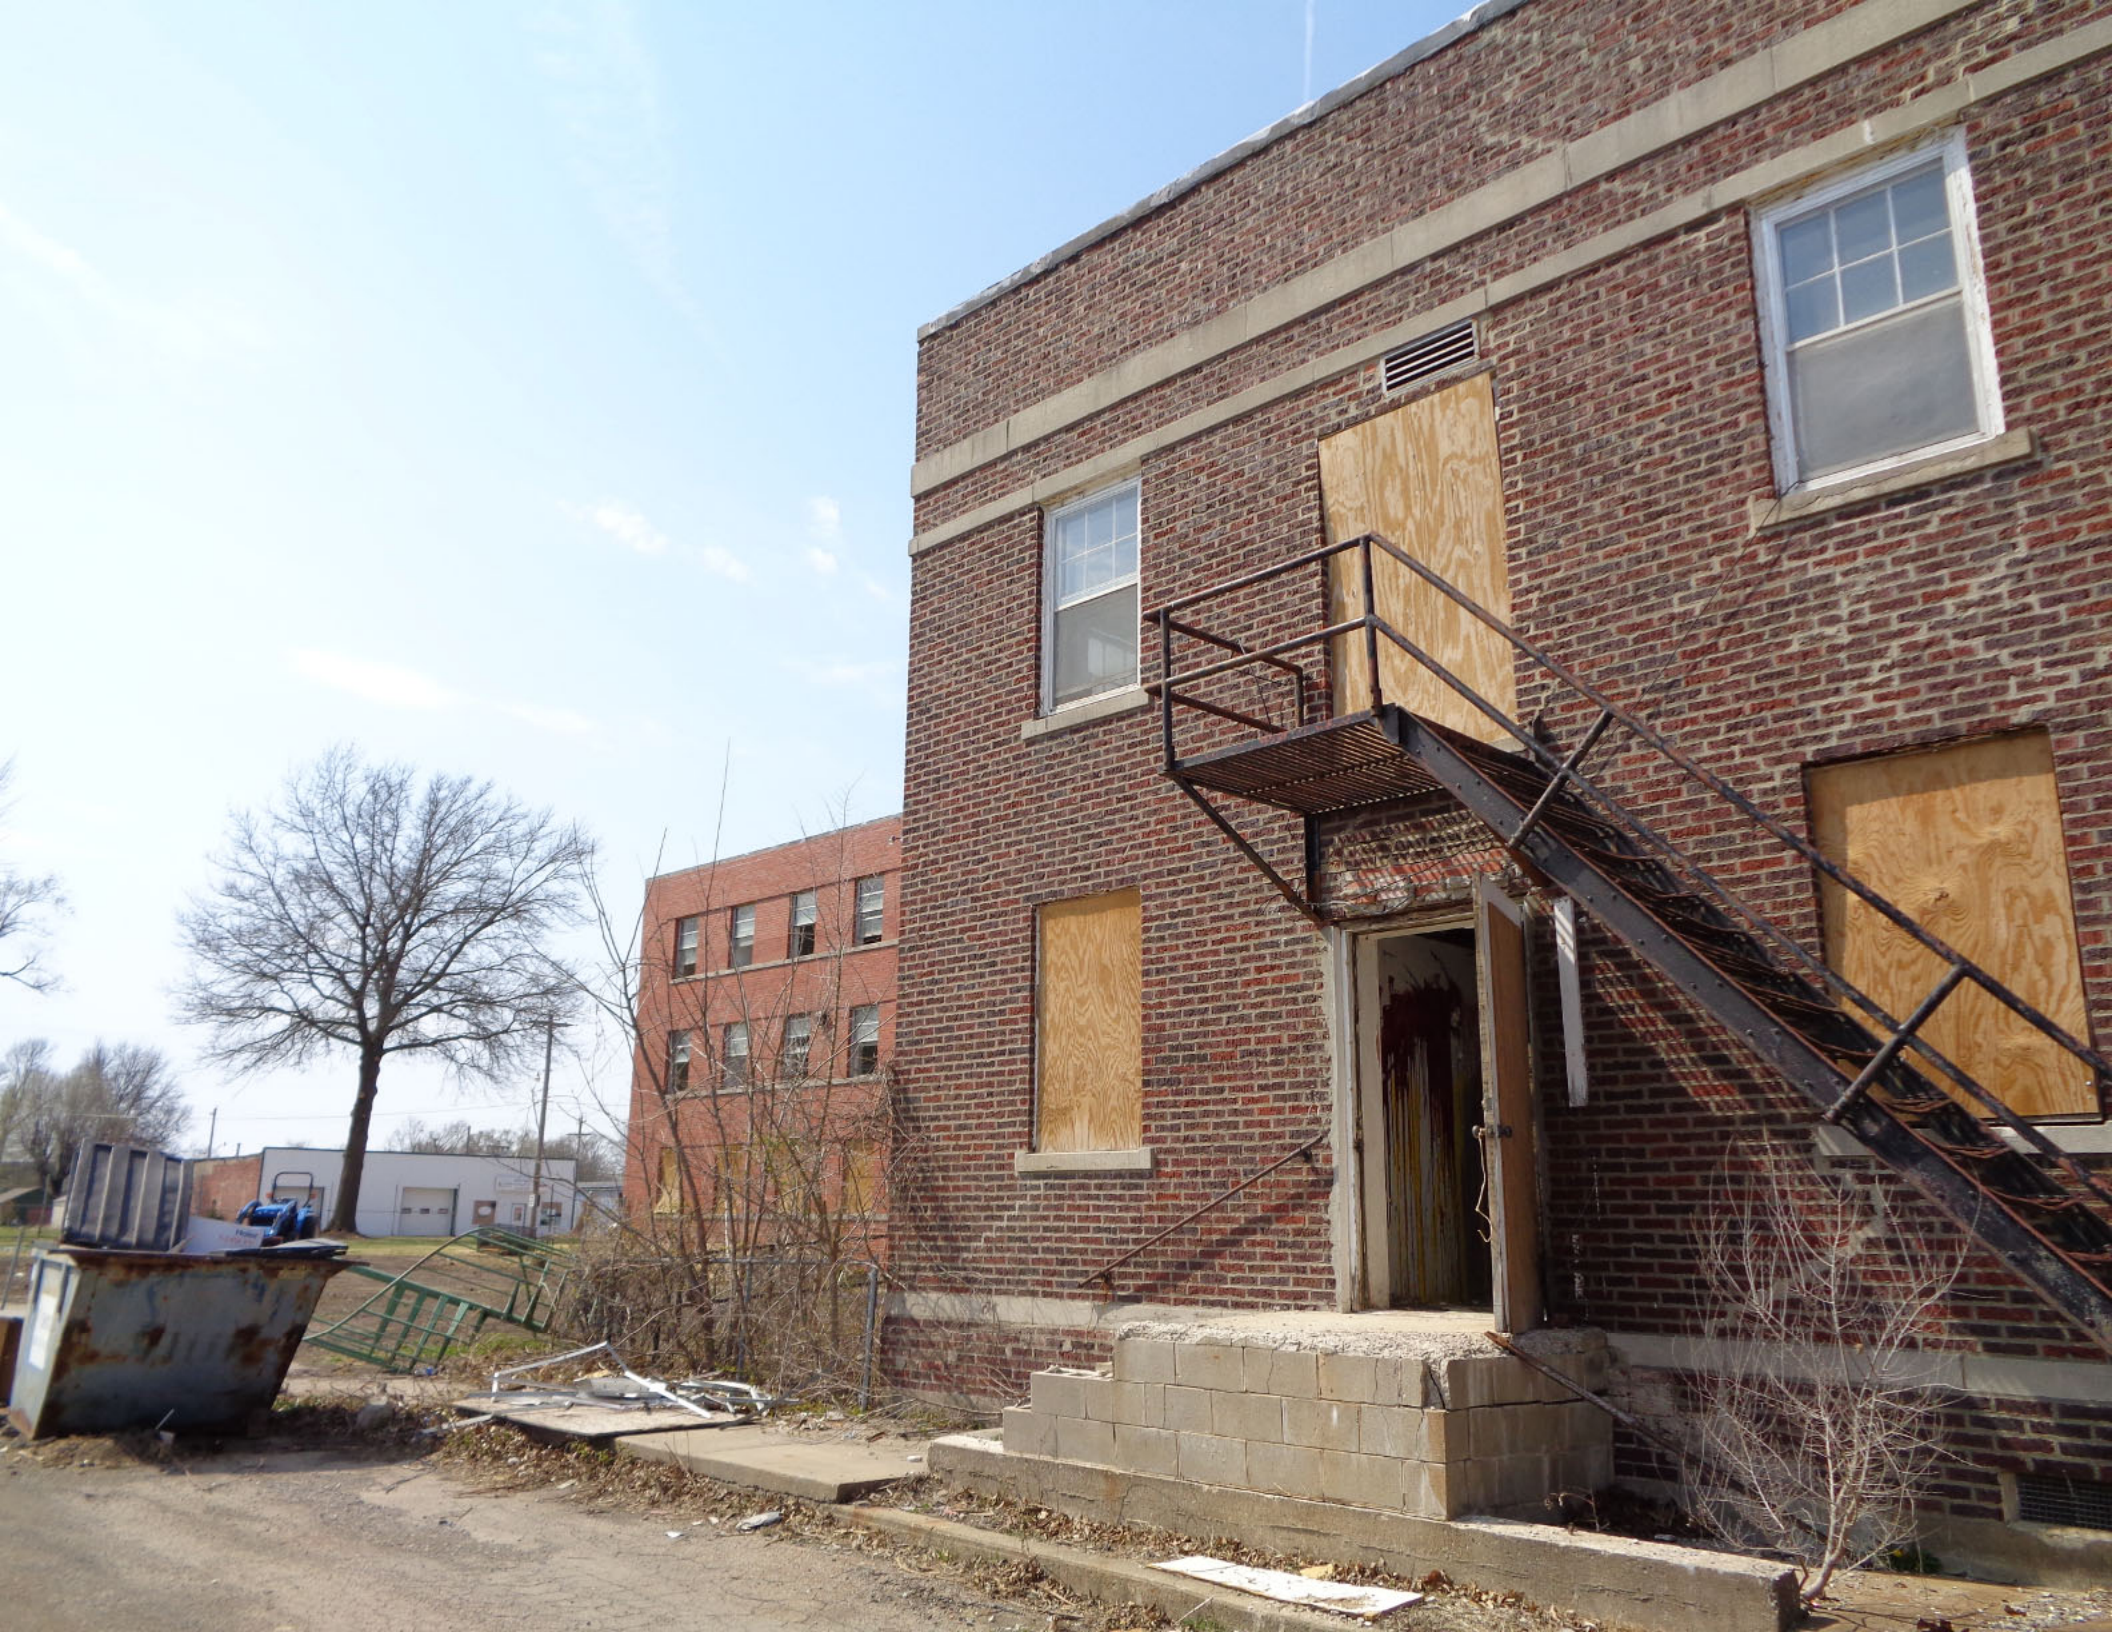
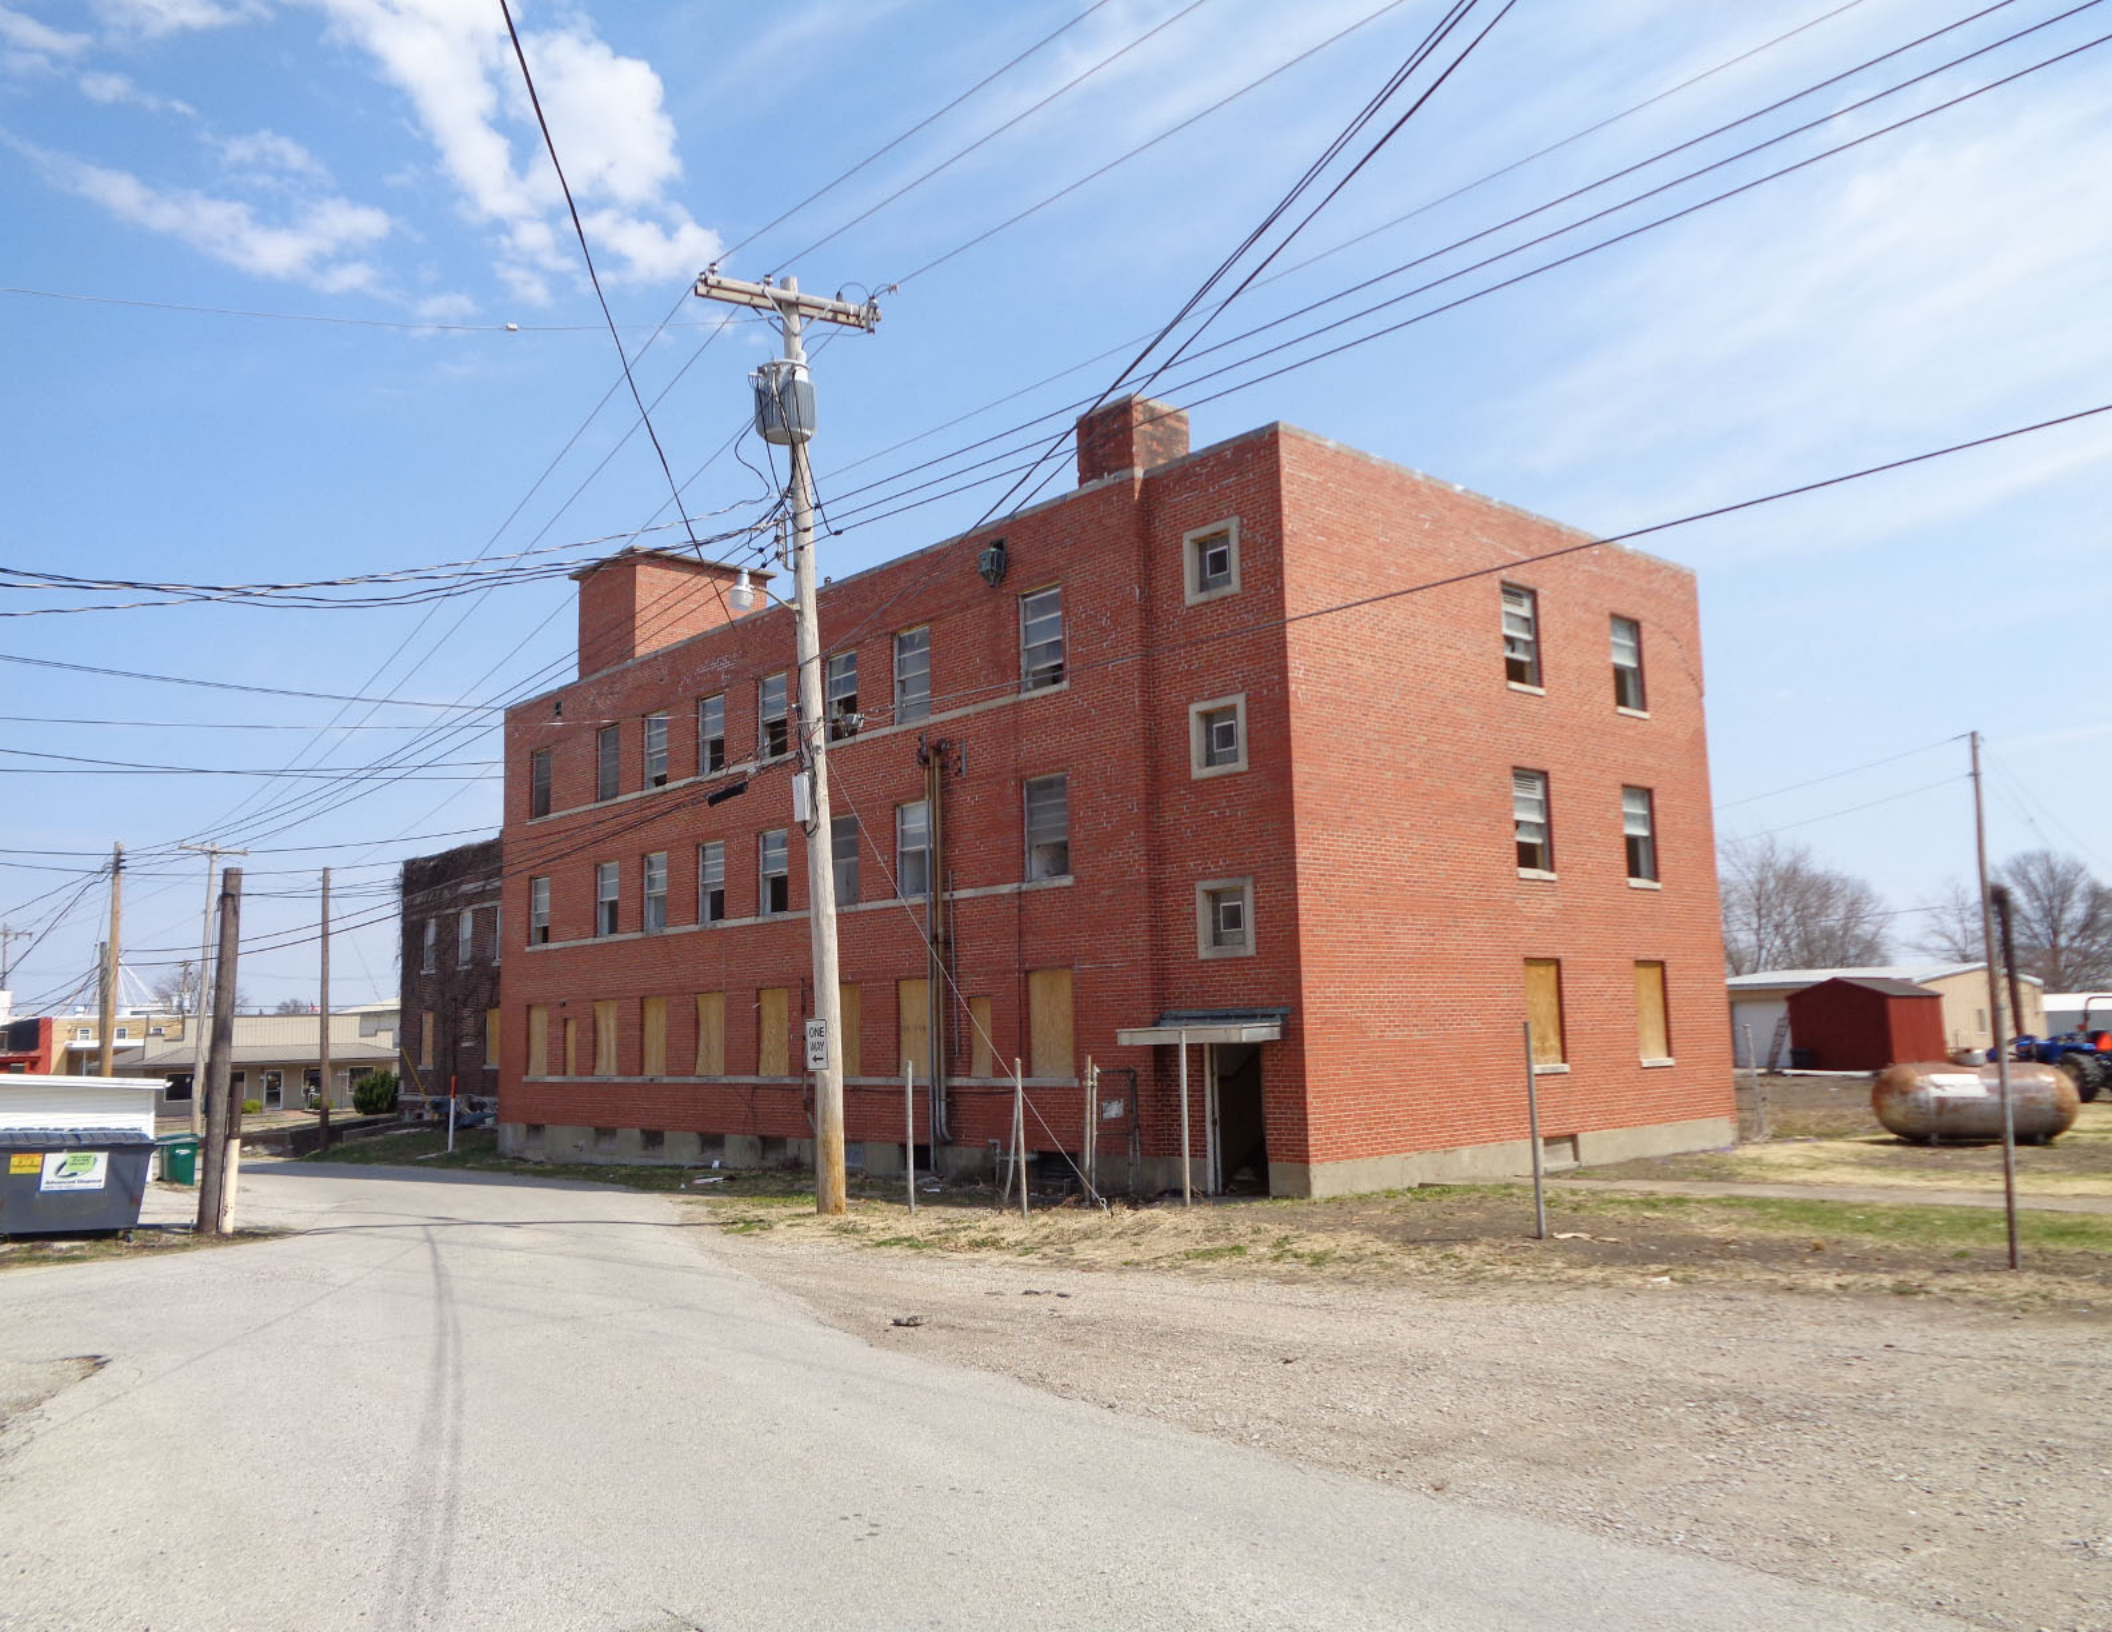
This hospital building has been altered several times through the years. The original building is two story and faces toward East Howell Street. There is a one story addition built in front of the original building. There is also a large three story addition constructed behind the original building that was constructed c. 1960.

The facade has four main bays starting from the east, there is a single window opening, followed by the addition this addition occupies a large portion of the facade. It has brick on the brick knee wall that surrounds this addition there are three boarded window openings, one on each side of the addition, in this addition and has a concrete portion with another band of brick above. Moving west there is a recessed opening in the addition. Moving west there are three remaining bays each with a single boarded windows. The upper level of the main building starting from the west has three evenly spaced windows in the protruding bay with five more windows in the eastern portion of the recessed bay the center window is smaller with two windows on either side evenly spaced. There is a raised parapet in over the protruding west bay.

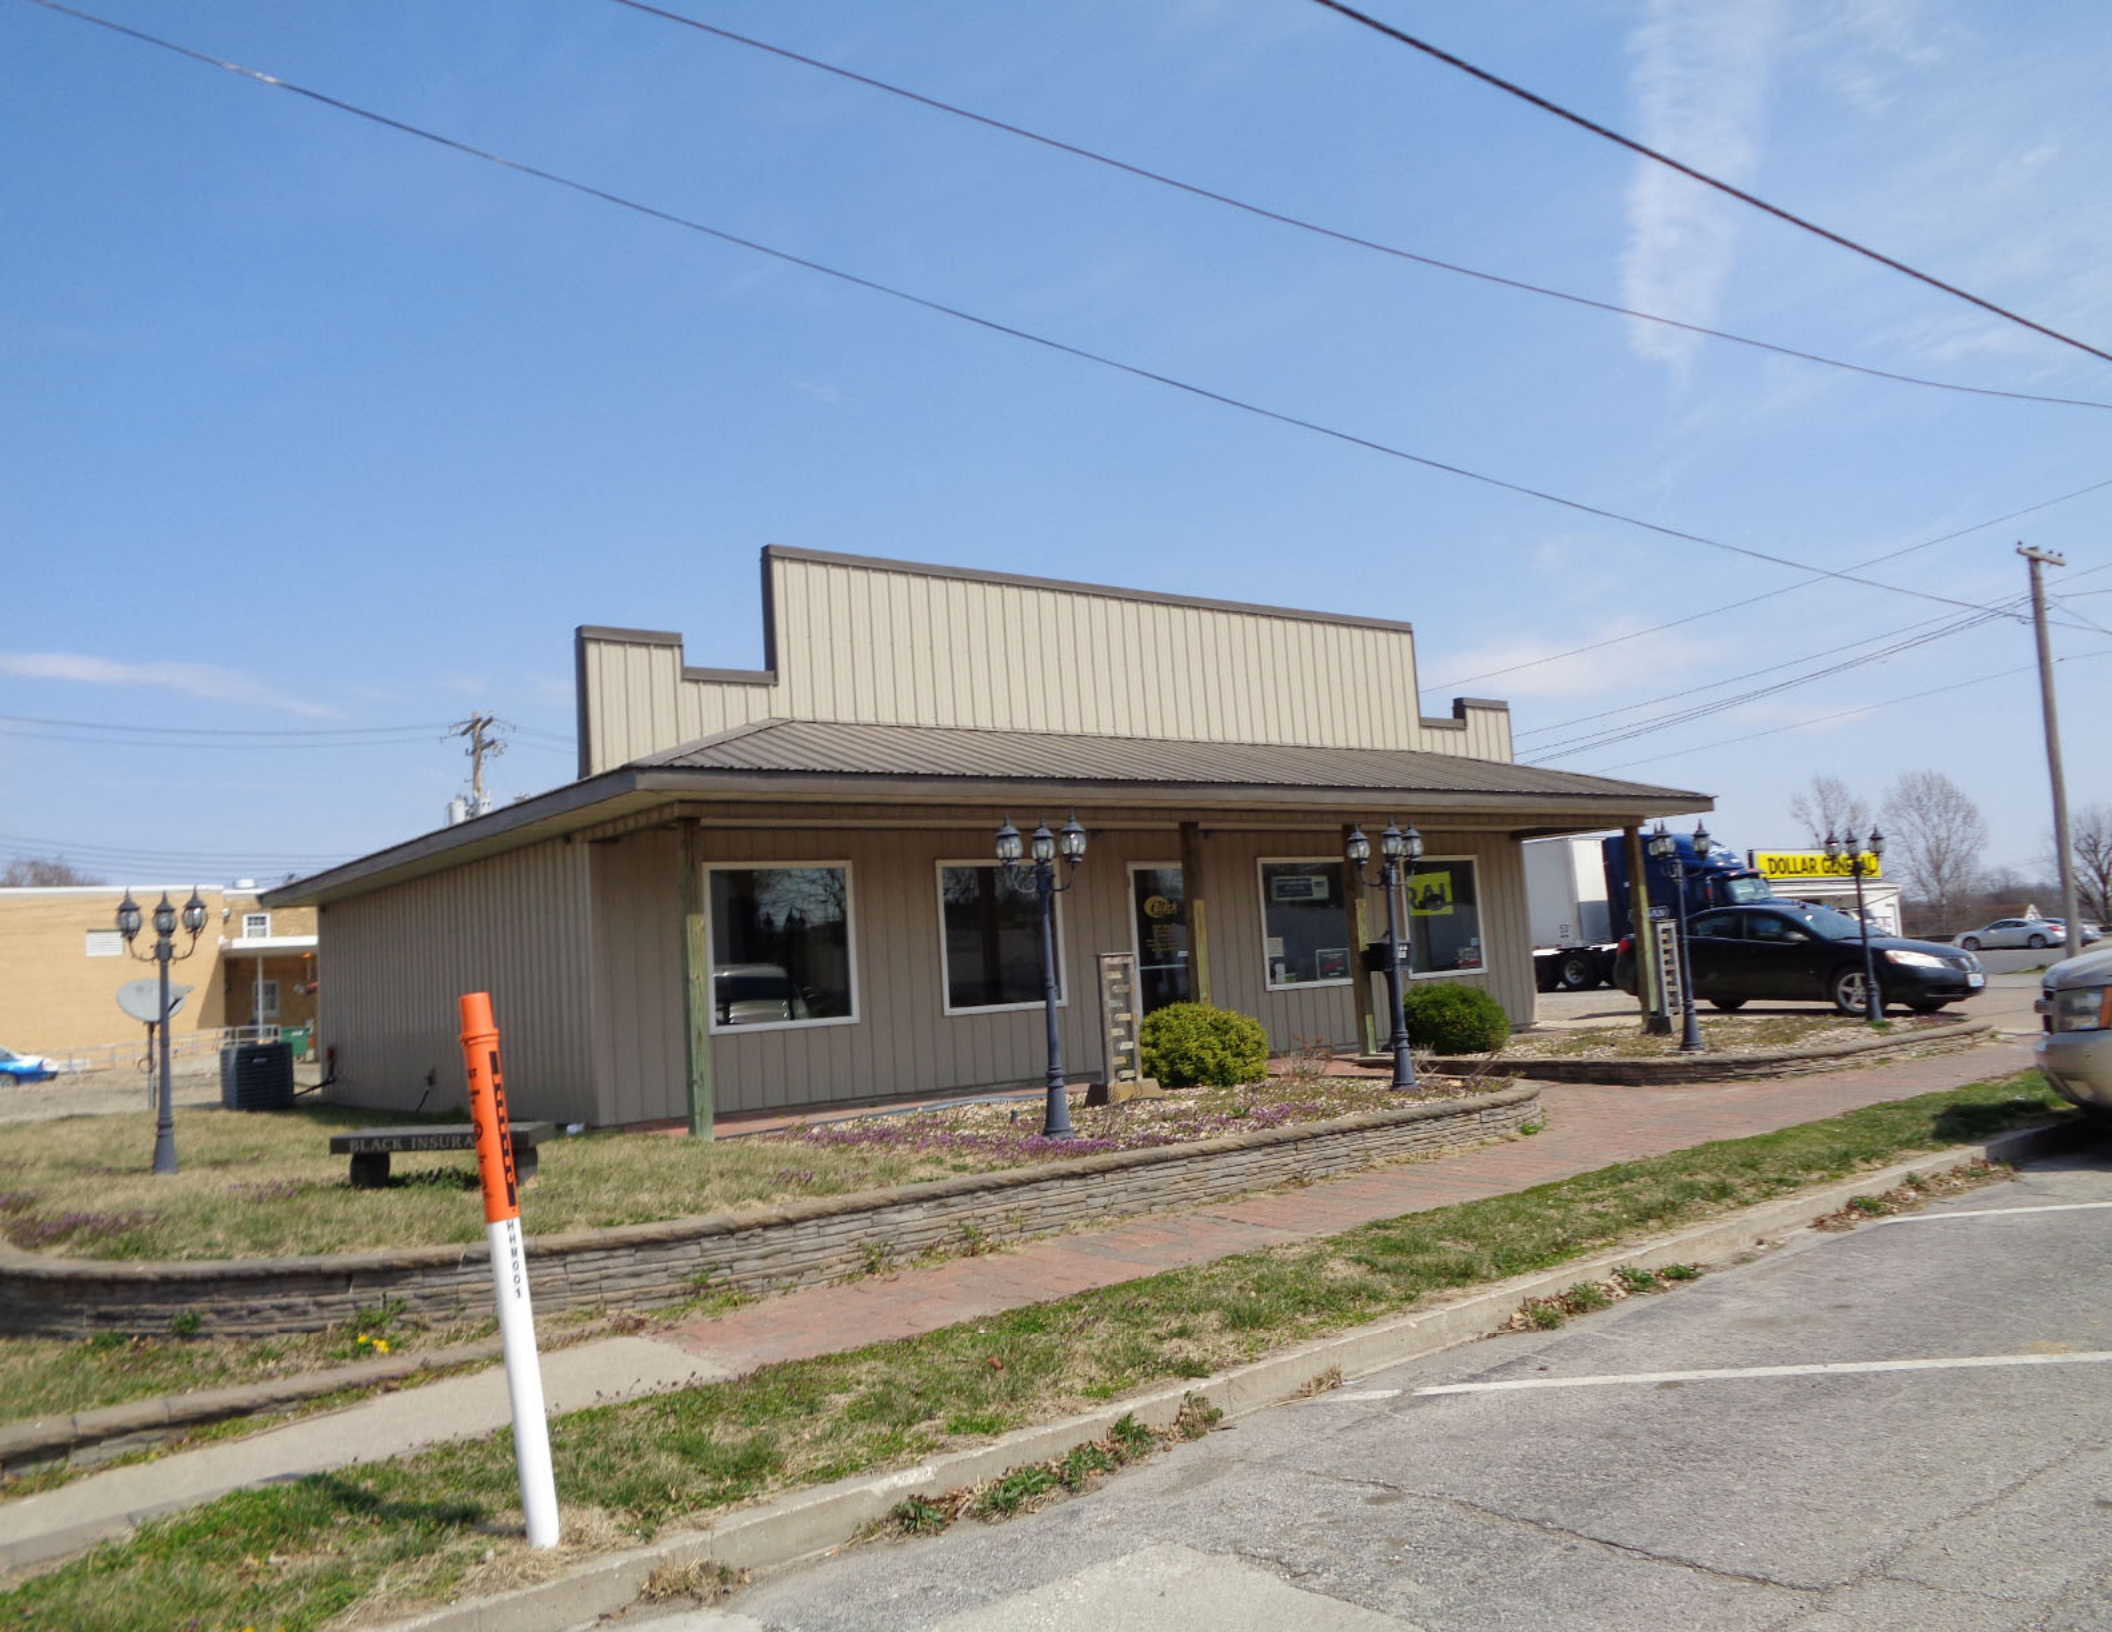
This is a modern metal building with that is symmetrical in design. From the east there is a large square fixed window in the first bay the second bay has an identical window. There is a single door that is metal with a large glass pane. The two western bays have identical fixed large windows. The building has a full-width porch with wood posts.
