MISSOURI DEPARTMENT OF NATURAL RESOURCES  
STATE HISTORIC PRESERVATION OFFICE, P.O. Box 176, Jefferson City, MO 65102  
**ARCHITECTURAL/HISTORIC INVENTORY FORM**

1. SURVEY NO. LI-AS-001-001		2. SURVEY NAME: Marceline Survey	
3. COUNTY: Linn		4. ADDRESS (STREET NO.) 275	STREET (NAME) West Broadway
5. CITY: Marceline	VICINITY: <input type="checkbox"/>	6. UTM: / /	7. TOWNSHIP/RANGE/SECTION: T: R: S:

8. HISTORIC NAME (IF KNOWN): Walt Disney's Childhood Home		9. PRESENT/OTHER NAME (IF KNOWN): Walt Disney's Childhood Home	
10. OWNERSHIP: <input checked="" type="checkbox"/> PRIVATE <input type="checkbox"/> PUBLIC		11A. HISTORIC USE (IF KNOWN): Single Dwelling	11B. CURRENT USE: Single Dwelling
<b>HISTORICAL INFORMATION</b>

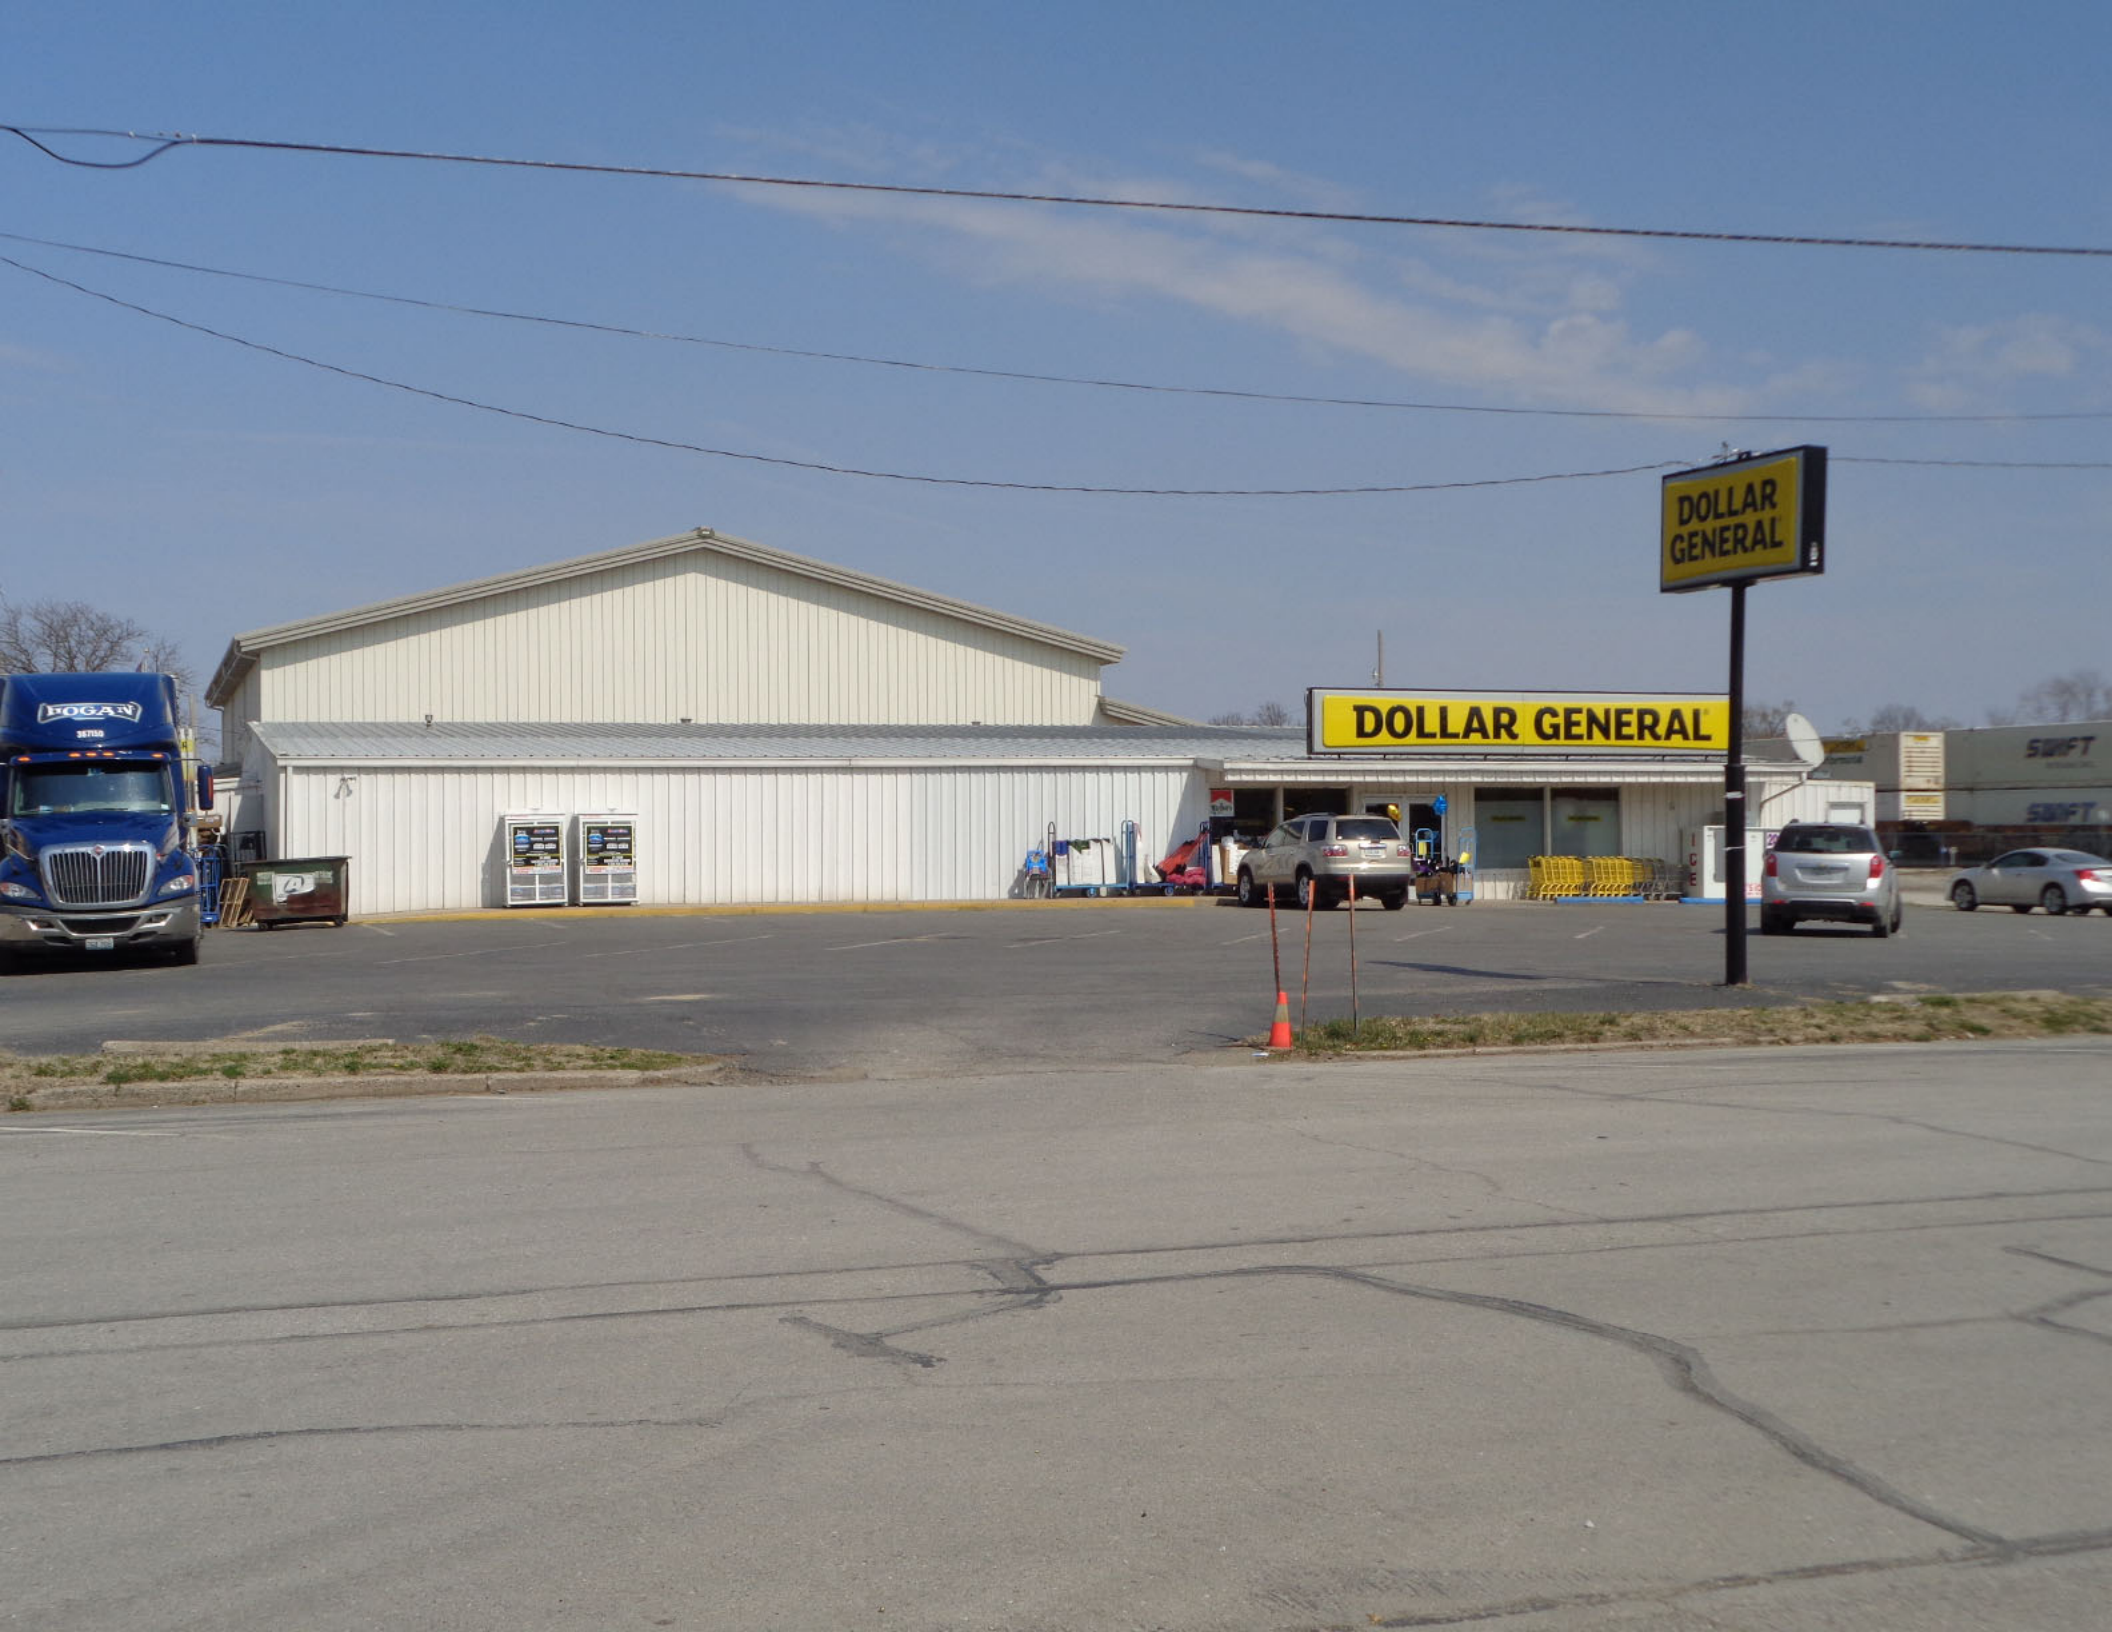
The rear of the building there is a flat roof portion of the building at the rear (or north elevation) of the building.

There is a partial width porch that covers the entrance and window bays of this building. There is a plastic illuminated "DOLLAR GENERAL" sign over the this porch.

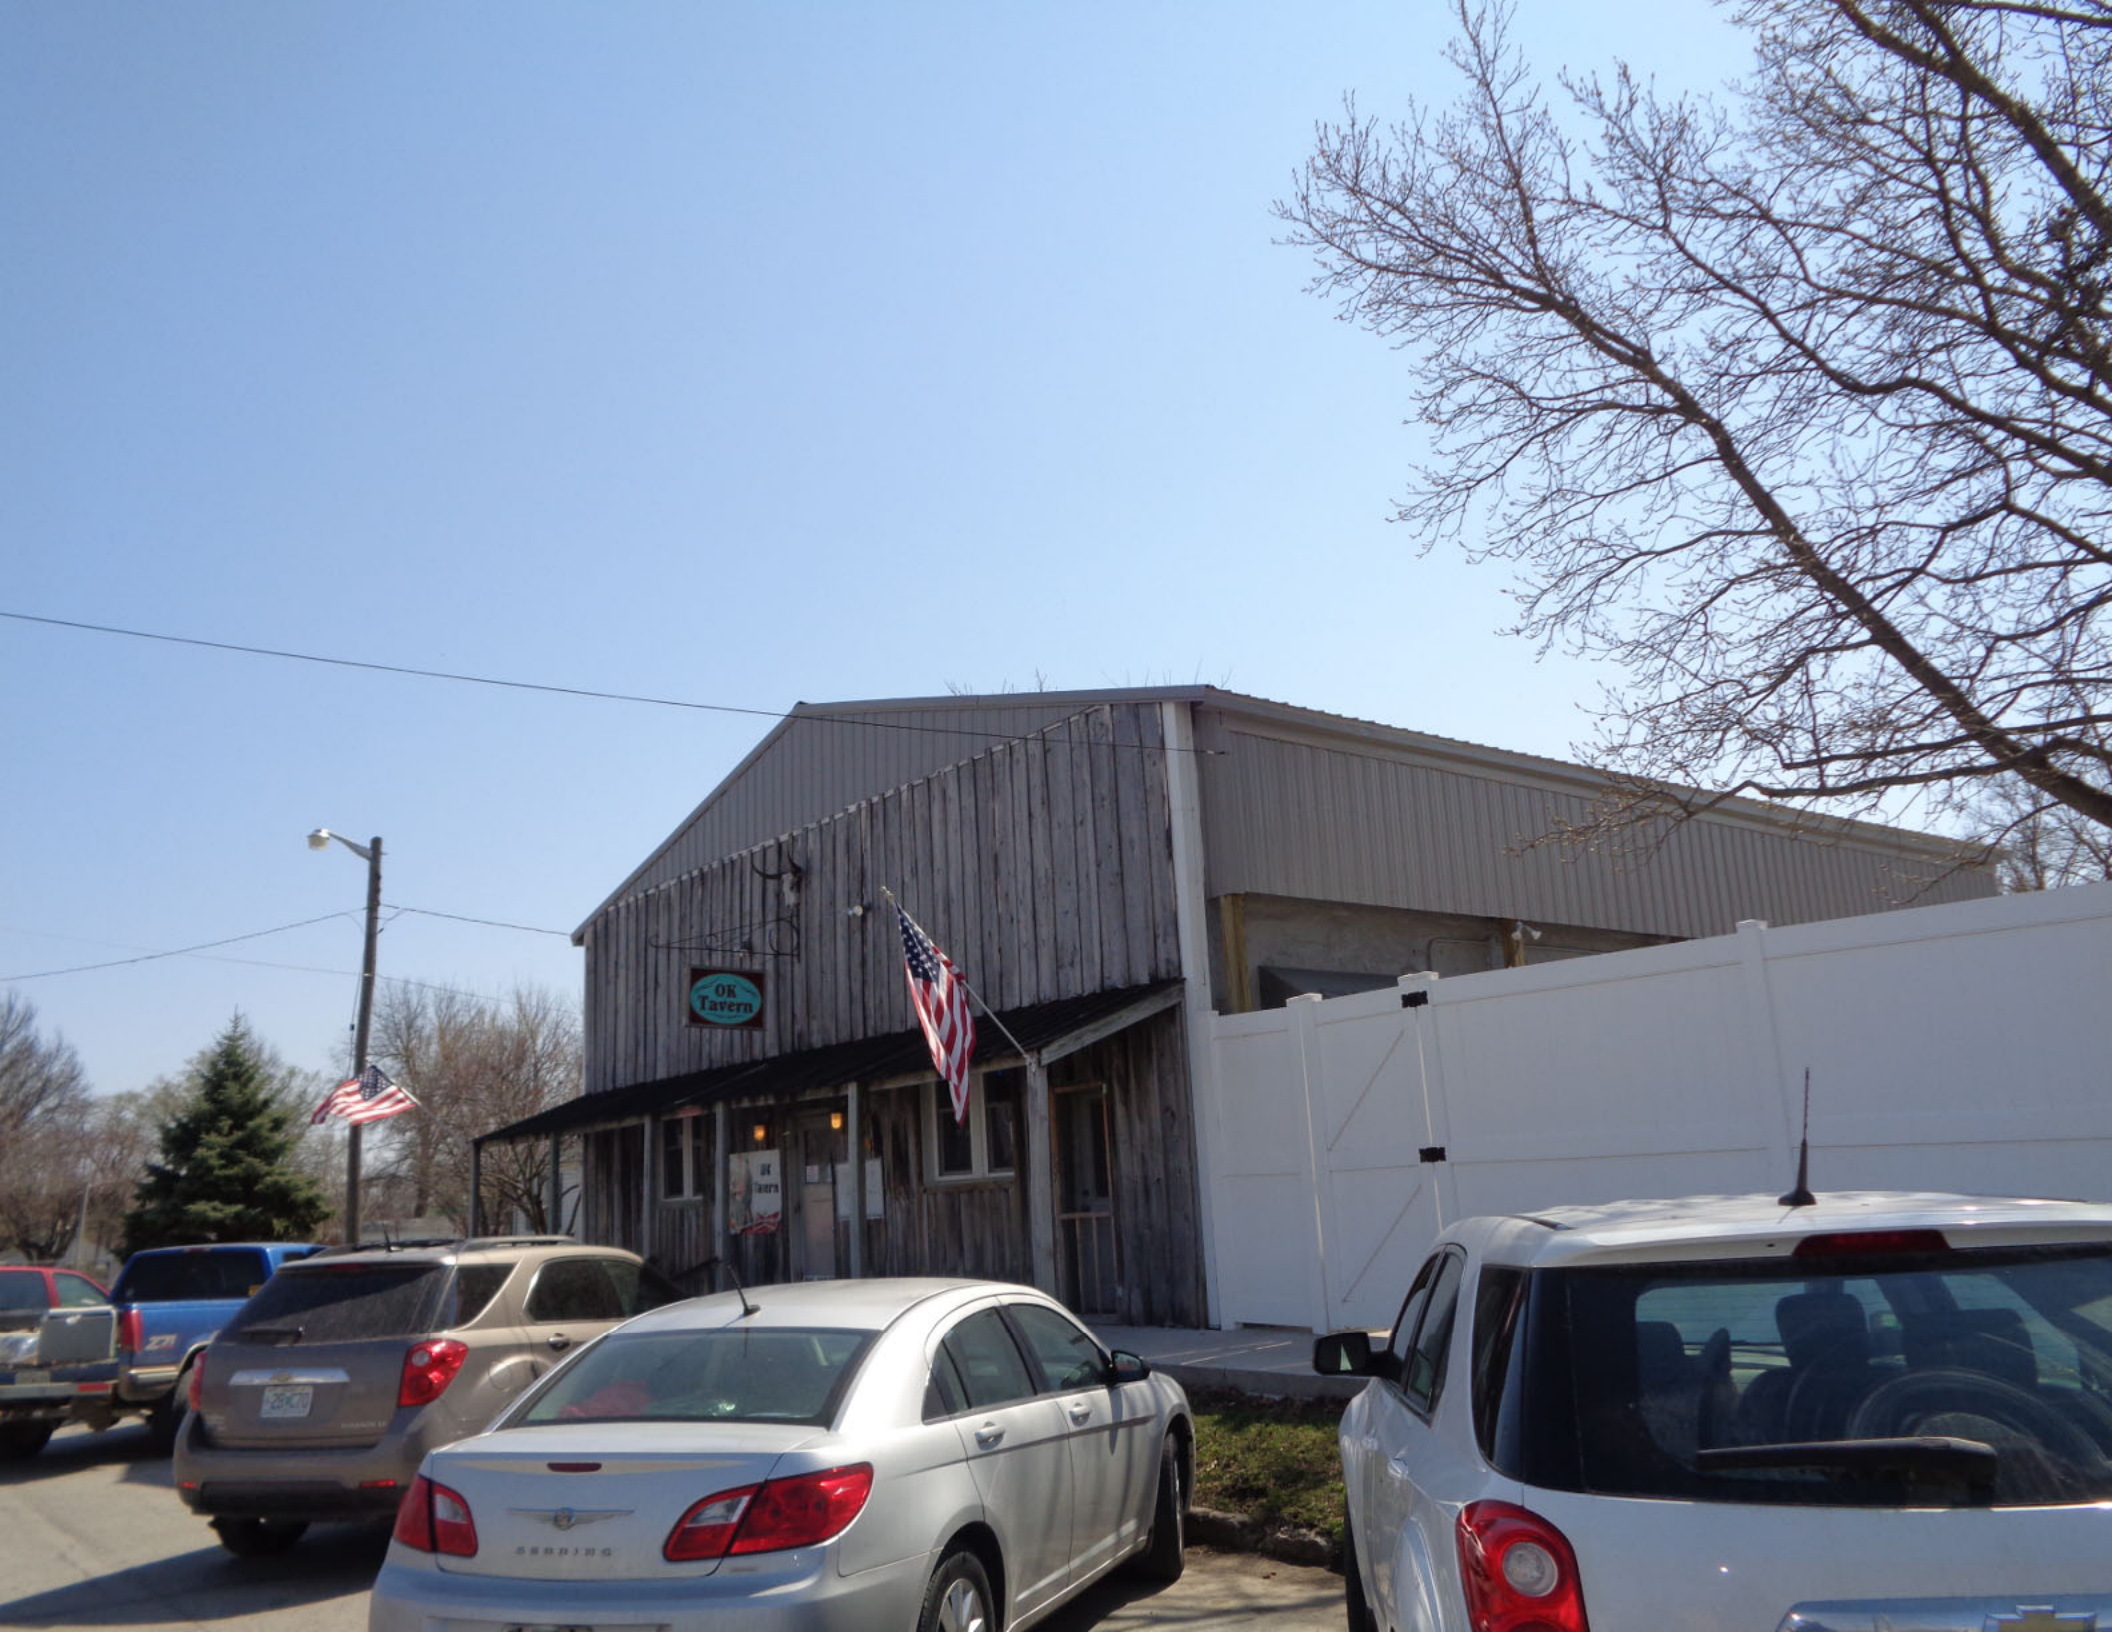
OK  
Tavern

The building is faced with vertical wood siding. The roof is metal front gable. The side elevations of the roof extends halfway down the the building on the east and west elevation.

There is a sign in the center of the porch there is also an animal skull mounted to the front of the building. There is also a house that is attached to the is building. See LI-AS-001-31 for more information about the attached house.

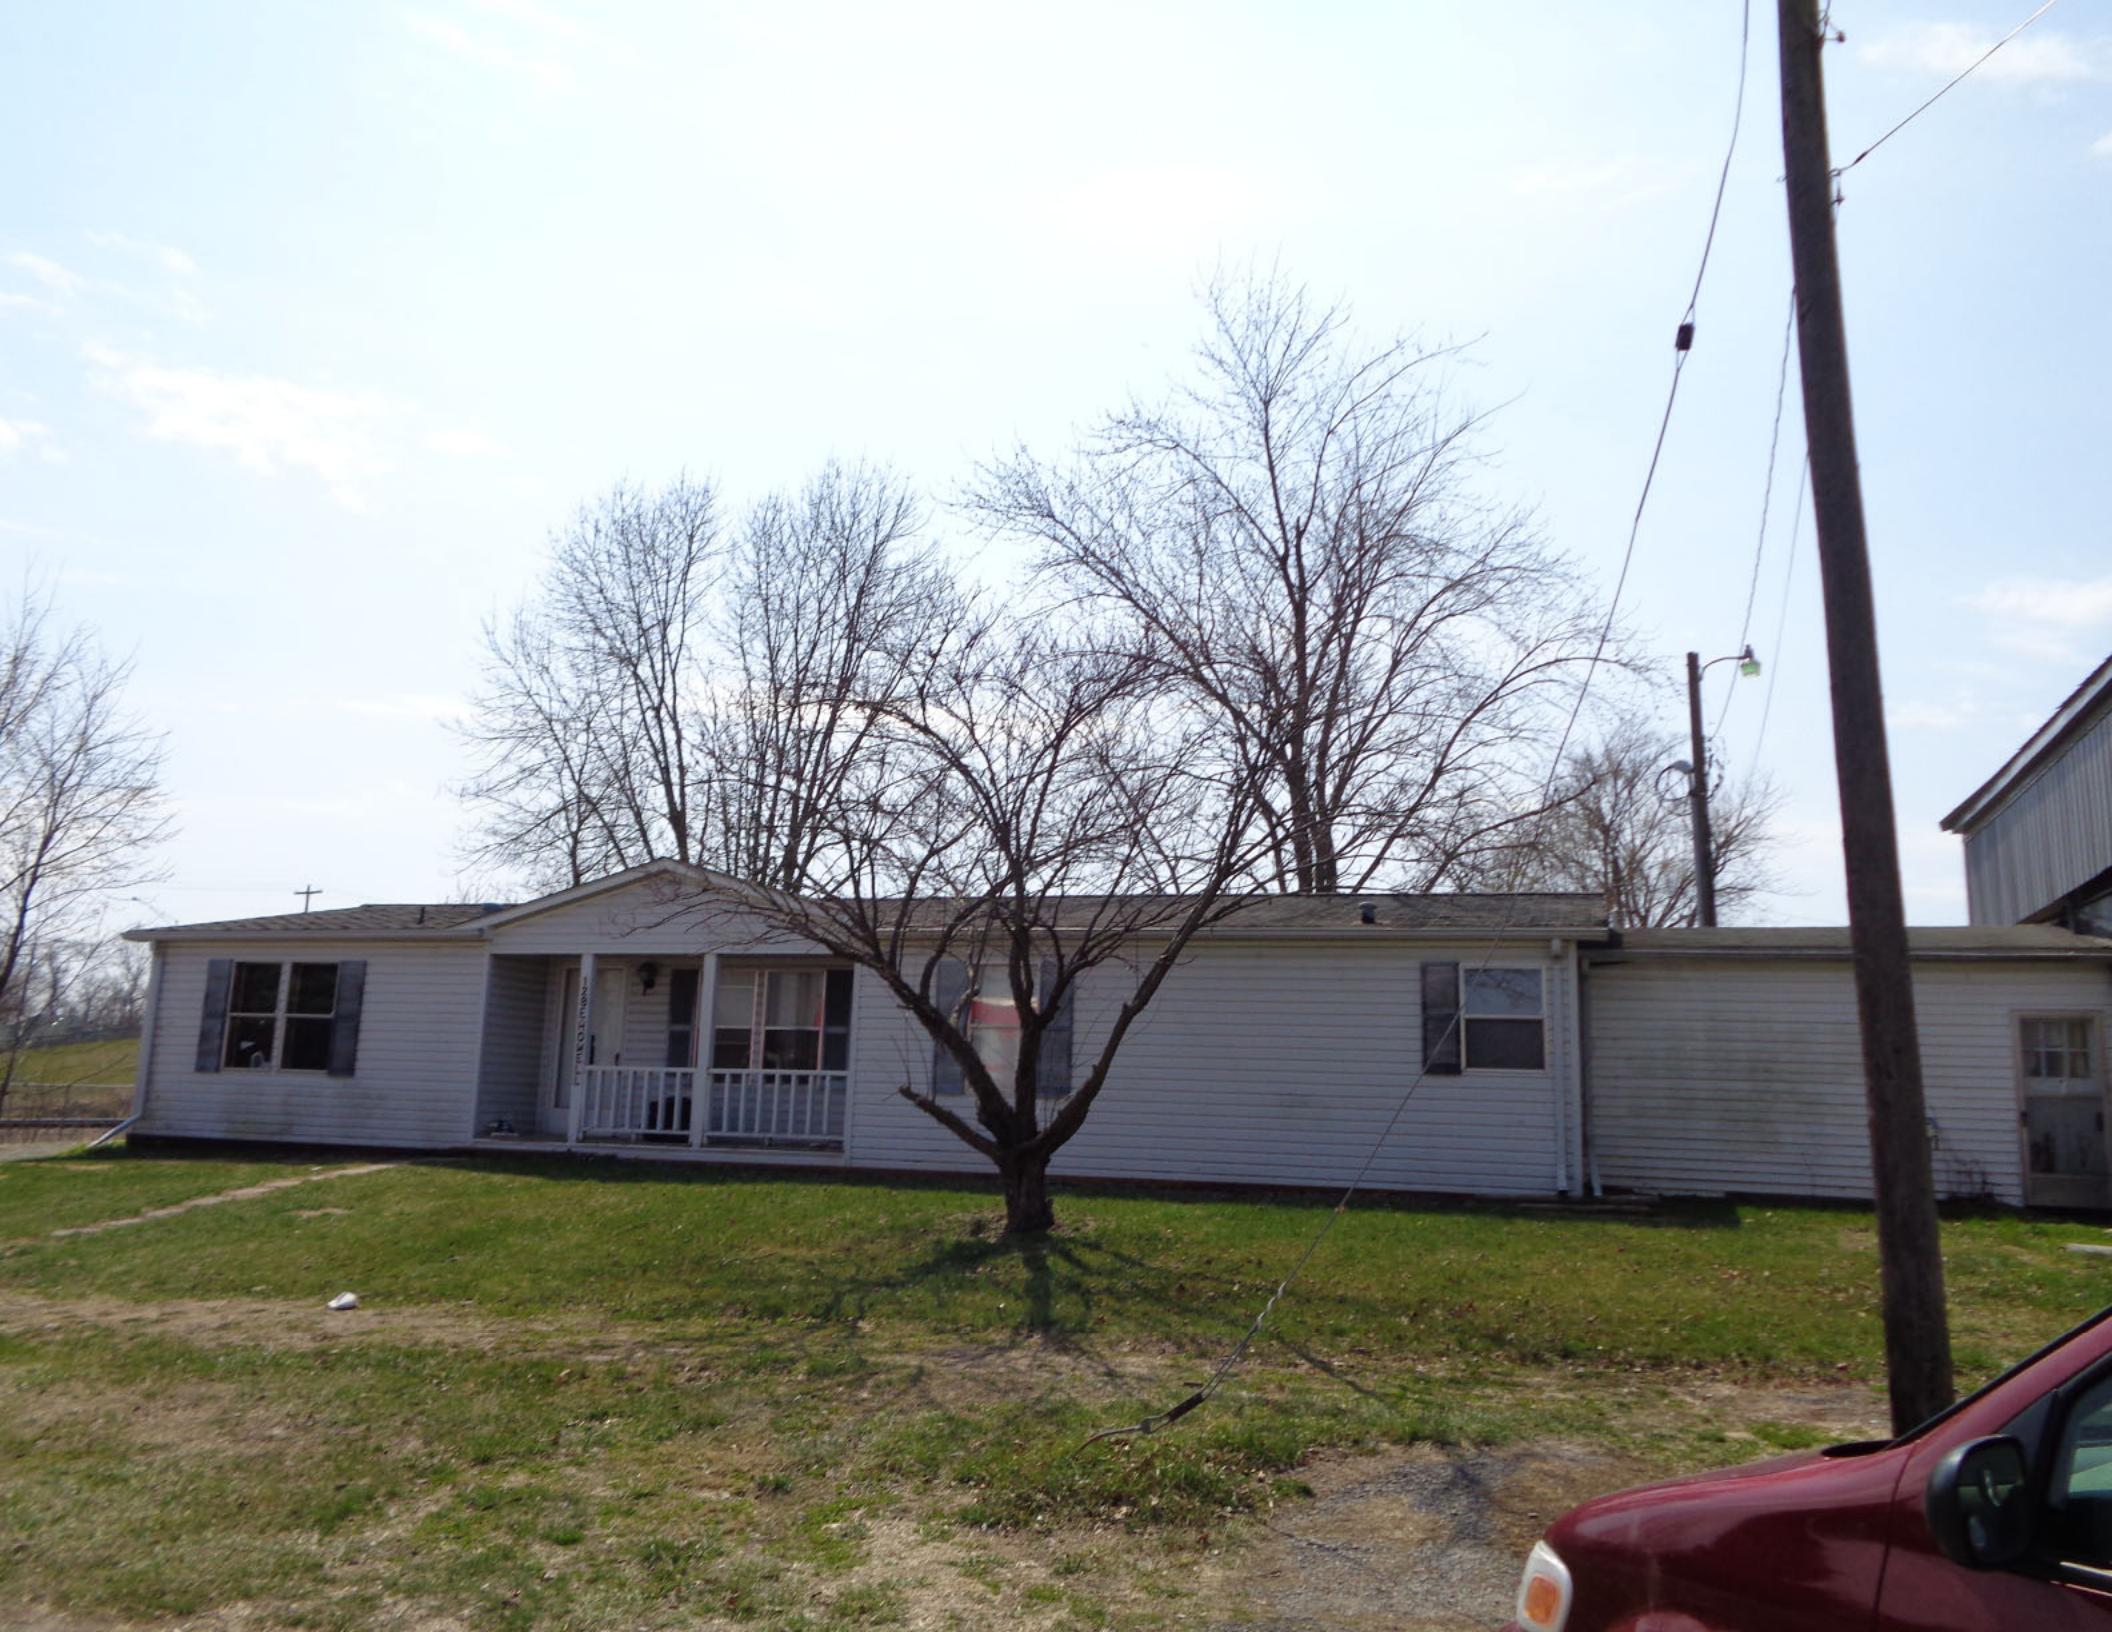
This is a single story building. Starting from the east there are a pair of one-over-one windows that are surrounded by synthetic shutters. The next two bays are located under the recessed porch. The next bay is a single door. Moving east there are a pair of one-over-one windows again with shutters. Moving east and out from under the porch there is a single one-over-one synthetic shutters. Further east has a small single window with one shutter. The final bay is the connection to the building located at 126 East Howell (LI-AS-001-30). There is a single door in this bay.

The porch is recessed under a small front gable, there is a railing with square supports.

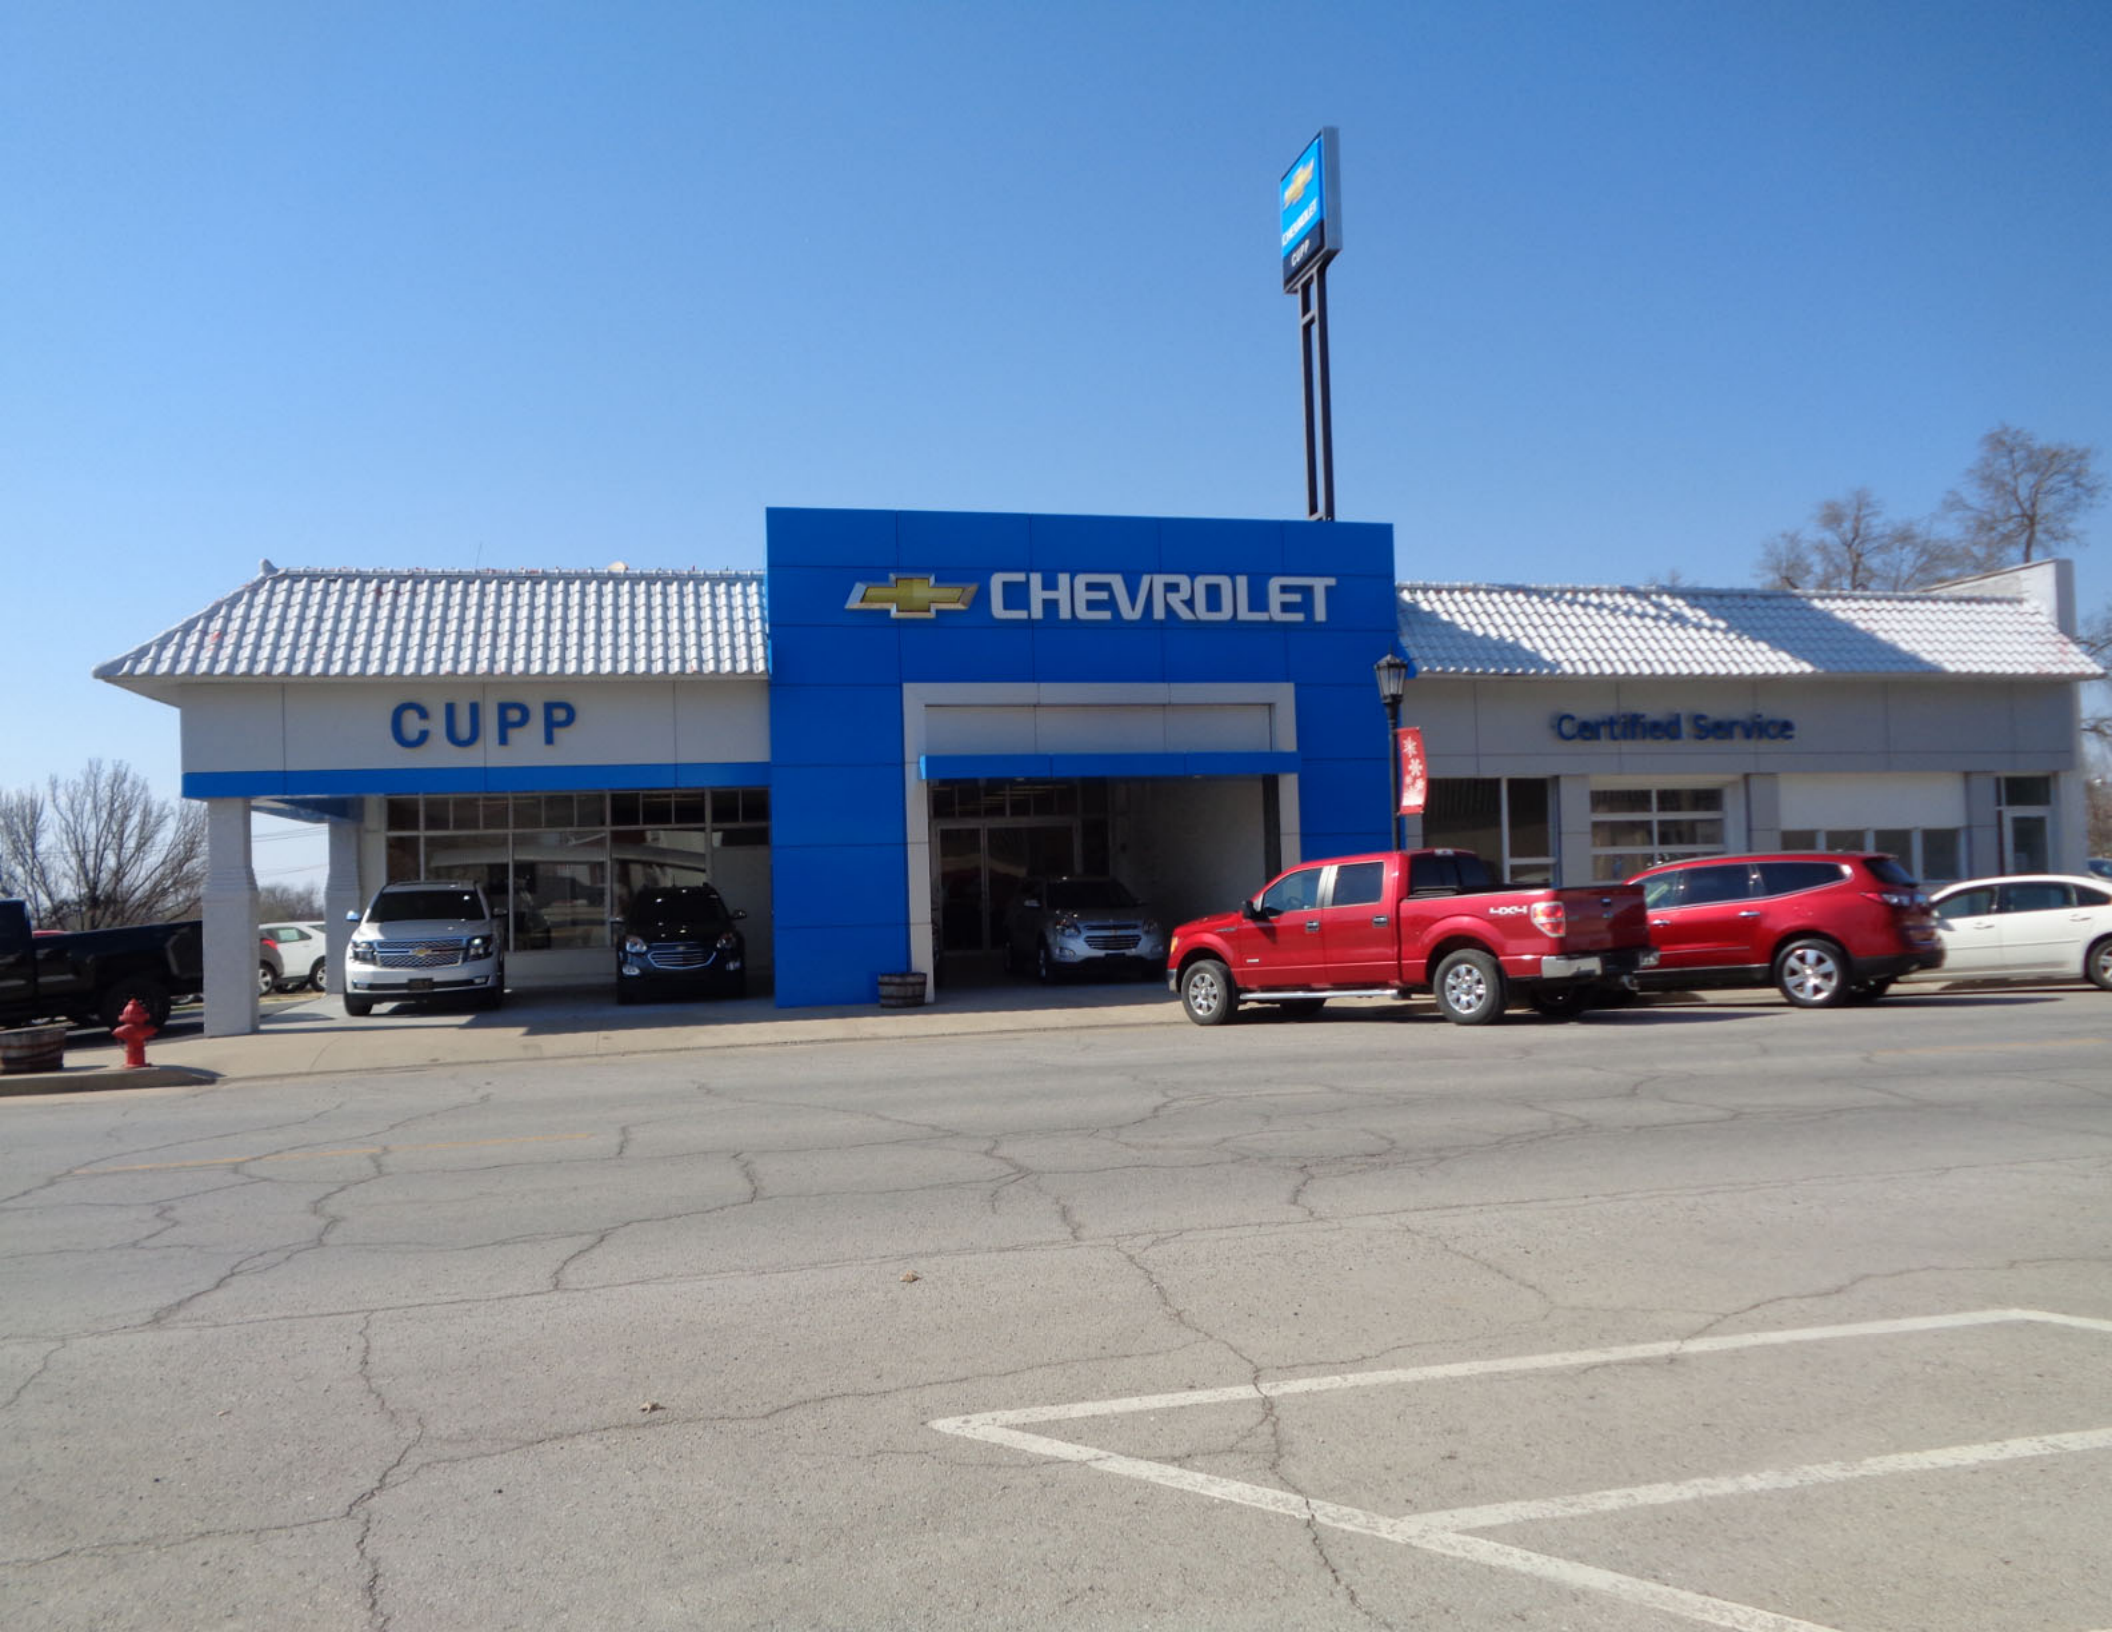
This is a one story building that has been used as a car dealership and auto repair. This building was altered recently to make this building keep with the "Chevrolet" branding. This building has an awning on the south side; the historic display windows are located under the awning. The windows have large panes on the lower level and three smaller panes on the top. The center bay has a metal panels that surround. Moving north the next bay has a divided window, moving north the next bay is a glass garage door. The next bay to the north is infilled there are four small fixed windows, the final bay is a single pedestrian door that is surrounded with fixed windows. Across the facade there is a false tile roof that has been painted gray.

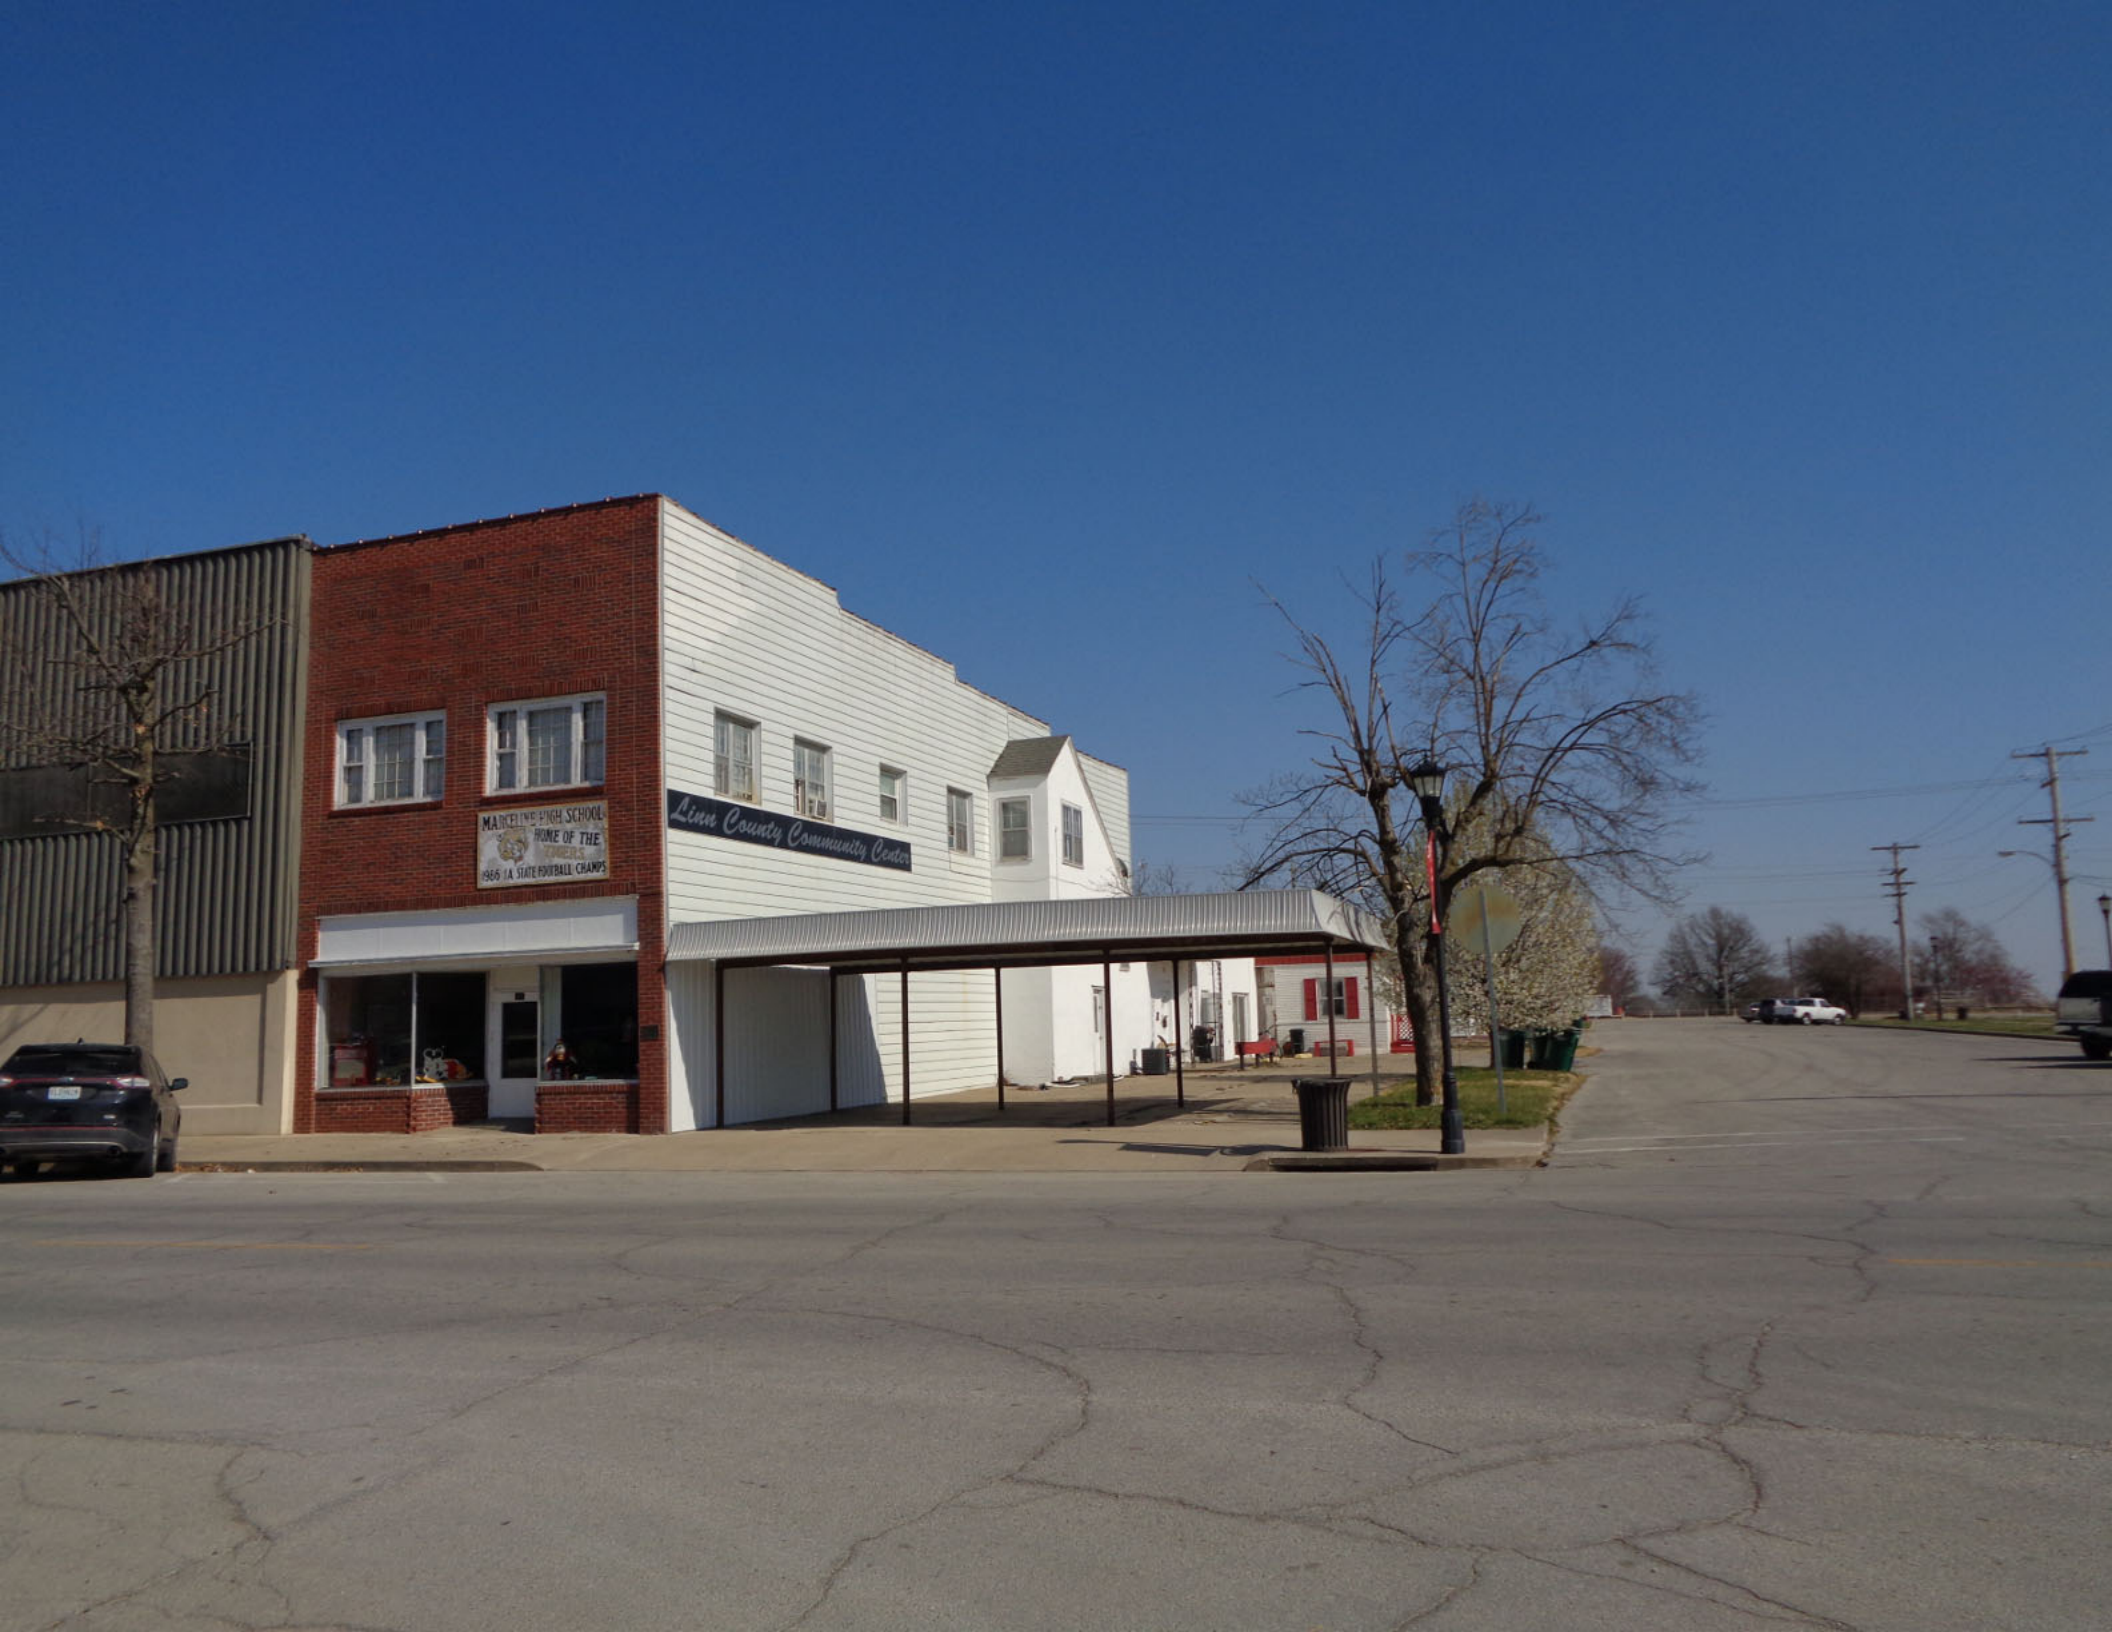
This is a two story building with a brick facade. There are three bays on the first floor. There is a recessed central entrance with a single wood door with a large window, between two large fixed storefront windows with brick knee walls. The area above the storefront has been infilled. The upper level, has two symmetrically placed window groups. Each window group has two four-over-four windows with a large multi-pane window in the center. The south of this building is open and is sided in vinyl. There is a projecting stairwell and there is also an projecting small brick addition to the south. This addition is used as the "chili shack" and has a metal shed roof and appears highly altered because it has concrete block.

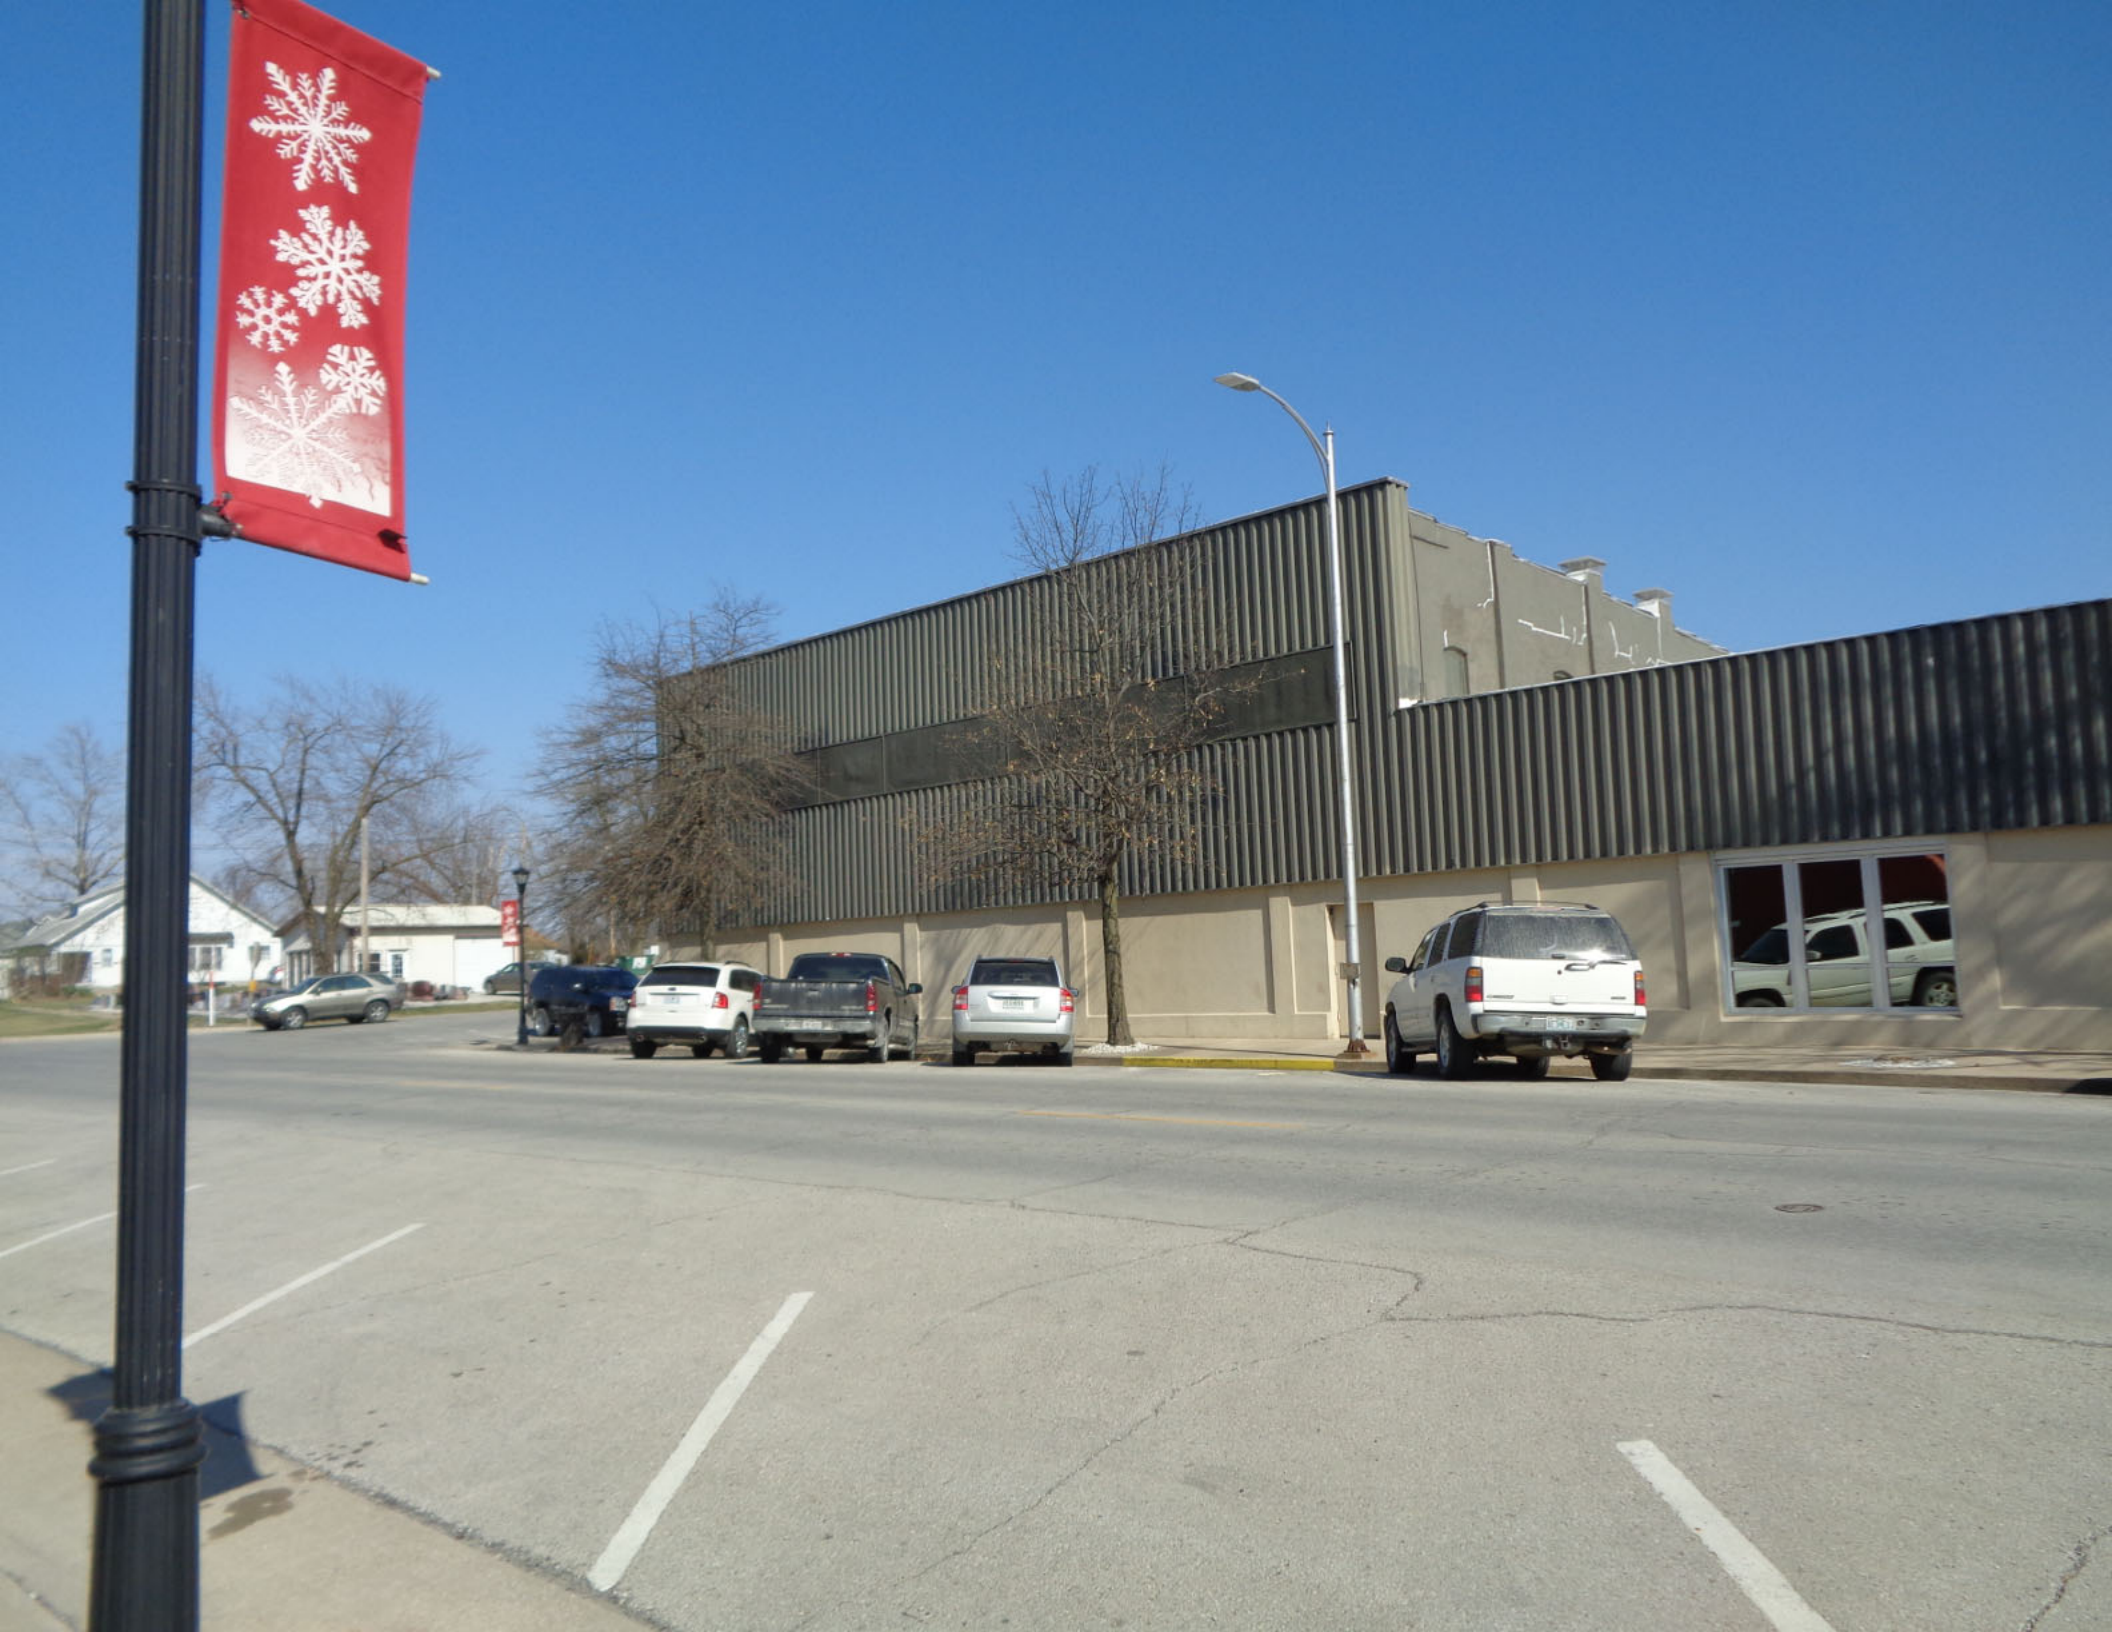
This is a large building that occupies the majority of the block. The first floor is covered in stucco the upper level is covered in metal siding. Starting from the north the first four bays are identical, on the first level they are blank stucco walls on the first floor and metal covering the upper level. Each bay is divided by a narrow pilaster. The fifth bay has a single metal door. The sixth bay has a three metal fixed windows with small panes on the bottom with larger panes above. The seventh bay is blank, with a small fire connection in the stucco wall and metal above. The eighth bay has five metal fixed windows with small panes on the bottom and larger panes above. The ninth bay has three similar windows. The tenth bay has a rock wall with a narrow entrance and a small awning above. The eleventh bay has three fixed metal windows that are similar to the other windows on this building. The twelfth and thirteenth bays are identical each of the lower bays is blank with stucco on the bottom and metal above. The final fourteenth bay has a single metal pedestrian door, the remainder of the bay is blank with stucco on the lower level and metal above.
