MISSOURI DEPARTMENT OF NATURAL RESOURCES  
STATE HISTORIC PRESERVATION OFFICE, P.O. Box 176, Jefferson City, MO 65102  
**ARCHITECTURAL/HISTORIC INVENTORY FORM**

1. SURVEY NO. LI-AS-001-001		2. SURVEY NAME: Marceline Survey	
3. COUNTY: Linn		4. ADDRESS (STREET NO.) 275	STREET (NAME) West Broadway
5. CITY: Marceline	VICINITY: <input type="checkbox"/>	6. UTM: / /	7. TOWNSHIP/RANGE/SECTION: T: R: S:

8. HISTORIC NAME (IF KNOWN): Walt Disney's Childhood Home		9. PRESENT/OTHER NAME (IF KNOWN): Walt Disney's Childhood Home	
10. OWNERSHIP: <input checked="" type="checkbox"/> PRIVATE <input type="checkbox"/> PUBLIC		11A. HISTORIC USE (IF KNOWN): Single Dwelling	11B. CURRENT USE: Single Dwelling
<b>HISTORICAL INFORMATION</b>

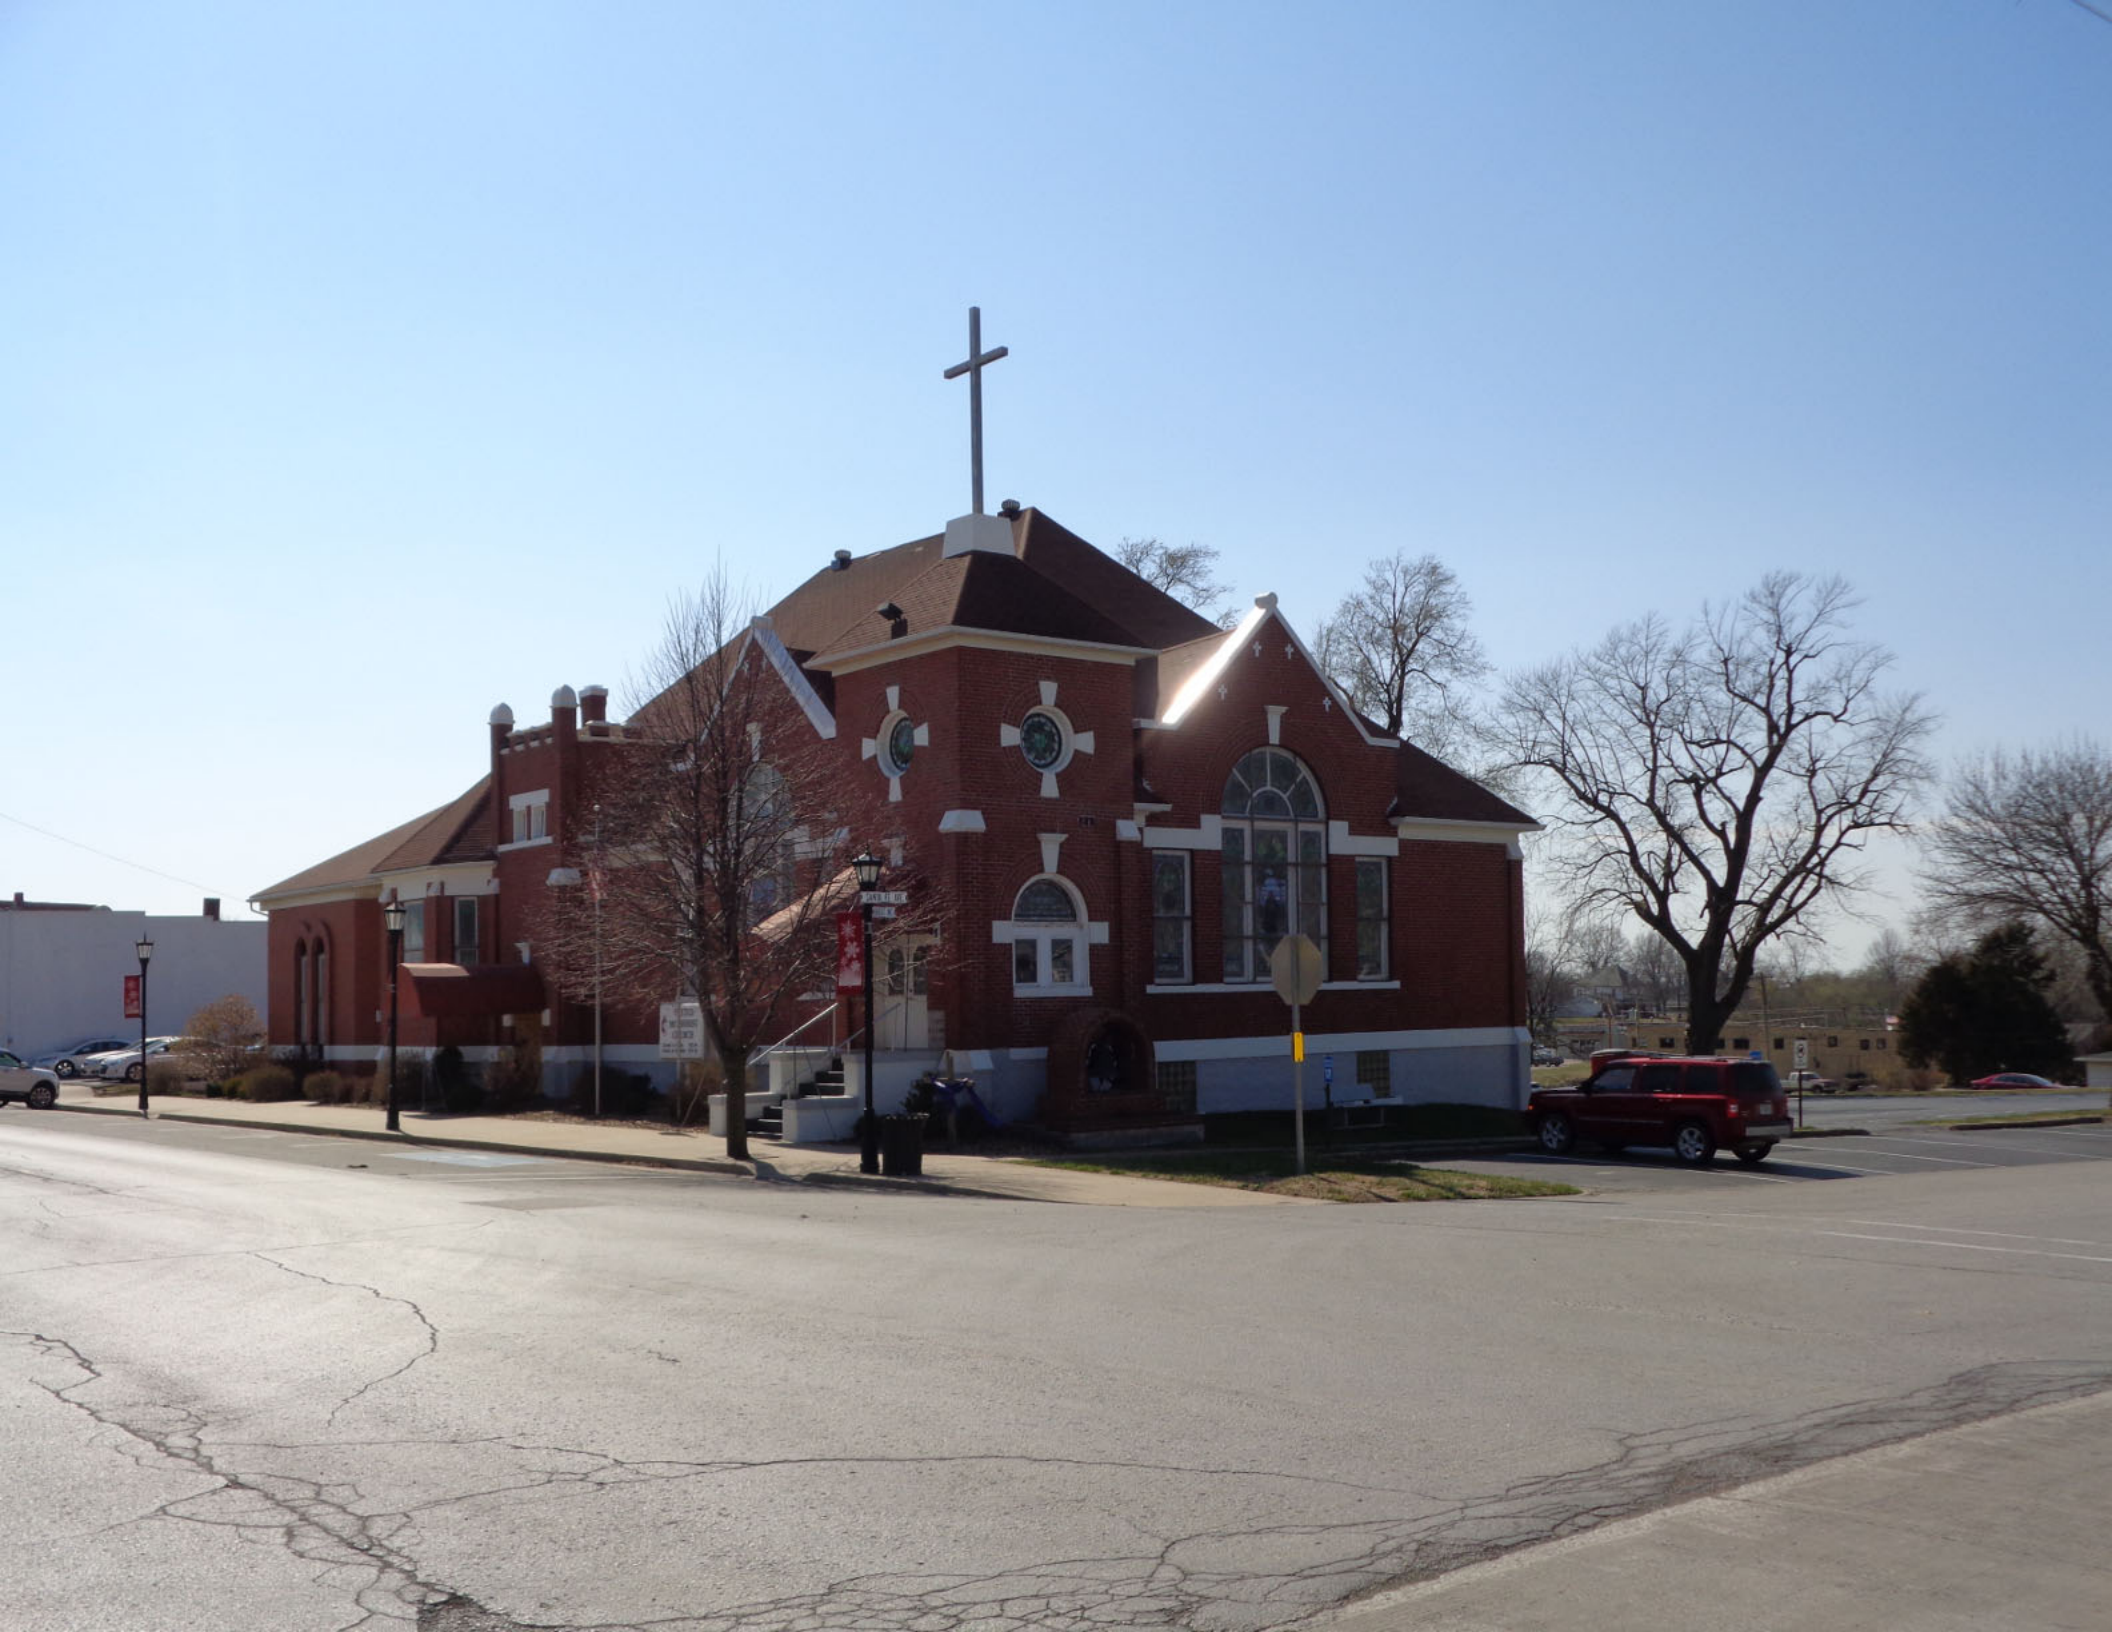
The church has an addition on the south end that mimics the main building but is clearly an addition.

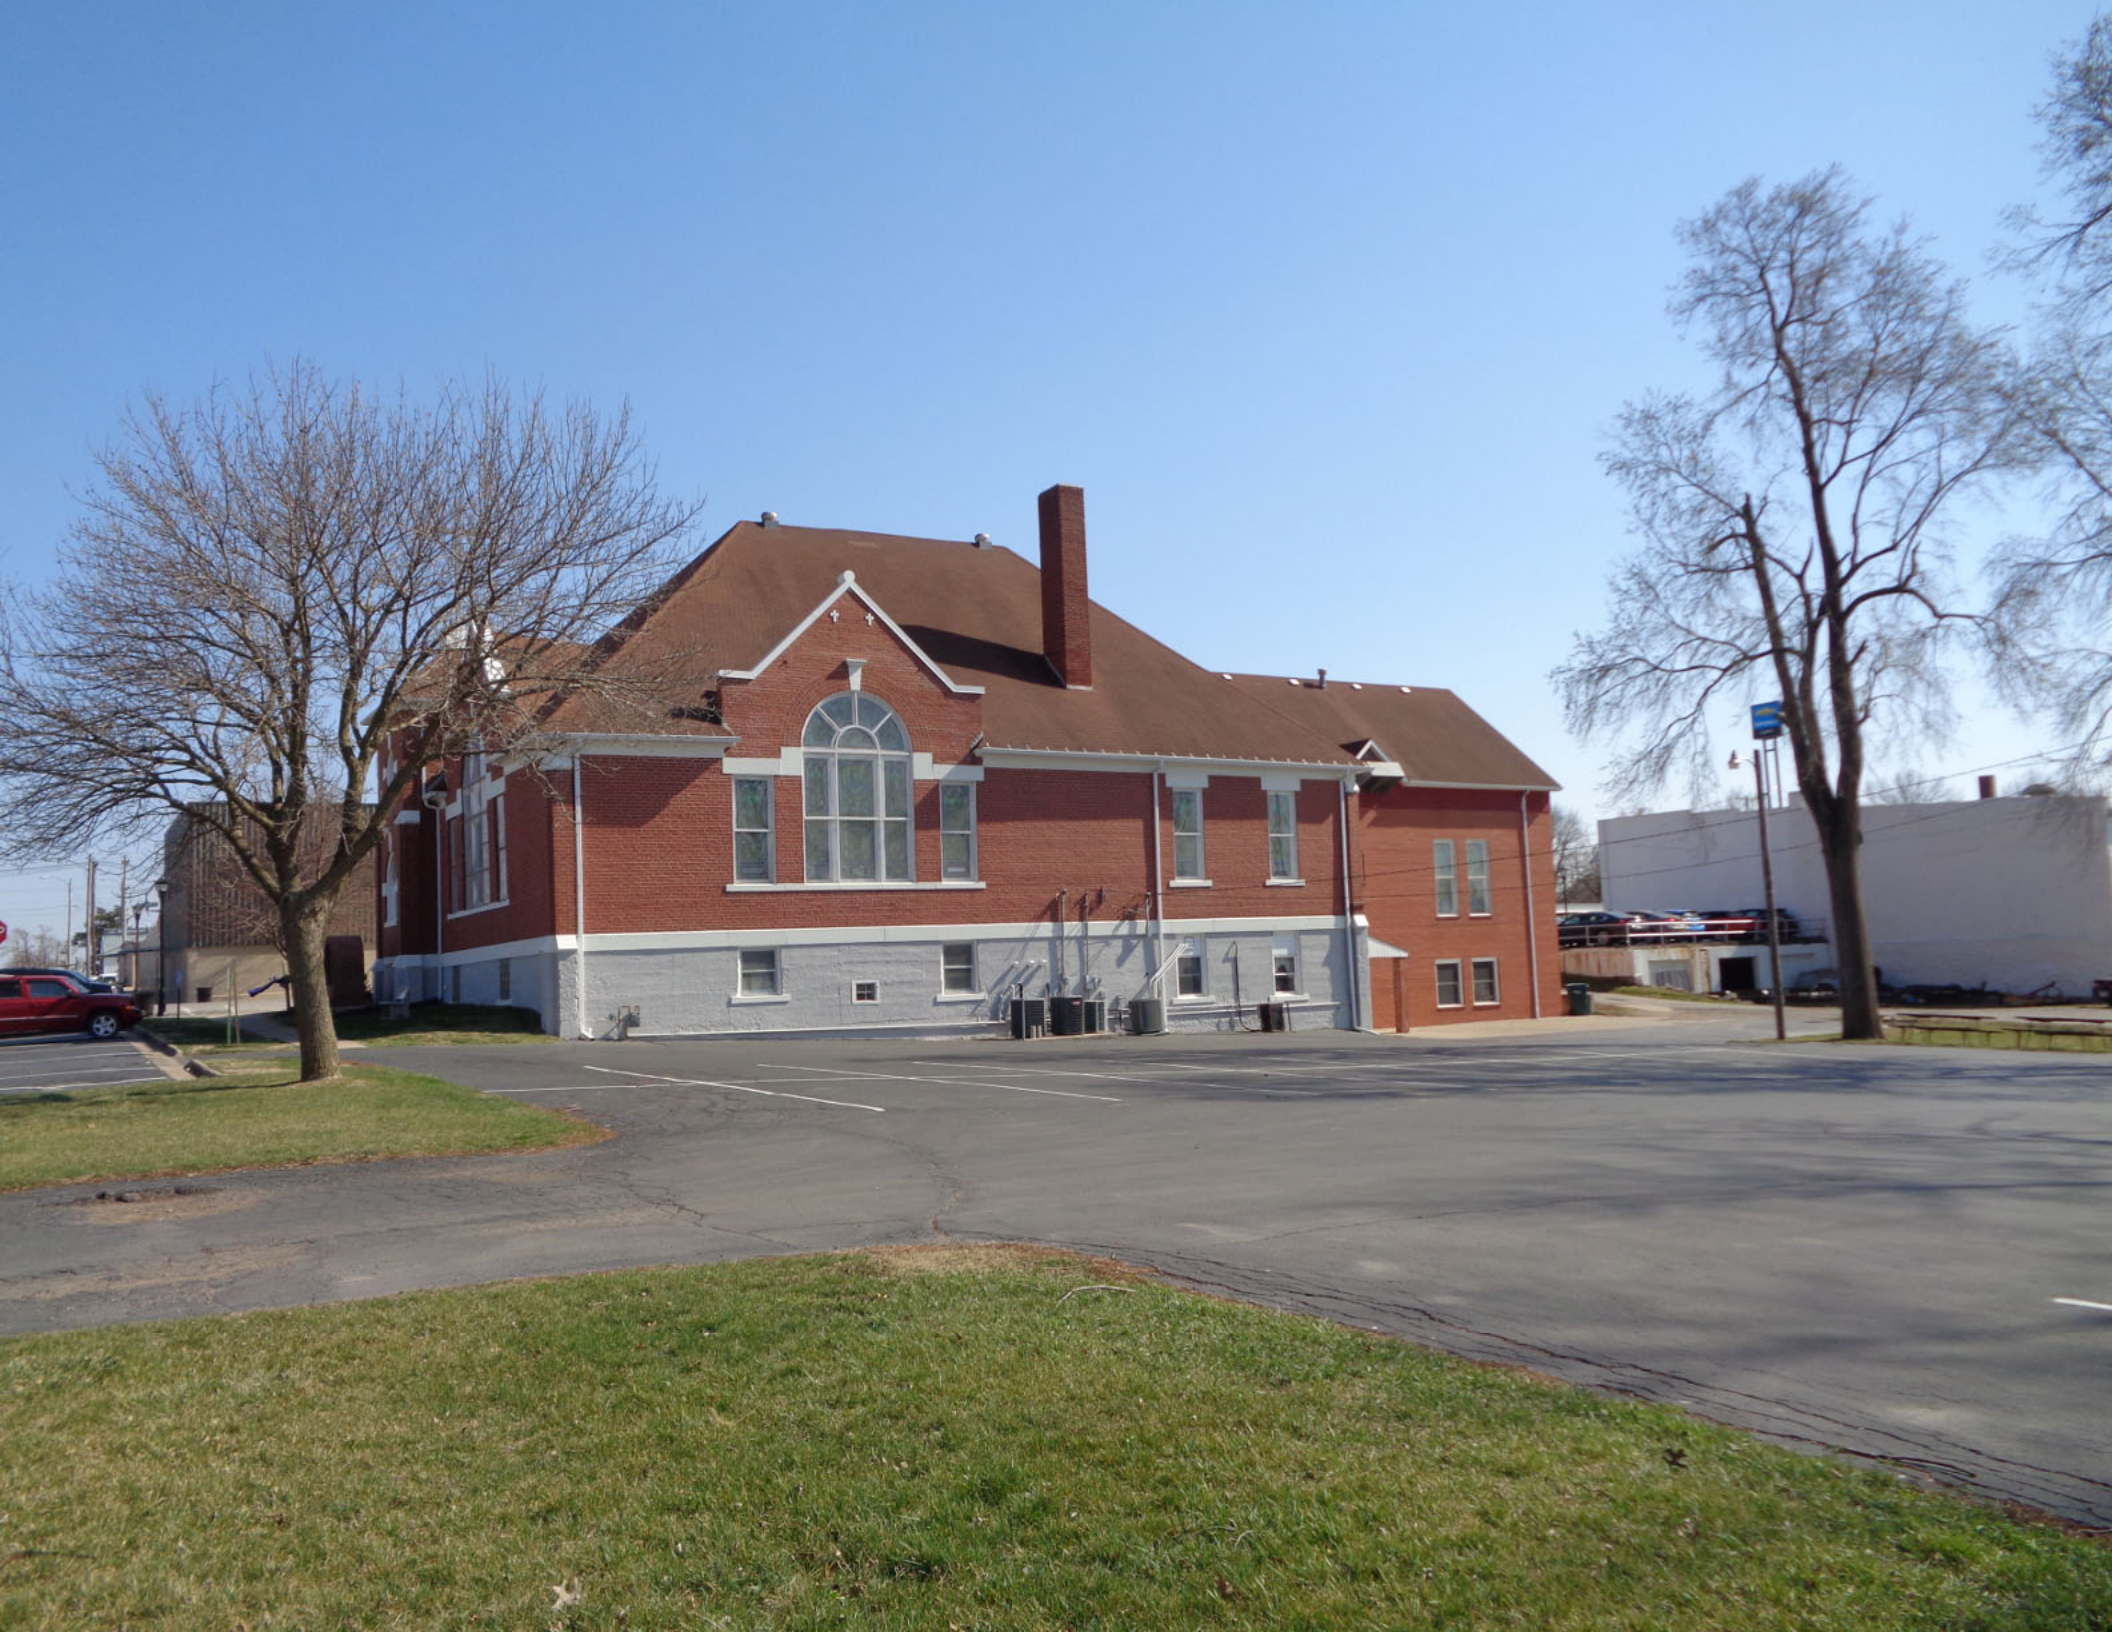
The primary facade of the church faces north toward Santa Fe Avenue. The church has a side steeple arrangement, the steeple is situated on the eastern part of the facade. There is a small arched window with a two small windows below. All windows described are fixed and have stained glass unless otherwise noted. The arched window has a keystone above. Above the first window is a rose window that has a starburst stone pattern surrounding it. The square steeple is topped with a pyramidal roof a tall metal cross rises from this roof. Moving east there is a large arched window that is made up of three large panes and an arched element above that. There are two single pane stained glass windows on either side of the main window. The window has a keystone above with four small crosses above this in the gable end. The third bay is blank and devoid of decoration.

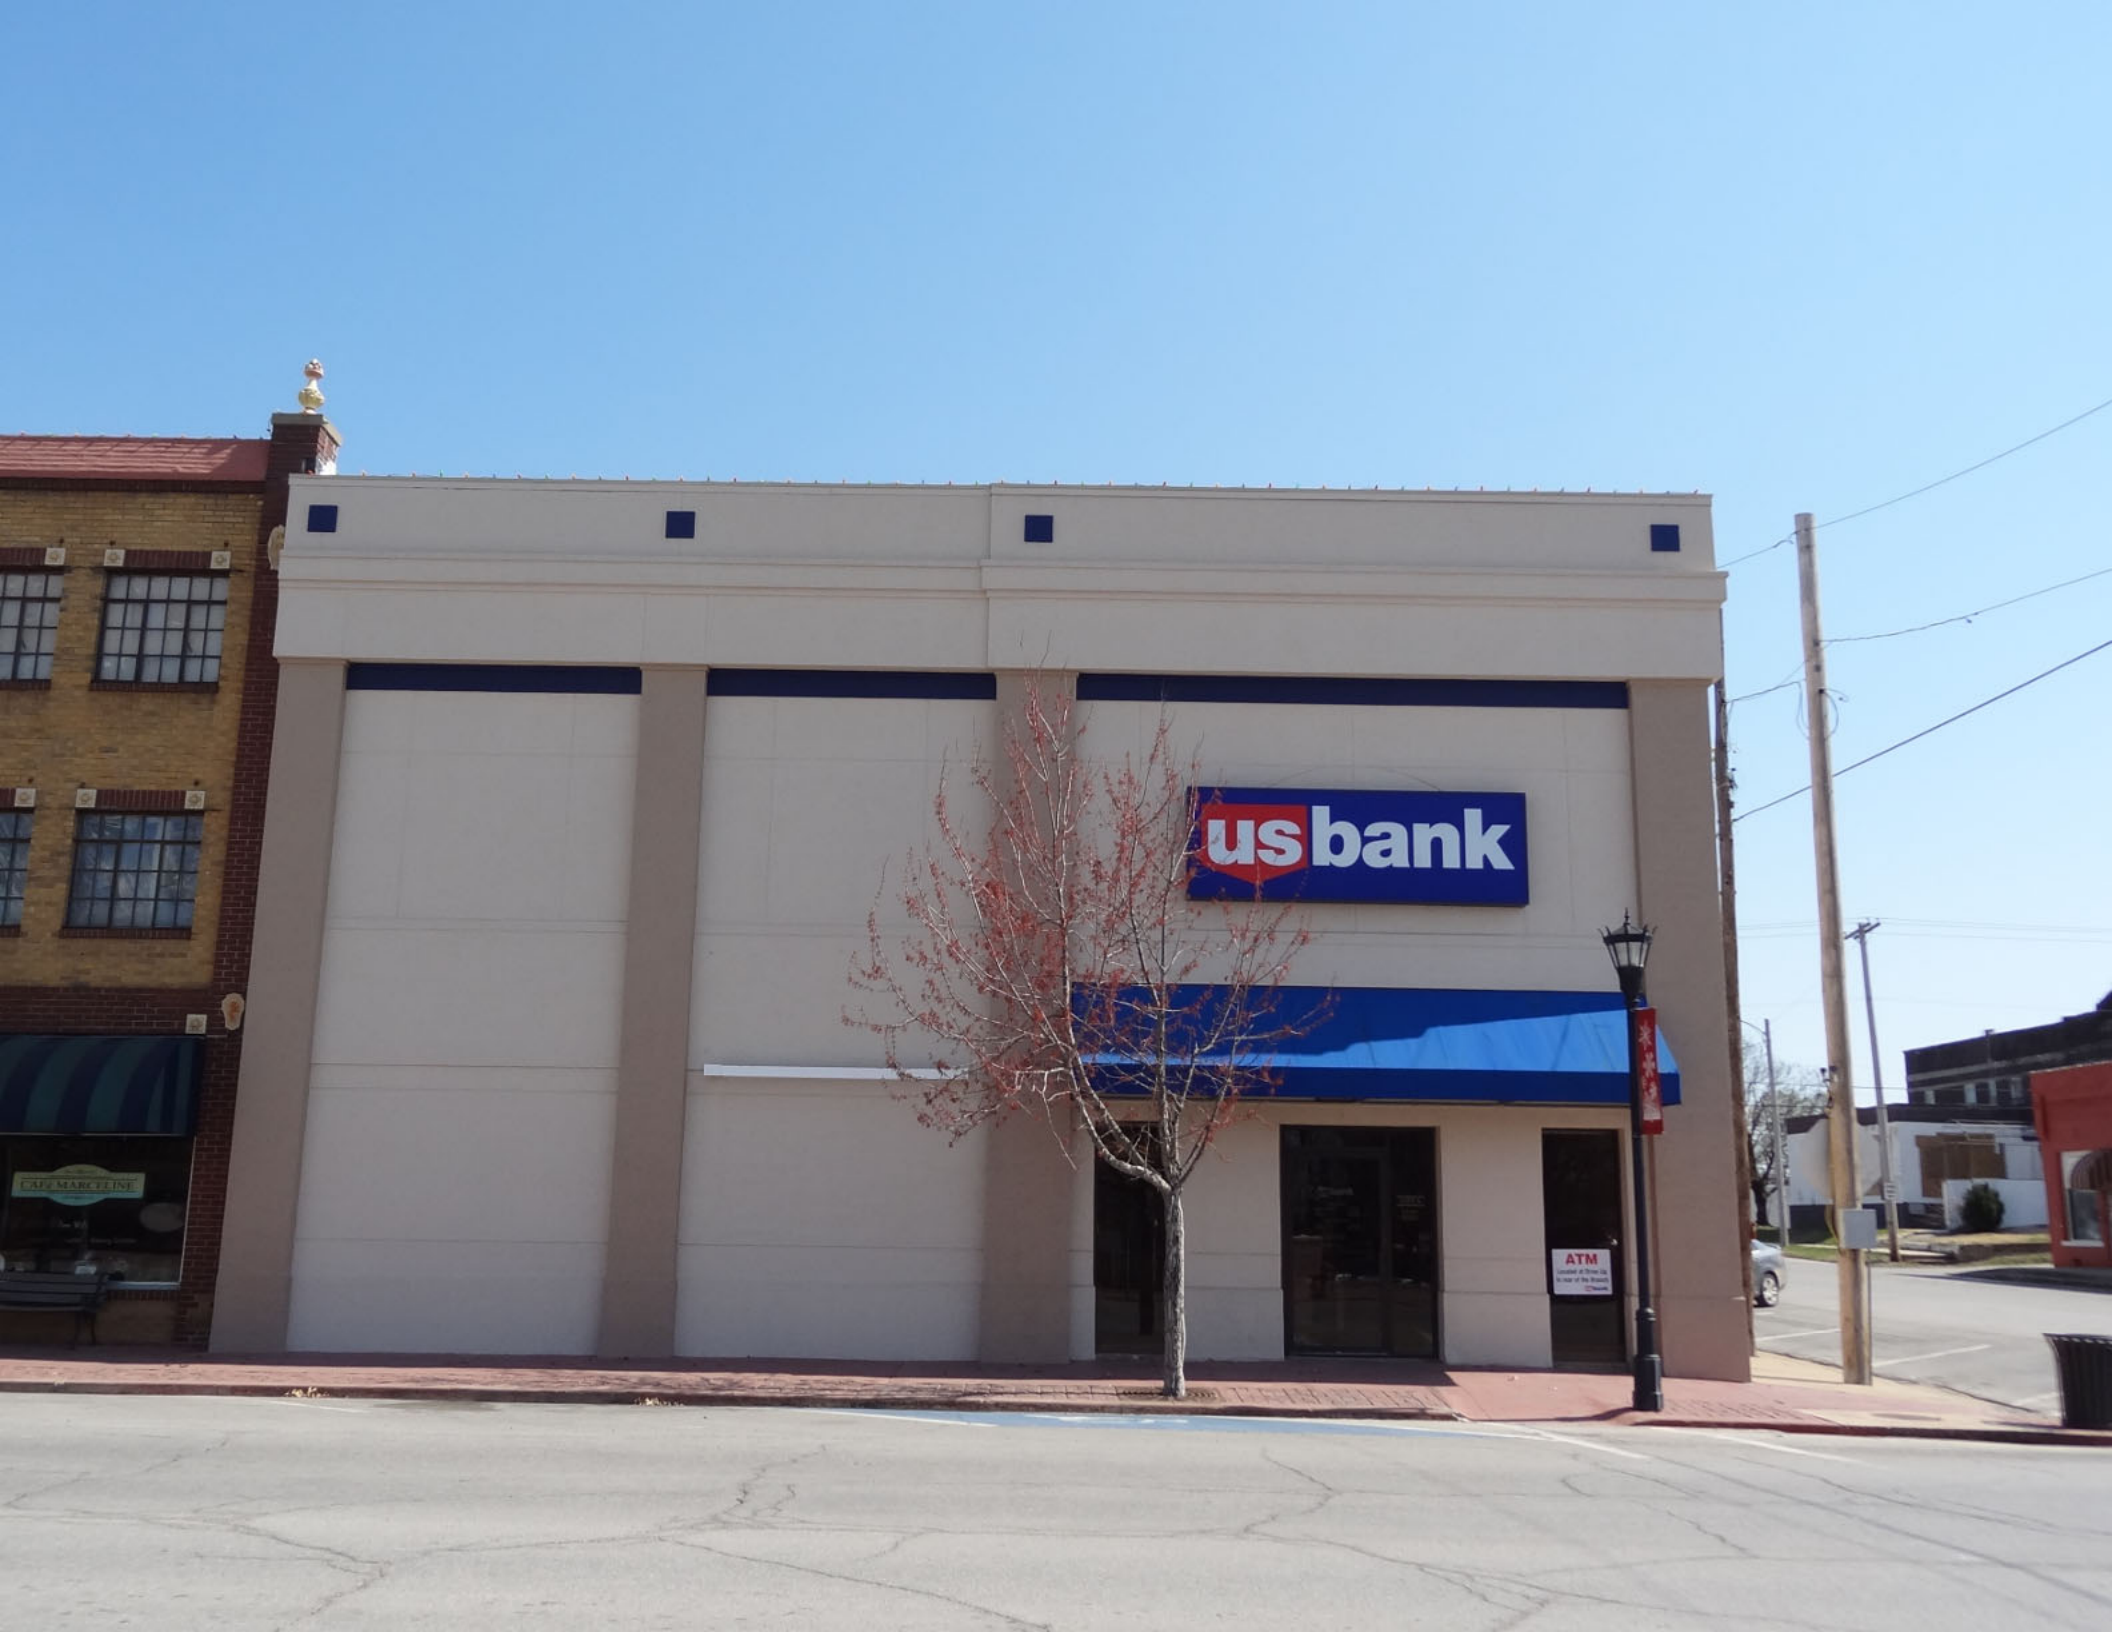
This two-part commercial block building has been dramatically altered, some time after 1963, with its entire facade and southern elevation covered in what looks like dryvit. Its face is divided into three sections by four simple pilasters. These stop well below the roof line; above the pilasters the building very generally mimics a classical entablature. It has minimal detailing; just below the roofline are four squares situated in line with the pilasters below. Between the first and second and second and third of the pilasters is a plain wall with stucco paneling. The third section is slightly wider and has three openings. The central opening is a single non-historic glass commercial door with a single paned sidelight to its south. The other two openings are windows with a single pane the same height as the door. Over these openings is a blue awning, above which is the sign for US Bank.

The south elevation, which faces Howell Avenue is similar to the front with pilasters in line with the simple decorative squares situated below the roof line. There is a single door on the east end of this elevation followed by a single story portion of the building that also houses a single door and a drive through that has been added to the building's rear. Above the drive through on the rear of the building the original brick, painted white, is visible.

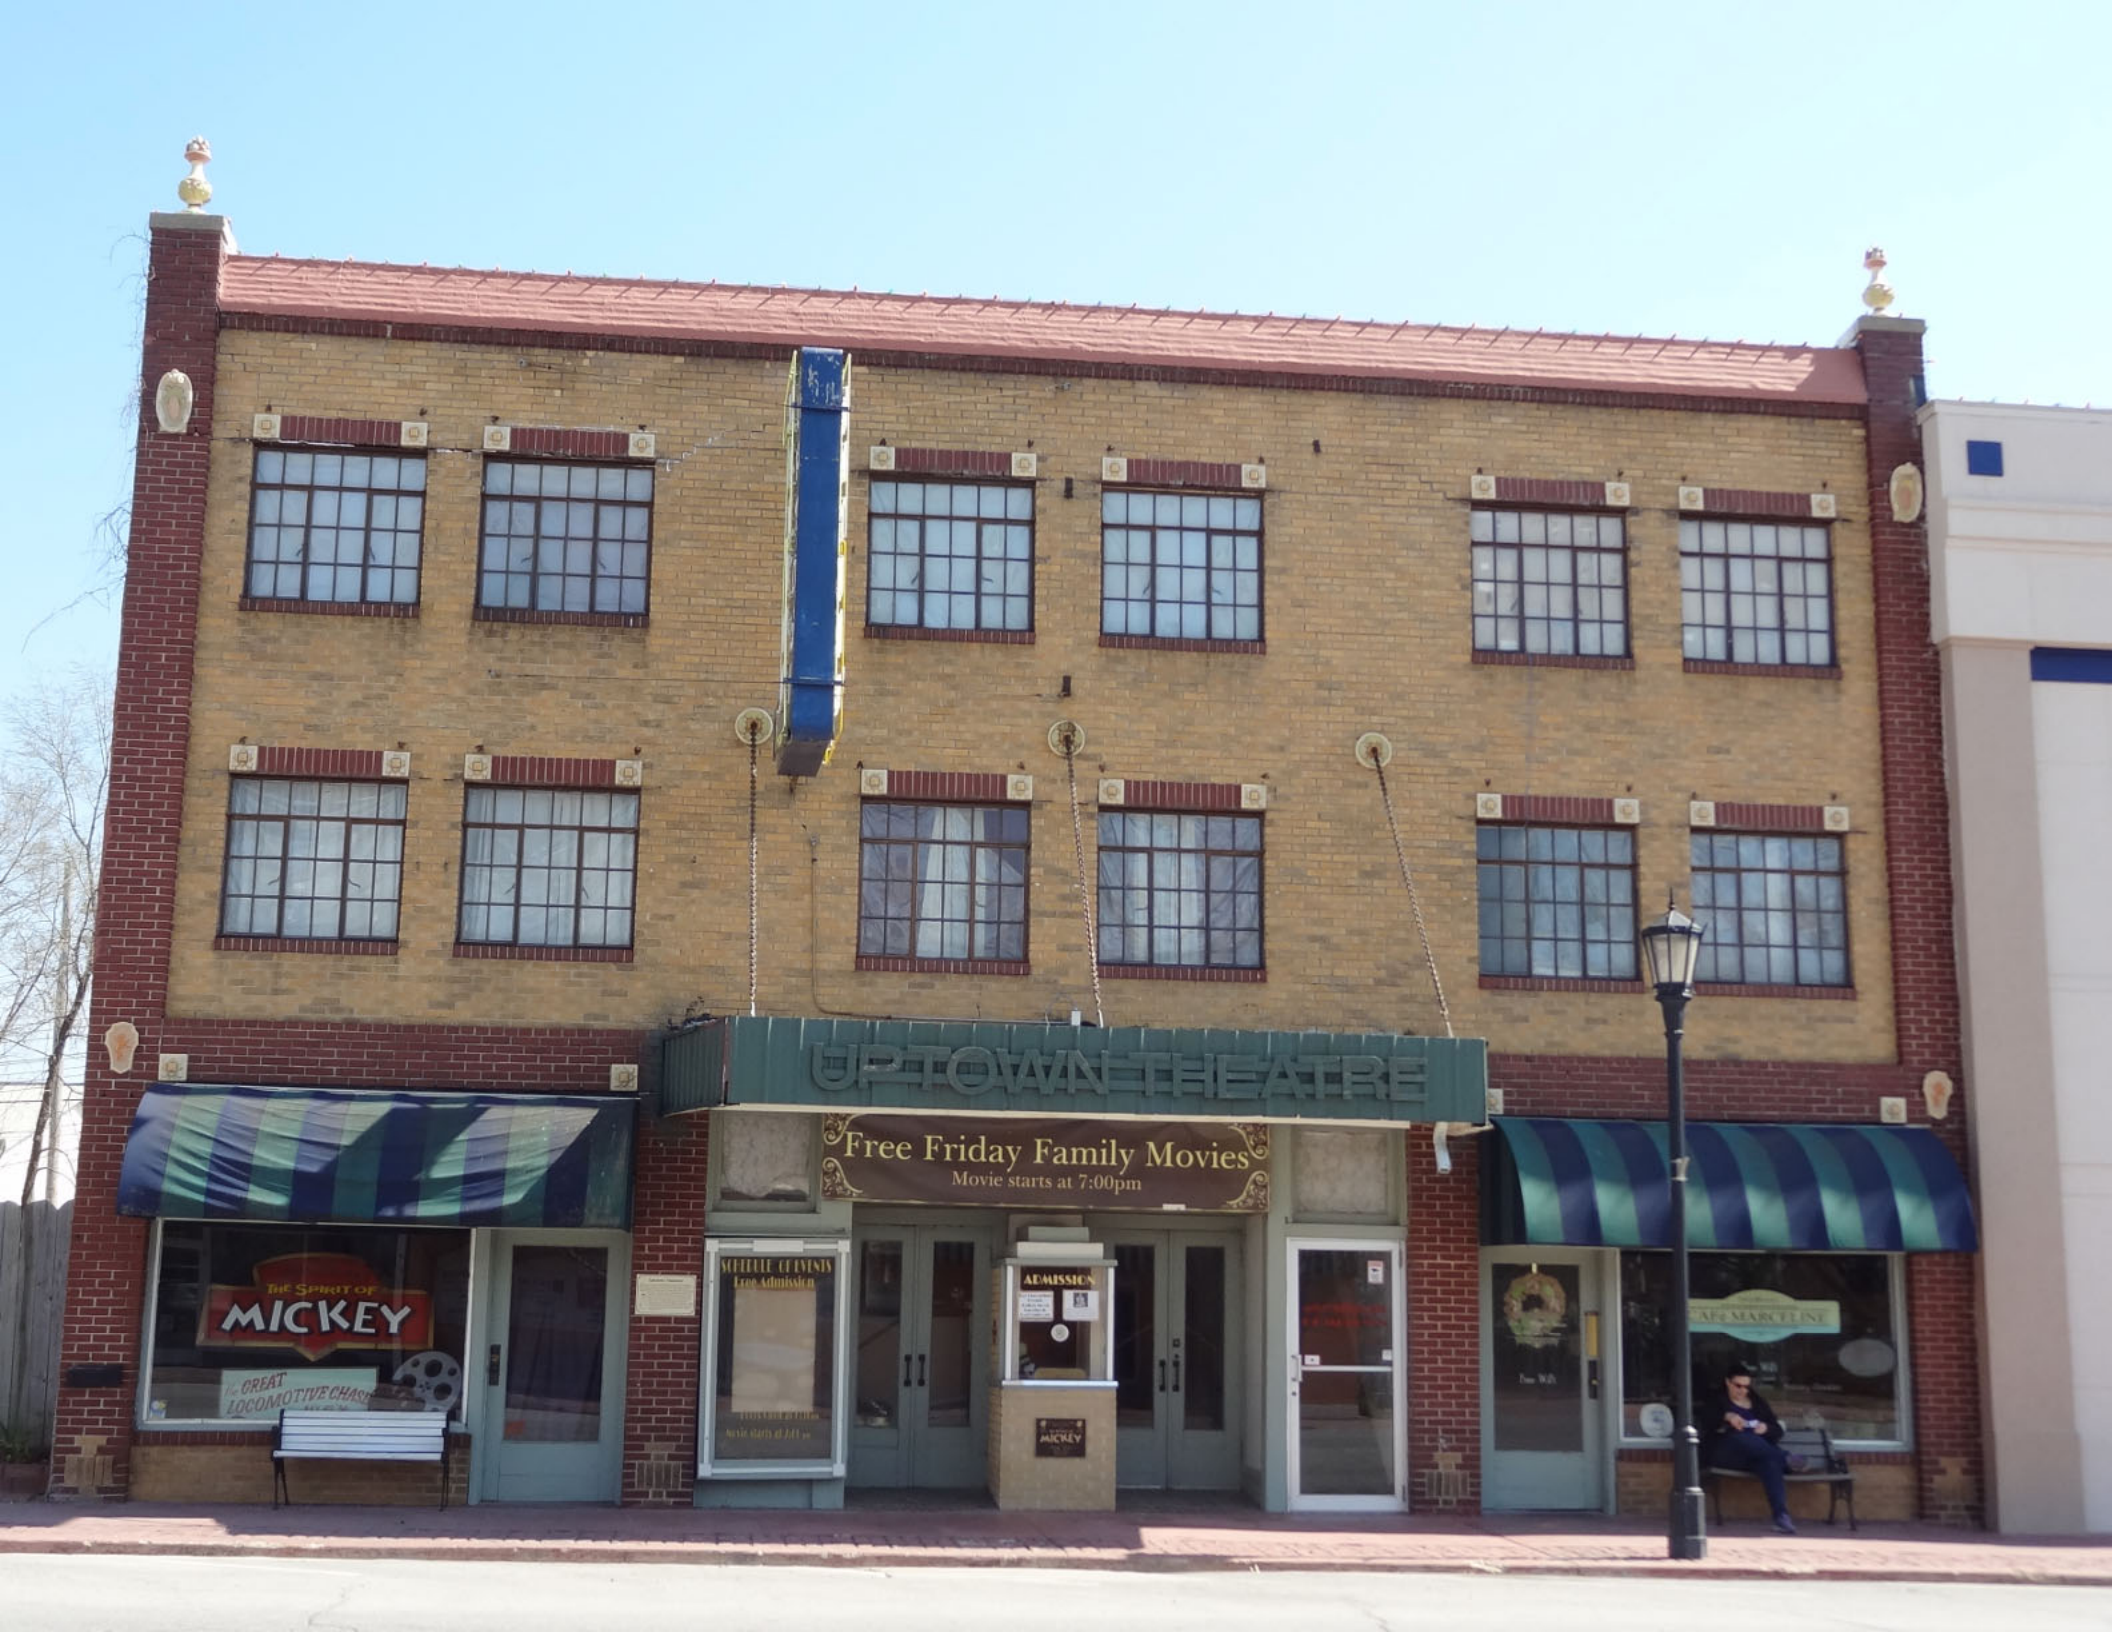
This is a 3 story building in brick running bond. At the north end there is a large storefront window followed by a single historic door. A centered metal canopy held up by 3 metal chains reads "Uptown Theatre" and shelters the theater's ticket box and 2 pairs of narrow historic double doors, one pair on each side of the box. There is then a single non-historic door followed by another single historic door and large storefront window for Cafe Marceline. A cloth canopy shelters both storefronts at either end of the building. Red brick pilasters divide the storefronts and mark each end of the building's face; beige brick geometric detailing is at the bottom of the pilasters. Beige brick is also visible under the storefront windows. The 1st floor is divided from the upper stories by red brick; only the red brick pilasters at each end of building continue to the roof, topped with urns. The rest of the upper stories are beige brick except for the rowlock brick window sills and flat lintels which are red. Rowlock brick is also visible under the roofline and the storefront windows. The 12 metal upper story windows, arranged symmetrically, appear original with 24 panes each. At the corners of the window lintels and the storefront canopies are beige blocks with floral detailing. Detailing in the form of a lion standing on its hind legs is on the brick at each end of the building dividing the 1st from the upper stories. The flat roof, which appears stuccoed, slants slightly between the 2 end pilasters. A sign extends out from the upper story reading "Uptown". The N elevation is stuccoed and houses 5 nonhistoric windows.

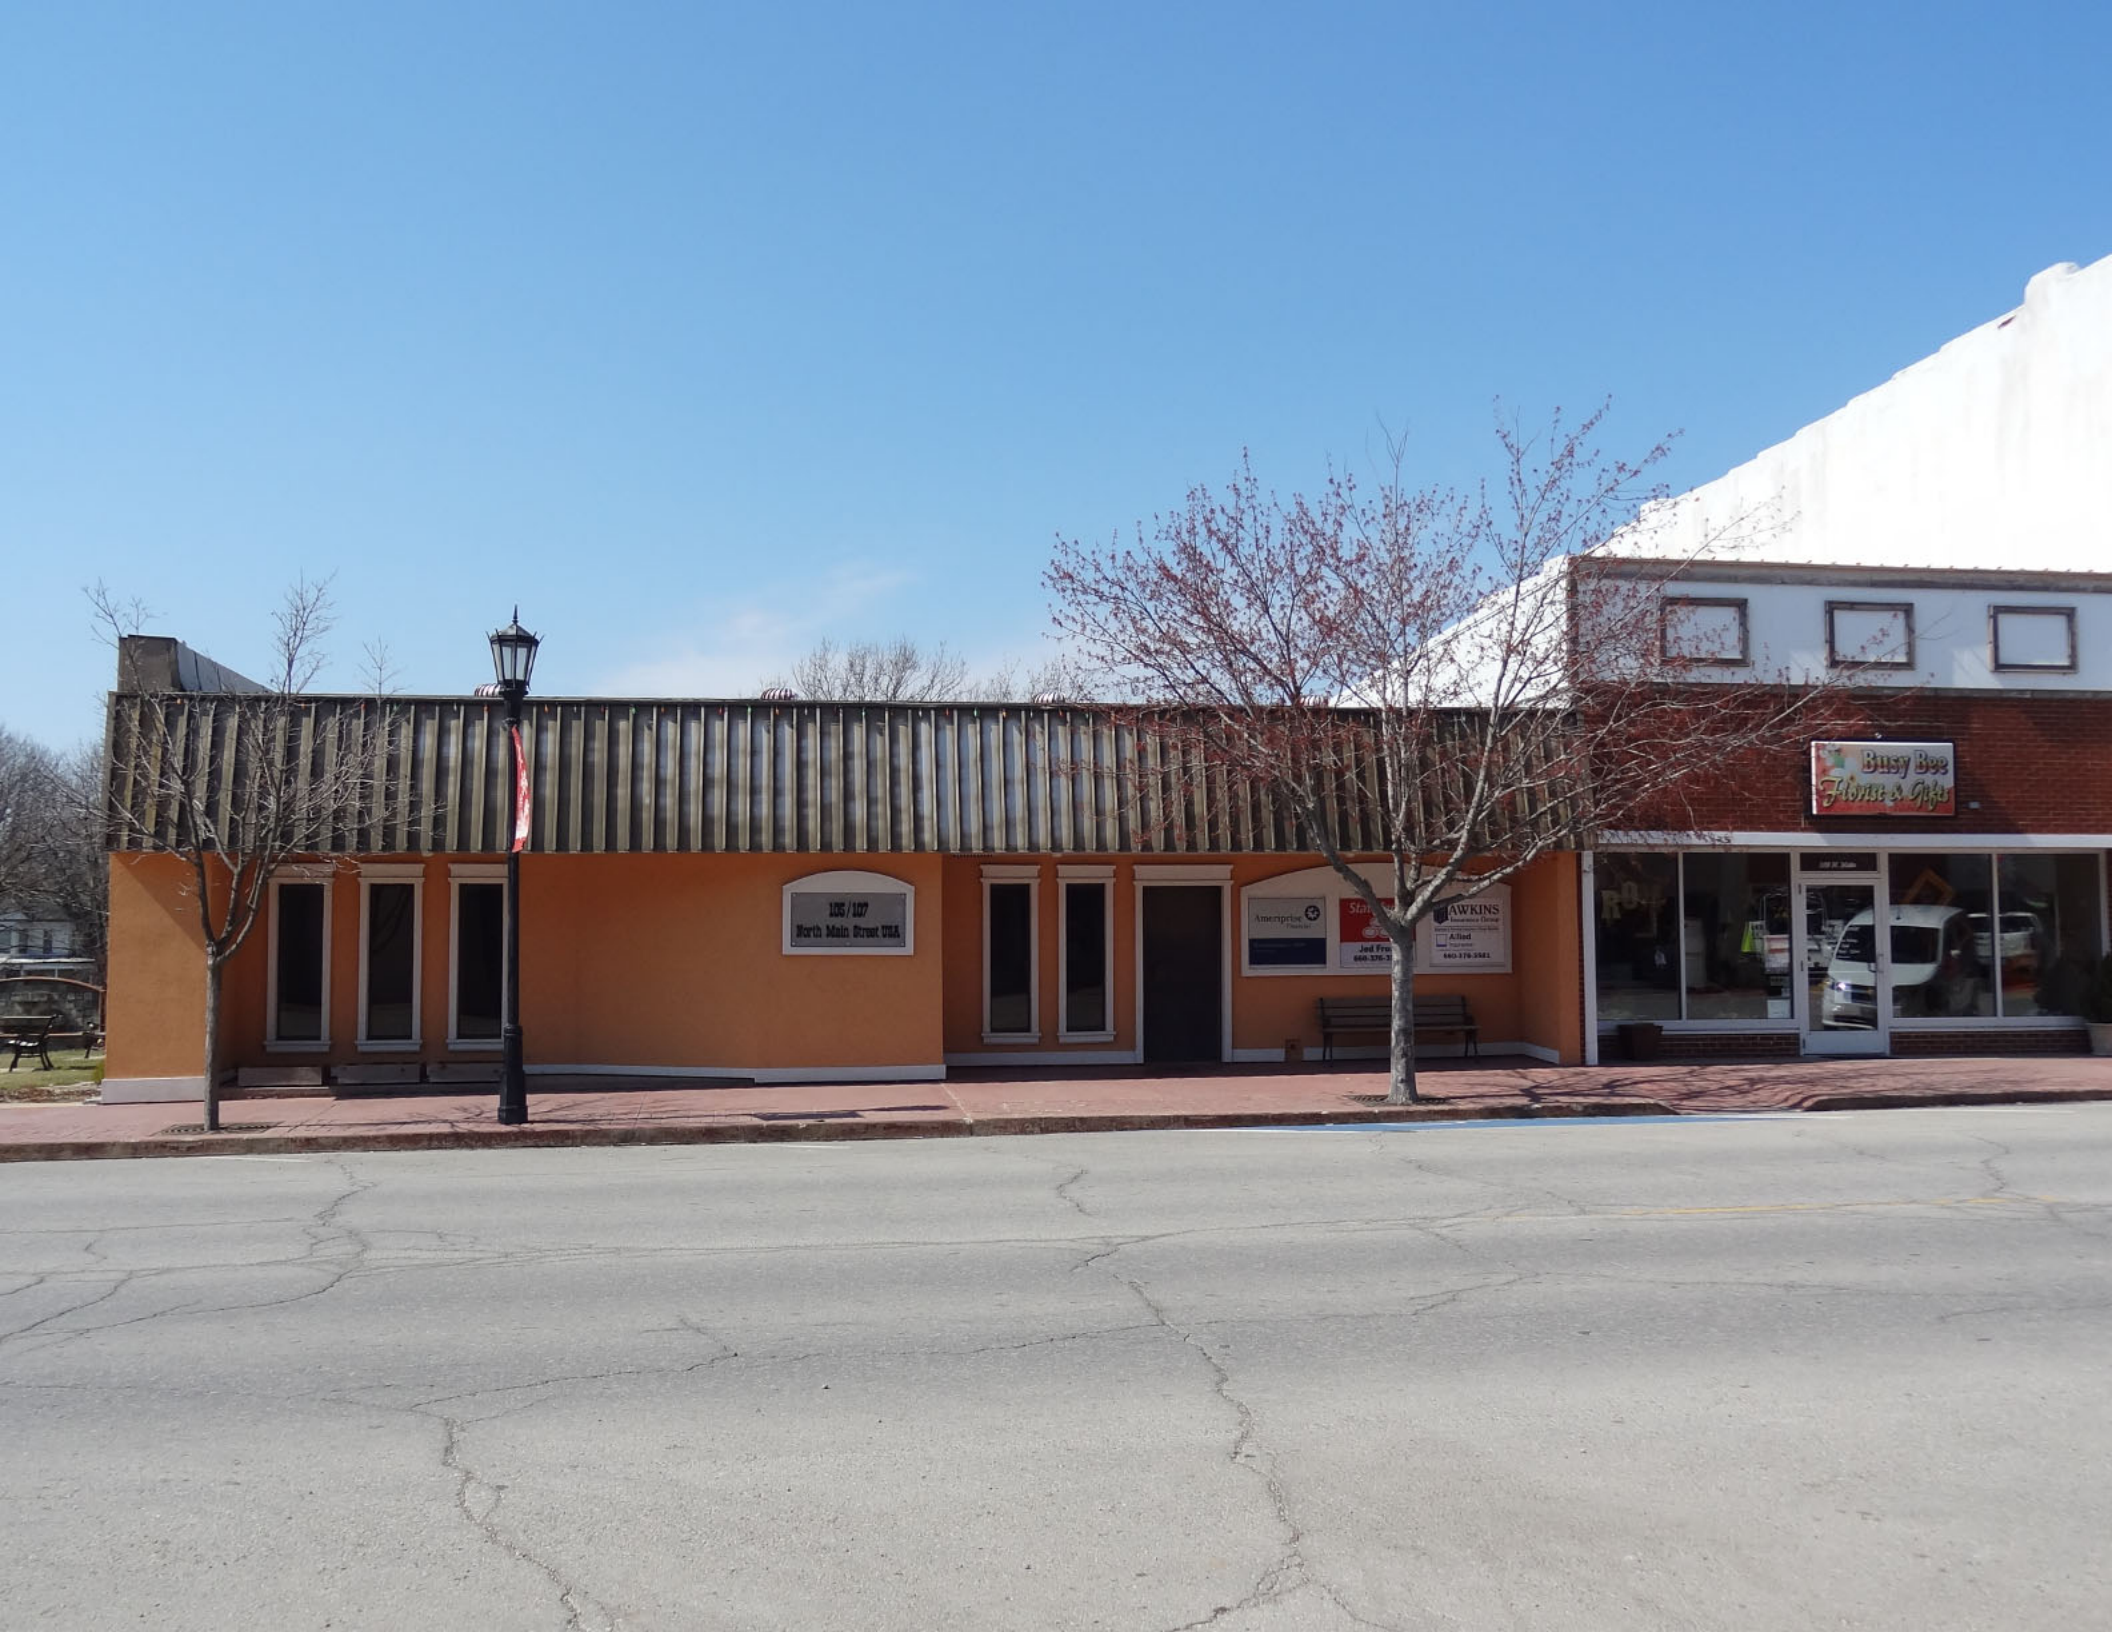
This is a one-part commercial block building. There are four bays on the facade starting from the south the bay is recessed and there are three large fixed pane windows that have wood surrounds, moving north there is a large bay that is angled and leads to a flush wall with a sign "105/107 North Main Street USA" Other than this the bay has no ornamentation and is covered in stucco. The next bay, is also recessed, this bay has two tall narrow fixed windows and a single pedestrian entrance all have wood surrounds. The fourth and norther most bay is also recessed and has a sign with the various business in the building and no other ornamentation. The roof line of the facade is covered with a large metal band, that looks like a Mansard roof, that creates a covered space on the facade. The southern wall is covered with metal siding. At the rear corner of the southern elevation there is an entrance to the building from the park area described in LI-AS-001-90/ Park. This entrance has a faux Mediterranean appearance with arched window openings and hipped tile roof this area is accessed via an elaborate flight of steps. The rear of the building has two parking areas that are covered by the first floor of the building. In the upper portion of rear elevation there are two window openings, one is centrally located with a pair of one-over-one hung windows covered with a cloth awning. The southern window opening is a large rectangle that is filled with a curved glass block window, this window is also covered with a cloth awning.

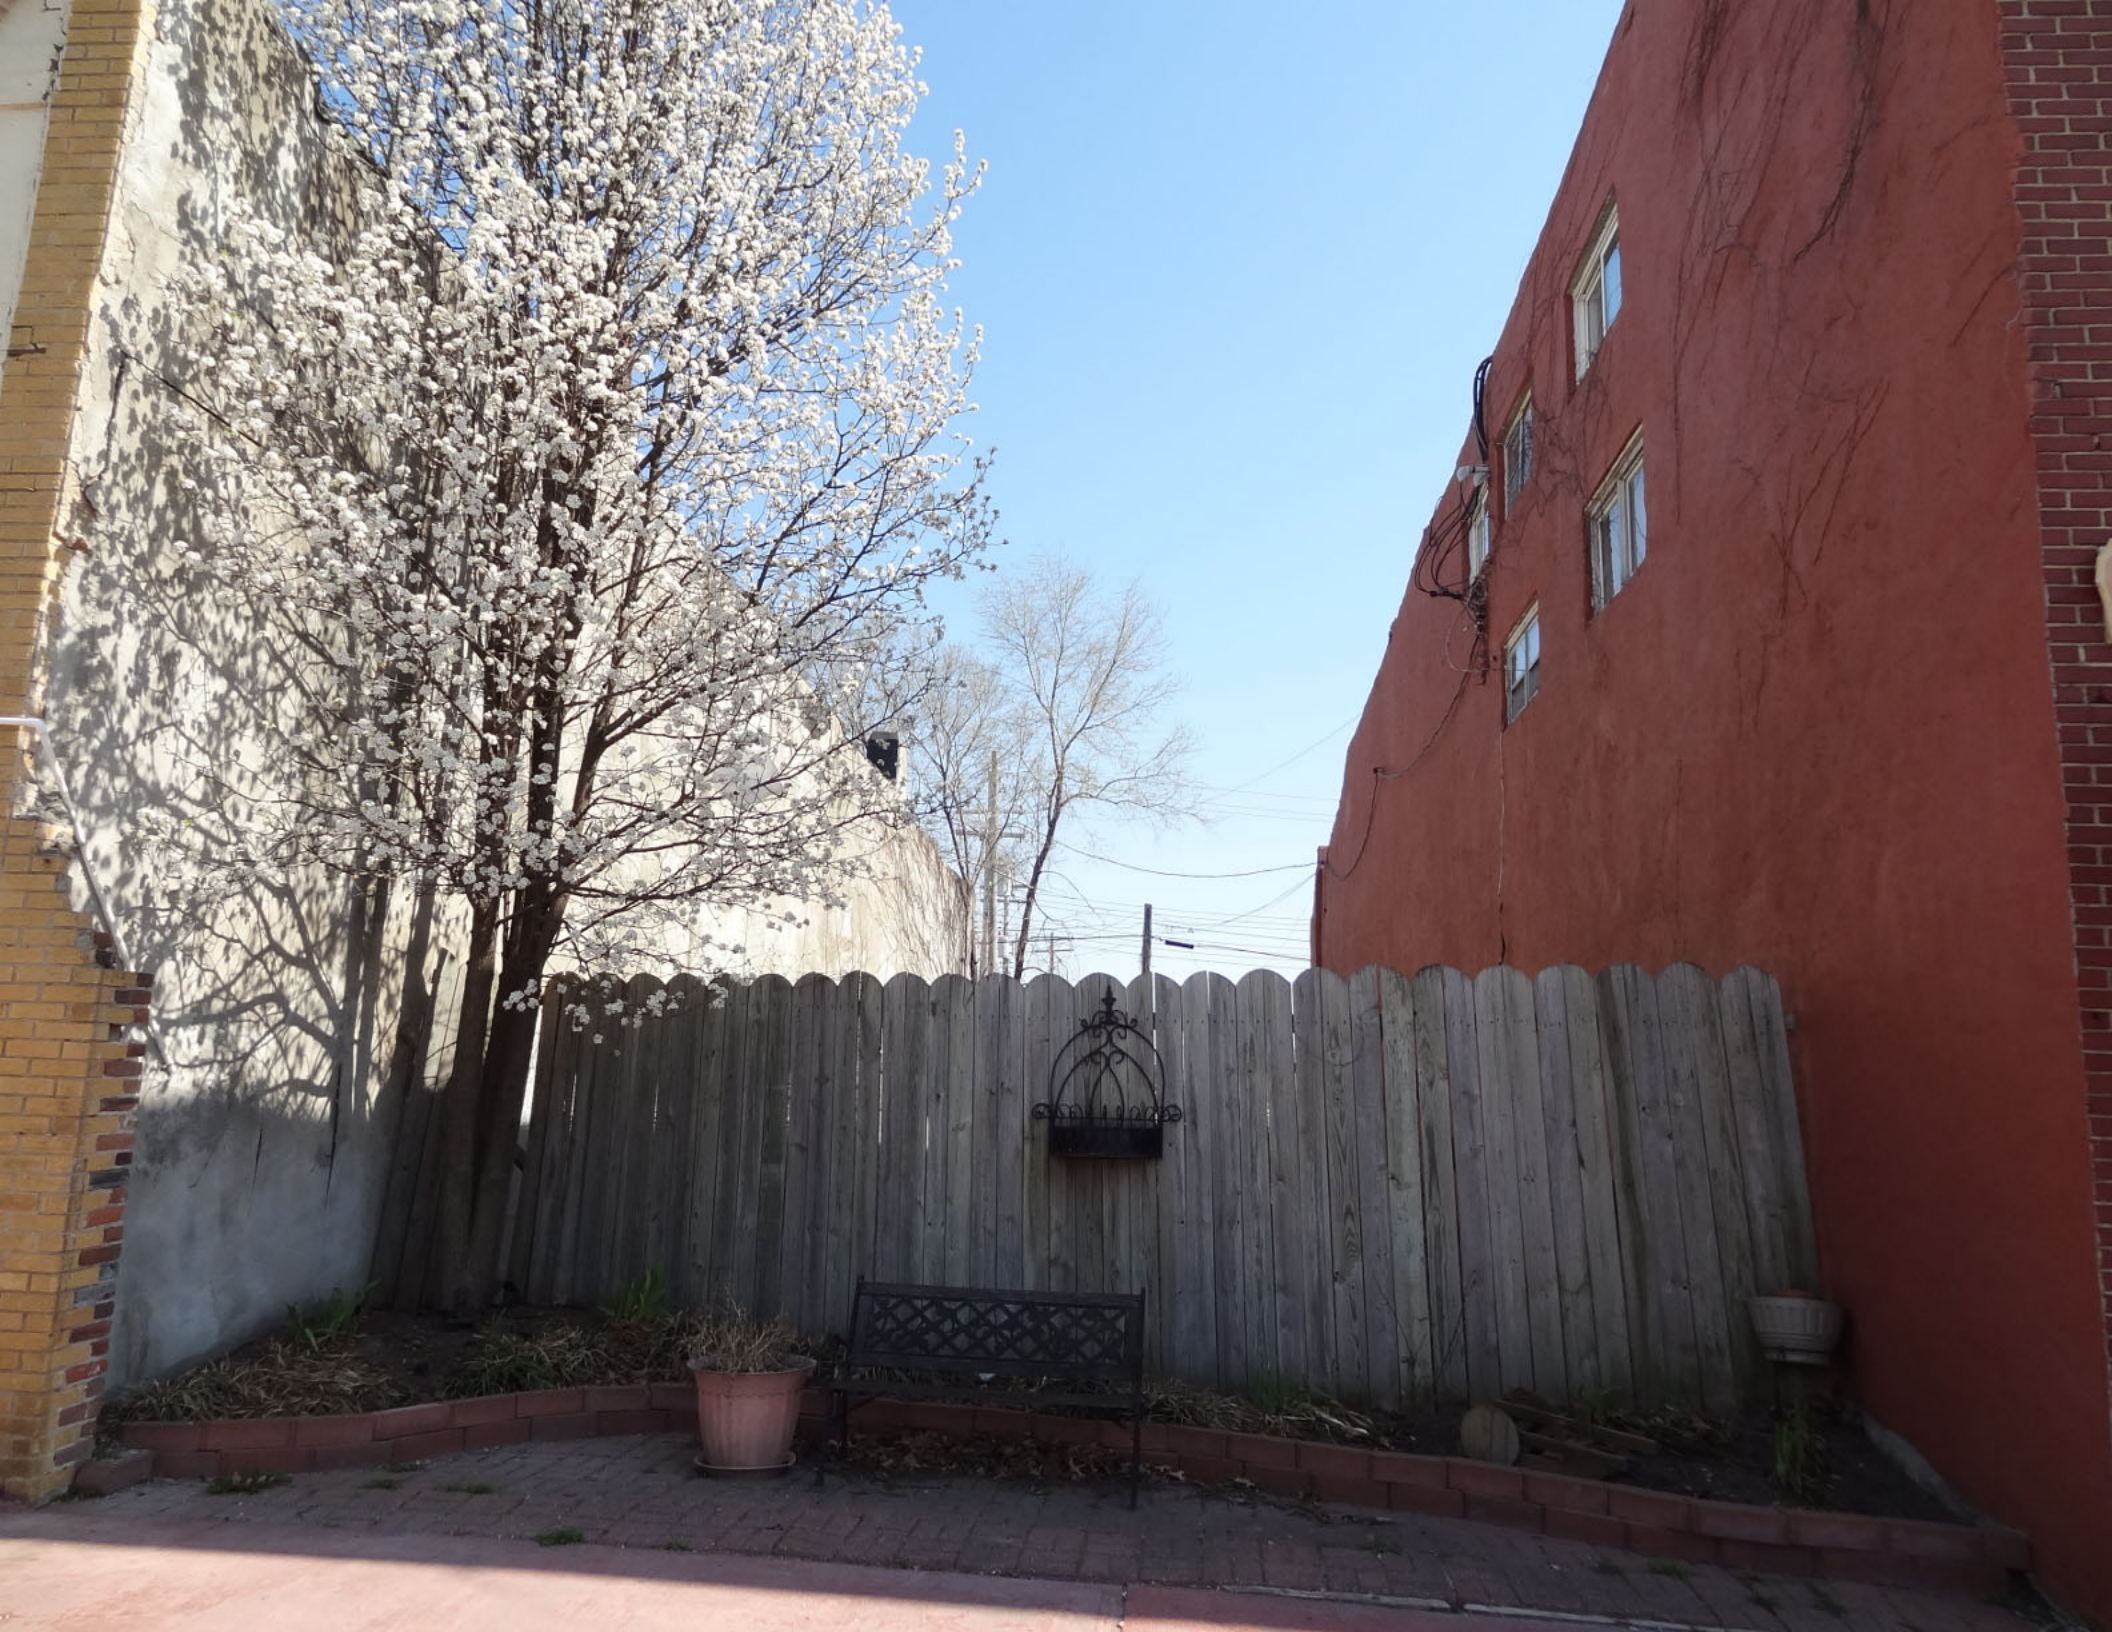
This is the site of a demolished building. A small portion of the original building's beige brick facade remains attached to the building to the north. Today, this narrow vacant lot has a wooden privacy fence that spans its west end. In front of the fence is a landscaped area, a bench, and a Bradford Pear tree.
