MISSOURI DEPARTMENT OF NATURAL RESOURCES  
STATE HISTORIC PRESERVATION OFFICE, P.O. Box 176, Jefferson City, MO 65102  
**ARCHITECTURAL/HISTORIC INVENTORY FORM**

1. SURVEY NO. LI-AS-001-001		2. SURVEY NAME: Marceline Survey	
3. COUNTY: Linn		4. ADDRESS (STREET NO.) 275	STREET (NAME) West Broadway
5. CITY: Marceline	VICINITY: <input type="checkbox"/>	6. UTM: / /	7. TOWNSHIP/RANGE/SECTION: T: R: S:

8. HISTORIC NAME (IF KNOWN): Walt Disney's Childhood Home		9. PRESENT/OTHER NAME (IF KNOWN): Walt Disney's Childhood Home	
10. OWNERSHIP: <input checked="" type="checkbox"/> PRIVATE <input type="checkbox"/> PUBLIC		11A. HISTORIC USE (IF KNOWN): Single Dwelling	11B. CURRENT USE: Single Dwelling
<b>HISTORICAL INFORMATION</b>

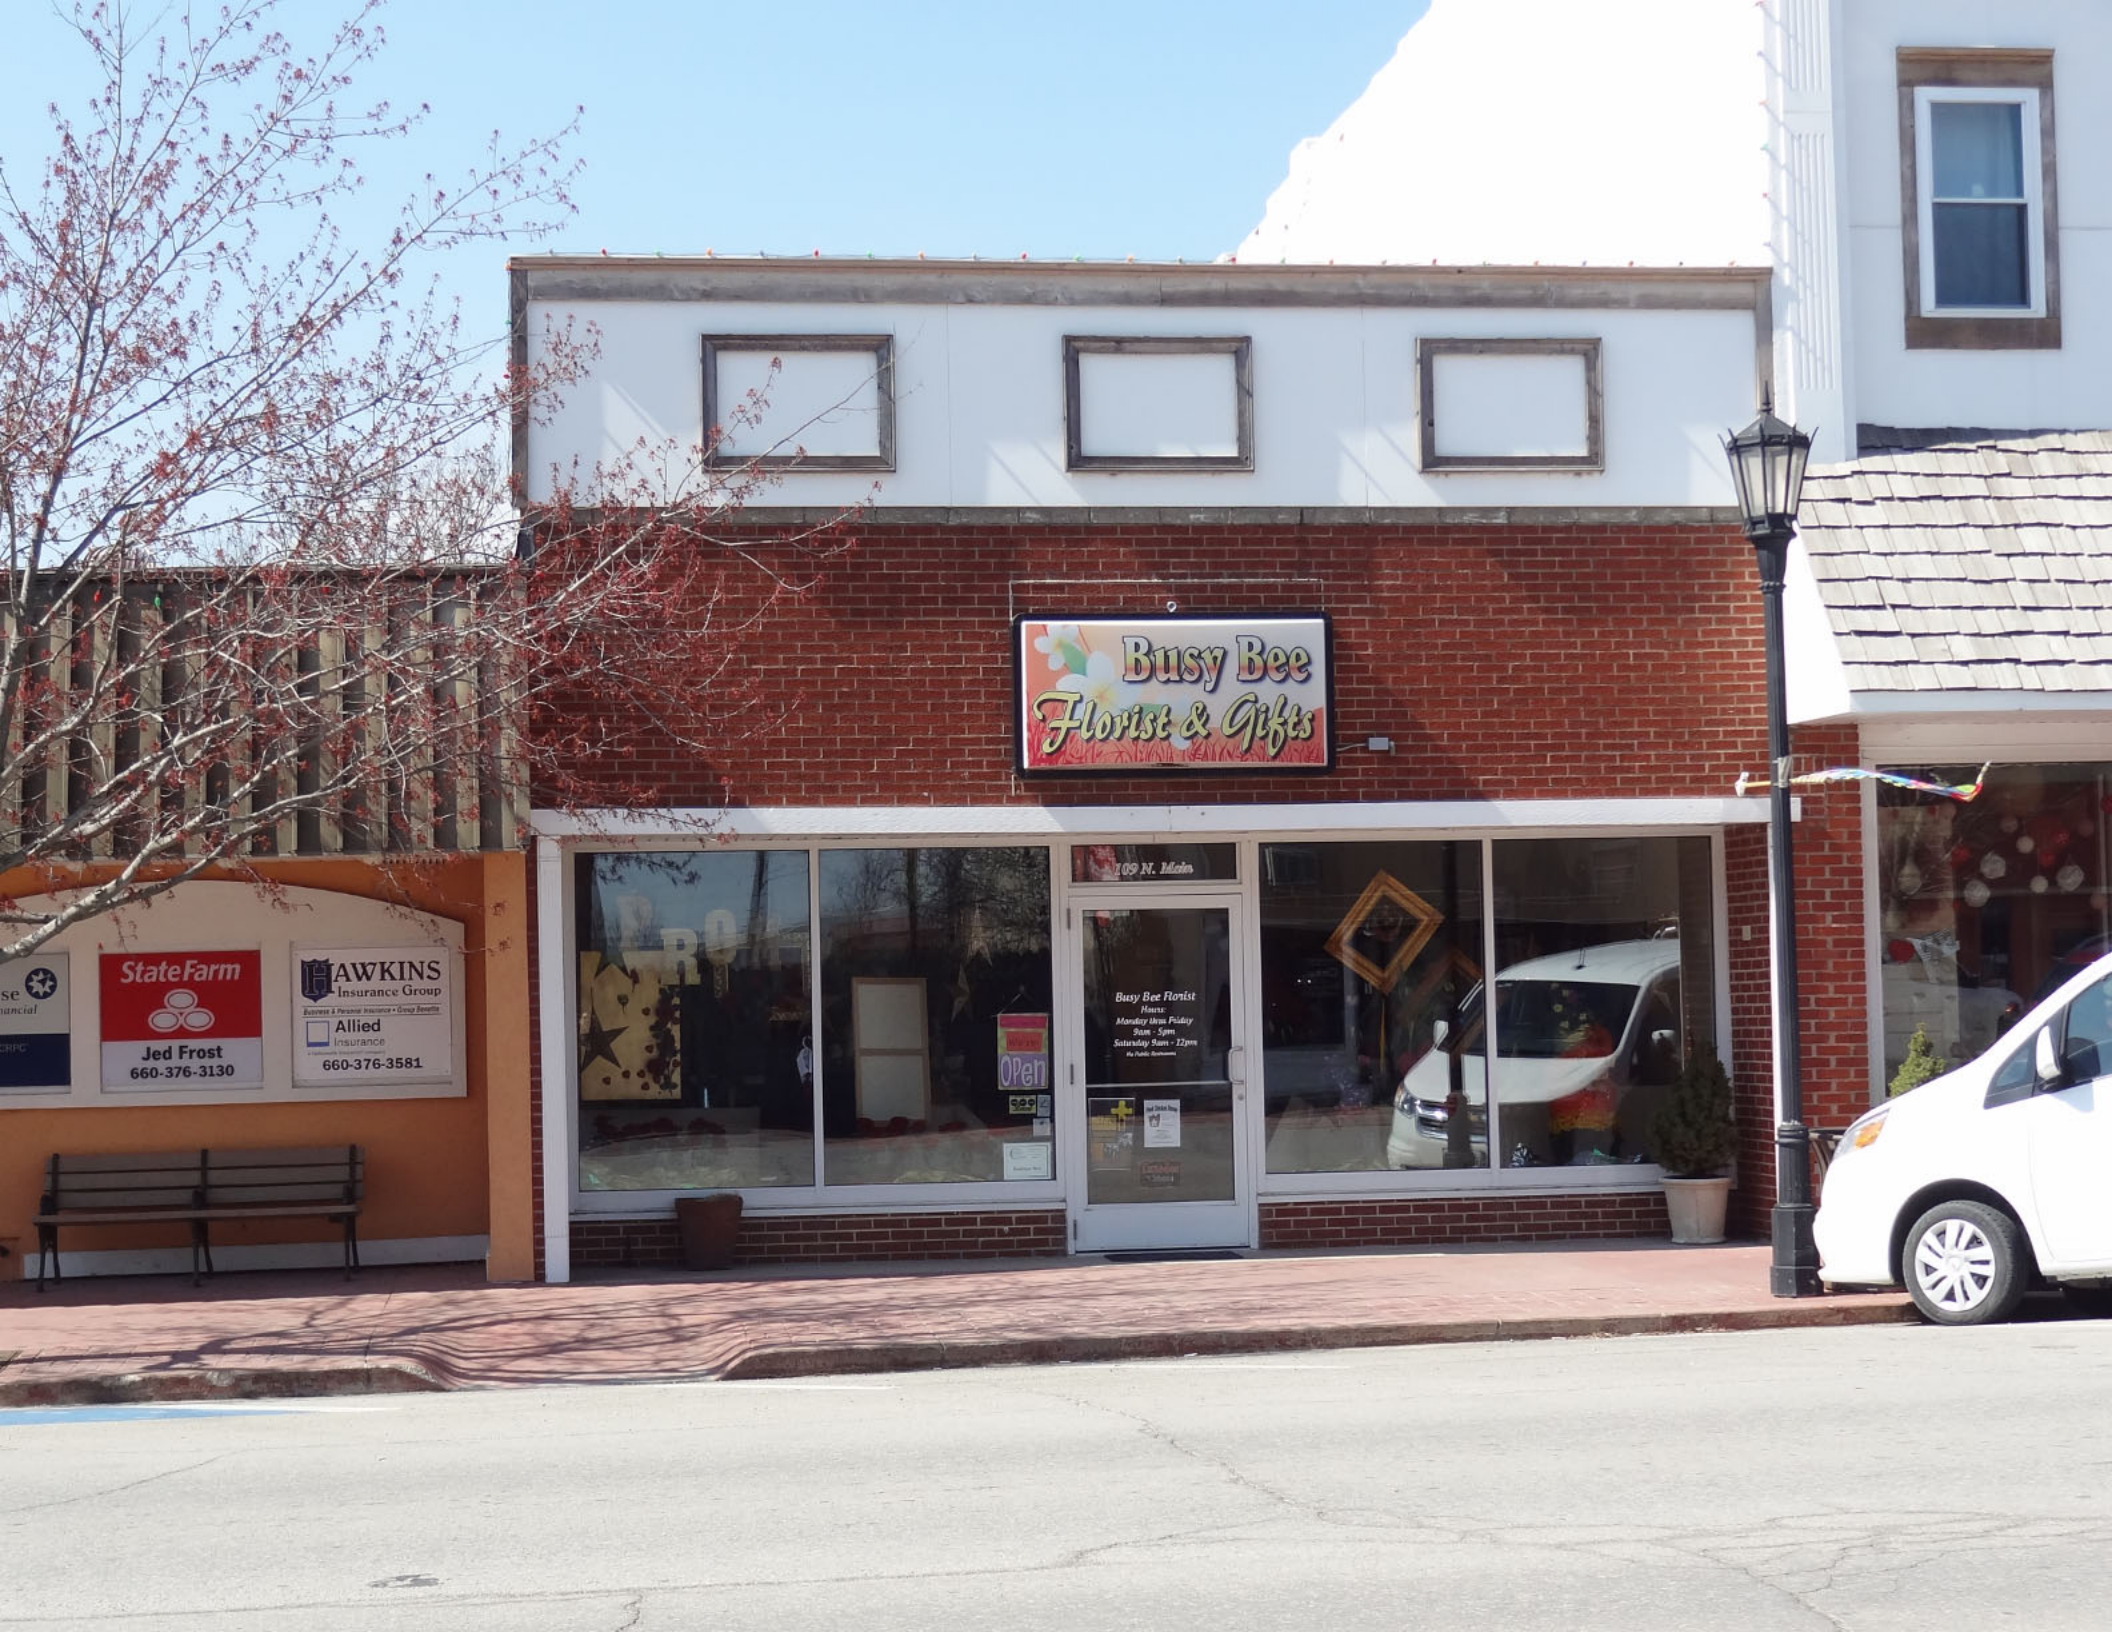
This is a one-part commercial block building that is faced with brick. The building has three symmetrically placed bays the central bay is a single glass door with an aluminum frame. There is a small transom window above the door. The bays to the north and south both have two large storefront windows that are surrounded by aluminum framing and supported by a short brick knee wall. The whole storefront is recessed under an awning. The area above the storefront is faced with brick and there is a central sign "Busy Bee Florist & Gifts". Above the brick is a parapet that has concrete coping and is topped with a concrete cap the area is filled with wood and three small evenly spaced wood frames.

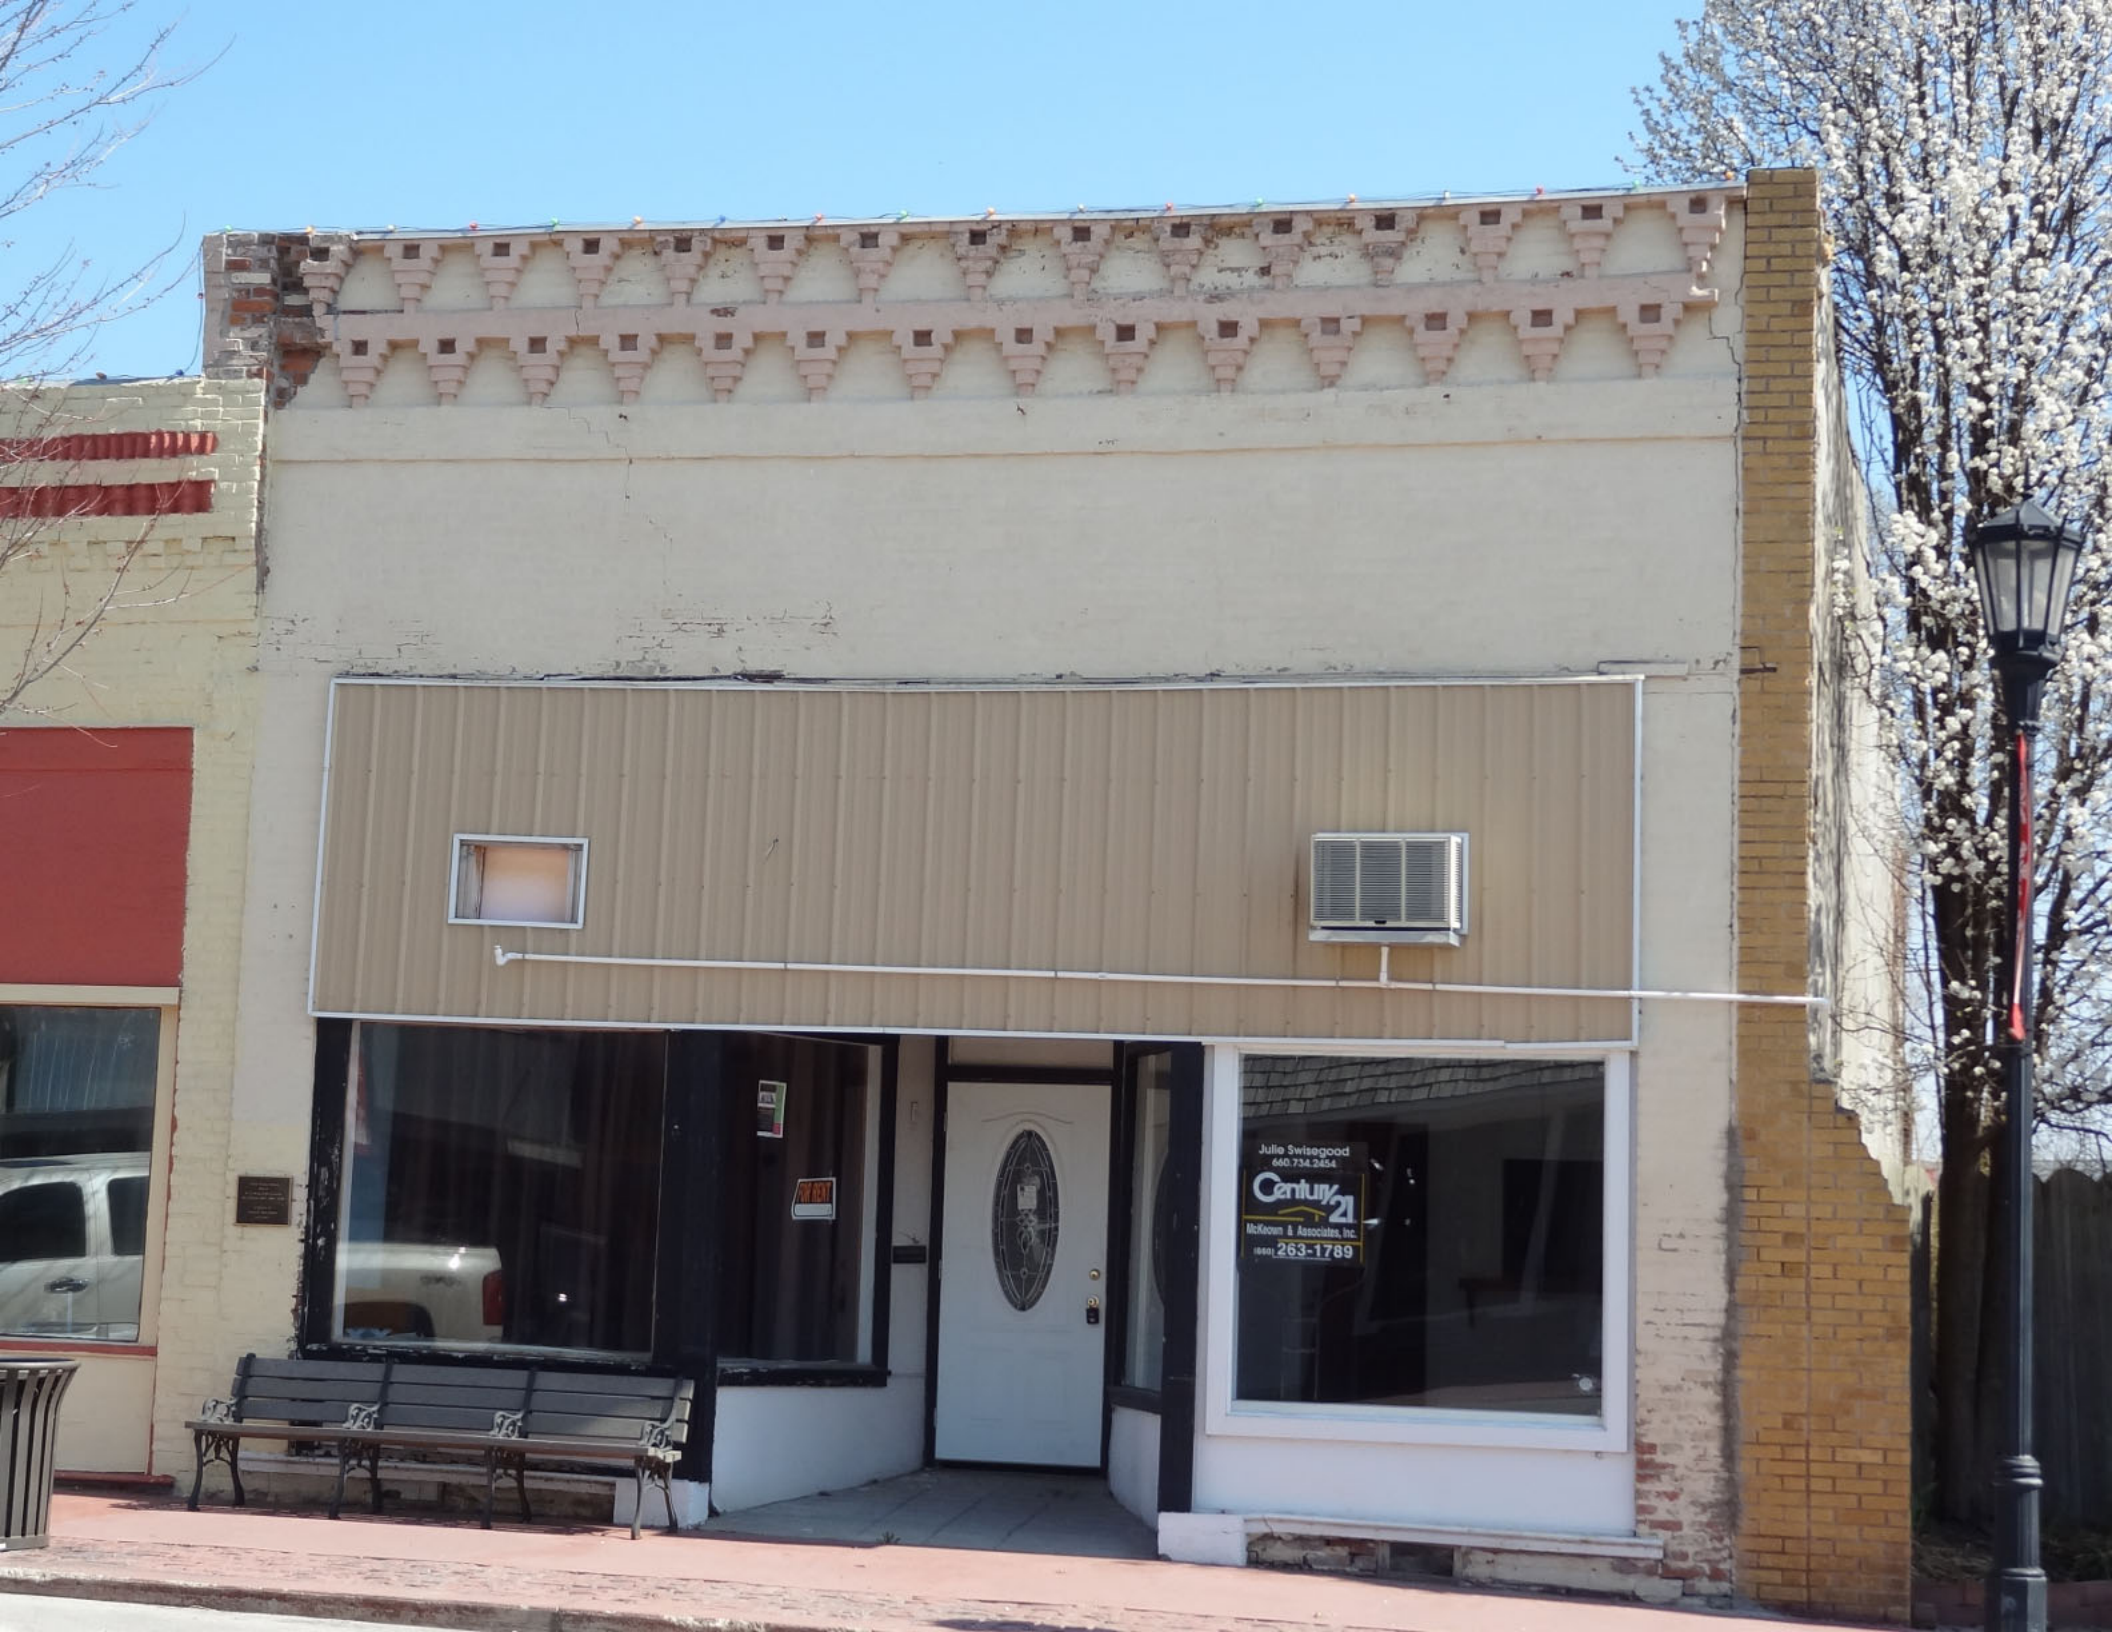
This single-story, flat-roofed, one-part commercial block building is faced in red brick that has been painted white. It sits slightly taller than the one-part commercial building to its north. It has three bays: the first holds an early large storefront window with one large pane facing the street and another slanted inward towards the recessed entrance door. The centered entrance is a single non-historic door with a centered oval light with intricate muntins. The third bay is another large storefront window with the northernmost pane slanted inwards towards the door. Due to the alterations to the window surround in the third bay it is unlikely to be early or original. Above the storefront a large metal panel was added with two small rectangular openings; the first is infilled and the second holds an air conditioning unit. Above the paneling there are no additional openings in the brick. At the roofline there are two rows of protruding brick detailing in a pale pink color. It gives the appearance of upside down pyramids: two header bricks with a space in the middle, followed by a stretcher brick narrower than the line made by the two bricks above, then three more bricks in decreasing size. Fourteen of these are on the bottom row and fifteen on the top row.

A small wooden opening in the foundation suggests a basement.

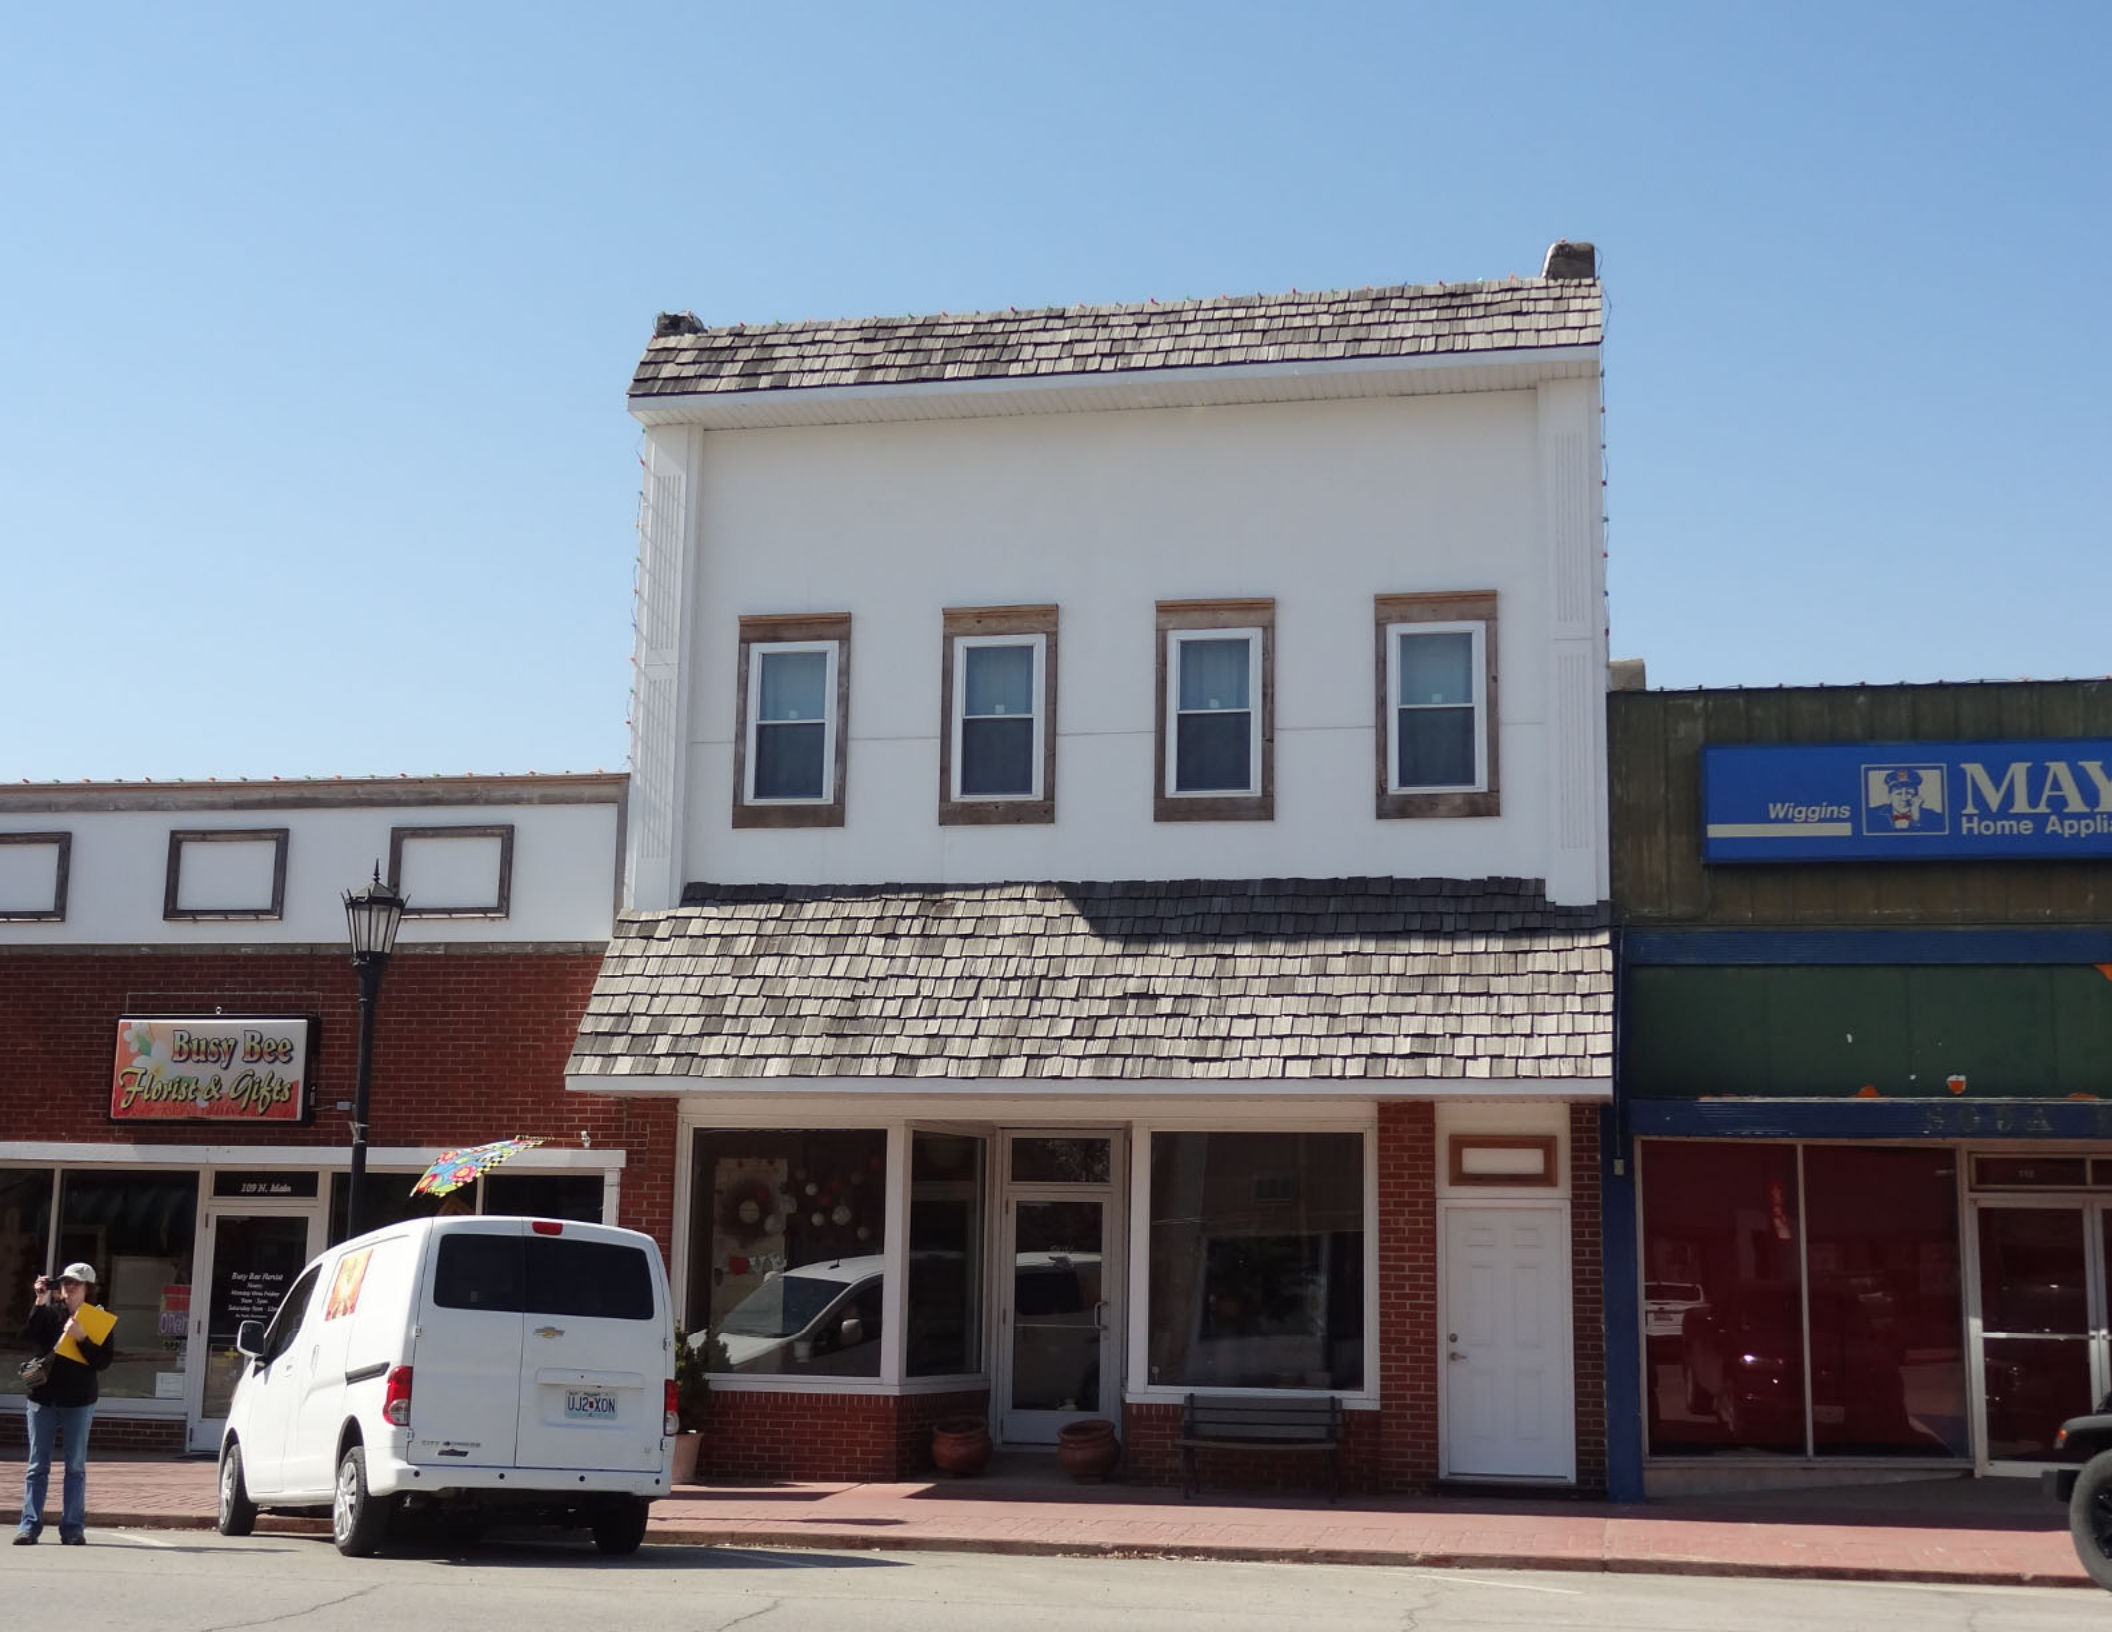
The second story has four evenly spaced one-over-one vinyl replacement windows that have modern wood surrounds. The wall area of the second story is covered with a paneling material that appears to be wood. On the exterior walls there is a fluted pilaster. The parapet area has been covered by a slight shed awning that is covered with wood shingles.

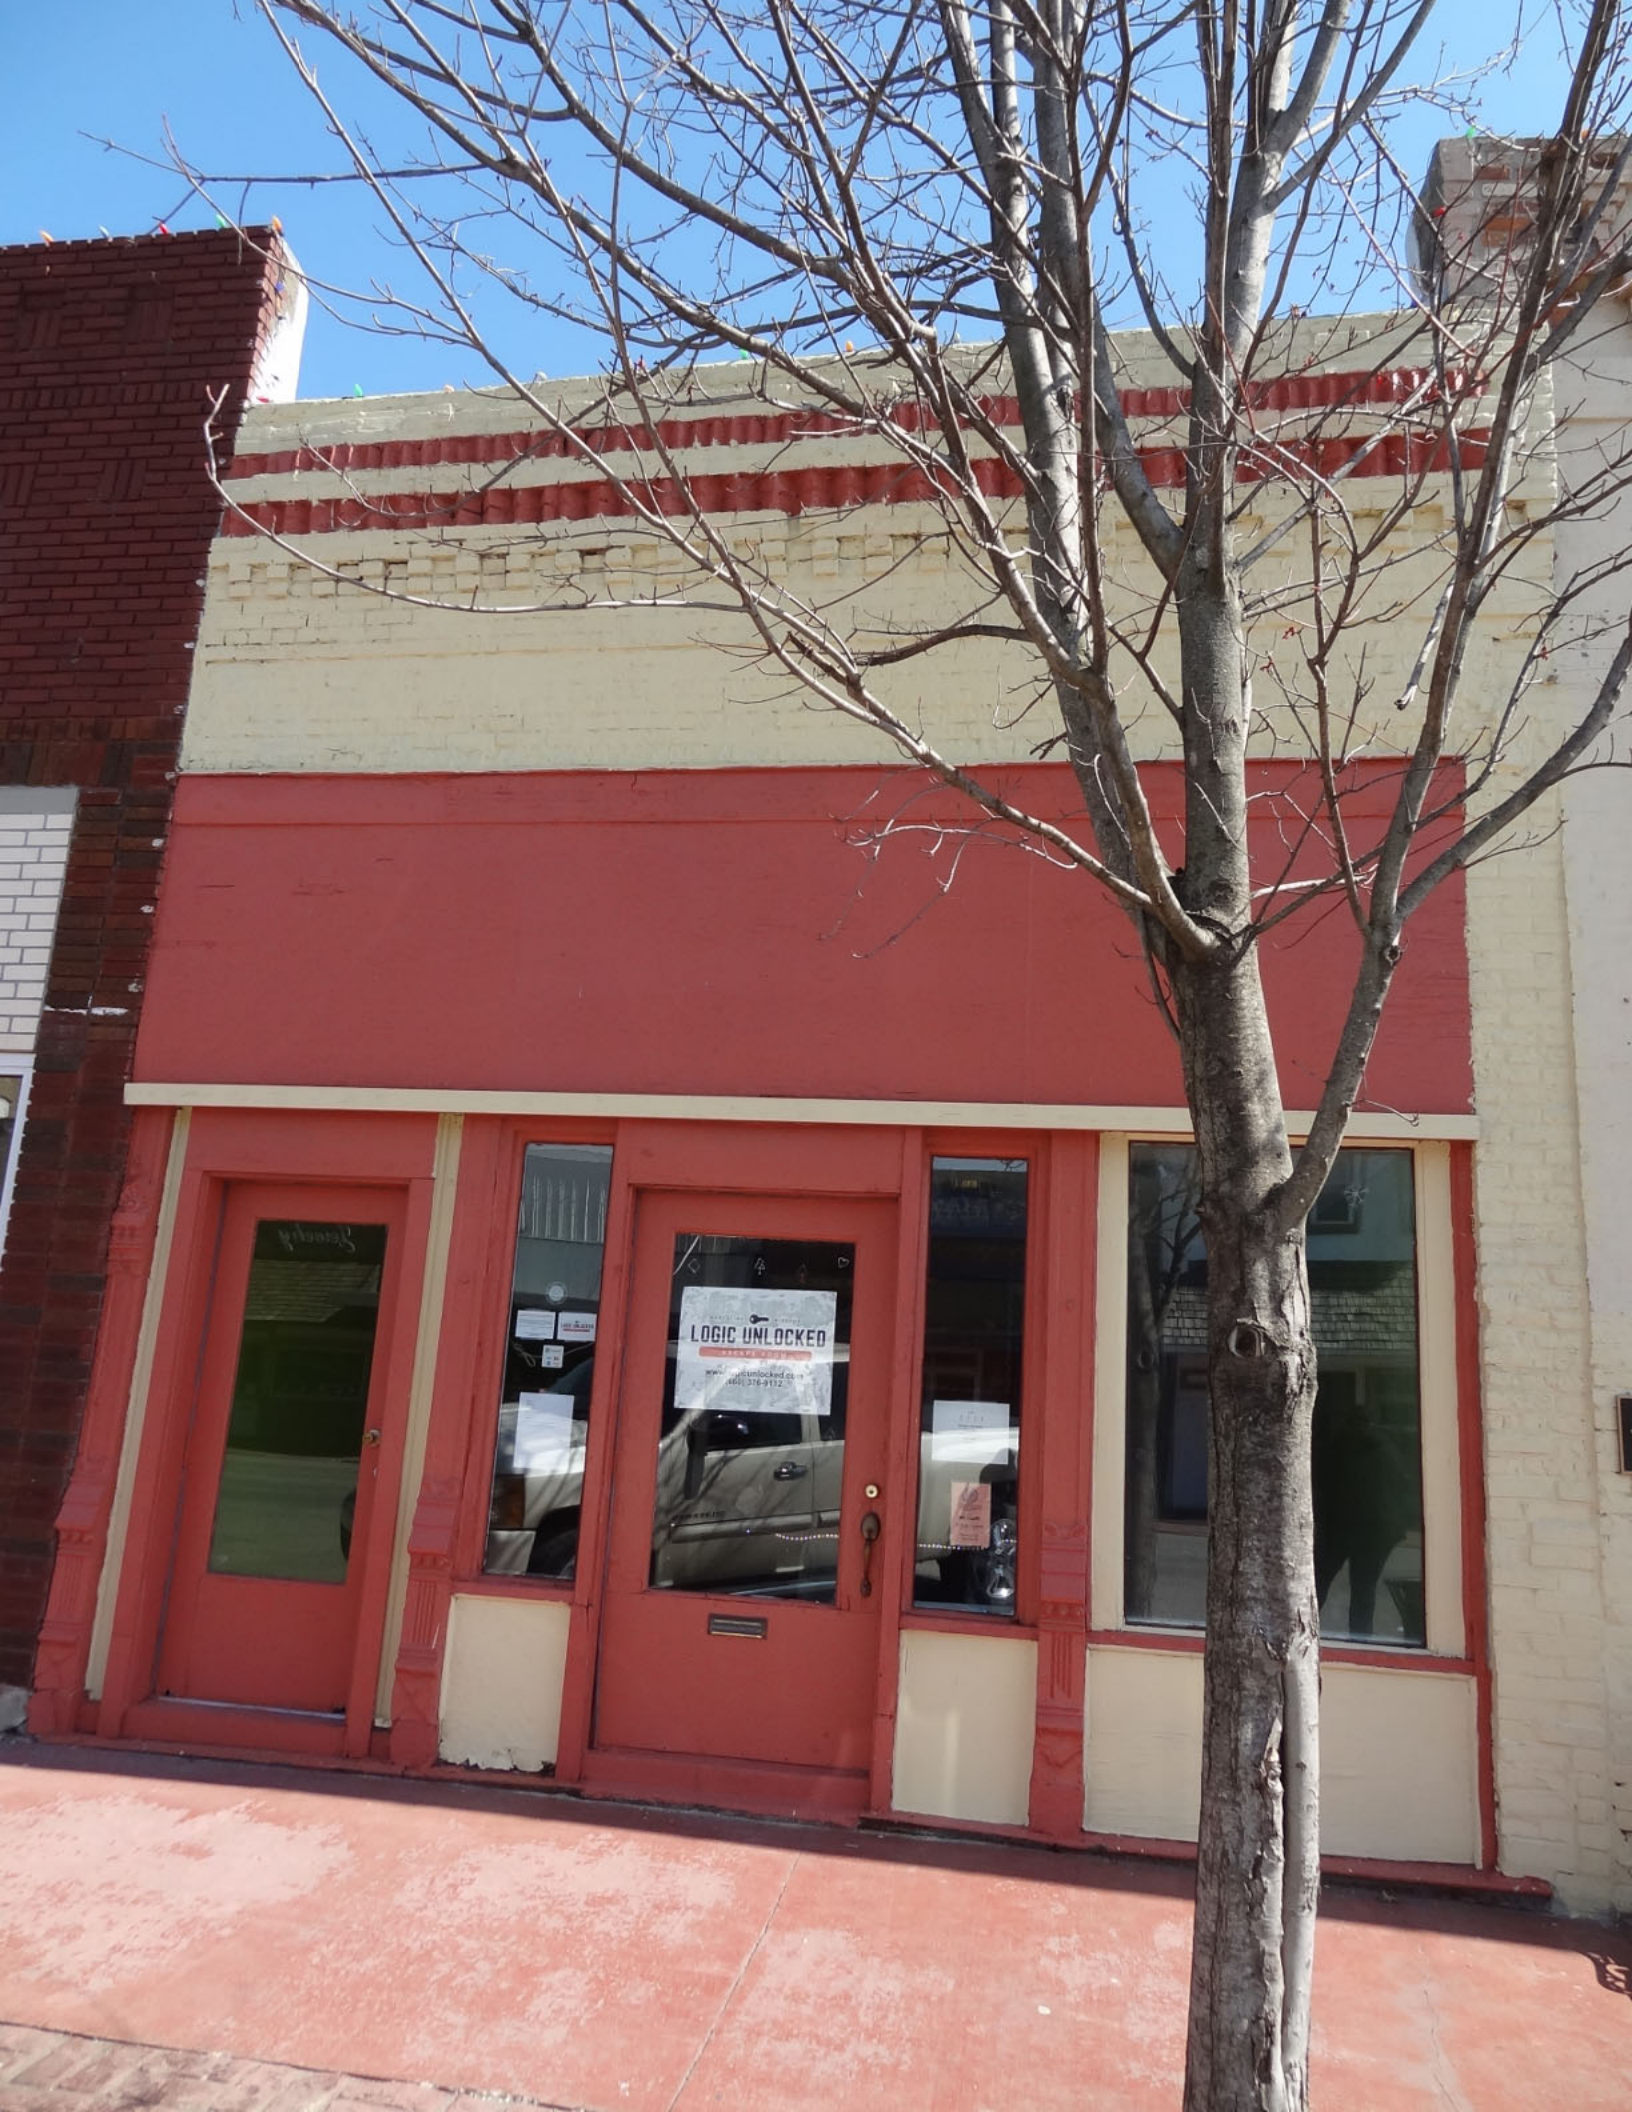
This brick one-part commercial block building with a flat roof has been painted pale yellow and red. It has three bays: a single door in the first, a centered single door with sidelights in the second, and a storefront window in the third. All materials appear early or original. The doors and detailing around the doors have been painted red; to the north of the first door and on the outside of each of the centered door's sidelights are carved, protruding wooden pieces also painted red. These end just above the door line where a large wood panel (where a sign was once located) has been painted red. Above the panel, the brick, painted pale yellow, is visible. The upper portion of the facade has brick in a decorative pattern, set out from the main brick line. Two rows of bricks with their corners facing outward are painted red.

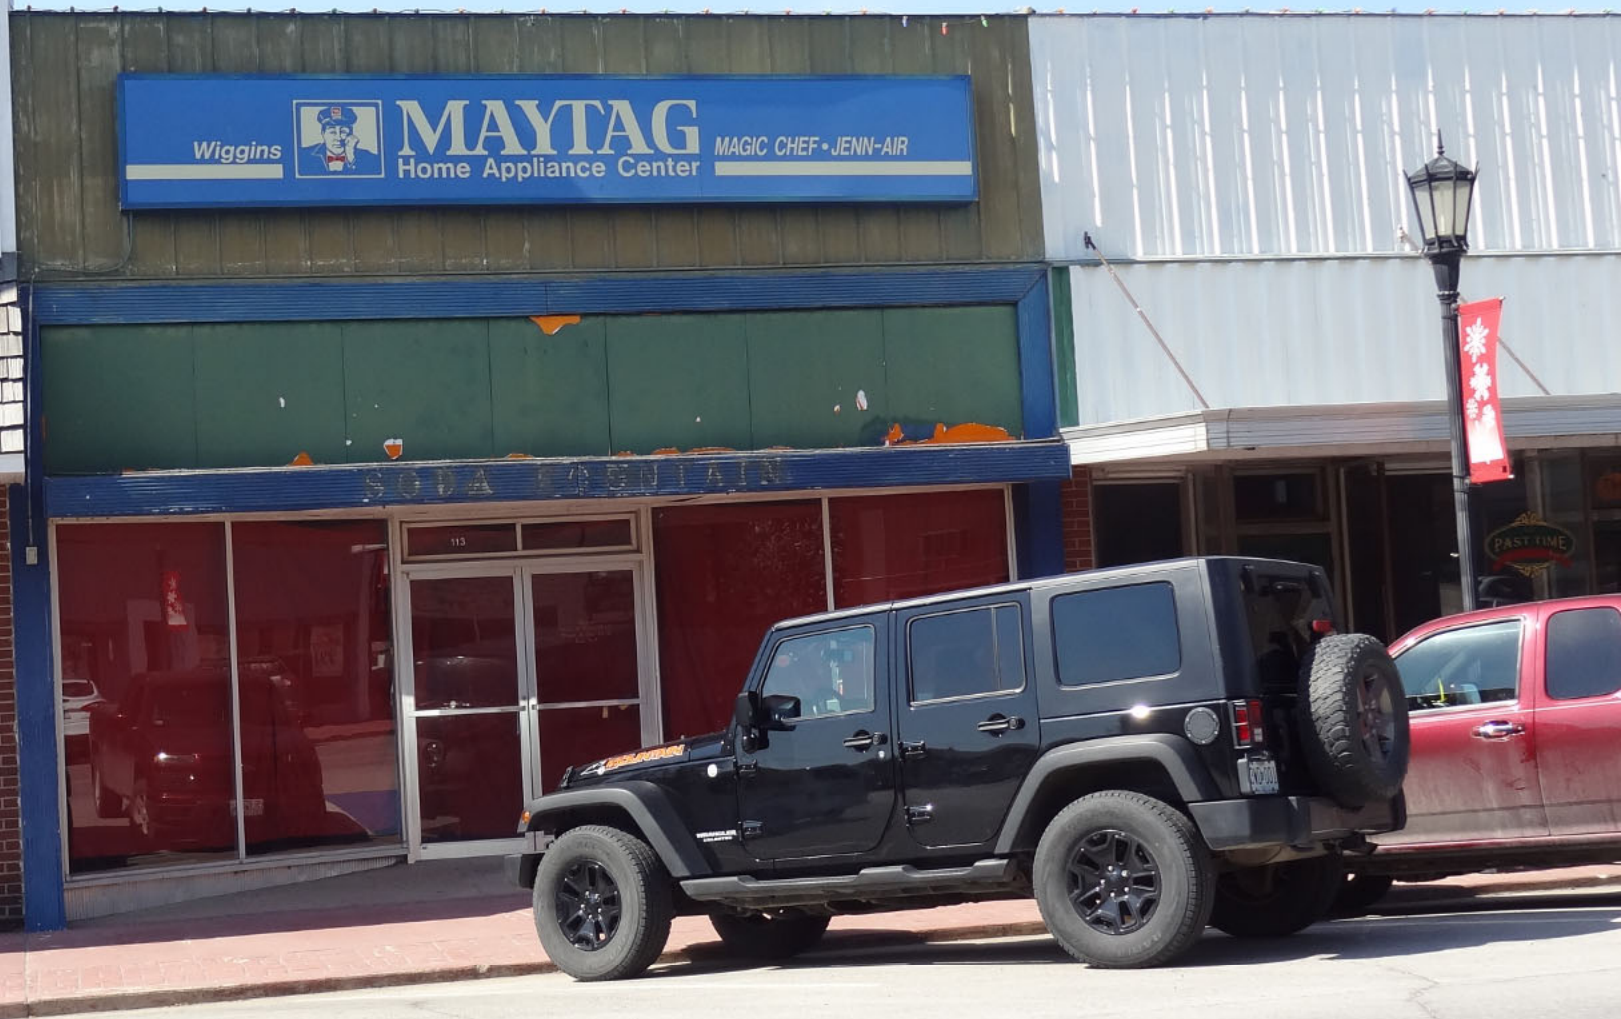
This is a one-part commercial metal building. The building has a symmetrical storefront, the building has a central entry. The central bay consists of two glass doors with aluminum framing there are small transom windows above each door. The central entry is slightly recessed and there is a slight grade change when accessing the entrance this is created by sloping concrete rather than a step. The north and south bays are identical with two large plate glass storefront windows with aluminum framing. There is a short concrete bulkhead that supports these windows. The storefront is covered with a flat aluminum awning. The clerestory windows have been infilled or possibly painted over. These windows are surrounded by metal. The parapet has a more modern metal siding along with signage for "Wiggins MAYTAG".

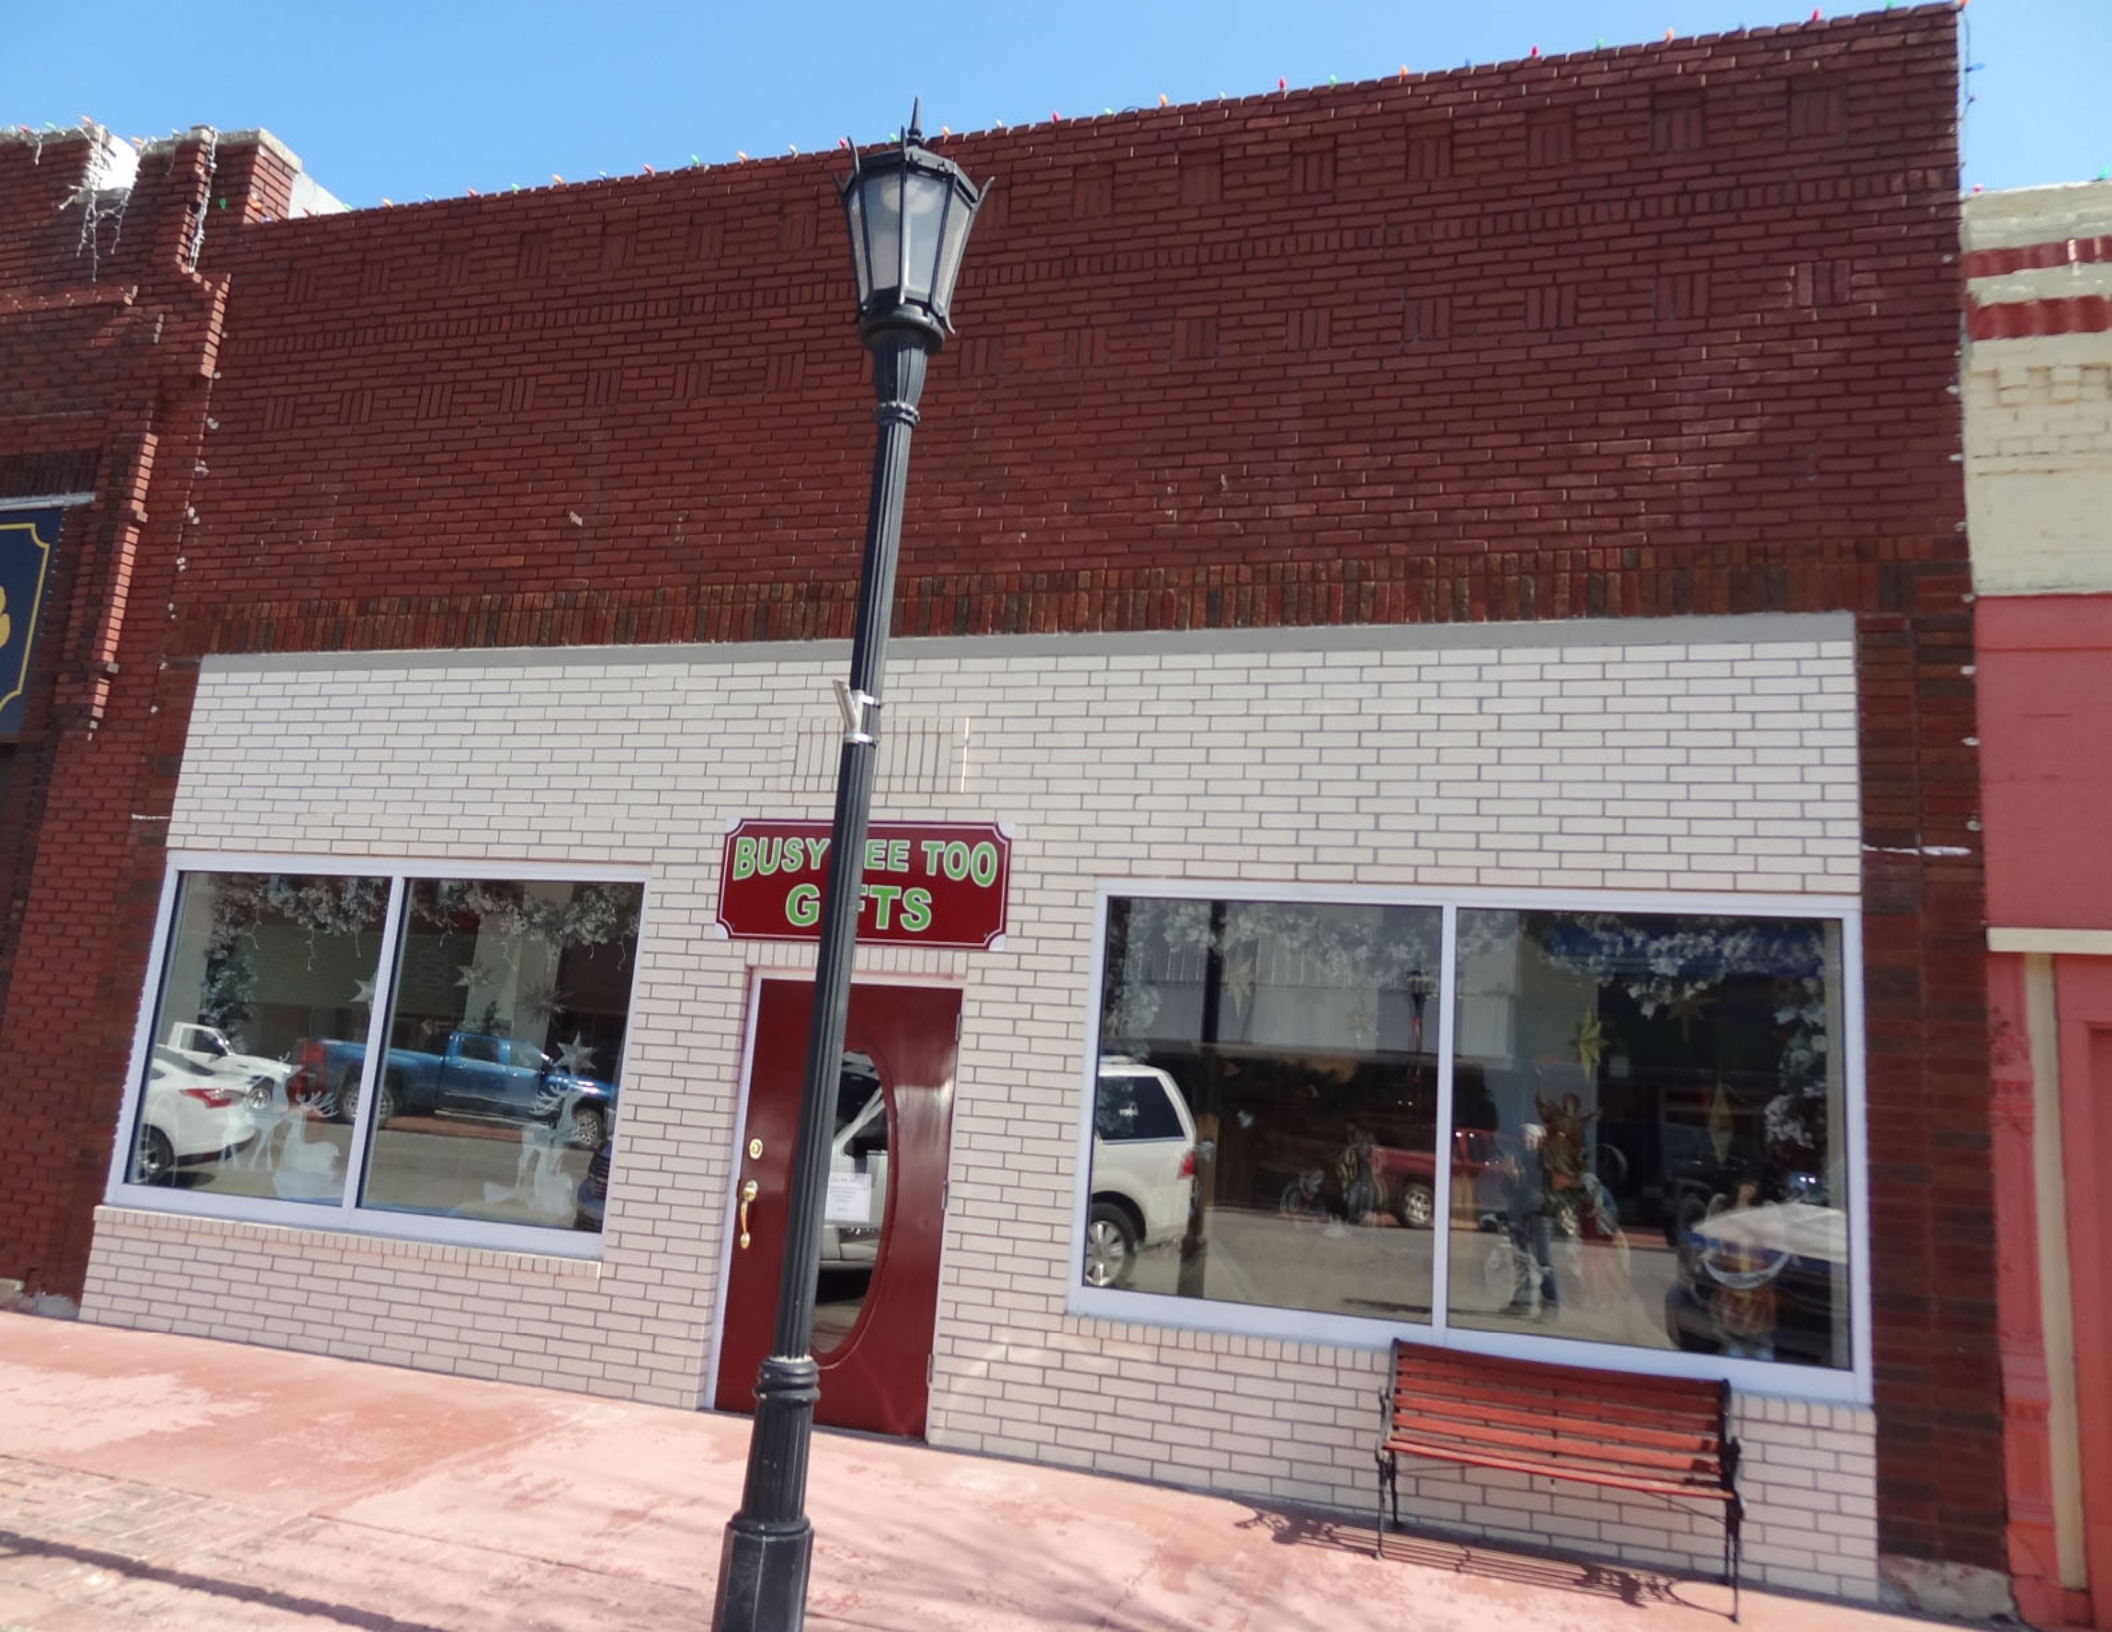
This flat roofed brick one-part commercial block building has had its storefront altered. It has three symmetrically arranged bays: the first has two large replacement storefront windows as does the third. The non-historic centered door is painted red and has a large centered oval light. Almost the entire lower half of the storefront has been infilled with white brick that is not original. Above this white brick infill the historic detailing in the brick remains. Immediately above the storefront is a row of soldier bricks followed by a row of rowlock bricks. Brick is then laid in a running bond pattern except for a row of soldier bricks in groups of three, then more running bond followed by a another rowlock row of brick. The parapet is in running bond except for one row of soldier bricks in groups of three topped with a stretcher brick.

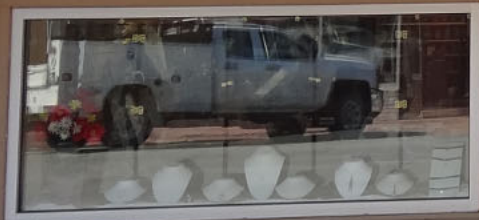
This is a brick one-part commercial building. This building has five bays on the first floor. The storefront is symmetrical with a central entry. The entrance door is metal with a small window in the upper portion. On both sides of the door there is a small fixed aluminum window set in a wood wall. The north and south bays are identical, each of these bays has a larger fixed aluminum window with a brick half wall below the windows are surrounded by wood framing. Above the store front there is shed roof awning with a small gable over the entrance. This awning covers the full-width of the building. Above the awning is a multicolored brick cornice. The wall is primarily blonde brick with red brick accent, quoining, a cap. There is also signage in on the brick wall: "YOCOM Jewelry."
