MISSOURI DEPARTMENT OF NATURAL RESOURCES  
STATE HISTORIC PRESERVATION OFFICE, P.O. Box 176, Jefferson City, MO 65102  
**ARCHITECTURAL/HISTORIC INVENTORY FORM**

1. SURVEY NO. LI-AS-001-001		2. SURVEY NAME: Marceline Survey	
3. COUNTY: Linn		4. ADDRESS (STREET NO.) 275	STREET (NAME) West Broadway
5. CITY: Marceline	VICINITY: <input type="checkbox"/>	6. UTM: / /	7. TOWNSHIP/RANGE/SECTION: T: R: S:

8. HISTORIC NAME (IF KNOWN): Walt Disney's Childhood Home		9. PRESENT/OTHER NAME (IF KNOWN): Walt Disney's Childhood Home	
10. OWNERSHIP: <input checked="" type="checkbox"/> PRIVATE <input type="checkbox"/> PUBLIC		11A. HISTORIC USE (IF KNOWN): Single Dwelling	11B. CURRENT USE: Single Dwelling
<b>HISTORICAL INFORMATION</b>

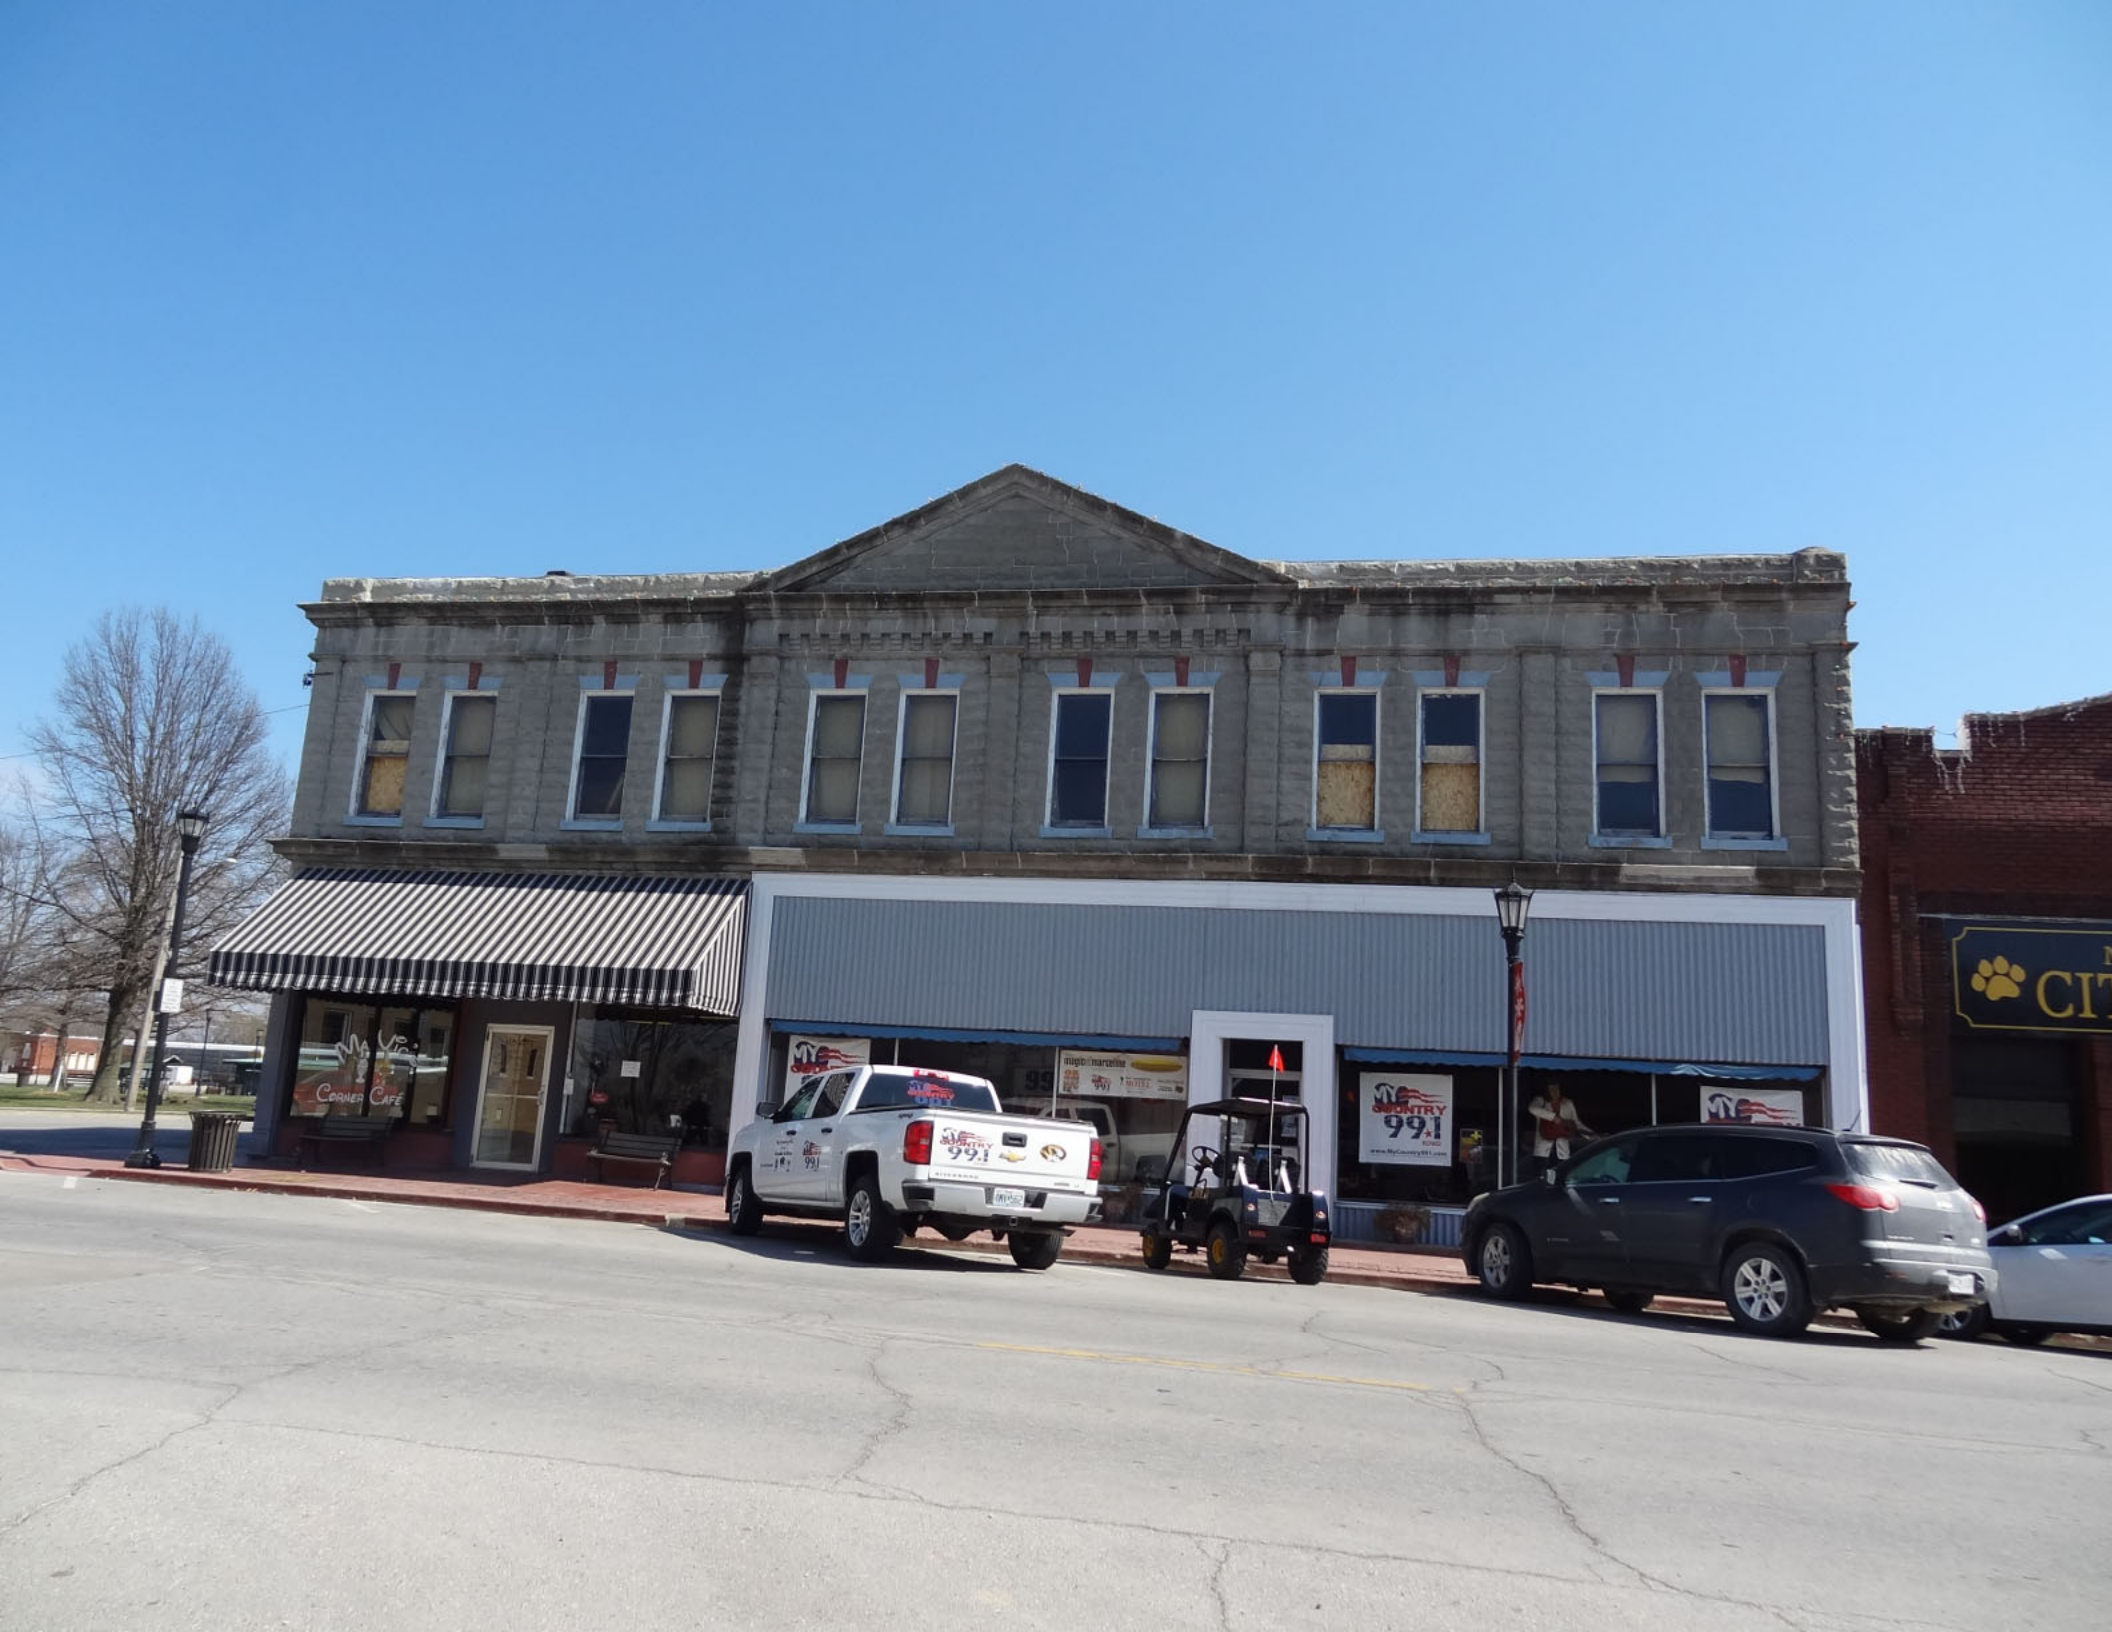
This 2 story, flat-roofed building is clad in concrete made to look like rough stone. A stone belt course divides the 1st and 2nd stories. Alterations on the facade created 2 distinct storefronts, one twice as large as the other, making up 6 bays. None of the windows and doors on the 1st floor are original. The 1st storefront (Ma Vic's Cafe) holds large storefront windows to either side of a single door. It is sheltered by a canopy below the belt course. The 2nd storefront has a bay of 3 large storefront windows, followed by a single door, then 3 more large windows. Above (up to the belt course) and below these windows the building is clad in metal. 12 original symmetrically arranged 1-over-1 sash windows are located in the 2nd story. They have flat baby blue lintels with a red center stone and baby blue sills. A pediment is centered at the roofline with dentals below. Pilasters are located at each corner and between pairs of windows. The north side of the building's 1st floor facing Ritchie holds 5 covered or partially covered windows, followed by a non-historic door (reached via 3 concrete steps), another partially covered window opening, an early door, 3 covered or partially covered openings, another non-historic door, and at the west end, 3 large windows associated with the cafe. There are 14 more historic windows in the 2nd story, along with 2 more pediments, all of the same style as the facade. The rear of the building has 7 windows on the 1st floor and 6 on the 2nd, all covered in plywood and with simple lintels and sills. An entrance to the basement is reached from the rear by set of narrow stairs.

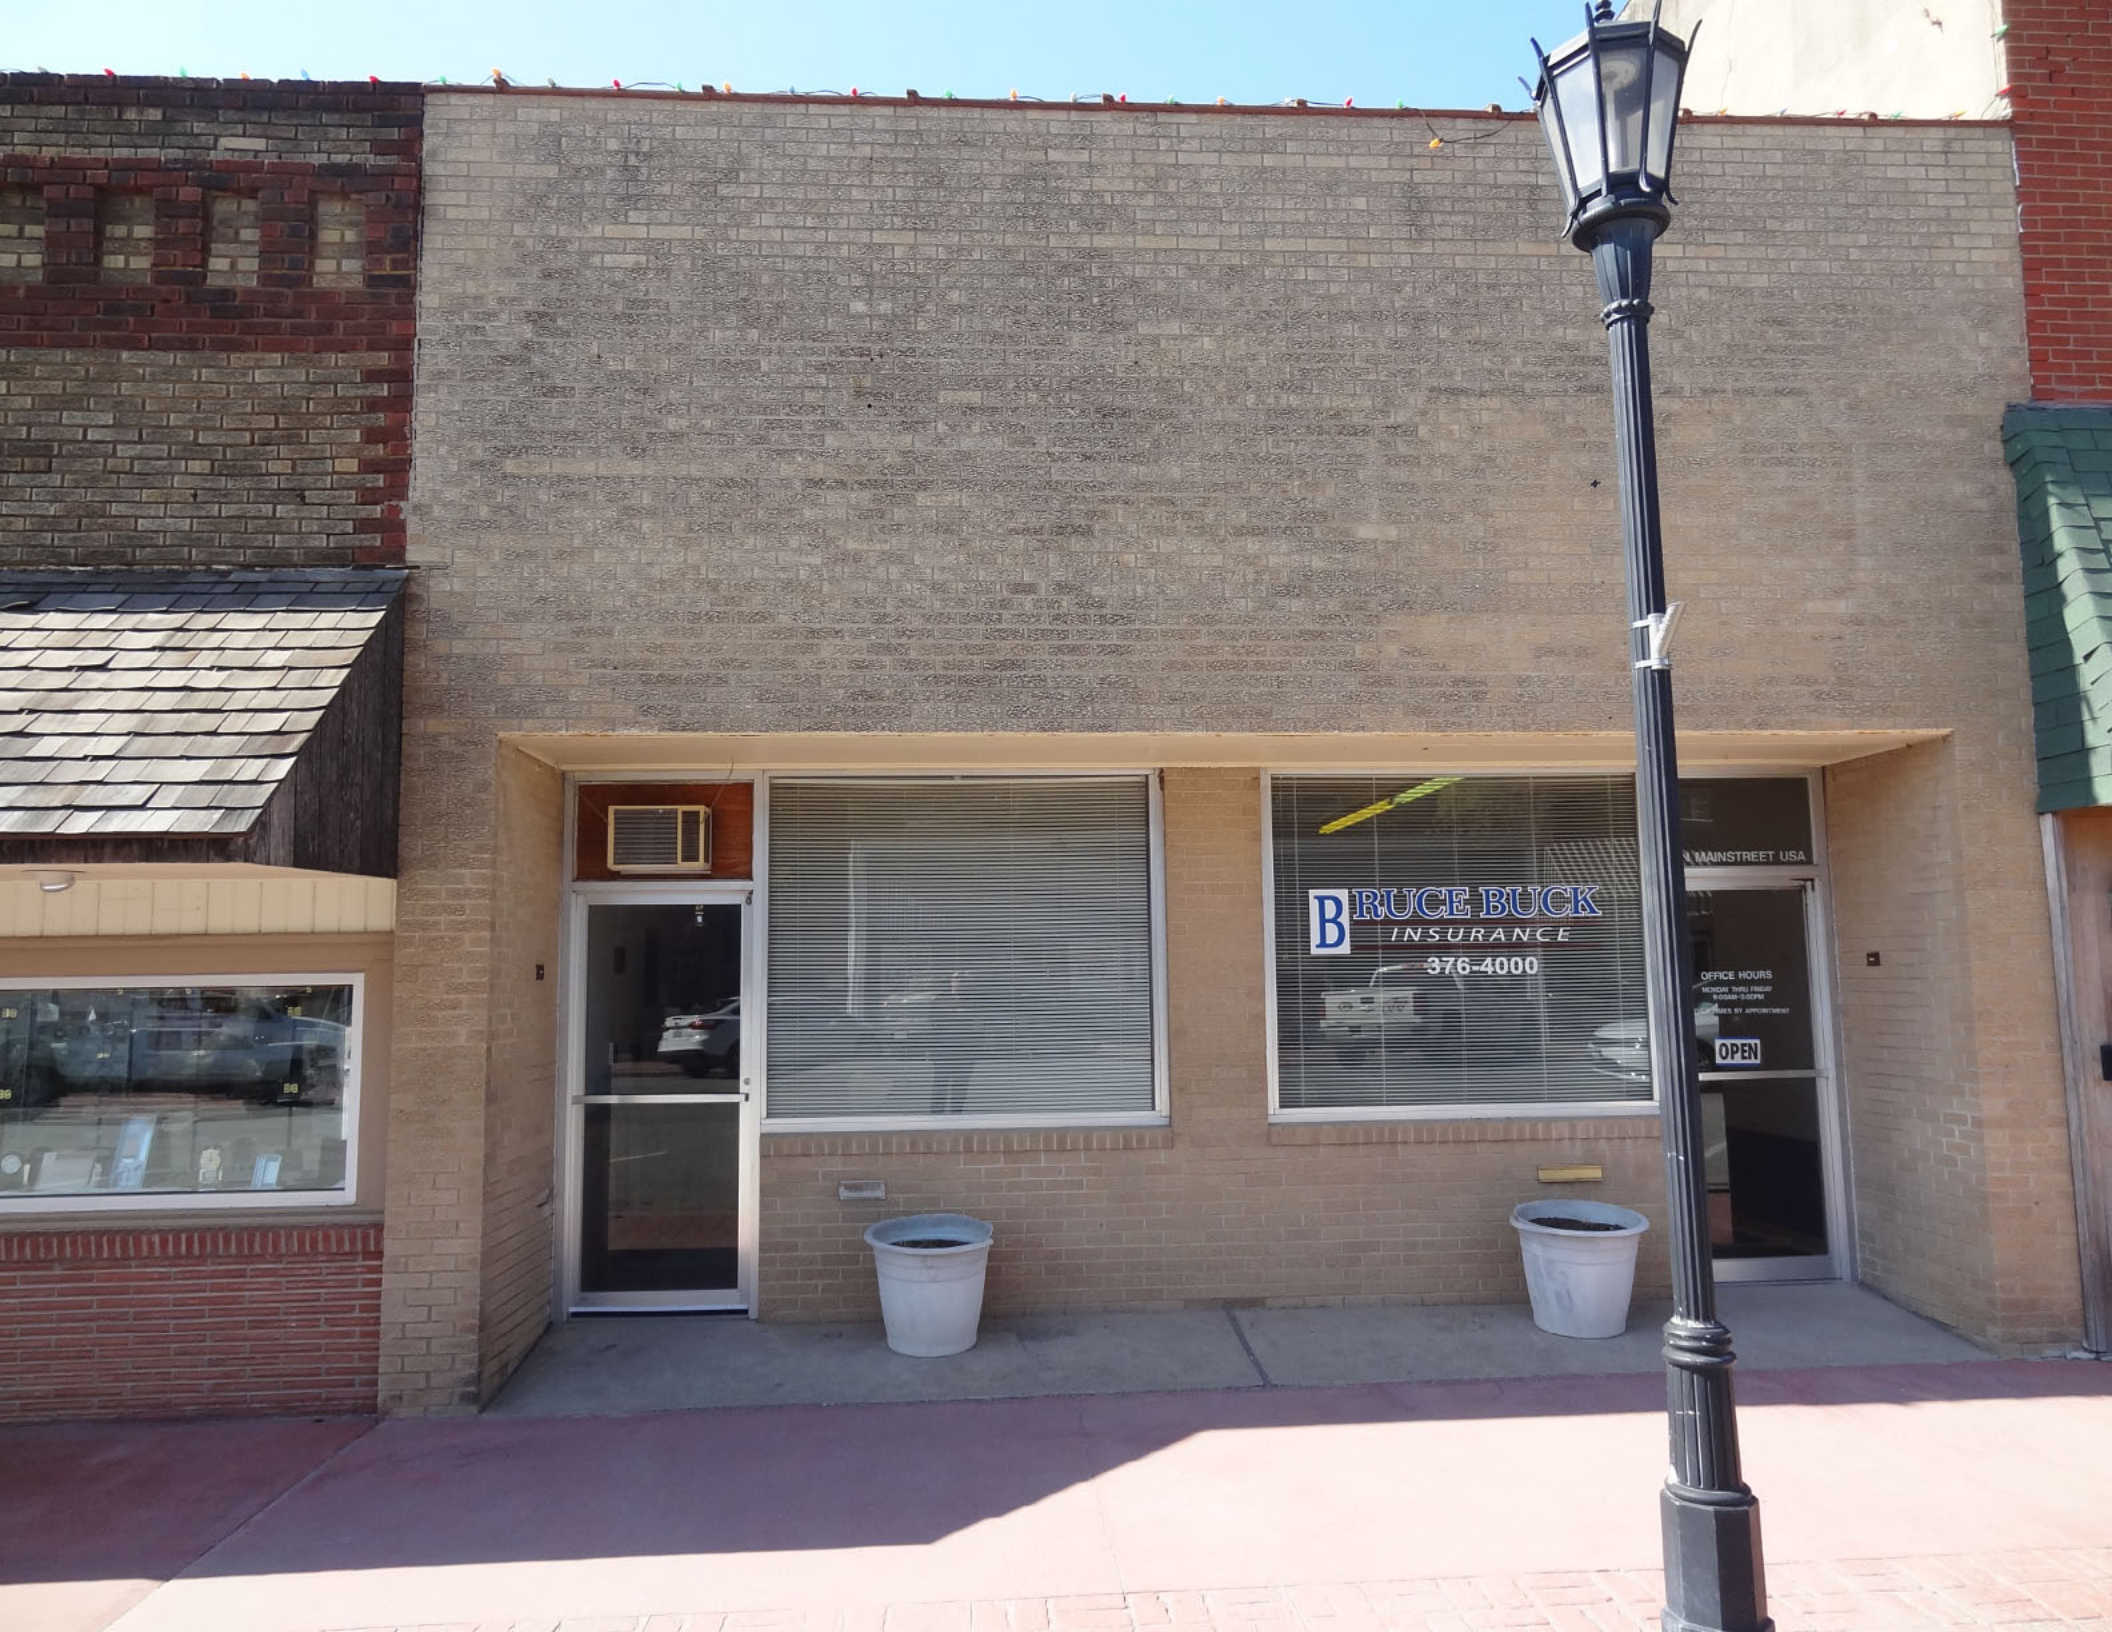
This is a one-story brick commercial building. The building has four bays in the storefront. Starting on the south side the first bay has a single glass aluminum frame door with a small transom window above, the transom window is infilled with an window air conditioning unit. The next bay has a single fixed aluminum frame window that is resting on a brick knee wall. There is a small brick partition between the second and third bay. The third bay from the south also has a single fixed aluminum frame window with a brick knee wall. The northernmost bay has a single glass aluminum frame door with a small transom window above. The storefront is inset creating a covered area. The area above the storefront is a solid blonde brick wall with out ornamentation or decoration. The top of the parapet wall is capped with a thin clay tile.

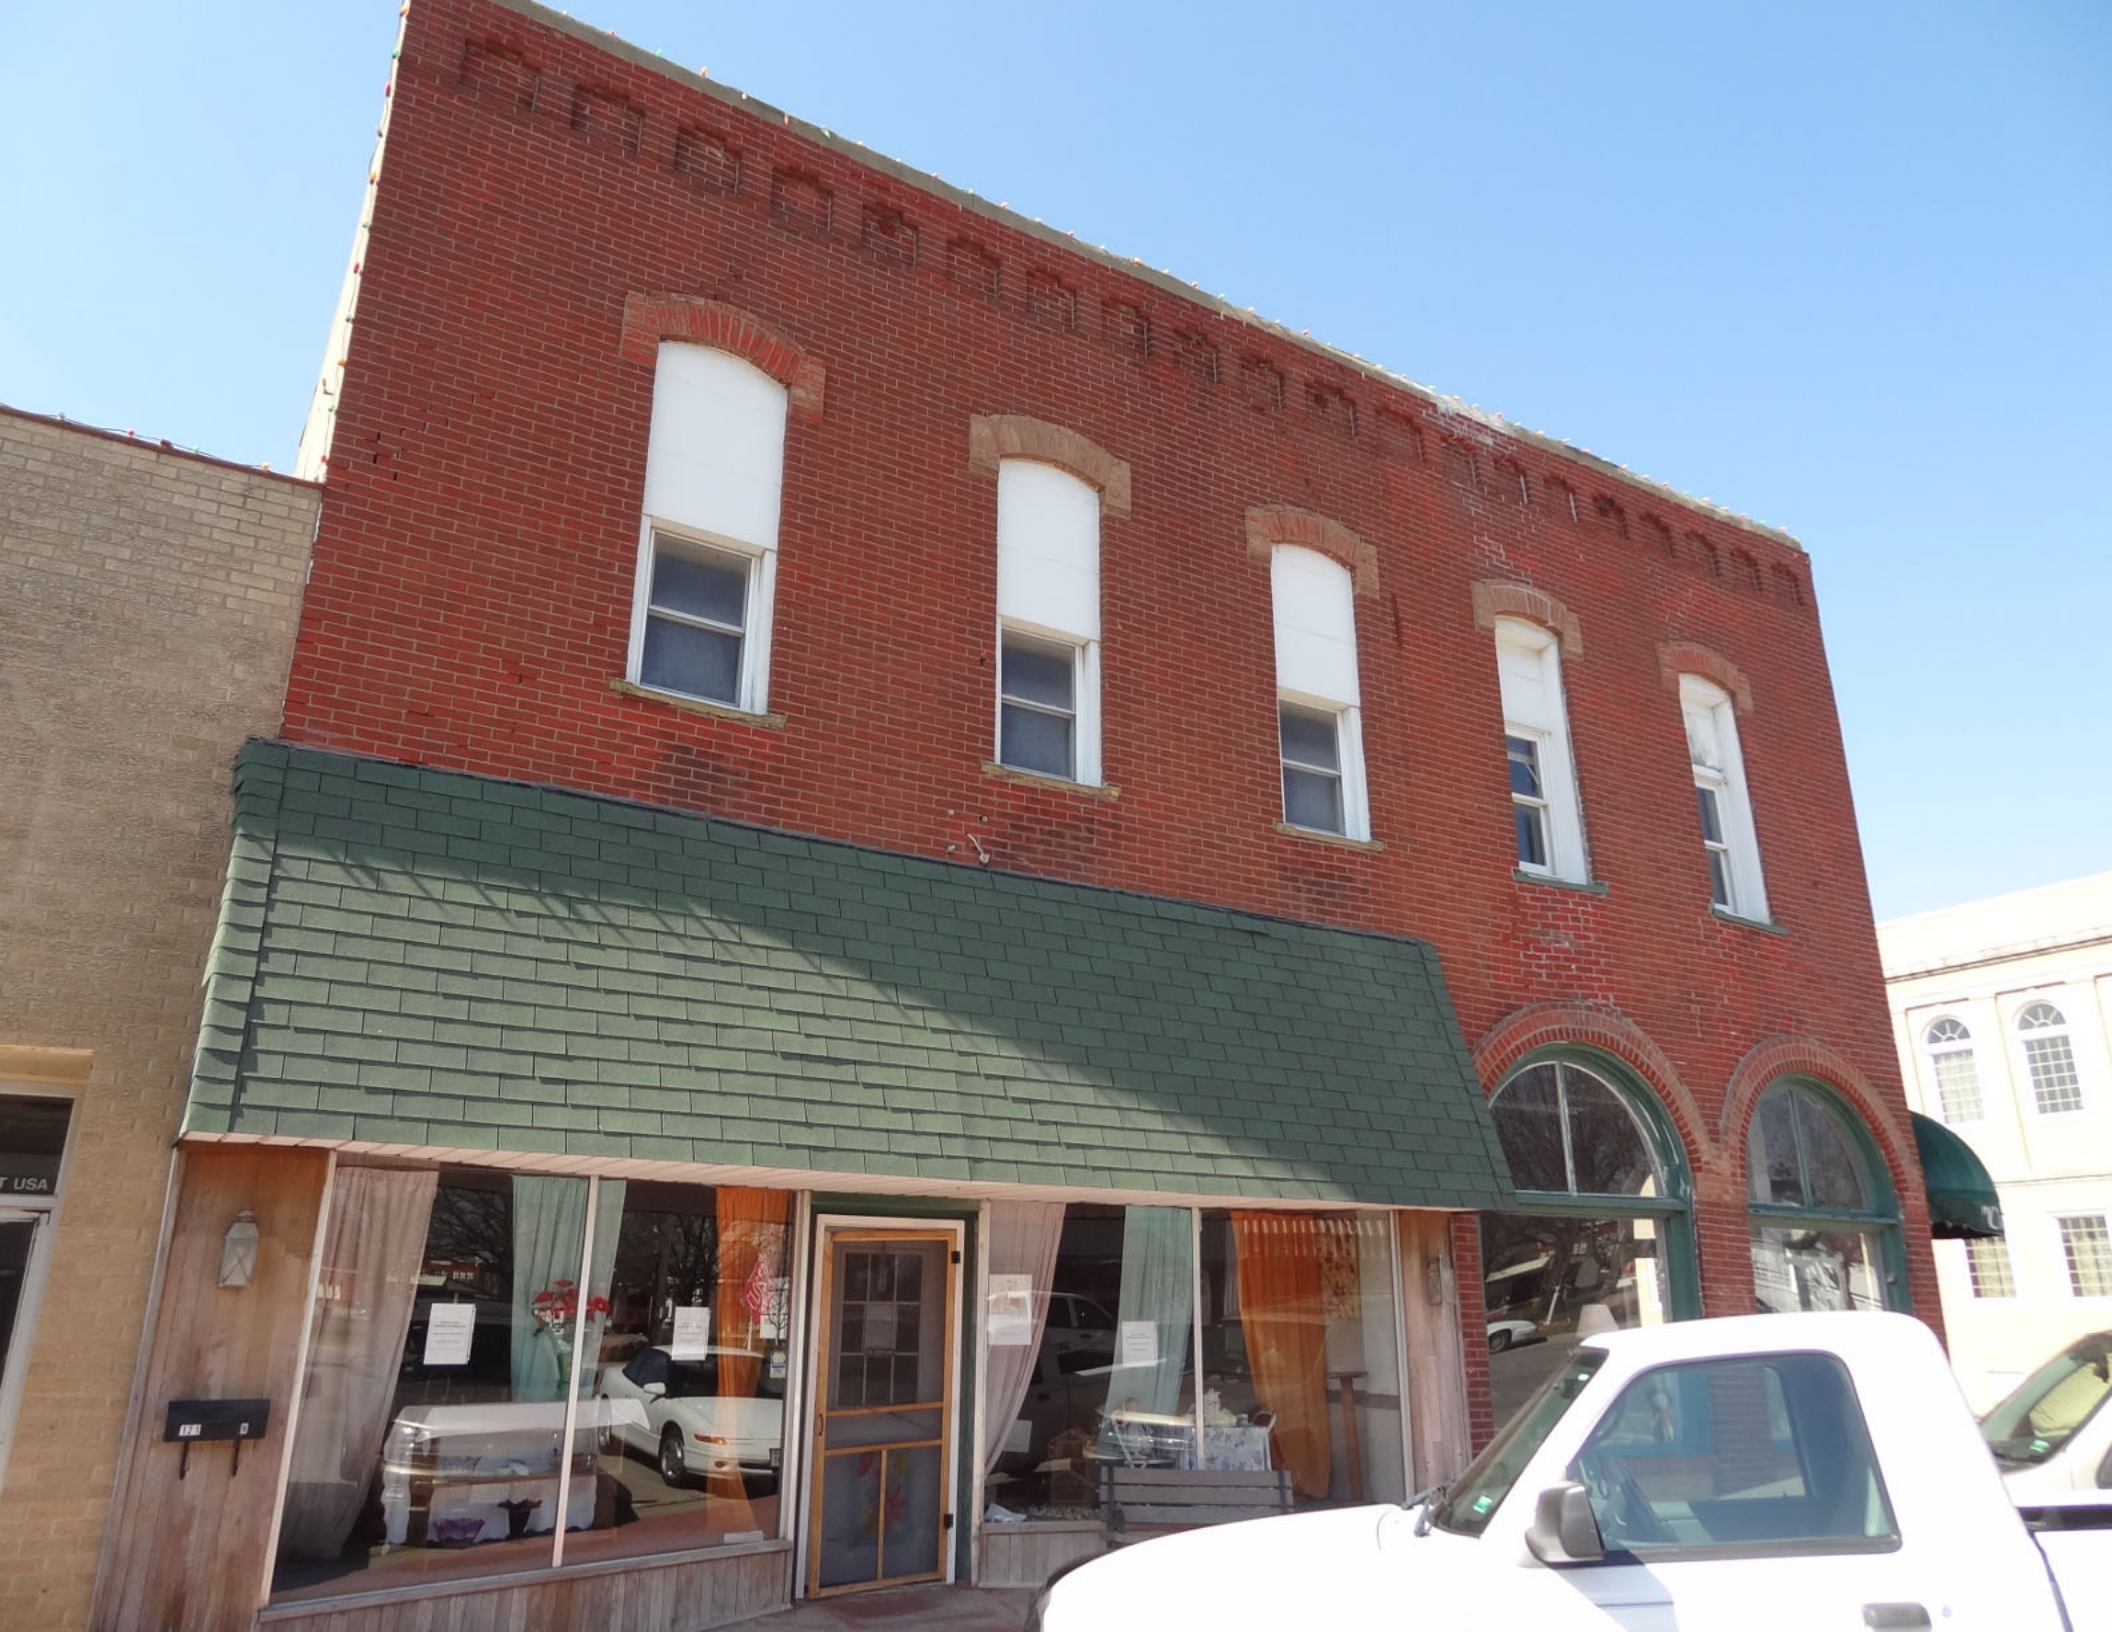
This flat-roofed, red brick 2-story building's SE facade faces Main. A 1st floor storefront is sheltered by an asphalt shingled awning below which are 2 large windows cantilevered in on either side of a single door (all not original). Under the awning the building is clad in vertical wood siding. To the right the cladding ends & there are 2 historic arched windows with 1 large lower pane and 2 upper panes that align with the window's arch. Beneath are rowlock brick sills. The arches have 2 rows of rowlock brick and 1 row of header brick. Below them is beige brick. In the 2nd story there are 5 1-over-1 replacement windows with upper infill & arched lintels. A recessed entrance is canted at the corner of the building with a window to its left in the recessed wall. The single door, sheltered by a domed canopy, is non-historic; above is an arched transom. Above this is a sign reading "ZURCHER" surrounded in beige header brick below paired nonhistoric windows. Above these is a carved sign that reads "Marceline Lodge No. 172 Knights of Pythias." The NE facade faces Ritchie. The first bay houses another large historic arched window. Following, all with arched brick lintels, are 2 3-paned windows, a single door, another 3-paned window, and a single door, all non-historic. 4 non-historic 1-over-1 windows are in the 2nd story, with upper infill. Along the roof line the brickwork is recessed to form simple geometric detailing. A 1-story portion of the building is located at the rear. It has no openings but is painted with a large Coca-Cola mural. The rear elevation is visible from the alley.

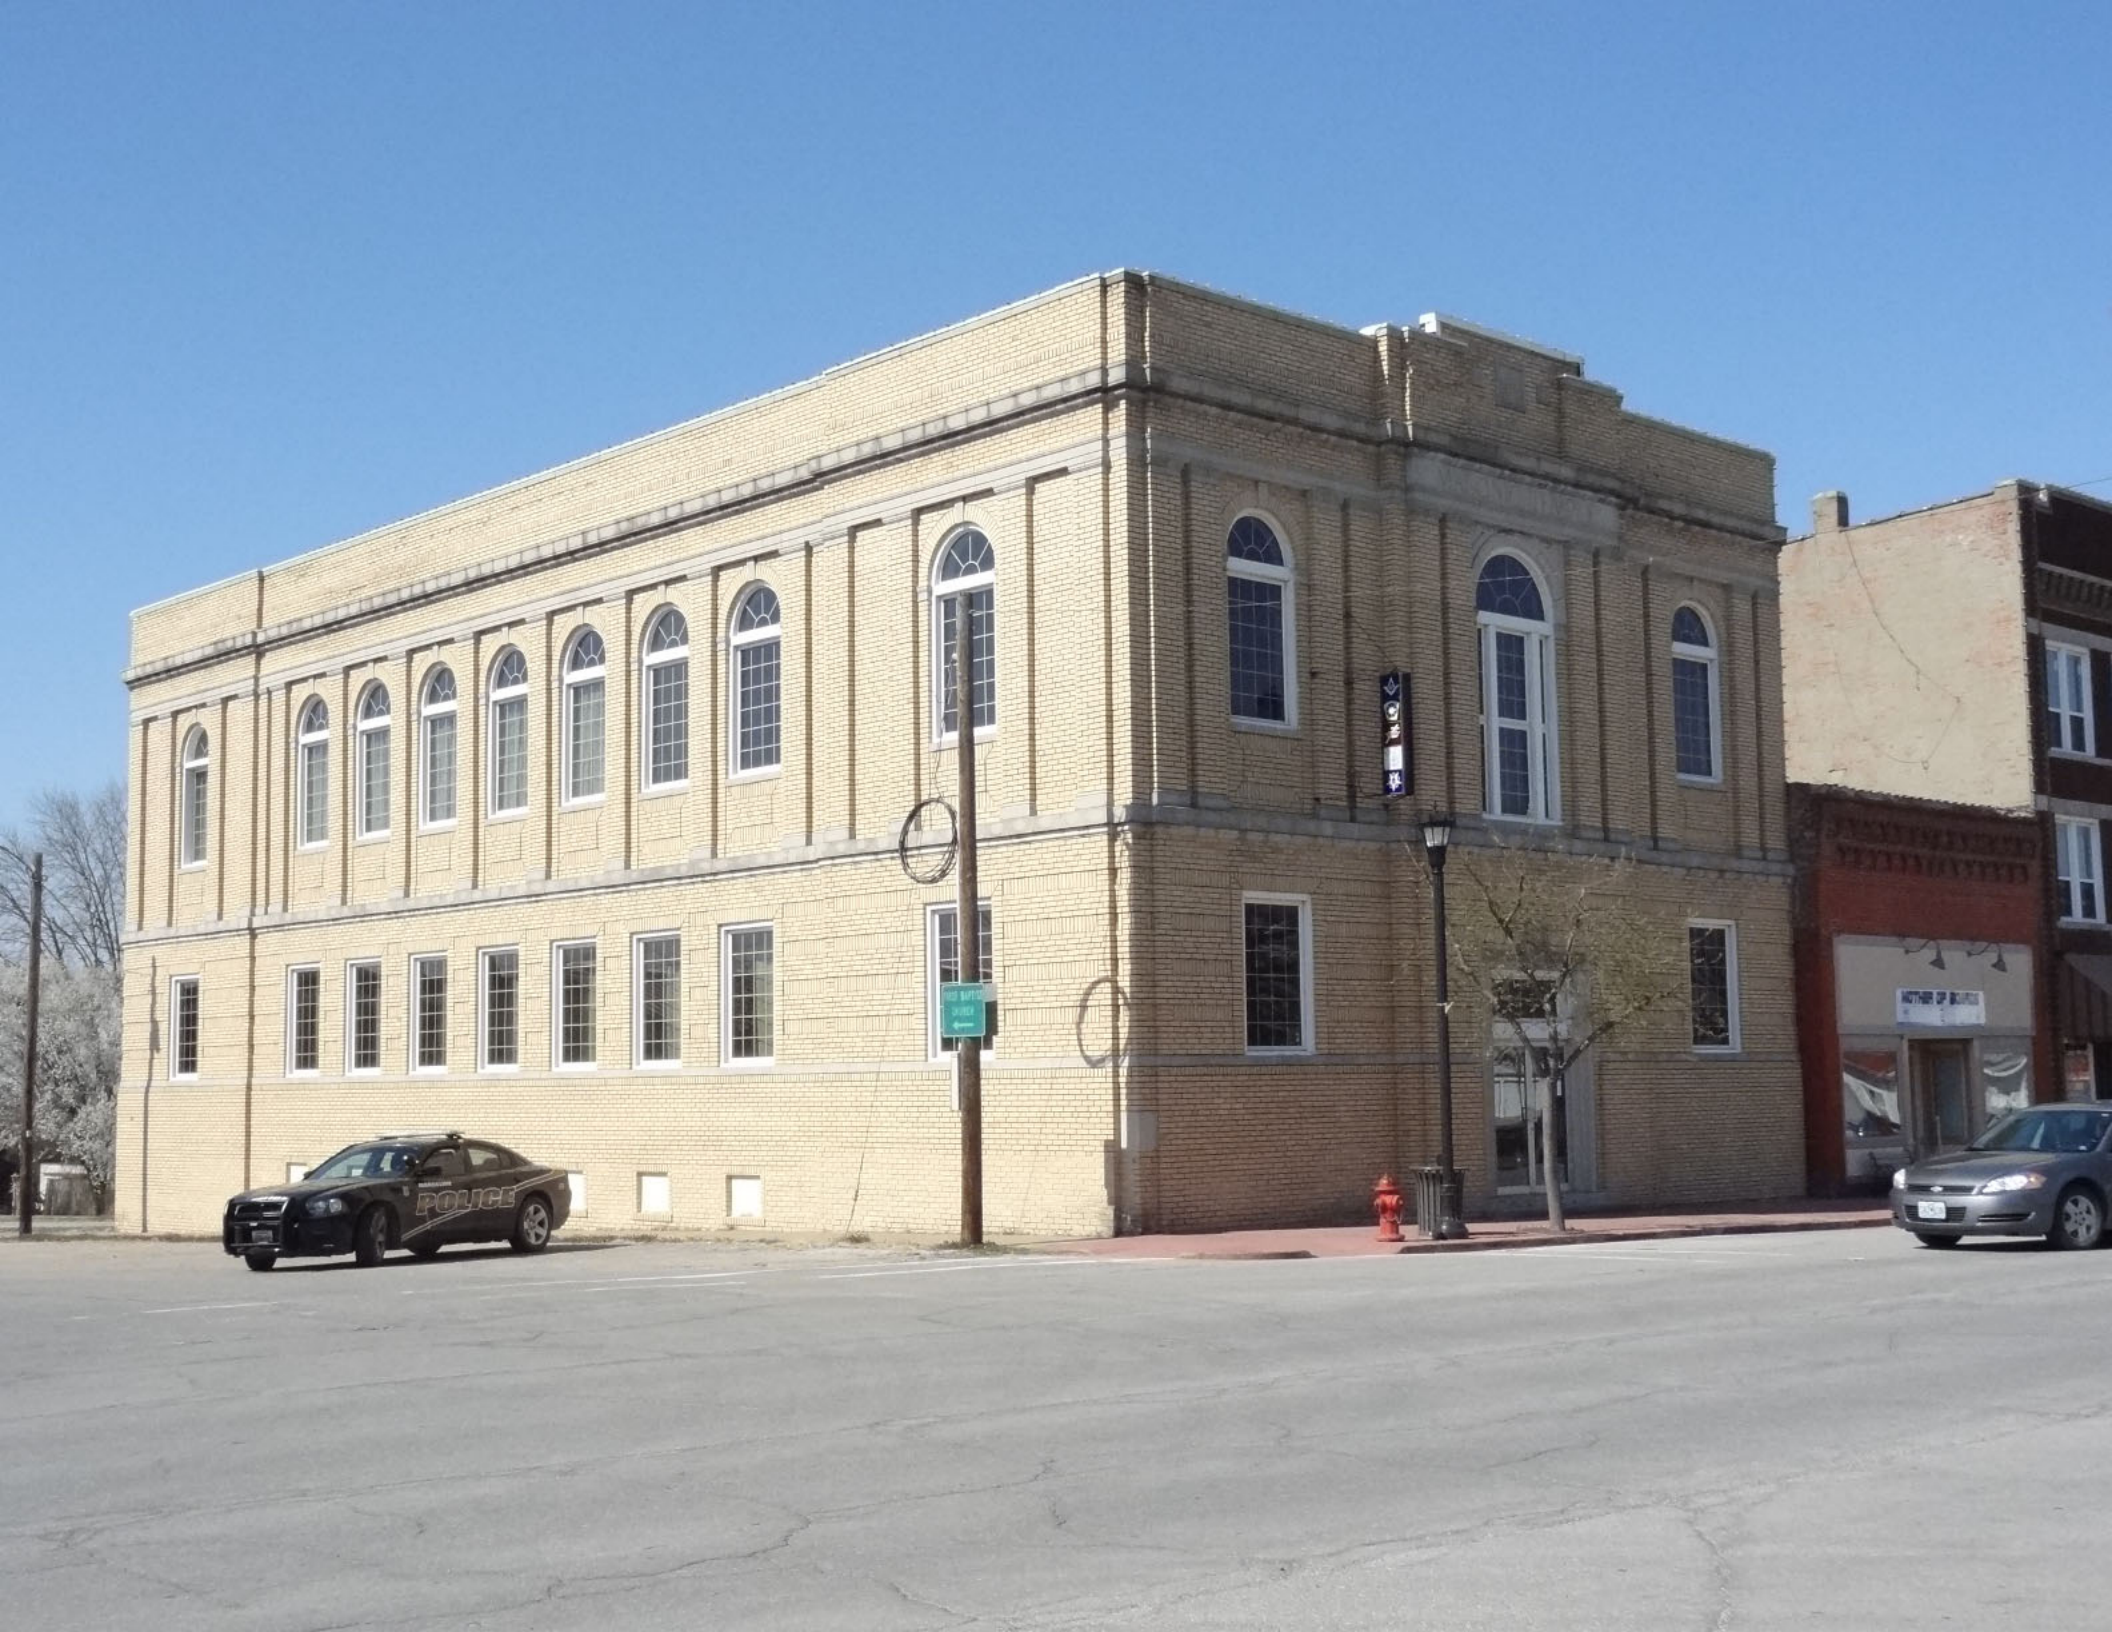
The second story starting at the southern end there is a centrally located arched window that is fixed fanlight window above a multi-pane fixed vinyl window. The central bay also has a large arched window opening the window has a fanlight above a large multi-pane windows. The northern bay has a window similar to the southern bay.

The central bay has a sign above the second story window that has "MASONIC TEMPLE" inscribed on it.

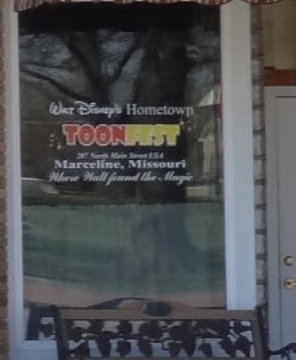
This is a one story commercial brick building. The building is symmetrical with a recessed central entry. The door is metal with nine-lights in the upper portion. On both sides of the entrance there is angled wall with a single shutter in place of windows with a wood knee wall. Moving further out from the center there are two fixed storefront windows that are framed with wood again with a wood panel knee wall. This storefront appears to have been replaced c. 1990. The original metal storefront columns are present at the point where the front walls meet the recessed angled wall portion the placement of these iron columns suggest the pattern of the storefront is original. Above the store front the area where a clerestory window likely was placed has been covered by a large wood pane with two metal lights. There is also a sign that reads "MOTHER OF BOARDS".

Above the clerestory window there is a brick portion that creates a parapet. The brick in the parapet has double arcaded corbeling and the parapet is capped with a small band of metal flashing.

This property lacks the significance necessary for individual listing in the National Register. The storefront has been considerably altered. Collectively, this area does not appear to be eligible for listing as a historic district due to an overall loss of integrity, thus this property is noted as not eligible.

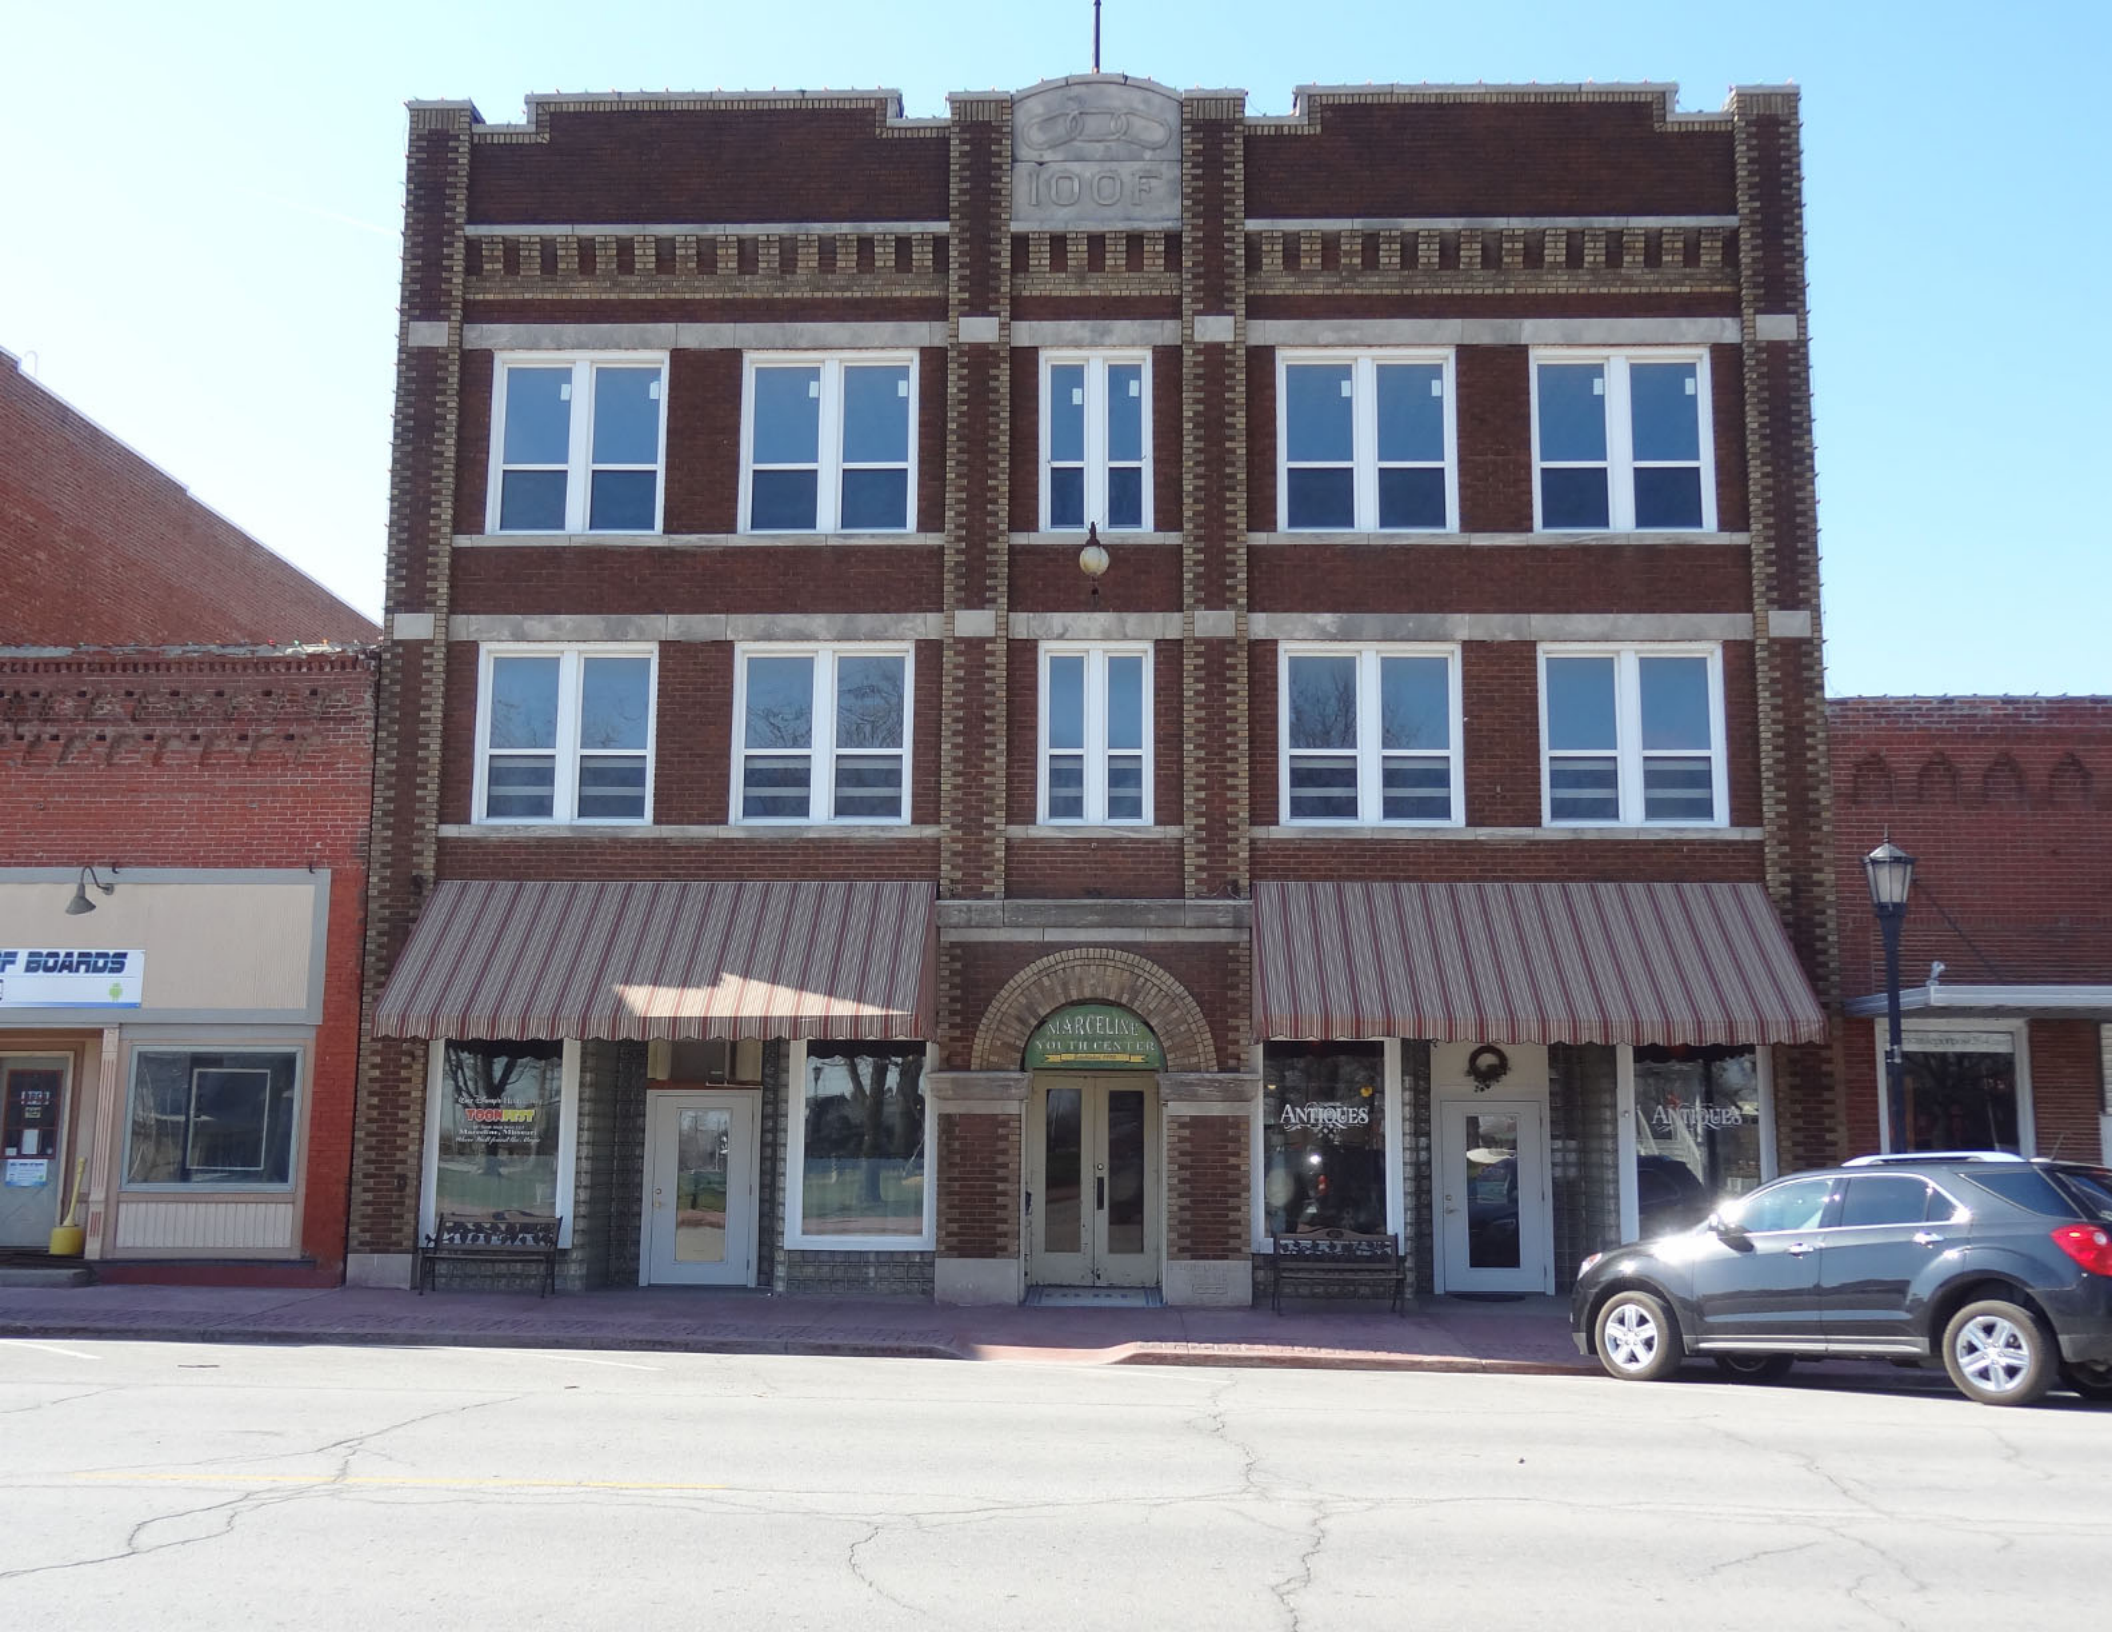
This is a three-story brick building with a flat roof. This building is organized into three main bays there are pilasters on each end of the building. There are also pilasters on each side of the central bay. The building is red brick with decorative buff brick patterns. The building has two storefronts each store front is identical they are located on the north and south sides of a central entrance. The storefronts have glass-block walls the with three bays the central bay is the entry. Each has a wood door with a large window. The doors are flanked by large fixed windows. There are cloth awnings above each store front. The central entry is located in the central bay of the building. This door is recessed behind an arched brick entry way with a sign in the arch that reads "Marceline Youth Center Established 1990". The doors are wood with large windows. On either side of the door there is a brick column the bottom of the northern column has the date stone.

The second and third stories are identical, from the south there are two paired one-over-one vinyl windows the central bay has a pair of narrow one-over-one windows. The northern bay has two paired one-over-one vinyl windows. There is a wide stone lintel and a narrow sill under each band of windows. There is a stepped parapet with concrete capping. In the center bay of the parapet there is a sign inset that reads "IOOF". There is also a historic light between the second & third floors in the center bay.
