MISSOURI DEPARTMENT OF NATURAL RESOURCES  
STATE HISTORIC PRESERVATION OFFICE, P.O. Box 176, Jefferson City, MO 65102  
**ARCHITECTURAL/HISTORIC INVENTORY FORM**

1. SURVEY NO. LI-AS-001-001		2. SURVEY NAME: Marceline Survey	
3. COUNTY: Linn		4. ADDRESS (STREET NO.) 275	STREET (NAME) West Broadway
5. CITY: Marceline	VICINITY: <input type="checkbox"/>	6. UTM: / /	7. TOWNSHIP/RANGE/SECTION: T: R: S:

8. HISTORIC NAME (IF KNOWN): Walt Disney's Childhood Home		9. PRESENT/OTHER NAME (IF KNOWN): Walt Disney's Childhood Home	
10. OWNERSHIP: <input checked="" type="checkbox"/> PRIVATE <input type="checkbox"/> PUBLIC		11A. HISTORIC USE (IF KNOWN): Single Dwelling	11B. CURRENT USE: Single Dwelling
<b>HISTORICAL INFORMATION</b>

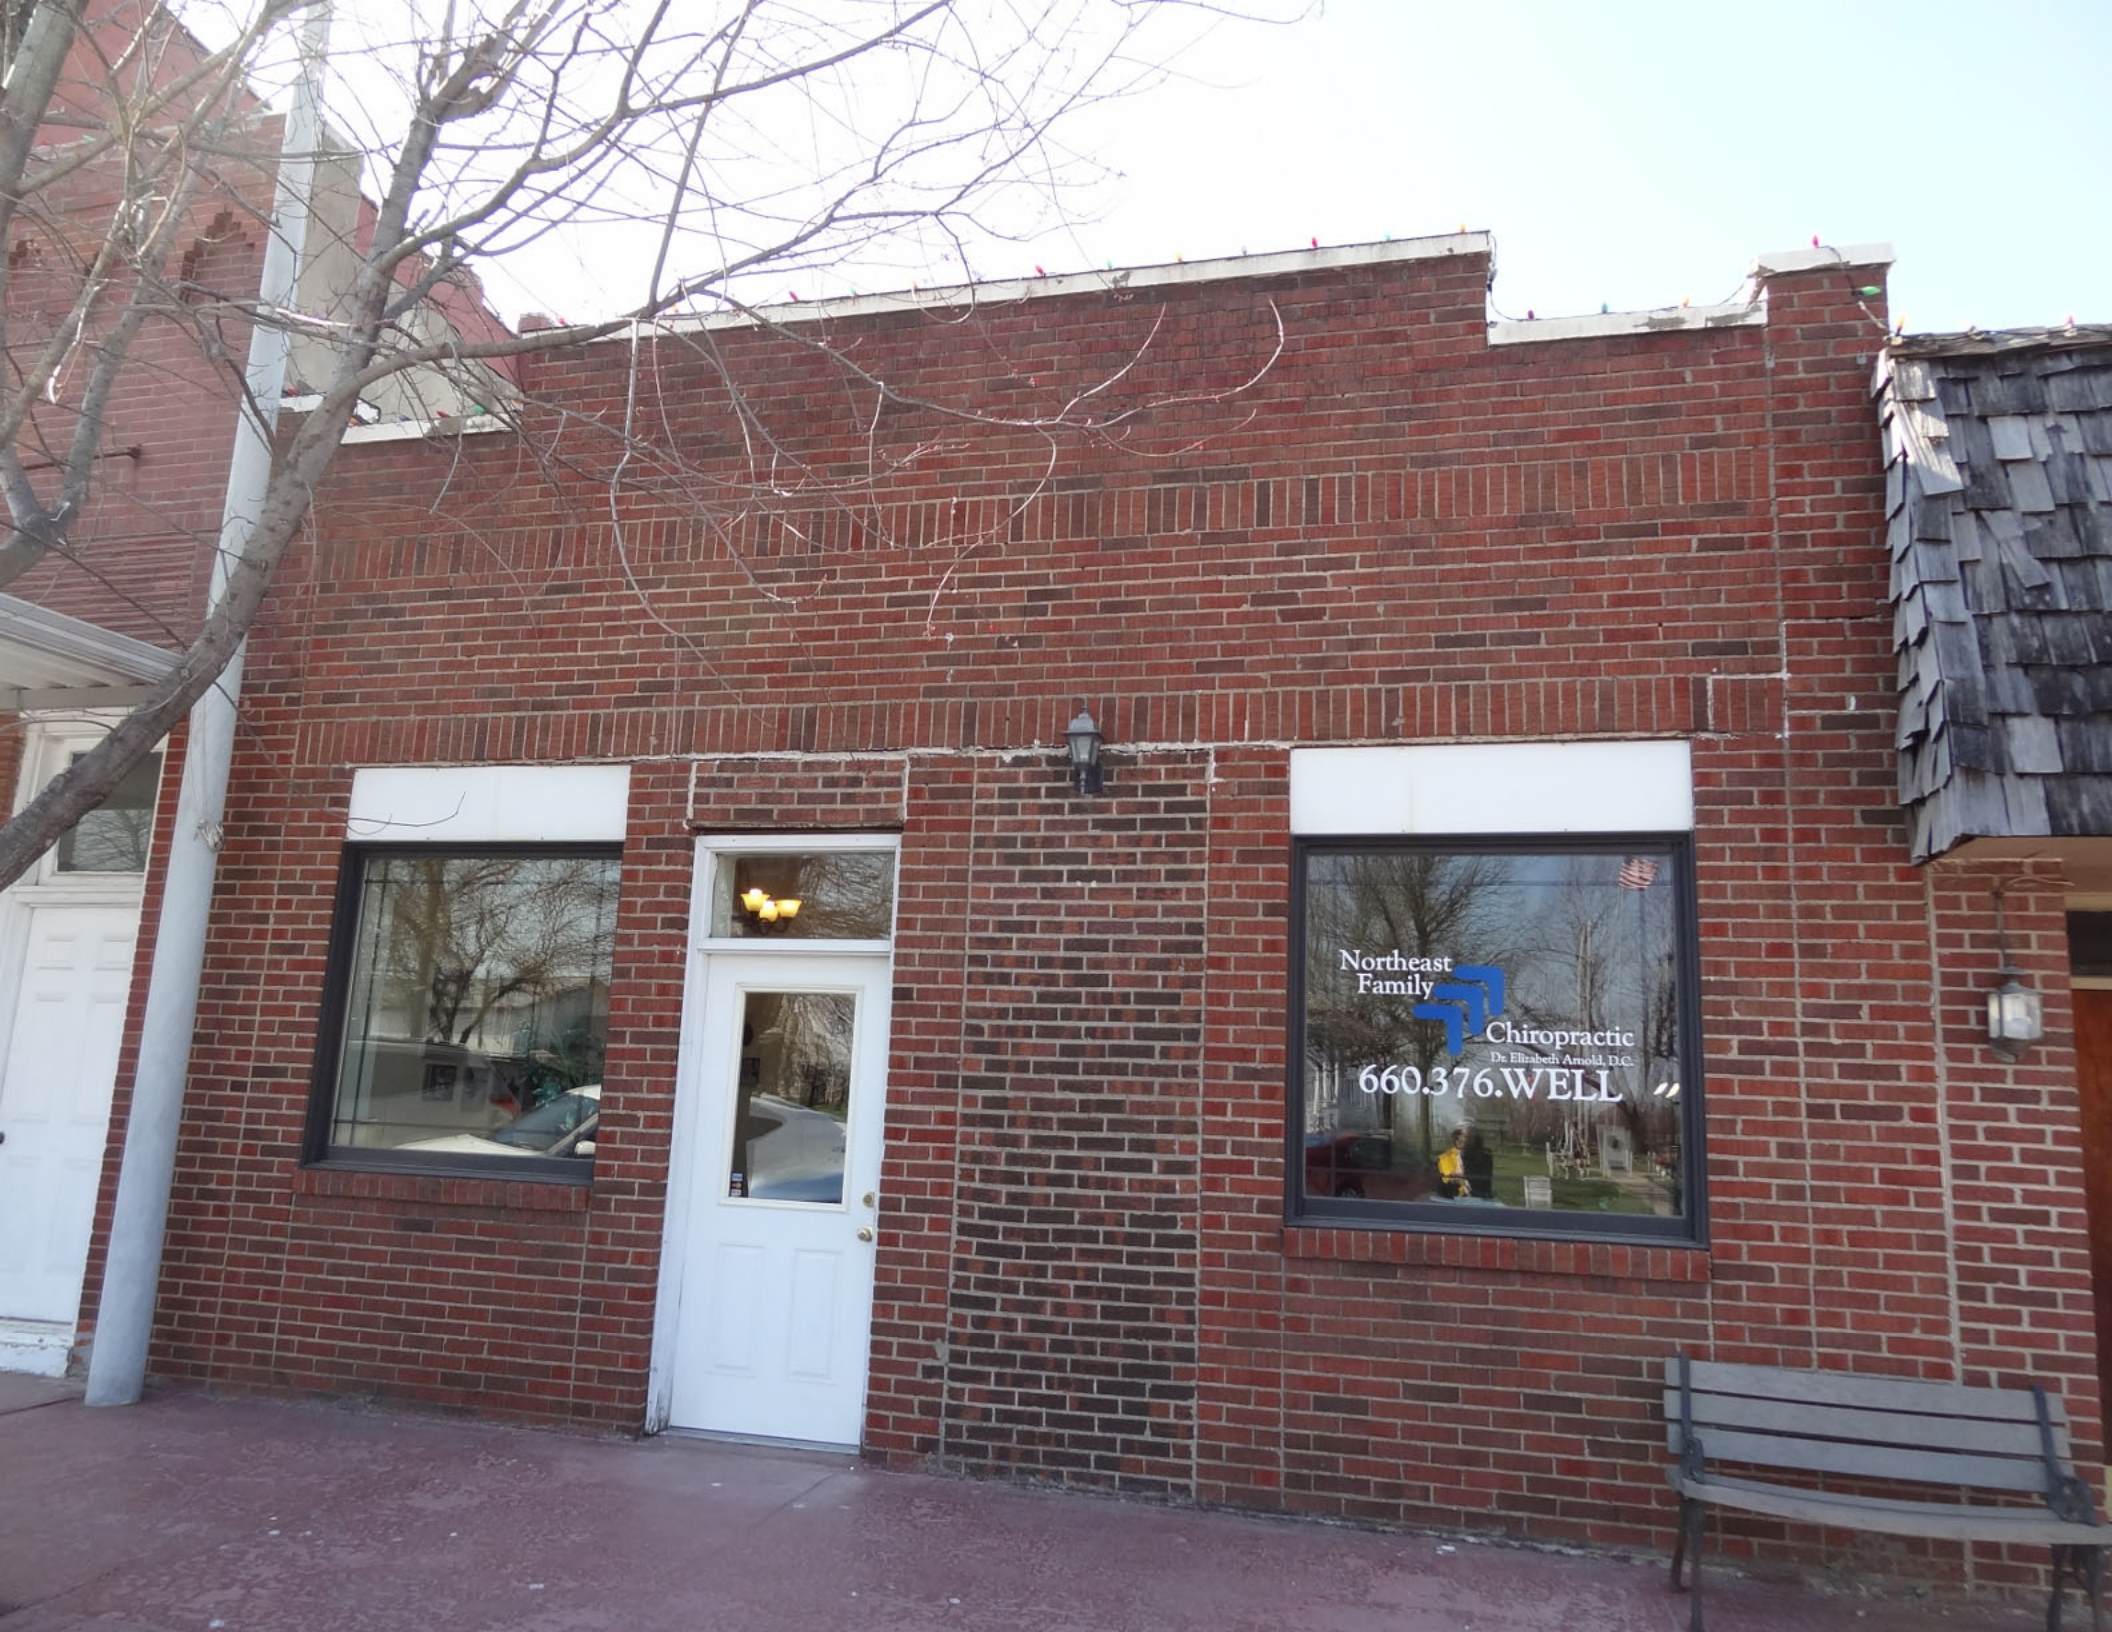
This is a simple one-part commercial block building with brick cladding and a flat roof with a parapet with metal coping; the parapet has a taller central portion and is also raised, though less so, on either end. There are three bays: the first and third are two single-paned non-historic windows; they do not completely fill the original window openings and the extra space has been infilled with vinyl. Two door ways had been centered on this facade. One has since been infilled with brick and the other filled with a modern door with transom that is still smaller than the original opening (the extra space has been infilled with brick). The windows have rowlock brick sills. Above the windows there is a row of soldier brick, then 10 rows of brick in running bond followed by another row of soldier brick. The changes to the storefront occurred some time after the early 1950s.

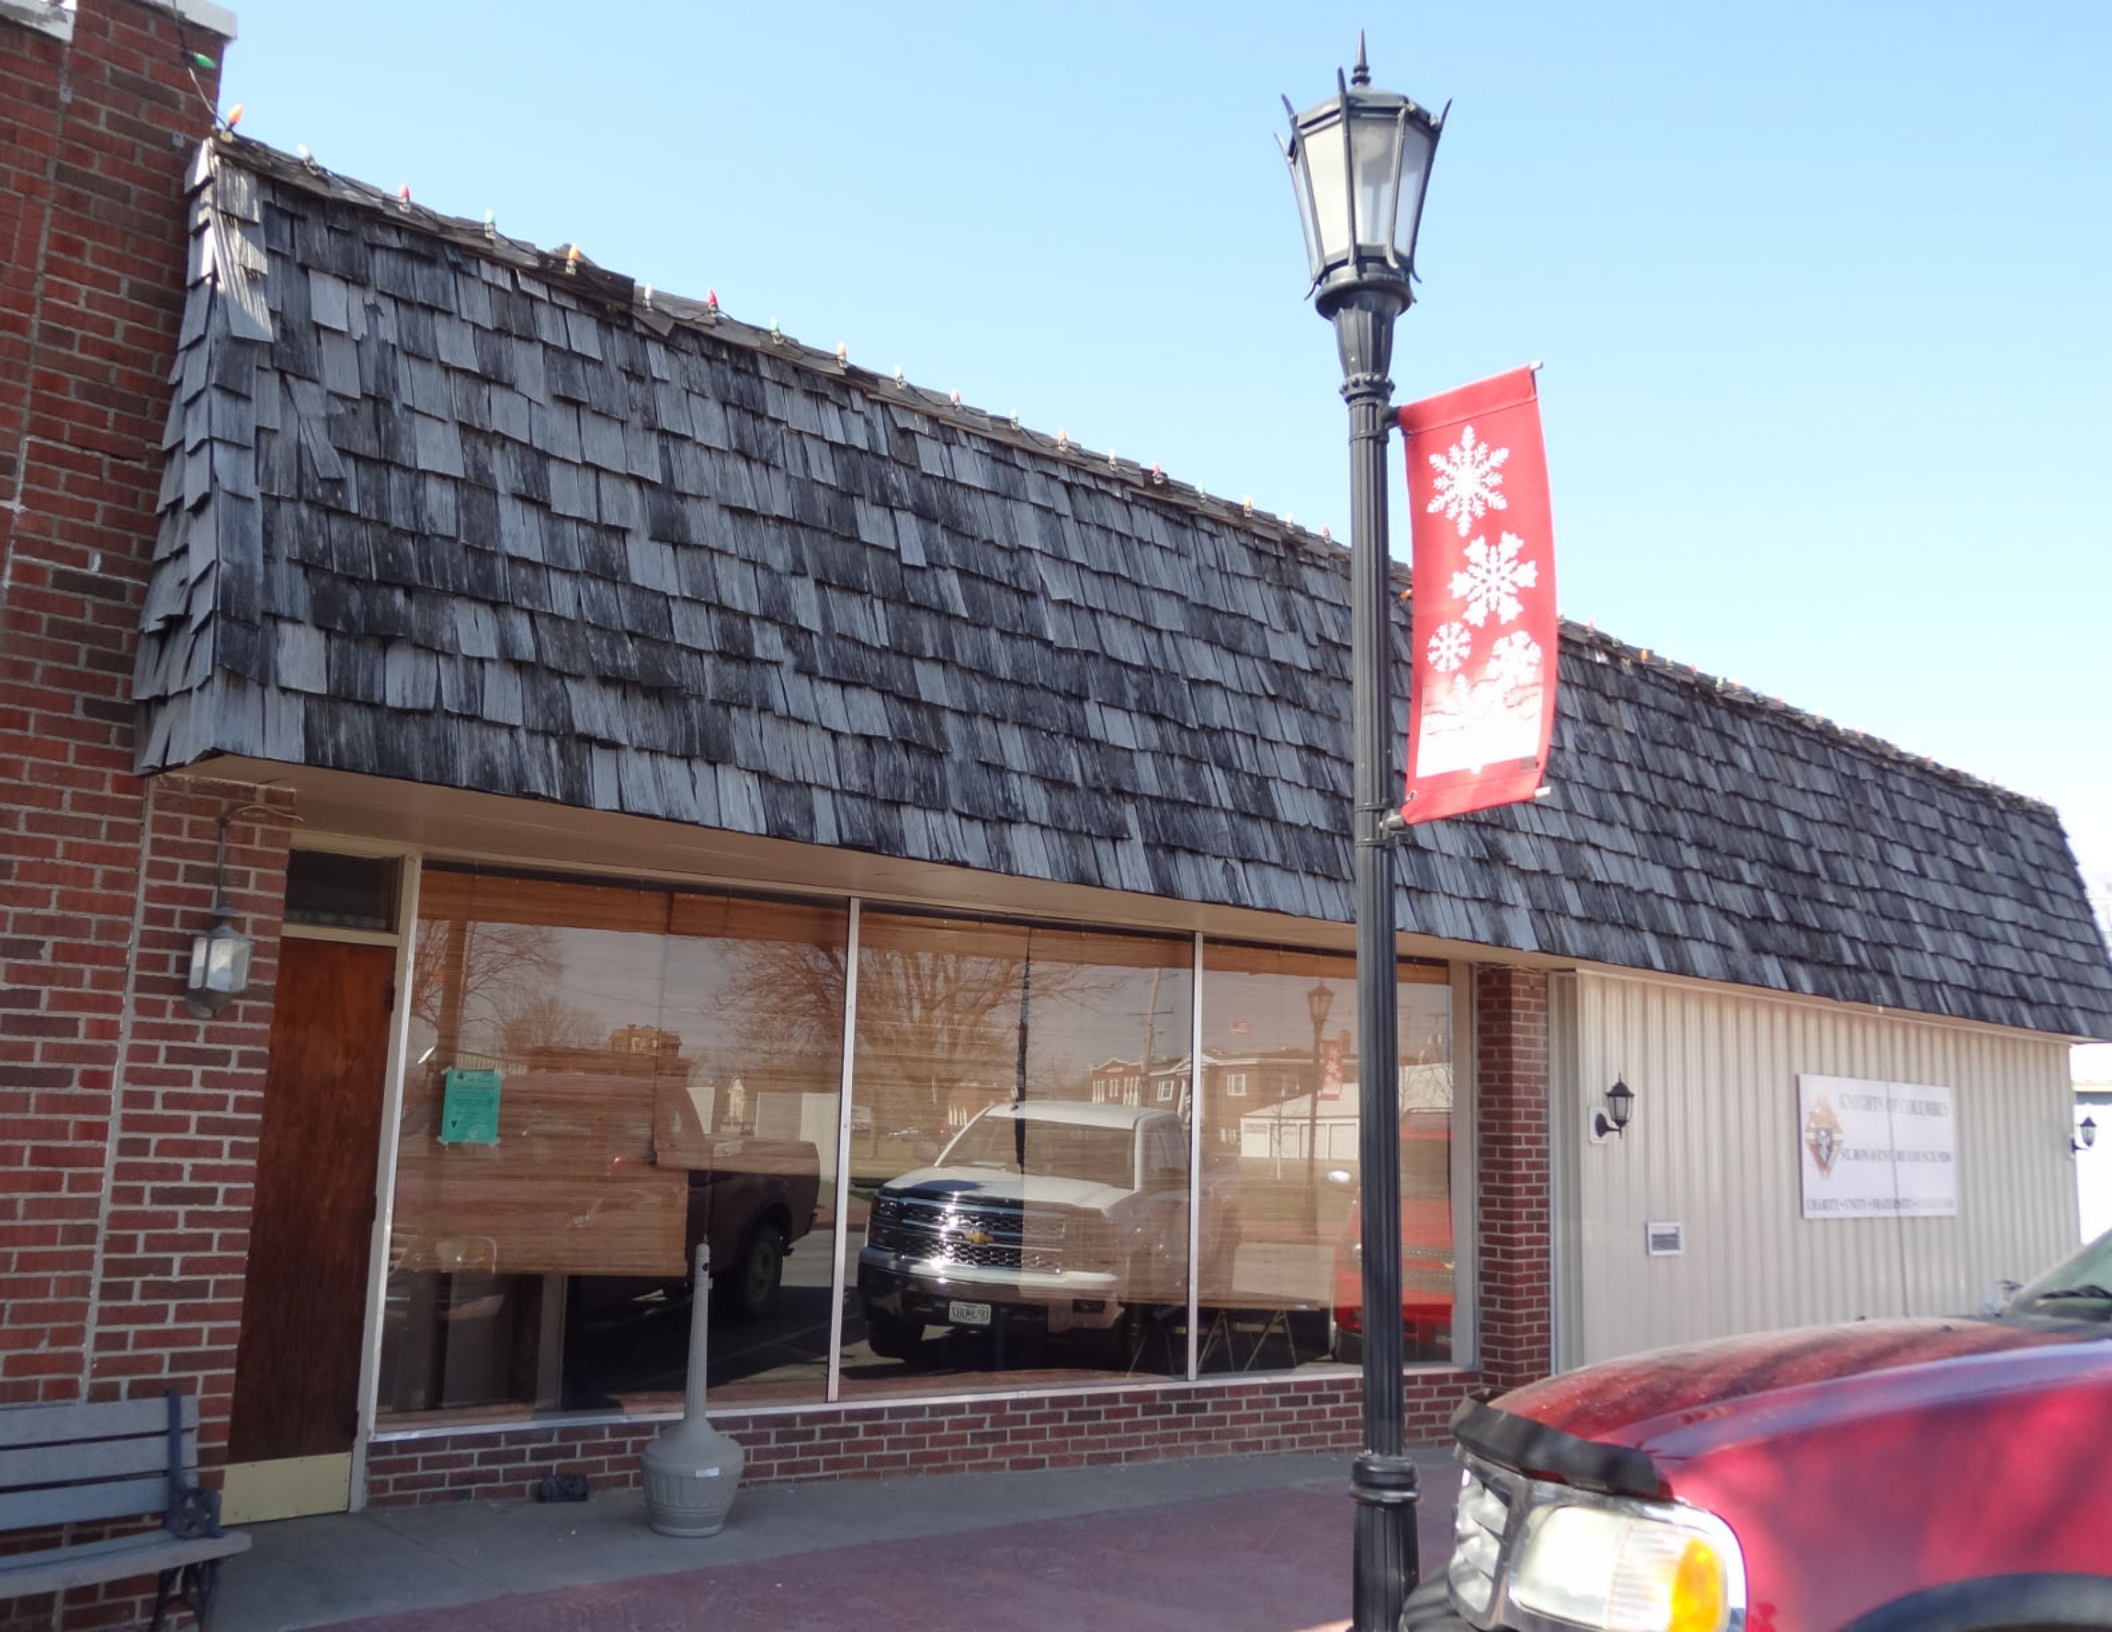
This one story commercial block building is clad in brick, but most of the building has been covered in metal siding. The southwestern (left) half of the facade still has brick cladding but is dominated by a single wood door with transom which abuts three large storefront windows. The door and windows may be date to the 1960s or later. The northeastern (right half) of the facade has been clad in metal and has no openings. The top third of the facade has been clad in wood shingles. The northeast elevation is visible from N Main Street; it has an attached gable metal roofed pavilion supported by square wooden posts and half walls that are also clad in metal. The pavilion can be entered via a single metal door.

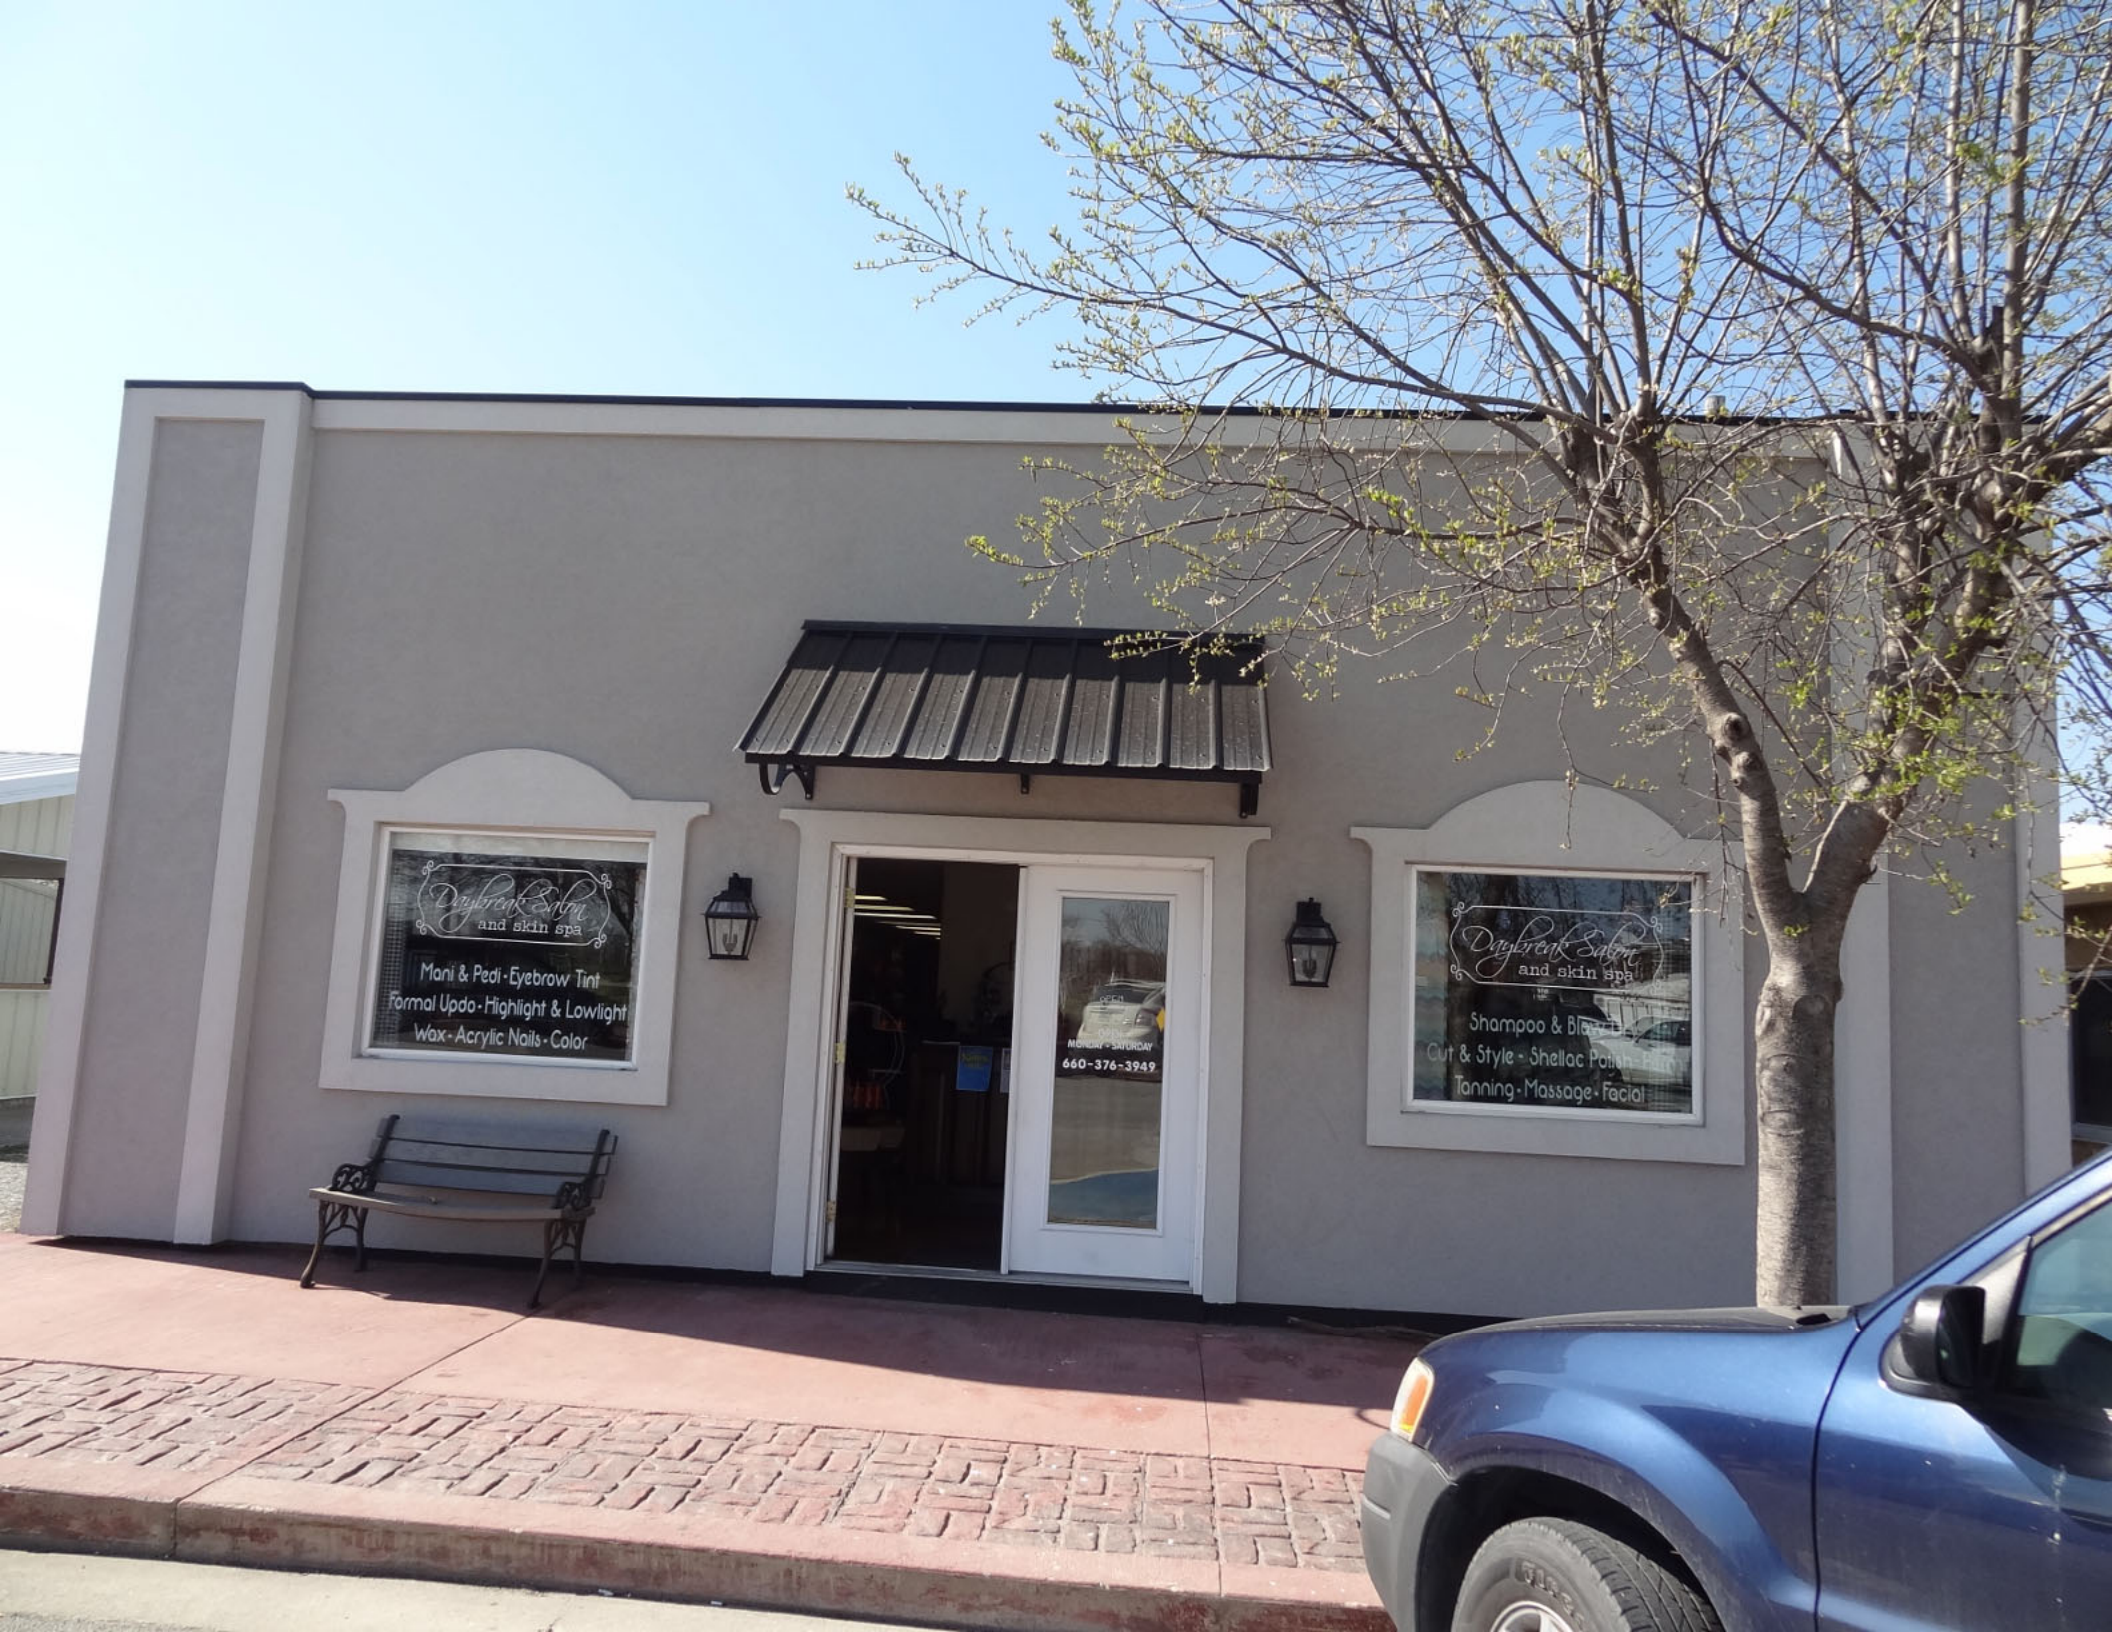
This building's facade, a false front, is stuccoed. The stuccoing was redone or painted between 2008 and 2014. It is likely a relatively modern building with modern windows and doors. The building is symmetrical with two single-paned storefront windows on either side of a double door entry. Above the entry is a short metal canopy. The northeast elevation faces California Ave and is clad in metal with a single double door entry that is not level with the ground (no stairs lead to the entry). The site slopes down towards the rear of the building, exposing the concrete foundation. There are no openings in the rear elevation, which is also clad in metal. The southwest elevation is visible from the green space between this building and 217 N Main. It has a single door entry that is also not level with the ground; there are no stairs to provide access to this door.

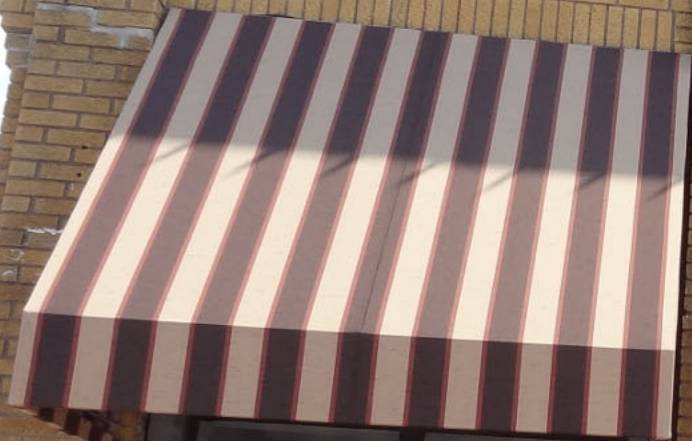
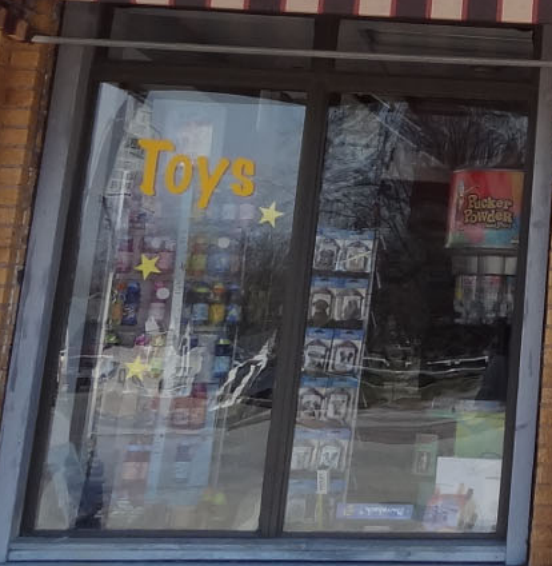
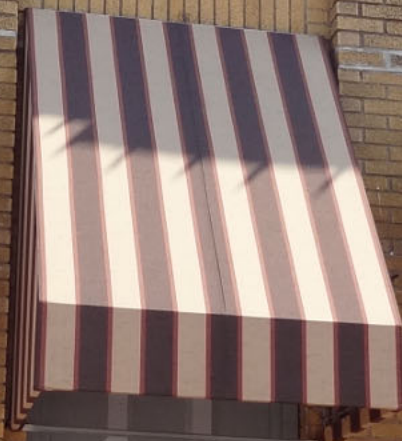
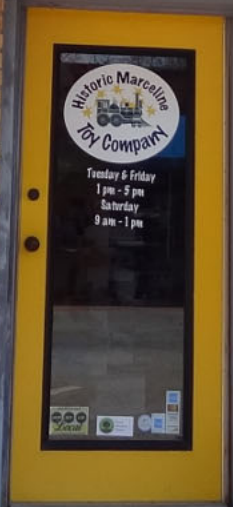
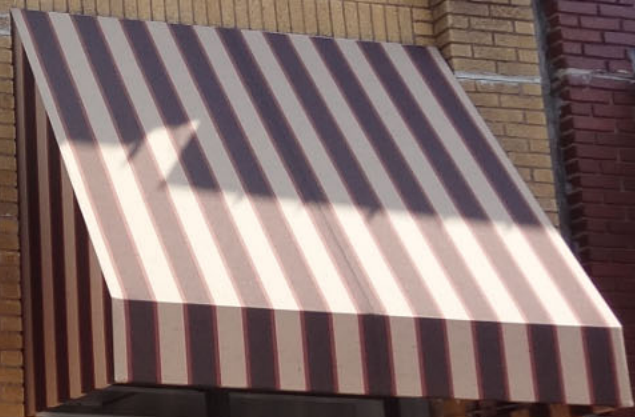
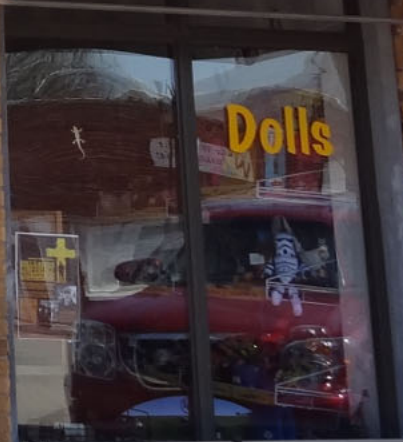
This flat roofed, beige brick, one-part commercial building has three symmetrically arranged bays. The 1st and 3rd bays have large 2-paned storefront windows with early wooden sills. The 2nd has a single entrance door. The door and the windows are likely replacements but in the original openings. Above each window and the door are cloth canopies. Four pilasters ending a foot or two above the canopies are capped in red; they are at each end of the facade and divide each bay. A row of soldier bricks sits immediately above the canopies between each pilaster. Above where the pilasters end is a limestone or concrete sign reading "FIRST NATIONAL BANK". The roof line has crenelation with red coping. The north side of the building has been painted red. Another large storefront window, with three tall panes under three short panes, sits in the northern elevation close to the facade's storefront. To its east are two narrow window openings with three horizontal panes that sit high on the wall within brick infilled openings. The rear half of the building, on the north face, has several identical office entrances. There is a large window, followed by single door with canopy; this pattern is repeated three times. Then there is are two infilled windows between which is a single narrow window. This elevation has some intricate detailing in the brick work at the bottom of the parapet. There are no openings on the rear of the building which is visible from the alley and Howell Avenue.

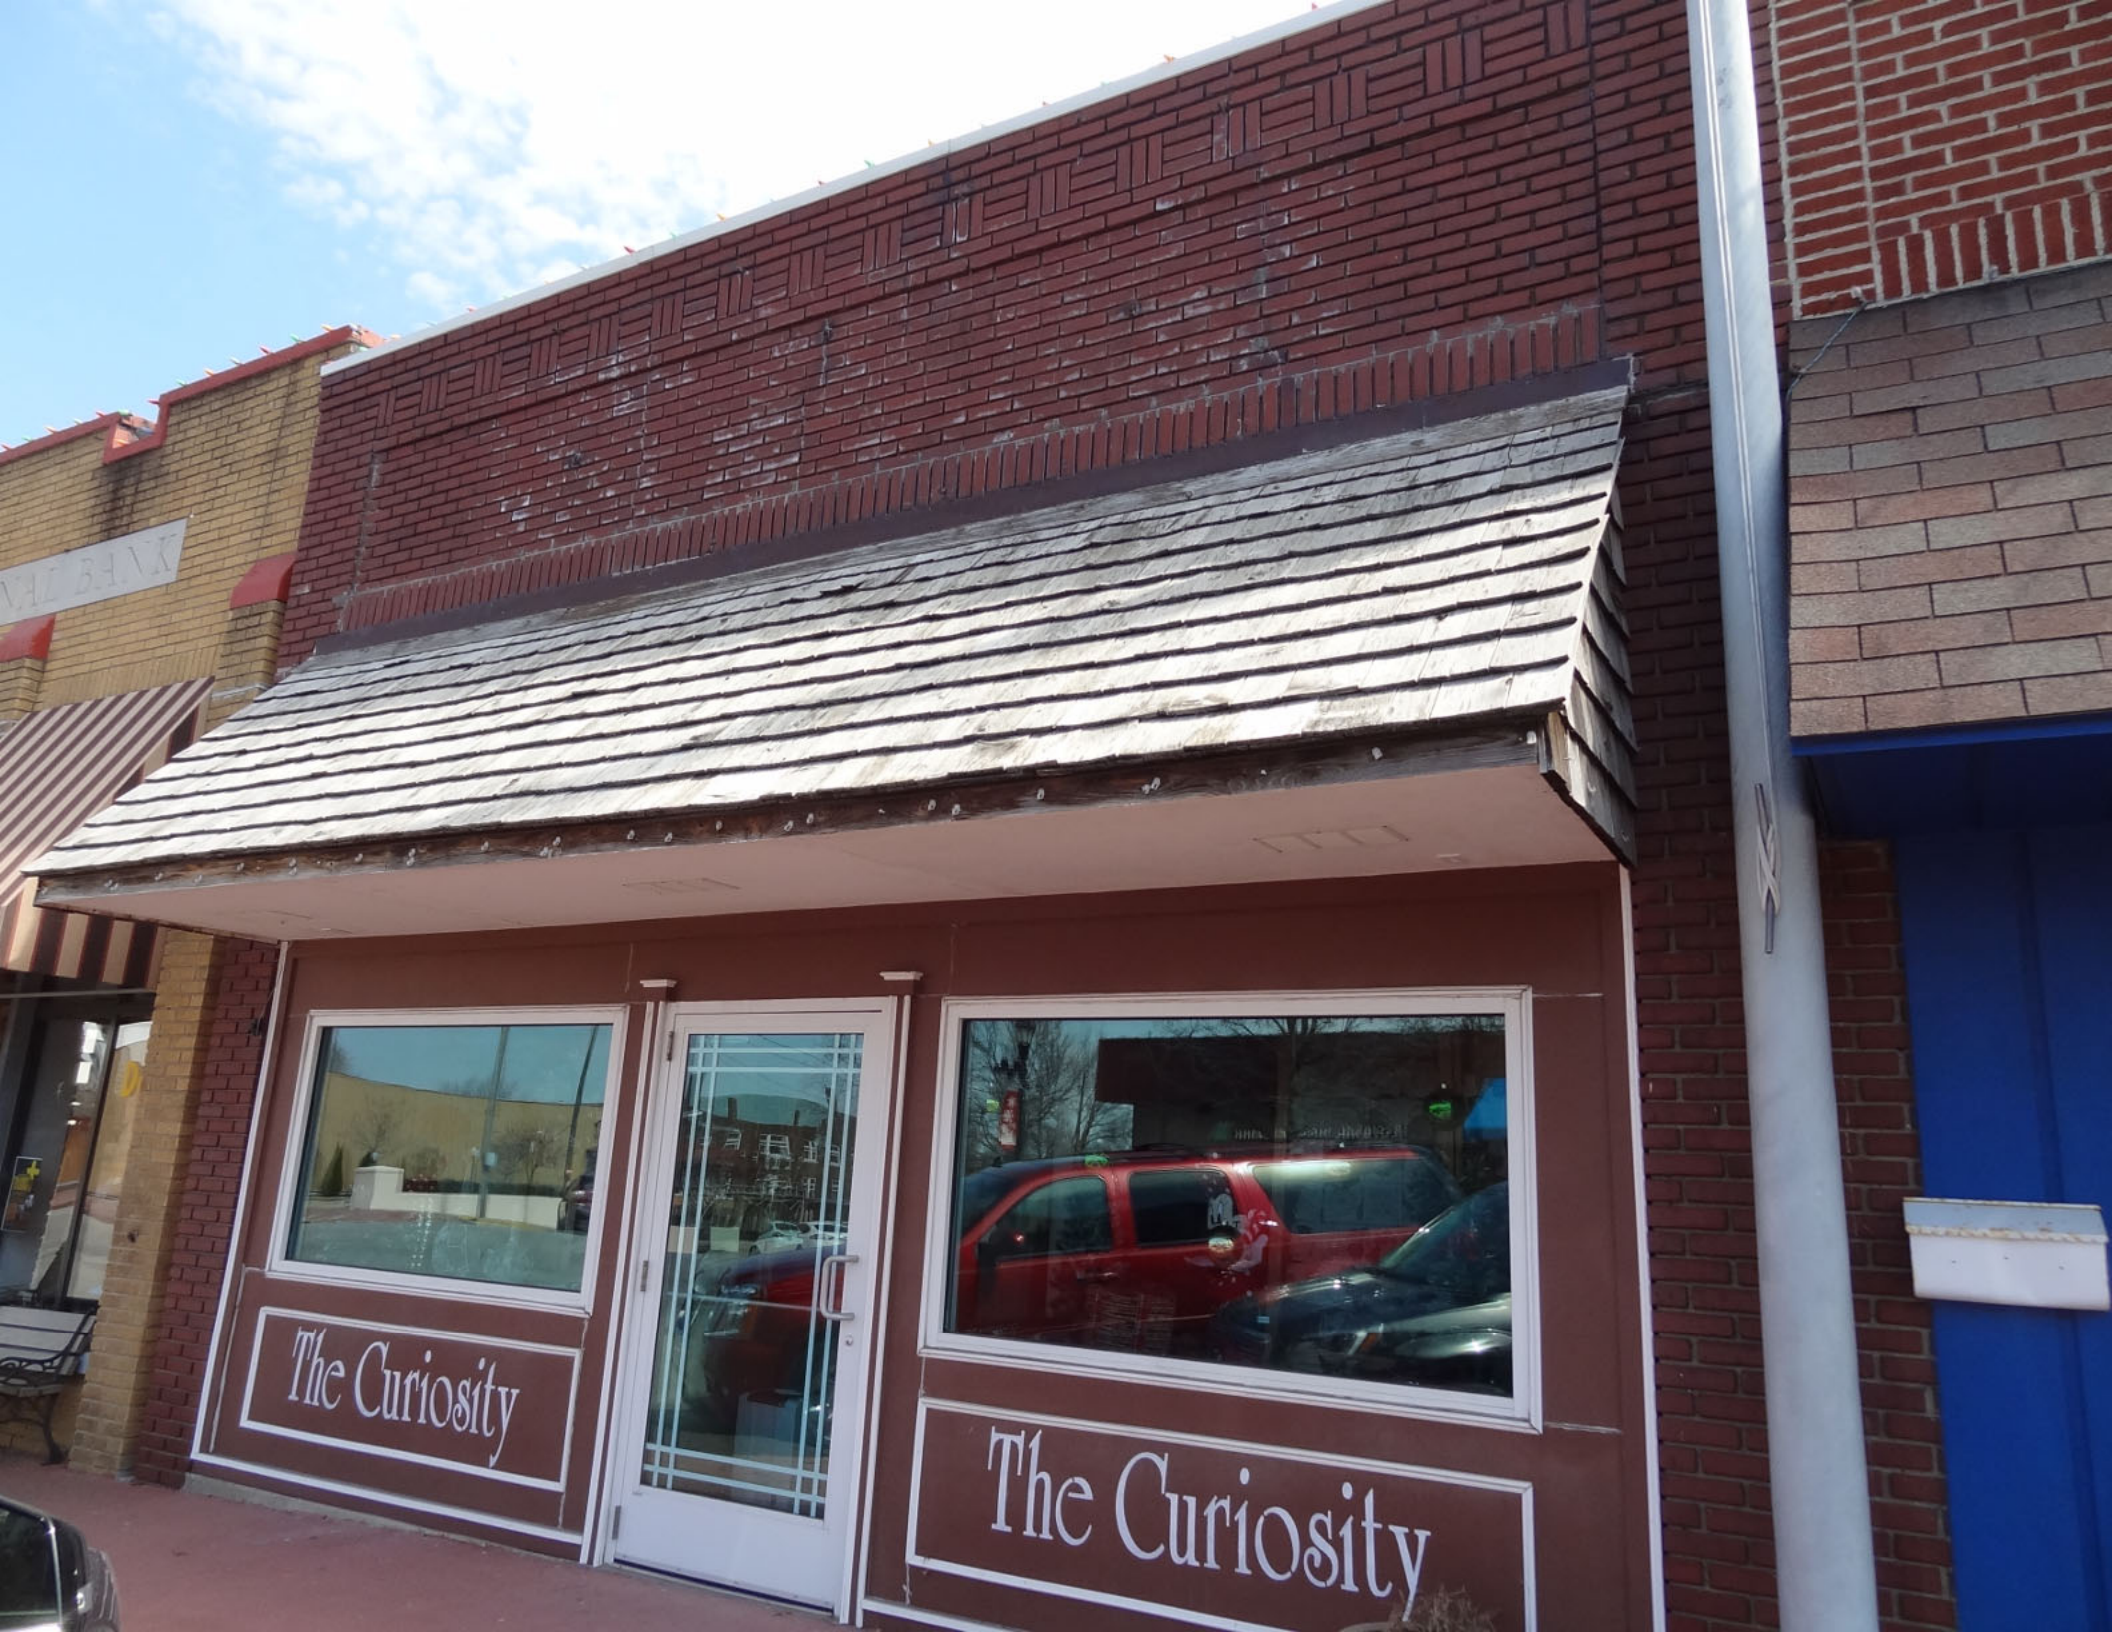
This simple flat-roofed one-part commercial block building has had its storefront altered. There are three symmetrical bays: a large replacement storefront window, a single non-historic door, and another large replacement window. Around the door and windows the building has been reclad in wood paneling. Beneath each window it reads "The Curiosity." Above the windows and door is a large wood shingled canopy above which the building's historic brickwork is visible, including a row of soldier bricks immediately above the canopy. Additional detailing in the brickwork is visible below the roofline, with a row of brickwork that has three soldier bricks side by side alternating with three stretcher bricks stacked together.

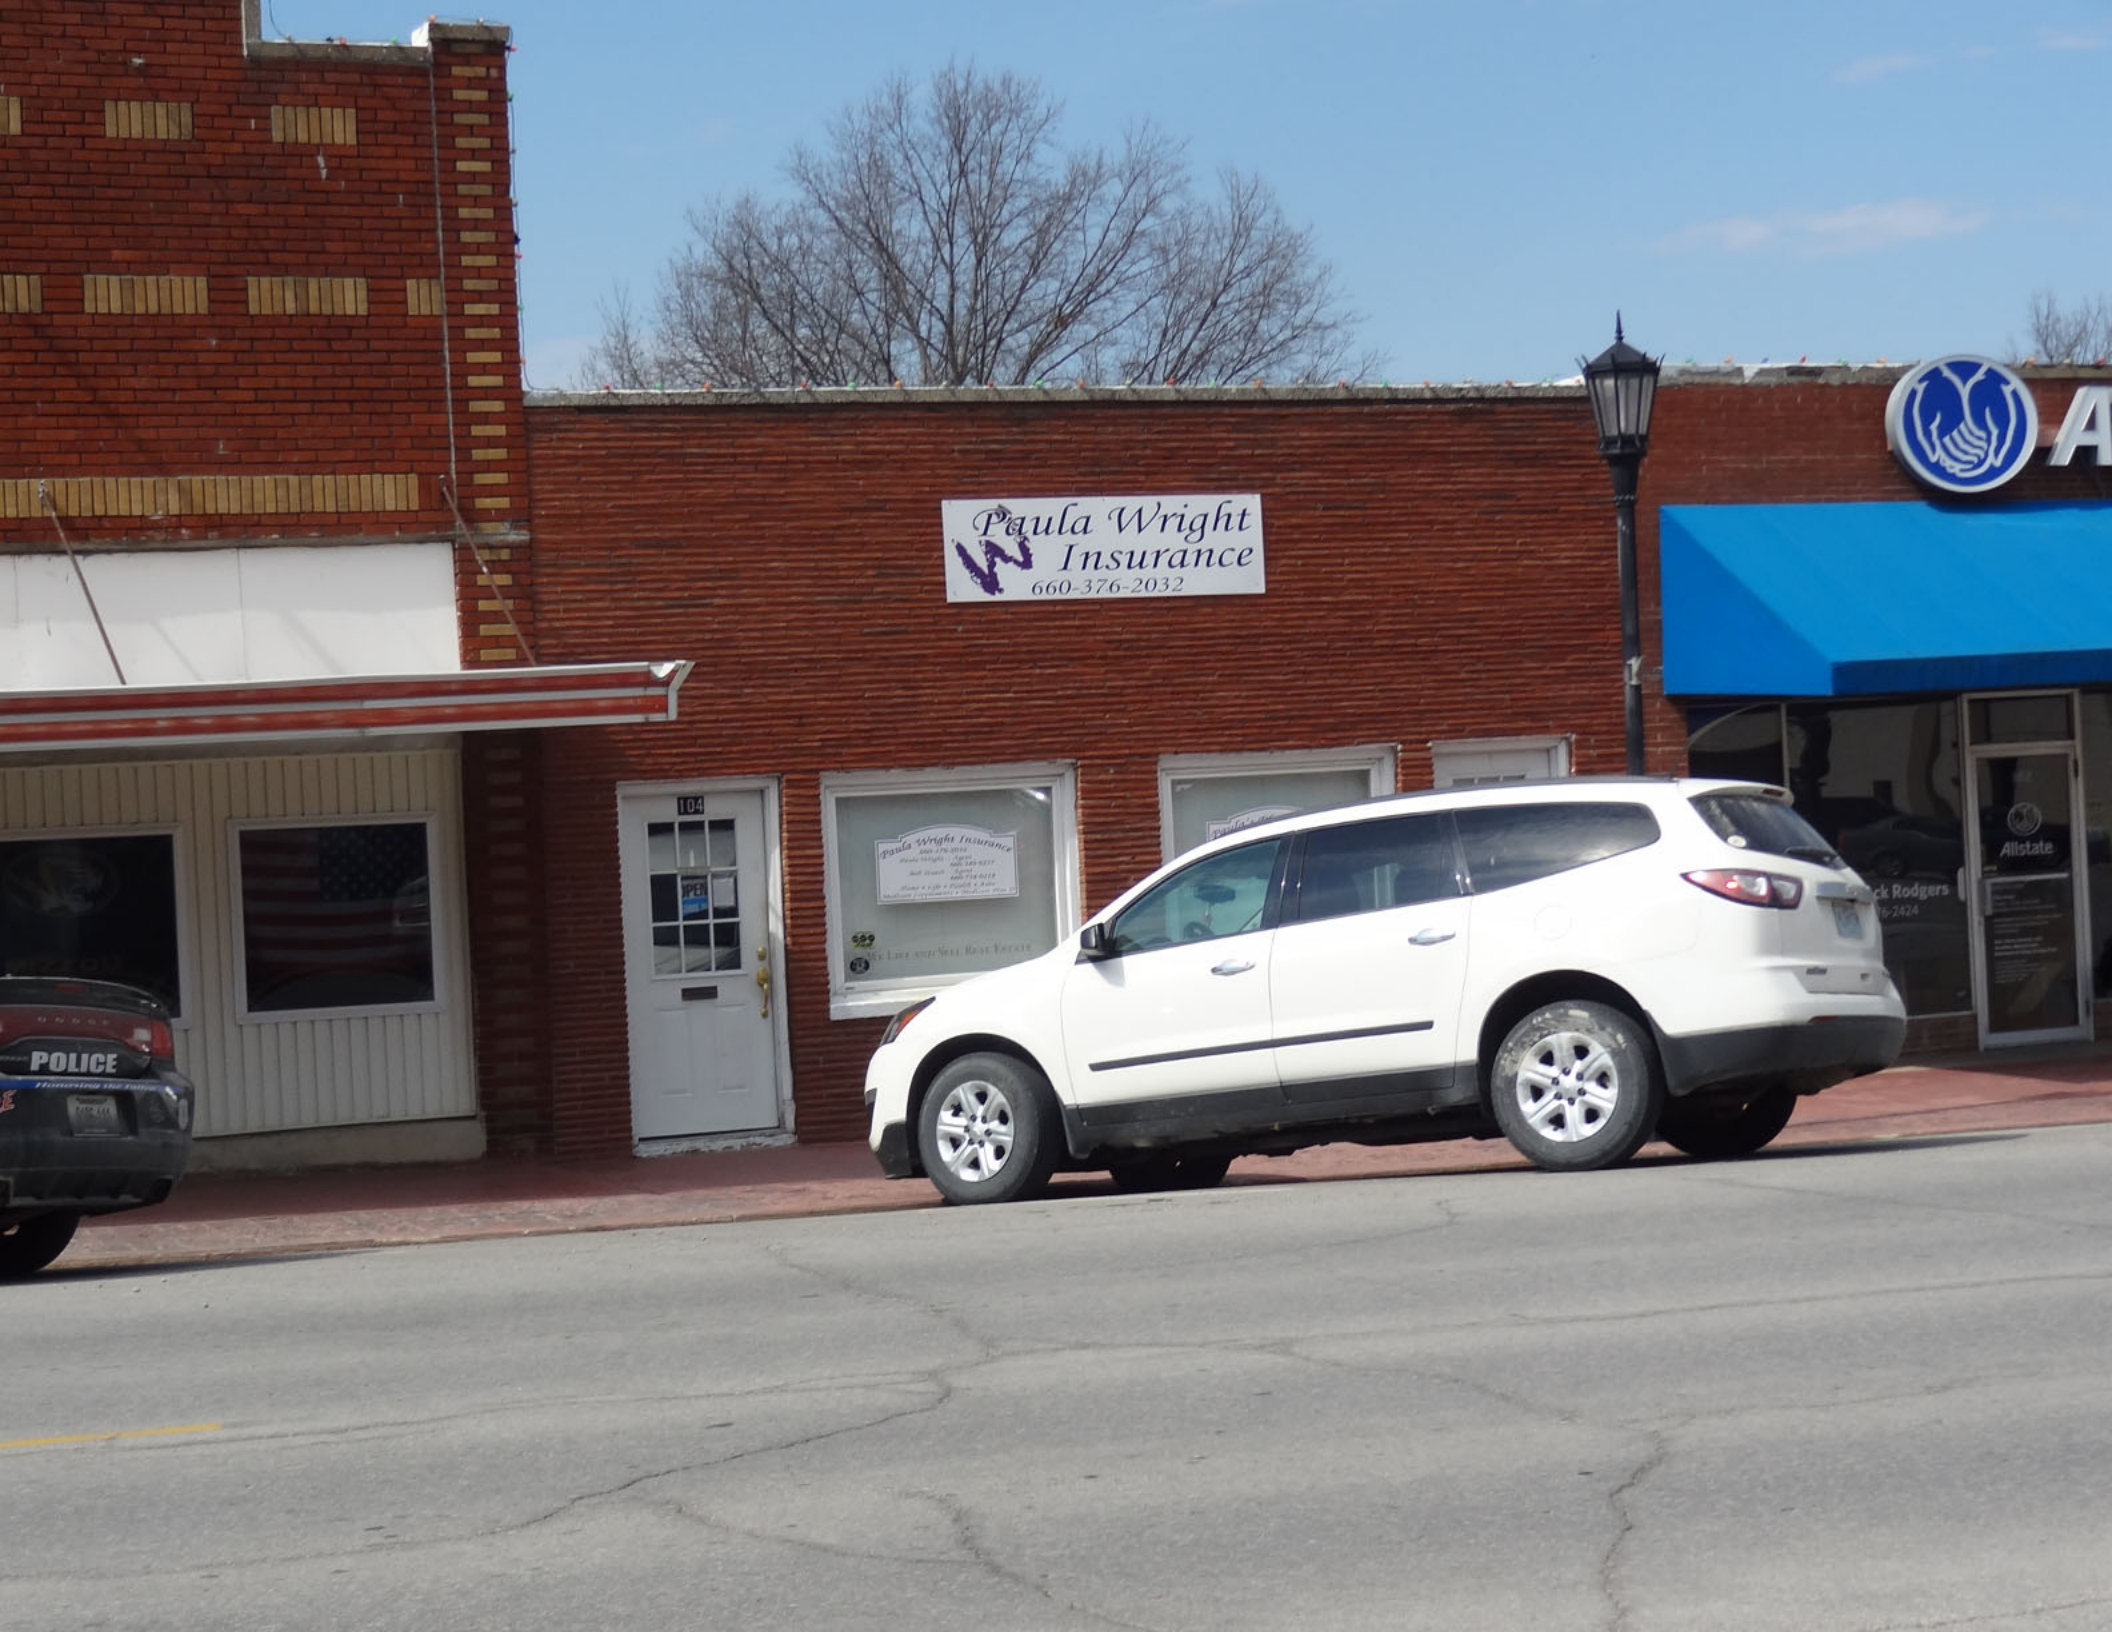
This is a commercial building. This building has four bays from the south there is a single door with a 9-light window. The next two bays are identical and they are large fixed window with a concrete sill. The northernmost bay has a door identical to the southern door a single door with a 9-light window.

The building is constructed of squat bricks and has a parapet with a concrete cap.
