MISSOURI DEPARTMENT OF NATURAL RESOURCES  
STATE HISTORIC PRESERVATION OFFICE, P.O. Box 176, Jefferson City, MO 65102  
**ARCHITECTURAL/HISTORIC INVENTORY FORM**

1. SURVEY NO. LI-AS-001-001		2. SURVEY NAME: Marceline Survey	
3. COUNTY: Linn		4. ADDRESS (STREET NO.) 275	STREET (NAME) West Broadway
5. CITY: Marceline	VICINITY: <input type="checkbox"/>	6. UTM: / /	7. TOWNSHIP/RANGE/SECTION: T: R: S:

8. HISTORIC NAME (IF KNOWN): Walt Disney's Childhood Home		9. PRESENT/OTHER NAME (IF KNOWN): Walt Disney's Childhood Home	
10. OWNERSHIP: <input checked="" type="checkbox"/> PRIVATE <input type="checkbox"/> PUBLIC		11A. HISTORIC USE (IF KNOWN): Single Dwelling	11B. CURRENT USE: Single Dwelling
<b>HISTORICAL INFORMATION</b>

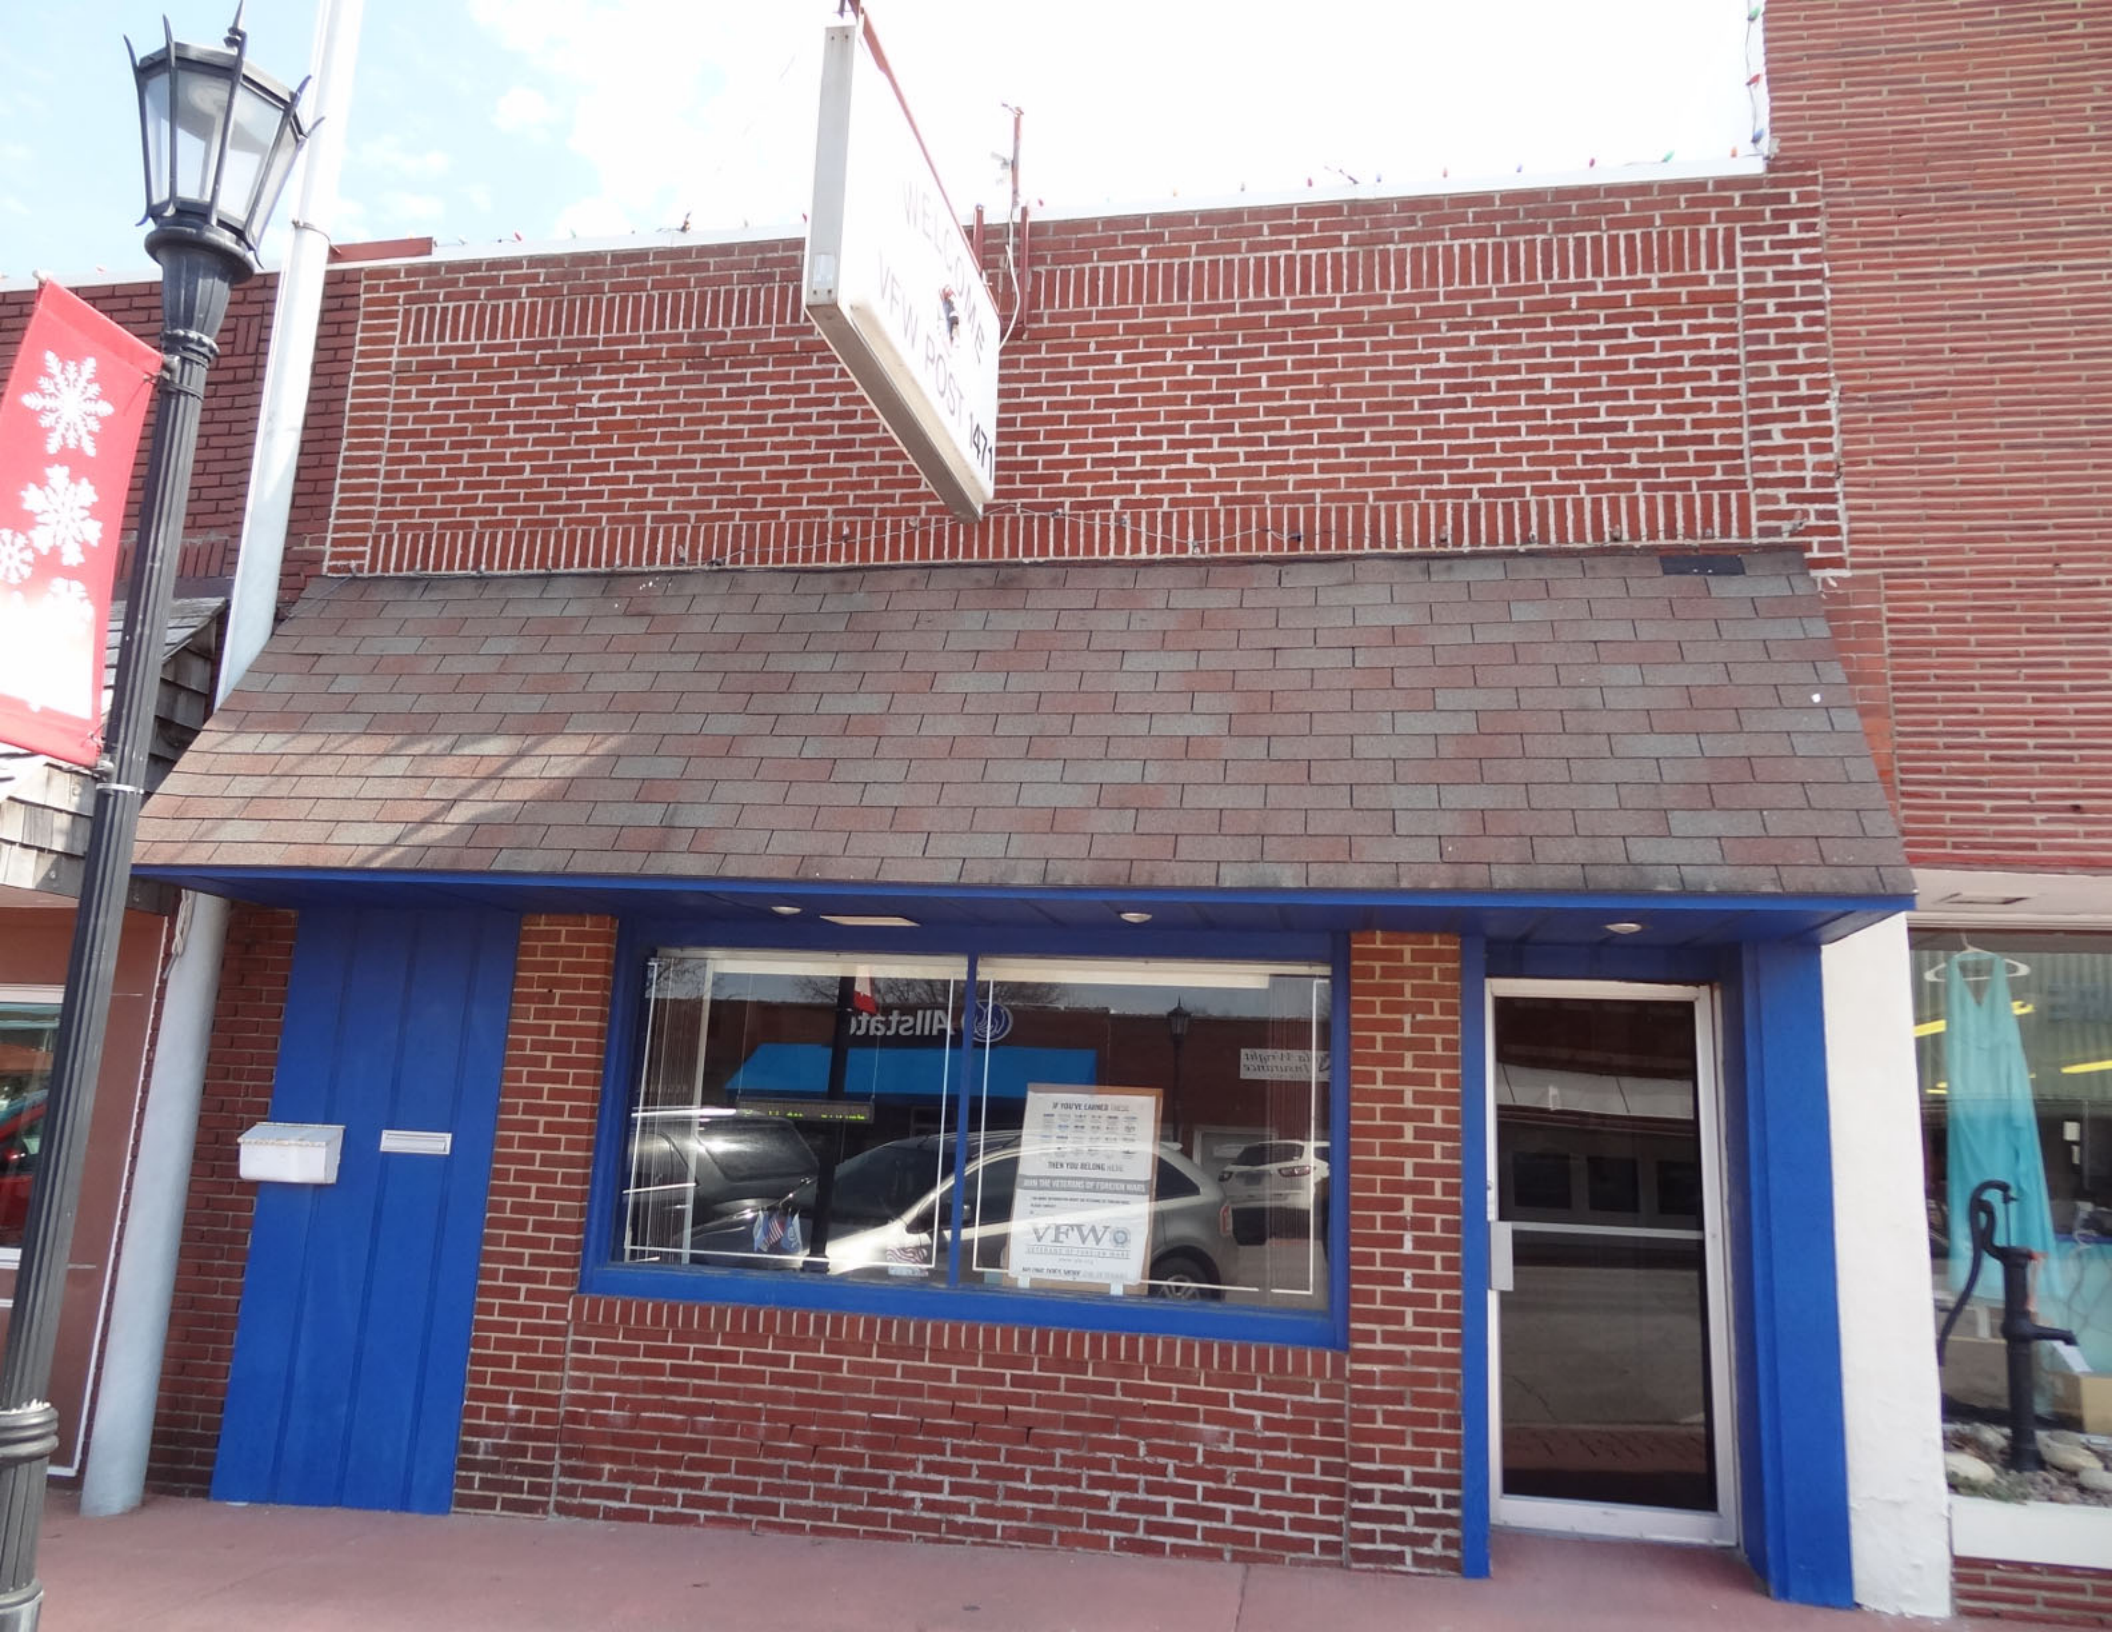
This brick one-part commercial block building has a flat roof. There are three bays, the first of which appears to have been an entrance or window that has been covered with vertical wood siding, painted a bright blue. The second has a large non-historic storefront window with two panes and a rowlock brick sill. The third is a slightly recessed entrance with a single door, also non-historic. Above the storefront is a large awning with asphalt shingles. Above the awning is a row of soldier brick; a little below the roofline is another row of soldier brick. A column of stretcher bricks is on the north end of the facade. The rest of the brick is in running bond. Incongruities in the brickwork suggest some alterations at an unknown date.

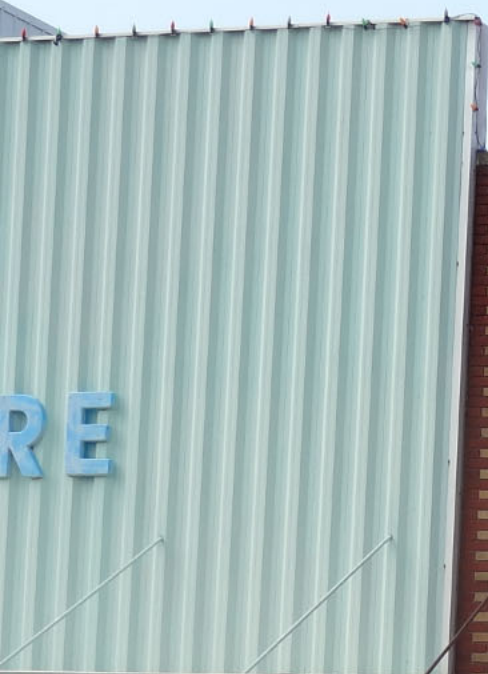
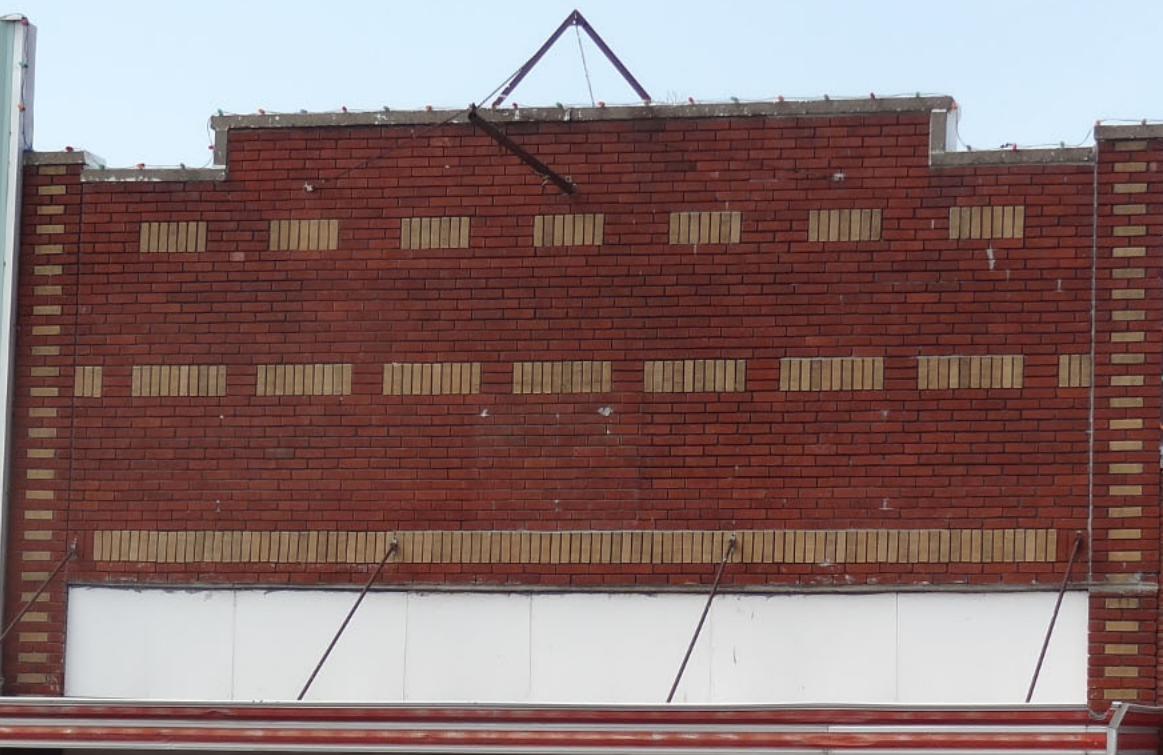
This is a commercial building. The first floor has been altered and the space that would have previously had a storefront display is infilled with siding. From the south the first bay has a large square vinyl fixed window. Moving north the next bay is the entrance and there is a door with a nine-light window. The next three bays to the north each have a single fixed square vinyl window. Above the windows is a full-width metal awning across the front of the building. Above the awning the clerestory windows have been infilled or have been boarded. The upper level of the storefront is a large brick parapet that has decorative patterns created with the use of buff and red bricks. The stepped parapet has a concrete cap. There is also a metal post that used to support a sign but currently on the support remains.

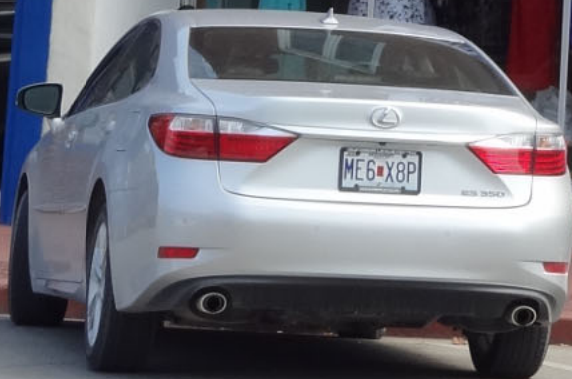
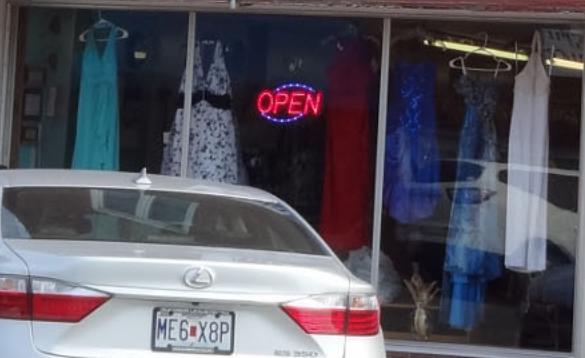
This property lacks historic integrity due to a recladding in a different type of brick, modern windows, and a modern storefront. This property lacks the significance necessary for individual listing in the National Register. Collectively, this area does not appear to be eligible for listing as a historic district due to an overall loss of integrity, thus this property is noted as not eligible.

This two-part commercial block building is clad in rough narrow brick in running bond. It has three bays, the first of which is a large non-historic storefront window with three panes; it takes up most of the first floor storefront. Immediately to the south is a single non-historic door providing entry into the store. To the south of this door is another single non-historic door that leads to the upstairs apartment. Above the storefront is a sign reading "Deja Vu Thrift and Consignment New & Lightly Used" above which are two pairs of non-historic one-over-one windows with red wooden sills. There is no other ornamentation. Based on the brick work utilized in the recladding of this building major alterations likely occurred after 1950 or later.

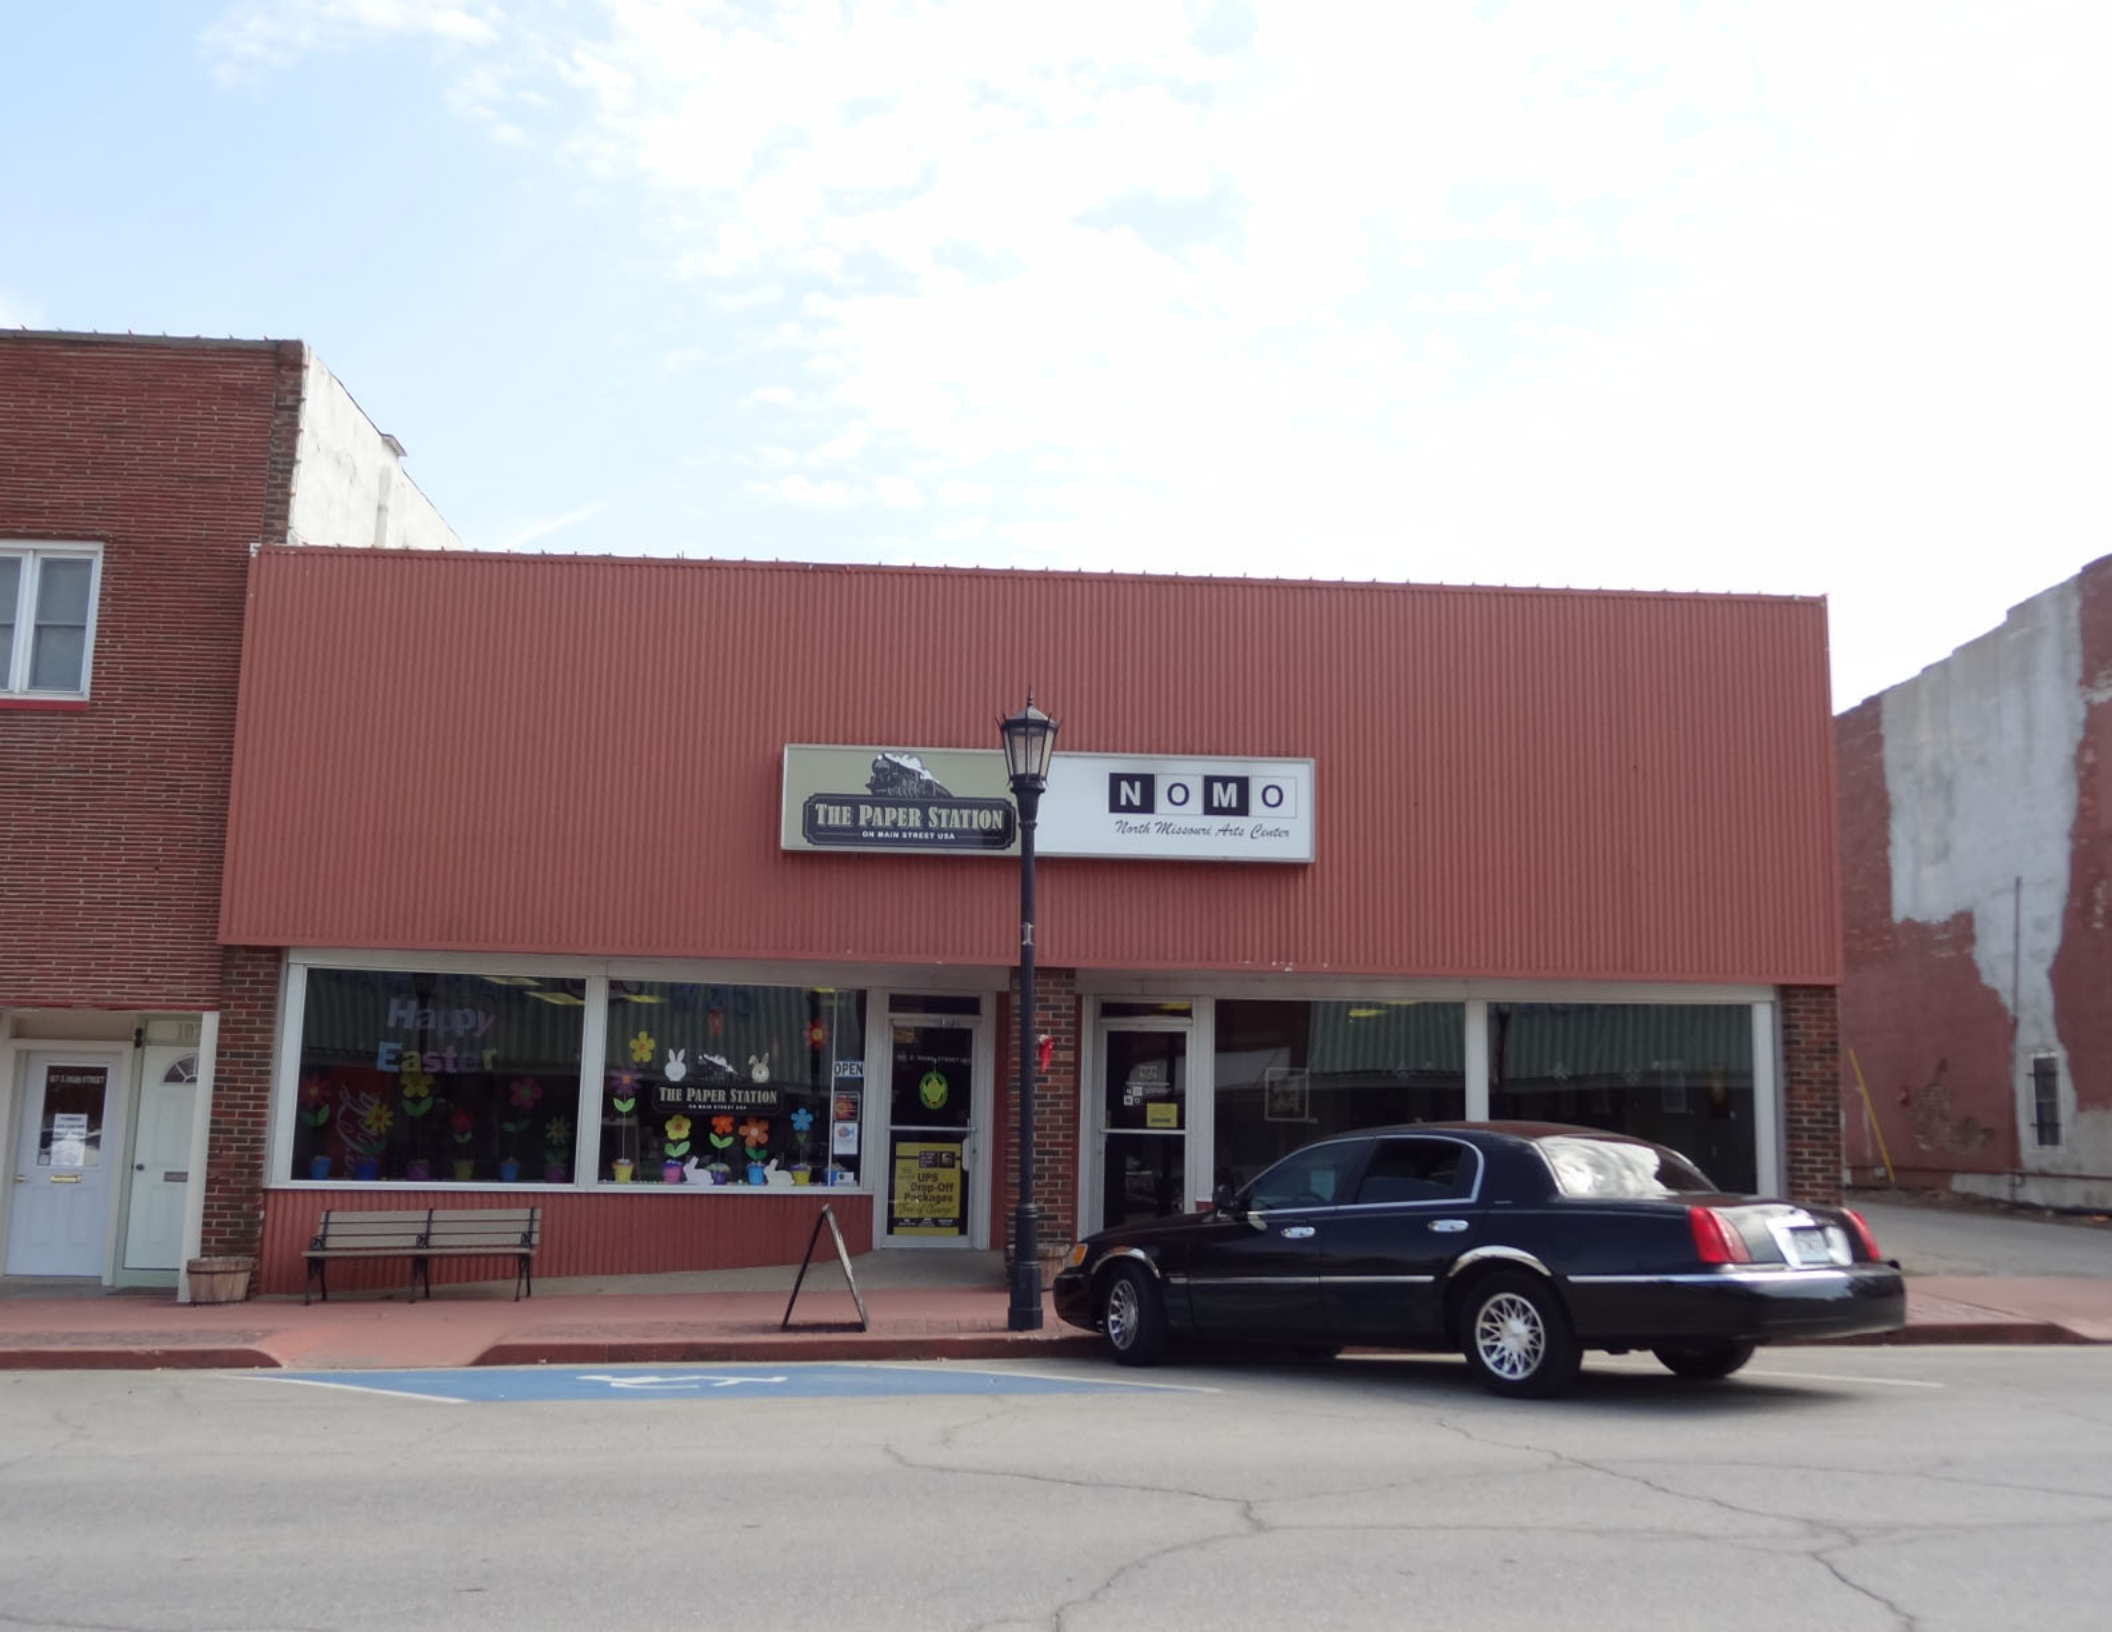
This property lacks historic integrity due to modern storefronts and the addition of metal cladding. It also lacks the significance necessary for individual listing in the National Register. Collectively, this area does not appear to be eligible for listing as a historic district due to an overall loss of integrity, thus this property is noted as not eligible.

This flat-roofed one-part commercial building has two bays. The first consists of two large storefront windows immediately followed by a single door. The next bay is made up of another single door adjacent to two more large storefront windows. Between the doors is a brick pilaster. Windows and doors all appear non-historic. Brick pilasters are visible at each corner of the building. Below and above the windows the building has been reclad in metal. Signs for the two businesses are conjoined and situated in the metal siding on the upper half of the building. The south side of the building, facing the alley, has been covered in white stucco. Three windows have been infilled with plywood on the outside of which are metal bars. A non-historic single metal door sits between the second and third window. What appears to be an early addition to the building is attached to the rear; it is clad in stuccoed concrete block and has a garage door entrance.

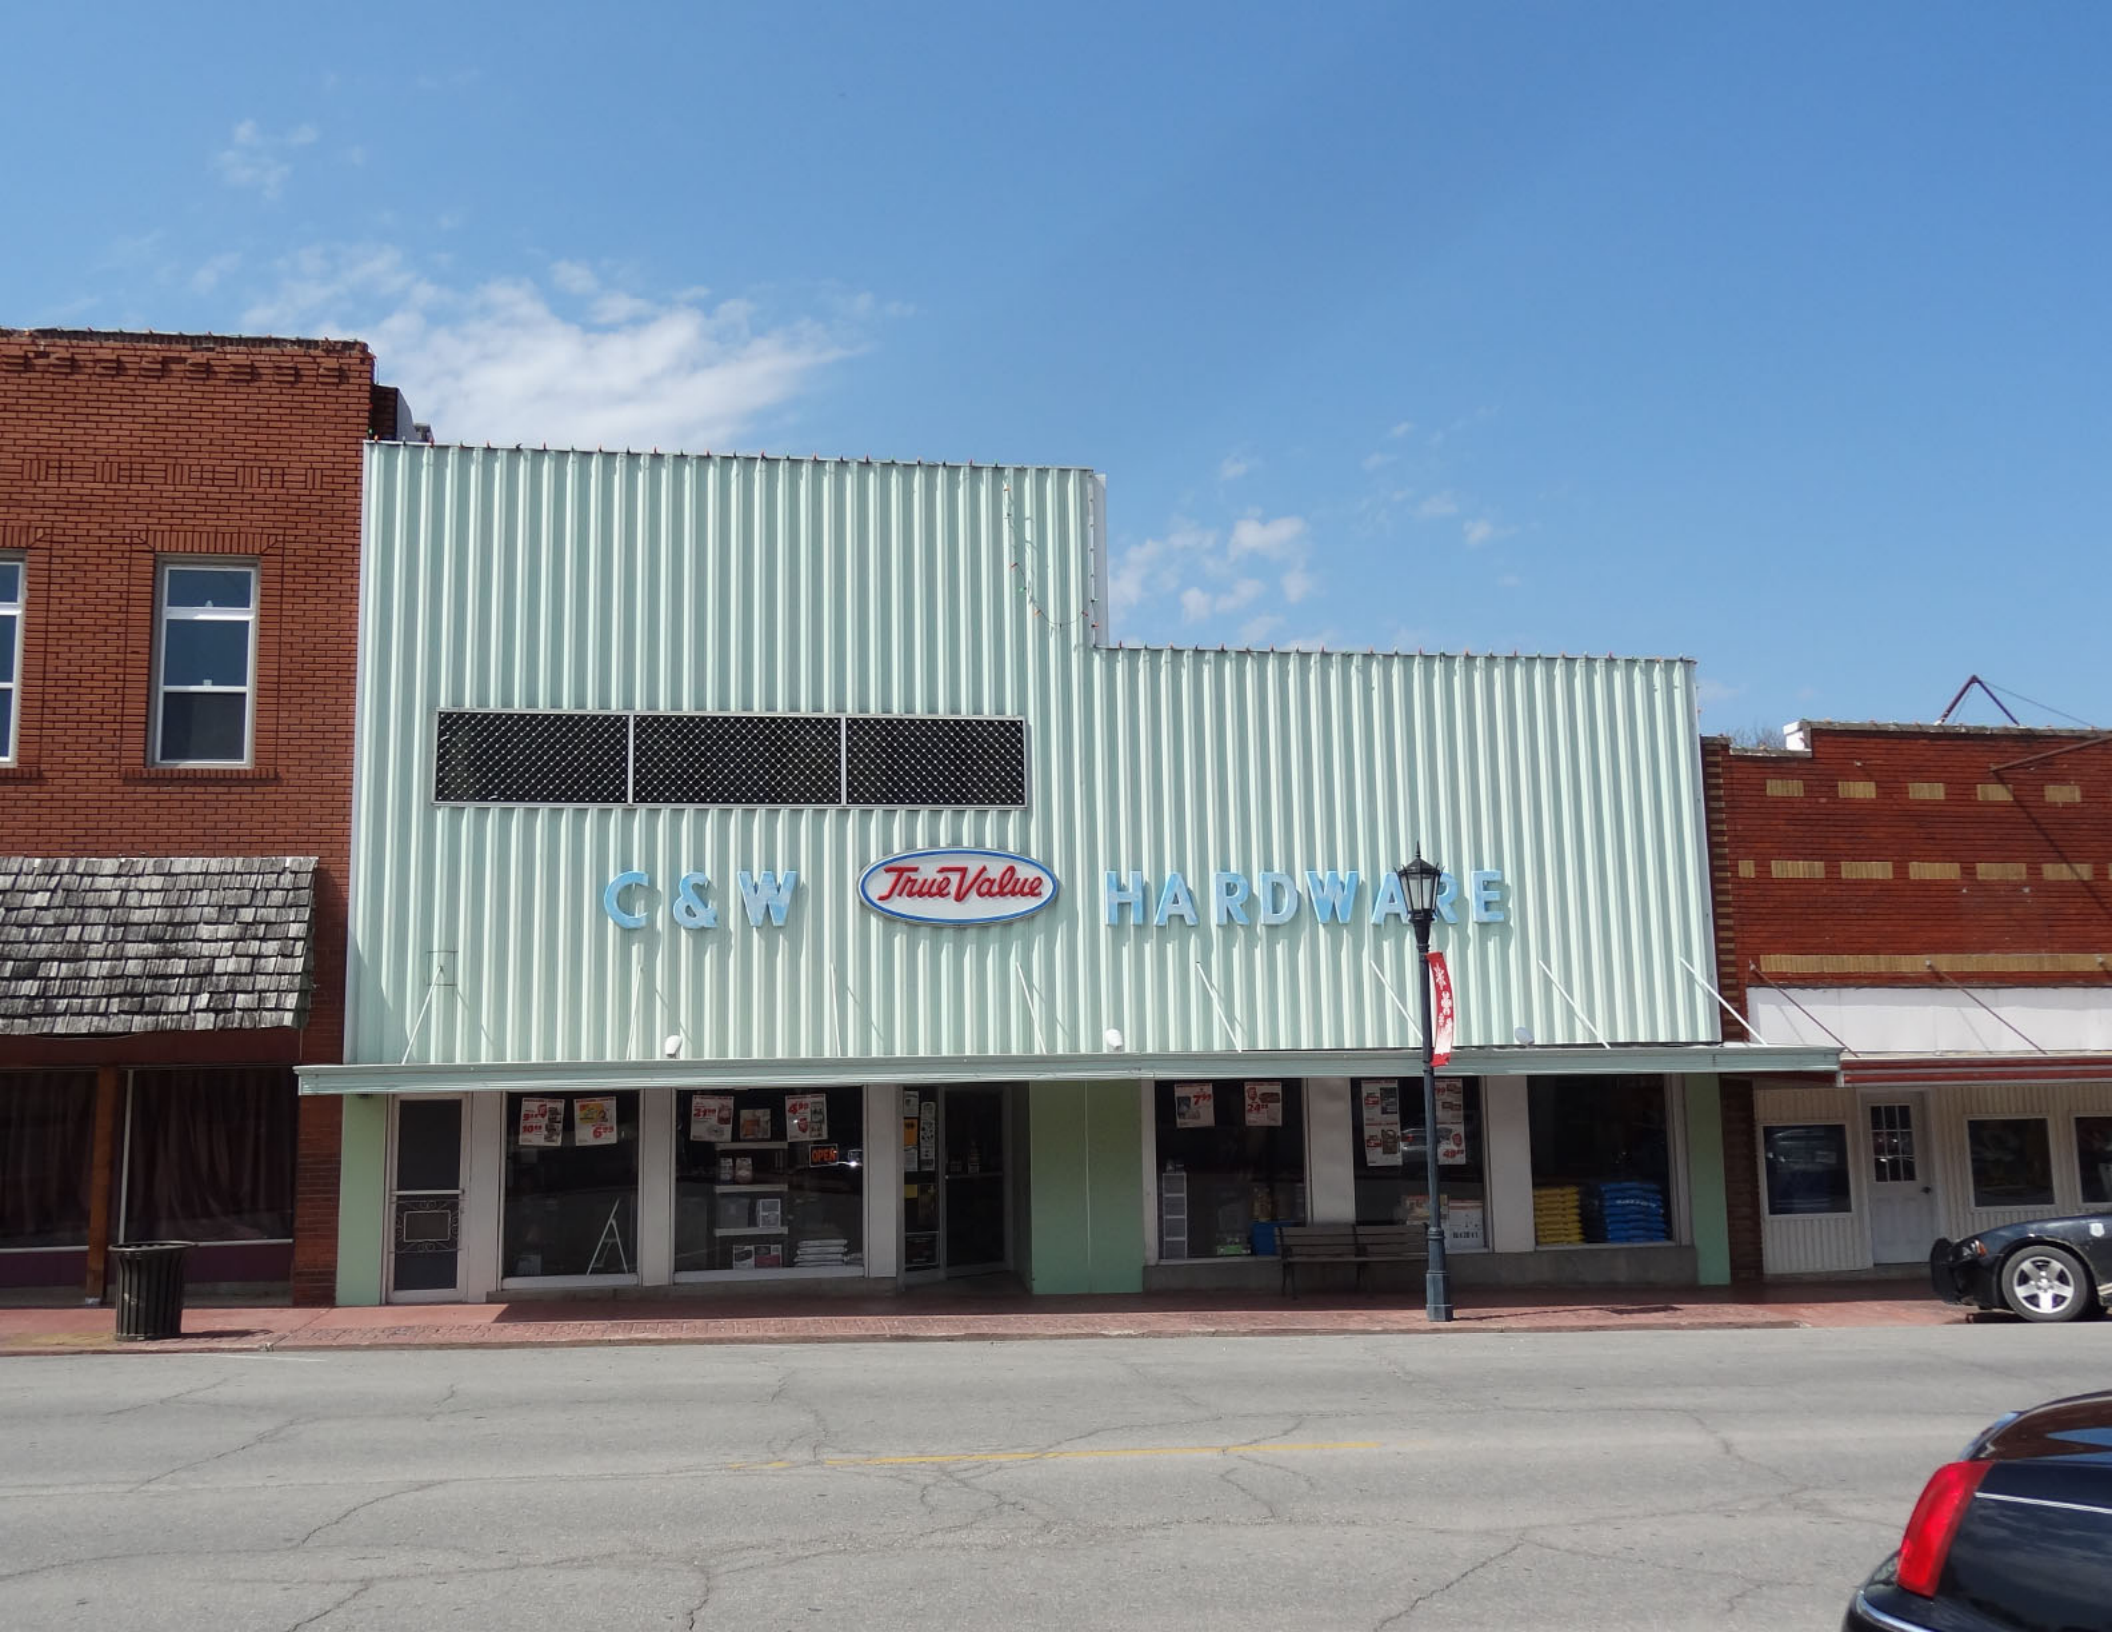
This property lacks the significance necessary for individual listing in the National Register. It has been considerably altered with metal cladding; the alterations could potentially be historic, but collectively this area does not appear to be eligible for listing as a historic district due to an overall loss of integrity, thus this property is noted as not eligible.

This is a commercial building that historically consisted of two different buildings. The northern building is one story and the southern building has two stories. The buildings have been covered with metal cladding.

The first floor starting from the south has seven bays. The southernmost bay is a single door with a screen aluminum door over the main door this entrance appears to provide access to the second story. Moving north the next two bays are filled with large fixed metal storefront windows with metal supports between. The fourth bay from the south has a recessed angled entrance it has an aluminum door with a small window immediately adjacent. The next bay to the north has a large metal panel followed by a large fixed storefront window. The final two bays to the north also have large fixed storefront windows with metal paneling between the windows. The storefront of this building is covered by a full-width metal awning. The area above the awning is clad in metal siding and has signage "C & W True Value HARDWARE" The is also a metal grate above the sign that presumably allows light into the second story.

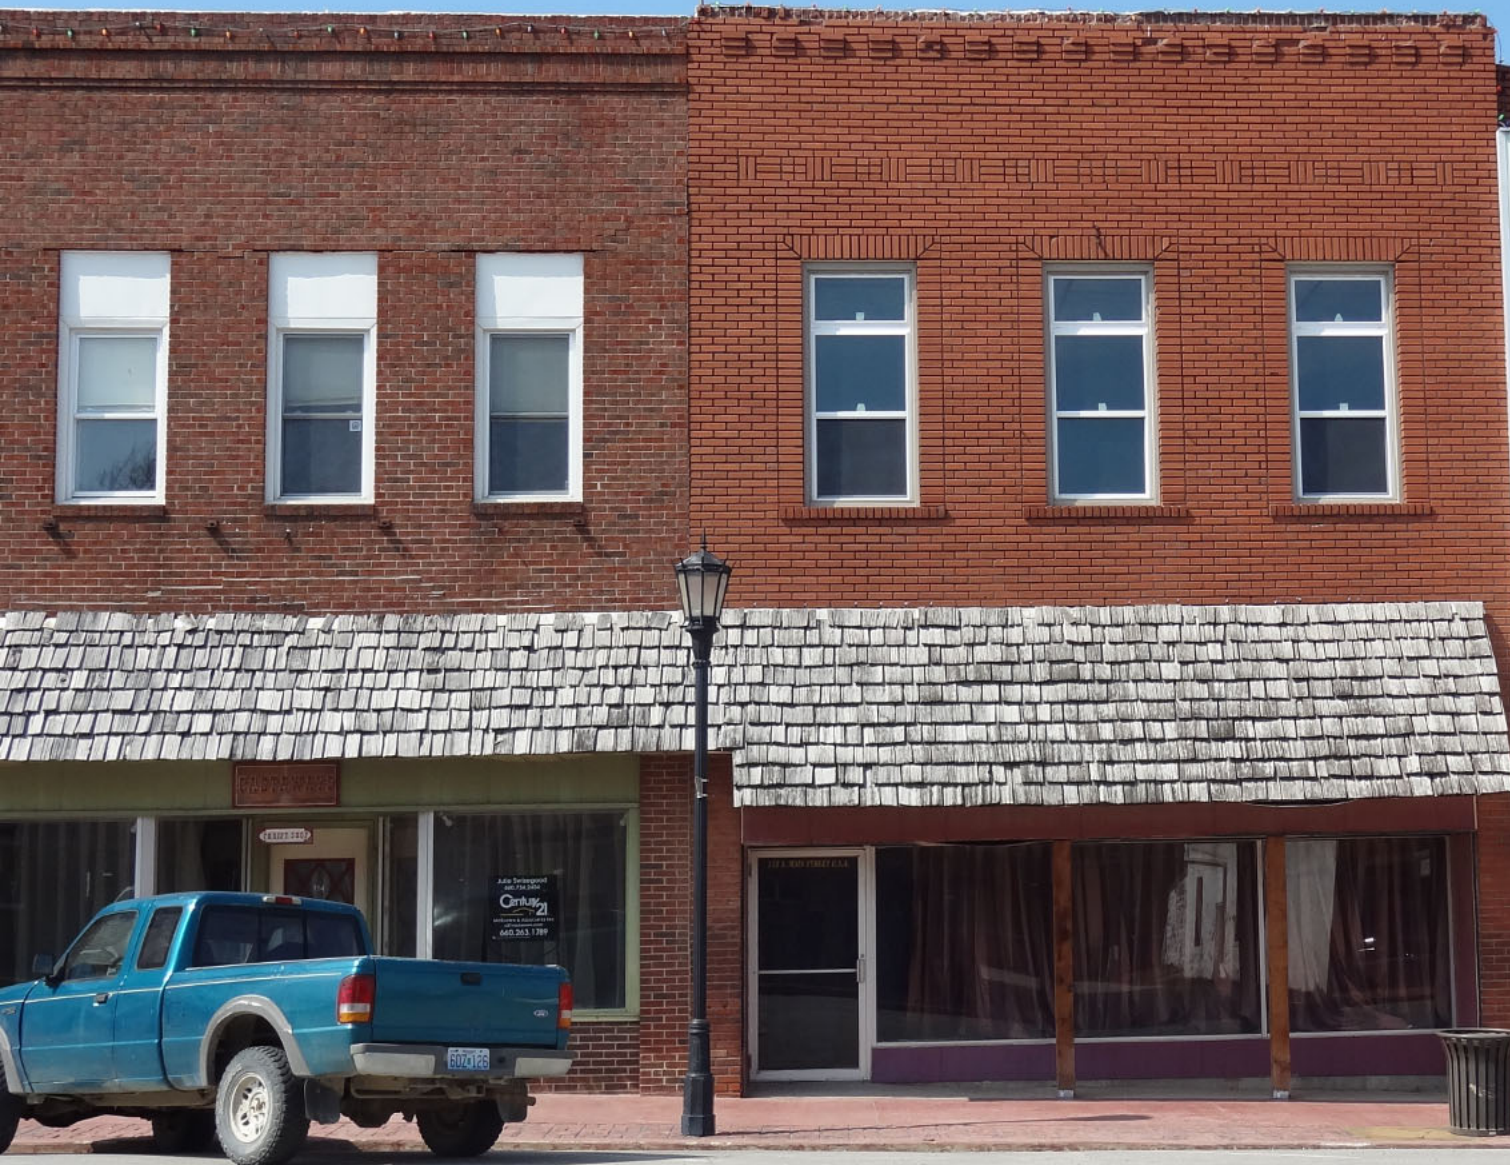
There is a wood shingle shed awning across the width of the building. The awning is supported by two wood supports.

The upper level has three evenly spaced vinyl windows the windows have one-over-one windows with transoms above. There is decorative brickwork that surrounds the windows and in the space above the windows. There is also some decorative brickwork in the parapet.

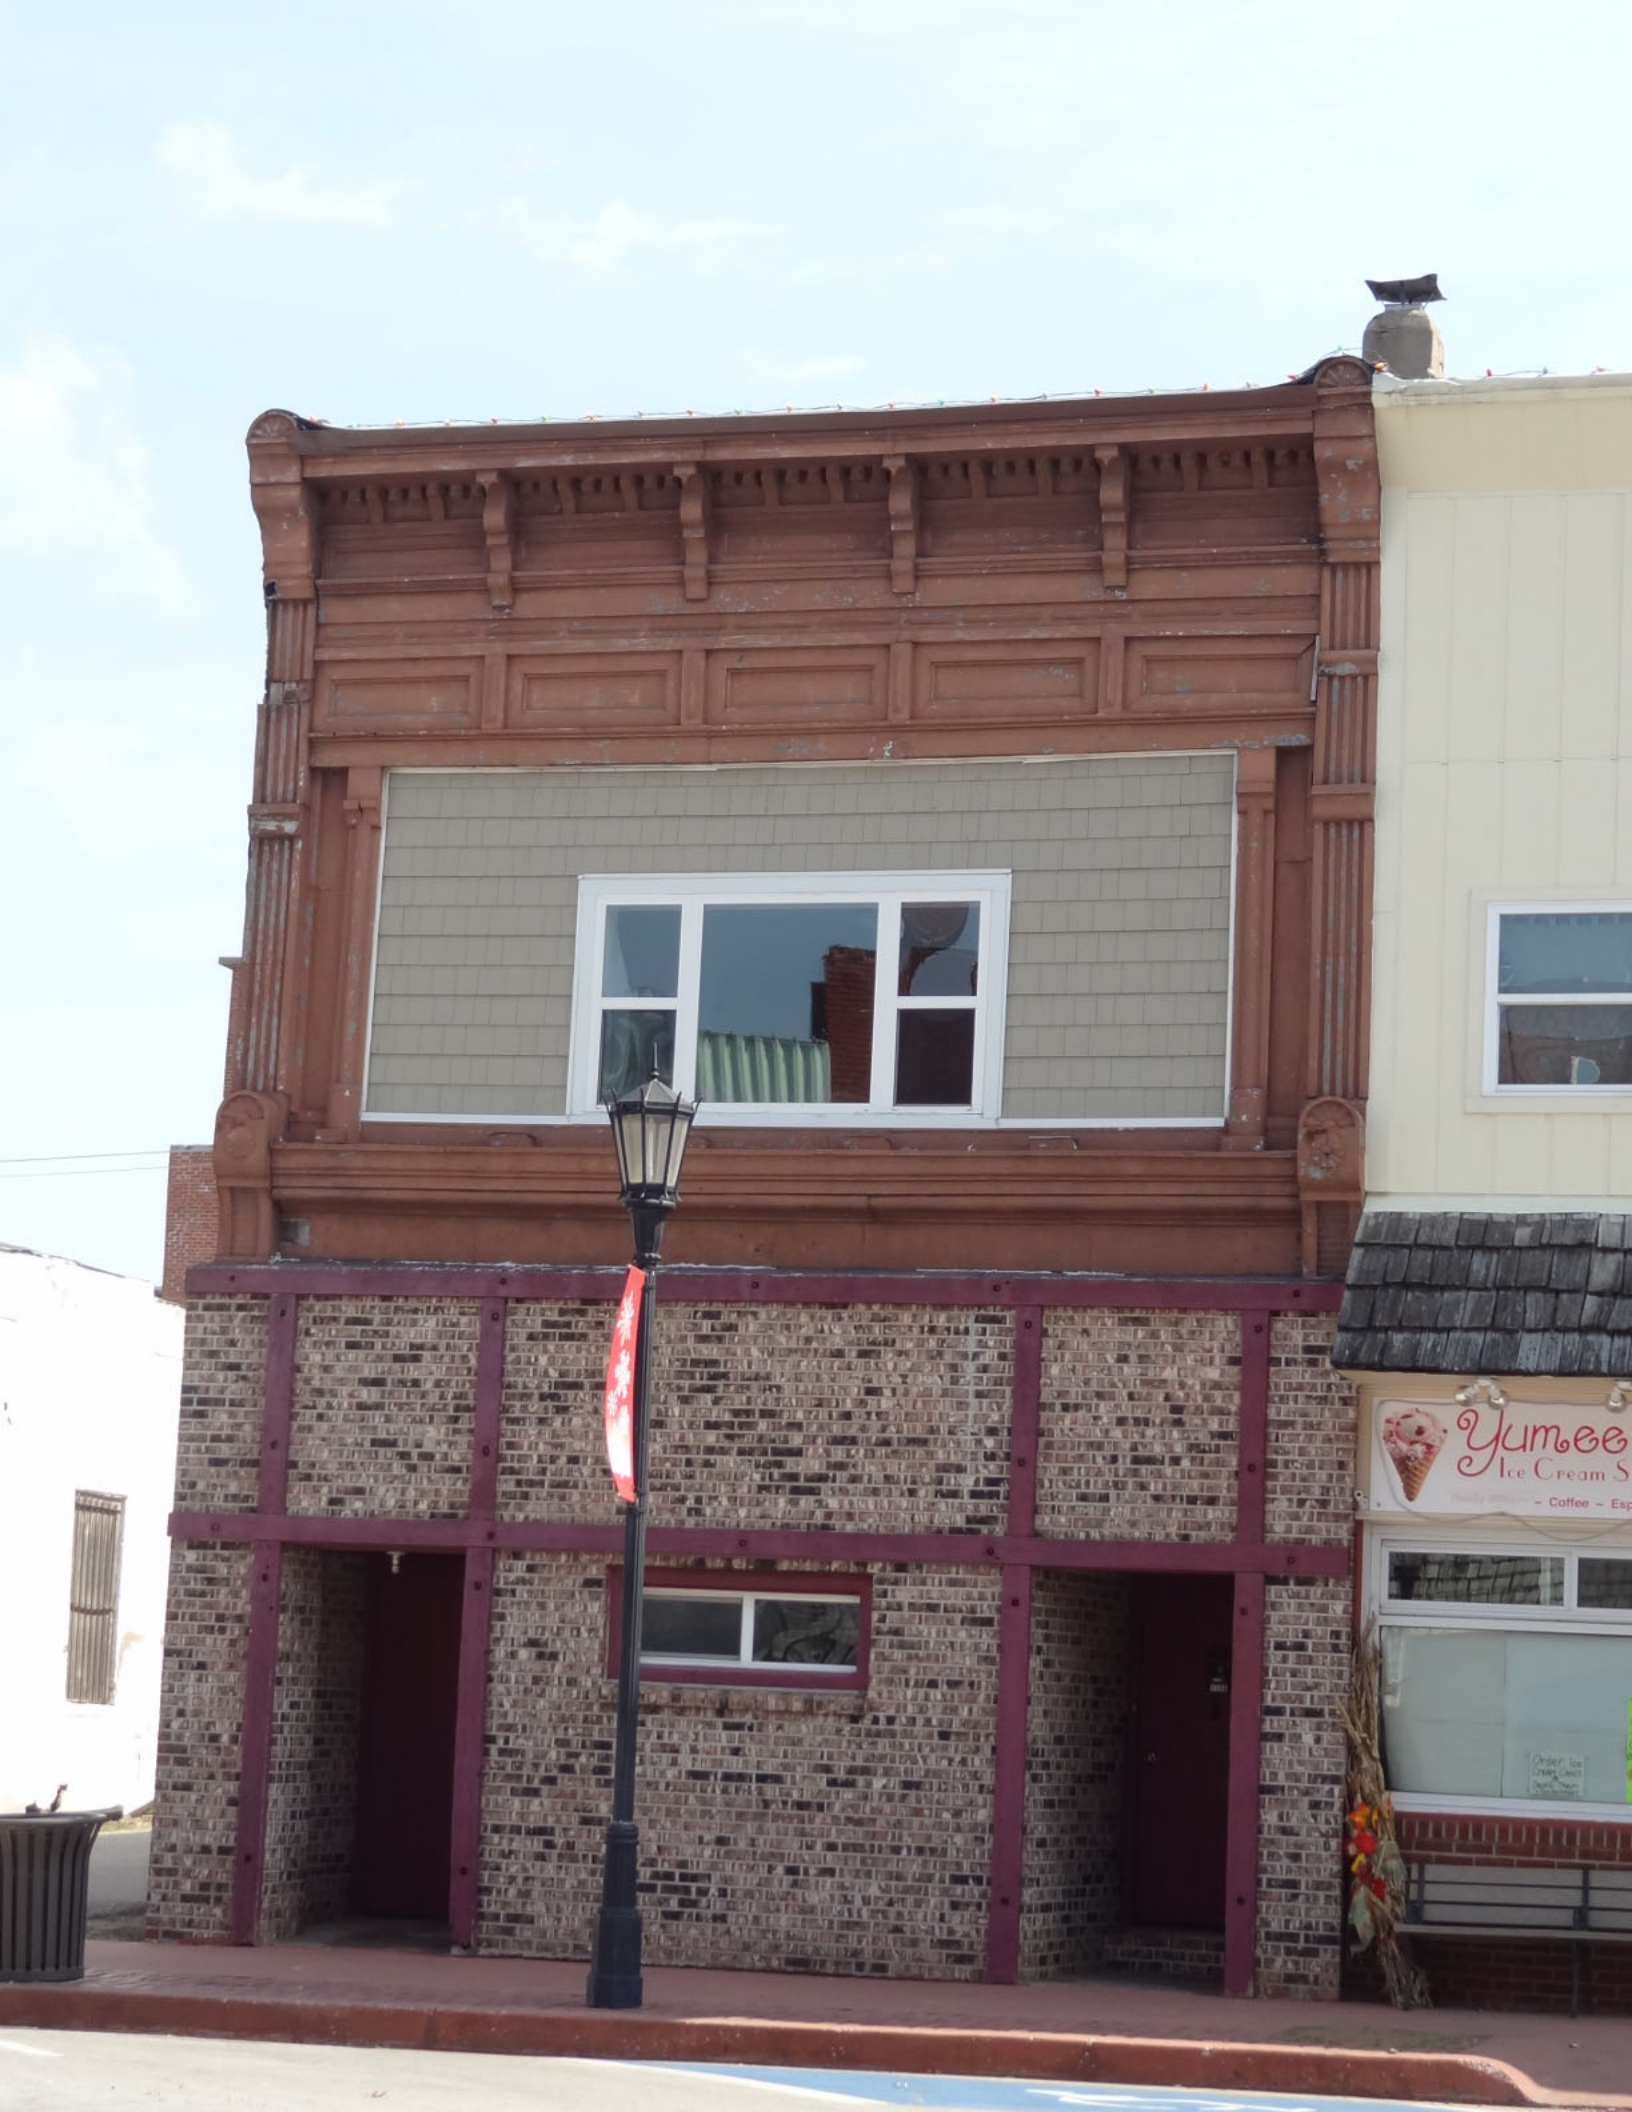
This is a two-story commercial building with a flat roof that now appears to serve as an apartment or residence. The first story of this building has been severely altered, with some alterations also evident on the second story. The first story has been reclad in brick and has three bays. The first and the third are recessed single wood entrance doors. The central bay is a single vinyl sliding window. Wood timbering breaks up the the brick on the first story. The second story appears to have maintained some of its historic metal cladding which includes a decorative cornice. The central portion of the second story has been infilled with vinyl siding and a nonhistoric picture window with a large central pane flanked by one-over-one windows. The building's northeast elevation is visible from an alley; this elevation is clad in brick and some stuccoing. Three windows with rowlock brick sills have been infilled.

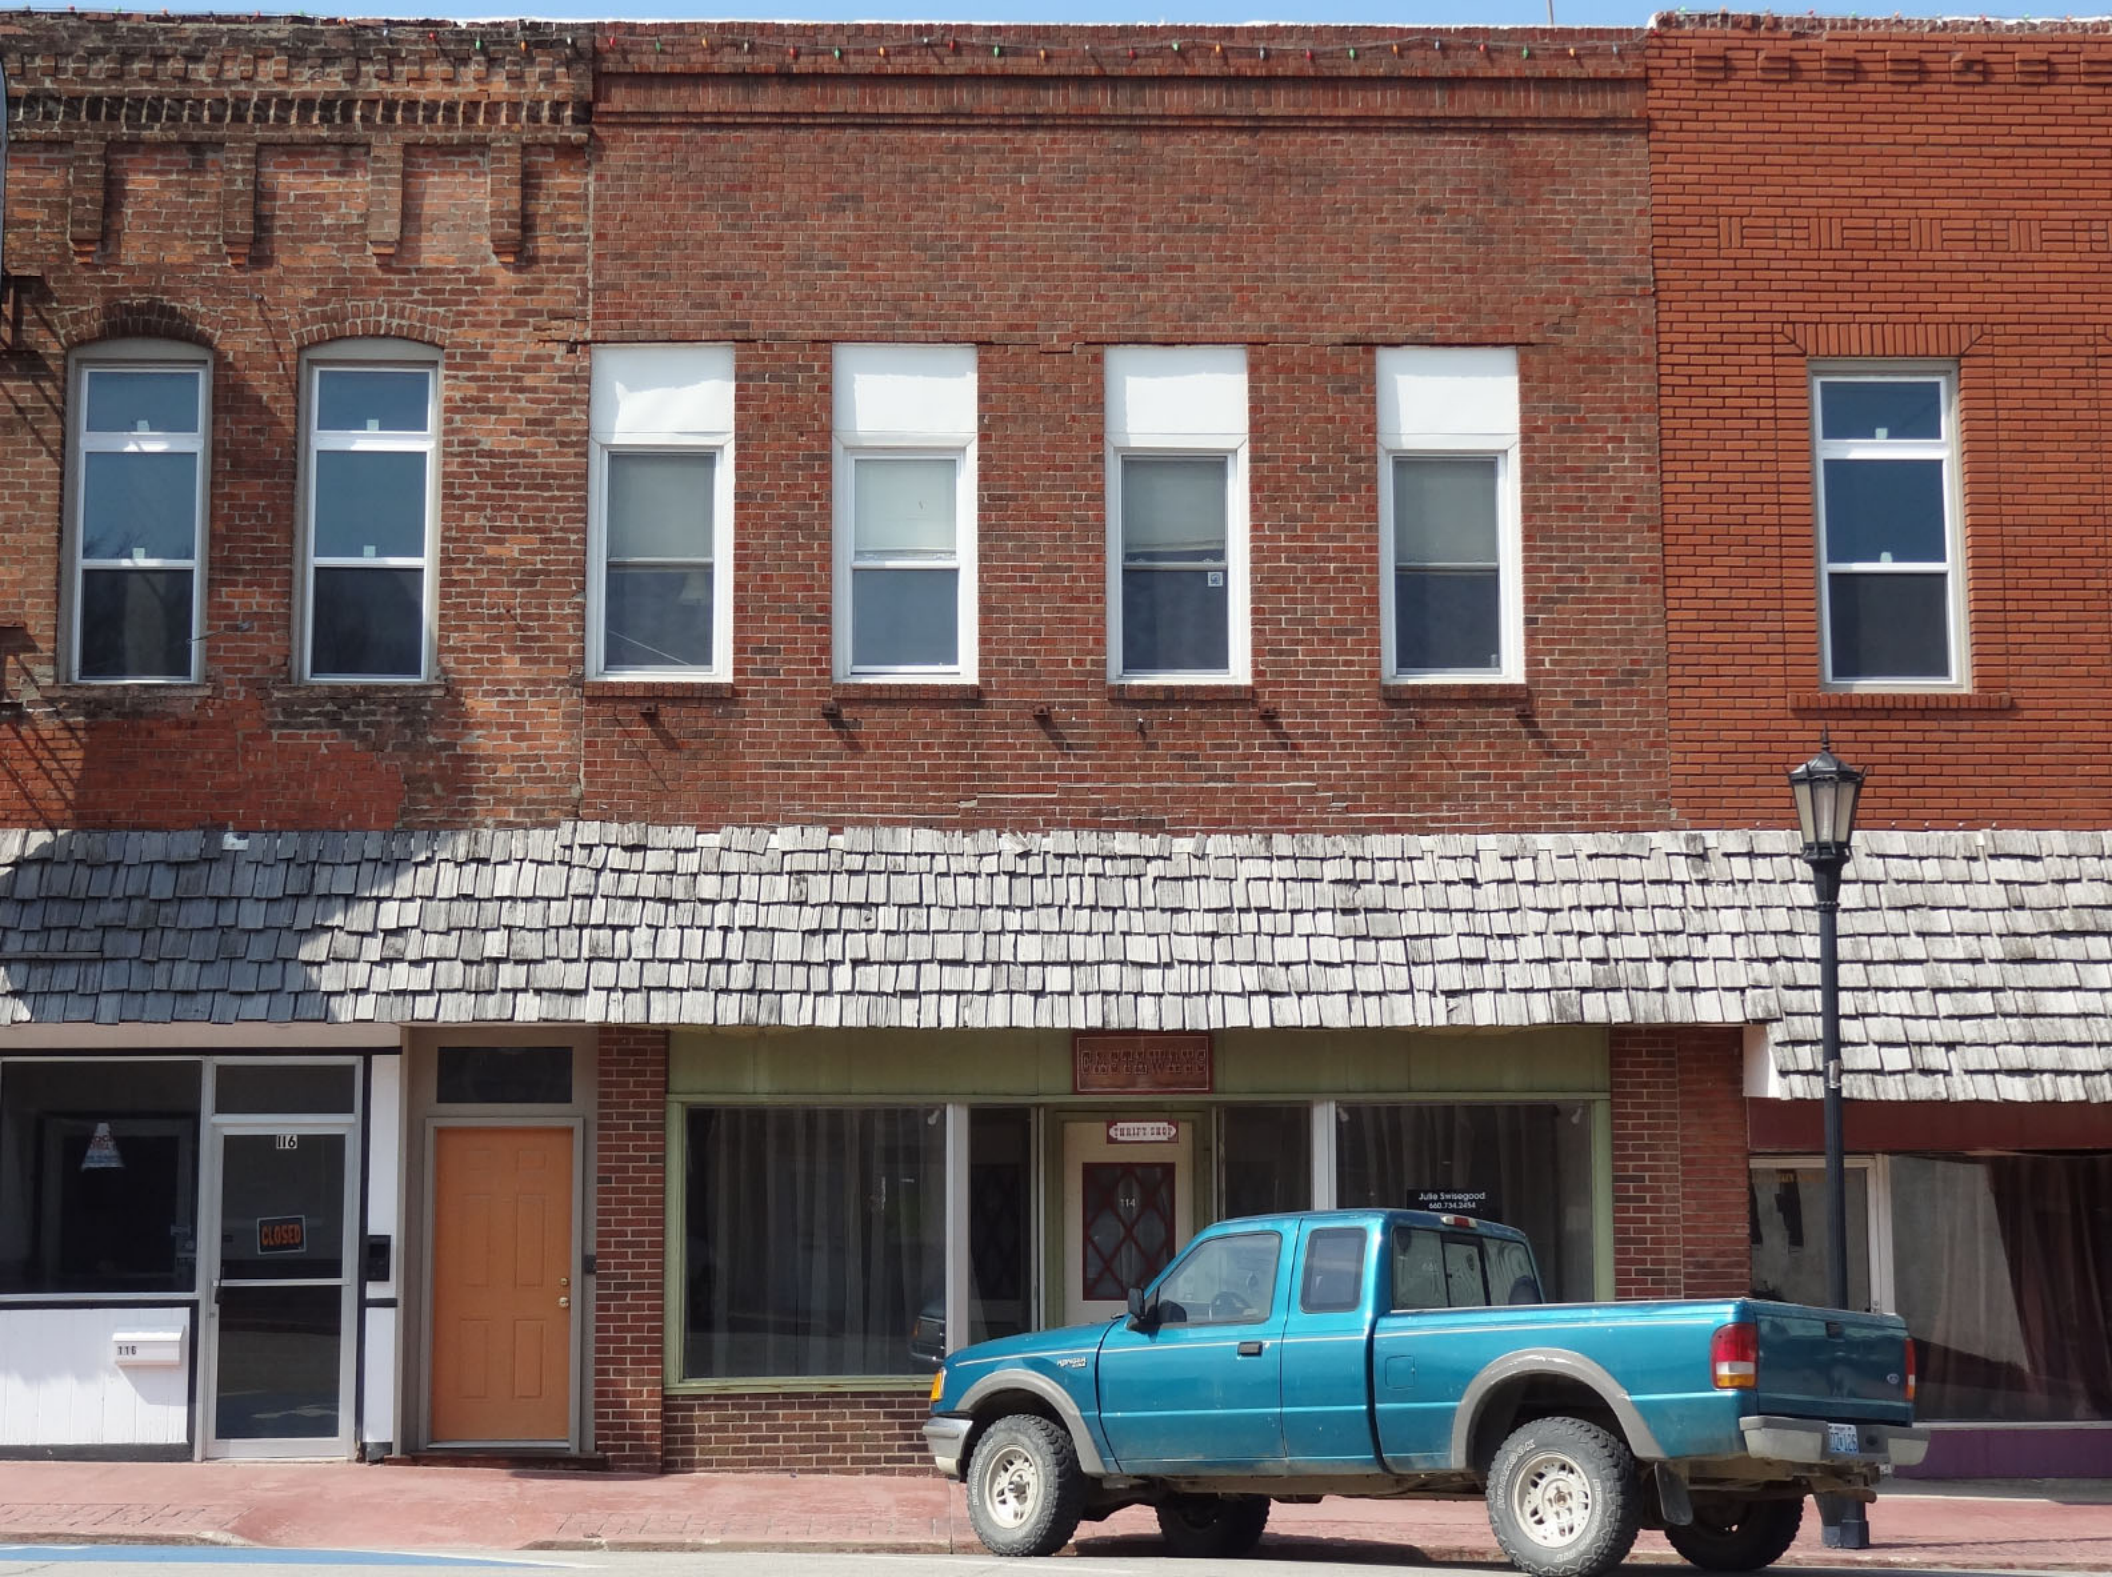
Above the storefront there is a wood shingle awning.

In the second story there are four window openings that have been infilled with wood and aluminum one-over-one windows. There is decorative brickwork in the parapet.
