MISSOURI DEPARTMENT OF NATURAL RESOURCES  
STATE HISTORIC PRESERVATION OFFICE, P.O. Box 176, Jefferson City, MO 65102  
**ARCHITECTURAL/HISTORIC INVENTORY FORM**

1. SURVEY NO. LI-AS-001-001		2. SURVEY NAME: Marceline Survey	
3. COUNTY: Linn		4. ADDRESS (STREET NO.) 275	STREET (NAME) West Broadway
5. CITY: Marceline	VICINITY: <input type="checkbox"/>	6. UTM: / /	7. TOWNSHIP/RANGE/SECTION: T: R: S:

8. HISTORIC NAME (IF KNOWN): Walt Disney's Childhood Home		9. PRESENT/OTHER NAME (IF KNOWN): Walt Disney's Childhood Home	
10. OWNERSHIP: <input checked="" type="checkbox"/> PRIVATE <input type="checkbox"/> PUBLIC		11A. HISTORIC USE (IF KNOWN): Single Dwelling	11B. CURRENT USE: Single Dwelling
<b>HISTORICAL INFORMATION</b>

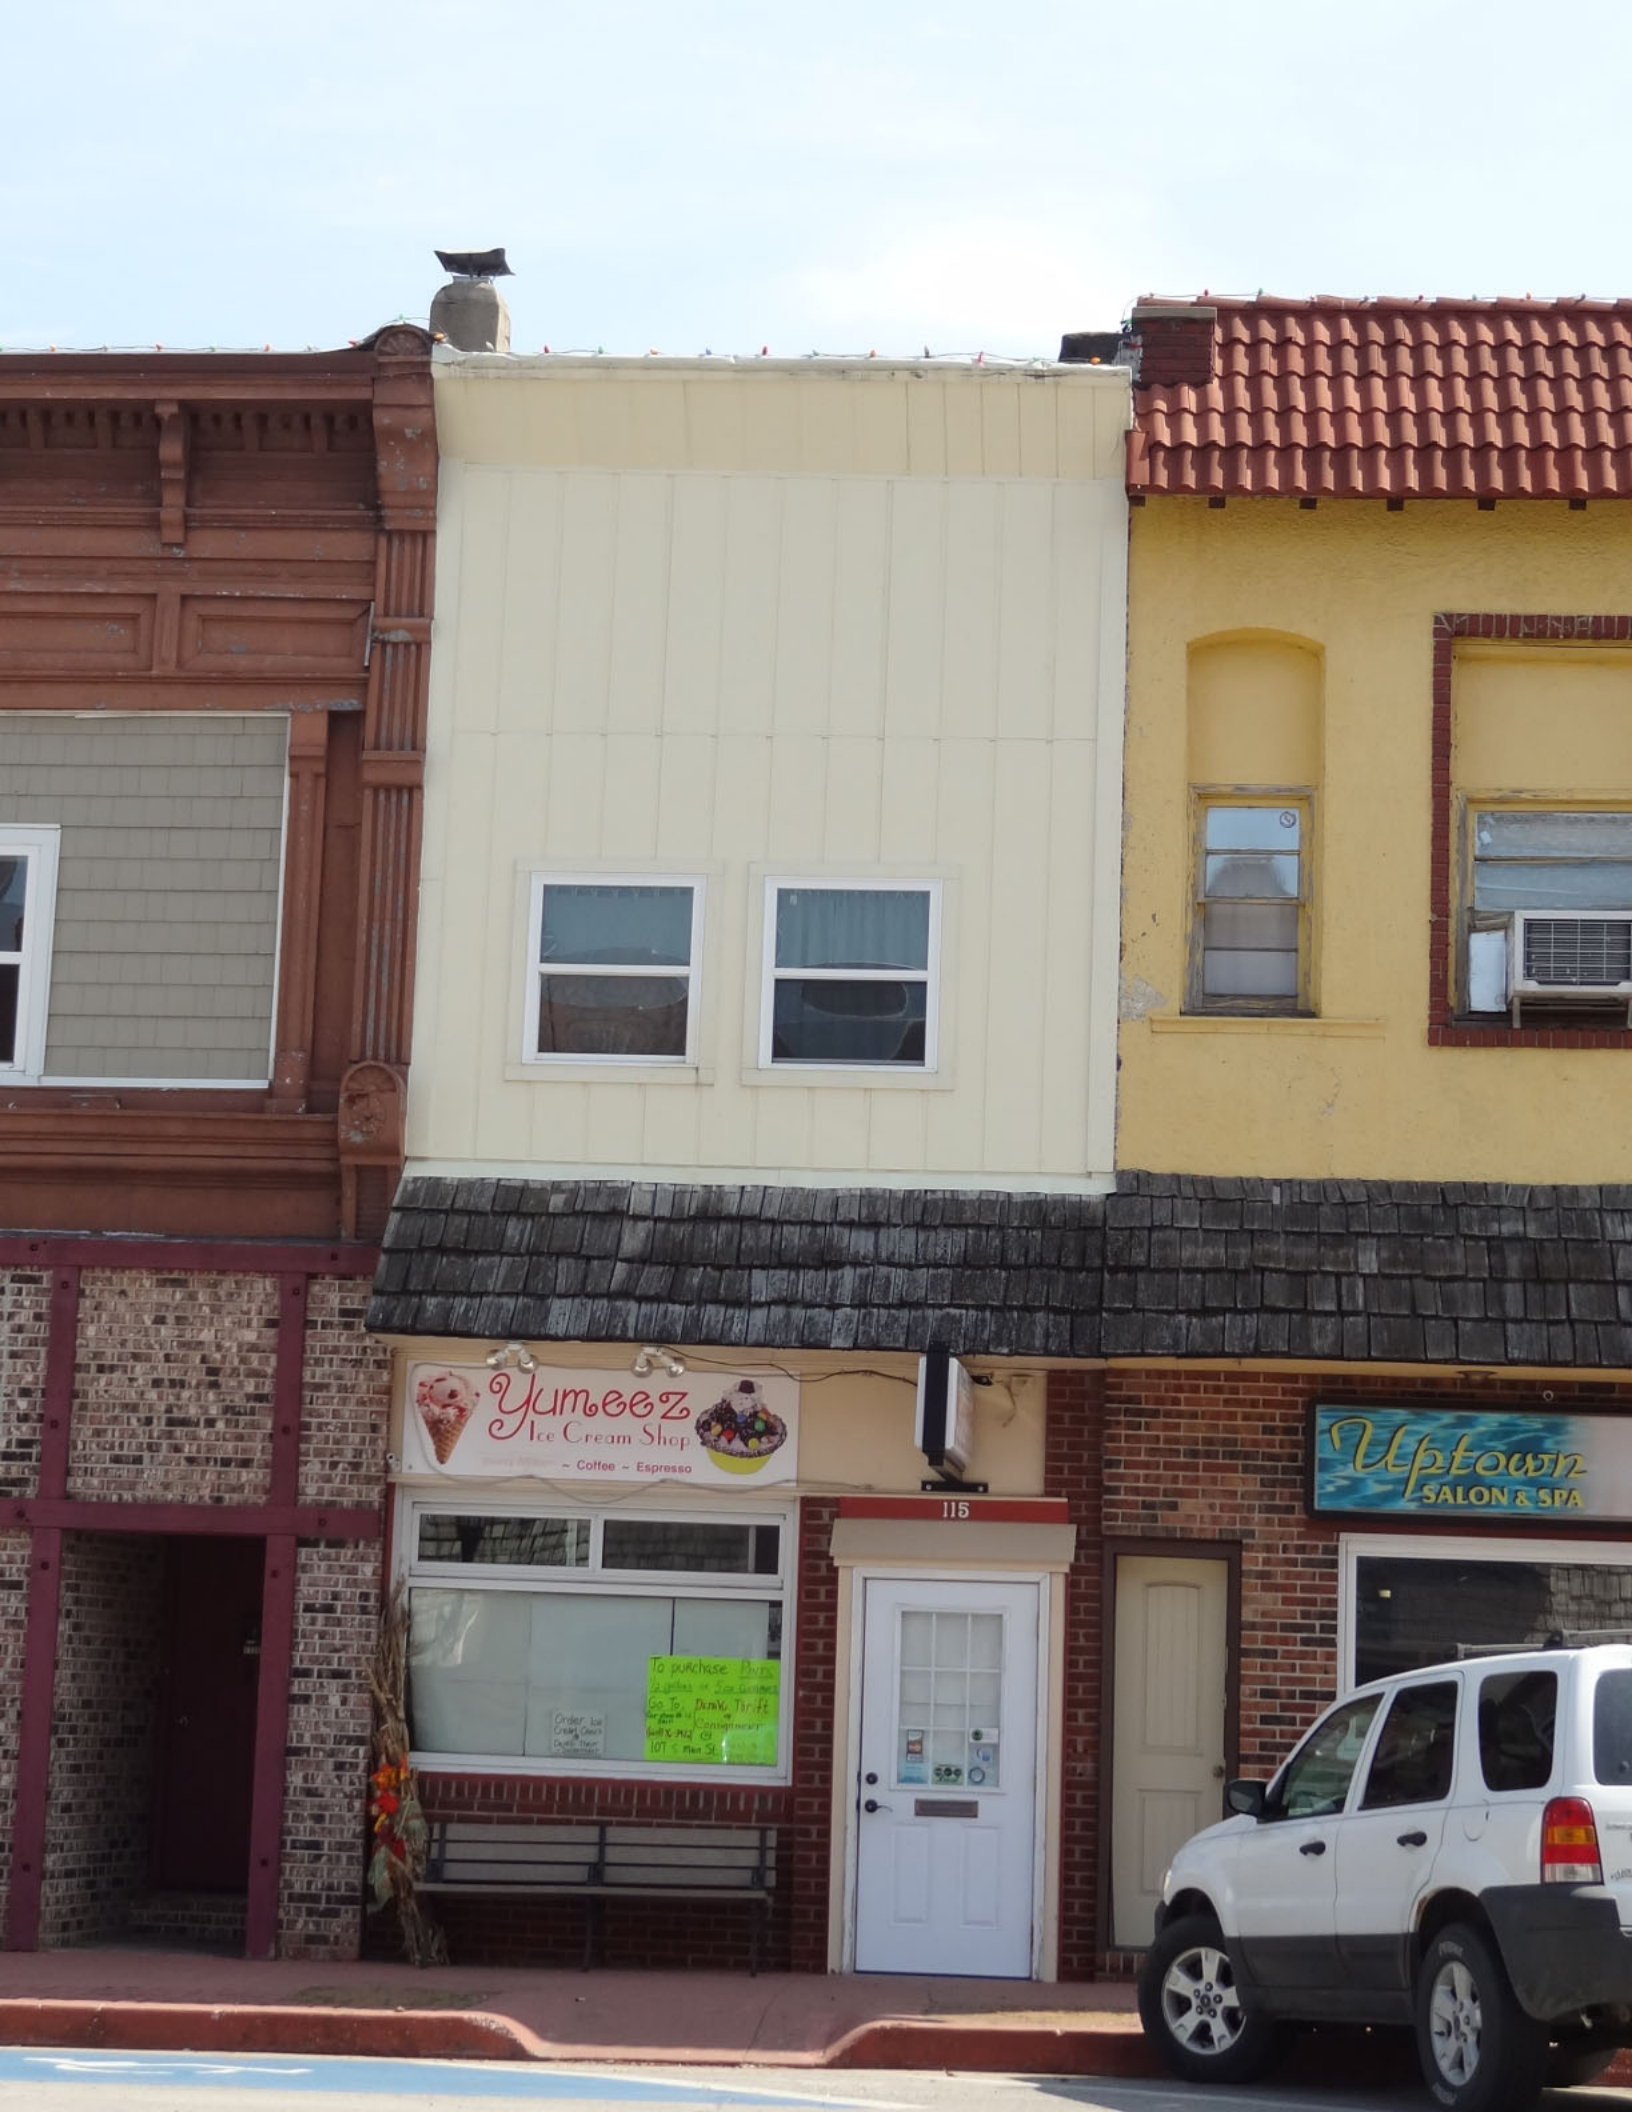
This narrow, two story, flat-roofed commercial block building has seen some alterations; the windows and doors all appear to be replacement and the upper story has been reclad in what appears to be vertical wood siding. Its first story has three bays: a large commercial window with a sliding window above it followed by a single door entry. The bottom floor is clad in brick; the storefront window has a rowlock brick sill. The two stories are divided by a wood shingled canopy. The second story has two, one-over-one vinyl windows.

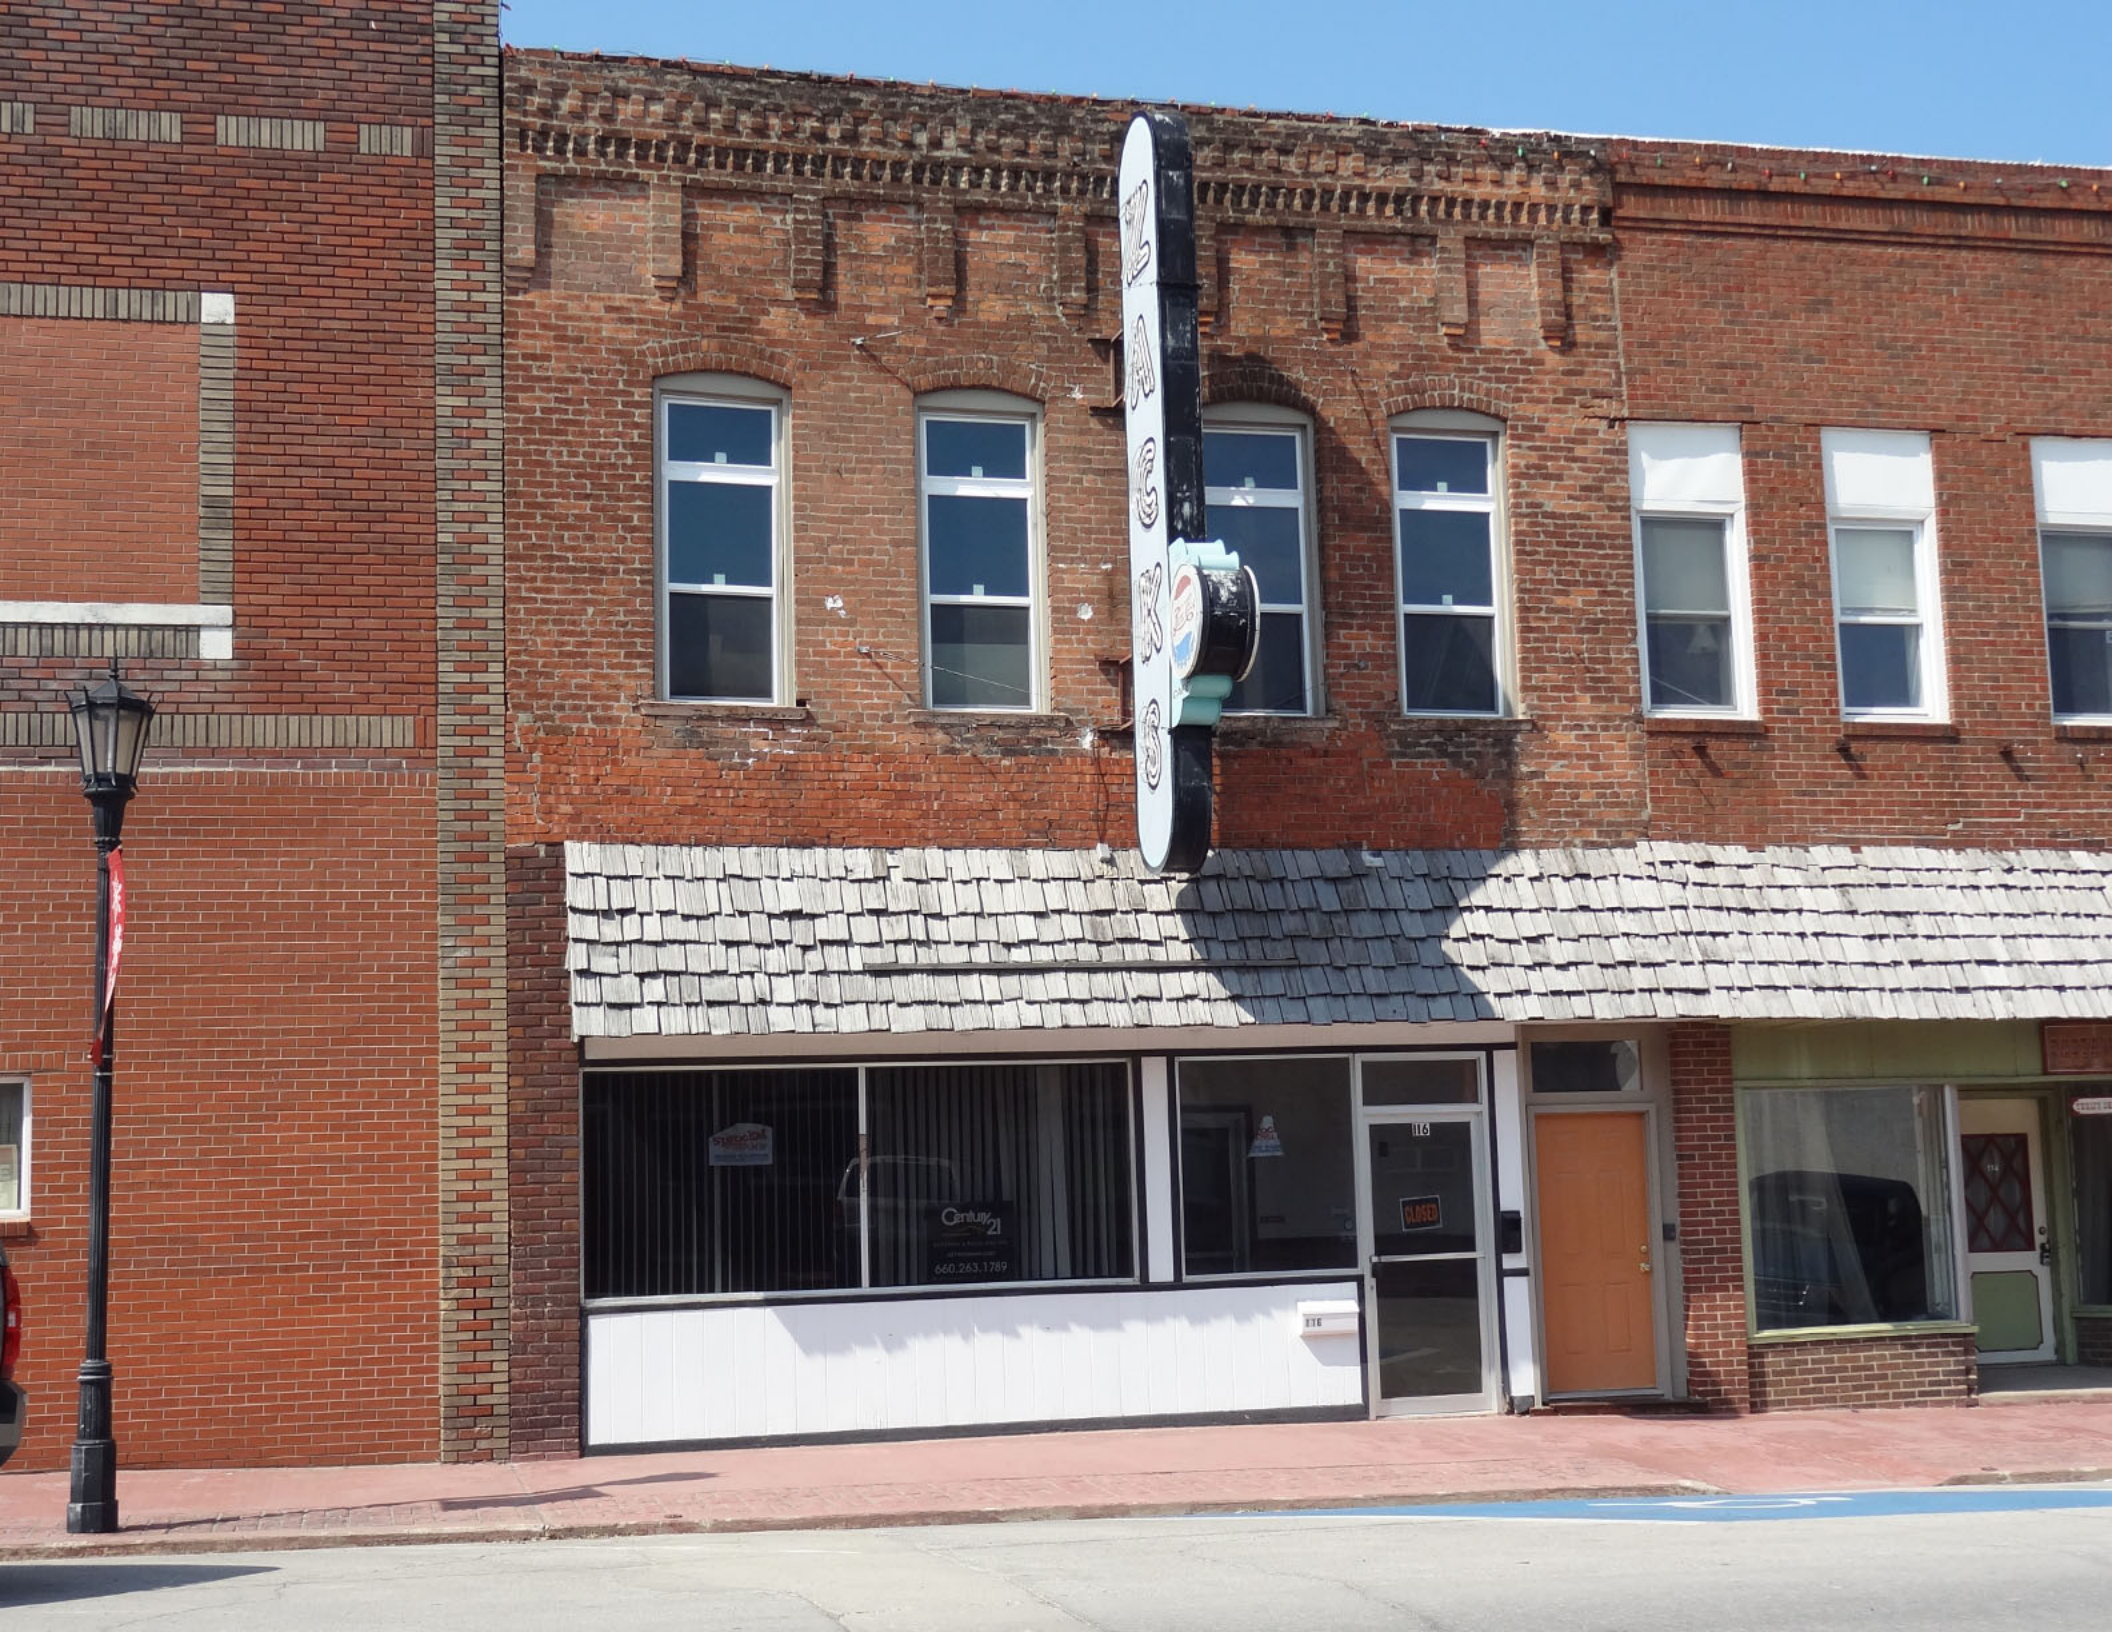
There is also a large metal sign that projects from the second story.

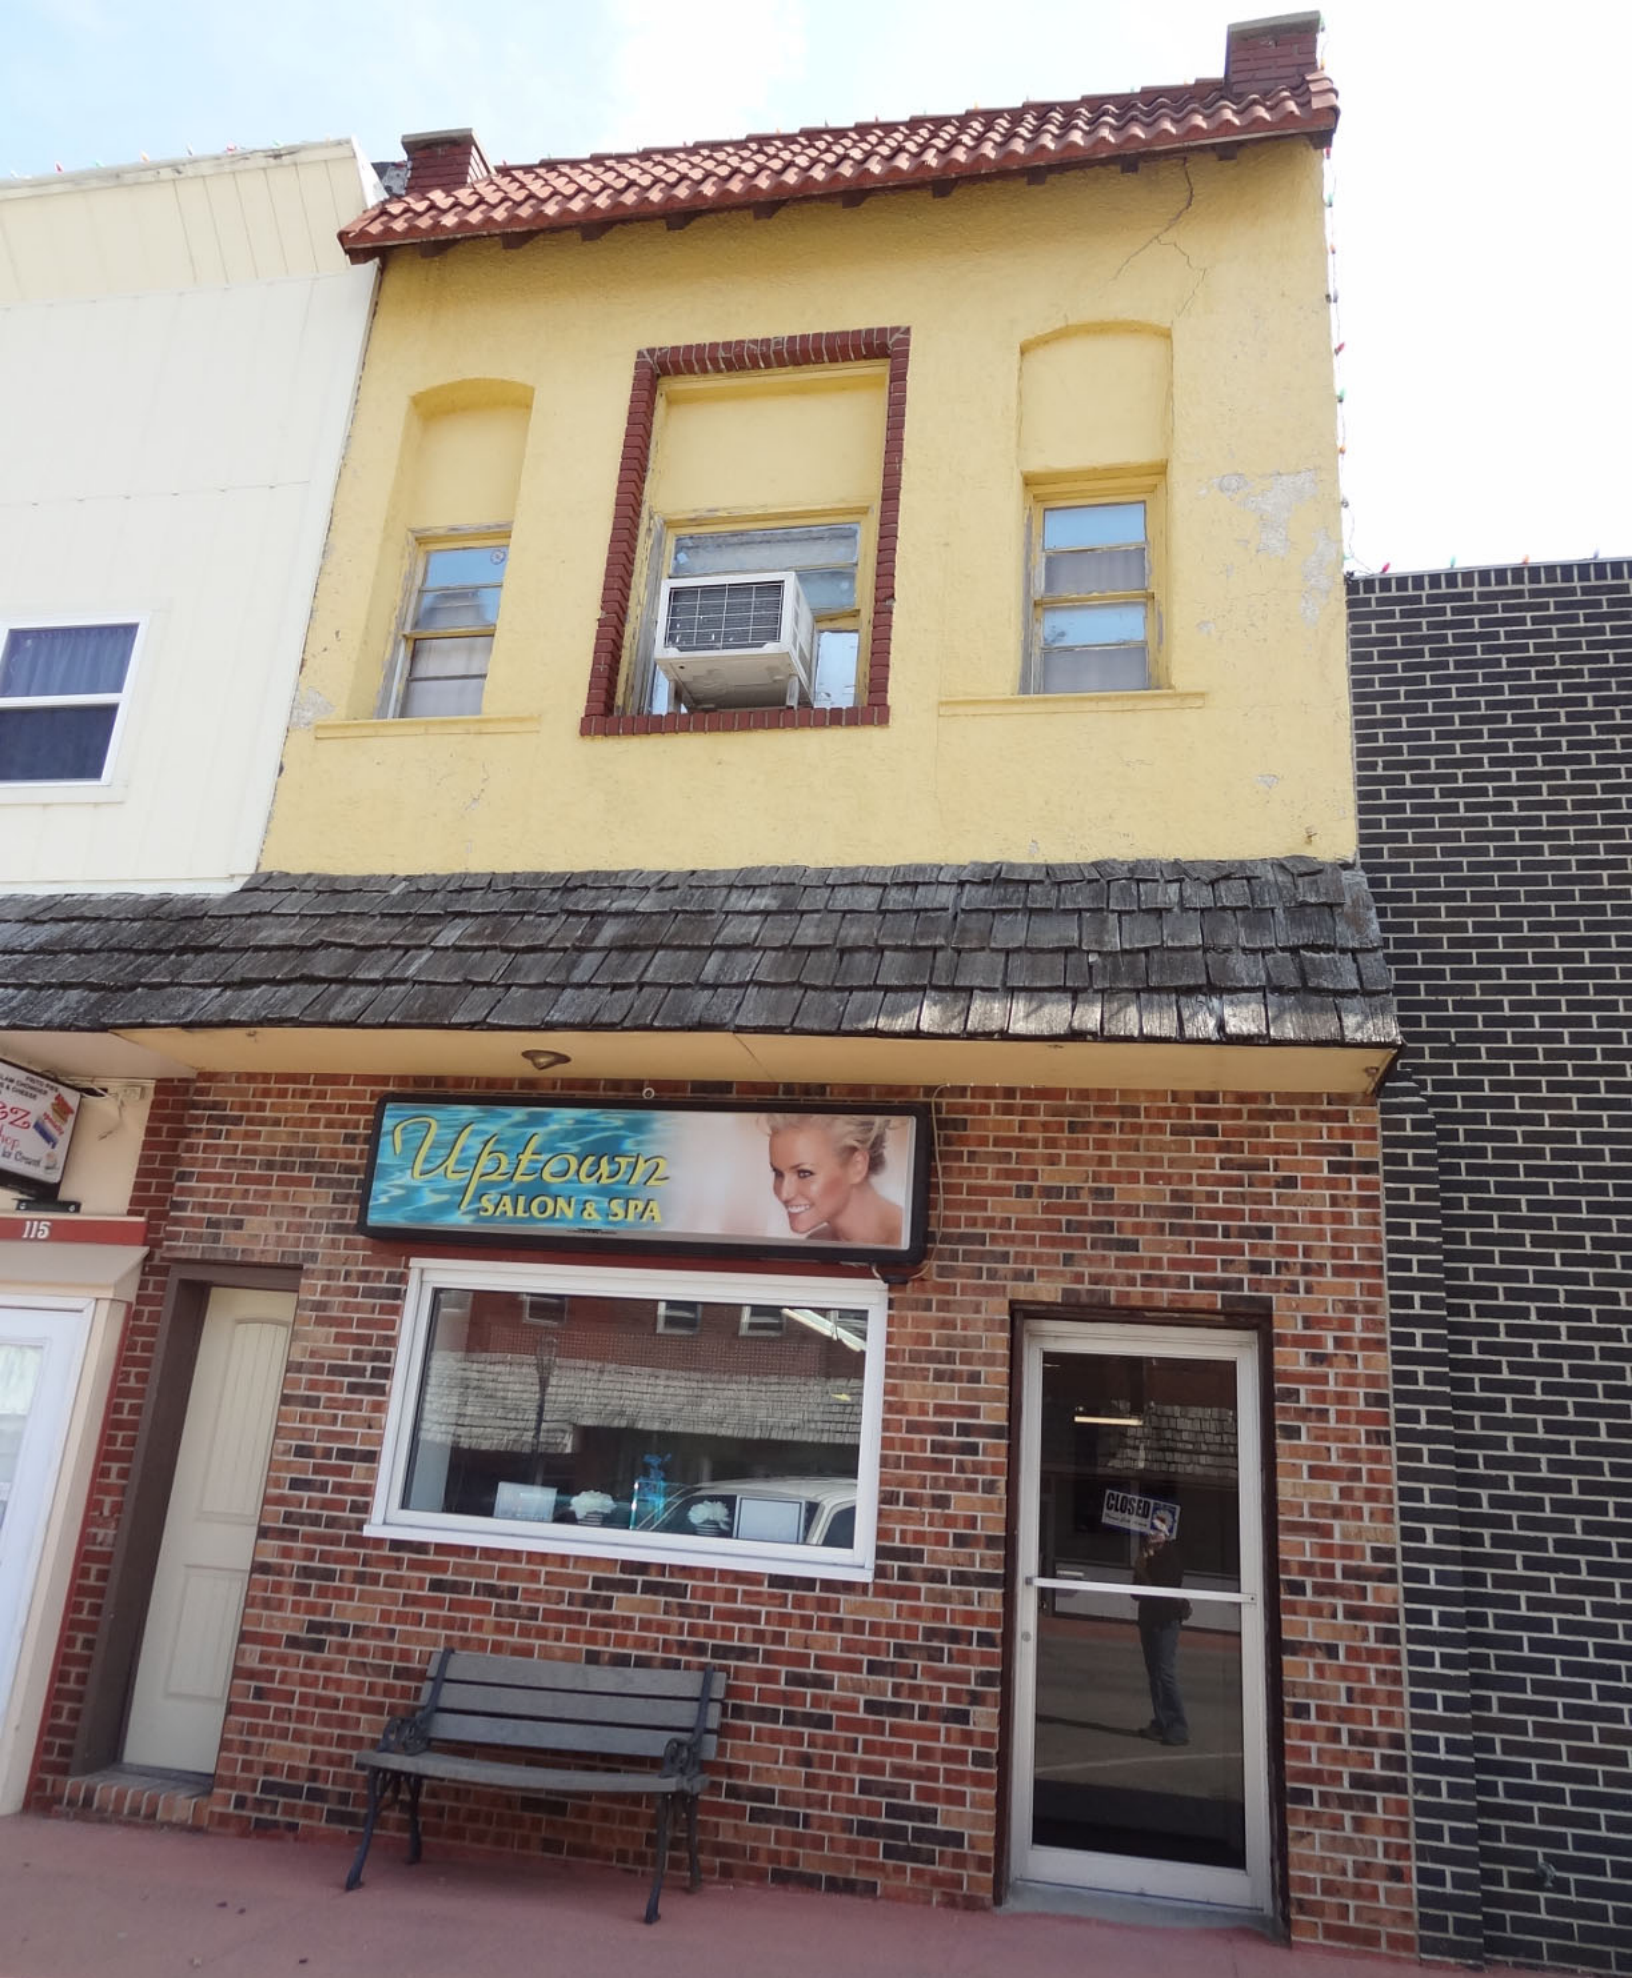
This property has seen some major alterations, including a new storefront, recladding, and replacement windows, and therefore lacks historic integrity, precluding it from listing in the National Register.

The first story of this two-story flat roofed building is clad in brick and has three bays. The first is a very narrow wooden door that may be early if not original. The second is a nonhistoric large single paned window. The third is a single nonhistoric glass door. Above the first story is a wood shingled canopy that the building shares with 115 S Main. The upper story has been stuccoed and has three windows. The windows are not original as the window openings appear to have been altered (indicating once larger windows, two of which had been arched), but they do appear to be early. They are two-over-two wood windows. The central window is wider than the other two and its original rectangular opening is surrounded in rowlock brick; it houses an air conditioning unit. A false shed roof with clay tiles projects out from the building diagonally along the roofline.

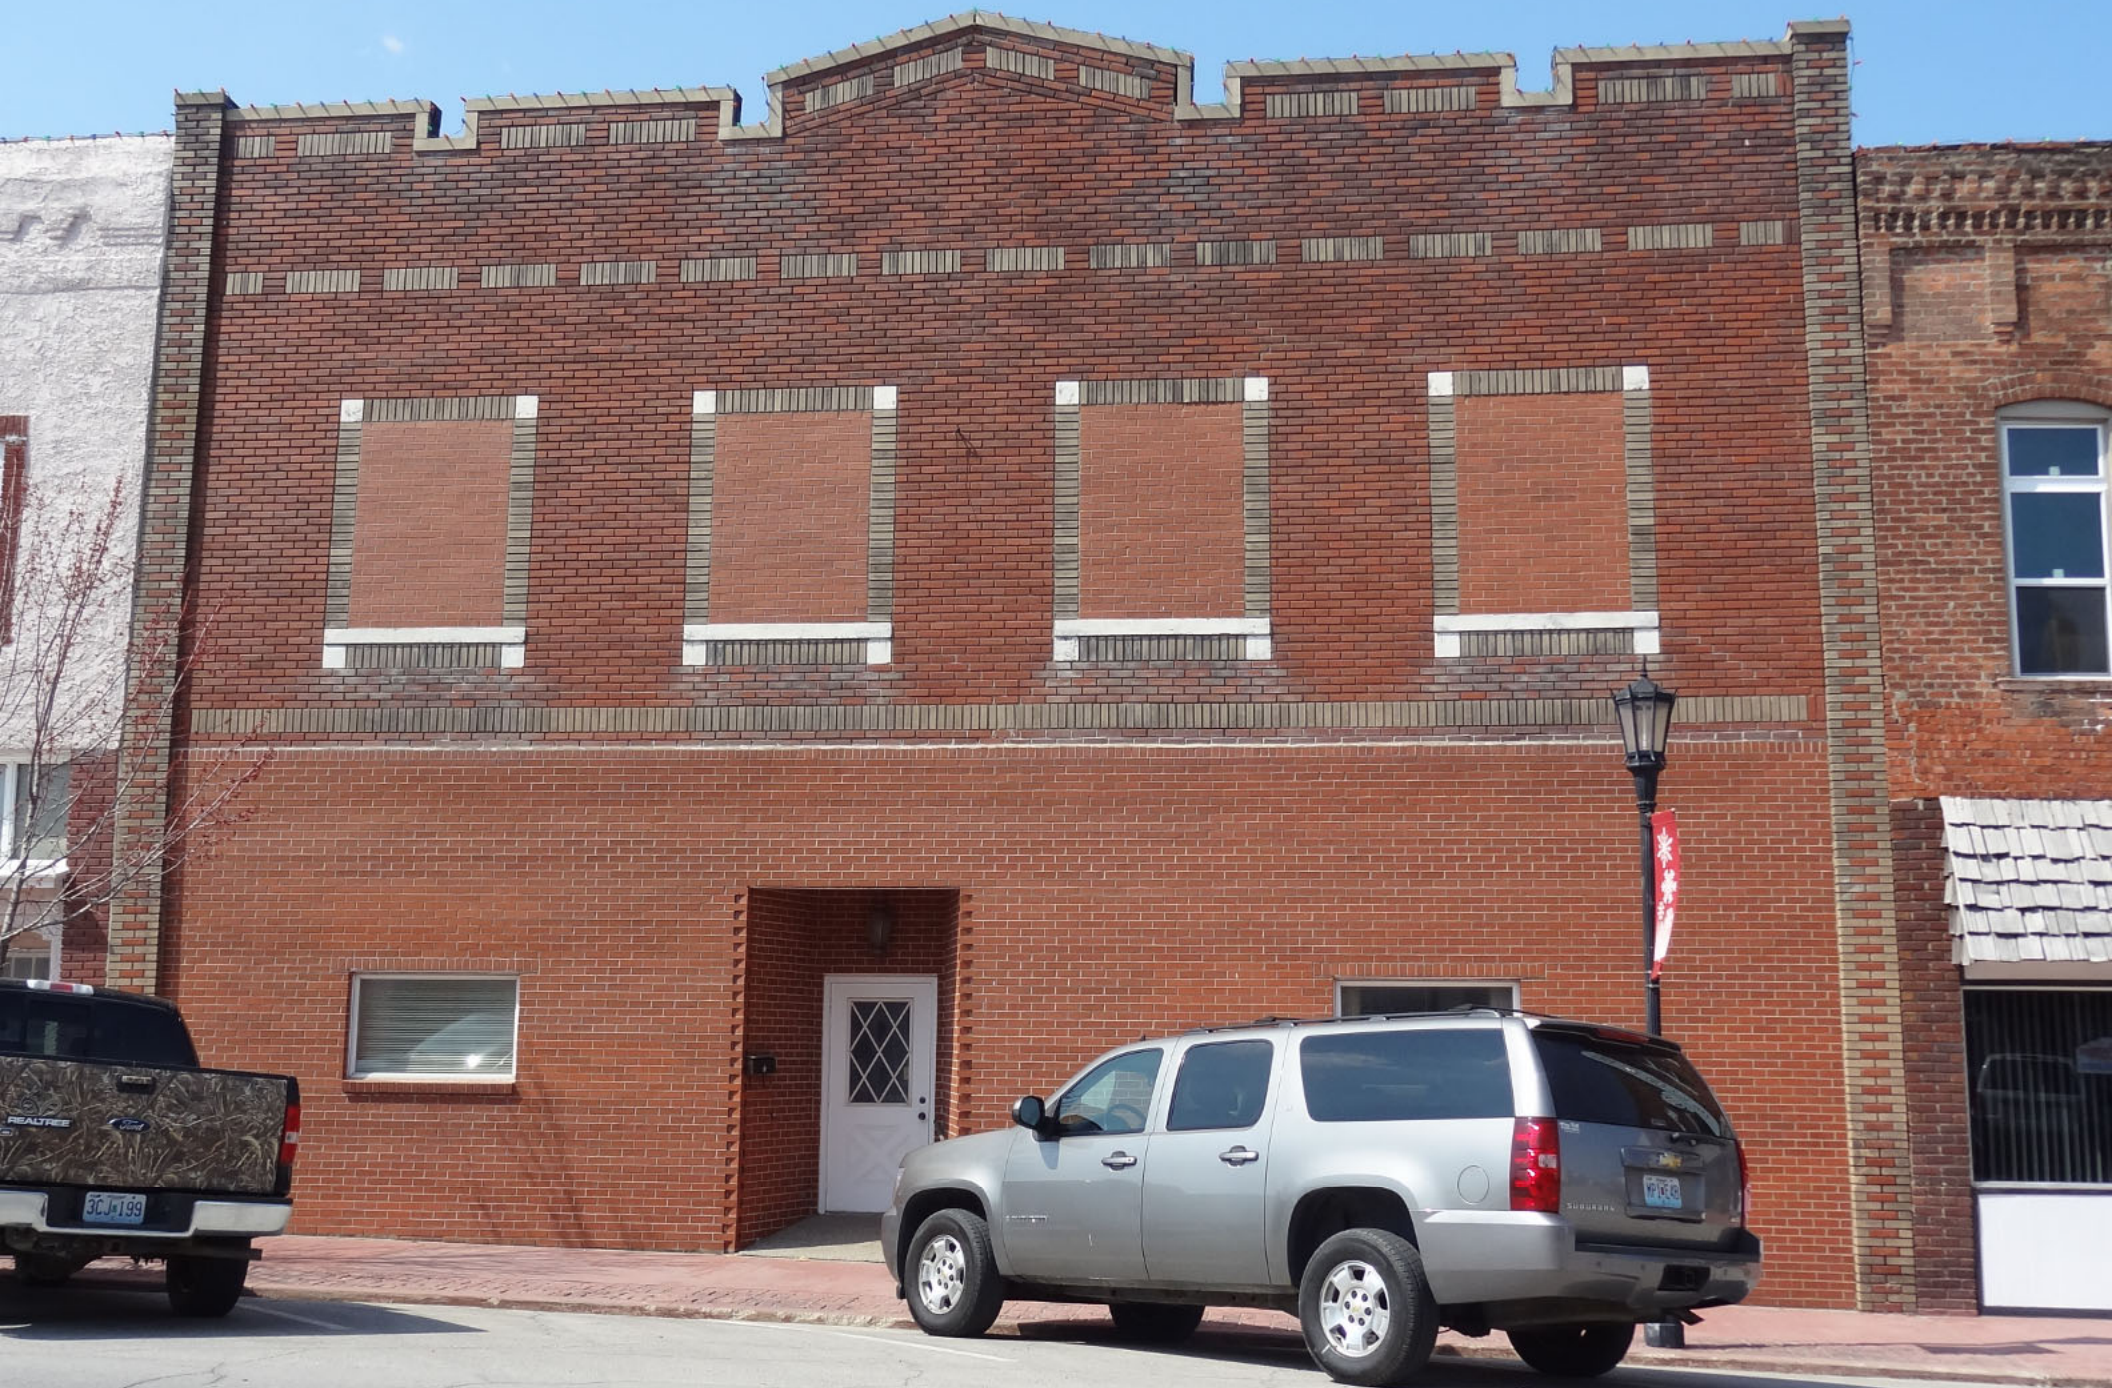
This building's historic integrity has been impacted by a nearly completely bricked in storefront and bricked in upper story windows. This property lacks the significance necessary for individual listing in the National Register. Collectively, this area does not appear to be eligible for listing as a historic district due to an overall loss of integrity, thus this property is noted as not eligible.

From the southern bay there is a single fixed vinyl window. The center bay, is the recessed door, the door is solid with a diamond pattern window in the door. The third bay is a single fixed vinyl window. All elements are nonhistoric.

The upper story has four windows openings that have been infilled with brick. There is historic brickwork in the upper level with multi-colored brick creating decorative patterns. The stepped parapet is capped with concrete.

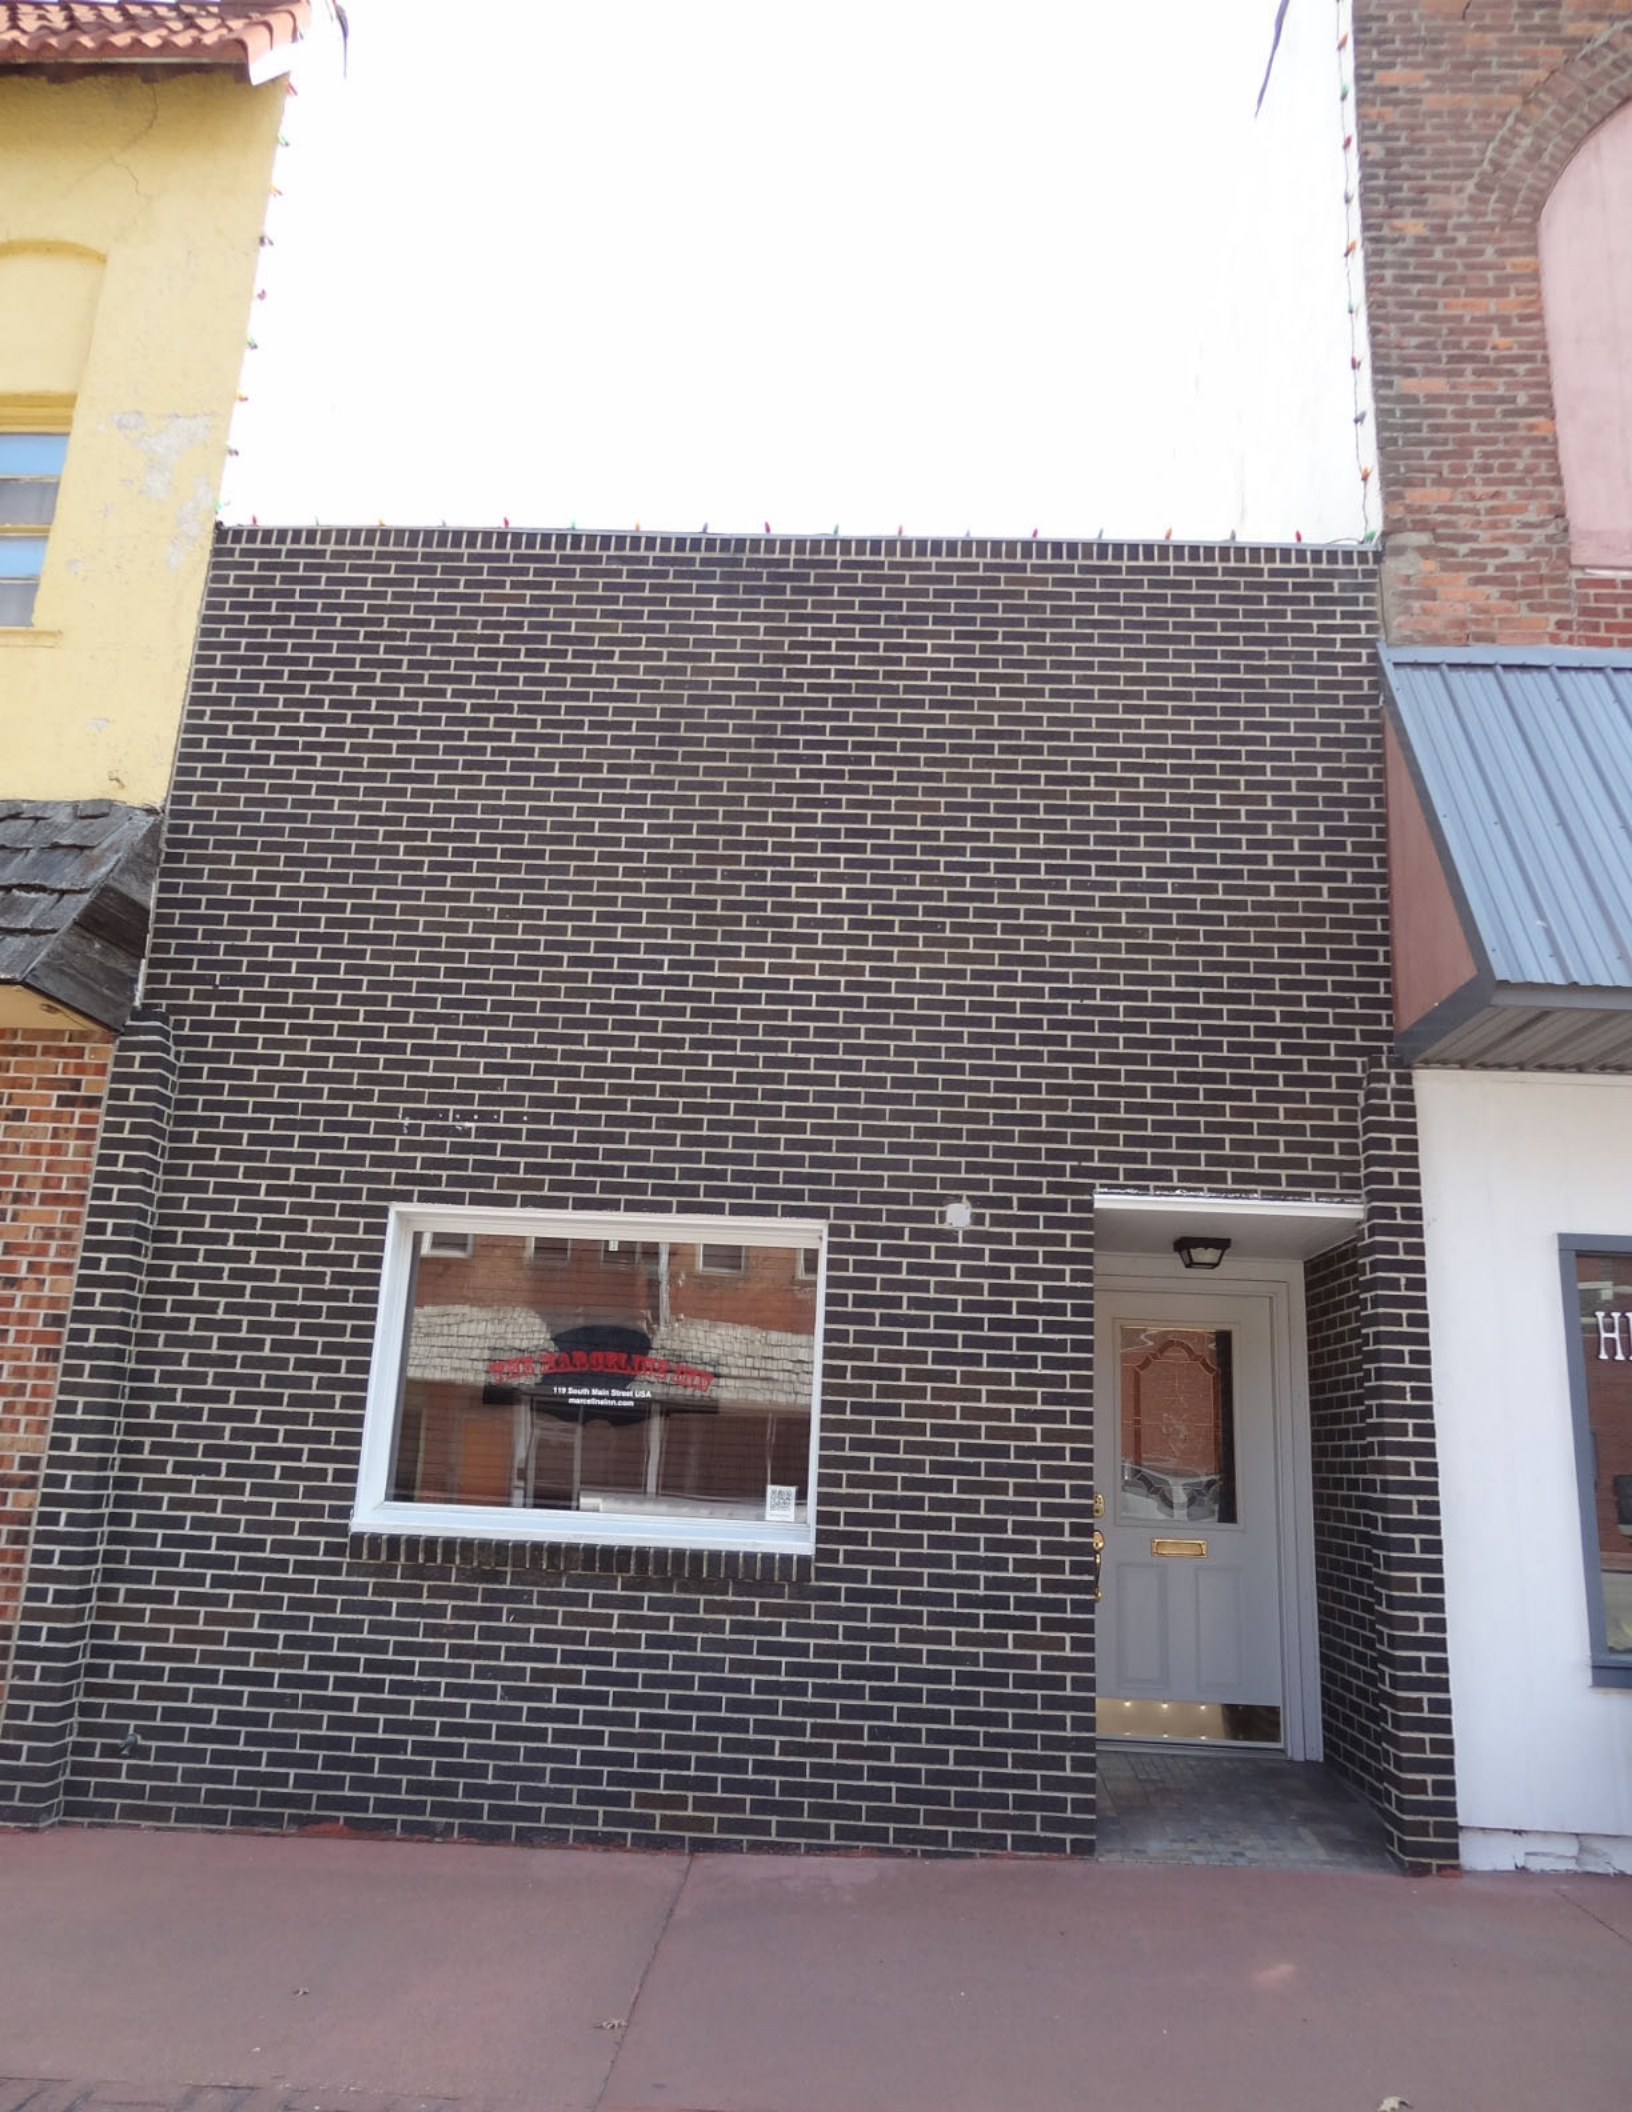
This is a simple, flat-roofed, one-part commercial block building which has been clad in a dark brick. It has two bays: one is a large single paned window and the other a single recessed door. Neither the cladding nor the window and door appear to be original. The window has a rowlock brick sill and the roofline is demarcated with a row of rowlock brick.

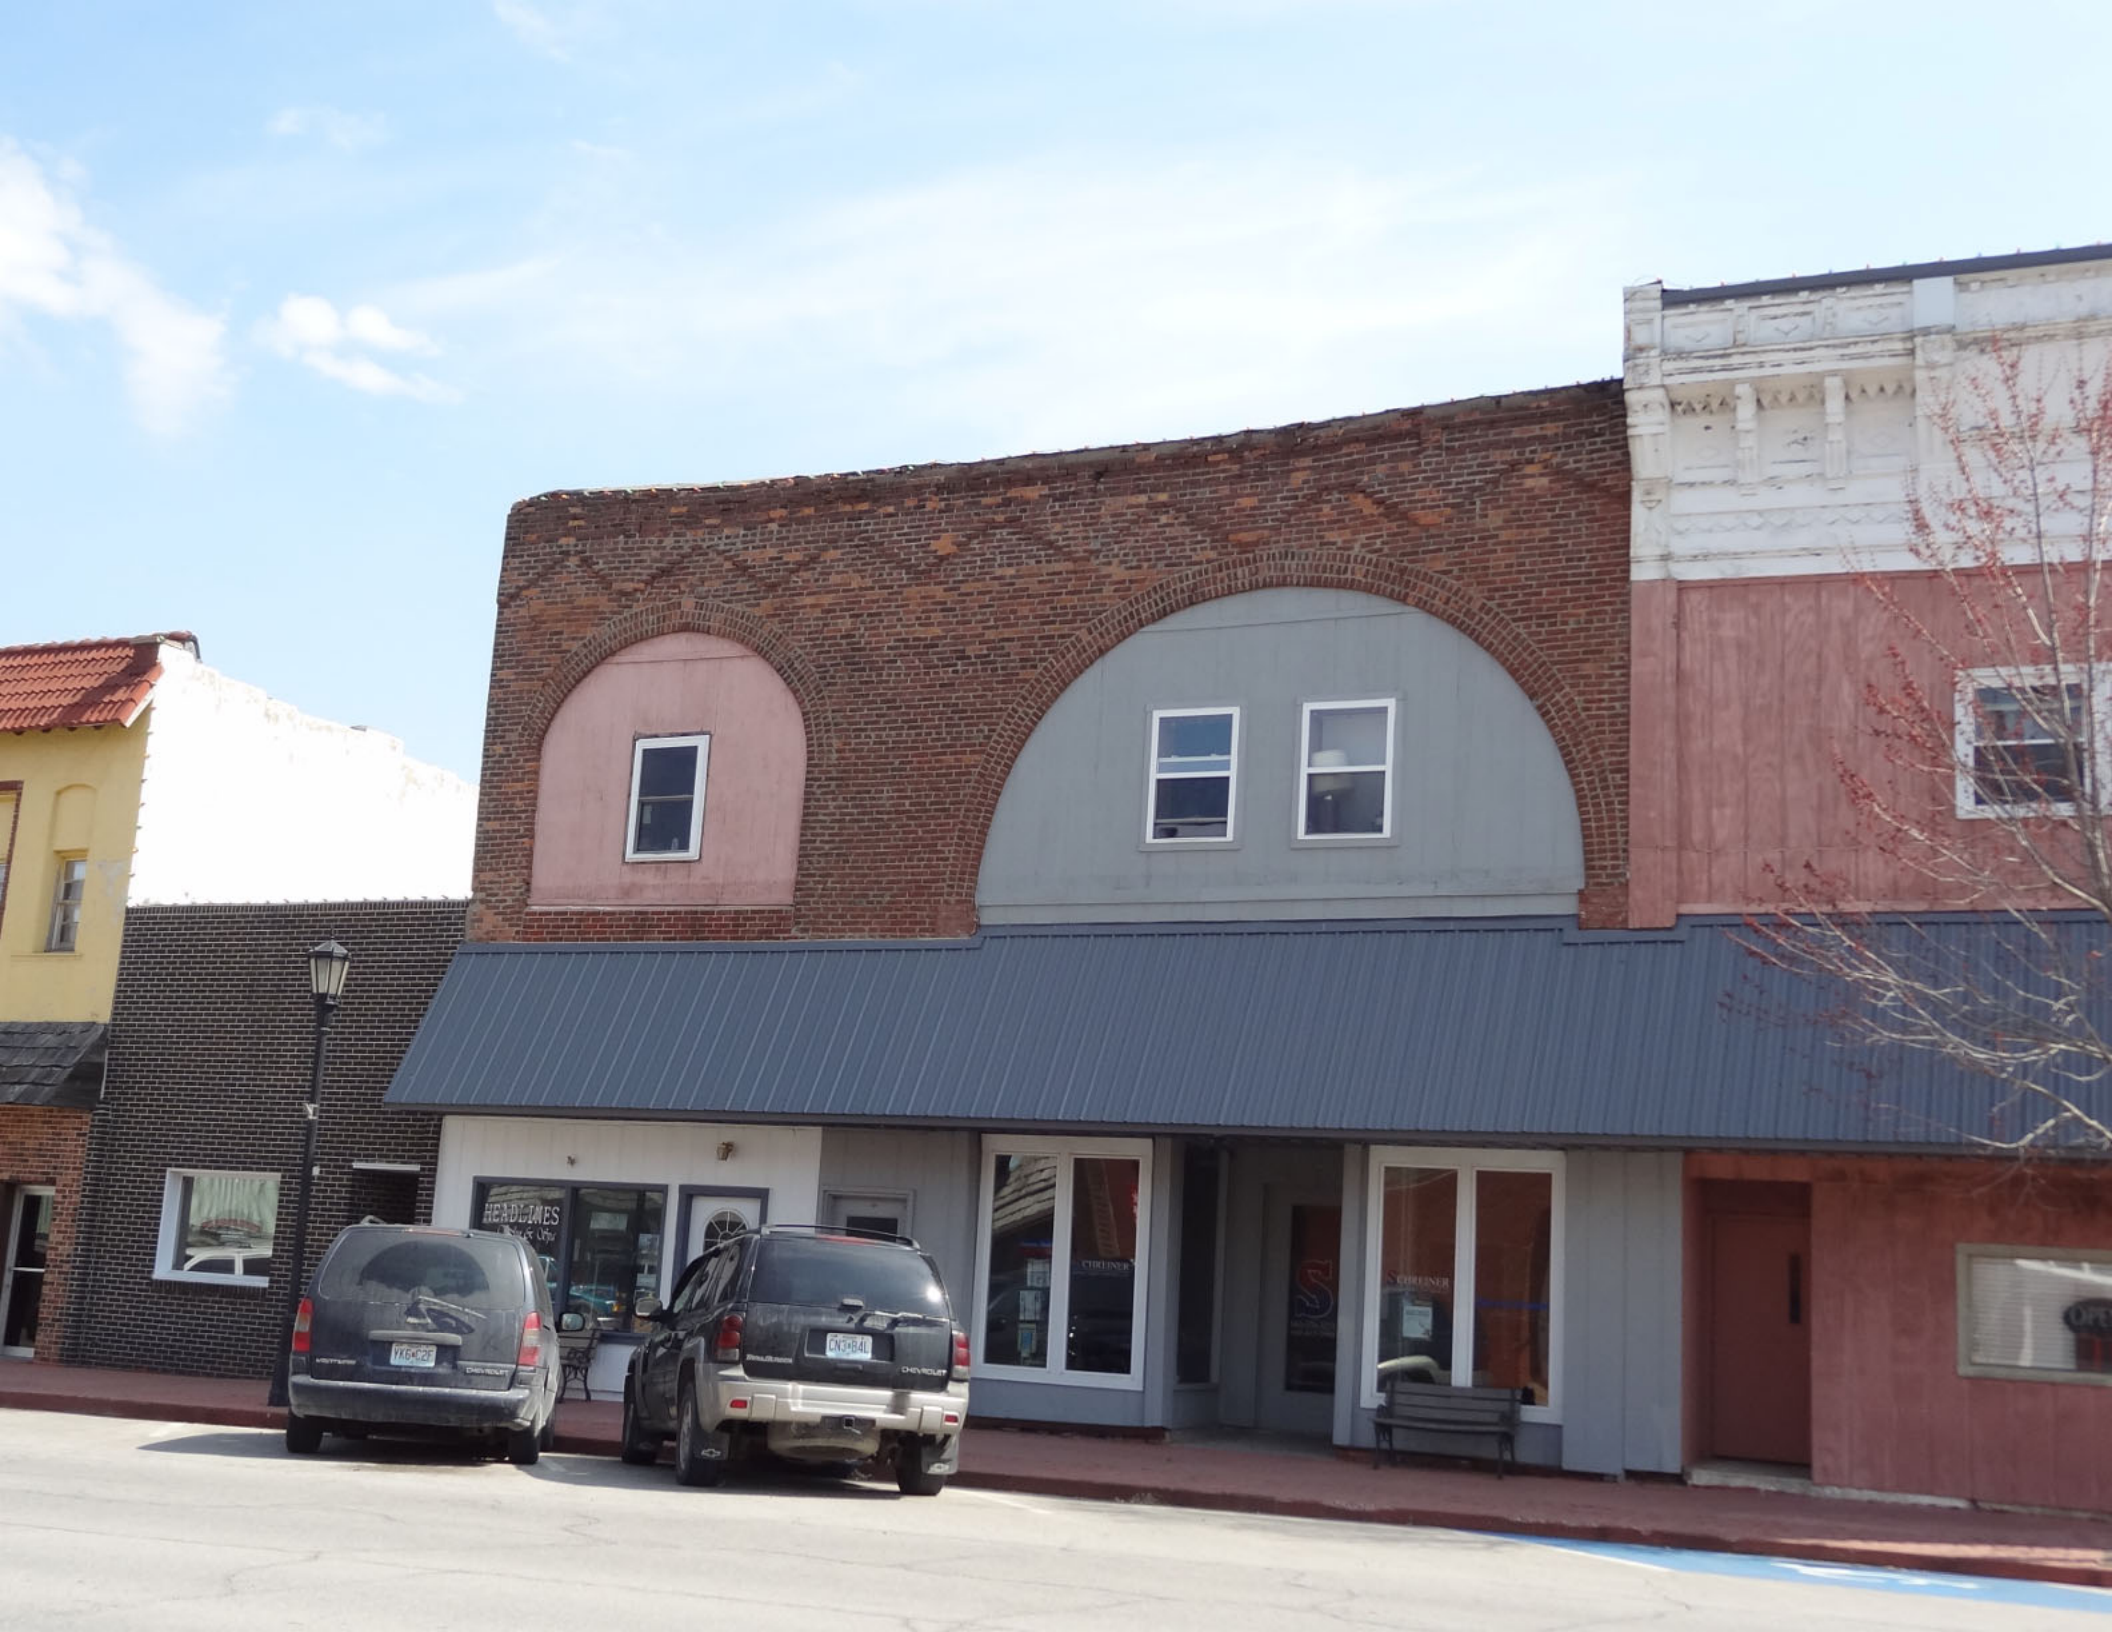
This is a flat-roofed, two part-commercial block building with 6 bays. The lower floor has been reclad in vertical wood planks. Windows and doors do not appear to be historic. The first bay, from left to right, houses two storefront windows and the second a single door. The window and door are both surrounded in blue painted timbering and the siding on this portion of the building is painted white. The rest of the first floor siding is painted blue. The third bay houses another single door, the fourth two tall storefront windows, and the fifth a recessed single door. The final bay matches the fourth, housing two tall storefront windows. These windows are surrounded in wide white frames. Above the first floor is a metal roofed canopy that spans the full facade of this building and the facade of the building to the south. The upper story maintains its original brick cladding and detailing, which includes two large arched openings that were once large windows; the archway to the north is approximately half the size of the archway to the south. The arches have three rows of rowlock brick sills. These openings have been infilled with vertical wood planks and small one-over-one windows. The first, smaller arched opening has a single window while the second has two windows. More brick detailing is along the roofline, including a zigzag design made with bricks that project out slightly.
