MISSOURI DEPARTMENT OF NATURAL RESOURCES  
STATE HISTORIC PRESERVATION OFFICE, P.O. Box 176, Jefferson City, MO 65102  
**ARCHITECTURAL/HISTORIC INVENTORY FORM**

1. SURVEY NO. LI-AS-001-001		2. SURVEY NAME: Marceline Survey	
3. COUNTY: Linn		4. ADDRESS (STREET NO.) 275	STREET (NAME) West Broadway
5. CITY: Marceline	VICINITY: <input type="checkbox"/>	6. UTM: / /	7. TOWNSHIP/RANGE/SECTION: T: R: S:

8. HISTORIC NAME (IF KNOWN): Walt Disney's Childhood Home		9. PRESENT/OTHER NAME (IF KNOWN): Walt Disney's Childhood Home	
10. OWNERSHIP: <input checked="" type="checkbox"/> PRIVATE <input type="checkbox"/> PUBLIC		11A. HISTORIC USE (IF KNOWN): Single Dwelling	11B. CURRENT USE: Single Dwelling
<b>HISTORICAL INFORMATION</b>

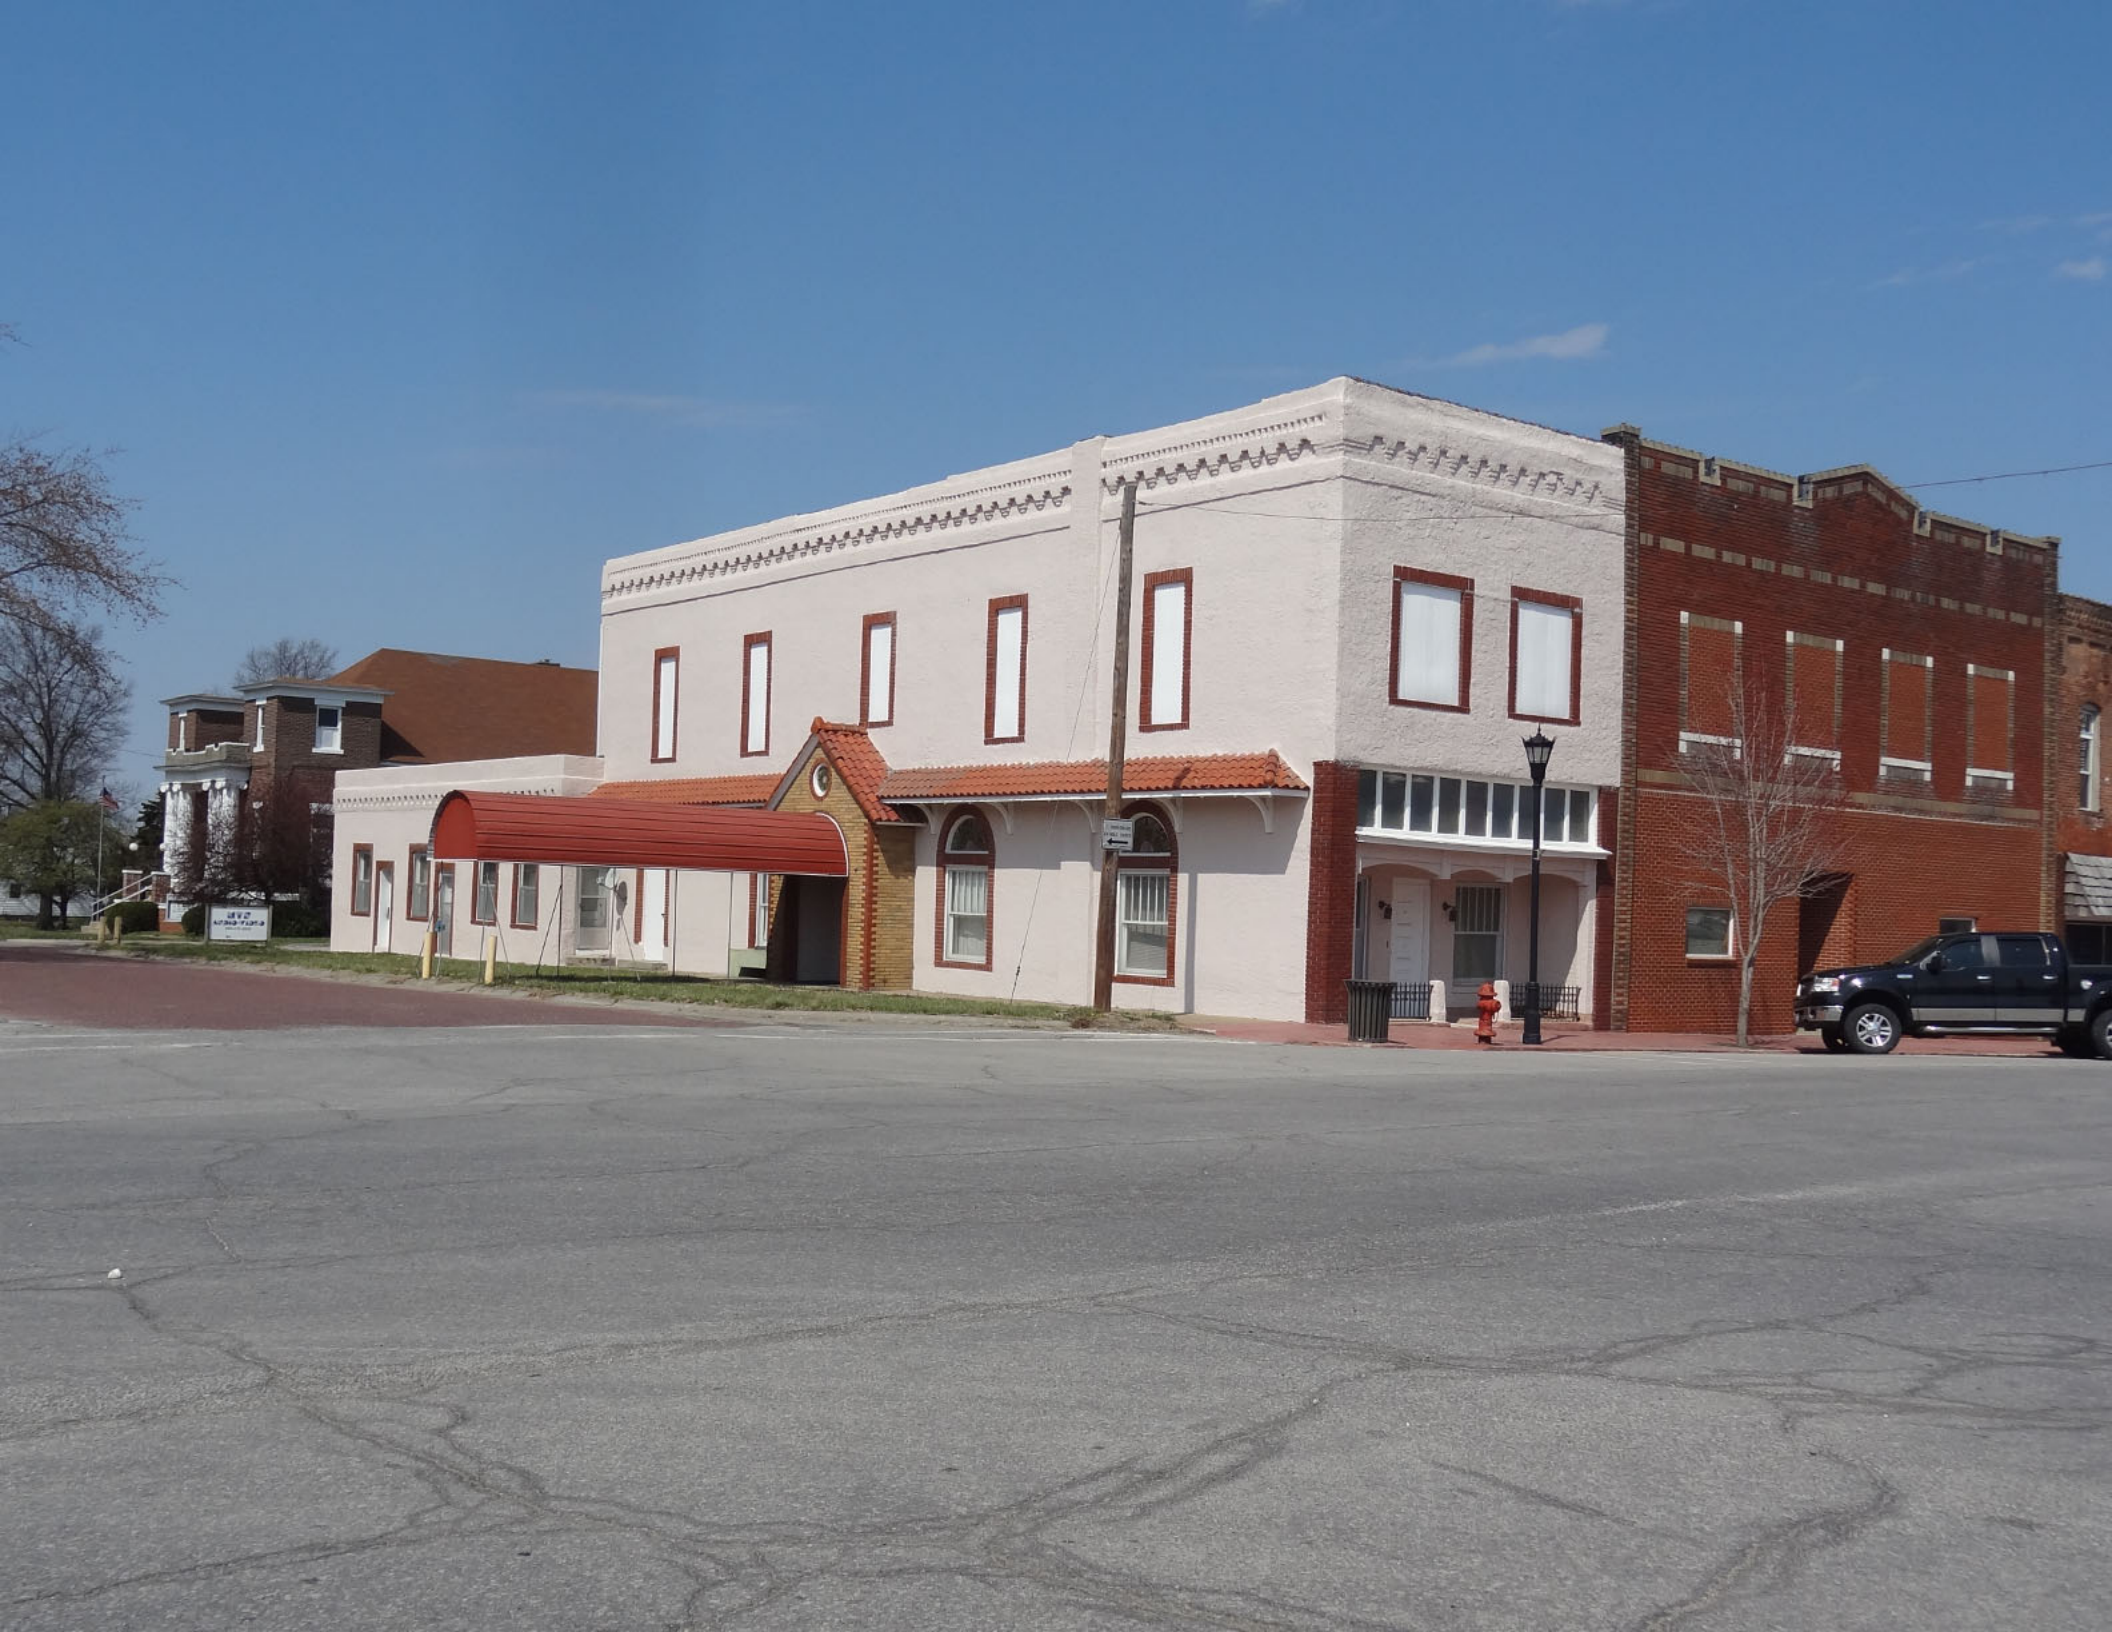
This building is a two story stucco clad commercial building. The storefront is recessed under an awning. There are three bays on the storefront. The southernmost bay has a six-over-one window and the center bay is a solid wood door. The third bay from the south also has a single six-over-one window. There is a metal railing that separates the sidewalk and the porch. Above the storefront there is a row of clerestory windows. The second story has a two windows that have been boarded. The southern elevation has also has a central entrance that is flanked by two arched windows to the west and one arched window followed by a single door with an arched transom. The entrance has a front gabled brick entrance and an awning from the building to the street. The roof is surrounded by decorative parapet.

In the one story addition to the rear it is also covered in stucco from the west there are two one-over-one windows then a a single entrance behind a metal screened windows. The next bay has another single window followed by another single door and single one-over-one single window. All openings in this part of the building are surrounded by brick.

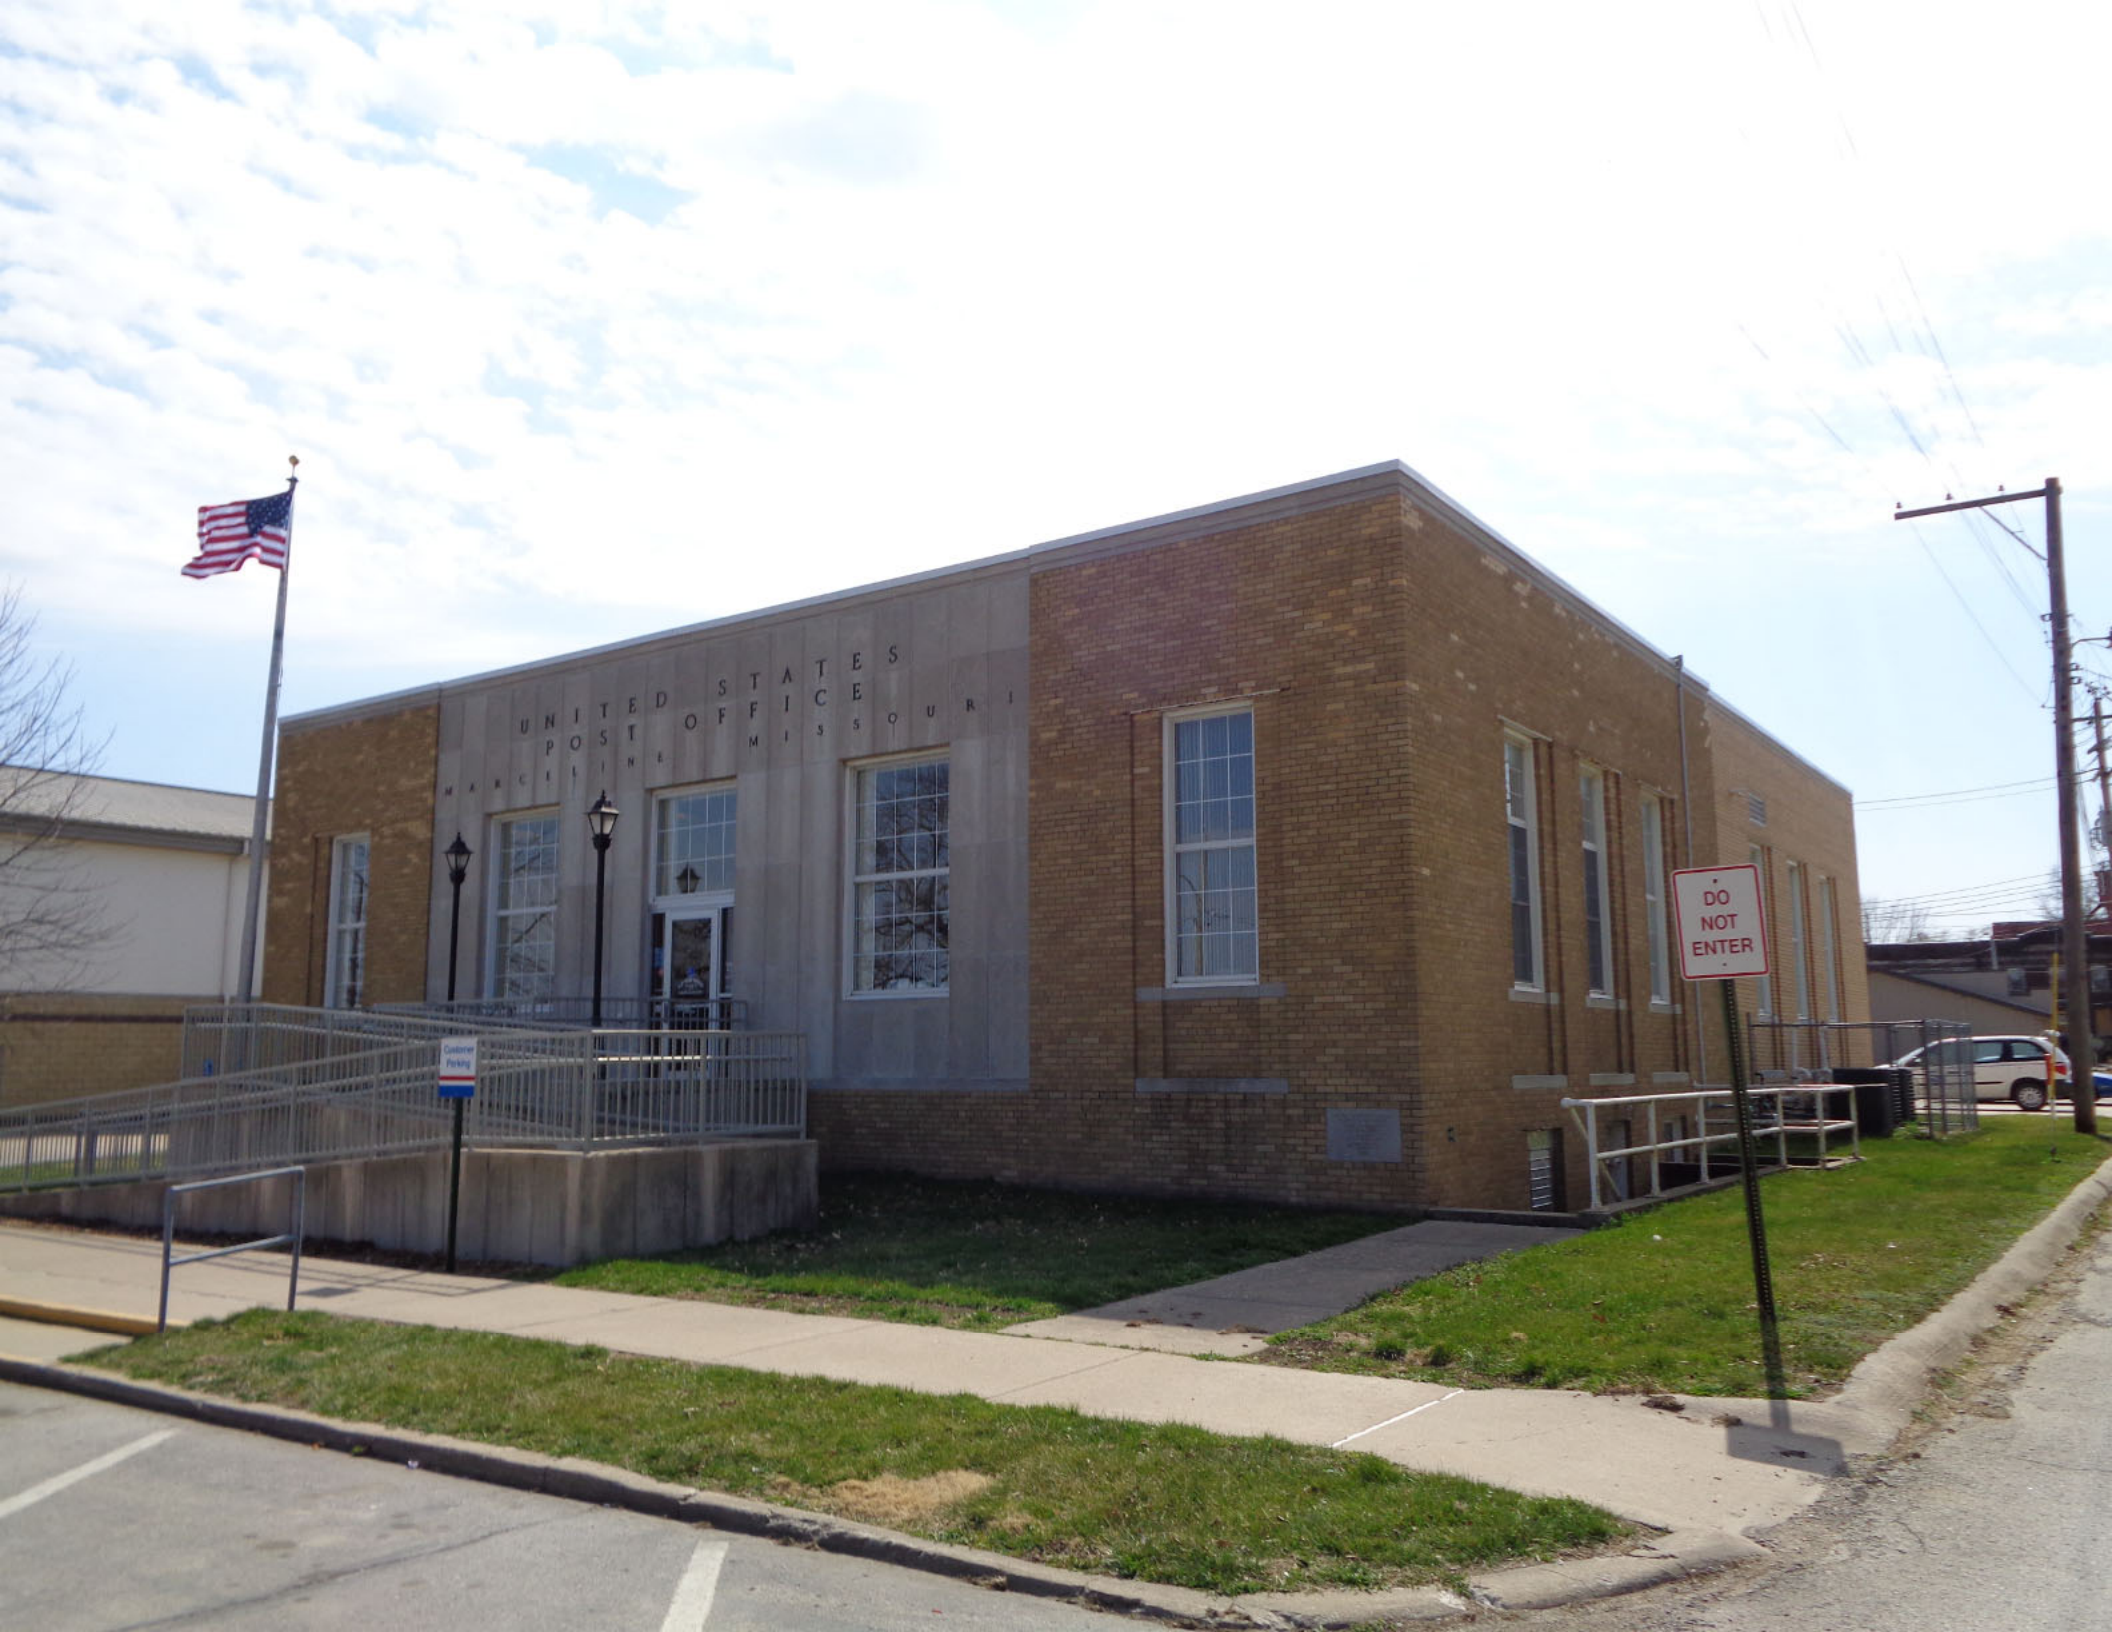
The rear of the building has a loading dock to the east and to the west there is an addition that was constructed c. 1960.

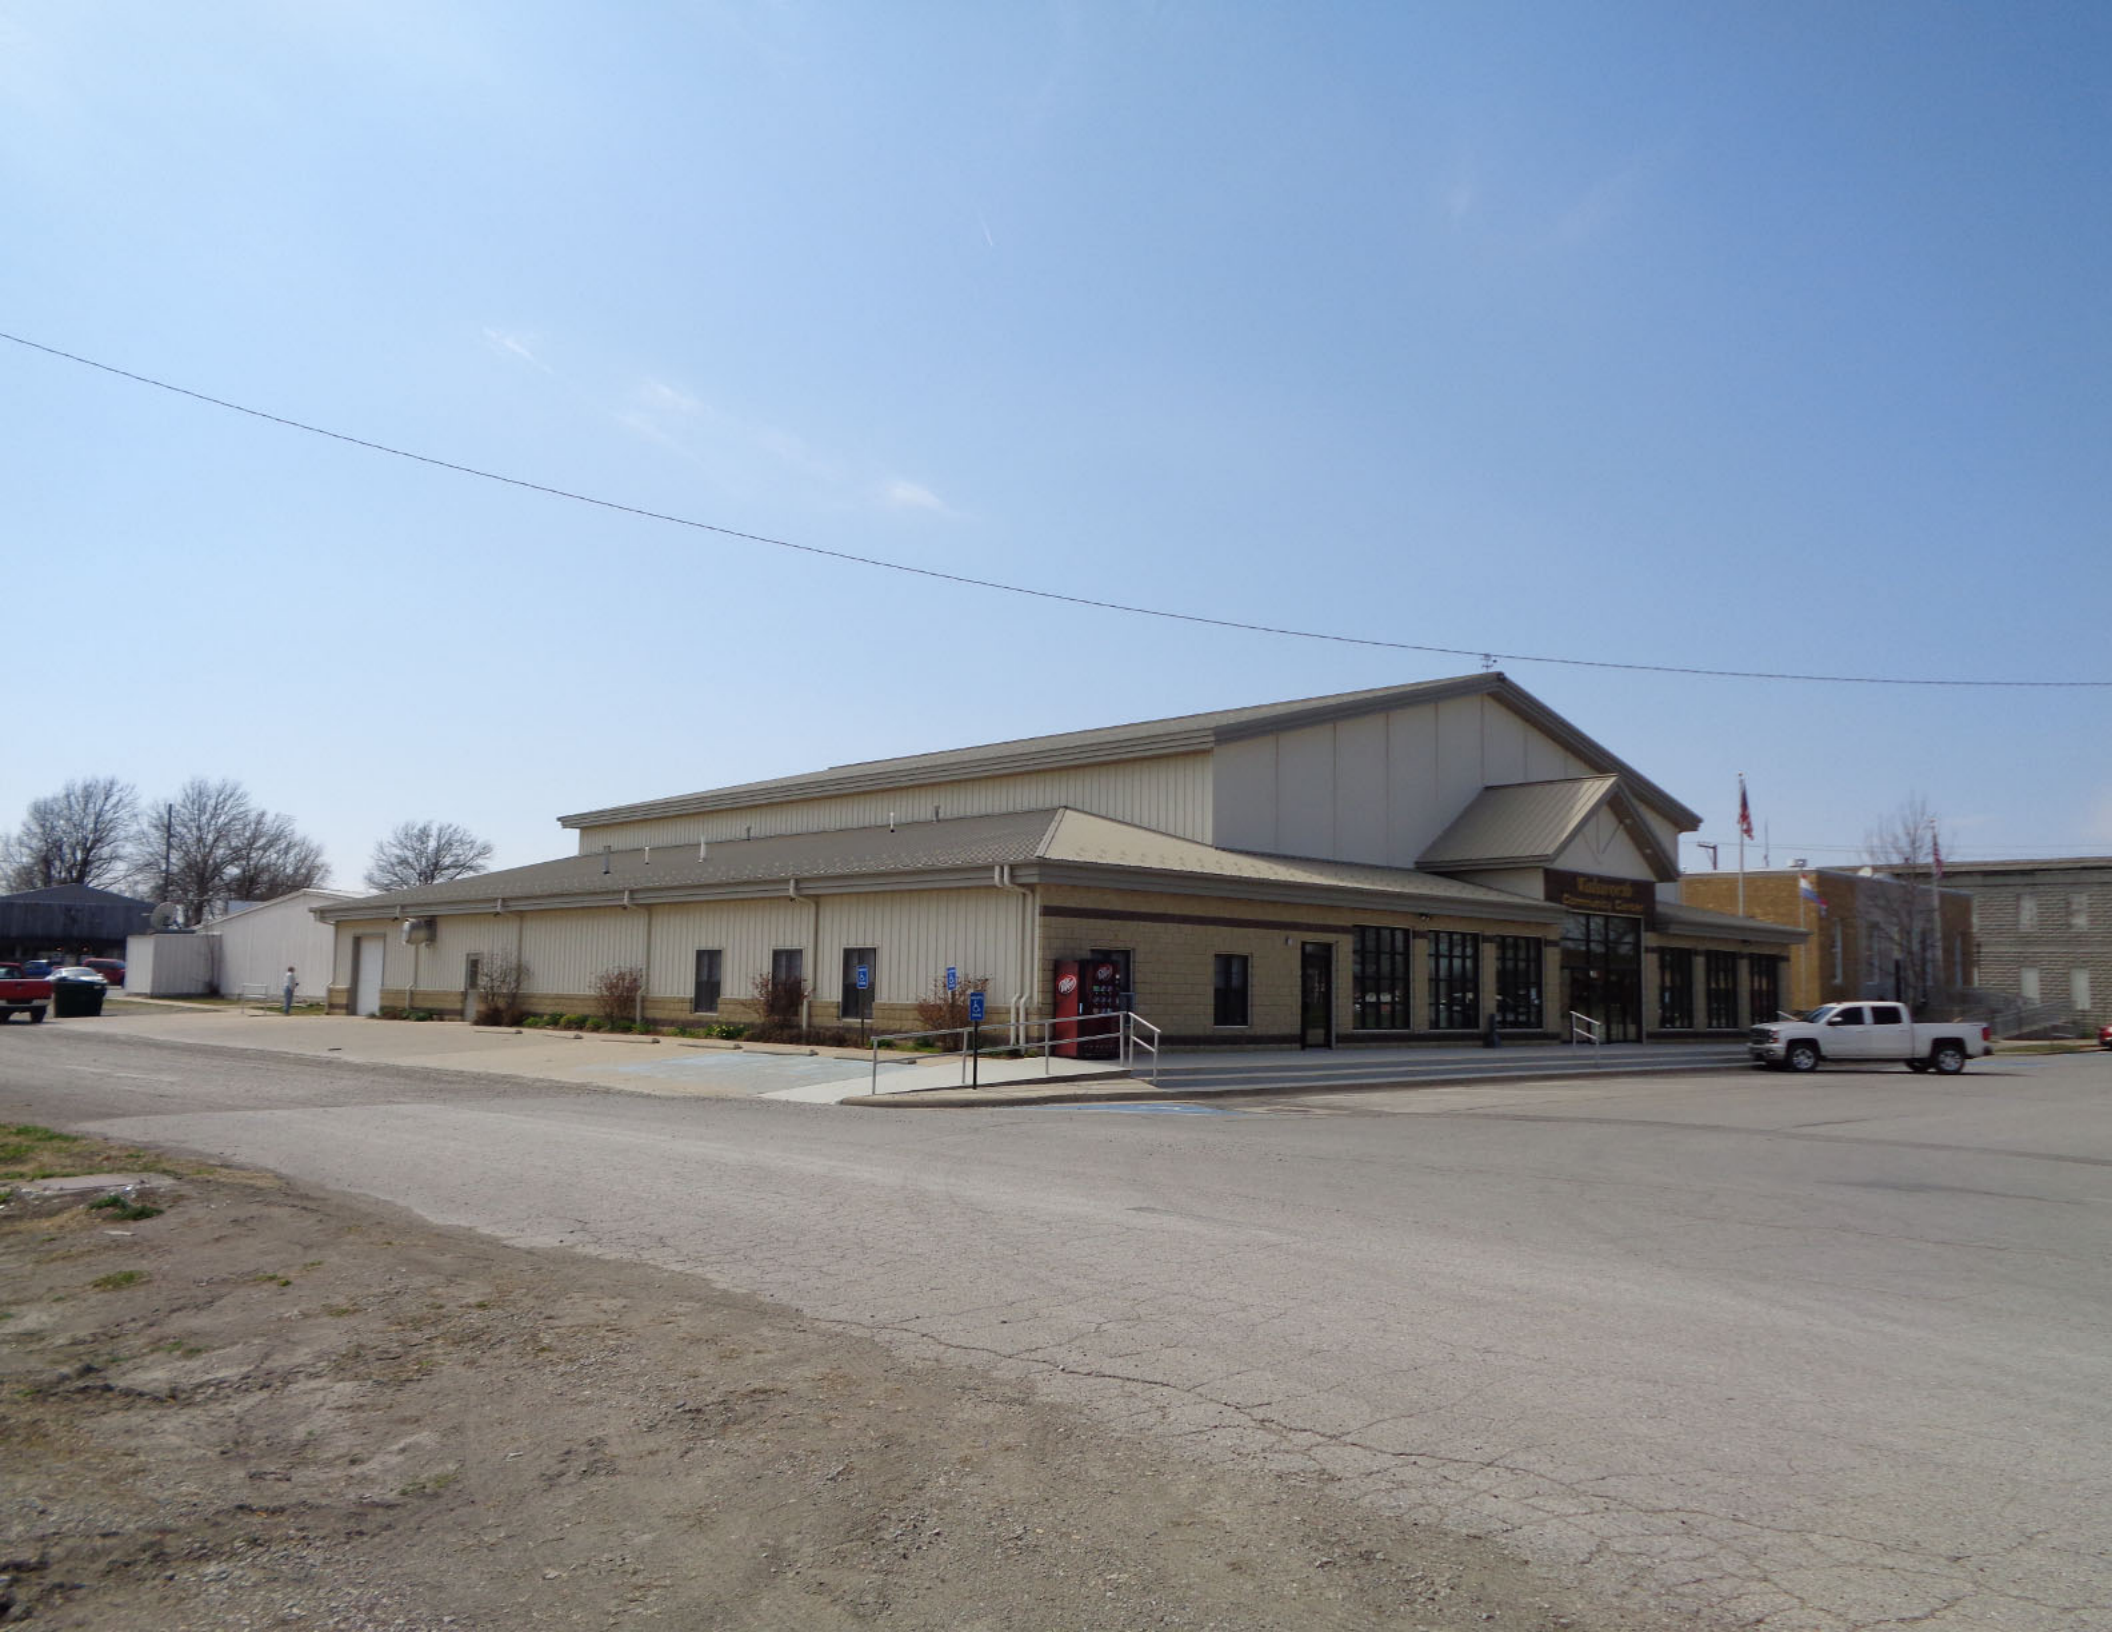
This is a one and half story community building. Starting from the east there is a pair of four-over-four hung windows moving west there is another pair of four-over-four windows. The next bay to the west is single metal door with a glass surround; there is a large window in the door. The next three bays are identical, each bay has a large sixteen pane fixed window. The seventh bay from the east is the main entrance. There is a front gable over this entrance. There are two double glass doors in this entrance the doors are surrounded by large pane fixed windows on each side and six fixed windows above. Each of the three bays (bays 8-10) west of the entrance has a large sixteen pane fixed window. The building has a low pitched hipped roof around the majority of the building. The center has a taller front gable roof that rises from the center of the building. There is also a front gable roof portion over the main entrance of the building.

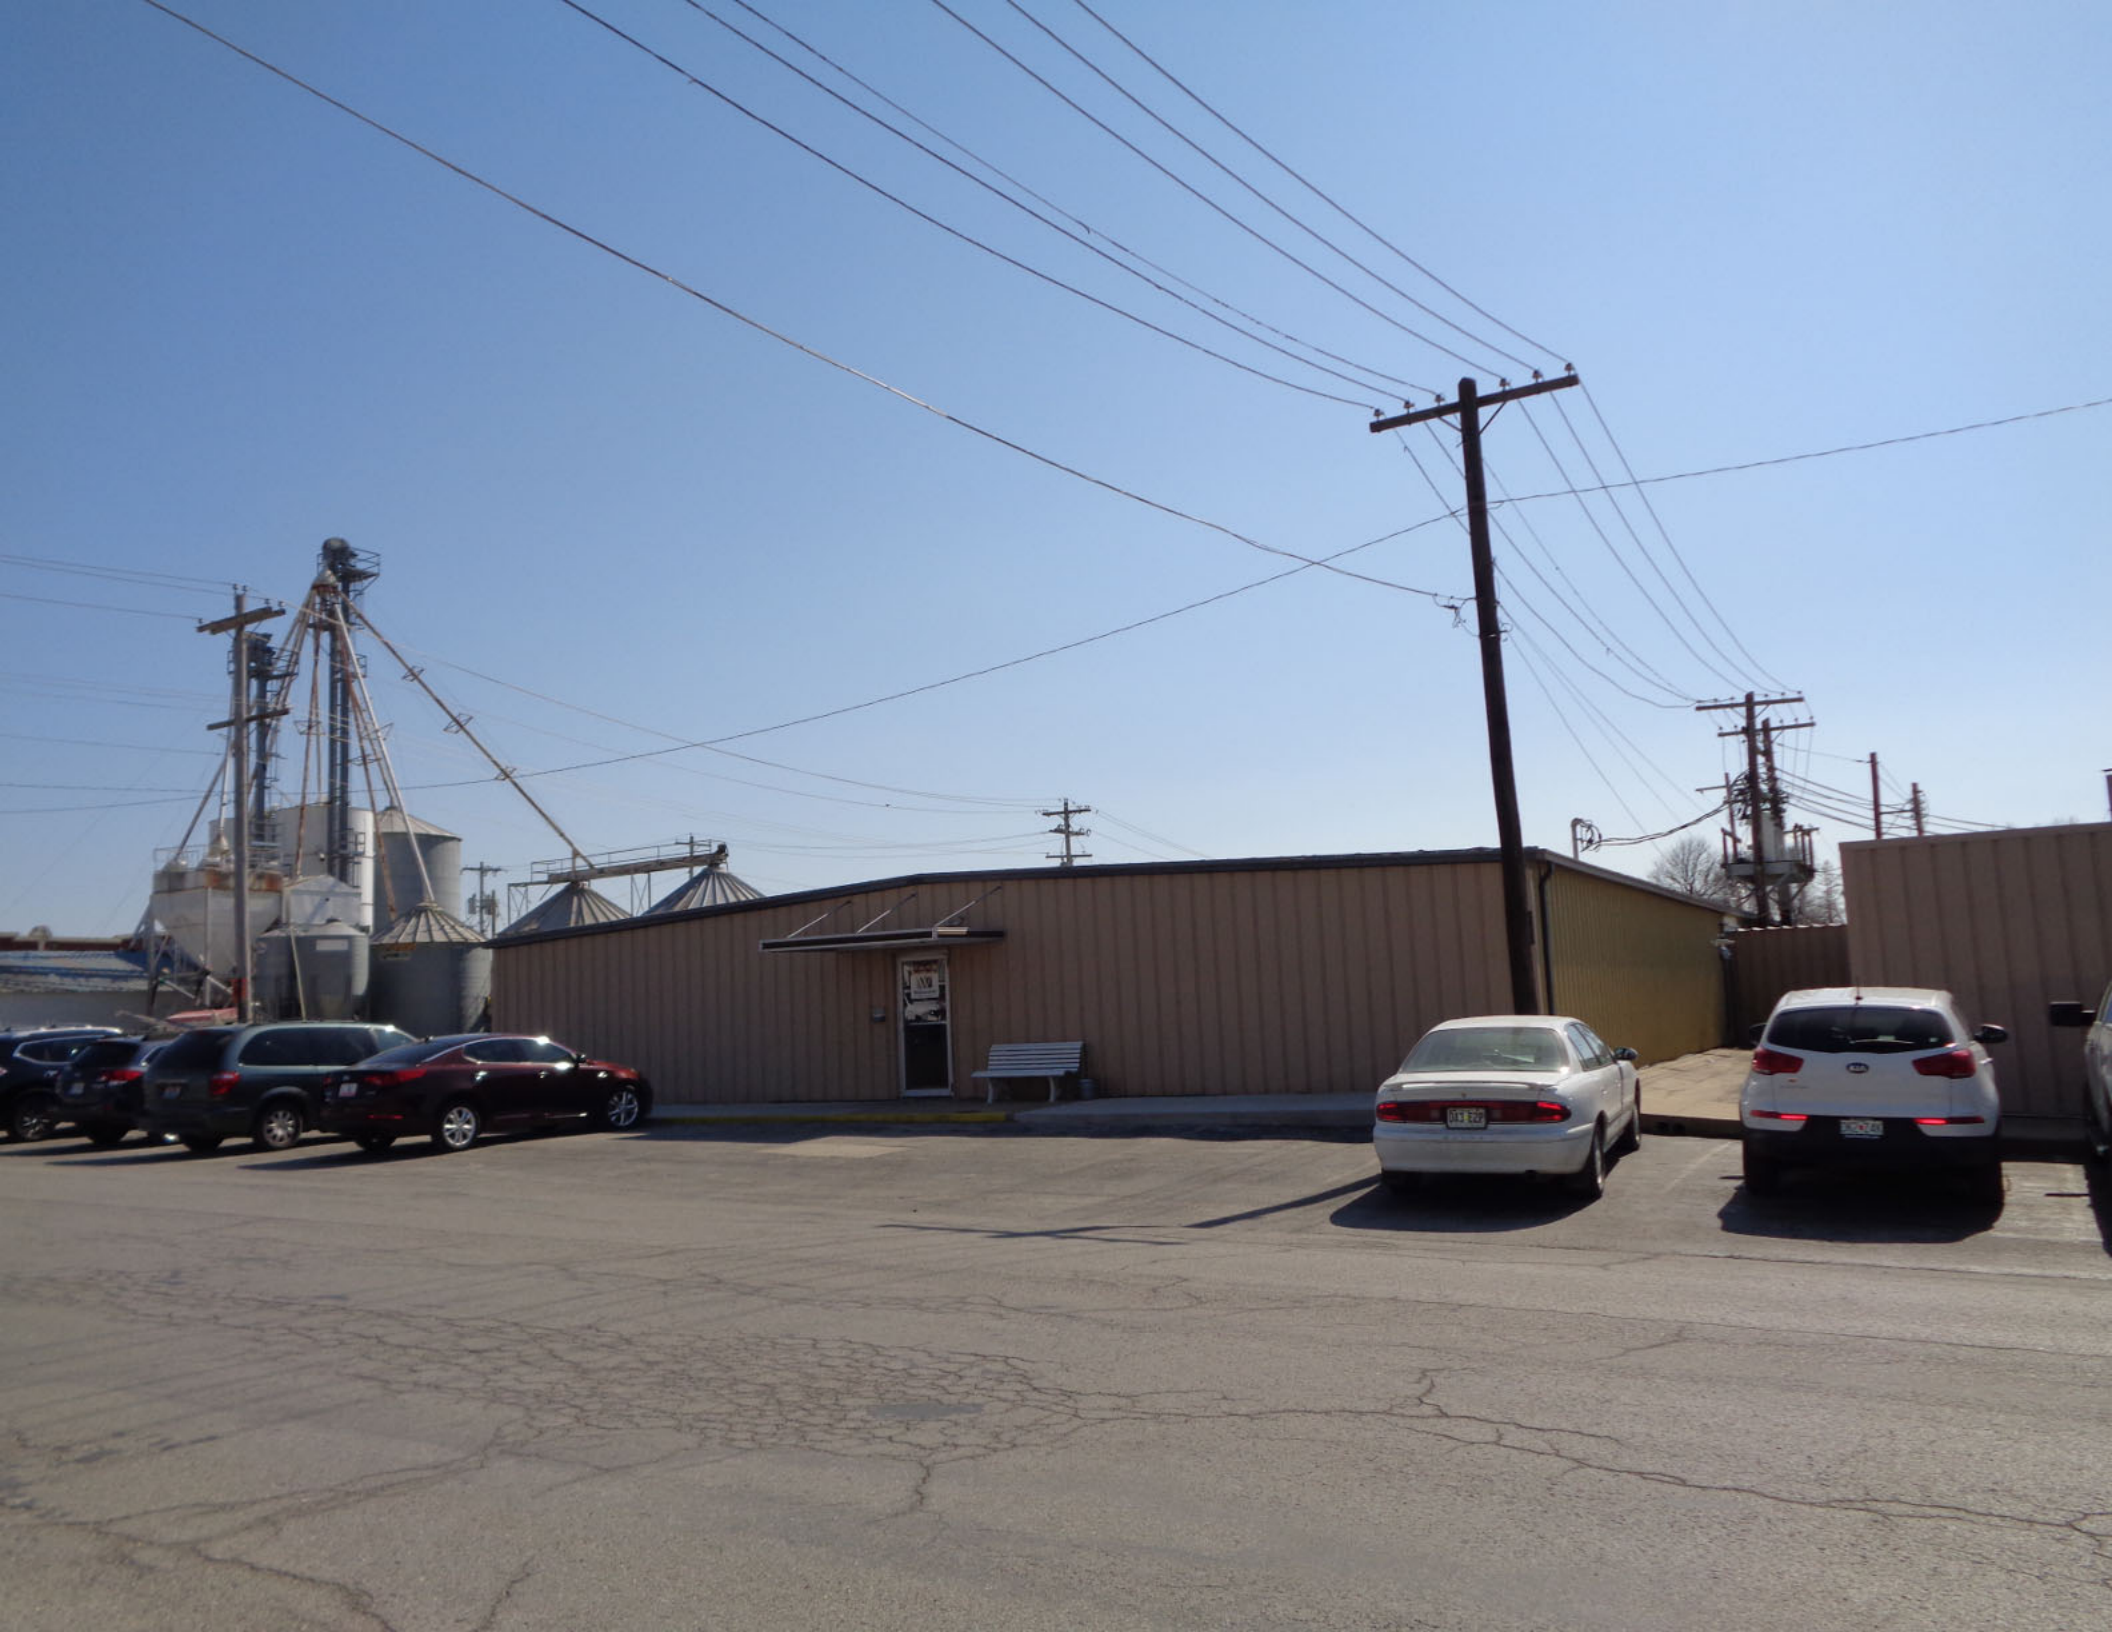
This is a simple metal building. The building has a single aluminum door entrance with a large glass pane. The only other ornamentation is a flat metal awning over the door. The side bays are devoid of decoration and are solid metal walls. There is a metal hyphen on the west elevation of this building connecting it to the rear of the main Walsworth Building located at 304-324 North Kansas LI-AS-001-034.

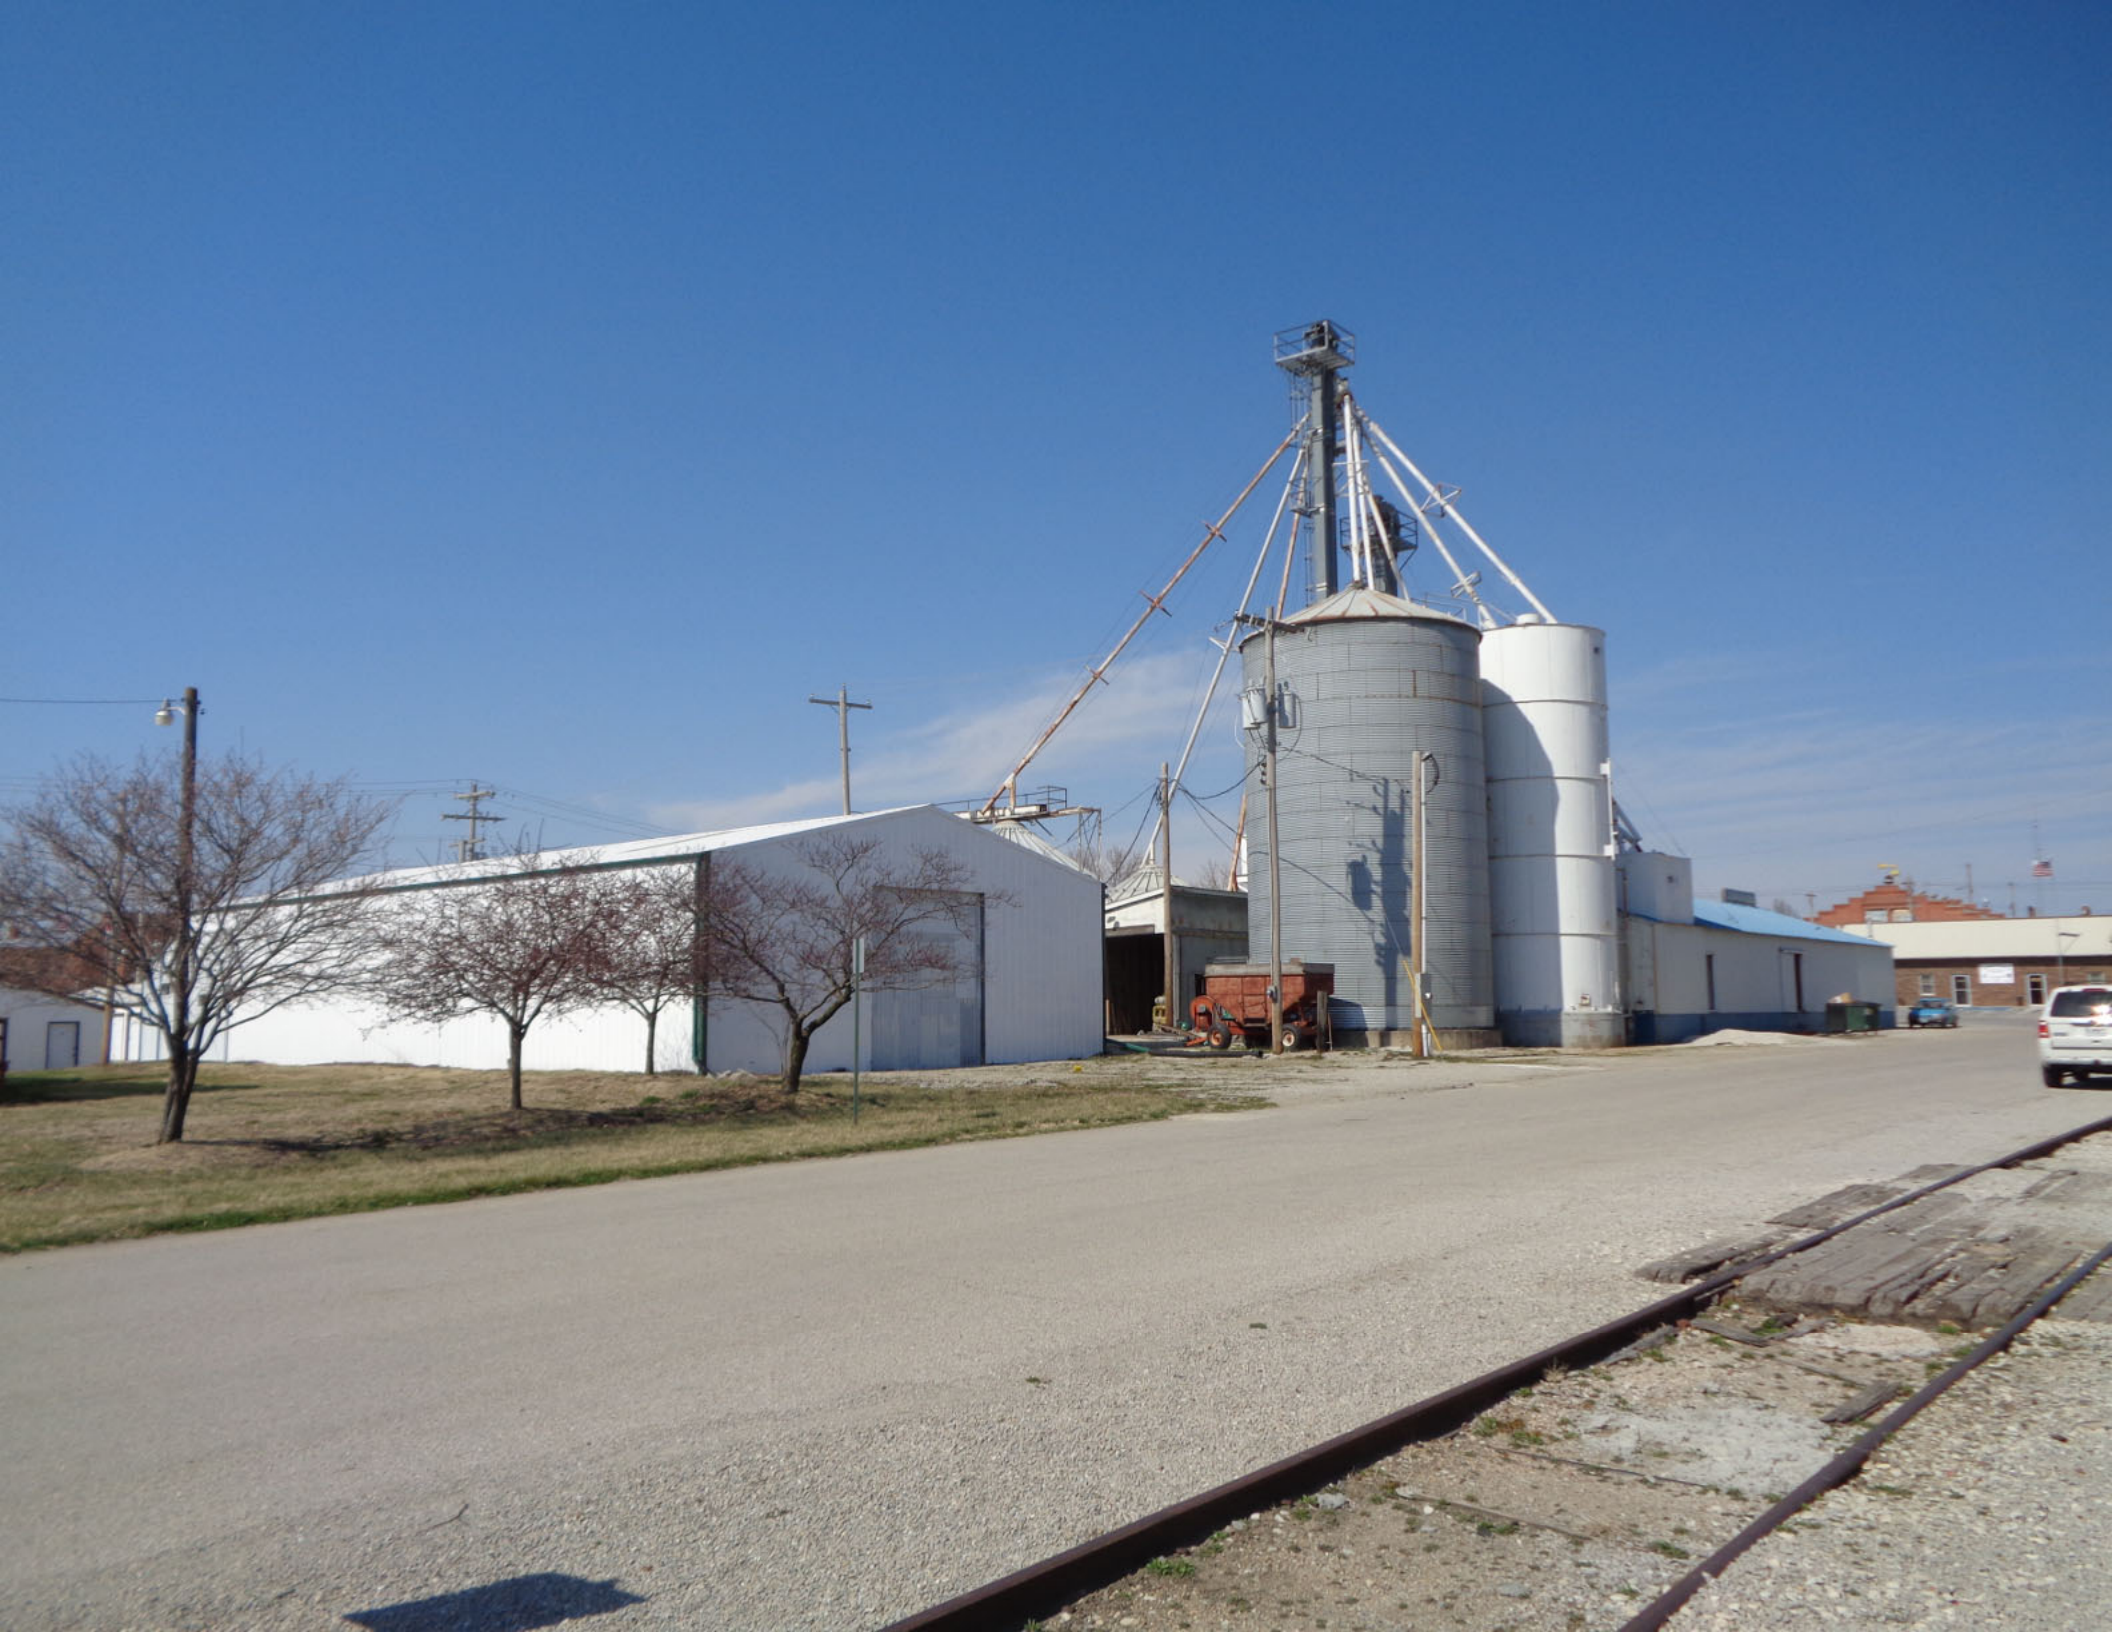
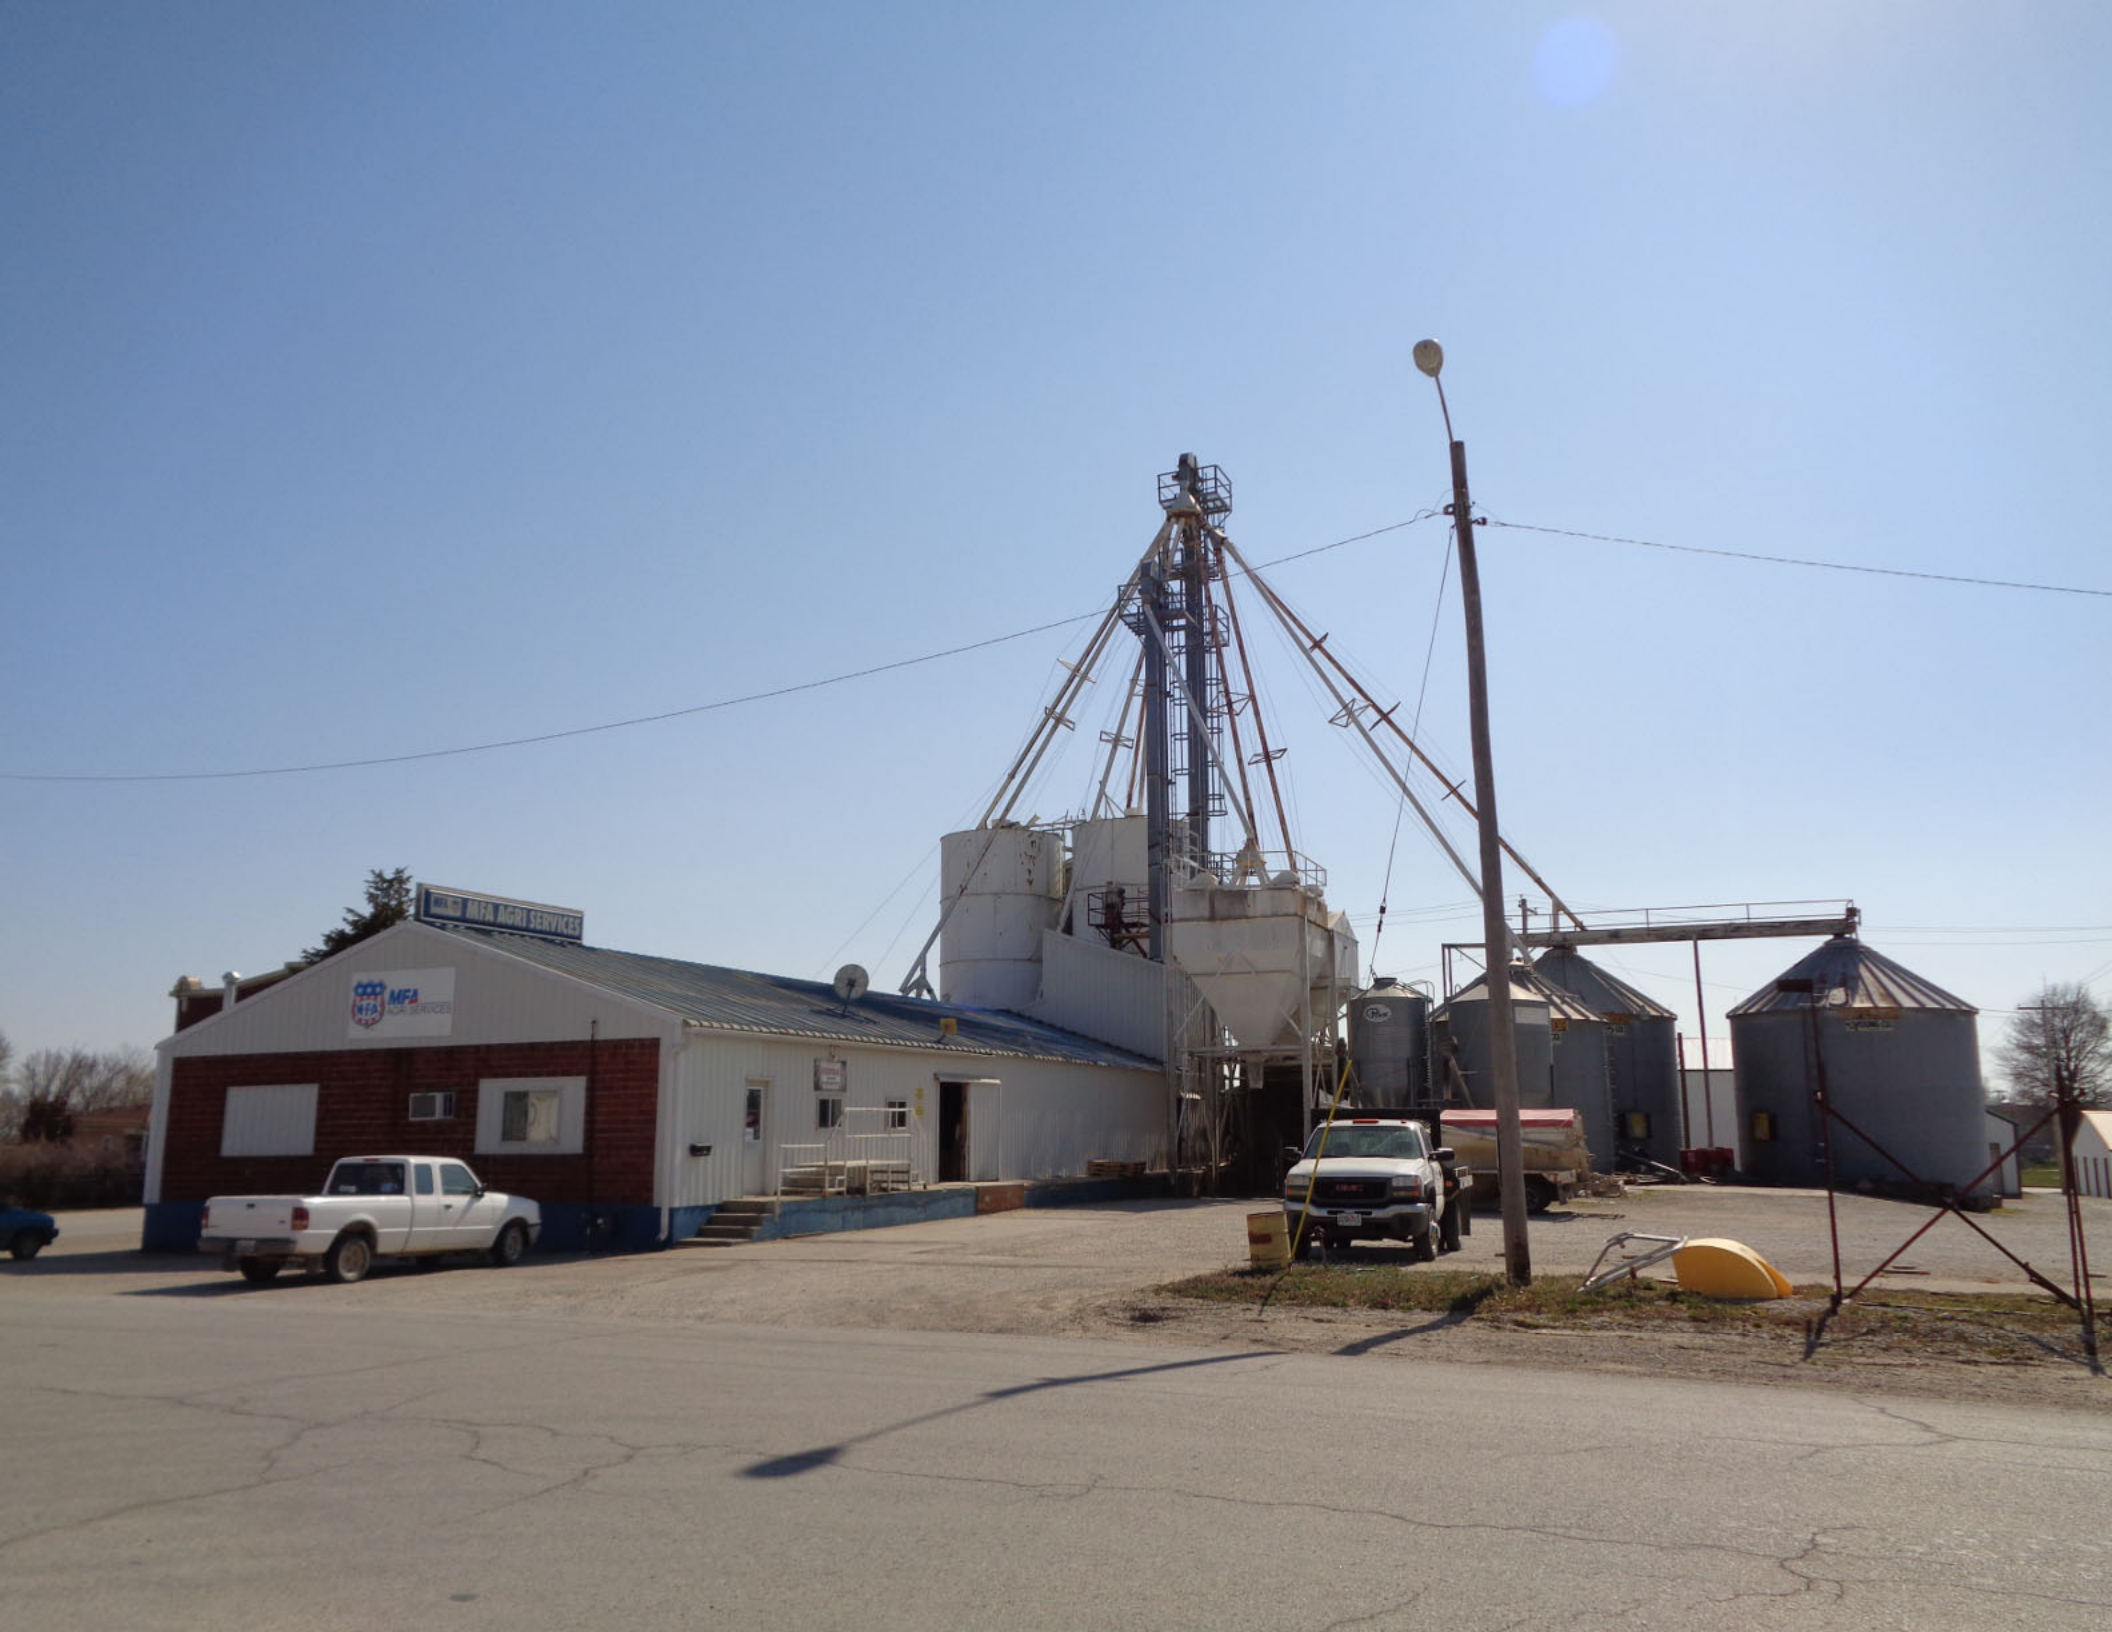
The MFA property comprises a main store building, a large warehouse type metal building, and 10 structures (the outbuildings are described above).

The main building starting on the north elevation is faced with clay tile in the main portion with two bays. The eastern most bay has been infilled with metal siding the western bay has been partially infilled with metal siding and a sliding vinyl window. The gable end has the same metal siding. The metal siding material is used across the western elevation. From the north on the western bay there is a single door, then two vinyl sliding windows. The final opening in this elevation is a large sliding vehicular sized door. There is a plastic sign on the ridge of the roof reading "MFA AGRI SERVICES".
