MISSOURI DEPARTMENT OF NATURAL RESOURCES  
STATE HISTORIC PRESERVATION OFFICE, P.O. Box 176, Jefferson City, MO 65102  
**ARCHITECTURAL/HISTORIC INVENTORY FORM**

1. SURVEY NO. LI-AS-001-001		2. SURVEY NAME: Marceline Survey	
3. COUNTY: Linn		4. ADDRESS (STREET NO.) 275	STREET (NAME) West Broadway
5. CITY: Marceline	VICINITY: <input type="checkbox"/>	6. UTM: / /	7. TOWNSHIP/RANGE/SECTION: T: R: S:

8. HISTORIC NAME (IF KNOWN): Walt Disney's Childhood Home		9. PRESENT/OTHER NAME (IF KNOWN): Walt Disney's Childhood Home	
10. OWNERSHIP: <input checked="" type="checkbox"/> PRIVATE <input type="checkbox"/> PUBLIC		11A. HISTORIC USE (IF KNOWN): Single Dwelling	11B. CURRENT USE: Single Dwelling
<b>HISTORICAL INFORMATION</b>

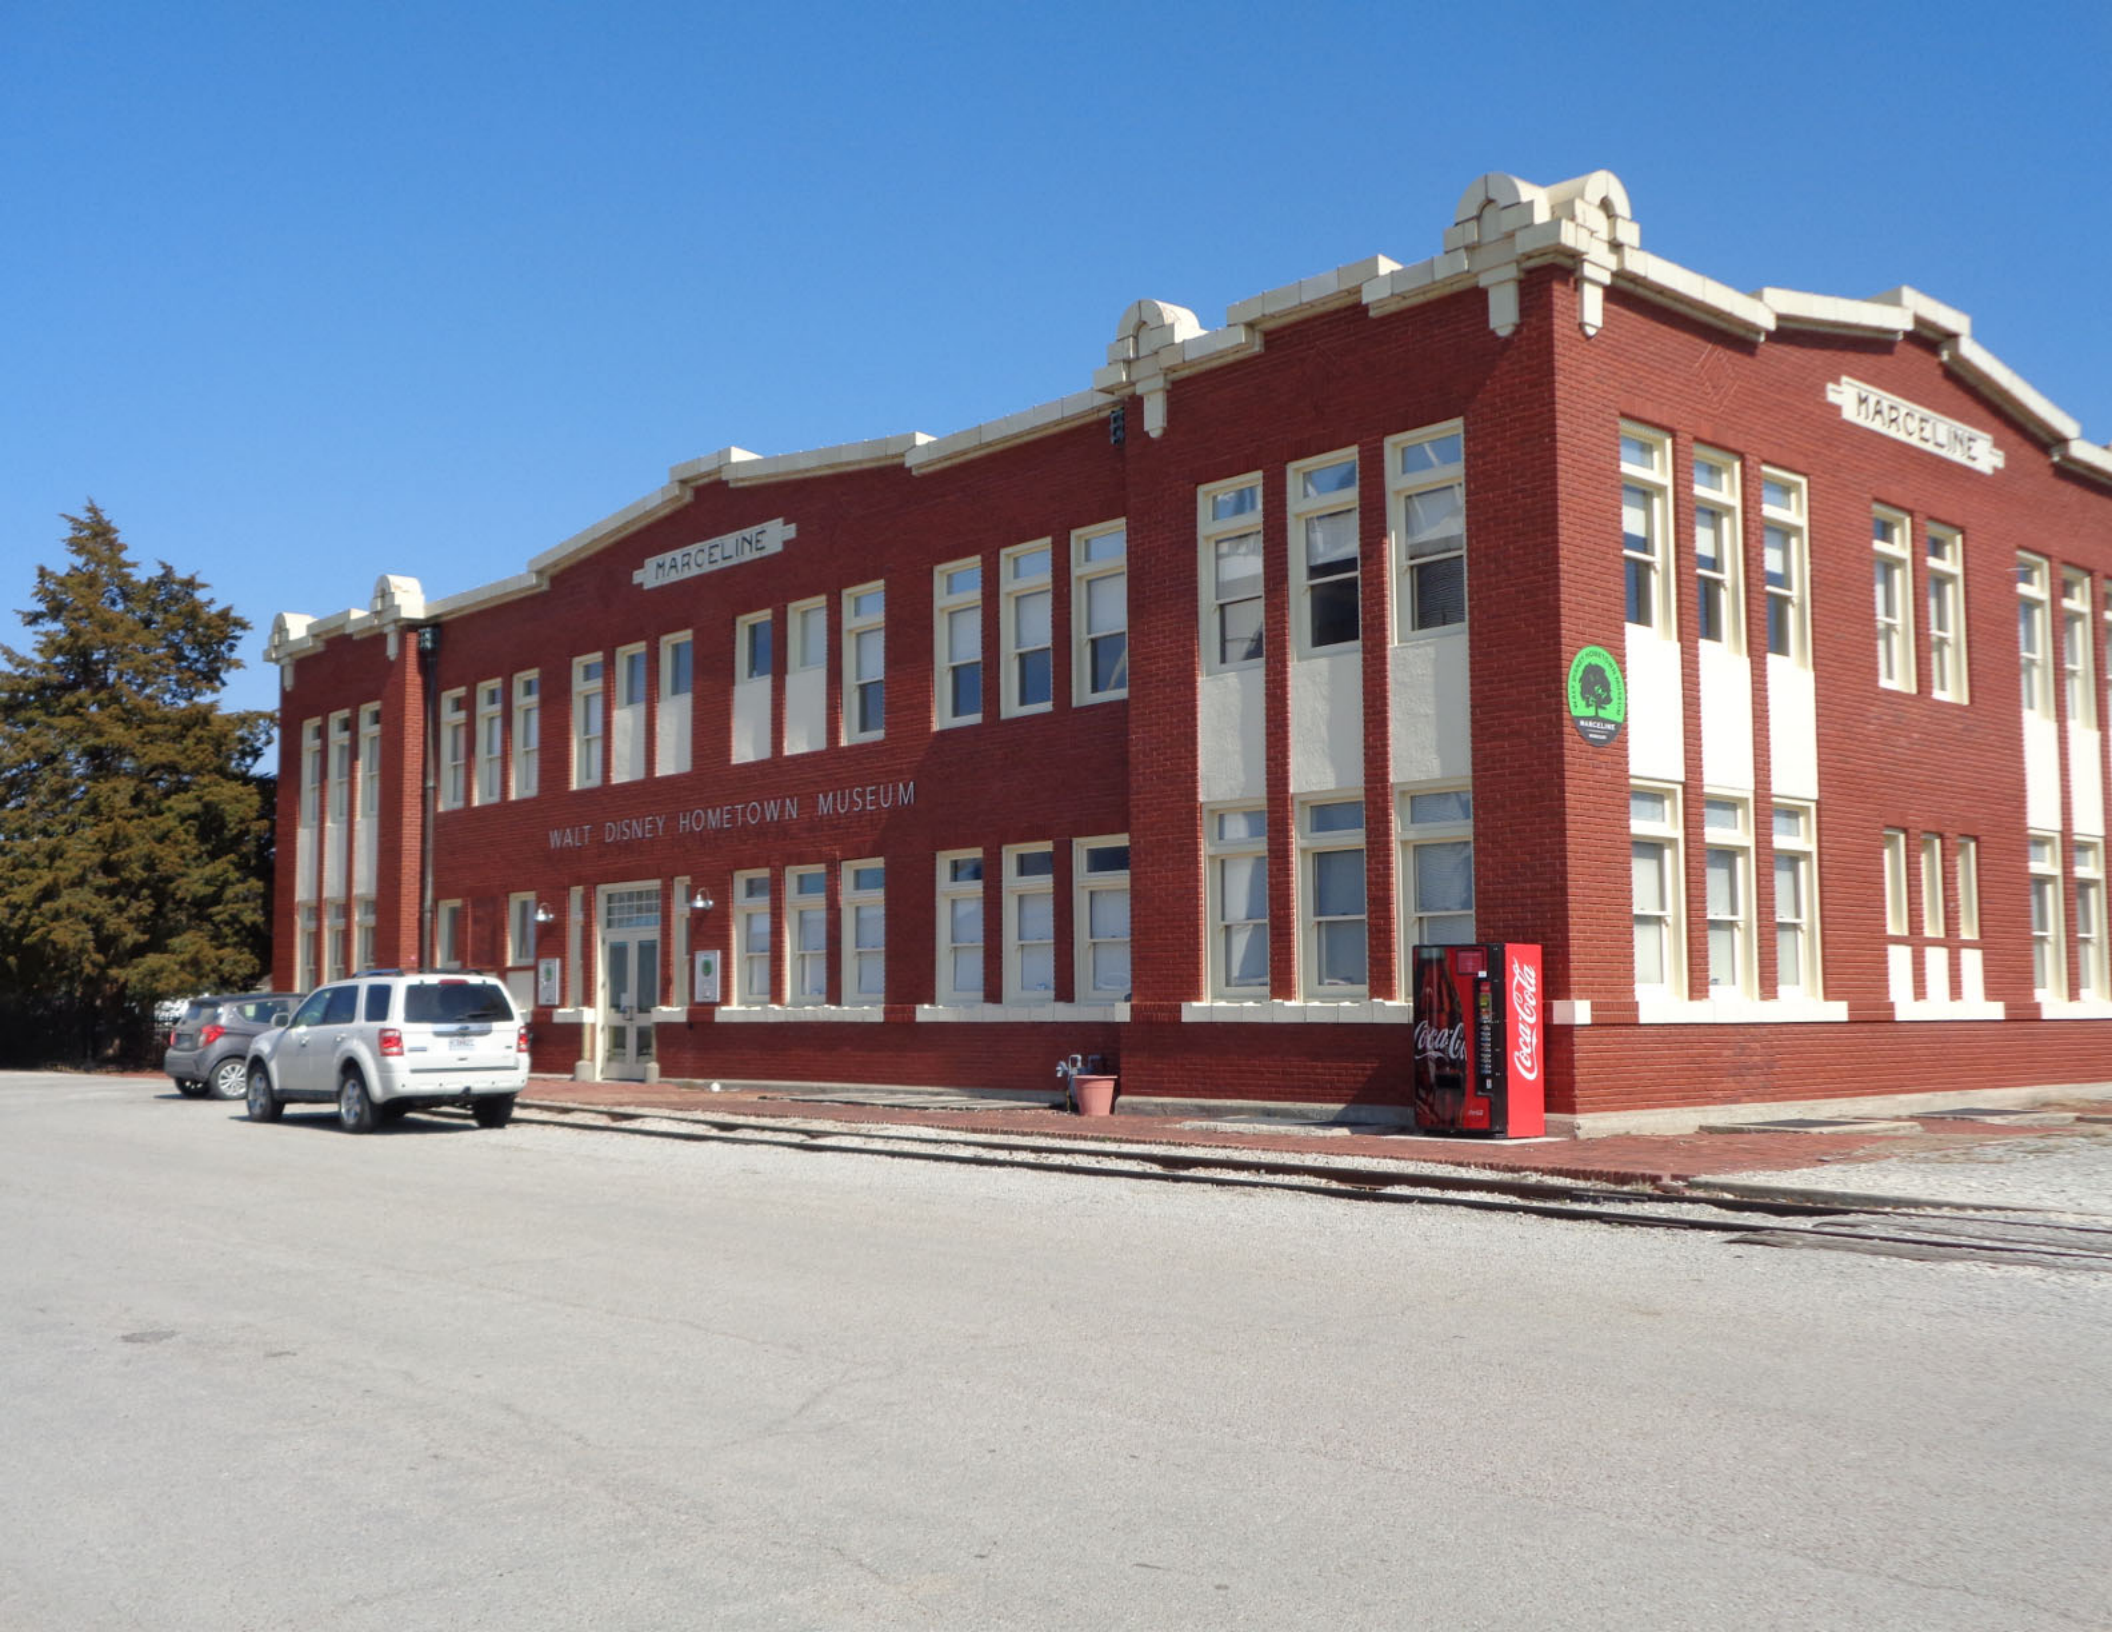
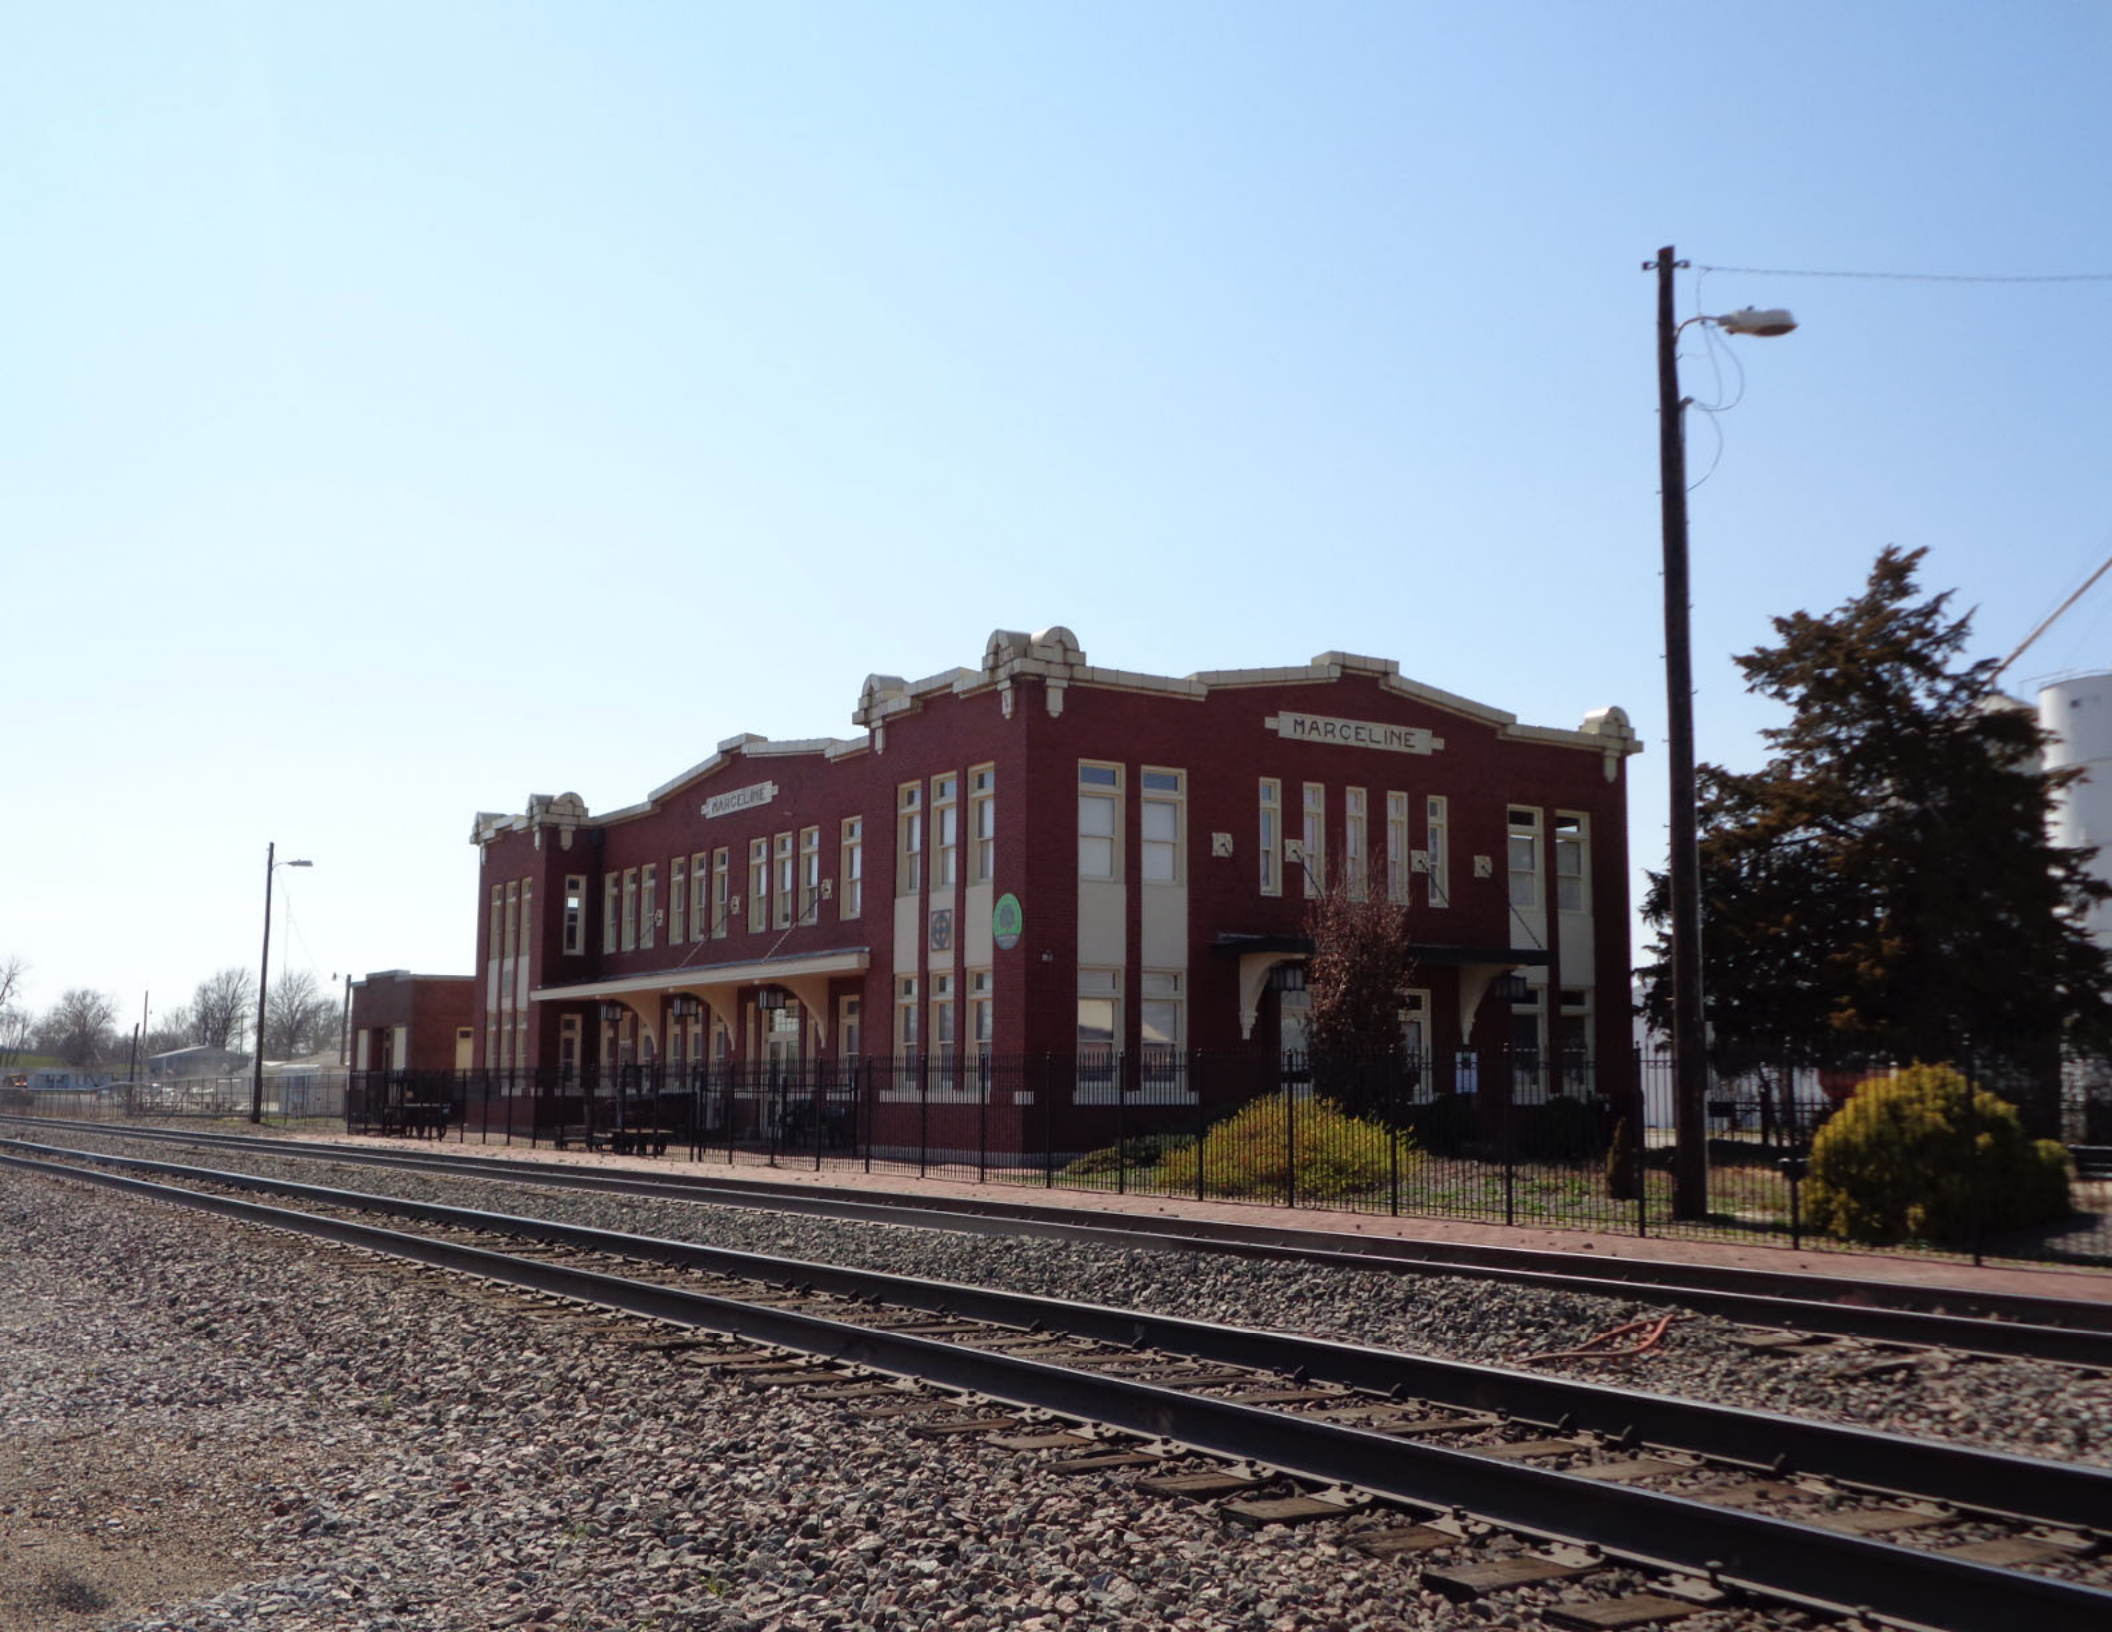
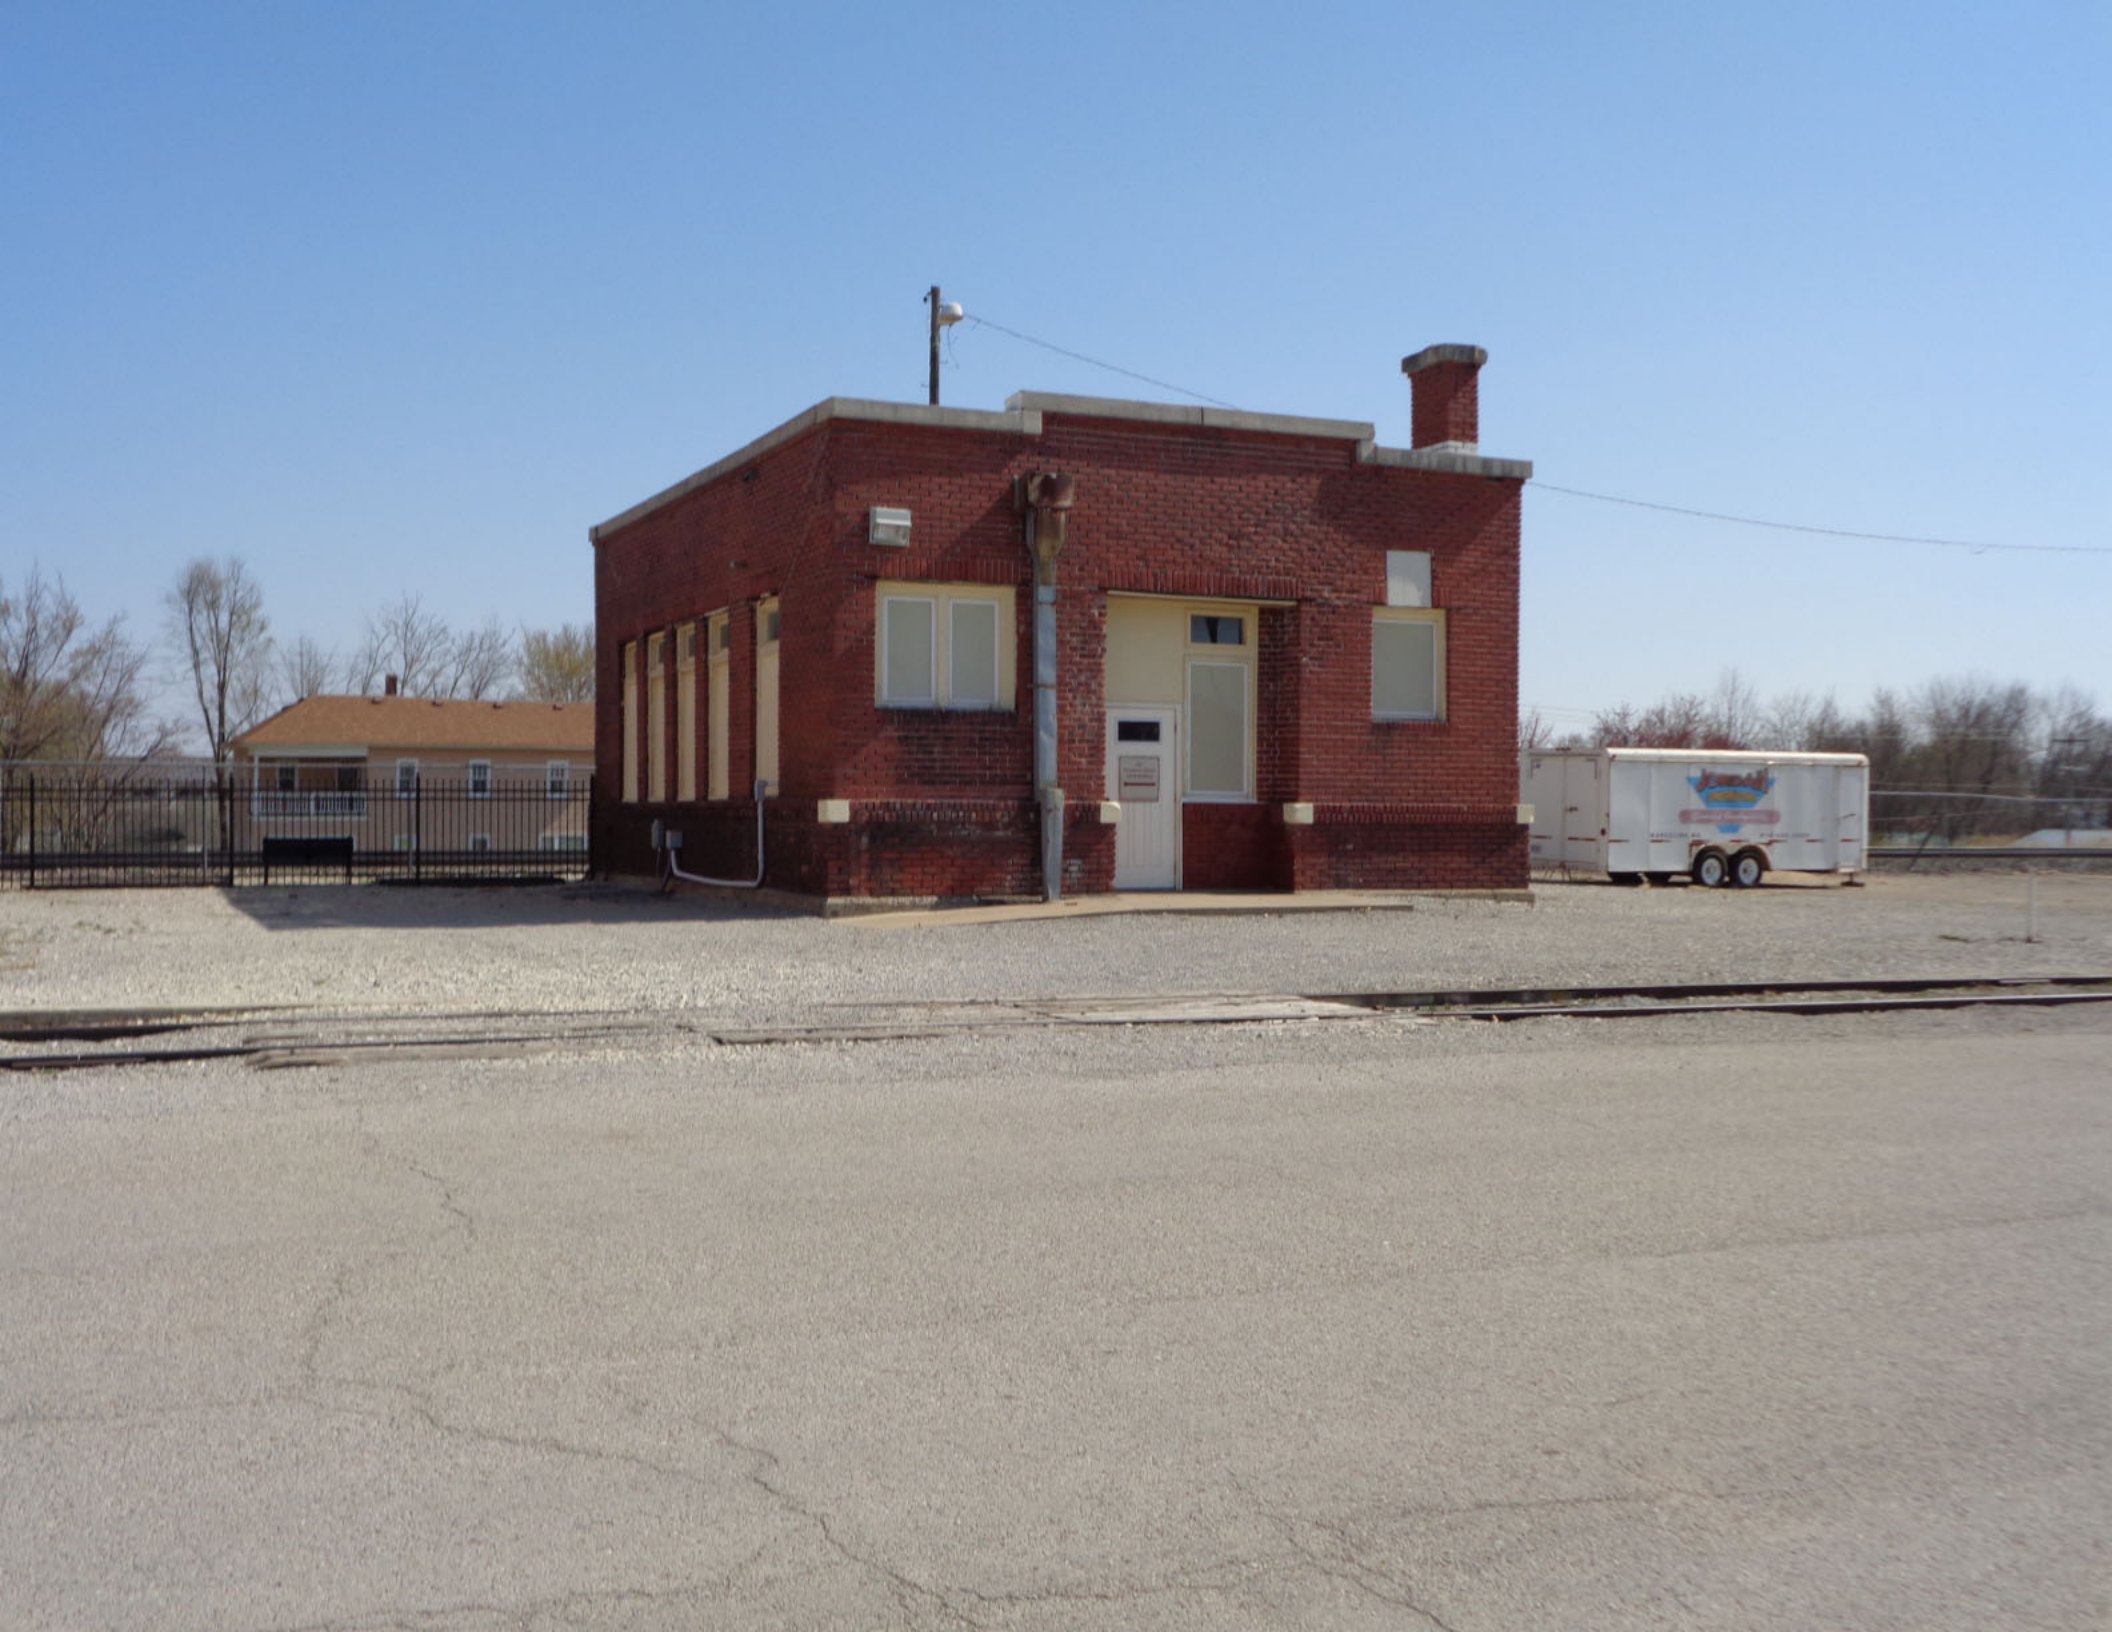
The Marceline Depot will be described by the west elevation, historically this would have been the rear of the building with the primary elevation facing the railroad tracks on to the east. The depot is a two story brick building with six bays on the first floor. Starting from the north there is a slightly projecting bay with three single windows all one-over-one with transoms located above. Moving south there is another grouping of three windows these are smaller fixed windows with the center window infilled with brick. The entrance bay is next there is a set of double metal doors with small one-over-one windows on either side with transoms above. Above the main entrance is a 18-light window in the transom above the door. Moving east there are two more groupings of three windows each with one-over-one windows with transoms. The final southern bay is also slightly projected with a grouping of three single one-over-one windows with transoms. The second story mimics the main level with six groupings of three windows. The third and fourth bays from the north have some stucco infill in the lower level. The roof is flat and there is a parapet that surrounds the roof that has terra cotta capping and decorative elements. Also all windows on the first floor have terra cotta sills. There is also a name plate in the center of the building with "MARCELINE" in terra cotta. The east elevation generally mimics the west with the exception of a canopy over the recessed portion of the first floor and additional decorative elements.
