MISSOURI DEPARTMENT OF NATURAL RESOURCES  
STATE HISTORIC PRESERVATION OFFICE, P.O. Box 176, Jefferson City, MO 65102  
**ARCHITECTURAL/HISTORIC INVENTORY FORM**

1. SURVEY NO. LI-AS-001-001		2. SURVEY NAME: Marceline Survey	
3. COUNTY: Linn		4. ADDRESS (STREET NO.) 275	STREET (NAME) West Broadway
5. CITY: Marceline	VICINITY: <input type="checkbox"/>	6. UTM: / /	7. TOWNSHIP/RANGE/SECTION: T: R: S:

8. HISTORIC NAME (IF KNOWN): Walt Disney's Childhood Home		9. PRESENT/OTHER NAME (IF KNOWN): Walt Disney's Childhood Home	
10. OWNERSHIP: <input checked="" type="checkbox"/> PRIVATE <input type="checkbox"/> PUBLIC		11A. HISTORIC USE (IF KNOWN): Single Dwelling	11B. CURRENT USE: Single Dwelling
<b>HISTORICAL INFORMATION</b>

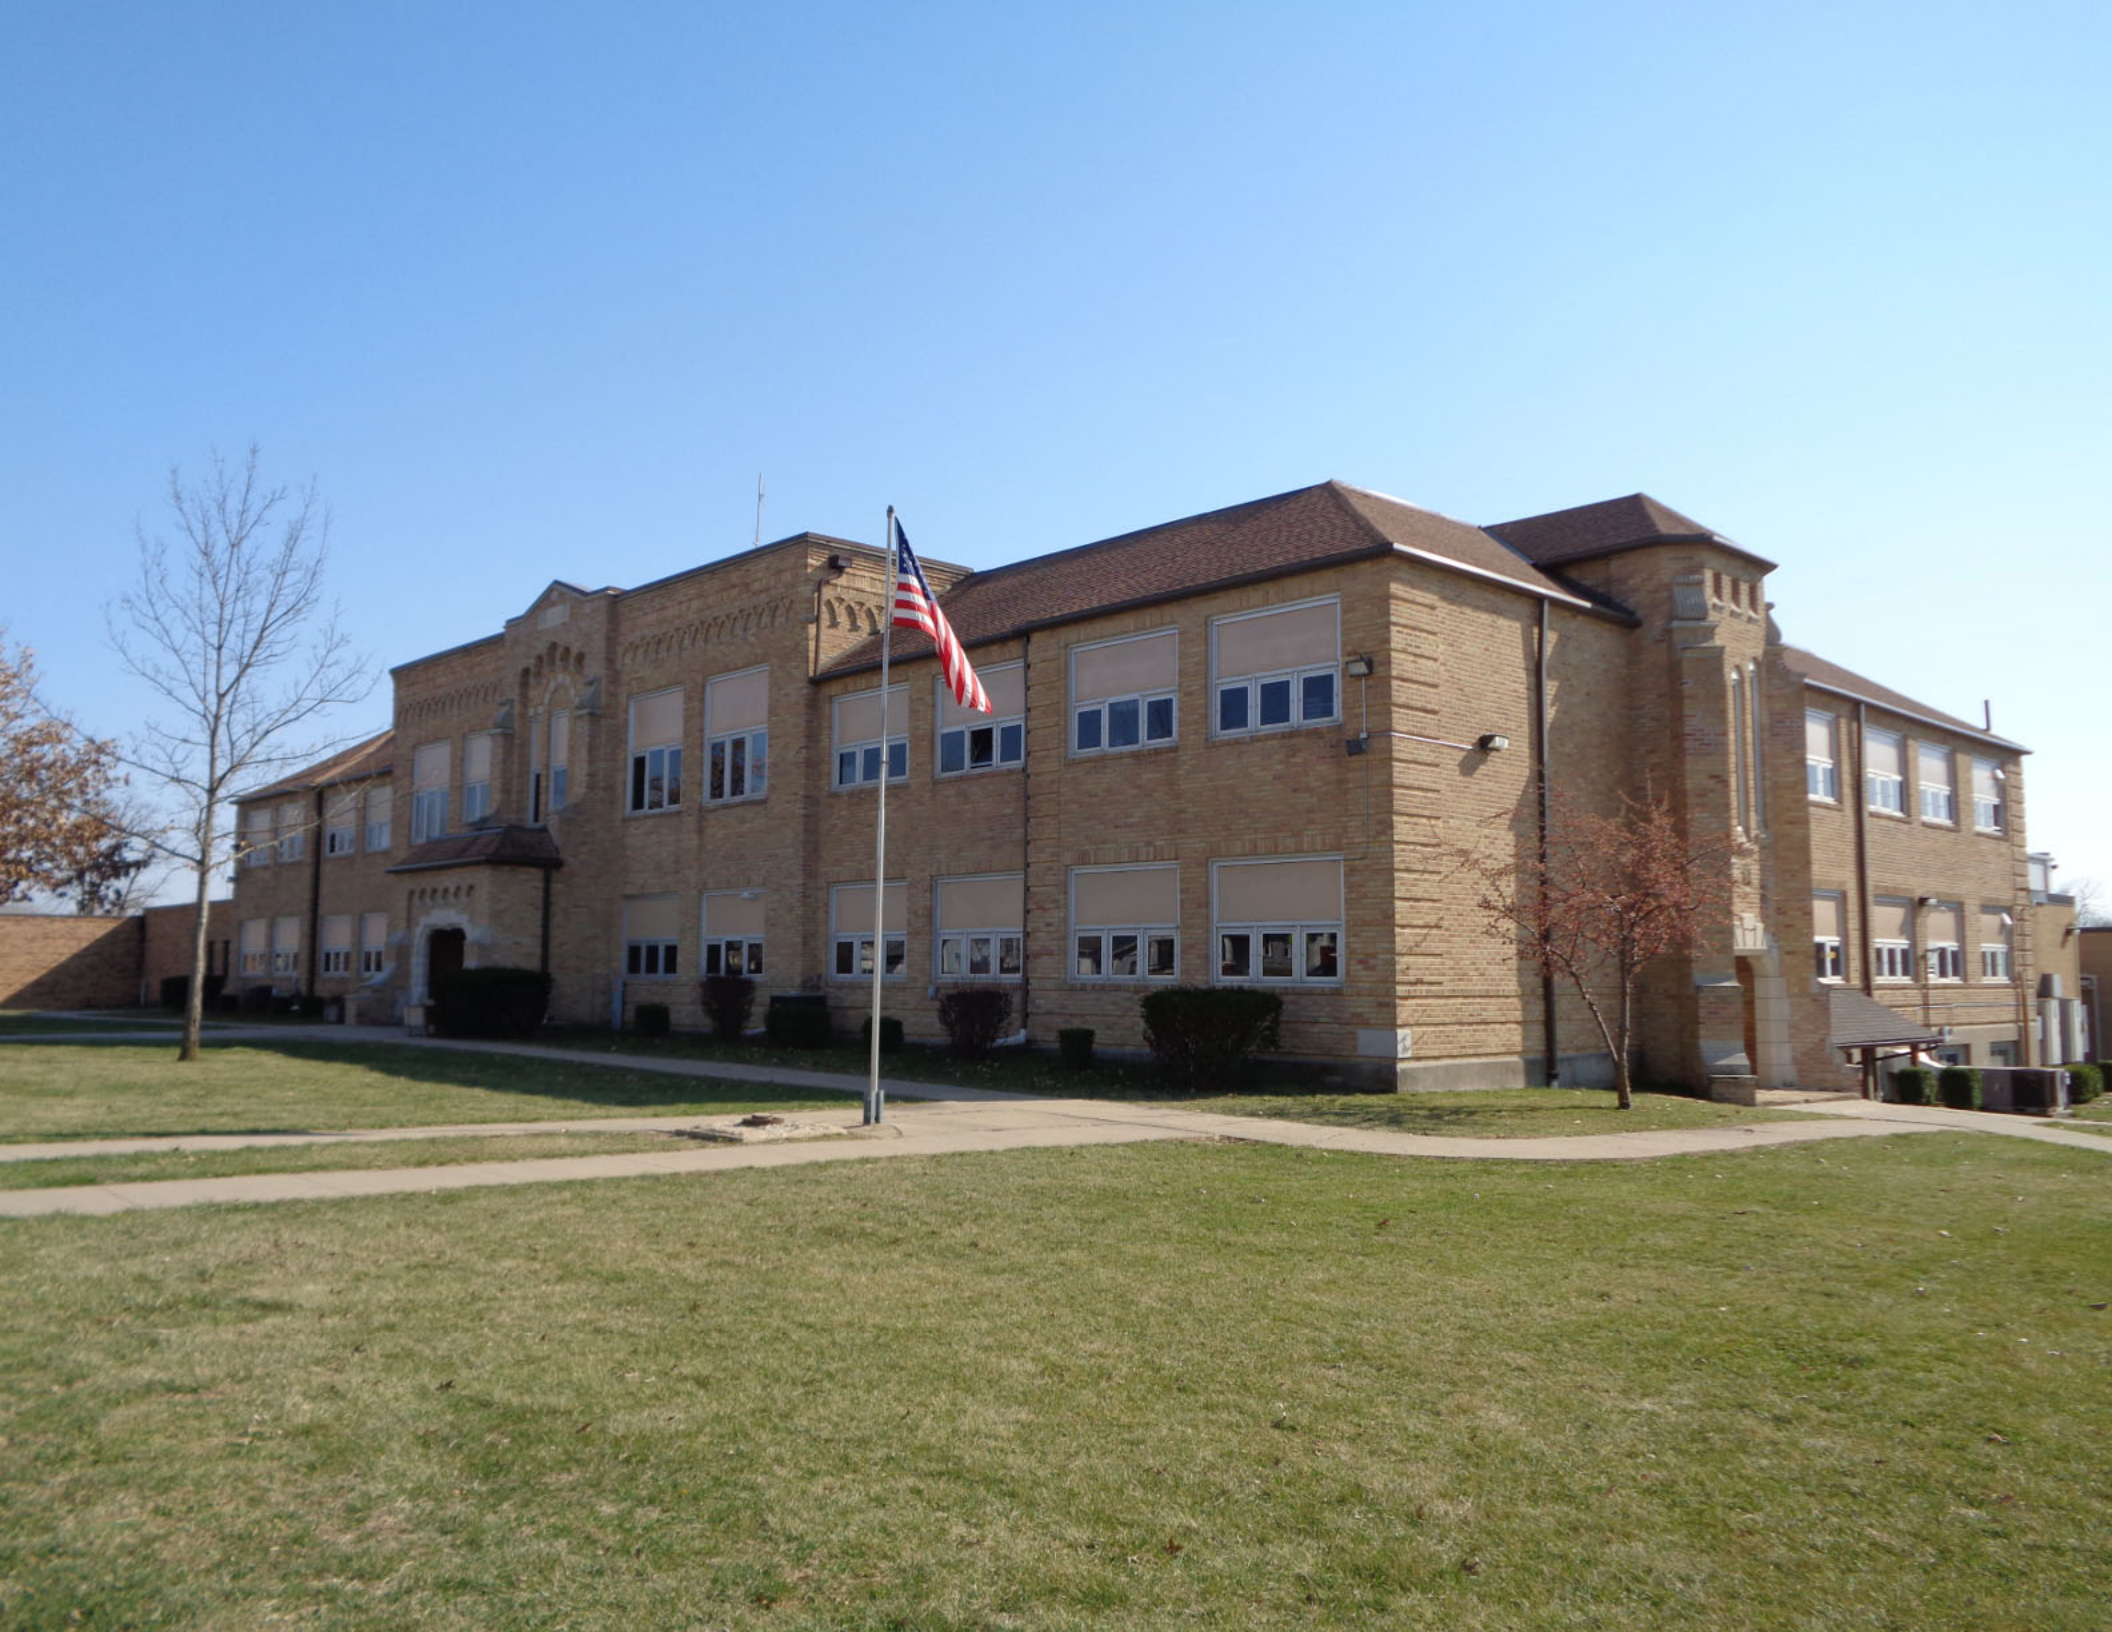
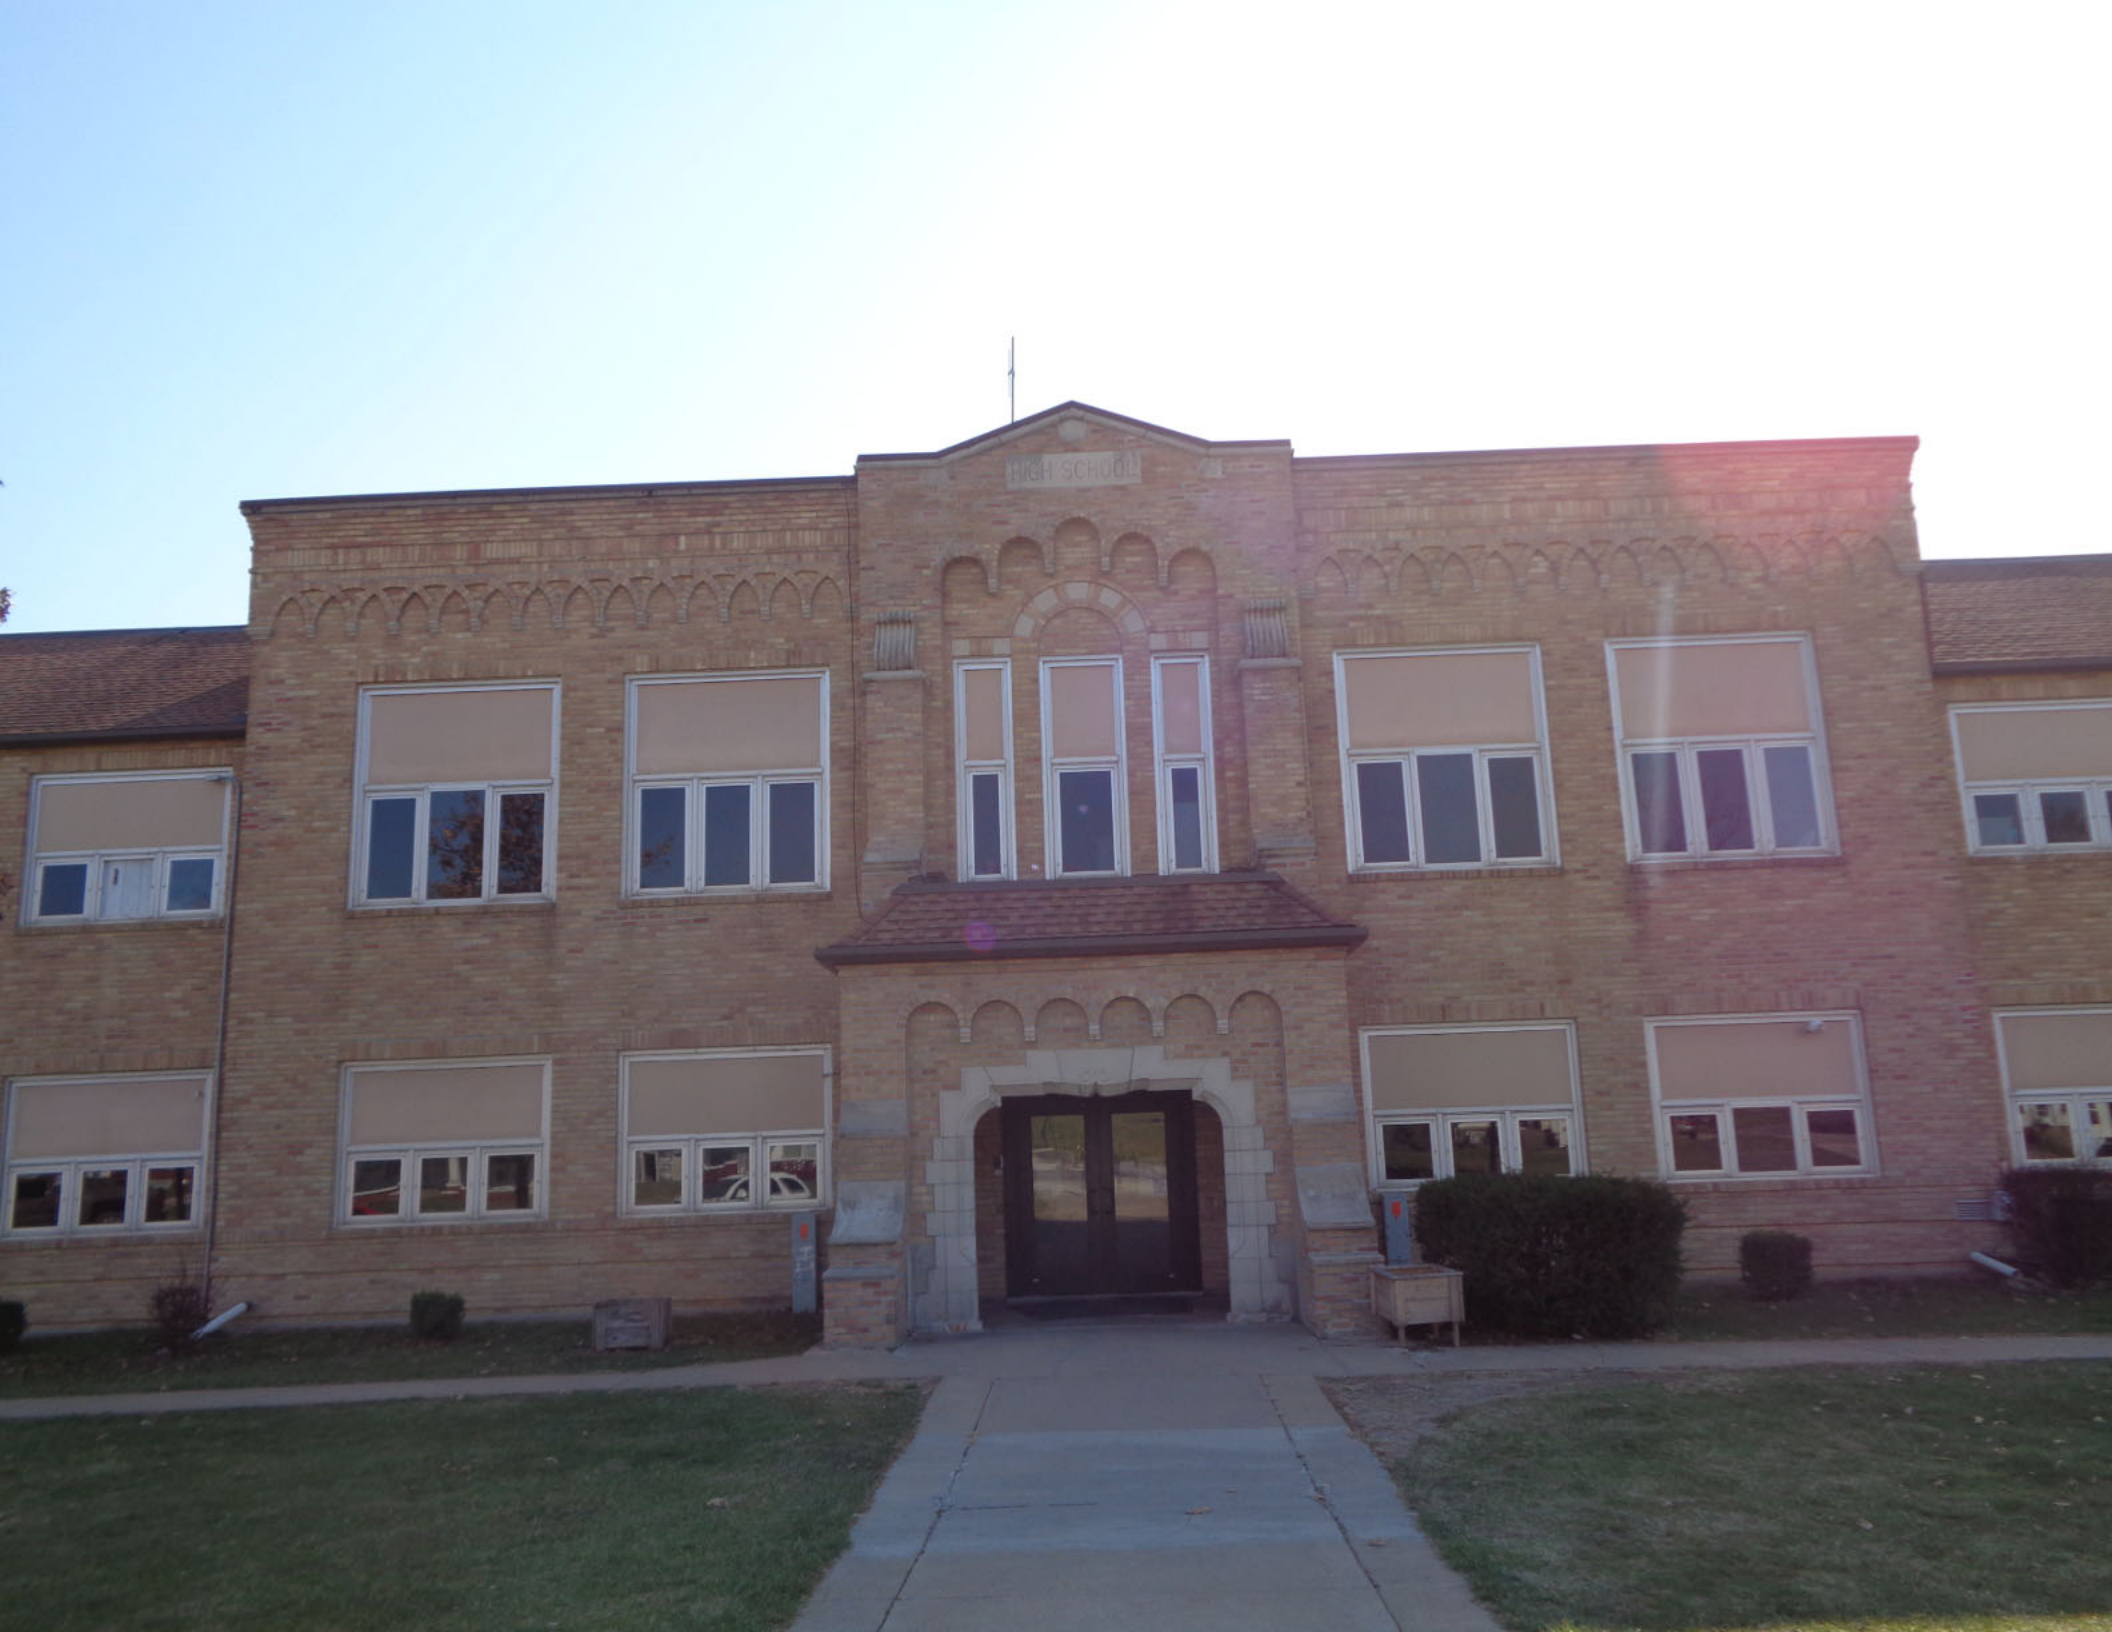
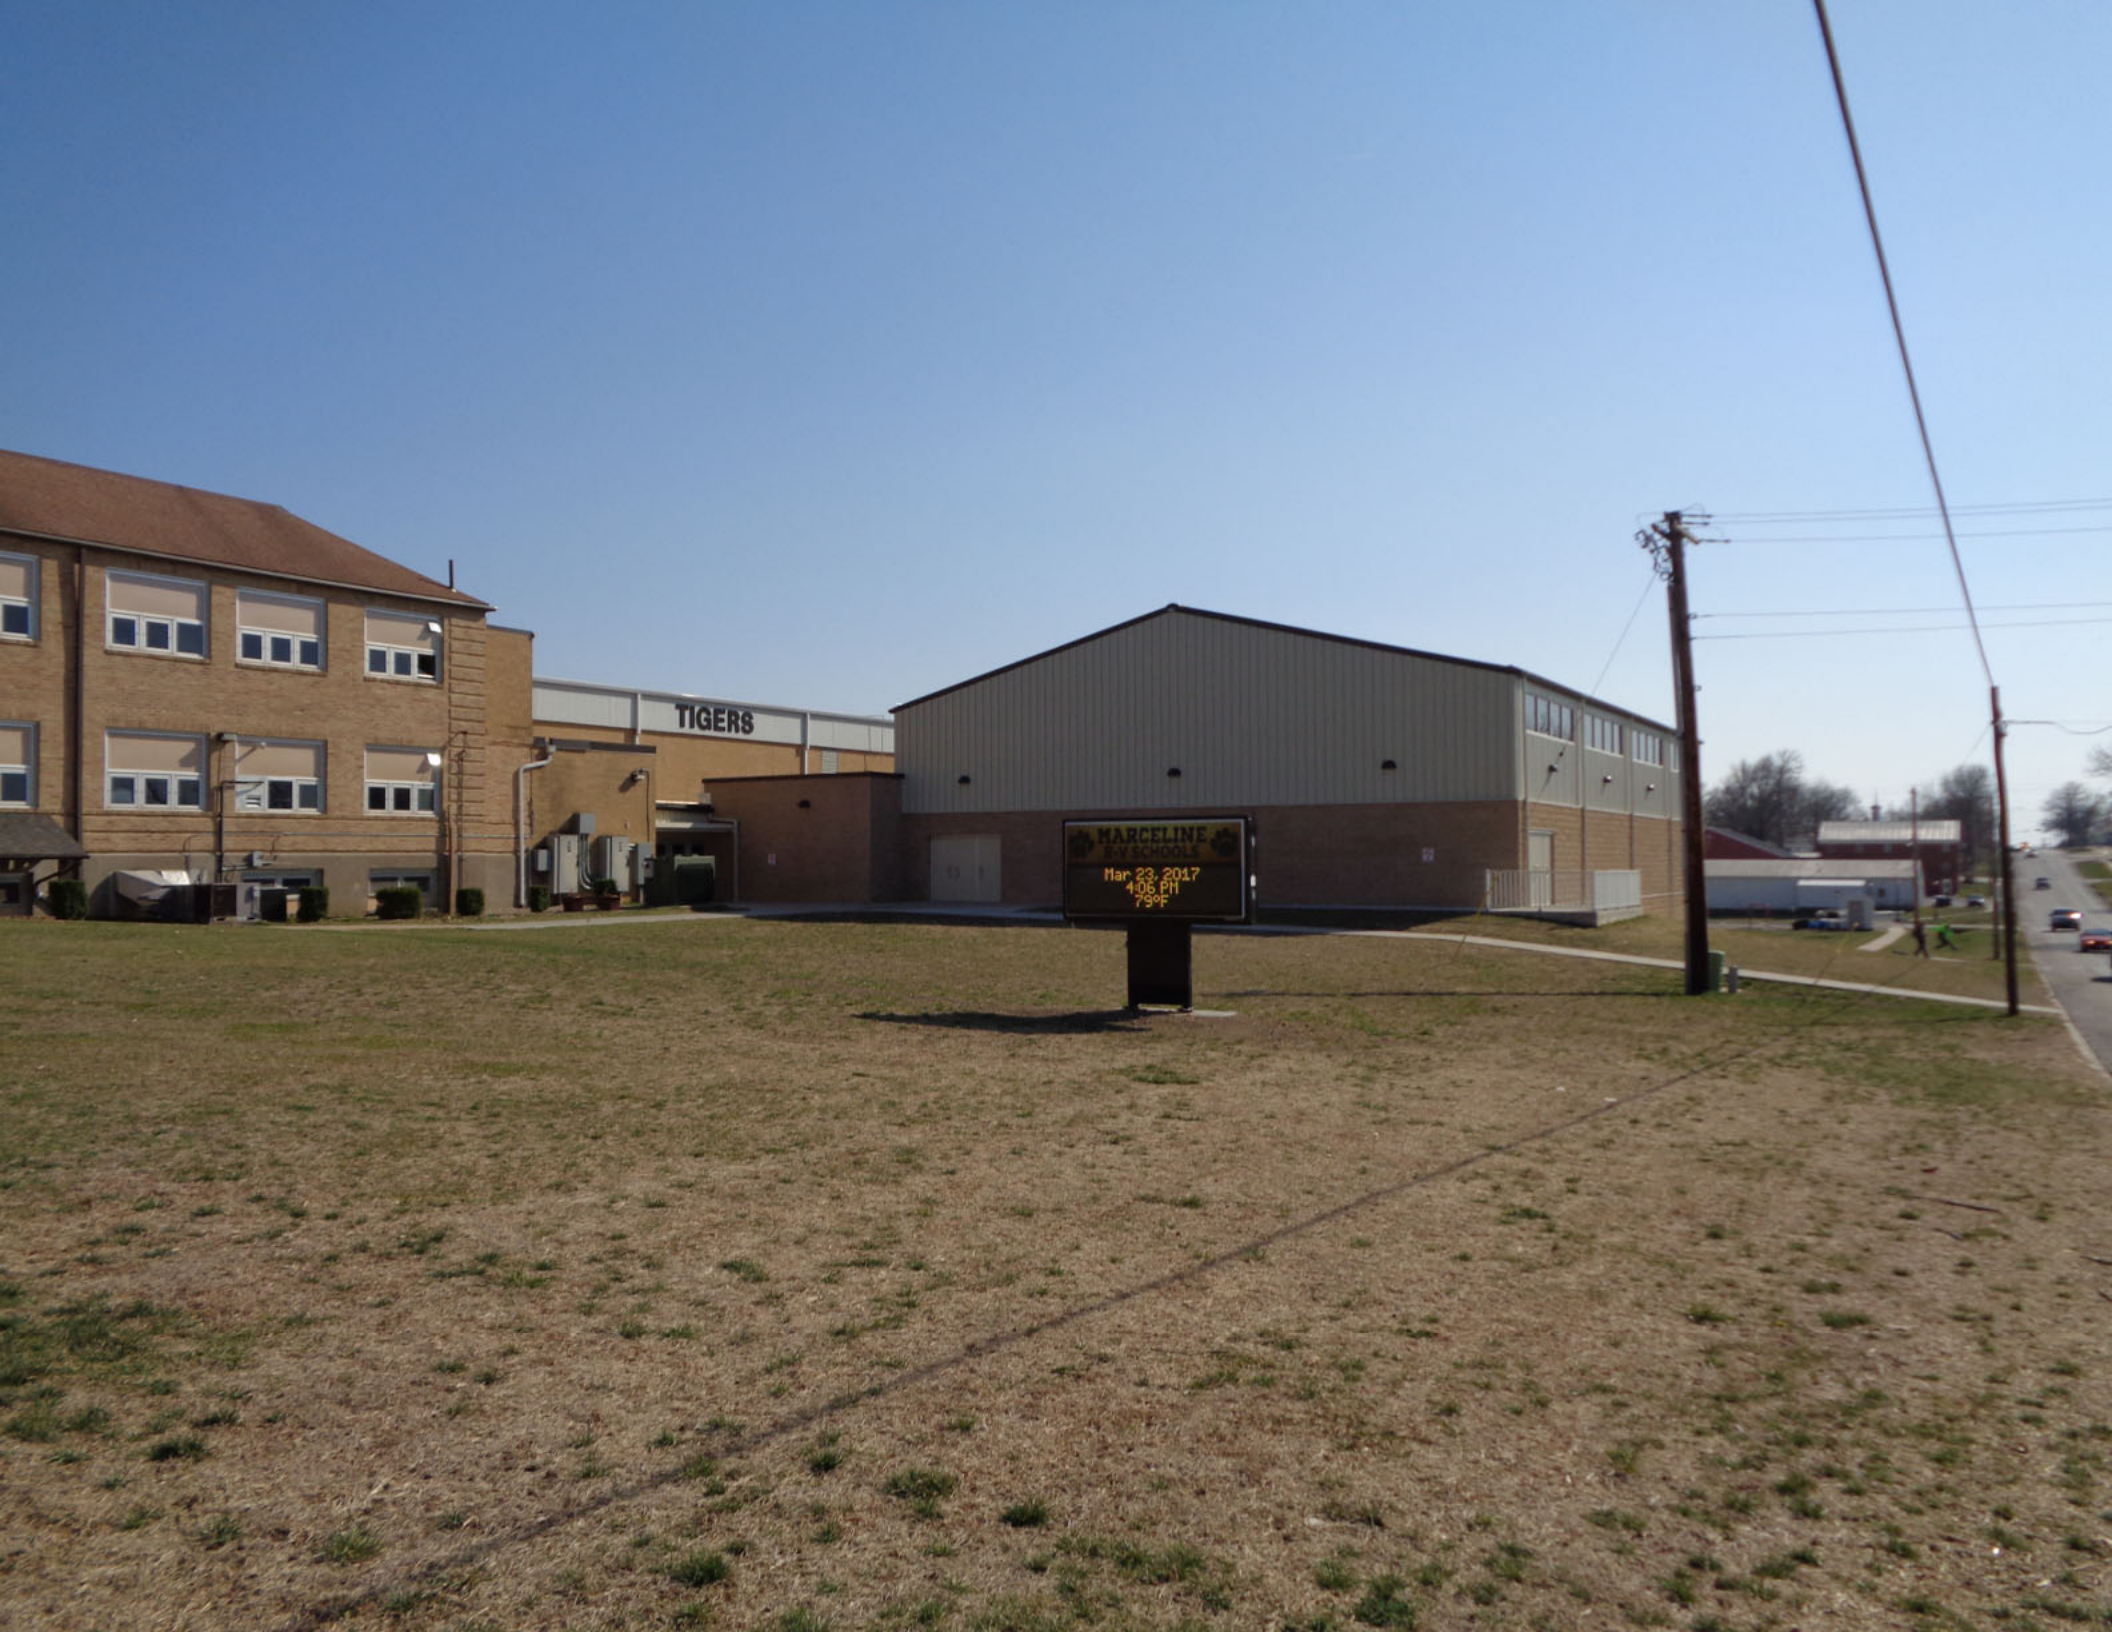
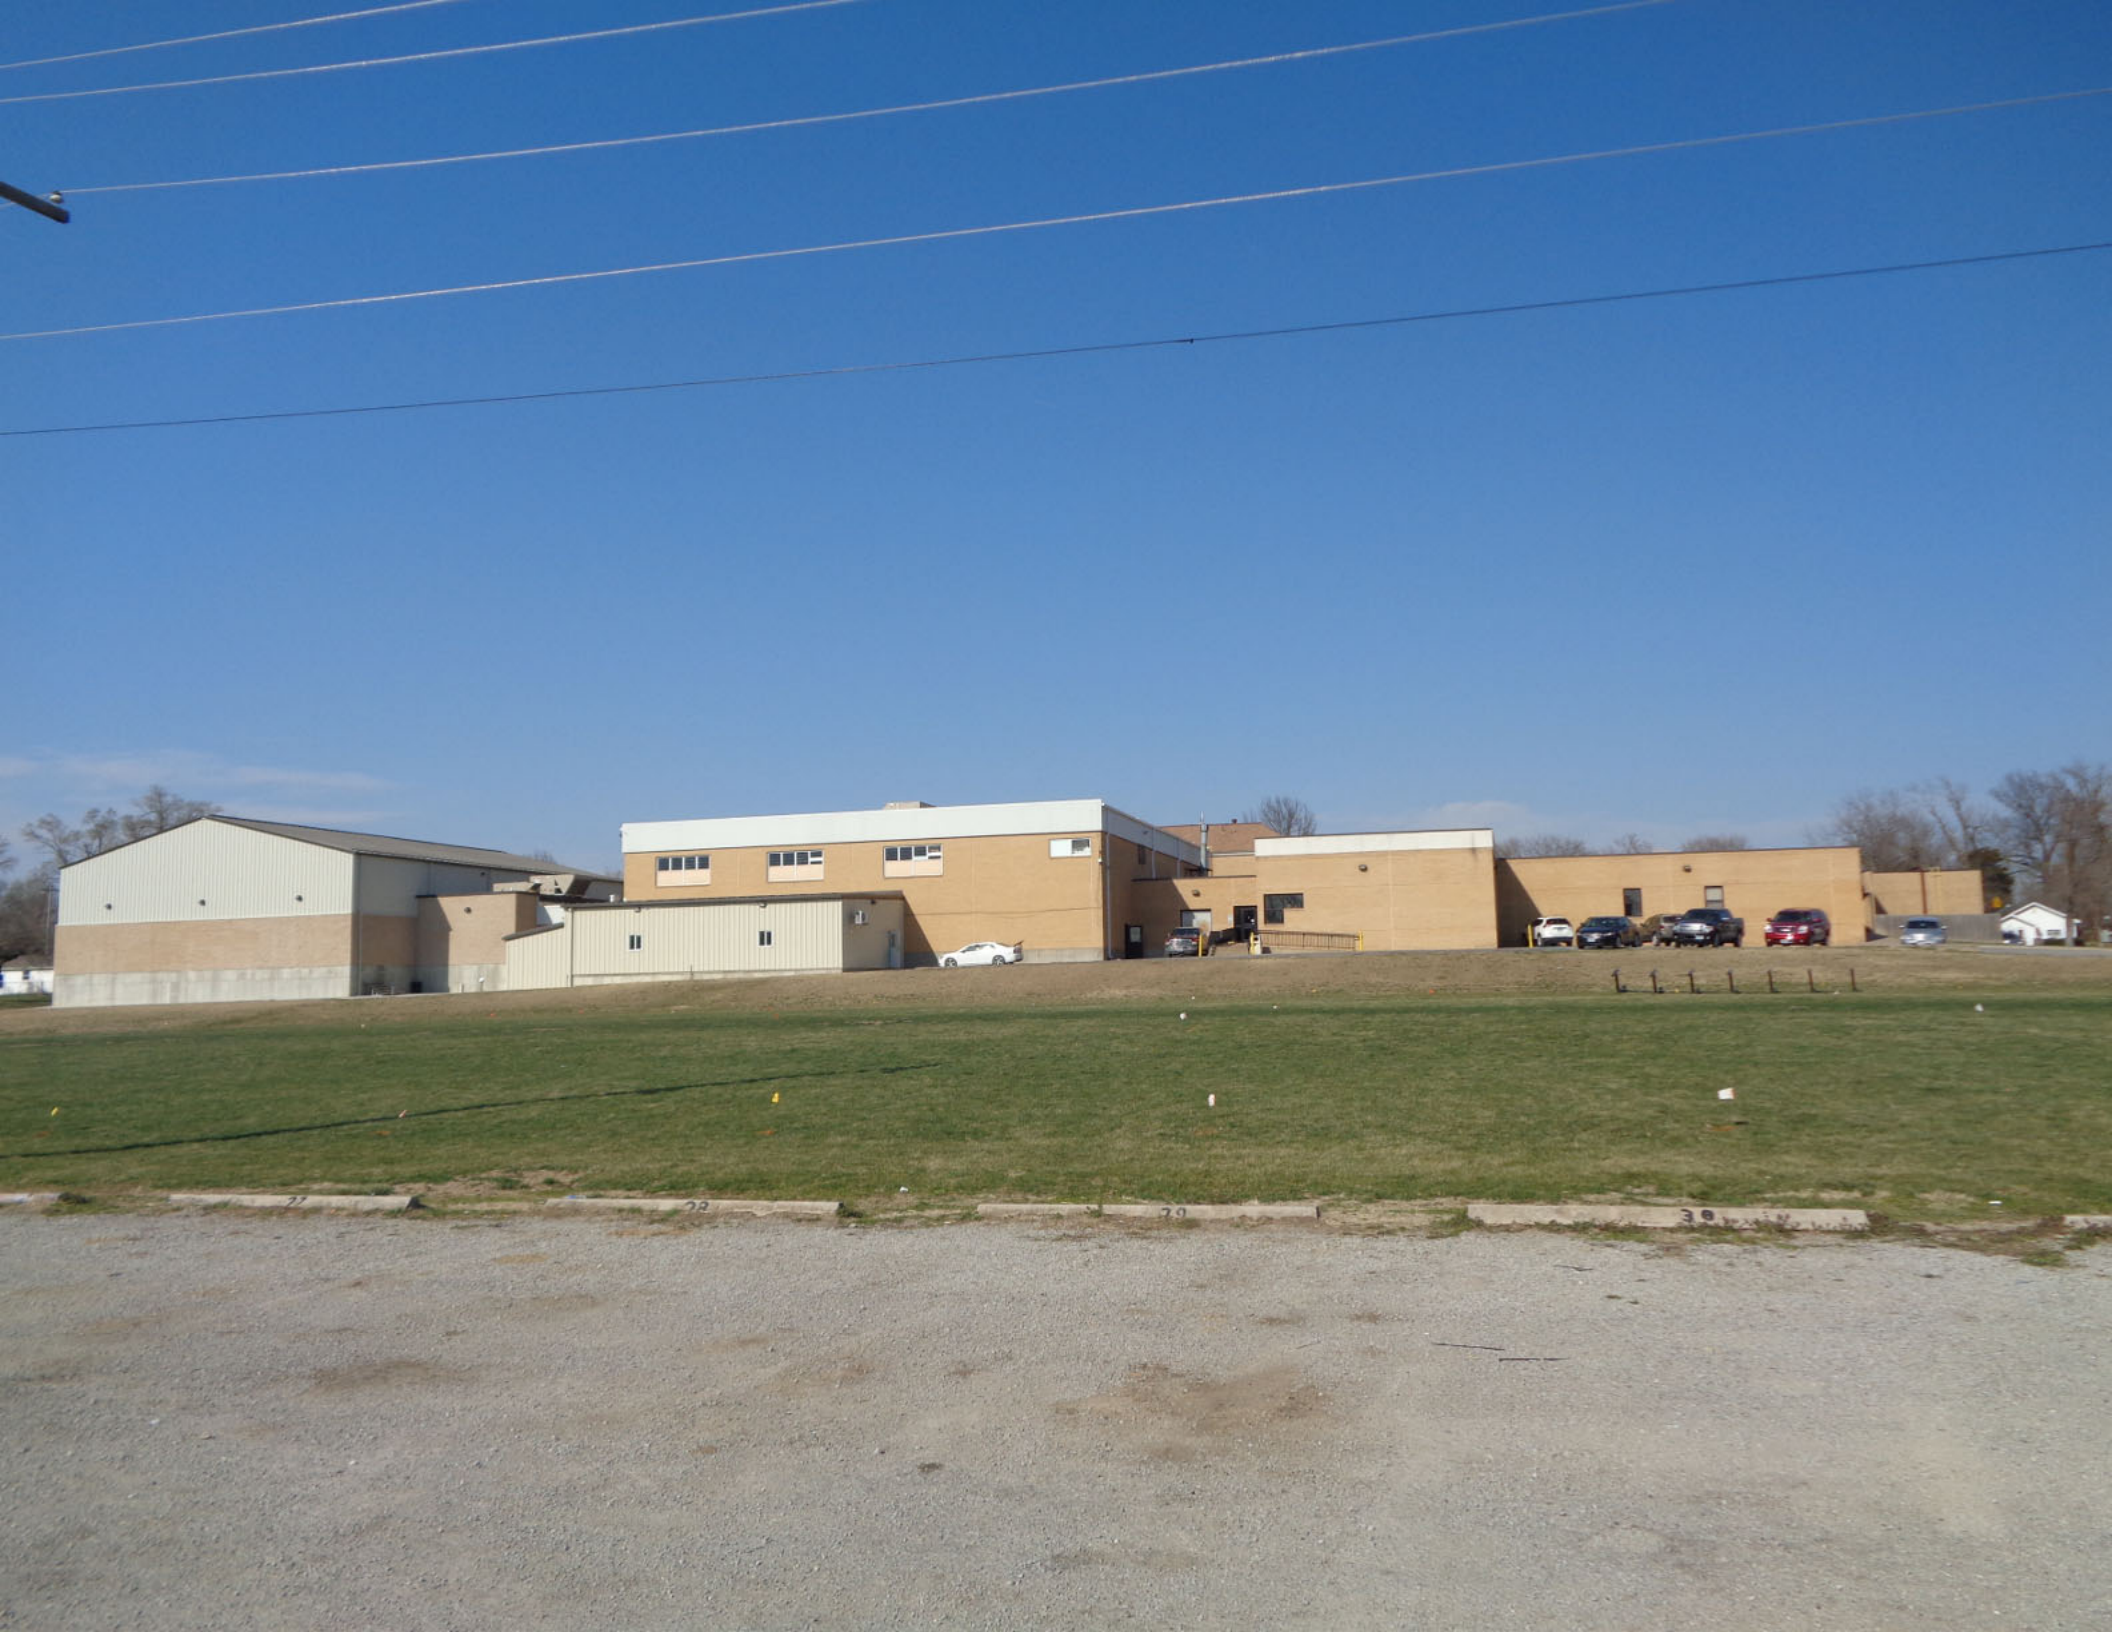
The original southeastern and southwestern elevations of this school have been obscured by large later additions. The primary facade faces NW; its western half is made up of a flat-roofed 1-story brick addition. The westernmost portion of the addition bumps out and houses a central recessed single door entry flanked by 2 narrow 1-over-1 windows on either side. The rest of the addition houses 3 small 1-over-1 windows followed by a double door entry with a large arched transom sheltered by a concrete vaulted canopy supported by 2 square brick columns. The original facade is symmetrical with a prominent central double door entry recessed in a small bump out which has a small hipped roof. Narrow decorative brick arches are above the entry and above 3 narrow windows in the 2nd story above the entry. The central portion of the building has a flat roof with a small faux pediment; the rest of the roofing appears hipped. On either side of the bumped out entry are 6 windows in the 1st and 2nd stories. All original windows have been replaced with metal windows; top panes are covered and sit above 3 small awning windows. Shallow pilasters divide some of the windows; some pilasters and the corners of the building are quoined. The northwestern elevation houses a 2-story bump out with entry above which are 3 nonhistoric narrow arched windows followed by 3 decorative vents. The ground slopes to expose the basement level which has 5 window openings that are smaller than the windows above: 5 windows in 1st & 2nd story like those on the facade. Following is a gable-roofed modern addition.
