MISSOURI DEPARTMENT OF NATURAL RESOURCES  
STATE HISTORIC PRESERVATION OFFICE, P.O. Box 176, Jefferson City, MO 65102  
**ARCHITECTURAL/HISTORIC INVENTORY FORM**

1. SURVEY NO. LI-AS-001-001		2. SURVEY NAME: Marceline Survey	
3. COUNTY: Linn		4. ADDRESS (STREET NO.) 275	STREET (NAME) West Broadway
5. CITY: Marceline	VICINITY: <input type="checkbox"/>	6. UTM: / /	7. TOWNSHIP/RANGE/SECTION: T: R: S:

8. HISTORIC NAME (IF KNOWN): Walt Disney's Childhood Home		9. PRESENT/OTHER NAME (IF KNOWN): Walt Disney's Childhood Home	
10. OWNERSHIP: <input checked="" type="checkbox"/> PRIVATE <input type="checkbox"/> PUBLIC		11A. HISTORIC USE (IF KNOWN): Single Dwelling	11B. CURRENT USE: Single Dwelling
<b>HISTORICAL INFORMATION</b>

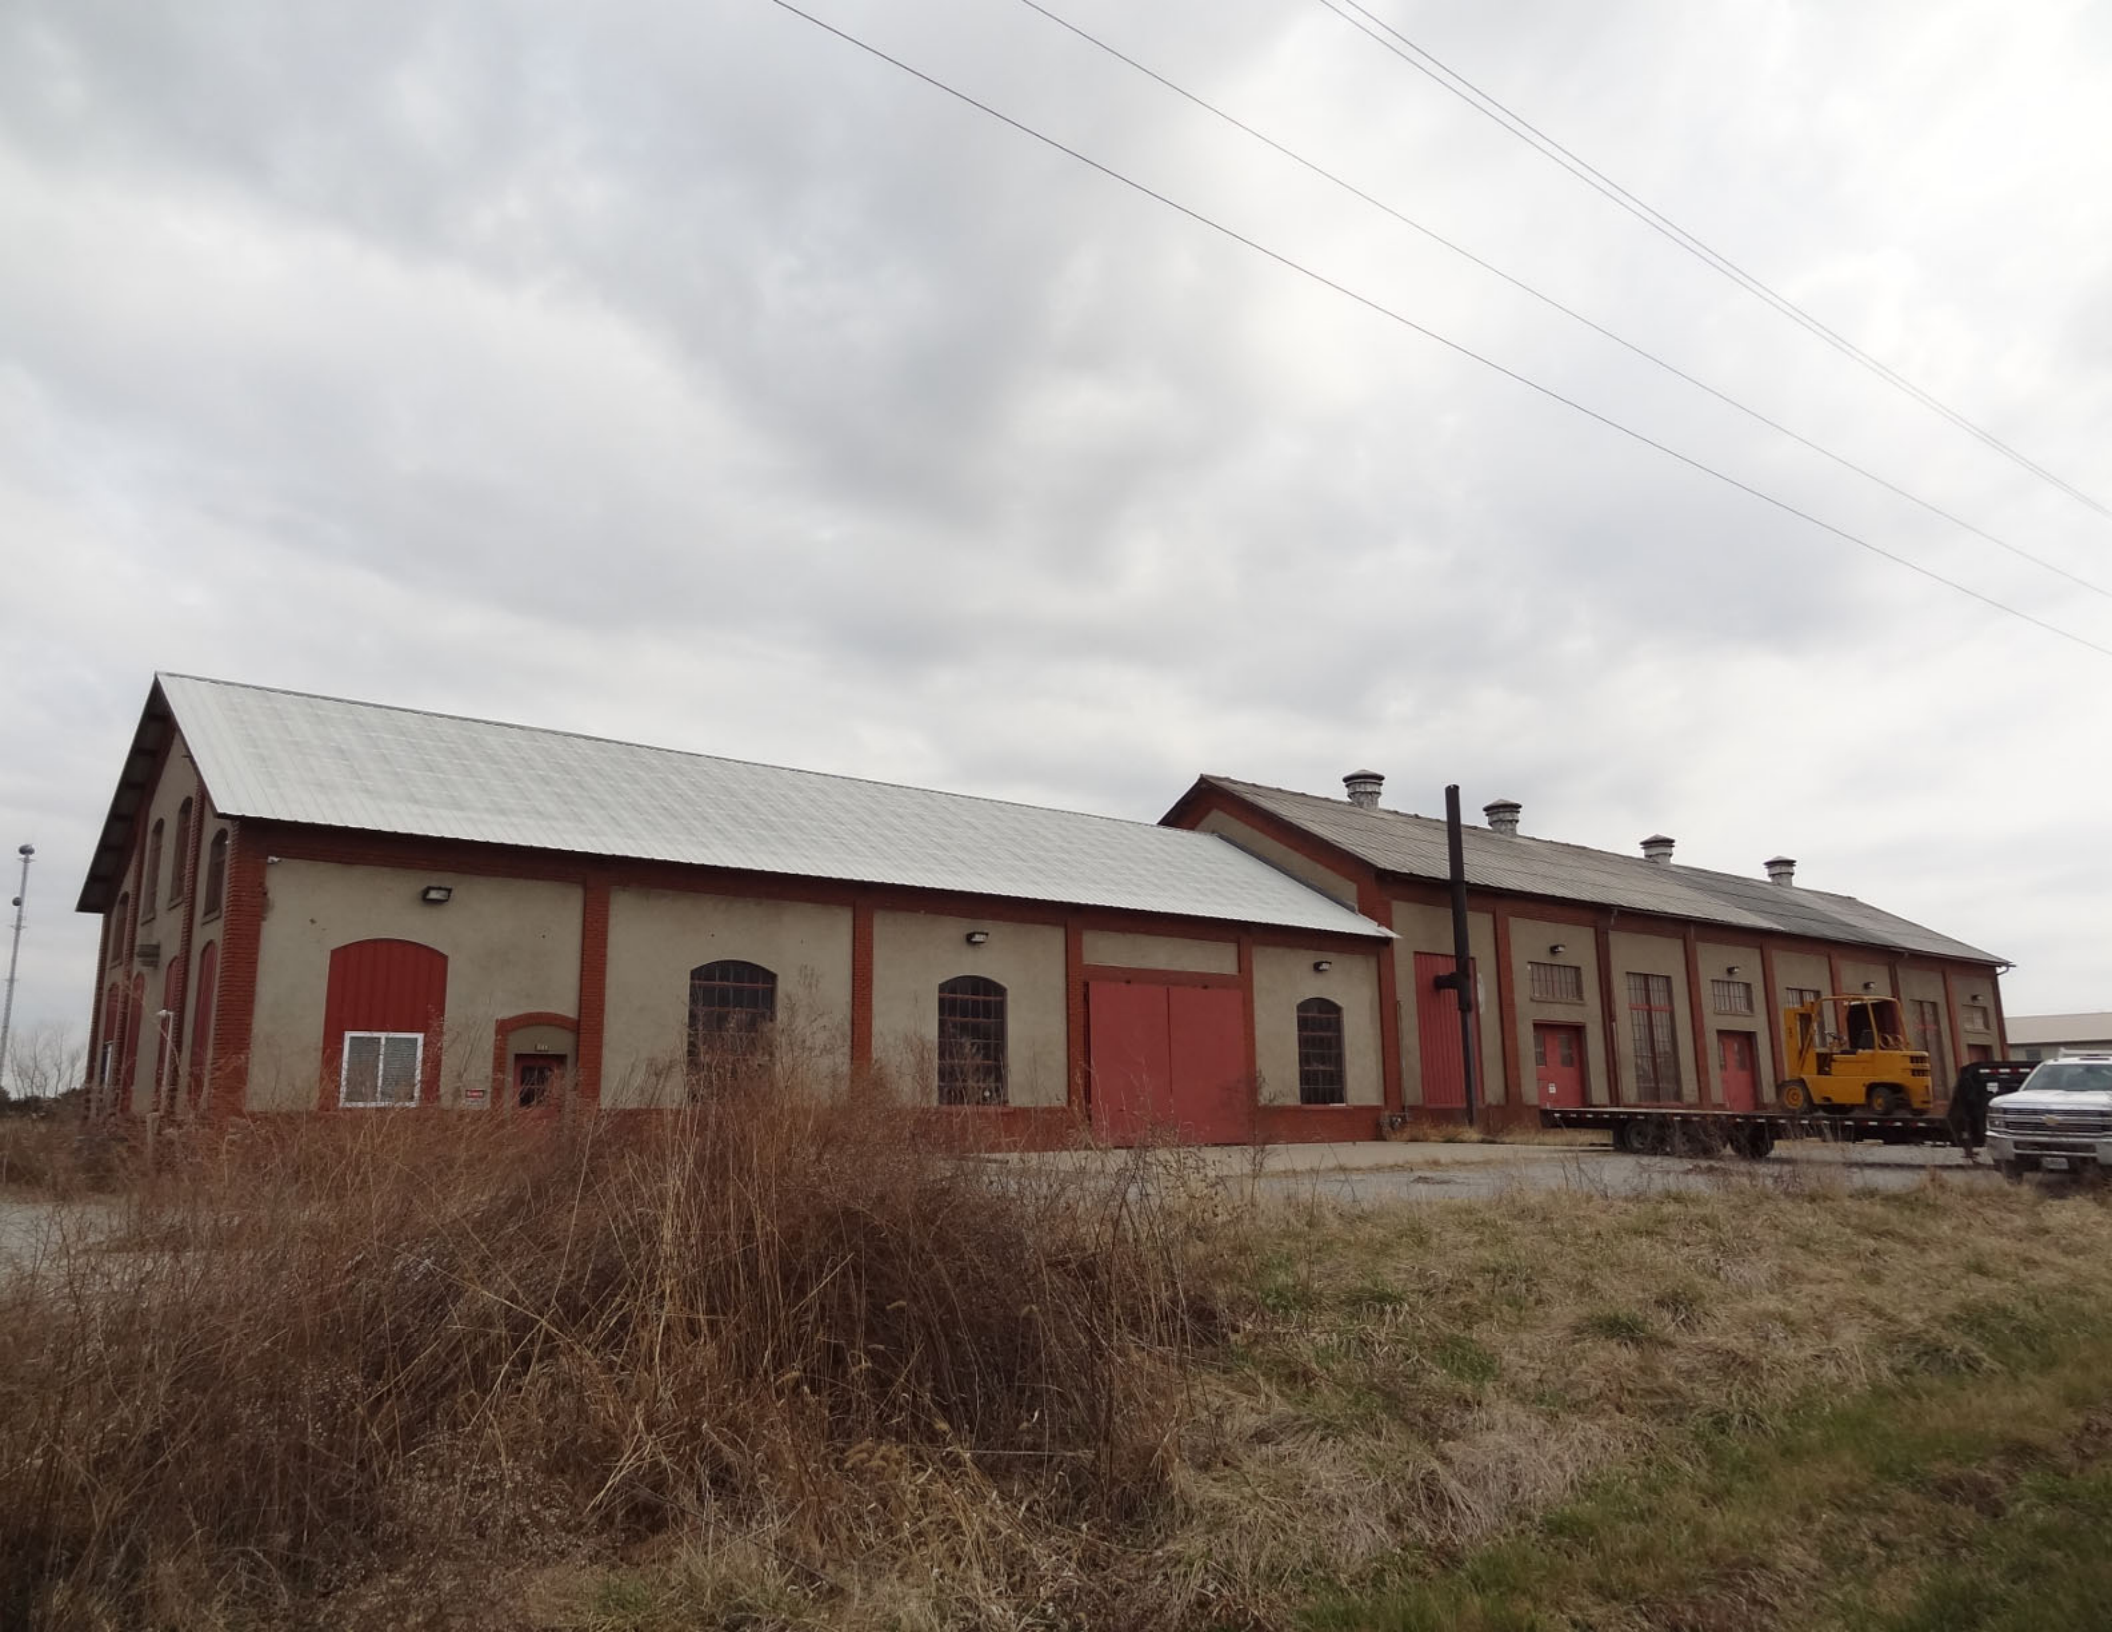
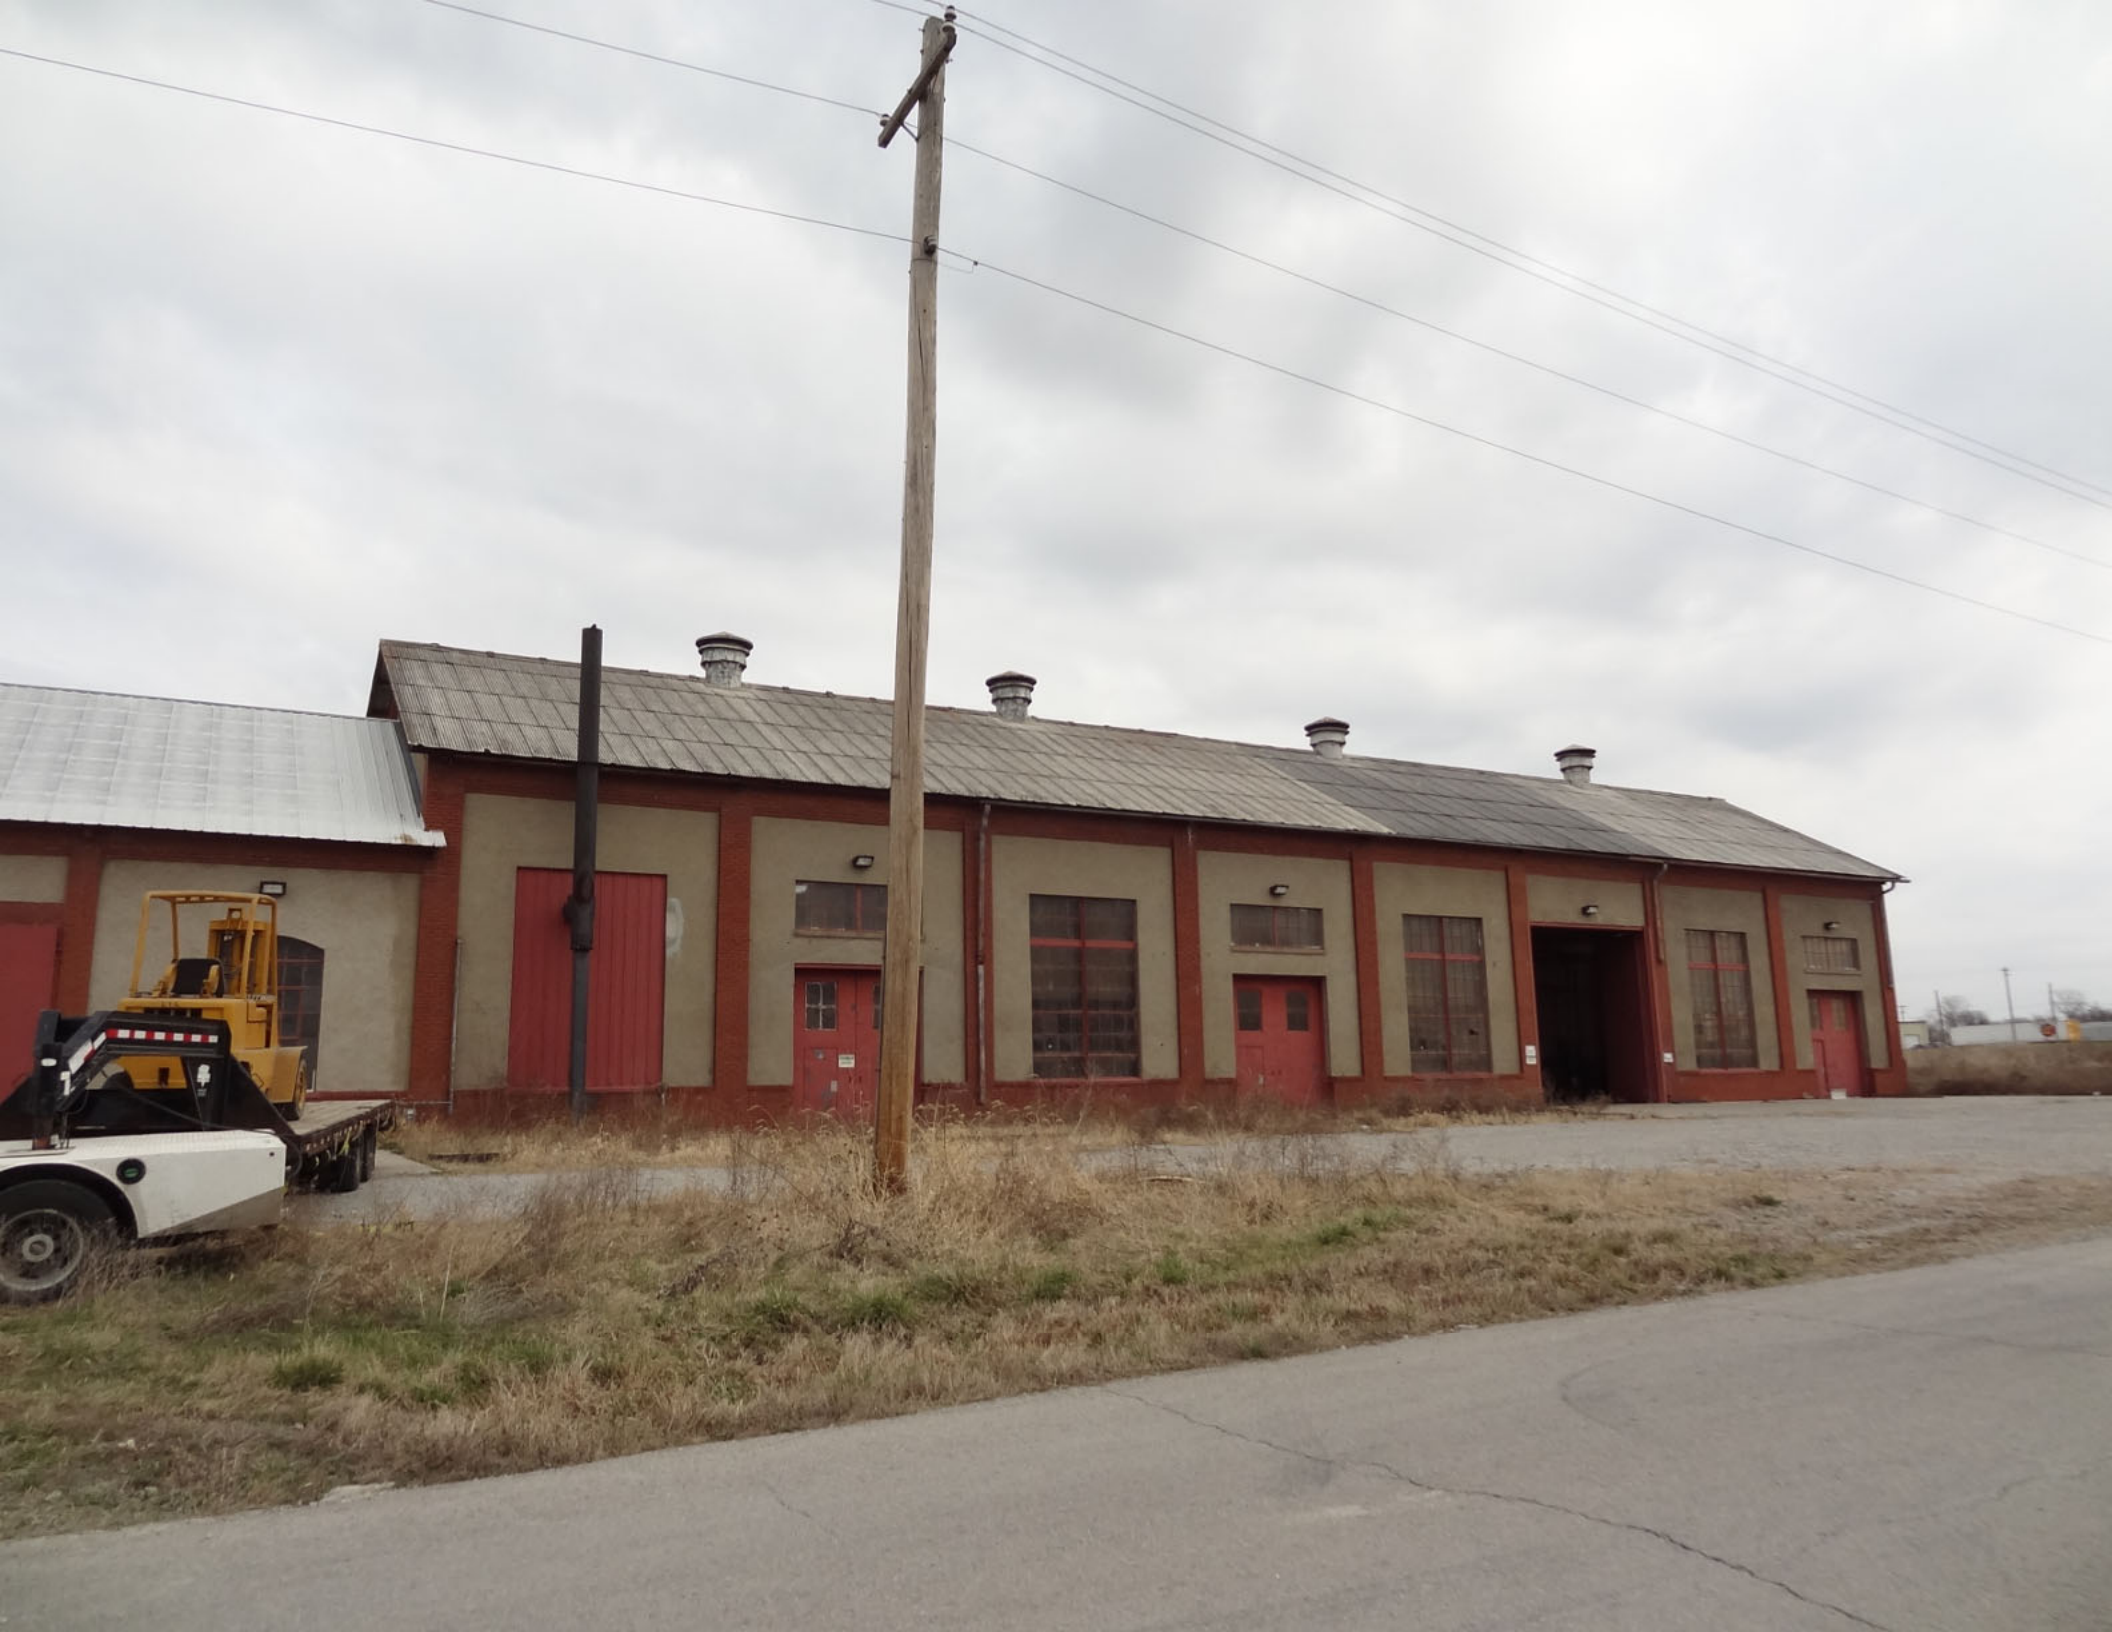
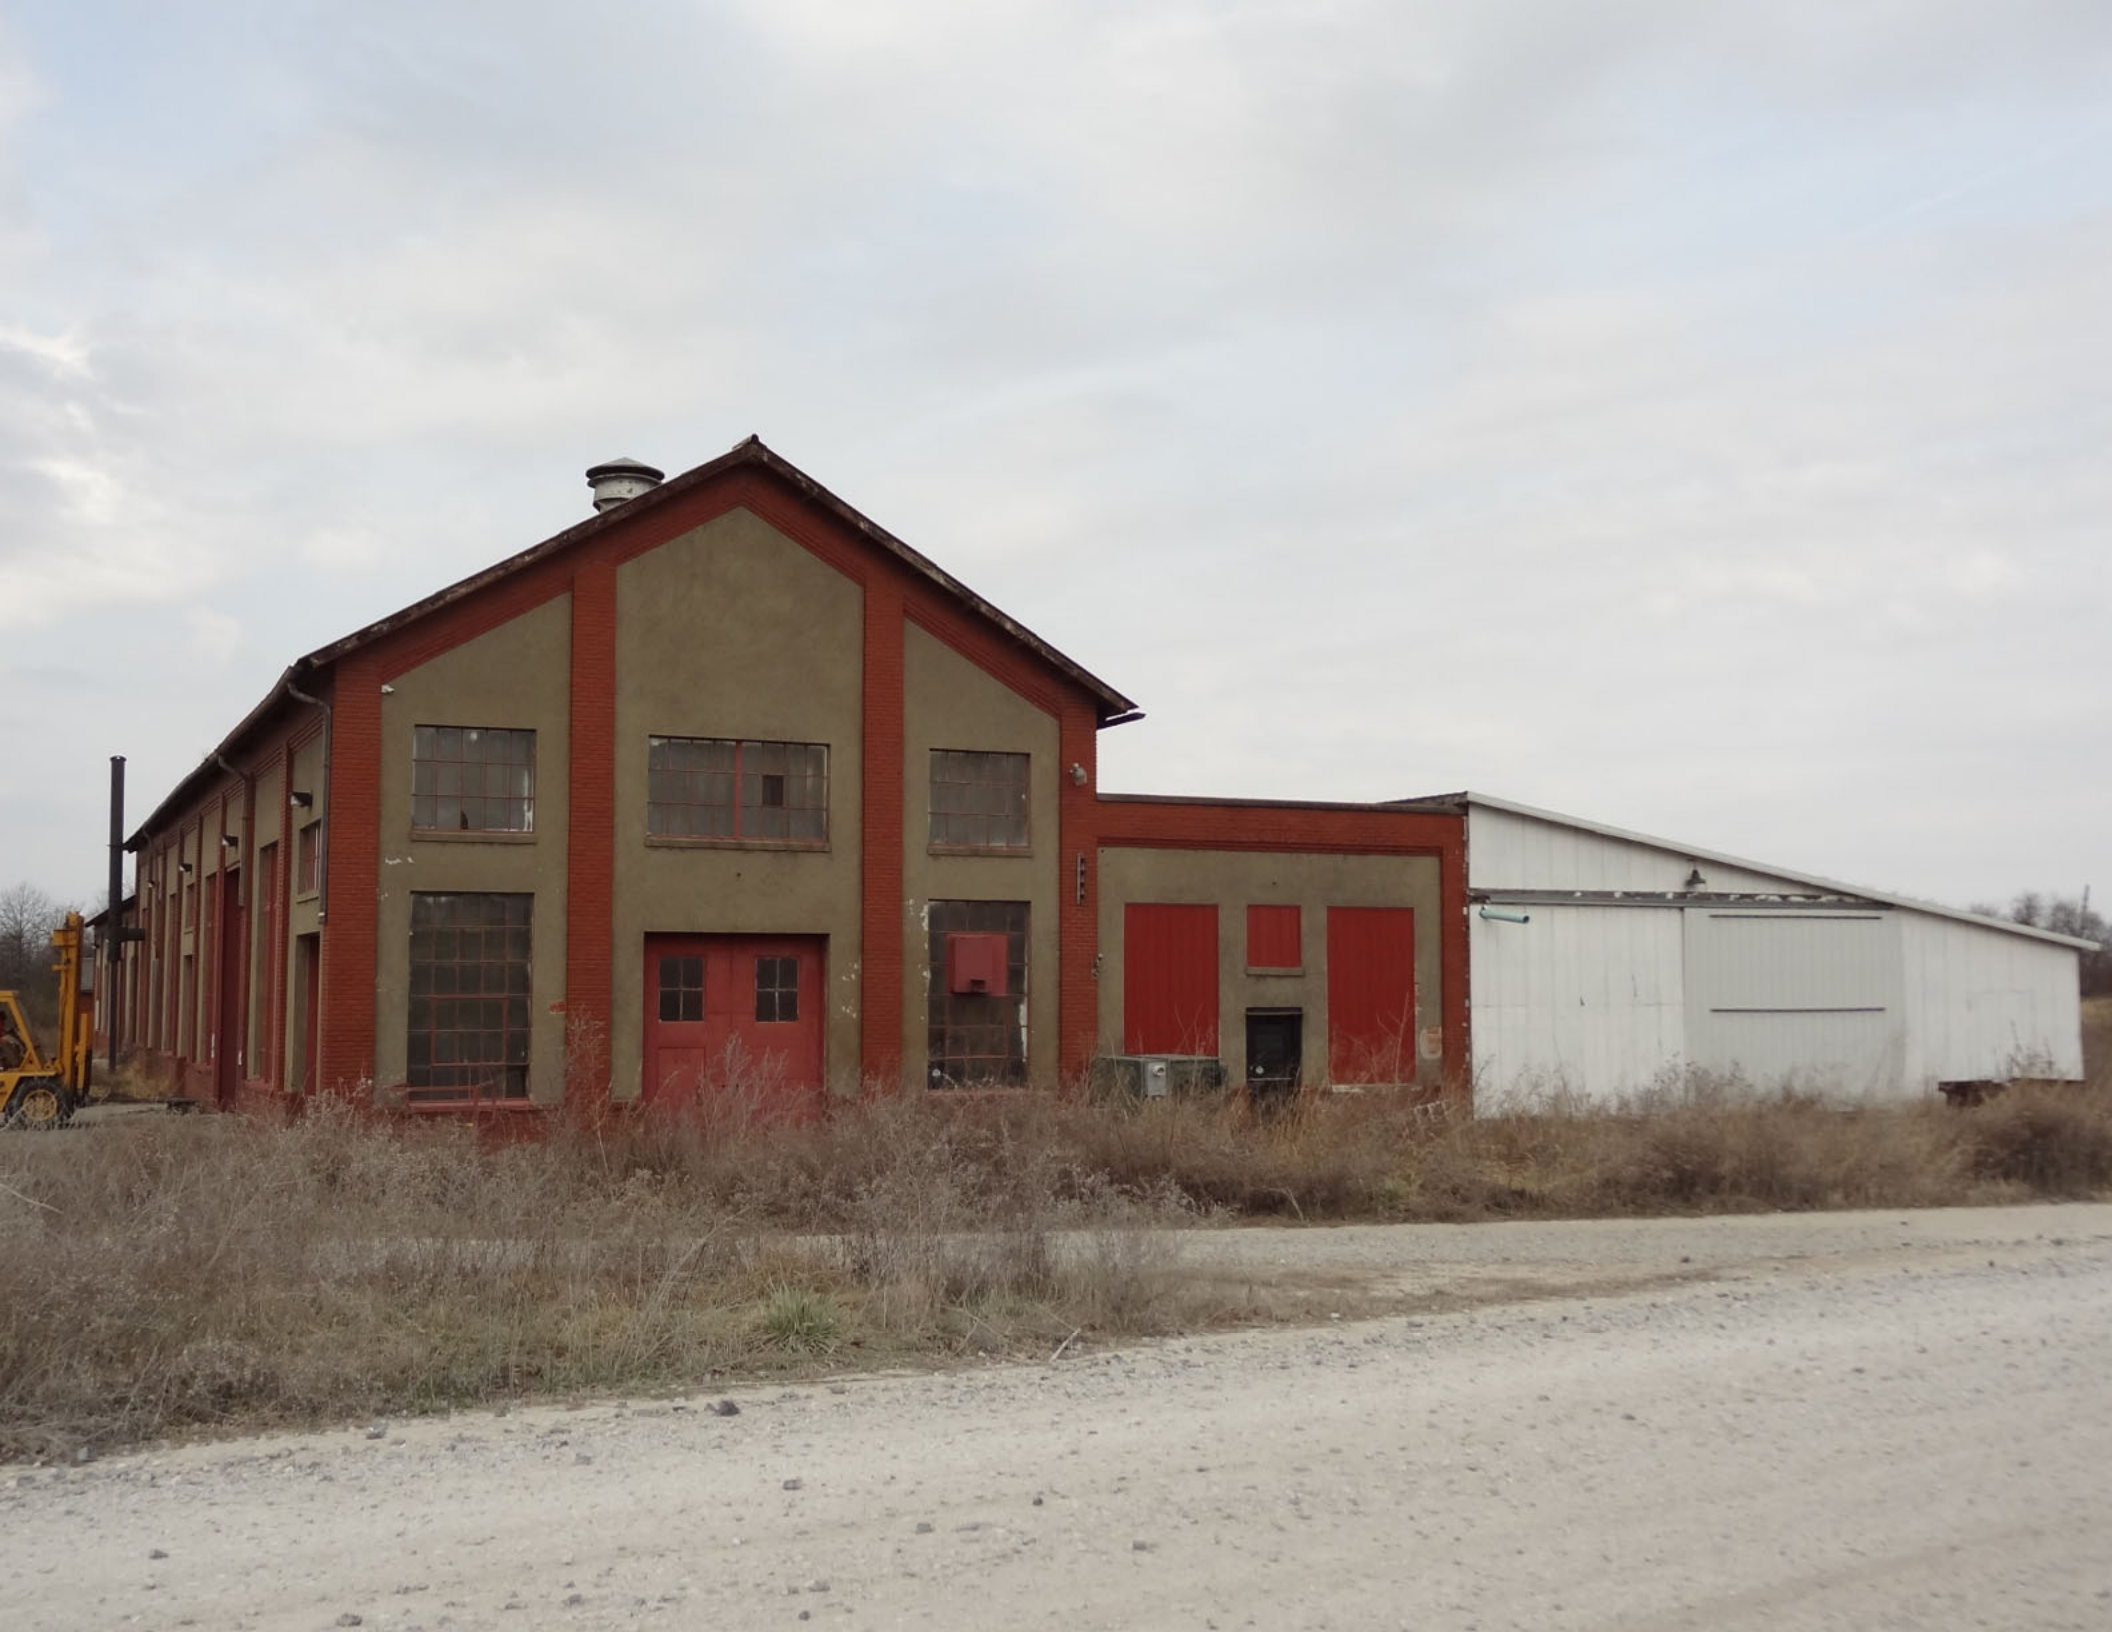
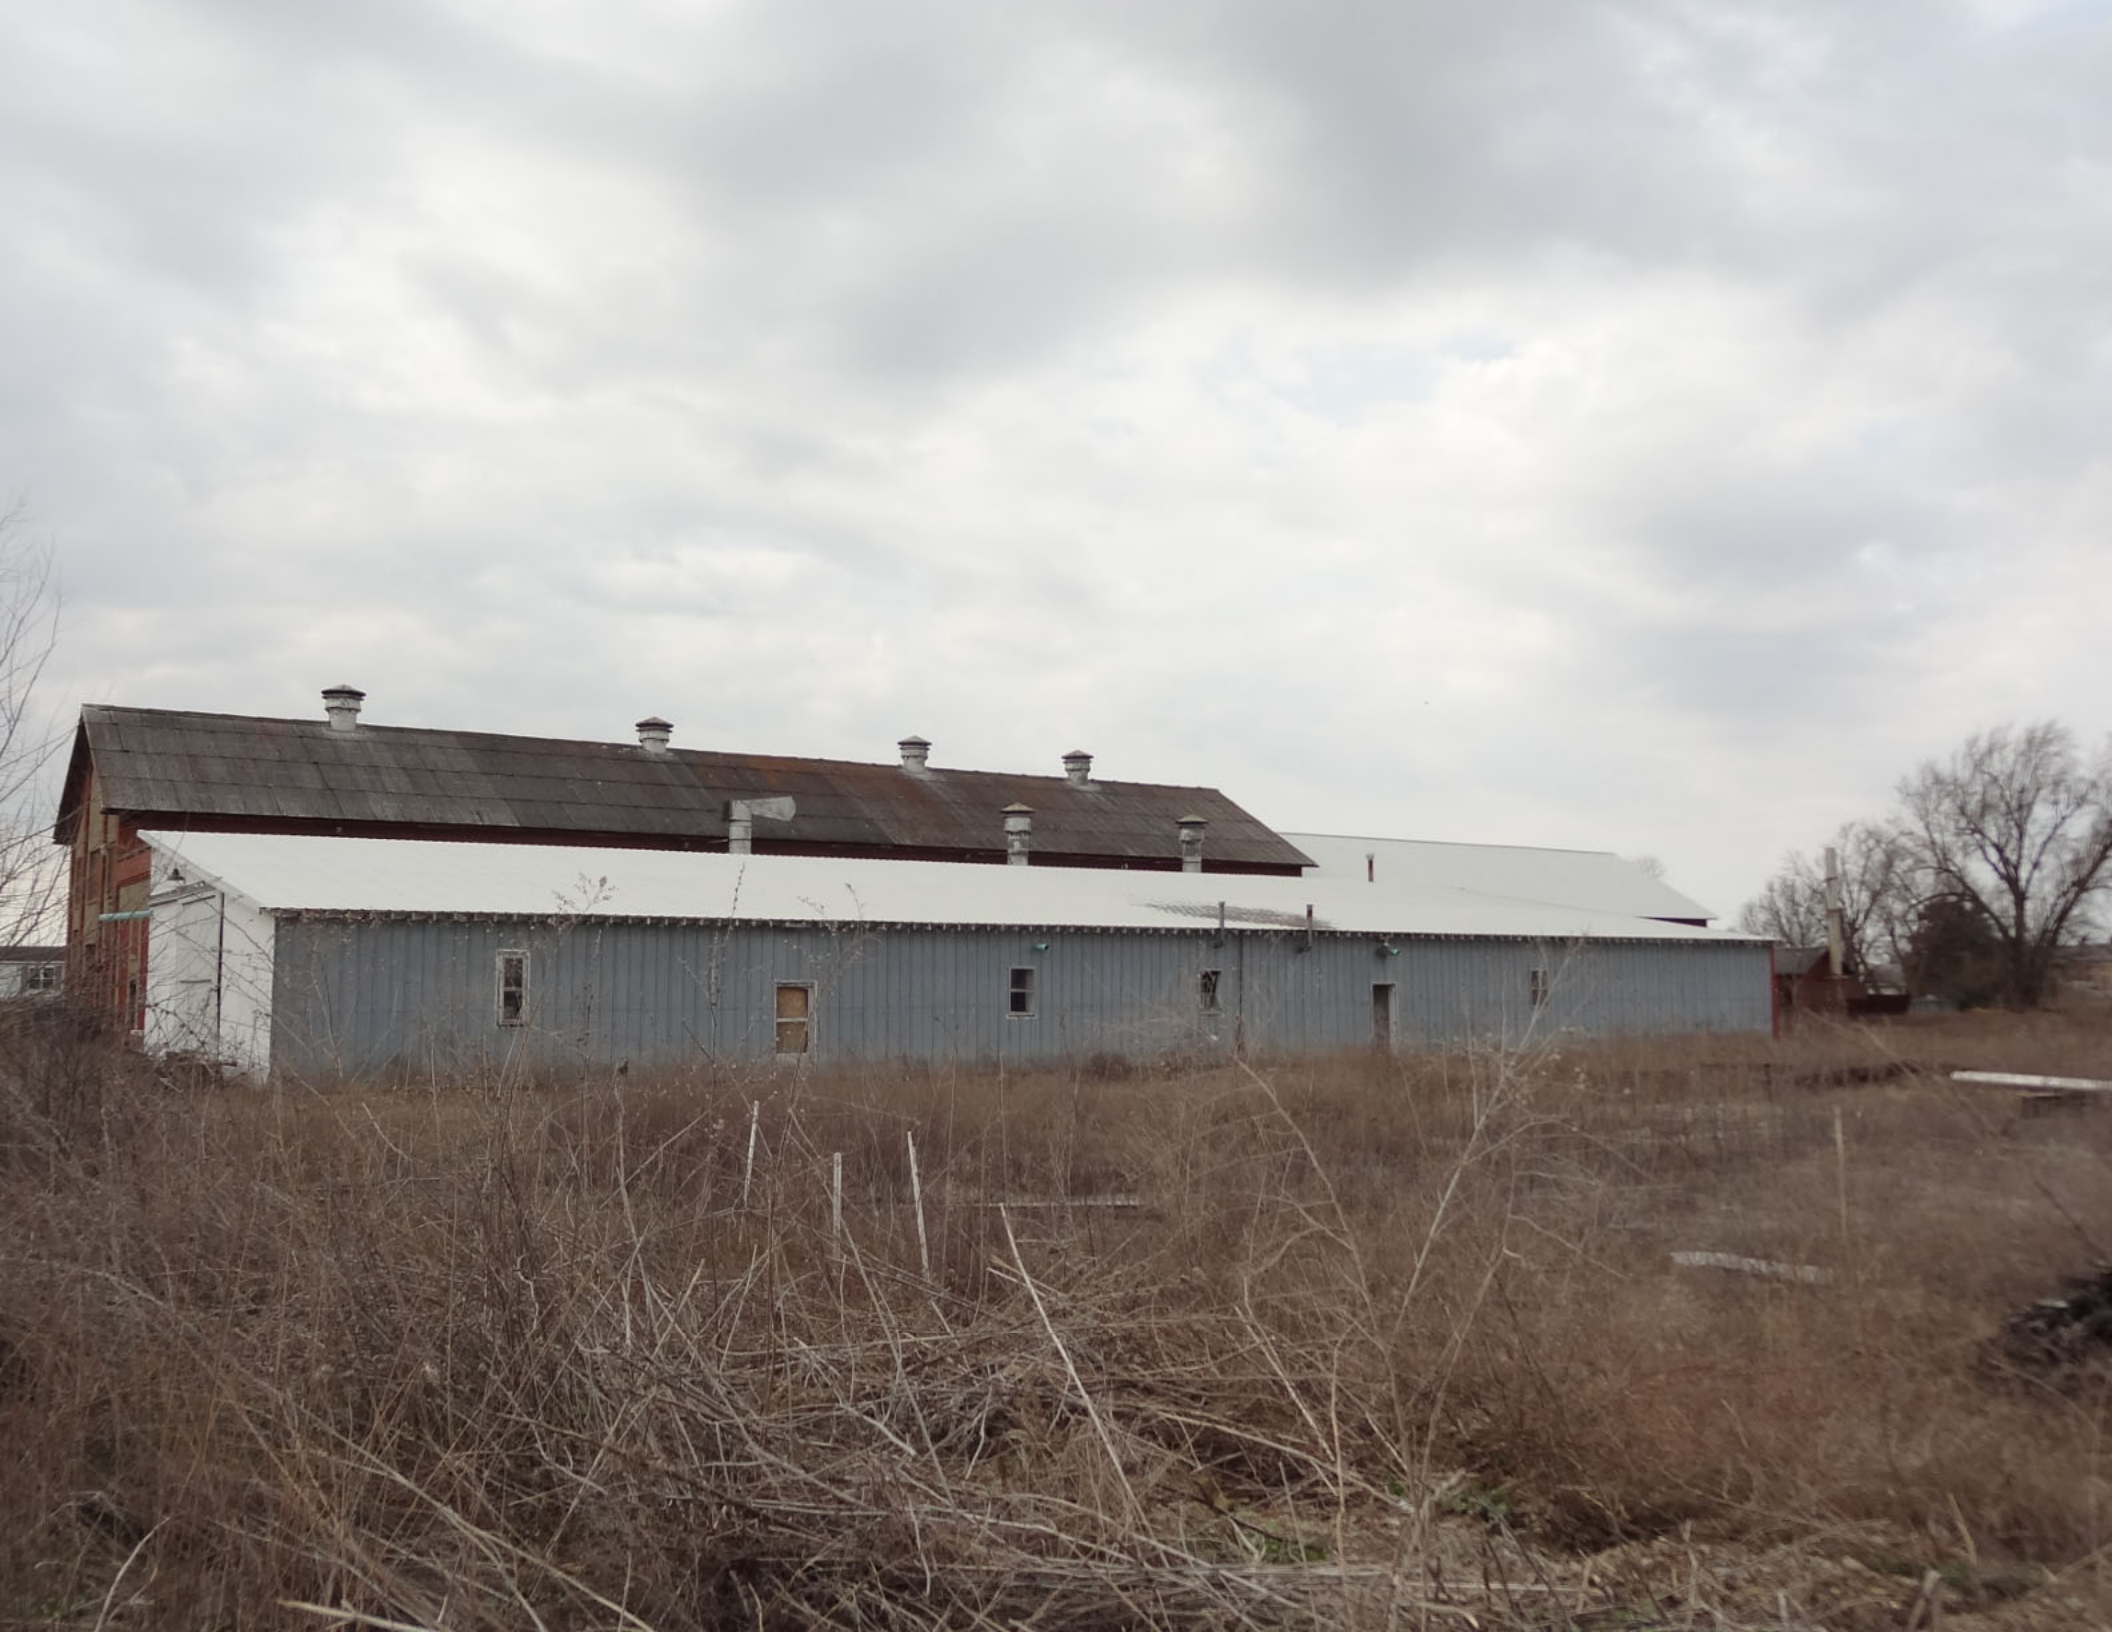
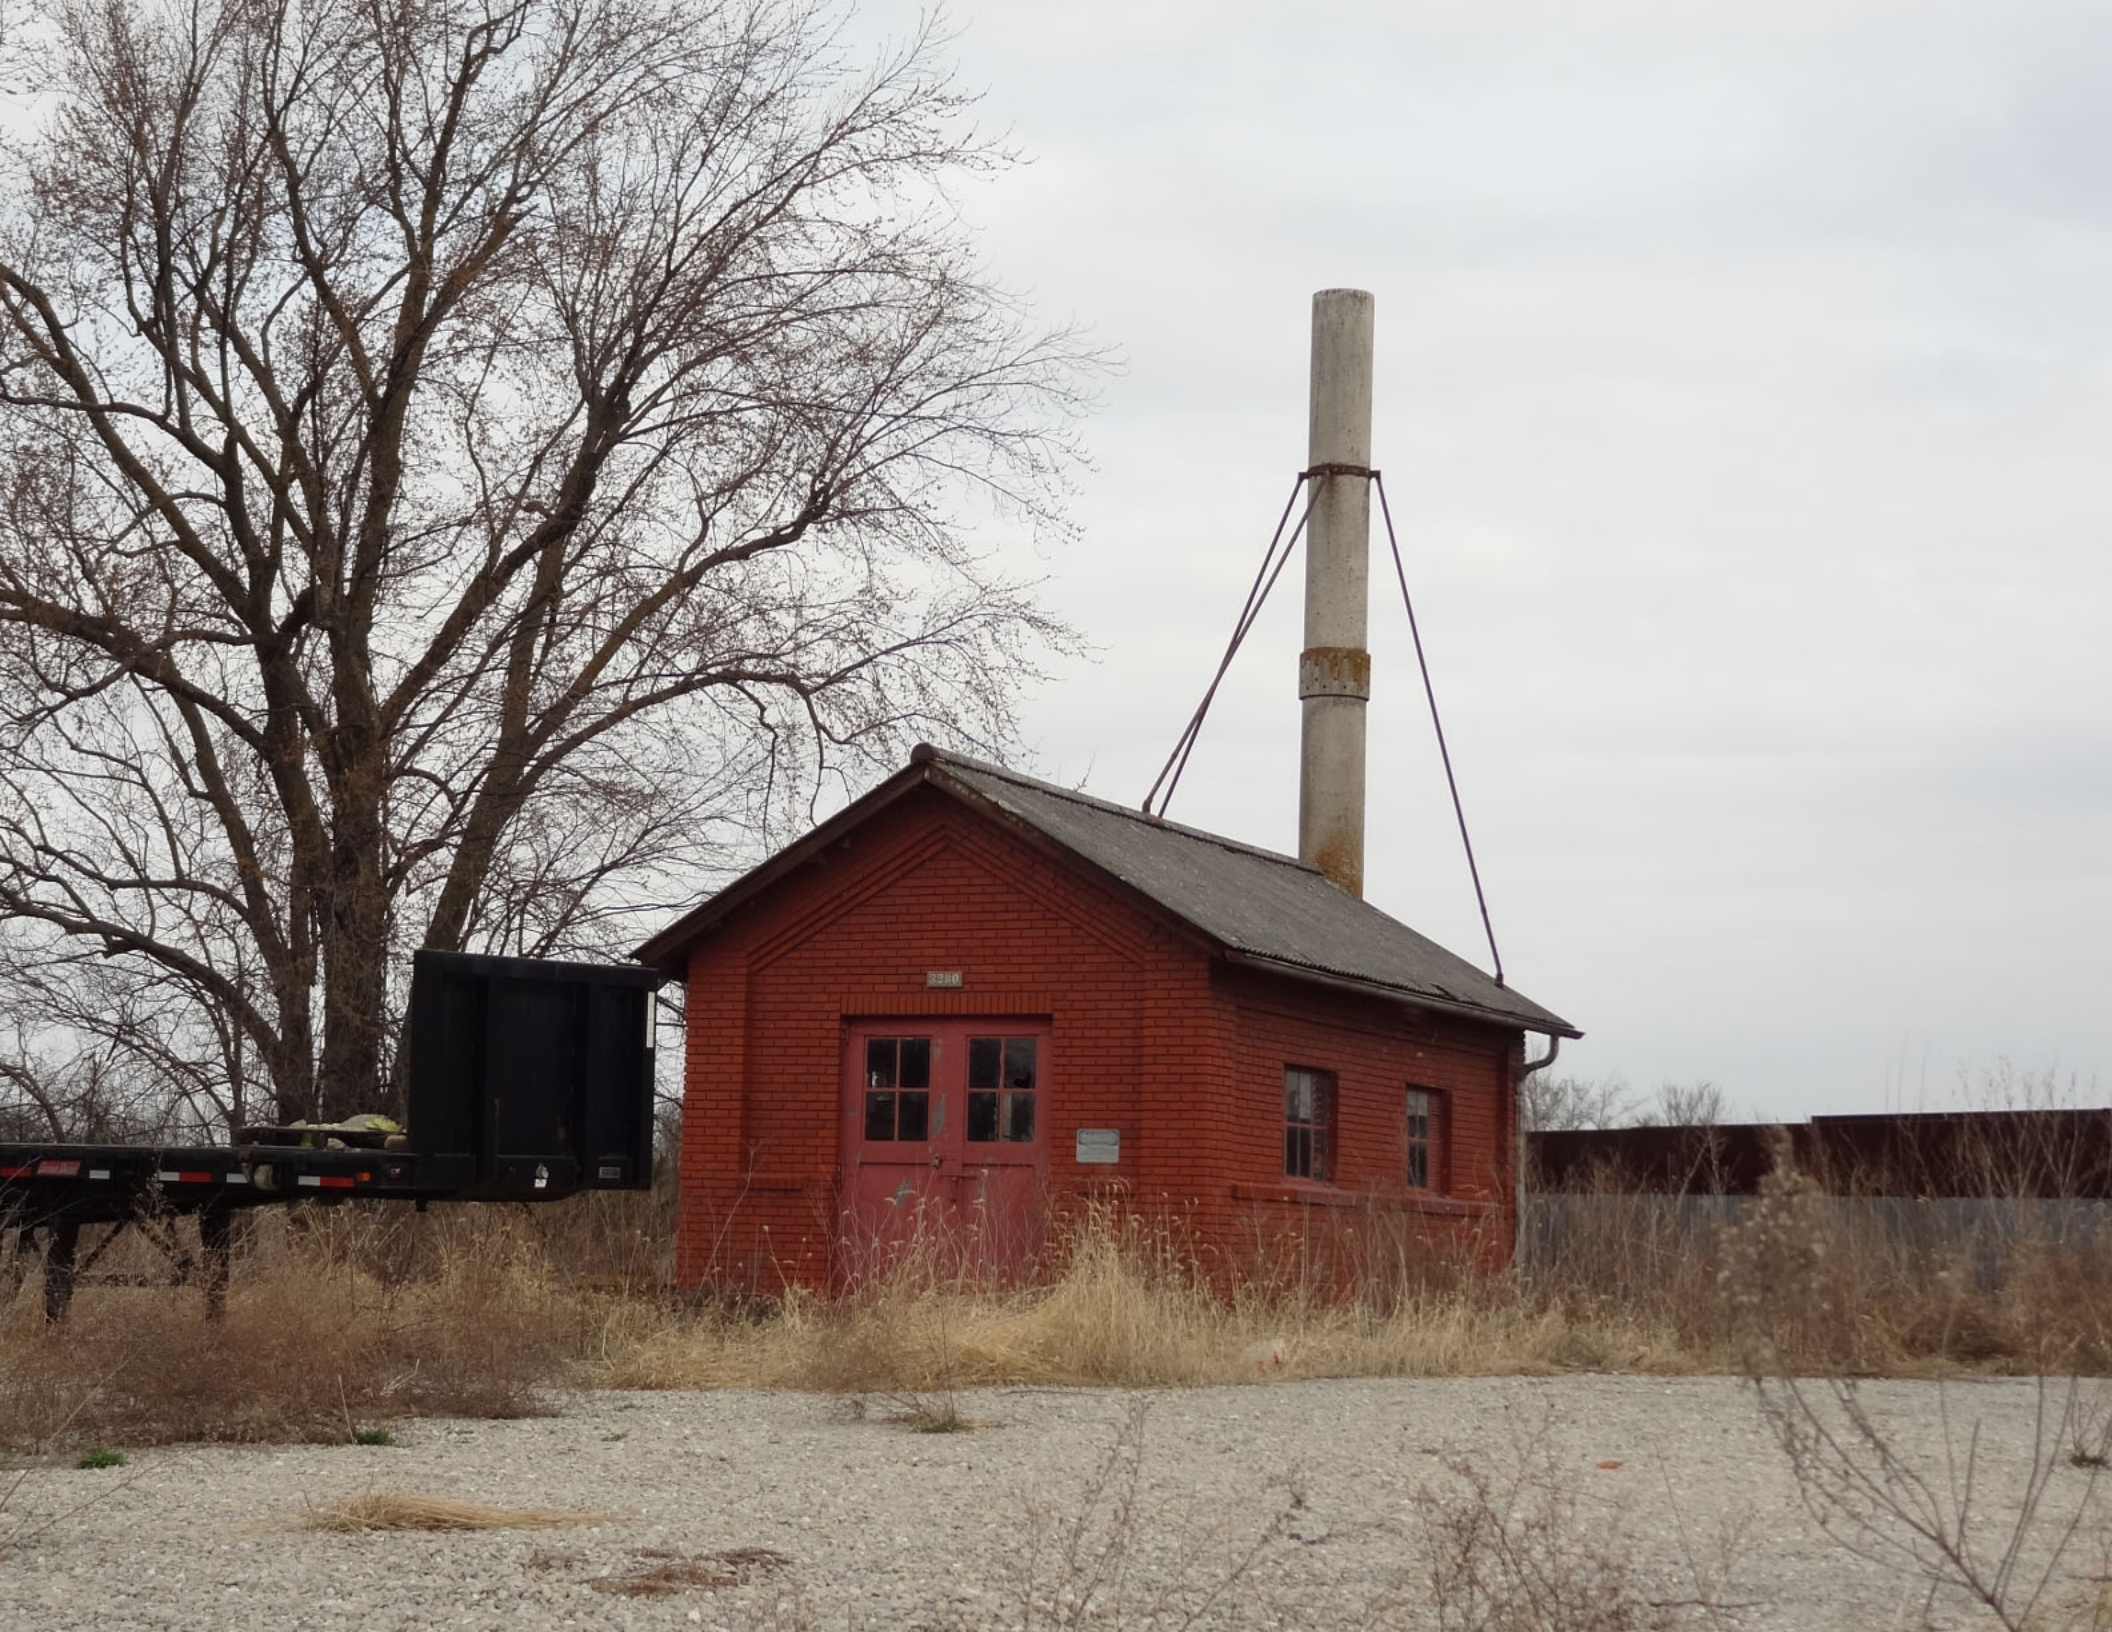
The east elevation has seven bays starting from the south there is a three bay portion that has a front gable roof. The center bay has a pair of metal doors with four window panes each flanked by bays with large metal multi-pane windows each bay has a large multi-pane metal window above. The next bay to the north also has three bays the center bay has a single metal door with a small boarded window above. The door is flanked by large boarded windows on either side. The northernmost bay is a metal building that is constructed of metal and has a shed roof and a large sliding metal door.

The southern elevation was constructed in two phases the eastern portion has eight bays with metal double doors, paired multi-pane windows, and an overhead garage door. The western portion has arched multi-pane metal windows and a pair of sliding metal doors. The western bay has a single pedestrian door and a single infilled window with a vinyl window.
