MISSOURI DEPARTMENT OF NATURAL RESOURCES  
STATE HISTORIC PRESERVATION OFFICE, P.O. Box 176, Jefferson City, MO 65102  
**ARCHITECTURAL/HISTORIC INVENTORY FORM**

1. SURVEY NO. LI-AS-001-001		2. SURVEY NAME: Marceline Survey	
3. COUNTY: Linn		4. ADDRESS (STREET NO.) 275	STREET (NAME) West Broadway
5. CITY: Marceline	VICINITY: <input type="checkbox"/>	6. UTM: / /	7. TOWNSHIP/RANGE/SECTION: T: R: S:

8. HISTORIC NAME (IF KNOWN): Walt Disney's Childhood Home		9. PRESENT/OTHER NAME (IF KNOWN): Walt Disney's Childhood Home	
10. OWNERSHIP: <input checked="" type="checkbox"/> PRIVATE <input type="checkbox"/> PUBLIC		11A. HISTORIC USE (IF KNOWN): Single Dwelling	11B. CURRENT USE: Single Dwelling
<b>HISTORICAL INFORMATION</b>

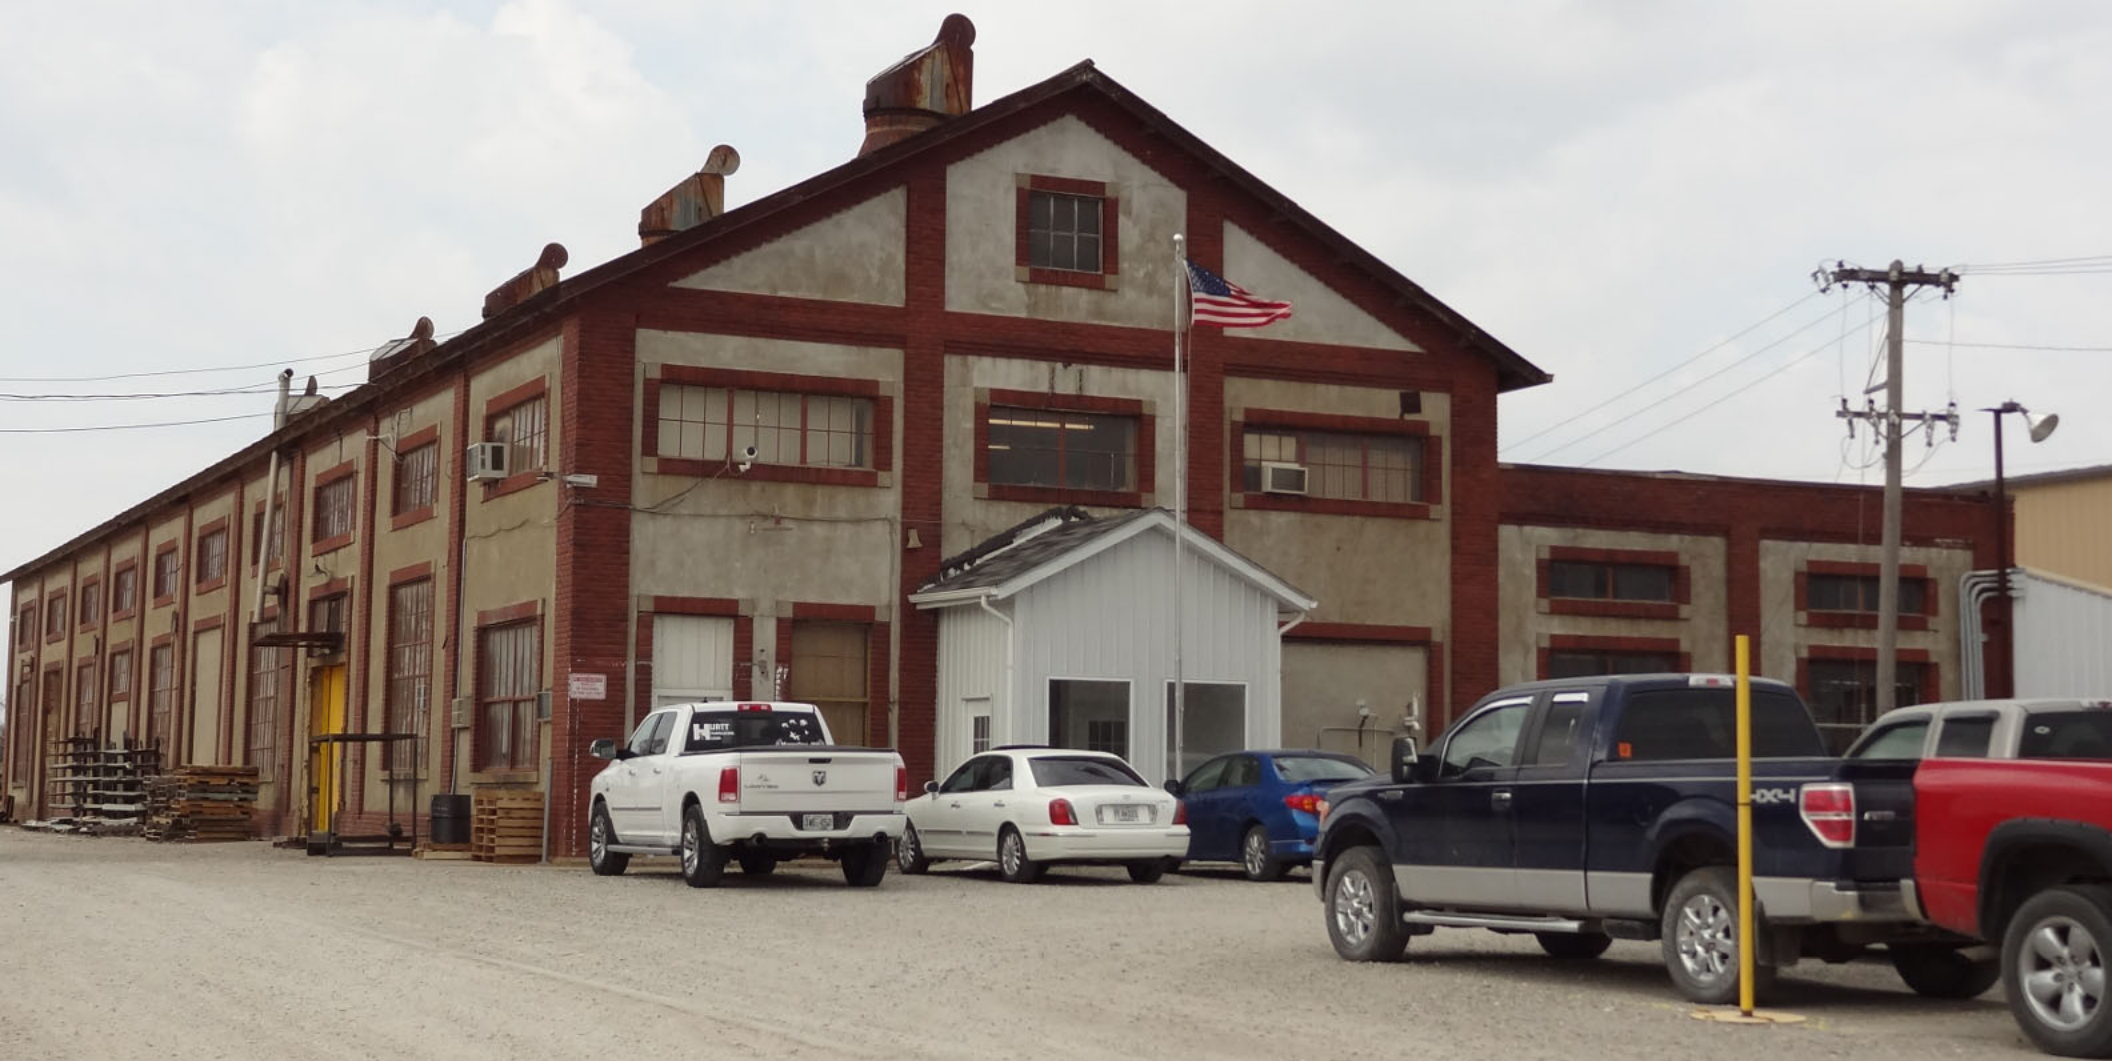
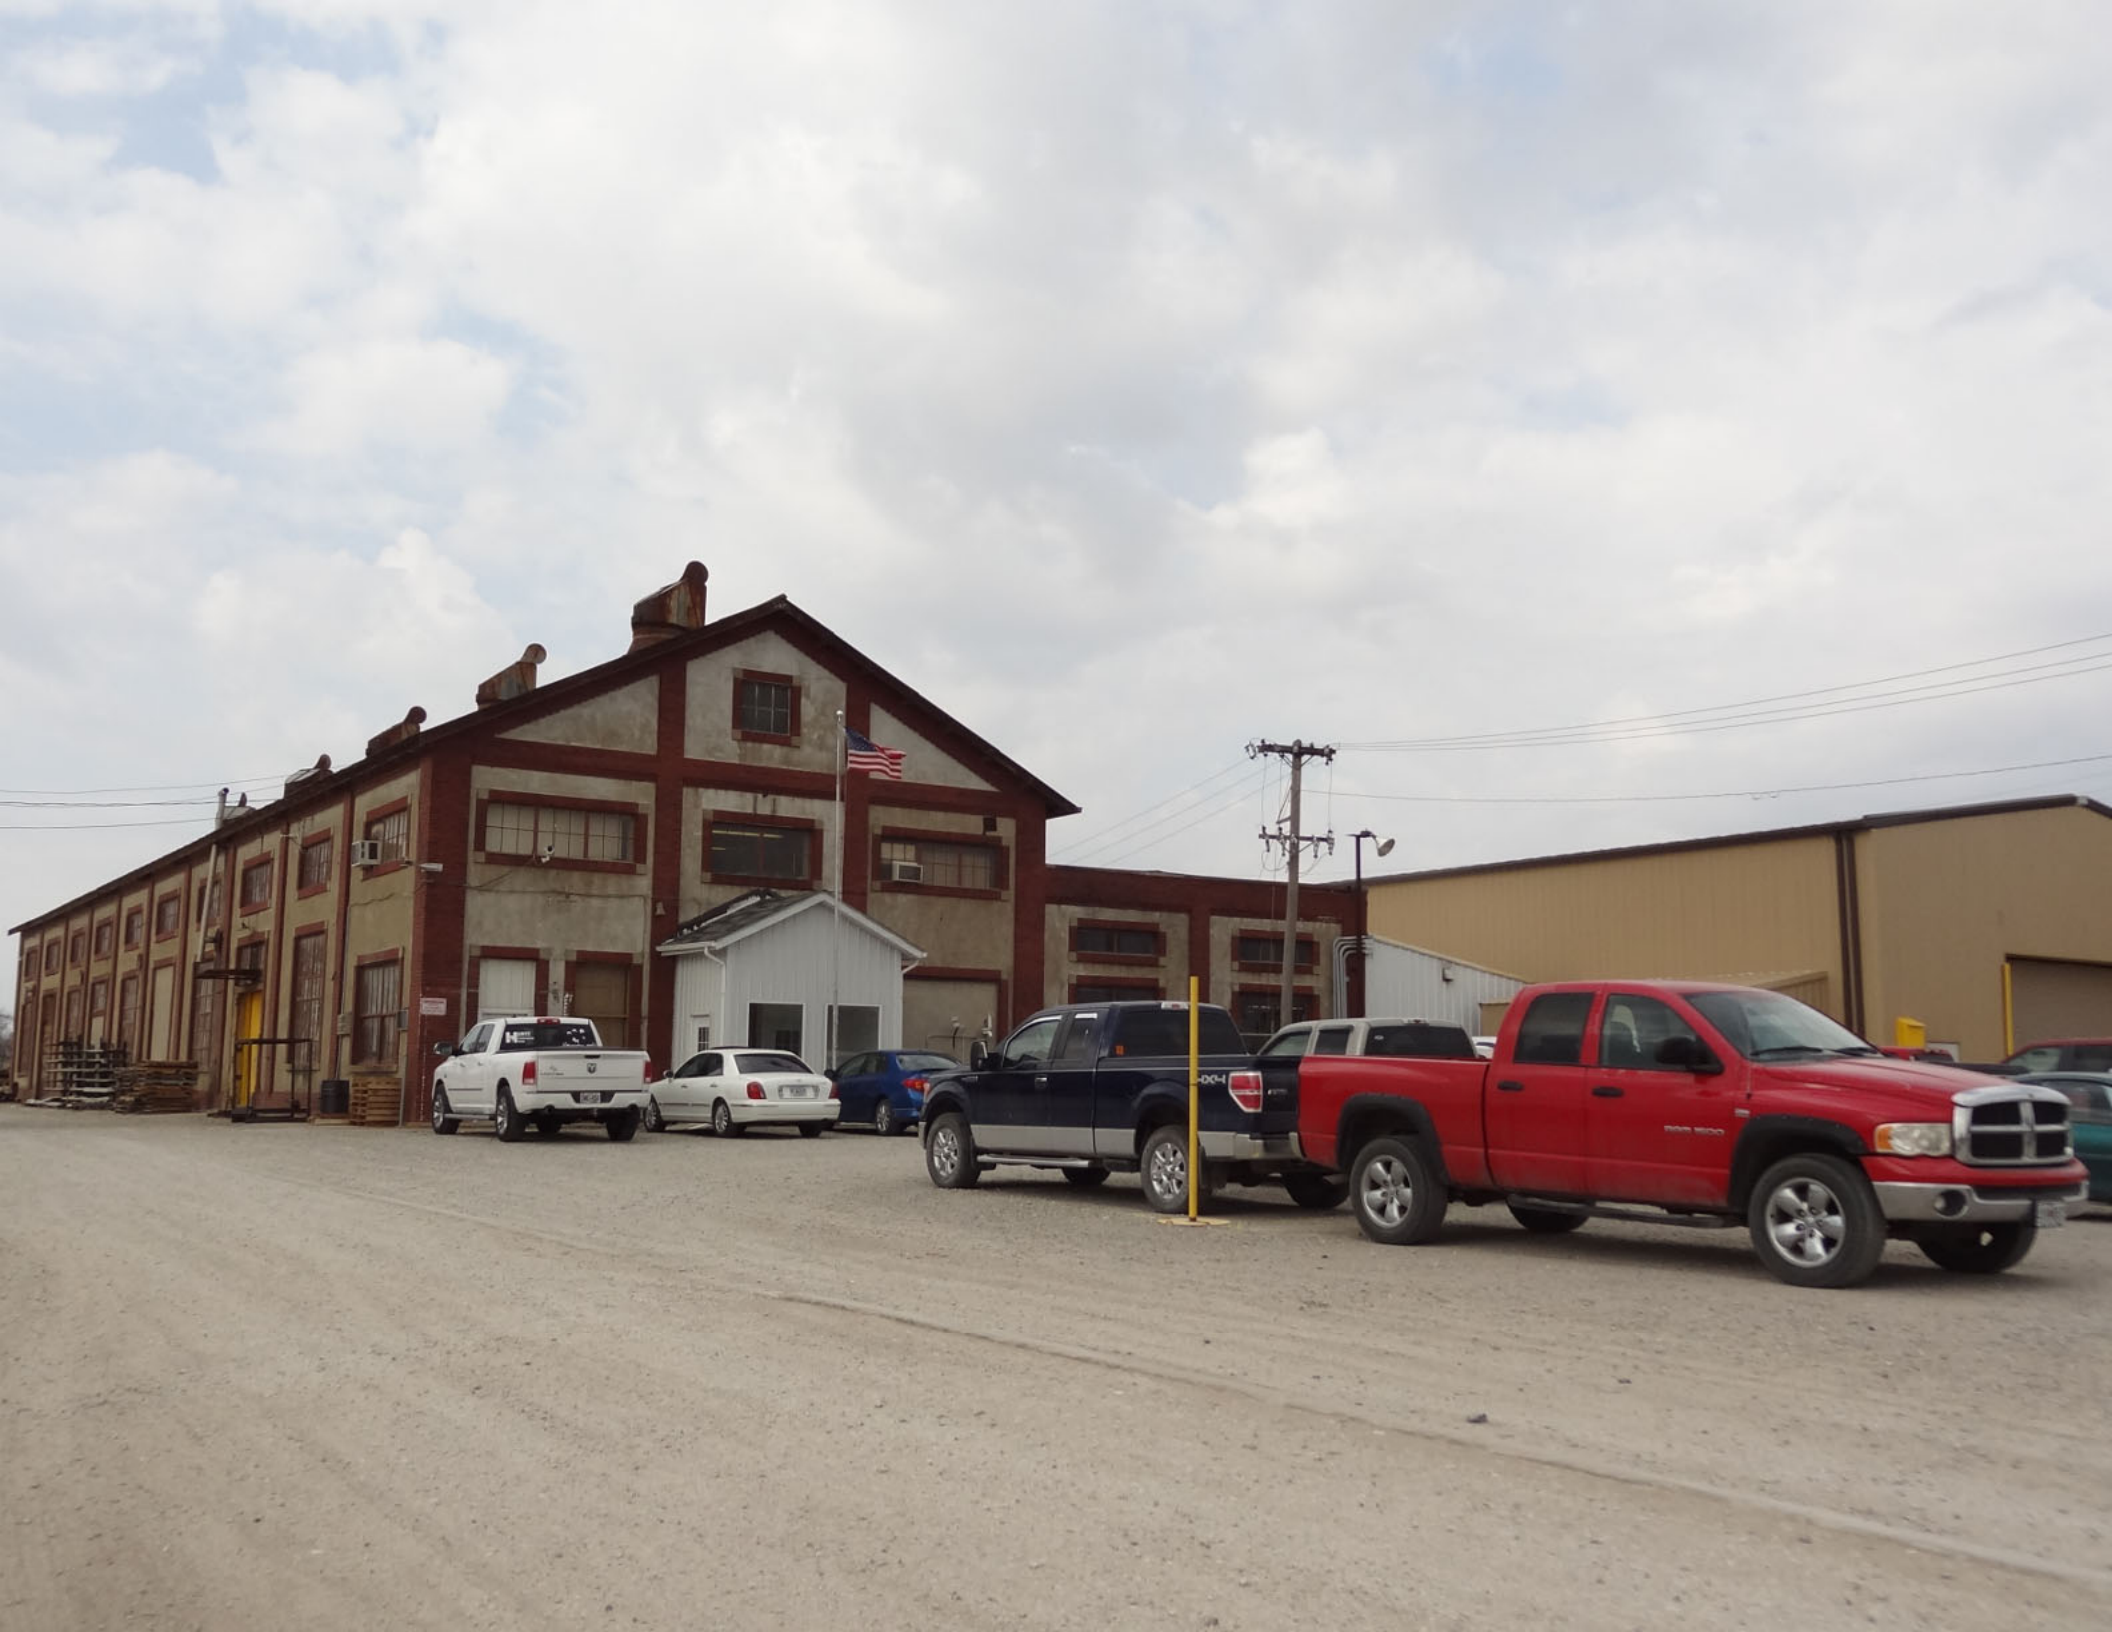
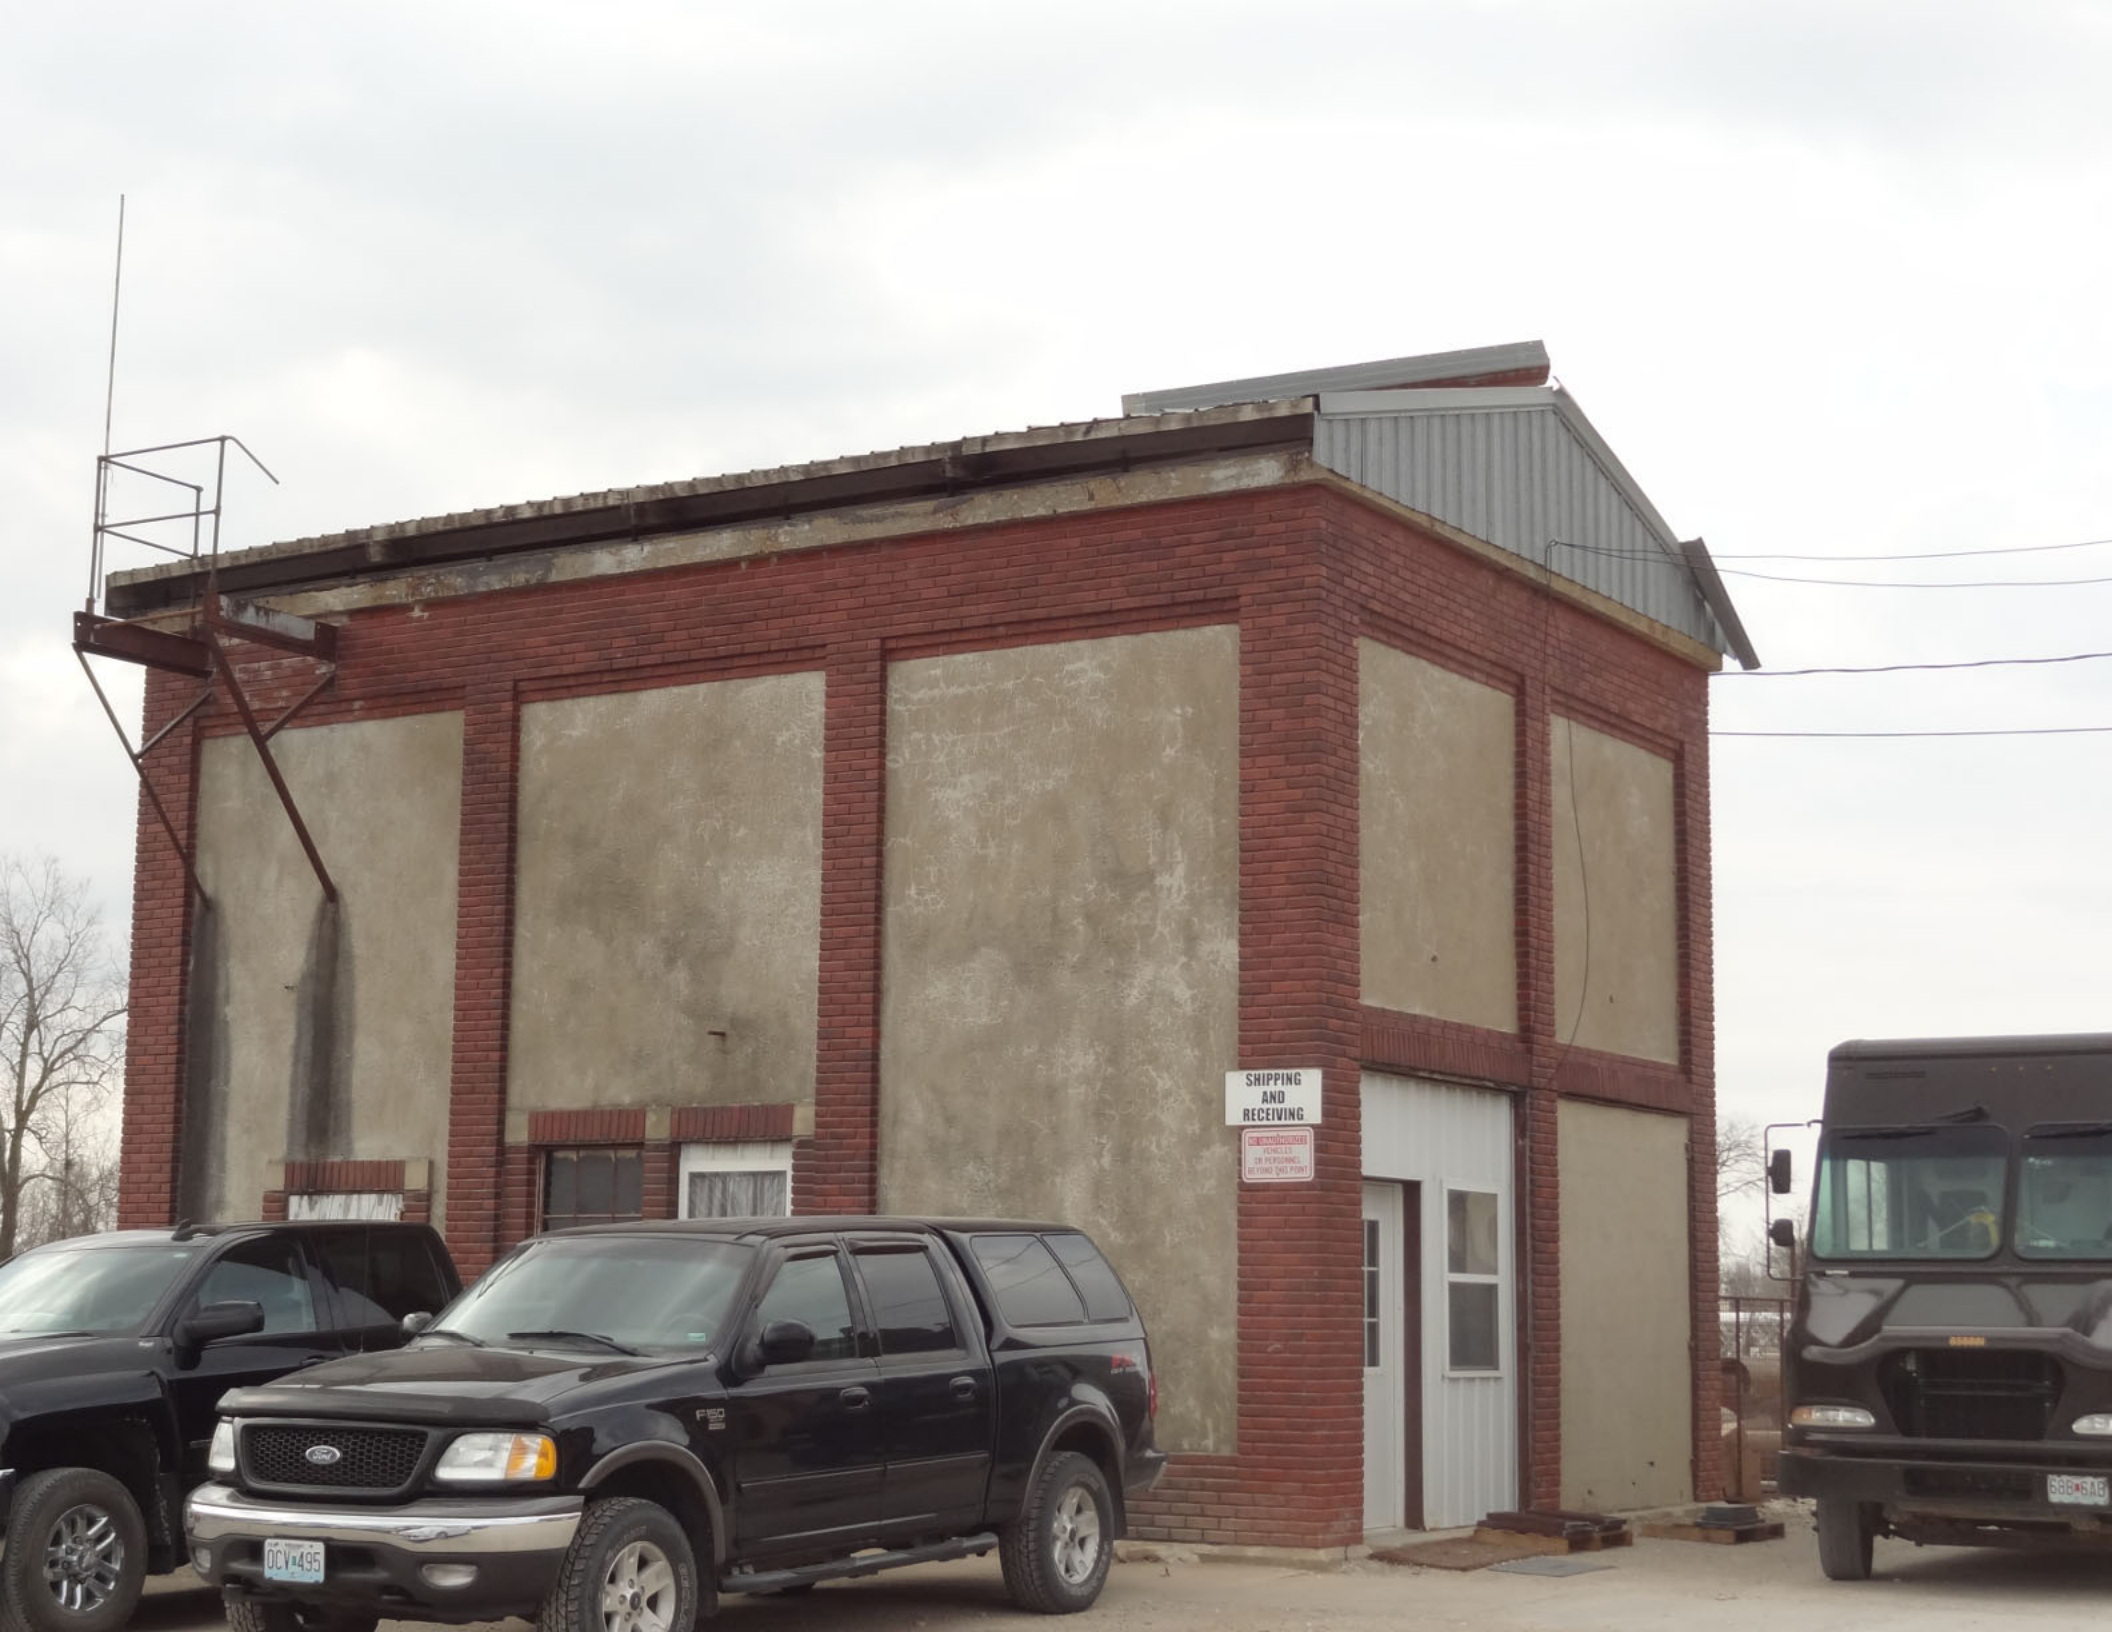
On the facade starting at the east corner, the first bay has two openings. The first is an infilled metal door, the next bay has a multi-pane window. The next bay is a metal addition with a front gable portion. There is a single door, with two fixed windows. The next bay is an infilled with stucco. The upper story of the main building has three bays each bay has a multi-pane metal windows. There is also a single window in the front gable of the third level.

Moving west there is another building that has a flat roof and two bays each bay has a large paired window metal multi-paned windows. The upper level of each bay also has a multi-pane fixed windows. There are also modern metal buildings that are attached to this building to the west of the historic buildings toward the railroad tracks.

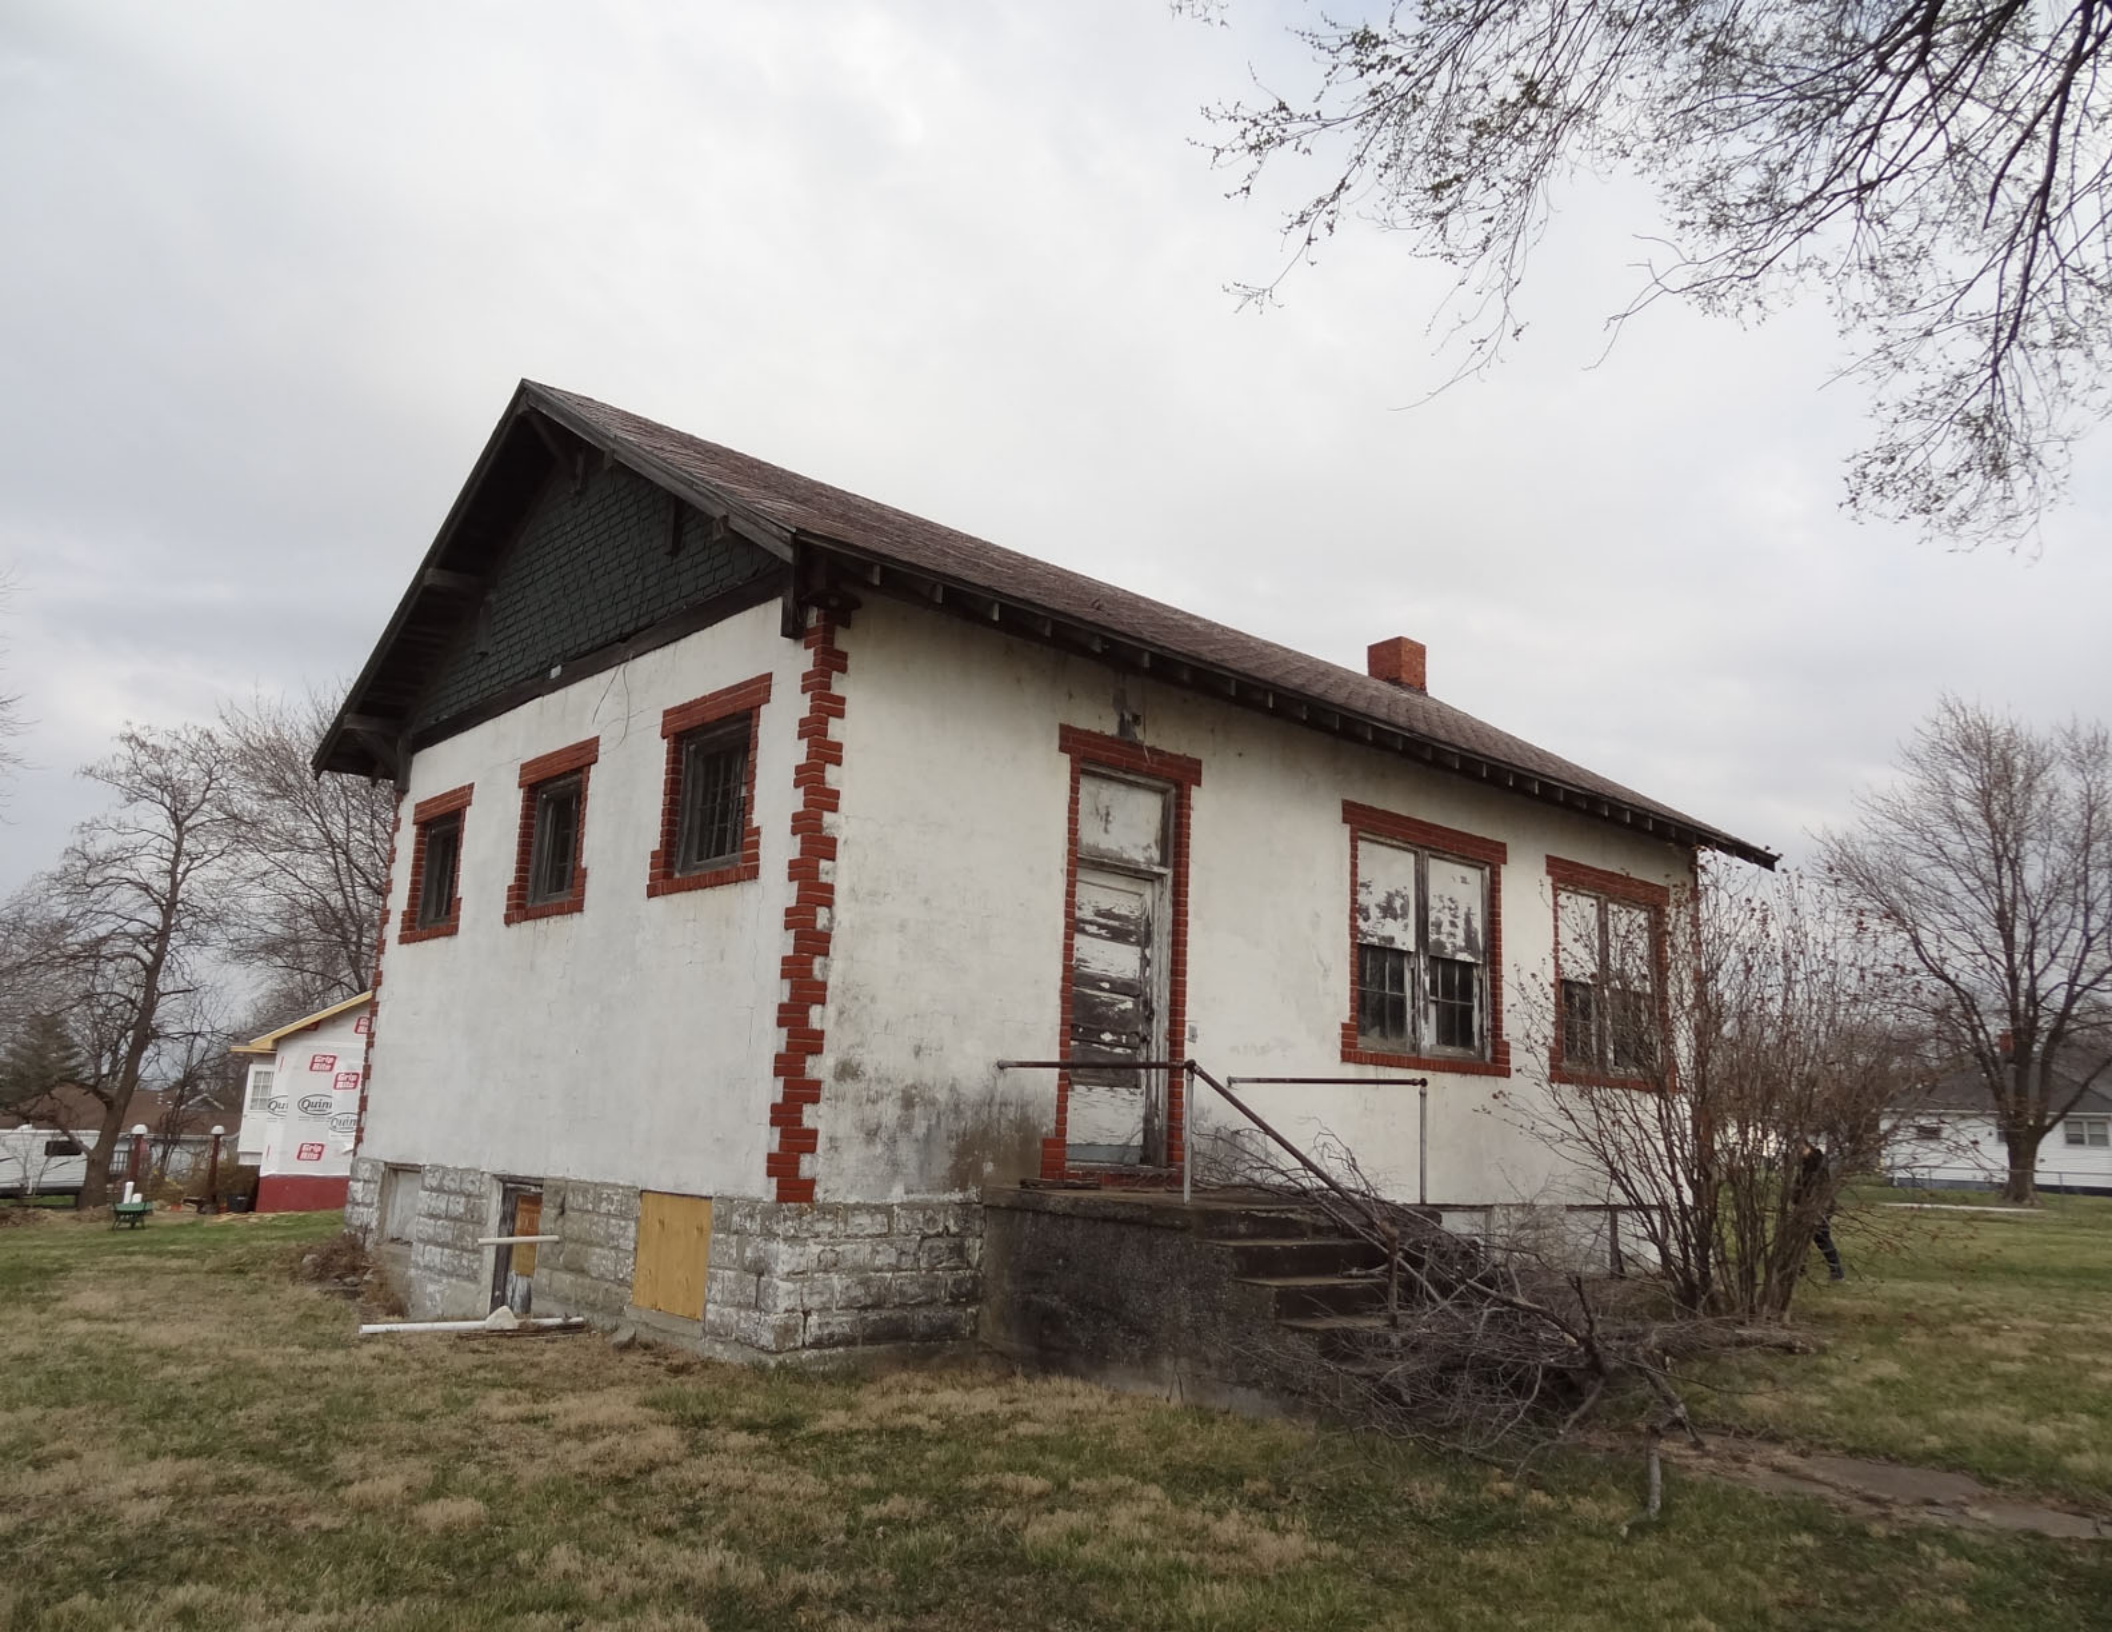
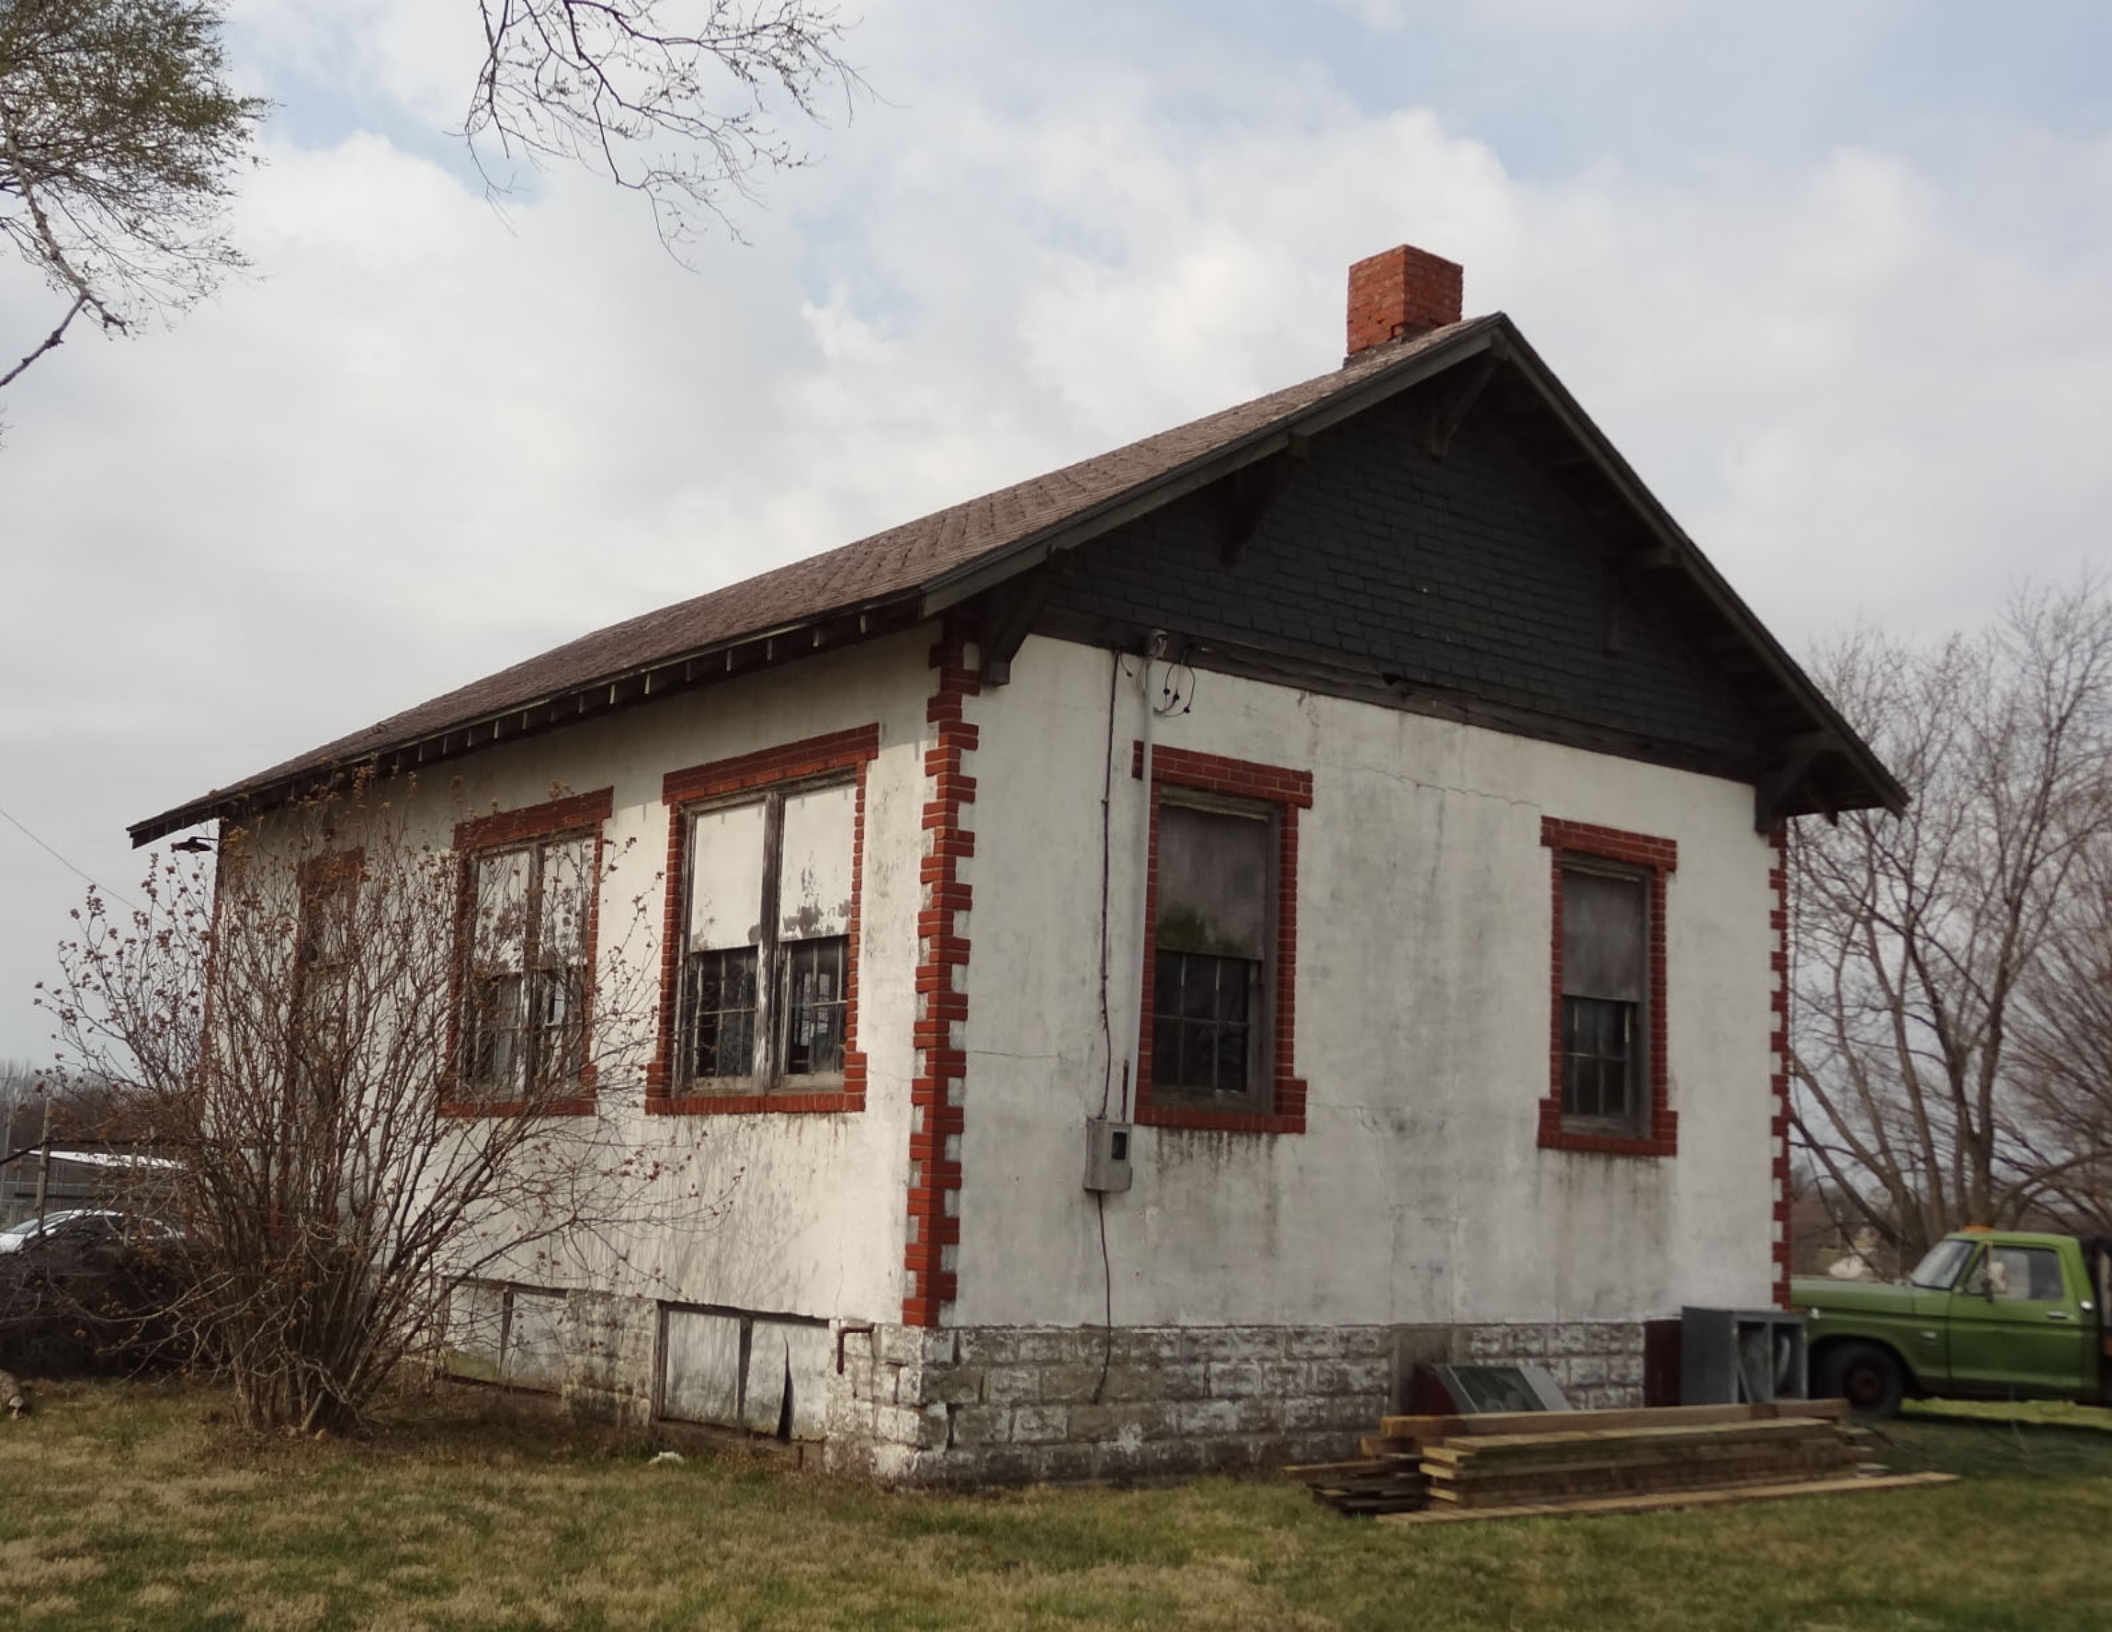
The Marceline Colored School is a one-room school that was constructed of ceramic block. On the main elevation facing east there is a single wood door with a transom above the door is accessible via a rise of concrete steps with a simple railing in the southern most bay. The center and northern bay each have a pair of six-over-six wood hung wood windows. Each has a brick sill and surround. The basement/ foundation is constructed of pressed concrete block and is visible around the building. On the east elevation there are two paired window openings under the first floor windows. All basement windows are currently boarded. The building is clad primarily in stucco and has brick quoining in all the corners. On the south elevation there are three small fixed six pane wood windows with brick surrounds there is also a door and two small windows in the basement level from this elevation. The west elevation has no openings other than a basement level windows. The north elevation has two single six-over-six wood windows that are evenly spaced. Both the north and south elevations have asphalt shingles in the gable ends and large triangular brackets on these ends. The side gable roof has exposed rafter tails.
