MISSOURI DEPARTMENT OF NATURAL RESOURCES  
STATE HISTORIC PRESERVATION OFFICE, P.O. Box 176, Jefferson City, MO 65102  
**ARCHITECTURAL/HISTORIC INVENTORY FORM**

1. SURVEY NO. LI-AS-001-001		2. SURVEY NAME: Marceline Survey	
3. COUNTY: Linn		4. ADDRESS (STREET NO.) 275	STREET (NAME) West Broadway
5. CITY: Marceline	VICINITY: <input type="checkbox"/>	6. UTM: / /	7. TOWNSHIP/RANGE/SECTION: T: R: S:

8. HISTORIC NAME (IF KNOWN): Walt Disney's Childhood Home		9. PRESENT/OTHER NAME (IF KNOWN): Walt Disney's Childhood Home	
10. OWNERSHIP: <input checked="" type="checkbox"/> PRIVATE <input type="checkbox"/> PUBLIC		11A. HISTORIC USE (IF KNOWN): Single Dwelling	11B. CURRENT USE: Single Dwelling
<b>HISTORICAL INFORMATION</b>

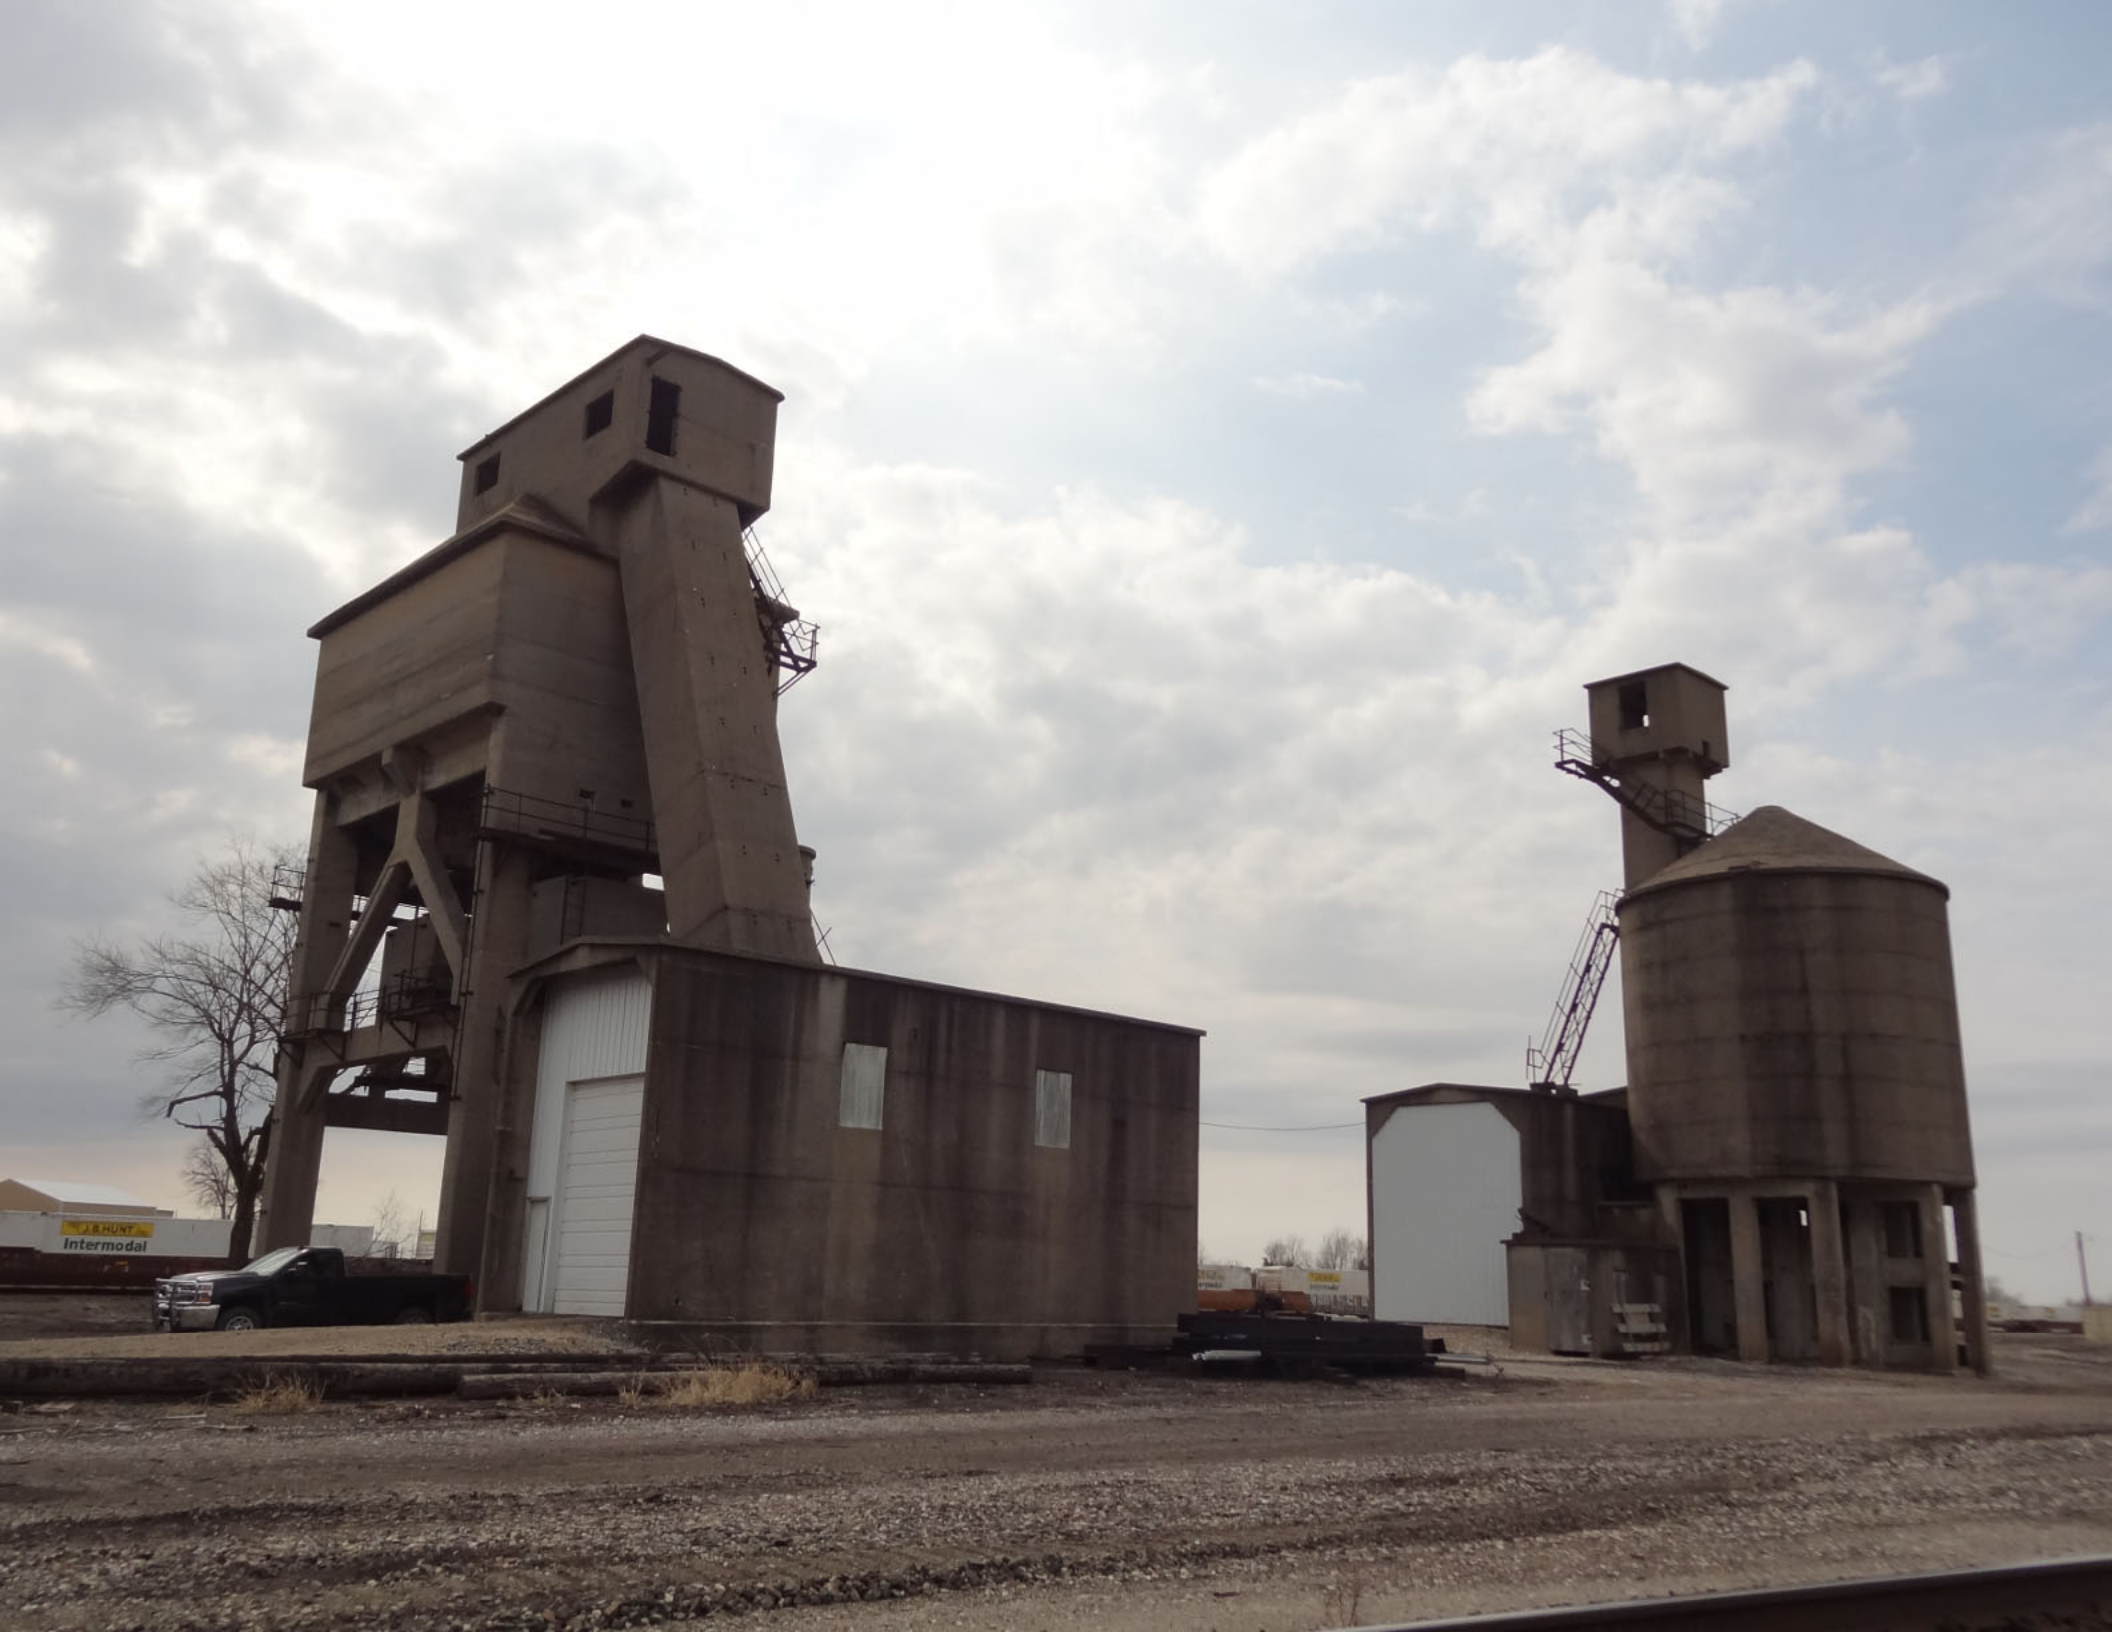
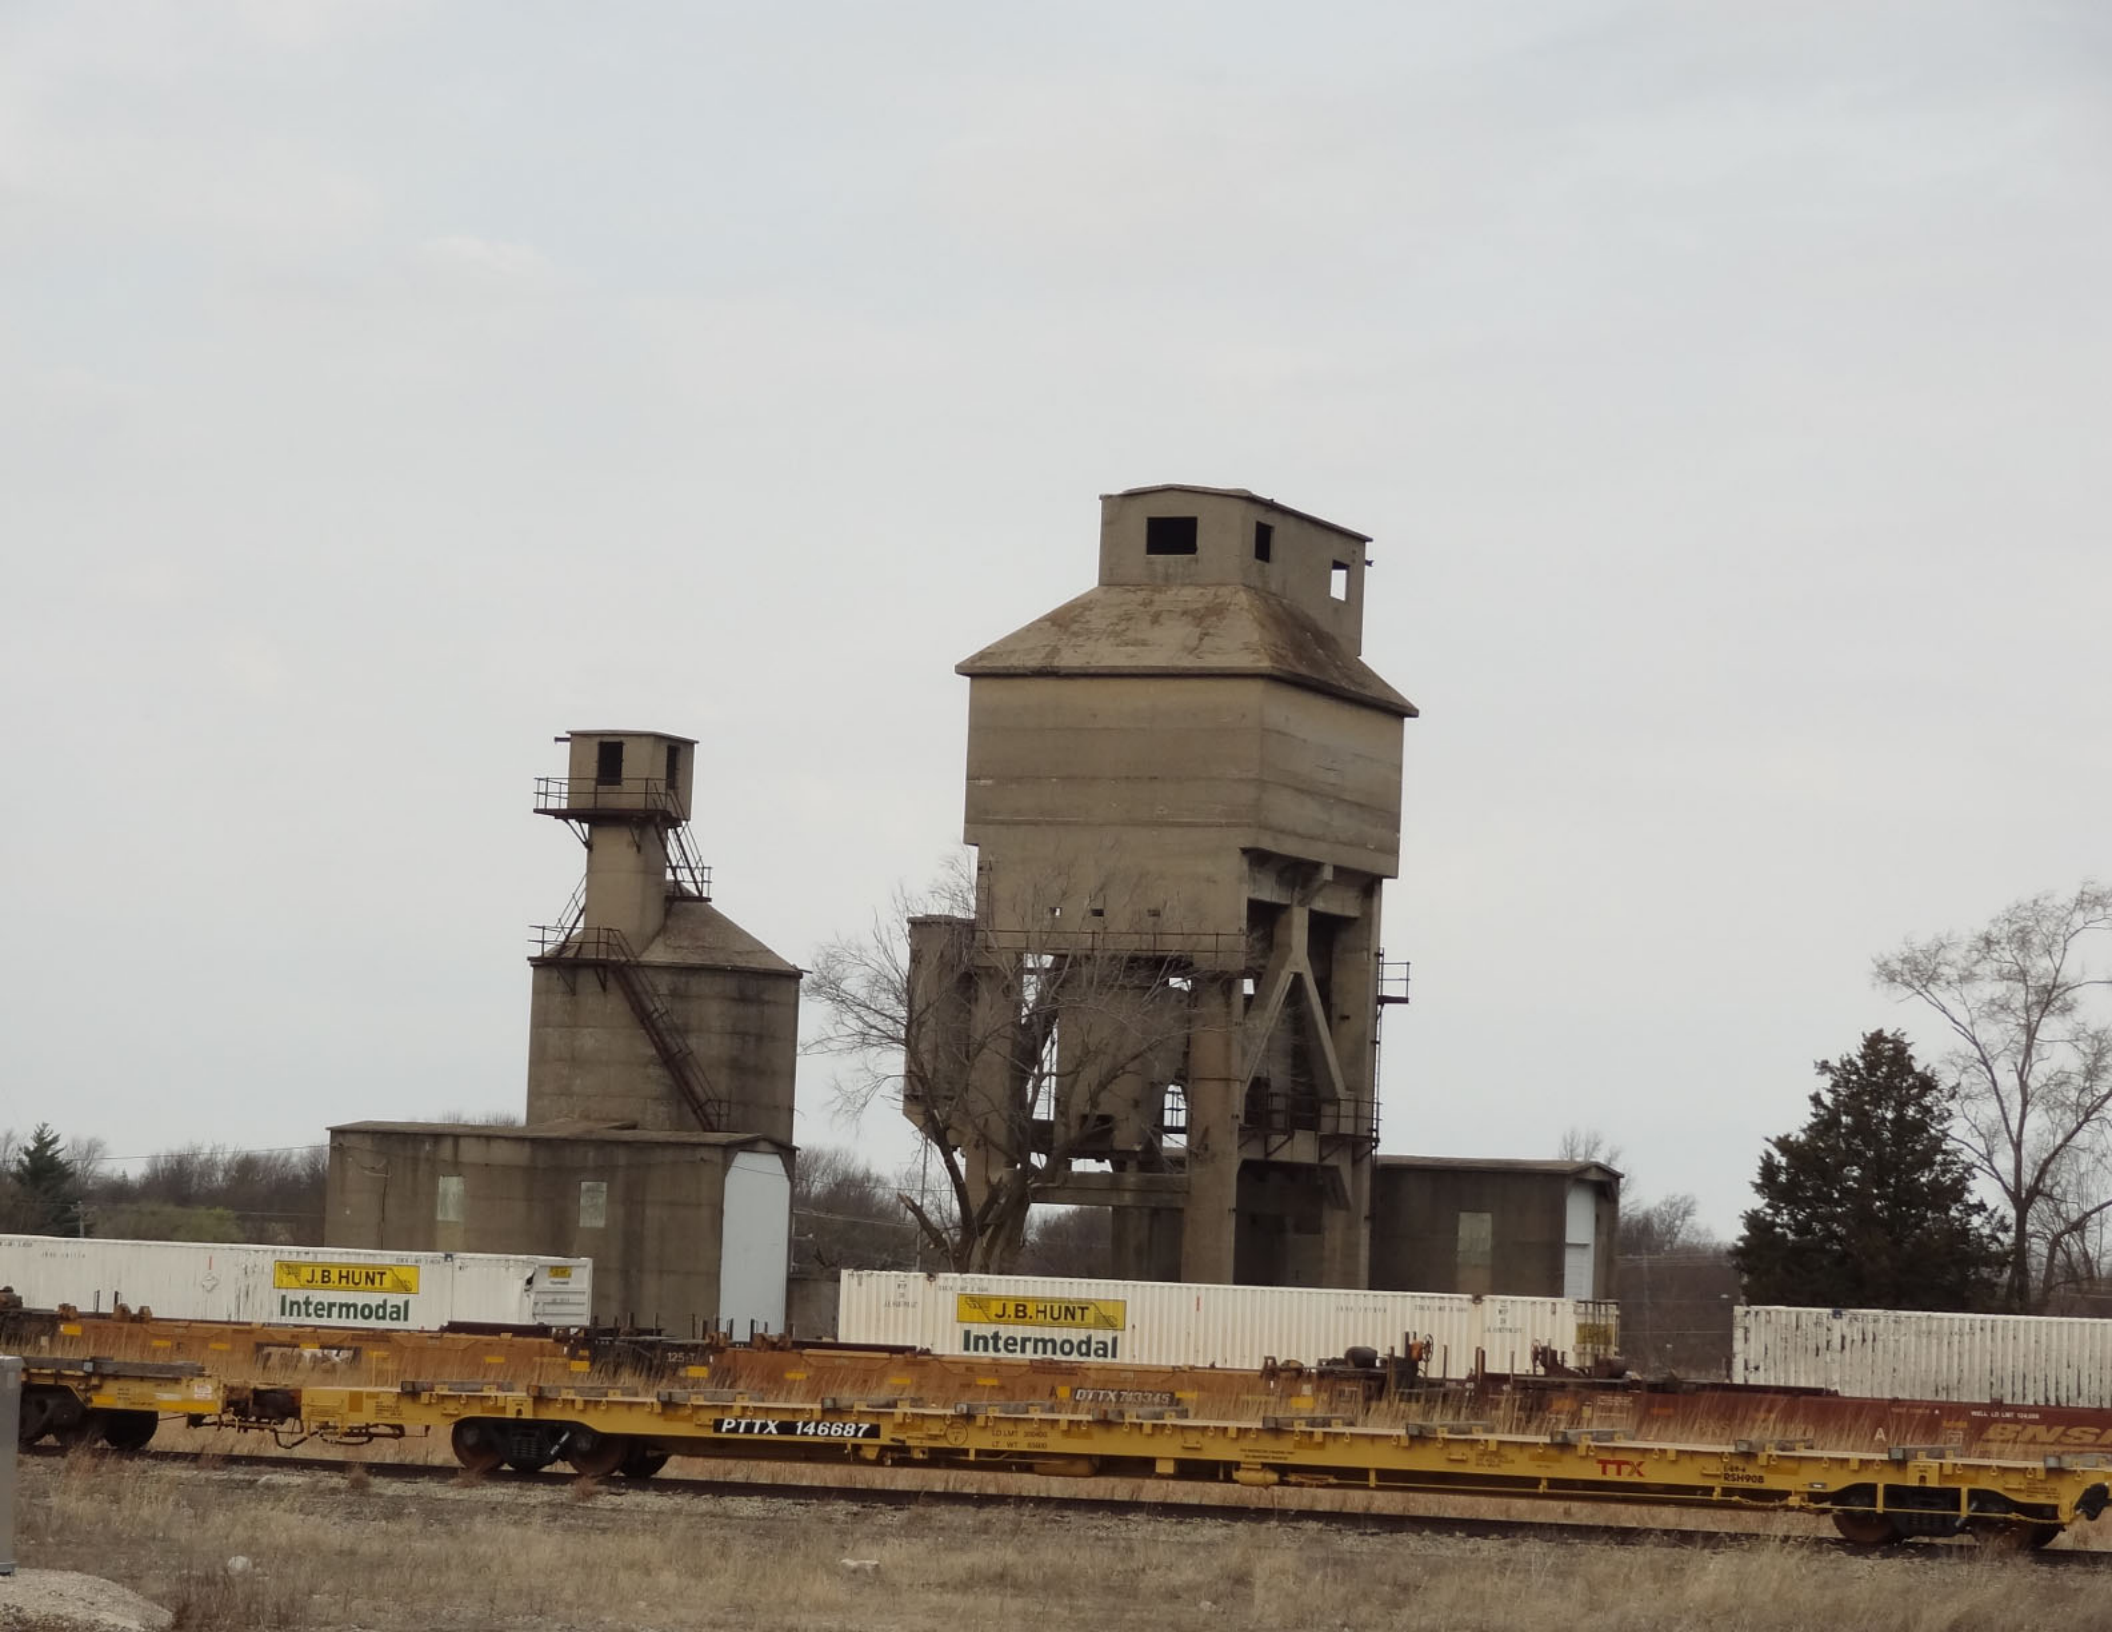
South of the coal chute is a sand storage structure. This property is round and is shorter than the coal chute. It is also constructed of concrete. The sand storage portion is supported by concrete columns supports. This structure also has metal stairs leading to a house type structure at the top of the structure. At ground level there is also a pass through that has been infilled with metal and an overhead door.

Train tracks used to approach these structures these tracks have sense been removed.

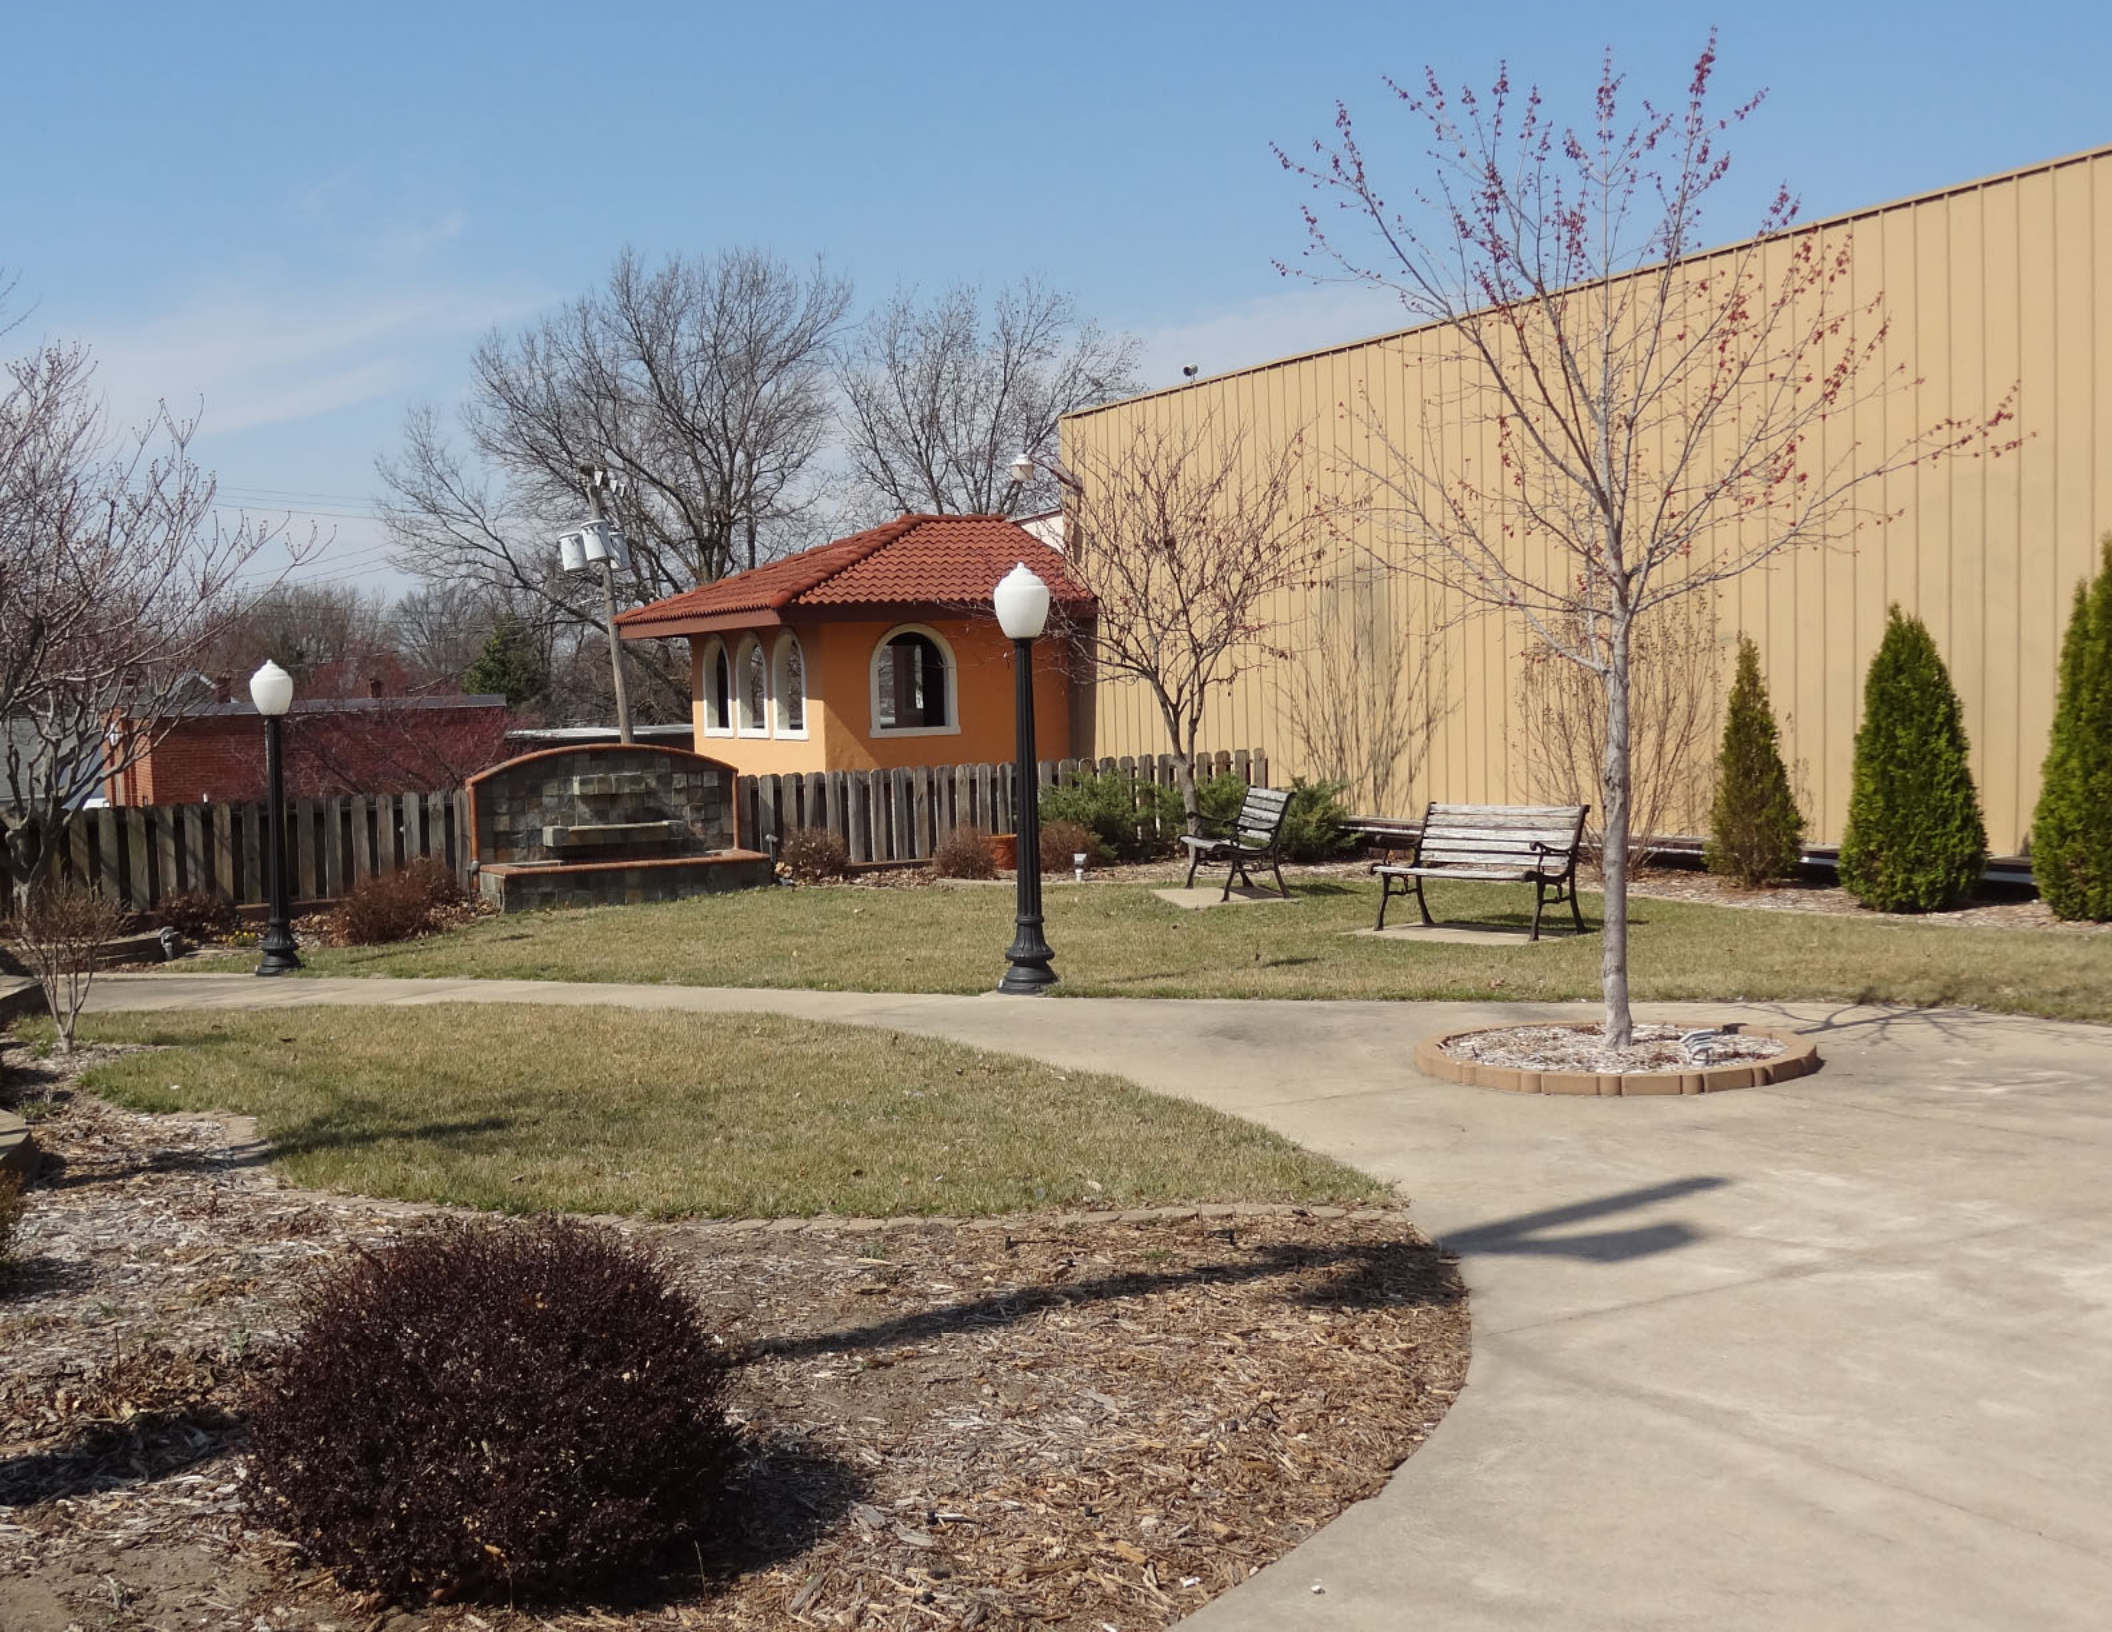
In the upper park area is a concrete walkway that leads through the landscaped space. There are two benches that are set on concrete pads. There are also three lamp posts that are or were manufactured to appear to be wrought iron with large glass light fixtures. In the rear of the park there is a arched, tiled fountain and a short wood fence that separates the upper from the lower space.

There rears section is bordered by a concrete wall that creates a planter space the wall has large gate posts with wooden doors and a taller wood fence is located along Howell Street creating a private space in the rear garden. Along the rear wall there is a wood pergola and the space appears to have concrete spaces.
