National Register of Historic Places
Registration Form

historic name The Maryland Apartments
other names/site number Parkview Homes

The Maryland Apartments
Jackson County, Missouri
Apartment Buildings on the North End of The Paseo Boulevard in Kansas City, Missouri

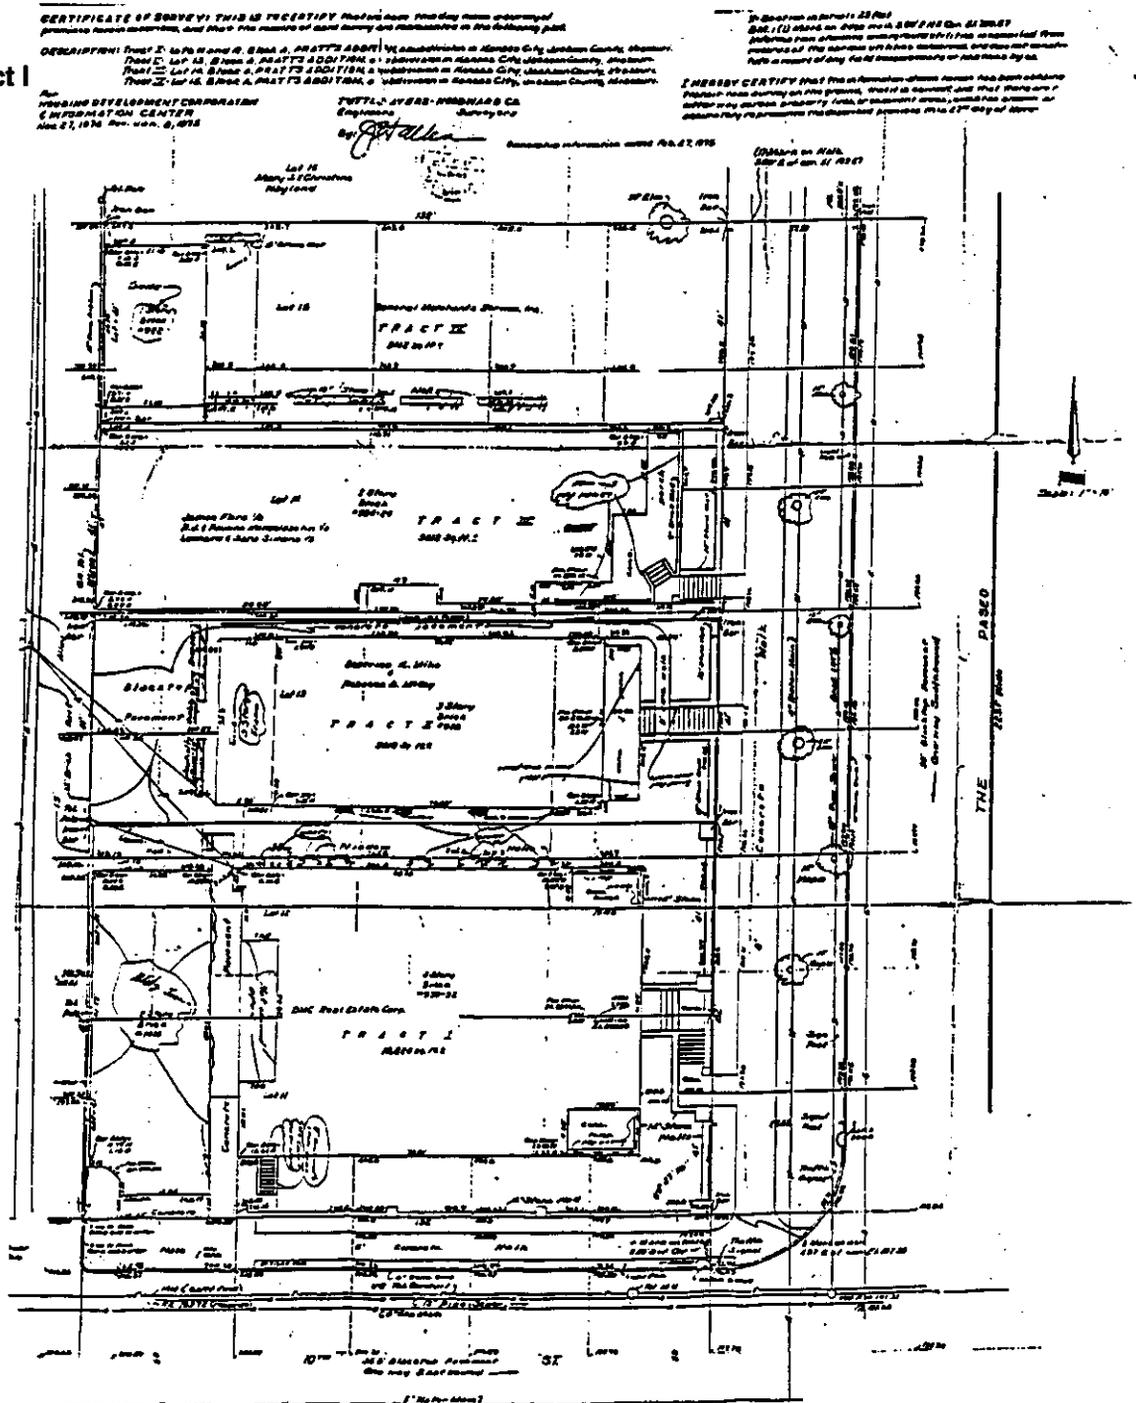
Figure 1: Survey, Tract I

FIG. 930 PASEO
#1 1975 Survey
Tract I

See Figure 1, Survey, Tract I

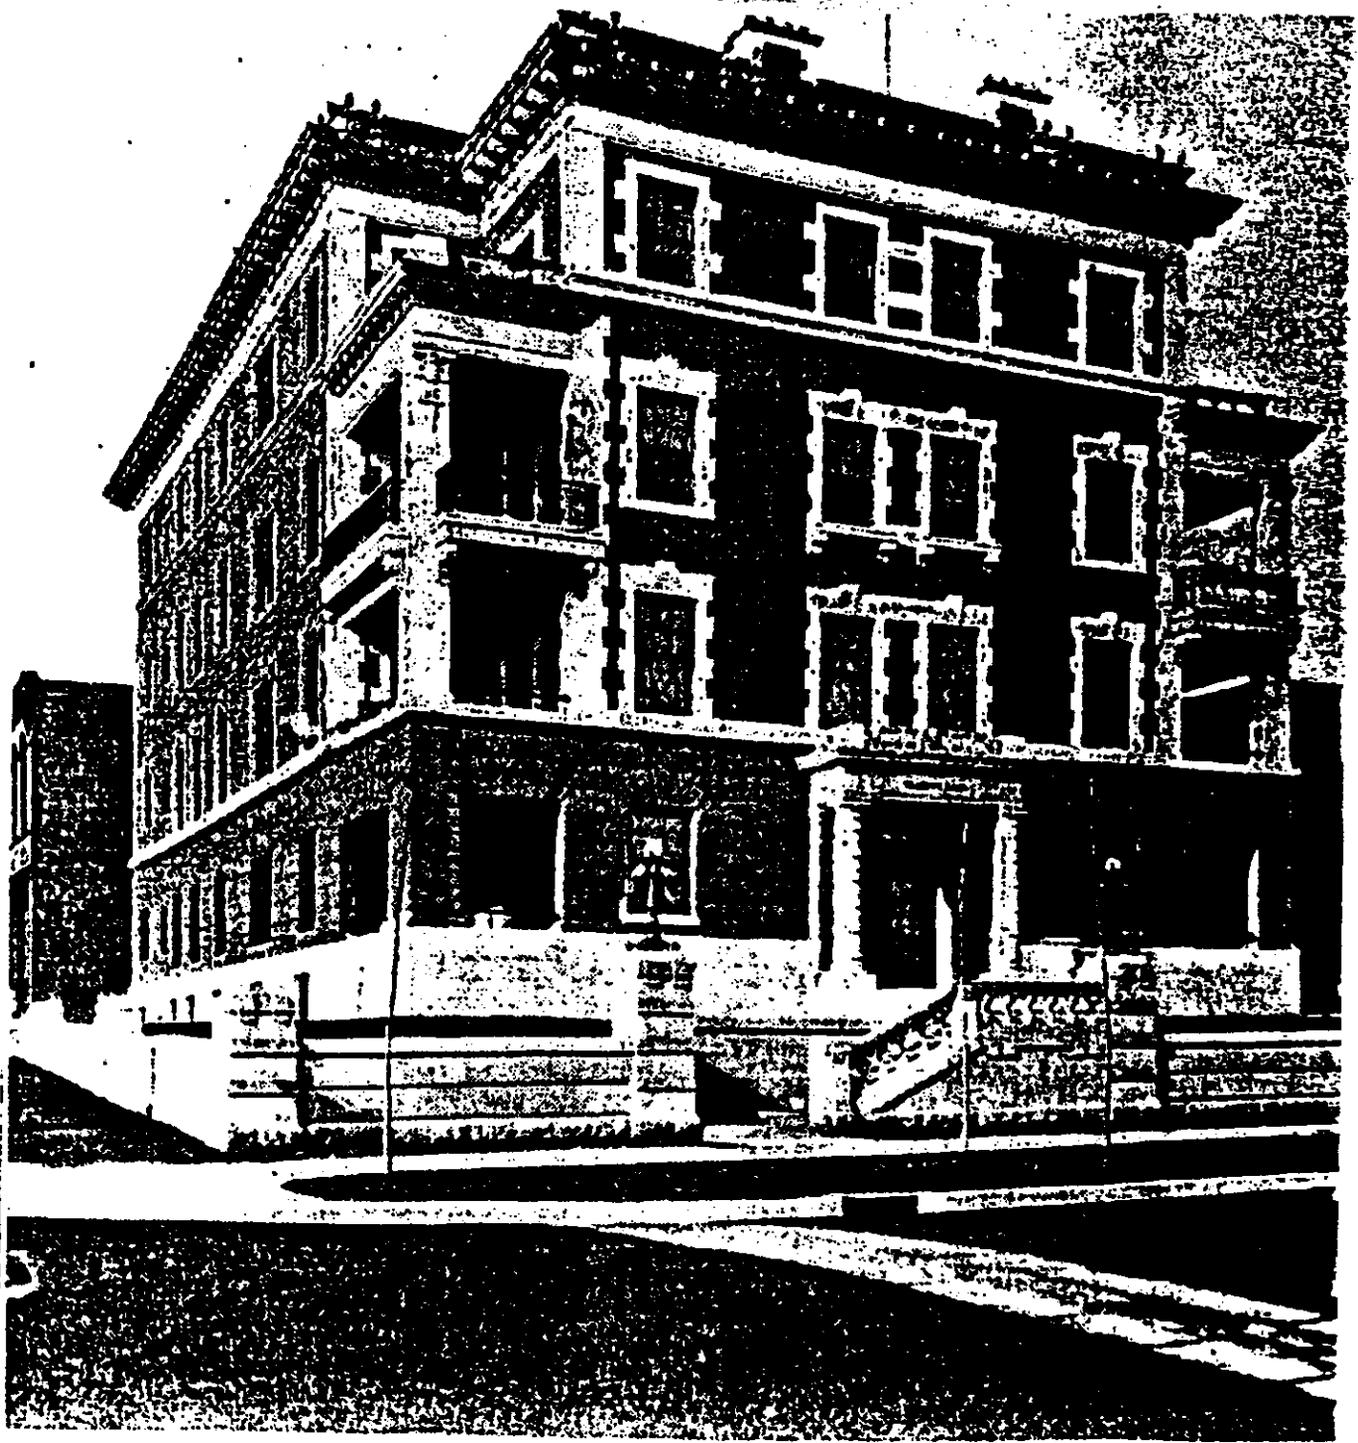
Figure 2 Photocopy of 1902 photograph of building, from 1902 Kansas City Illustrated

The Maryland Apartments at the northwest corner of 10th and Paseo was constructed in 1901, consistent with the period of construction of adjacent apartment buildings on the north end of The Paseo. Featured in the 1902 *Kansas City Illustrated*, The Maryland is one of the largest and most elaborate in ornamentation of eleven remaining apartment buildings on The Paseo. The apartment buildings on the west side of The Paseo were constructed along this newly developed boulevard from the turn of the century through 1913 and thrived as apartments for young families and professionals for a short period thereafter. Walter Davis, a prominent local politician and real estate man (and brother of Kansas City Mayor Webster Davis), was identified as the owner of the Maryland apartments on the 1901 water permit. See MPL cover document for further information. Walter Davis was also the owner/builder of two other apartment buildings in the area: The Missouri and Maine apartment buildings at 1300 and 1304 Paseo, also constructed in 1901 and the Alameda/Parkview Hotel at 1000 The Paseo, constructed in 1913. Exhaustive research did not uncover the architect of the Maryland apartment building.

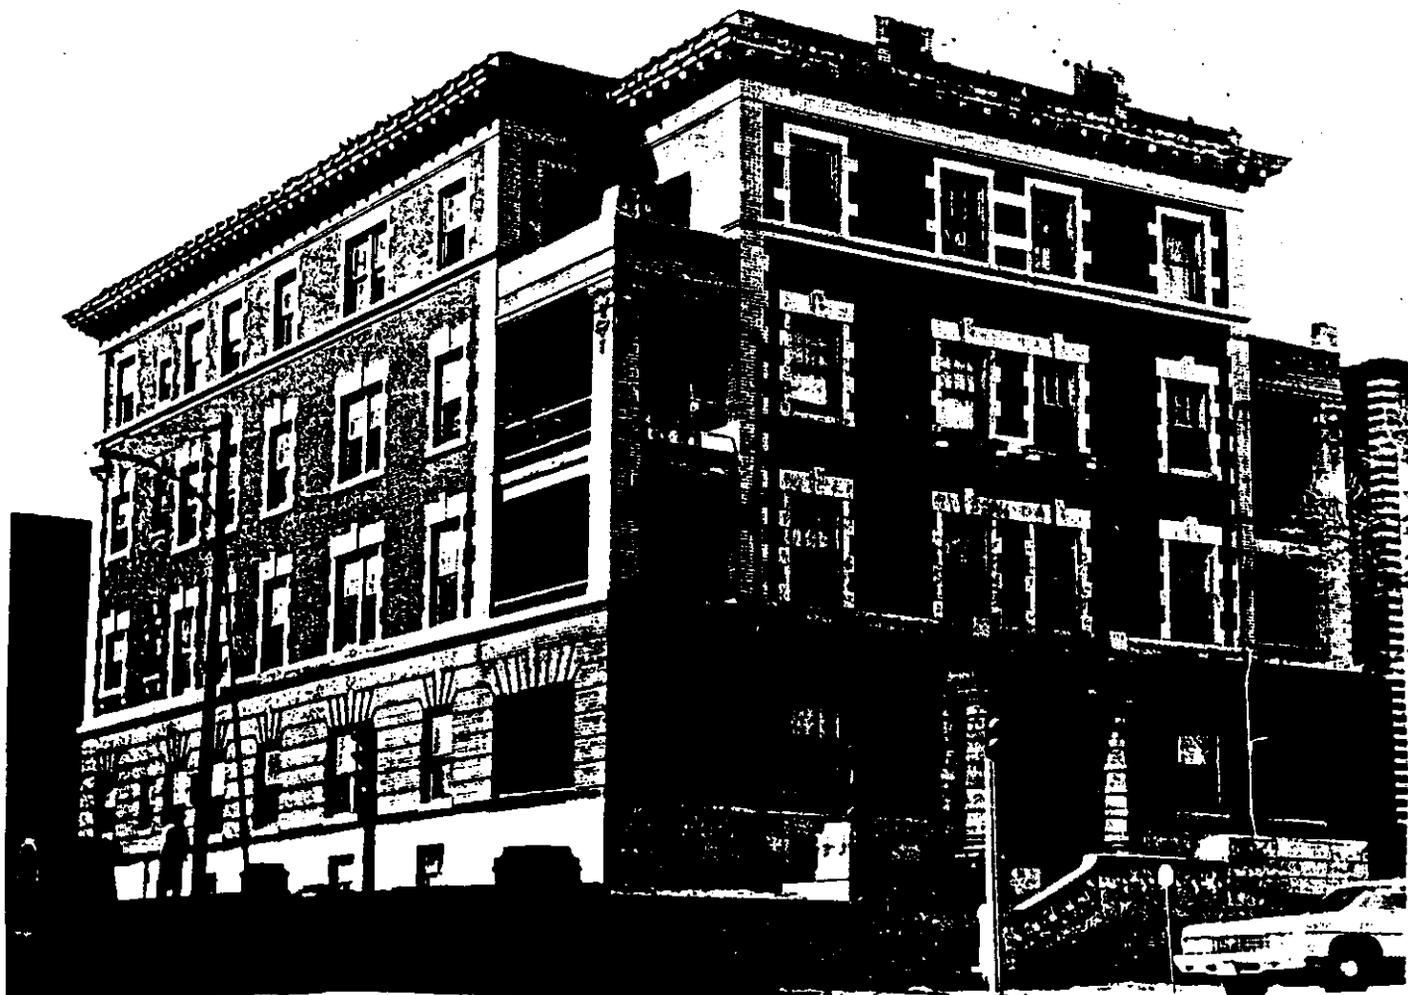
Figure 3: Photocopy of 1975 photo of building, from 1975 drawings for HUD remodeling, William Johnson, architect

The only existing historic fabric visible on the building's interior is the stairway. The 1975 HUD remodeling included extensive interior remodeling in addition to the replacement of porch railings, porch steps, windows and doors and the installation of the rear fire escape. The changes in this building are common modifications as defined in the property type registration requirements. These modifications do not significantly affect the integrity of the property to cause it to be ineligible for listing.
