Property Name: Patrick and Moire McMullen House

National Register of Historic Places Registration Form

historic name McMullen, Patrick and Moire, House

McMullen, Patrick and Moire, House
St. Louis County, Missouri
Historic Resources of Kirkwood, Missouri

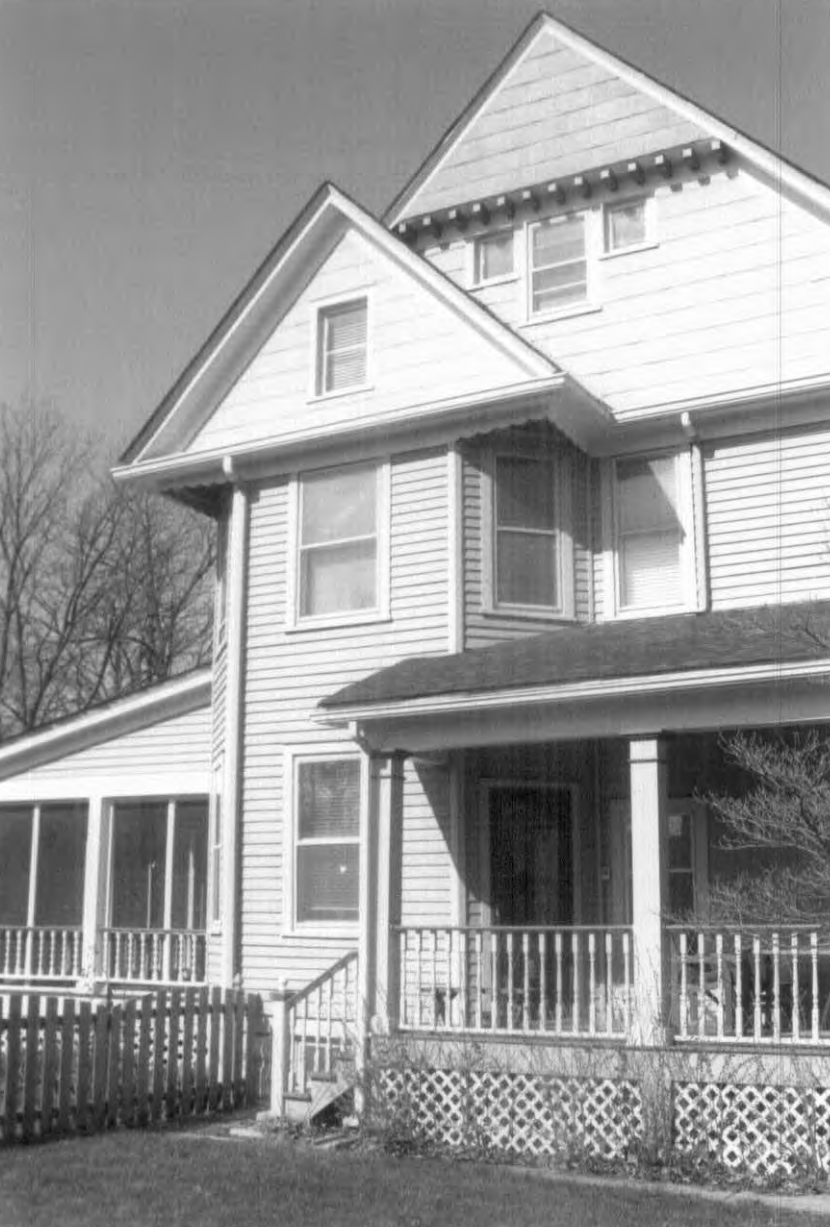
The house is large, two-and-a-half stories tall, with a very steeply pitched side-gabled roof. The roofline is complex, with multiple lower cross gables, two of which cover polygonal bays (one each on the north and east elevations). All of the gable ends are pedimented, and wide, plain cornice boards run along the top of the second floor. Jig-sawn spandrels ornament the edges of the cross gables which overhang the window bays. The large gable ends of the main roof are stepped, with a shallow row of simple brackets running along the top of the third floor windows. Those windows are grouped in sets of three. (See photo 3.)

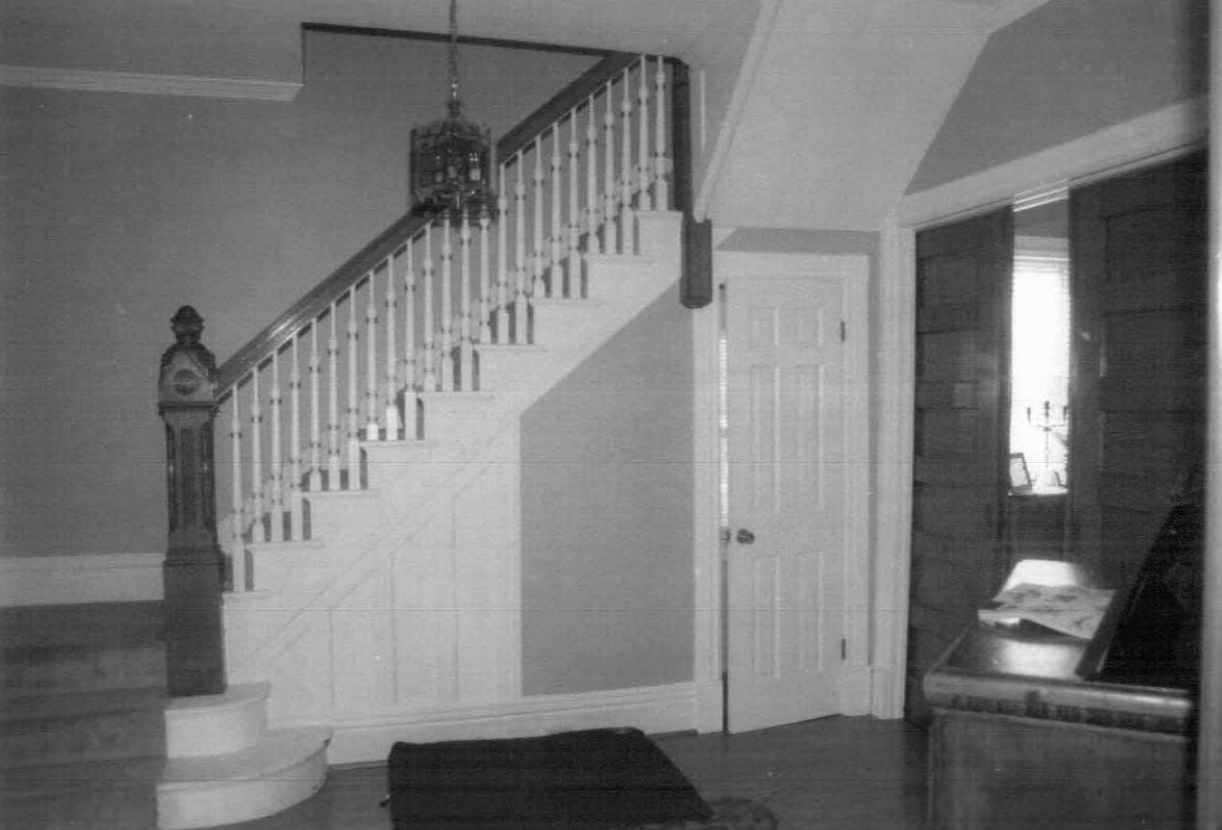
The interior of the house is highly intact; almost all original detailing remains in place. The front door opens to a spacious stair hall, which is separated from the front parlor and dining rooms by wide pocket doors. (See photo 6.) Each pocket door has six horizontal panels, and both sets of doors are operational. The L-shaped staircase has an elaborate newel post, and slender turned balusters. Interior door and window trim is heavily molded, with tall base blocks and square plinth blocks along the upper corners. Most of the original tall, molded baseboards and simple crown molding are also intact and in good condition.
