National Register of Historic Places Registration Form

historic name Miller-Seabaugh House and Dr. Seabaugh Office Building

street & number 341 Market Street [n/a] not for publication

**Miller-Seabaugh House and Dr. Seabaugh Office Building
Cape Girardeau County, MO**

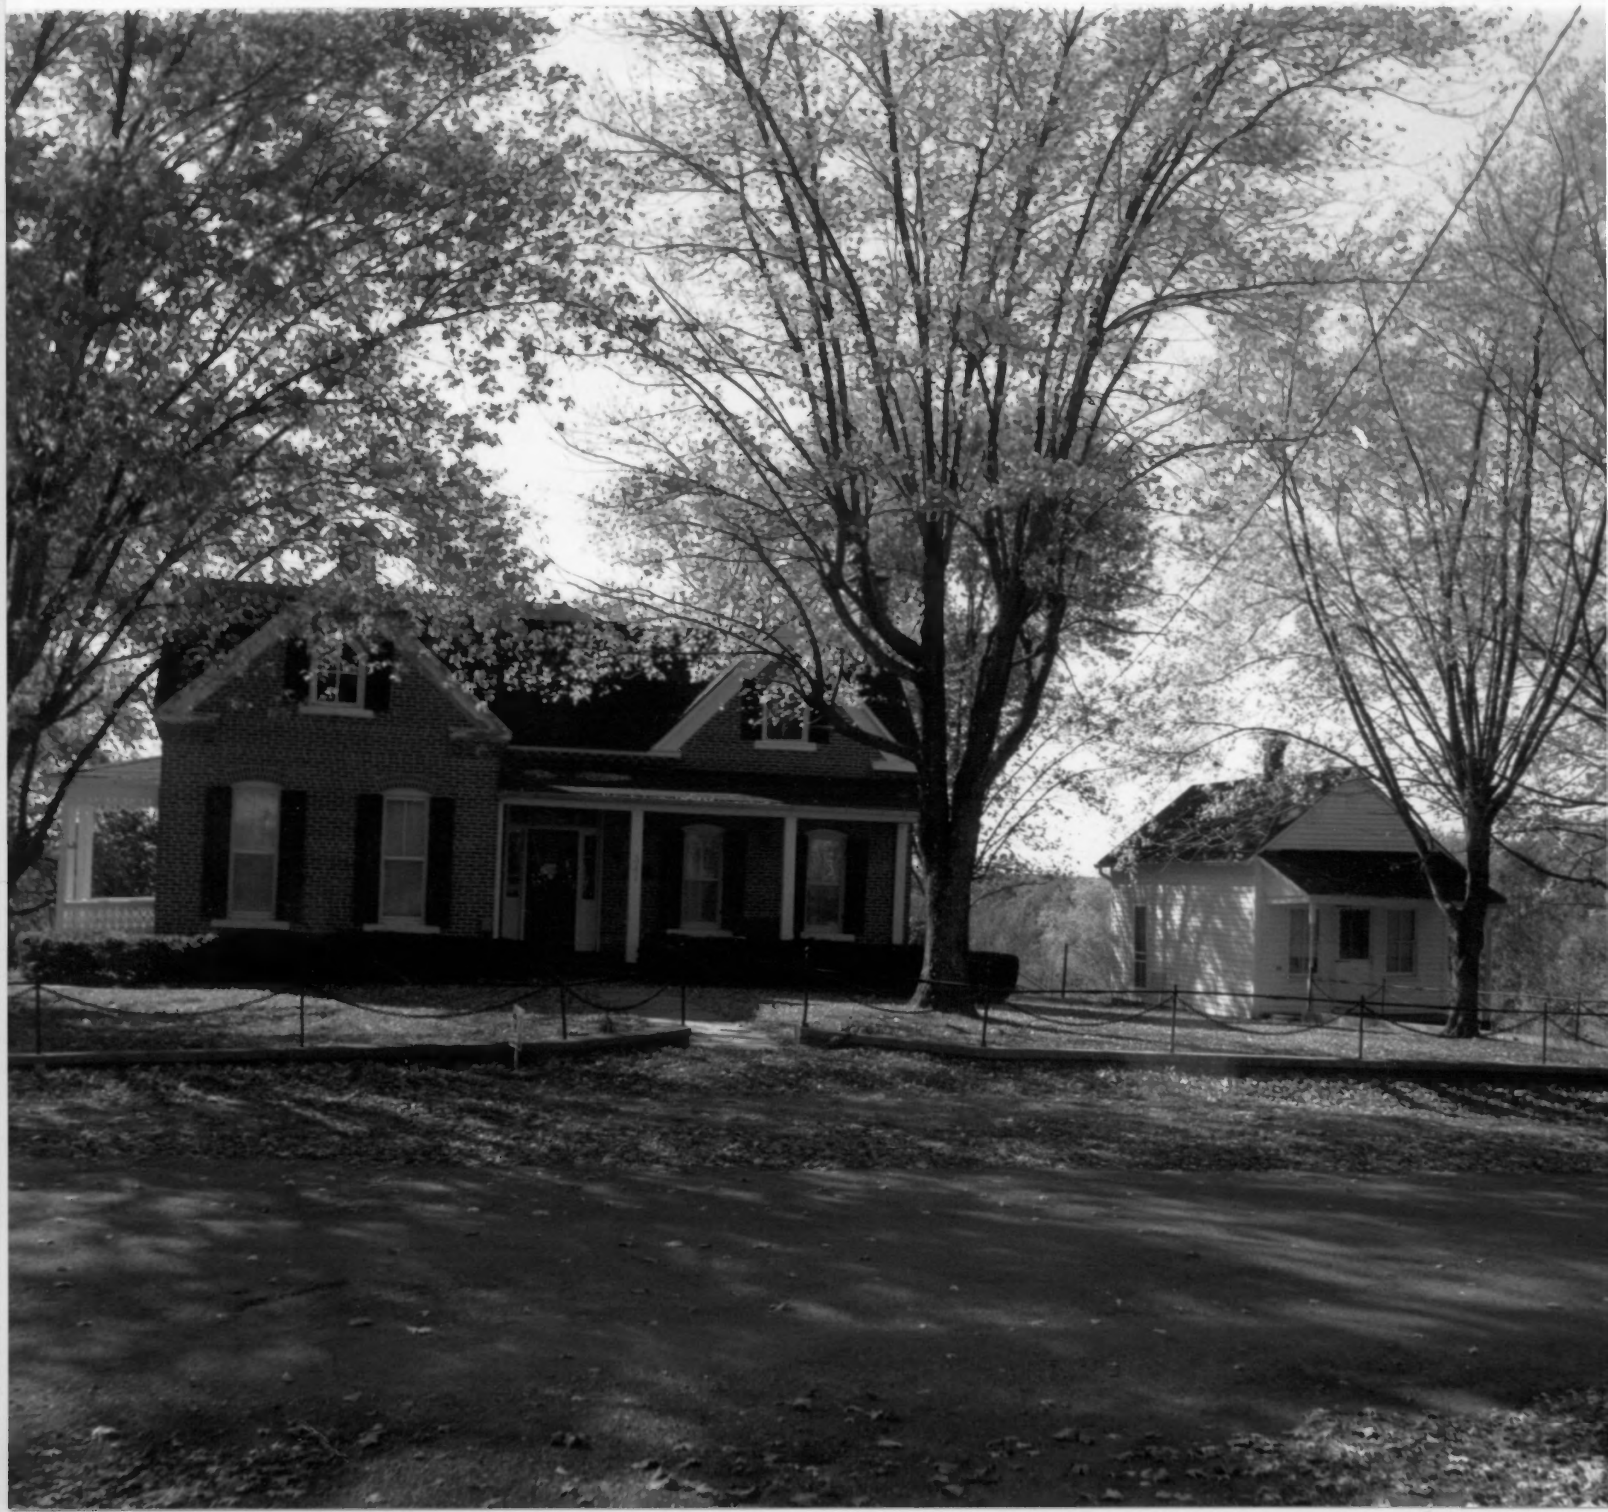
Miller-Seabaugh Property; Cape Girardeau, Missouri; Photo
Smith; 11/2/1994; Negative: Tony Thompson; west
doctor's office

Directly west of the Miller-Seabaugh House, is the gable front, bevel sided doctor's office on a sandstone foundation. Running north and south, this building features a shed roof front porch supported by two spindle columns. A central front door is flanked by one two-over-two window. This same window is present in the southwest corner and south wall of the building. A doorway in the southeast corner completes the bays. Located near the office's center is a corbeled chimney. The doctor's office is currently utilized for storage.

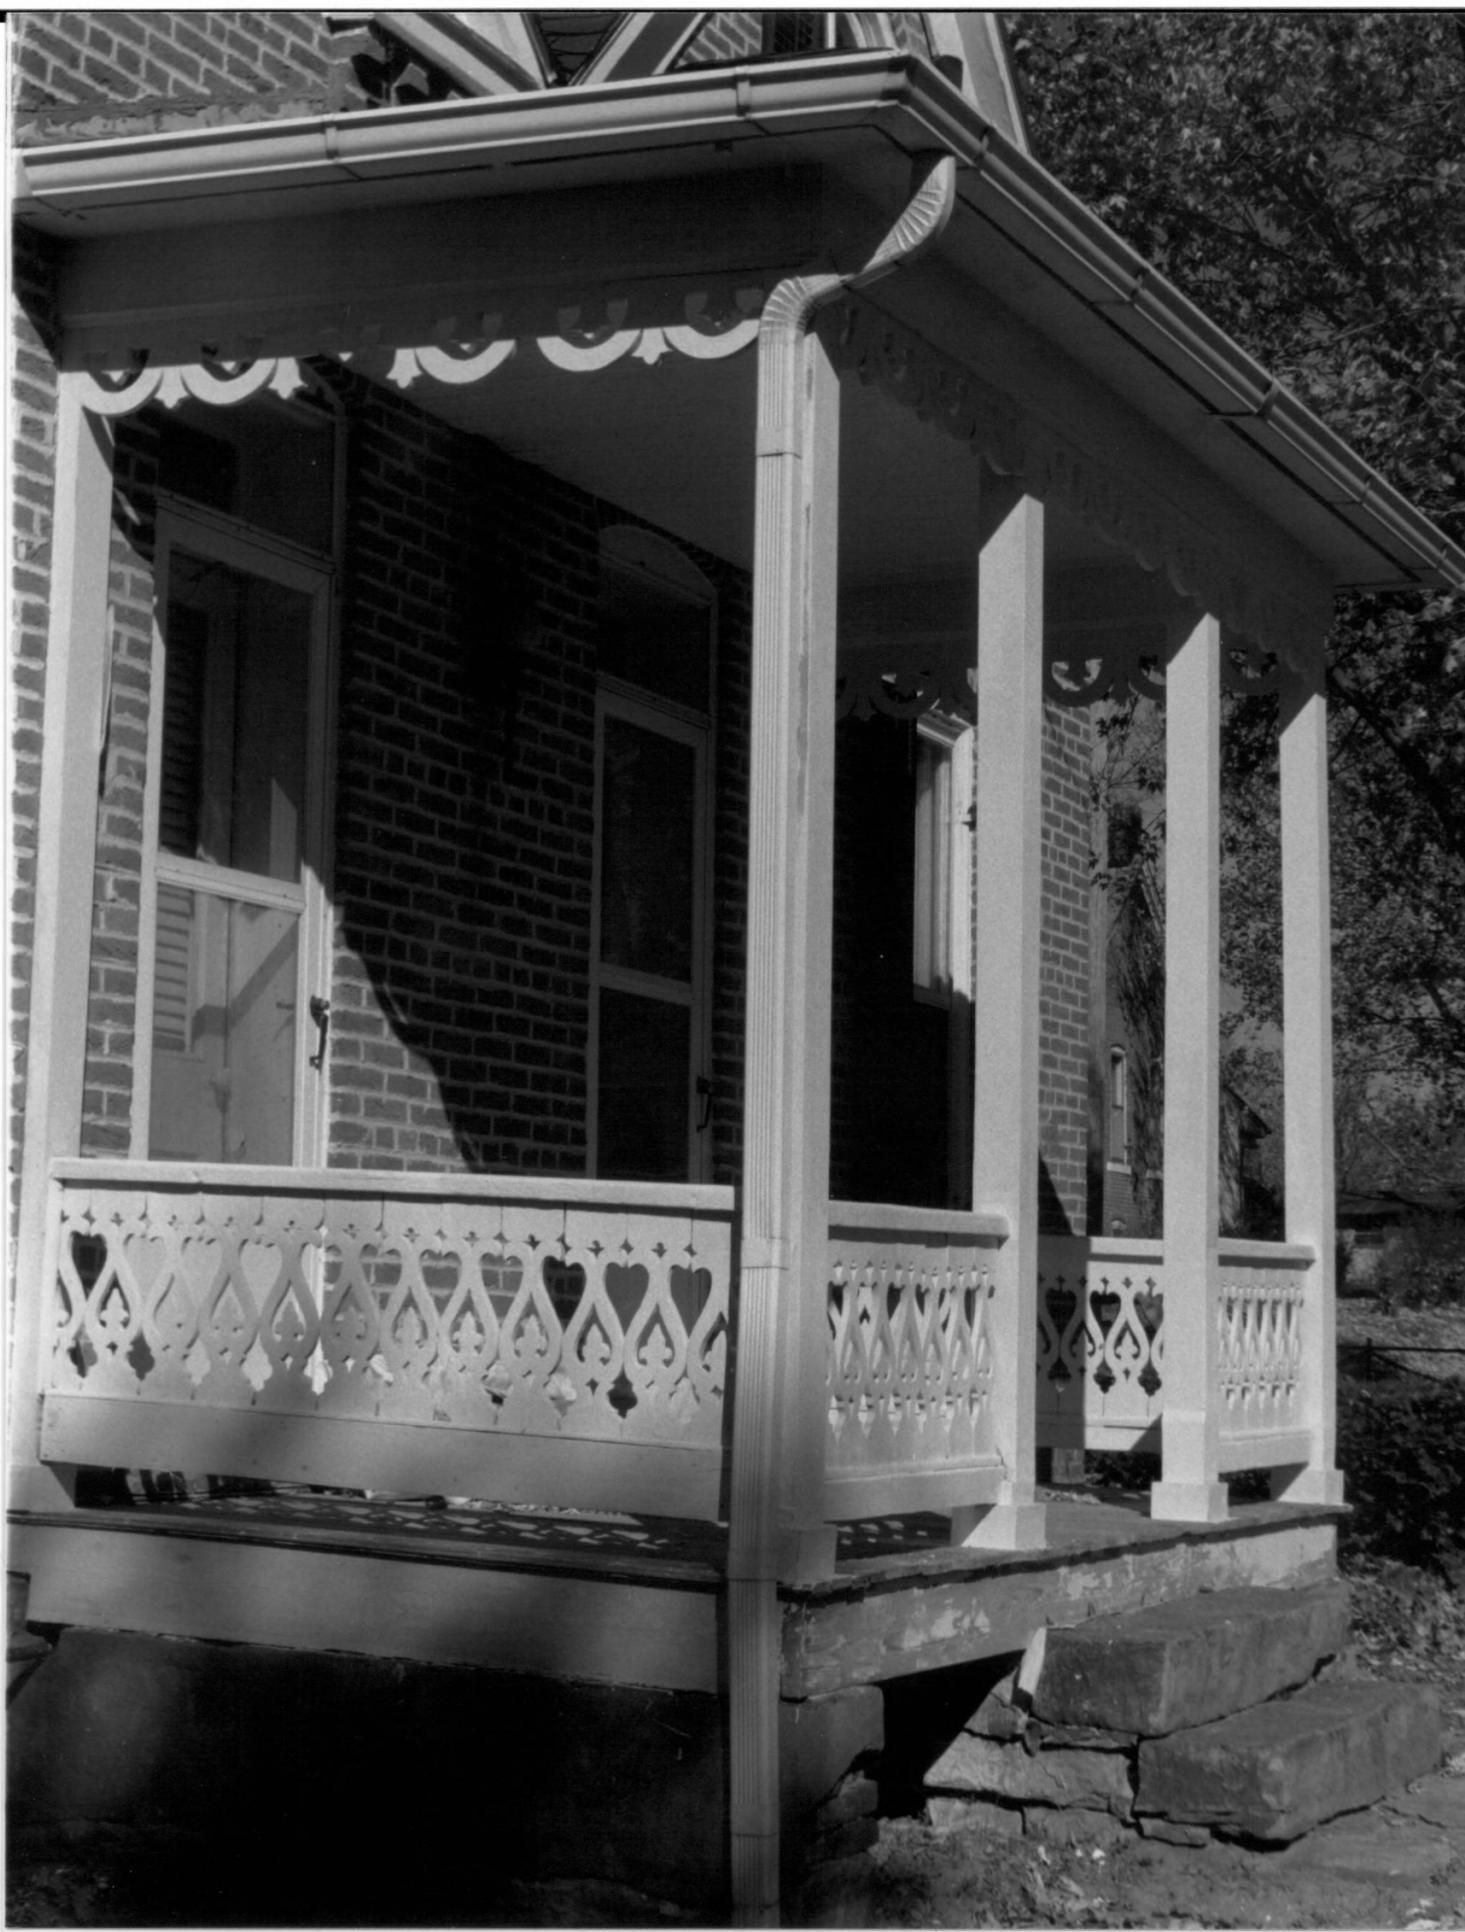
Miller-Seabaugh Property; Cape Girardeau
Photo by Bryan Smith; 11/2/1994; Negative
Thompson; view of the south east porch
the bathroom addition (white).

The rear or south of the residence consists of a brick gable that features two two-over-two arched windows on the main floor and one smaller two-over-two window at the basement level. In the southeast corner of the structure there is an "L" shaped porch area that contours the house. Below this porch is the entrance to the basement. A portion of this rear porch was converted into a bathroom in the 1970's. The bathroom contains a double hung window facing south and a foundation of modern fired brick. Access to the porch from the house is gained through a door near the porch's corner, and five steps give access to the yard. Although the porch railing has been altered, the gingerbread work (added between 1890 and 1906) beneath the eaves is still present.

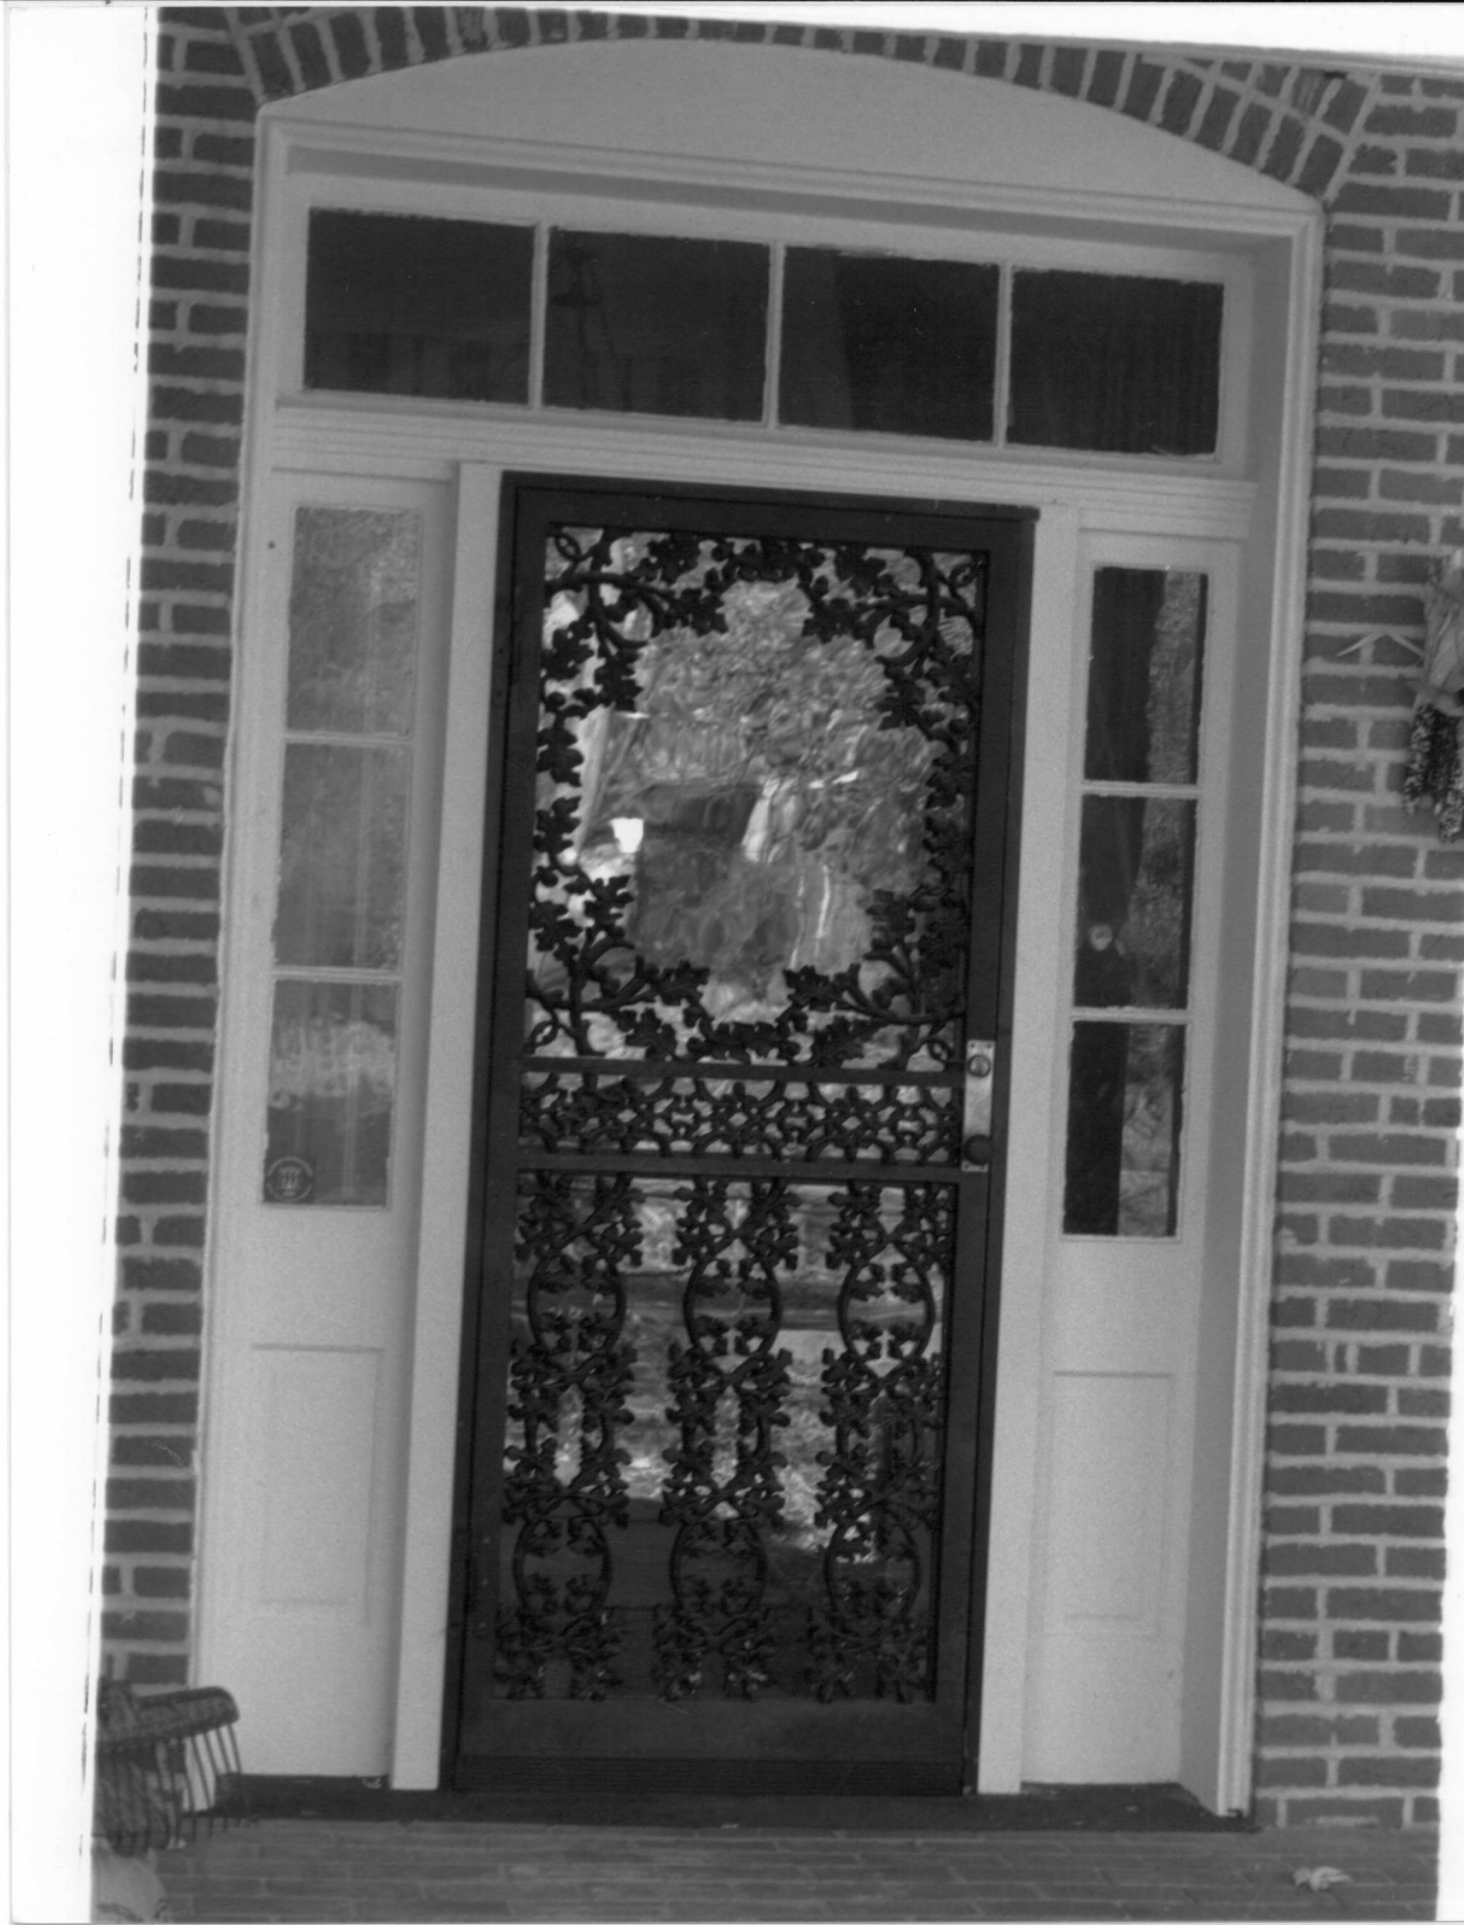
Miller-Seabaugh Property; Cape Girardeau, Mis
Photo by Bryan Smith; 11/2/1994; Negative
Thompson; House from the South East.

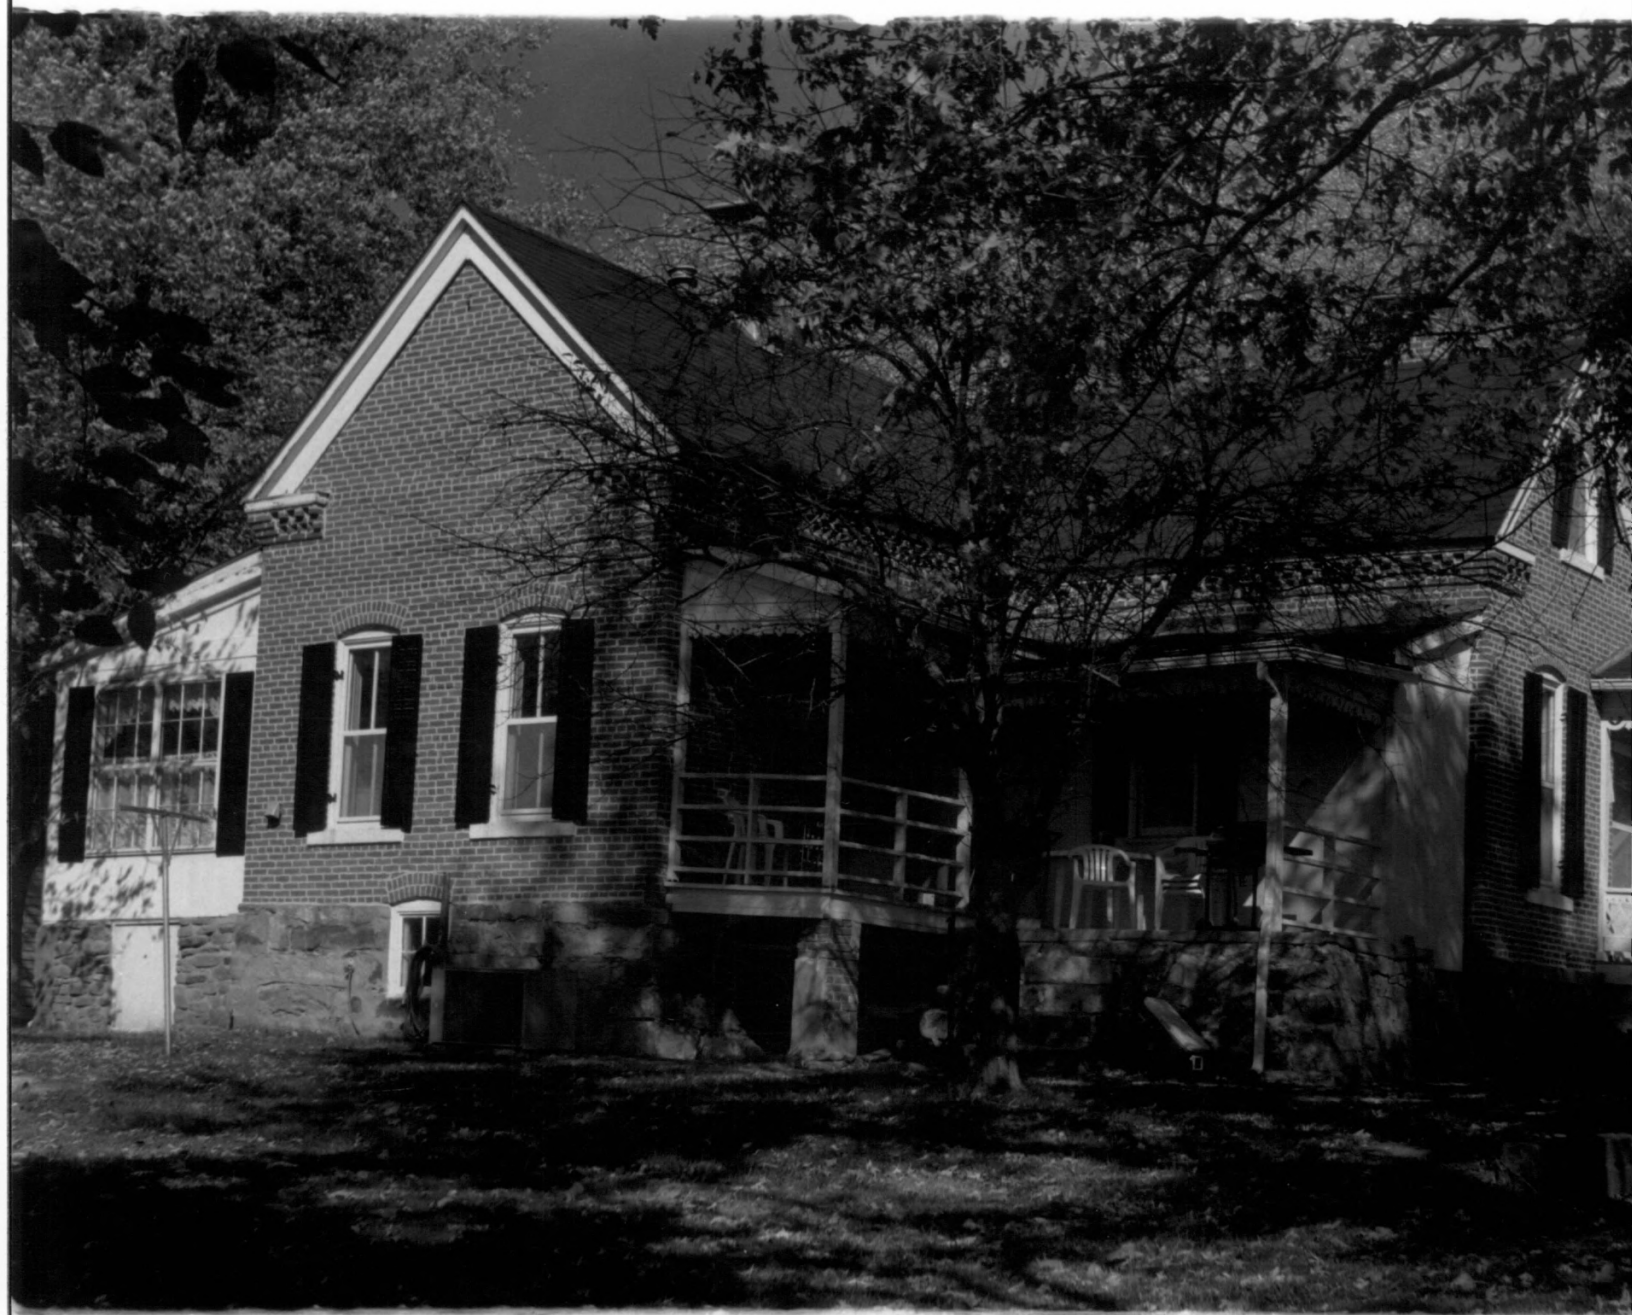
Miller-Seabaugh Property; Cape Girardeau, Missouri; Photo
Smith; 11/2/1994; Negative: Tony Thompson; West view
house, including enclosed porch (white).

The west side of the Miller-Seabaugh House consists of two two-over-two windows on the main floor. On the southwest corner of the house is a sunroom that was constructed in the 1970's. This white frame addition rests on concrete columns and a sandstone foundation. The stone of this new foundation is smaller and the mortar is thicker than that on the original house. Two aluminum storm doors open to the west of the sunroom, while two aluminum windows placed side by side face south.

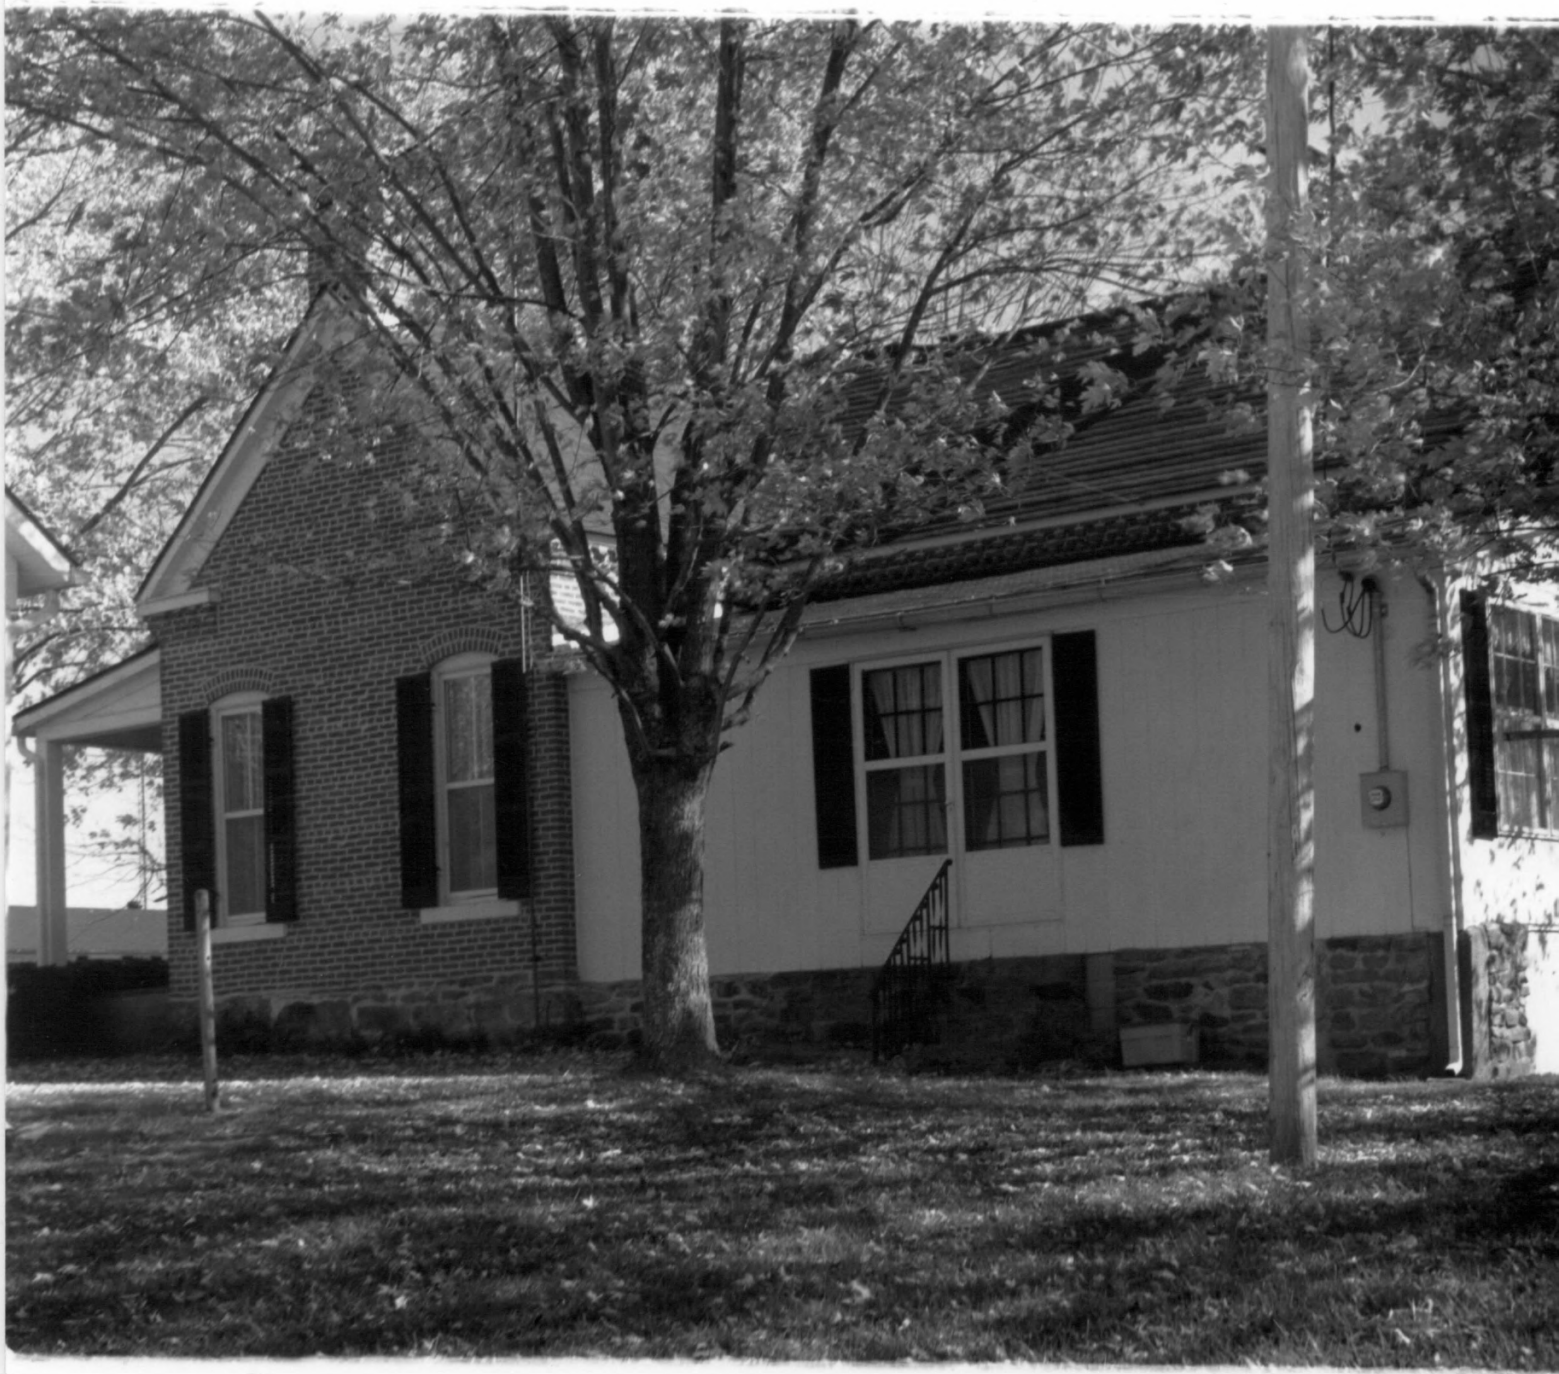
Miller-Seabaugh Property; Cape Girardeau, Missouri; PH
Bryan Smith; 11/2/1994; Negative: Tony Thompson; D
from the south west

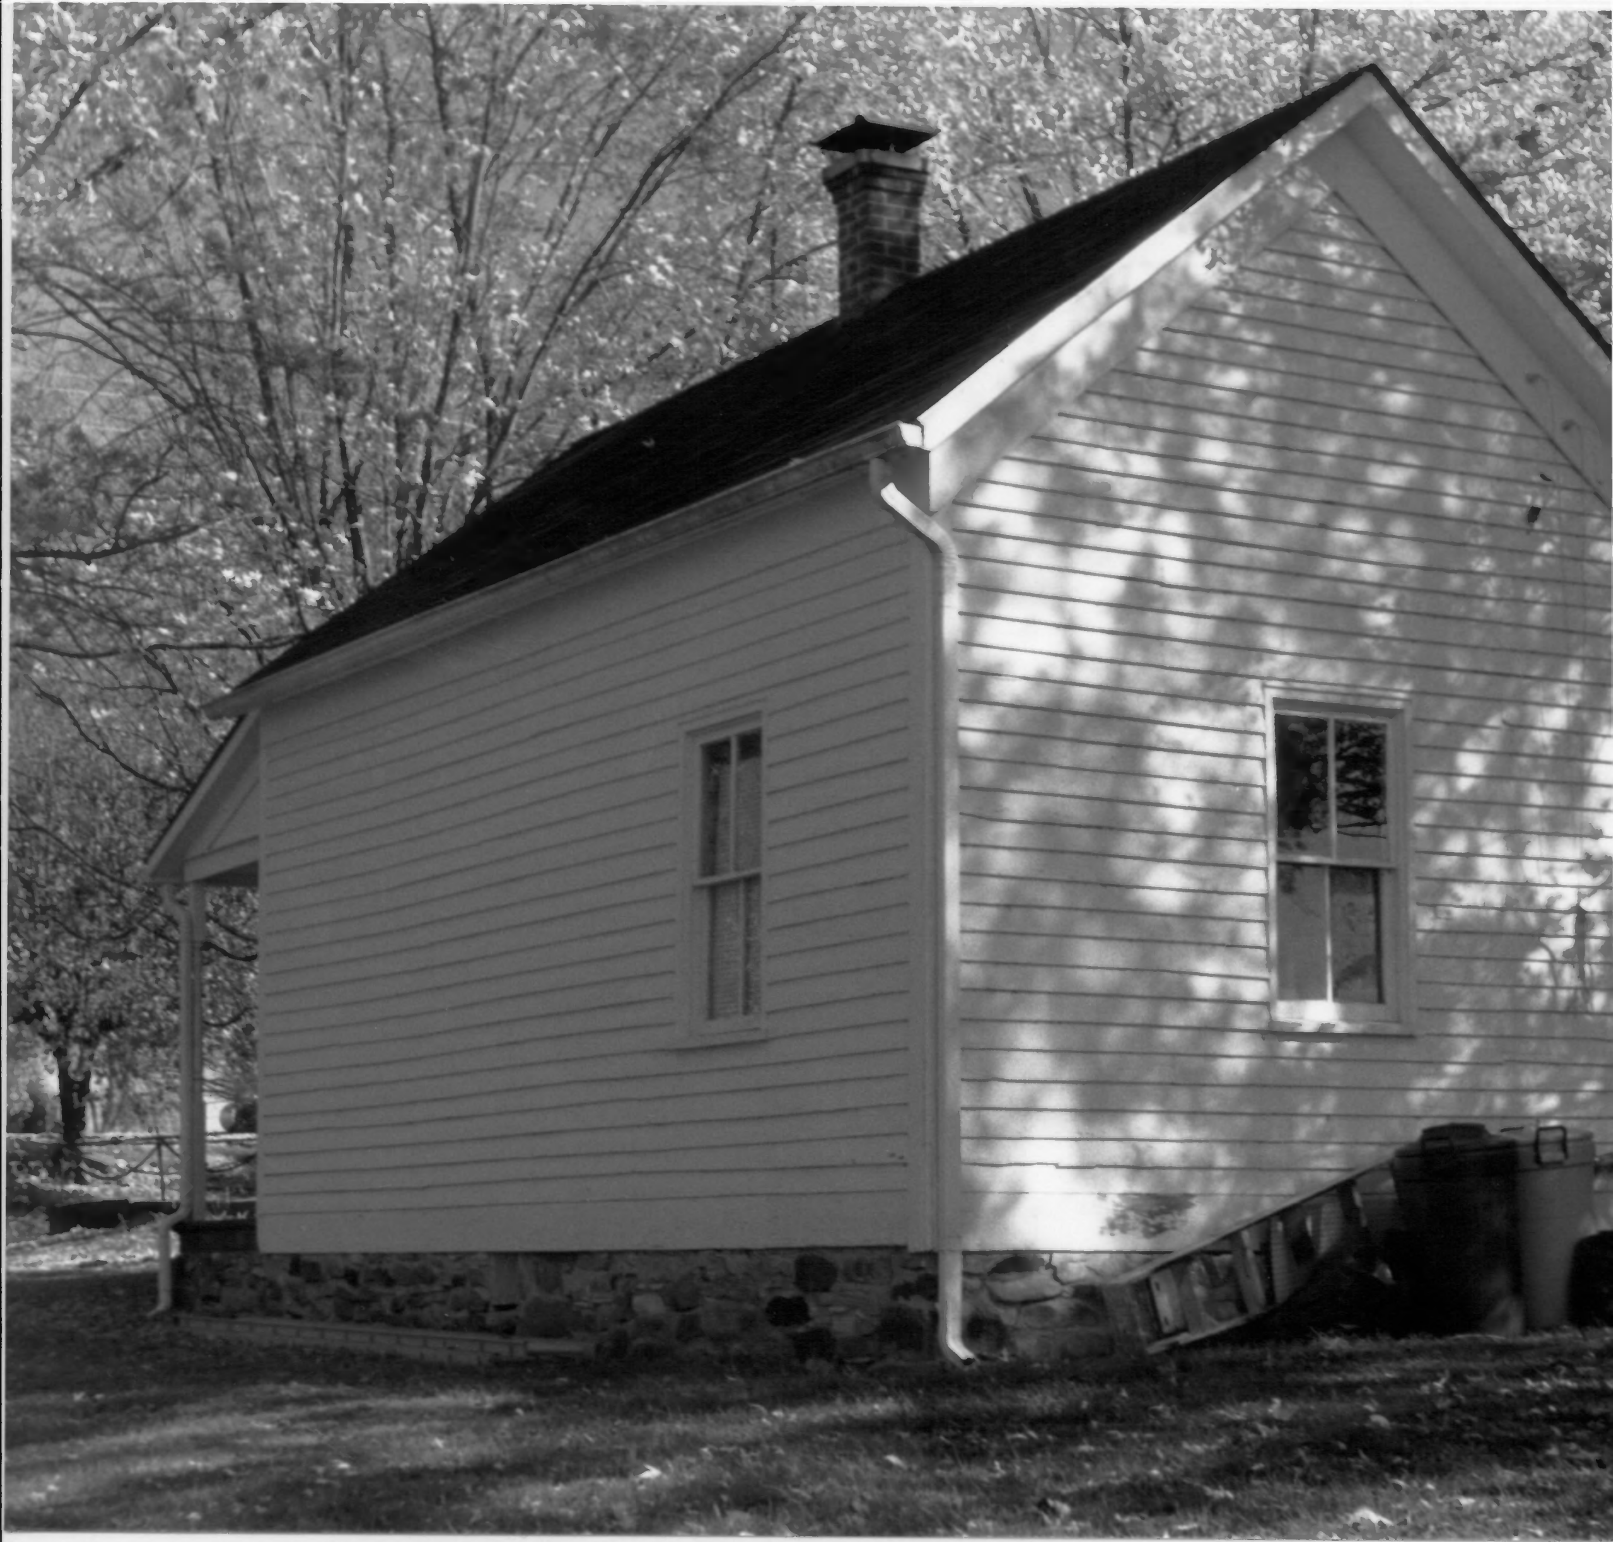
Miller-Seabaugh Property, Cape Girardeau, Missouri
Photo by Bryan Smith, 11/2/1994; Negative: T
Thompson; East porch

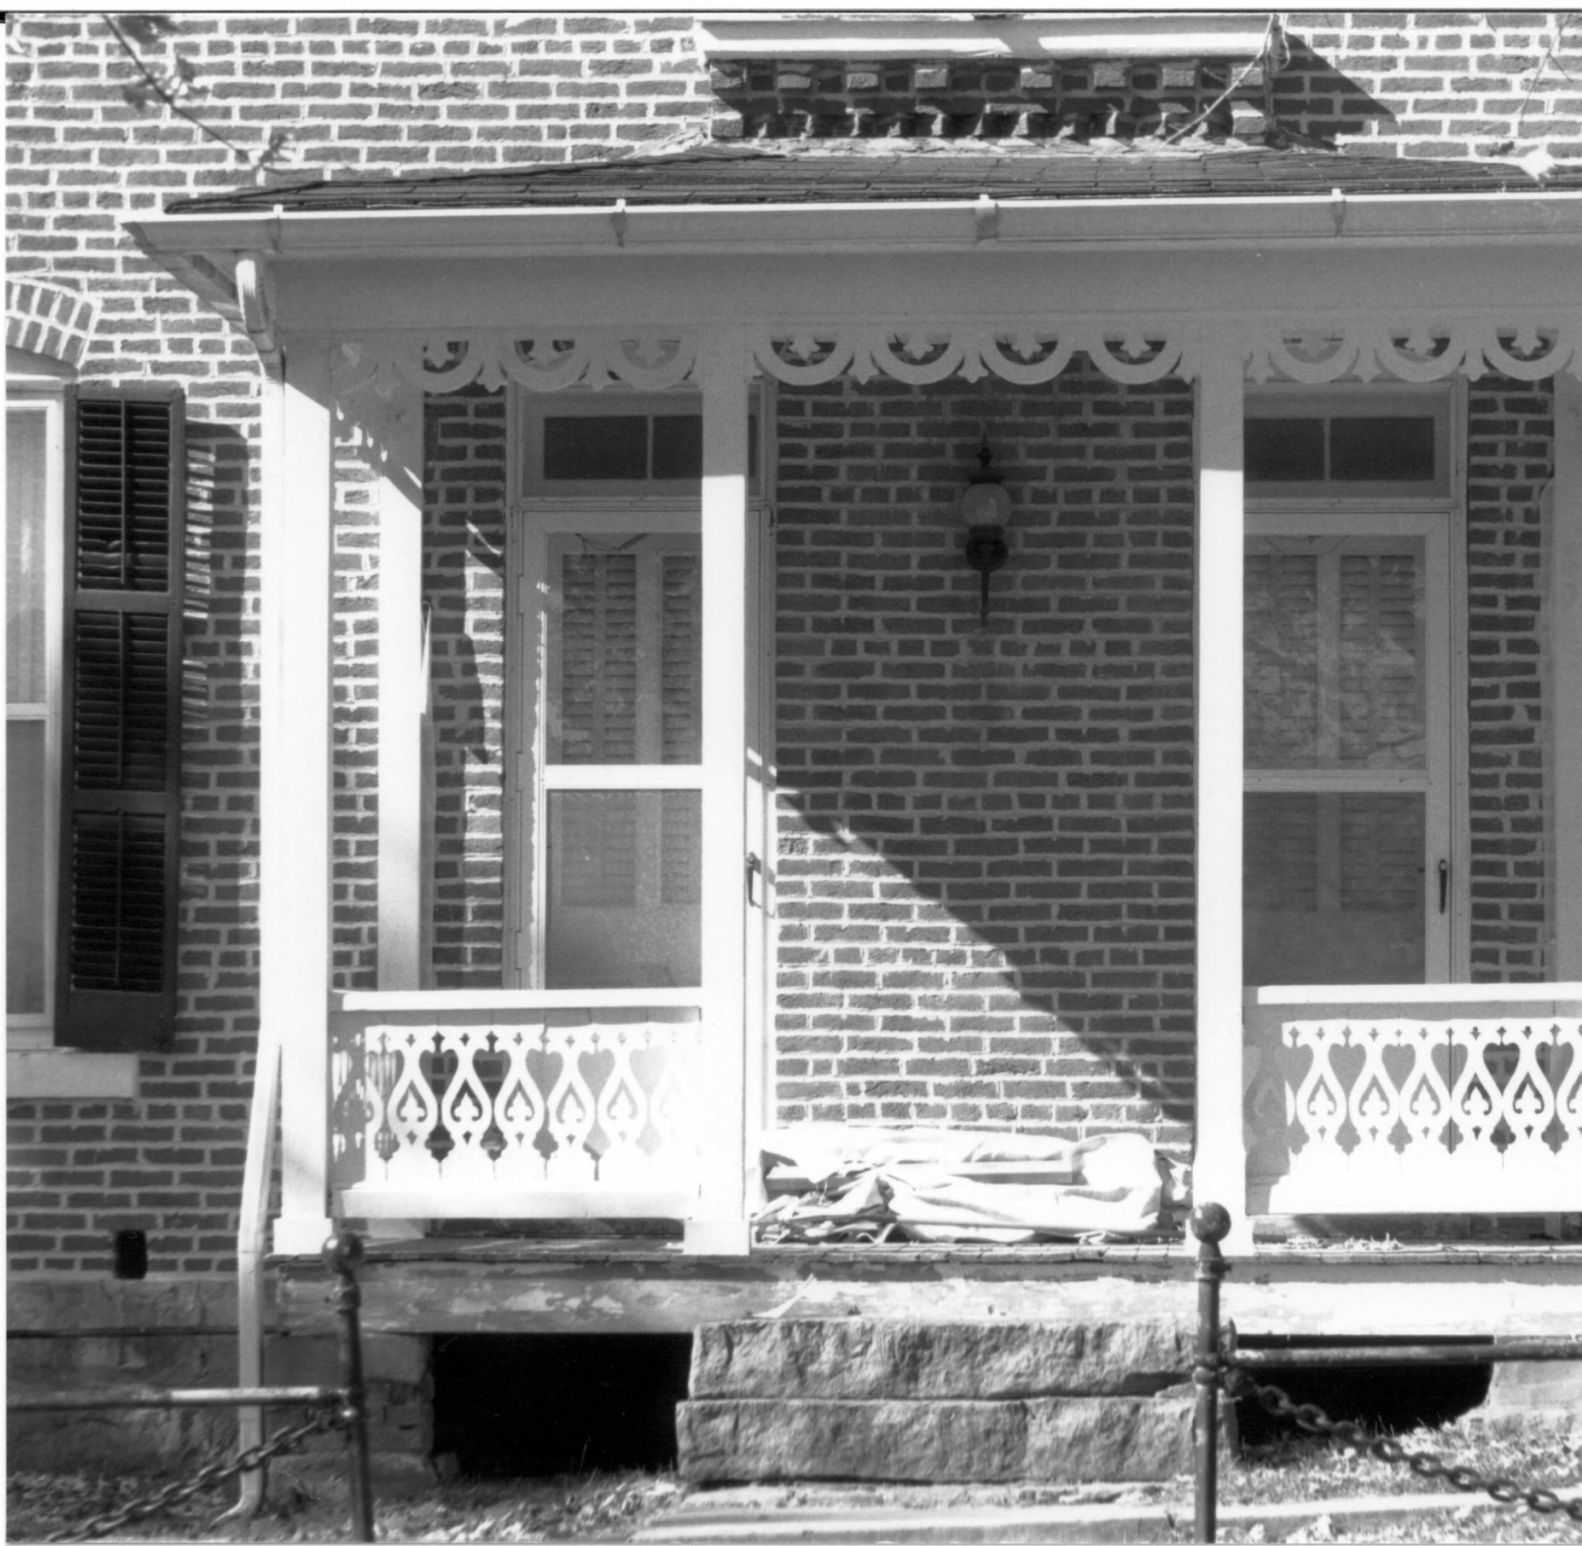
Miller - Seabaugh Property; Cape Girardeau,
Missouri; Photo by Bryan Smith; 11/2/1994;
Negative: Tony Thompson; Detail: East porch and
doorway.

A double gable configuration forms the east side of the Miller-Seabaugh residence. Each gable comprises one interior room, the gables are mirror images of one another. The arched four light peak window and one two-over-two main floor window is present in each gable. A doorway with a two light transom is present on either side of the gable junction. These two doors provide access to a joint

porch. Four full and two half square columns support the structure. Gingerbread added after construction is present on this porch.

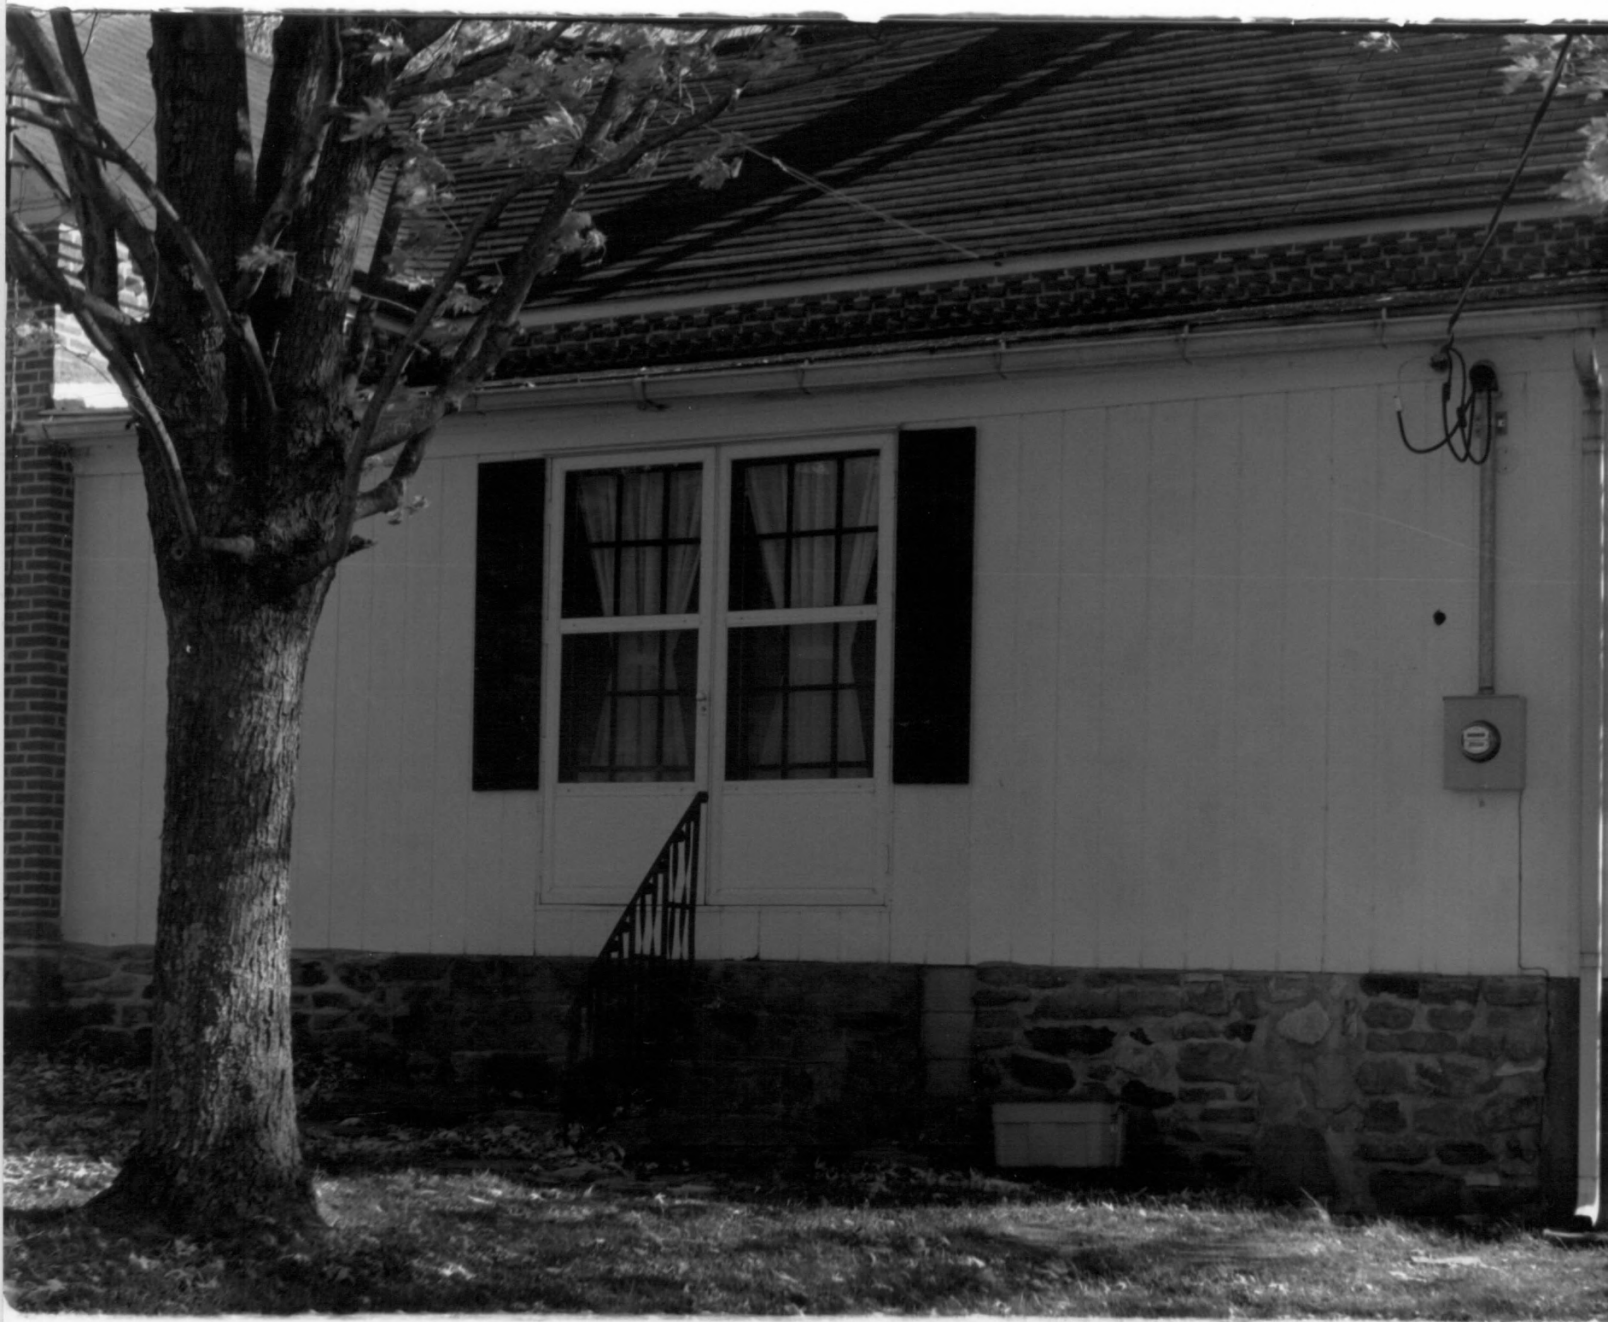
Miller-Seabaugh Property; Cape Girardeau, M
Photo by Bryan Smith; 11/2/1994; Negative:
Thompson; Detail: corbelled return, view from
northeast.

Twelve of the fourteen original windows have corresponding black shutters. Four courses of the original brick corbelling follow the eaves and returns of the structure.

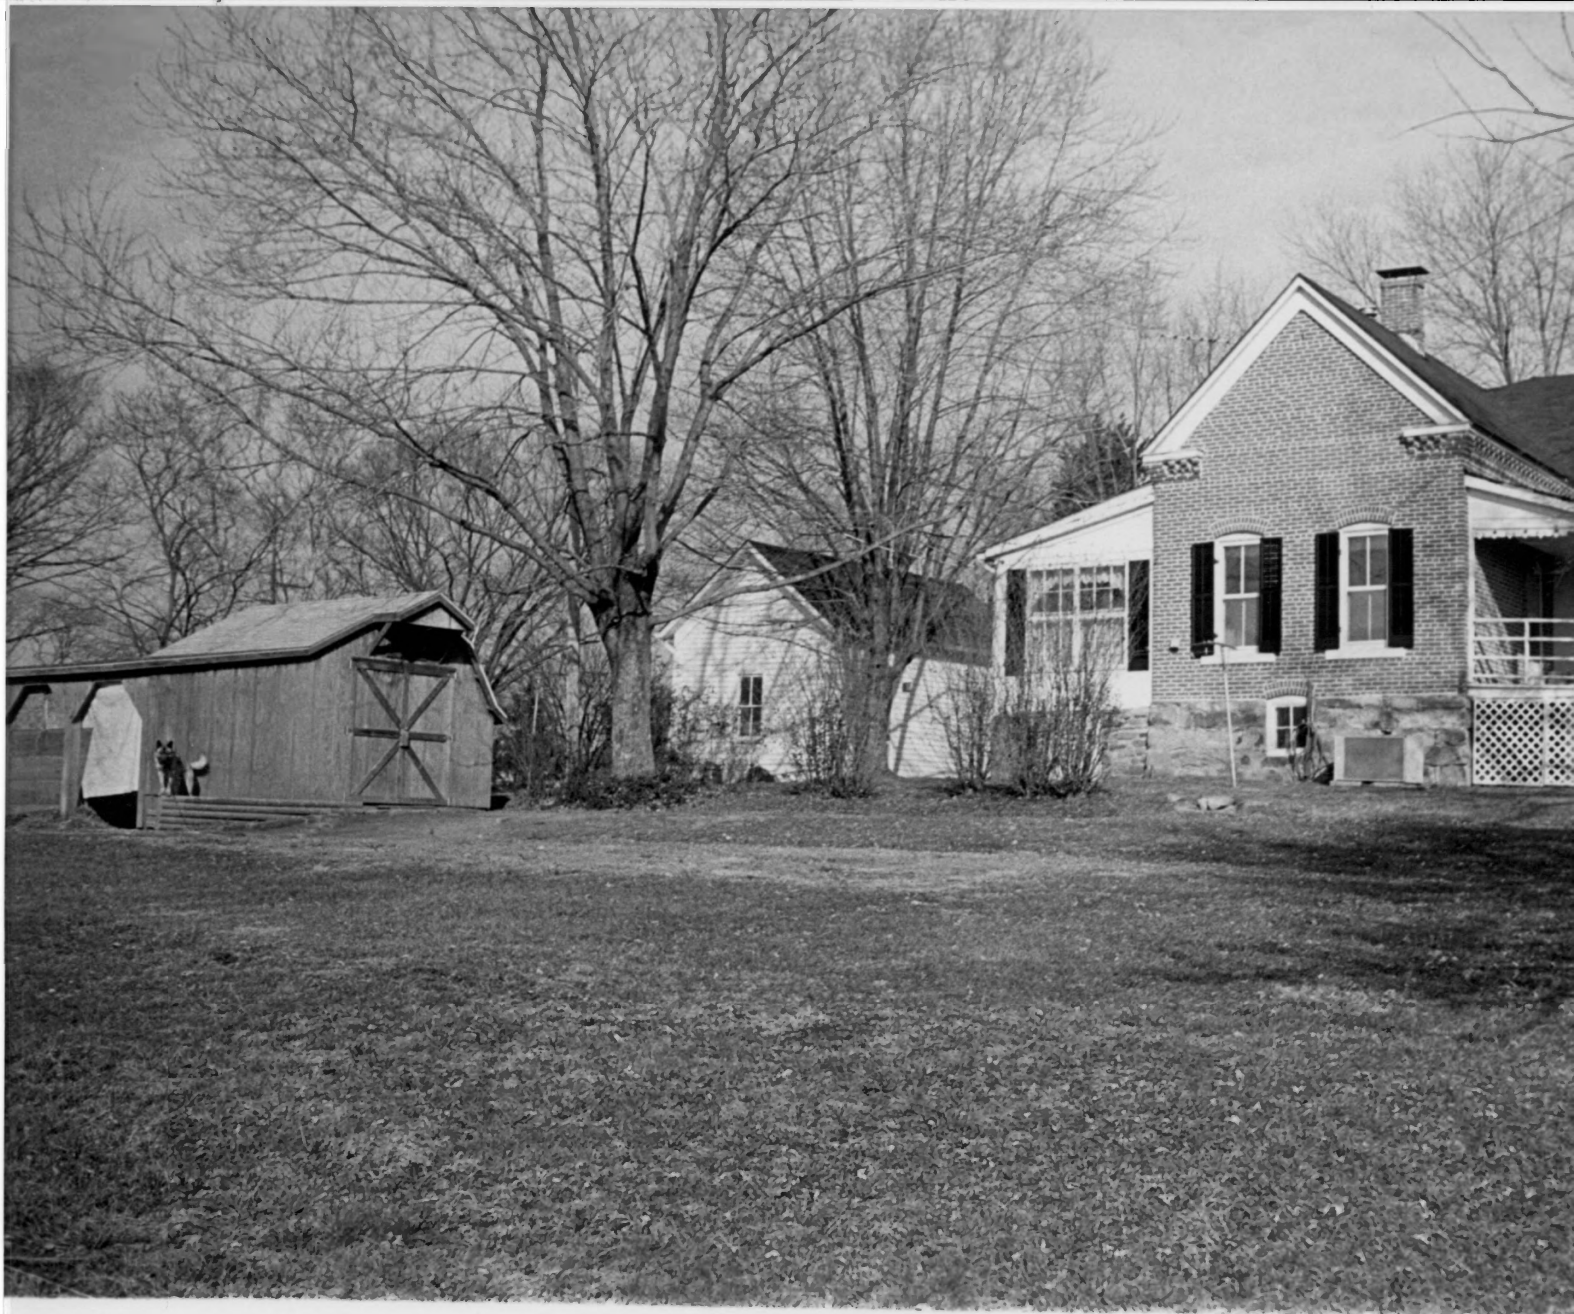
Miller - Seabaugh Property; Cape Girardeau, Missouri;
Bryan Smith; 11/2/1994; Negative: Tony Thompson
House, fence, and doctor's office from the north
