National Register of Historic Places Registration Form

historic name Miller-Seabaugh House and Dr. Seabaugh Office Building

street & number 341 Market Street [n/a] not for publication

**Miller-Seabaugh House and Dr. Seabaugh Office Building
Cape Girardeau County, MO**

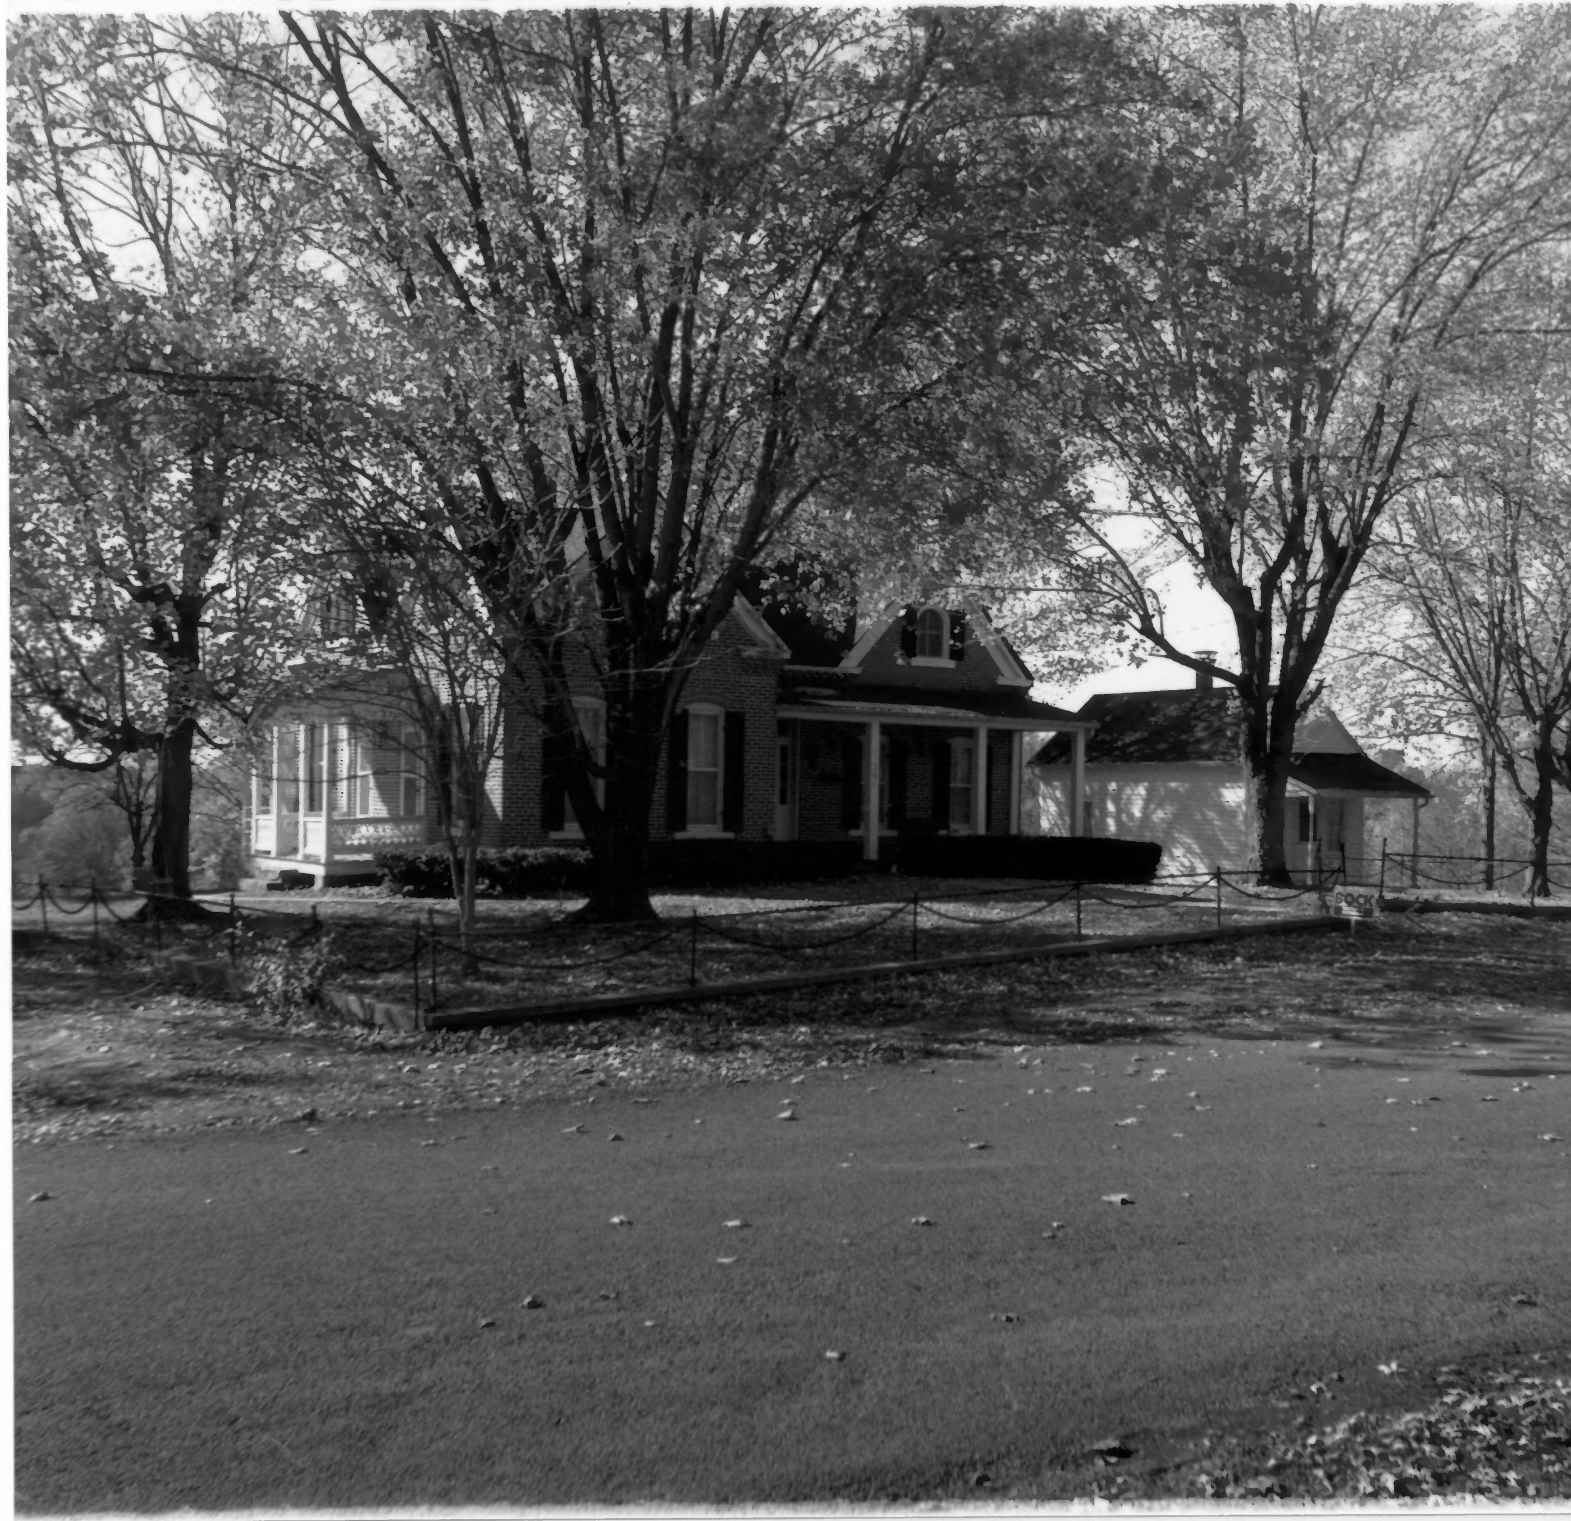
Miller-Seabaugh Property; Cape Girardeau, Missouri;
Bryan Smith; 11/2/1994; Negative: Tony Thompson
from the east.
