ARCHITECTURAL/HISTORIC INVENTORY FORM

1. Survey No. CO-AS-005-001		2. Survey name: Moreau Drive Neighborhood Survey	
3. County: Cole		4. Address: 1202 Elmerine Ave.	
5. City: Jefferson City	Vicinity: <input type="checkbox"/>	6. UTM: / /	7. Township/Range/Section: T: R: S:
8. Historic name (if known):		9. Present/other name (if known):	
10. Ownership: <input checked="" type="checkbox"/> Private <input type="checkbox"/> Public		11. Historic use (if known): Residential	11. Current use: Residential

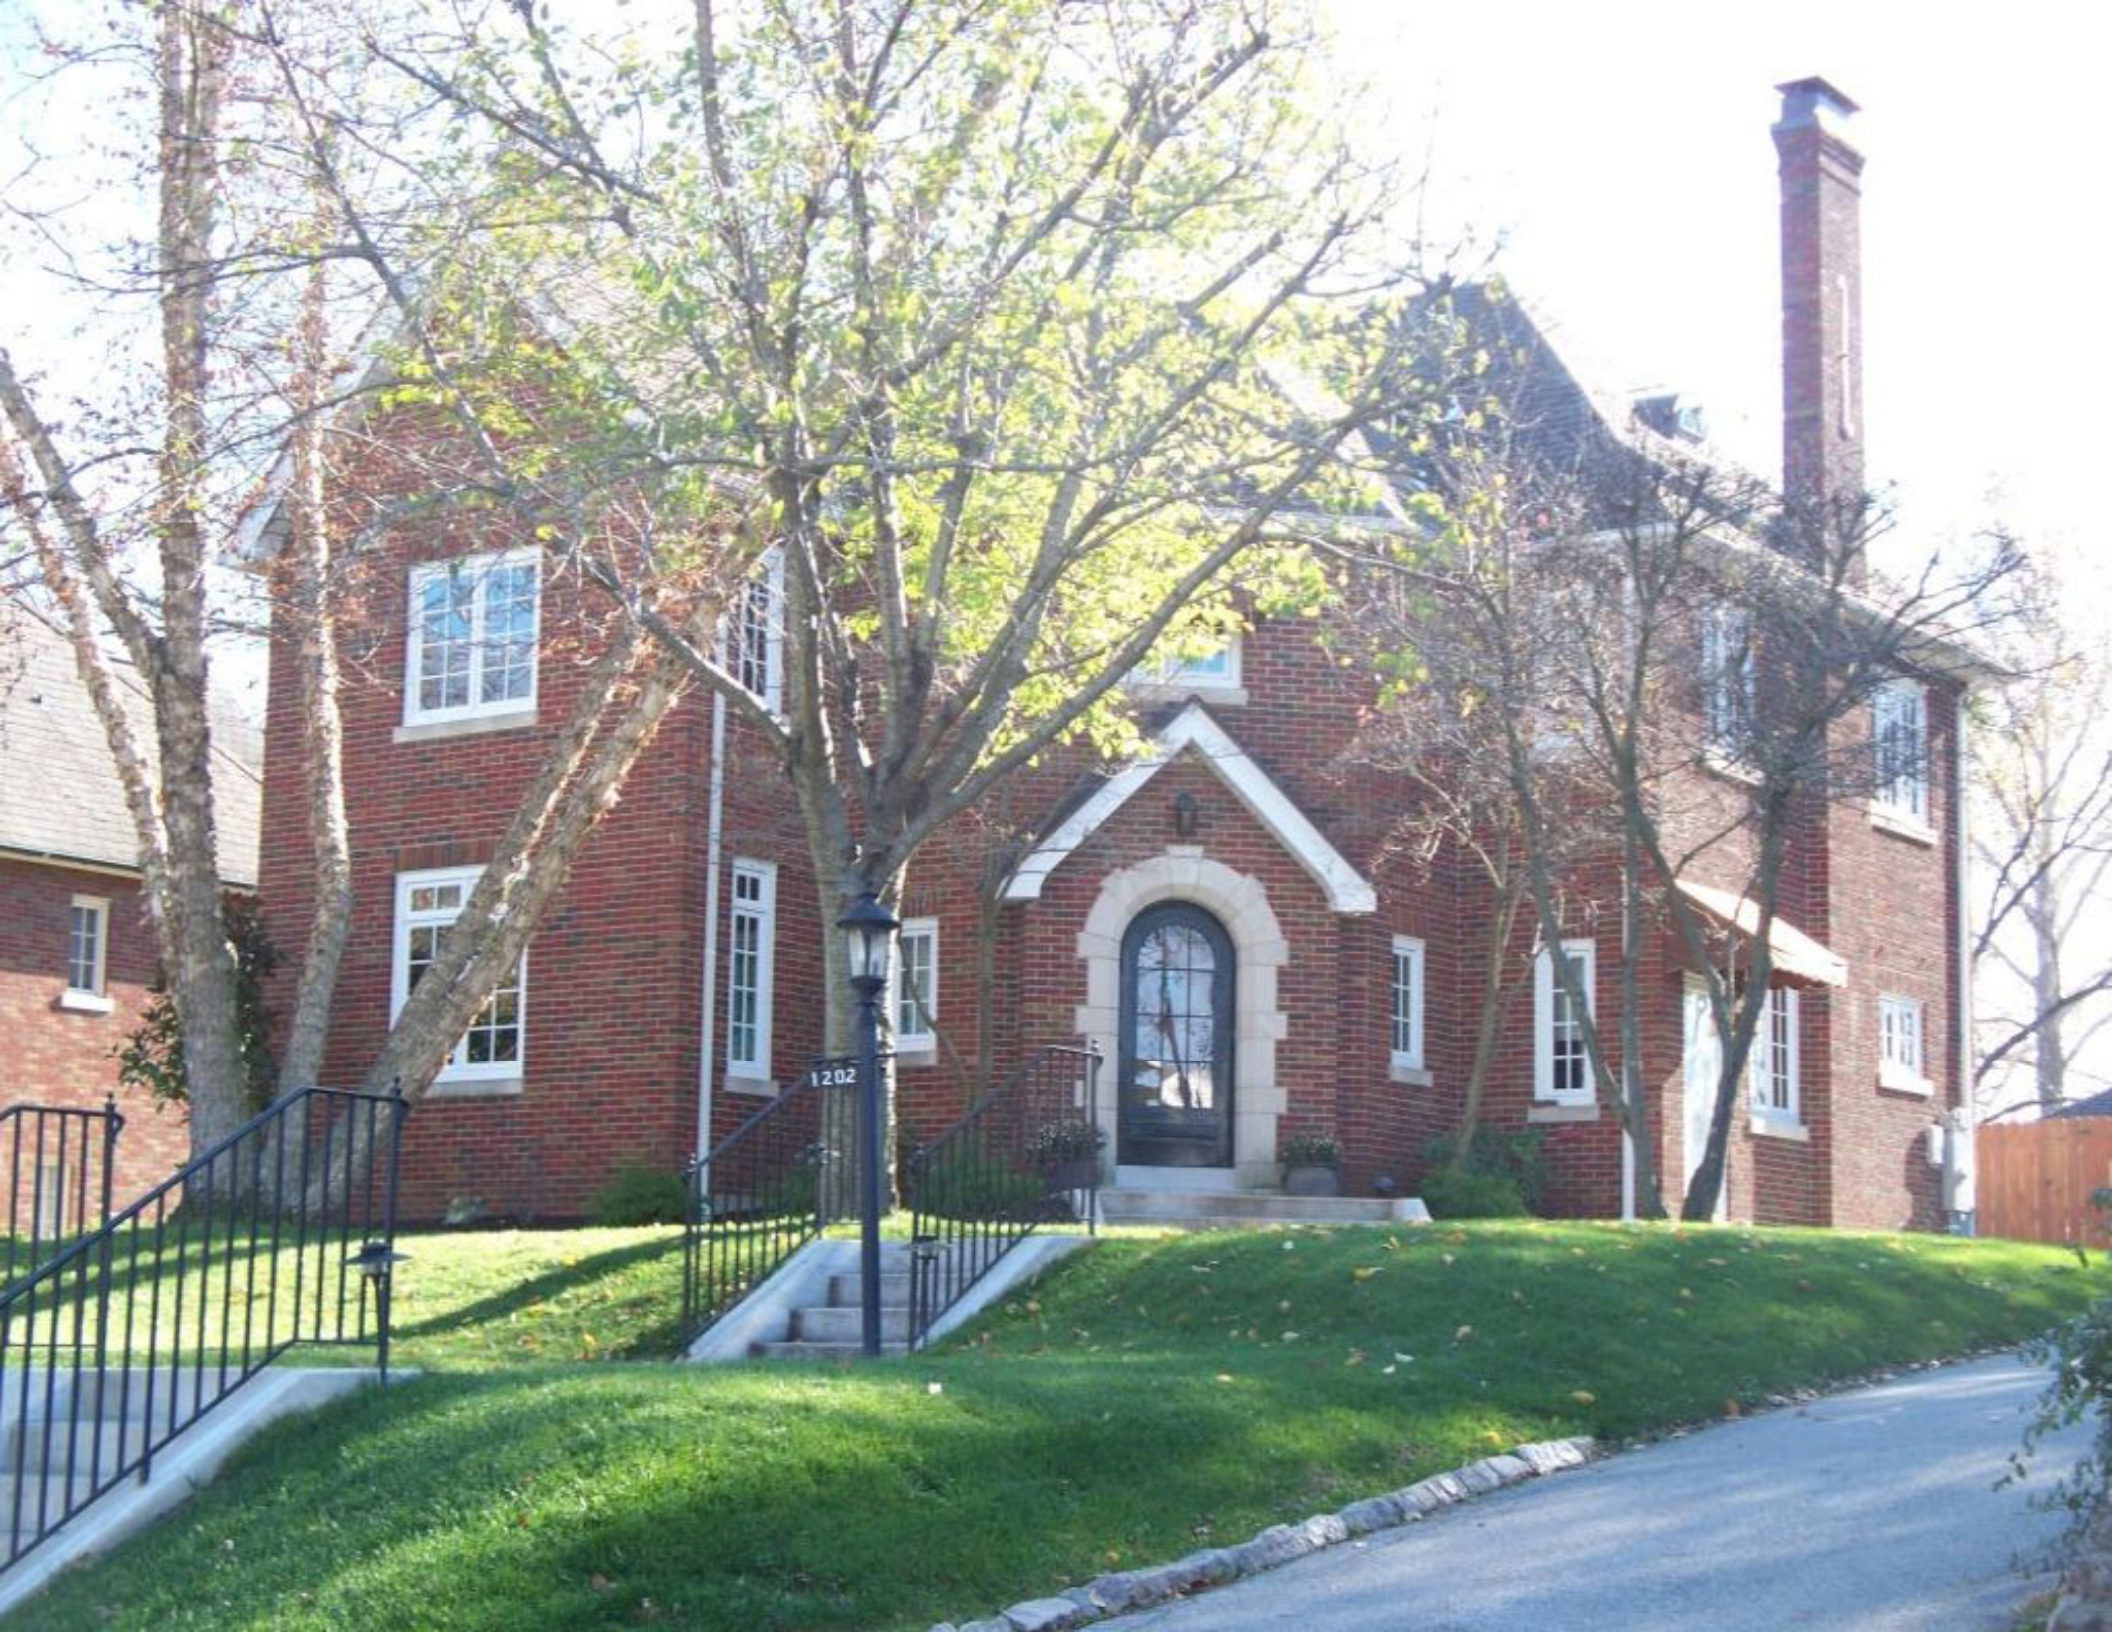
1202

This is a two story brick cross gable home with the entrance at the junction of the front gable facing Elmerine and the recessed “wing” with a secondary entrance facing west (towards Moreau Drive.) The front gable is one bay wide and has paired windows (8x 8 replacements) on each story, with the lower story windows having transoms (also replacement). Each window has a concrete or stone sill and above the second story window is a decorative bas relief ribbon of concrete or limestone. There is a small arched vent in the gable of this bay. Between the gable bay and entrance is a single multi-light casement window on the first floor with a limestone sill. It may or may not be historic. The entrance projects slightly and is capped with a projecting gable. The entrance is arched with stone quoining and appears to retain its original wooden door (behind a modern glass door). Above the gabled entrance is a multi-light casement window that may or may not be replacement. The next bay has a single narrow multi-light window on each floor both with stone sills. There is a small concrete pad that serves as a stoop in front of the entrance. The tall chimney that extends highly over the irregular roof line and the quoining around the arched door suggest Tudor stylistic influence.

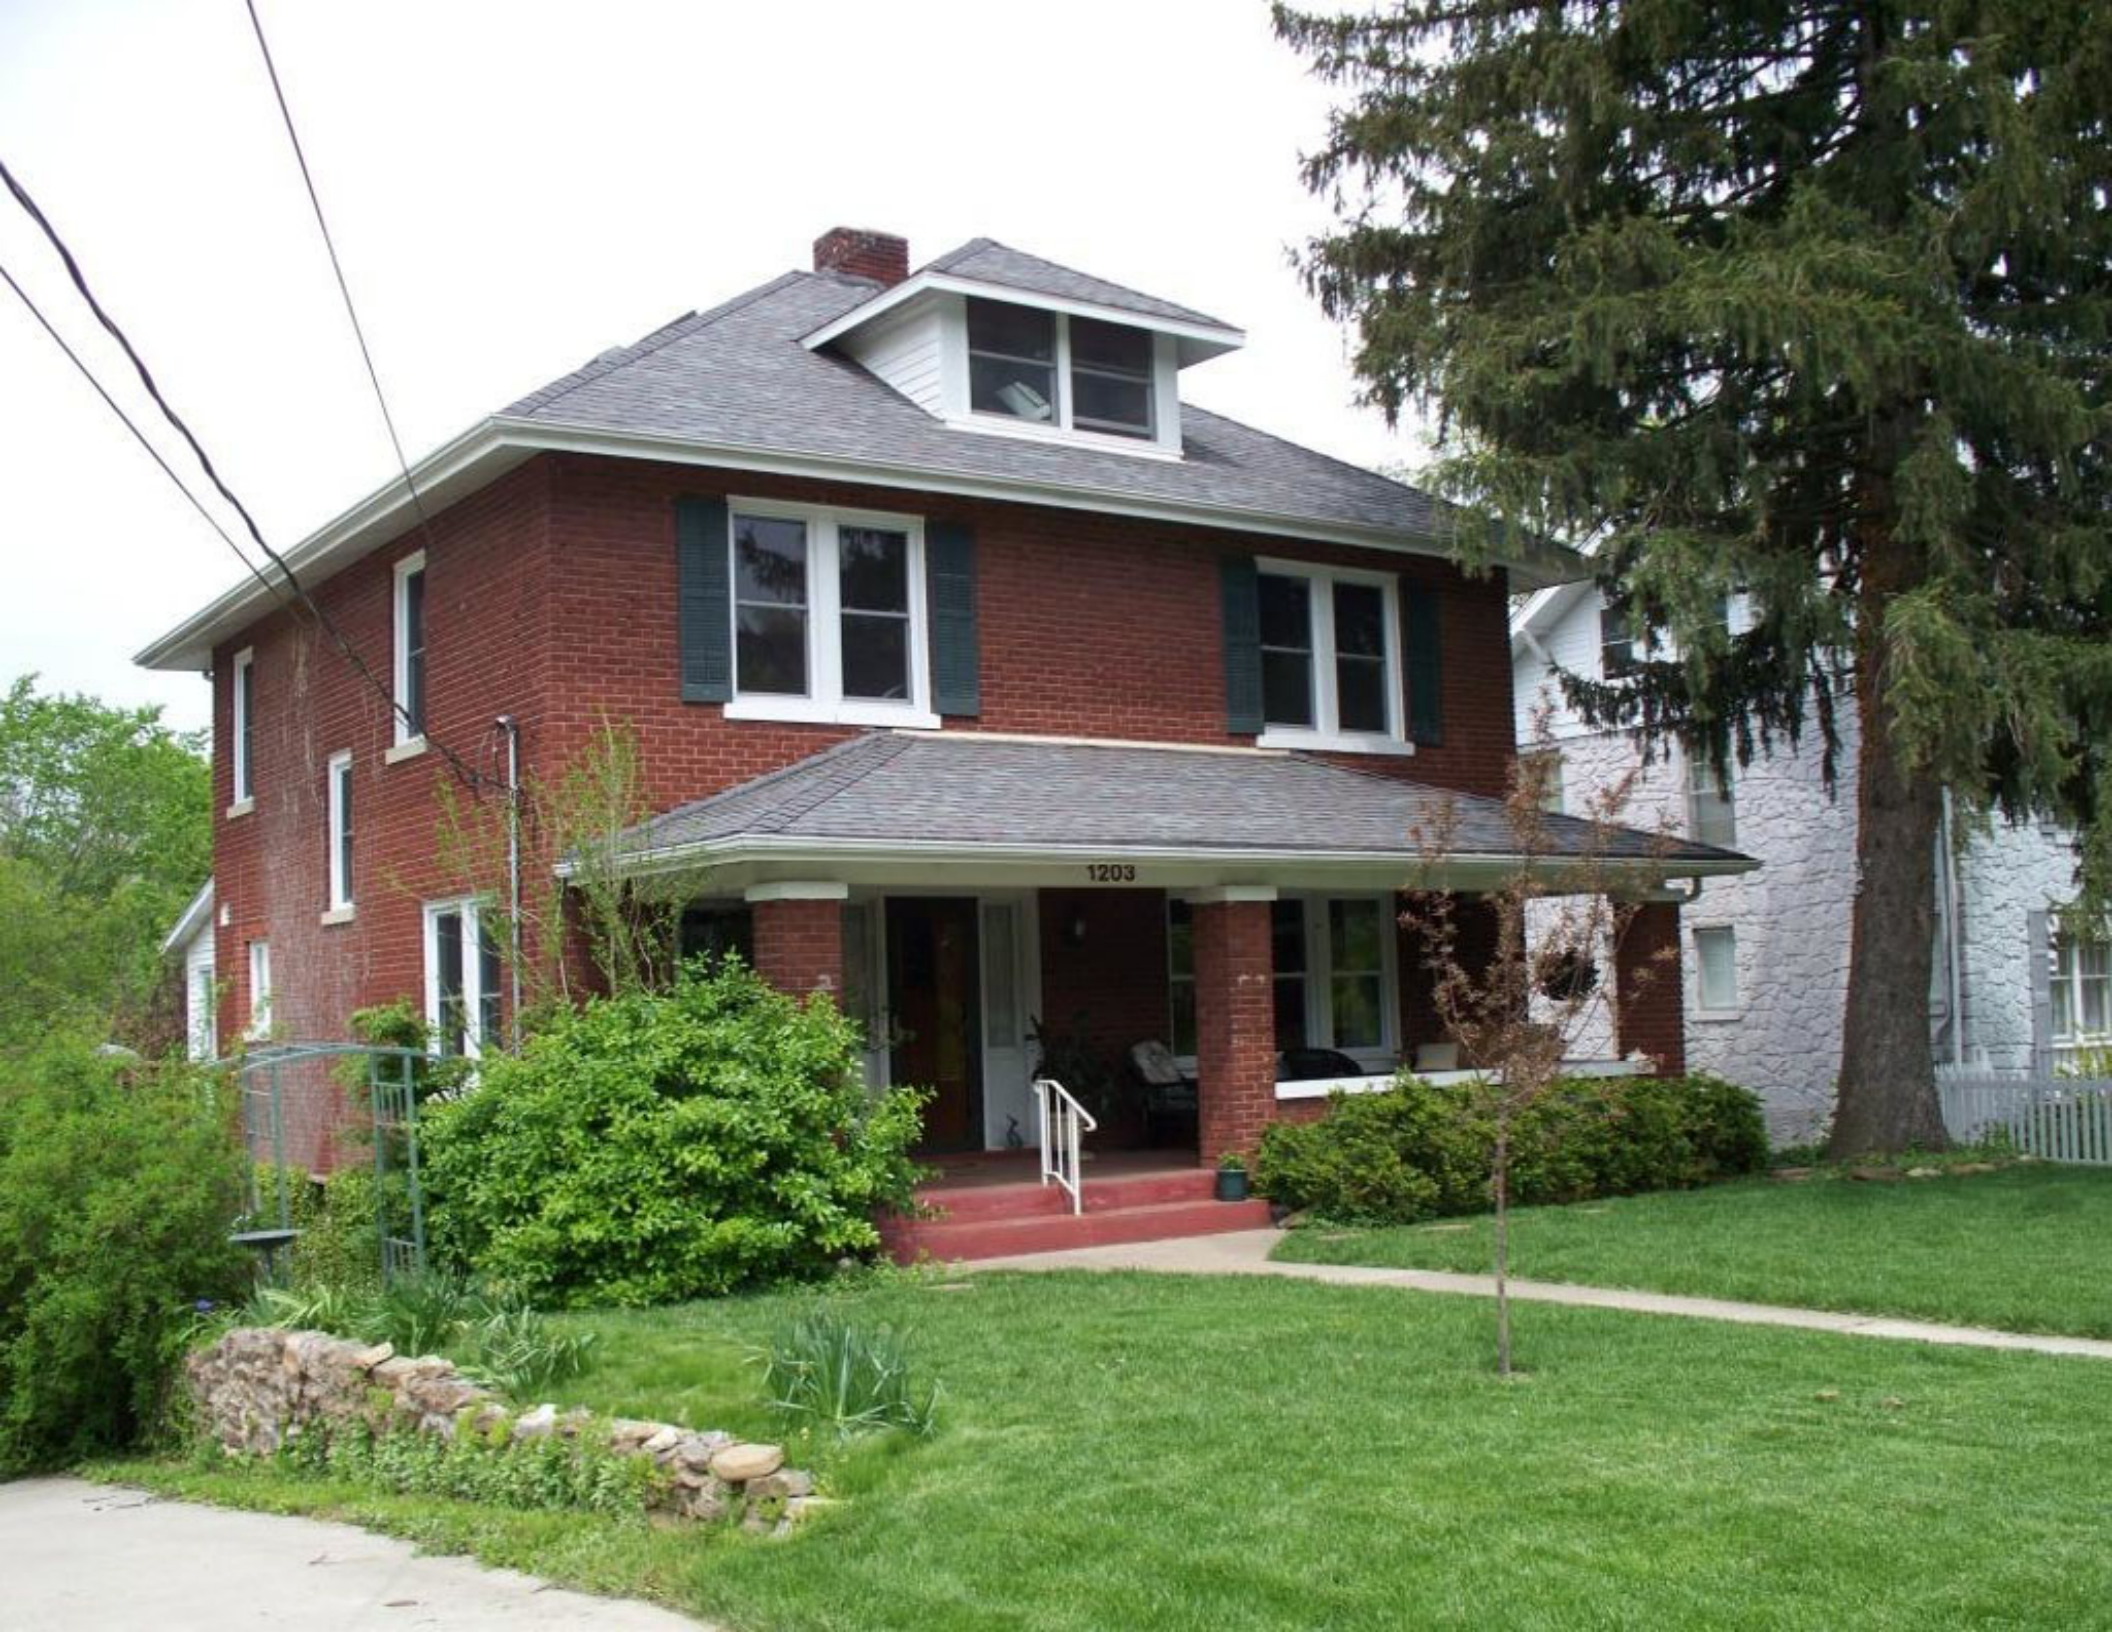
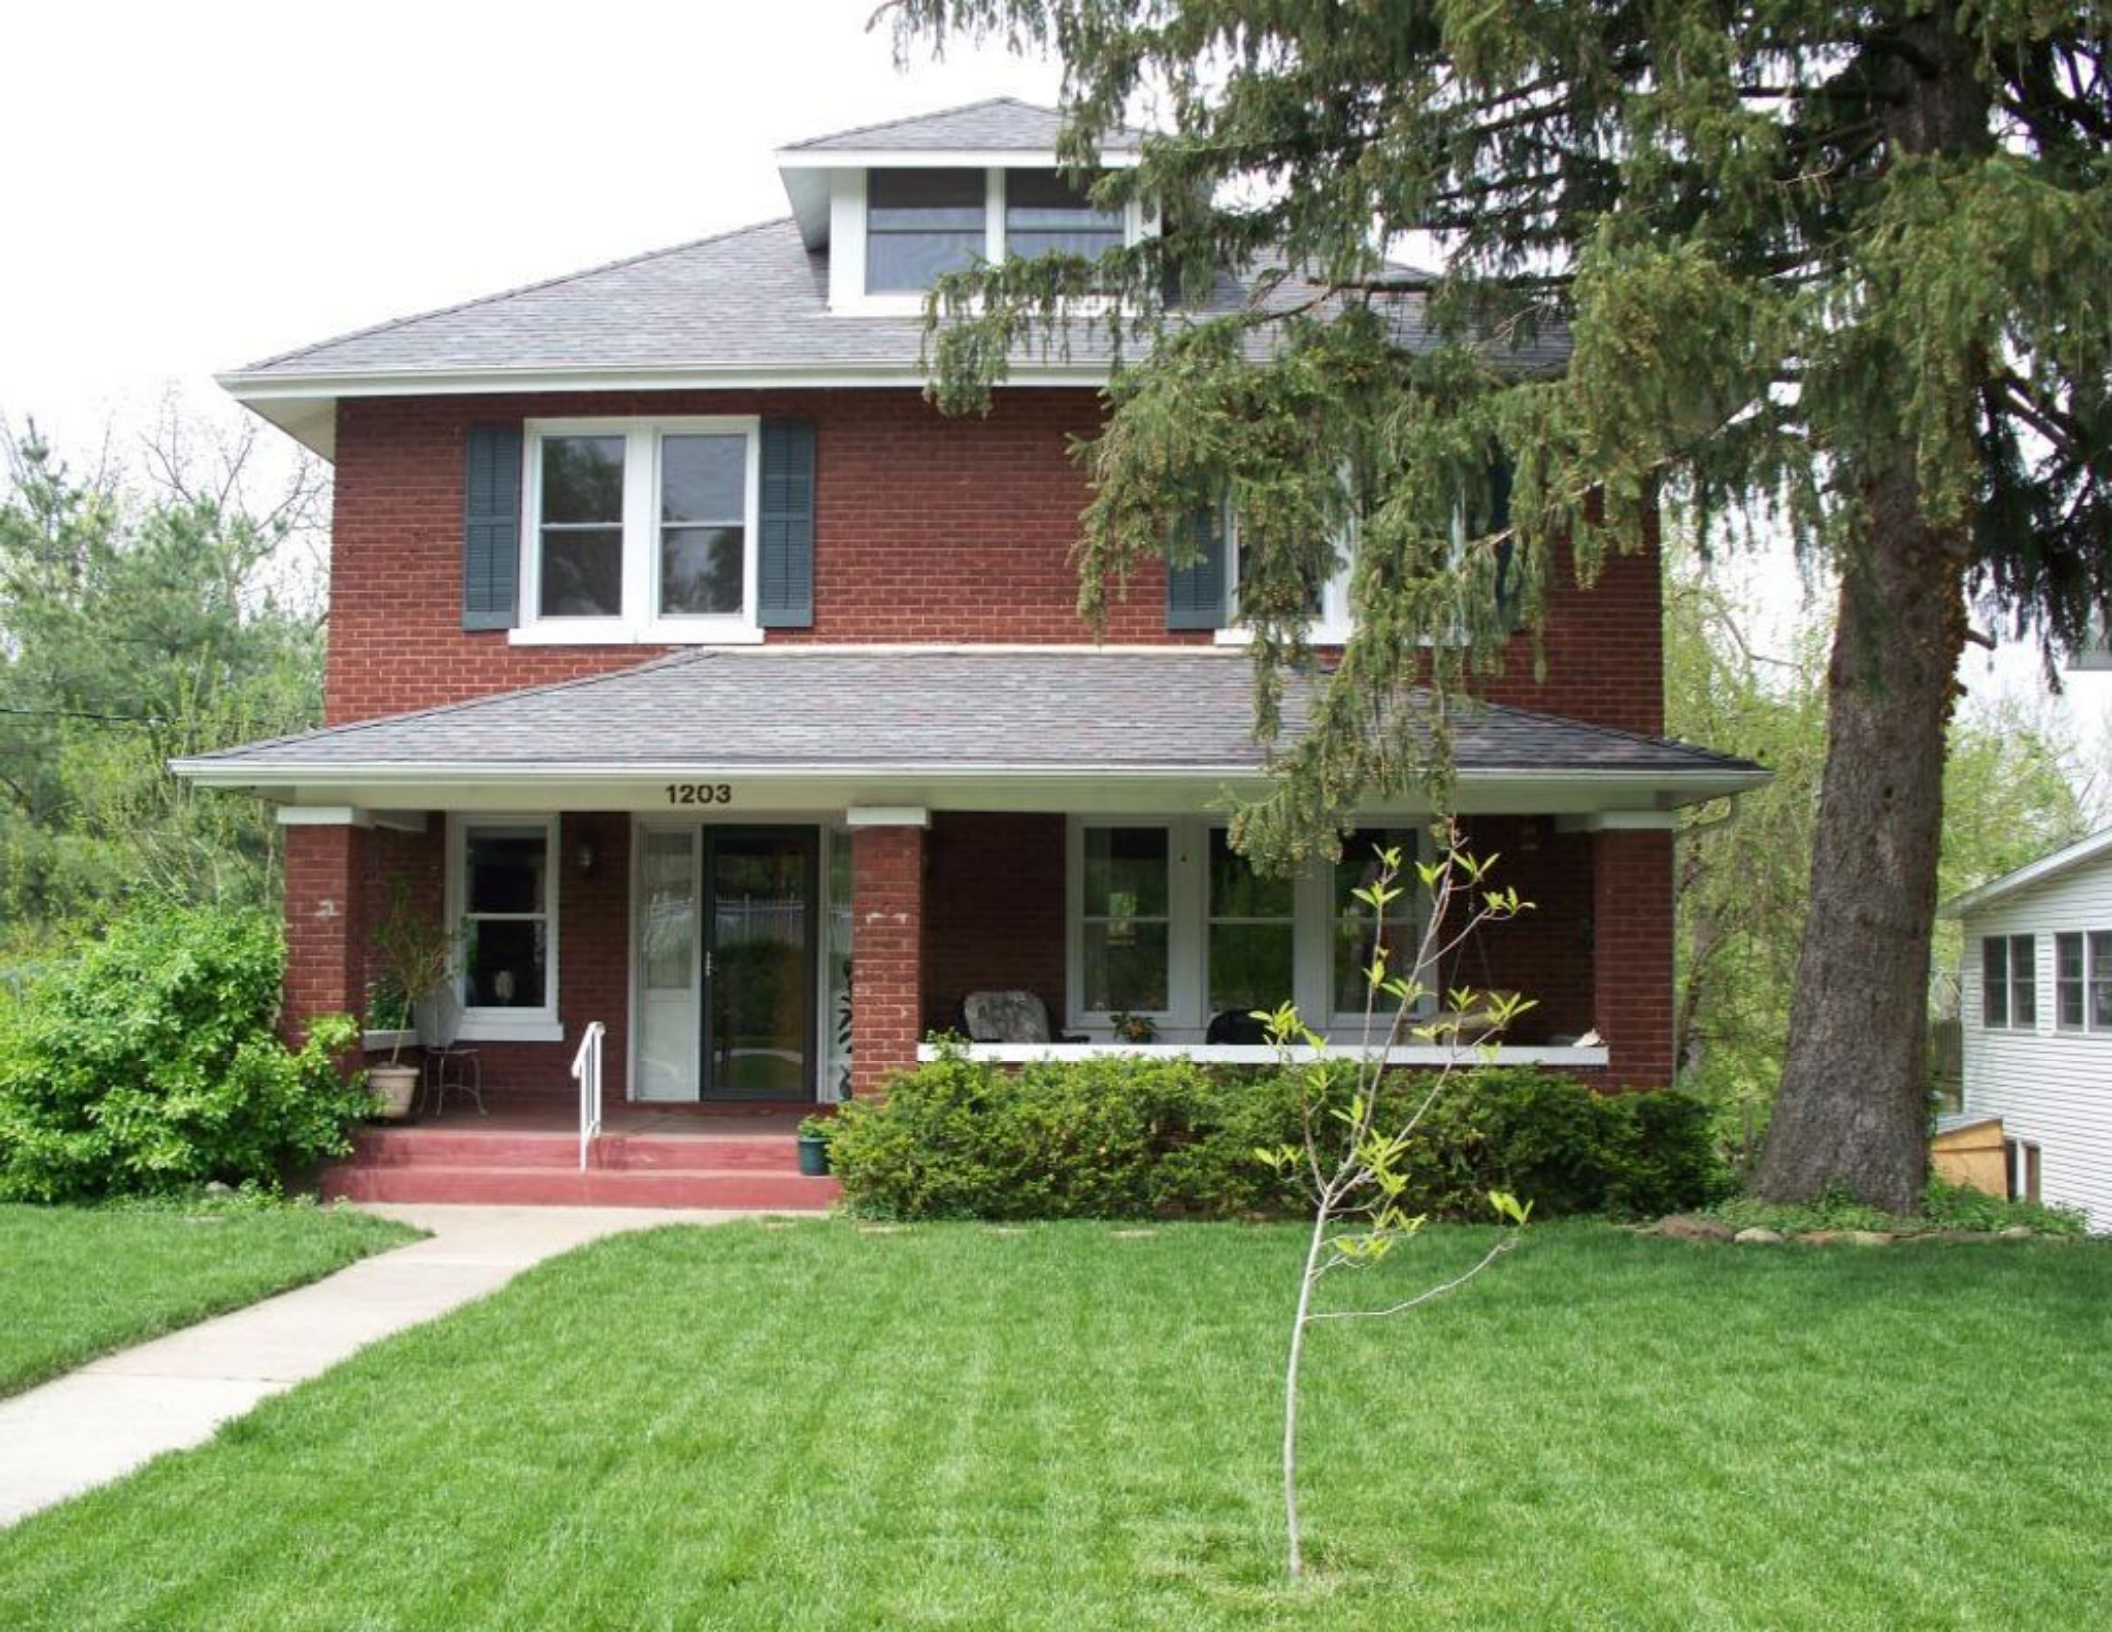
1203

This two and a half story brick home has a high hipped or pyramidal roof with the chimney located at the peak. There is a central dormer with a high hipped/pyramidal roof with paired replacement 1/1 windows. The second floor has two paired 1/1 replacement windows with shutters. The first story (from the left) has a single 1/1 replacement window, the entrance with sidelights and what appears to be the original historic door, and a row of three 1/1 replacement windows. The full width front porch feature brick piers and half wall capped in concrete or limestone. Two limestone steps lead to the porch and are divided down the center with a metal rail.

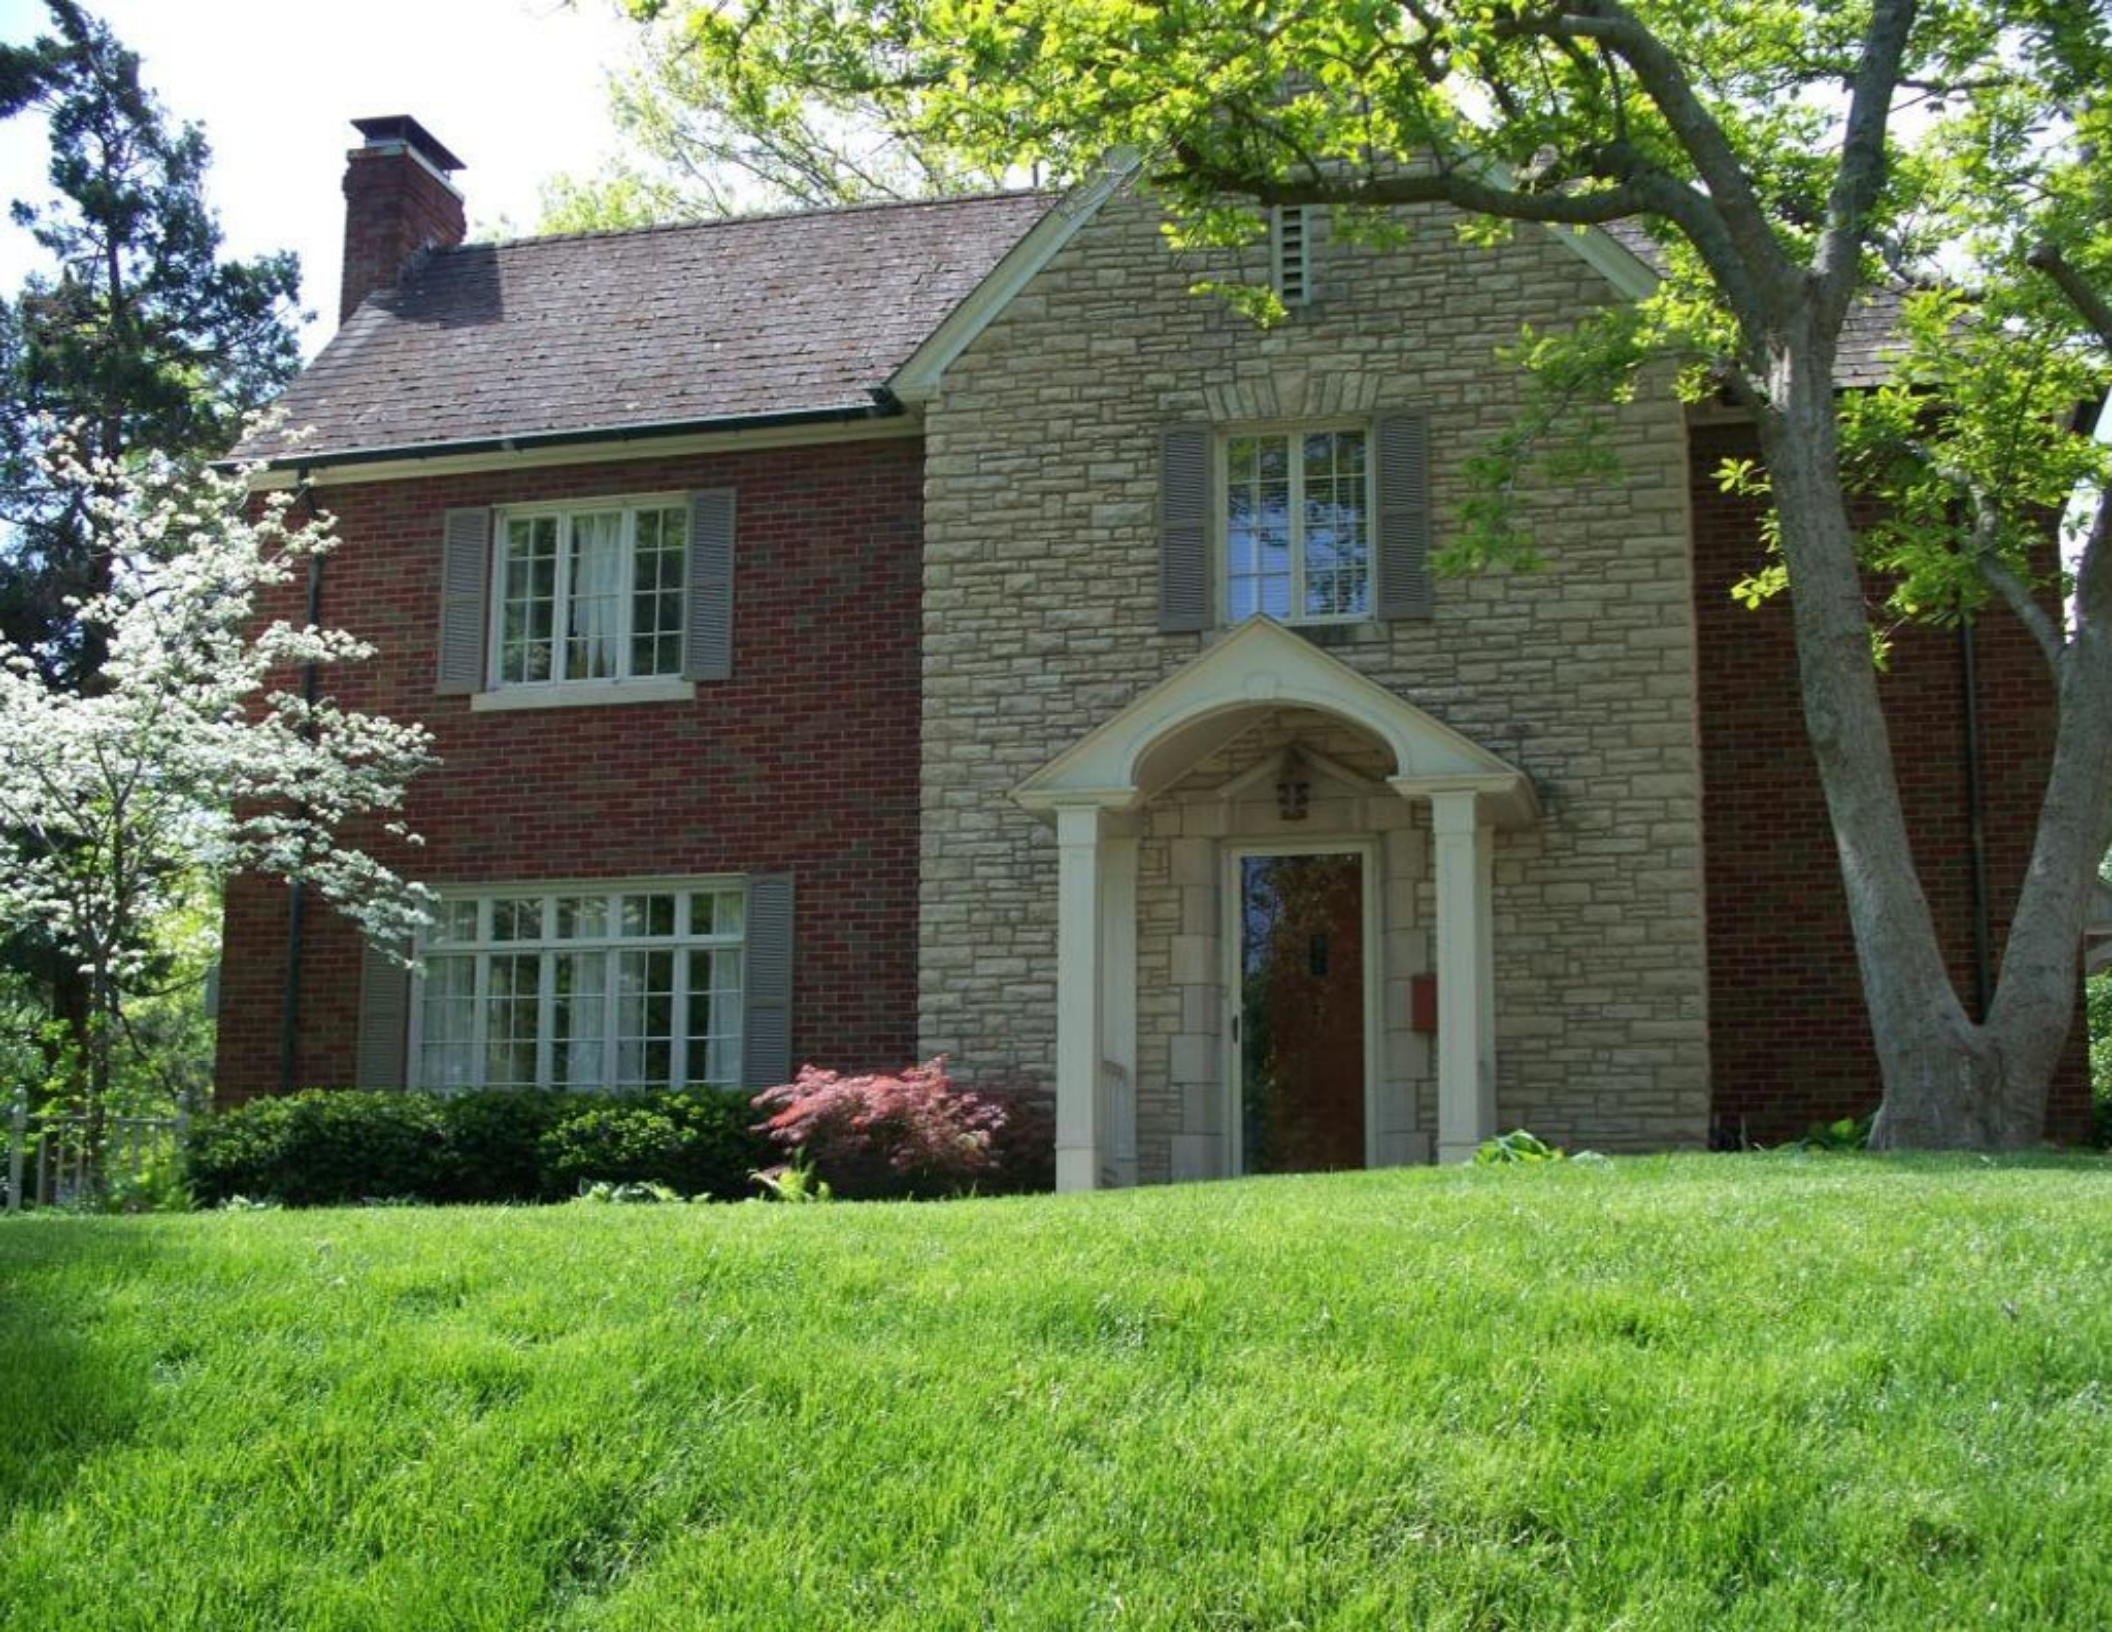
40. (cont.) Description of environment and outbuildings. Expand box as necessary, or add continuation pages.
There is a detached brick garage with a hipped or pyramidal roof that appears historic, although the door is likely a replacement.

41. (cont.)
This is a two story brick cross gable home. The front gable is one bay long and project slightly from the center (slightly off center to the right) of the home and is clad in stone. The gable has a small rectangular vent and the second story window and contains 8x8 windows with a keystone jack arch with shutters on the second floor and the entrance on the first. The entrance appears to retain its original door and has stone quoining around the entrance that is capped by a pediment. The entrance is covered by a gabled portico with square piers that meet an arched opening.
The first bay is clad in brick and contains a row of three 8 light casement windows on the second floor and five 8 light window with transoms and shutters on the second. All of the windows appear to be modern. The other side of the entrance bay is blind.

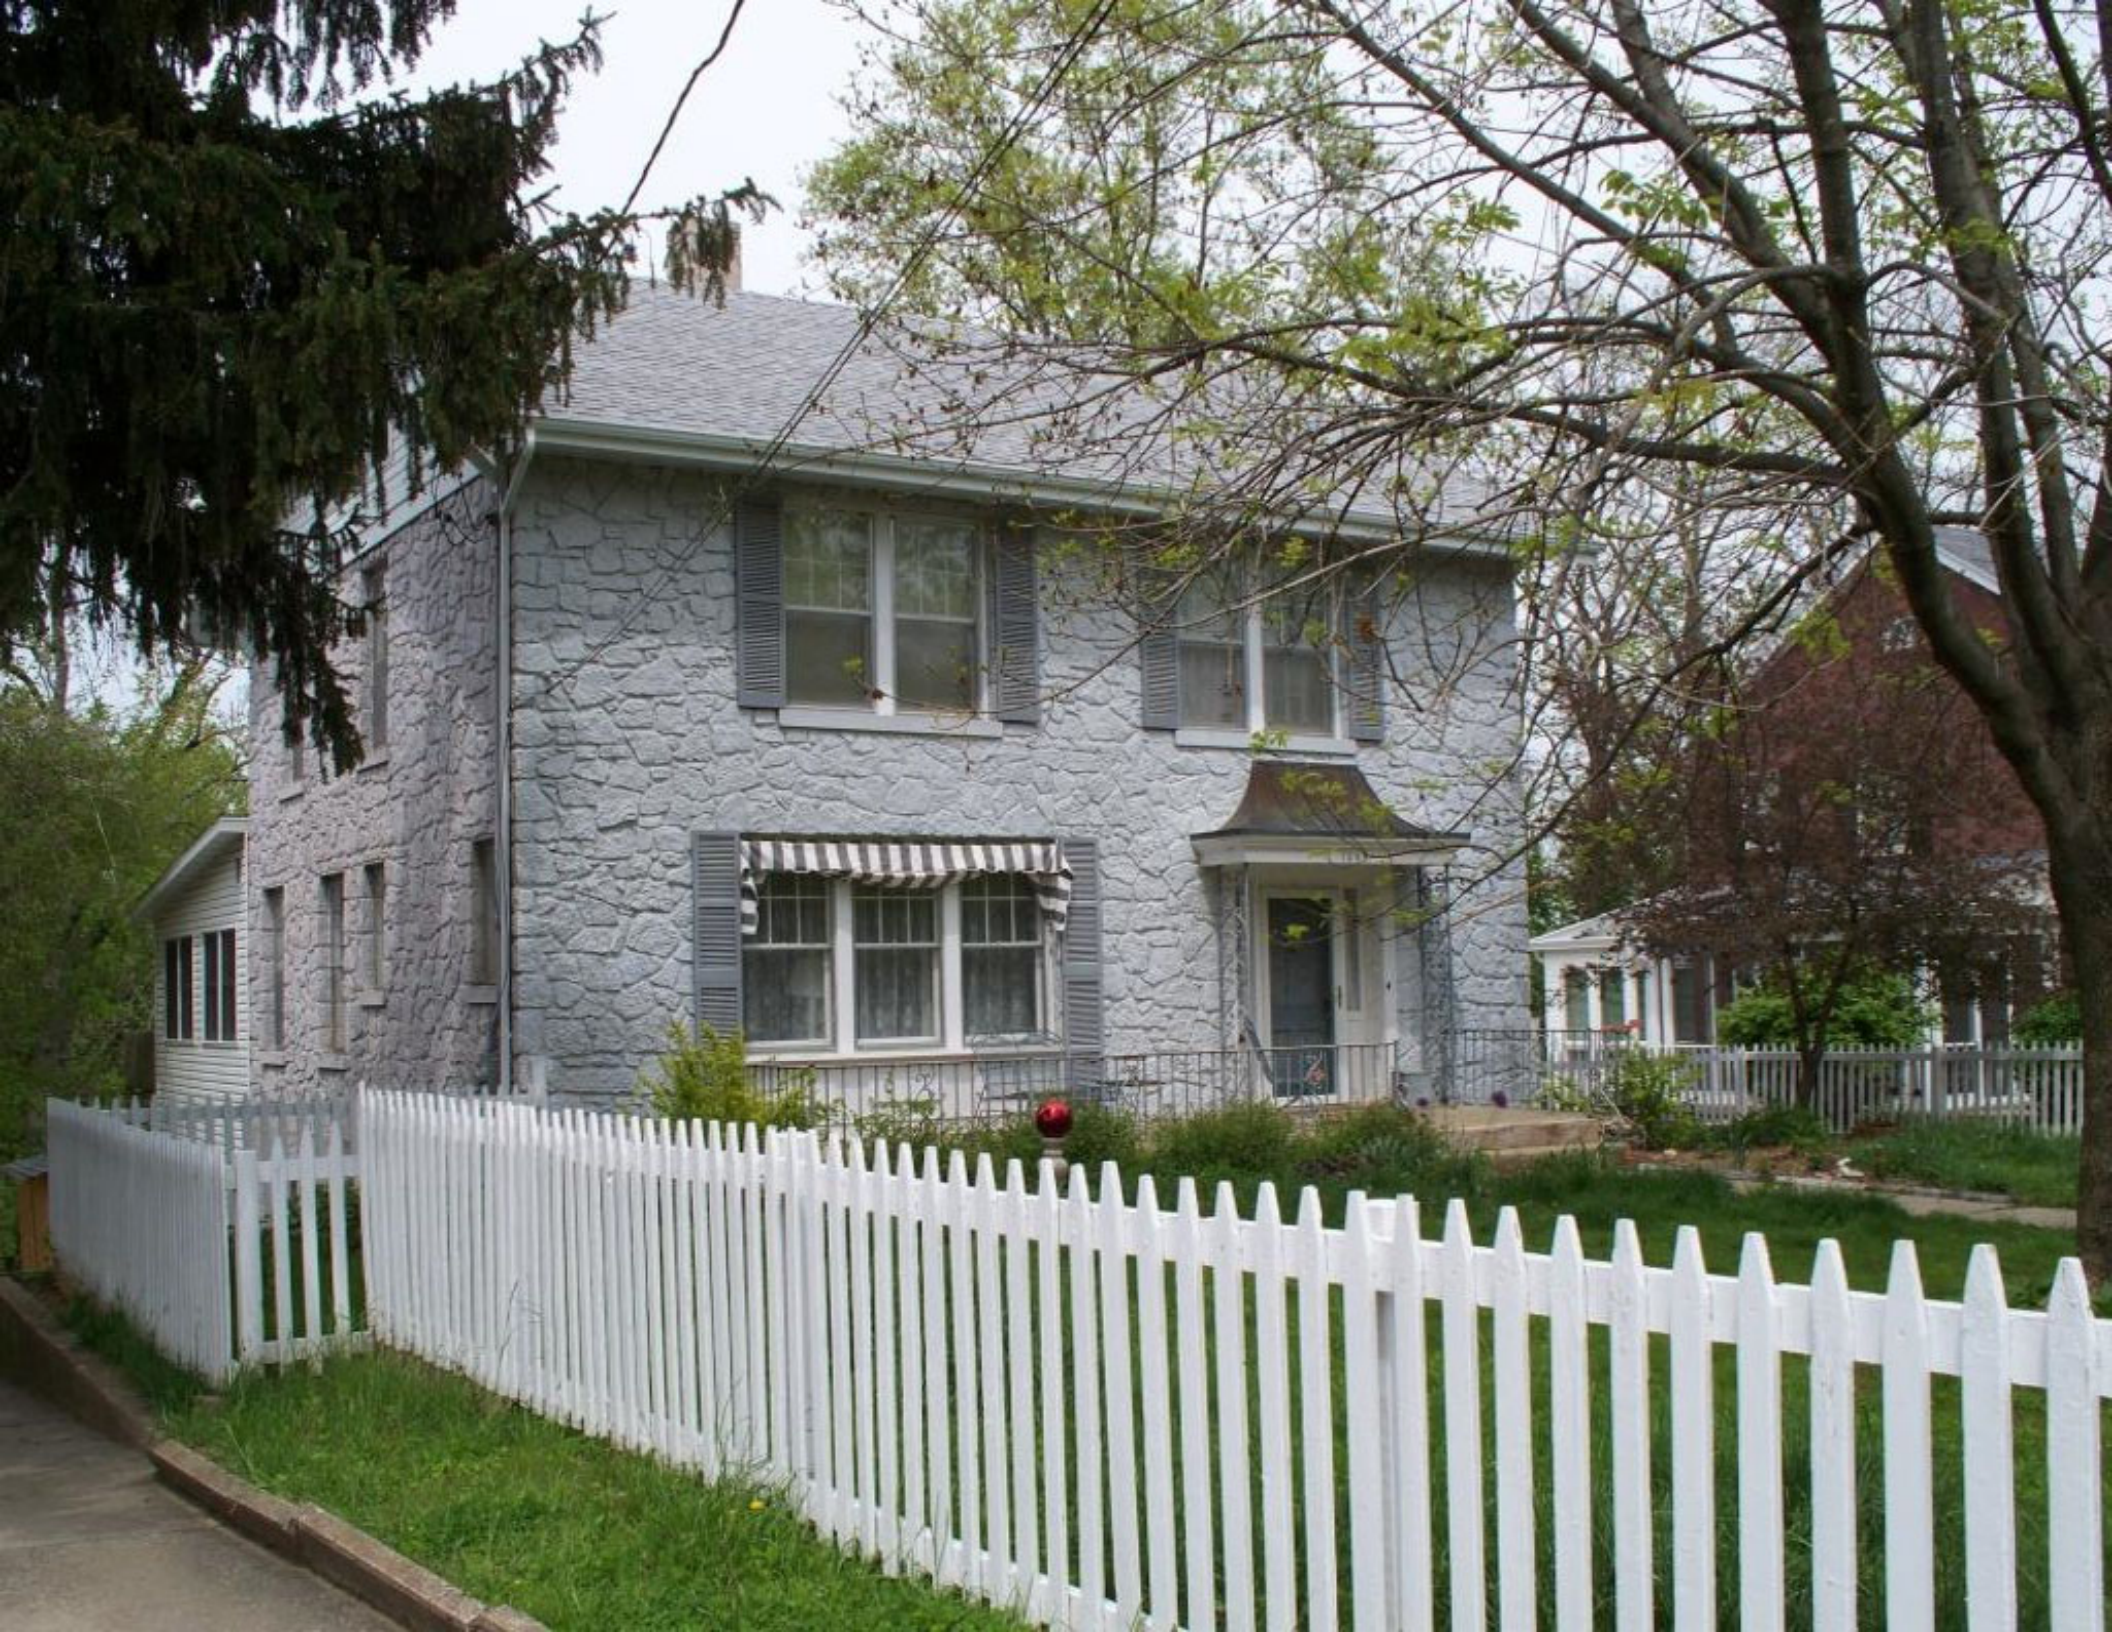
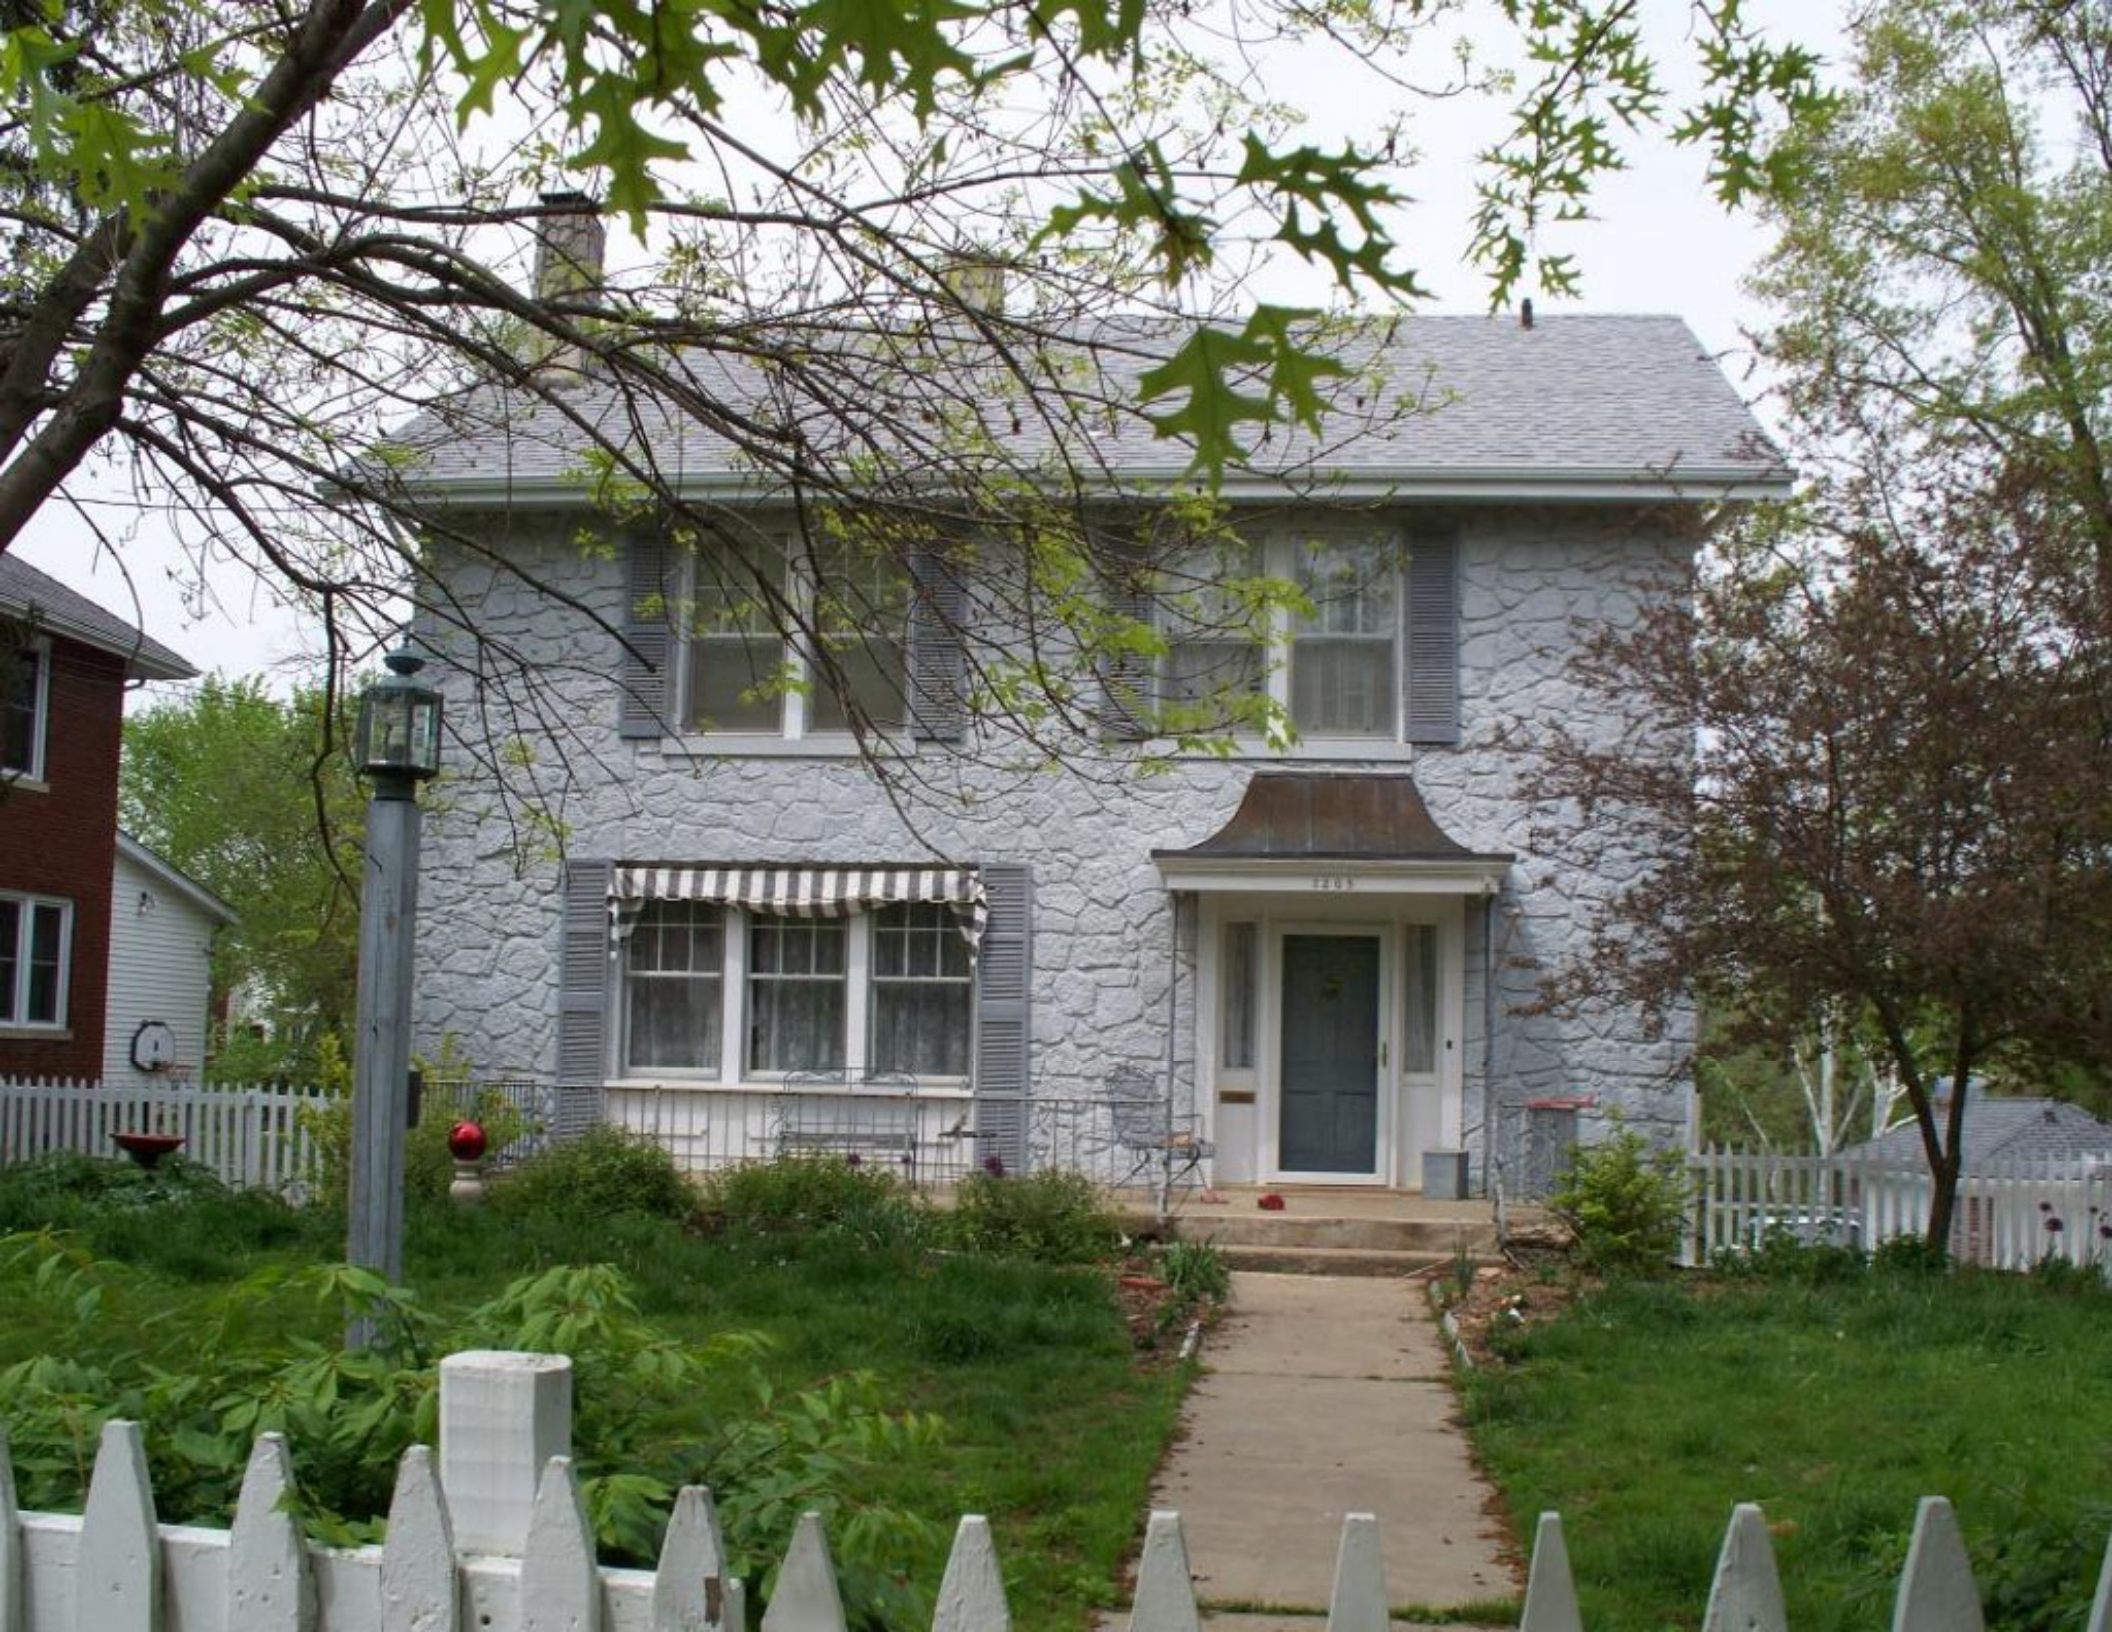
This two-story home has stone siding that has been painted a uniform grey, which makes it seem faux at first glance. The unpainted stone chimneys that rise from the left side of the home and the center are a strong indicator that the stone is authentic. The property has a side gable roof and two paired 6/1 windows with limestone sills and shutters. The first floor has a row of three 6/1 windows with paneling underneath and shutters that extend to the porch. There is a cloth awning over this opening. The right bay contains the entrance; a paneled door with sidelights that is covered by a bellcast hipped metal hood with decorative rails that extend to the porch. The porch consists of a full width concrete pad with decorative metal railing.
