ARCHITECTURAL/HISTORIC INVENTORY FORM

1. Survey No. CO-AS-005-001		2. Survey name: Moreau Drive Neighborhood Survey	
3. County: Cole		4. Address: 1202 Elmerine Ave.	
5. City: Jefferson City	Vicinity: <input type="checkbox"/>	6. UTM: / /	7. Township/Range/Section: T: R: S:
8. Historic name (if known):		9. Present/other name (if known):	
10. Ownership: <input checked="" type="checkbox"/> Private <input type="checkbox"/> Public		11. Historic use (if known): Residential	11. Current use: Residential

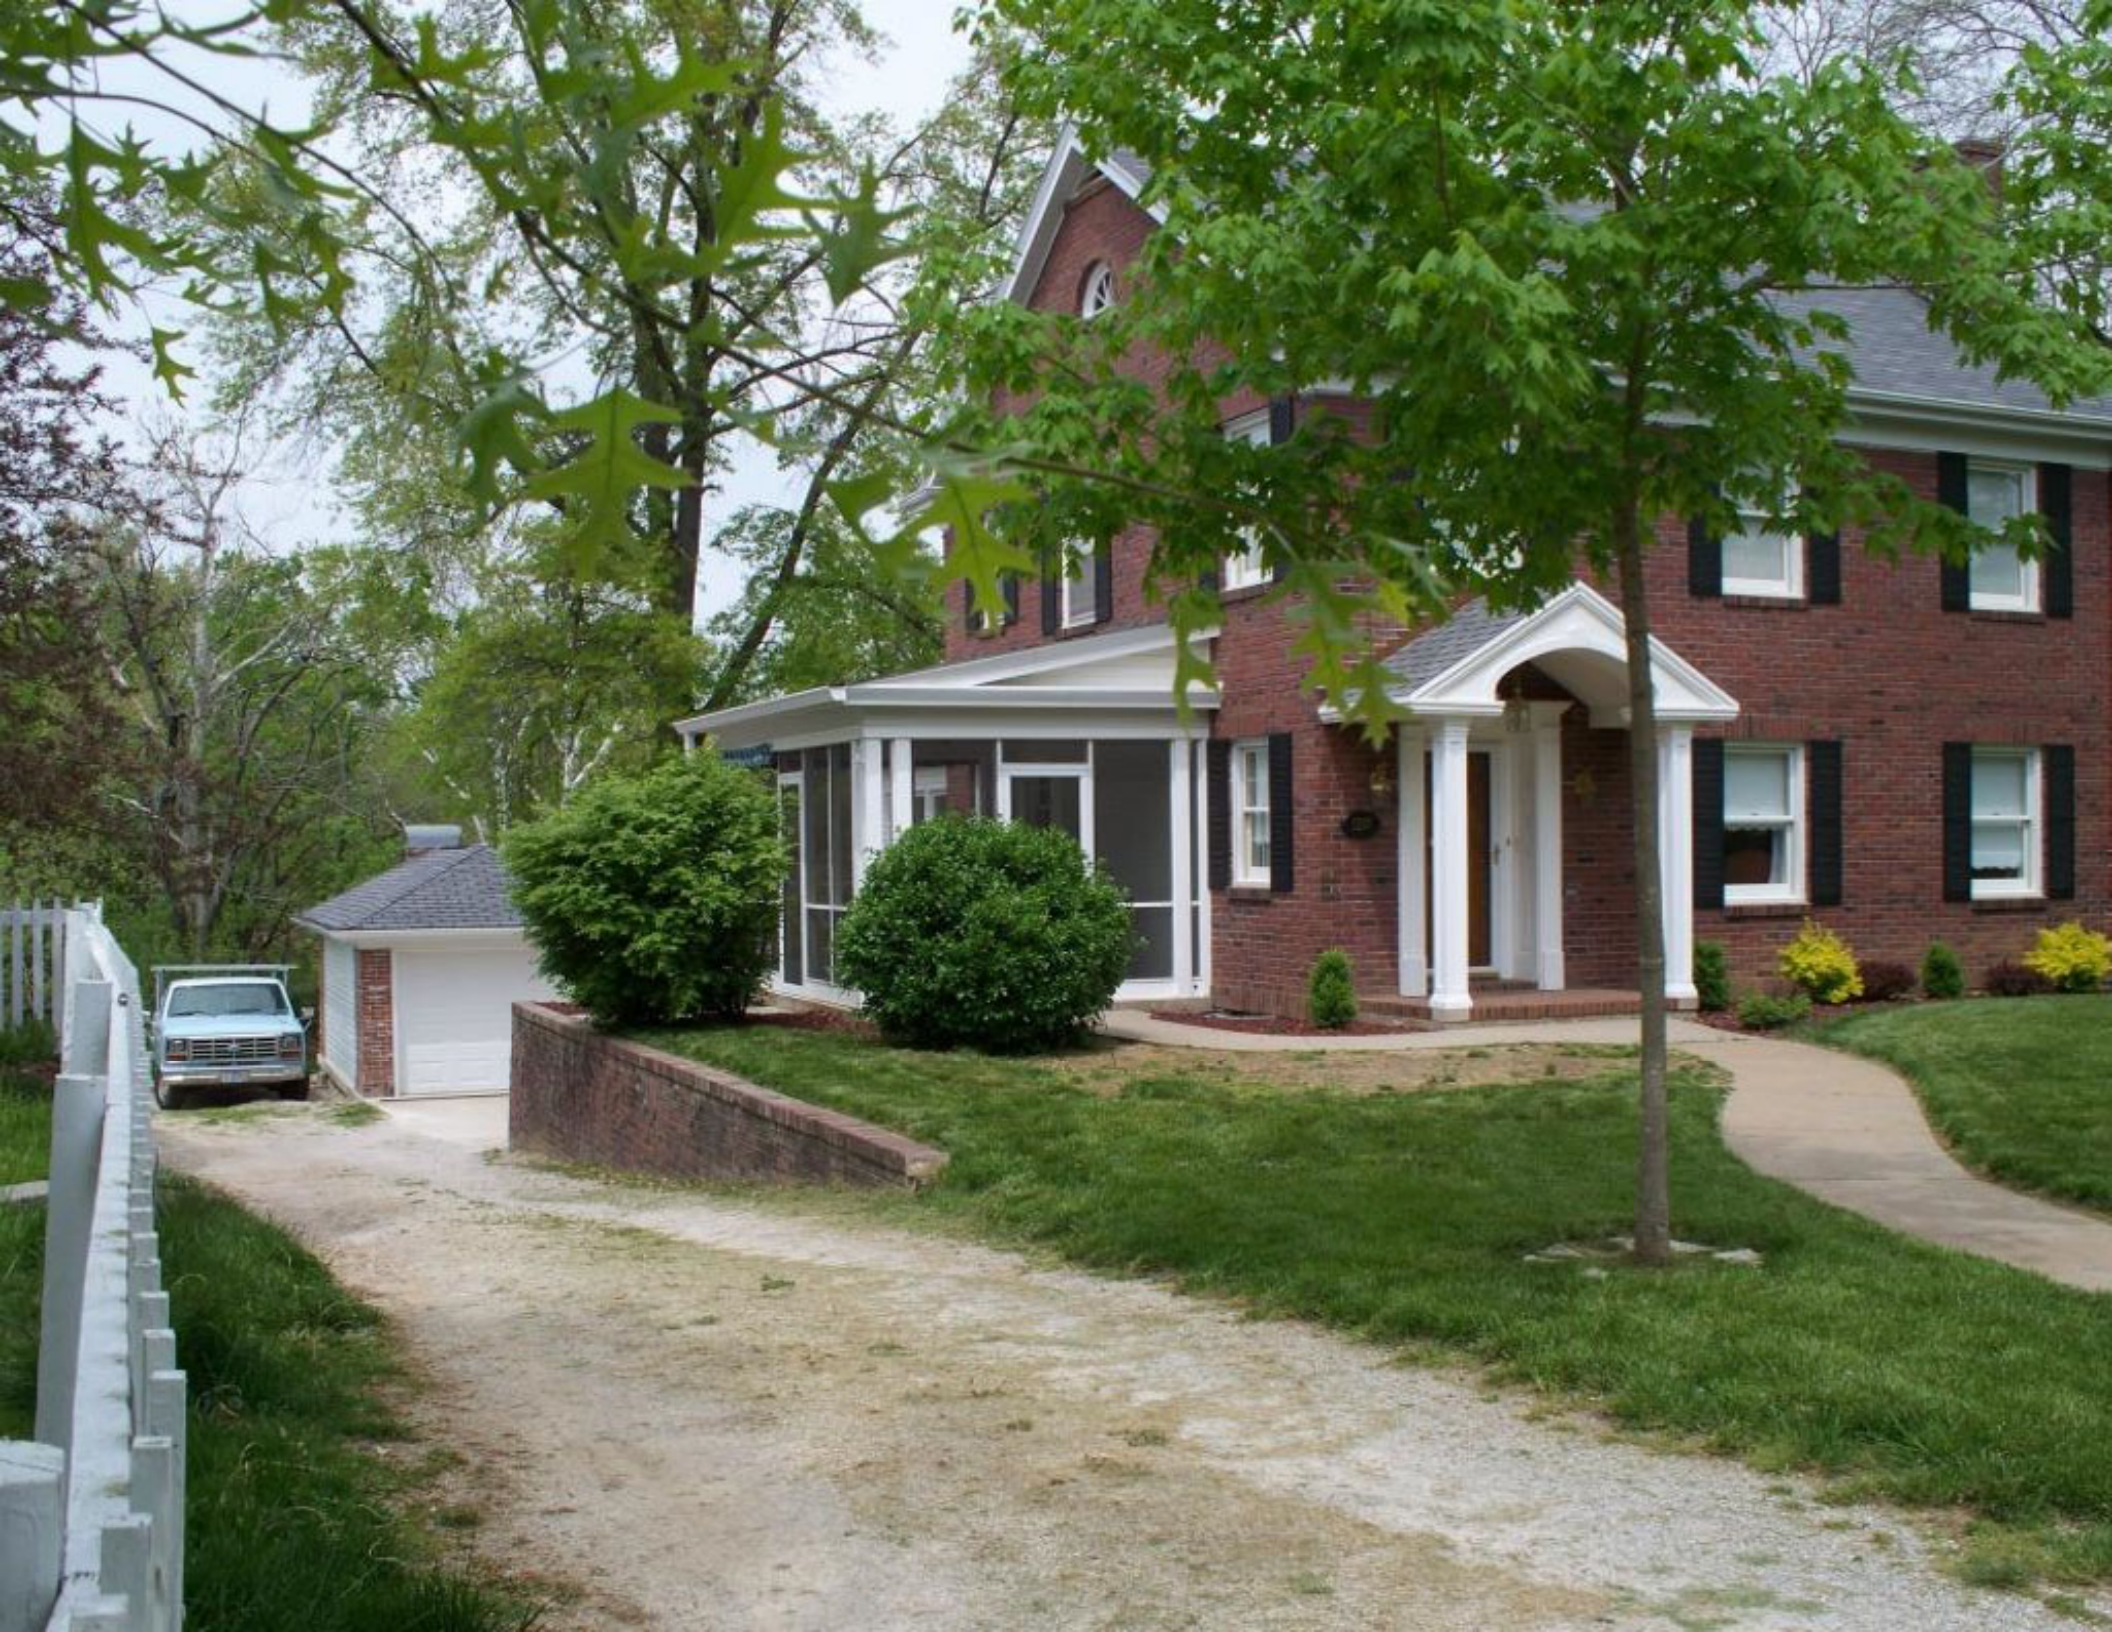
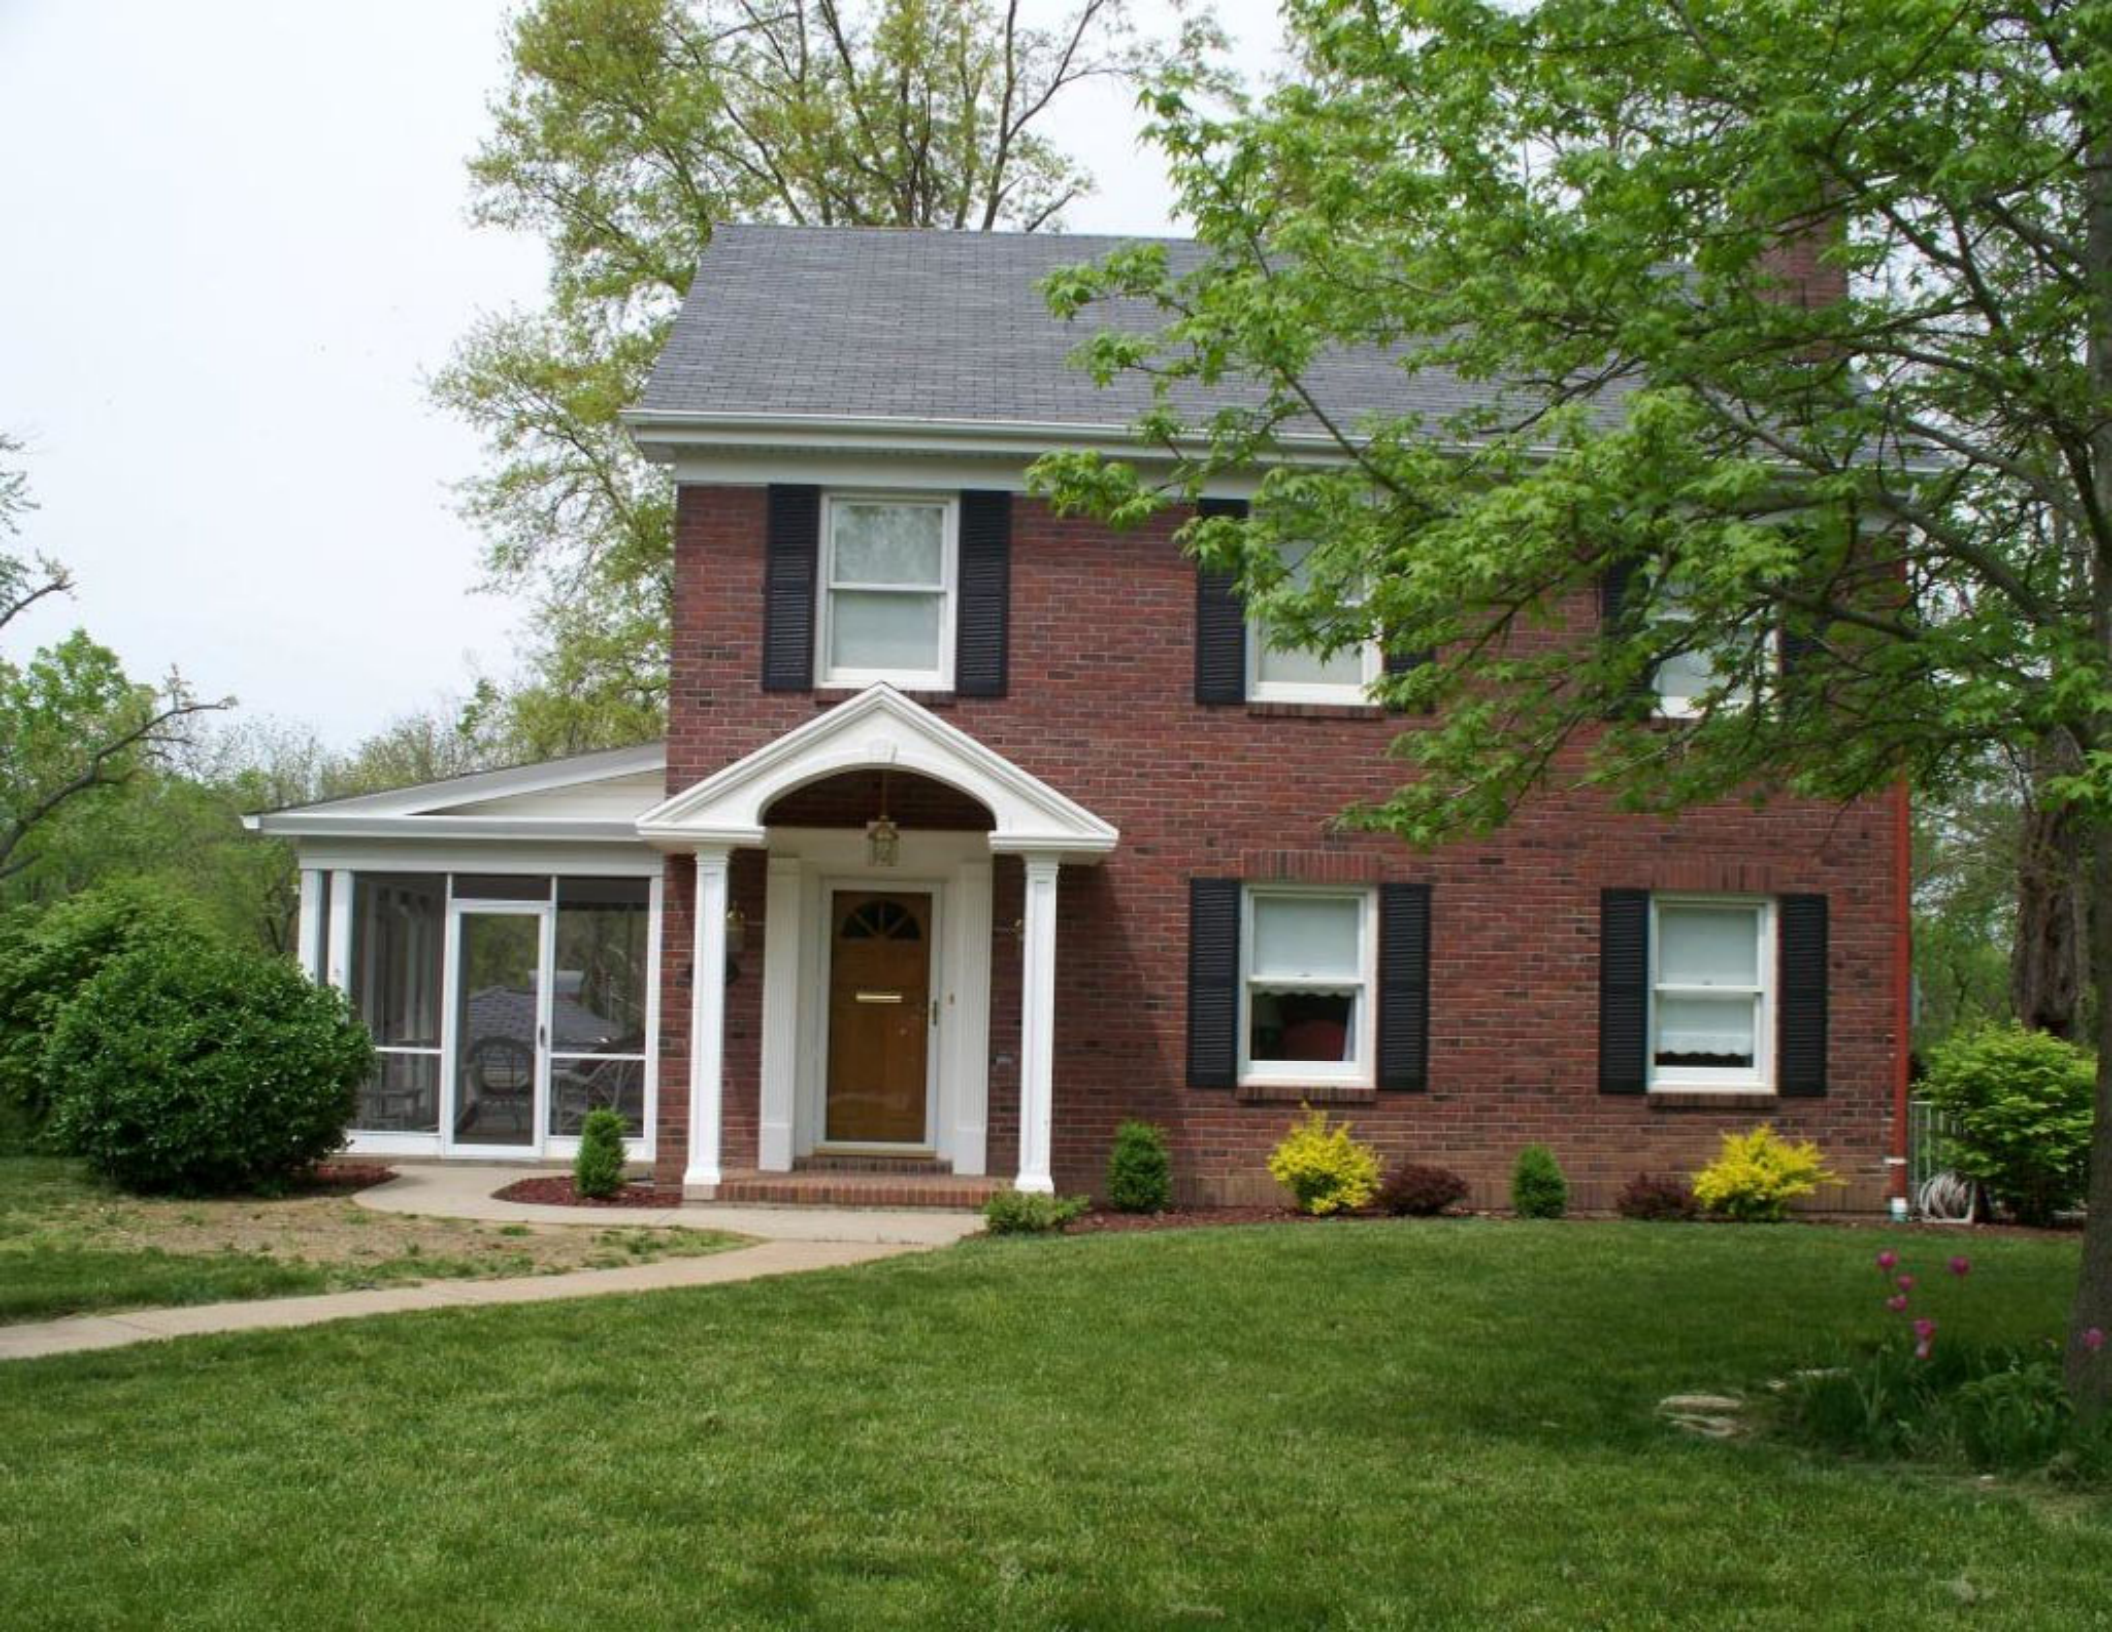
41. (cont.)
This two-story brick home does not appear on the 1943 Sanborn map. The Tax Assessor's Office dates it to 1920. More research is necessary to determine date, although it does appear that it was built prior to 1950 so it is considered contributing. The home has a side gabled roof and three vinyl 1/1 windows with shutters. On the first floor, from the right, the first bay contains a pediment portico with a basket handle arch and square columns that could be modern and a modern door with fanlight with an ornate door surround. The next two bays have vinyl 1/1 windows with shutters. All of the windows have brick rowlock sills. The windows on the first floor have soldier course flat arches. A one-story screened-in porch with a shed roof is slightly set back on the left side of the building

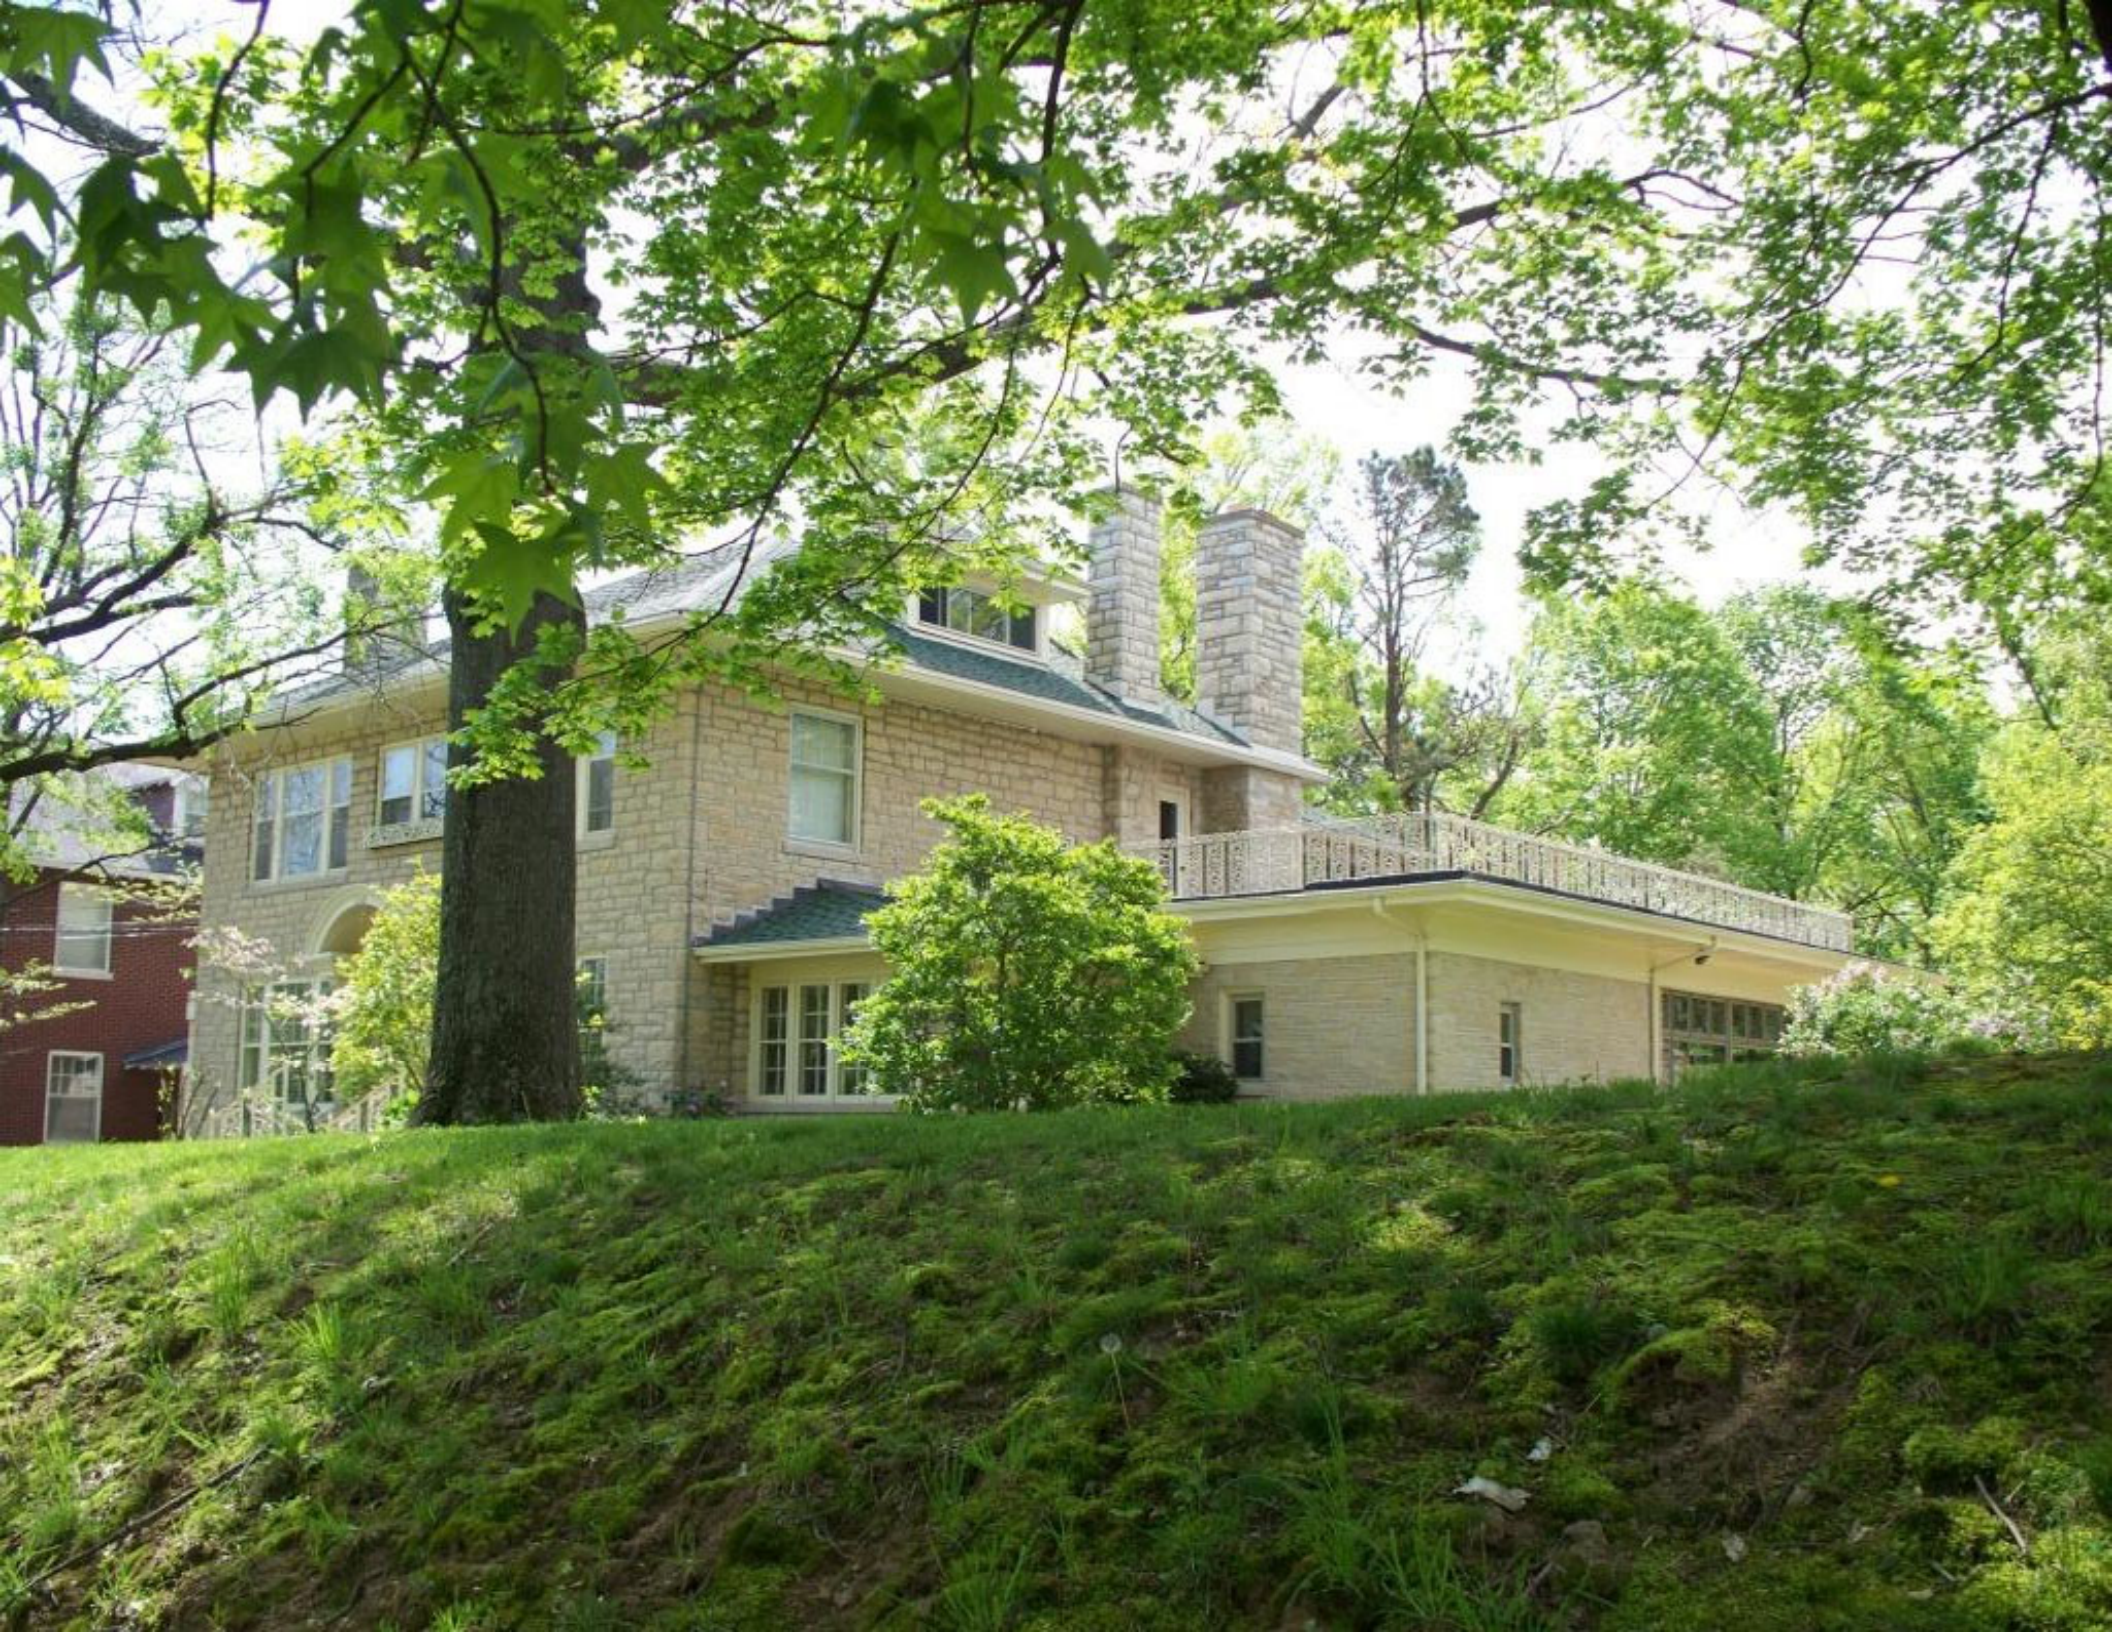
This two story stone home has a hipped roof with wide eaves. The upper floor has two tri-part windows flanking smaller paired windows. All of the windows appear to be modern replacements. The first floor has tri-part windows flanking the centered entrance that has a concrete stoop with iron rails and an ornate arched hood on brackets. To the left is a one story sunroom that is slightly set back from the main façade. It has a hipped roof with wide eaves and a row of four 8 light windows. Set back from this is a one story addition with a flat roof with ornate iron/metal railing and a small 1/1 window.

According to Gary Kremer this property was built in 1926, the Tax Assessor's office puts it at 1930.

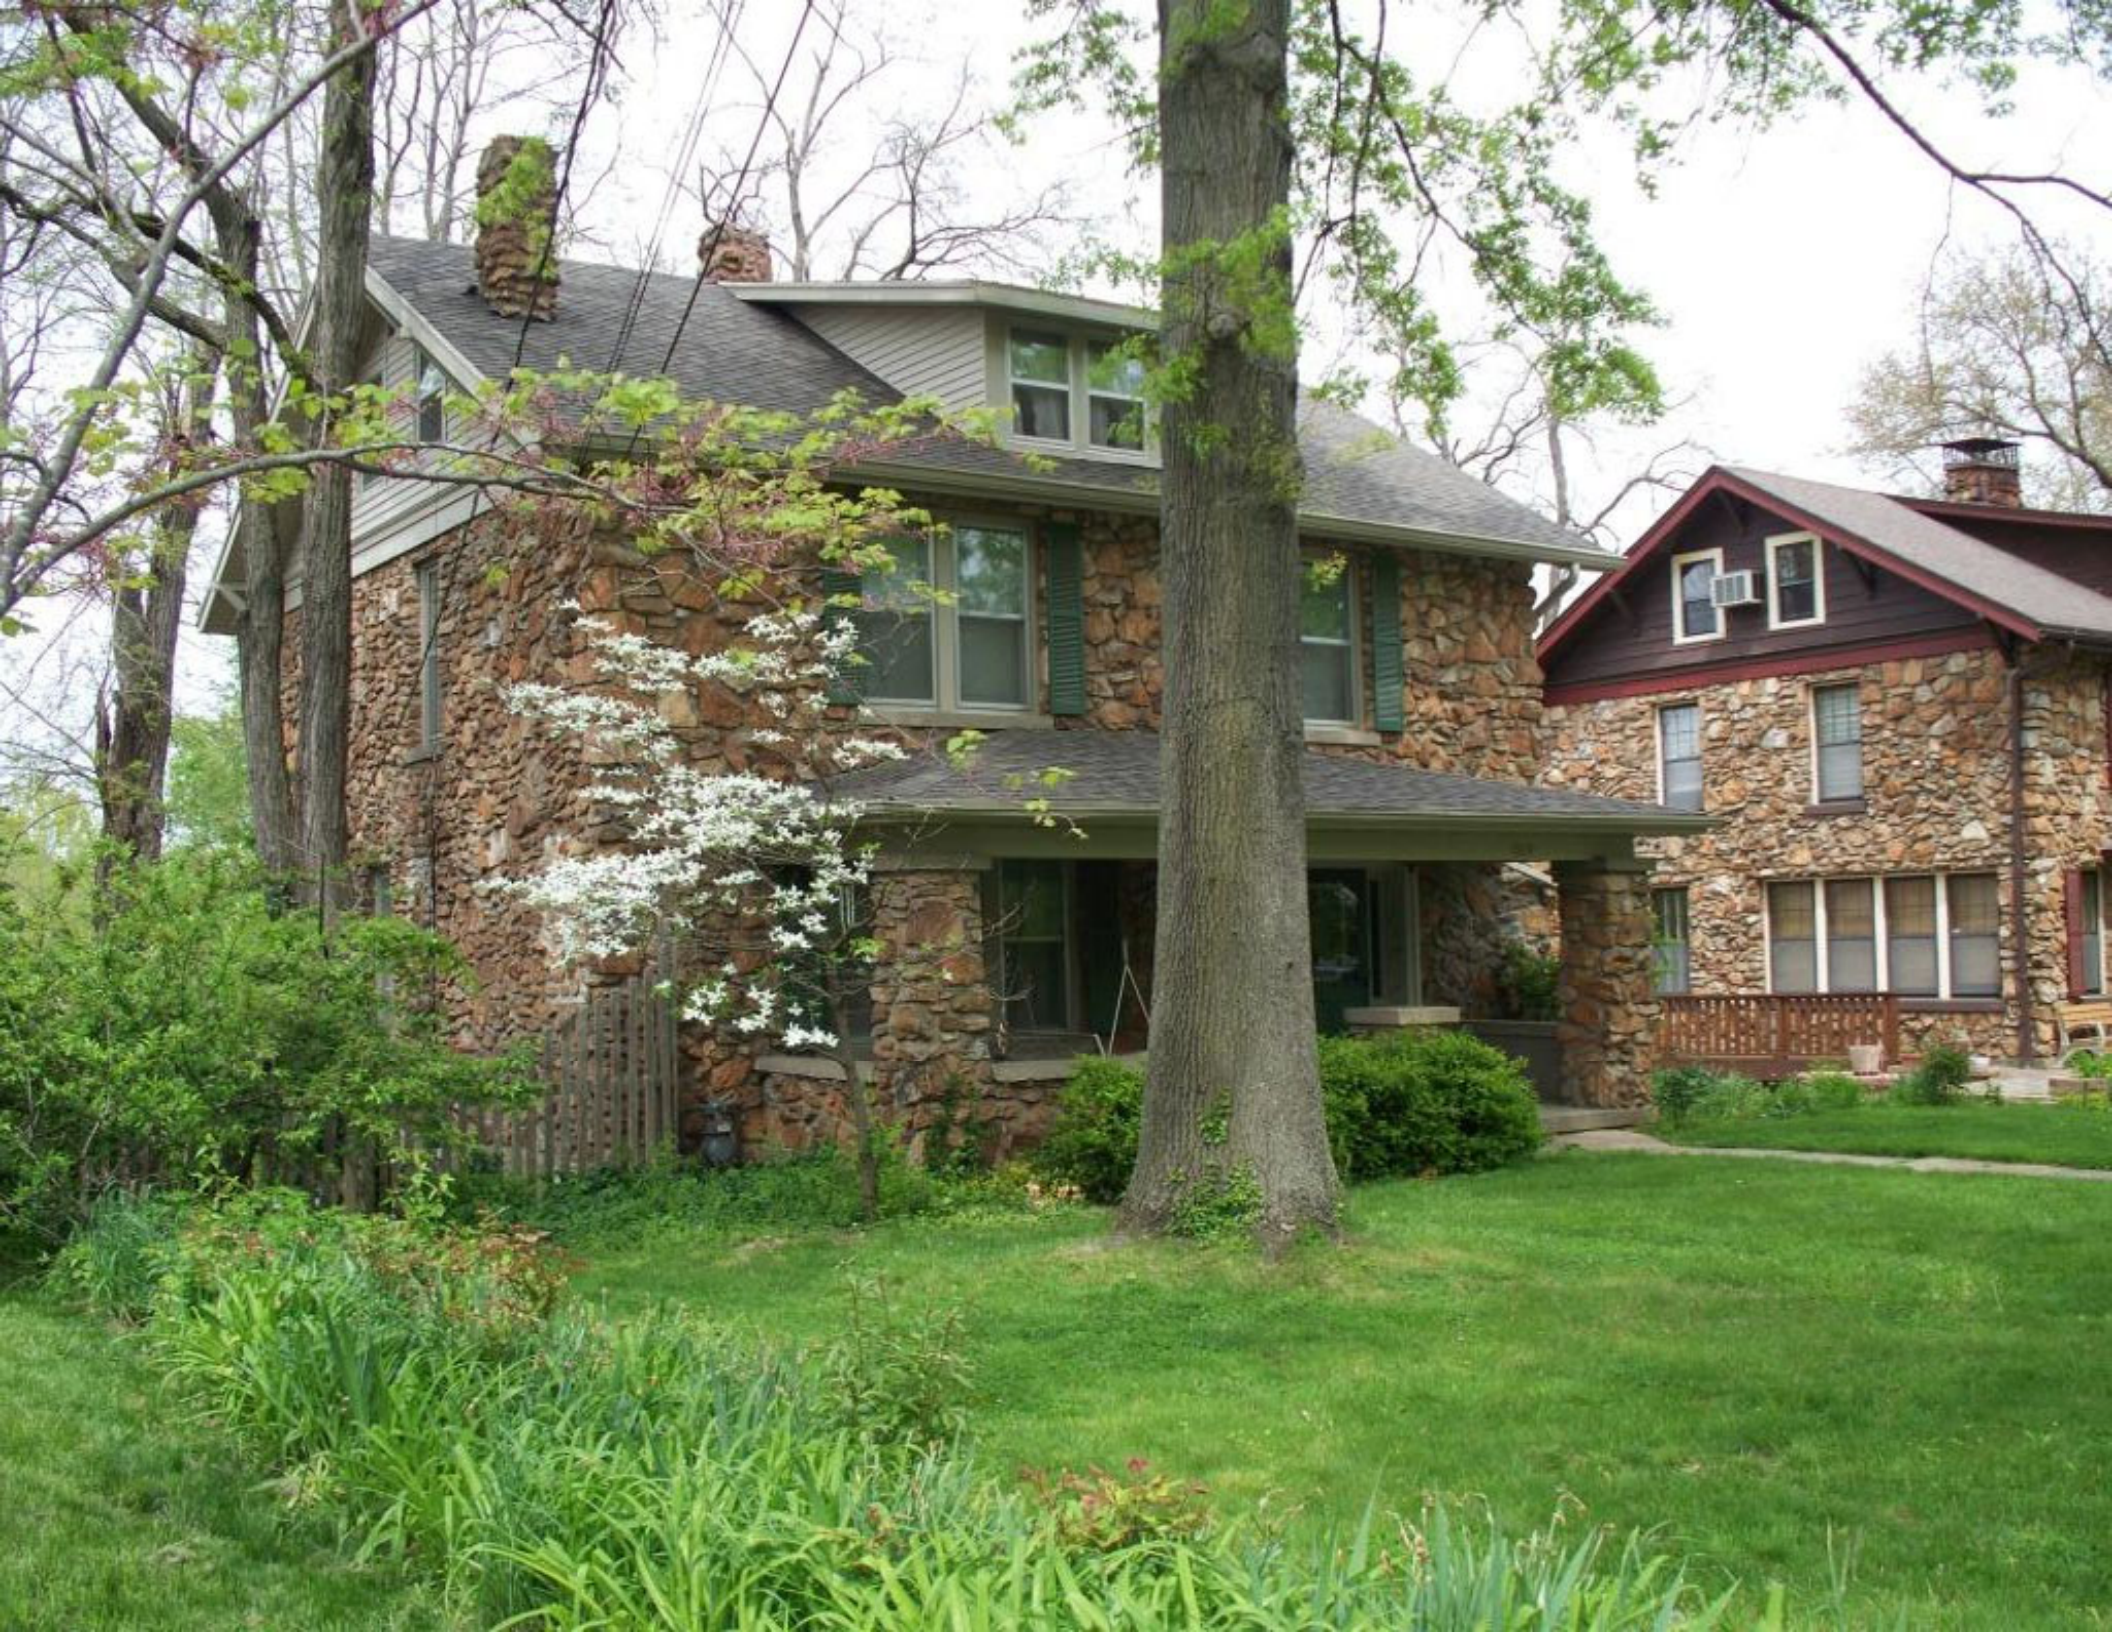
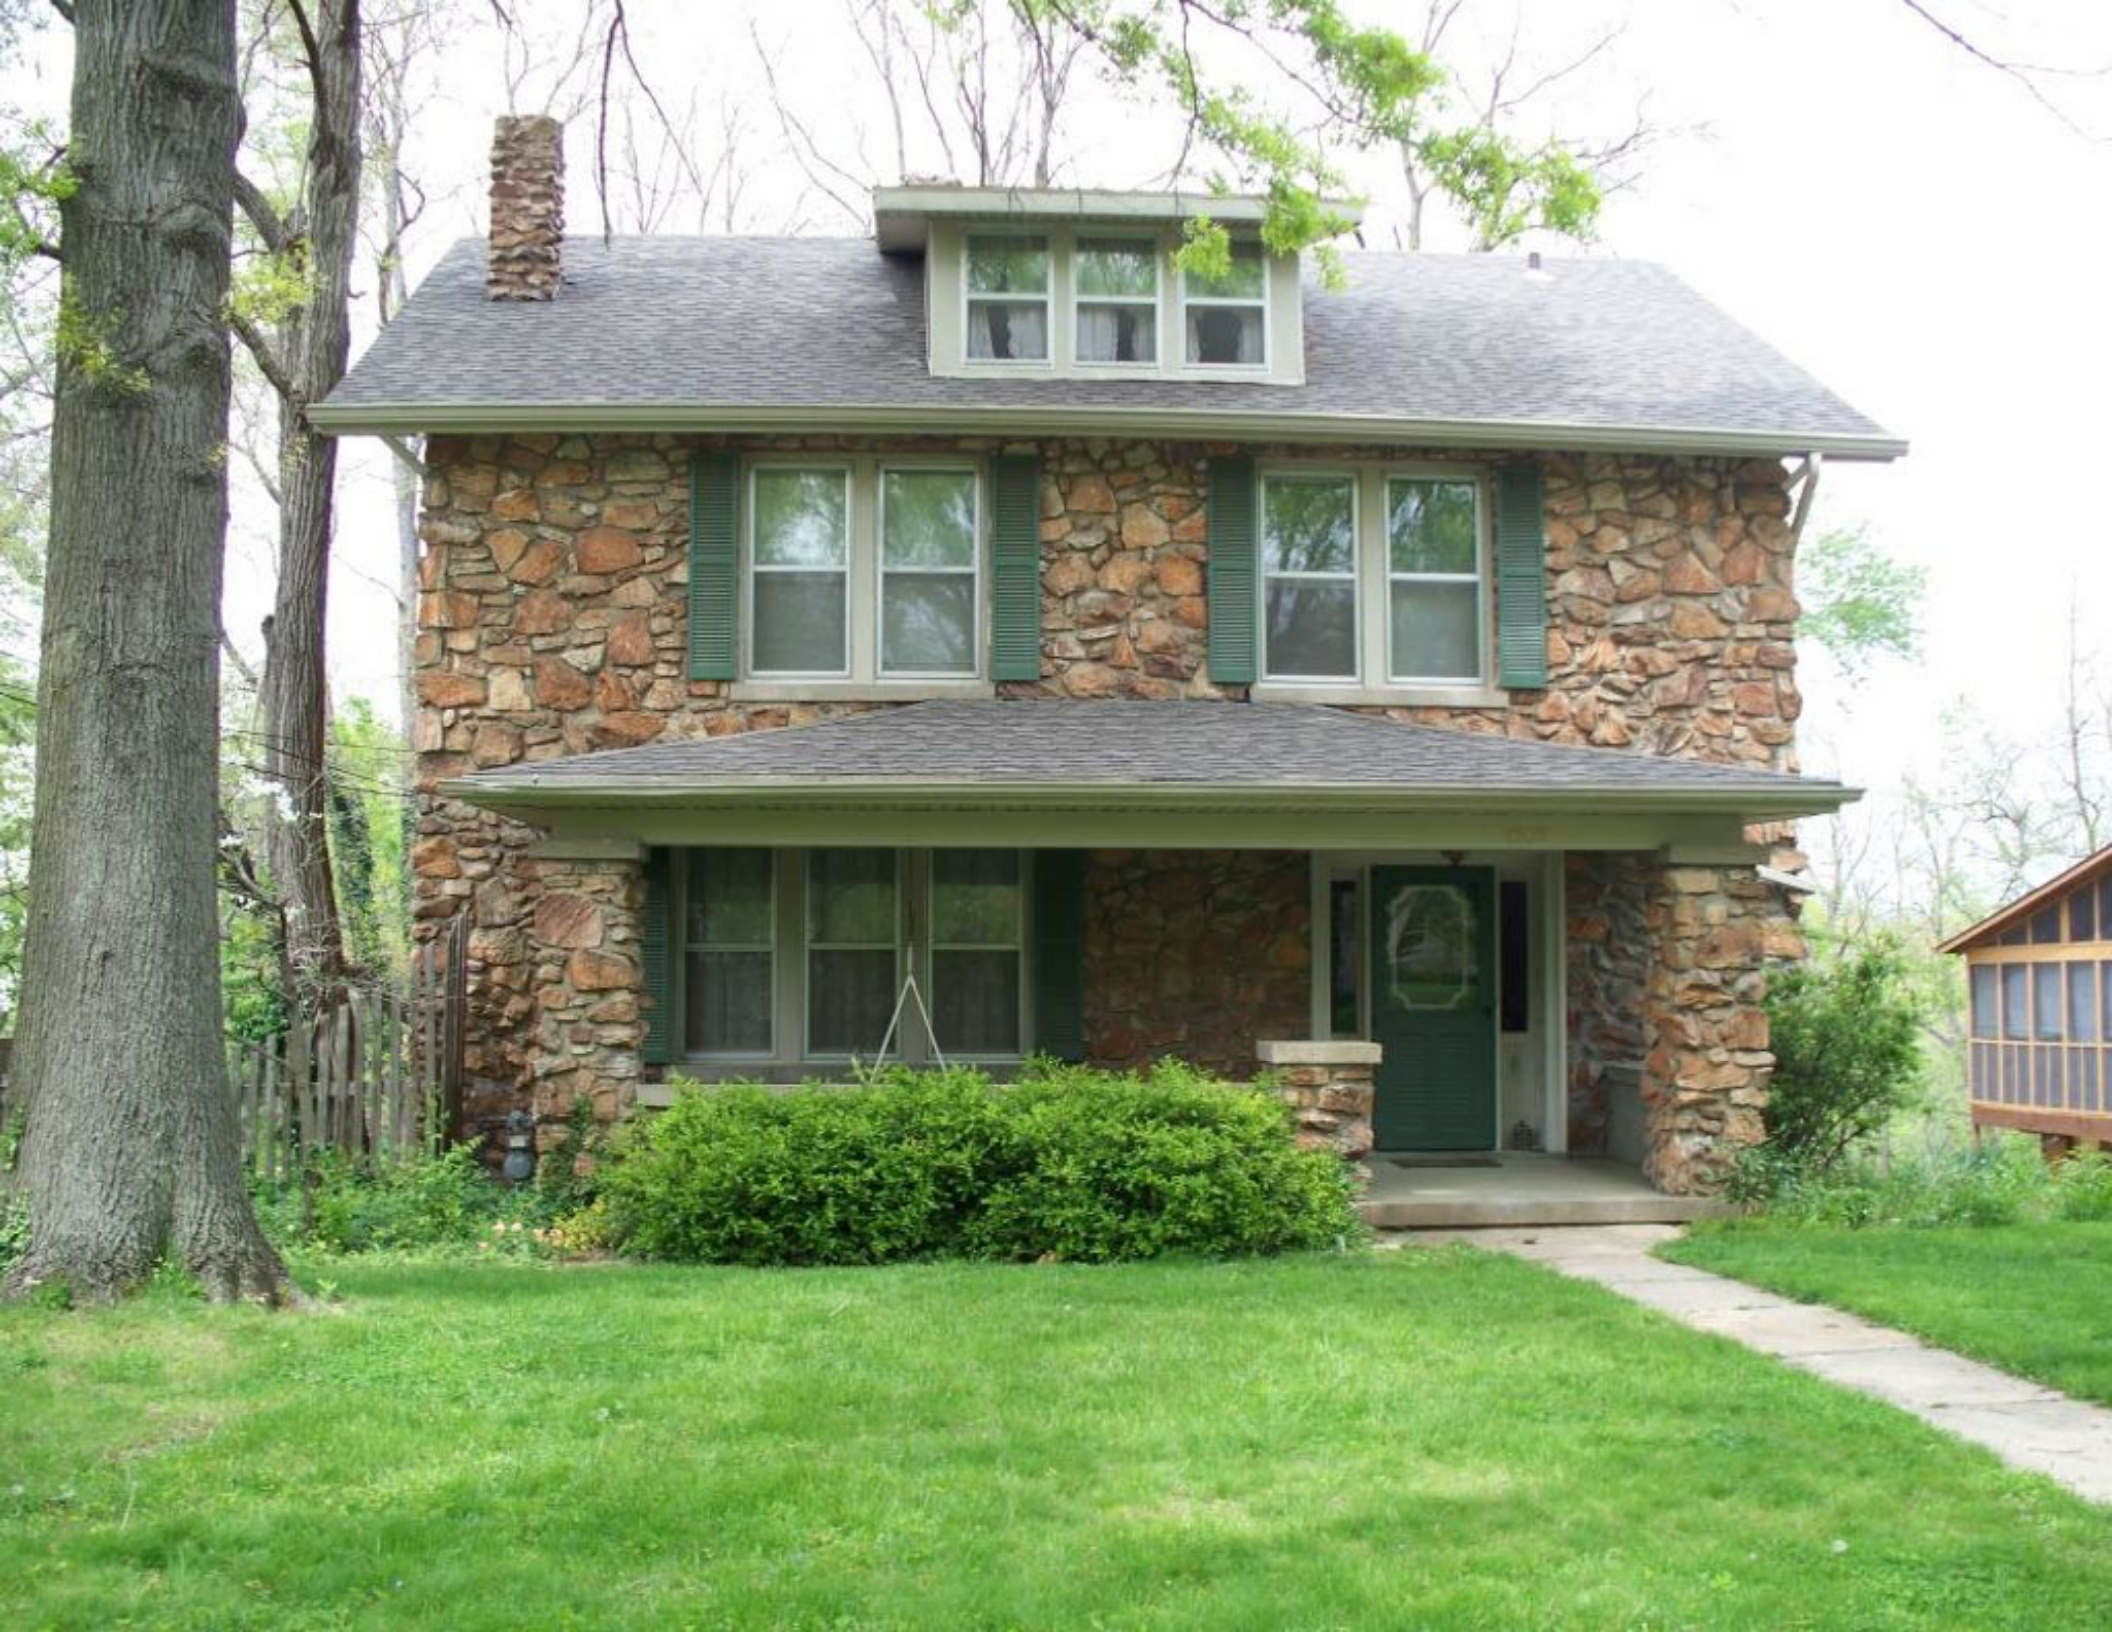
This 2 ½ story home is clad in uncut/rough cut rubble that appears to be Ozark Rock. The property has a side gable roof with a central shed dormer with two paired 1/1 windows with shutters. All of the windows on this property have aluminum screens so it is difficult to determine if they are historic or not. The second story has two paired 1/1 windows with shutters. The first floor has a row of three 1/1 windows with shutters in the left bay and the entrance with sidelights in the right. There is a nearly full-width porch with Ozark rock half walls and piers capped in limestone or concrete that supports a hipped roof. A chimney clad in Ozark Rock extends through the left side of the roof.
