ARCHITECTURAL/HISTORIC INVENTORY FORM

1. Survey No. CO-AS-005-001		2. Survey name: Moreau Drive Neighborhood Survey	
3. County: Cole		4. Address: 1202 Elmerine Ave.	
5. City: Jefferson City	Vicinity: <input type="checkbox"/>	6. UTM: / /	7. Township/Range/Section: T: R: S:
8. Historic name (if known):		9. Present/other name (if known):	
10. Ownership: <input checked="" type="checkbox"/> Private <input type="checkbox"/> Public		11. Historic use (if known): Residential	11. Current use: Residential

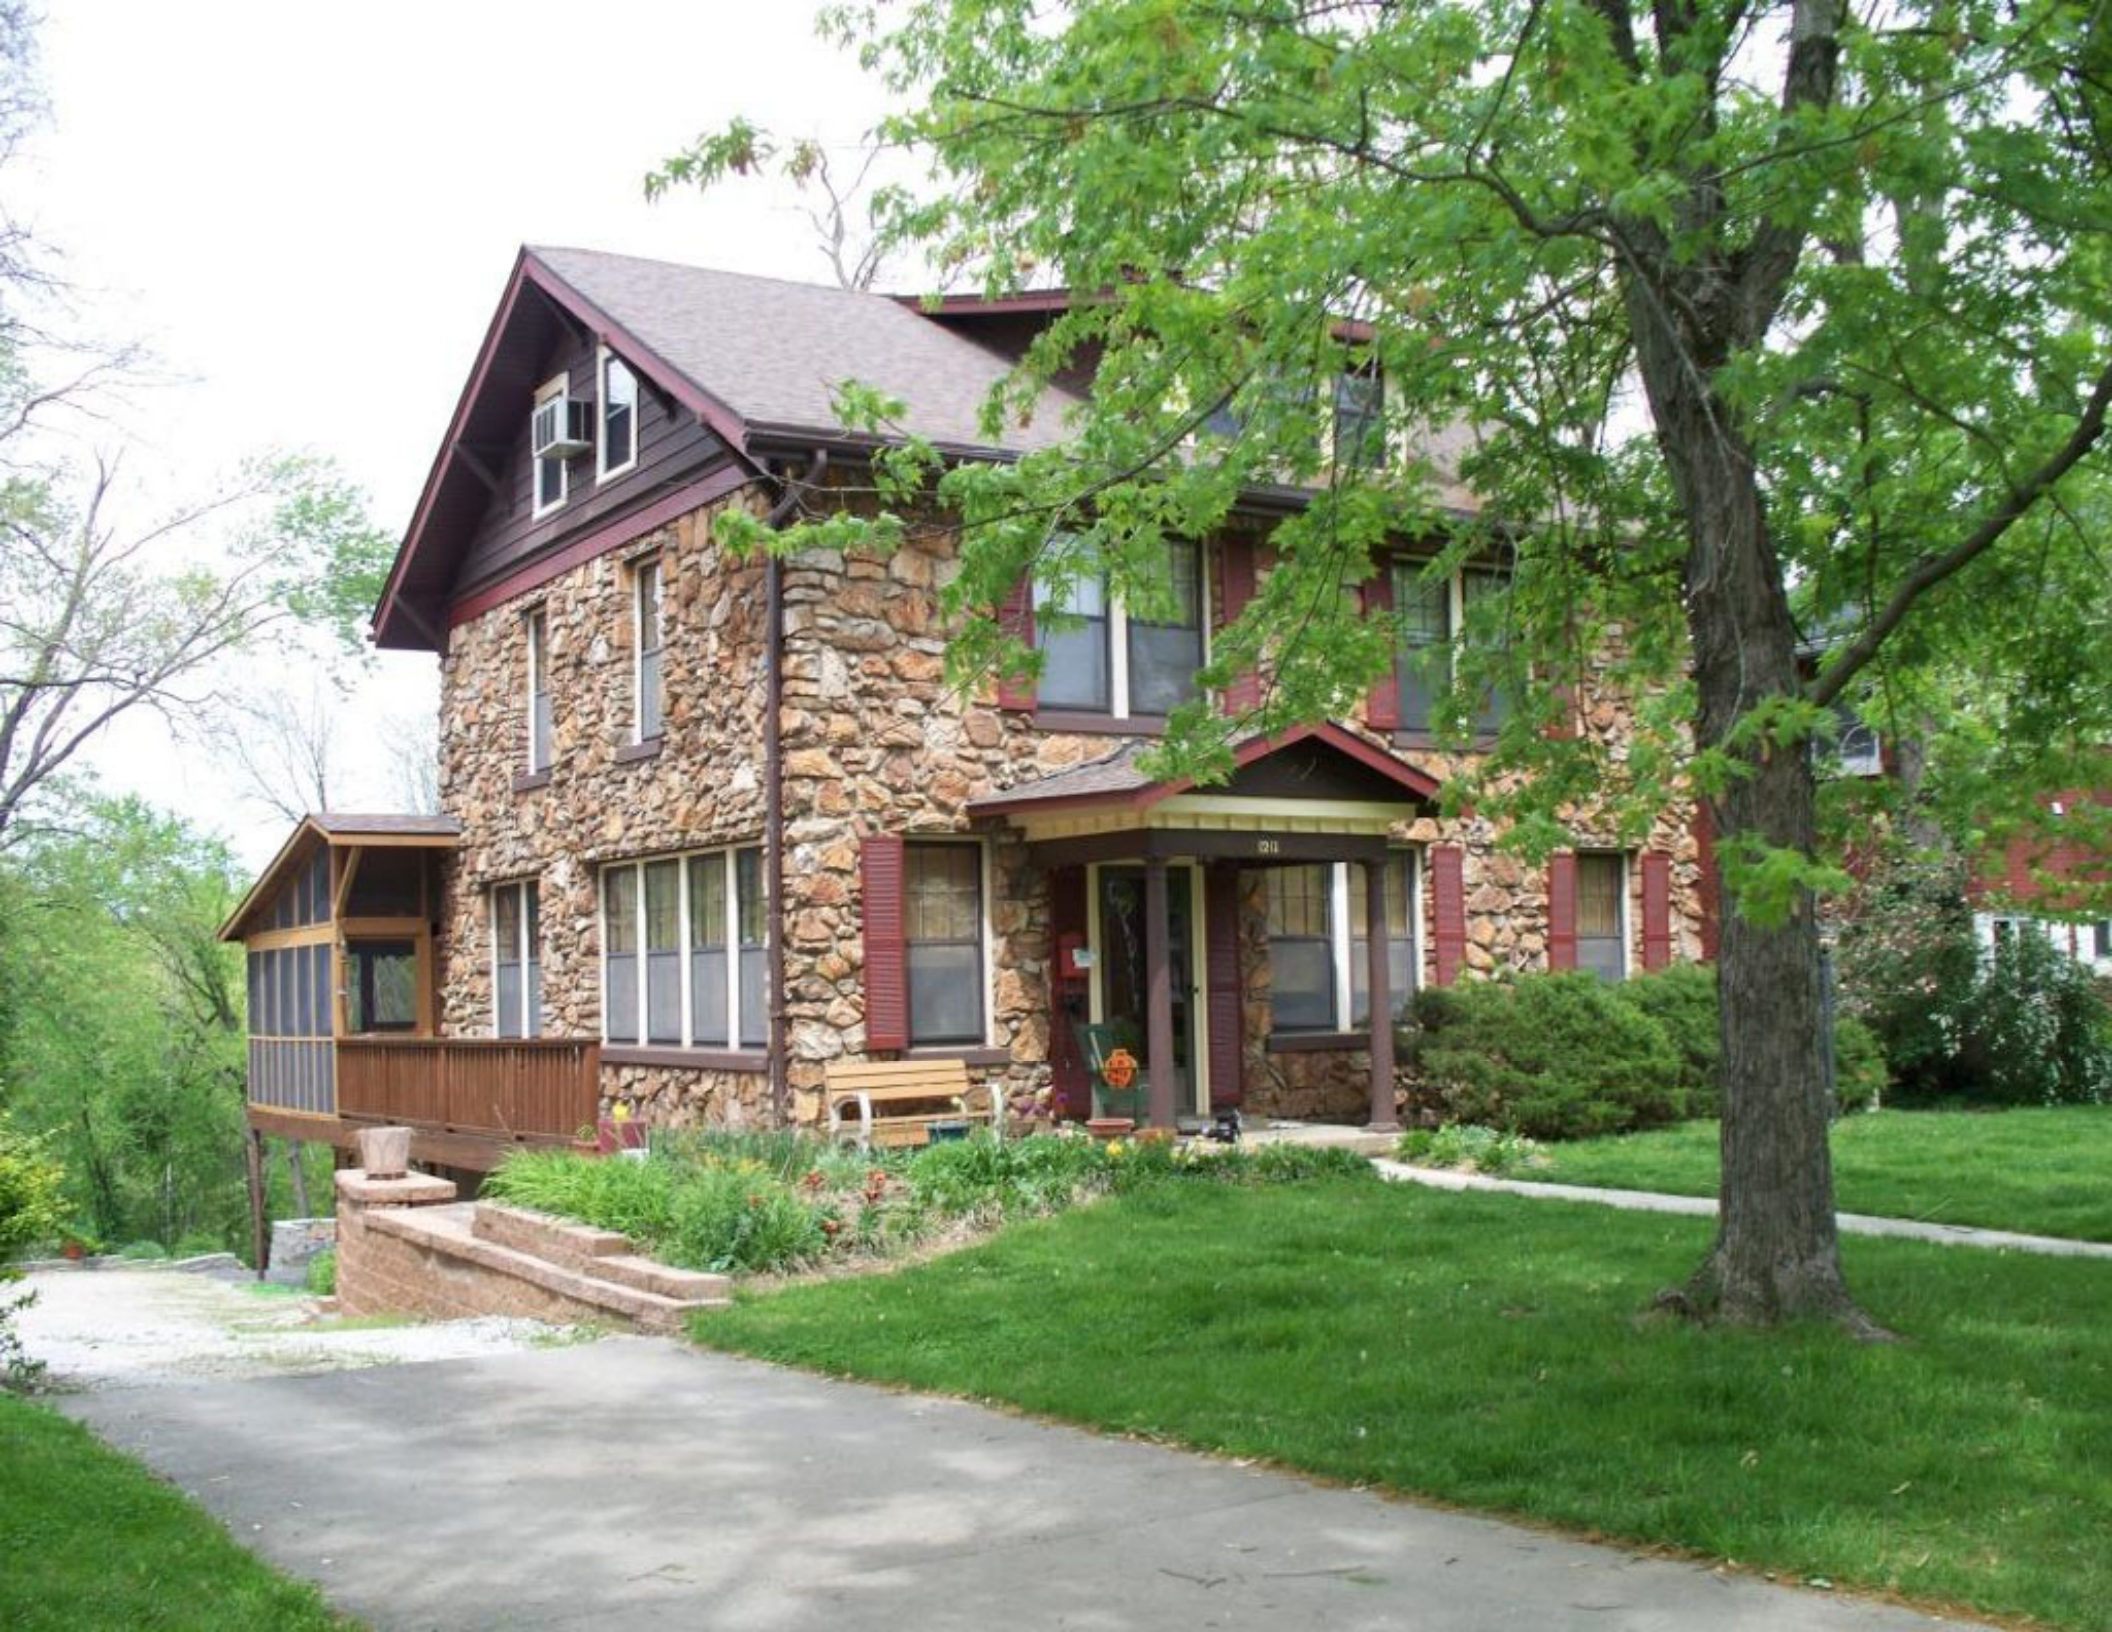
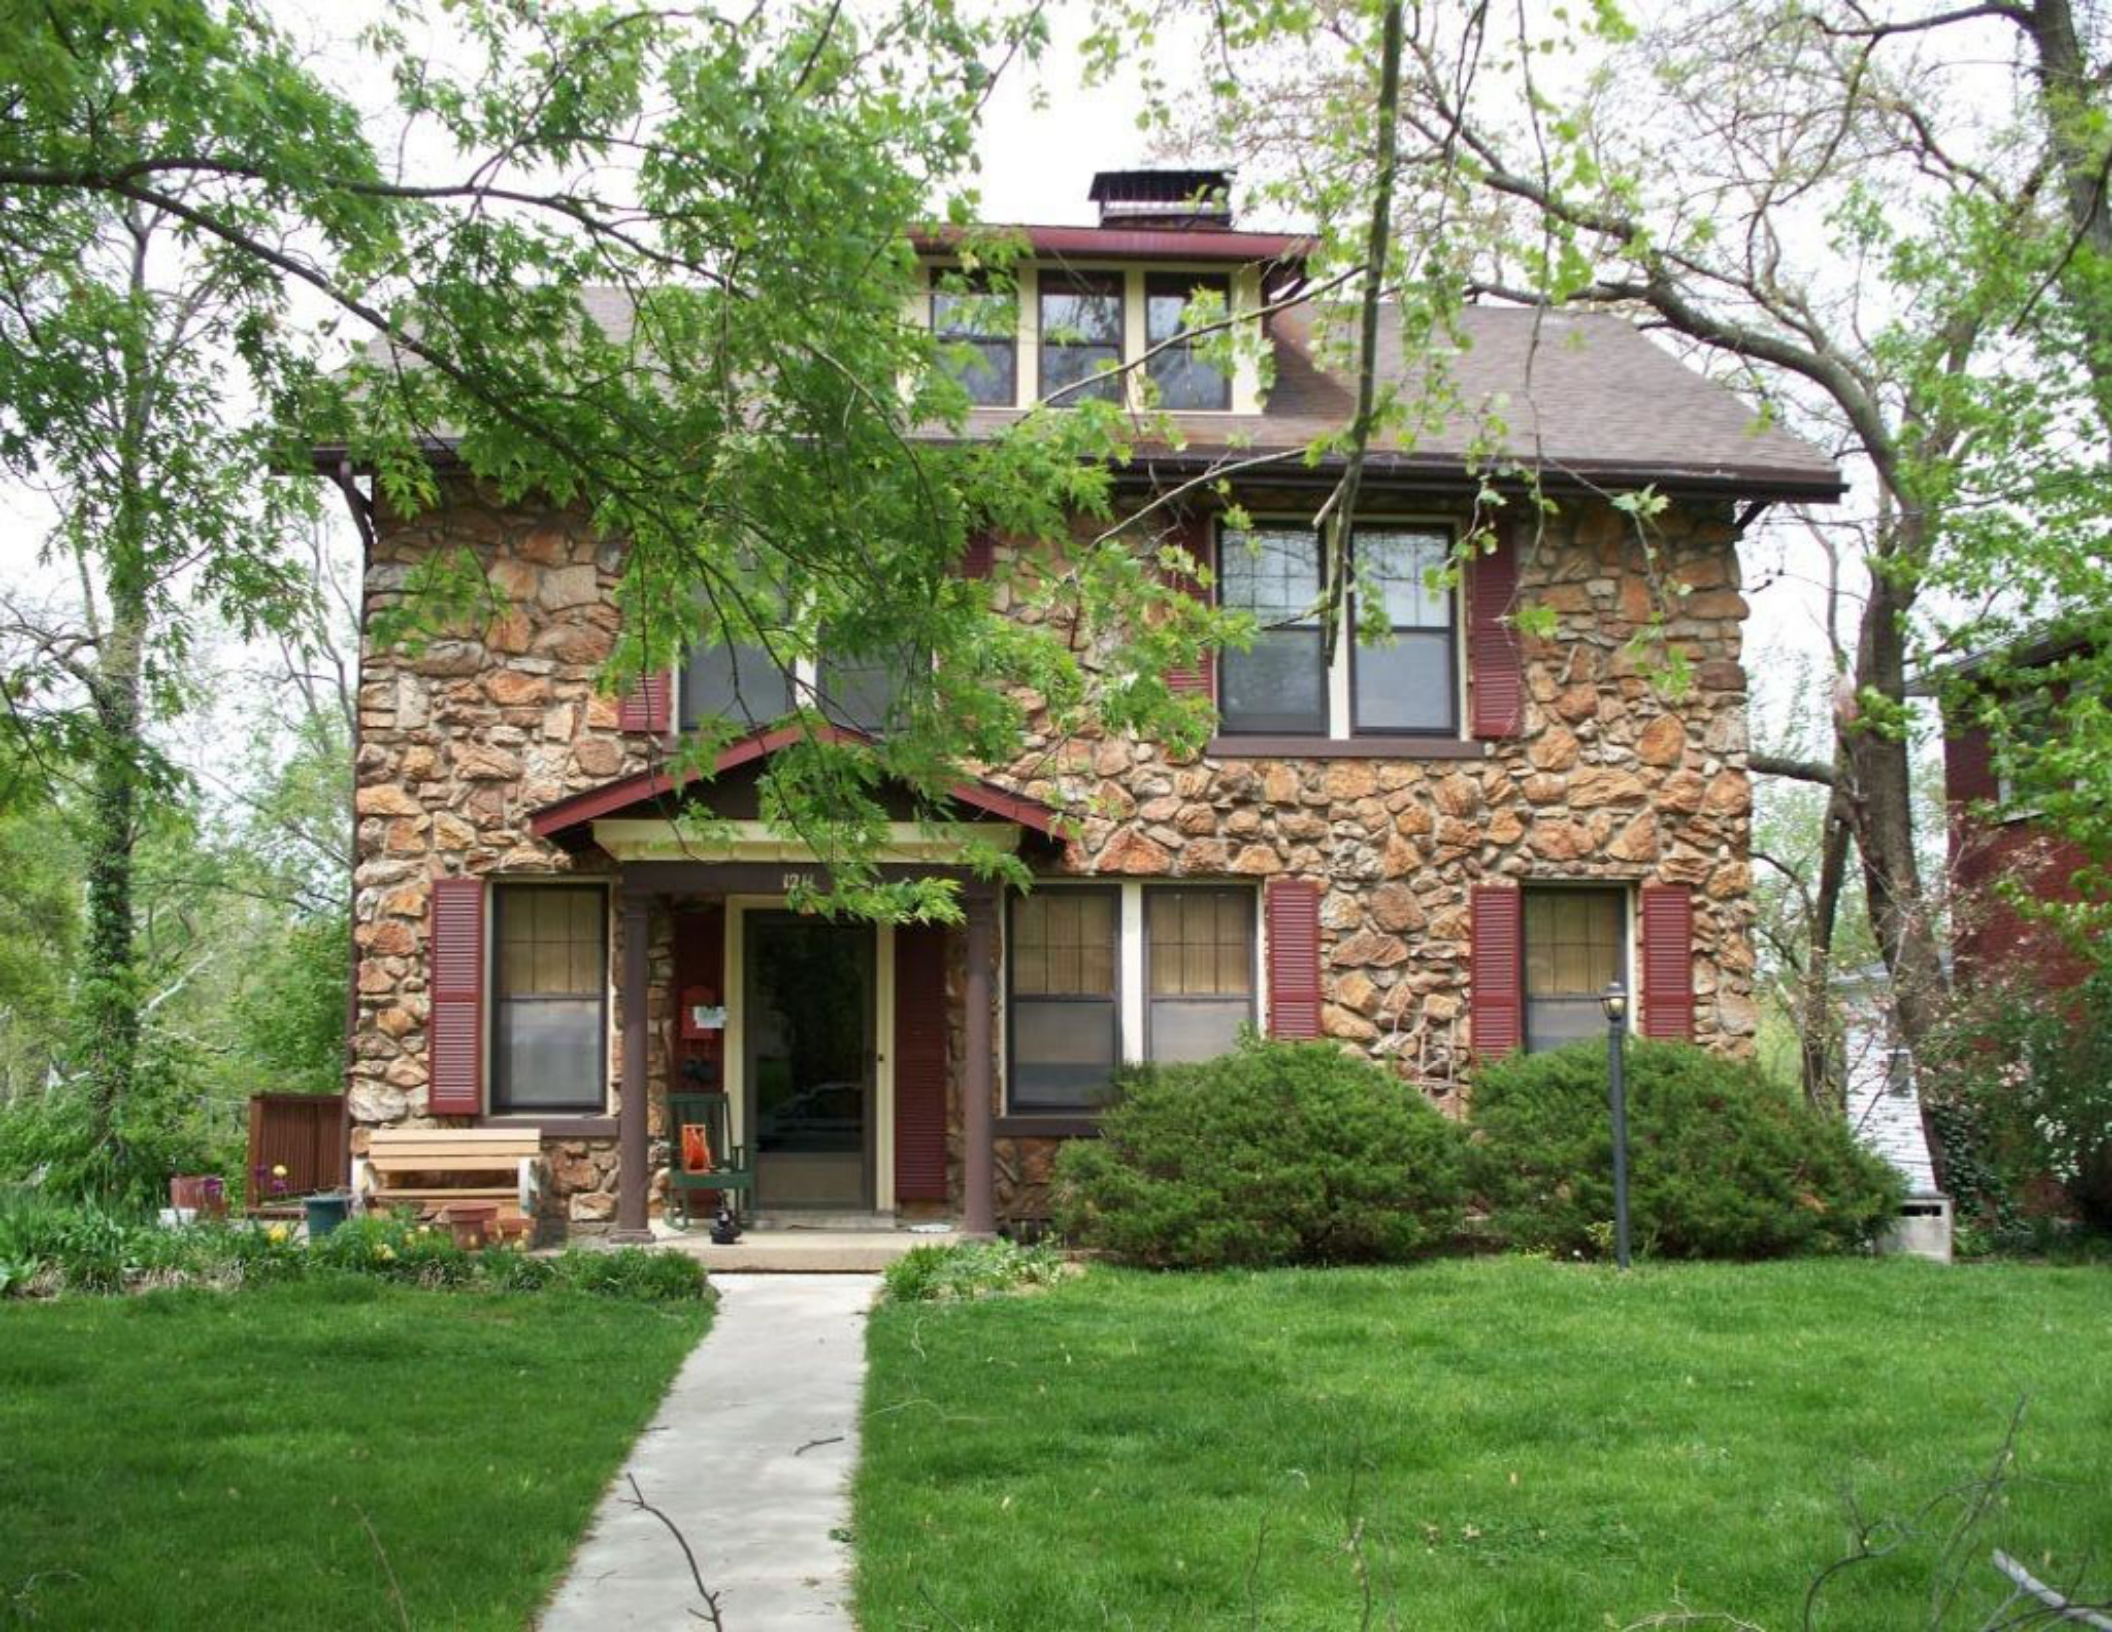
This 2 ½ story home is clad in uncut/rough cut rubble that appears to be Ozark Rock. The property has a side gable roof with a central shed dormer with three 1/1 windows. The second story has two paired 6/1 windows. All of the windows have shutters, stone or concrete sills and all appear to be modern. The first floor starting from the left has a single 6/1 window, the second bay contains the entrance with full length shutters and a gabled portico with round columns, the third bay paired windows and finally a single 6/1 window in the fourth bay. On the left side of the building is a wooden walkway with railing that leads to a screened-in back porch.

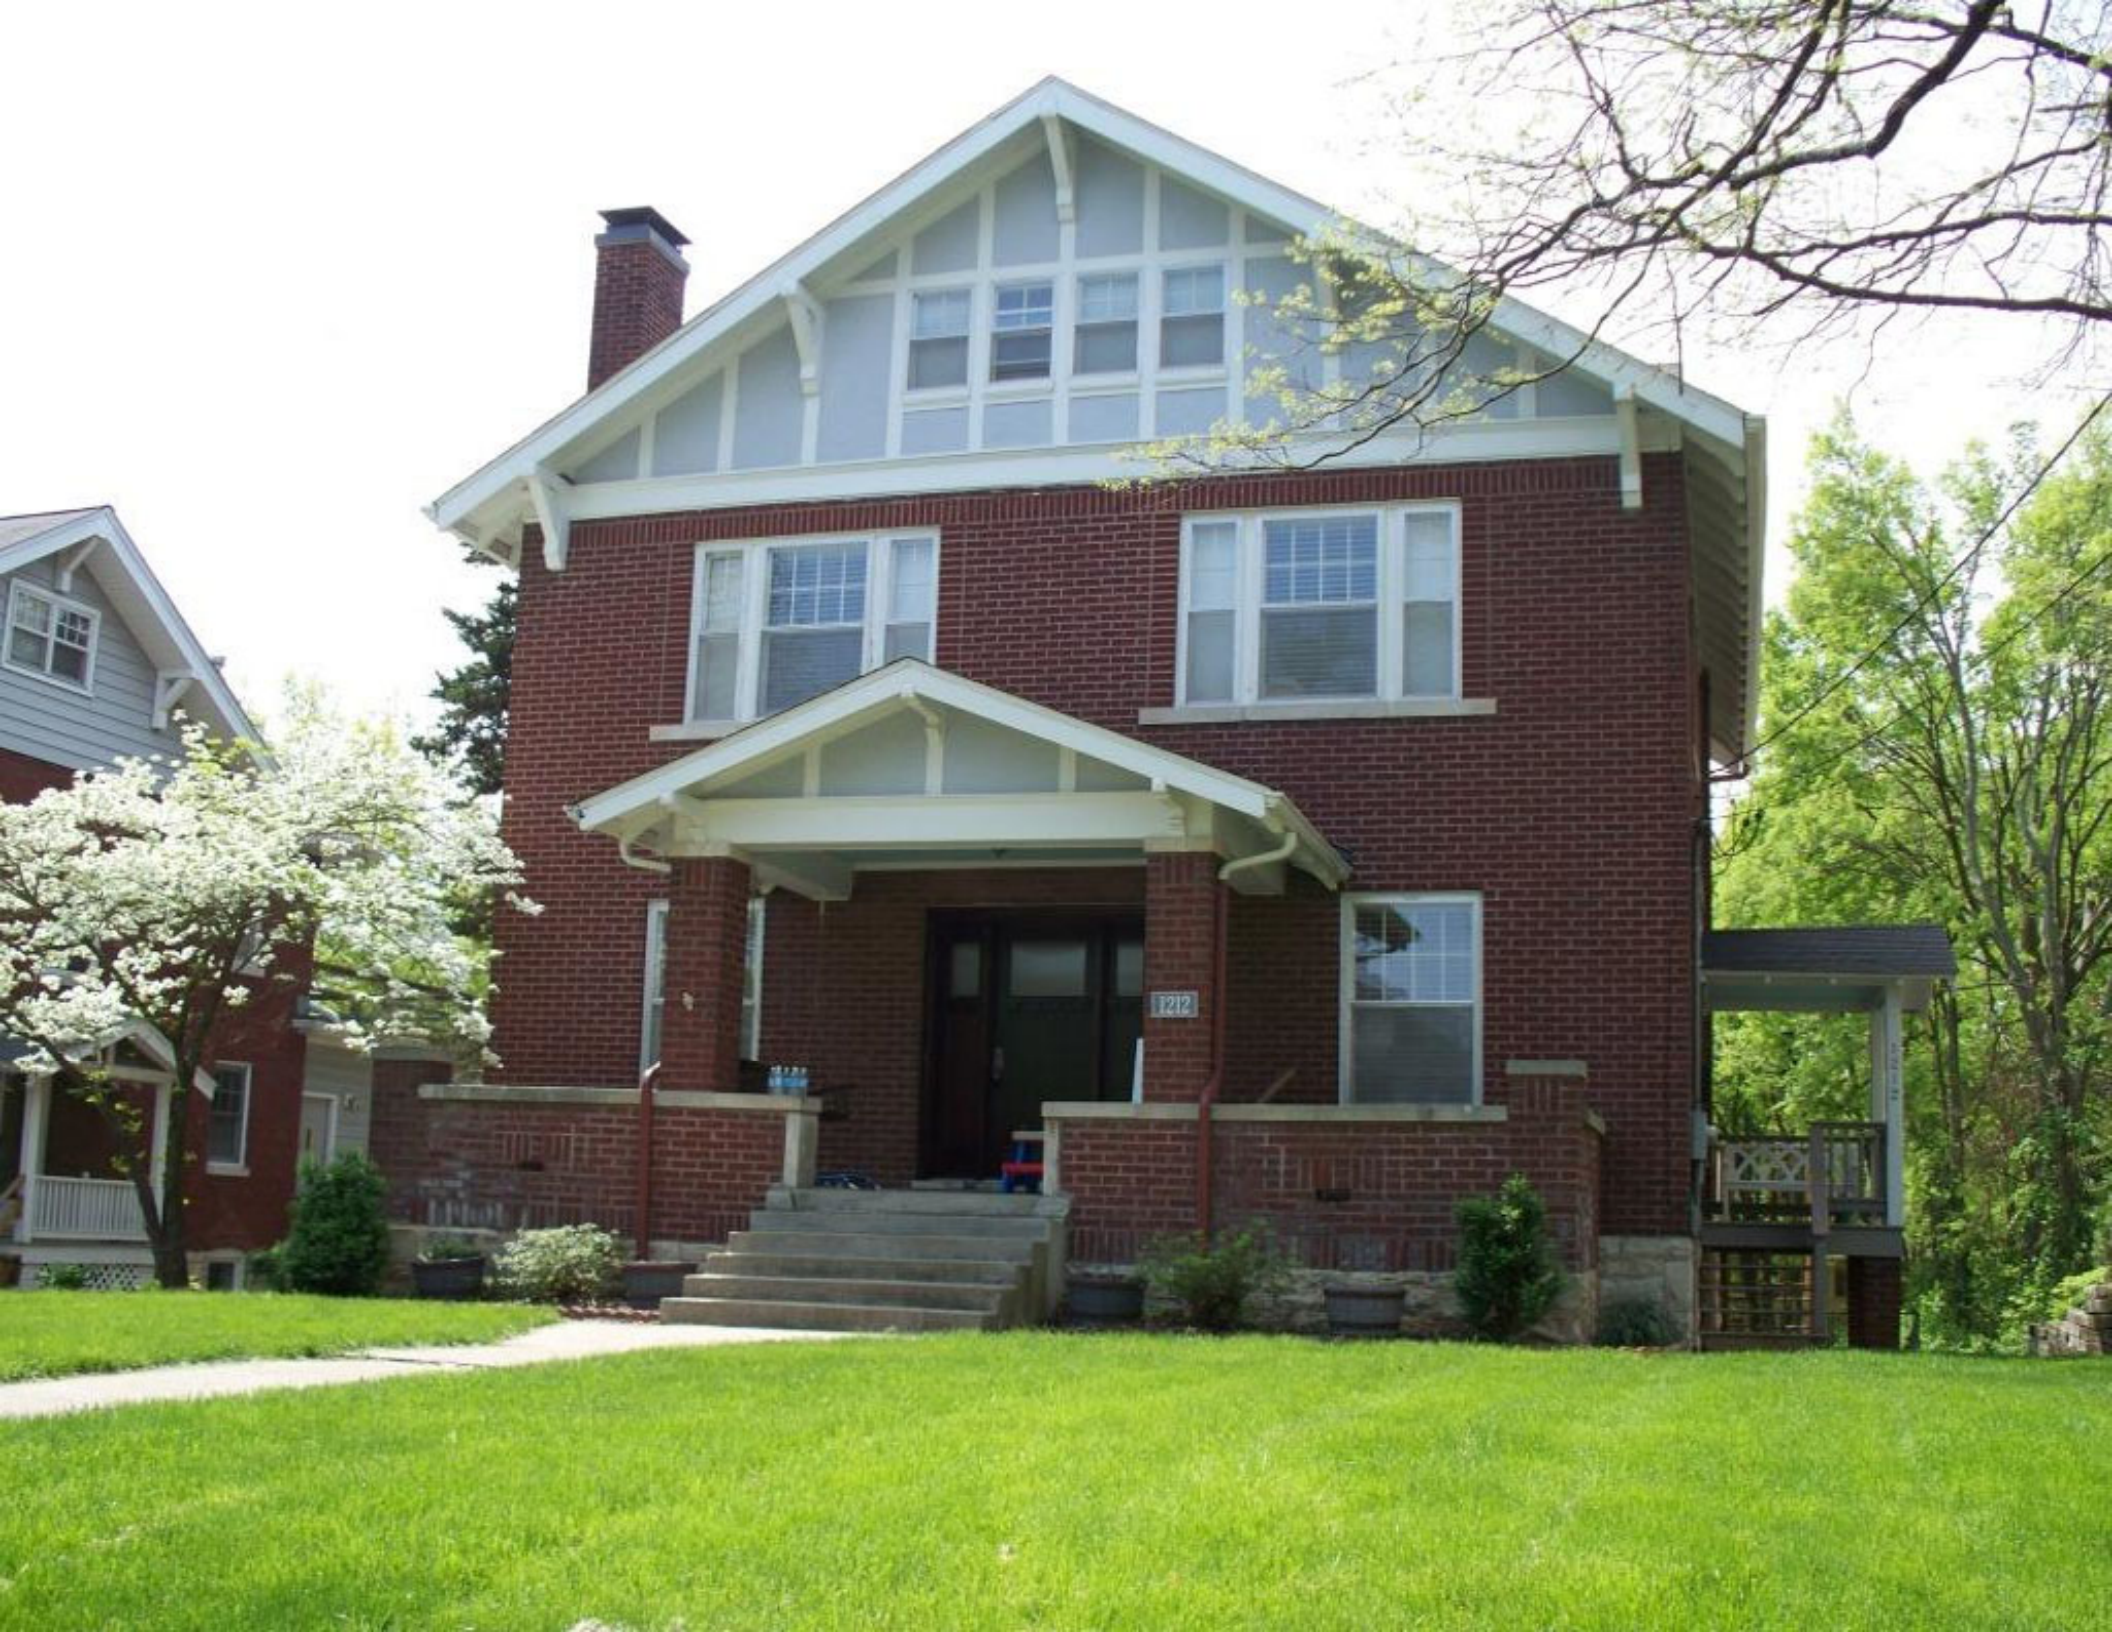
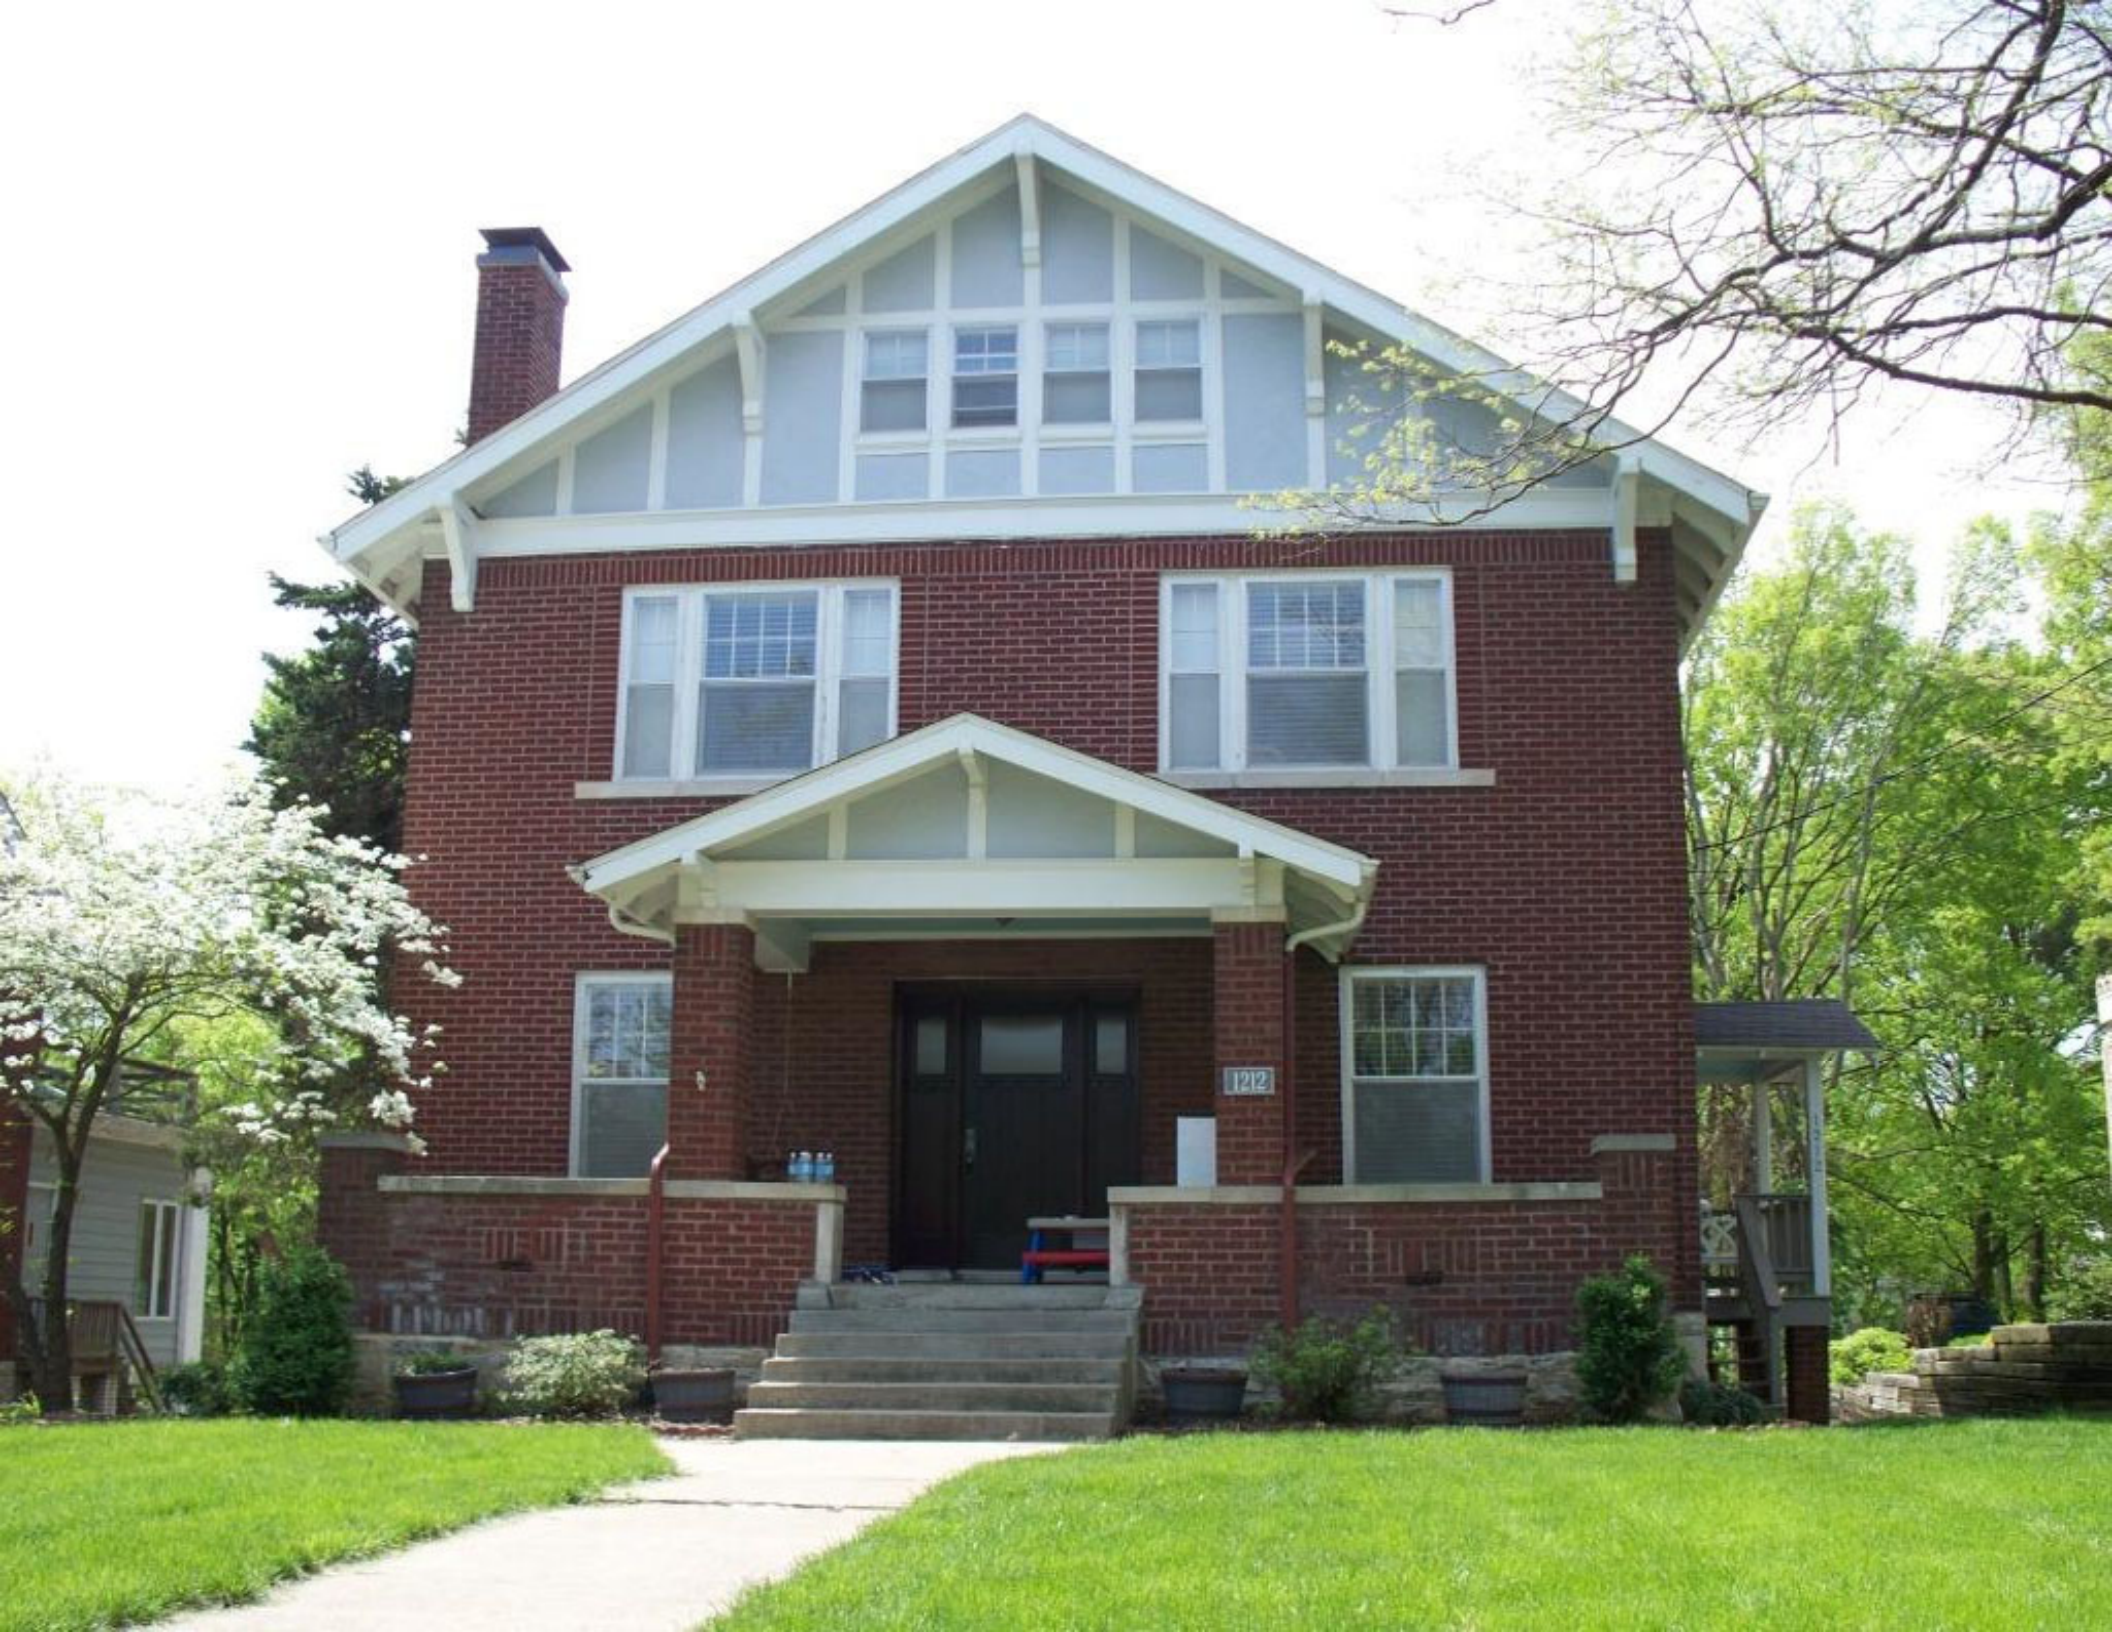
1212

This two story brick home is a little wider than a traditional American Four-Square although it has a similar appearance. The gable is stuccoed and features half timbering and knee braces. There is a row of four small 4/1 windows. The sides of the gable have rafter tails. The upper story has two tri-part windows that may be modern (4/1 flanking 8/1). The first floor has two 8/1 windows flanking the entrance. The entrance has side lights that are paneled with a single pane on the upper portion; the door also features a single light. The porch consists of brick knee walls capped in limestone or concrete. There are two piers in front of the entrance that extend to meet a large stuccoed gable with half timbering, rafter tails, and brackets all of which are characteristic of the Craftsman Style.

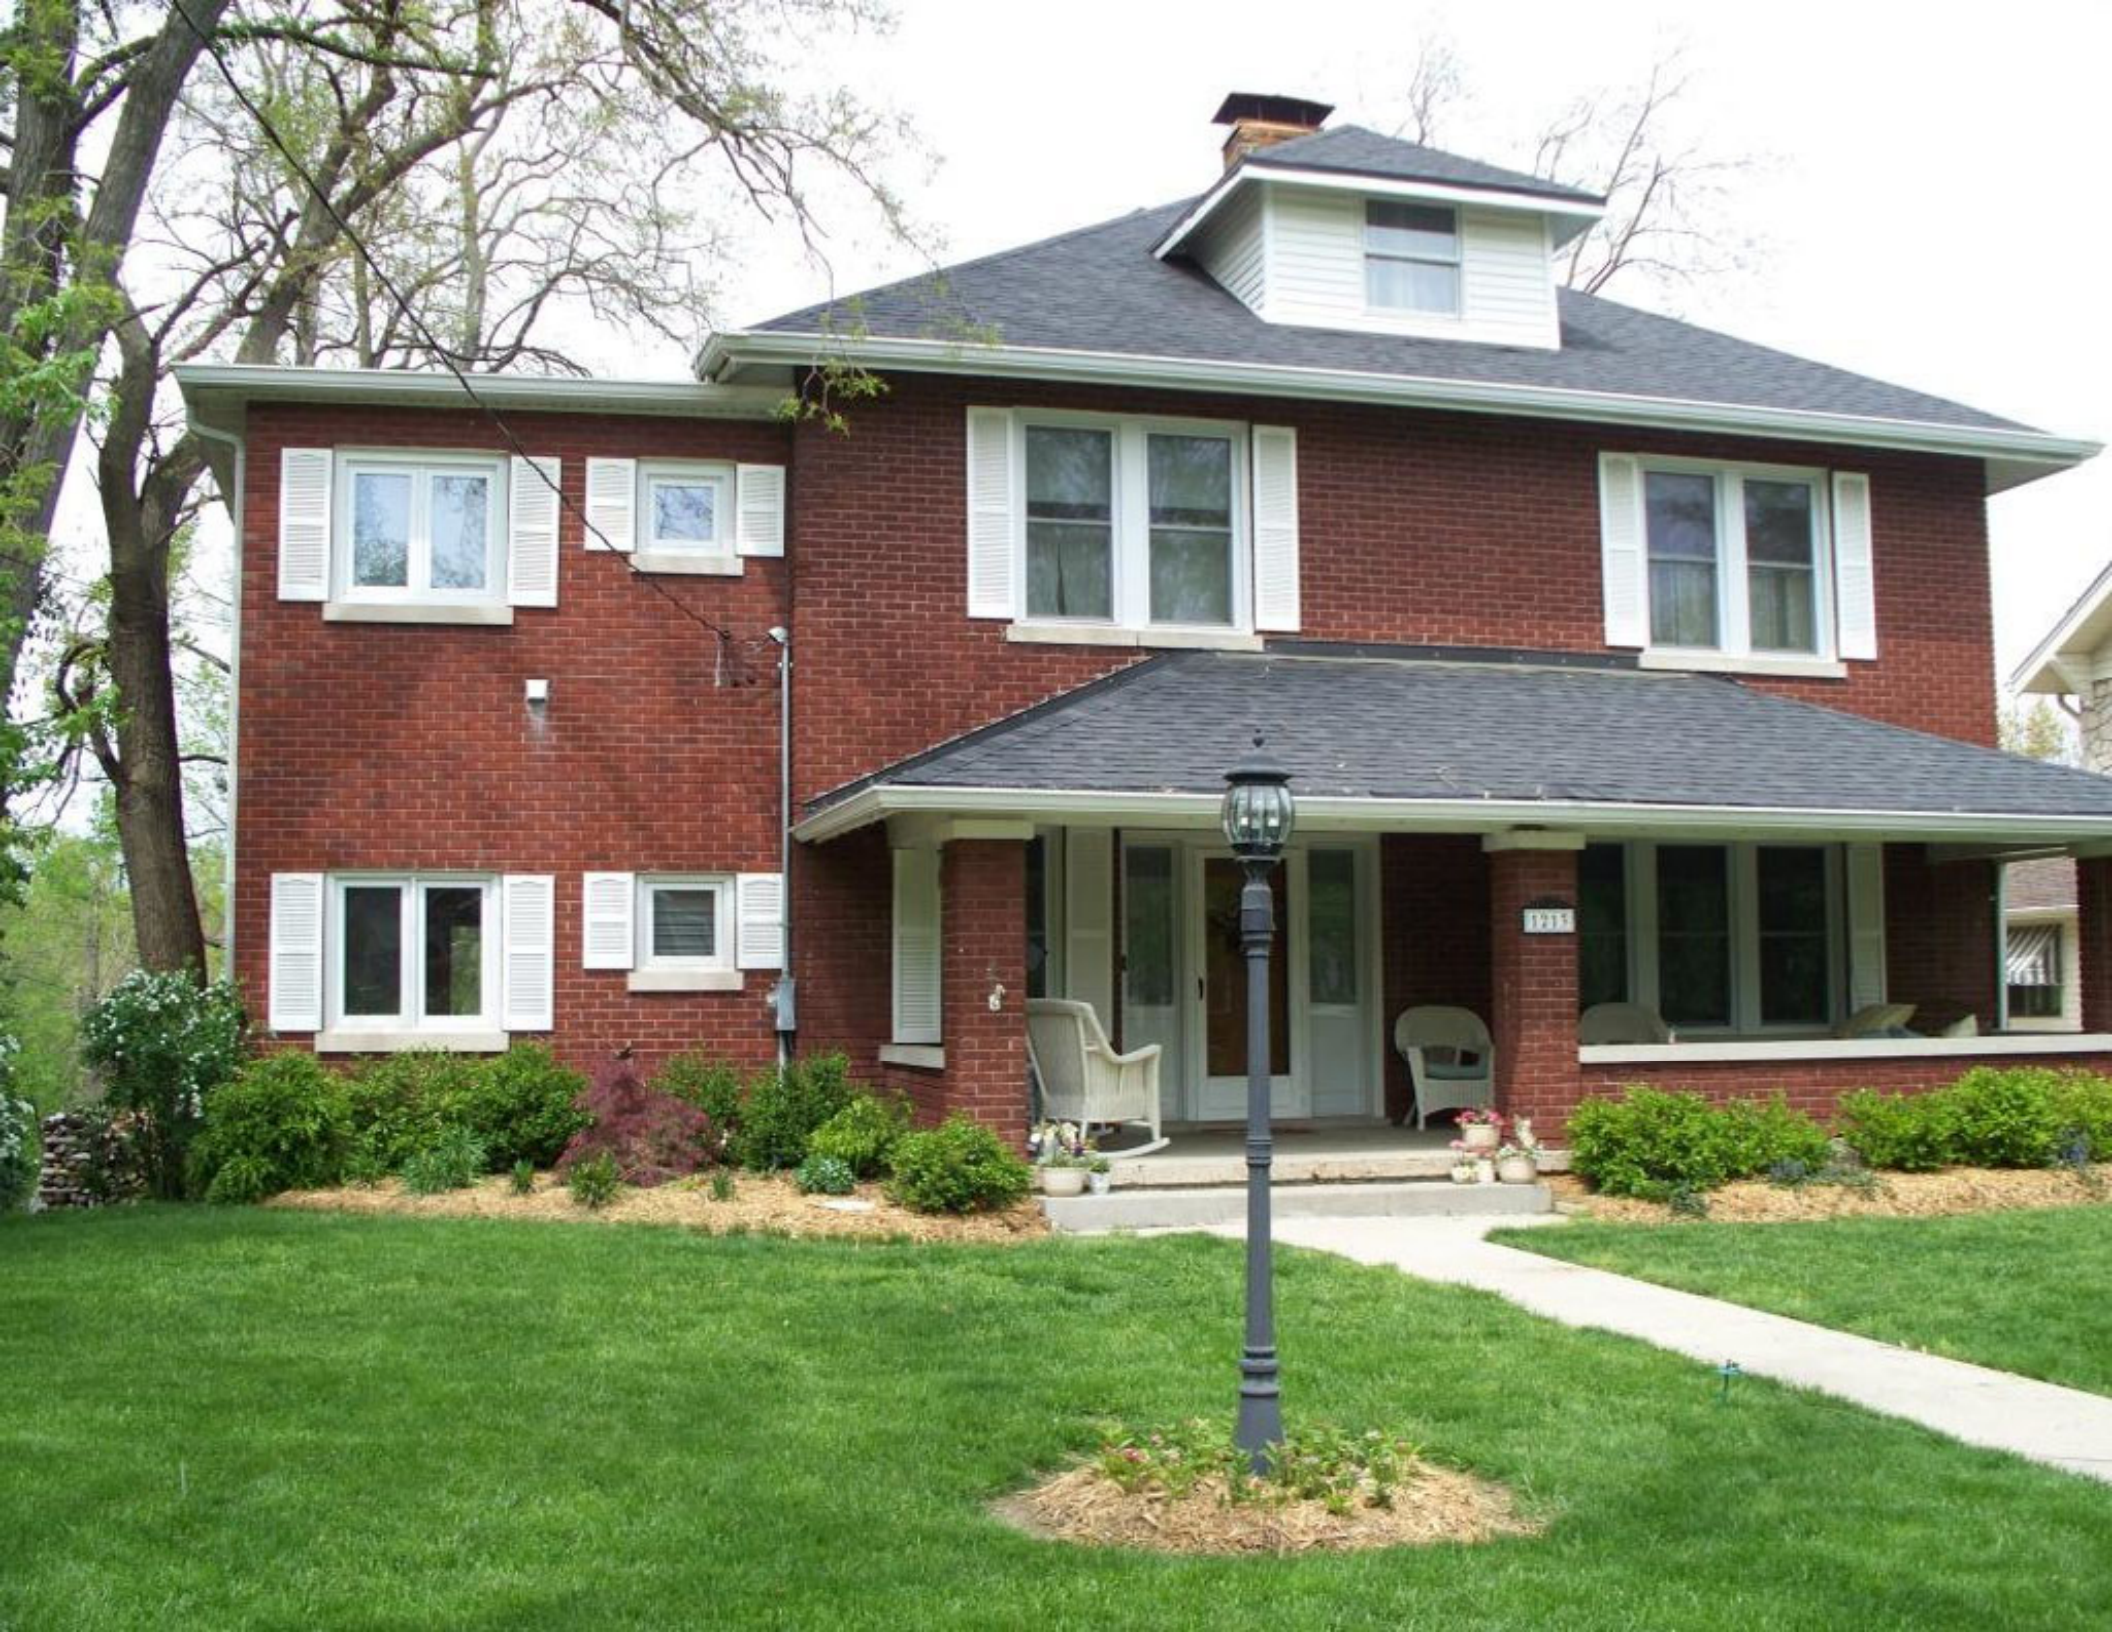
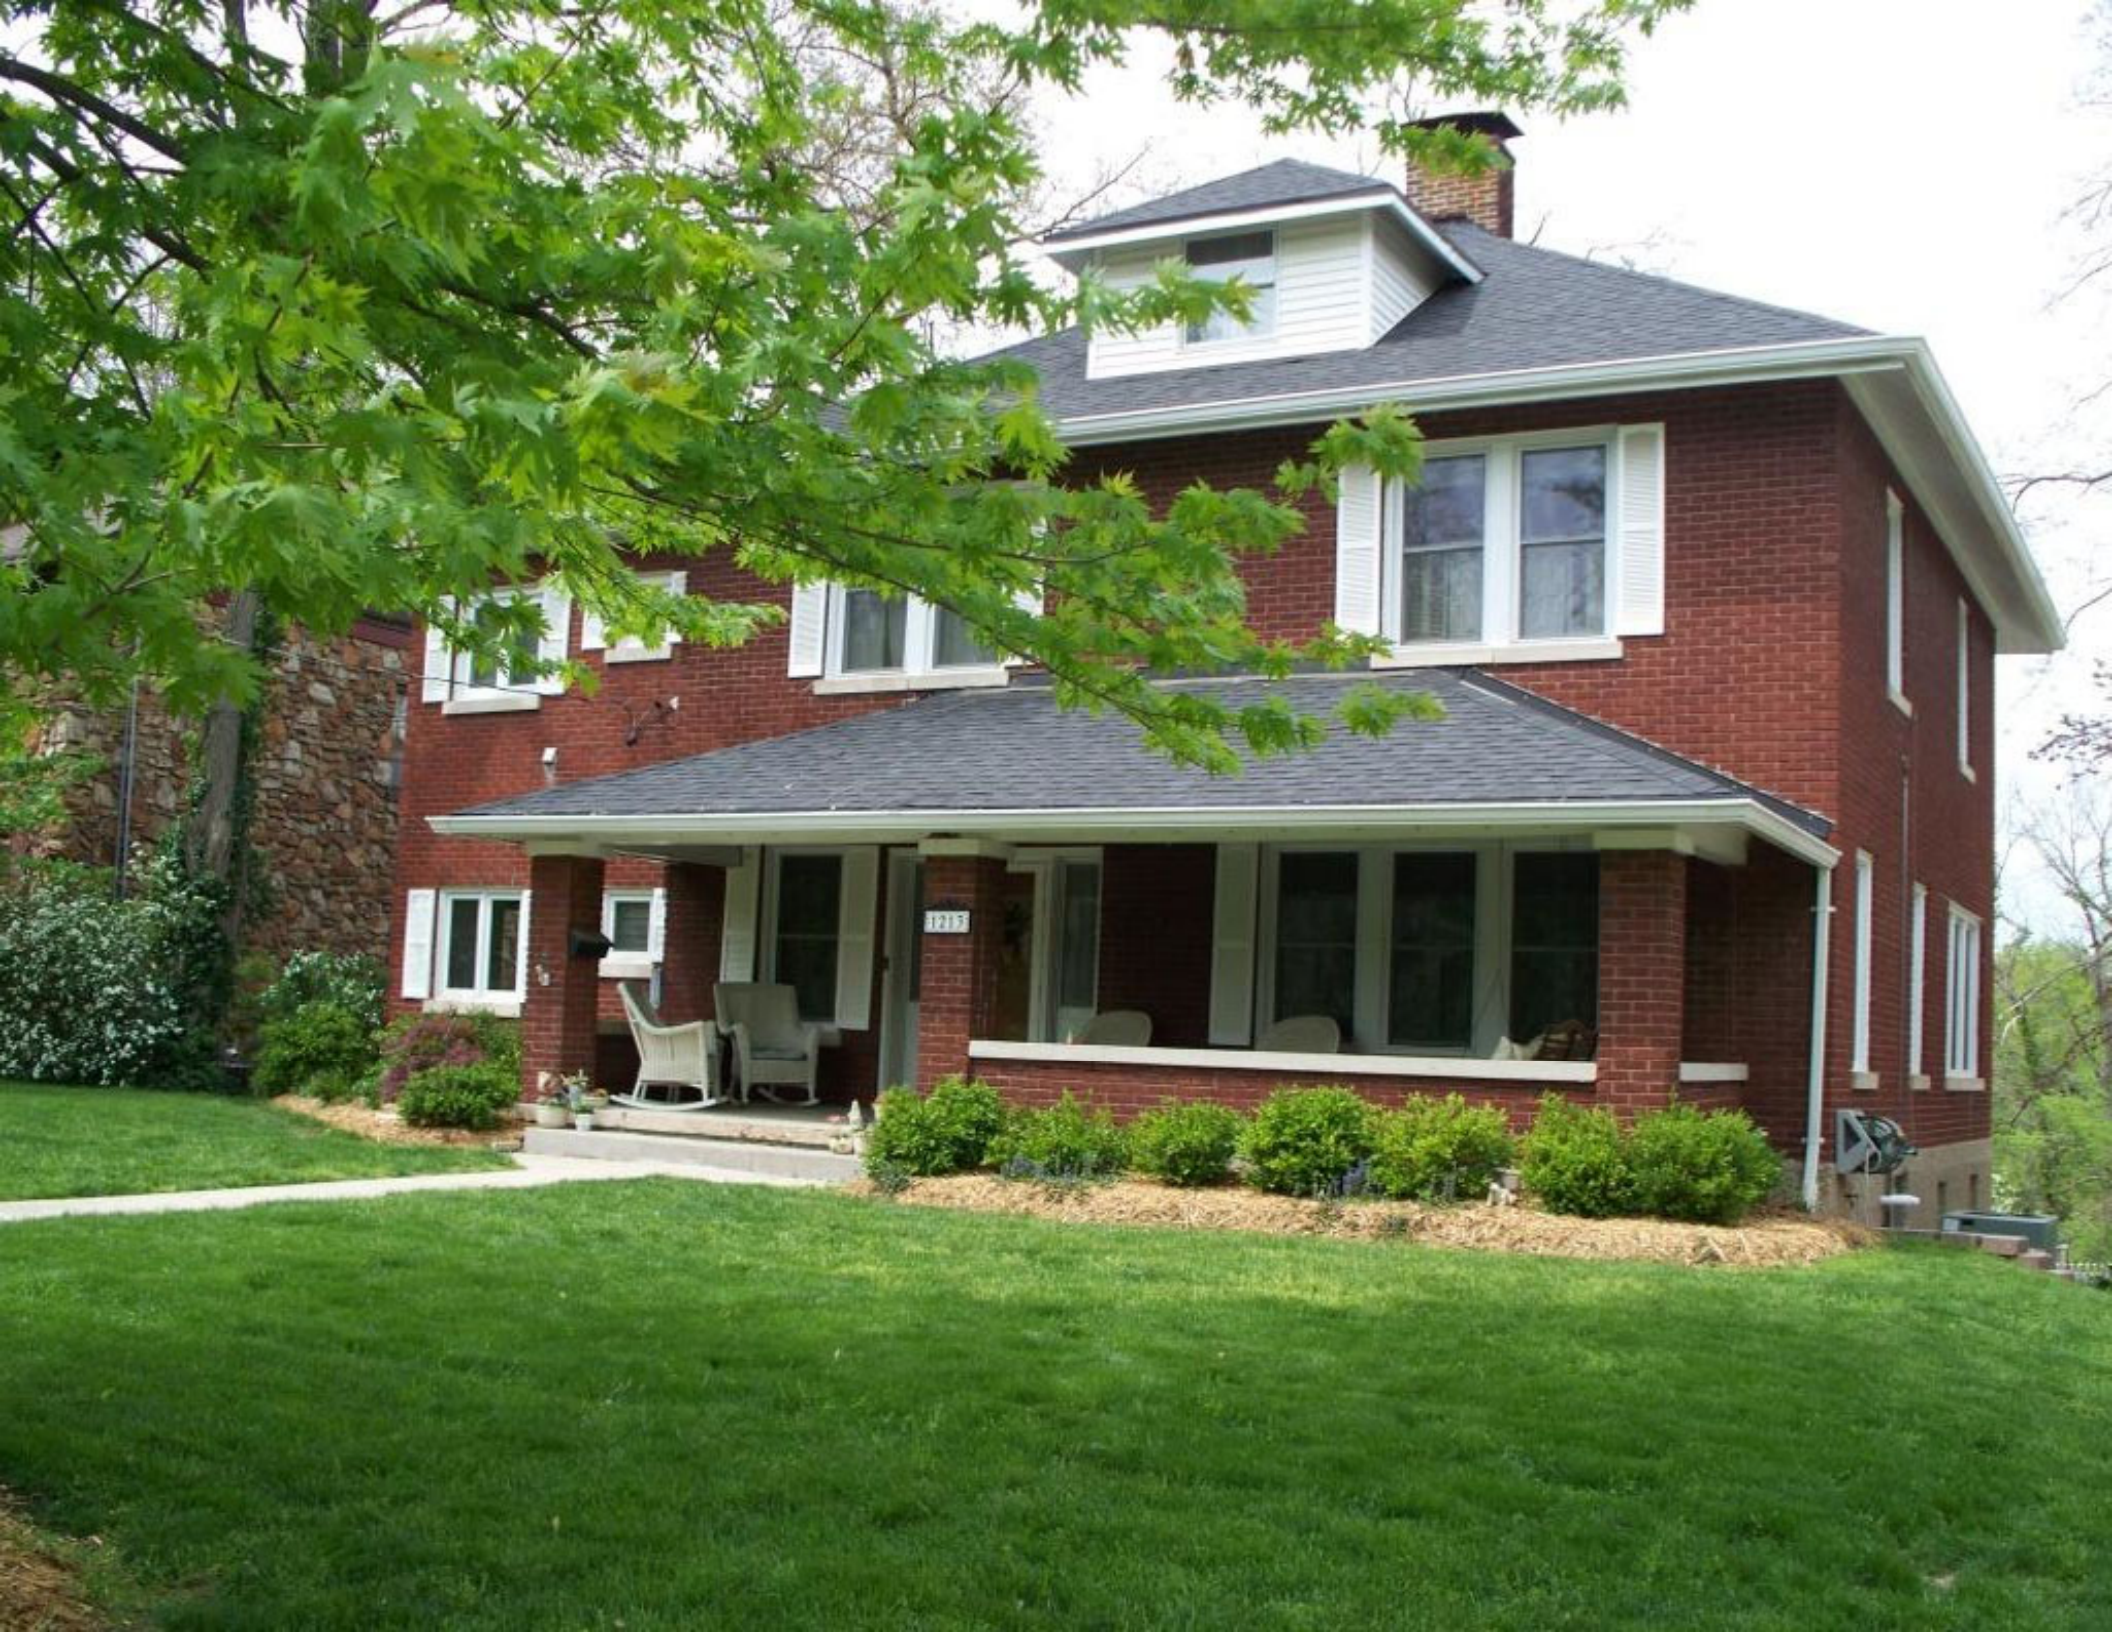
This 2 ½ story home is clad in brick with a high hipped or pyramidal roof with a central hipped dormer clad in vinyl with a 1/1 replacement window. The second floor has two paired 1/1 windows with shutters and concrete sills. The porch has a deeply hipped roof with brick piers and half walls capped in concrete. Other than the dormer, all of the windows have shutters and concrete sills. All of the windows appear to be replacements. The first bay on the ground floor has as single 1/1 window, the next bay contains the entrance and sidelights, the third bay has a row of three 1/1 windows. There is a two story addition with a flat roof and wide eaves that is slightly set back from the main façade. It contains paired single-light vinyl casement windows on the first bay on both floors and smaller square vinyl casement window on the right on both stories. Like the rest of the property the windows have concrete sills and shutters. The property may have been built with this addition or it was it added shortly after construction as it appears on the Sanborn maps.
