ARCHITECTURAL/HISTORIC INVENTORY FORM

1. Survey No. CO-AS-005-001		2. Survey name: Moreau Drive Neighborhood Survey	
3. County: Cole		4. Address: 1202 Elmerine Ave.	
5. City: Jefferson City	Vicinity: <input type="checkbox"/>	6. UTM: / /	7. Township/Range/Section: T: R: S:
8. Historic name (if known):		9. Present/other name (if known):	
10. Ownership: <input checked="" type="checkbox"/> Private <input type="checkbox"/> Public		11. Historic use (if known): Residential	11. Current use: Residential

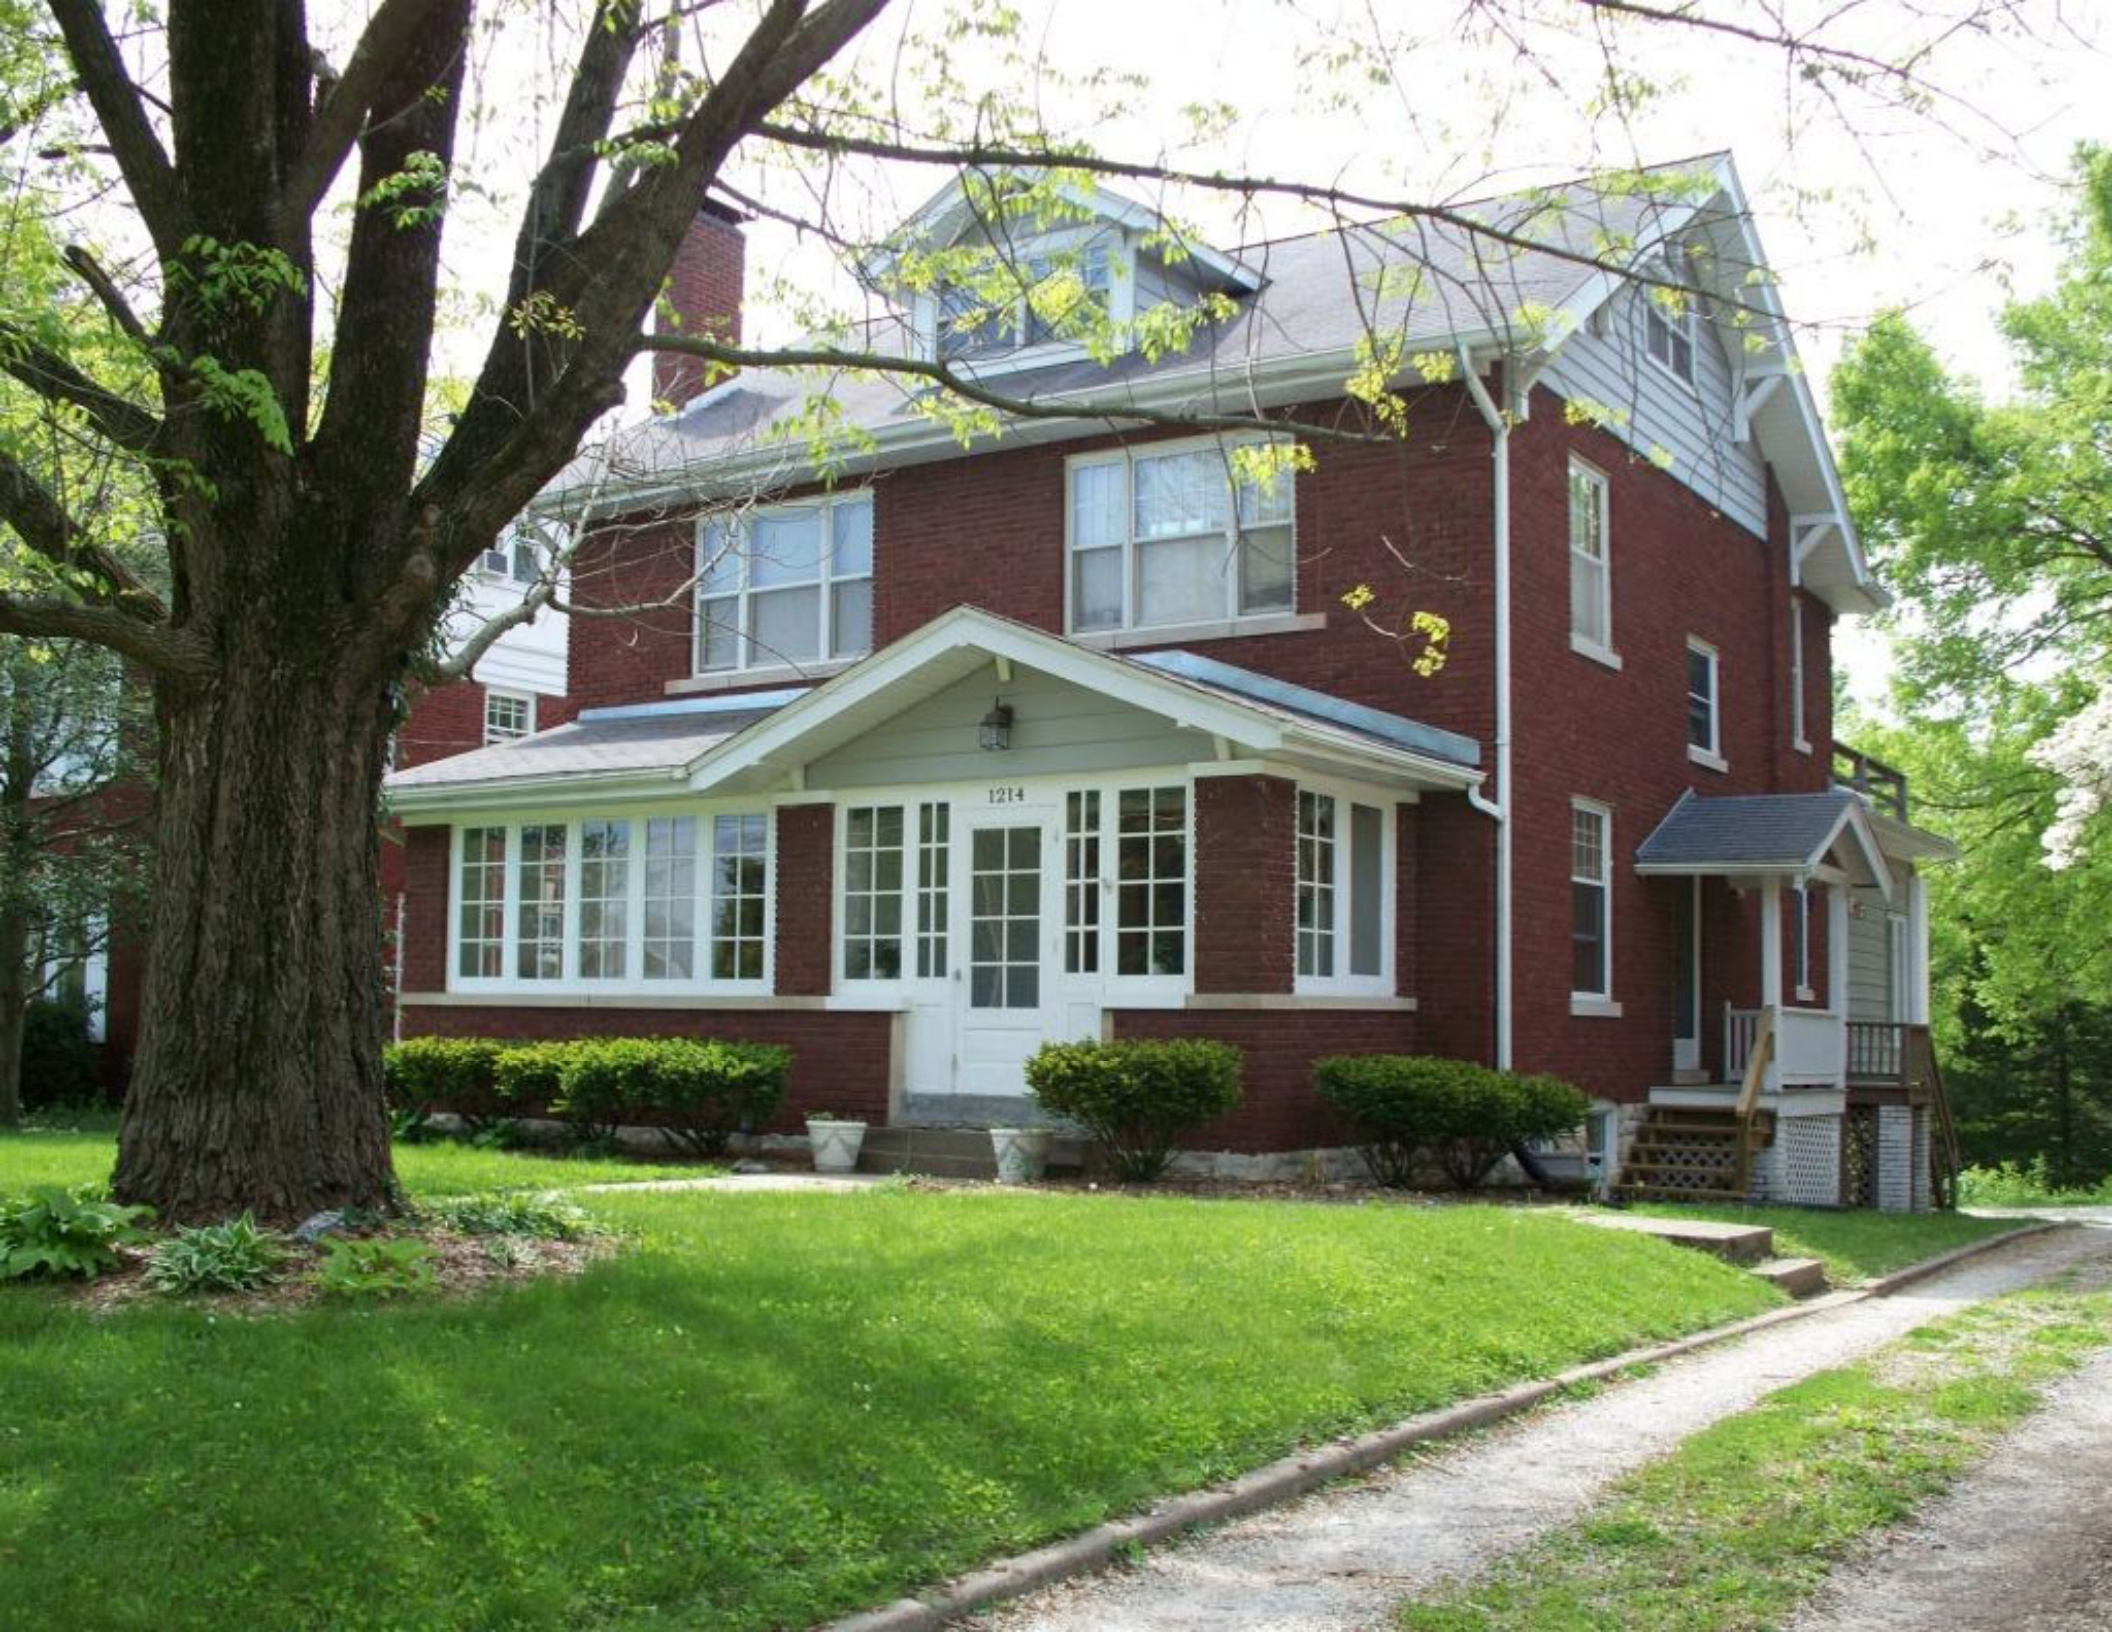
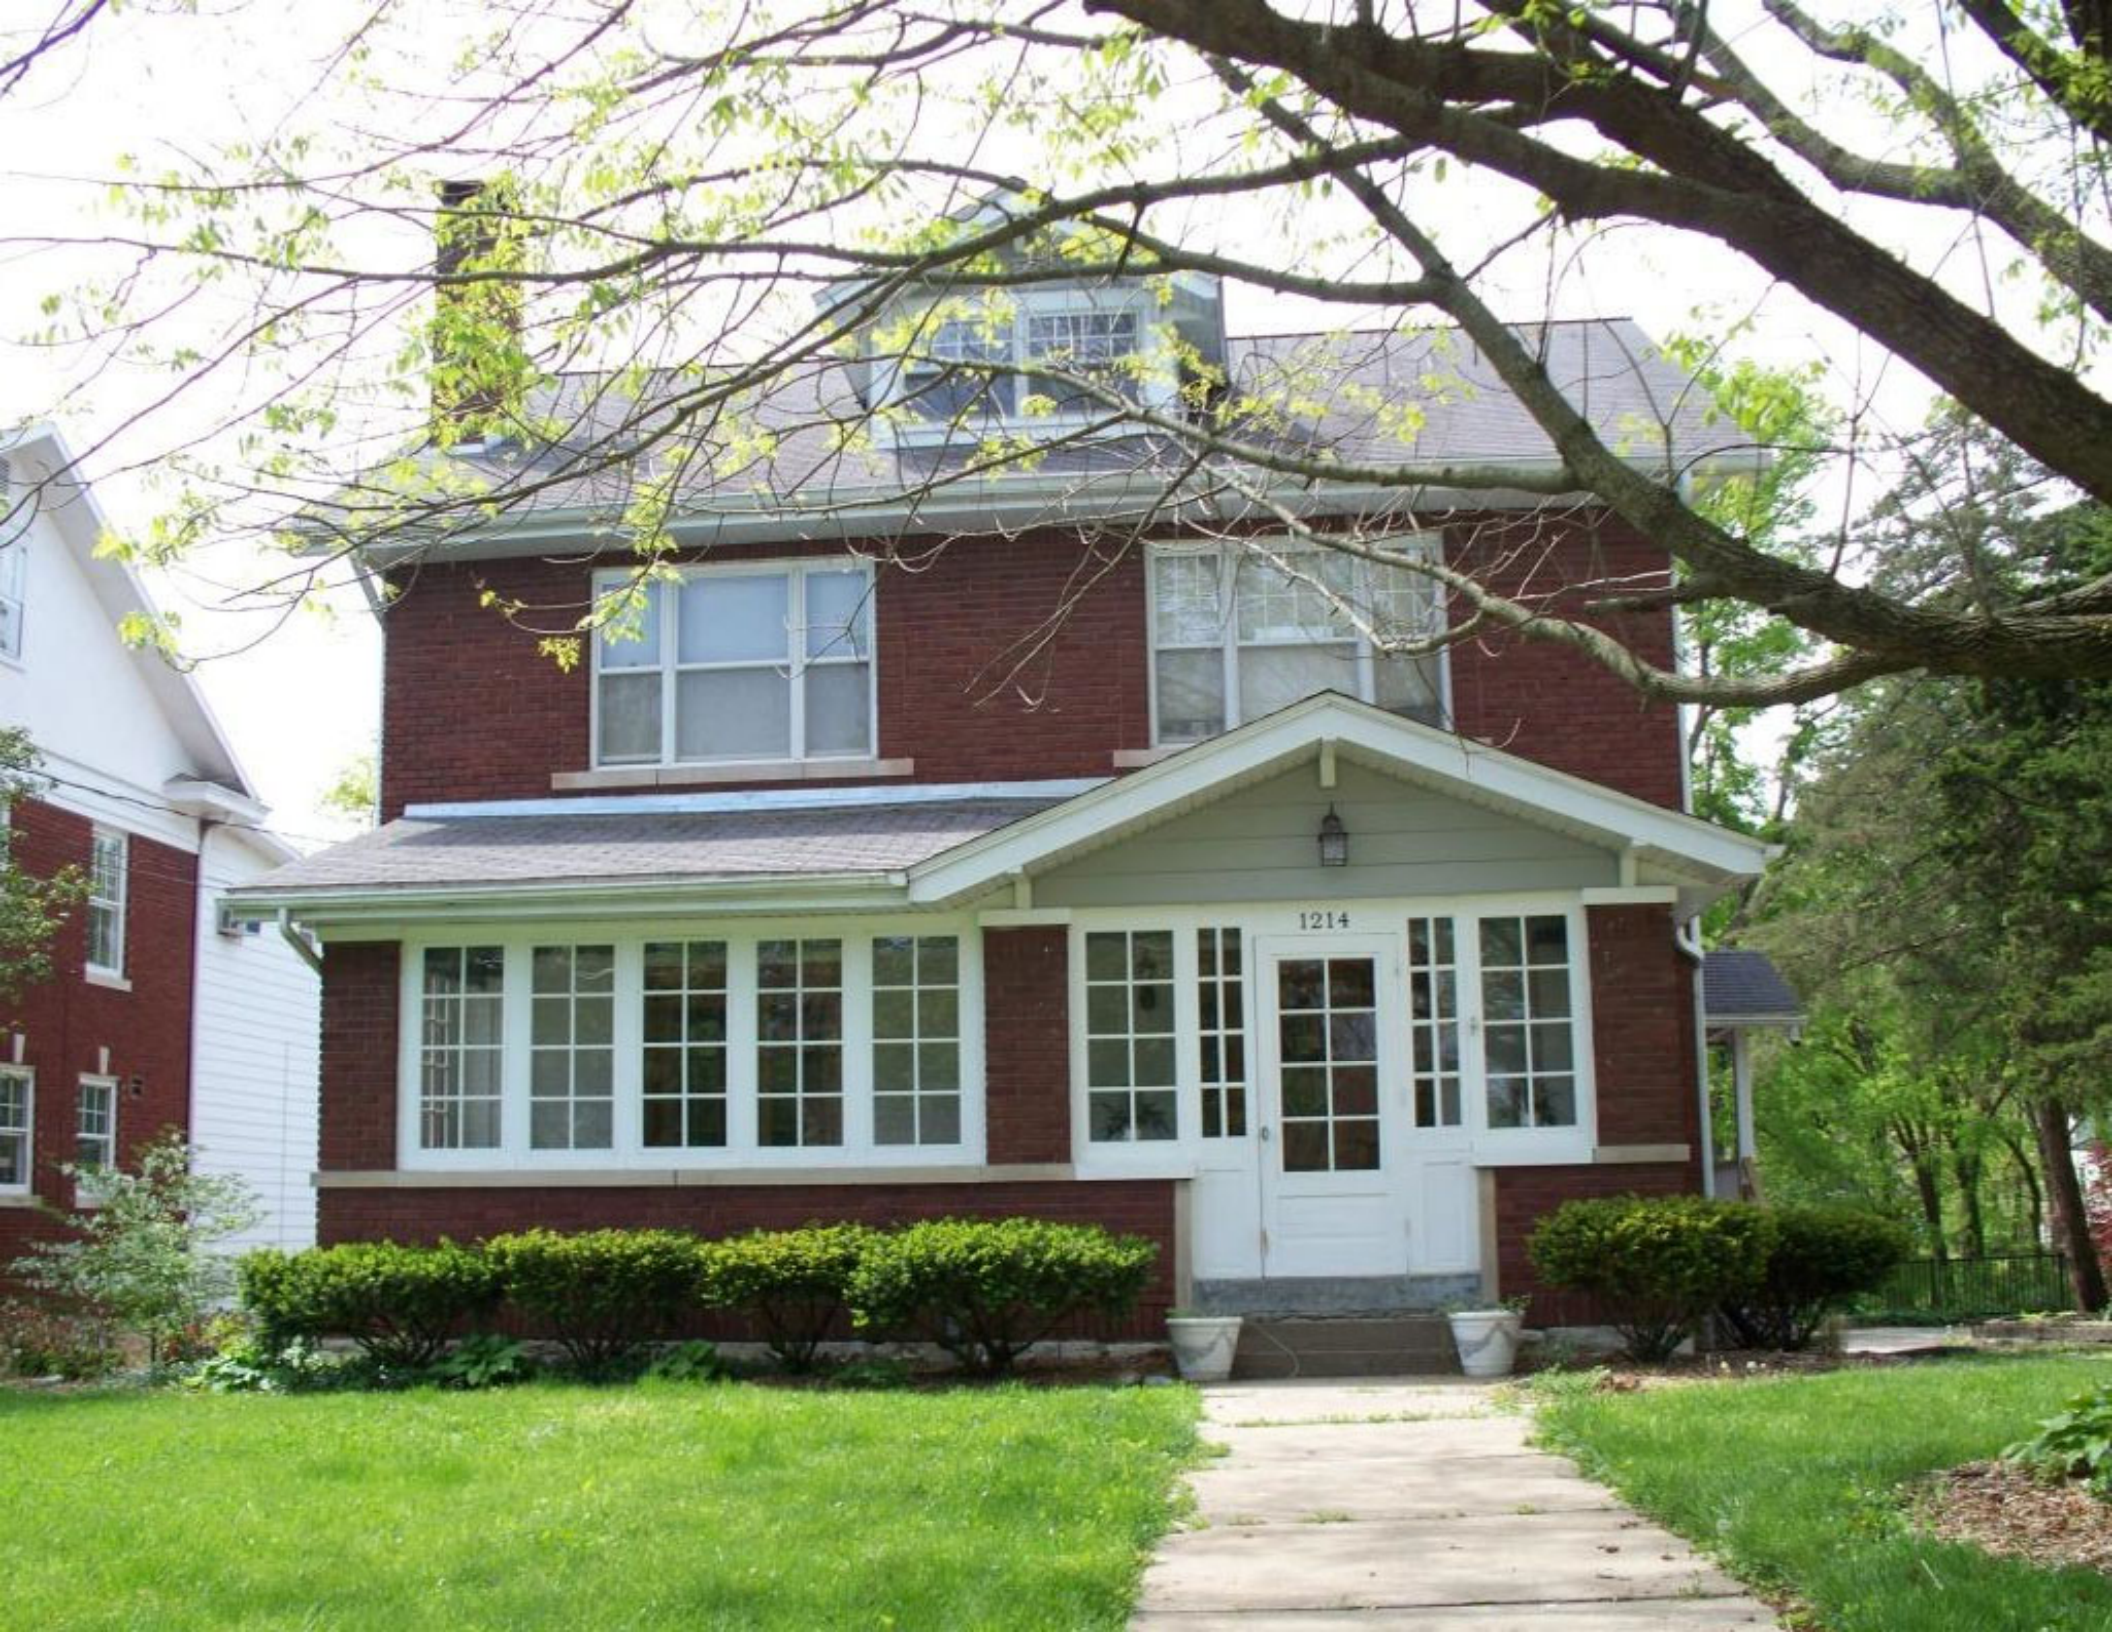
1214

This two and a half story brick four square has a central gabled dormer with two 8/1 windows that are likely replacement. The second floor has two tri-part windows. The one in the left bay are all 1/1, the one in the right are 6/1 flanking 8/1. The porch has brick piers and half walls and has been enclosed with windows (8 light). The roof of the porch is shed with a gable over the entrance with brackets. The windows have concrete sills and appear to be largely replacement.

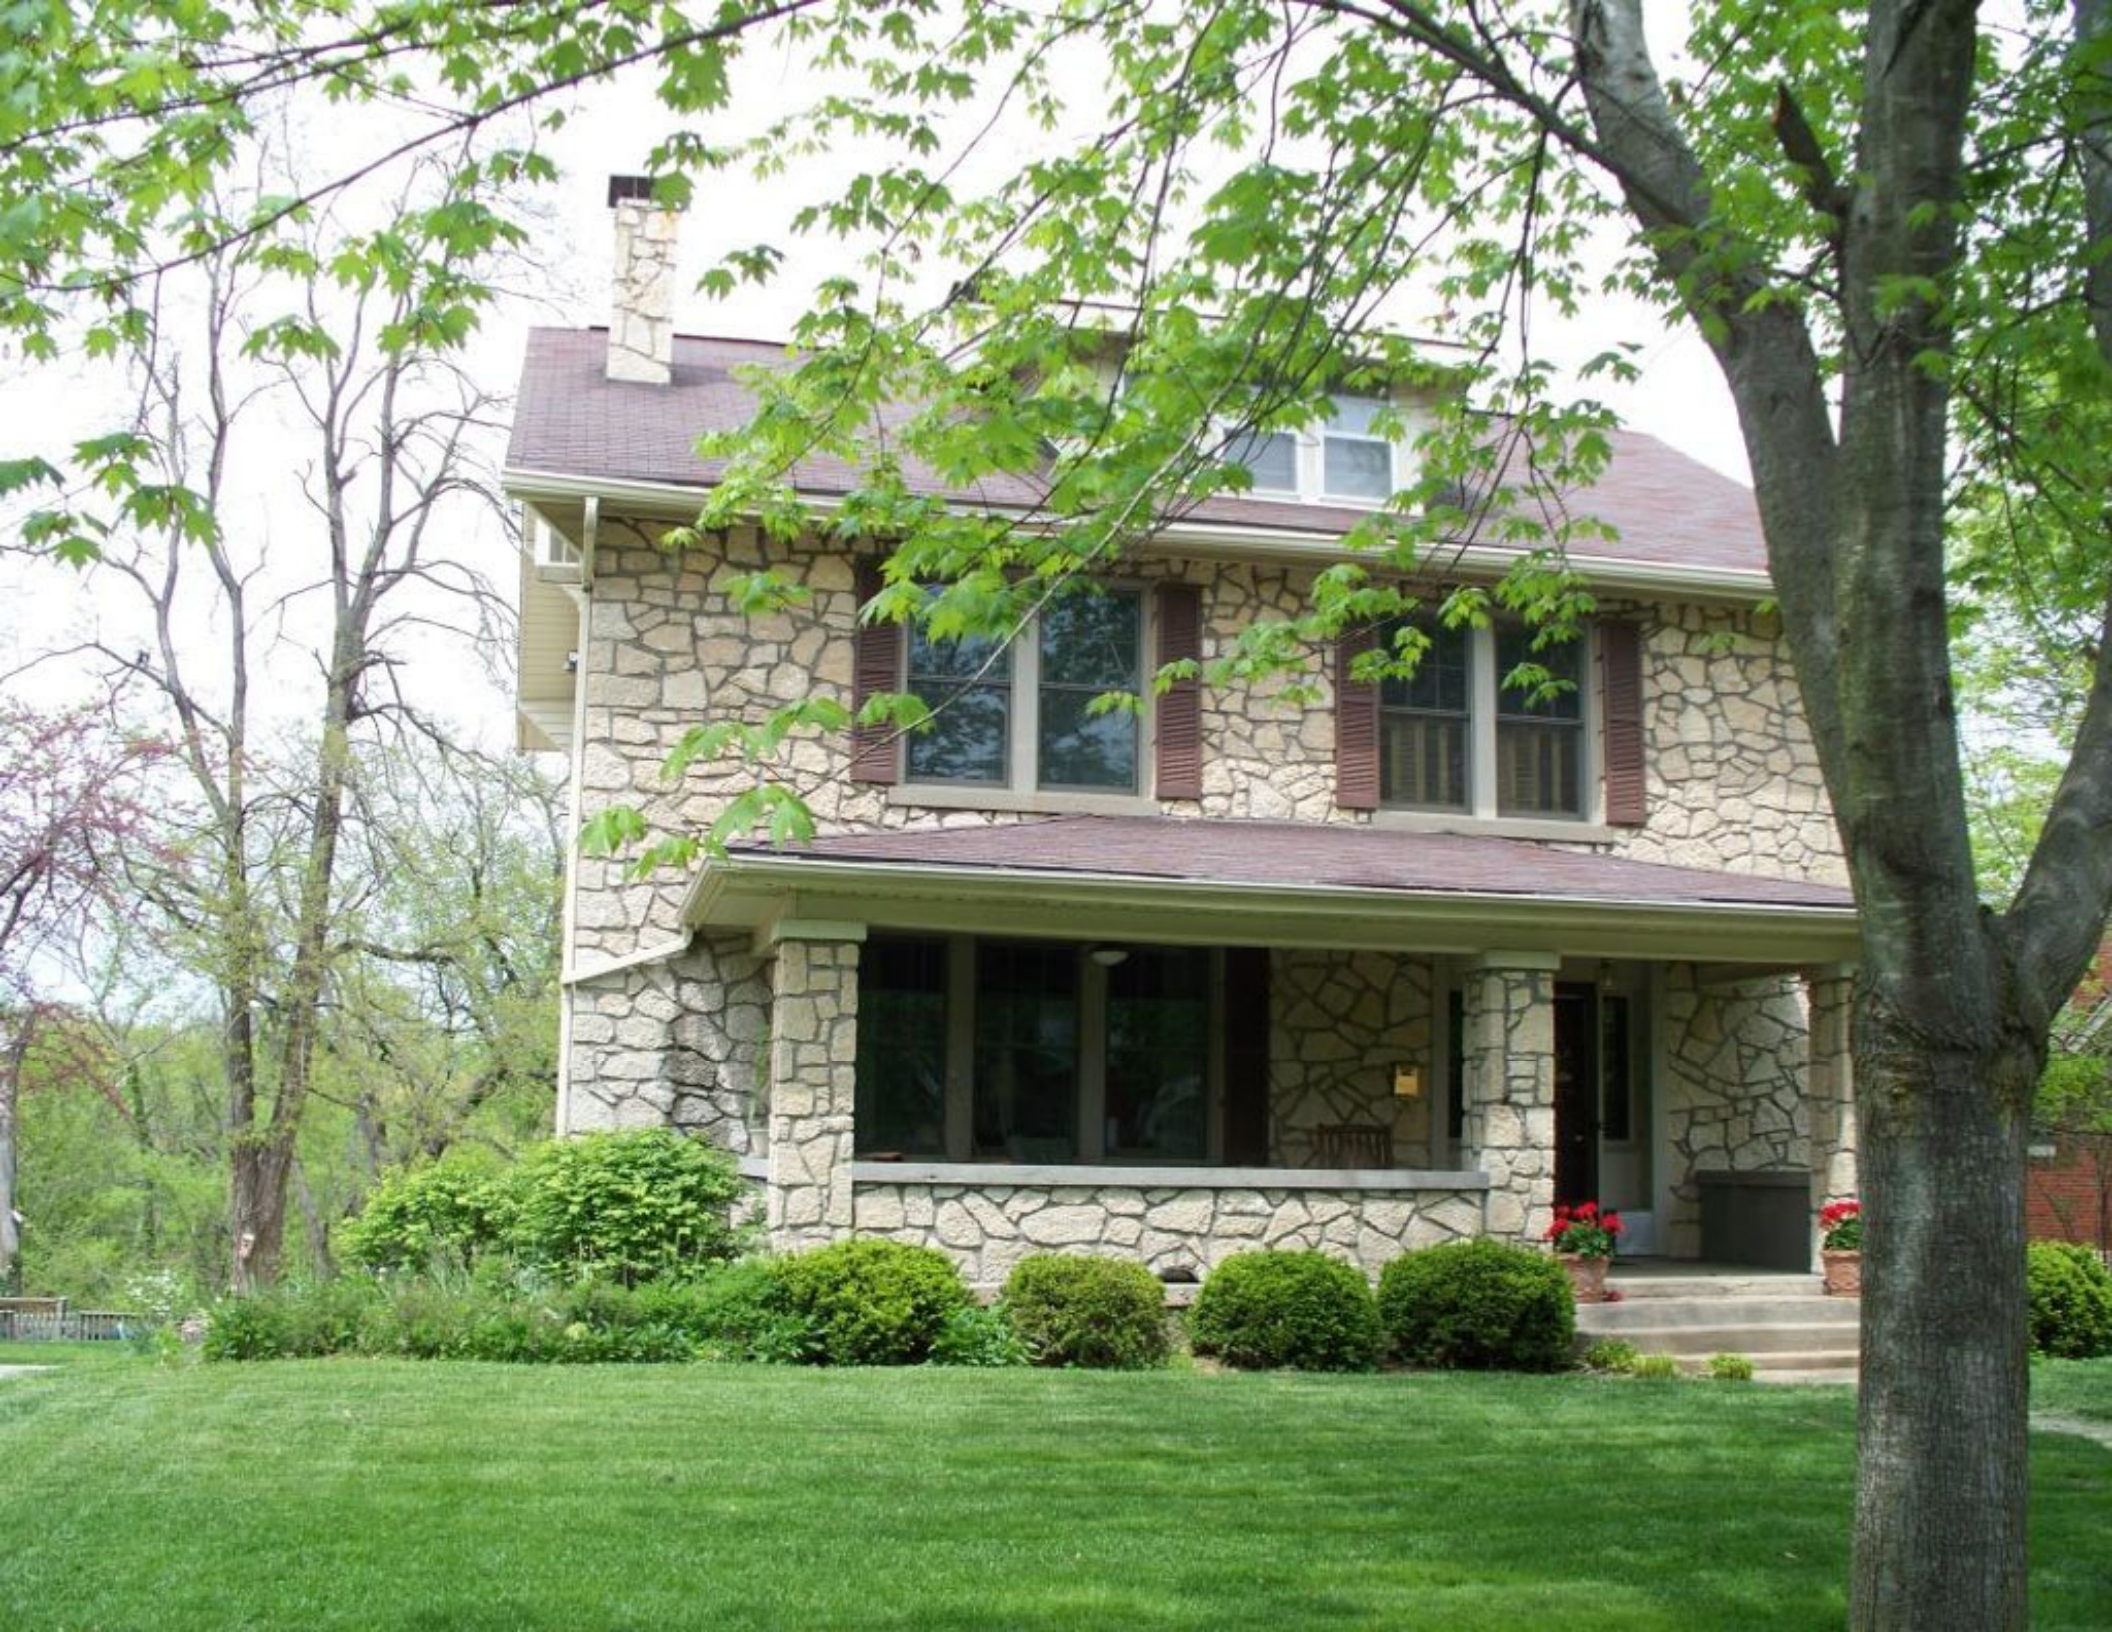
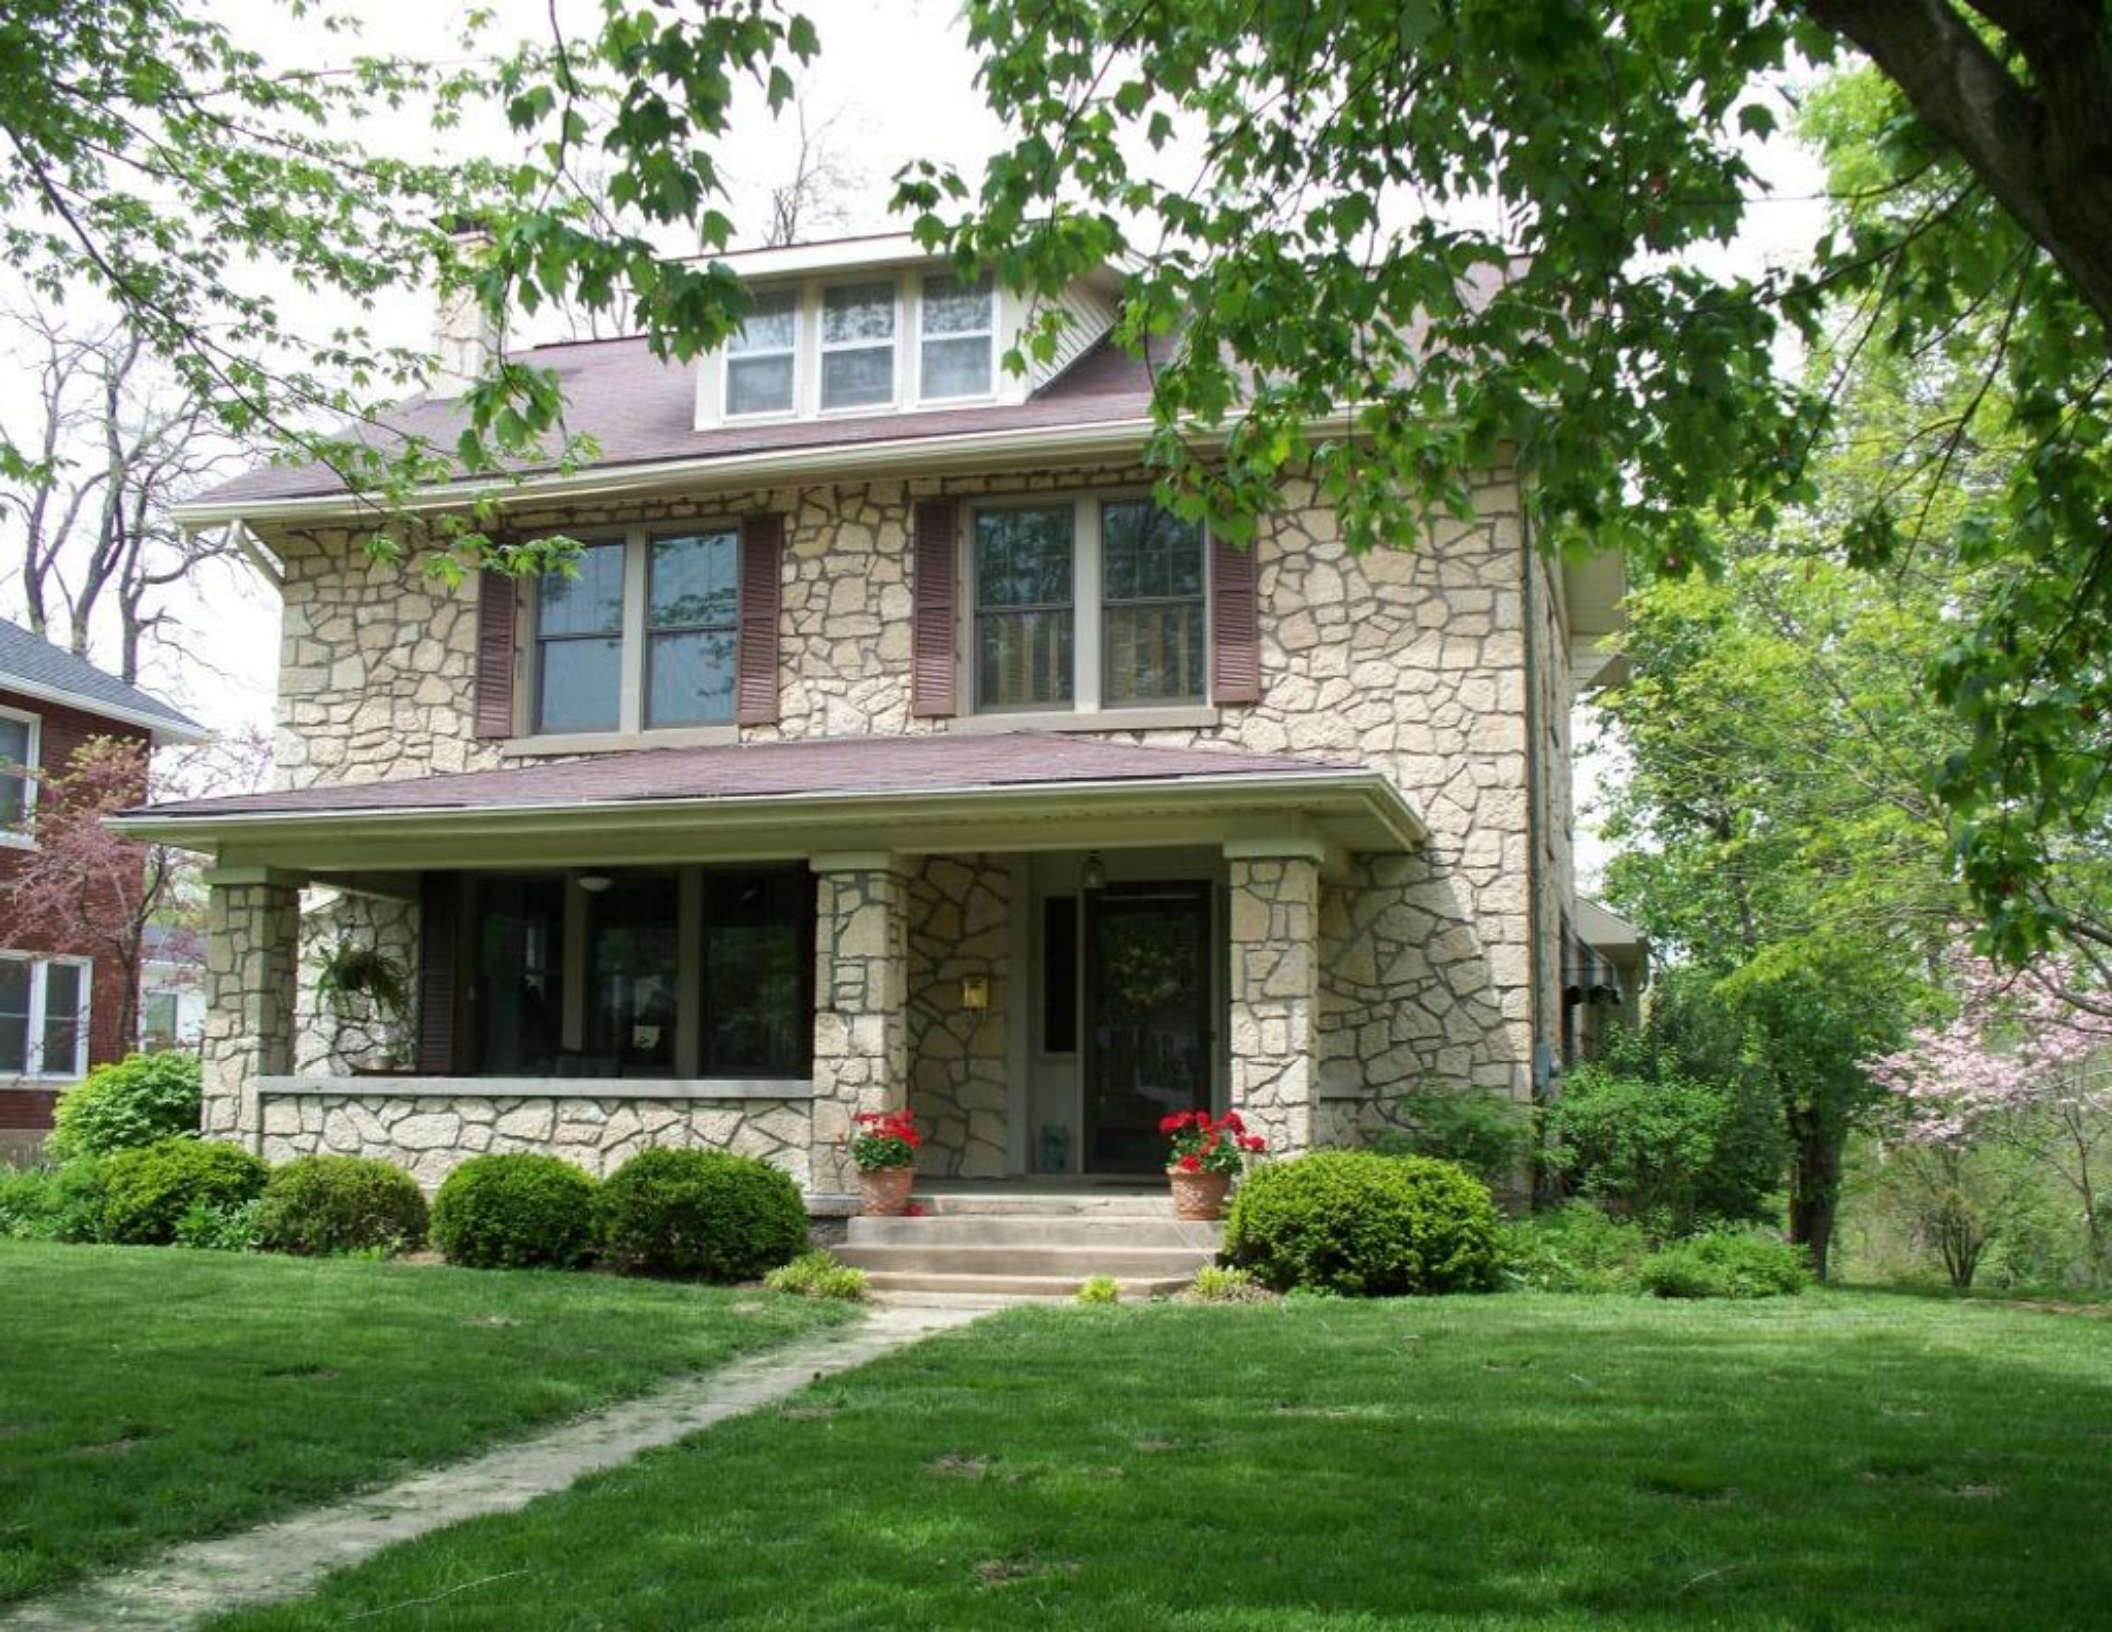
40. (cont.) Description of environment and outbuildings. Expand box as necessary, or add continuation pages.
There is a non-historic shed at the back of the property.

41. (cont.)
This 2 ½ story stone four square has a side gable roof with a central shed dormer with three 6/1 windows. The roof has vinyl soffits and knee braces. The second floor has two paired 6/1 windows with shutters. The first floor has a row of three 6/1 windows with shutters in the left bay. The right bay contains the entrance with sidelights. The porch is ¾ width and features stone piers and half walls capped in limestone or concrete. All of the windows appear to be modern replacements.

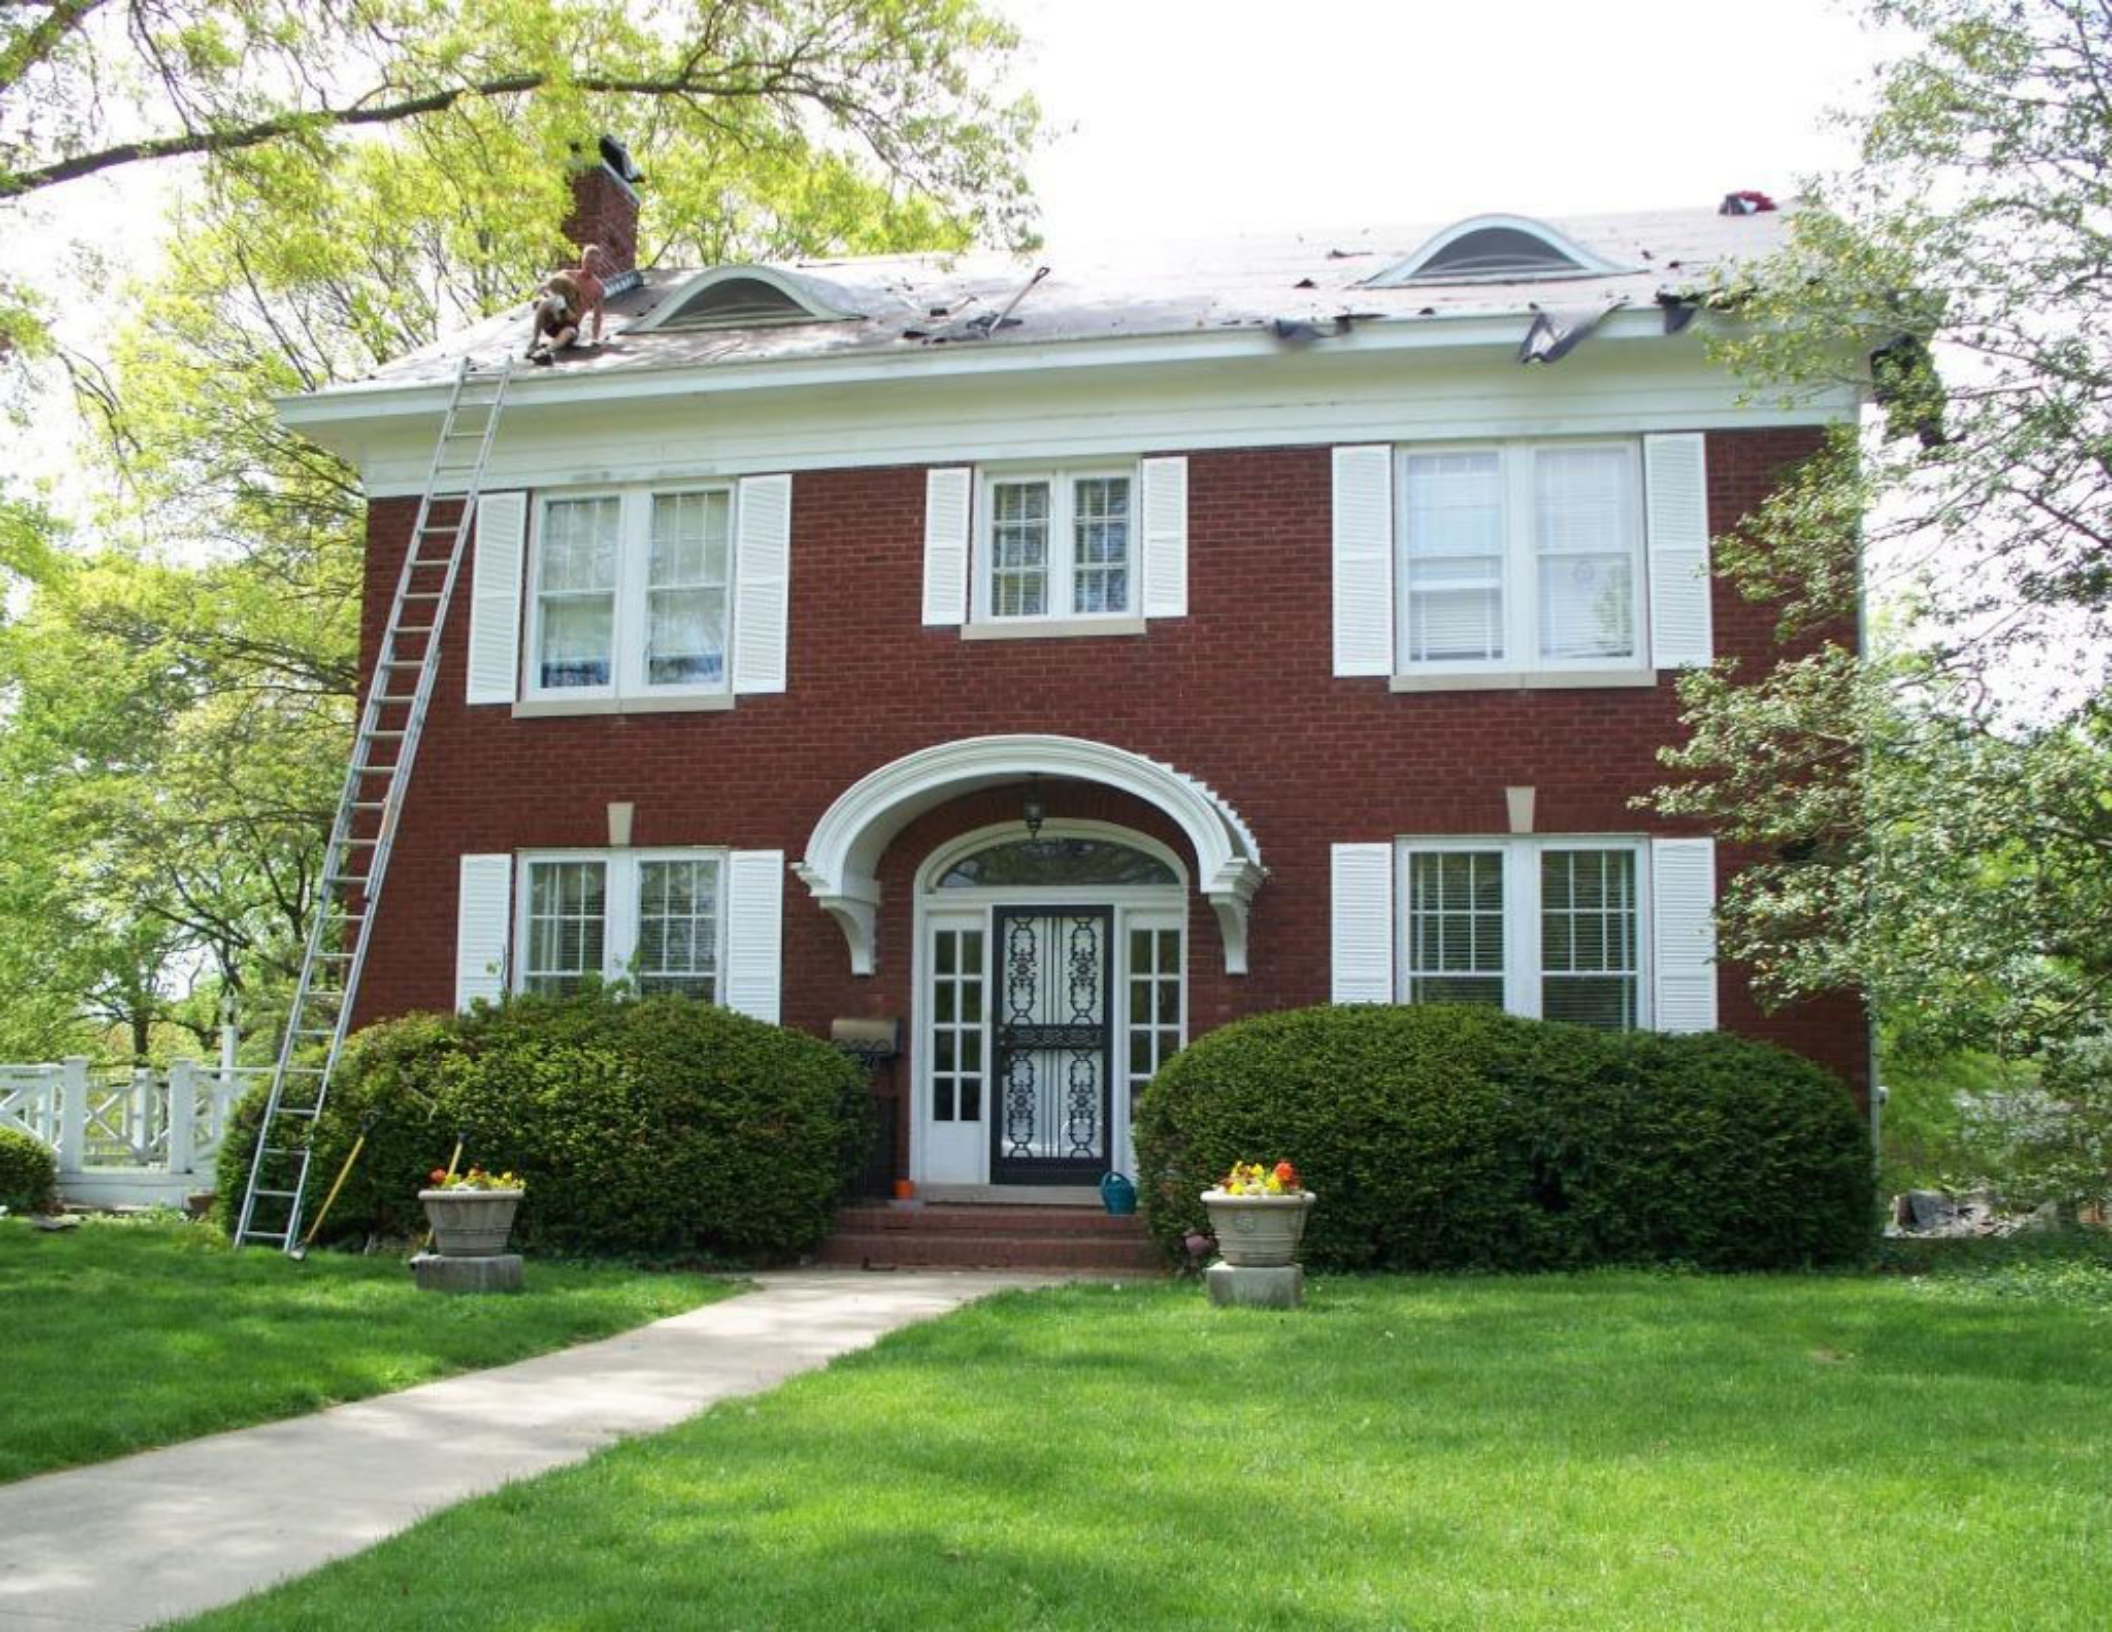
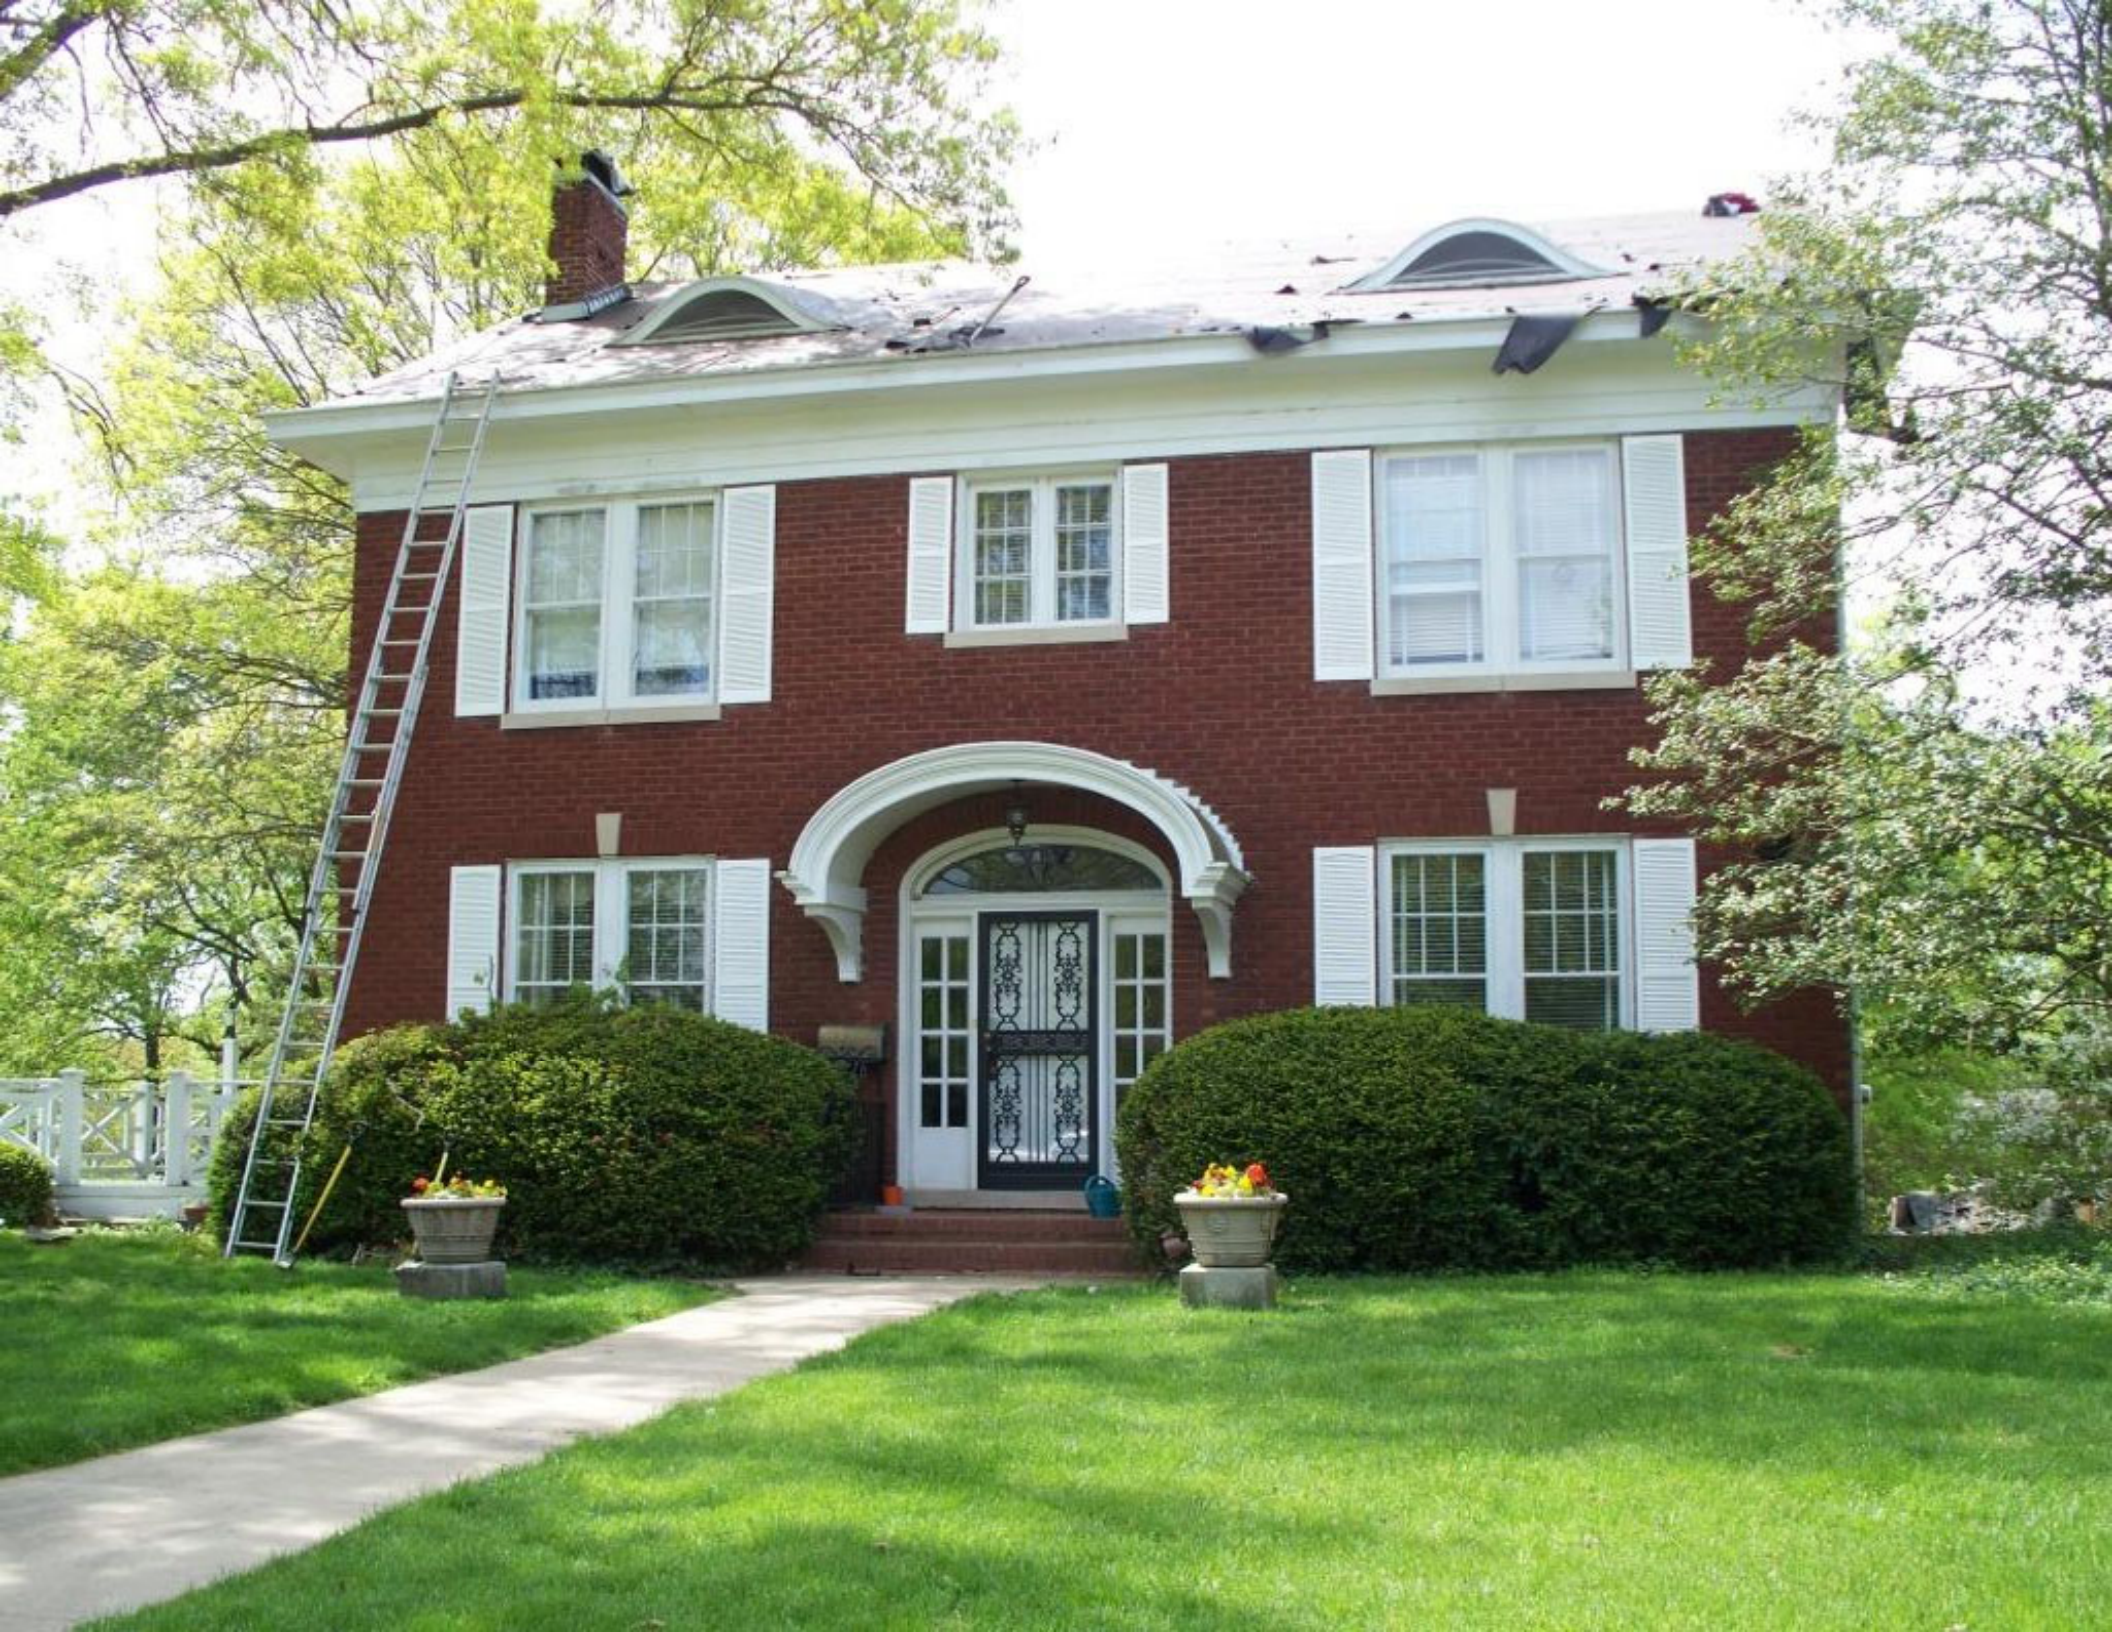
This two story brick Colonial Revival has a side gable roof with two eyebrow windows that are flush with the roof. There is a wide wooden cornice. On the second story there are two 6/1 paired windows flanking a smaller paired 6x6 windows that appear historic. They have storm windows. The first floor has paired 6/1 windows (appear to be modern replacements) with concrete or limestone key stones in a jack brick arch flanking the entrance. All of the windows have shutters and concrete sills. The entrance has an arched transom that appears to be ornate leaded glass. The door features multi-light sidelights that appear original. An ornate screen door obscures if the door is original or not. A large basket handle hood with brackets covers the entrance and the brick stoop. A wooden porch with wood railing is off to the right of the house and beneath it there appears to be a stone carport for two cars.
