ARCHITECTURAL/HISTORIC INVENTORY FORM

1. Survey No. CO-AS-005-001		2. Survey name: Moreau Drive Neighborhood Survey	
3. County: Cole		4. Address: 1202 Elmerine Ave.	
5. City: Jefferson City	Vicinity: <input type="checkbox"/>	6. UTM: / /	7. Township/Range/Section: T: R: S:
8. Historic name (if known):		9. Present/other name (if known):	
10. Ownership: <input checked="" type="checkbox"/> Private <input type="checkbox"/> Public		11. Historic use (if known): Residential	11. Current use: Residential

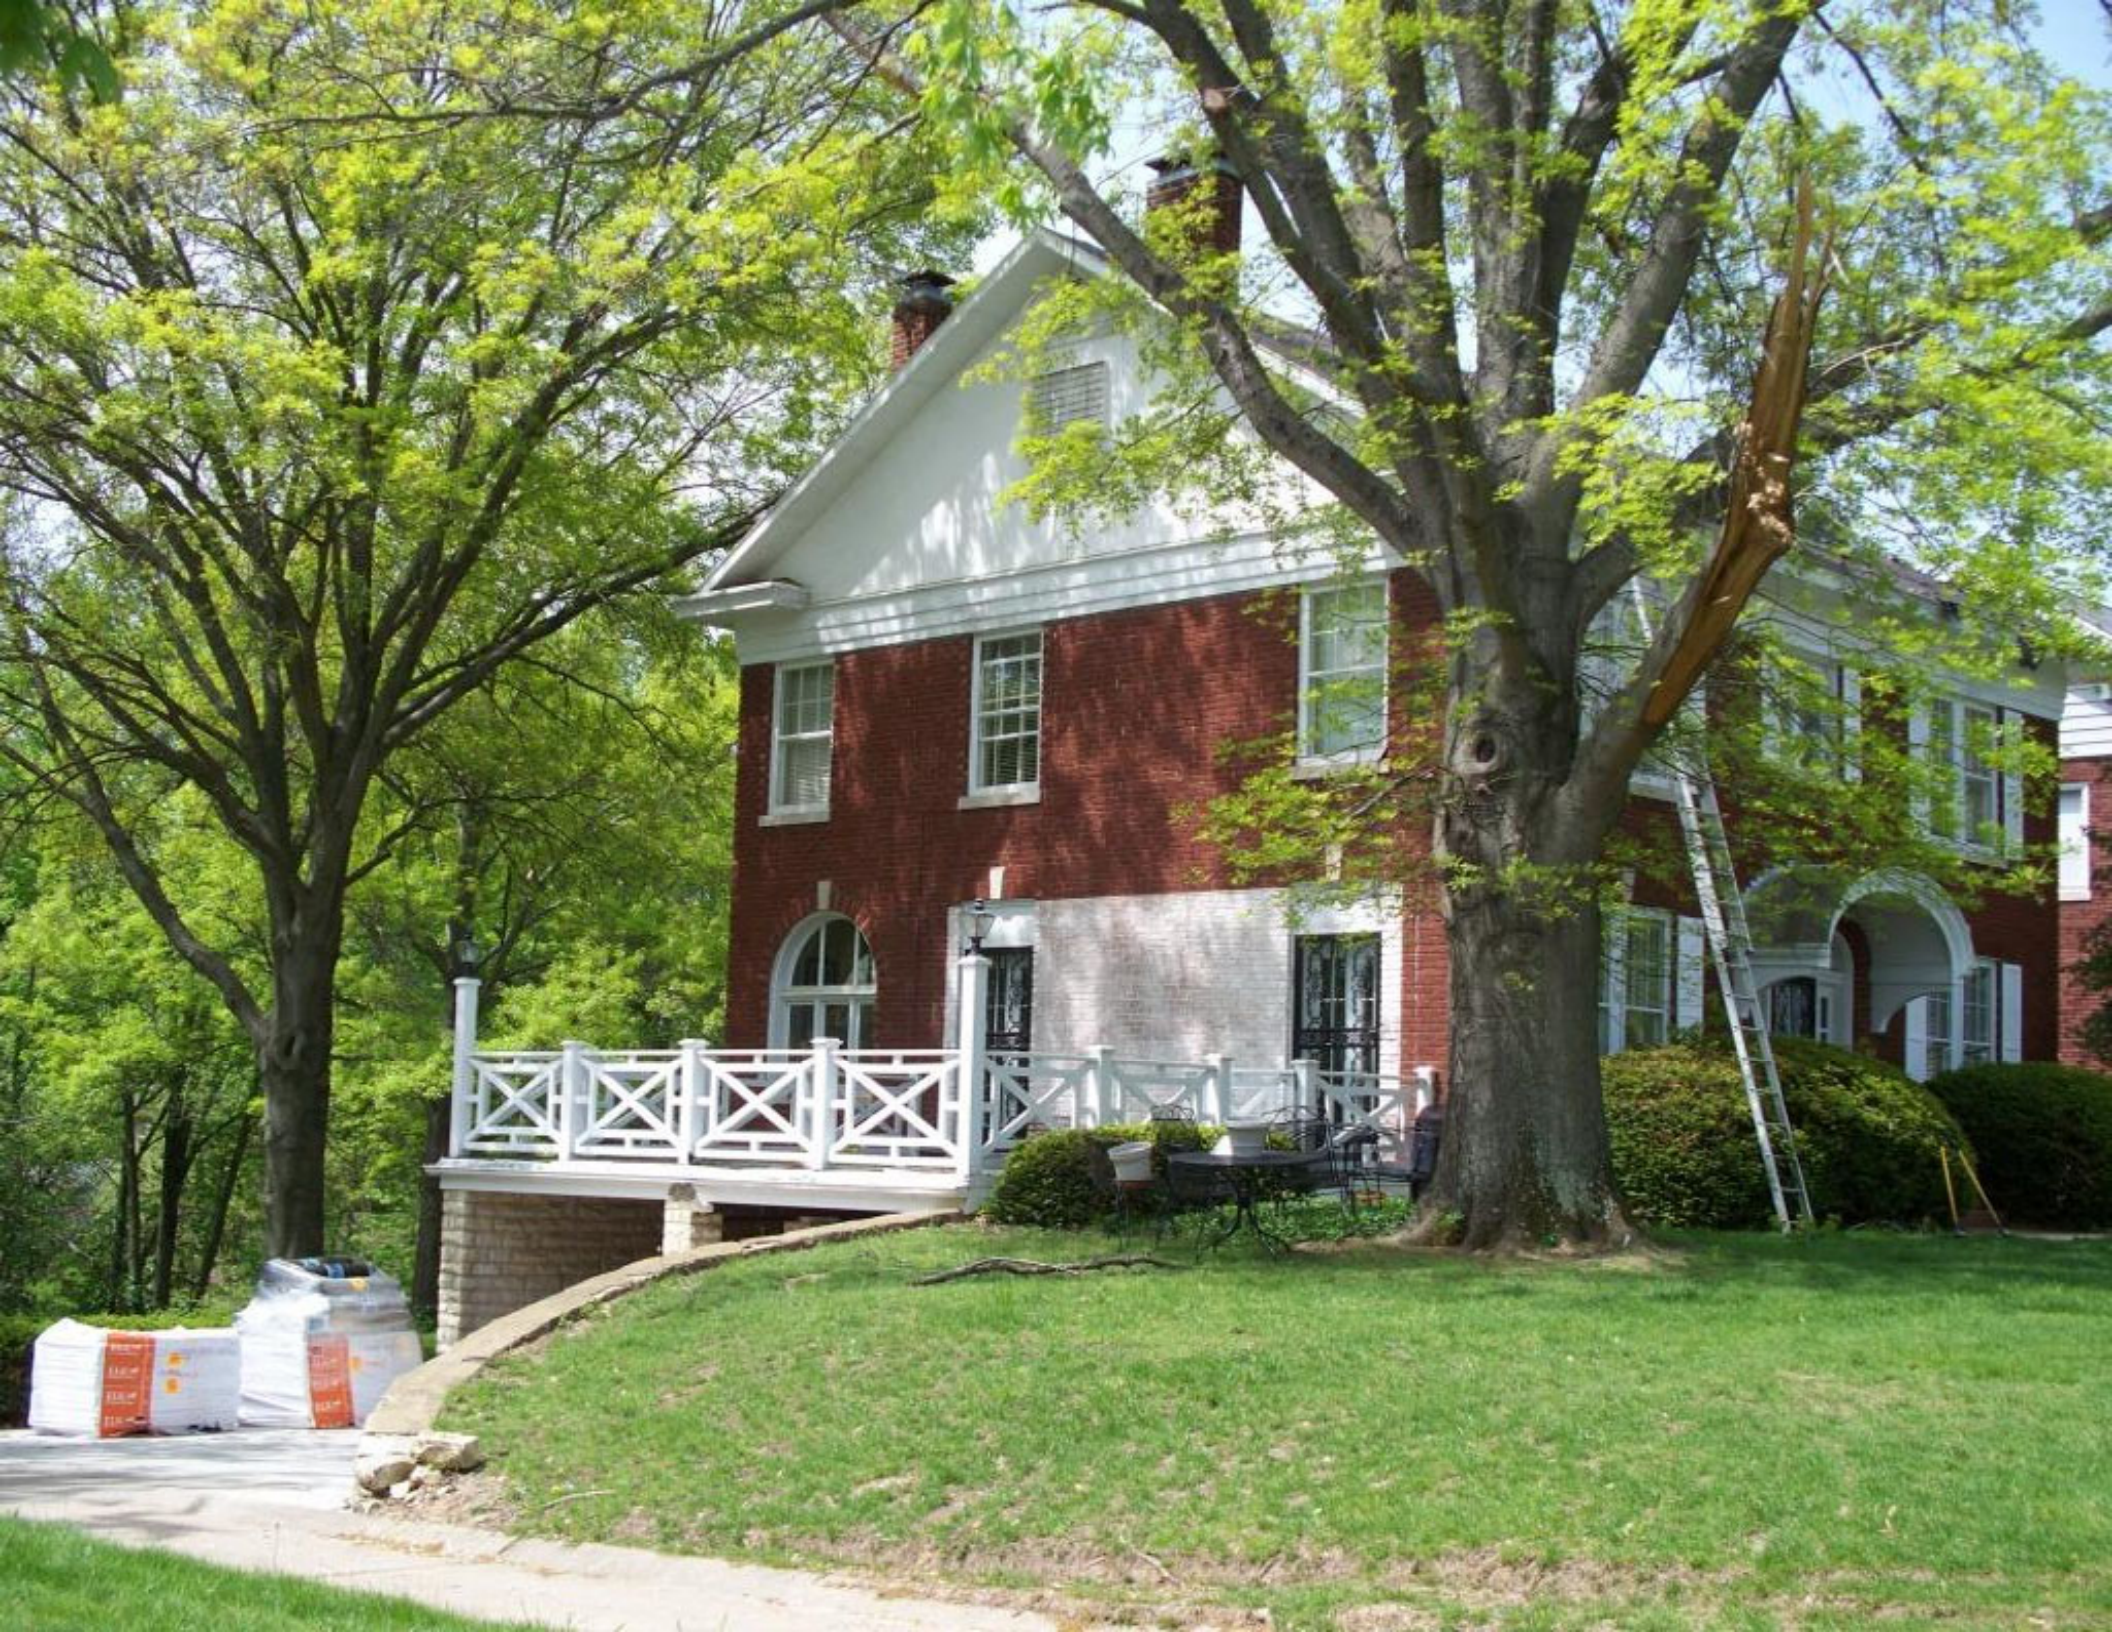
This two story brick Colonial Revival has a side gable roof with two eyebrow windows that are flush with the roof. There is a wide wooden cornice. On the second story there are two 6/1 paired windows flanking a smaller paired 6x6 windows that appear historic. They have storm windows. The first floor has paired 6/1 windows (appear to be modern replacements) with concrete or limestone key stones in a jack brick arch flanking the entrance. All of the windows have shutters and concrete sills. The entrance has an arched transom that appears to be ornate leaded glass. The door features multi-light sidelights that appear original. An ornate screen door obscures if the door is original or not. A large basket handle hood with brackets covers the entrance and the brick stoop. A wooden porch with wood railing is off to the right of the house and beneath it there appears to be a stone carport for two cars.

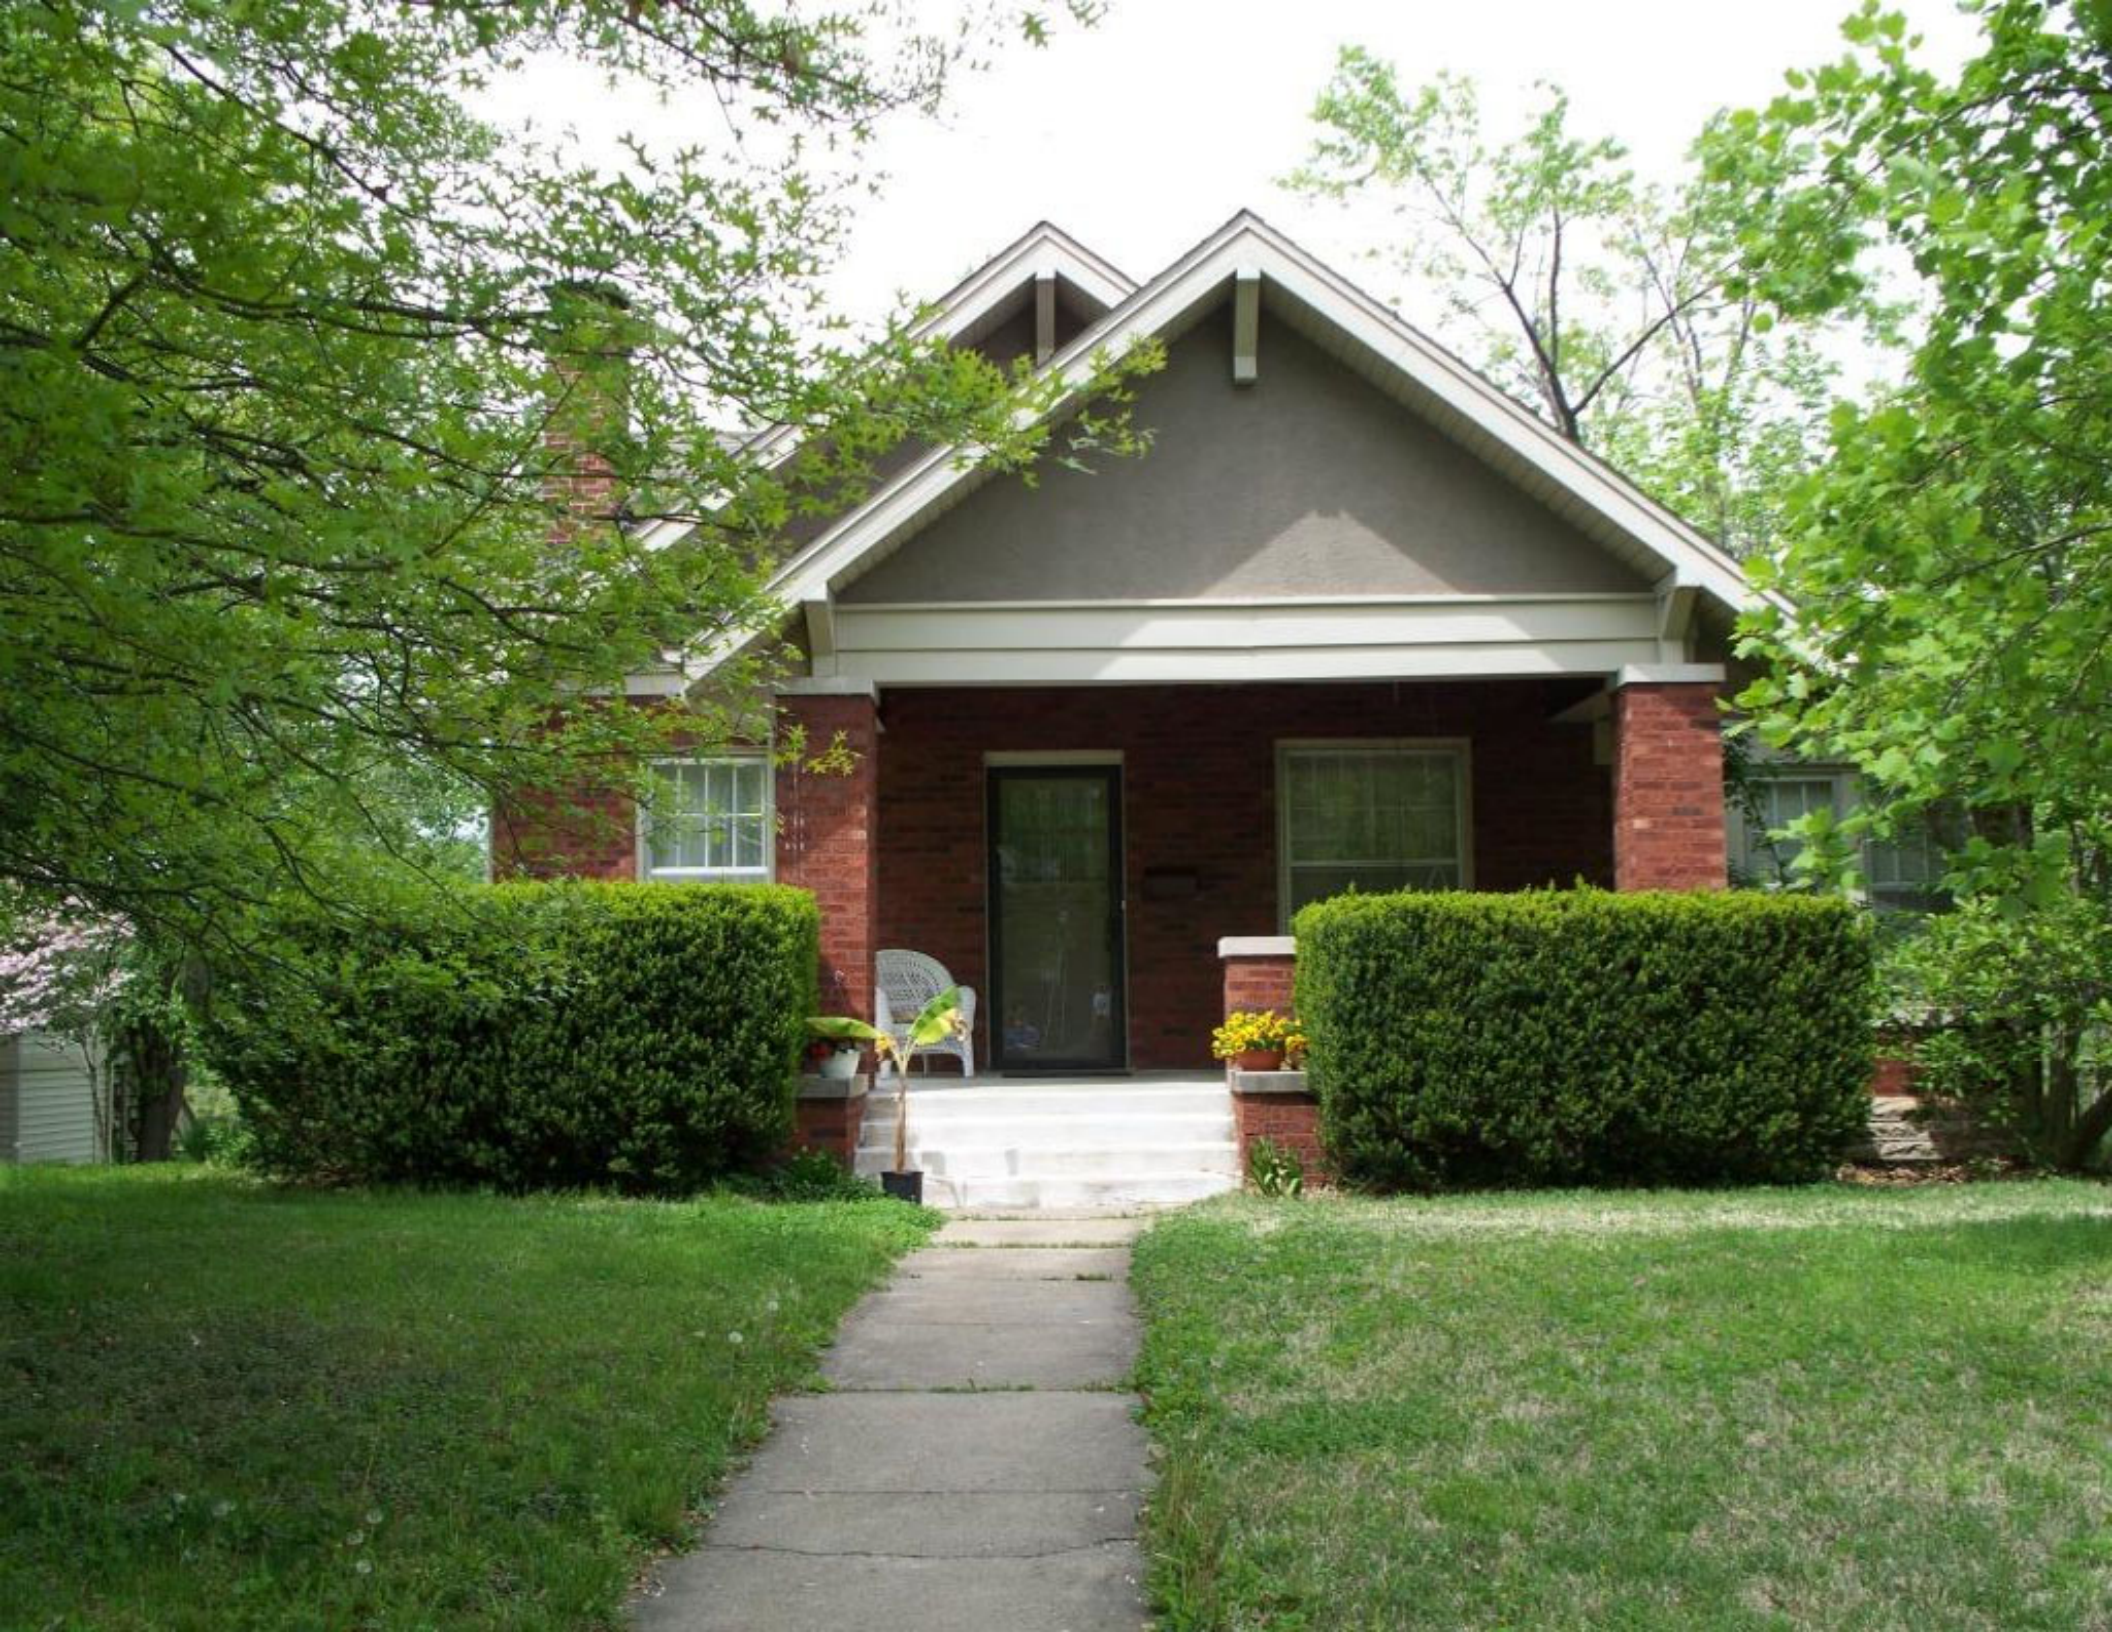
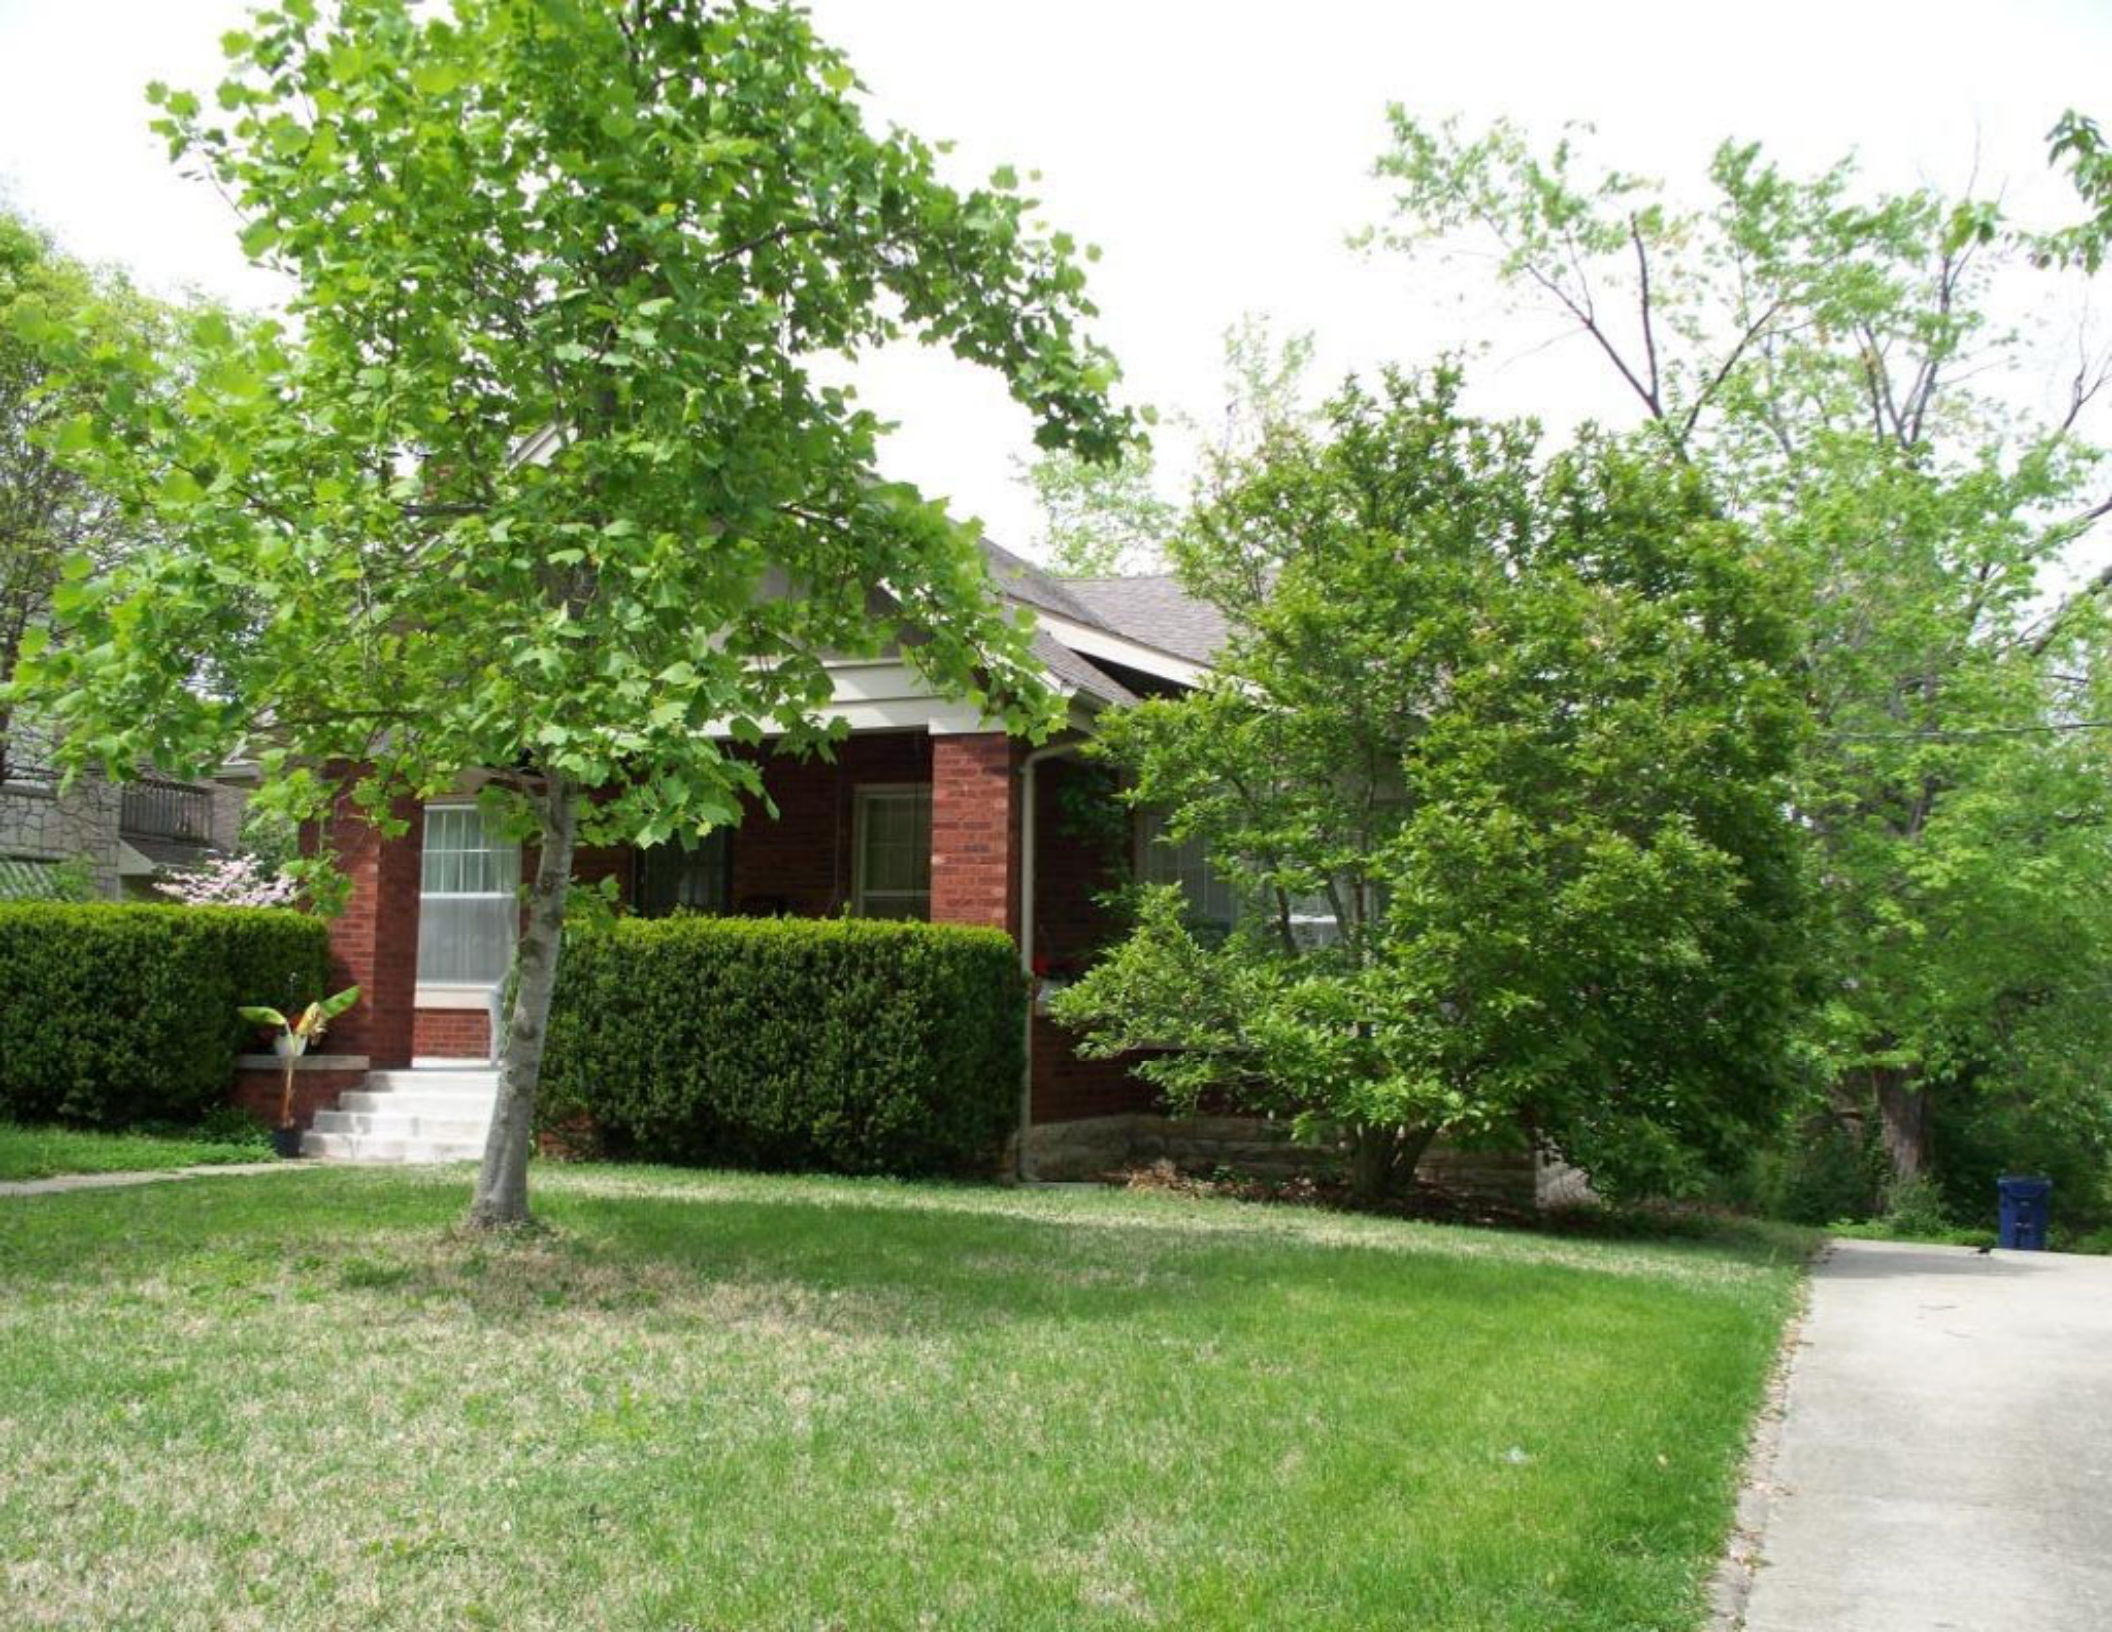
This one story brick bungalow has a double front gable roof that is stuccoed and features brackets. The porch, entrance, and a multi-light modern window are in the front gable that projects from the rest of the property. The porch is centered and has brick piers and half walls capped in concrete. The door in the left bay has 8 panes of glass towards the top and may or may not be historic. A large 12/1 window is in the center bay. The right bay is not covered by the porch and contains a row of three windows (foliage obscured division). In the gable end that is set back to the left is a modern 8/1 window.

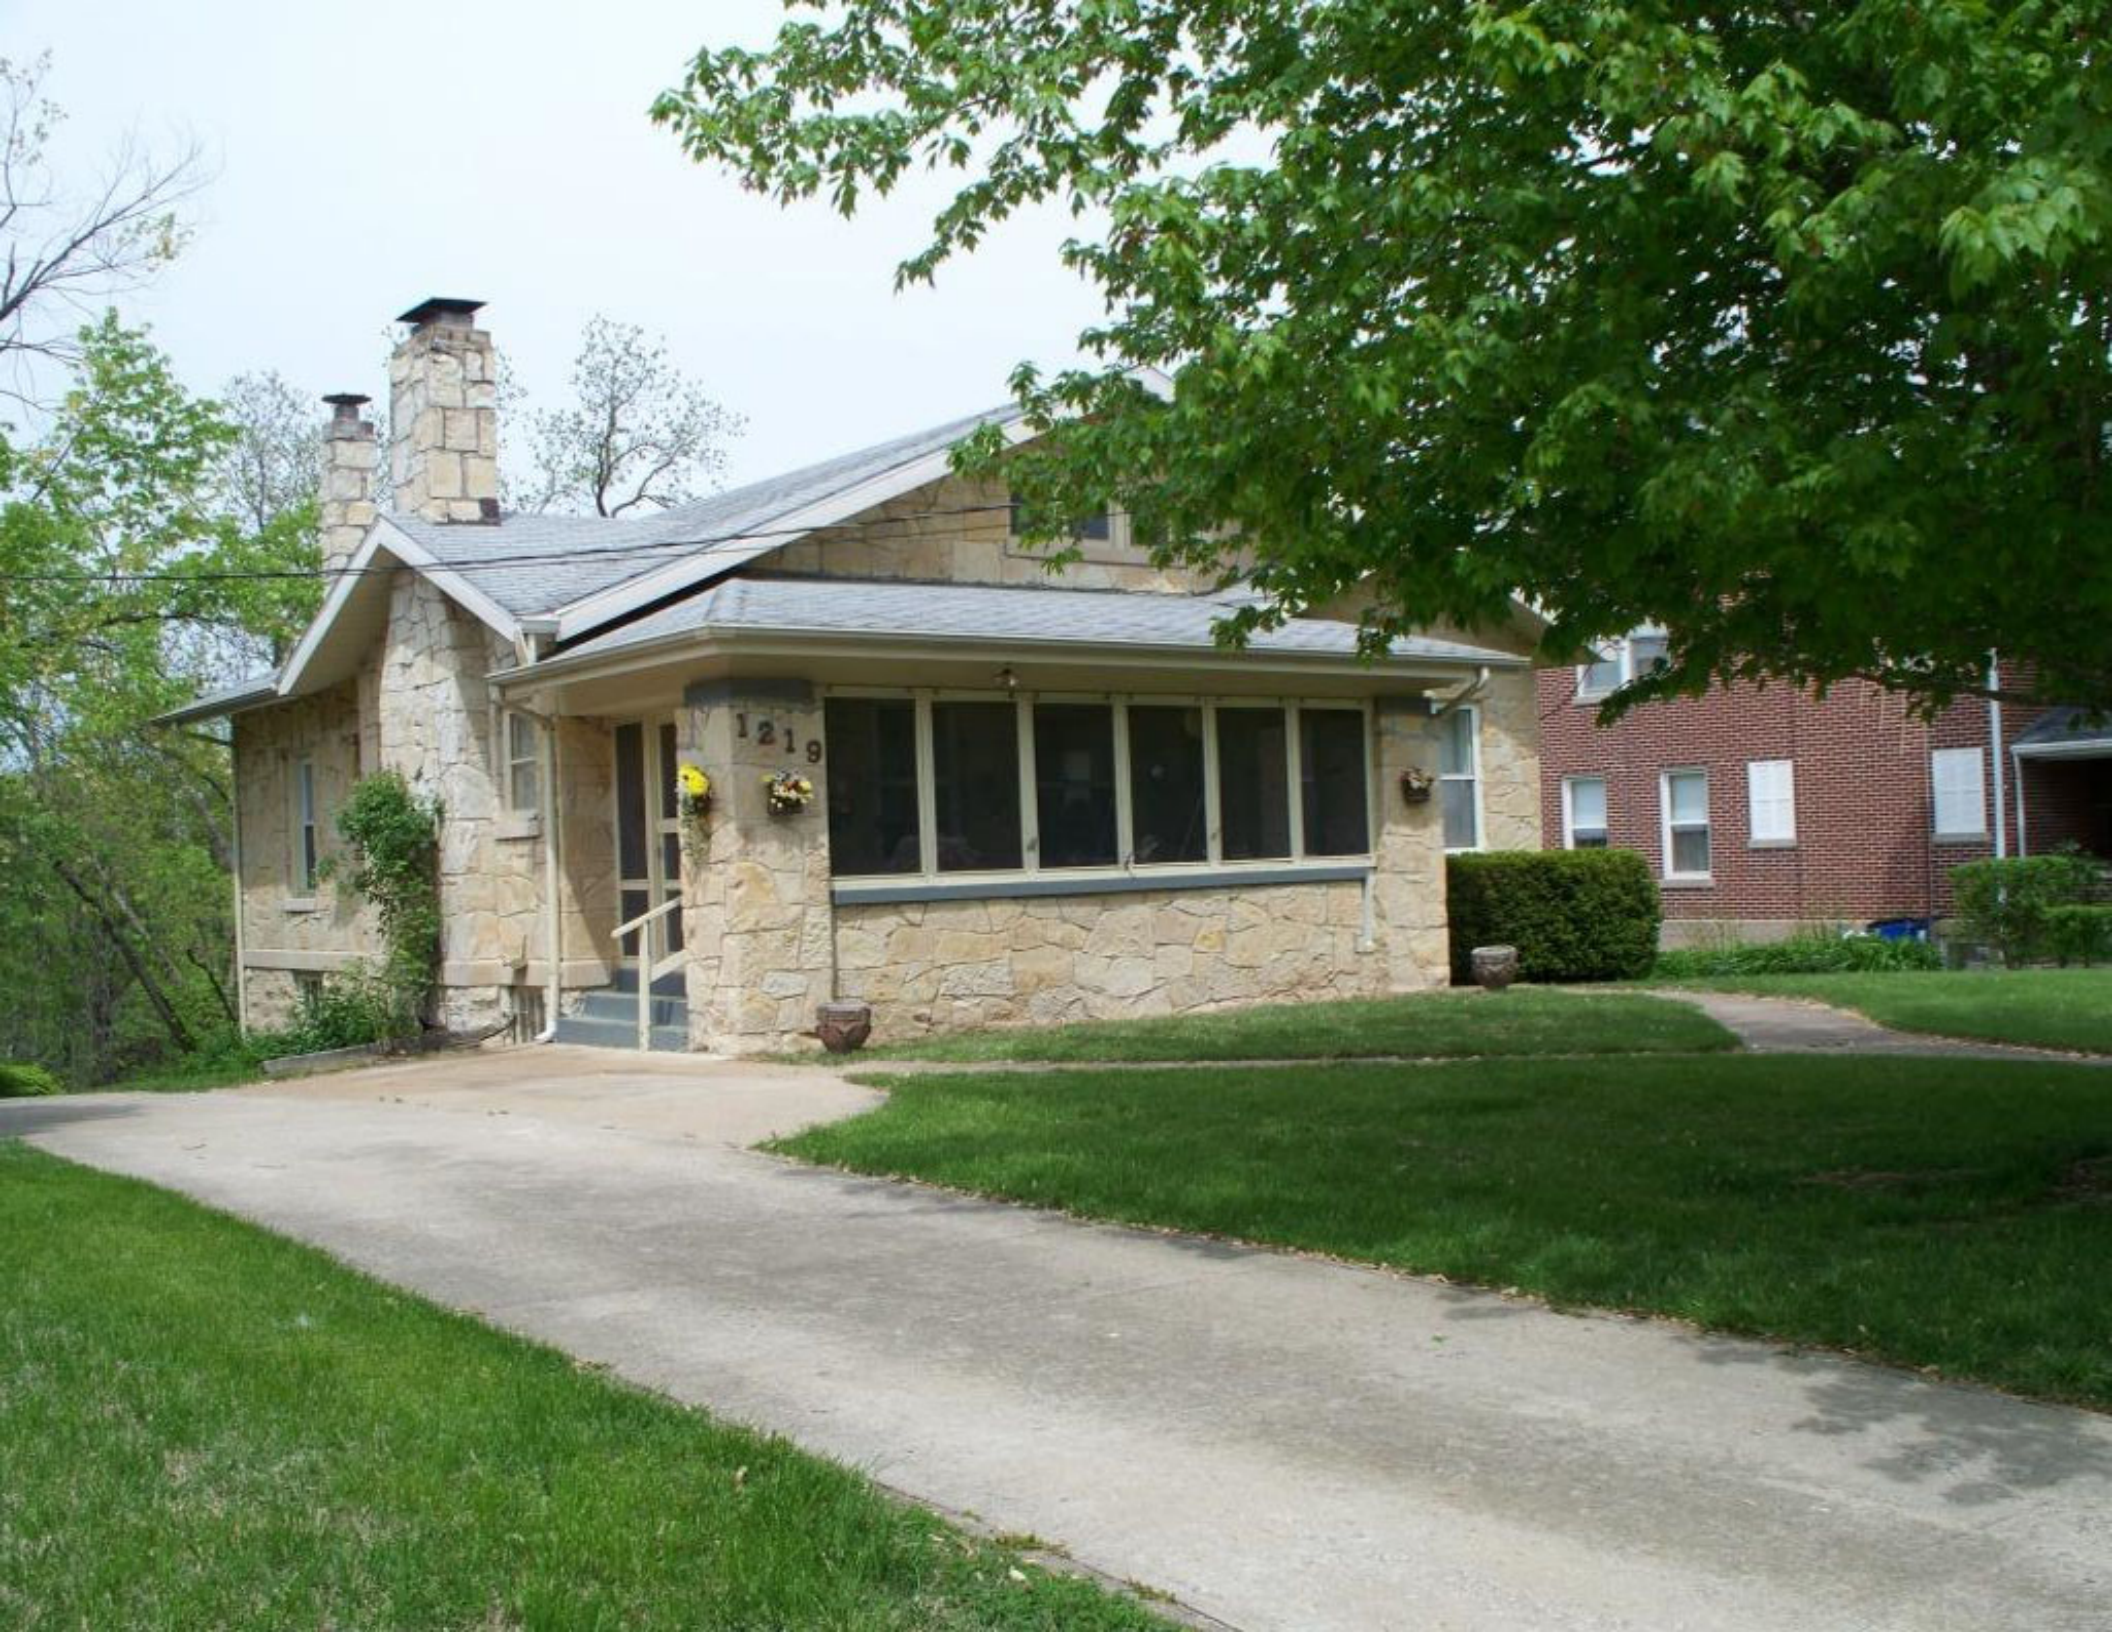
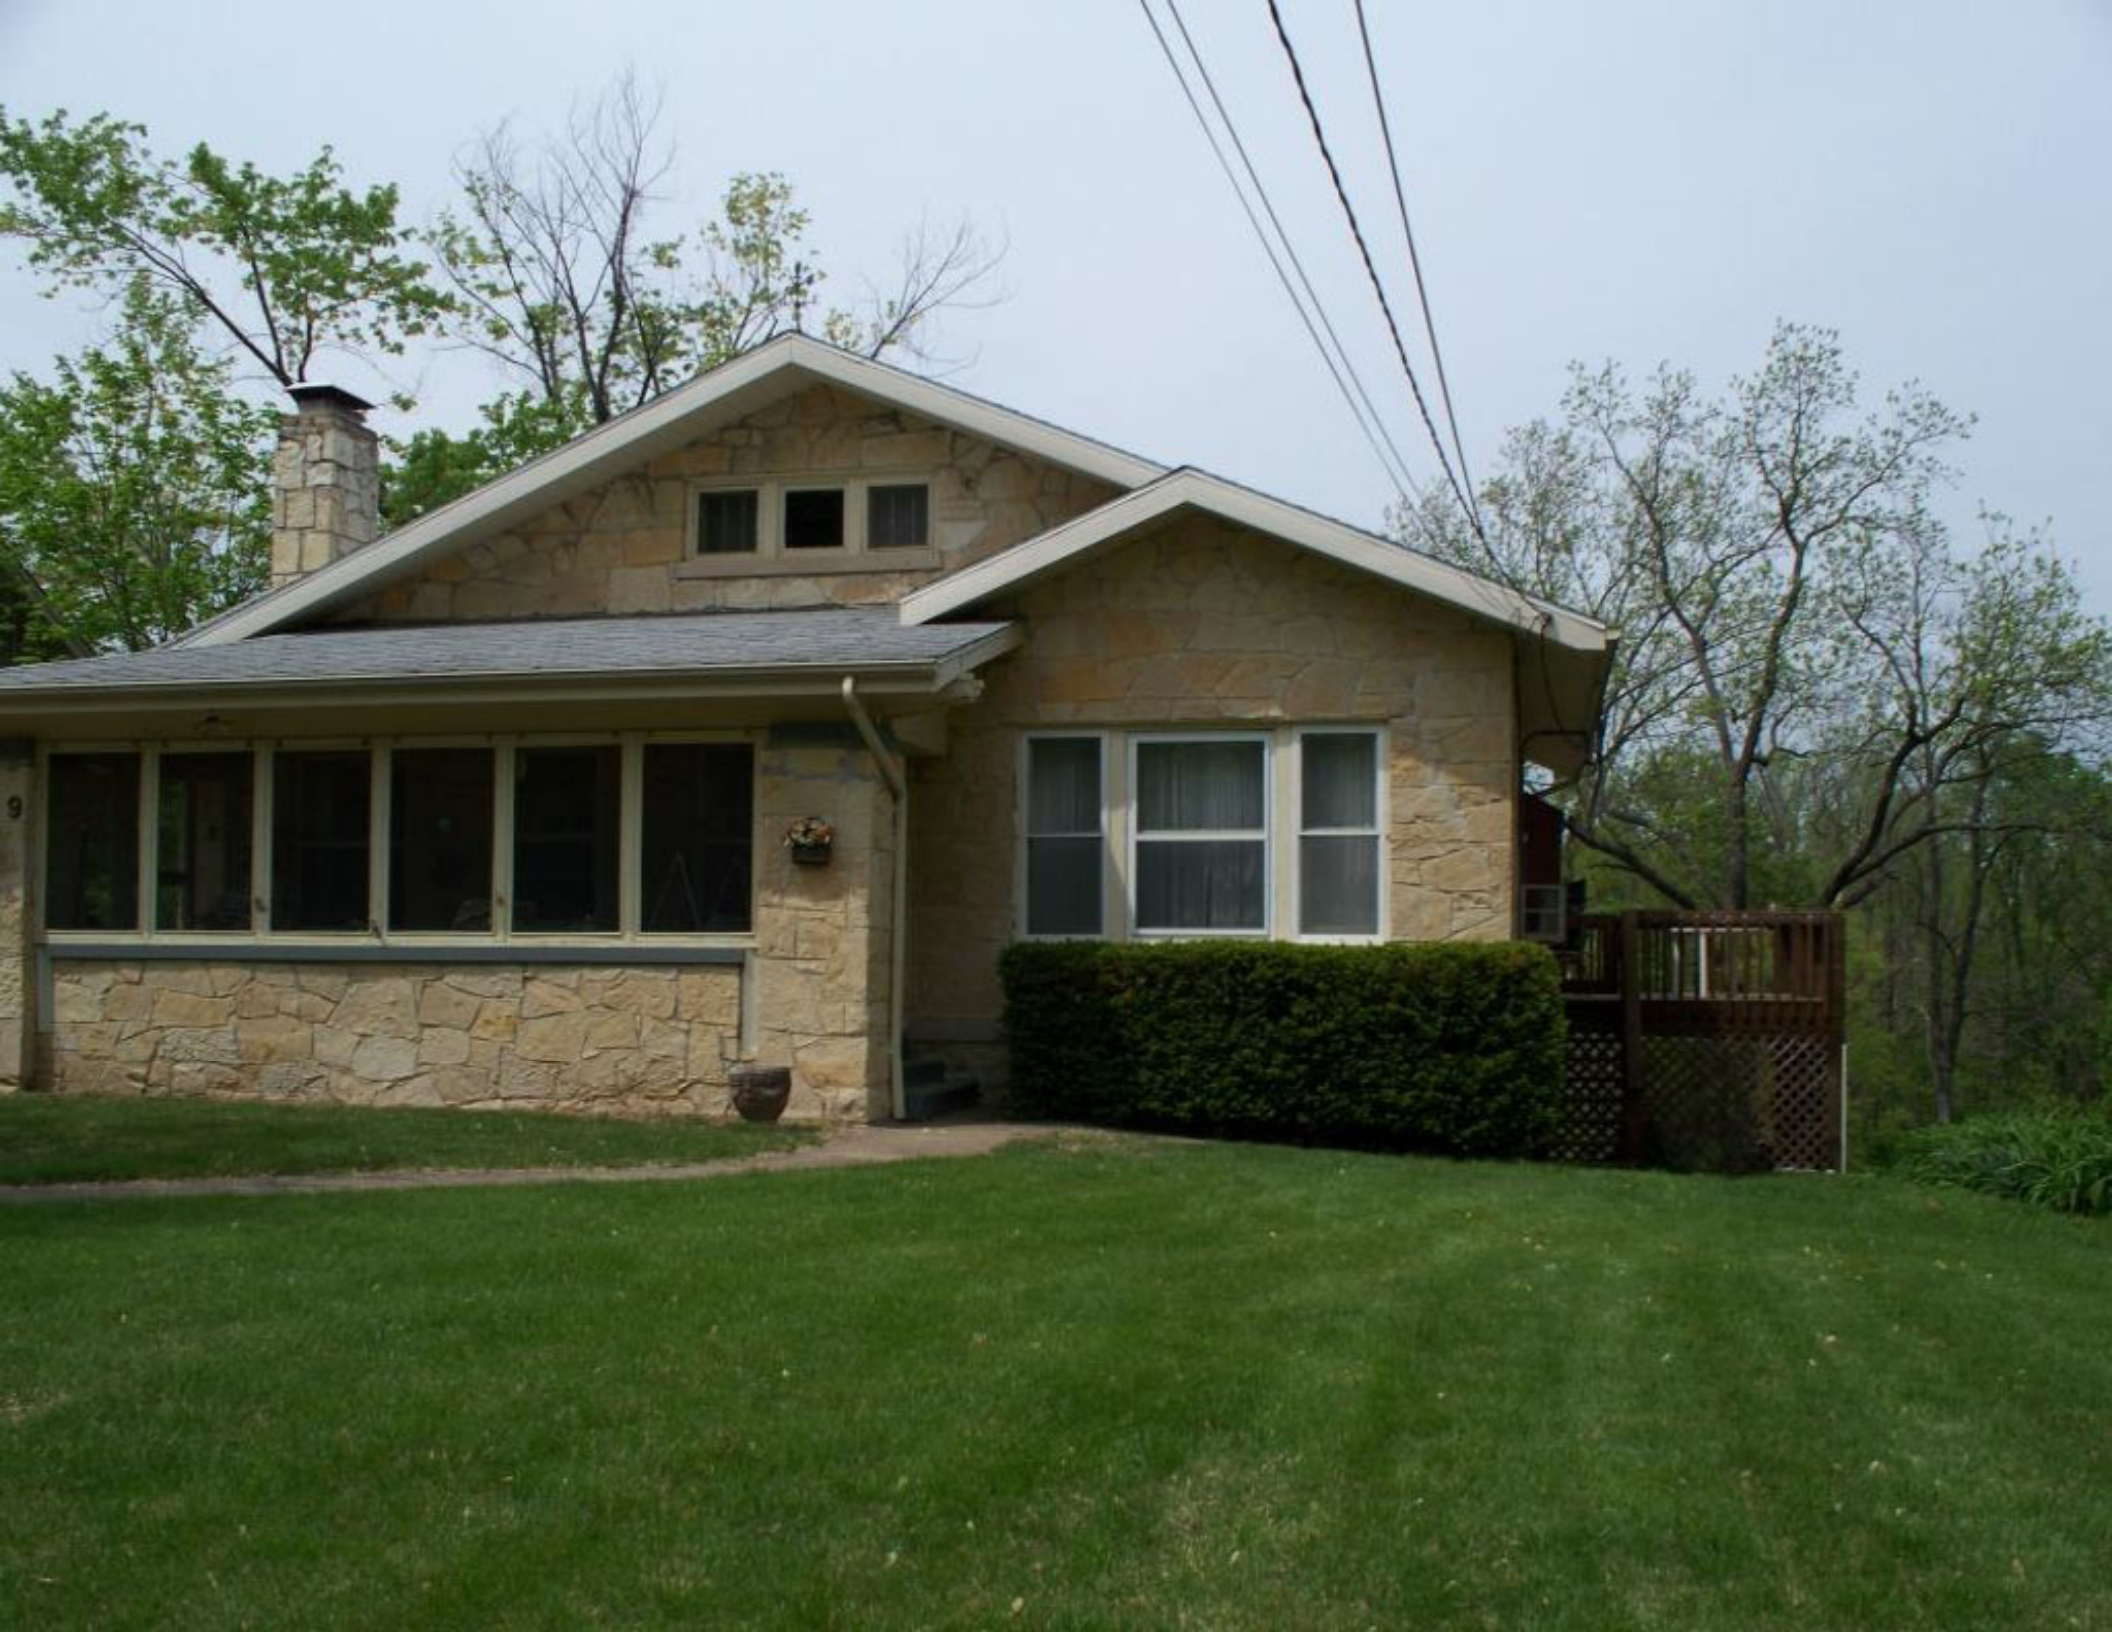
This 1 ½ stone bungalow has a gable roof with a row of three casement windows. The first and third are three-light and the middle is a single pane. These appear historic. On the first floor there in the right bay is another smaller front gable that covers a tri-part replacement window (1/1). All of the windows have limestone or concrete sills. The porch projects from the property and has a shed roof with stone half walls and pilasters capped in limestone or concrete. It has been screened in with 6 windows on the front of the property. The porch and entrance are accessed at either end of the porch via a set of stairs. There is a wooden porch that is setback and projects from the right side of the home.
