ARCHITECTURAL/HISTORIC INVENTORY FORM

1. Survey No. CO-AS-005-001		2. Survey name: Moreau Drive Neighborhood Survey	
3. County: Cole		4. Address: 1202 Elmerine Ave.	
5. City: Jefferson City	Vicinity: <input type="checkbox"/>	6. UTM: / /	7. Township/Range/Section: T: R: S:
8. Historic name (if known):		9. Present/other name (if known):	
10. Ownership: <input checked="" type="checkbox"/> Private <input type="checkbox"/> Public		11. Historic use (if known): Residential	11. Current use: Residential

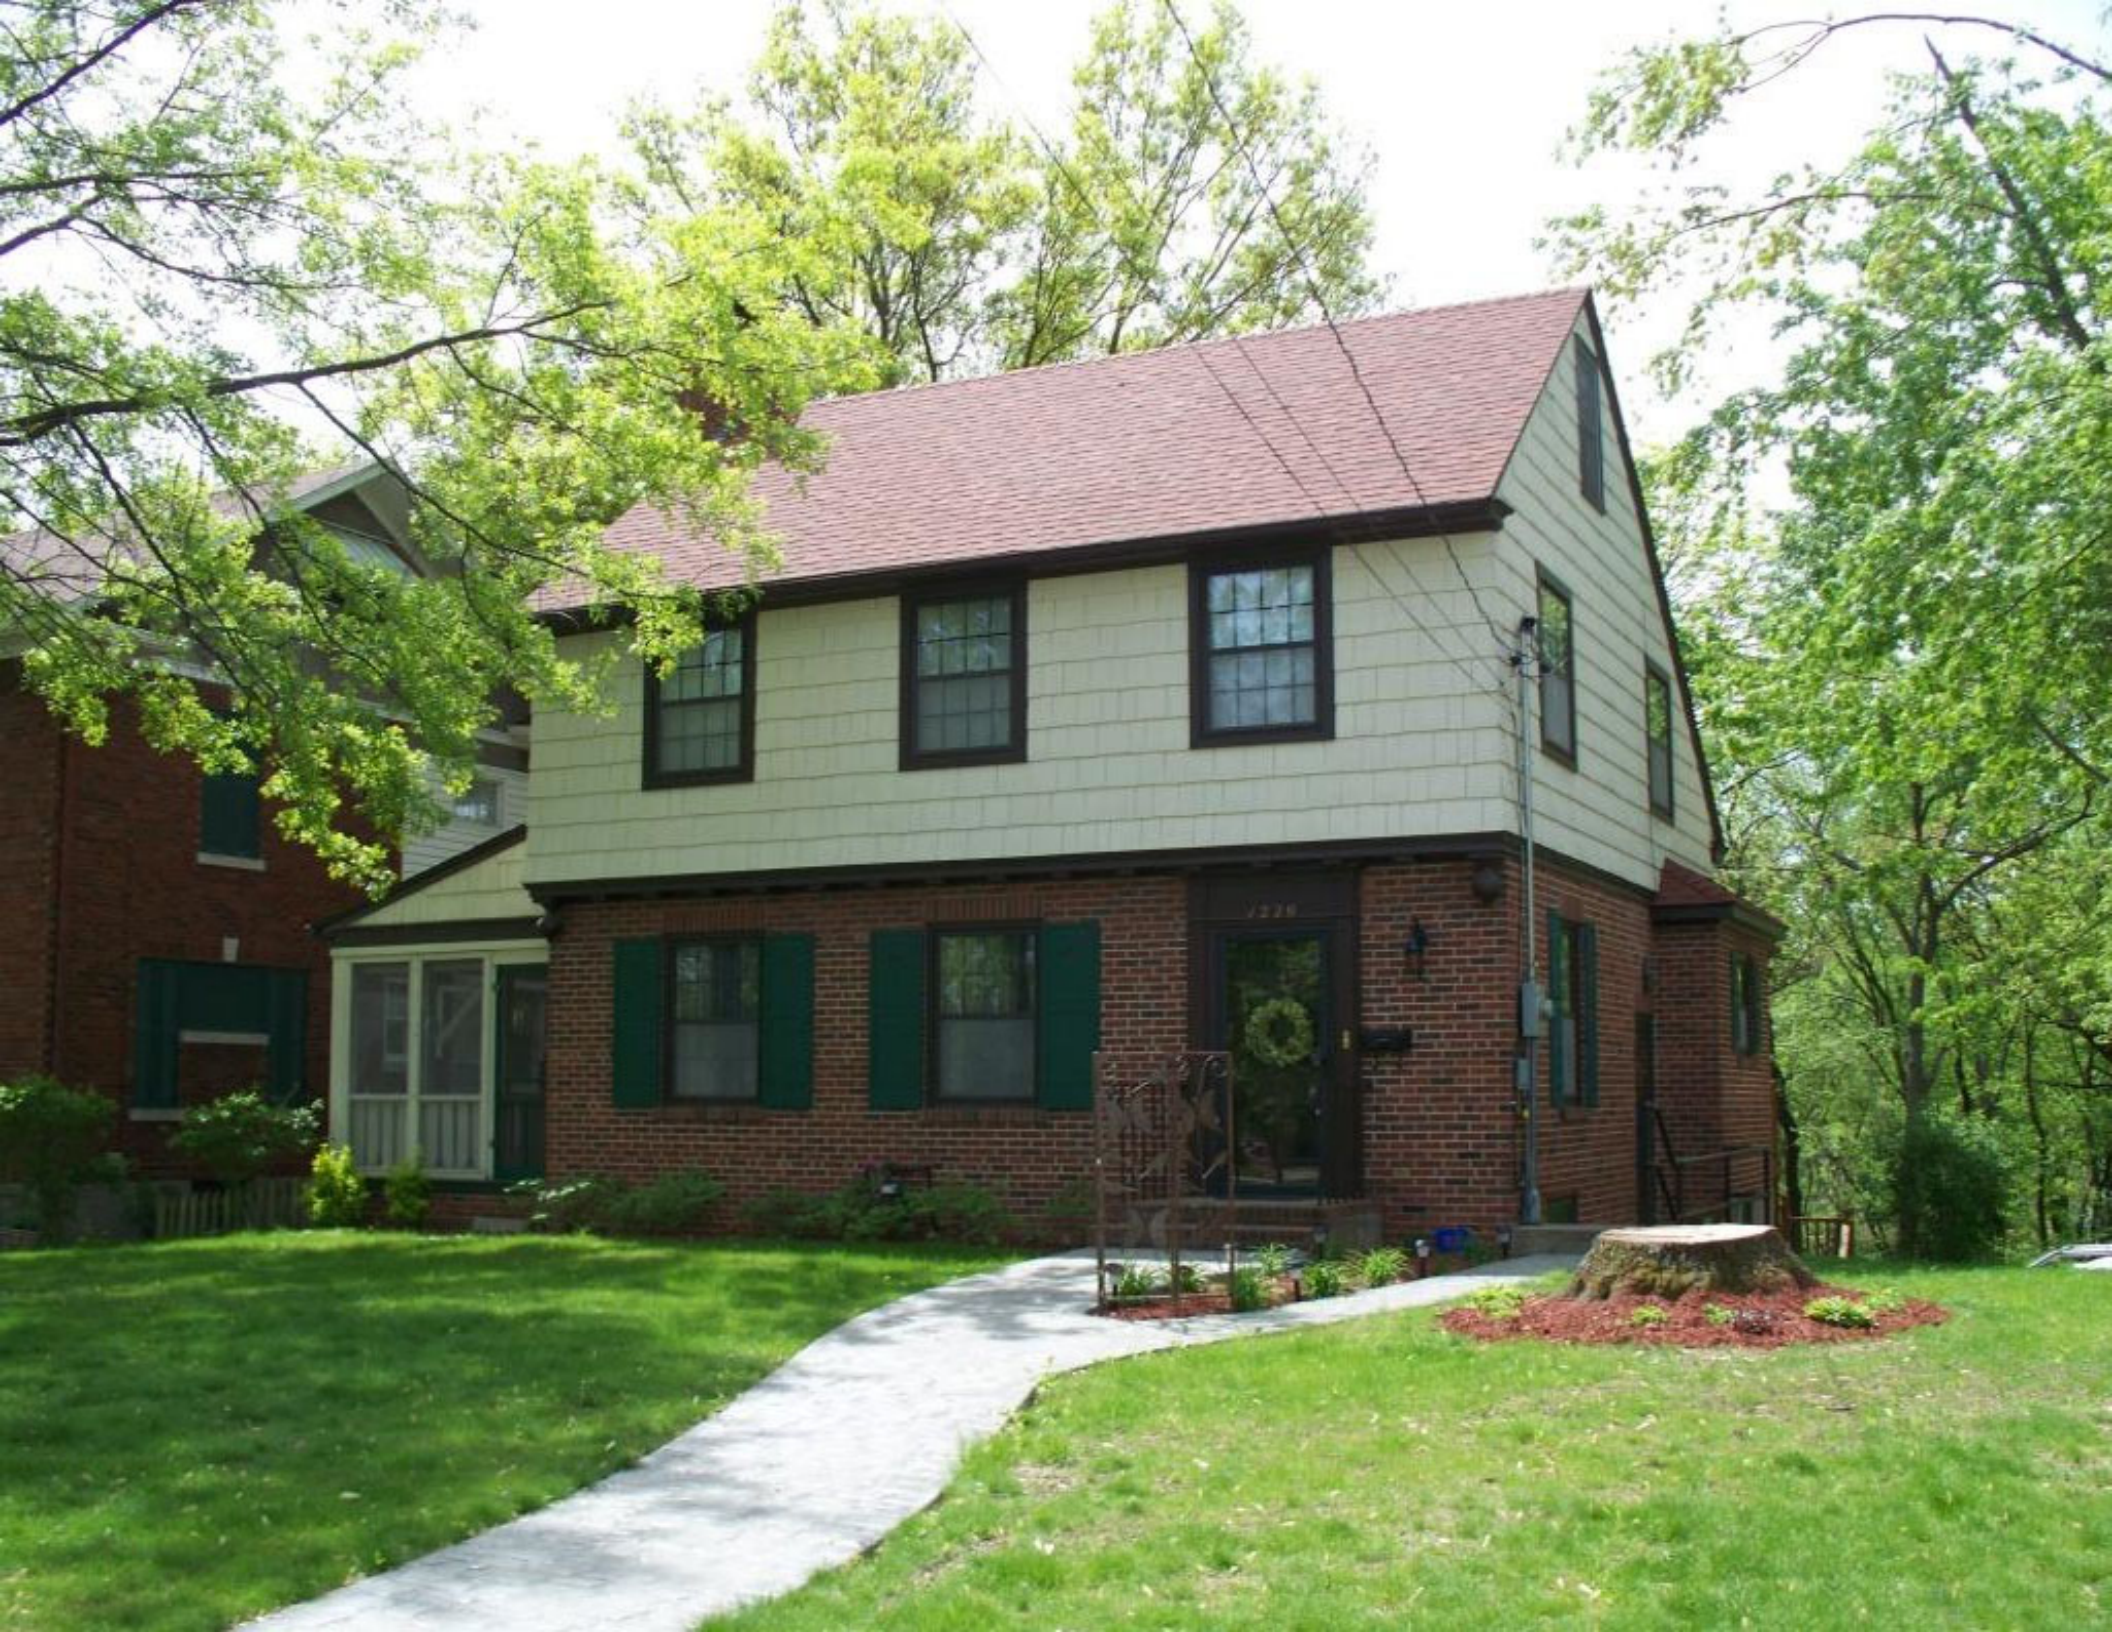
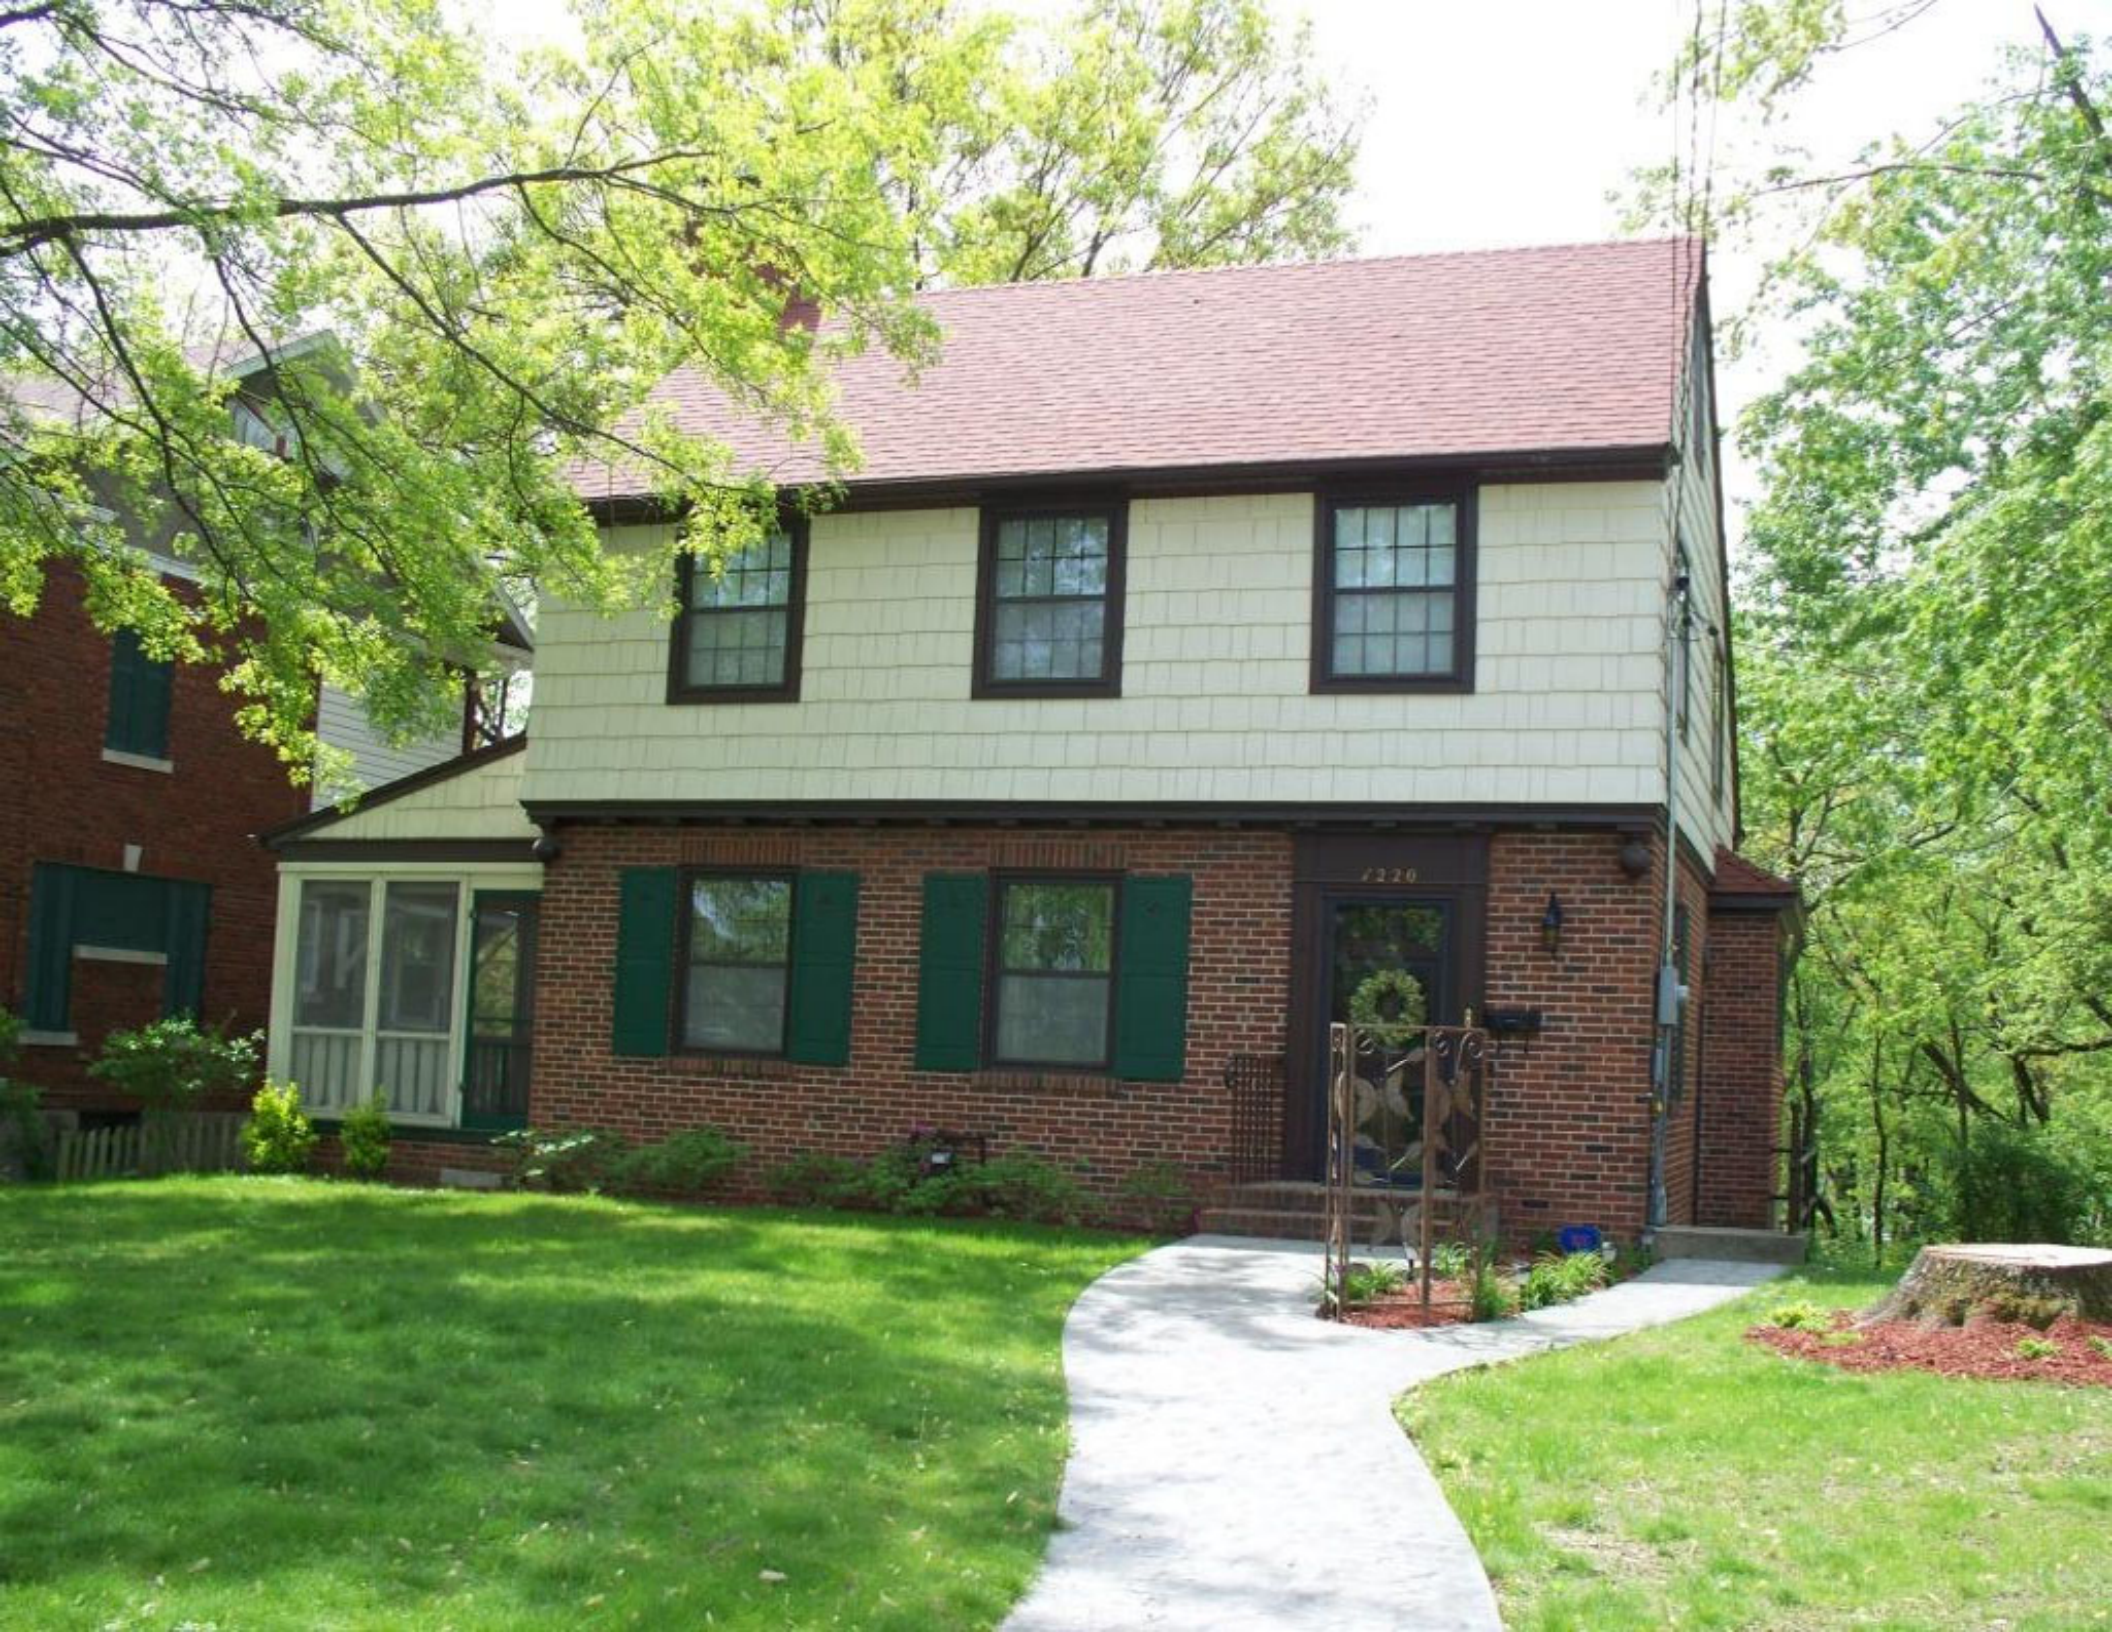
This two story home has a side gable roof that slopes lower in the back of the property than the front lending it somewhat of a salt box shape. The second story is clad in shingle (material undetermined) and contains three 8/8 windows. The lower and upper floors are divided by a decorative wooden cornice with suspended finials on both sides. The first floor is clad in brick and has two 8/8 windows (modern?) with shutters in the first and second bay. The entrance is in the final bay (right side) and has a door surround with entablature. Leading to it is a brick stoop with metal rails. A screened in sunroom is set back on the left side of the property and features a shed roof with shingles in the half gable.

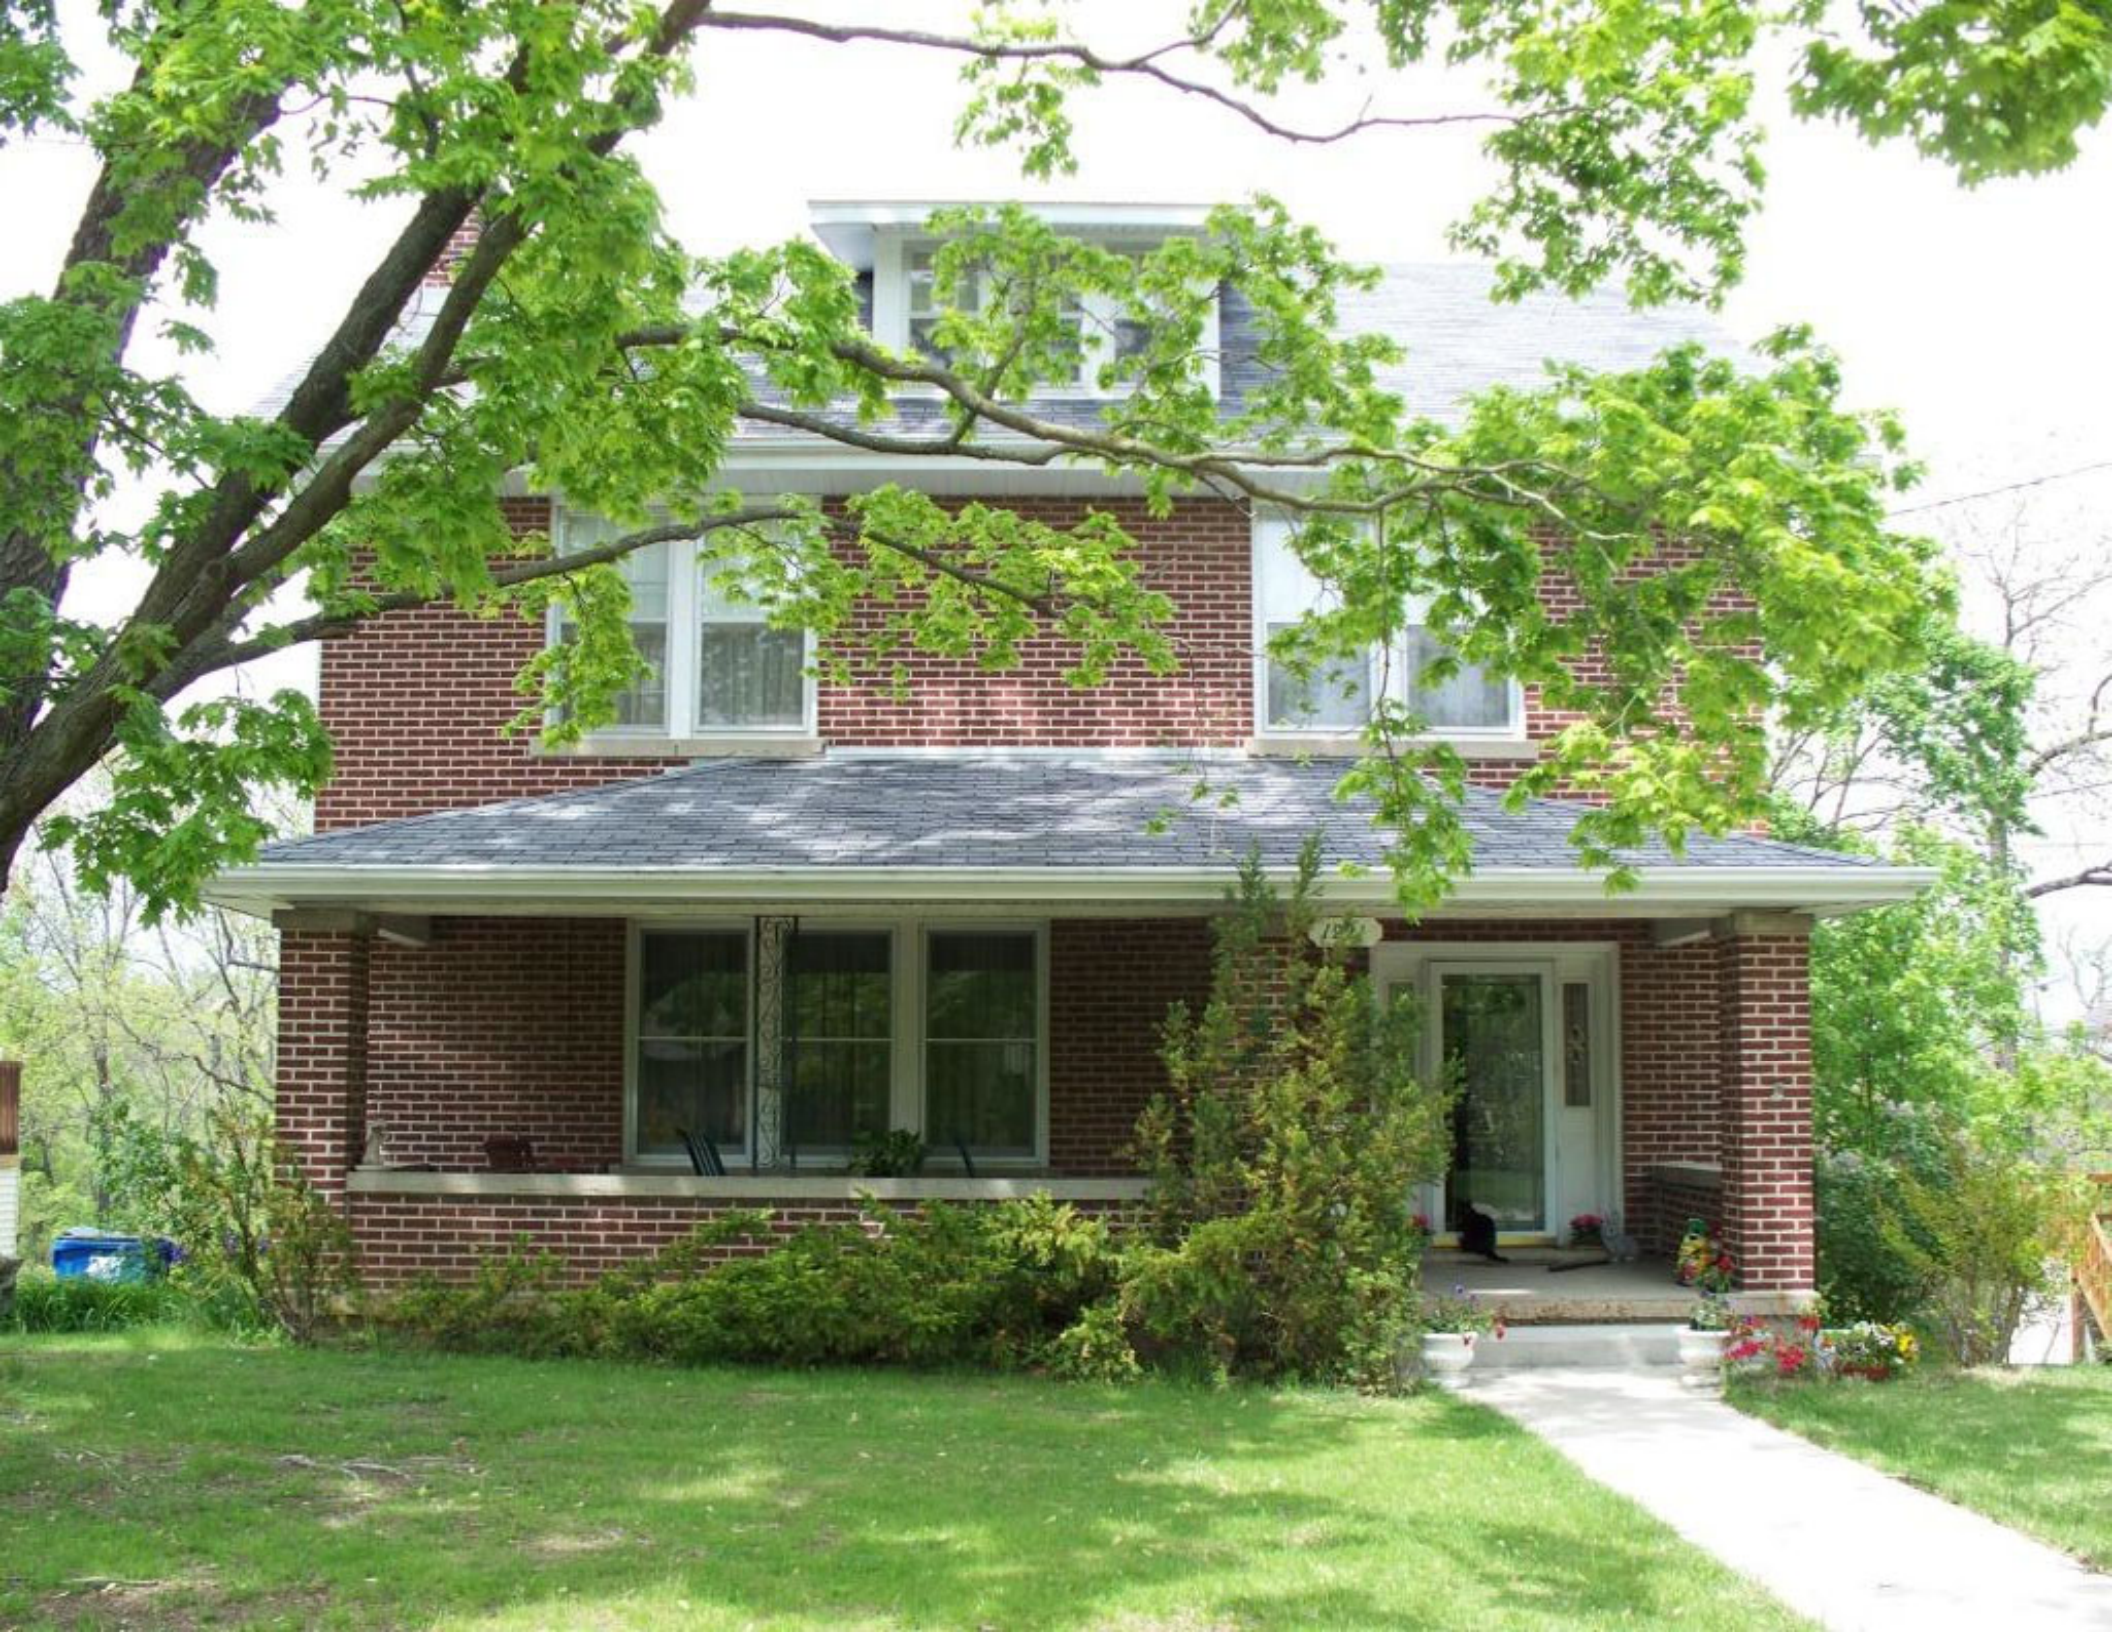
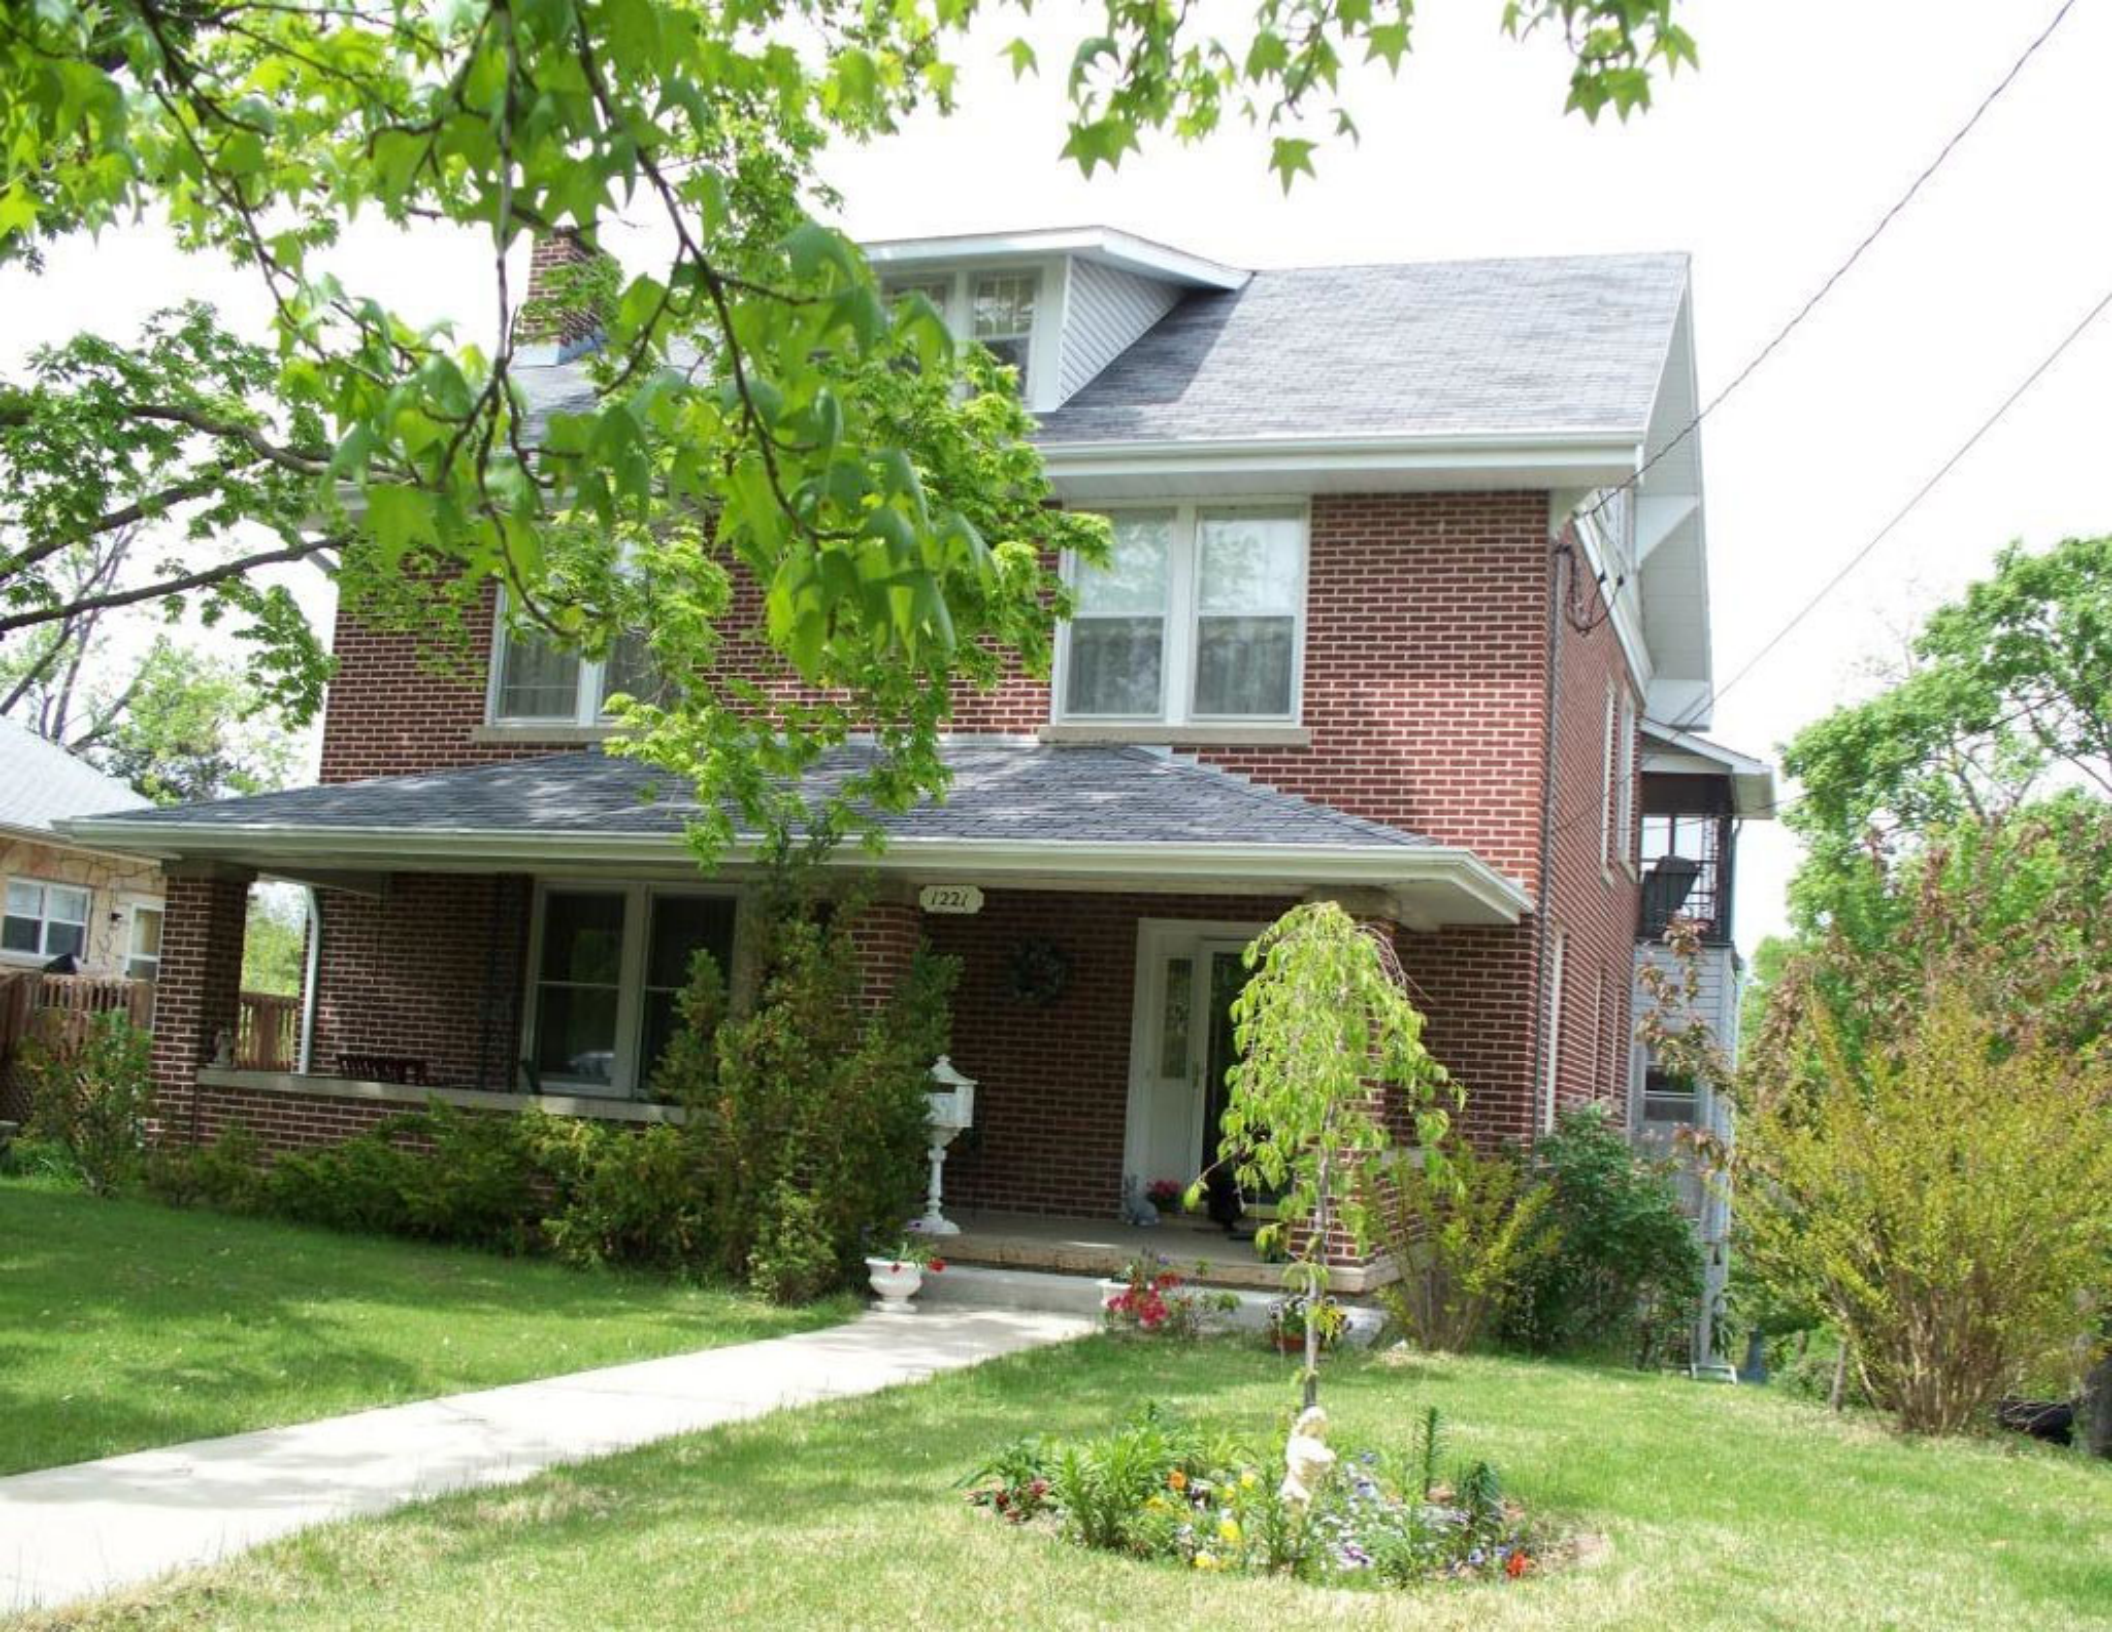
This 2 ½ story brick four square has a side gable roof with a central shed dormer with three historic 3/1 windows. All of the windows have limestone sills. The second floor has two paired 3/1 historic windows. The left bay on the first floor has a row of three 1/1 replacement windows (material unknown). The entrance is in the right bay and has side lights with art glass in the upper portions. The full width porch has a hipped roof brick piers and half walls capped in limestone.

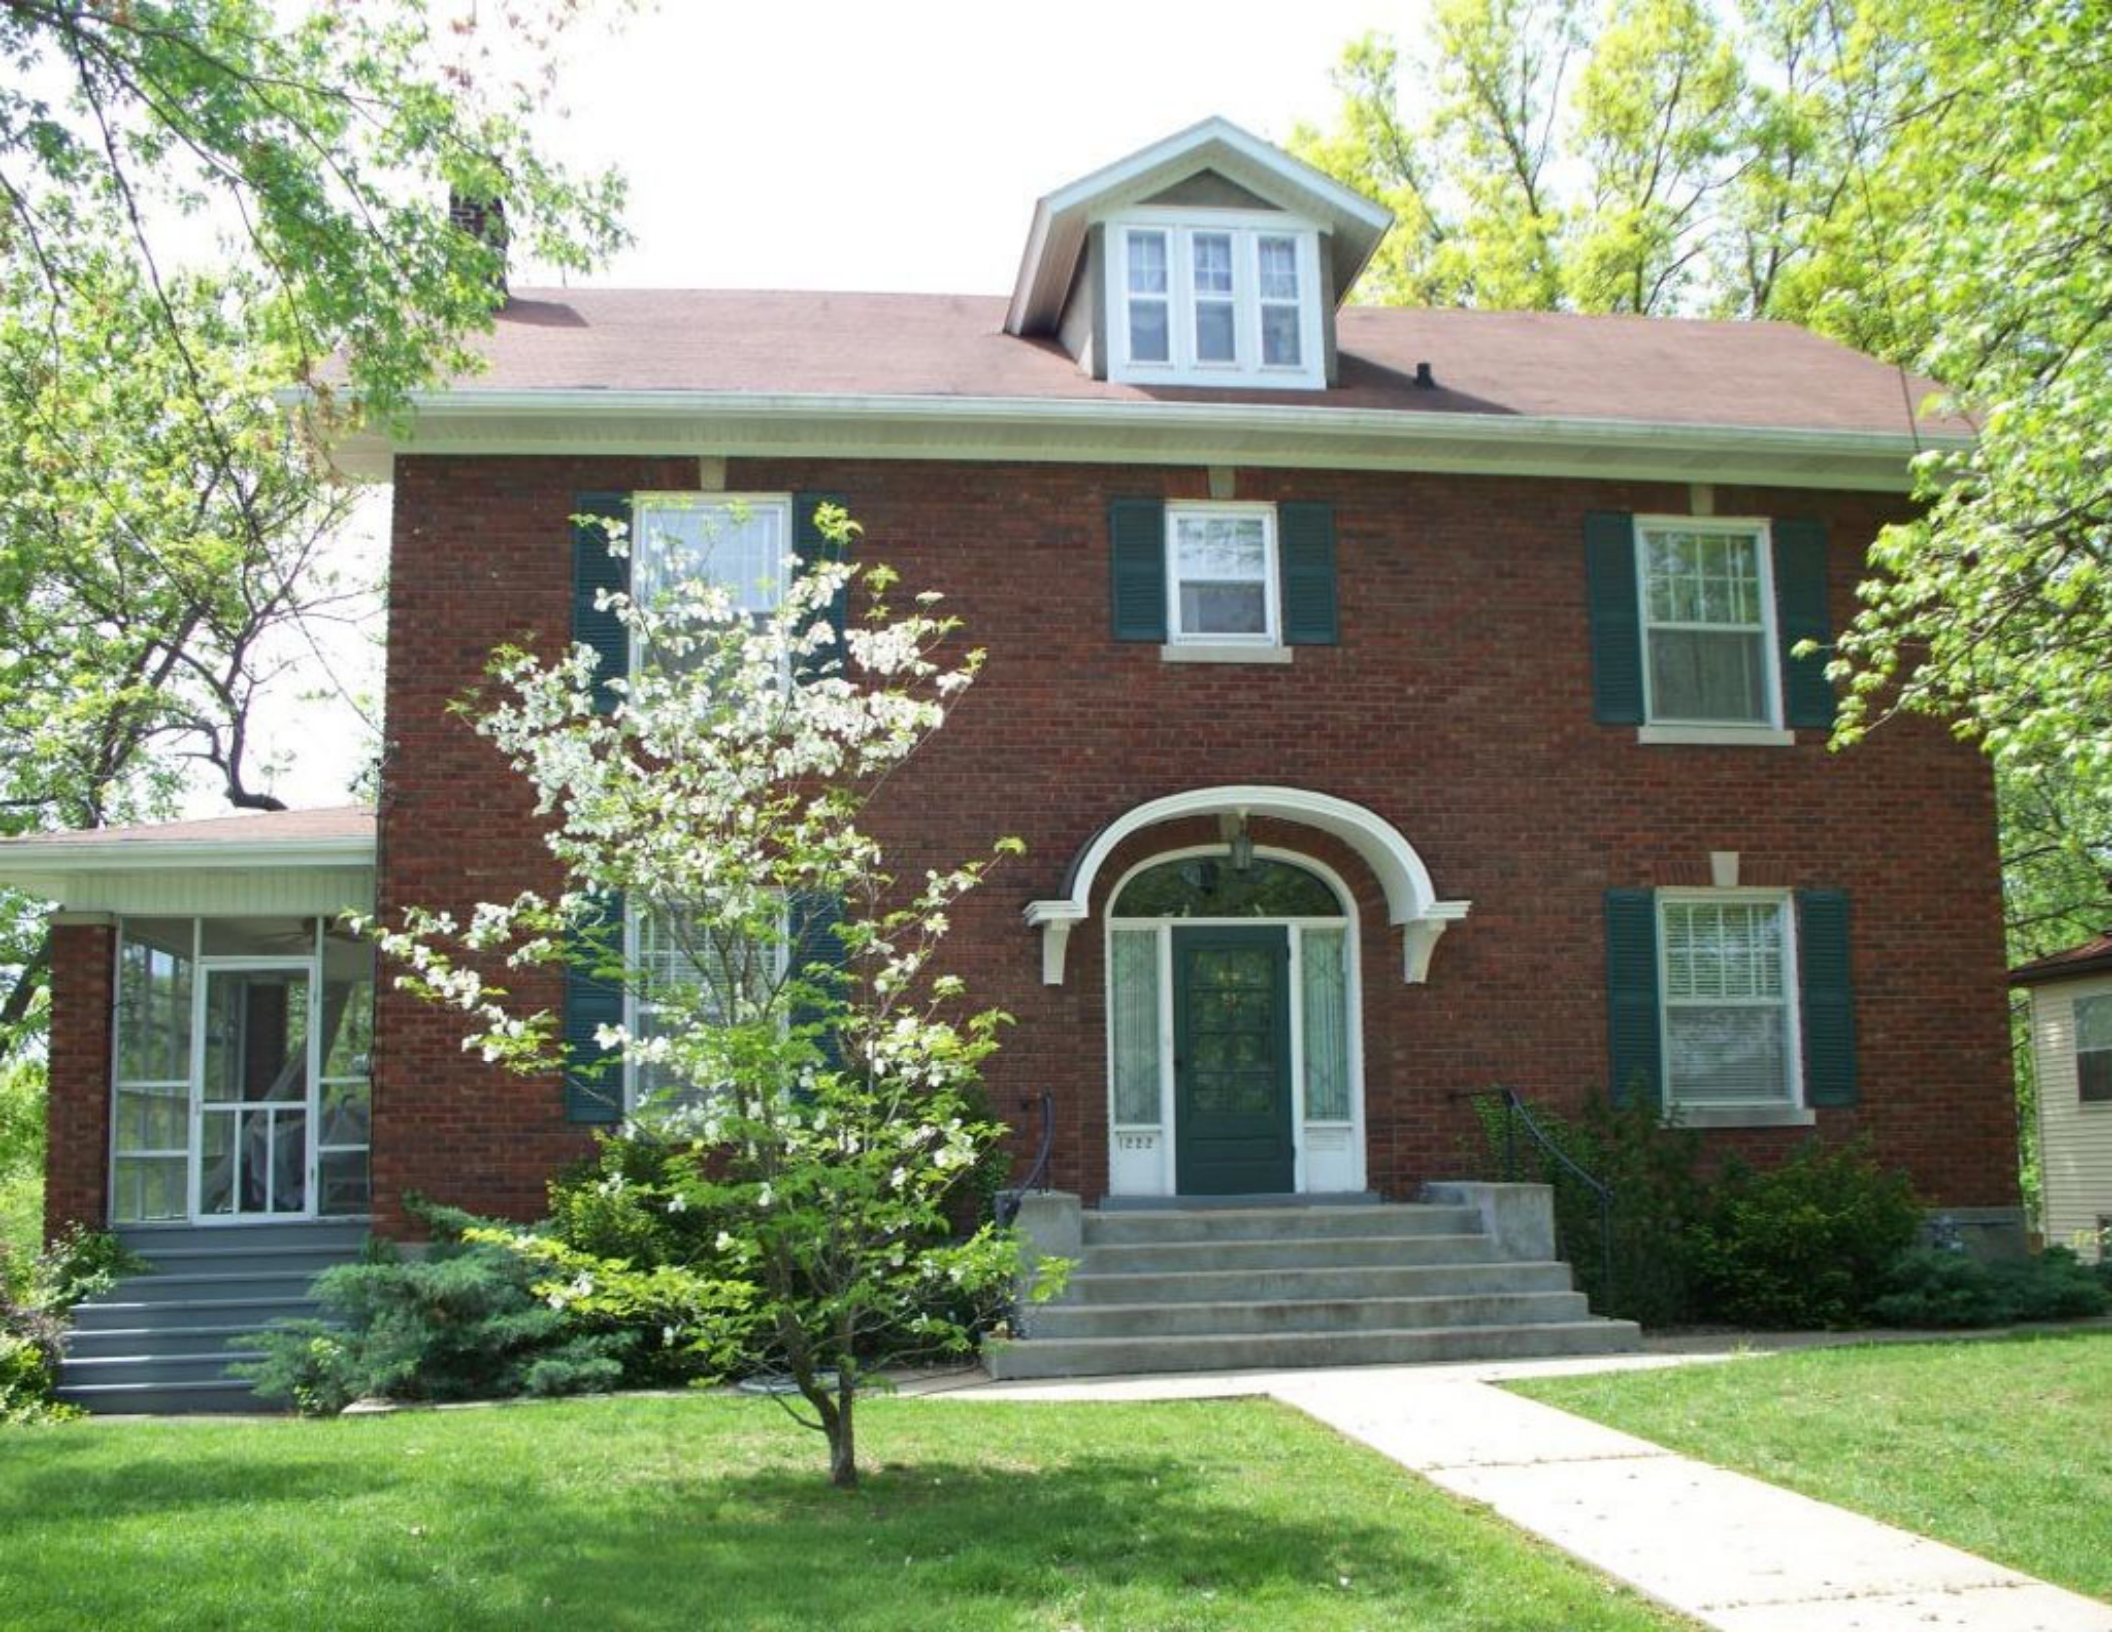
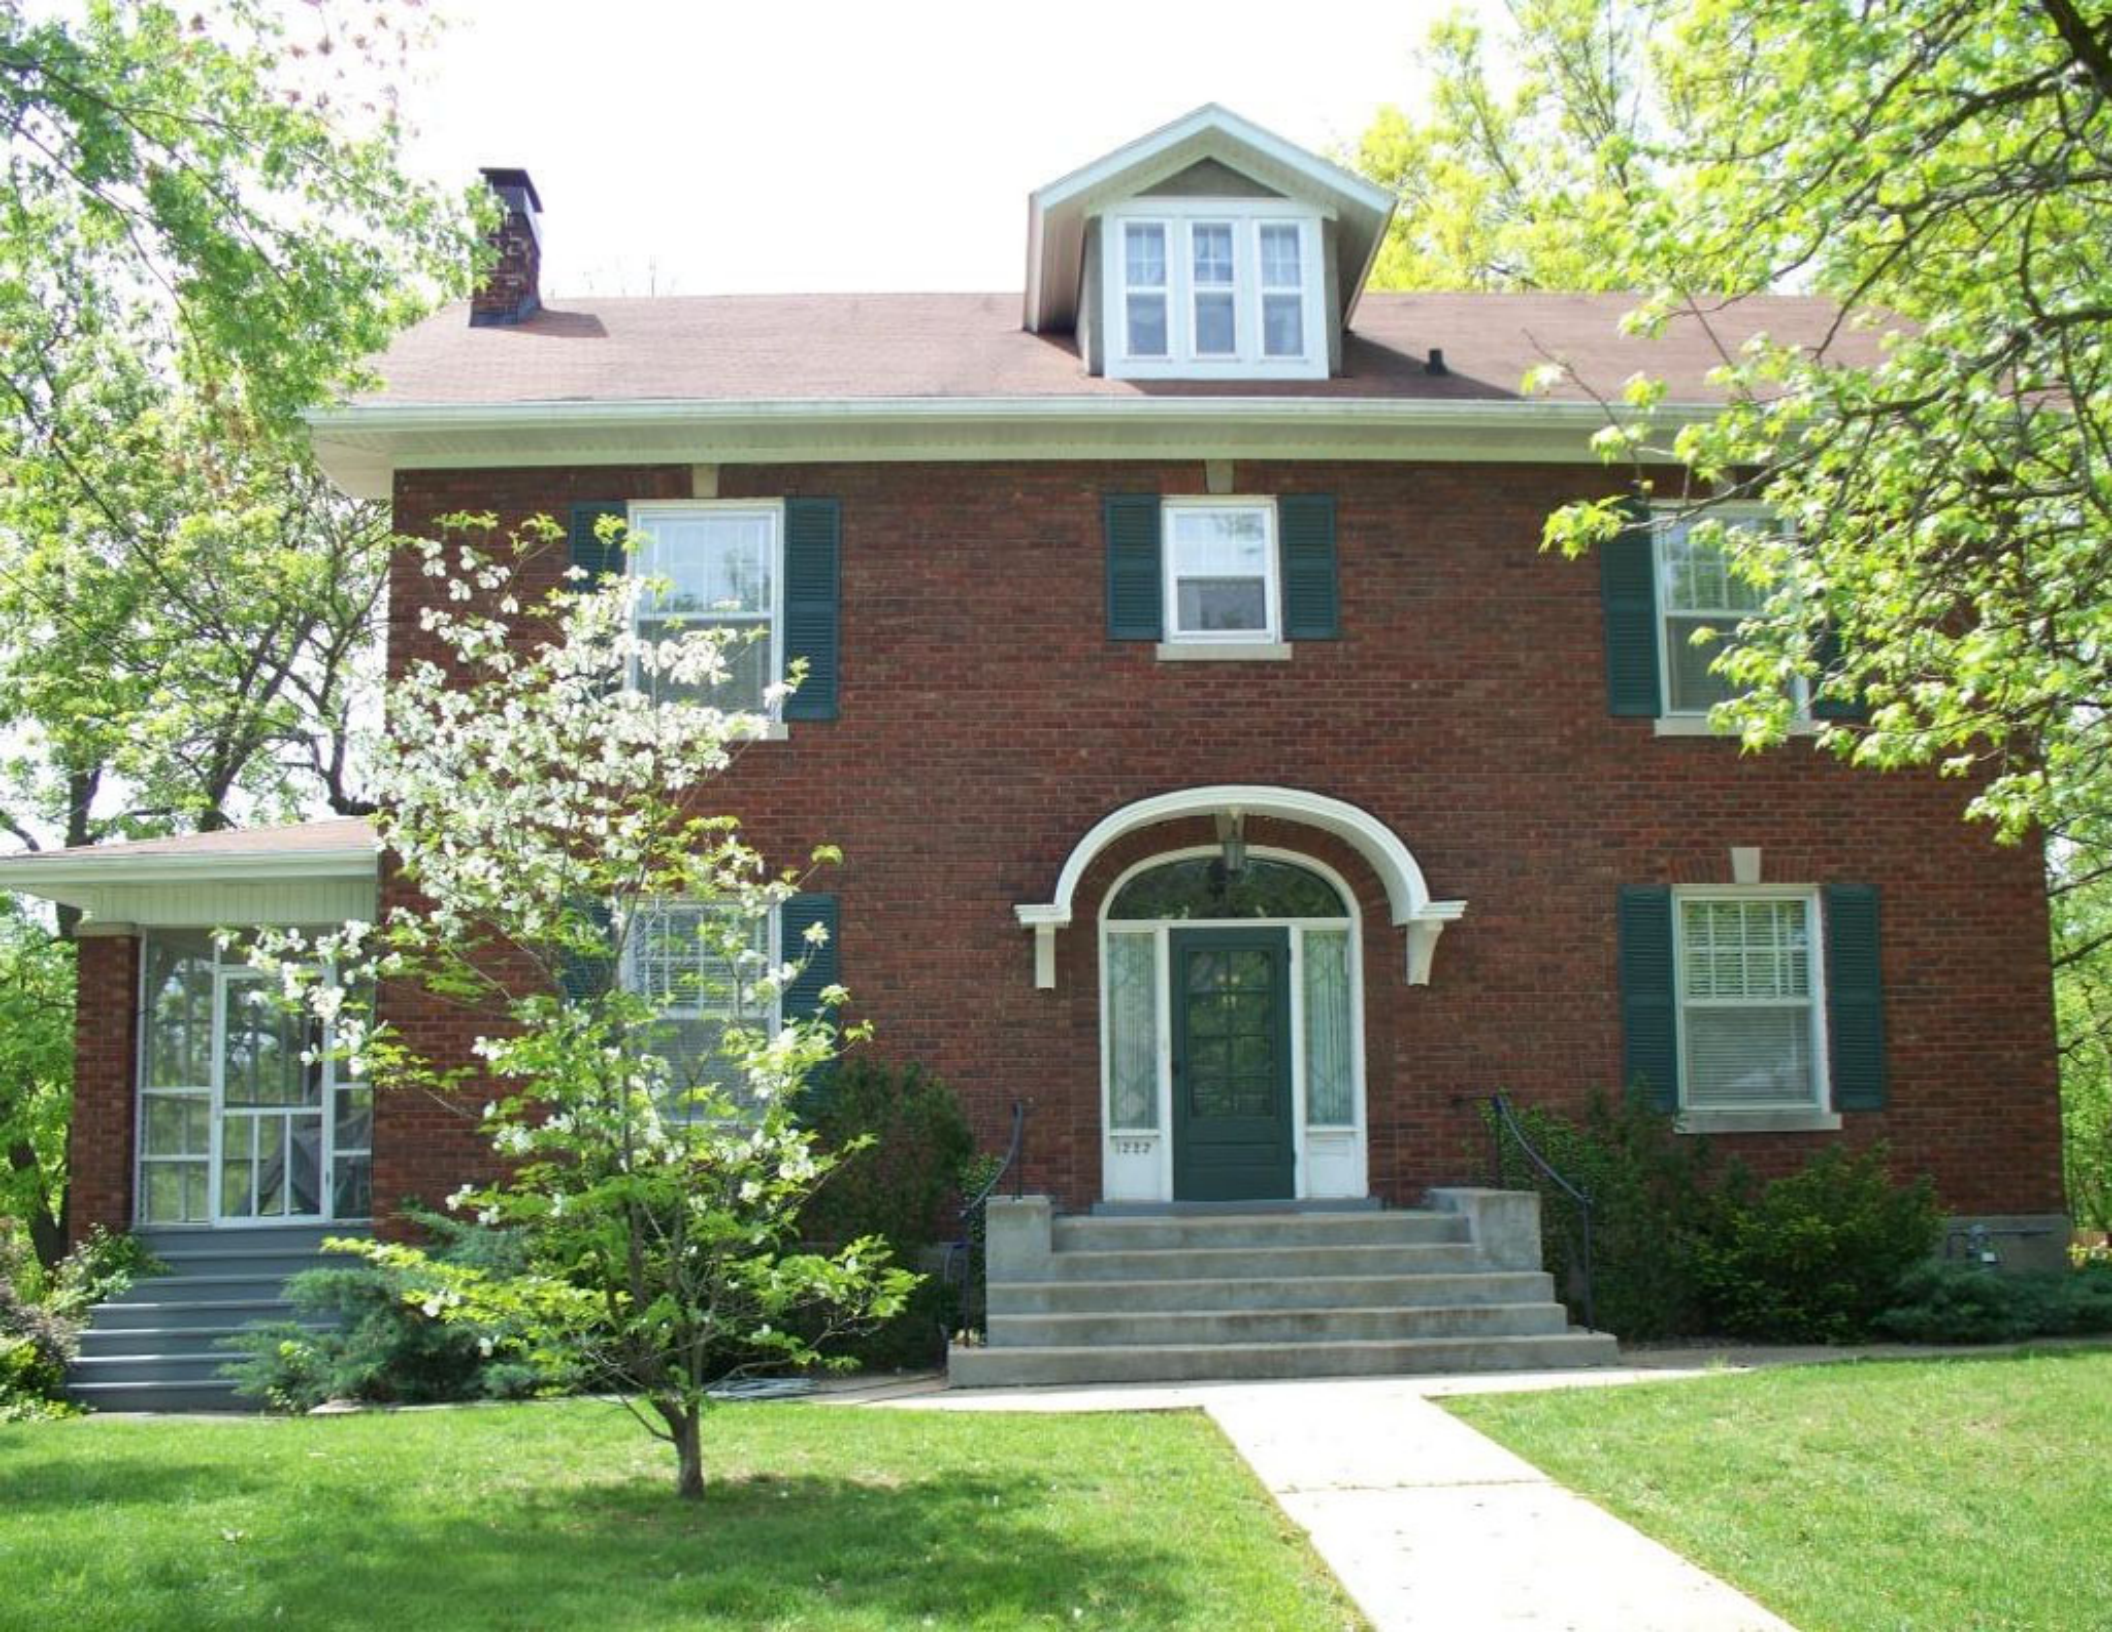
This two and a half story brick Colonial has a side gable roof with a central gable dormer with a row of three narrow 4/1 windows. The second floor has two historic 8/1 windows flanking a smaller 6/1 window. The lower story has two 8/1 windows flanking the centered entrance. All of the windows have shutters, concrete or limestone sills, brick flat arches with a concrete or stone keystone. The entrance is defined by a brick arch and has sidelights and an arched transom with art glass and is reached by a set of concrete stairs with pipe rails. It is covered by a basket-handle hood on brackets. Set back on the left side is a porch that has been screened in with and features an additional entrance that can be reached by a set of wooden stairs.
