ARCHITECTURAL/HISTORIC INVENTORY FORM

1. Survey No. CO-AS-005-001		2. Survey name: Moreau Drive Neighborhood Survey	
3. County: Cole		4. Address: 1202 Elmerine Ave.	
5. City: Jefferson City	Vicinity: <input type="checkbox"/>	6. UTM: / /	7. Township/Range/Section: T: R: S:
8. Historic name (if known):		9. Present/other name (if known):	
10. Ownership: <input checked="" type="checkbox"/> Private <input type="checkbox"/> Public		11. Historic use (if known): Residential	11. Current use: Residential

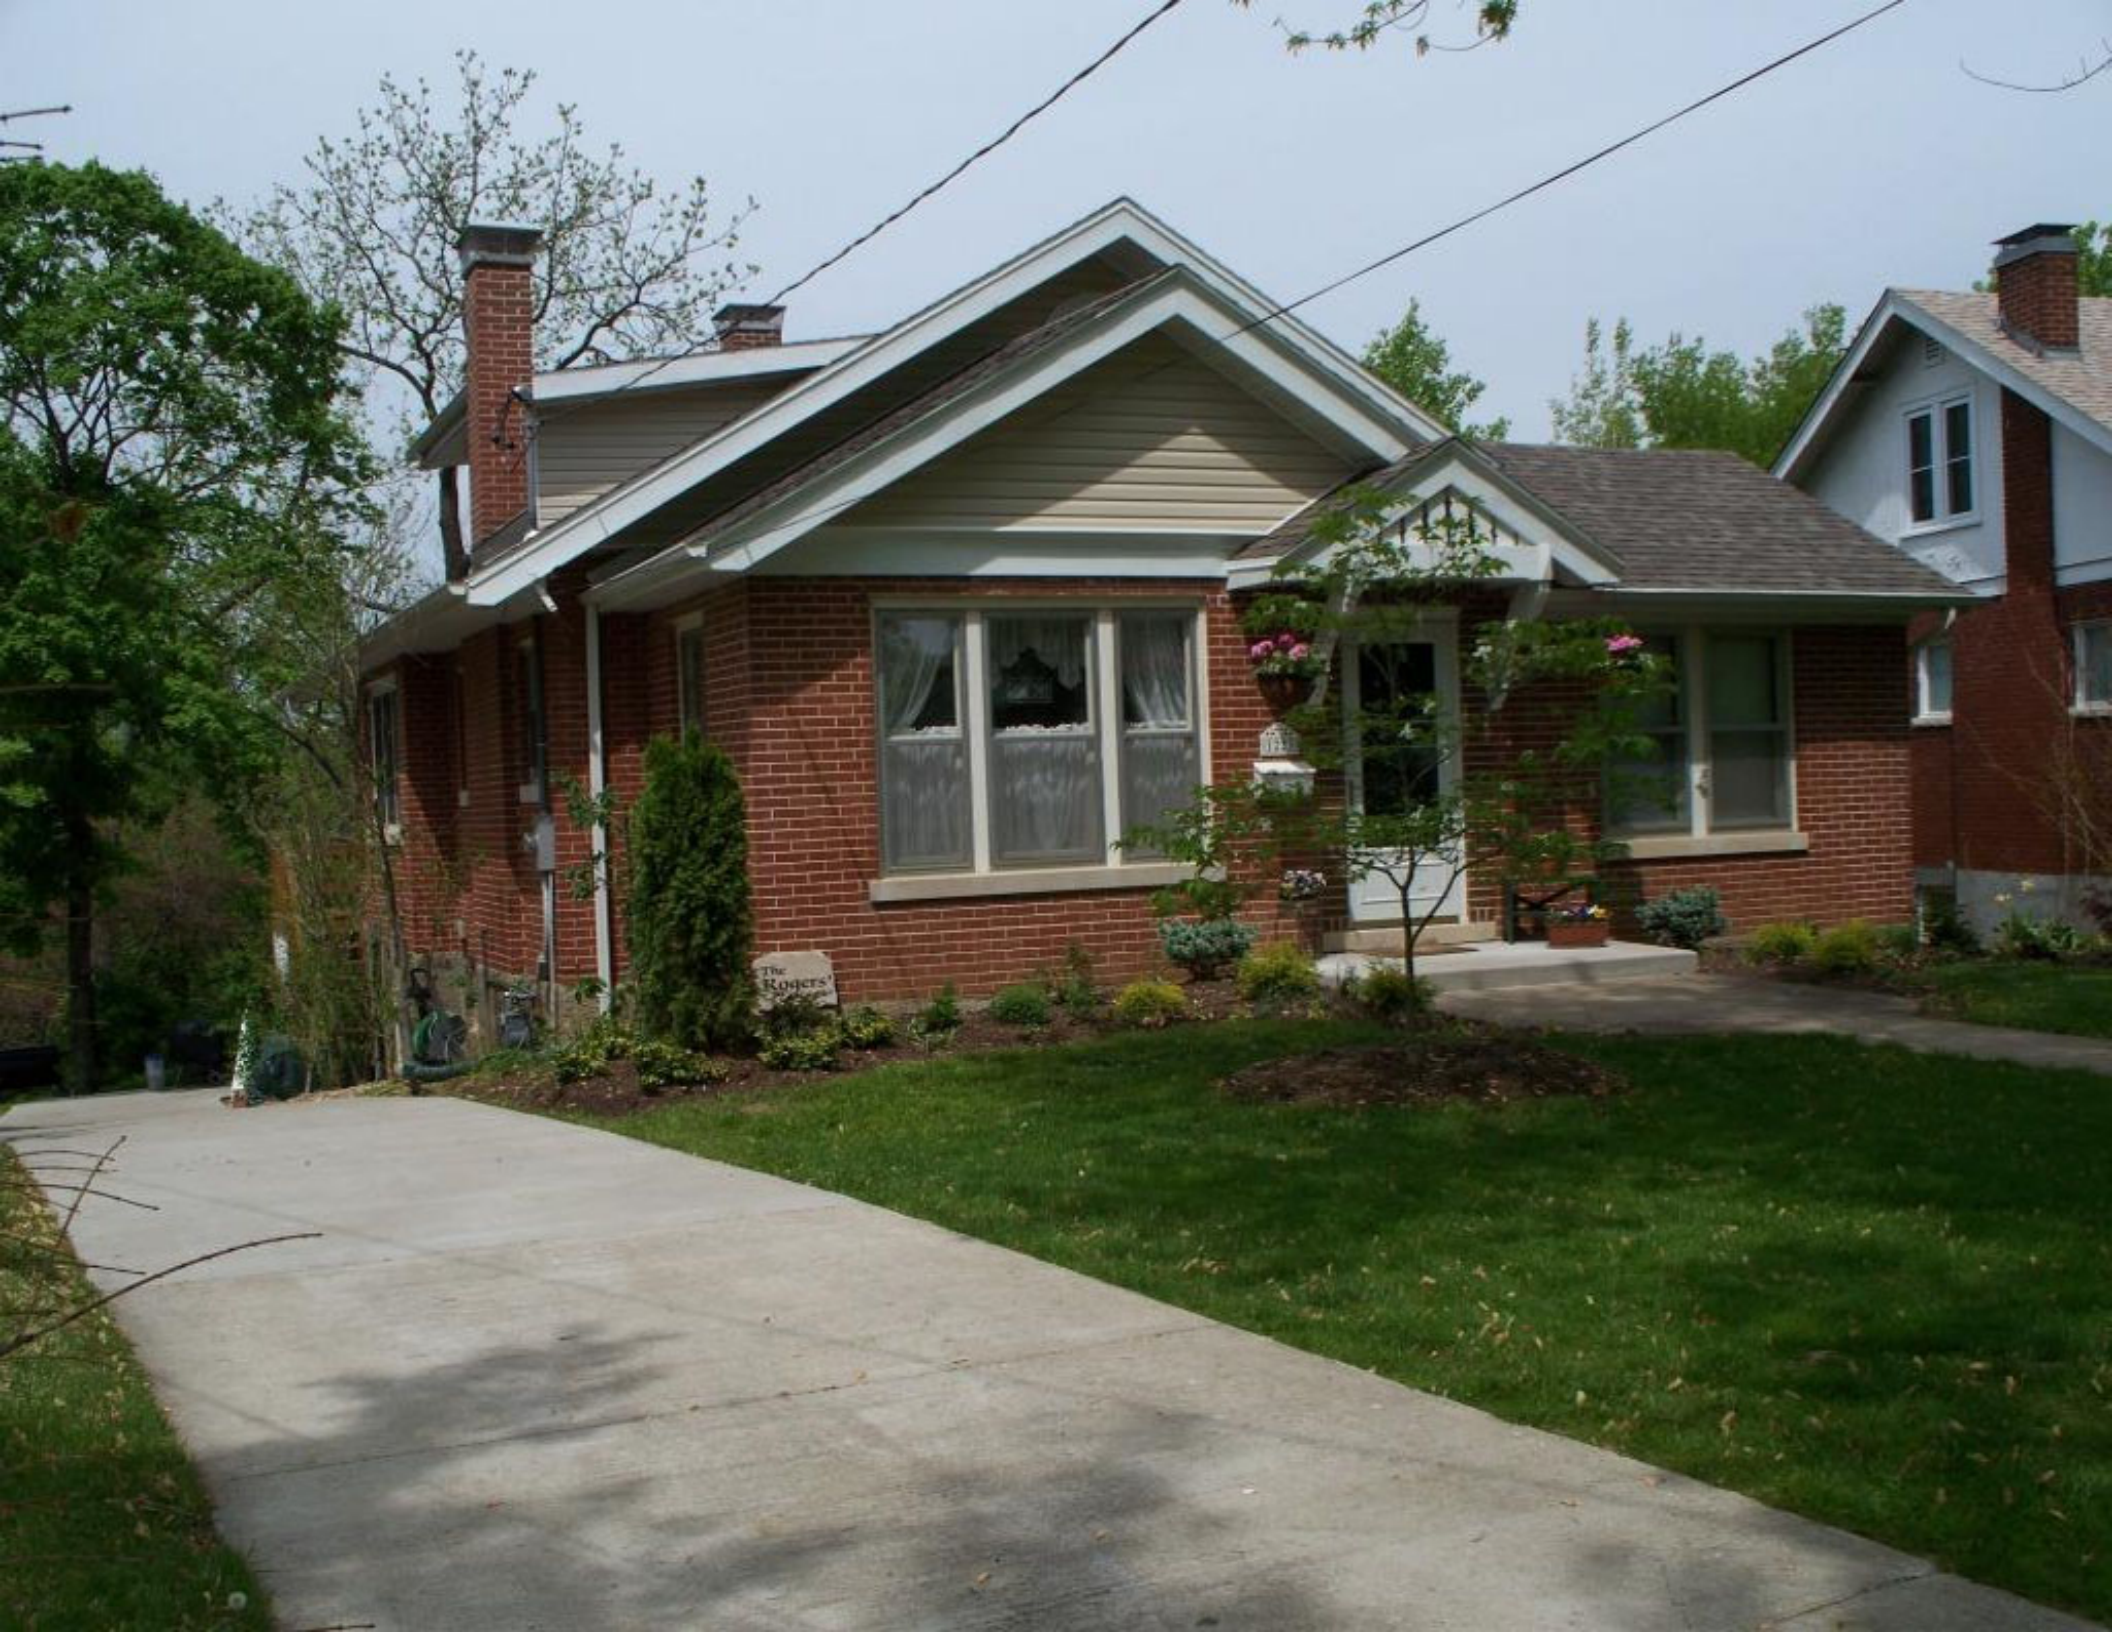
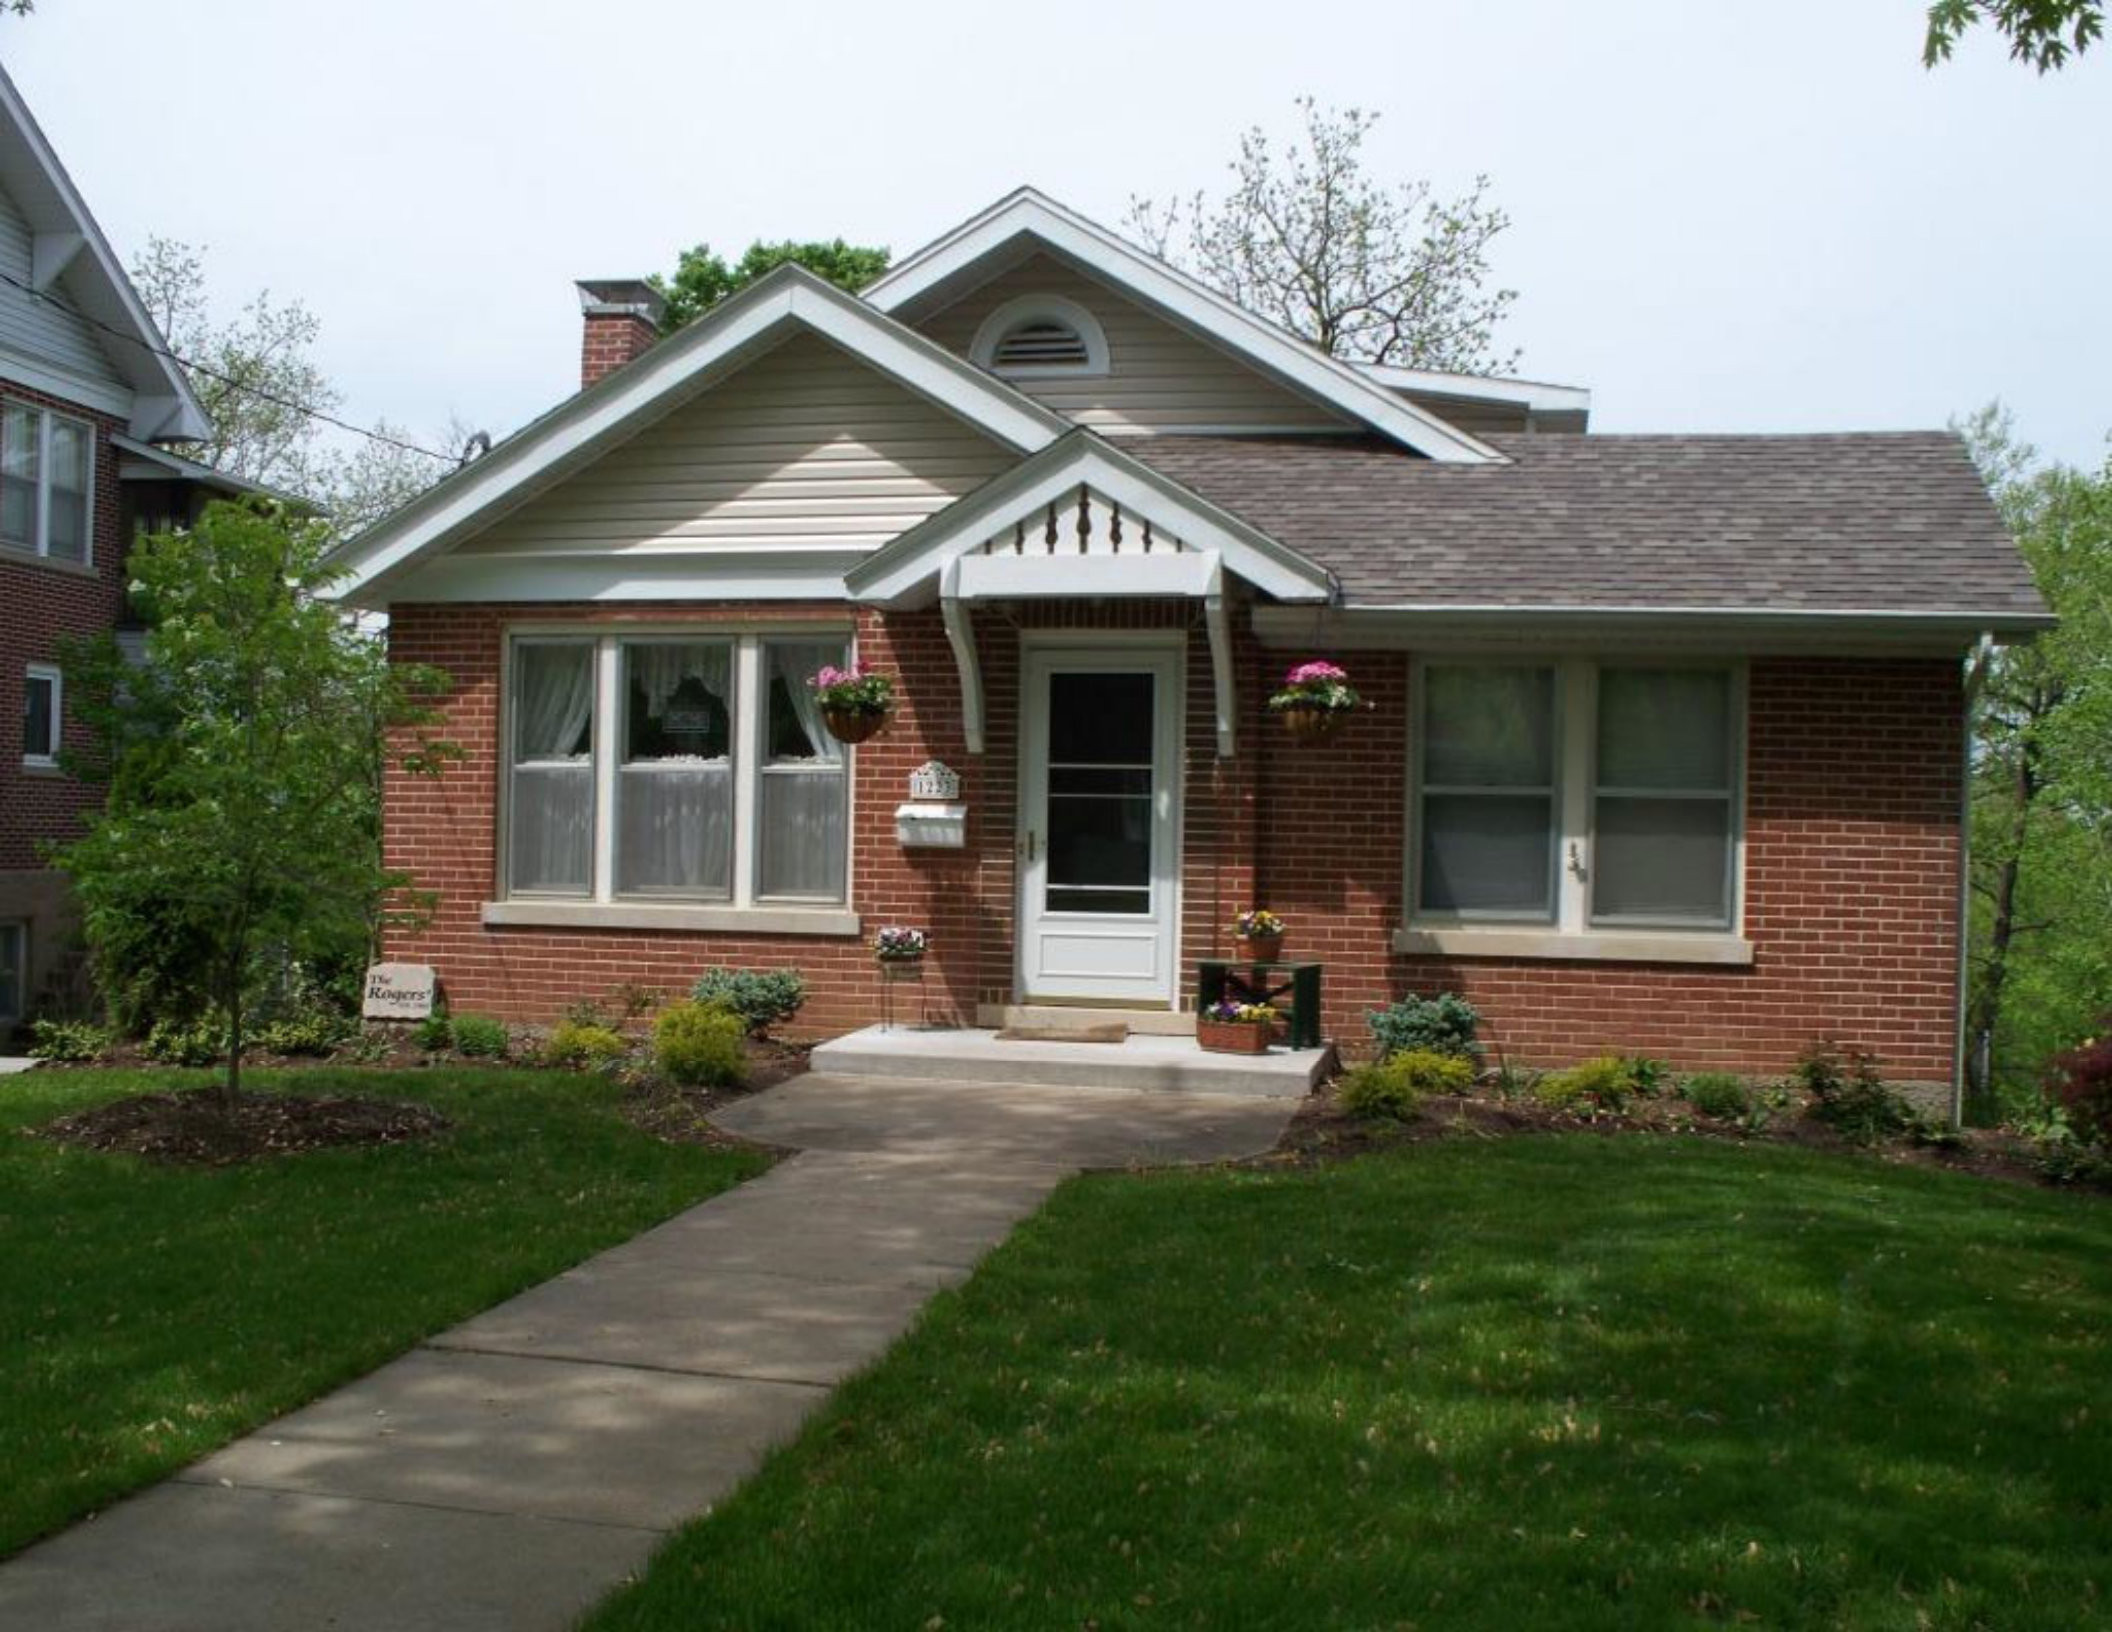
This 1 ½ story brick Minimal Traditional home has a cross gable roof. There is an upper half story in the back of the home, however the front is one story. The first bay (left) has a double front gable (larger is set back, extends to the right and contains an arched vent) and contains a row of three 1/1 windows. The front gable also includes the entrance in the center bay that has a slatted gable hood on brackets and a concrete stoop. The third bay has a side gable roof and contains paired 1/1 windows. All of the windows have limestone or concrete sills.

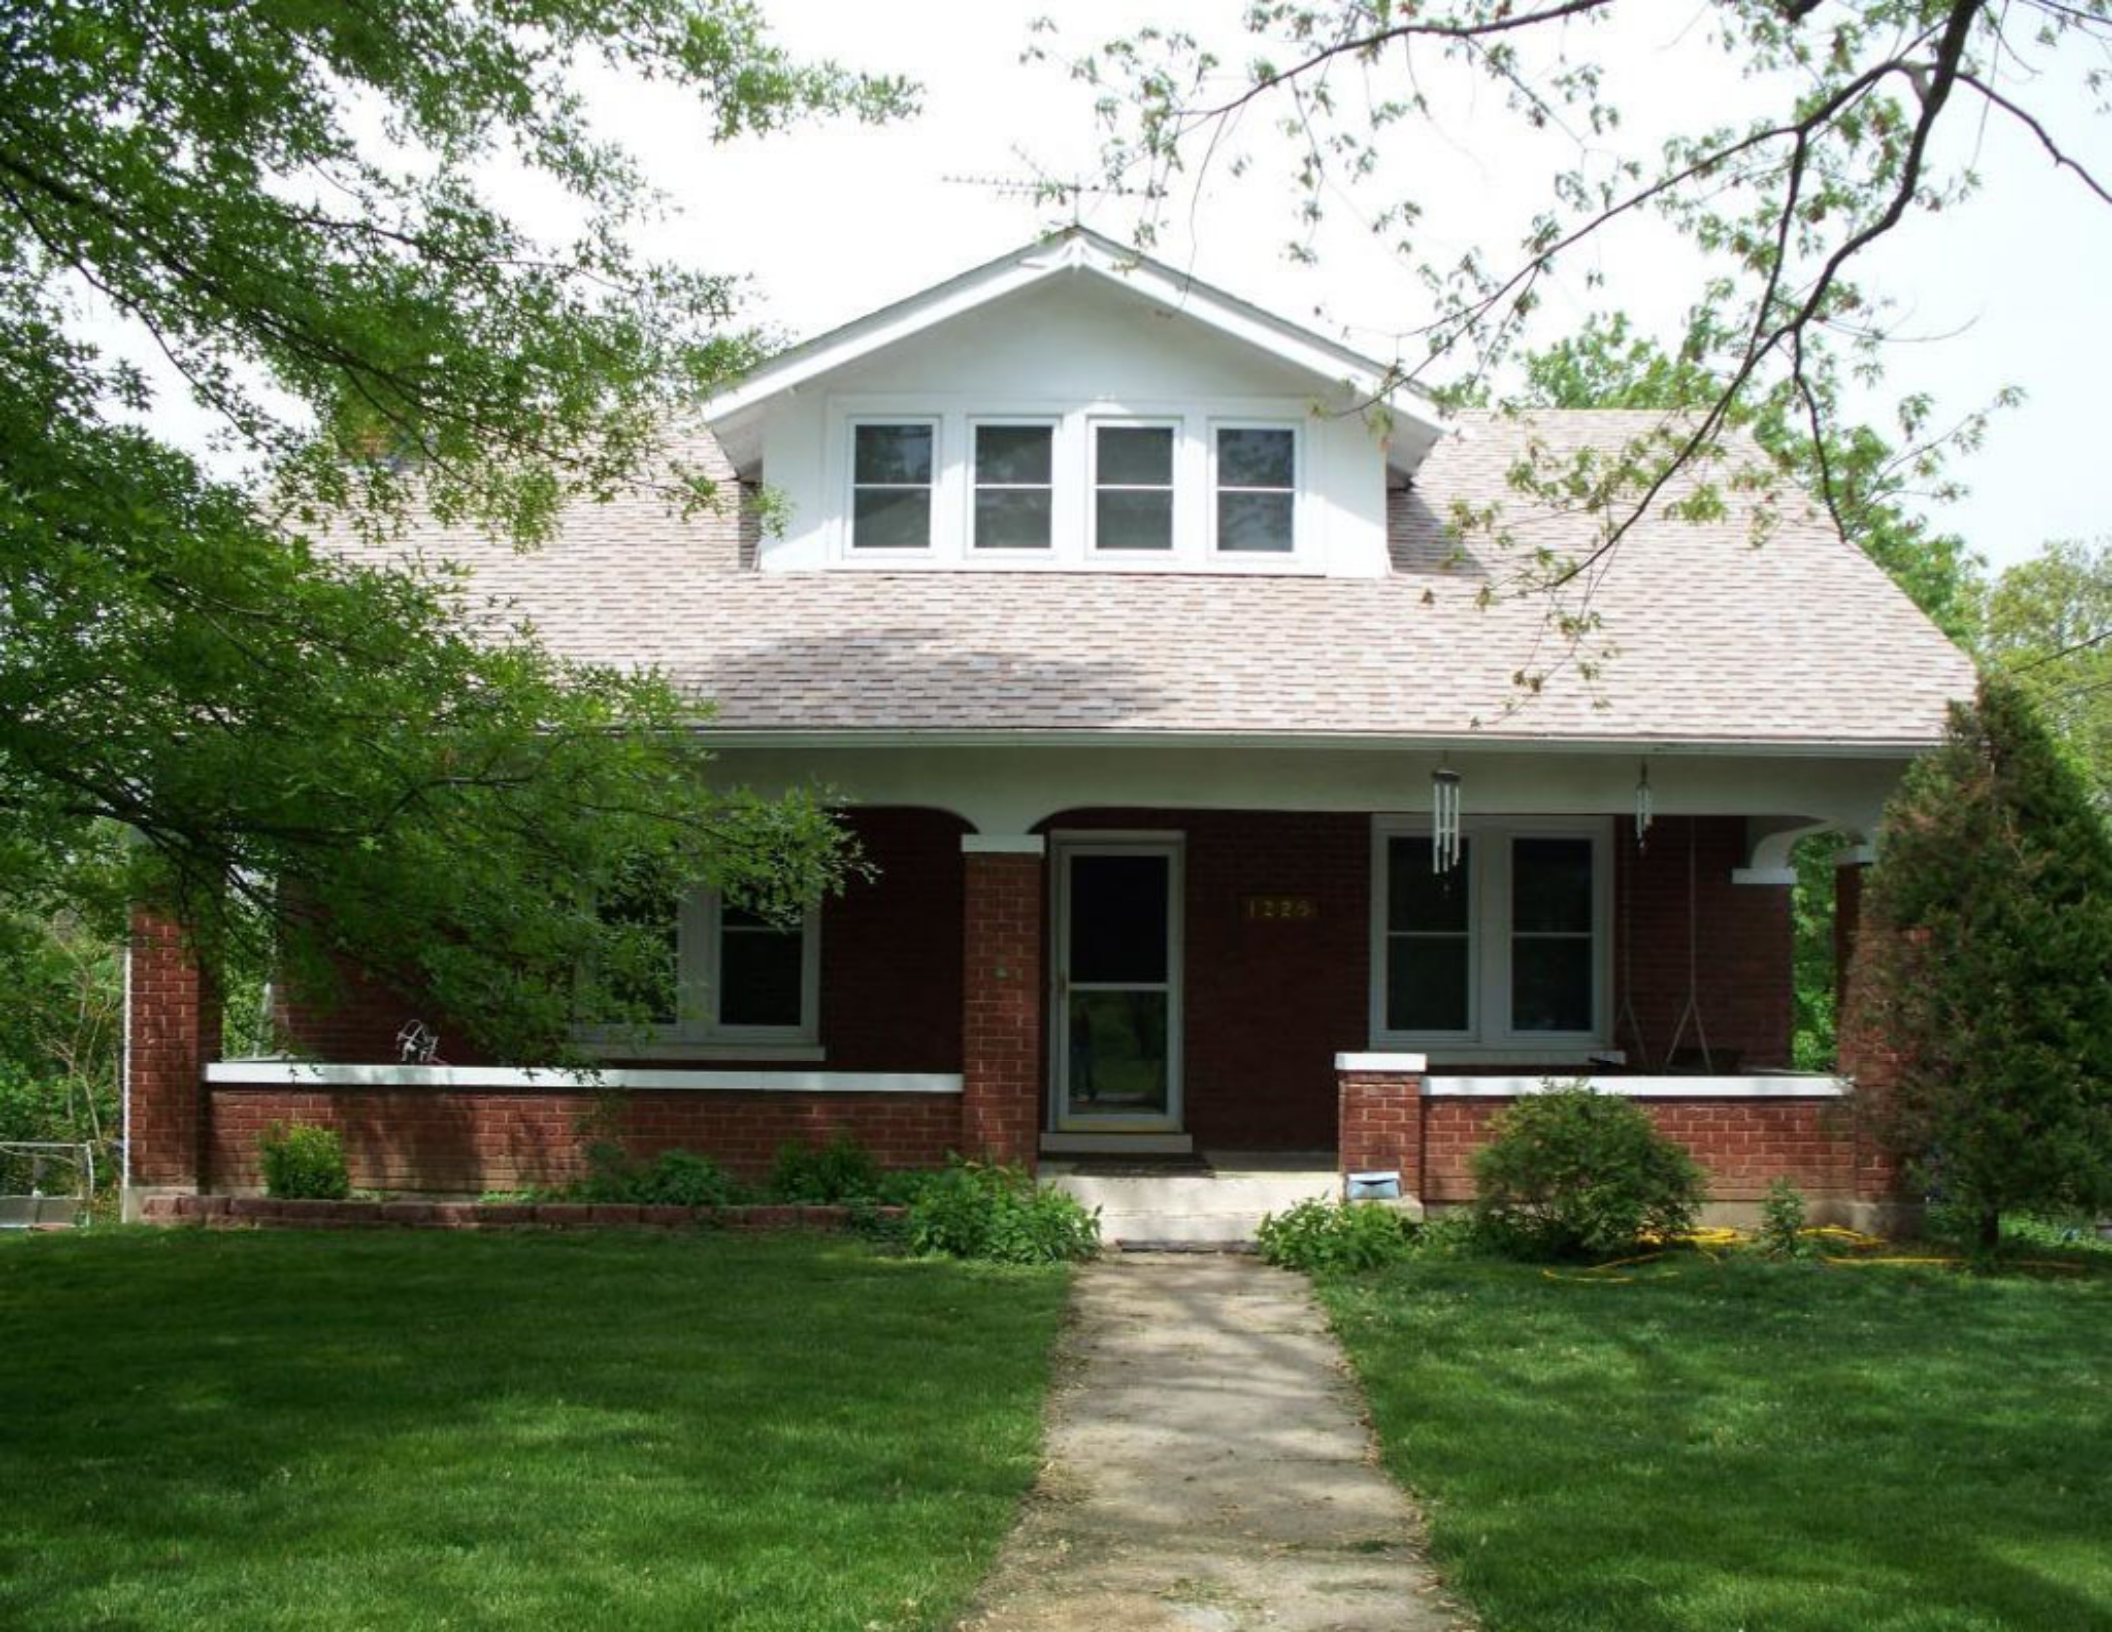
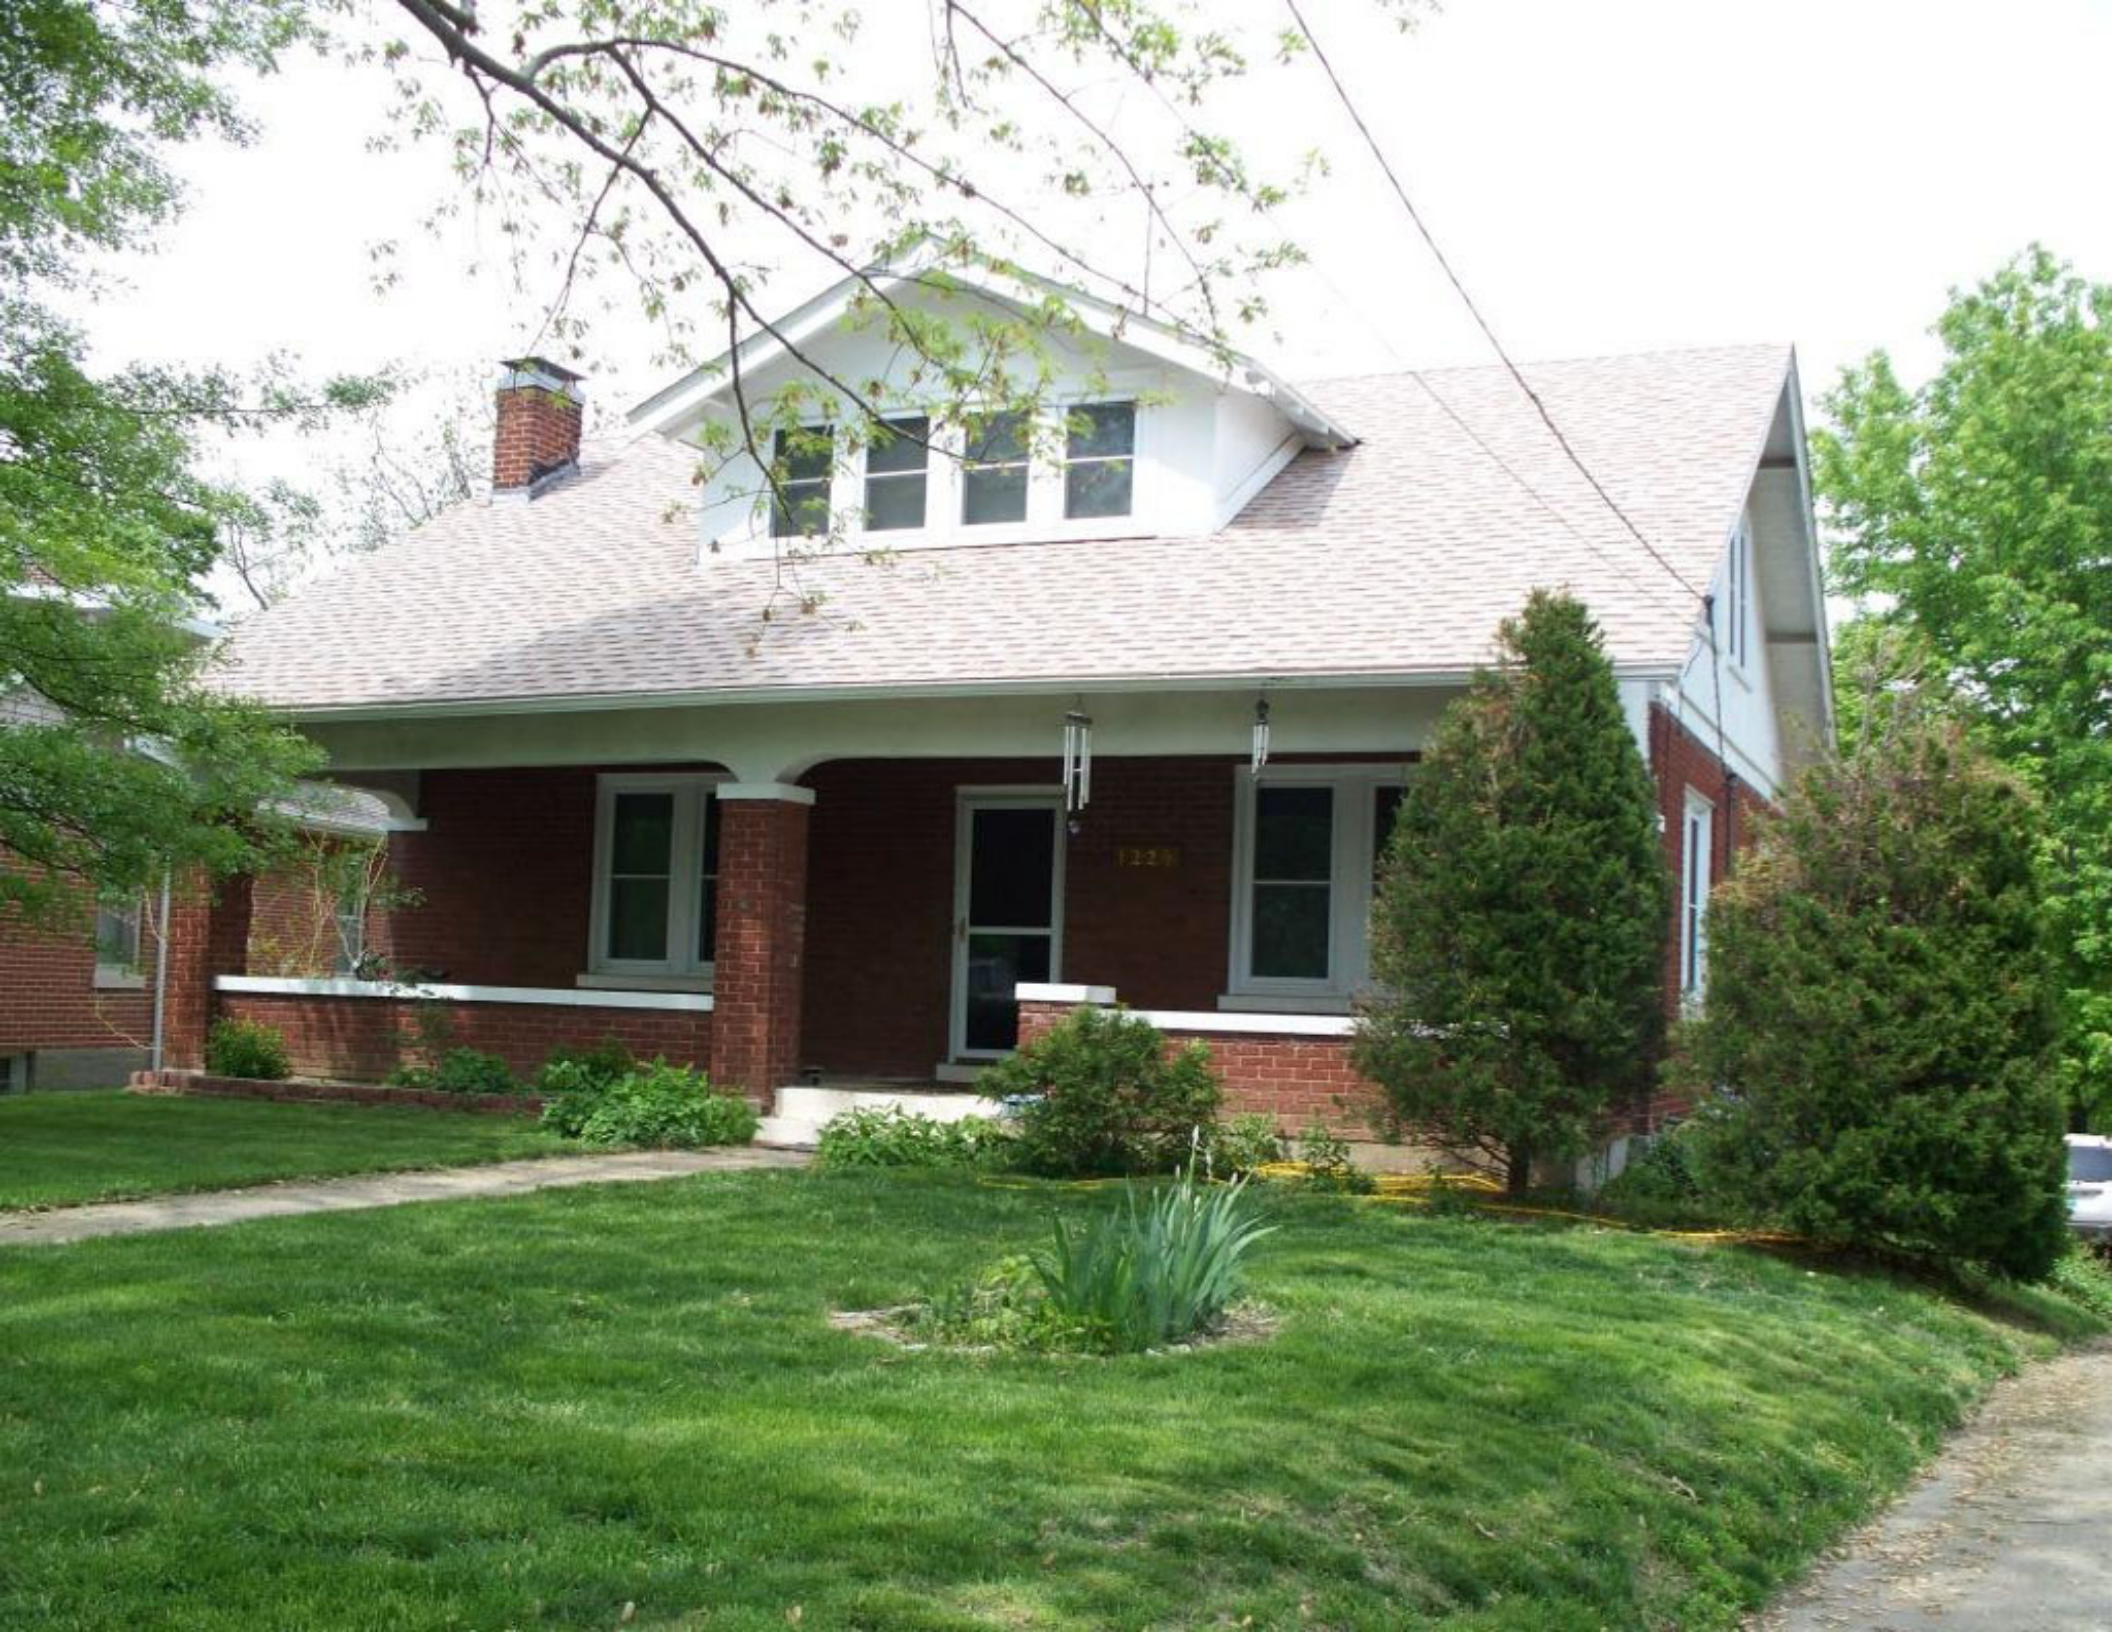
This 1 ½ story brick bungalow has a deep side gable with a centered gable dormer with rafter tails and detailing in the gable. The dormer has been covered with stucco or Dryvit and contains four 1/1 vinyl windows. The first floor has two paired 1/1 vinyl windows with concrete or limestone sills flanking the centered entrance. The full width porch features brick piers and half walls capped in limestone or concrete. The piers support a basket handle frieze.

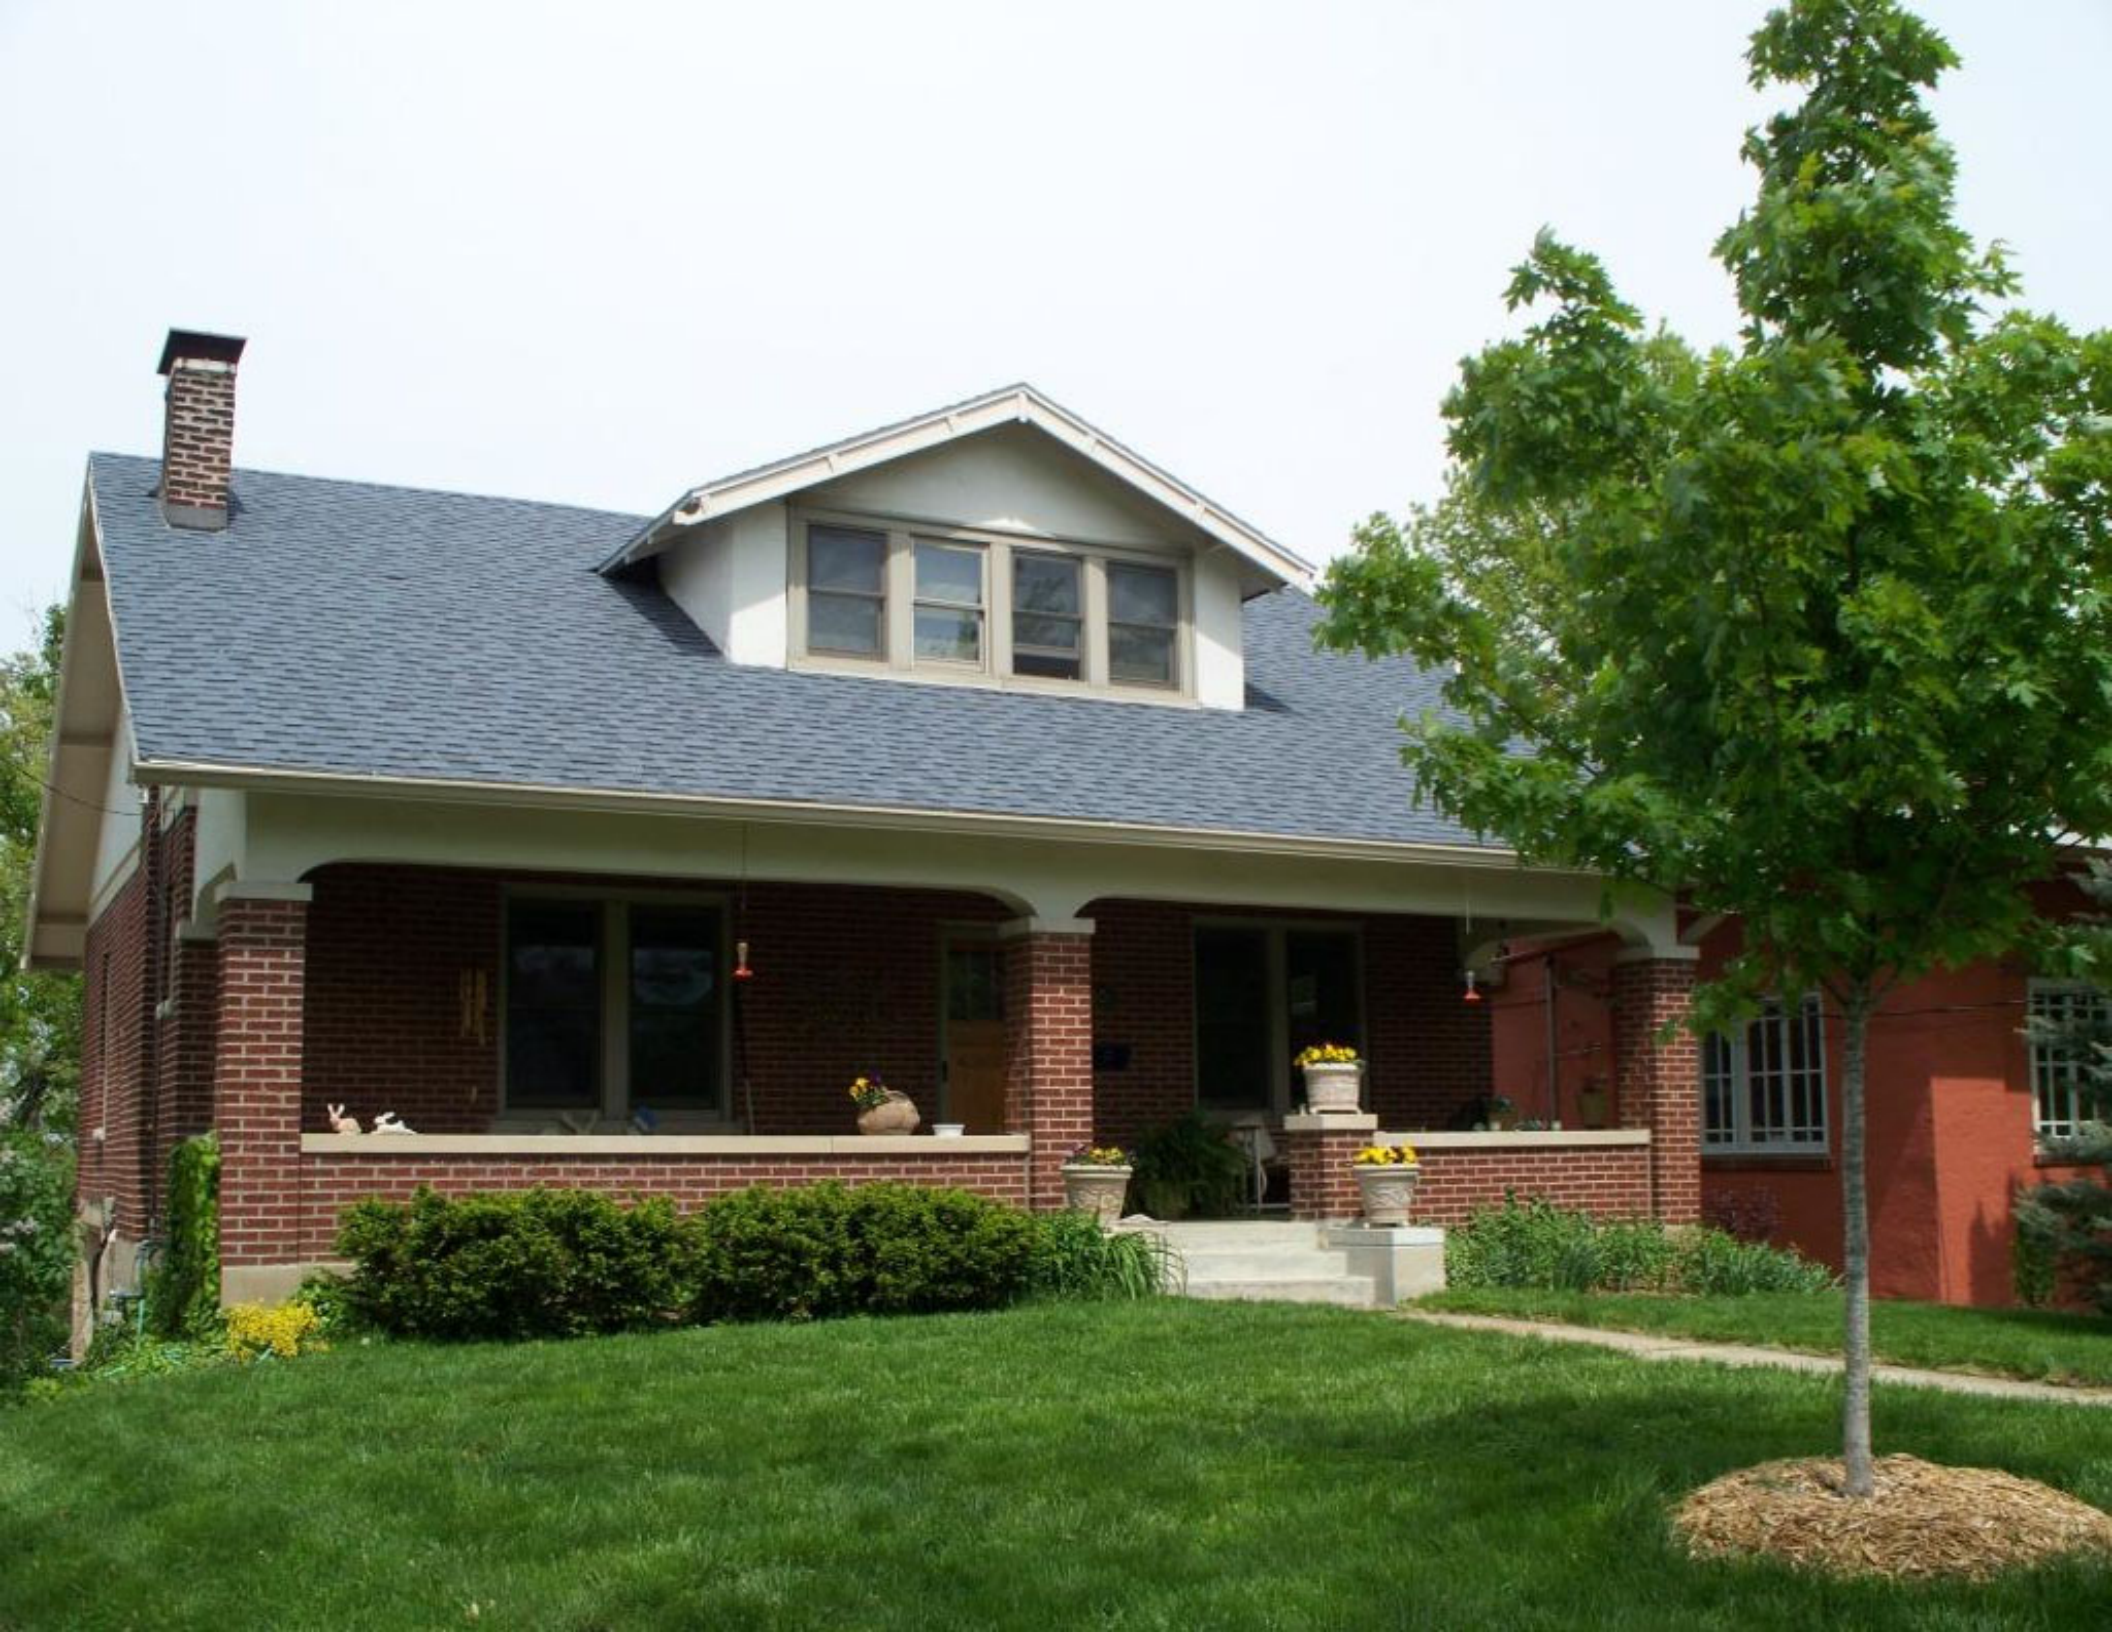
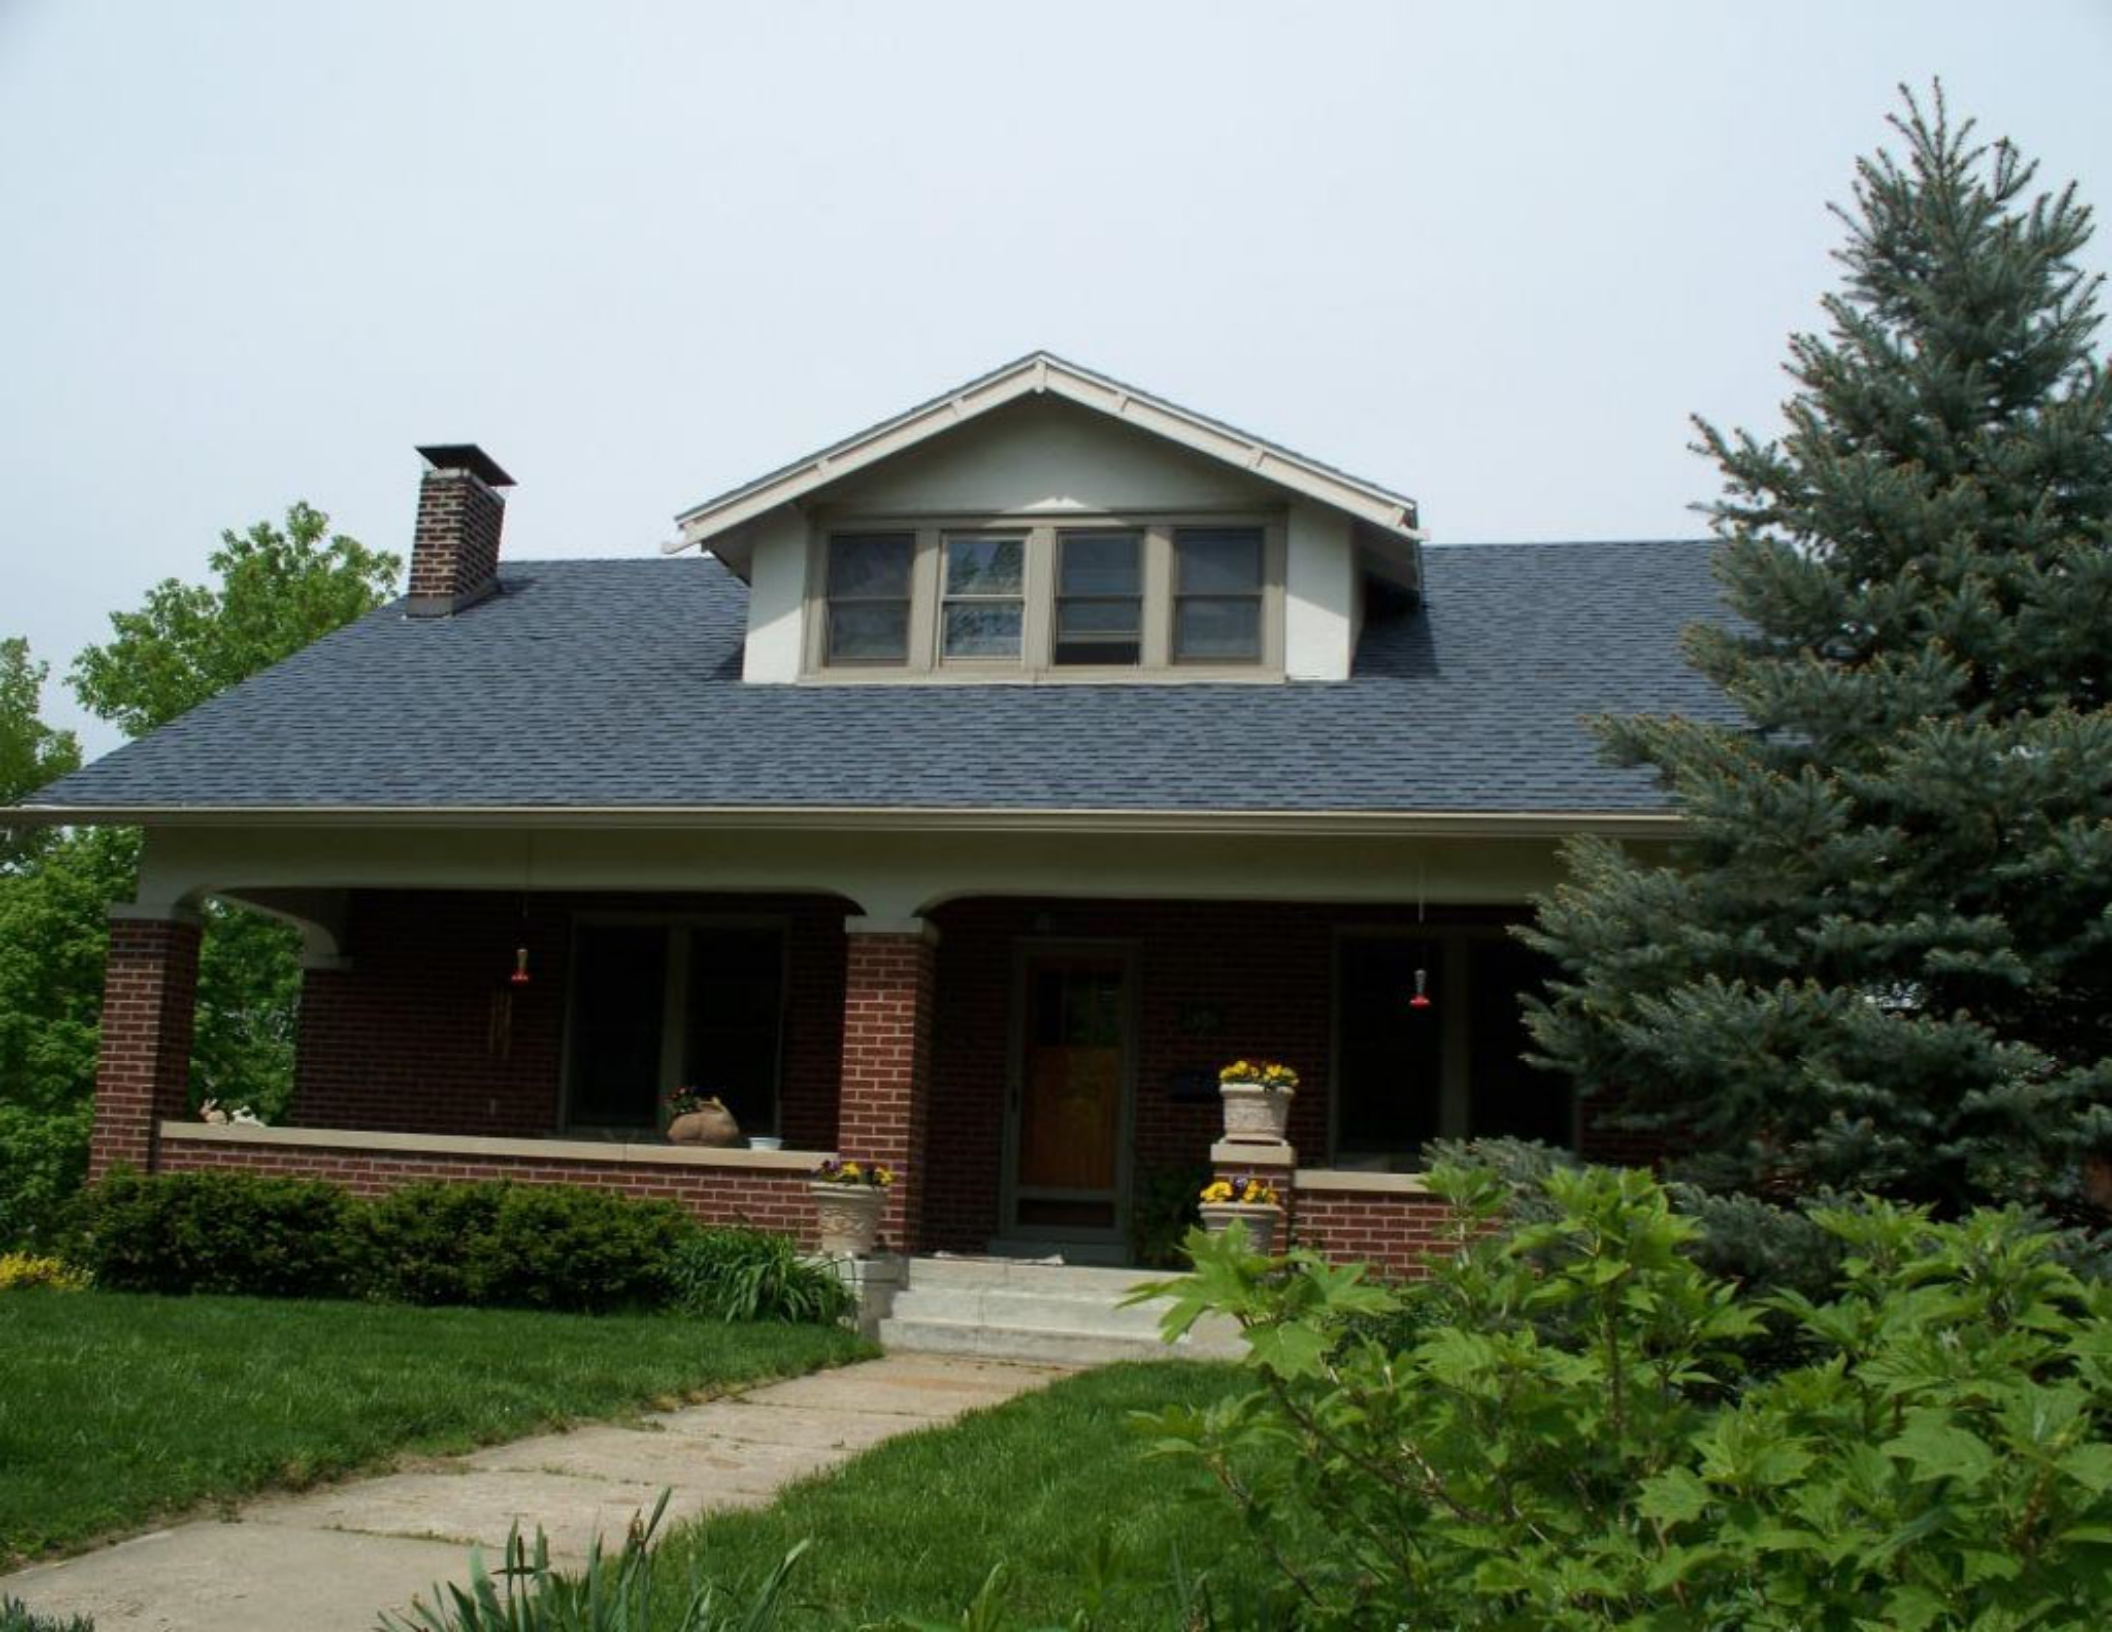
This 1 ½ story brick bungalow has a deep side gable with a centered gable dormer with rafter tails. The dormer has been covered with stucco or Dryvit and contains four 1/1 vinyl windows. The first floor has two paired windows (division obscured) with concrete or limestone sills flanking the centered entrance with what appears to be a historic wooden door with multi-lights on the upper portion. The full width porch features brick piers and half walls capped in limestone or concrete. The piers support basket handle friezes.
