ARCHITECTURAL/HISTORIC INVENTORY FORM

1. Survey No. CO-AS-005-001		2. Survey name: Moreau Drive Neighborhood Survey	
3. County: Cole		4. Address: 1202 Elmerine Ave.	
5. City: Jefferson City	Vicinity: <input type="checkbox"/>	6. UTM: / /	7. Township/Range/Section: T: R: S:
8. Historic name (if known):		9. Present/other name (if known):	
10. Ownership: <input checked="" type="checkbox"/> Private <input type="checkbox"/> Public		11. Historic use (if known): Residential	11. Current use: Residential

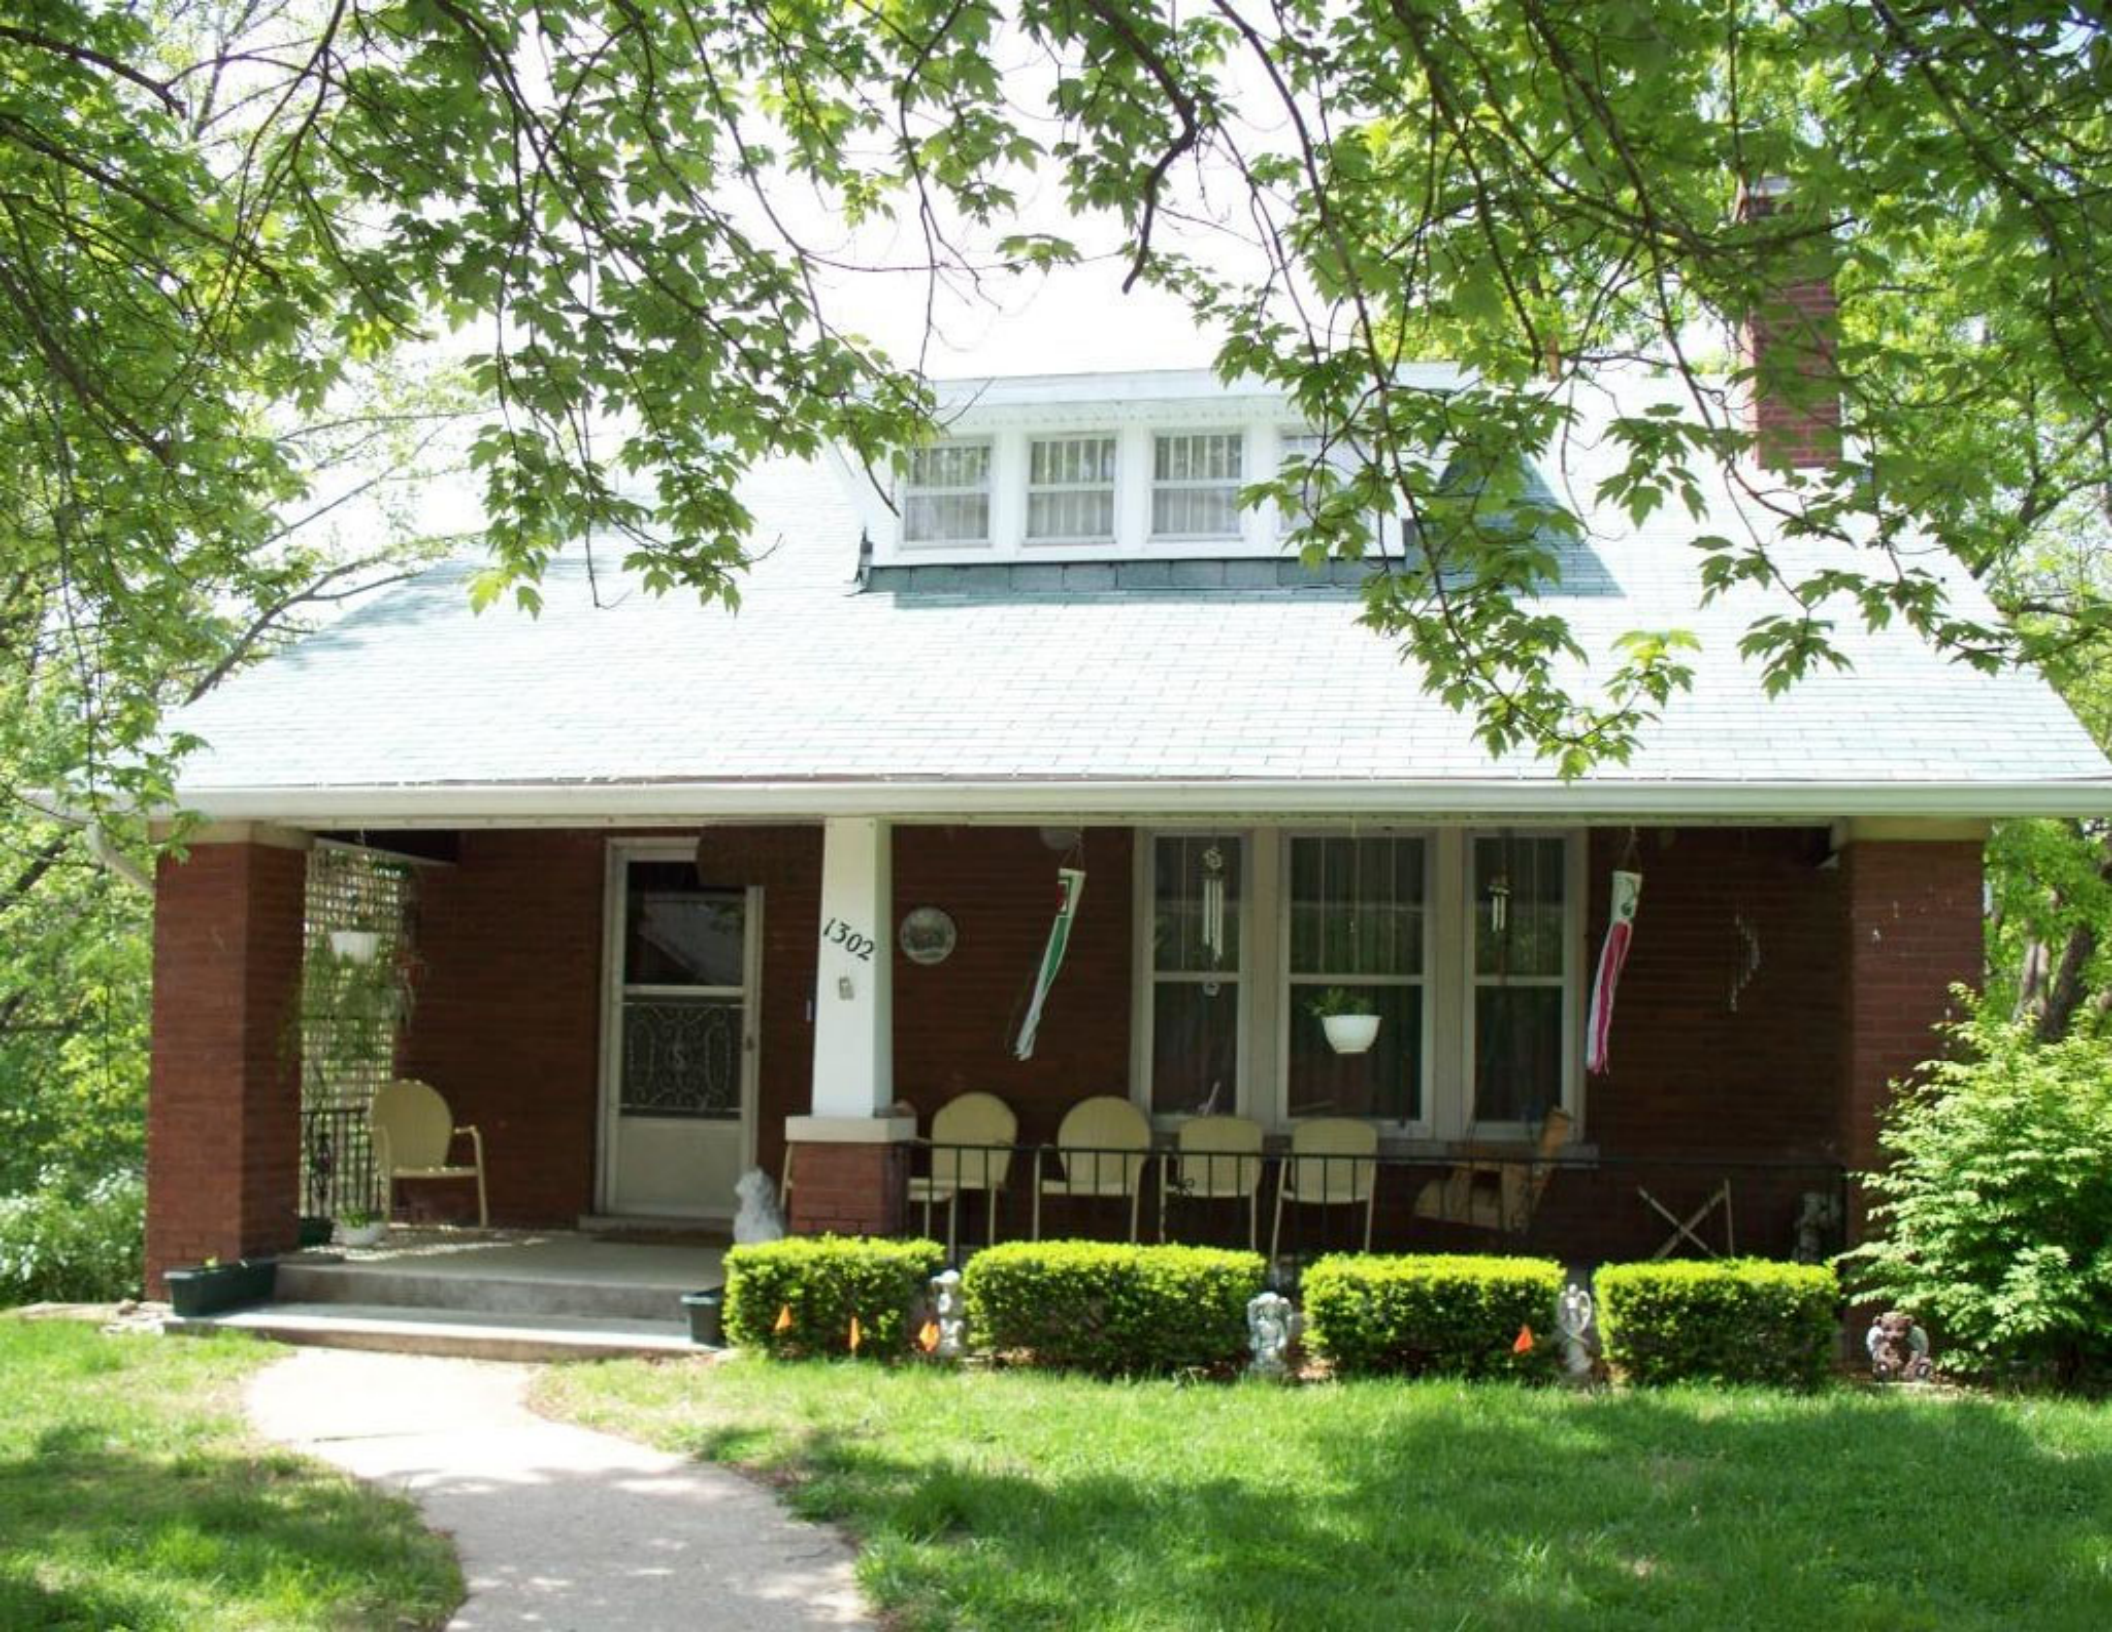
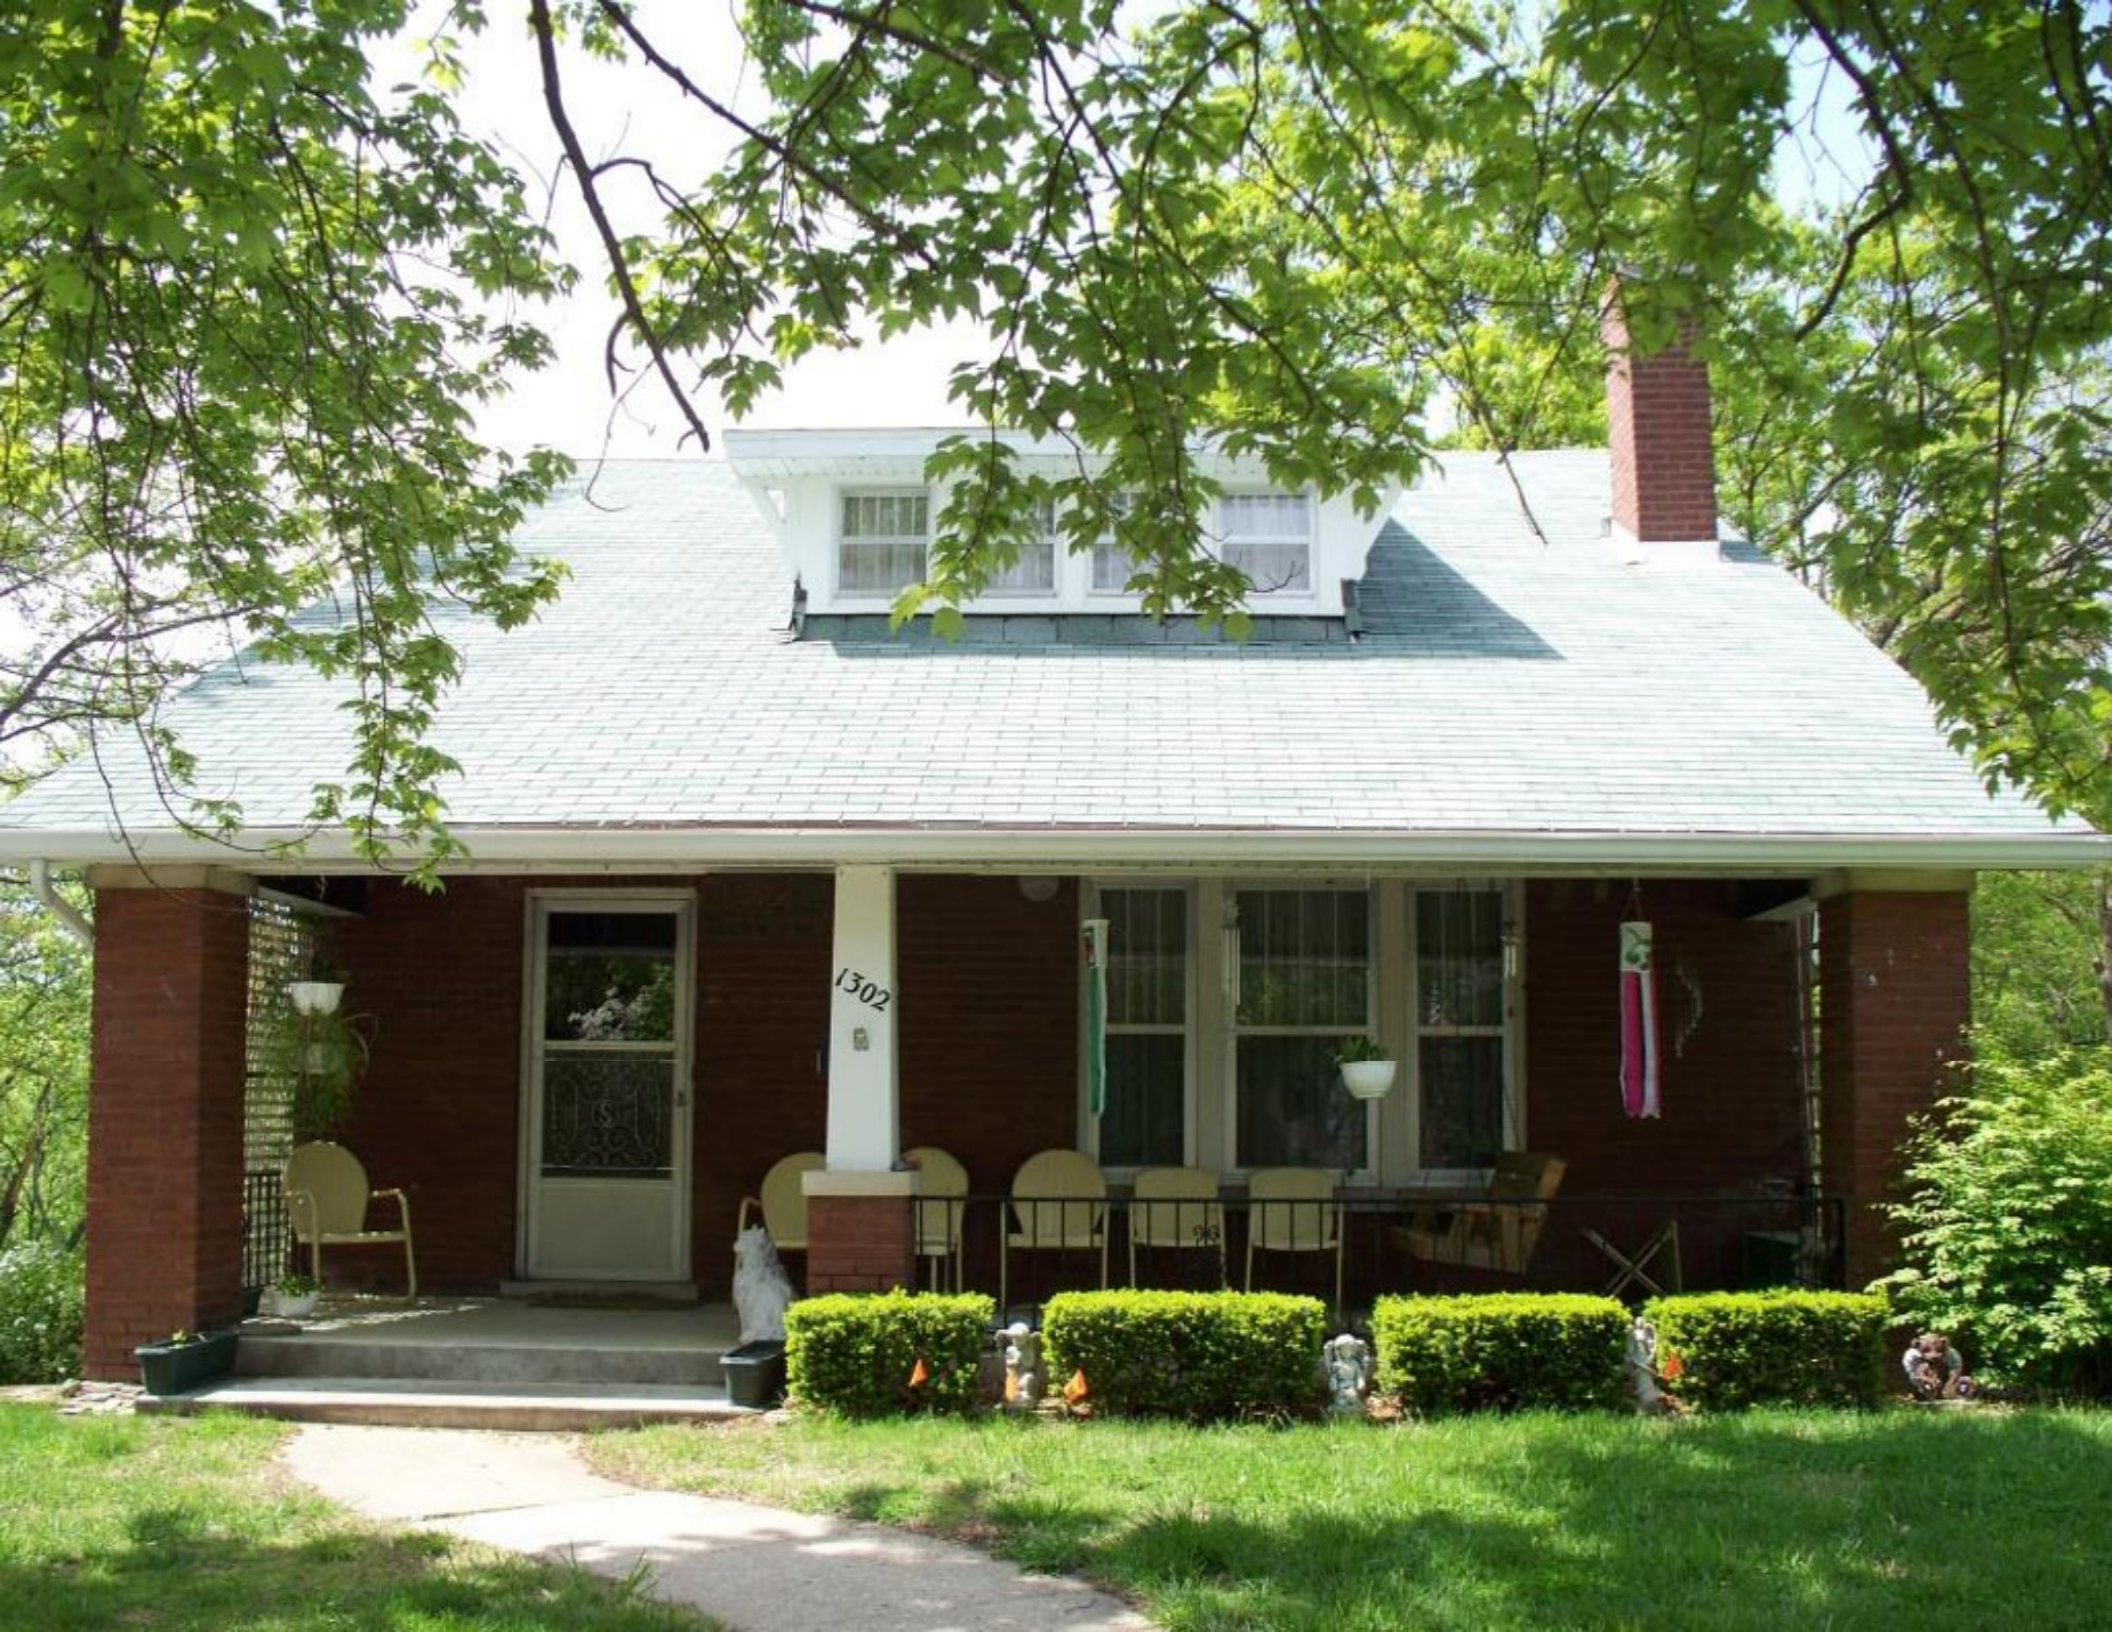
1302

This 1 ½ story brick bungalow has a deeply pitched side gable roof with a central shed dormer with wide eaves, brackets and a row of three 5/5 historic windows. The first floor has the entrance in the left bay and a tri-part window (historic 3/1 flanking 4/1) in the right. The full width porch has brick piers capped in limestone or concrete, the center pier supports a tapered wooden pier. There is metal railing between this pier and the large square pier at the right side of the property.

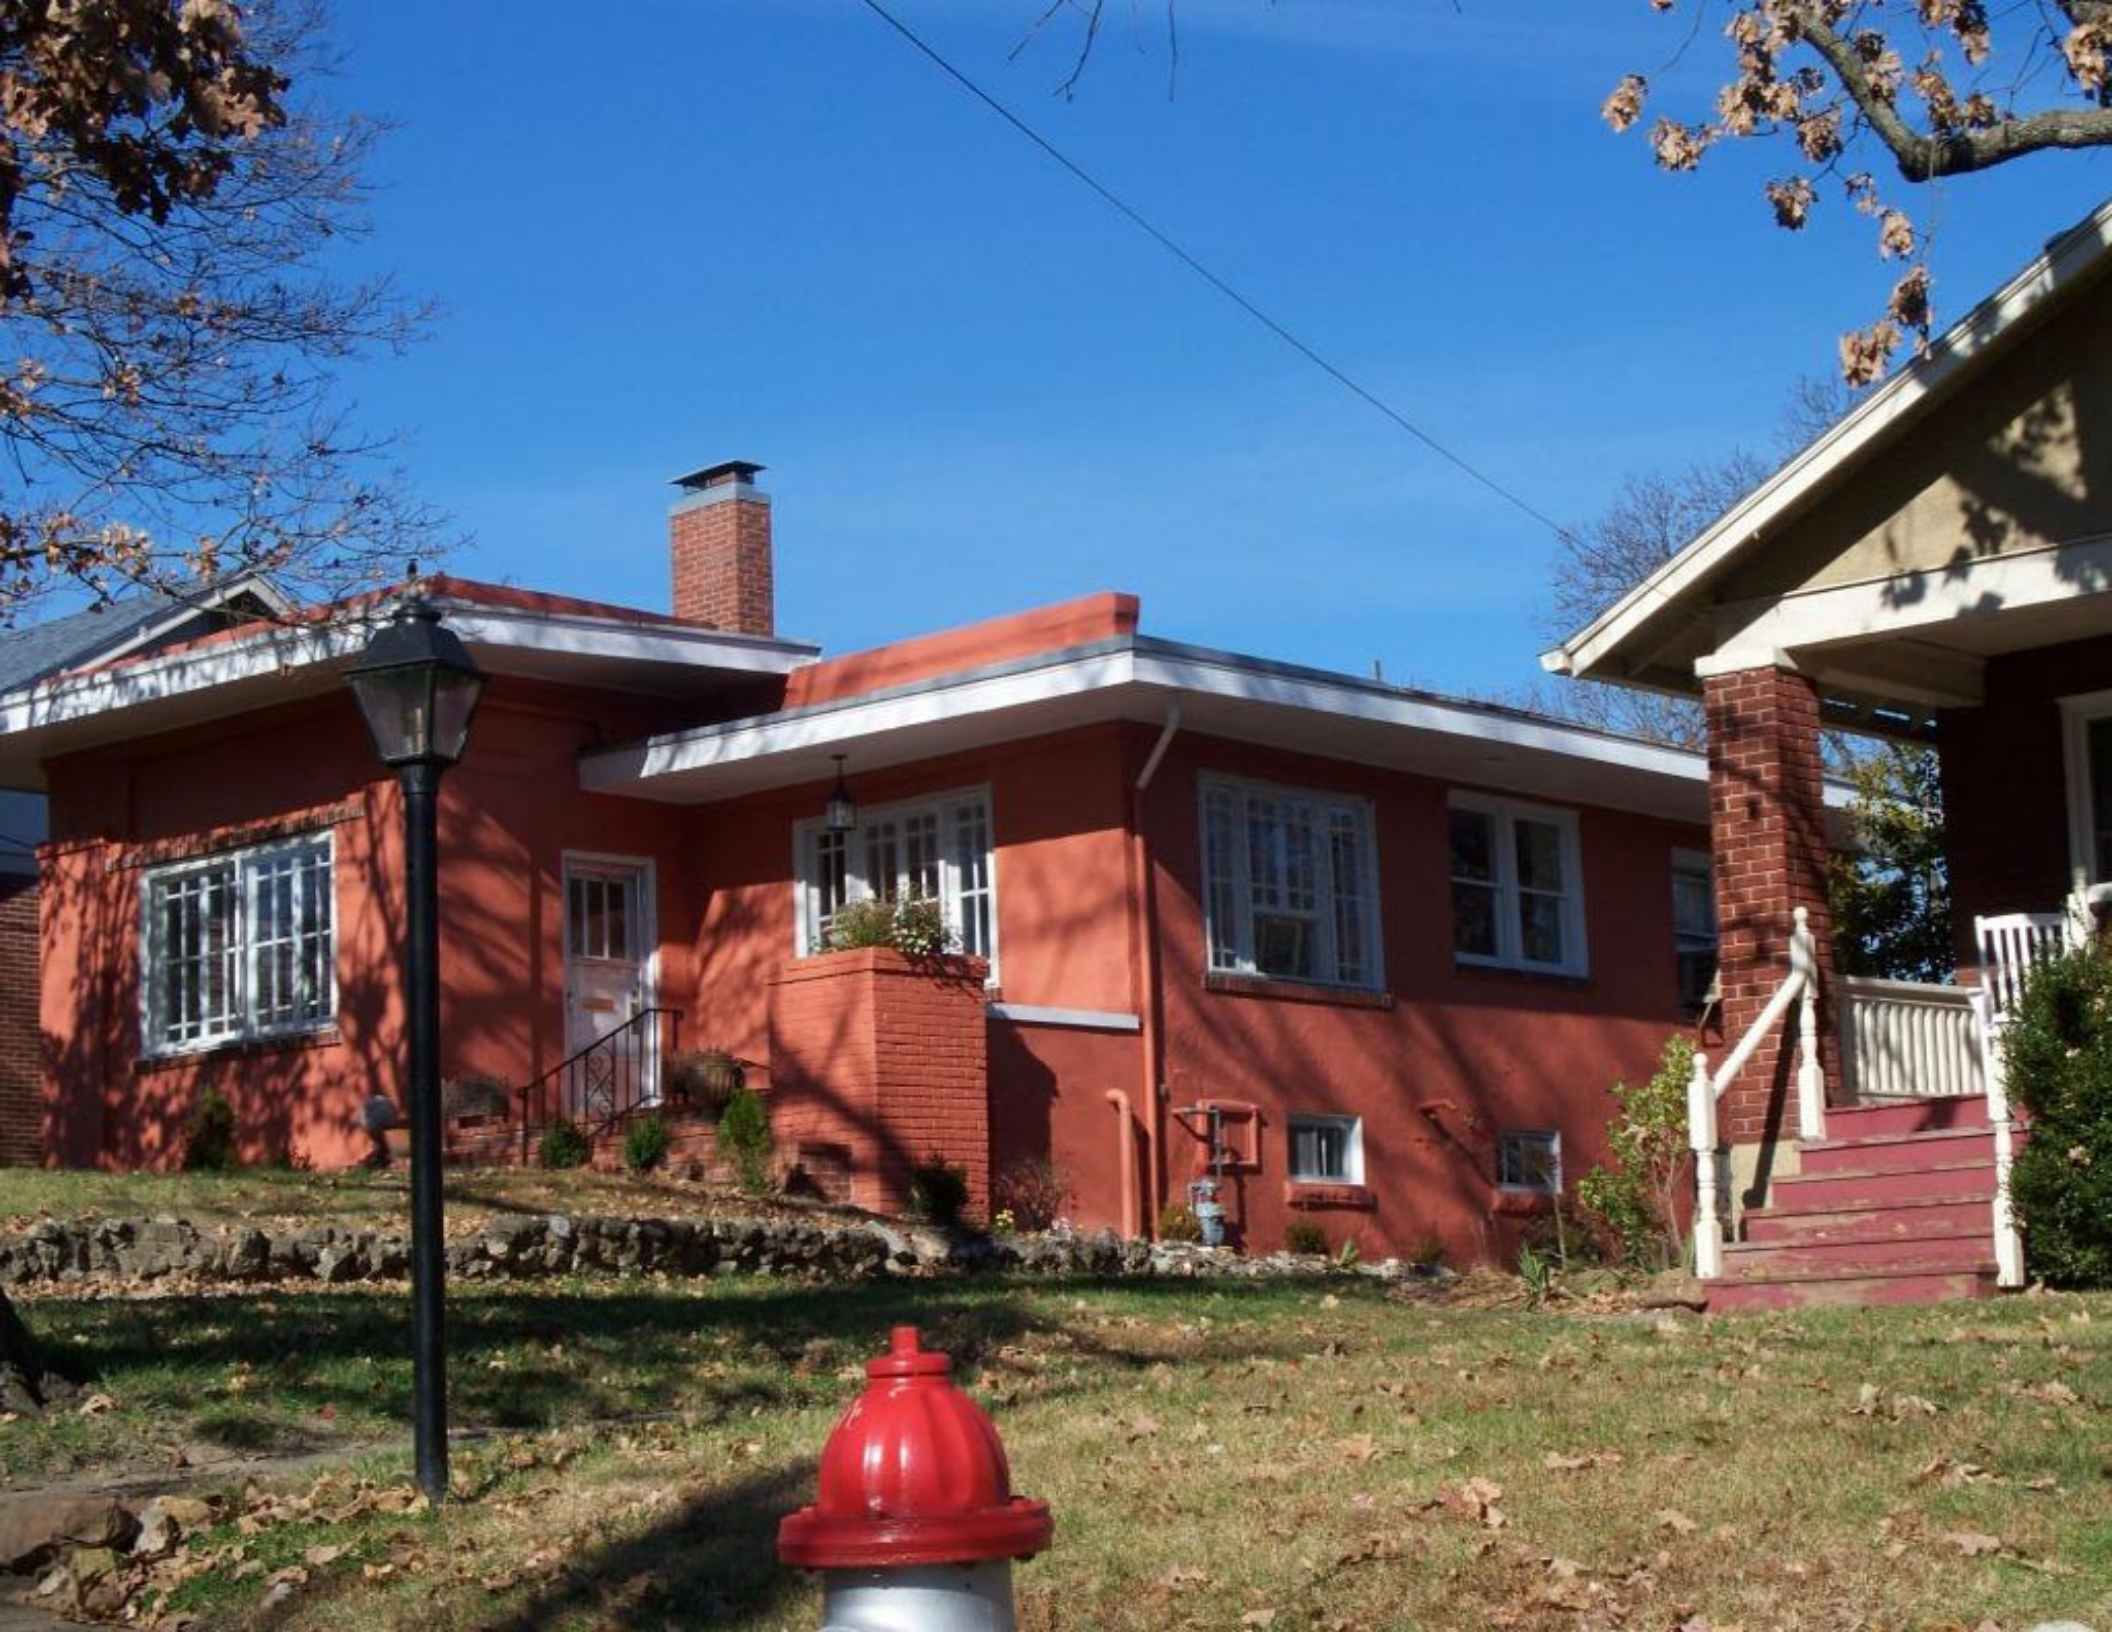
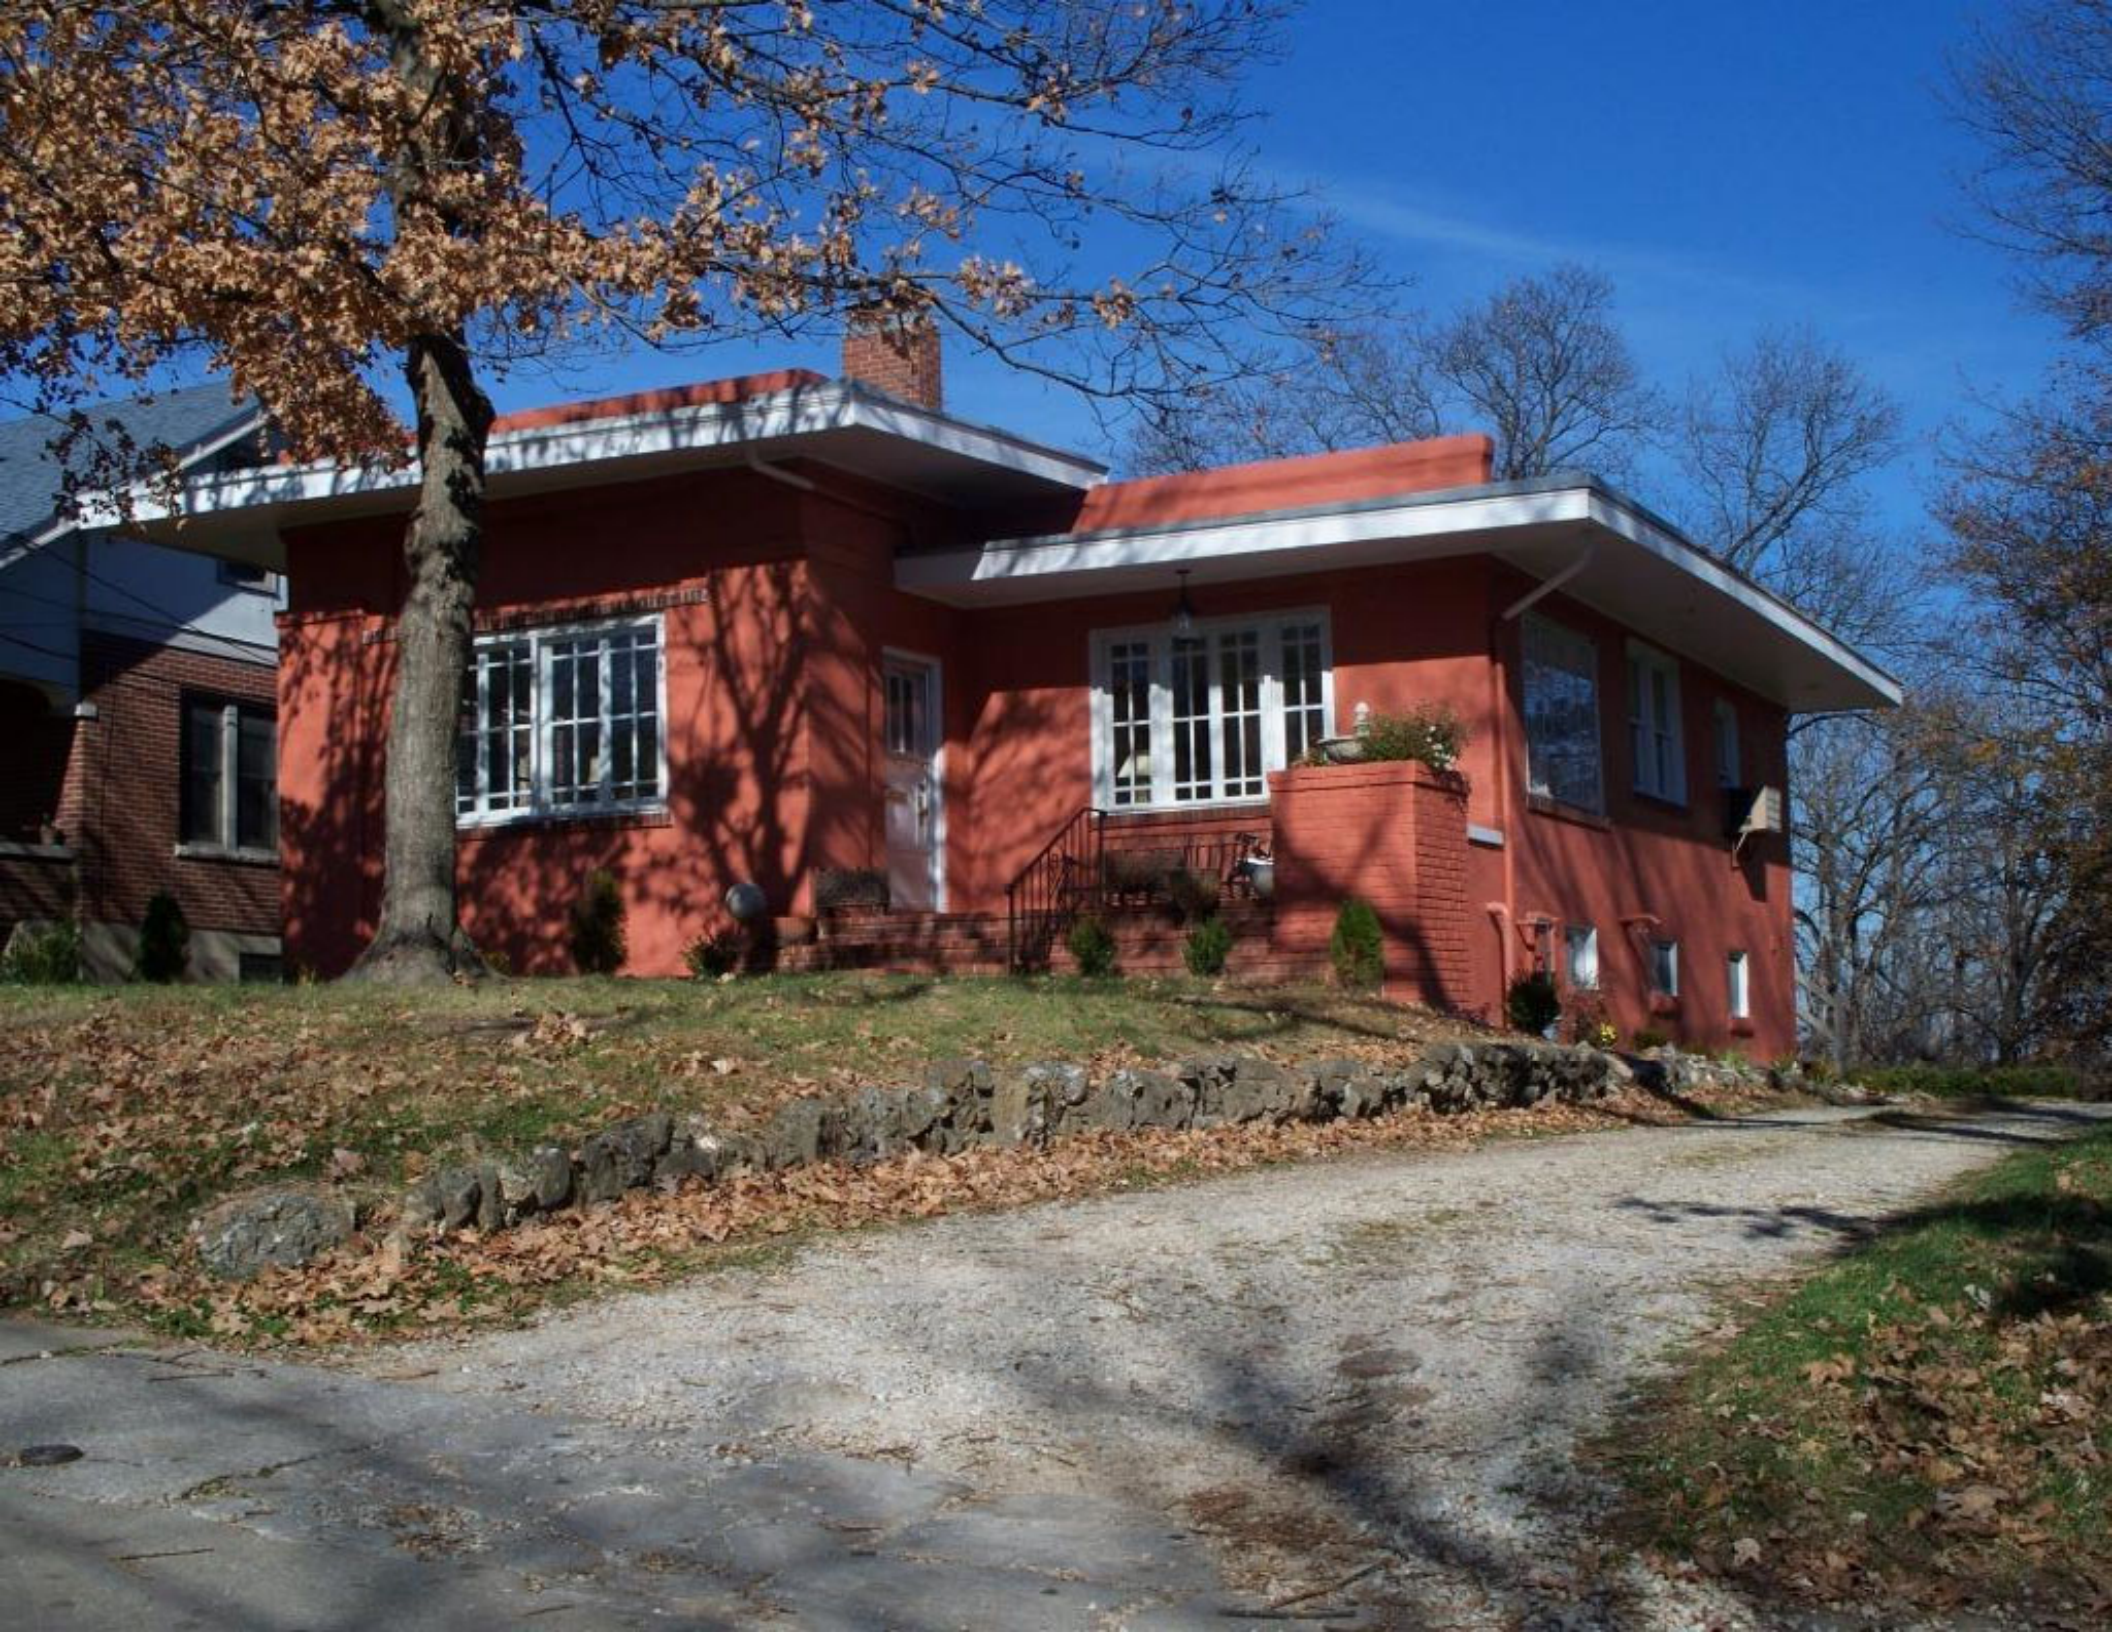
This one story stucco home has a flat roof with wide eaves. The first bay (left) projects from the entrance and porch. A parapet wall pierces the roof on both bays. The first bay contains a row of four multi-light casement windows that have a course of rowlock brick as a lintel and a shorter course of rowlock brick as a sill. The right bay is set back and contains the entrance on the inner corner and similar windows to that on the left bay. A set of brick stairs with railing lead up to the brick porch that features one large square brick pier and a short half wall that is stuccoed. The wide overhanging eaves and horizontal quality of the windows are hallmarks of the Prairie Style.

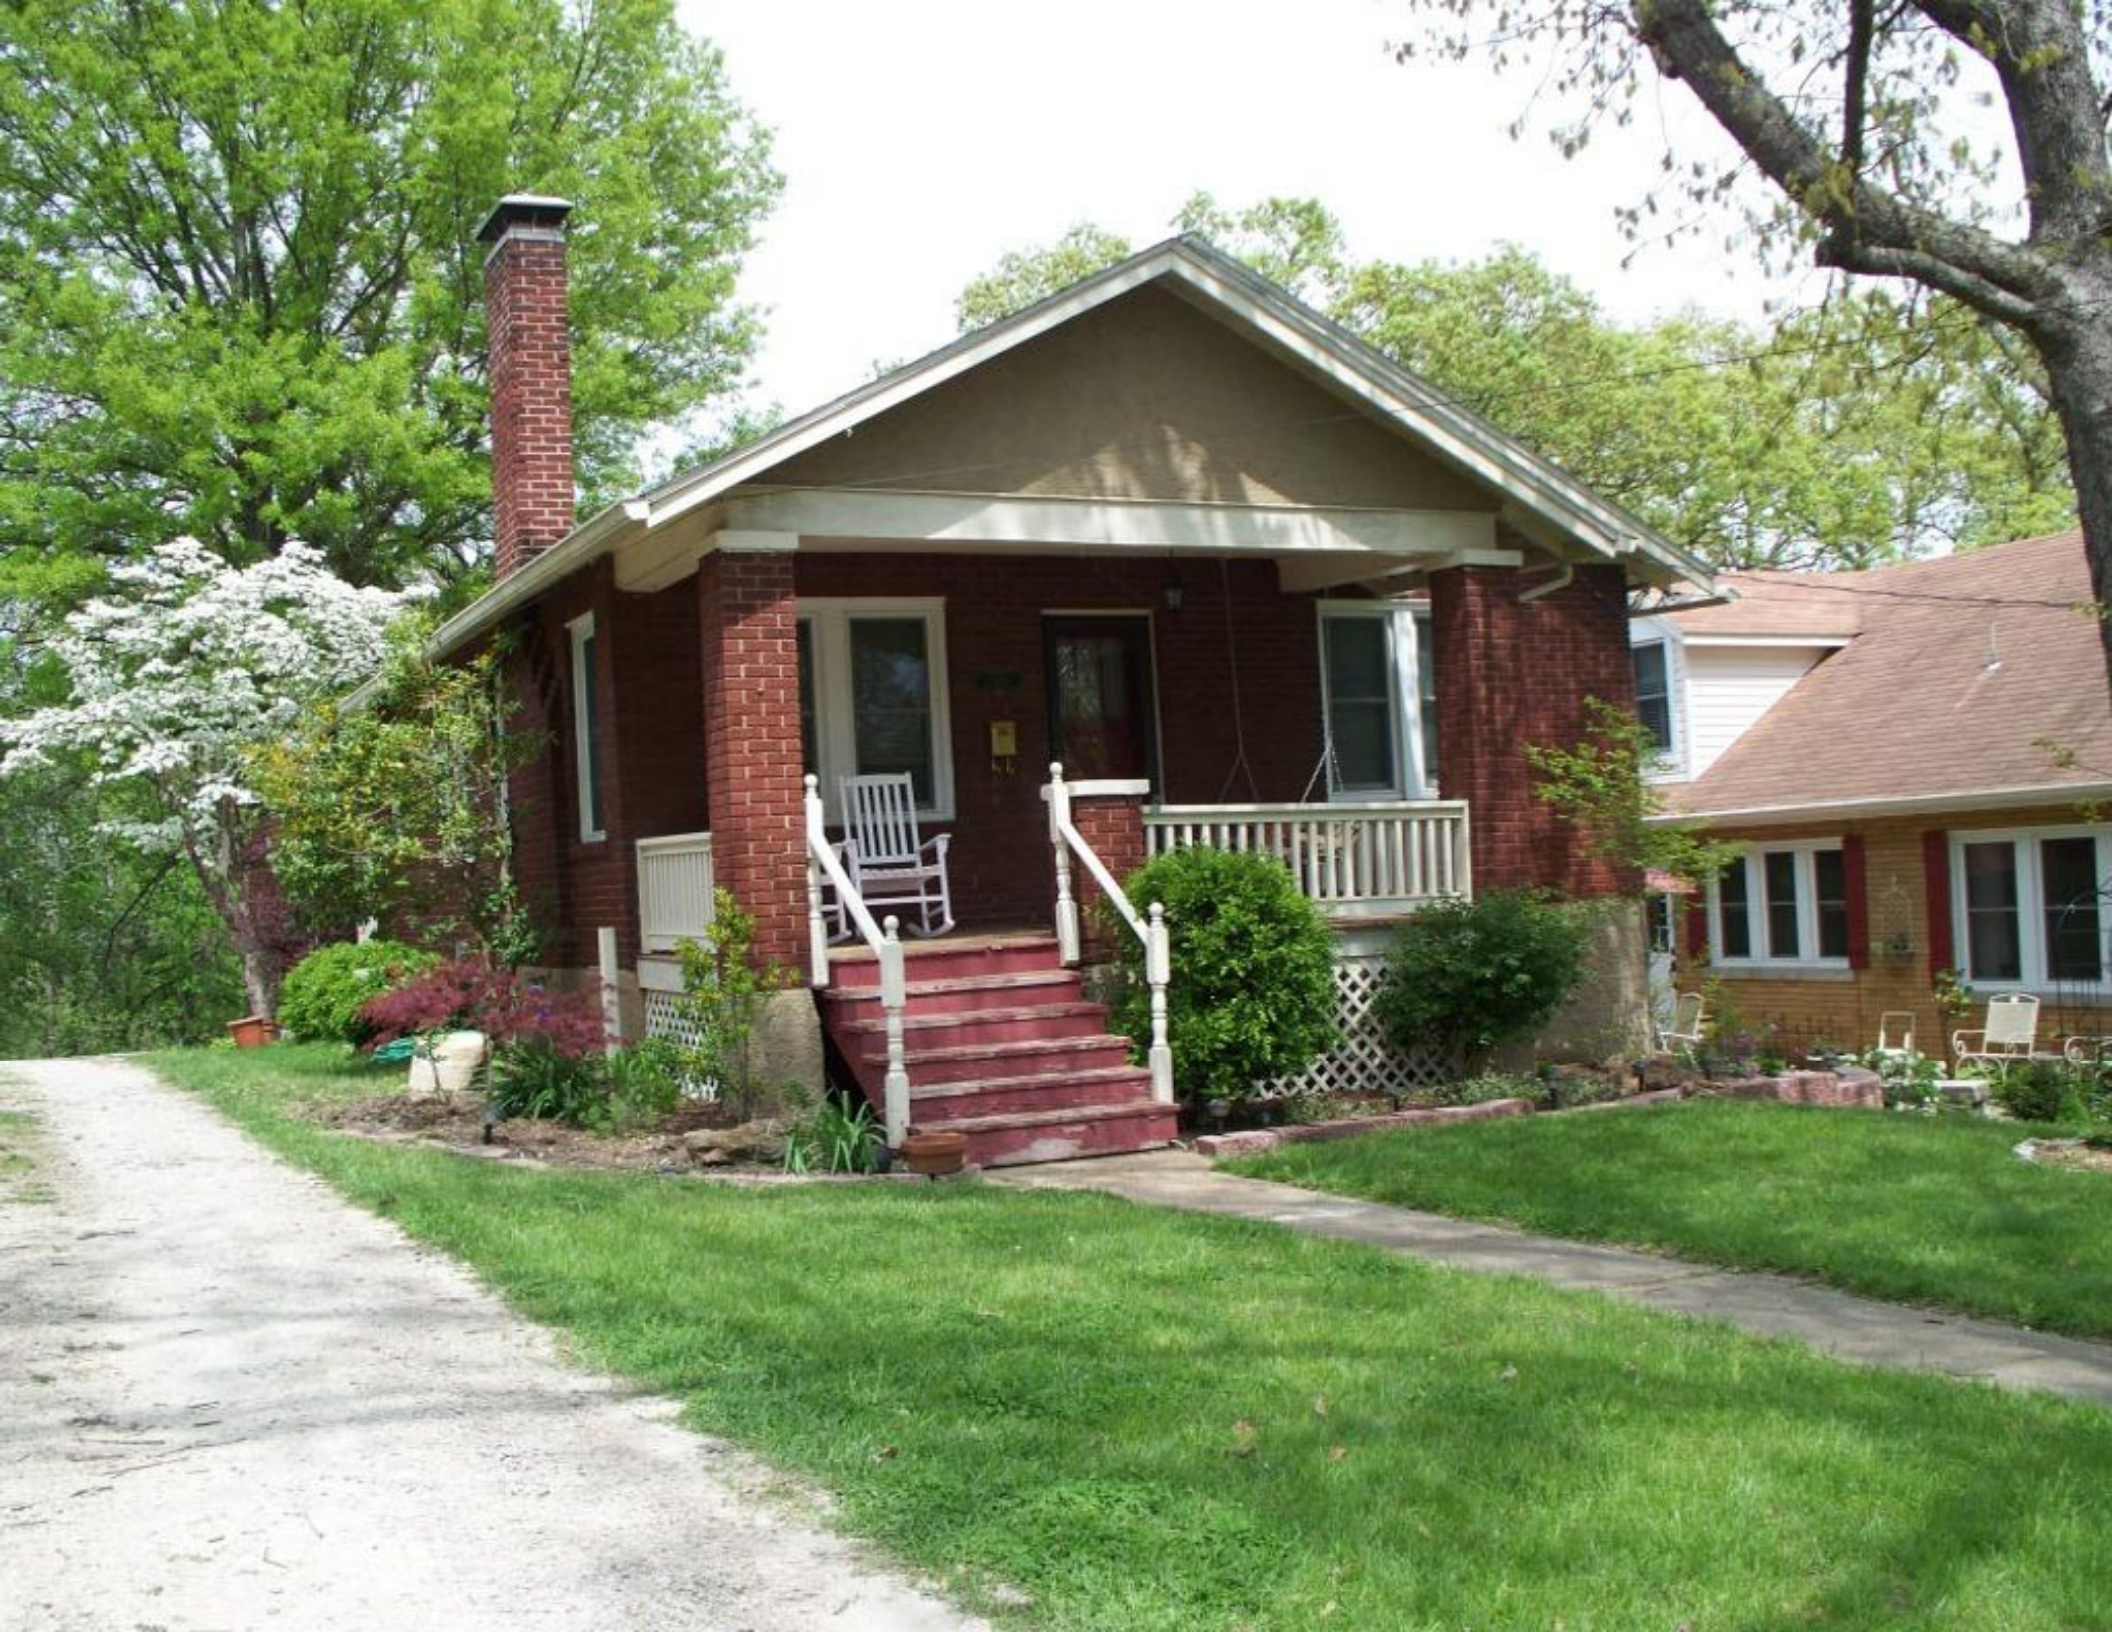
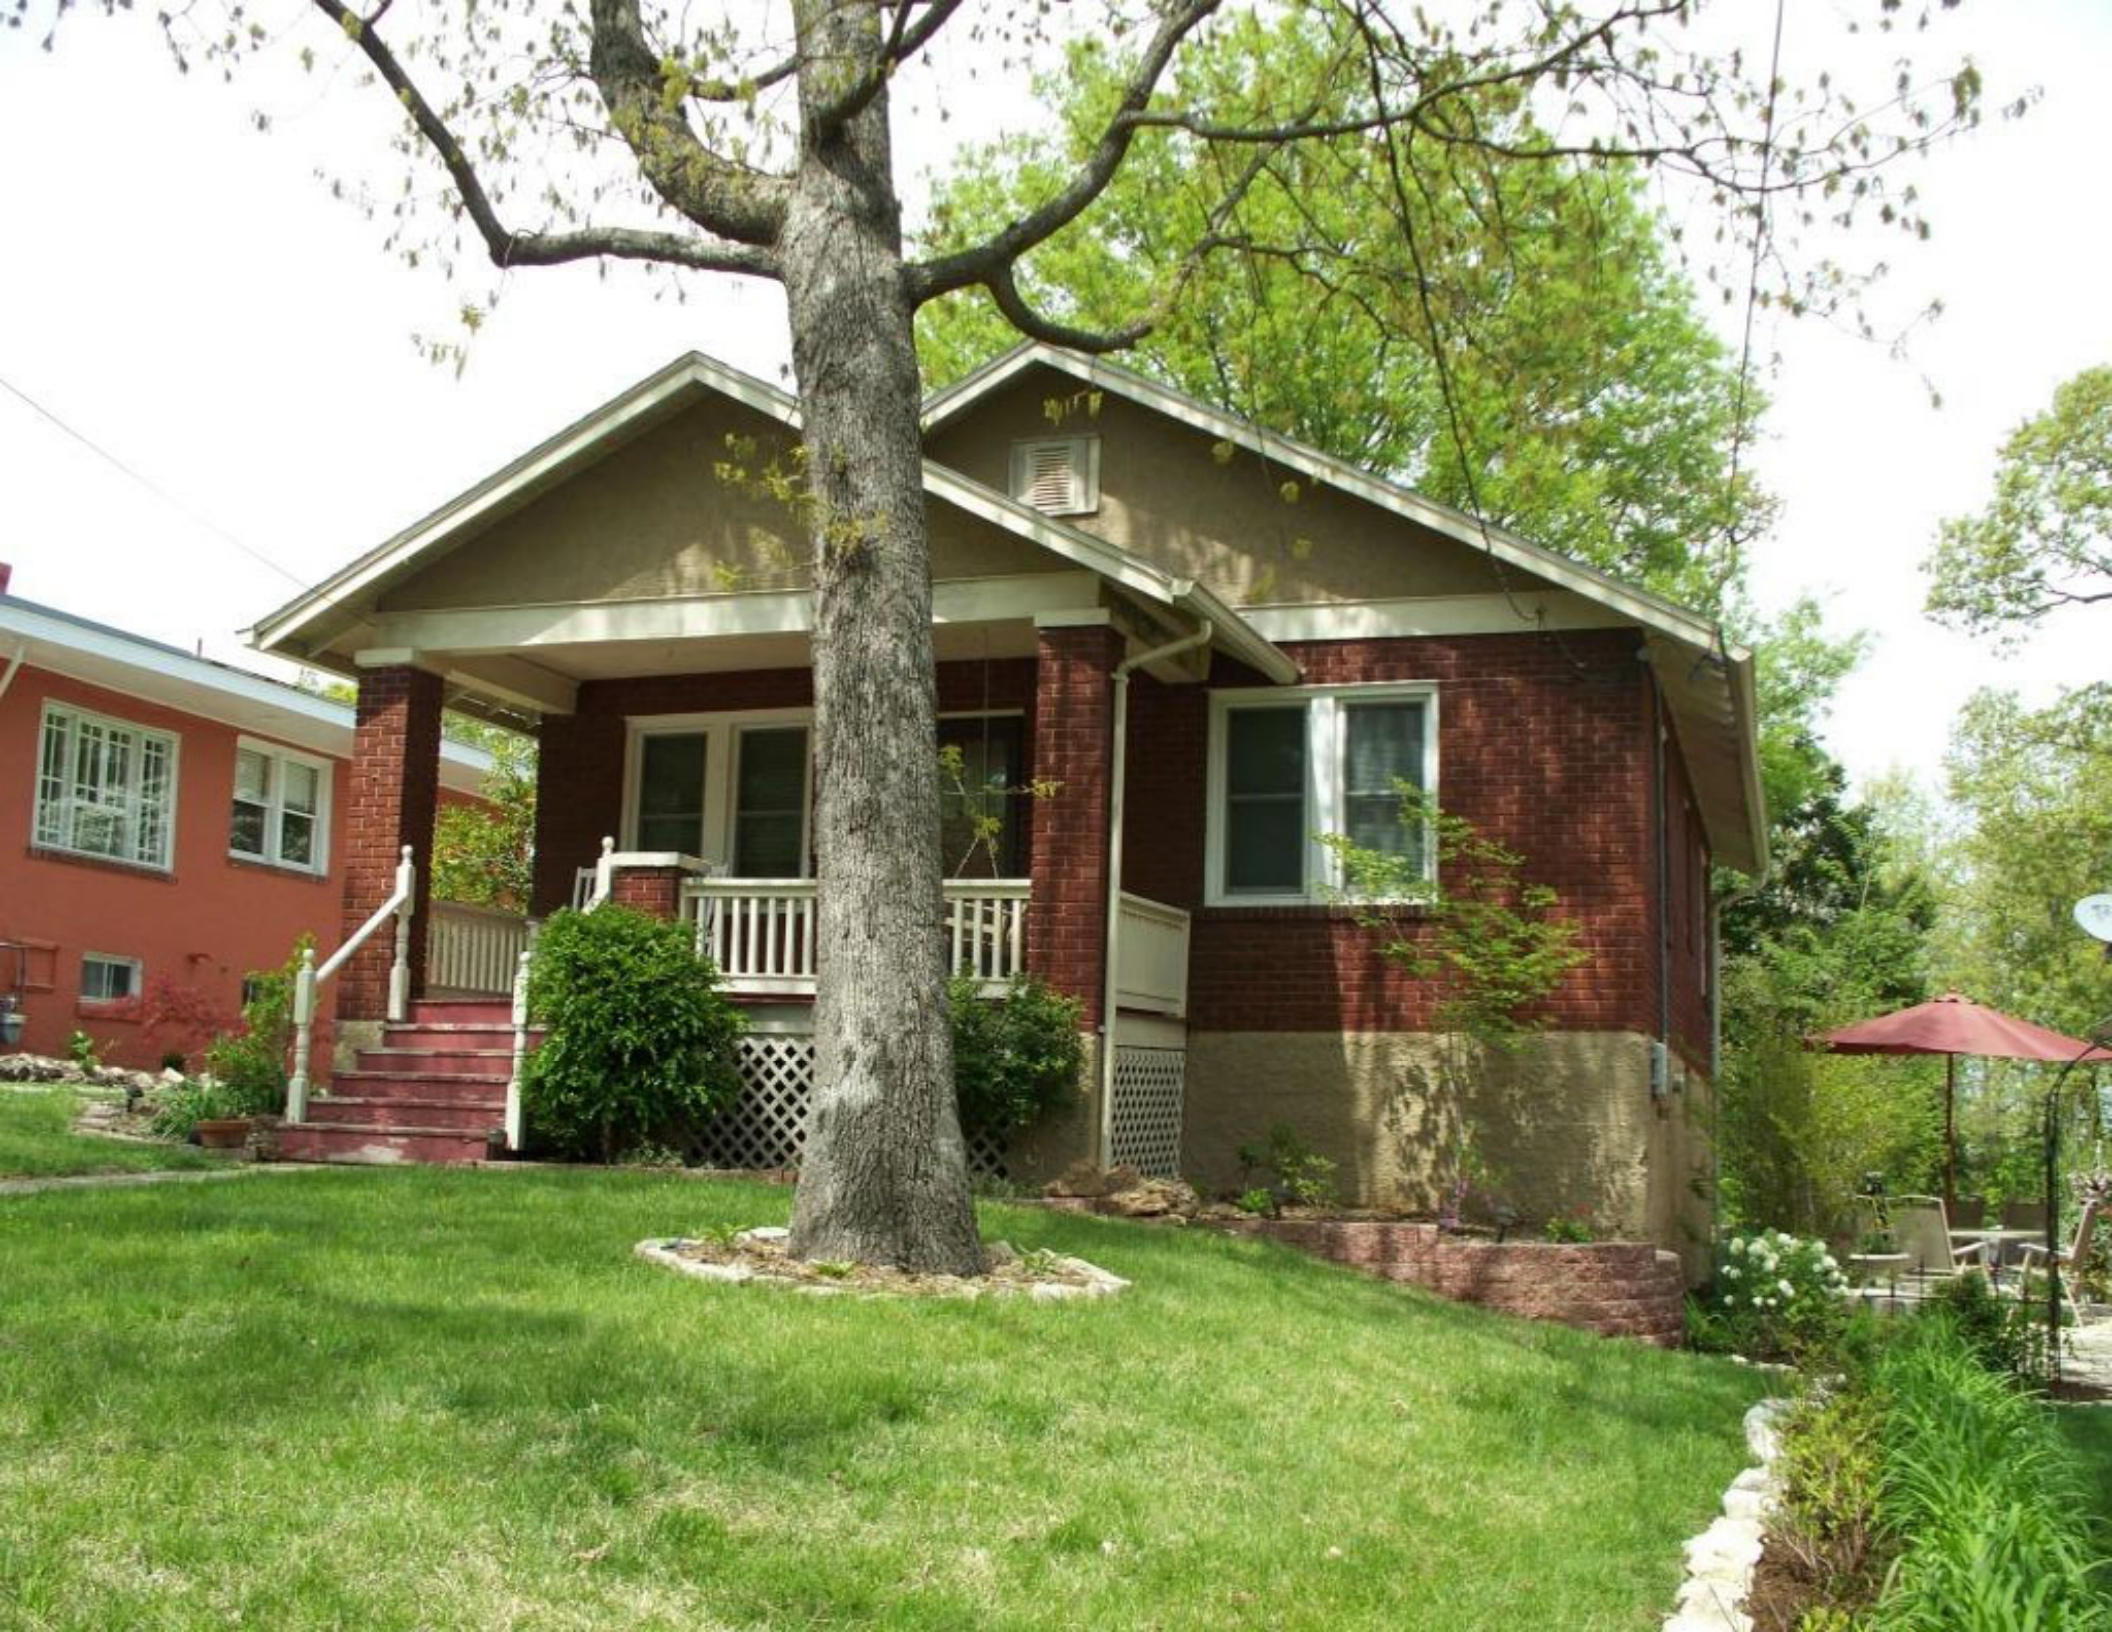
This one story brick bungalow has a front gable roof. Paired 1/1 replacement windows flank the entrance. The wooden door appears original and has three lights in its upper portion. A porch with a gable roof extends from the main property and covers the first two bays (from the left). The gable end is stuccoed and has a wide entablature that is supported by brick piers with wooden railing. A set of wooden steps with modern wood posts and rails leads up to the porch. The crawlspace is covered by a wood or vinyl trellis. According to the Historic City of Jefferson's Bungalow Tour this property was built in the 1920s.
