ARCHITECTURAL/HISTORIC INVENTORY FORM

1. Survey No. CO-AS-005-001		2. Survey name: Moreau Drive Neighborhood Survey	
3. County: Cole		4. Address: 1202 Elmerine Ave.	
5. City: Jefferson City	Vicinity: <input type="checkbox"/>	6. UTM: / /	7. Township/Range/Section: T: R: S:
8. Historic name (if known):		9. Present/other name (if known):	
10. Ownership: <input checked="" type="checkbox"/> Private <input type="checkbox"/> Public		11. Historic use (if known): Residential	11. Current use: Residential

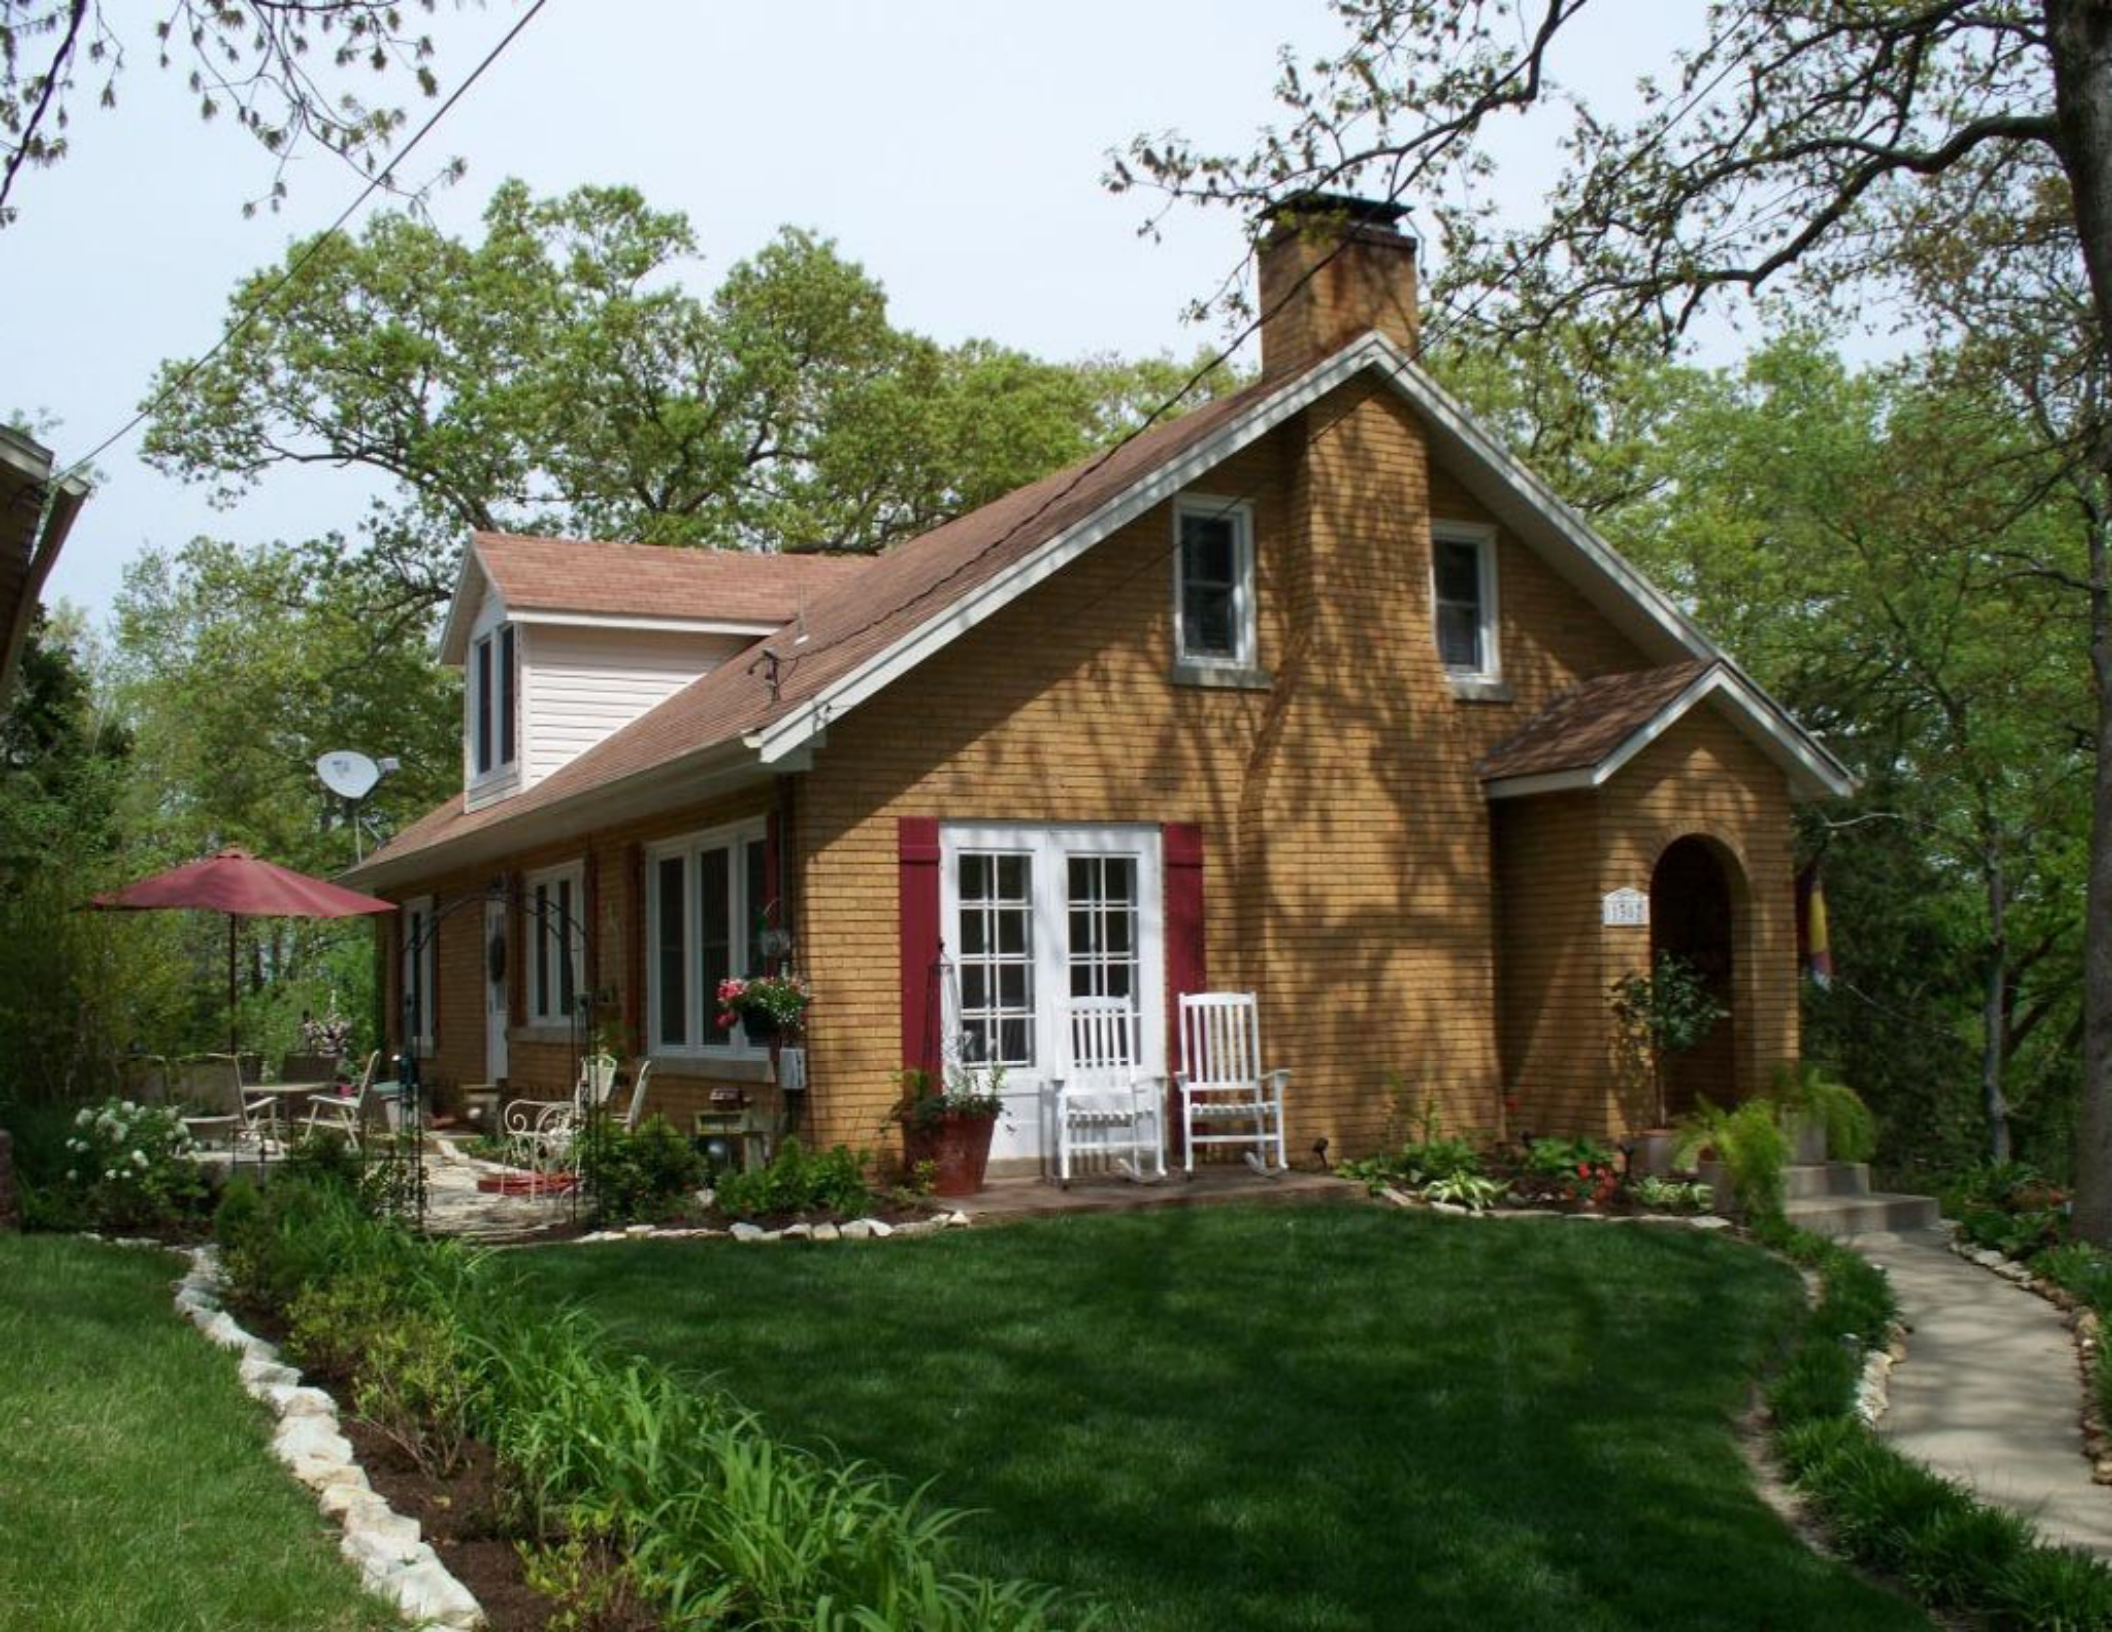
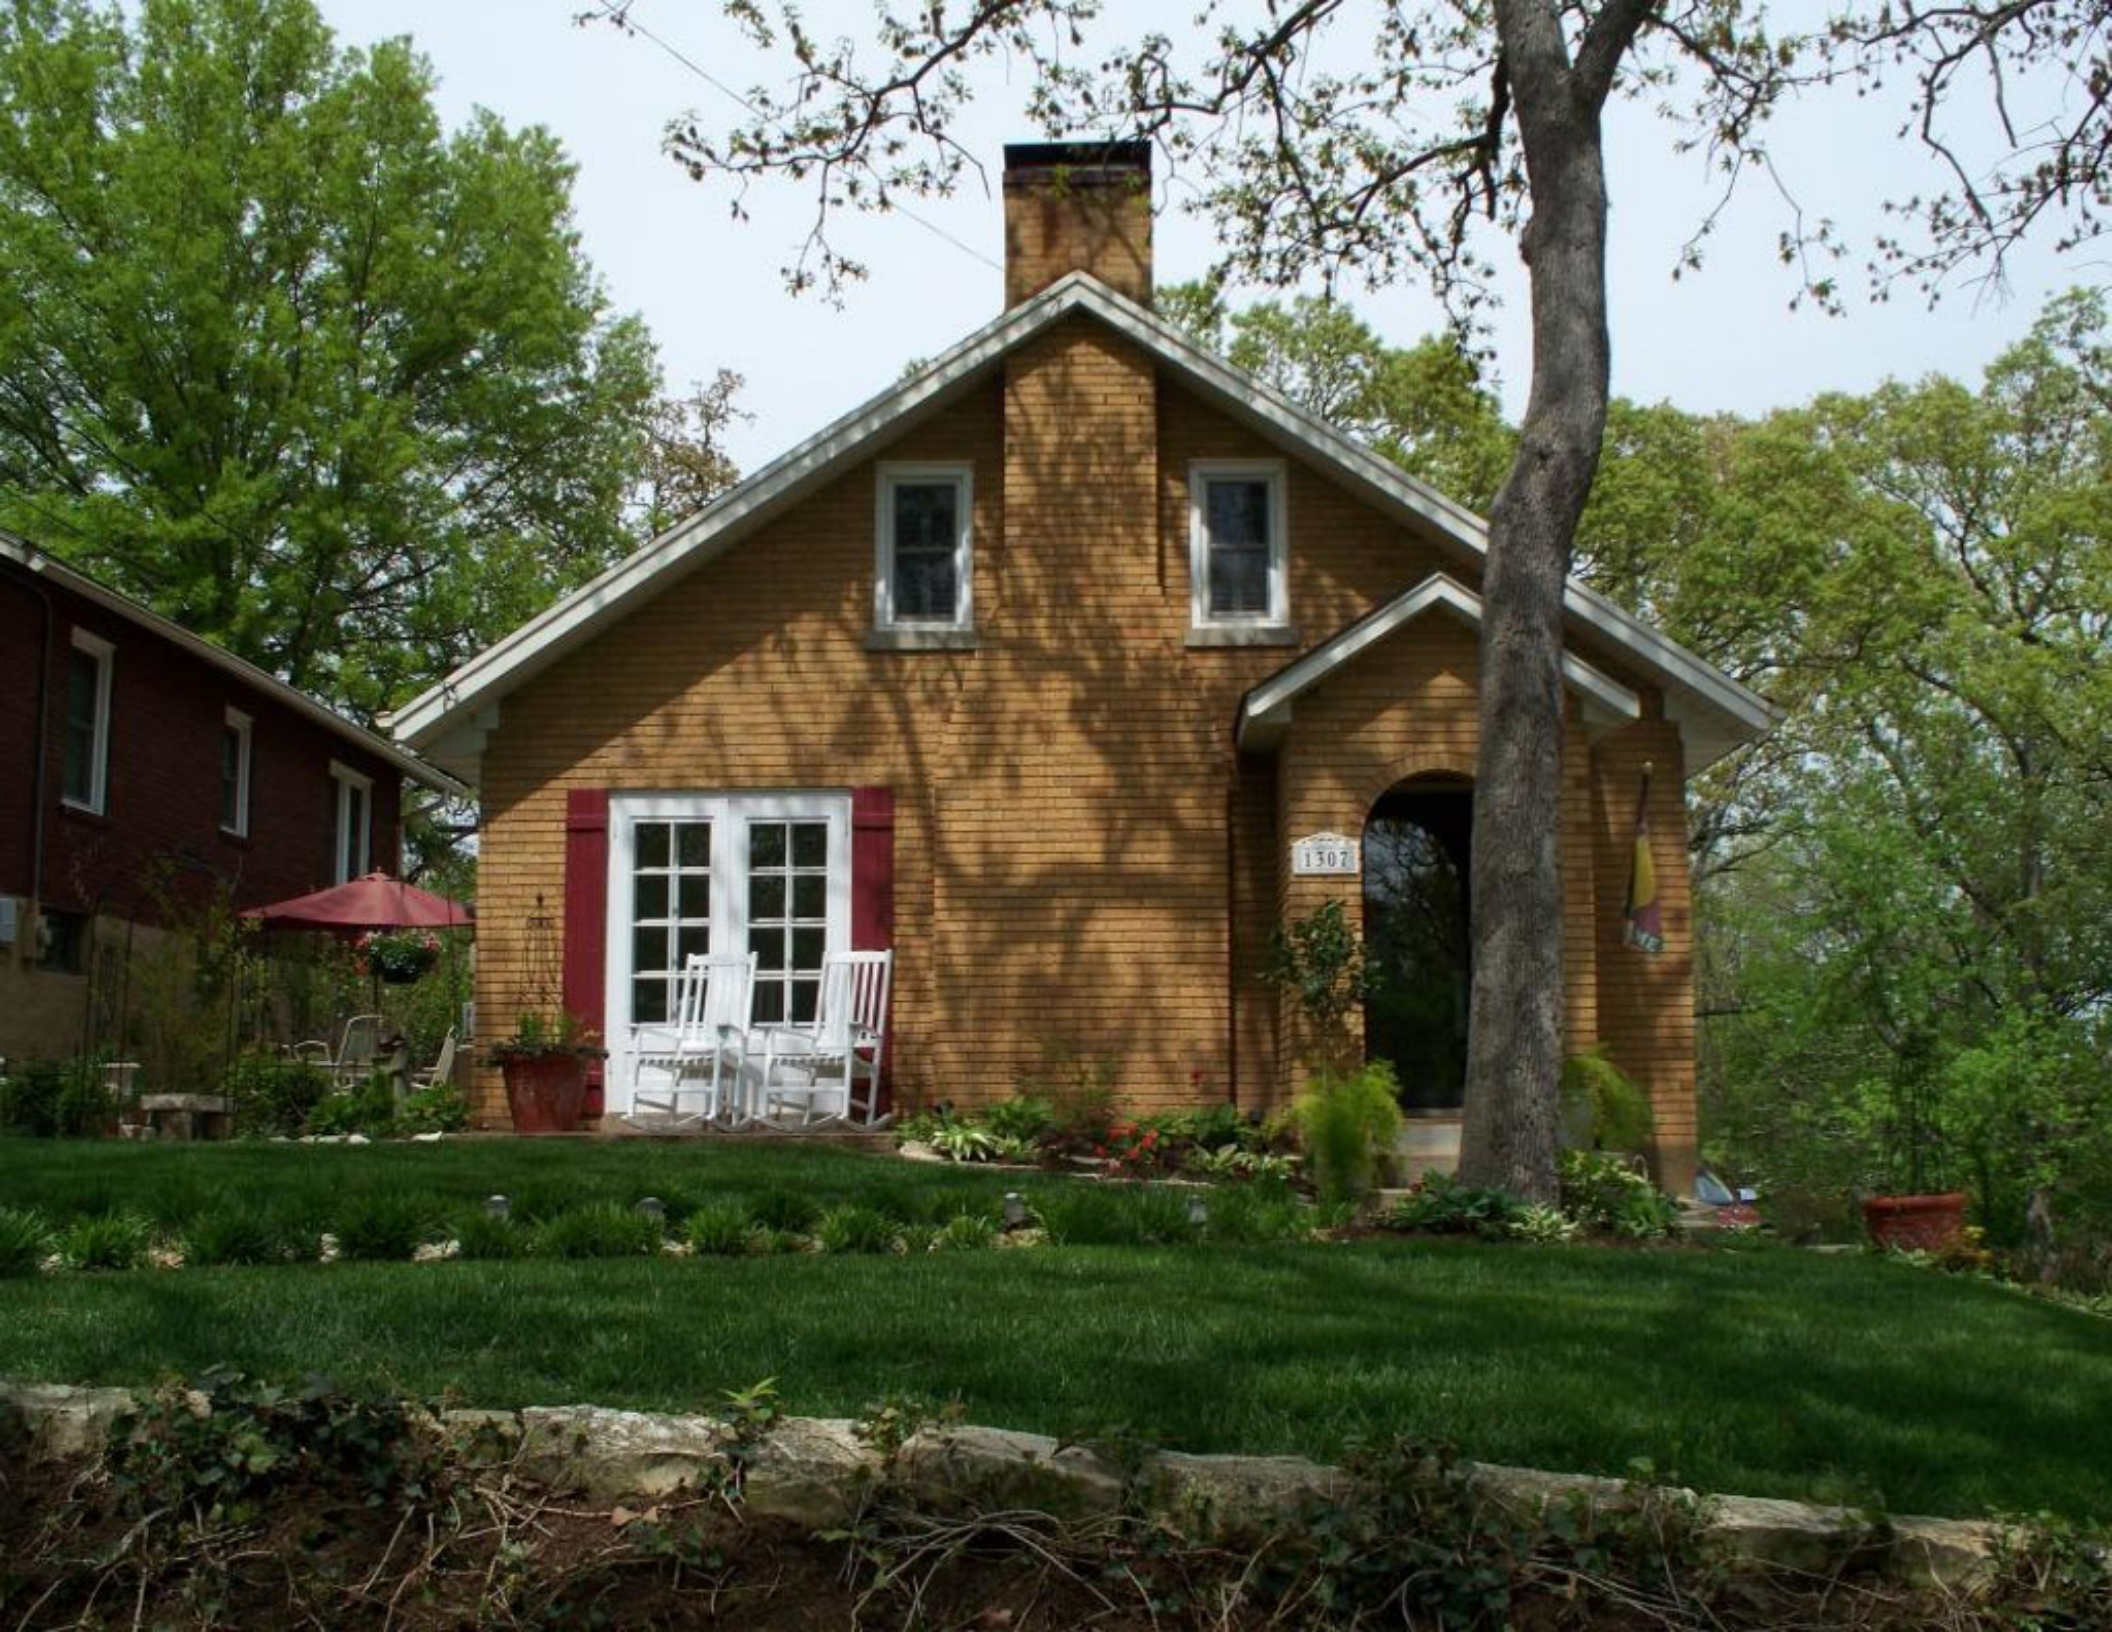
41. (cont.)
This 1 ½ story brick property has a front gable roof and a chimney that extends from the center front façade of the building. It is flanked by 1/1 windows on the upper story (may or may not be historic). The left bay on the lower floor contains multi-light French doors with wooden shutters. The right bay has a projecting brick enclosed portico with a gable roof and an arched entrance. A small set of concrete stairs acts as a stoop. Due to the chimney placement and gabled entrance this property is considered to have Tudor stylistic features.

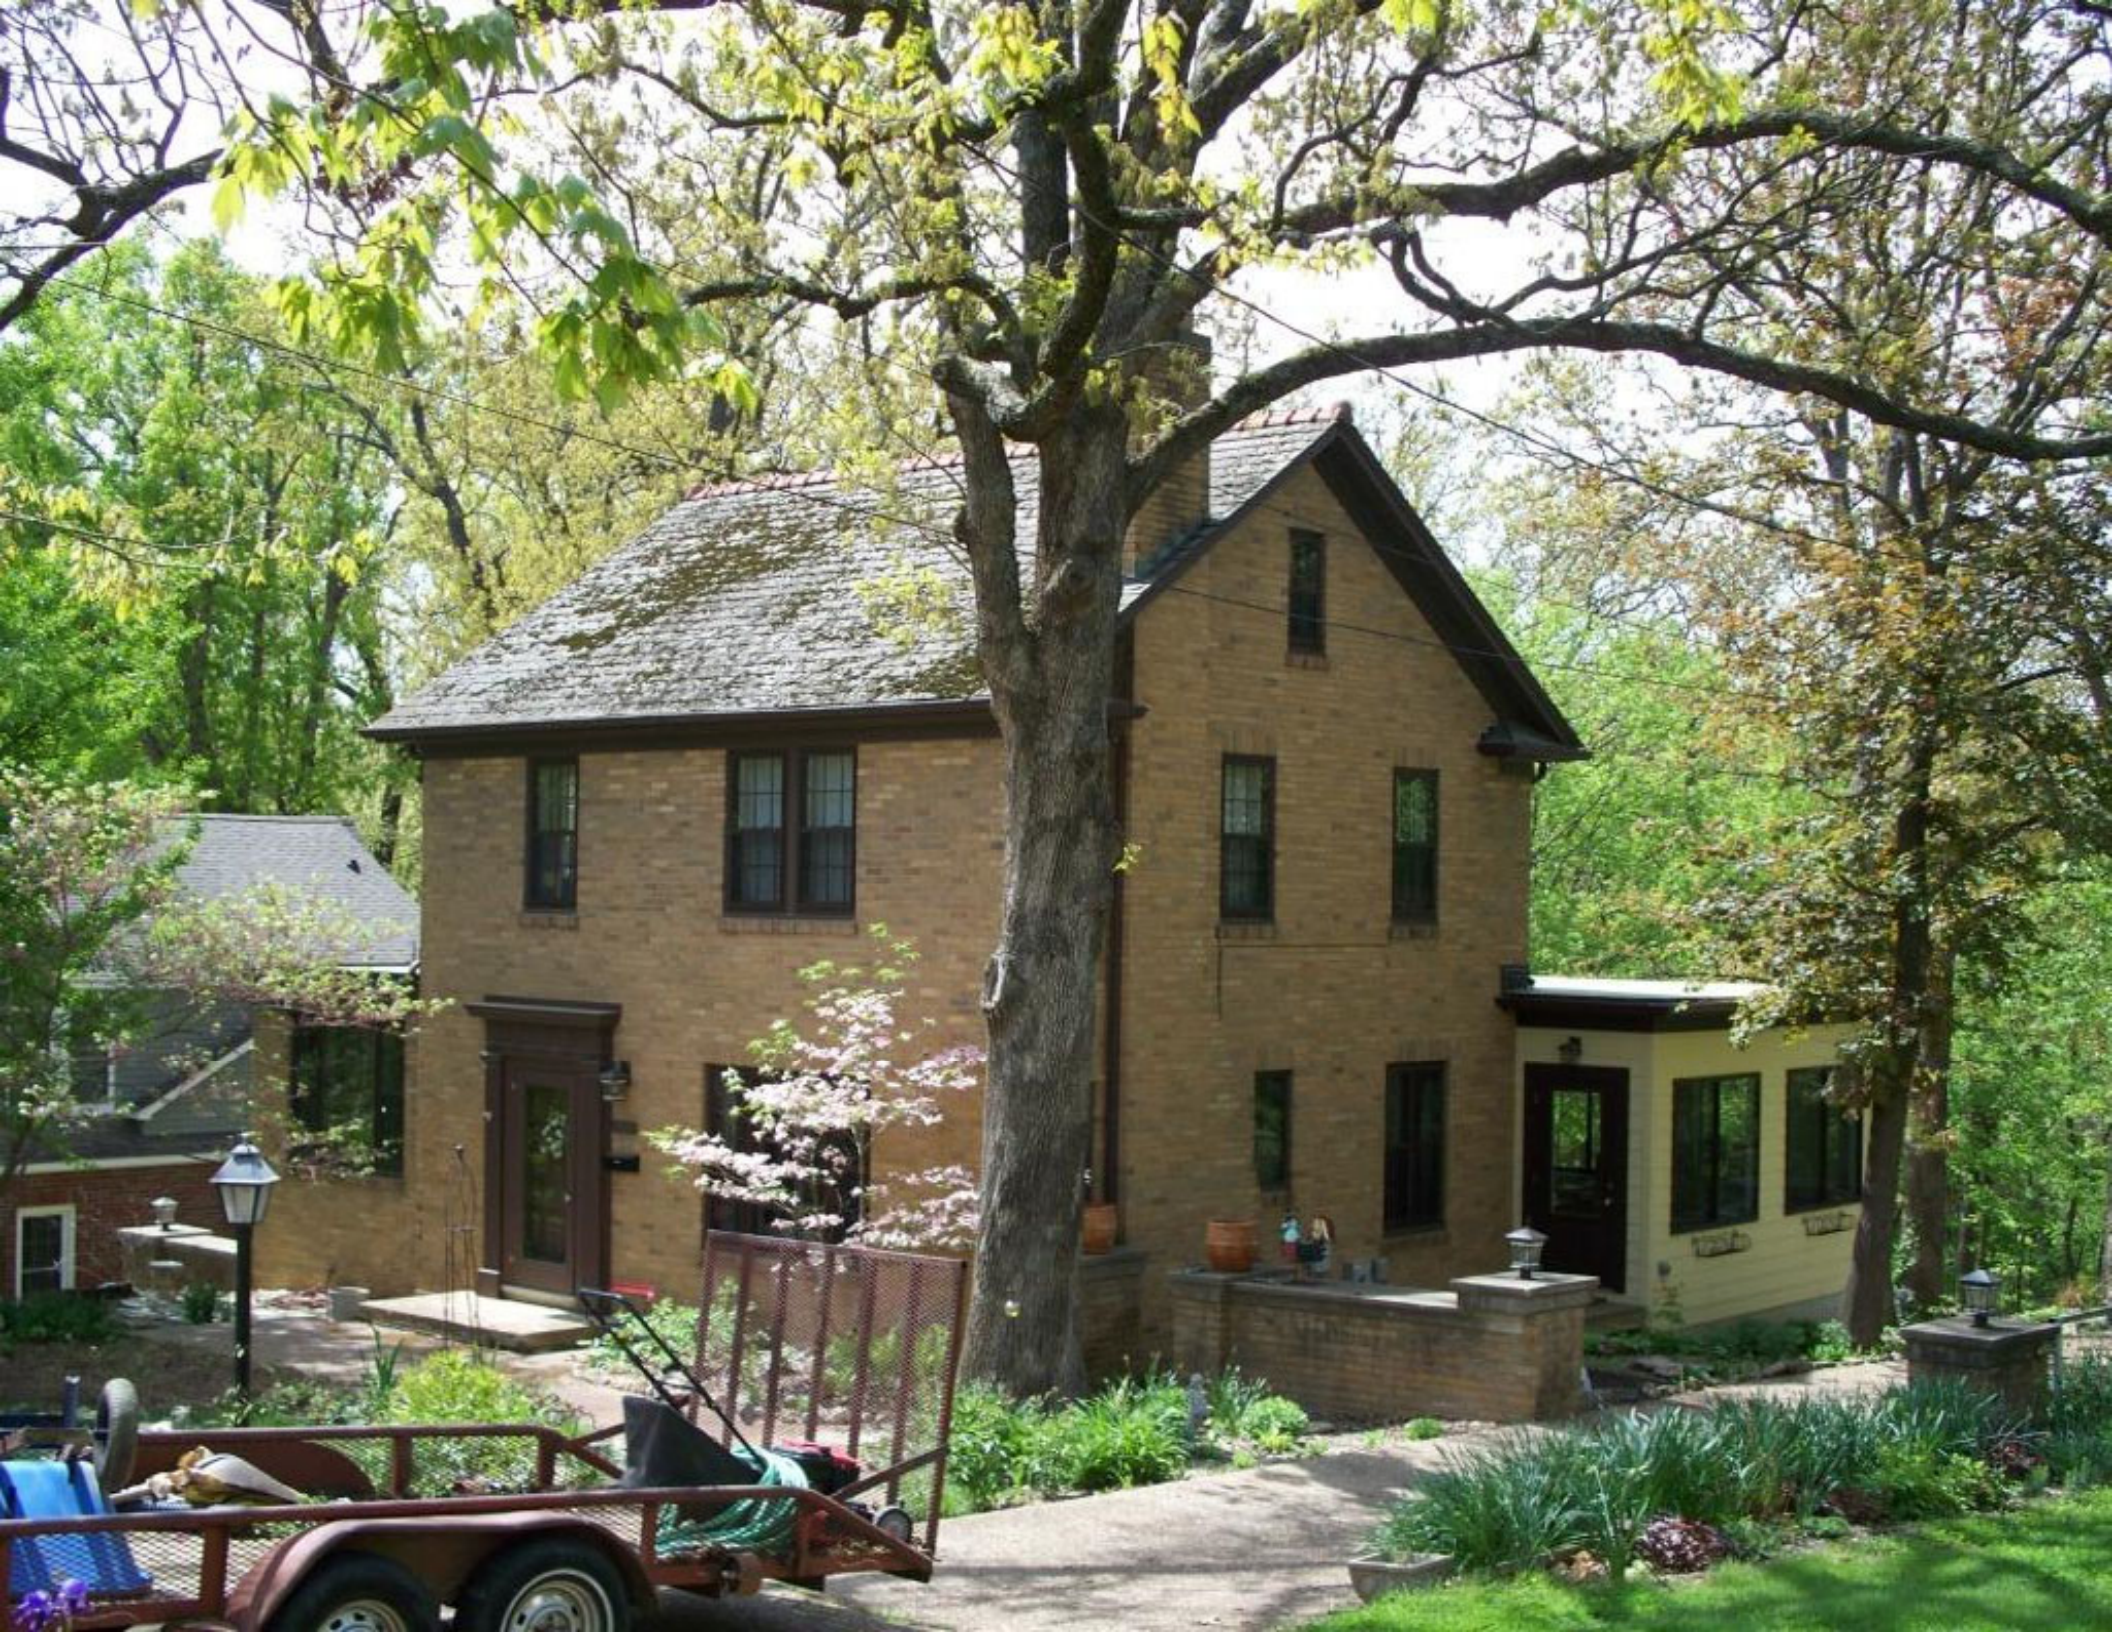
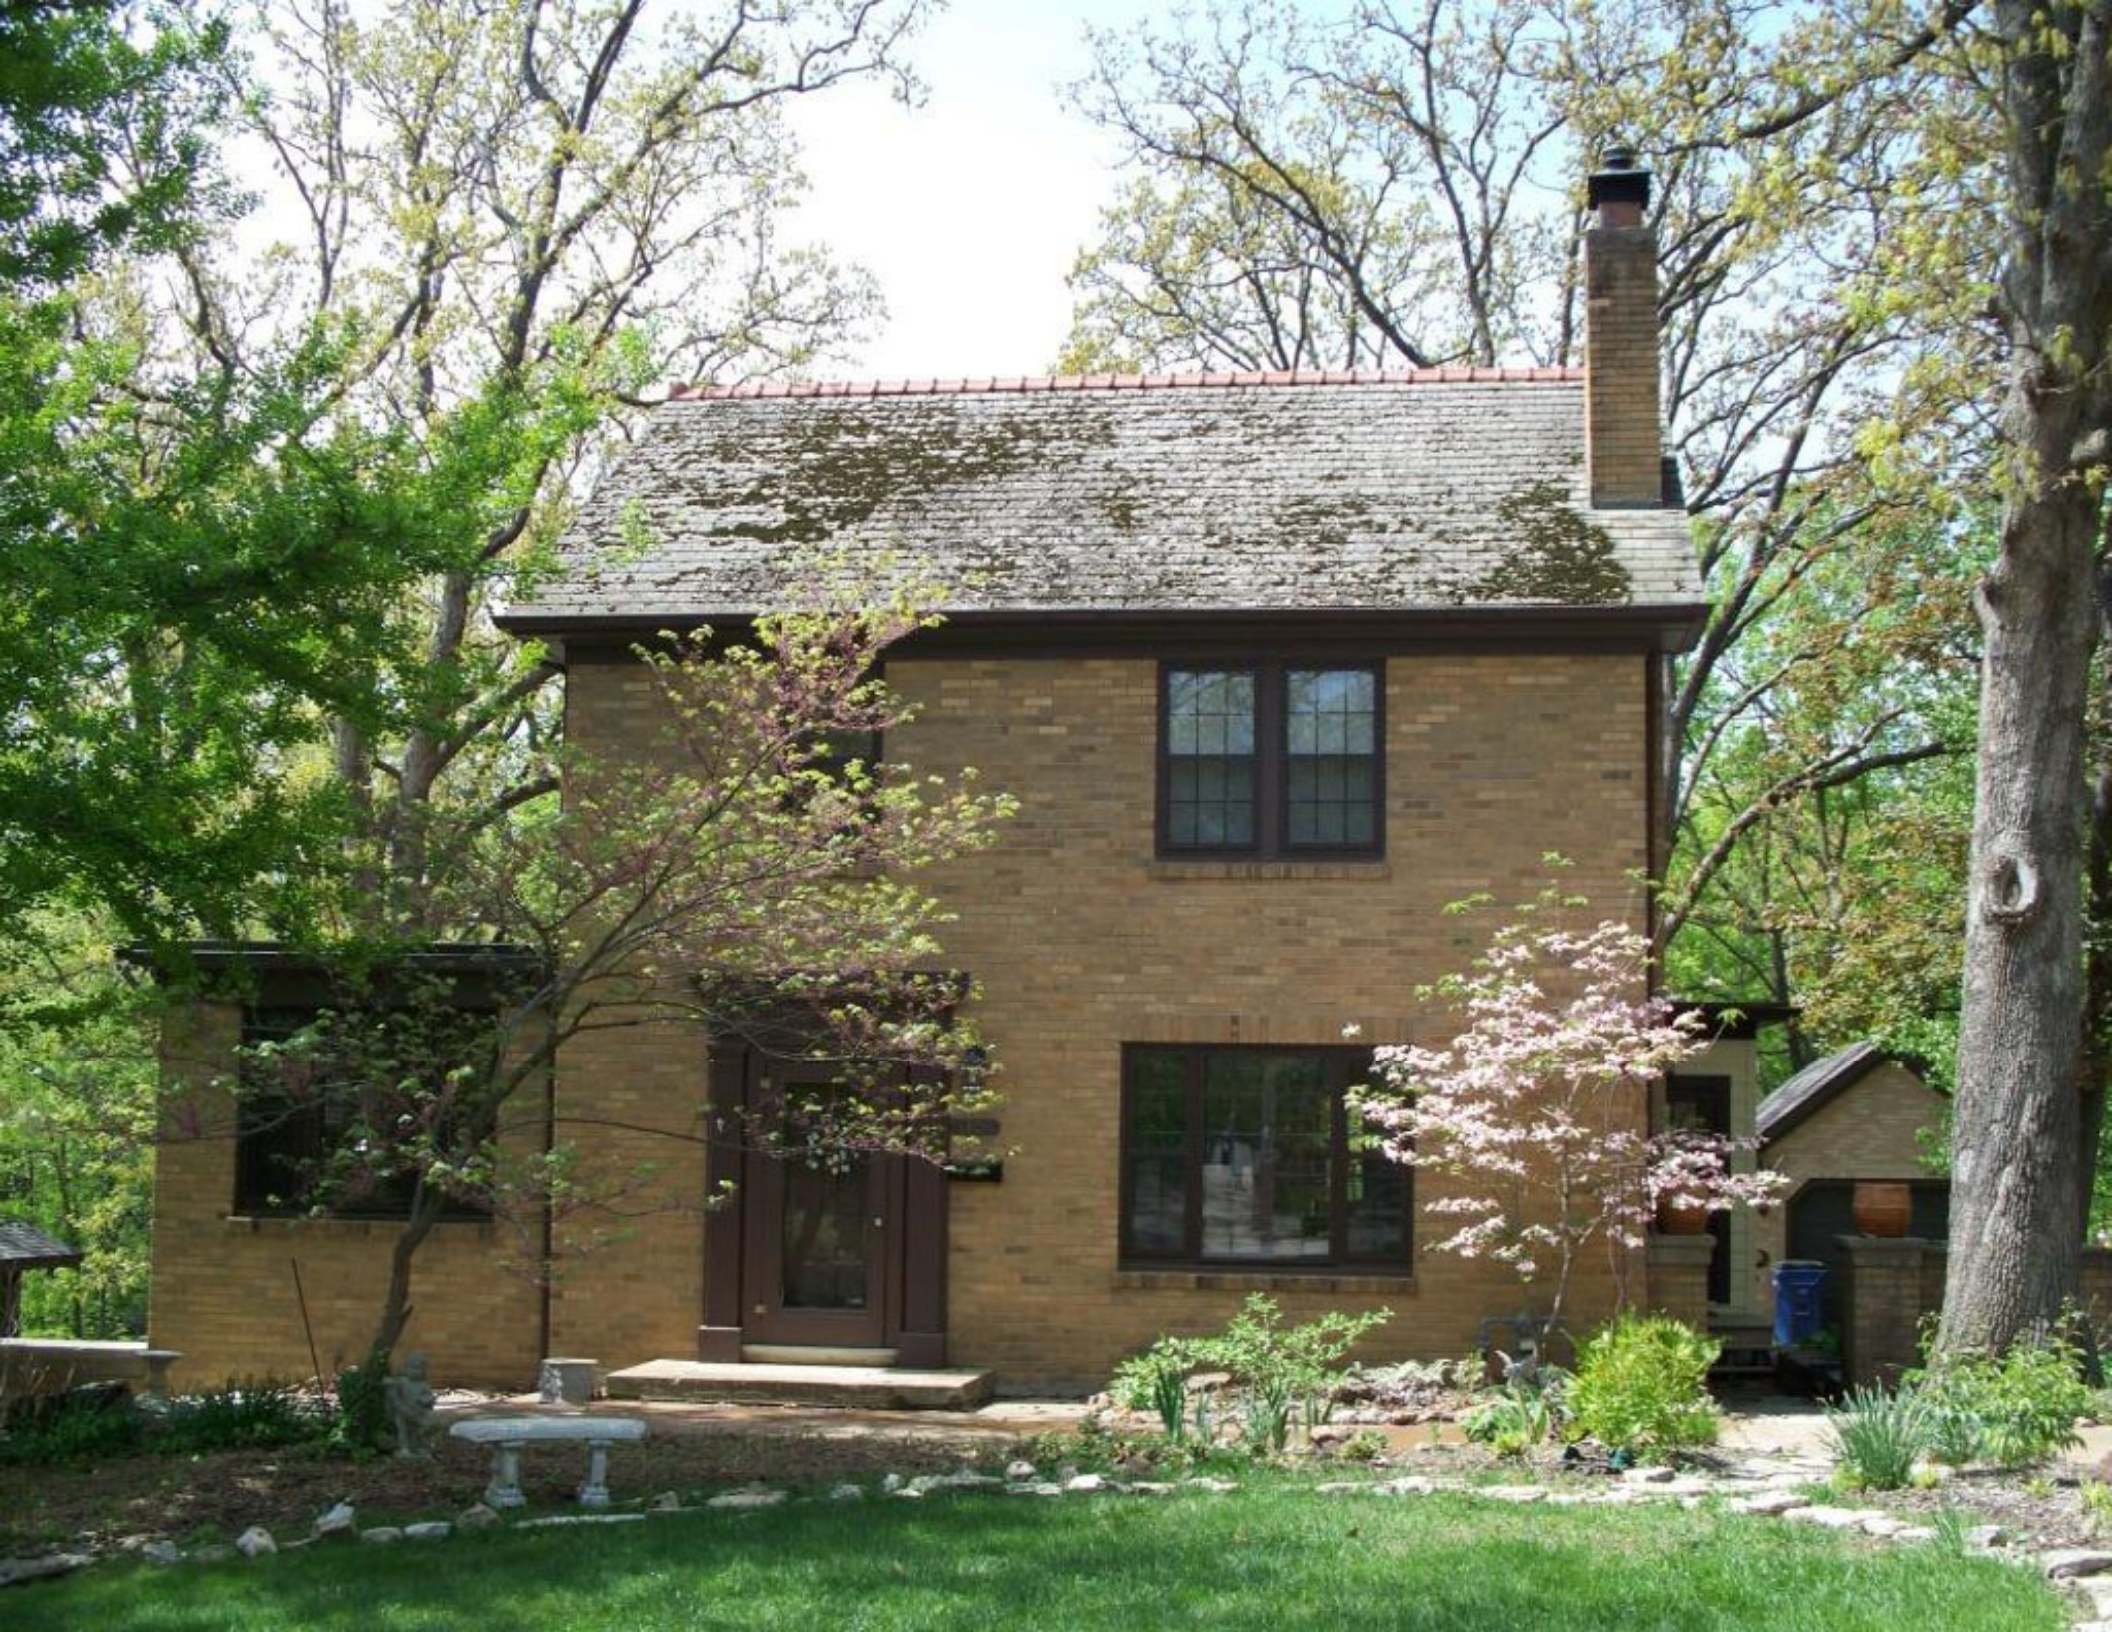
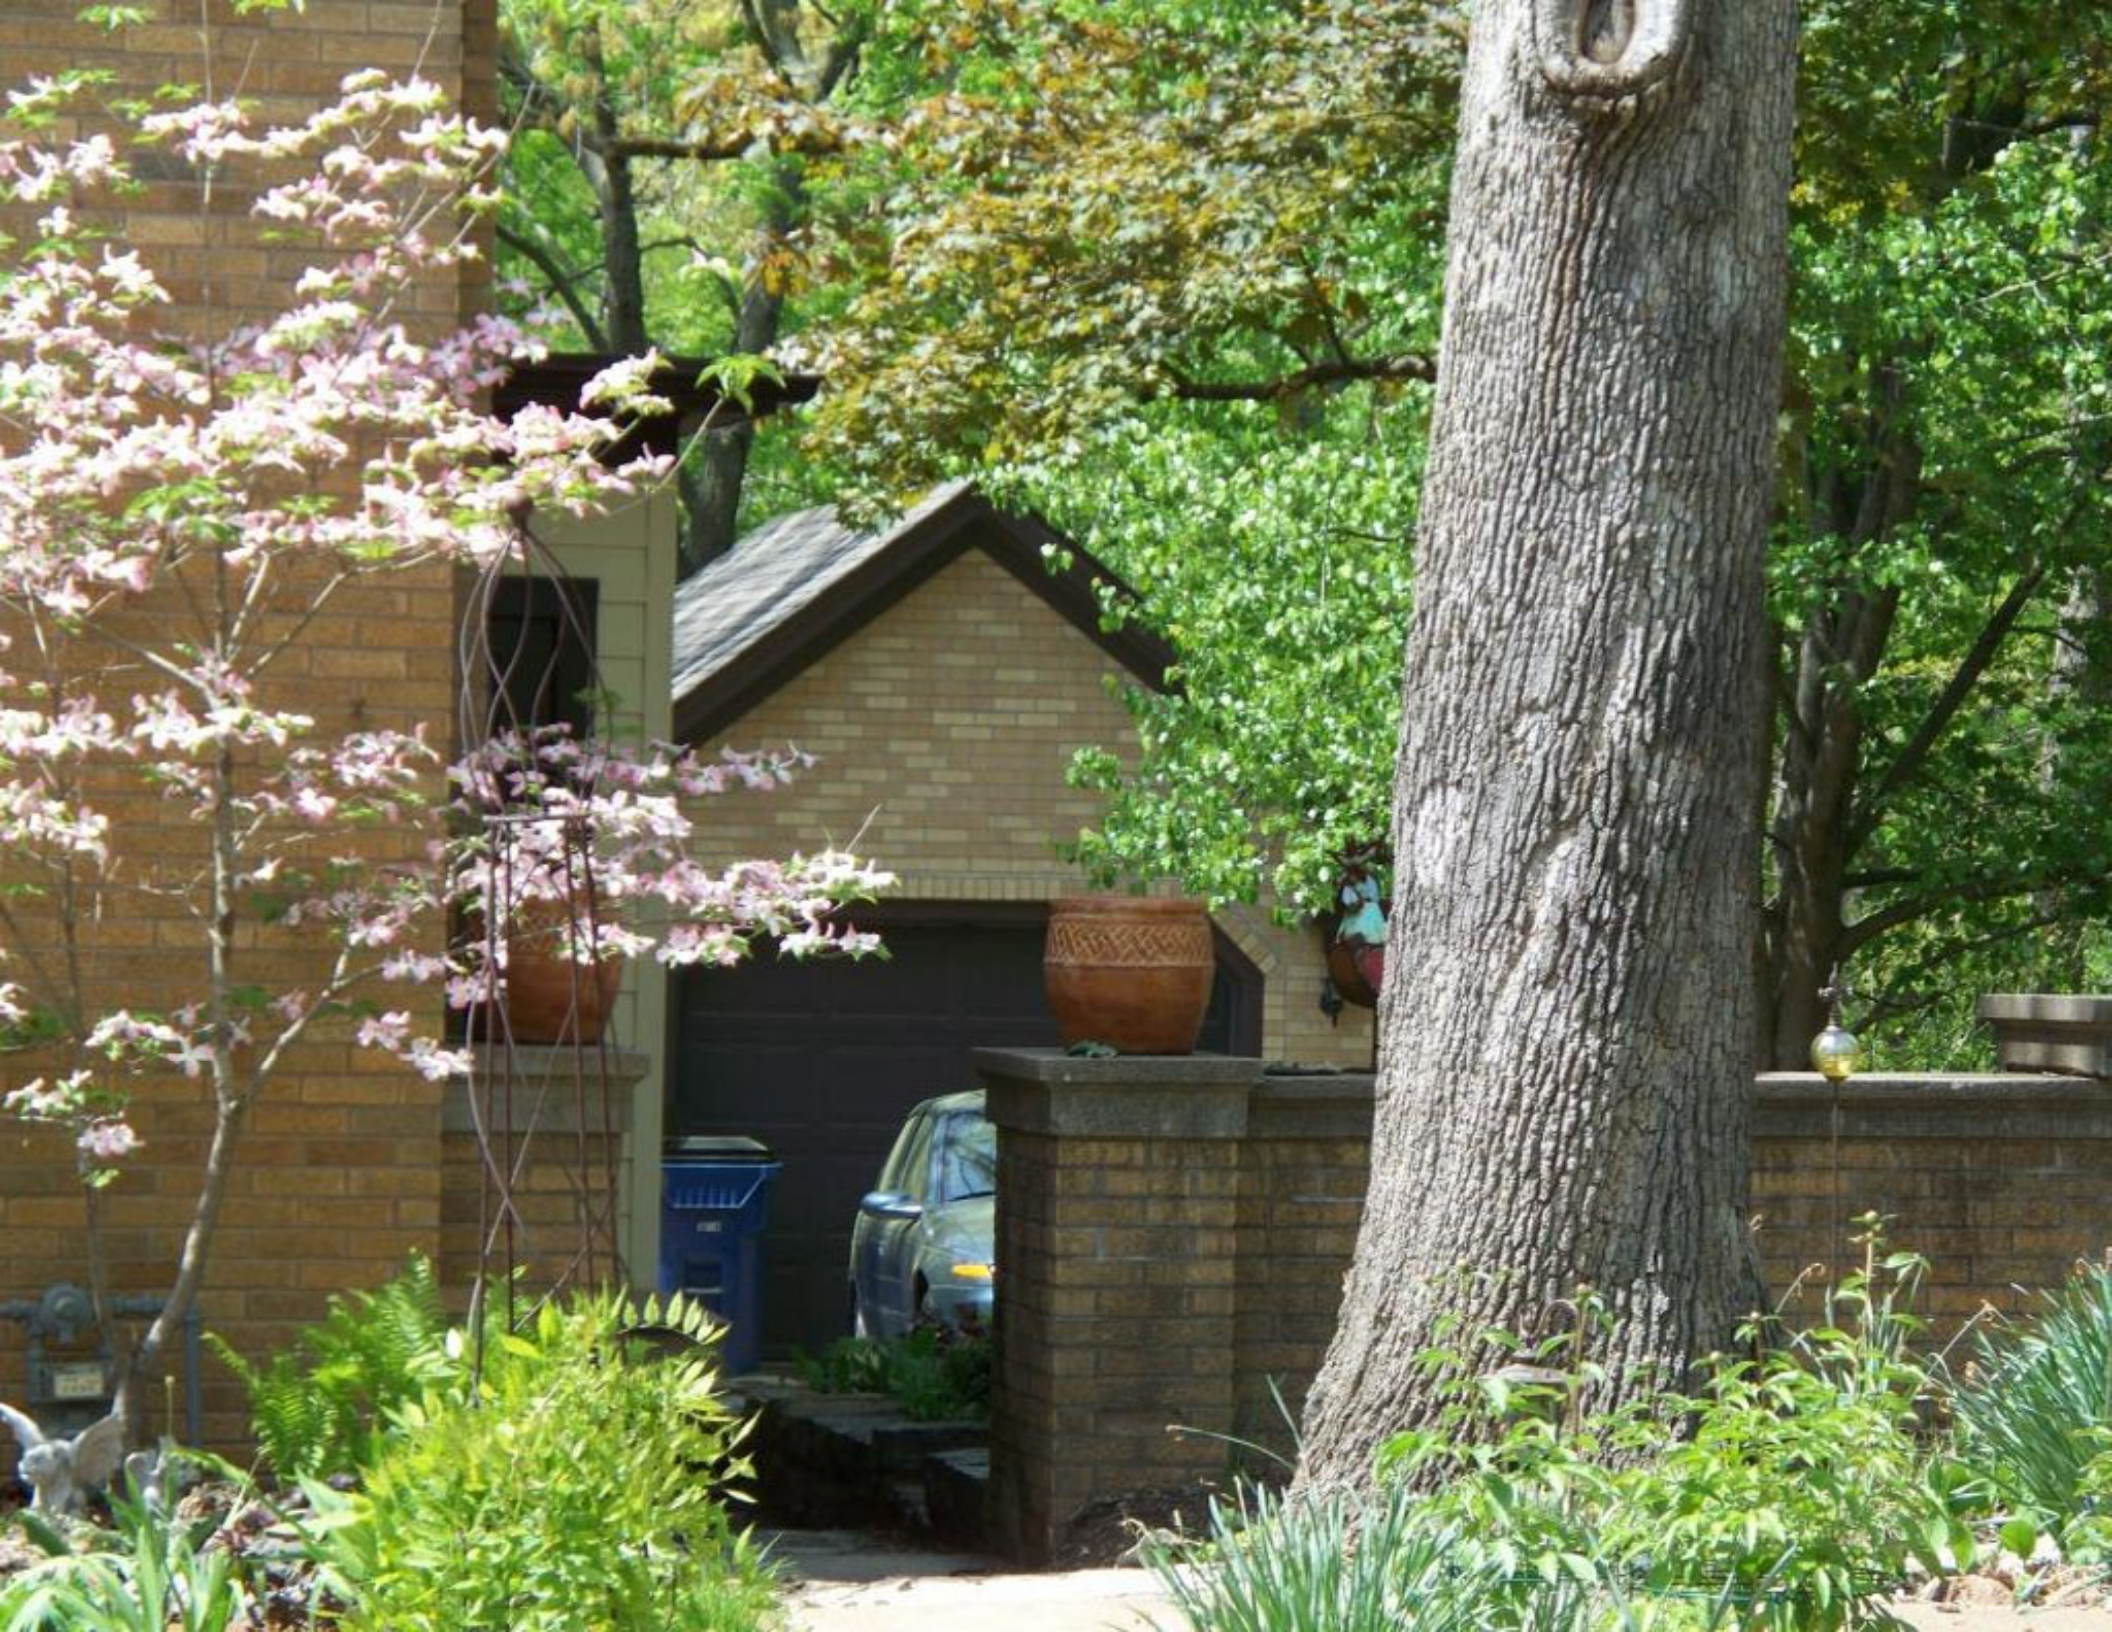
40. (cont.) Description of environment and outbuildings. Expand box as necessary, or add continuation pages.
There is a one car brick garage set back on the right side of the property. It has a gable roof and paneled door. Although it does not appear on the 1939 Sanborn map it appears historic and would contribute to a possible historic district.

41. (cont.)
This two story brick four square has a side gable asphalt shingle roof with clay tile on the ridge. The second story has a single 6/6 window in the left bay and paired 6/6 windows on the right. The entrance is underneath the single window and has a door surround with entablature; a concrete pad serves as a stoop. The right bay has a row of four multi-light windows. The windows appear historic but they could be good reproductions. All of the windows have rowlock brick sills while the window on the first floor also has a soldier course brick lintel. To the left and slightly set back is a one story sun room with a flat roof. It has similar windows as those on the first floor.
