ARCHITECTURAL/HISTORIC INVENTORY FORM

1. Survey No. CO-AS-005-001		2. Survey name: Moreau Drive Neighborhood Survey	
3. County: Cole		4. Address: 1202 Elmerine Ave.	
5. City: Jefferson City	Vicinity: <input type="checkbox"/>	6. UTM: / /	7. Township/Range/Section: T: R: S:
8. Historic name (if known):		9. Present/other name (if known):	
10. Ownership: <input checked="" type="checkbox"/> Private <input type="checkbox"/> Public		11. Historic use (if known): Residential	11. Current use: Residential

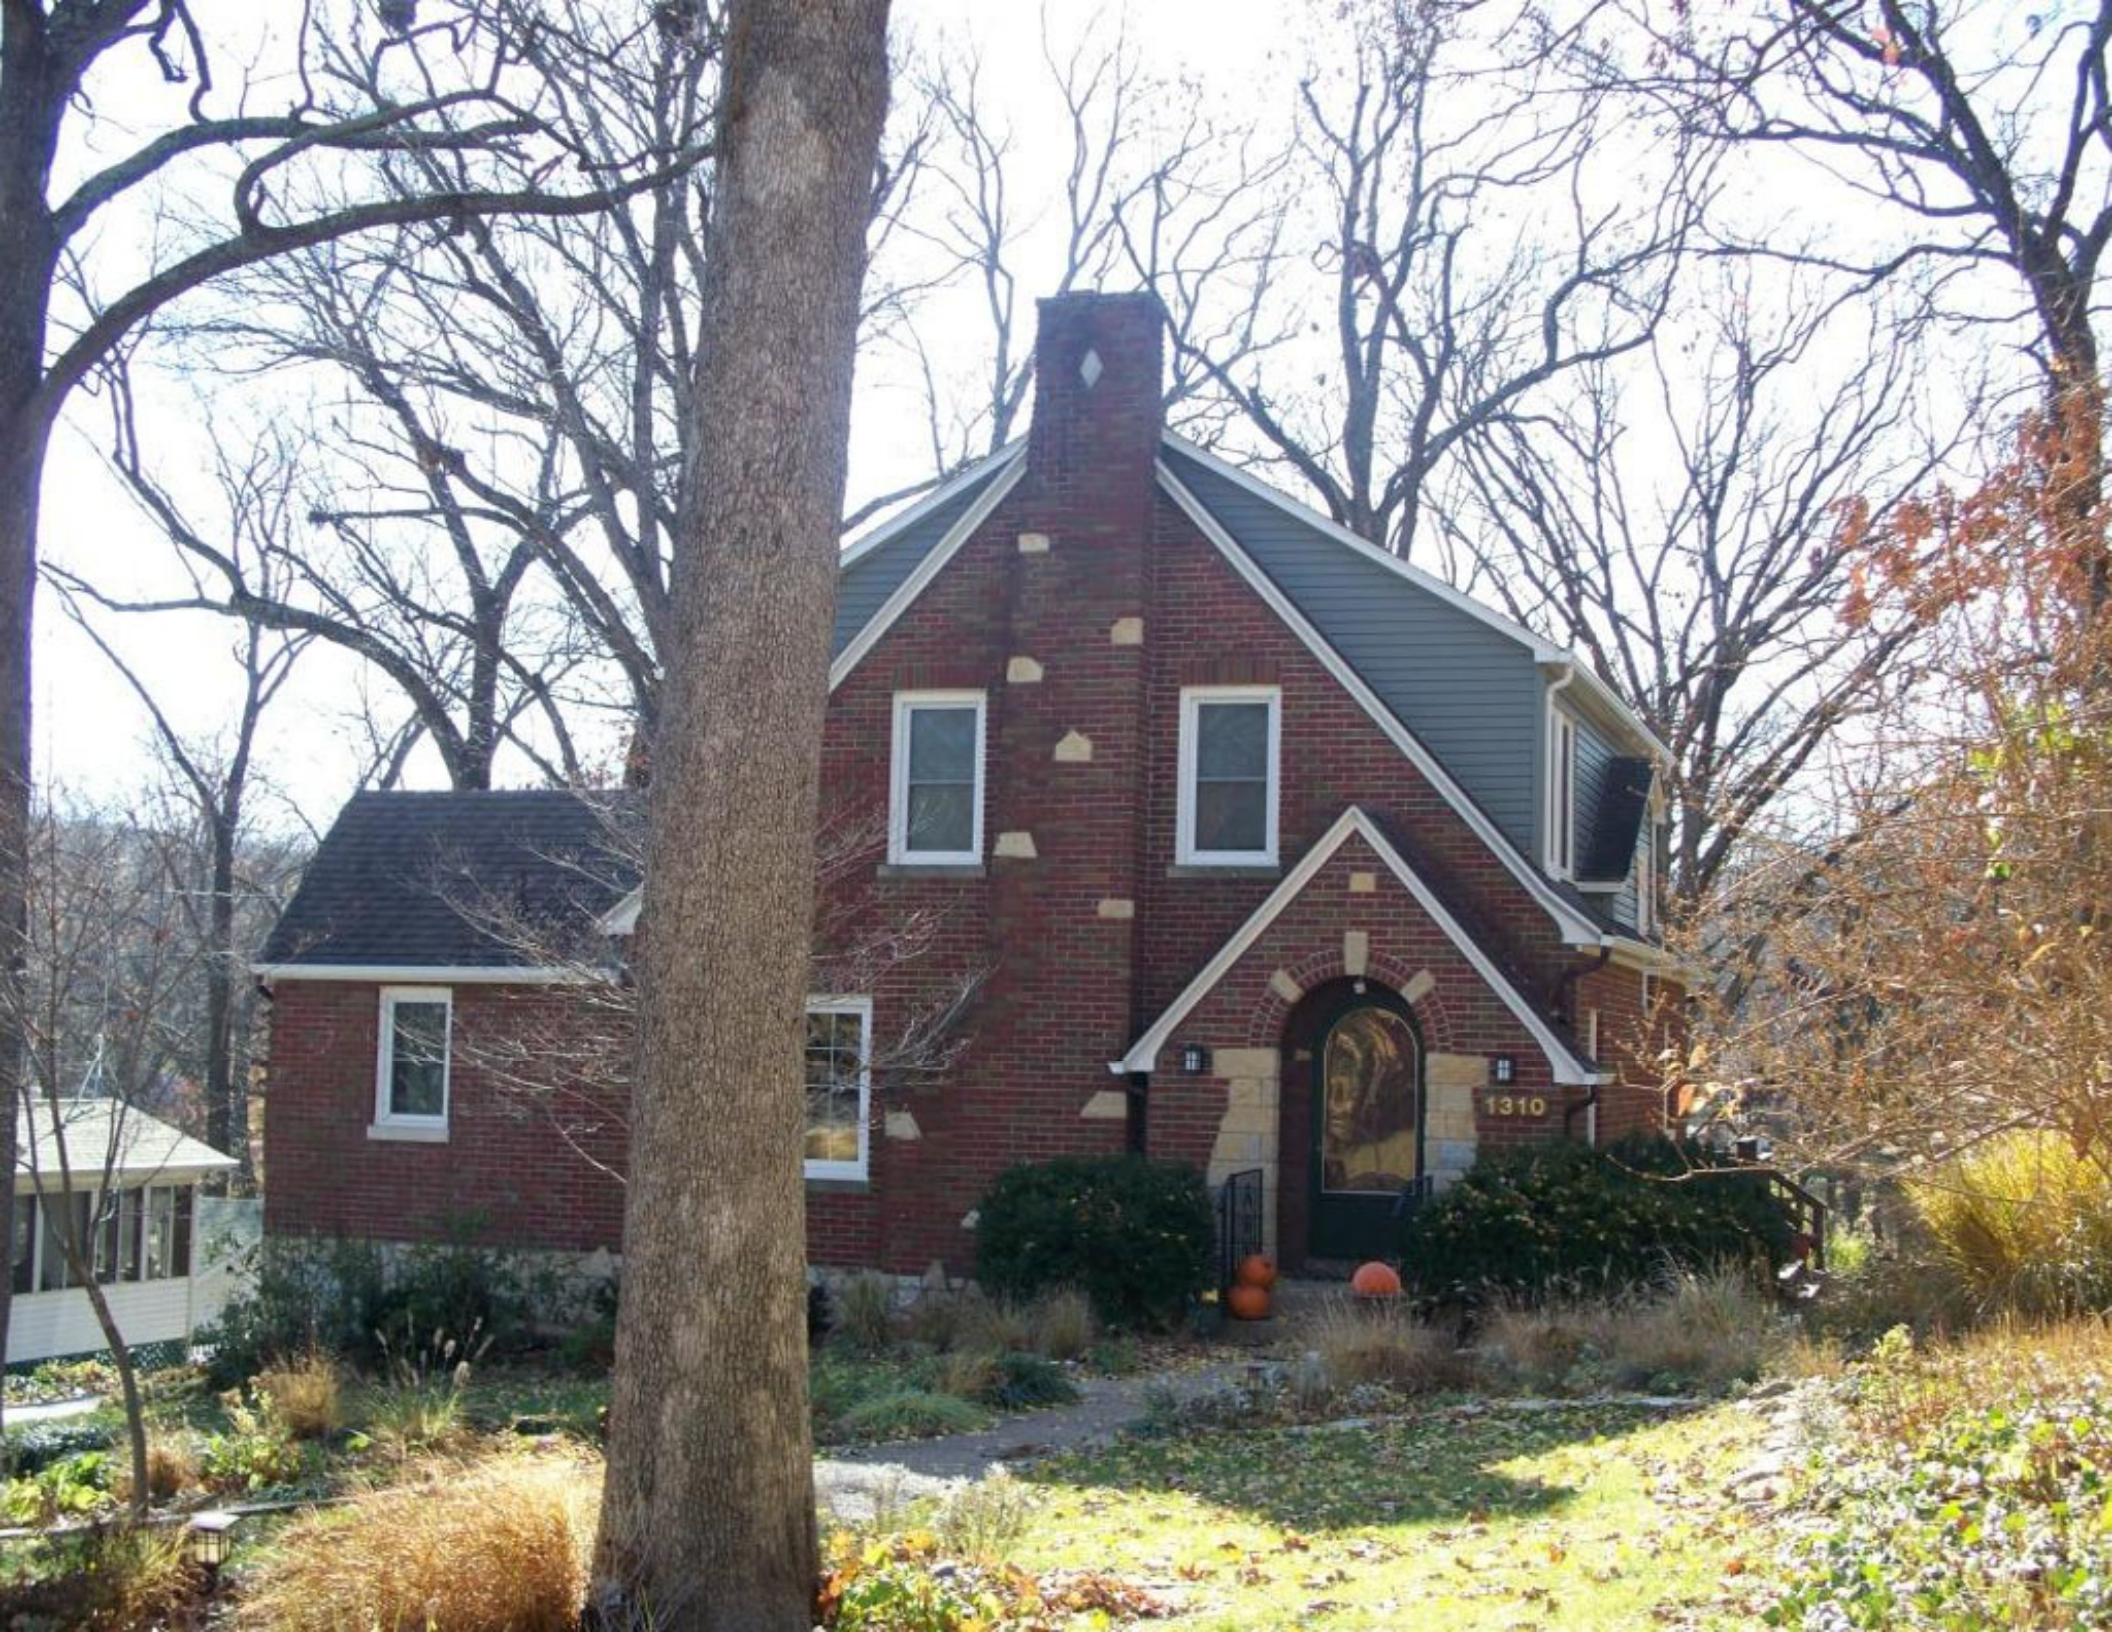
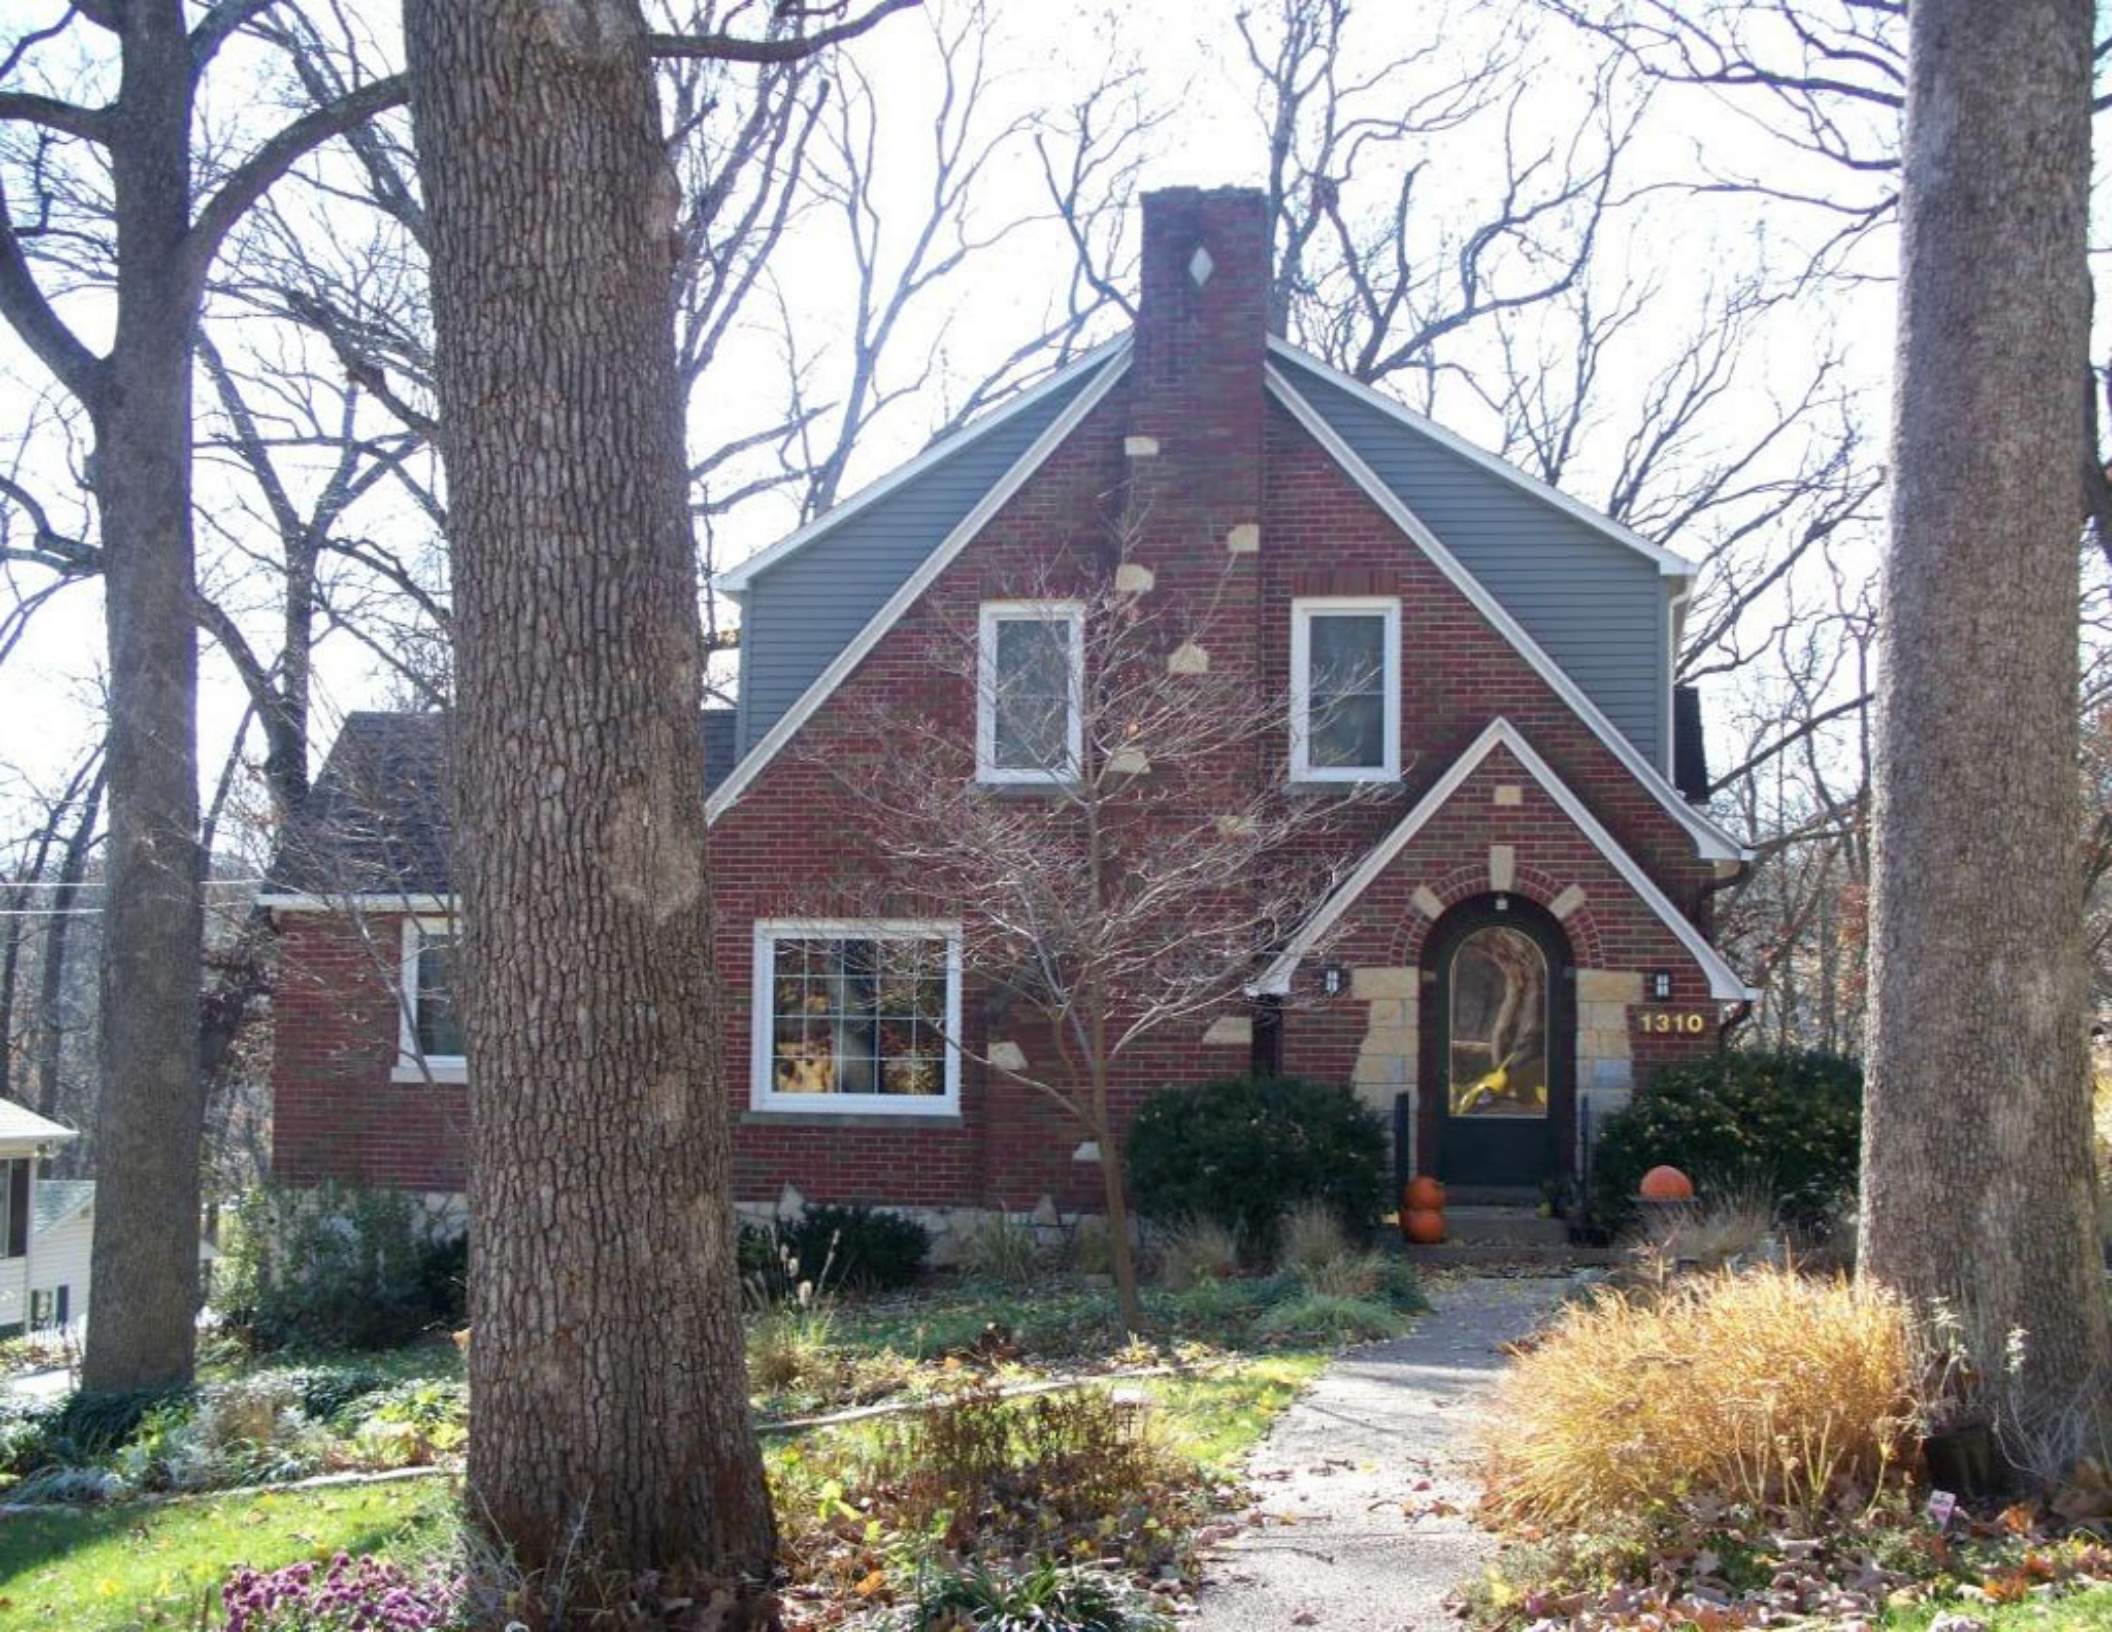
This 1 ½ story brick Tudor has two continuous dormers that extend from both sides of the steeply-pitched front gable roof and are clad in vinyl. A wide brick chimney with stone detailing projects from the façade of the property over the peak of the gable. It is flanked on the upper story by replacement 6/6 windows. From the right, the entrance is located in the first bay that projects slightly and has a gable roof. The entryway is arched and features stone detailing and keystones. The door is also arched and is reached via a concrete stoop with metal rails. On the other side of the chimney is a modern multi-light picture window. The last bay is one story with a side gable roof and has a single smaller 6/1 window. All of the windows have concrete or limestone sills and soldier course lintels.

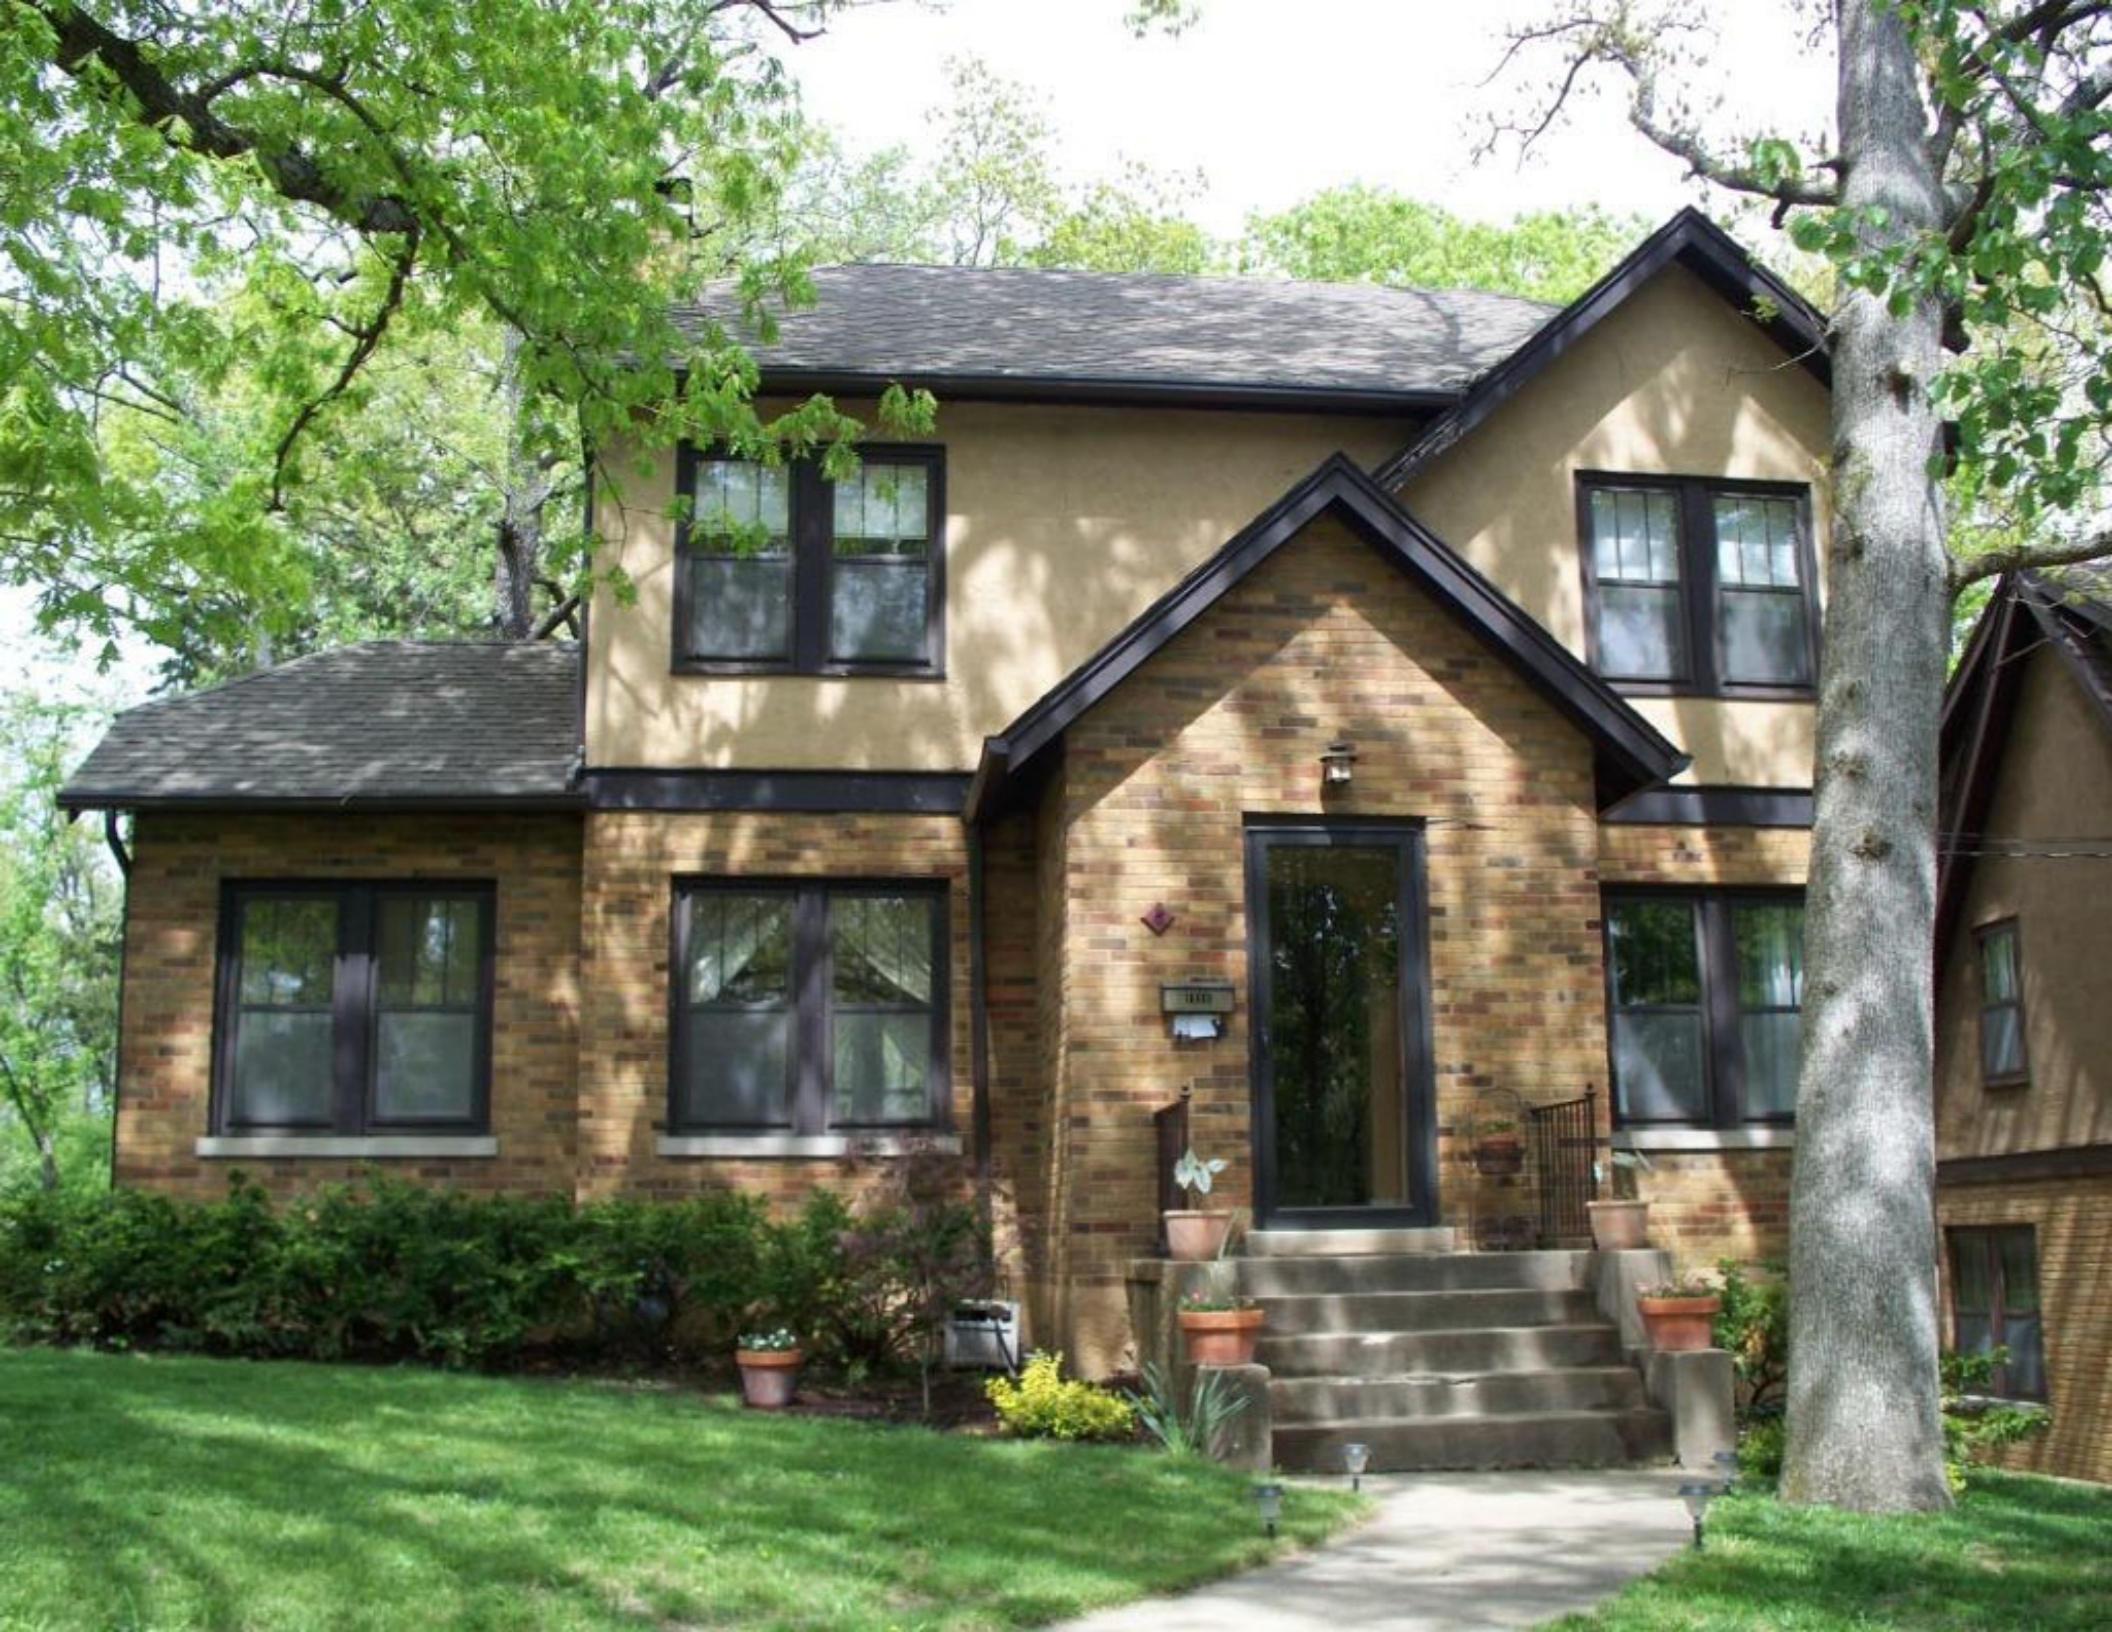
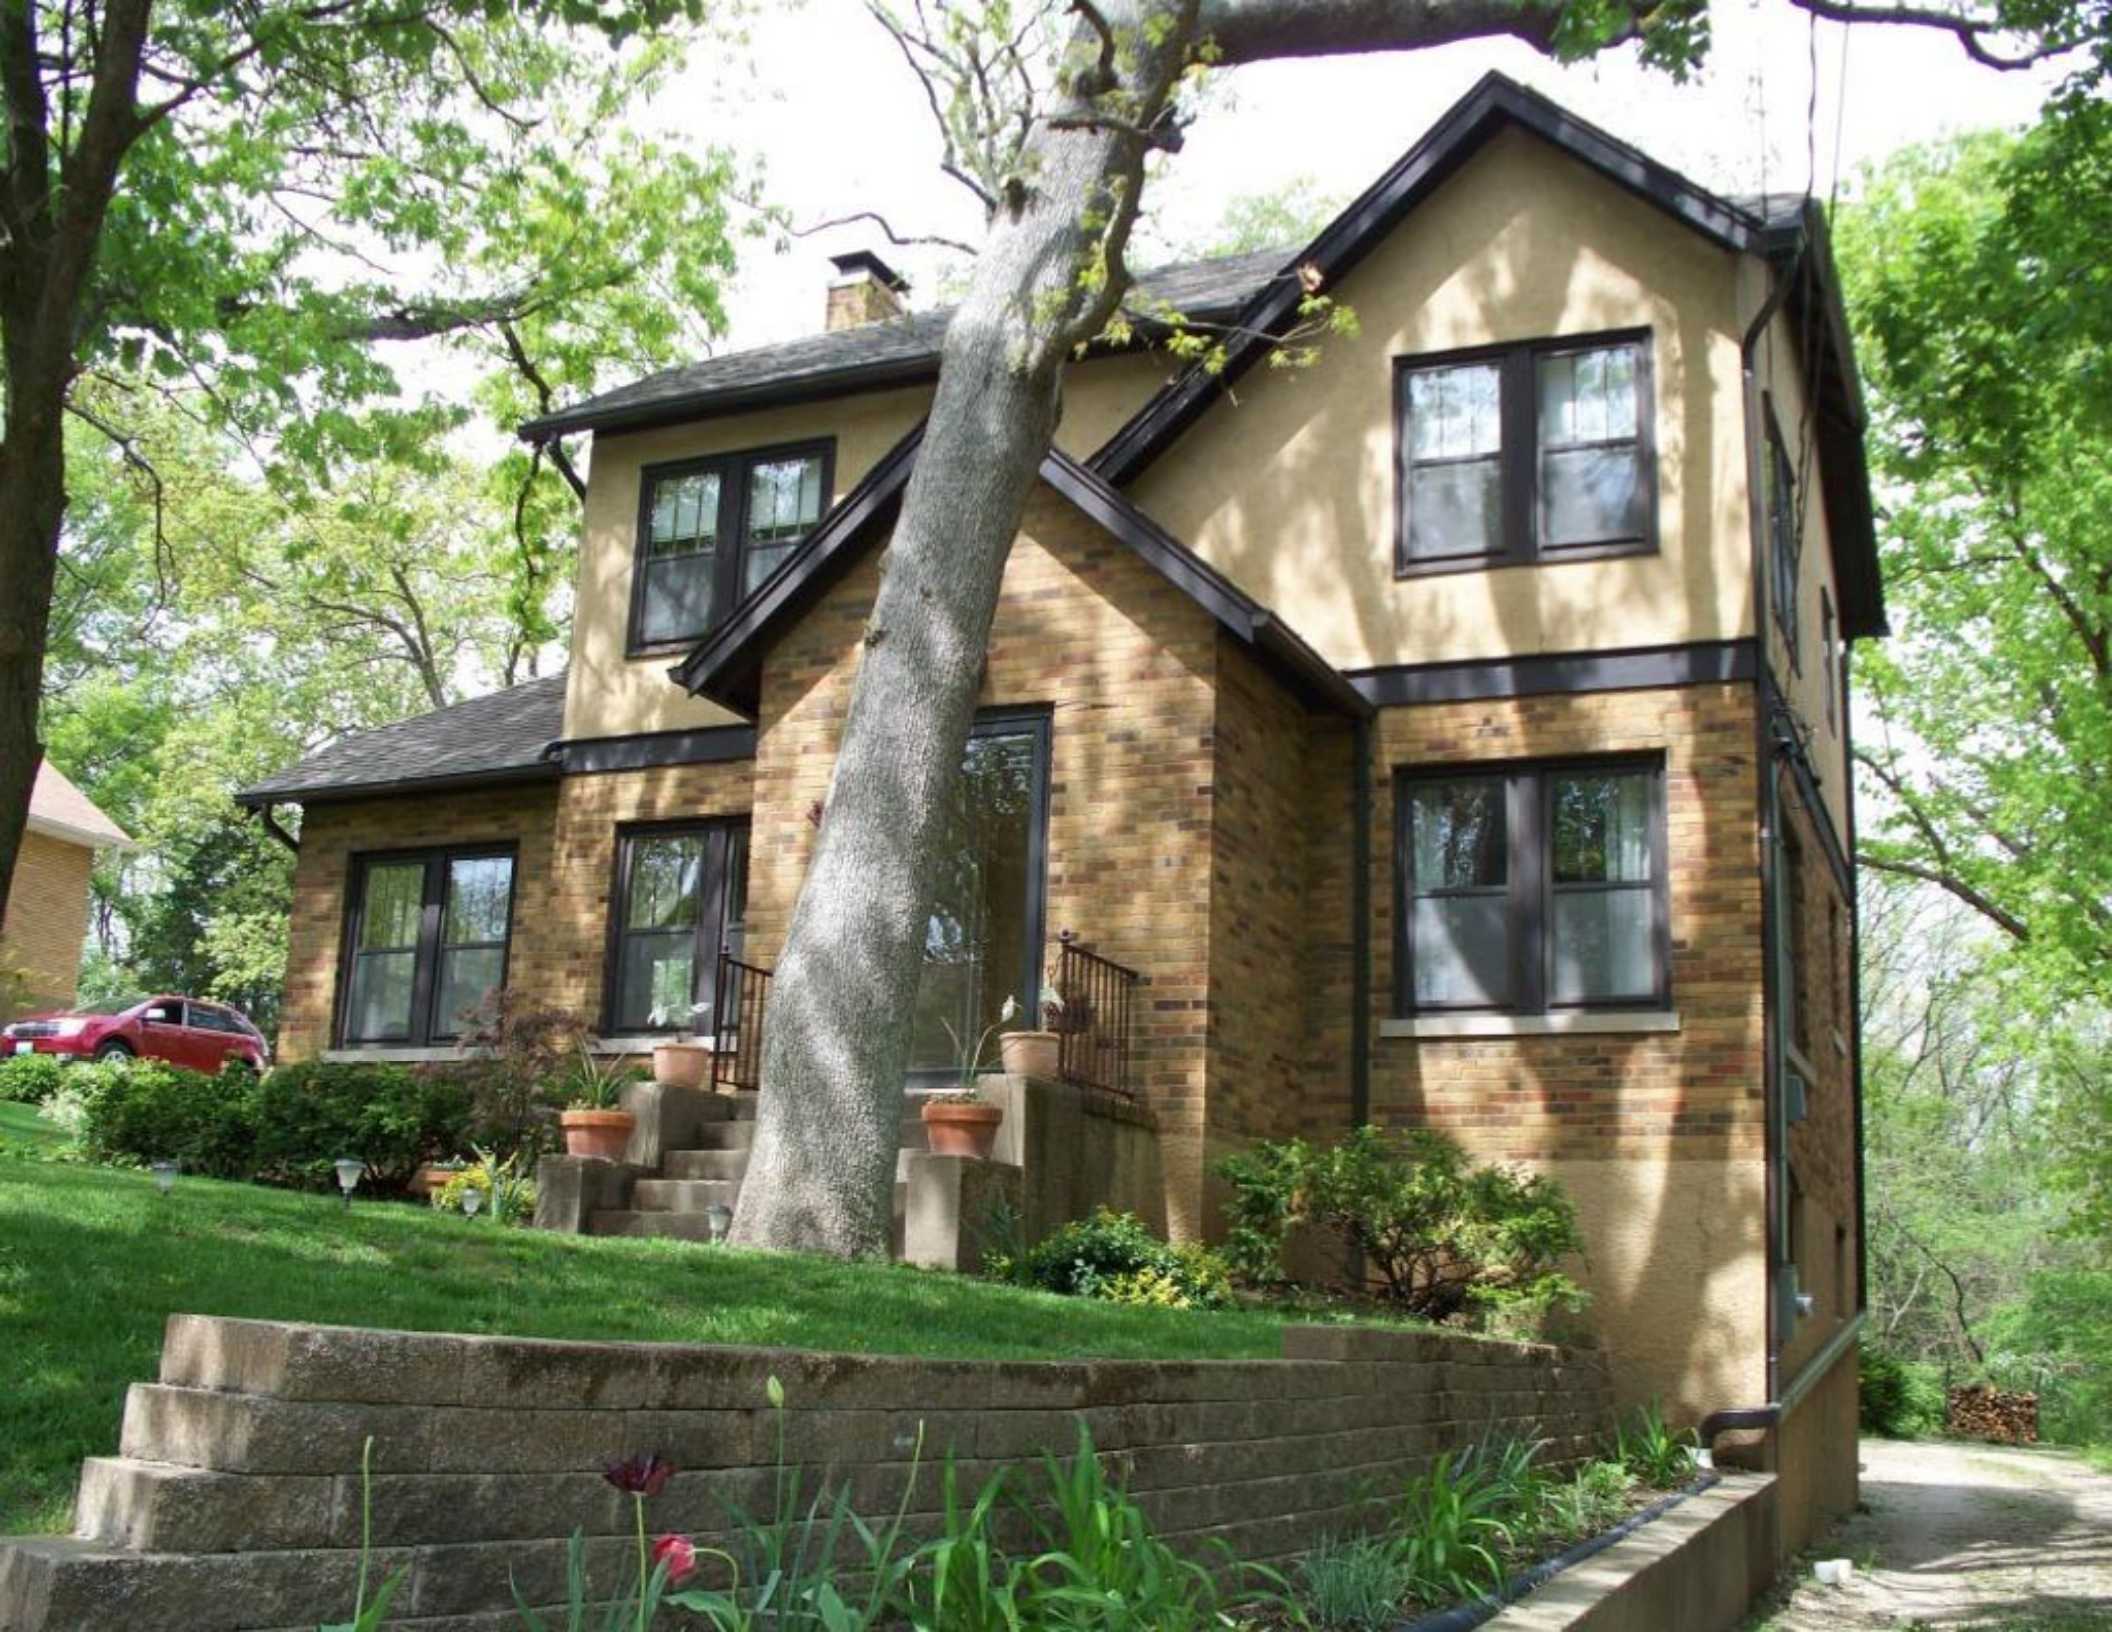
This two story brick home has a side gable roof. The upper story is stucco and has two historic paired 3/1 windows. The window in the right bay has a gable over it that slopes lower on the left side than the right (Tudor influence). The first floor also has historic paired 3/1 windows that flank the centered entrance, which projects from the main facades and has a gable roof. The entrance is reached by a set of concrete stairs and stoop with metal railing. On the left side of the property is a one story brick “sunroom” with a hipped roof and historic paired 3/1 windows that is set slightly back from the main façade.

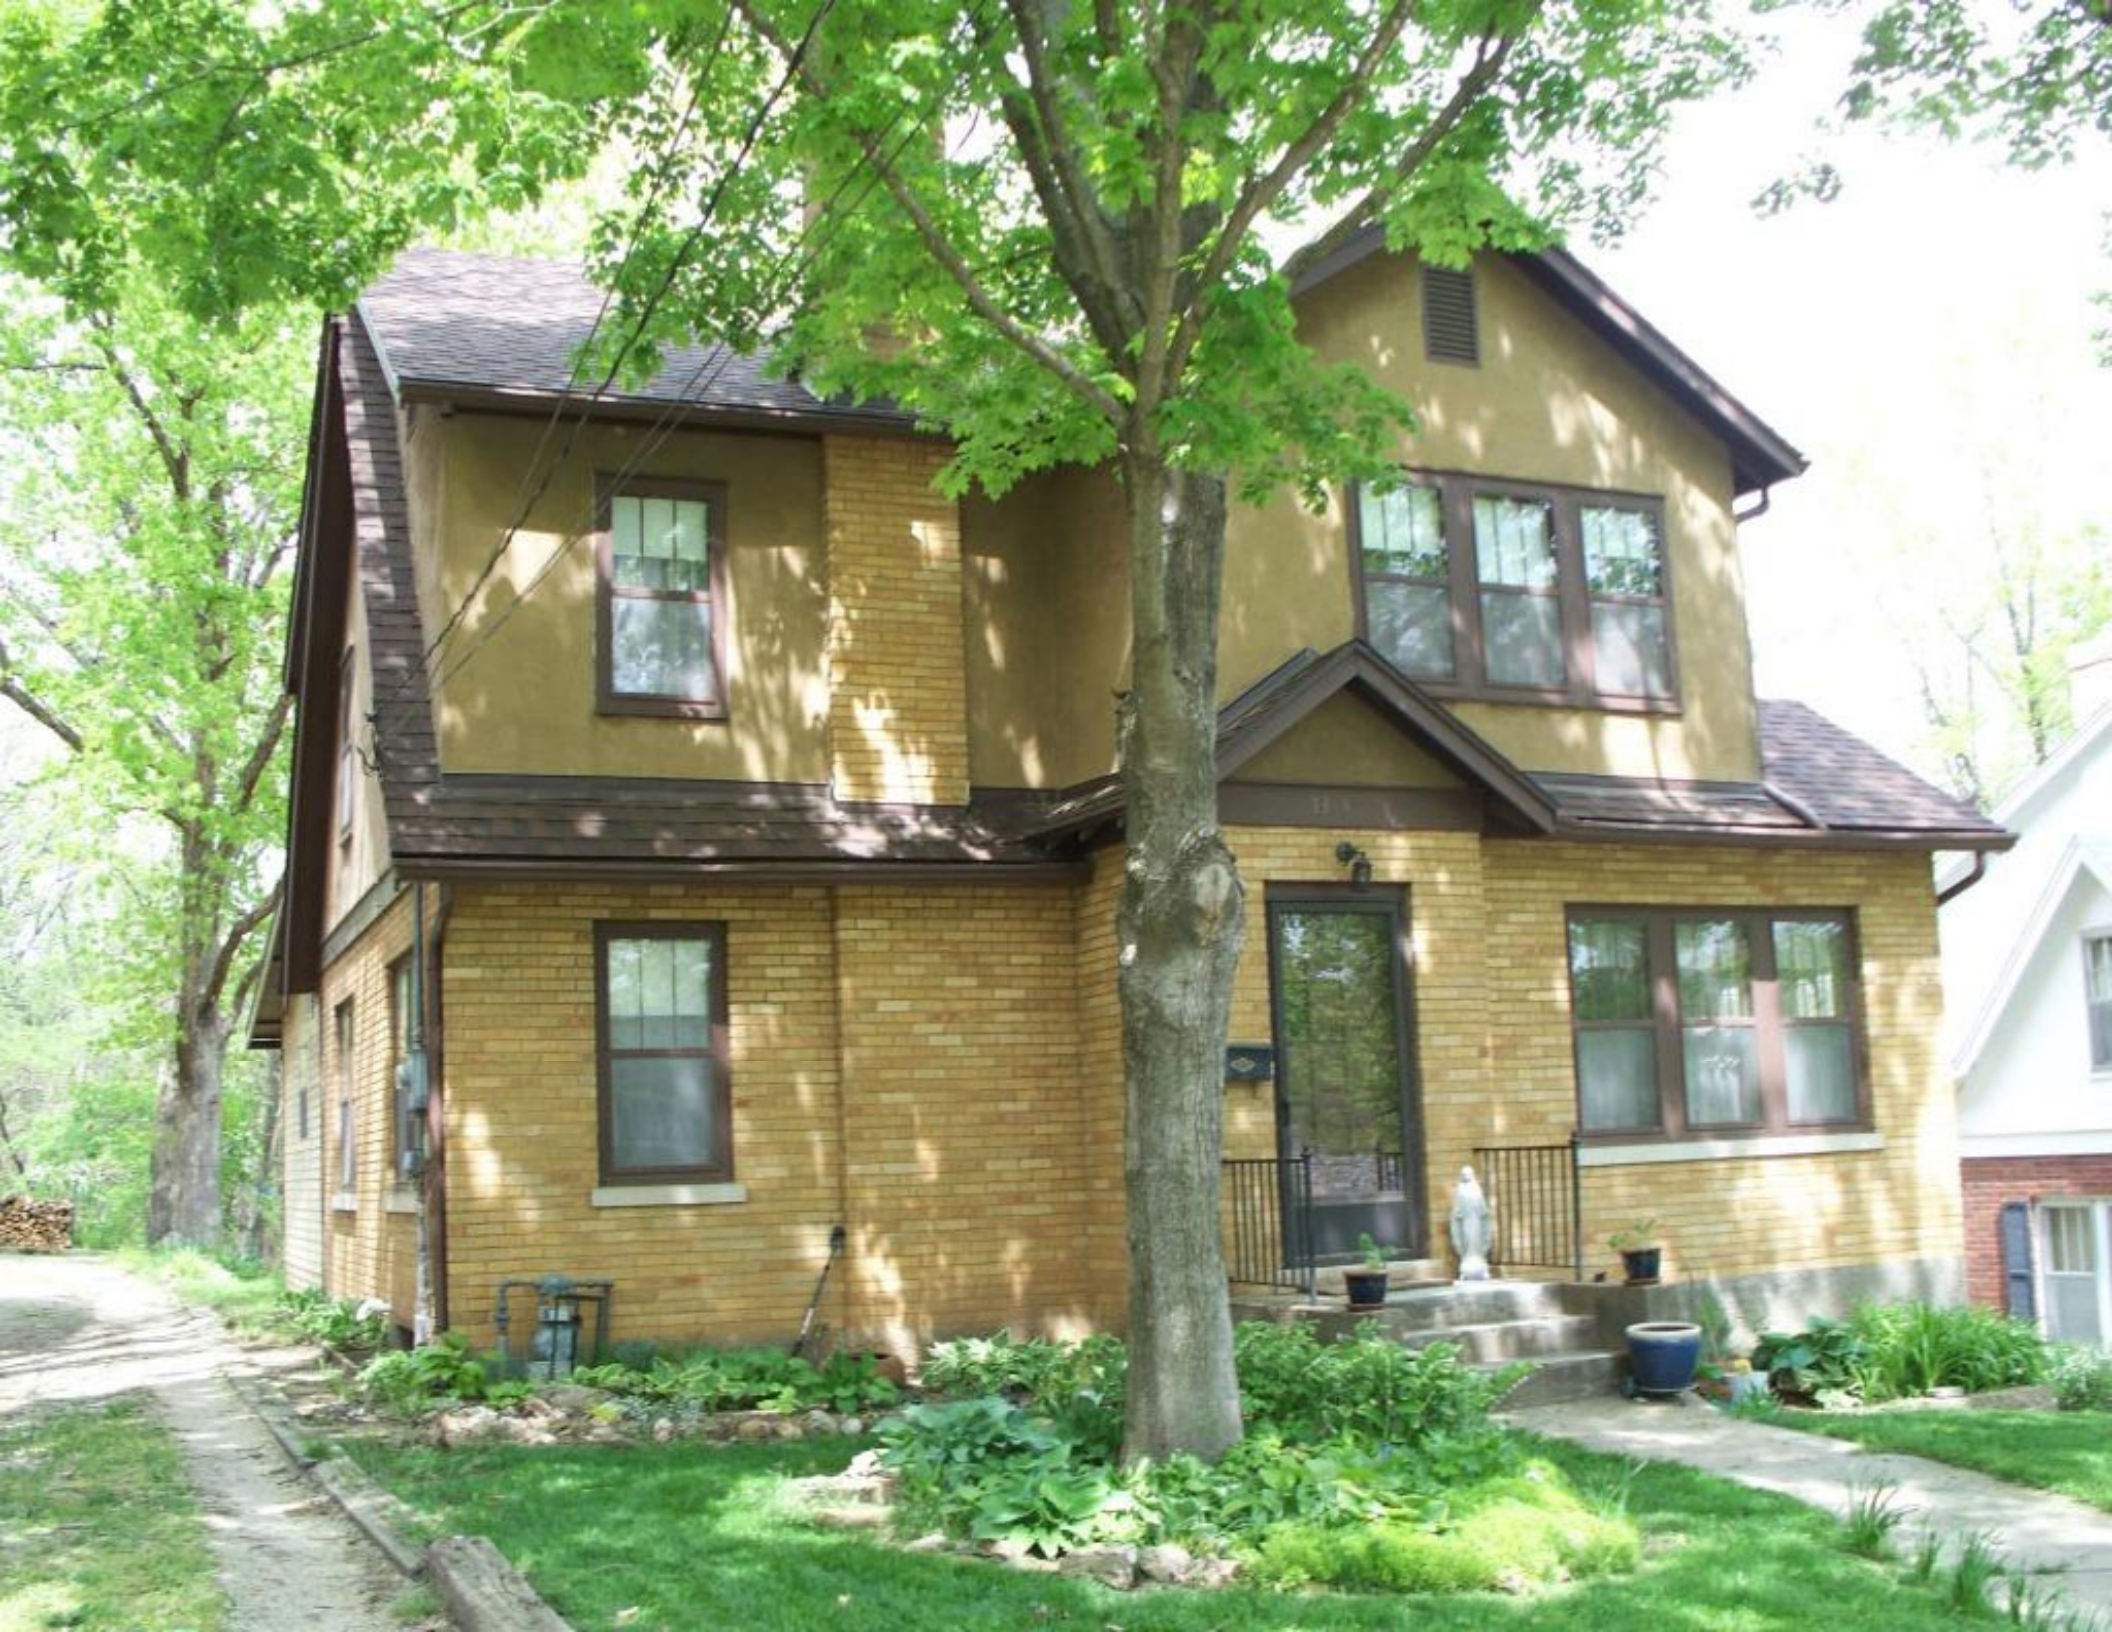
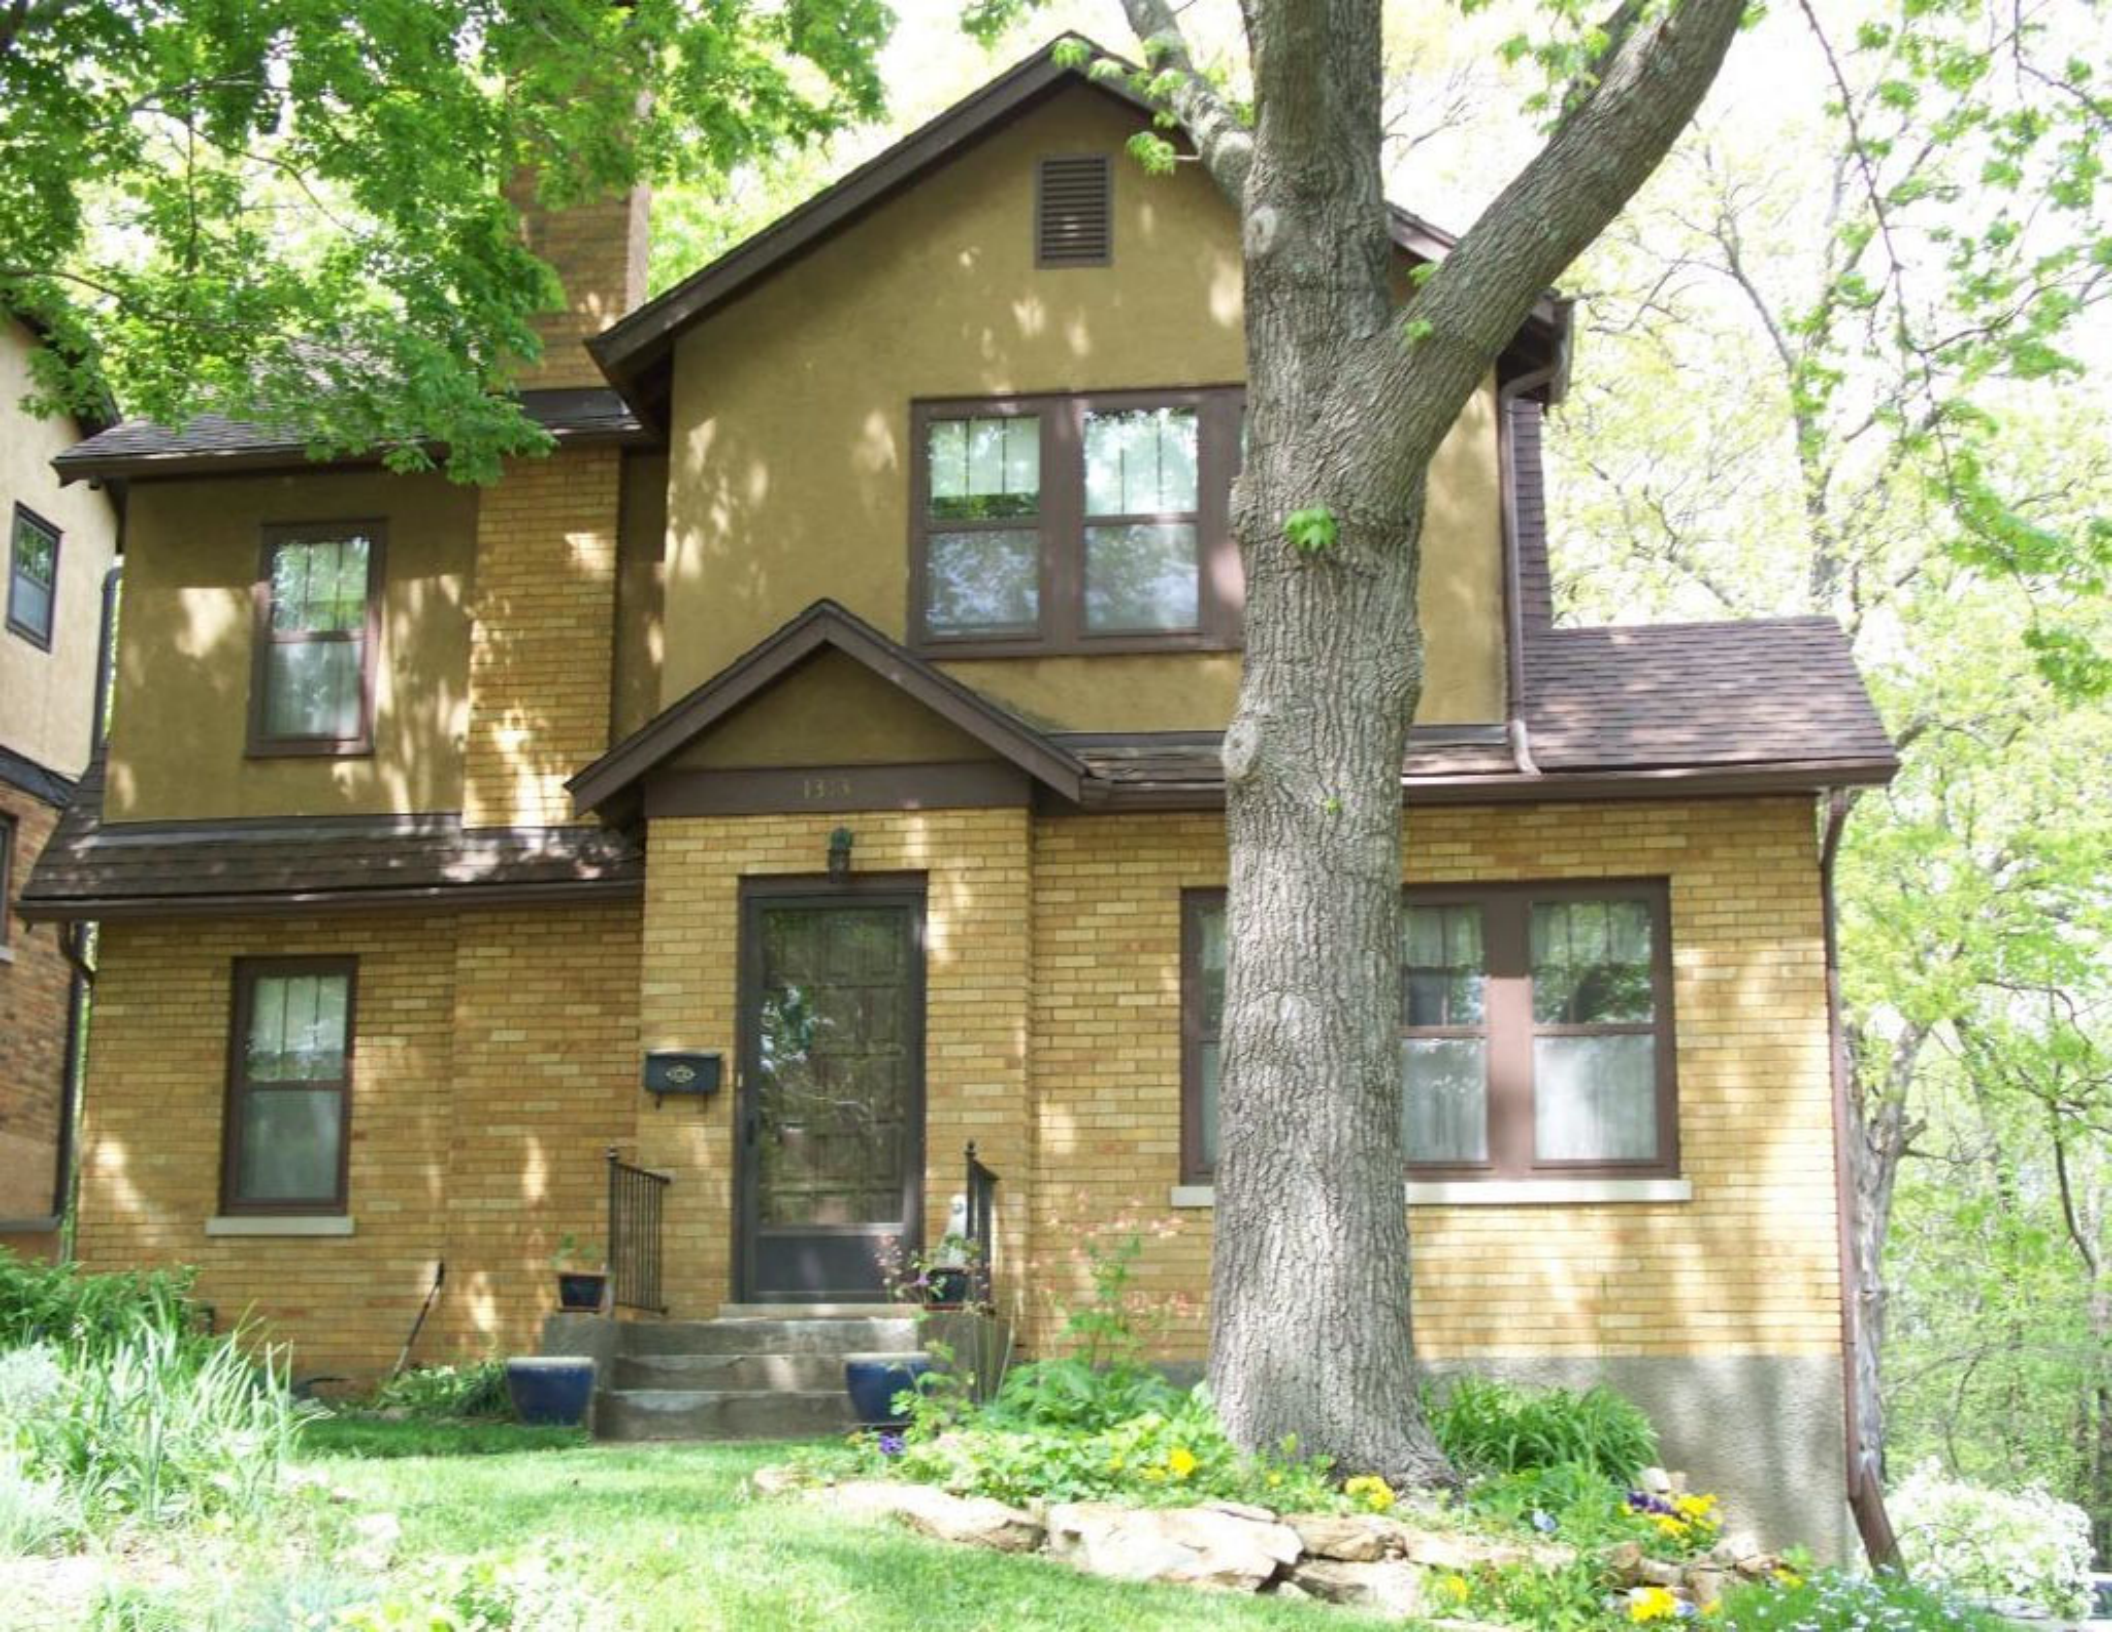
This two story brick home has a side gable roof. The upper story is clad in stucco and has a continuous dormer with a shed roof in the left bay and contains a historic 3/1 window. The chimney extends projects on this bay and through the shed roof although it appears flush with the façade on the lower story. The right bay on the upper floor projects from the roof, has a gable roof and contains historic paired 3/1 windows. The lower floor has a single historic 3/1 window in the left bay. The center and right bay project and contain the entrance and a row of three historic 3/1 windows. The door projects slightly and is capped with a gable that is stuccoed. A concrete stoop with metal rails and a set of concrete stair lead up to the entrance. The various gables, projecting elevations, and front chimney are what give this property a minimal Tudor influence.
