ARCHITECTURAL/HISTORIC INVENTORY FORM

1. Survey No. CO-AS-005-001		2. Survey name: Moreau Drive Neighborhood Survey	
3. County: Cole		4. Address: 1202 Elmerine Ave.	
5. City: Jefferson City	Vicinity: <input type="checkbox"/>	6. UTM: / /	7. Township/Range/Section: T: R: S:
8. Historic name (if known):		9. Present/other name (if known):	
10. Ownership: <input checked="" type="checkbox"/> Private <input type="checkbox"/> Public		11. Historic use (if known): Residential	11. Current use: Residential

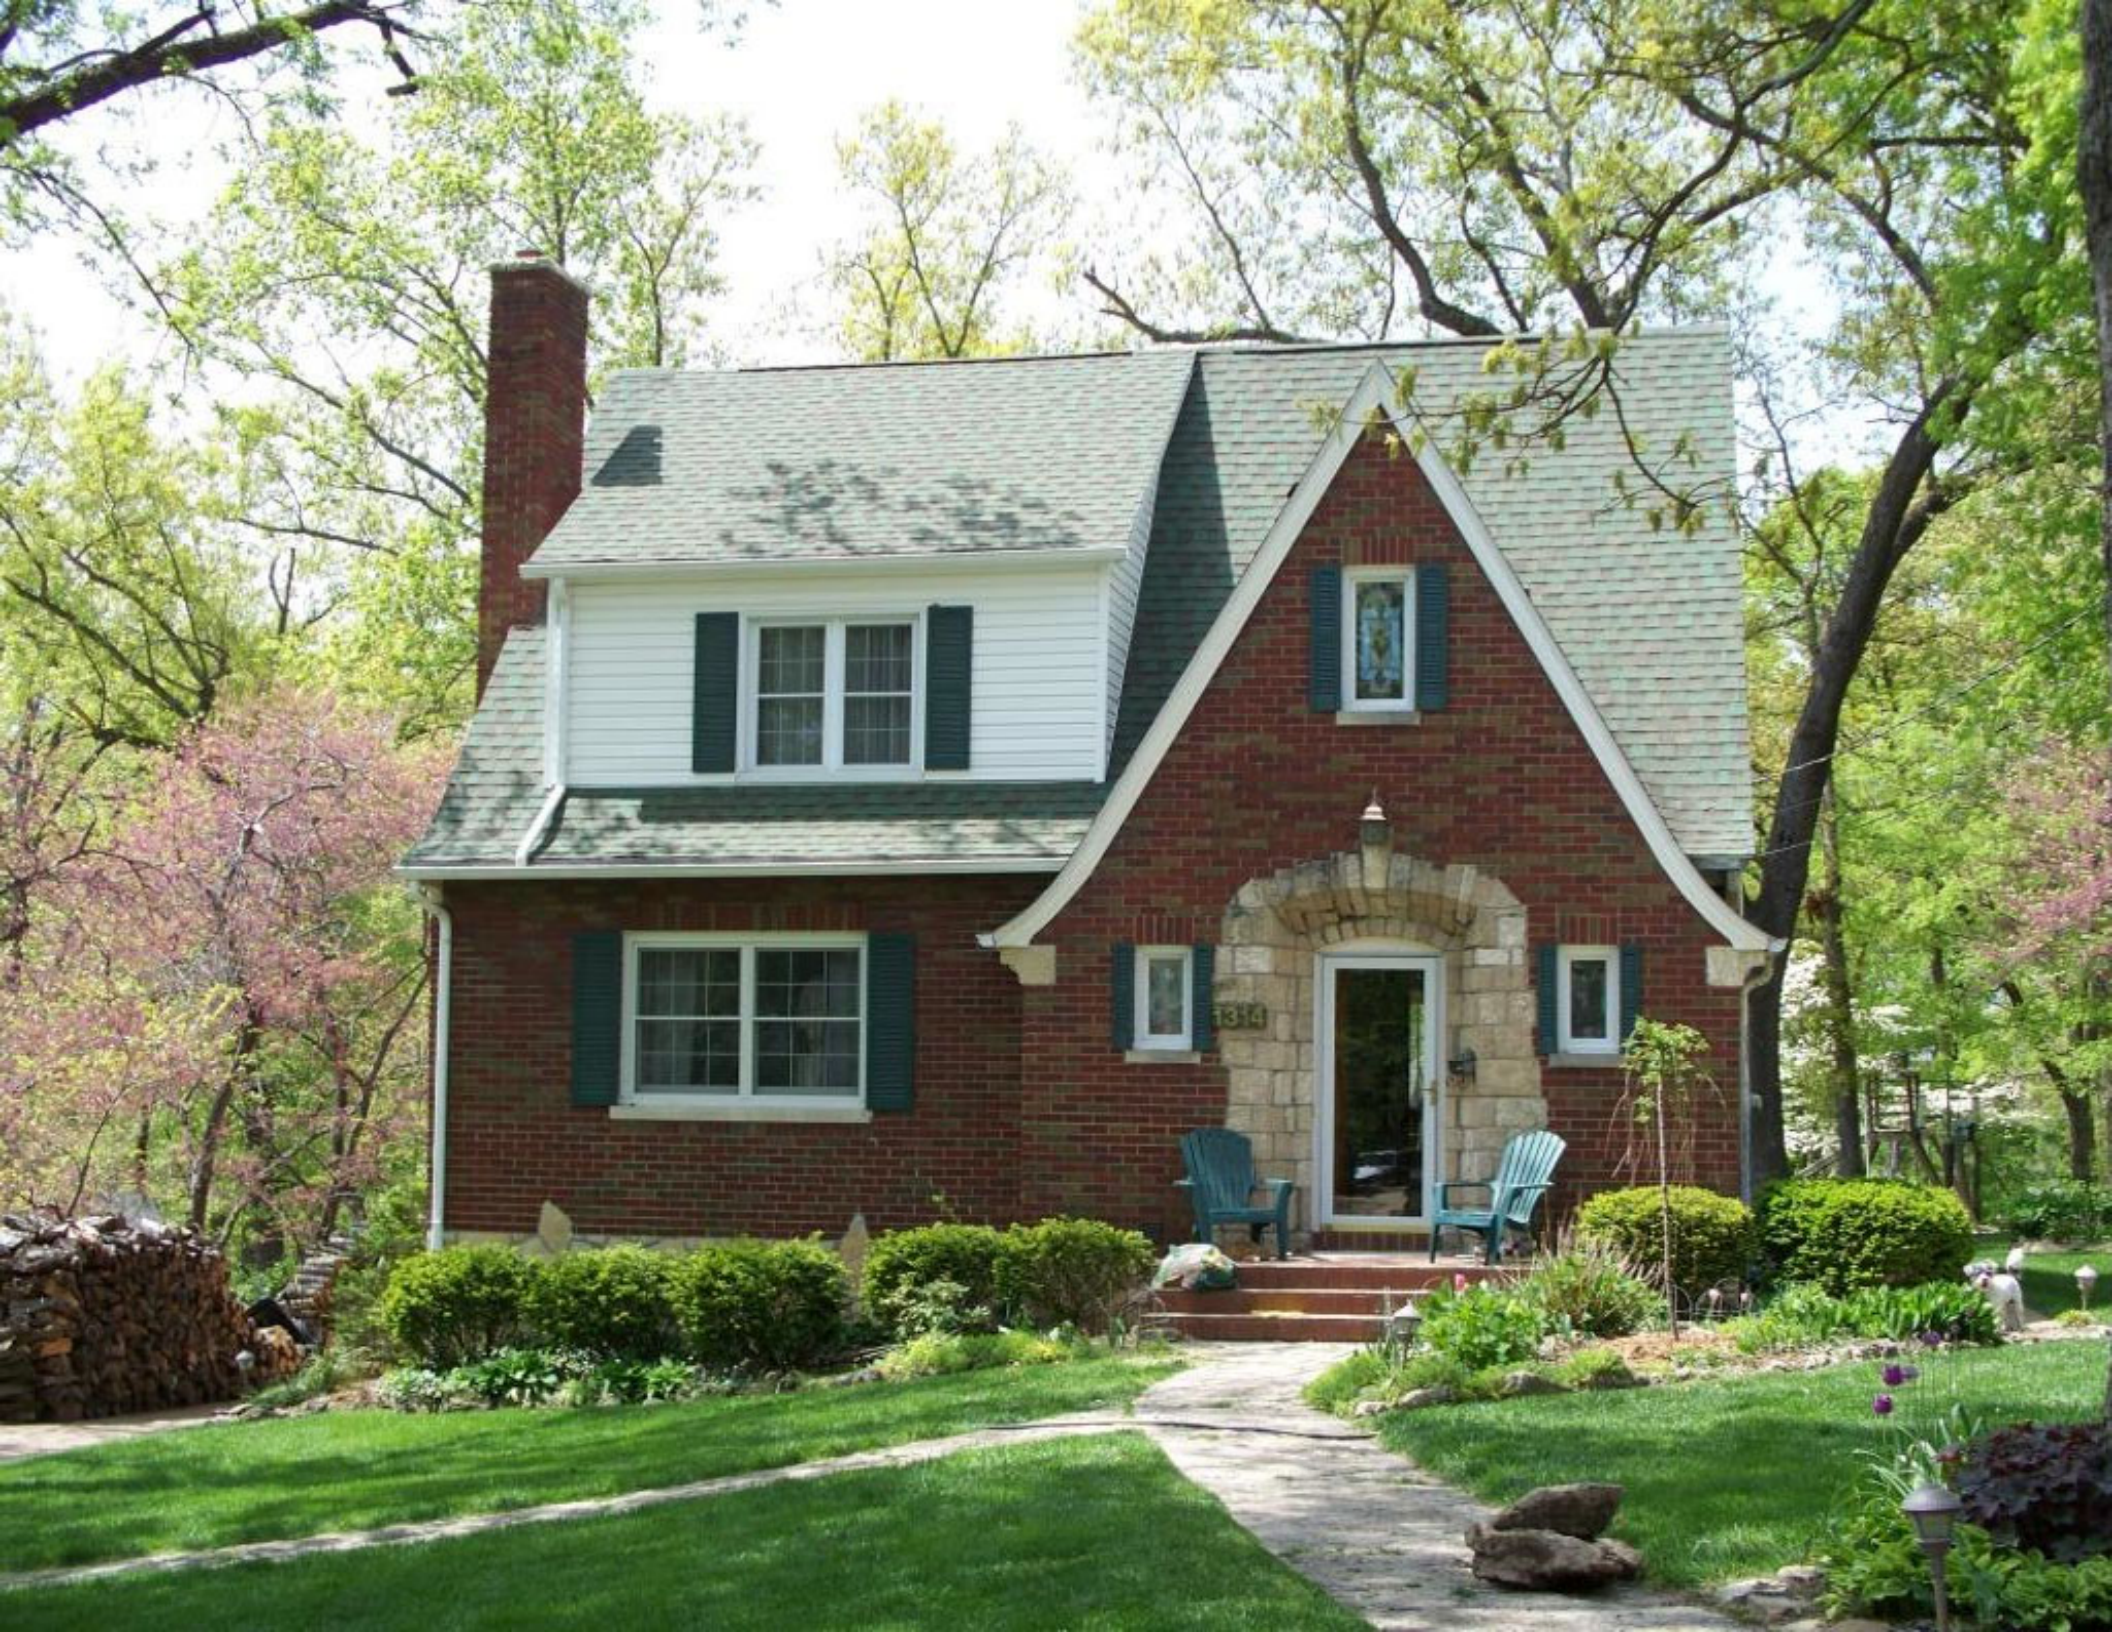
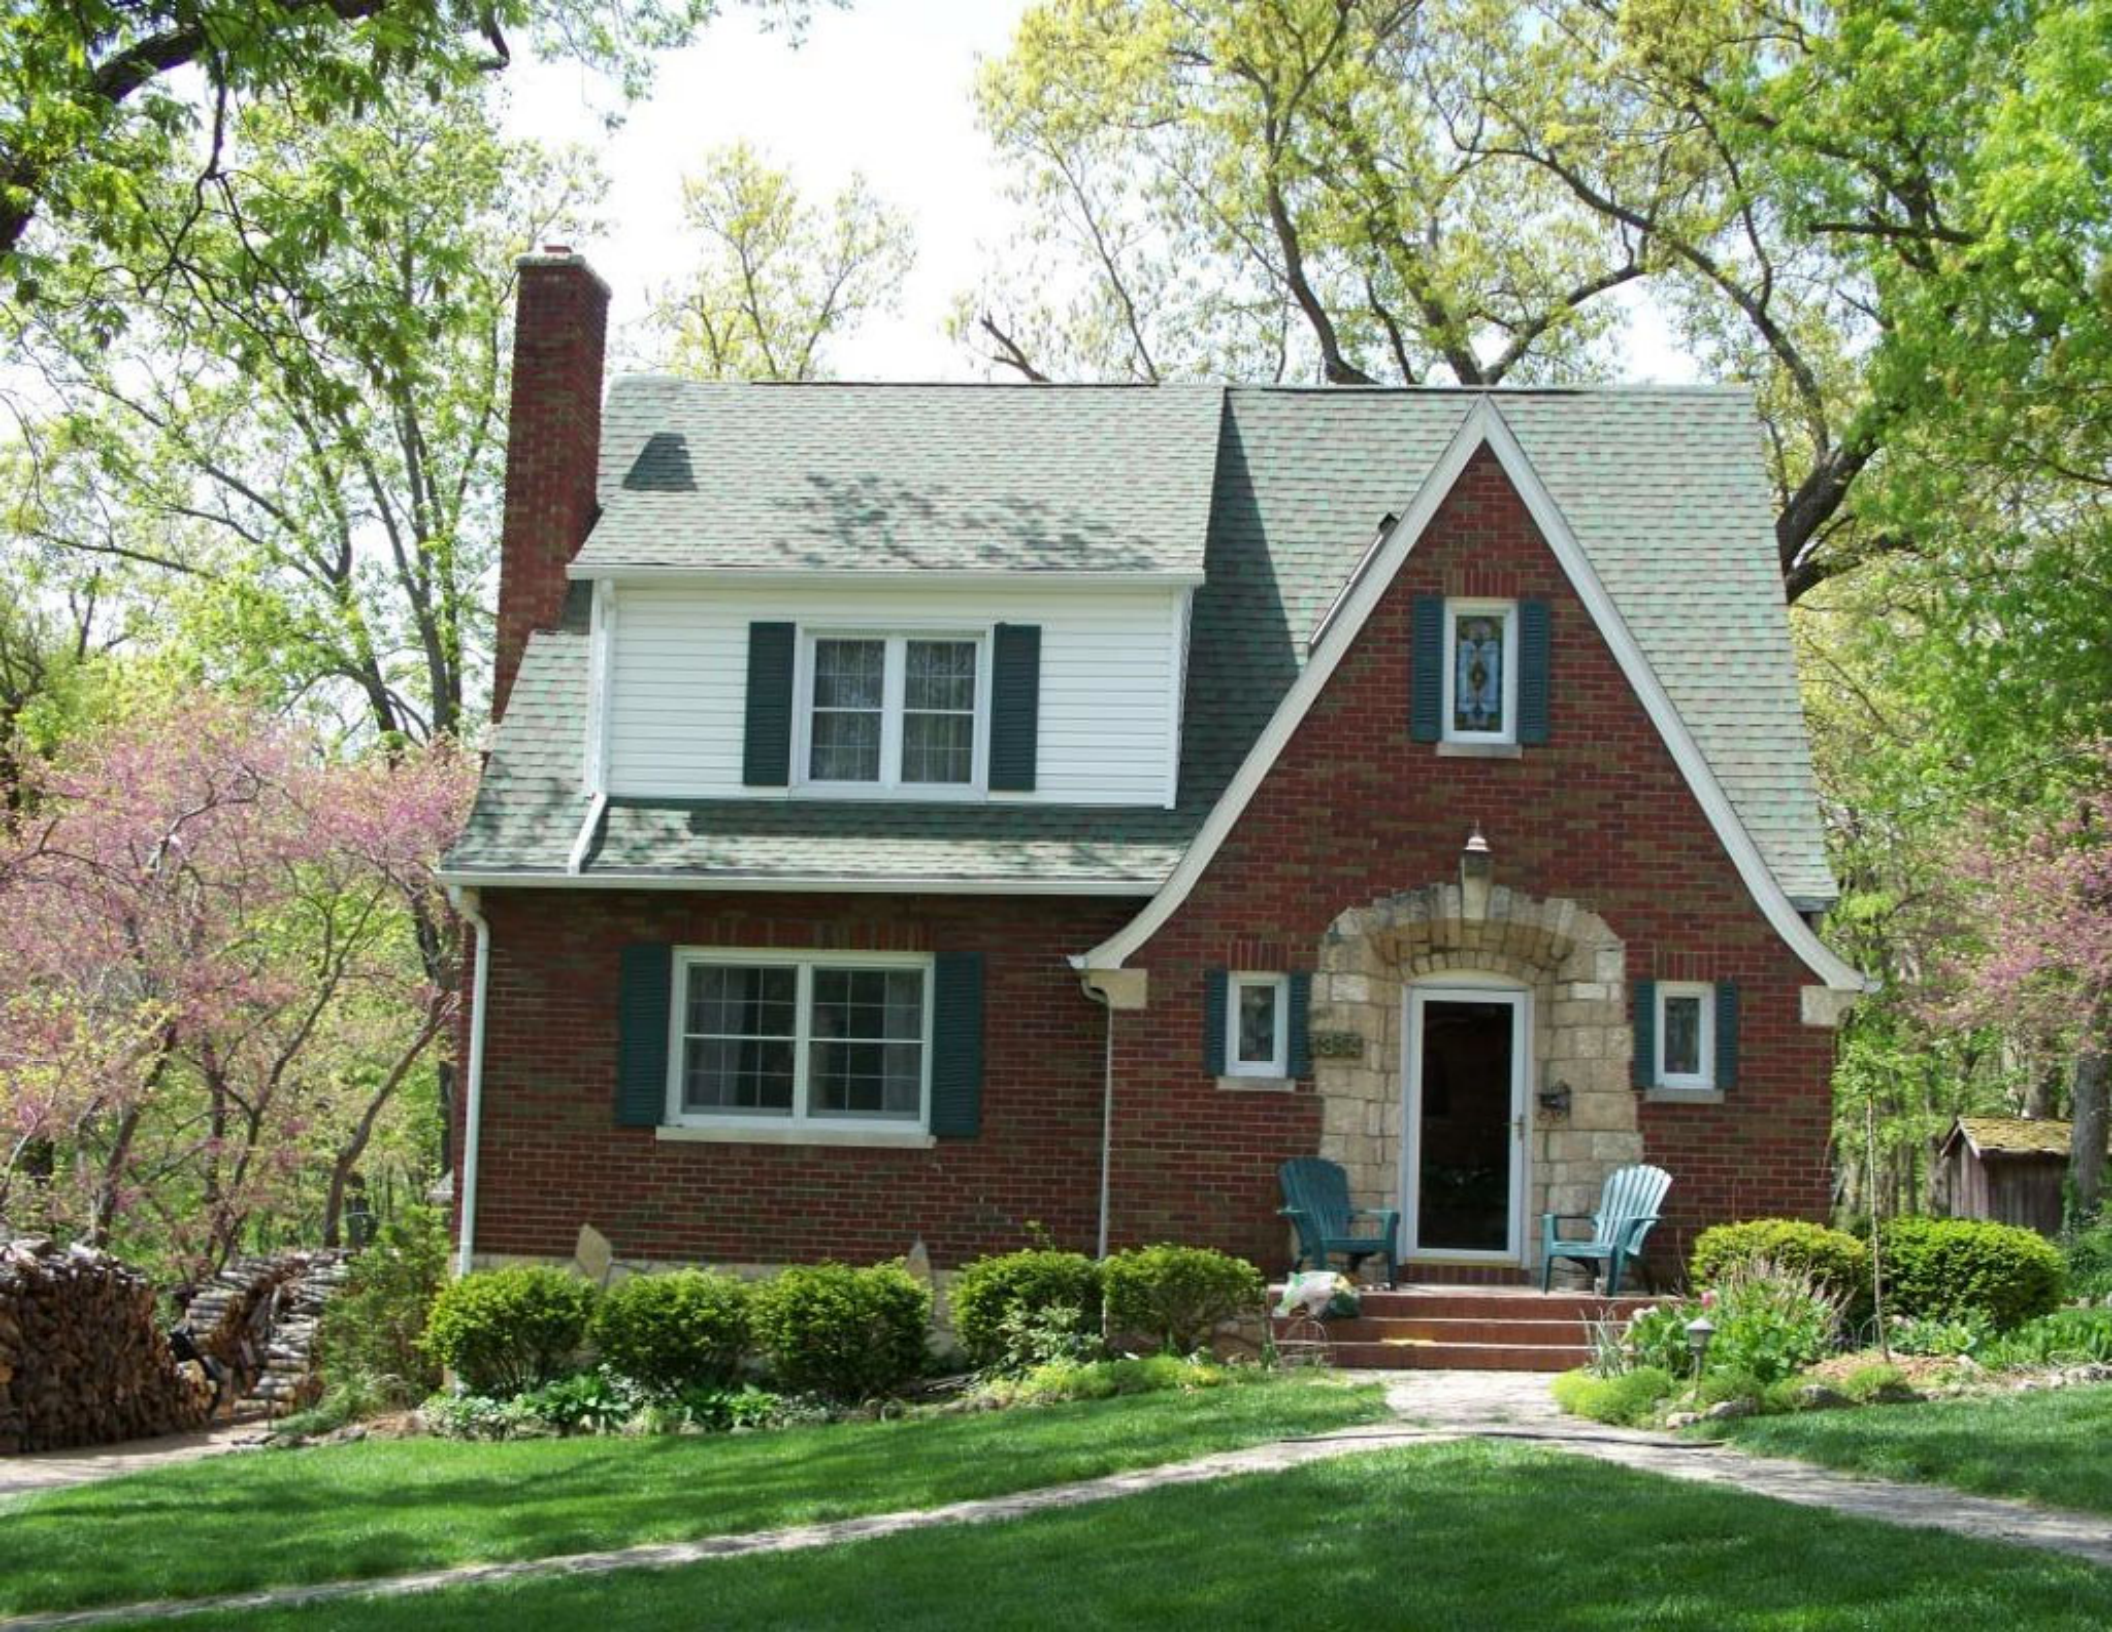
40. (cont.) Description of environment and outbuildings. Expand box as necessary, or add continuation pages.
There is a two car garage with a single door clad in stone with a side gable roof at the back of the property off set to the left. Although it does not appear on the 1939 Sanborn Map it was probably built prior to 1950. If this is the case it would contribute to a potential district.

41. (cont.)
This 1 ½ story brick Tudor has a steeply pitched front gable in the first bay (right) of the property. It projects slightly from a full width cross gable roof. In the peak of this gable and on either side of the door are smaller casement windows of stained glass that feature narrow wood shutters and concrete or limestone sills. The segmental arched entrance, which is reached by a brick stoop, is slightly recessed and surrounded by stone that extends out to both stained glass windows. The door appears to have been replaced as the arch has been in-filled around the doorjamb. There is also stone detailing under the flare of each gable end. On the upper floor on the side gable section of the home (left bay) is a large shed dormer clad in vinyl with paired replacement 6/6 windows with shutters. Like the stained glass windows in the first bay, these windows have limestone or concrete sills with soldier course brick lintels. Beneath these windows on the first floor are similar but wider paired 6/6 replacement windows with shutters, limestone/concrete sills, and soldier course brick lintels. The stone foundation juts up to the main brick façade in two places in the left bay.

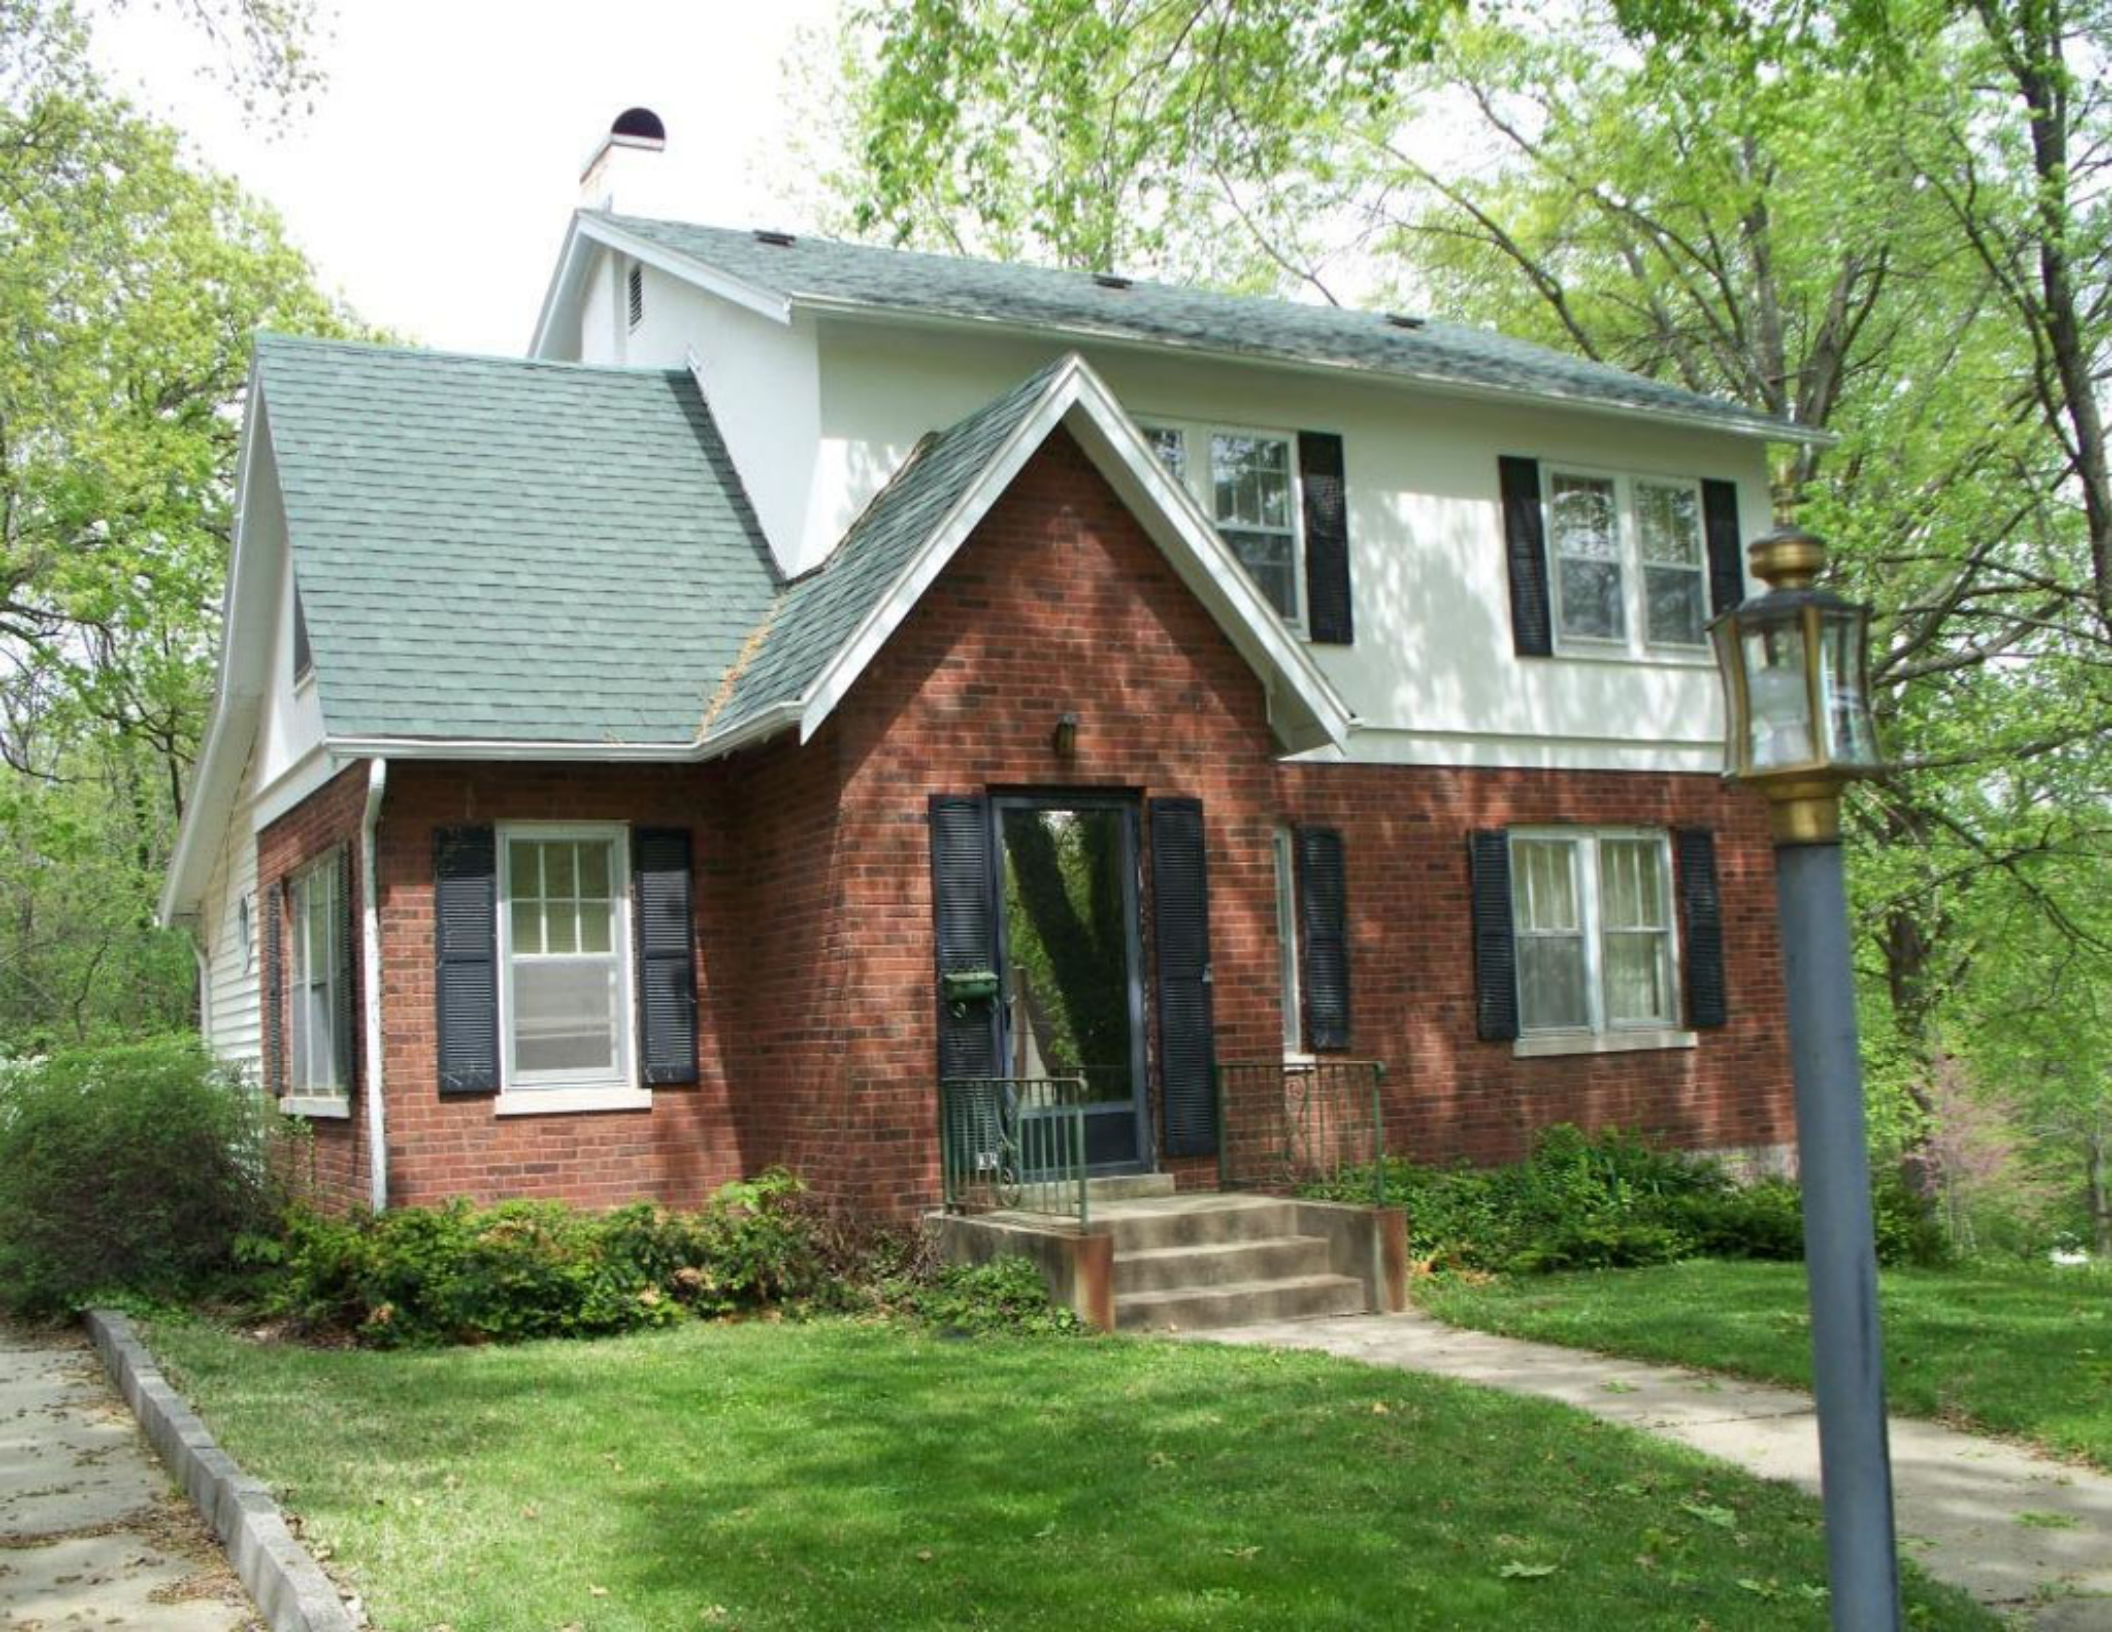
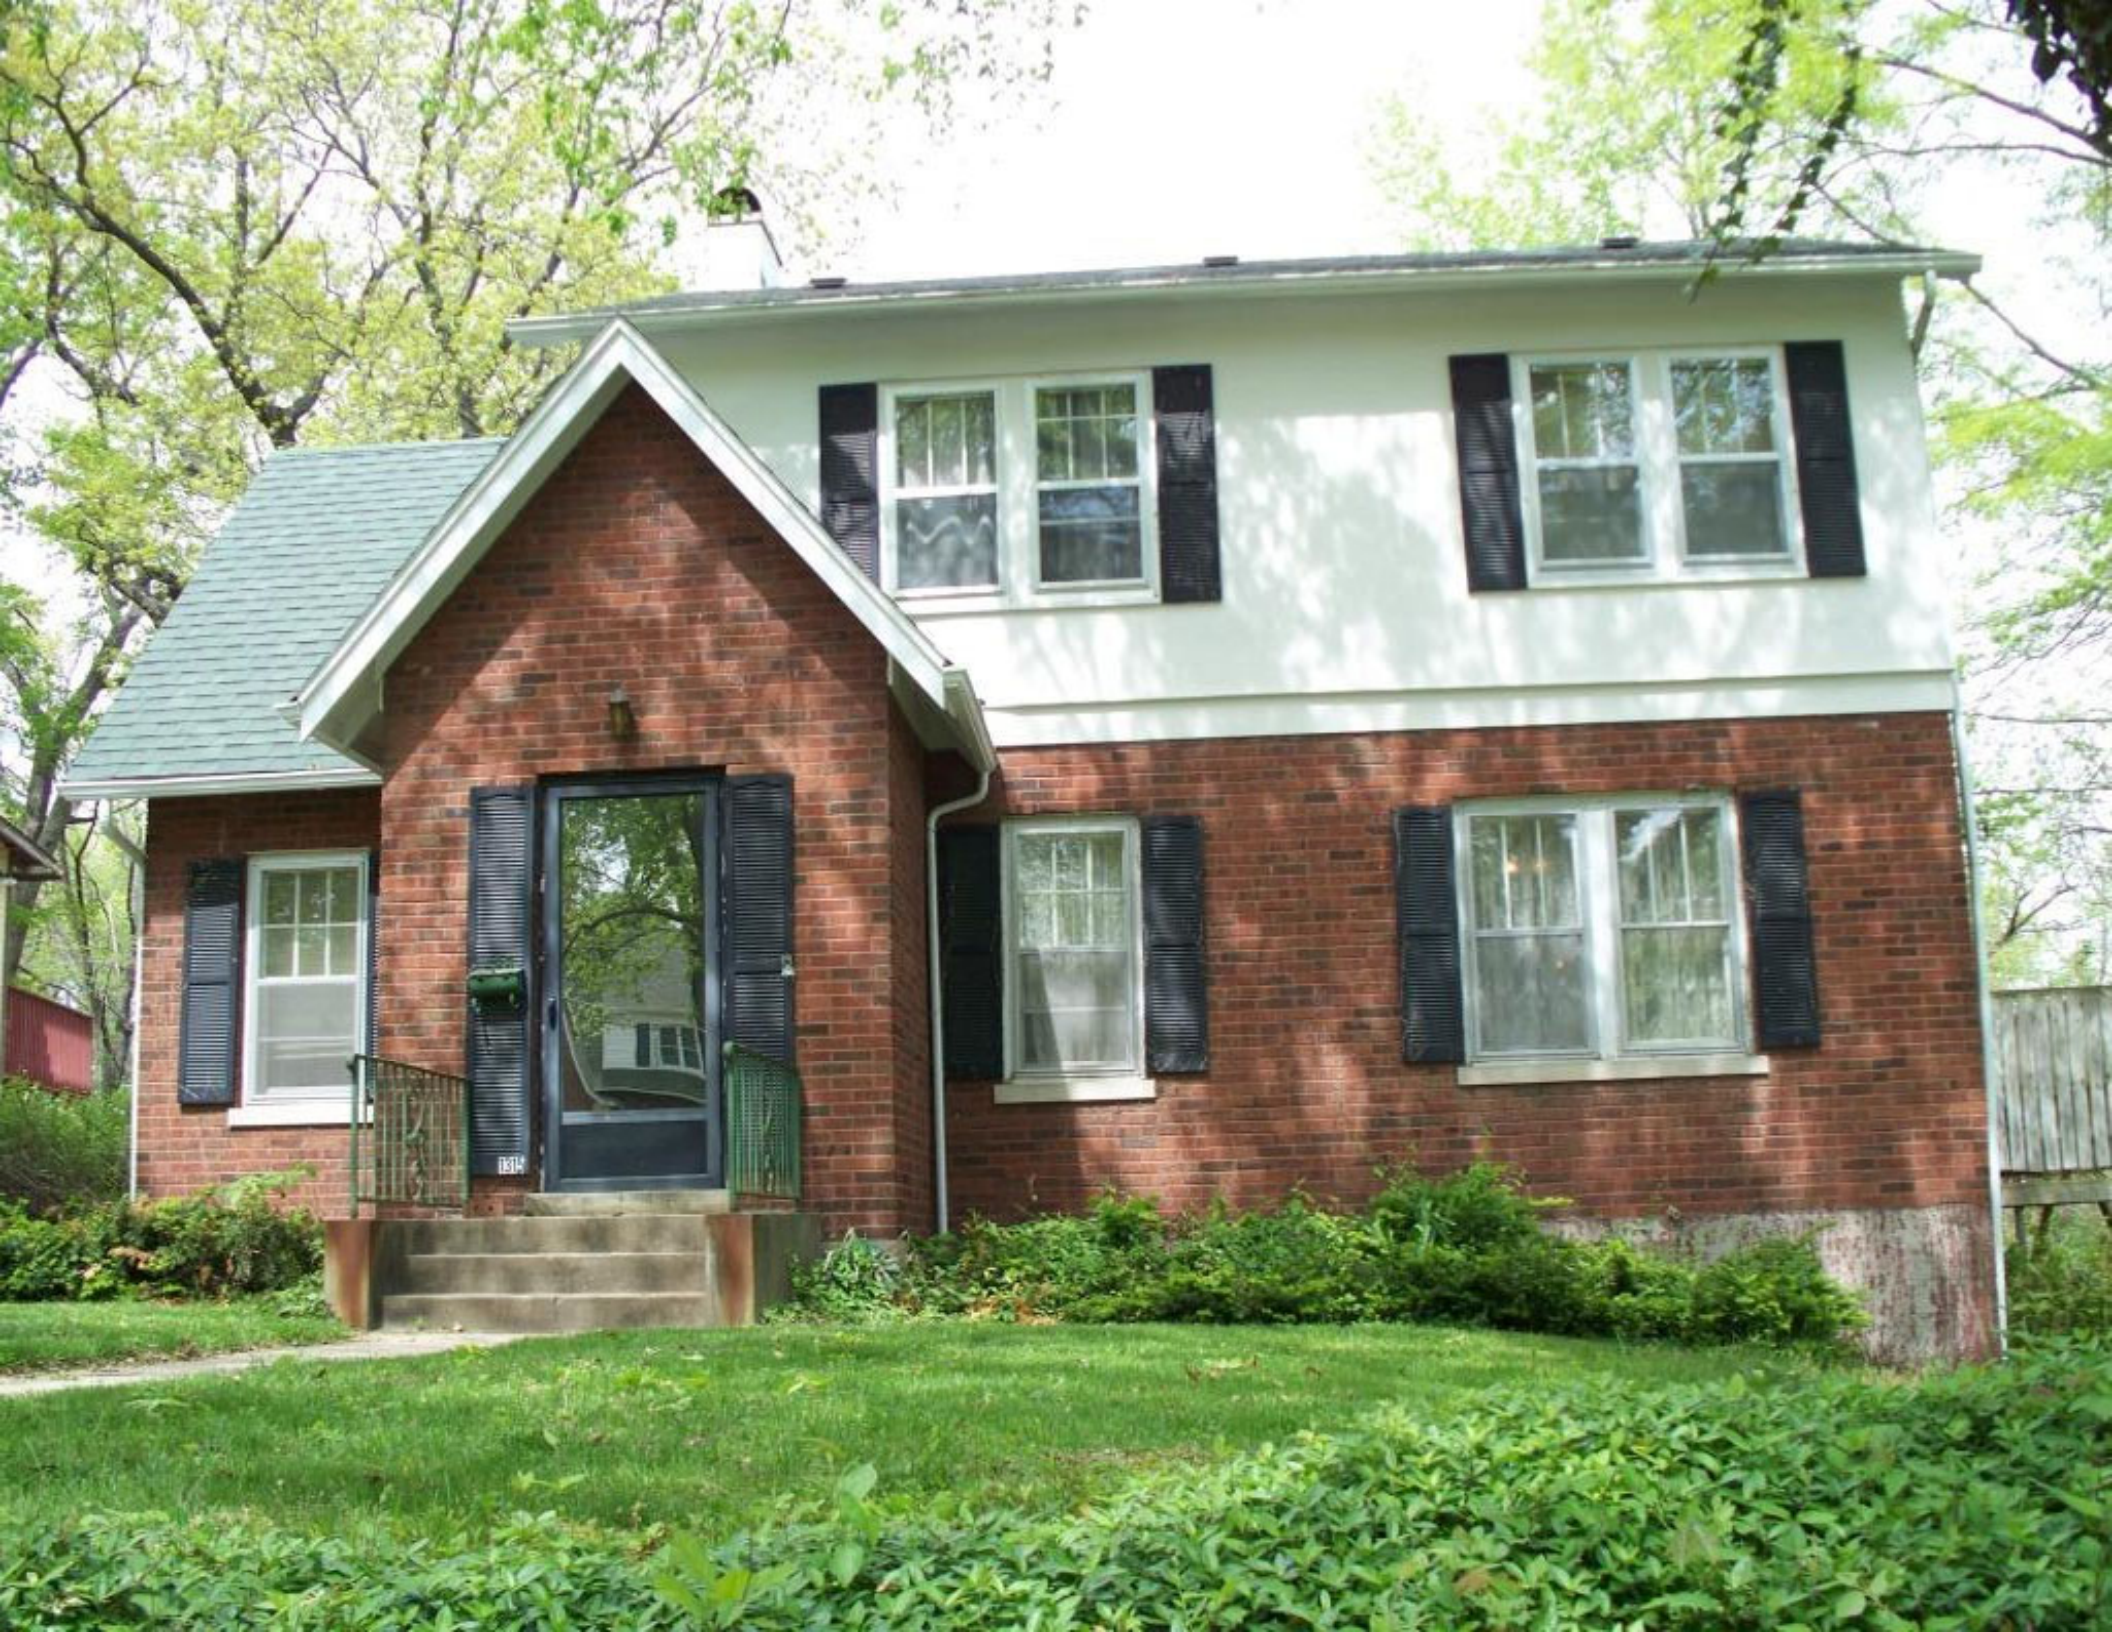
41. (cont.)
This two story brick home has a side gable roof. The upper story is clad in stucco and has a continuous dormer with a shed roof in the center and right bay. It contains two paired 3/1 historic windows with shutters. The lower story has a single 3/1 window with shutters in the left bay. The entrance projects and has a gabled roof. It is framed with shutters and has a concrete stoop with metal rails and a set of concrete steps. The third bay has a single 3/1 window with shutters and the right bay contains paired 3/1 window with shutters. Both windows are historic. Although the property is very similar to its neighbors, it lacks enough detailing to be considered a Tudor. For the purposes of this survey, it is considered a side gable property type.

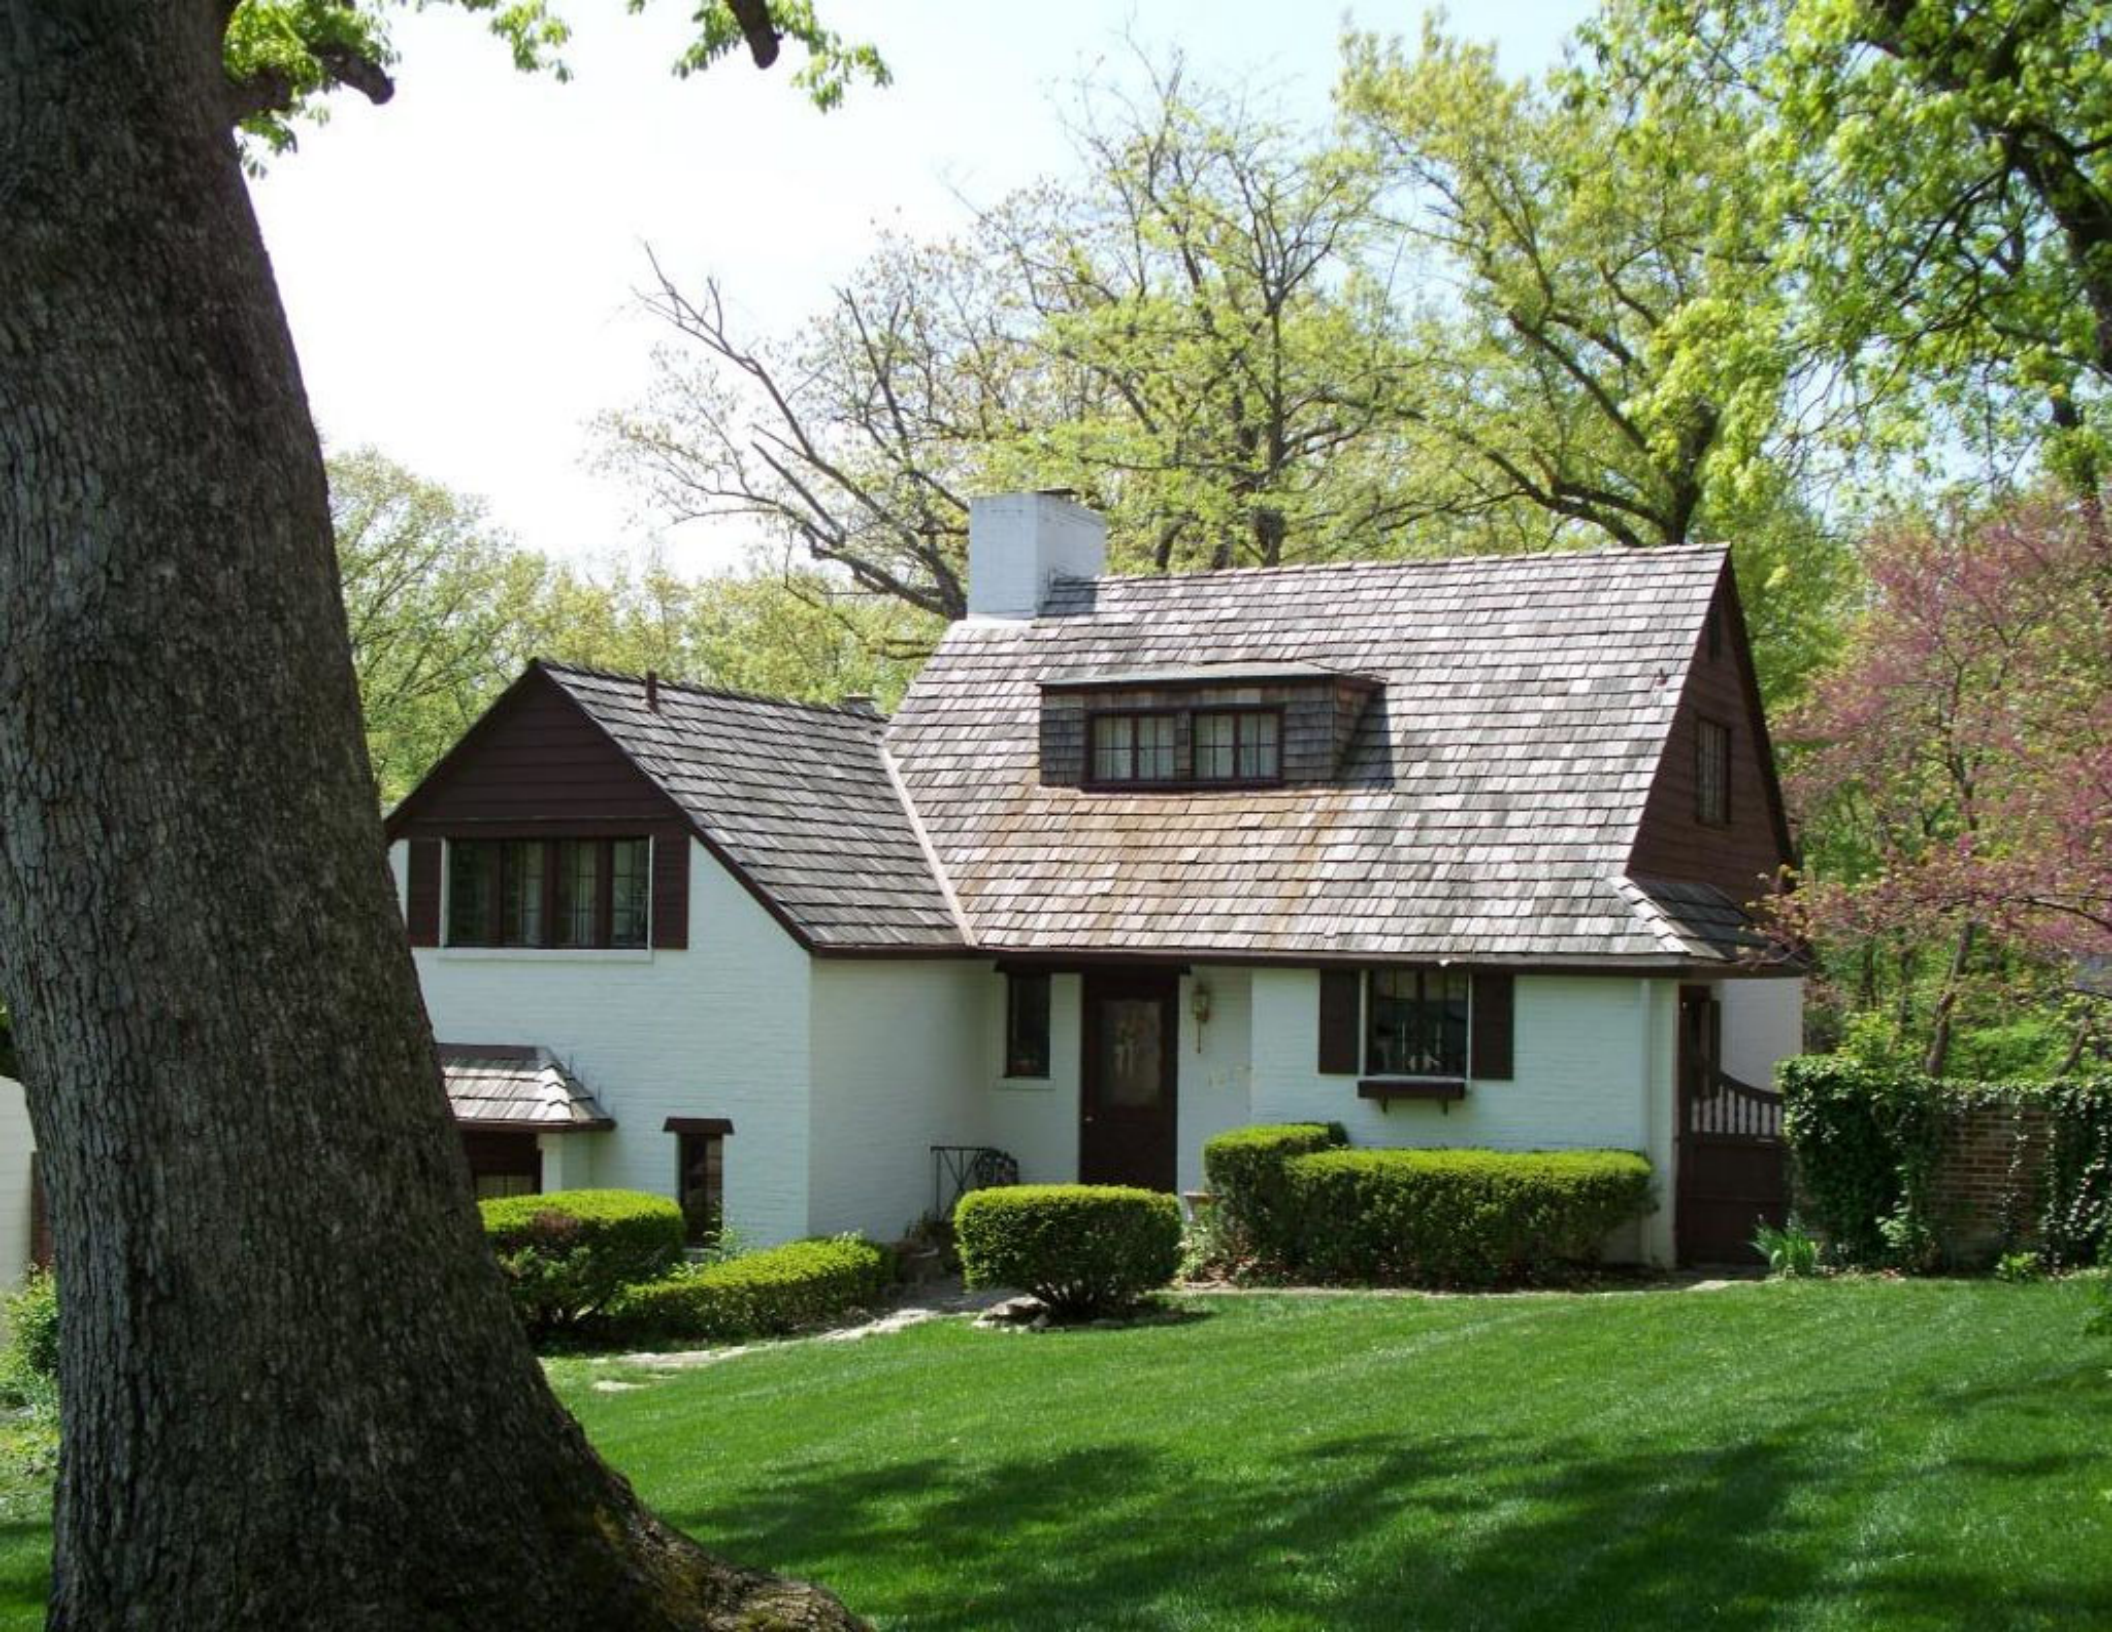
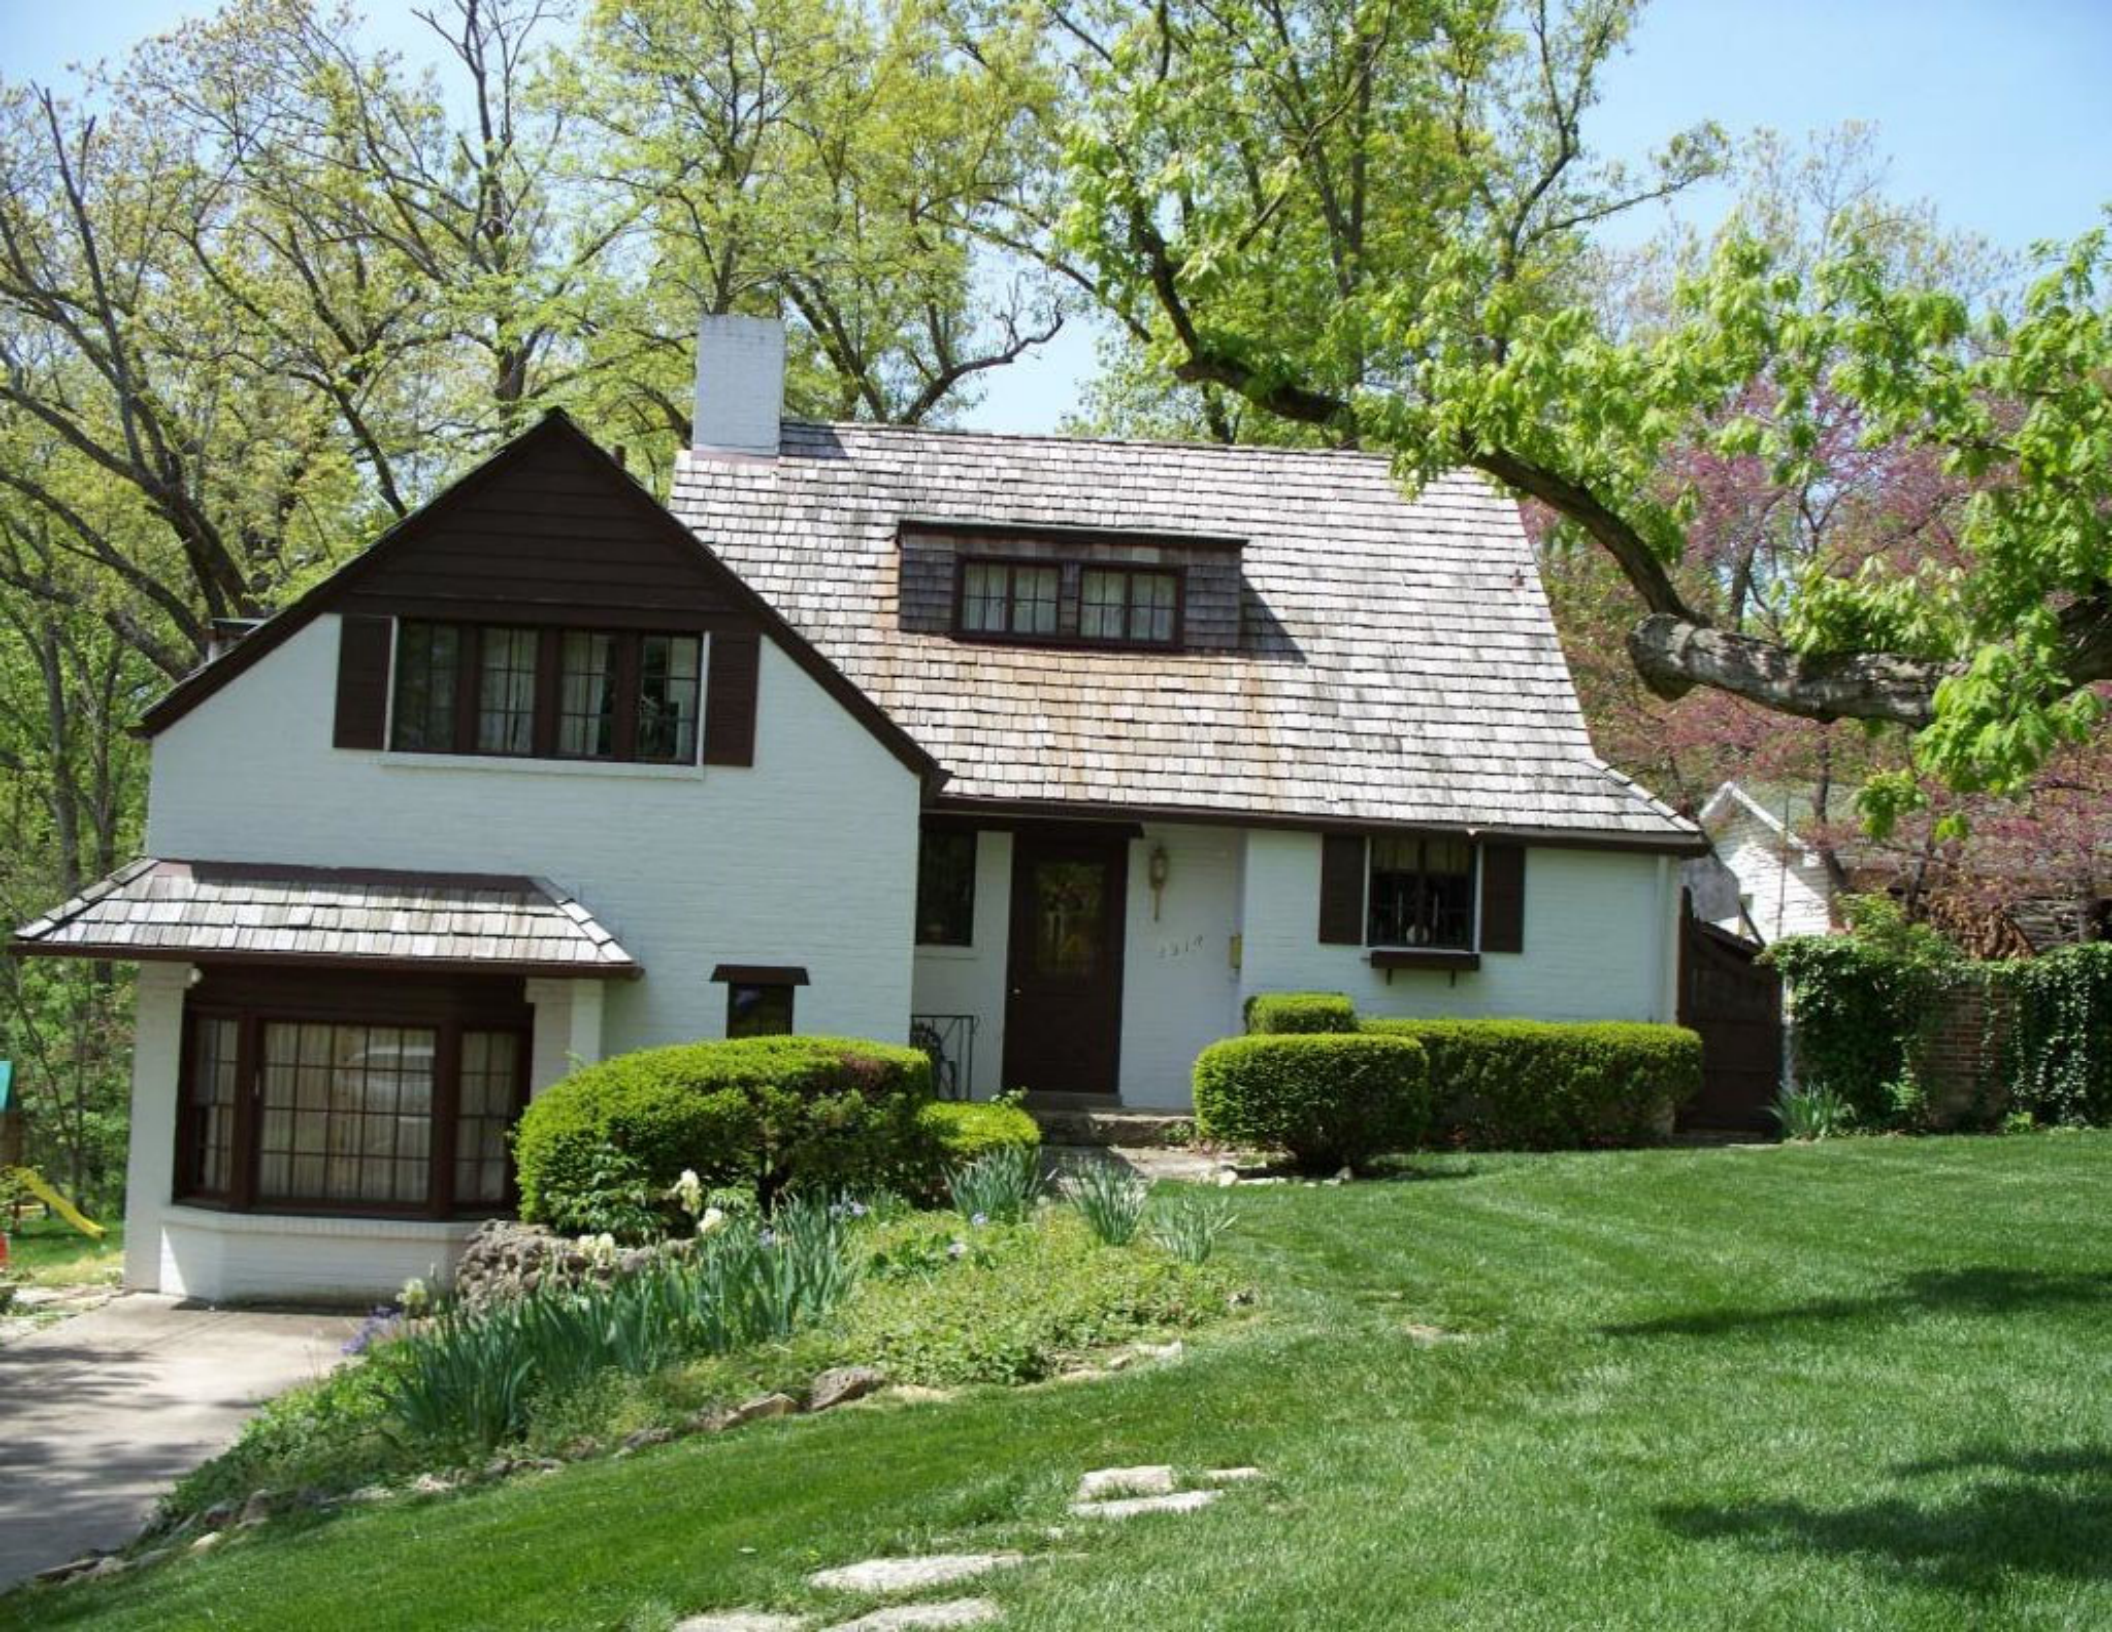
This 1 ½ story brick home has a steeply pitched side gabled roof with flared hipped eaves. At the left side of the house a cross front gable extends slightly below grade. The roof is clad in wood shingles. With this roof type the property most closely resembles the French Eclectic Style. In the center of the side gable is a low hipped wooden shingle dormer with two 4x4 casement windows. The right bay has paired multi-light casement windows with shutters and a flower box. The center bay is recessed and contains the door and a single casement window to its left. The next bay is the extended front gable that sits slightly lower than the rest of the property. The peak of this gable is clad in dark brown shingle and has a row of four 6 pane casement windows with shutters and rowlock brick sills. The lower story of this bay has a single casement window with a flat arch of dark brown (material unknown). To the right of this is a canted multi-light bay window that is capped by a hipped wooden shingle roof.
