ARCHITECTURAL/HISTORIC INVENTORY FORM

1. Survey No. CO-AS-005-001		2. Survey name: Moreau Drive Neighborhood Survey	
3. County: Cole		4. Address: 1202 Elmerine Ave.	
5. City: Jefferson City	Vicinity: <input type="checkbox"/>	6. UTM: / /	7. Township/Range/Section: T: R: S:
8. Historic name (if known):		9. Present/other name (if known):	
10. Ownership: <input checked="" type="checkbox"/> Private <input type="checkbox"/> Public		11. Historic use (if known): Residential	11. Current use: Residential

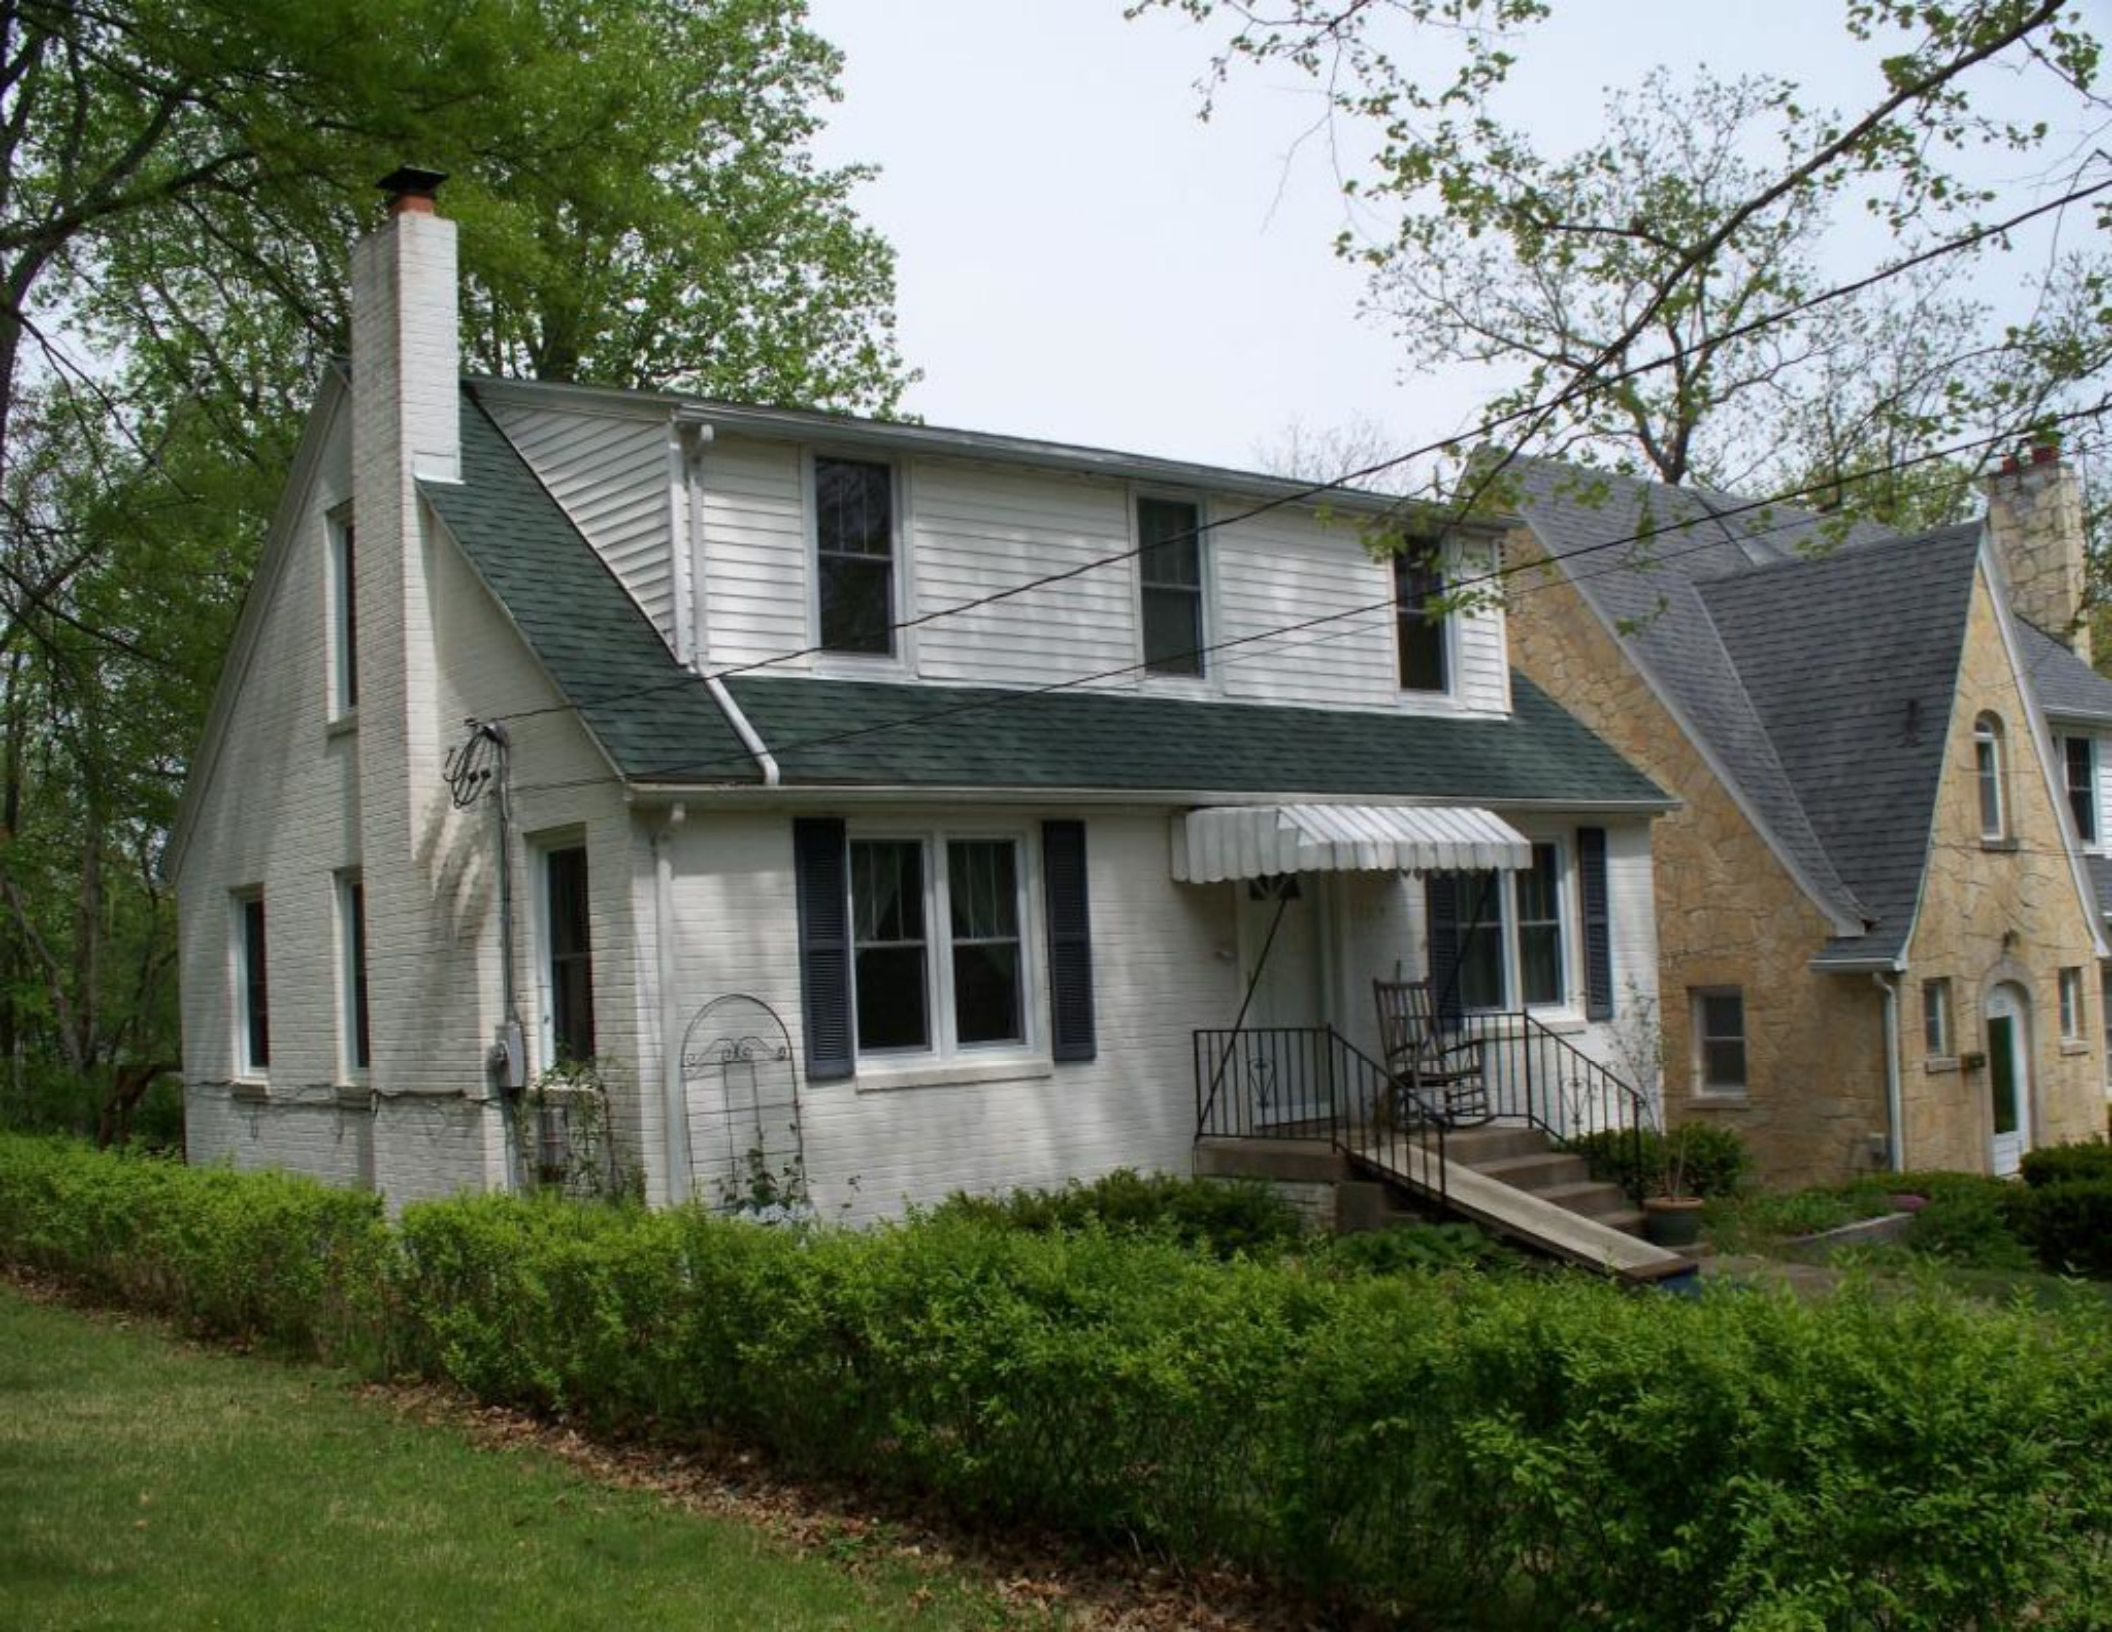
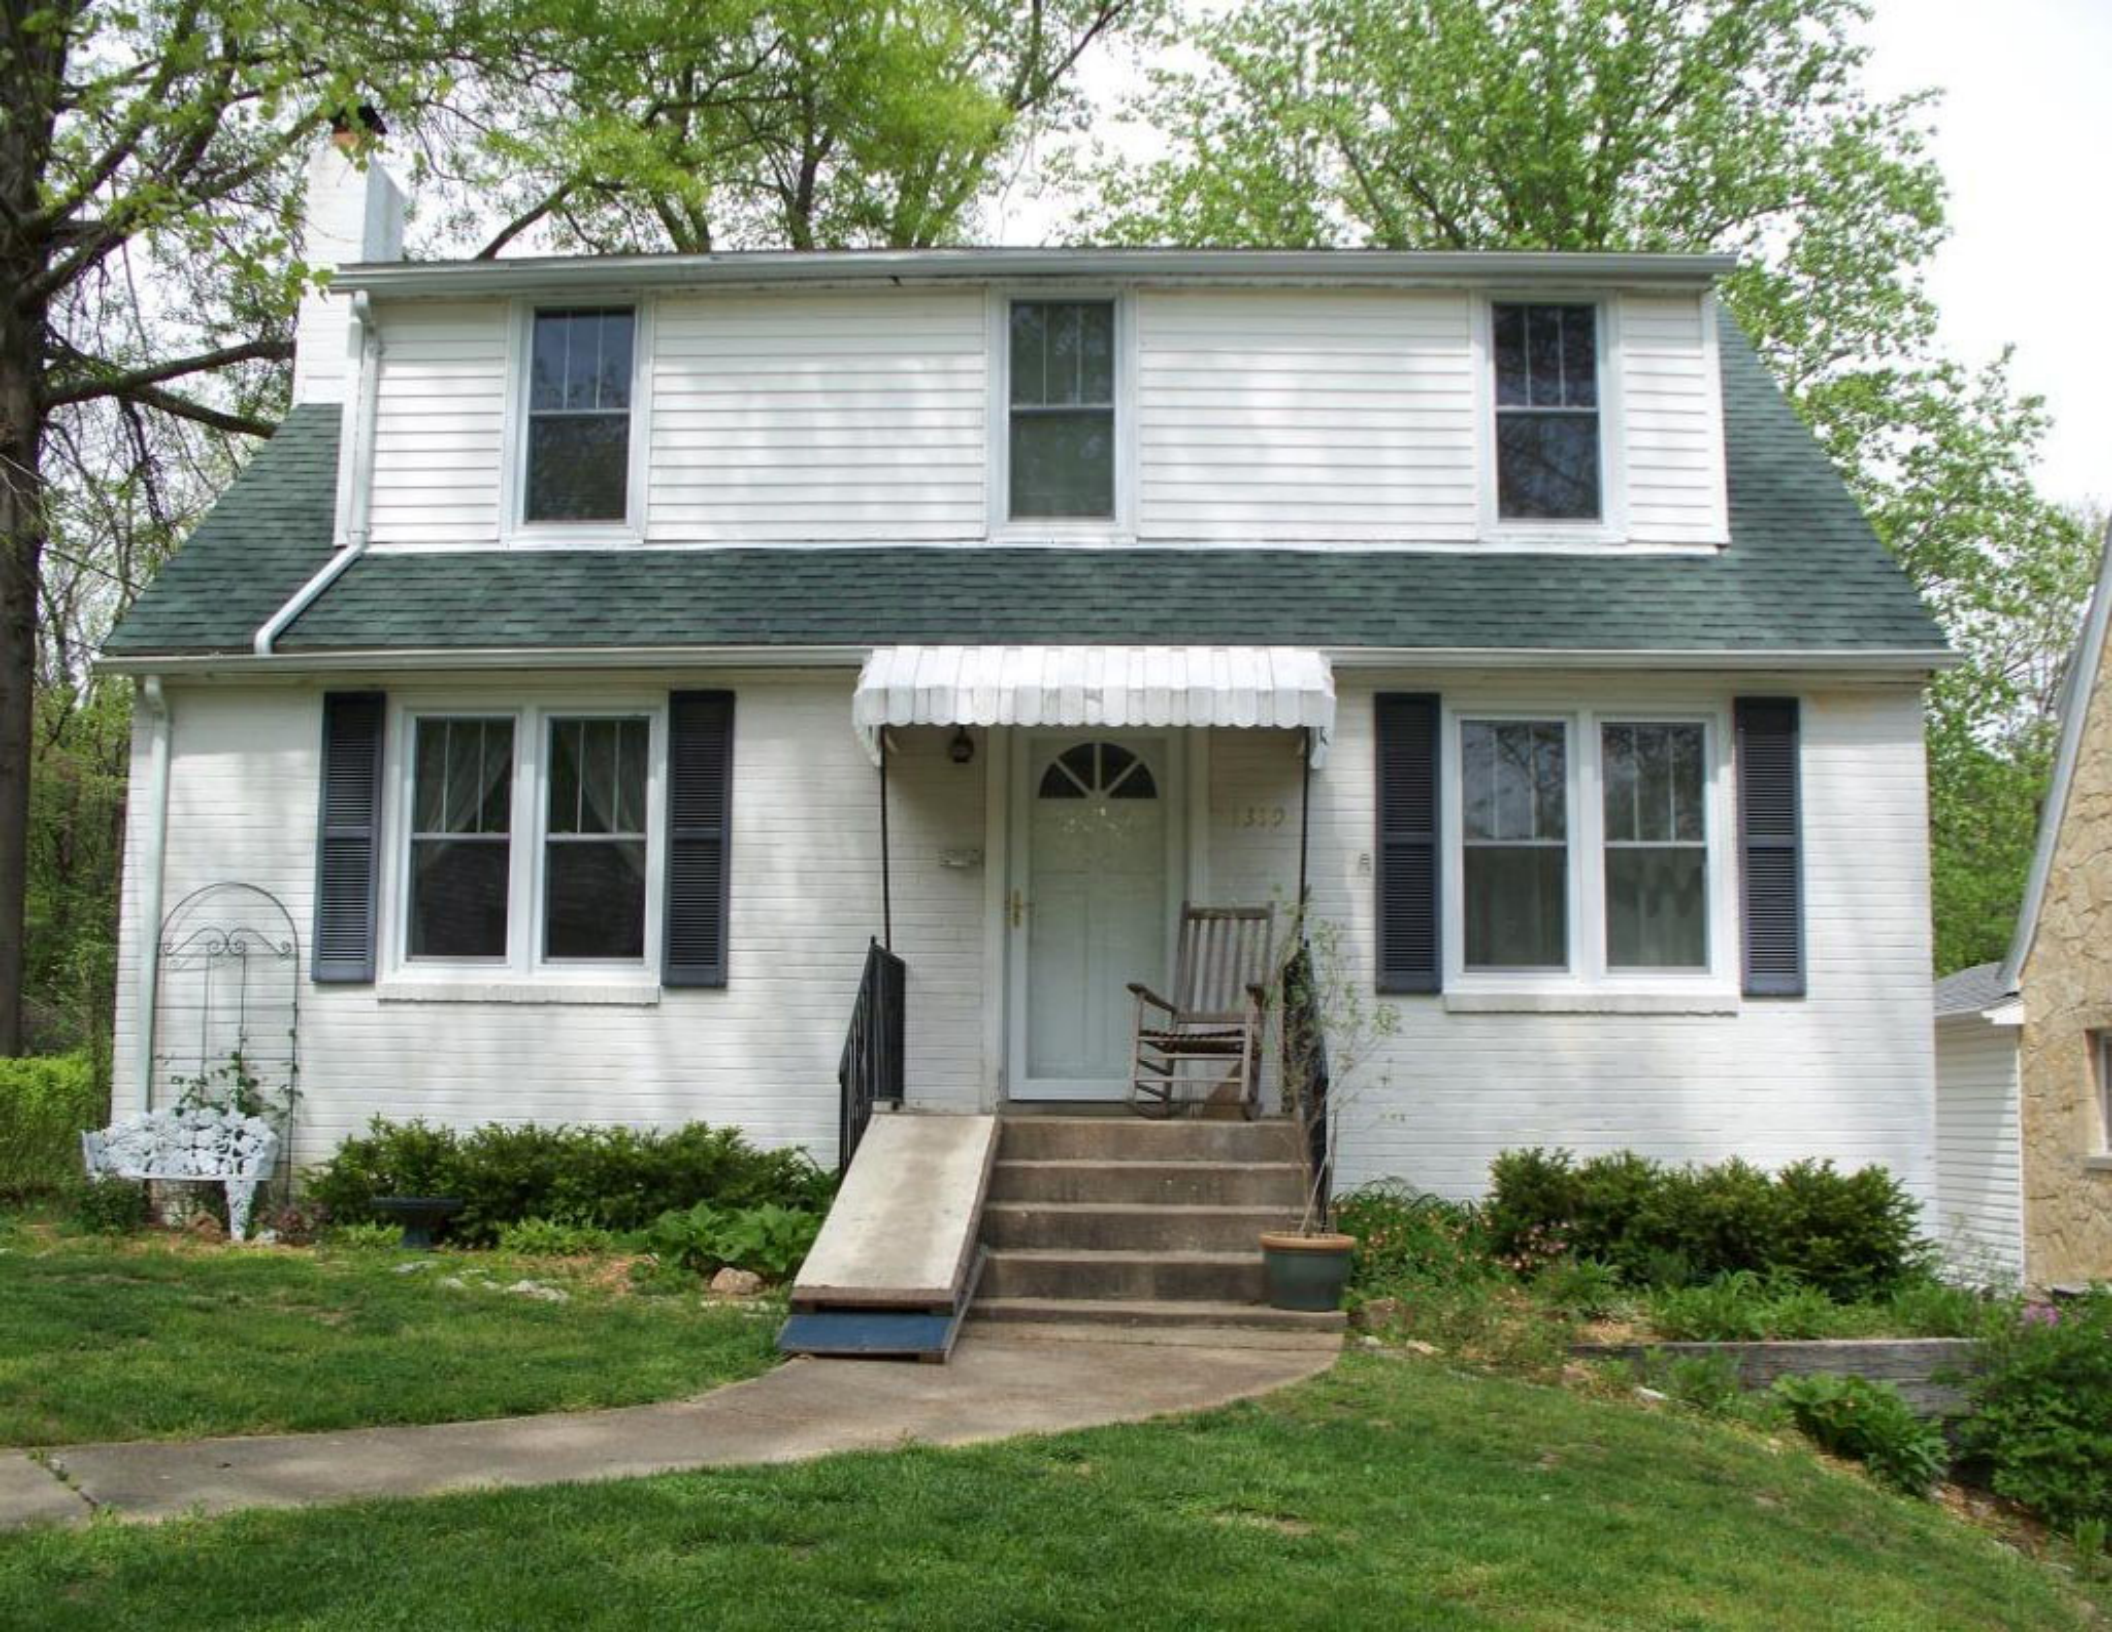
This 1 ½ story brick home has a side gable roof with a continuous vinyl shed dormer with three 3/1 windows. The ground floor has two paired 3/1 windows with shutters flanking the centered entrance that appears to have a replacement fanlight door. A set of concrete stairs and stoop with metal railing lead up to the door and is sheltered by a metal hood with braces. The windows have a historic profile but the muntins appear too thin and thus they could possibly be modern replacements. The Tax Assessor's Office dated this property at 1947, however it appears on the 1943 Sanborn map.

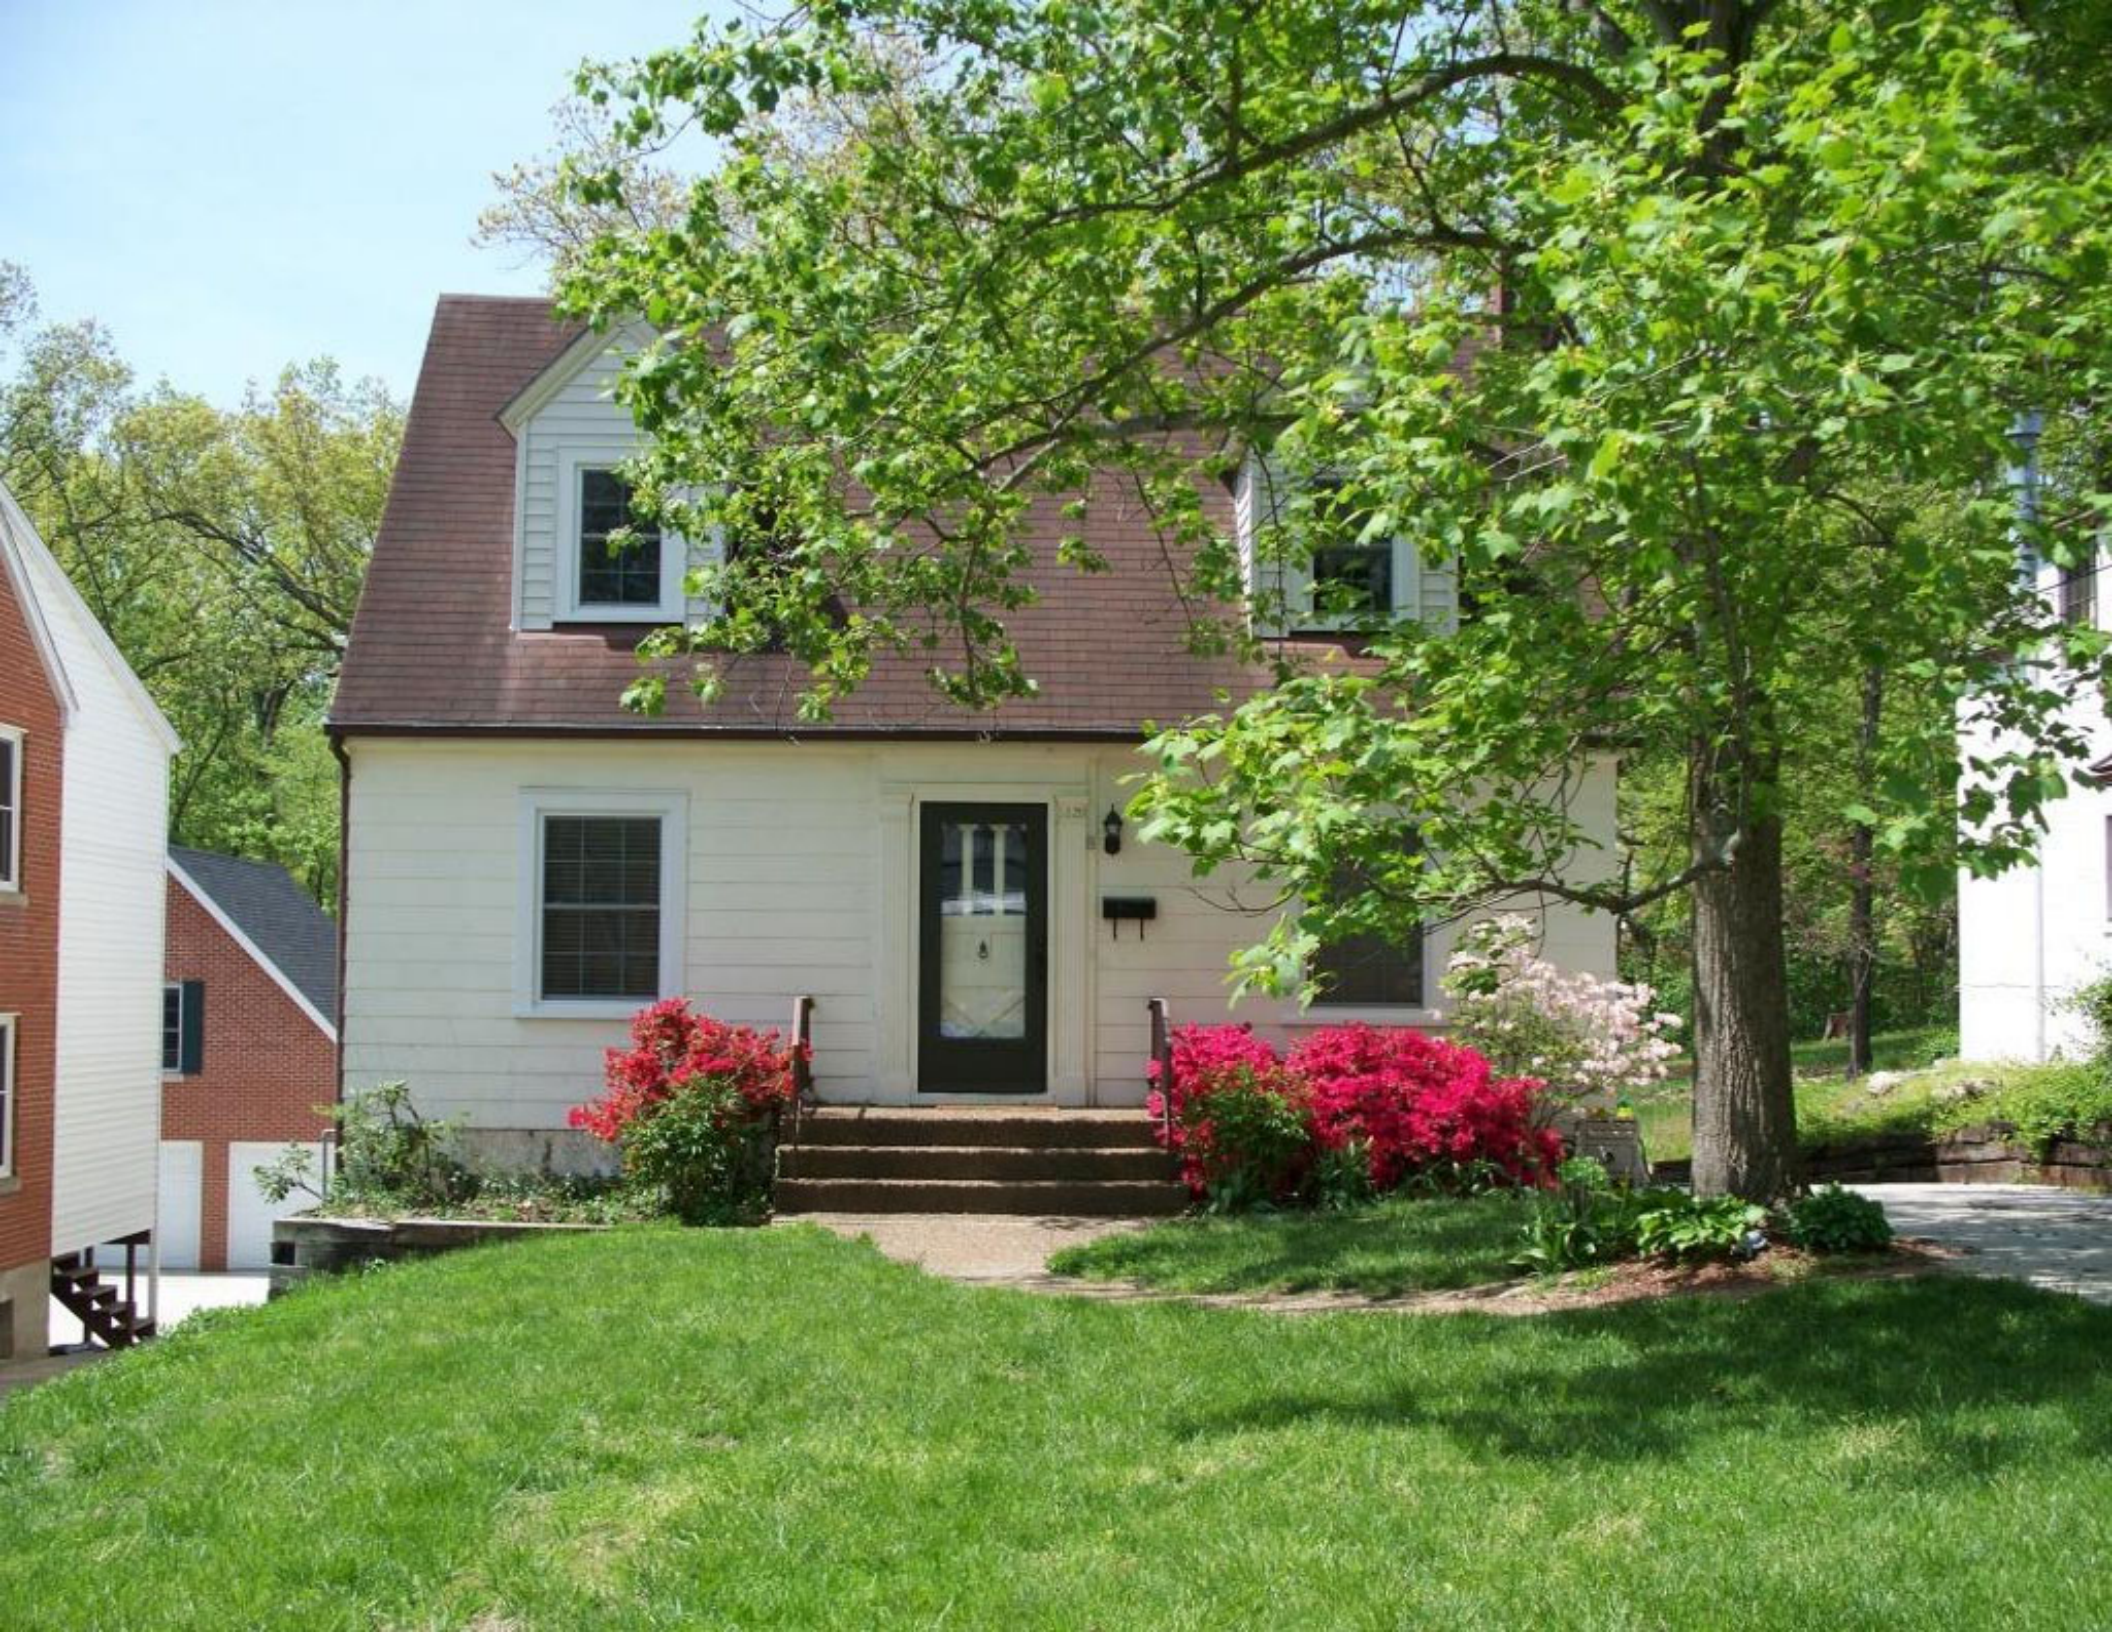
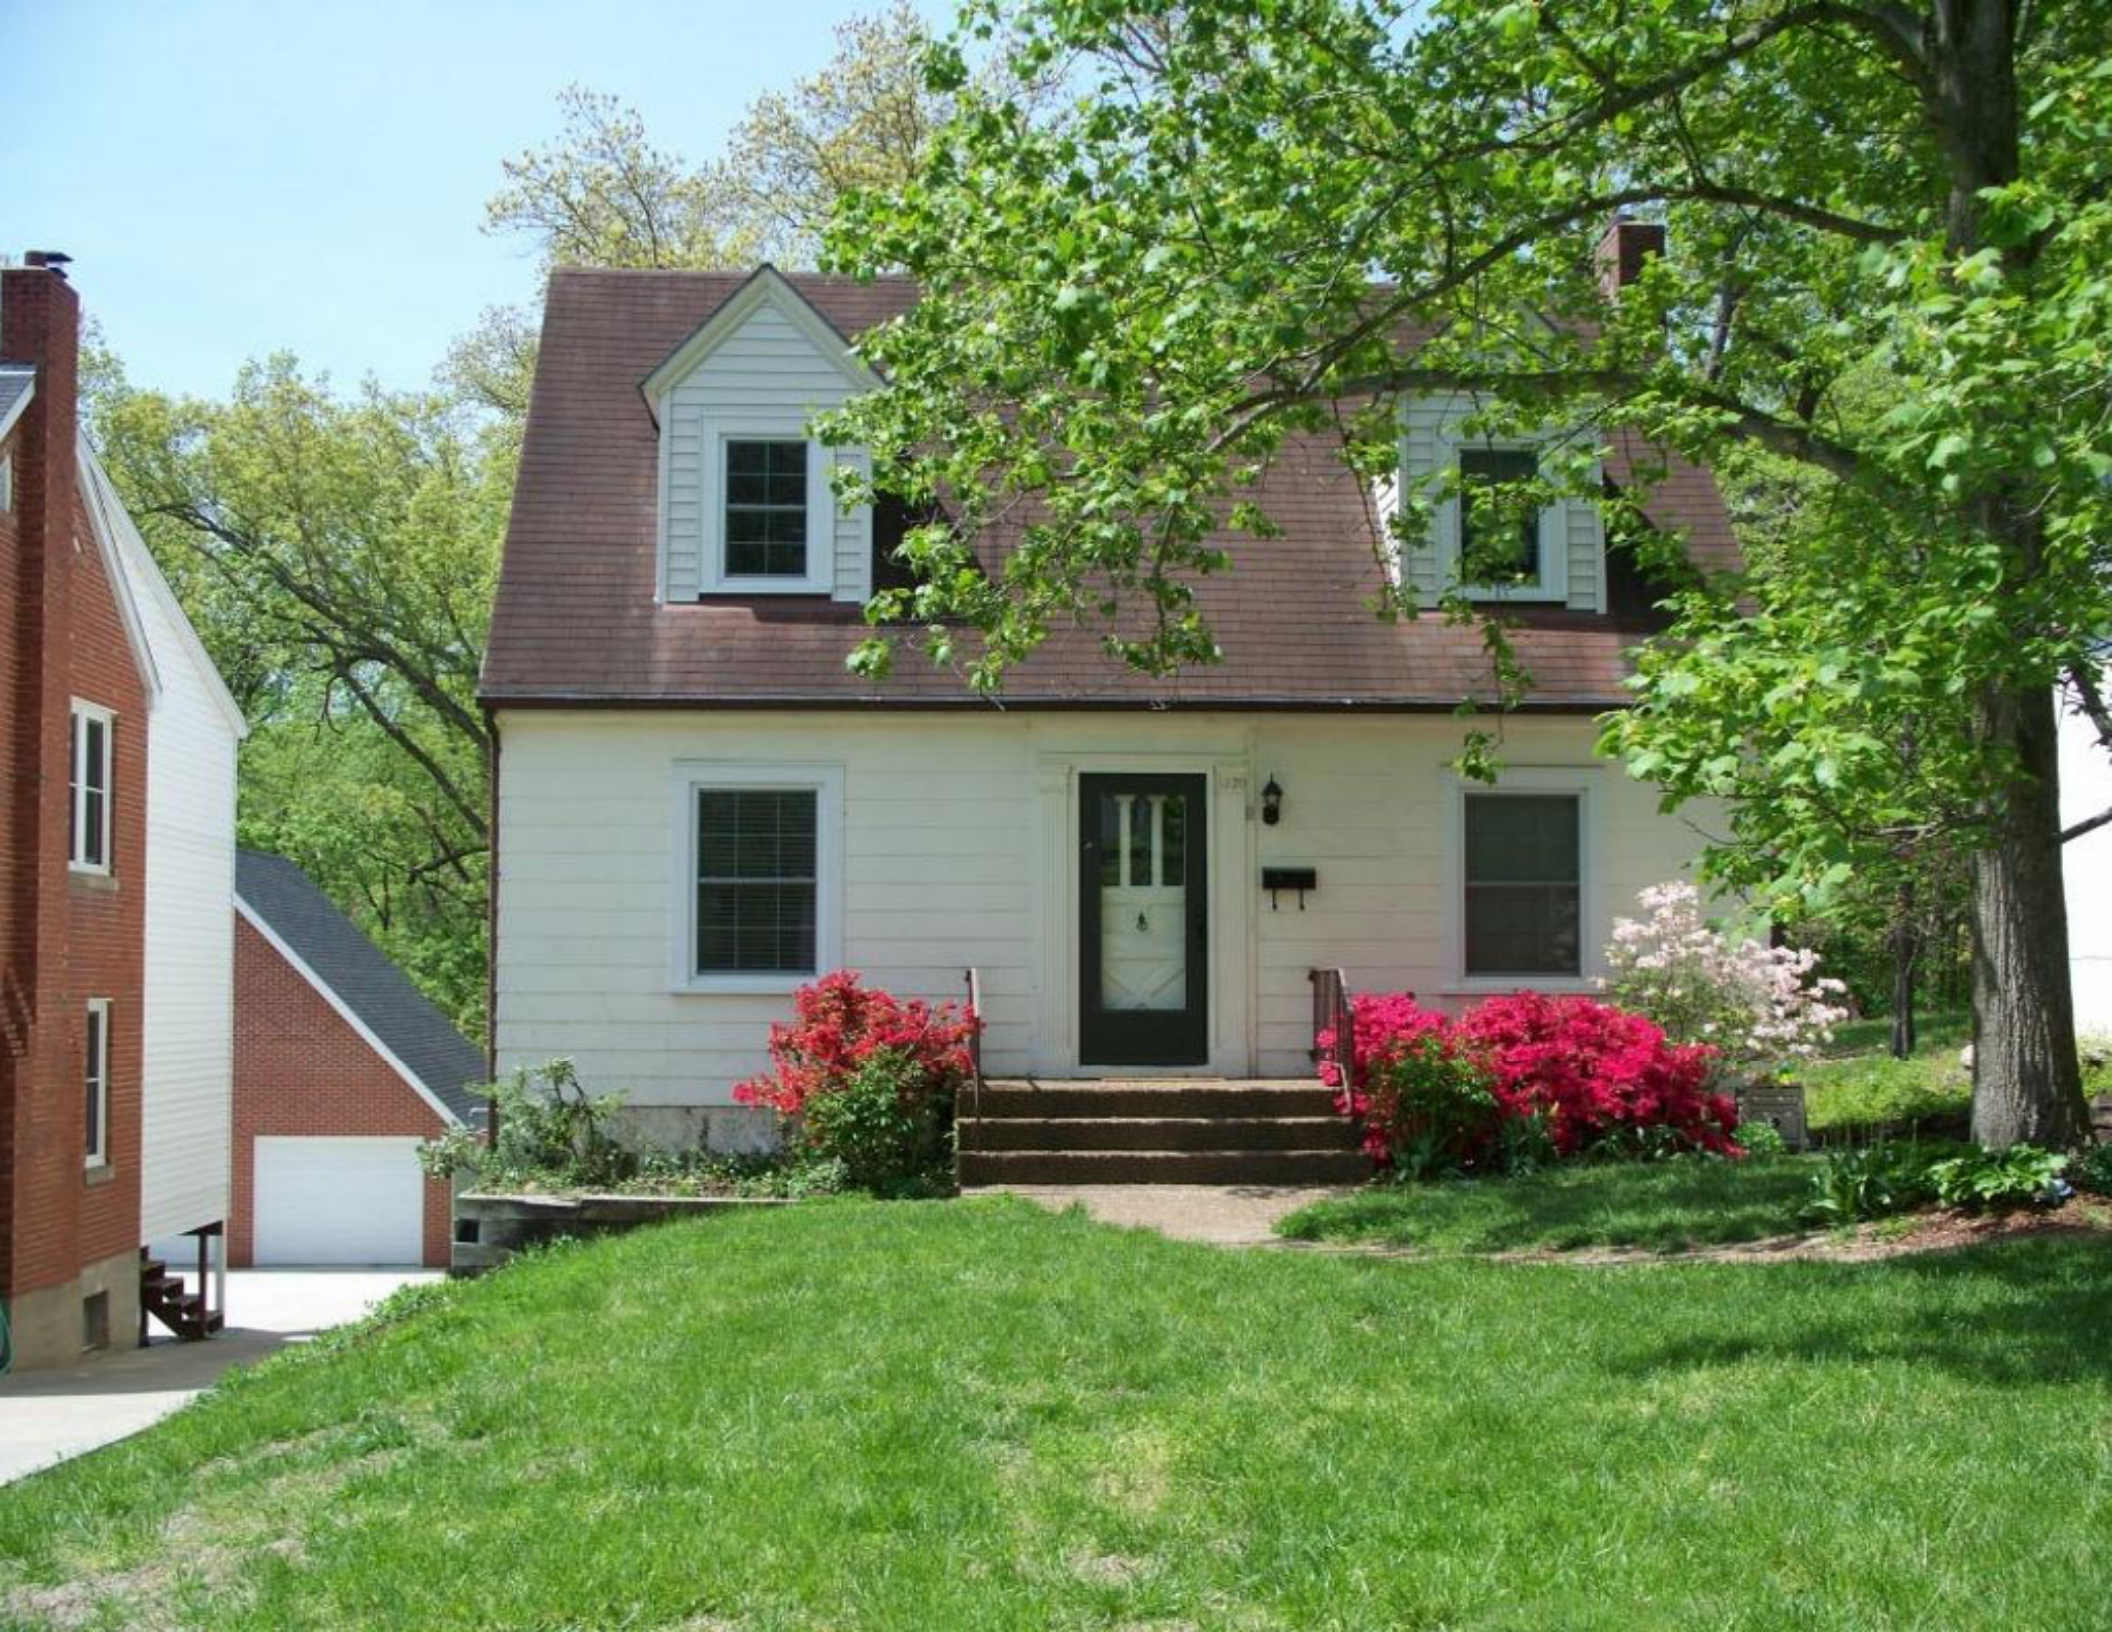
This 1 ½ story Cape Cod is clad in wood siding. It has a side gable roof with two gable dormers clad in vinyl with 4/4 windows. On the first floor there are two 6/6 window flanking the entrance, which has a Classical door surround with entablature. All of the windows are modern. A set of stairs with metal railing serves as the stoop.

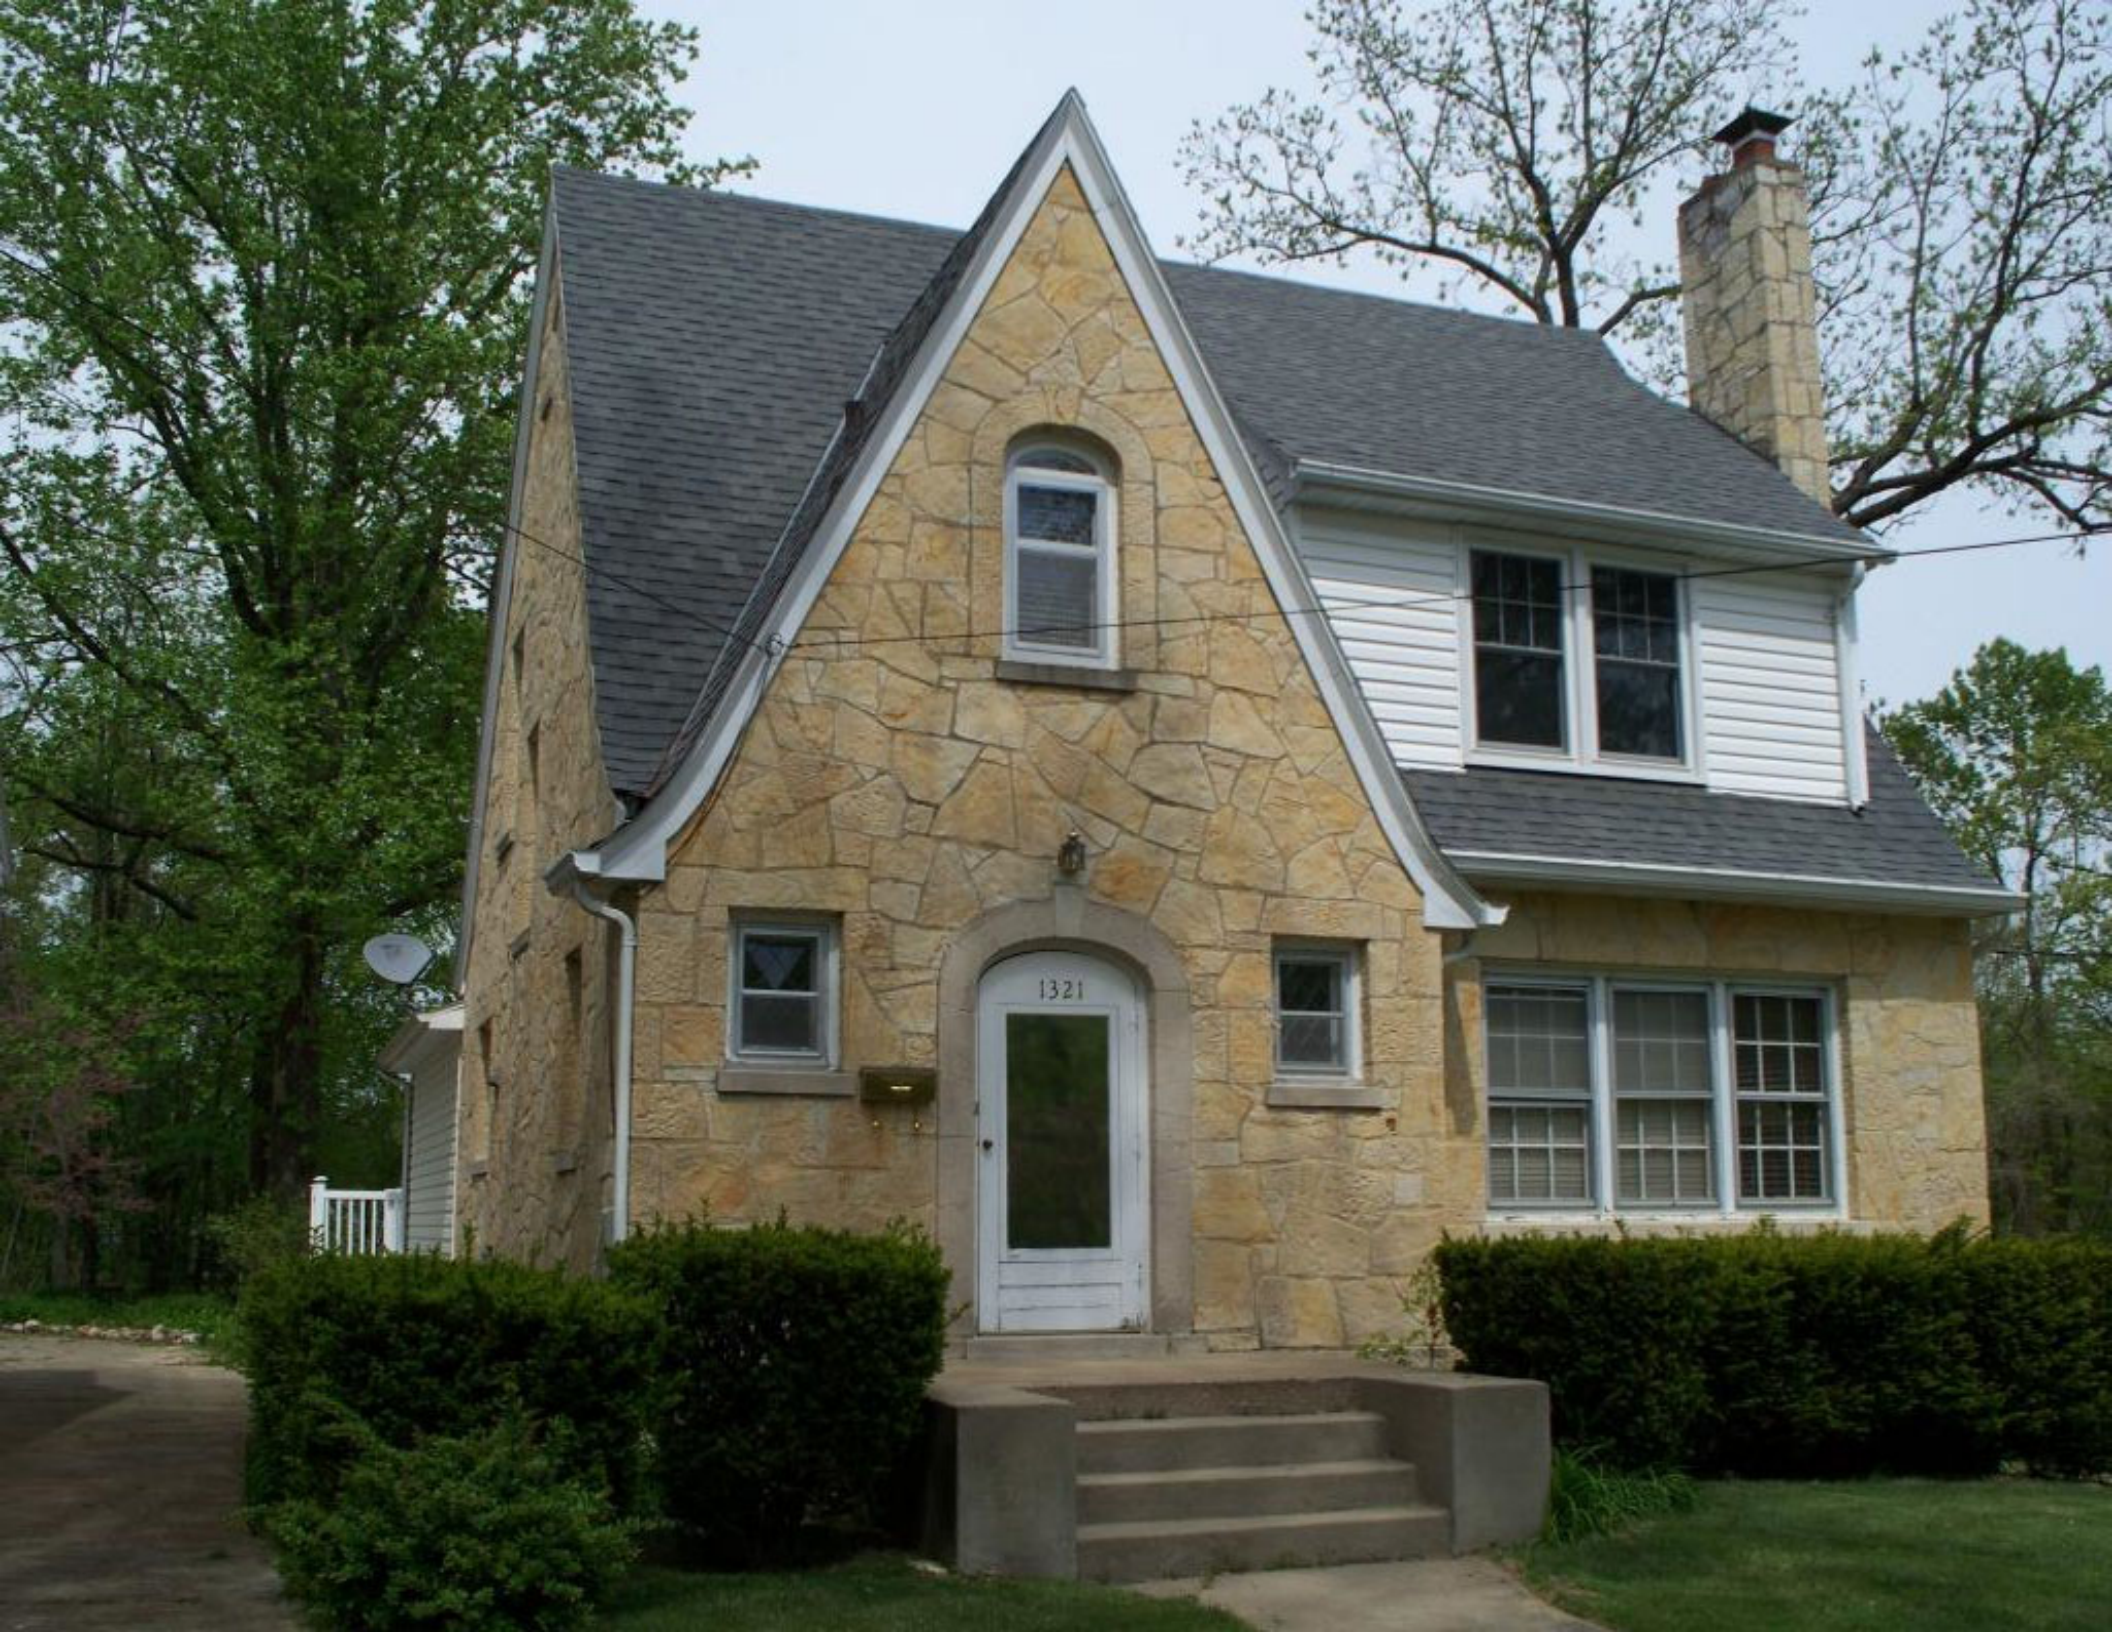
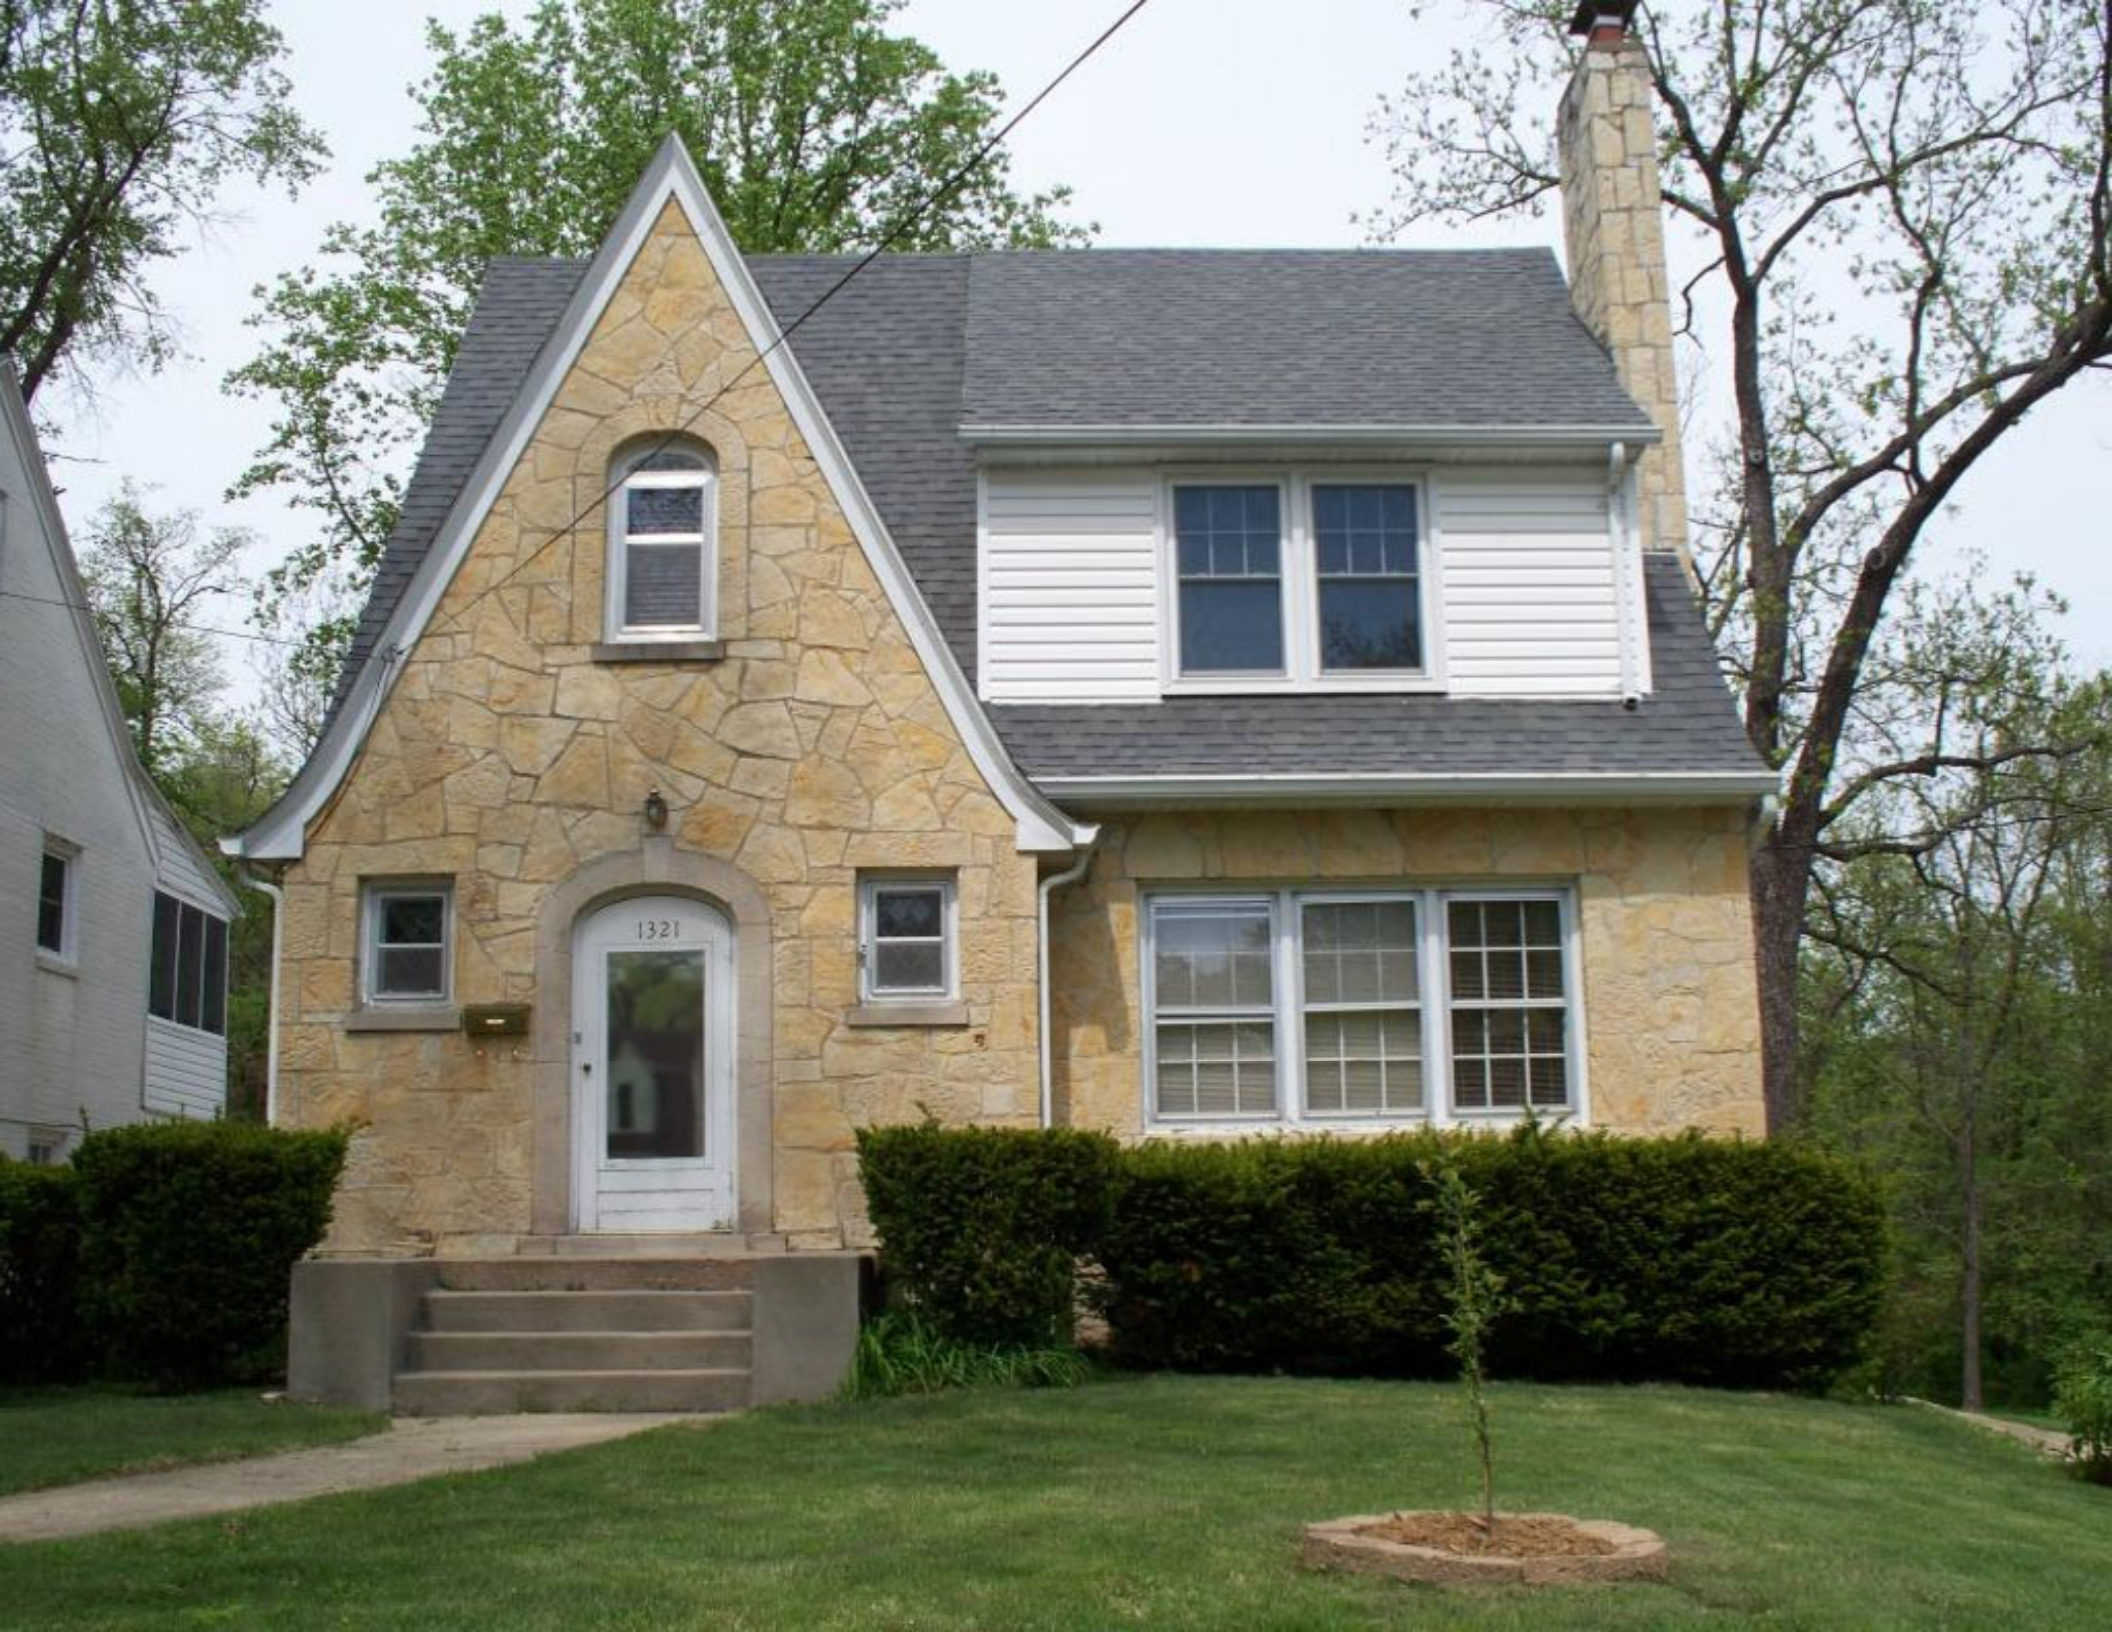
This 1 ½ story stone home has a side gable roof with a steeply pitched front gable in the first bay (left) that has a semi-circle arched window with transom in art glass. This window has a storm window and an arch with keystone formed out of the stones of the facade. In the right bay on the upper story is a shed dormer clad in vinyl with paired 6/1 windows.
The left bay projects slightly and contains two smaller casement windows in art glass with storms flanking a semi-circle entrance with a stone archway and keystone (limestone?). The windows in this bay on both floors have limestone sills. There is a row of three 6/6 replacement windows in the right bay. A concrete stair and stoop lead up to the entrance.
