ARCHITECTURAL/HISTORIC INVENTORY FORM

1. Survey No. CO-AS-005-001		2. Survey name: Moreau Drive Neighborhood Survey	
3. County: Cole		4. Address: 1202 Elmerine Ave.	
5. City: Jefferson City	Vicinity: <input type="checkbox"/>	6. UTM: / /	7. Township/Range/Section: T: R: S:
8. Historic name (if known):		9. Present/other name (if known):	
10. Ownership: <input checked="" type="checkbox"/> Private <input type="checkbox"/> Public		11. Historic use (if known): Residential	11. Current use: Residential

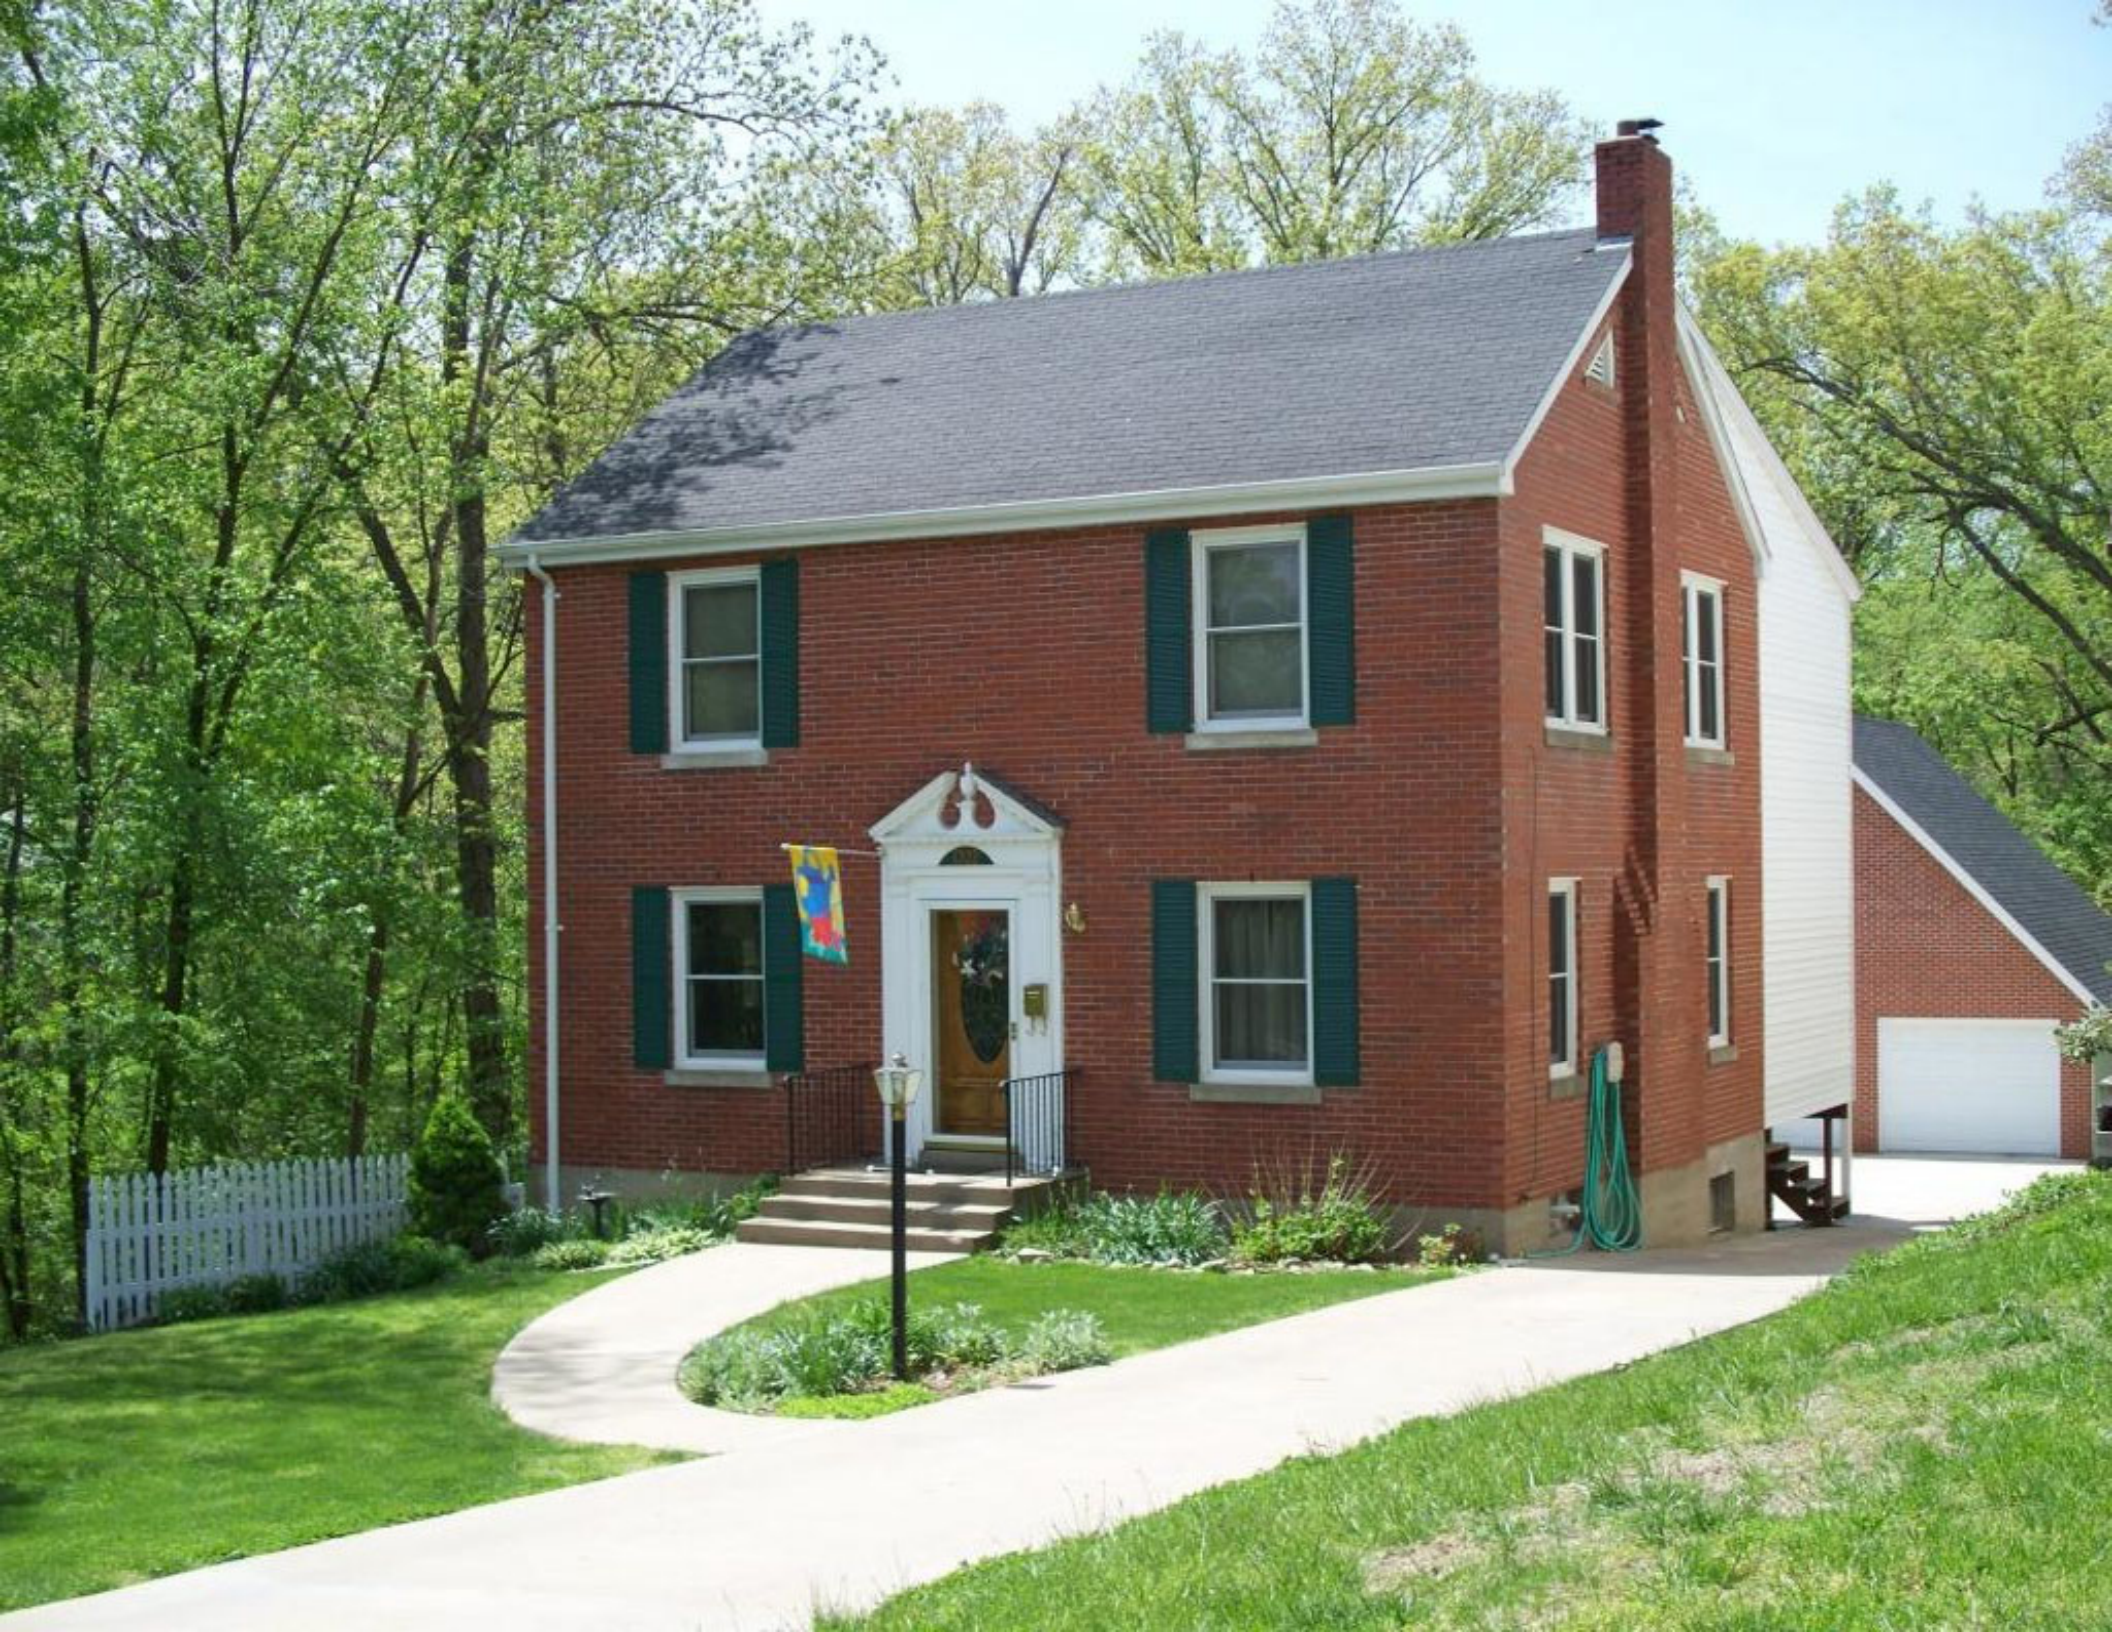
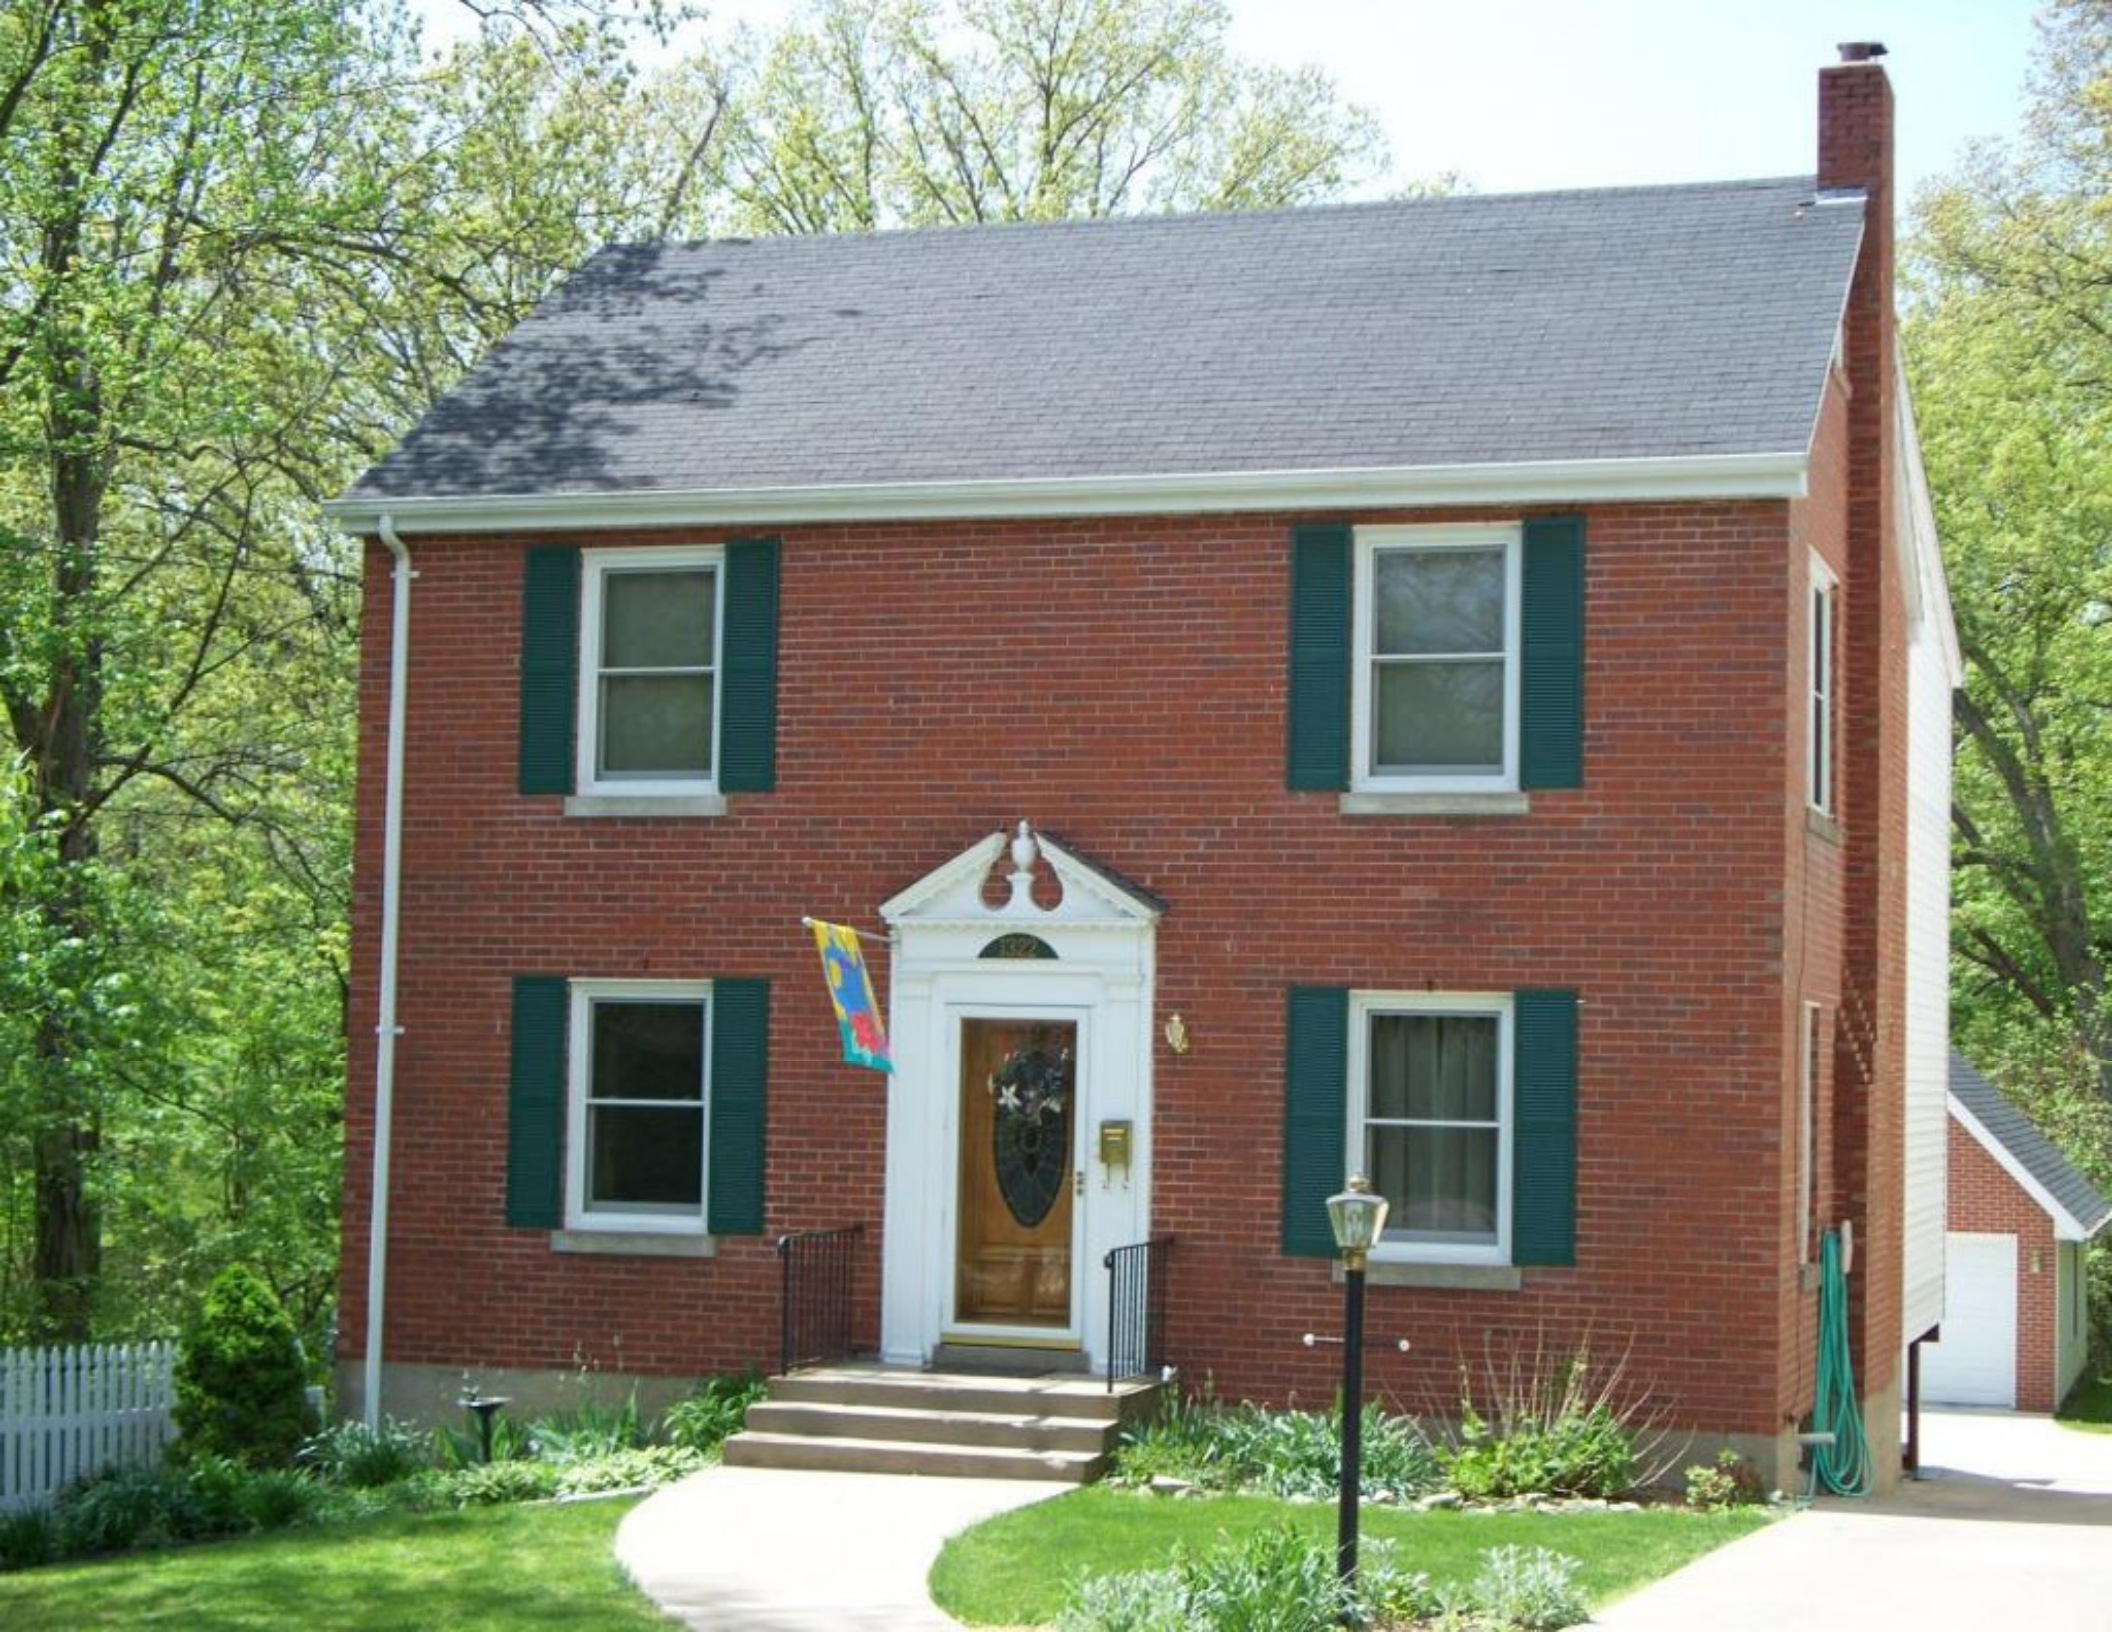
41. (cont.)
This two story brick home I-House has Colonial Revival detailing (shutters, door surround). The home has a side gable roof and two windows 1/1 replacement windows on each floor. The entrance is centered and has an ornate broken pediment door surround. The windows have shutters and concrete sills. A centrally located concrete stair with metal railing serves as the stoop. A two story addition has been added to the back and clad in vinyl.

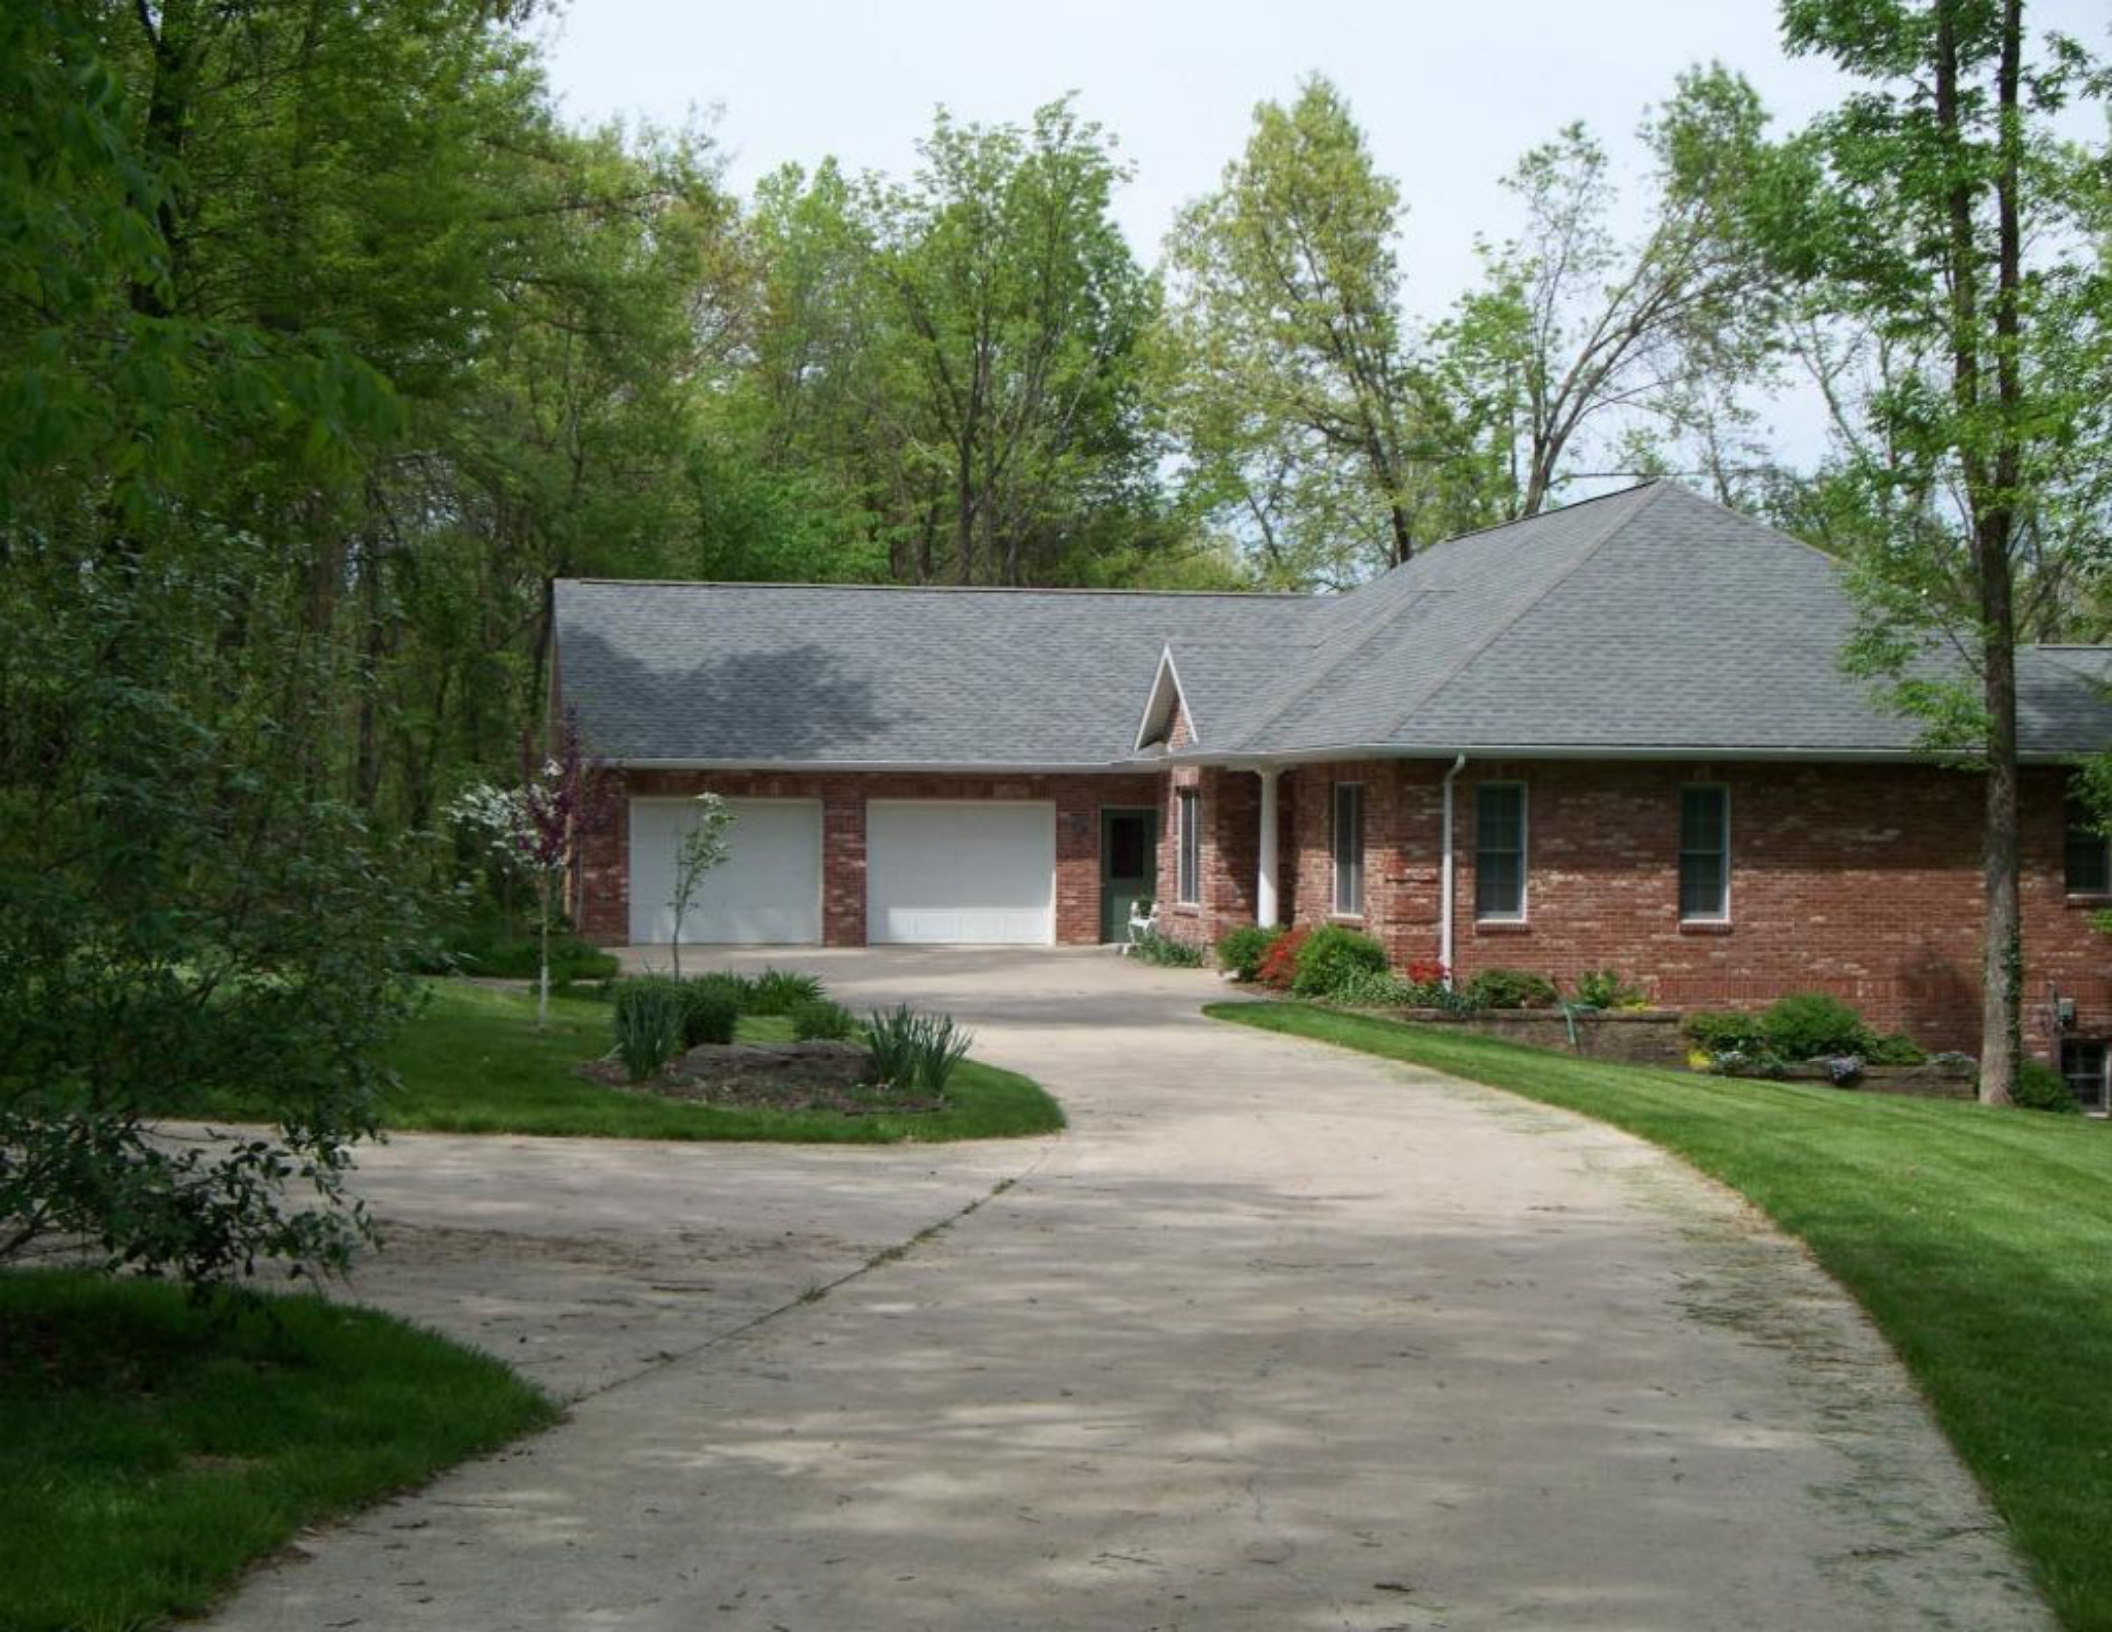
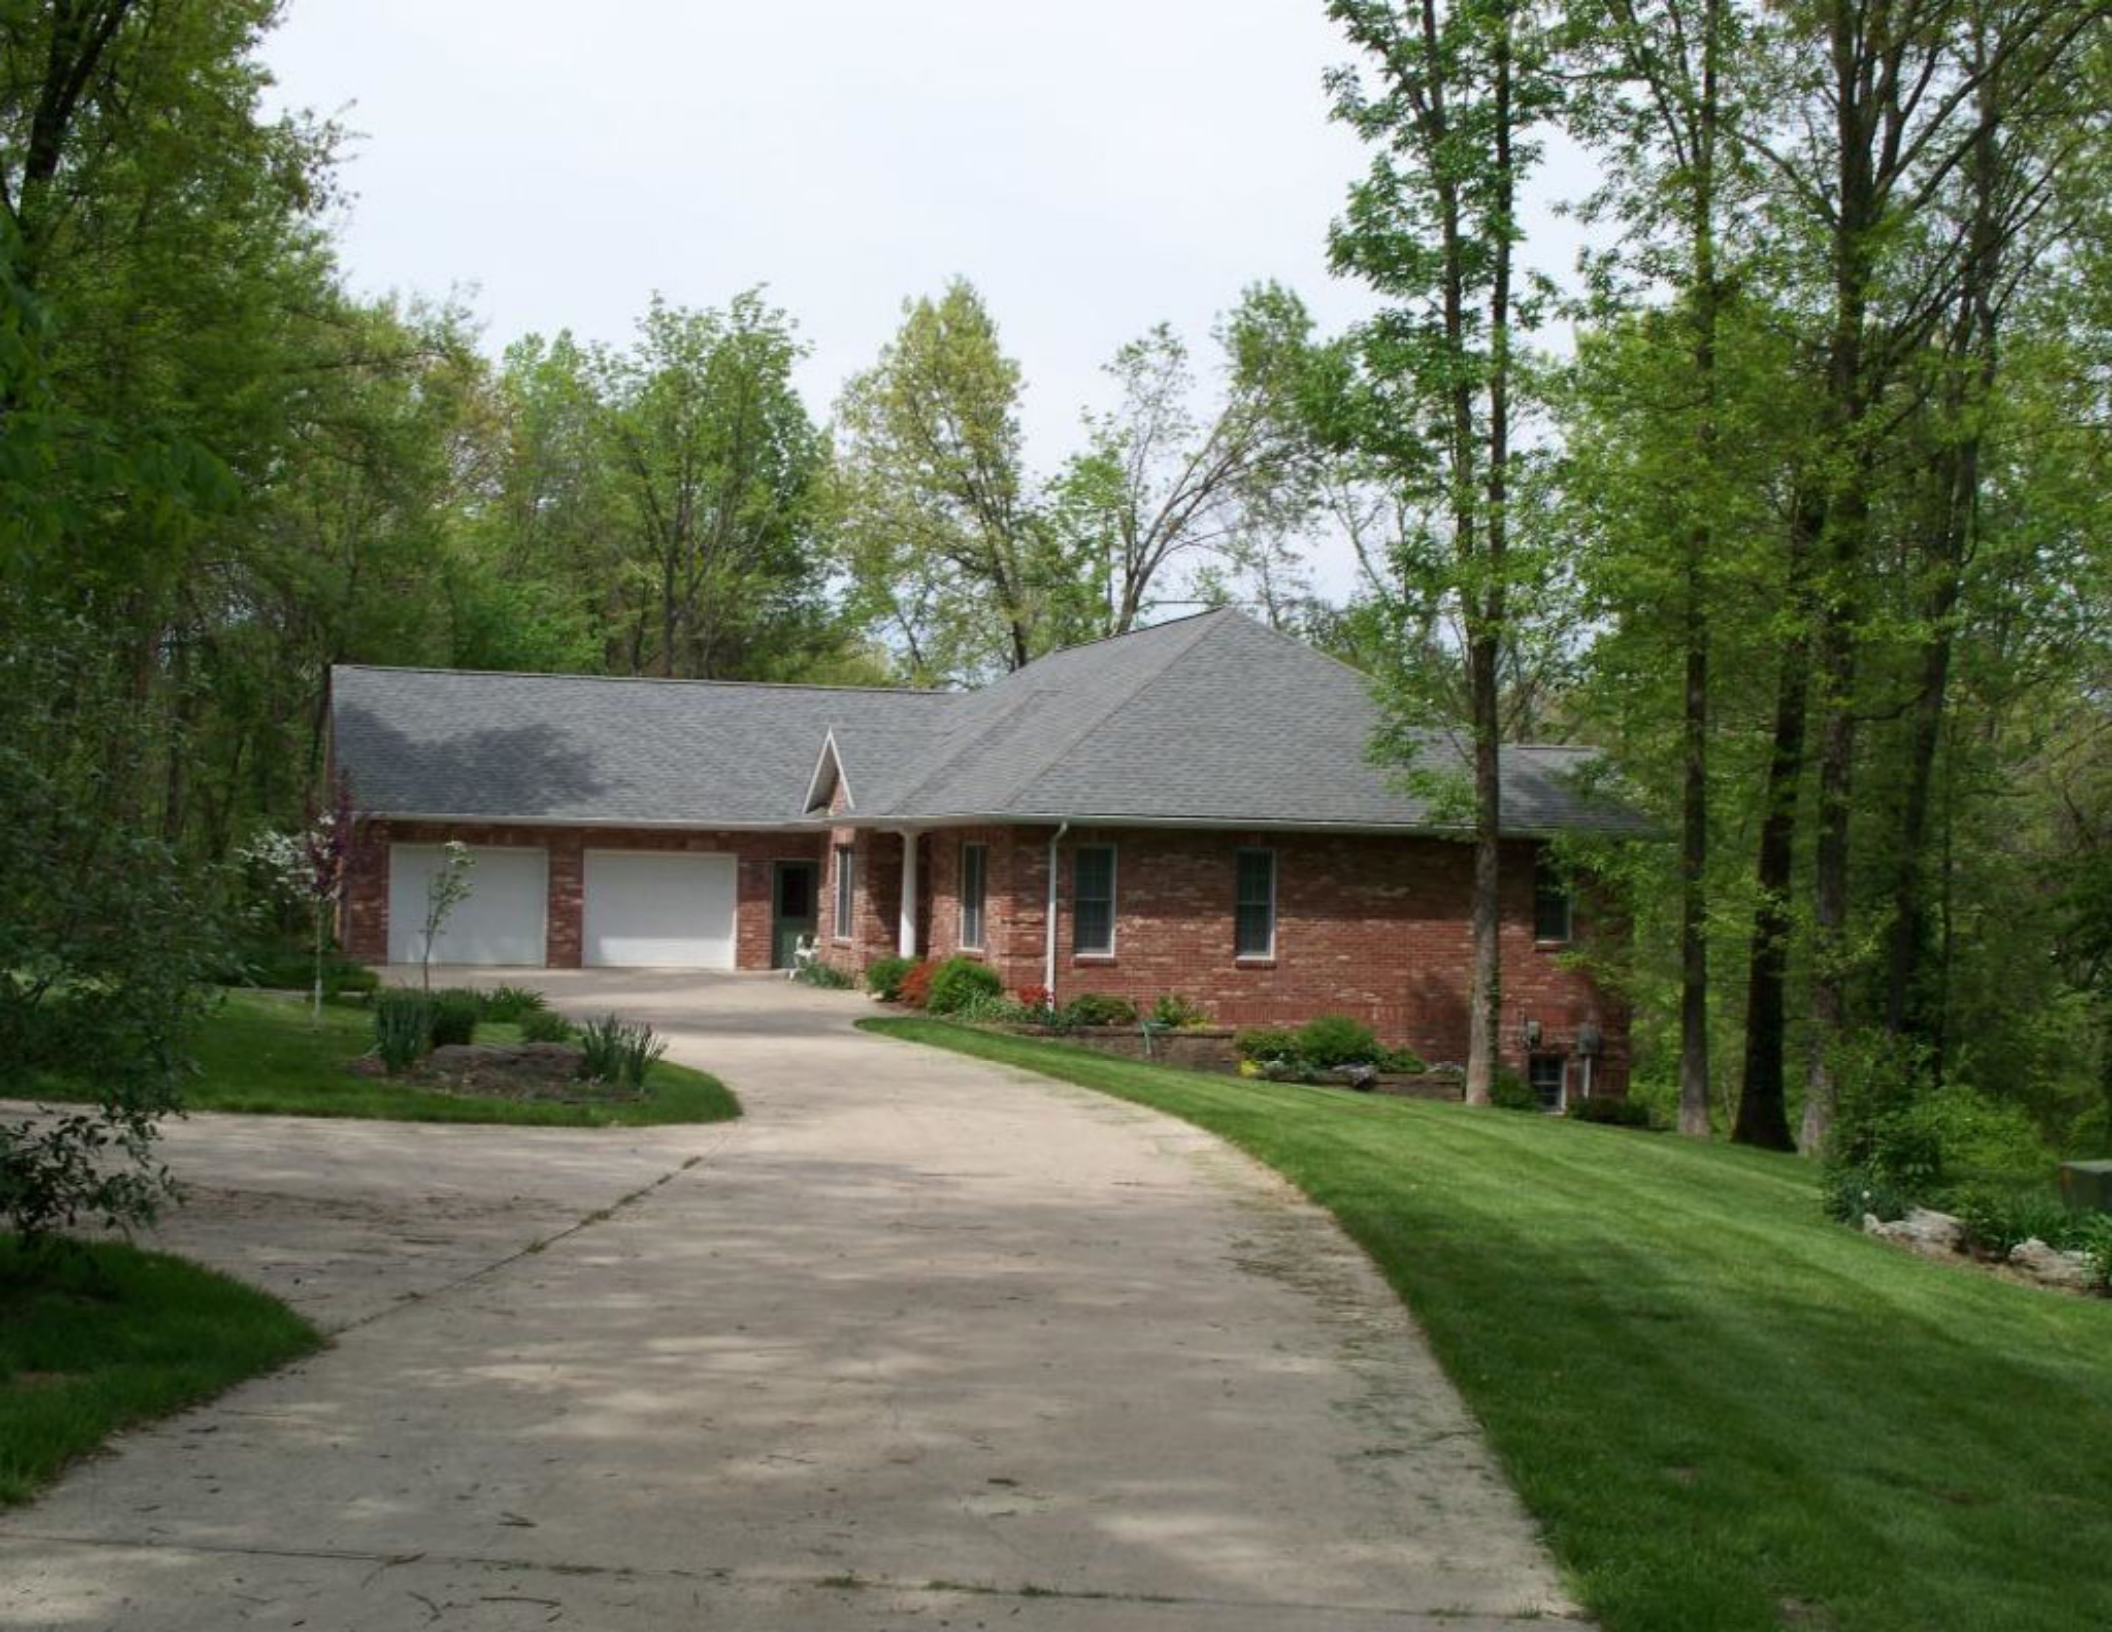
41. (cont.)
This is a modern brick ranch home that is either L shaped or T shaped with attached two car garage. Due to the construction date it would not contribute to a historic district.

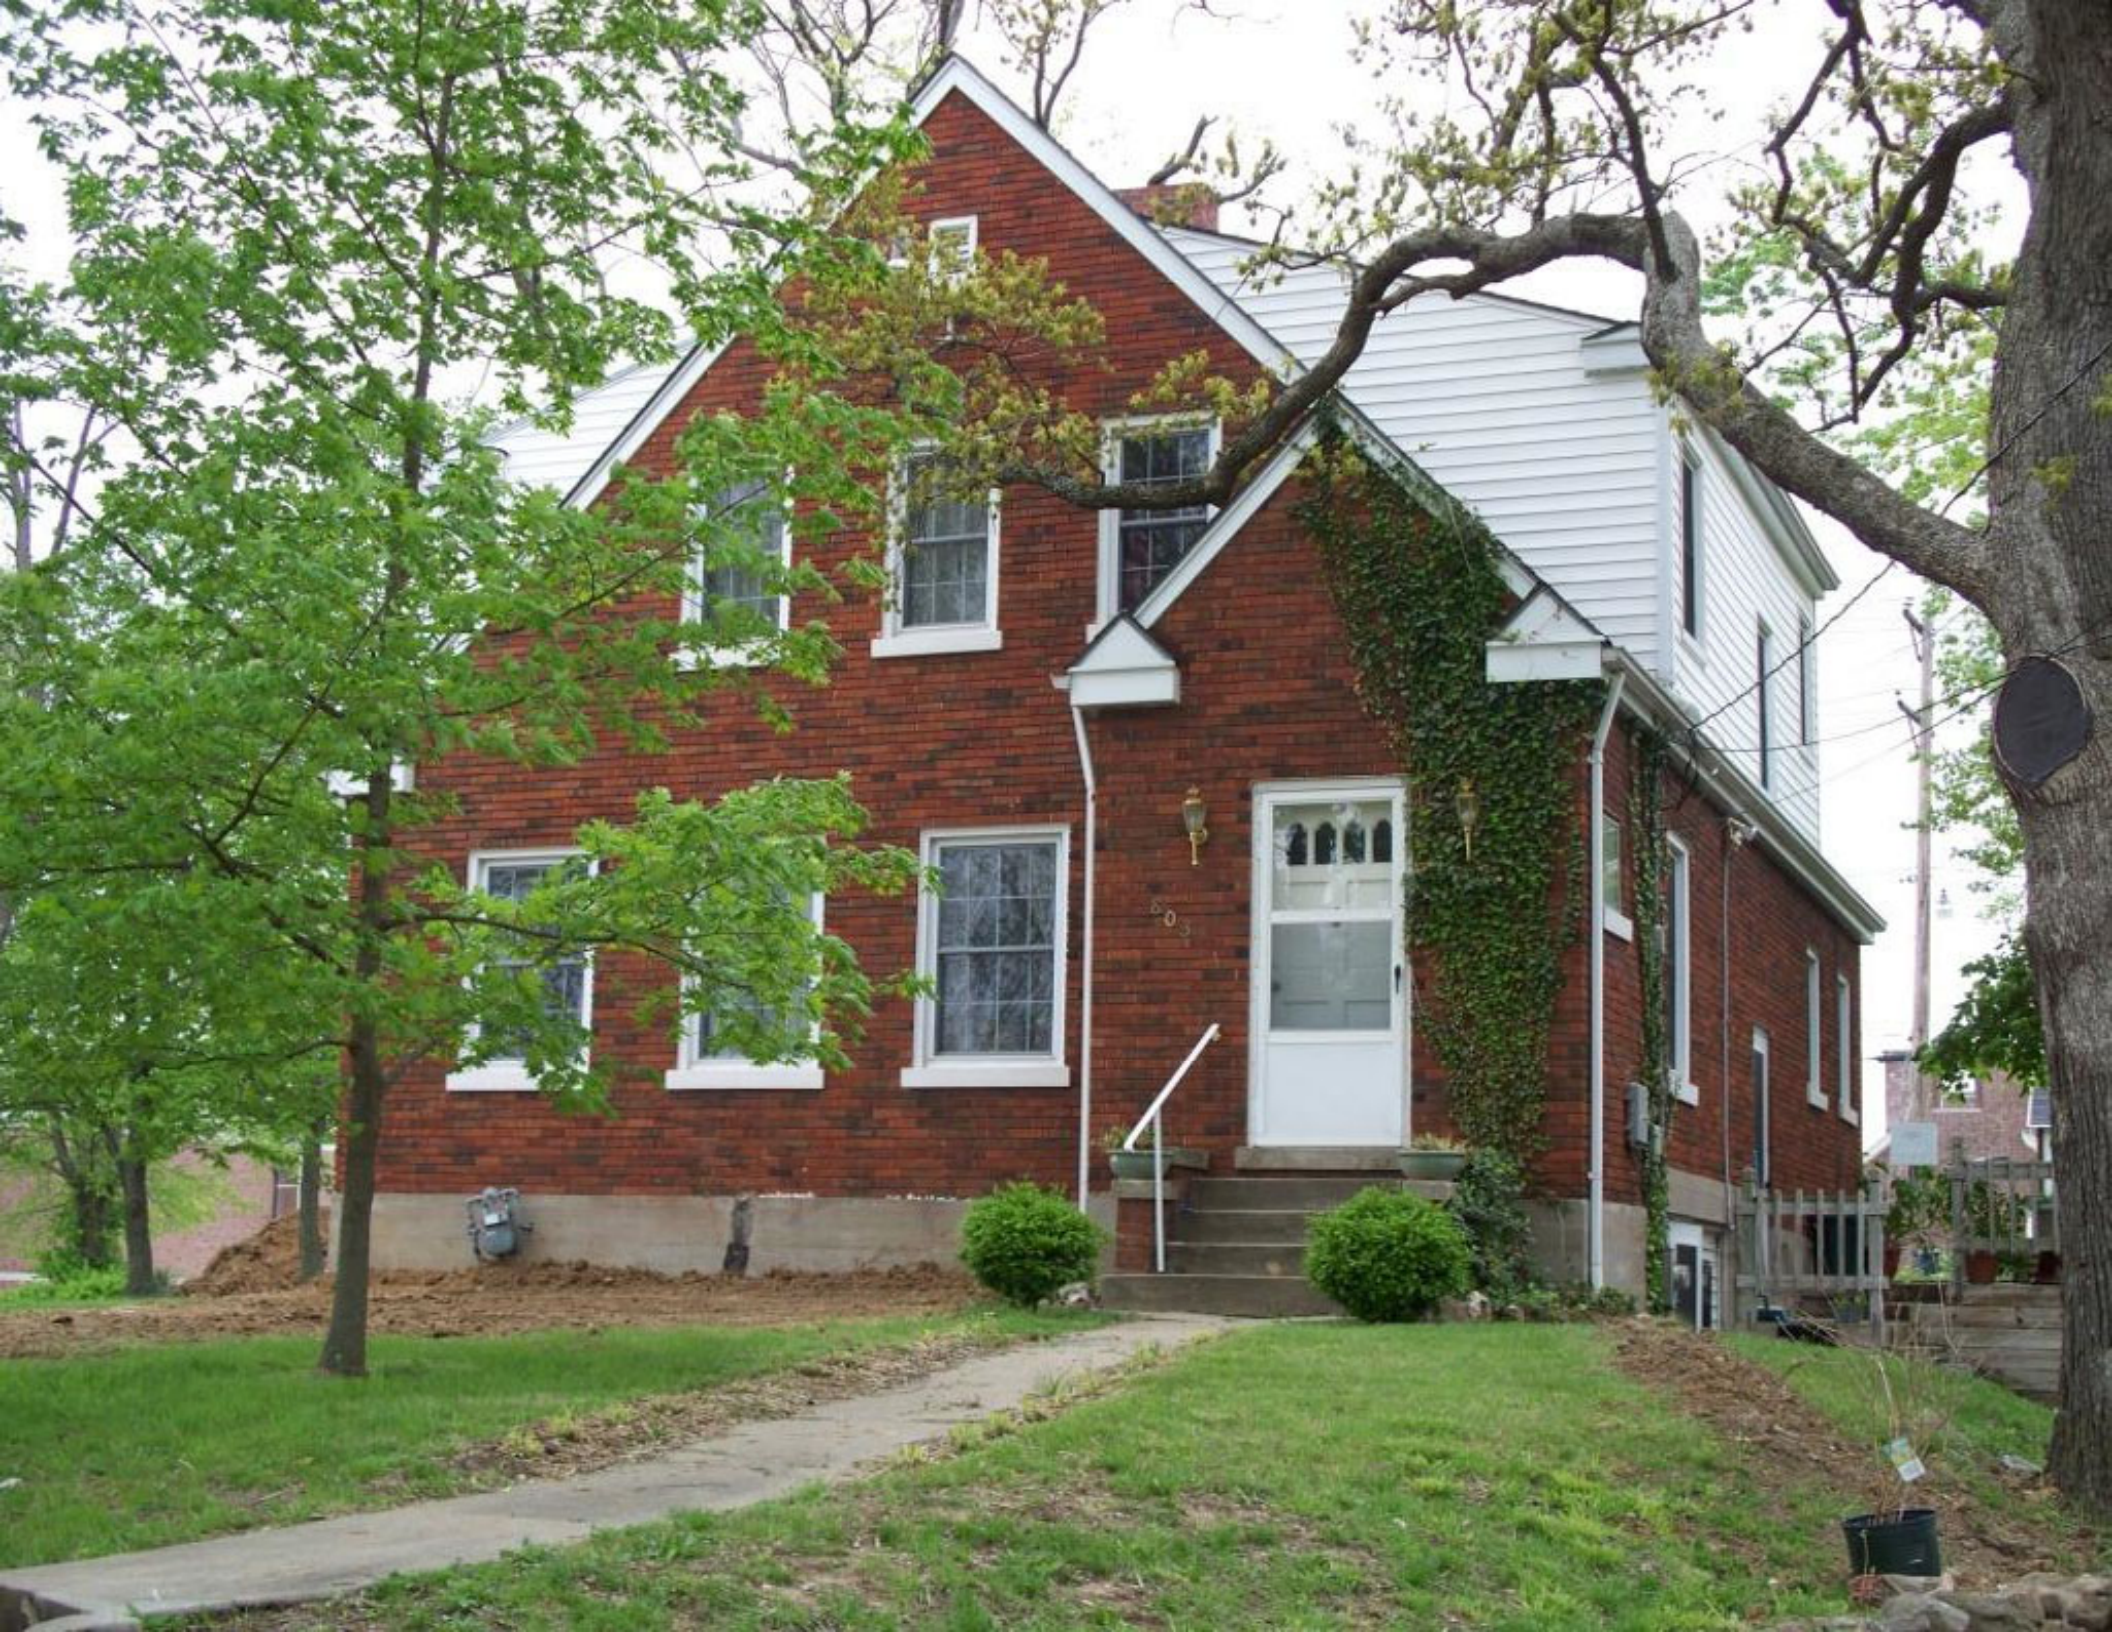
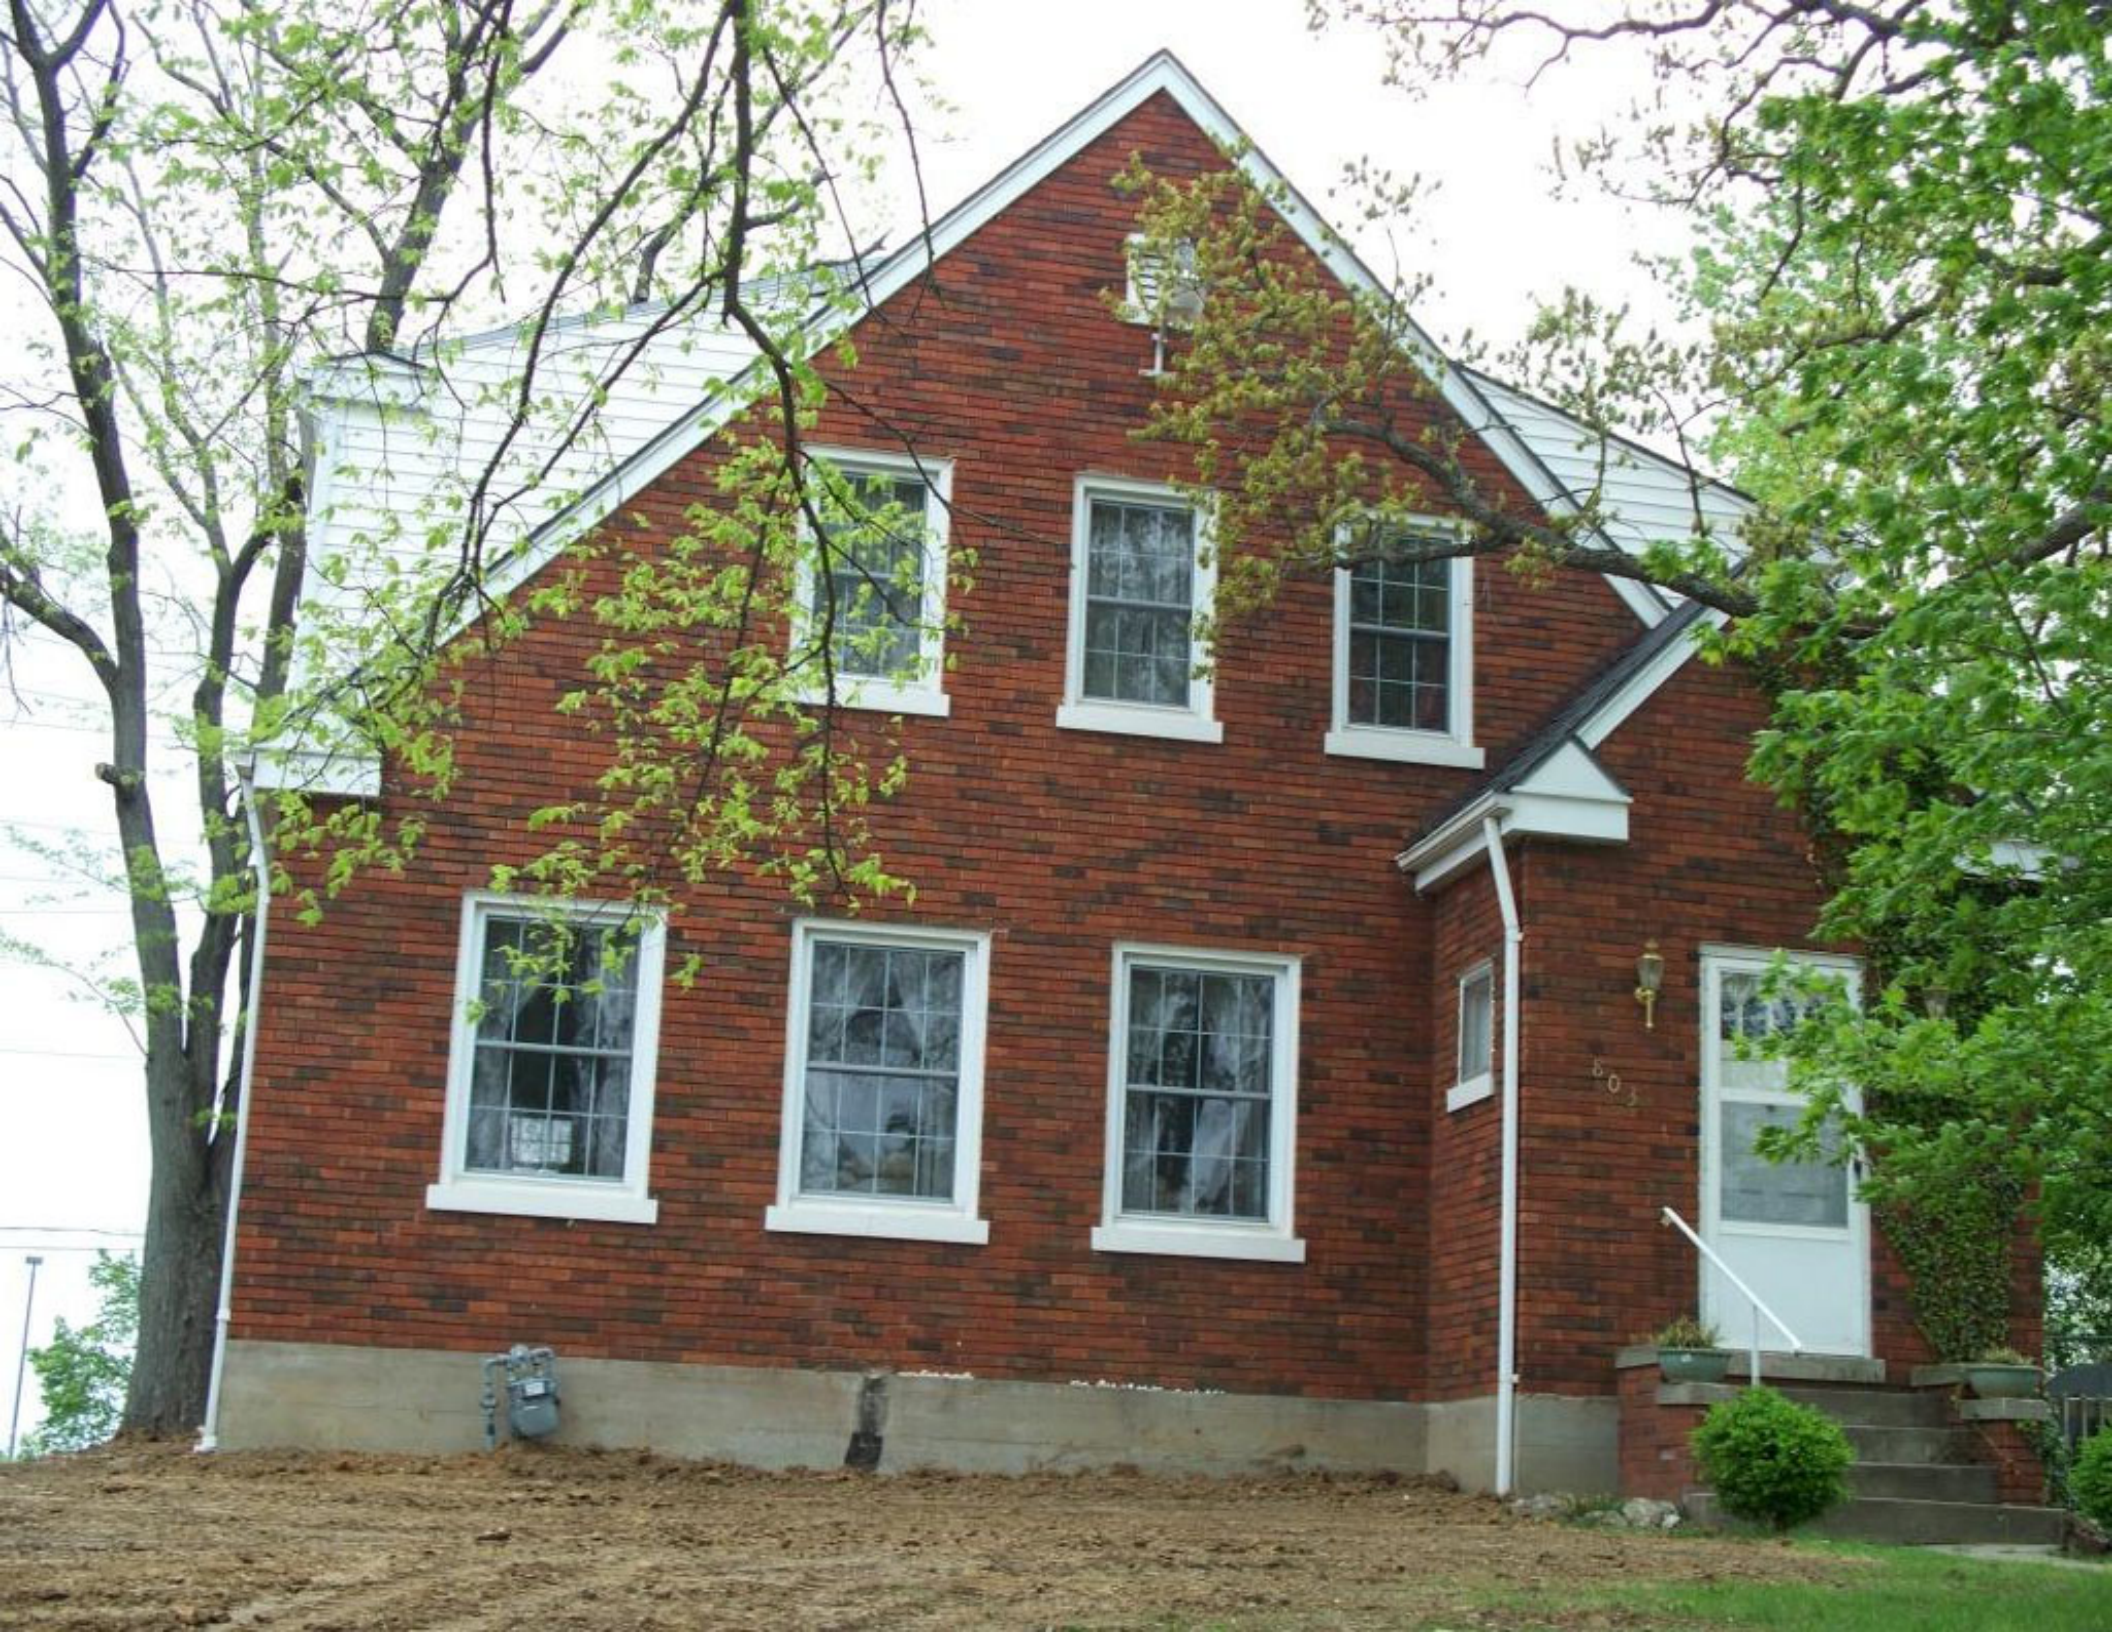
This brick Tudor has two large dormers that stretch from each side of the roof, making the original one-and-a-half-story building two-stories tall. The dormers are clad in vinyl. On the main façade of the home there is a vent in the gable and three 6/6 replacement windows on the second floor. The first floor has three replacement 8/8 windows. To the right of these windows is the gabled entrance that projects from the façade. The gabled return of this portion of the home has decorative pediments flanking the door, which may also be modern. A concrete stair and stoop with brick half-walls lead up to the entrance. Due to the modern windows and large dormers the property may be non-contributing to the district. However it retains its Tudor style and original footprint so it's possible it could be contributing. For now it is considered undetermined.
