ARCHITECTURAL/HISTORIC INVENTORY FORM

1. Survey No. CO-AS-005-001		2. Survey name: Moreau Drive Neighborhood Survey	
3. County: Cole		4. Address: 1202 Elmerine Ave.	
5. City: Jefferson City	Vicinity: <input type="checkbox"/>	6. UTM: / /	7. Township/Range/Section: T: R: S:
8. Historic name (if known):		9. Present/other name (if known):	
10. Ownership: <input checked="" type="checkbox"/> Private <input type="checkbox"/> Public		11. Historic use (if known): Residential	11. Current use: Residential

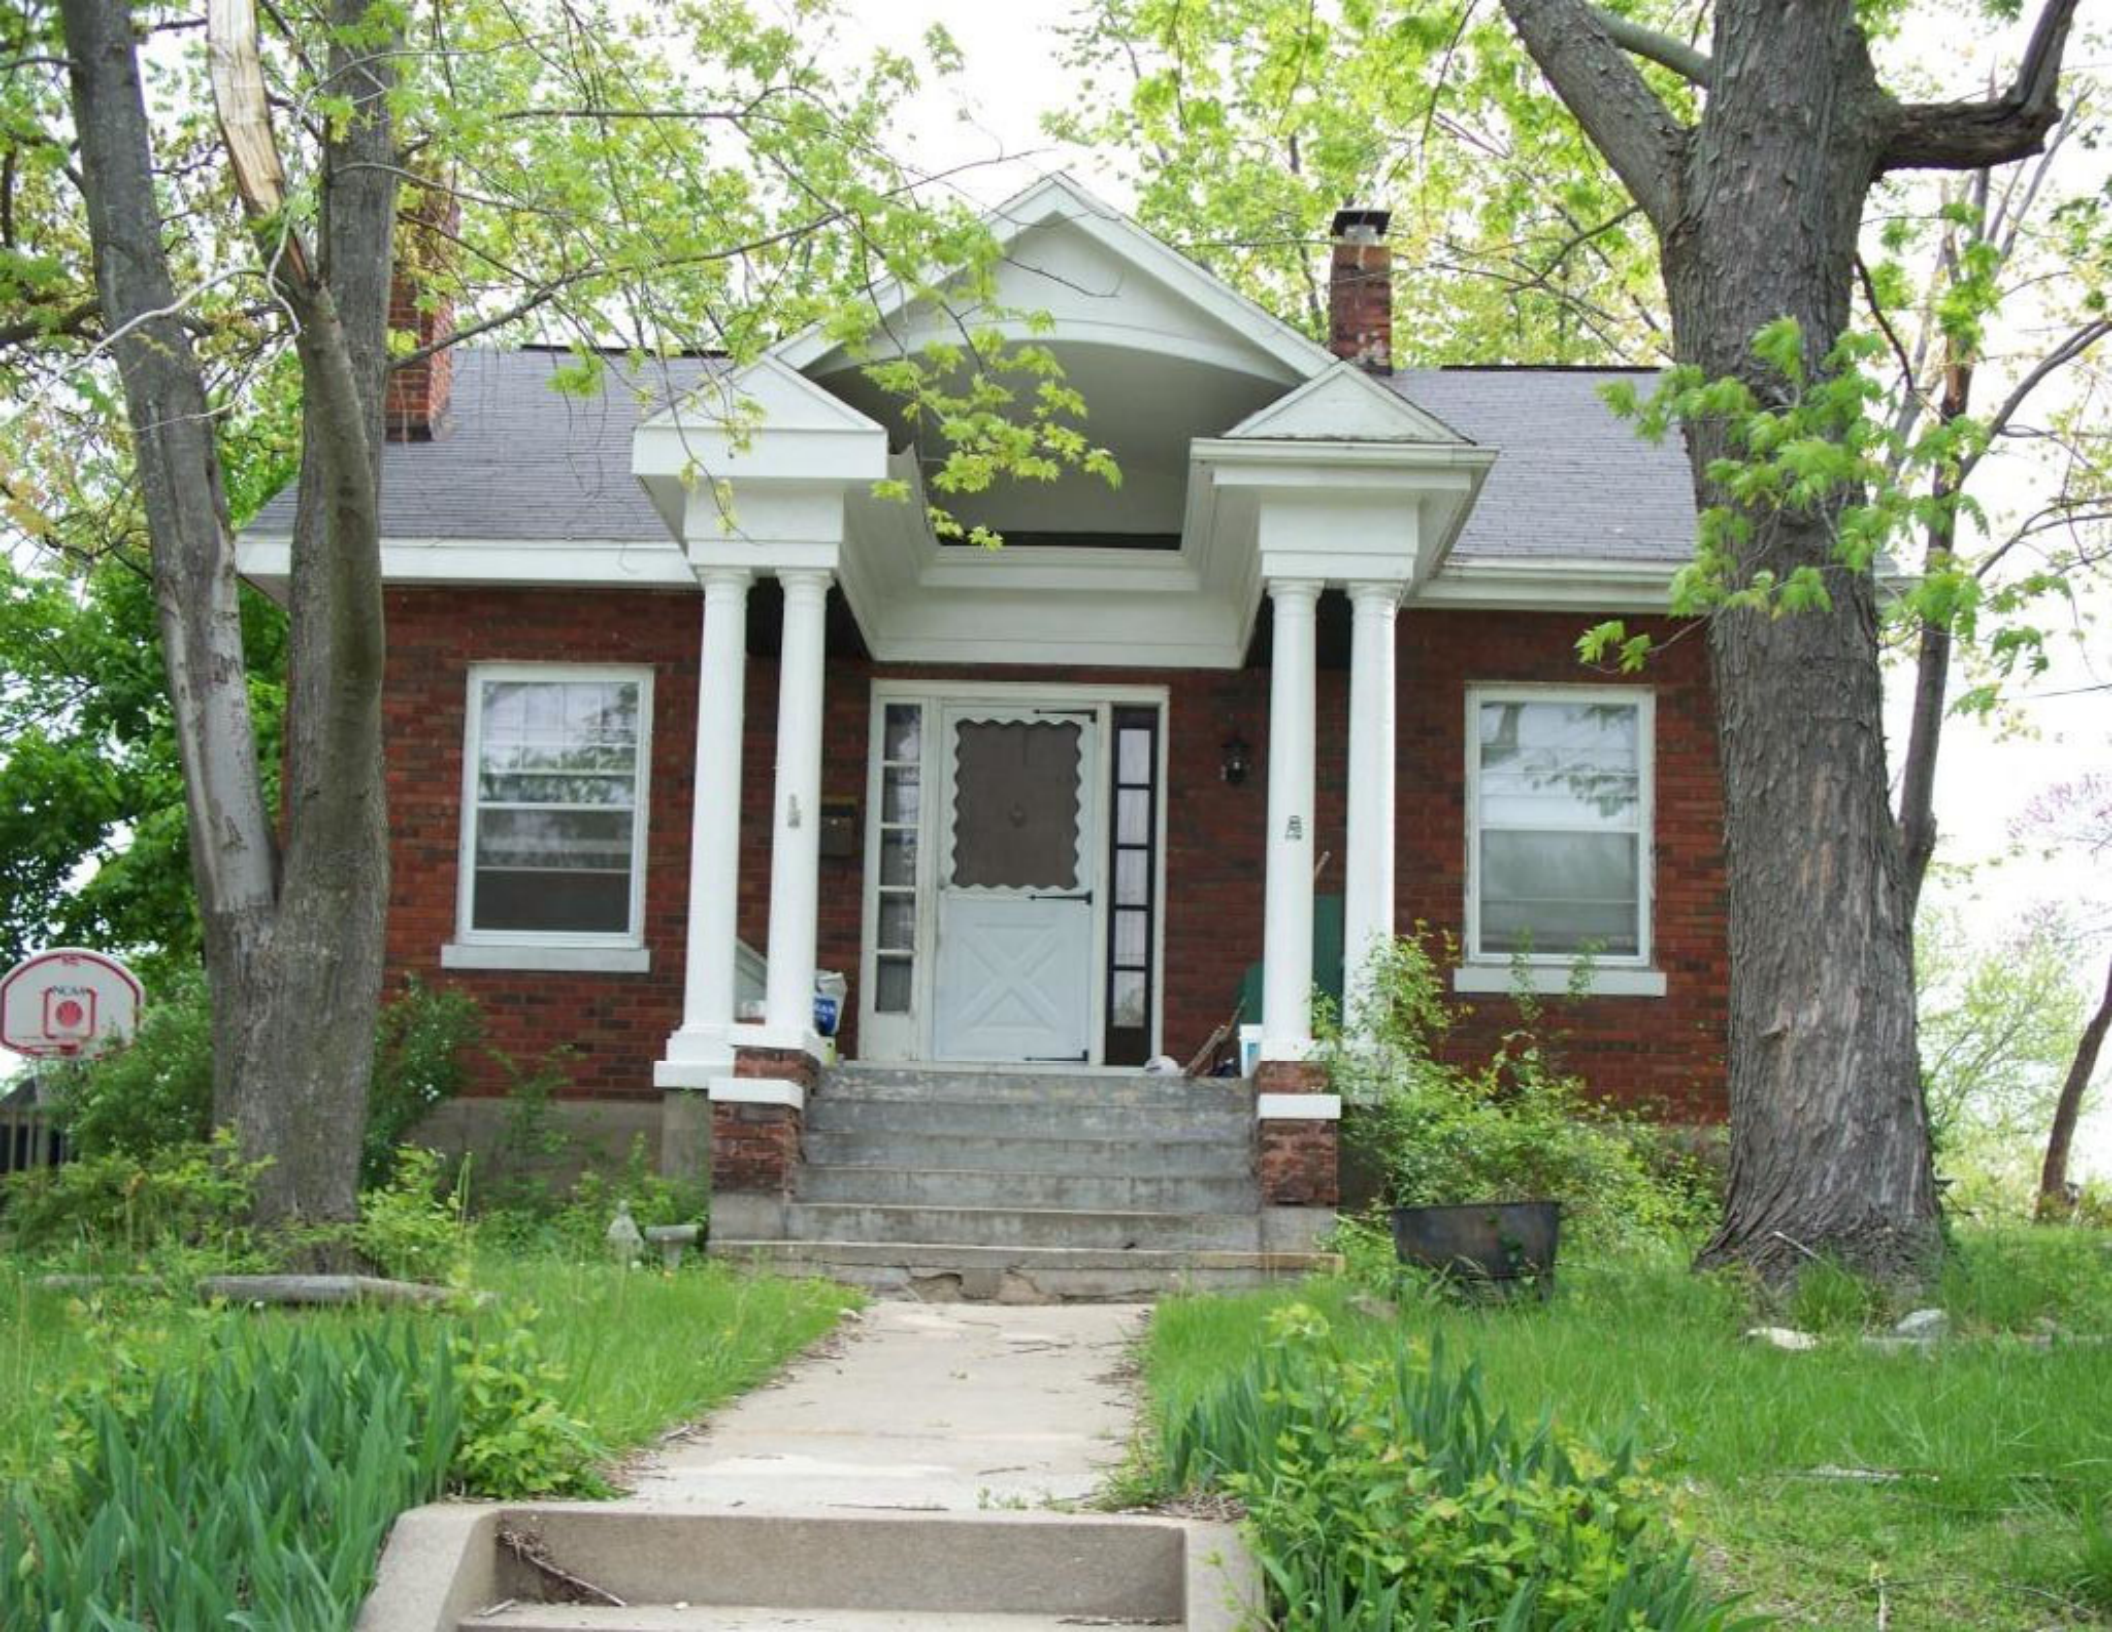
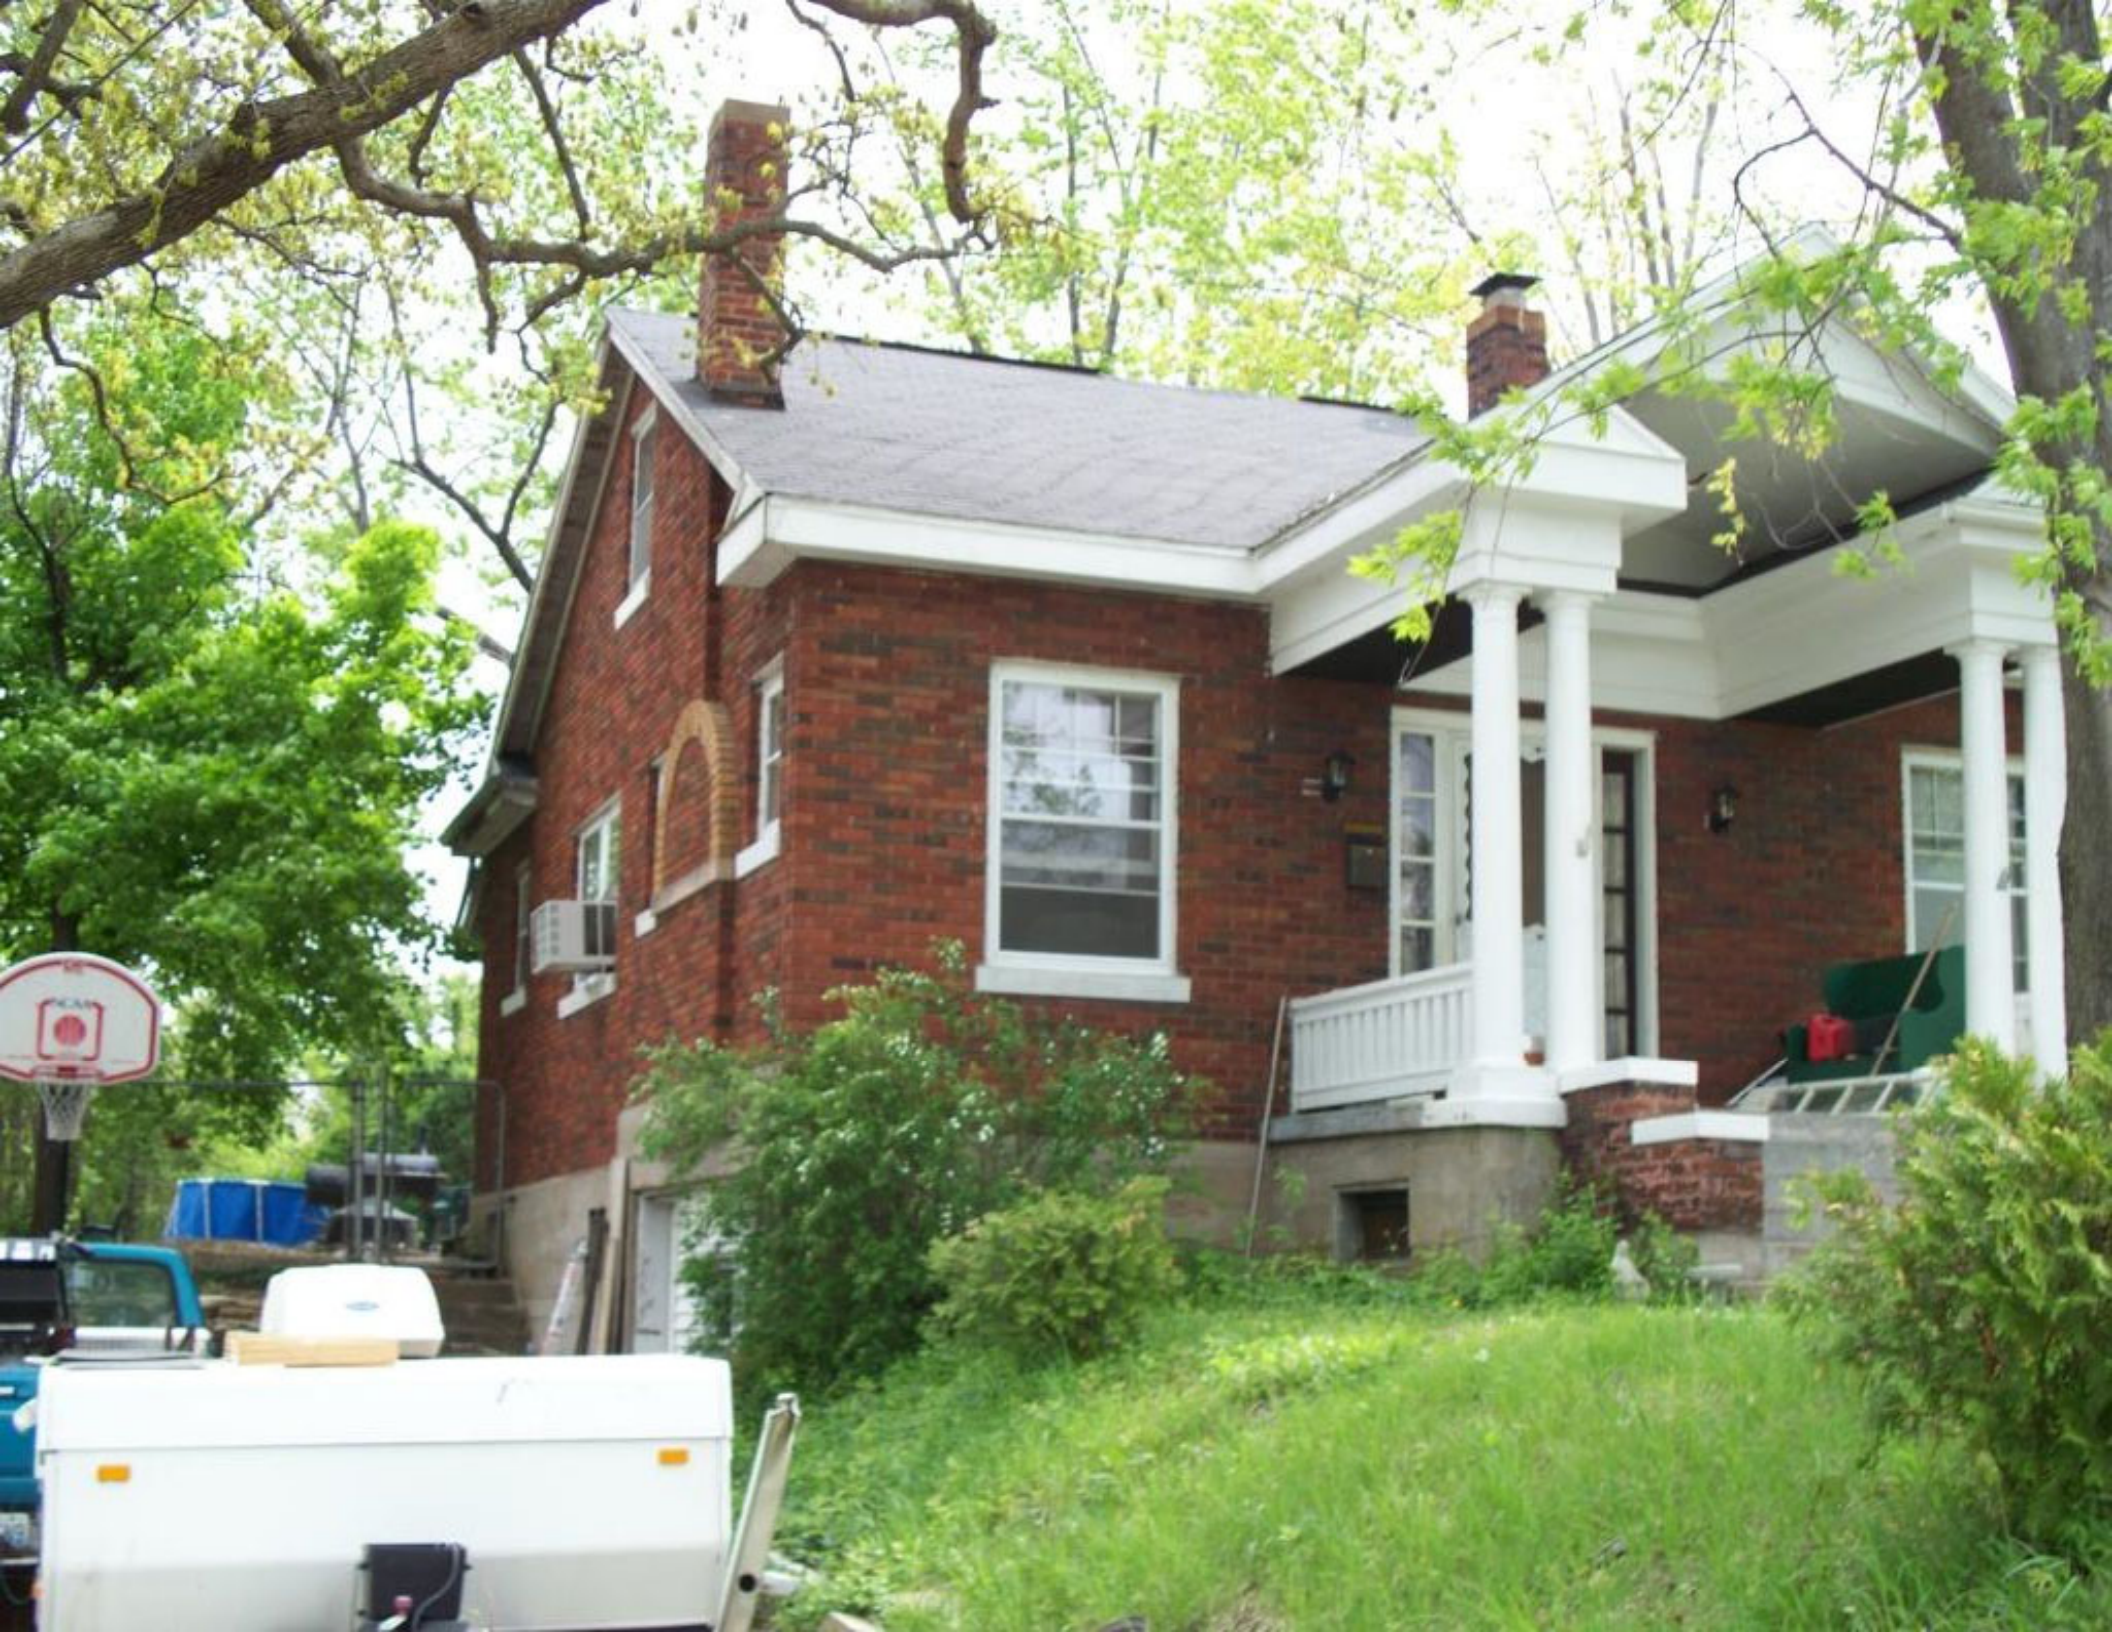
This small one-story brick side-gabled property has a massive portico with four Ionic columns that connect to a small pediment on either side of the concrete porch stair. A larger pediment sits atop and has a concave interior resting on the peaks of the smaller pediments that are connected to a wide entablature. The portico is modern and lends the modest property a Neo-Classical Revival stylization. The porch is concrete but features brick knee-walls on the side of the concrete stairs and a wooden rail on the left side of the porch. The 4/1 windows flanking the entrance appear historic, likewise the sidelights of the door remain intact. However, due to the modern portico changing the historic character of the building it is currently considered non-contributing to the district.

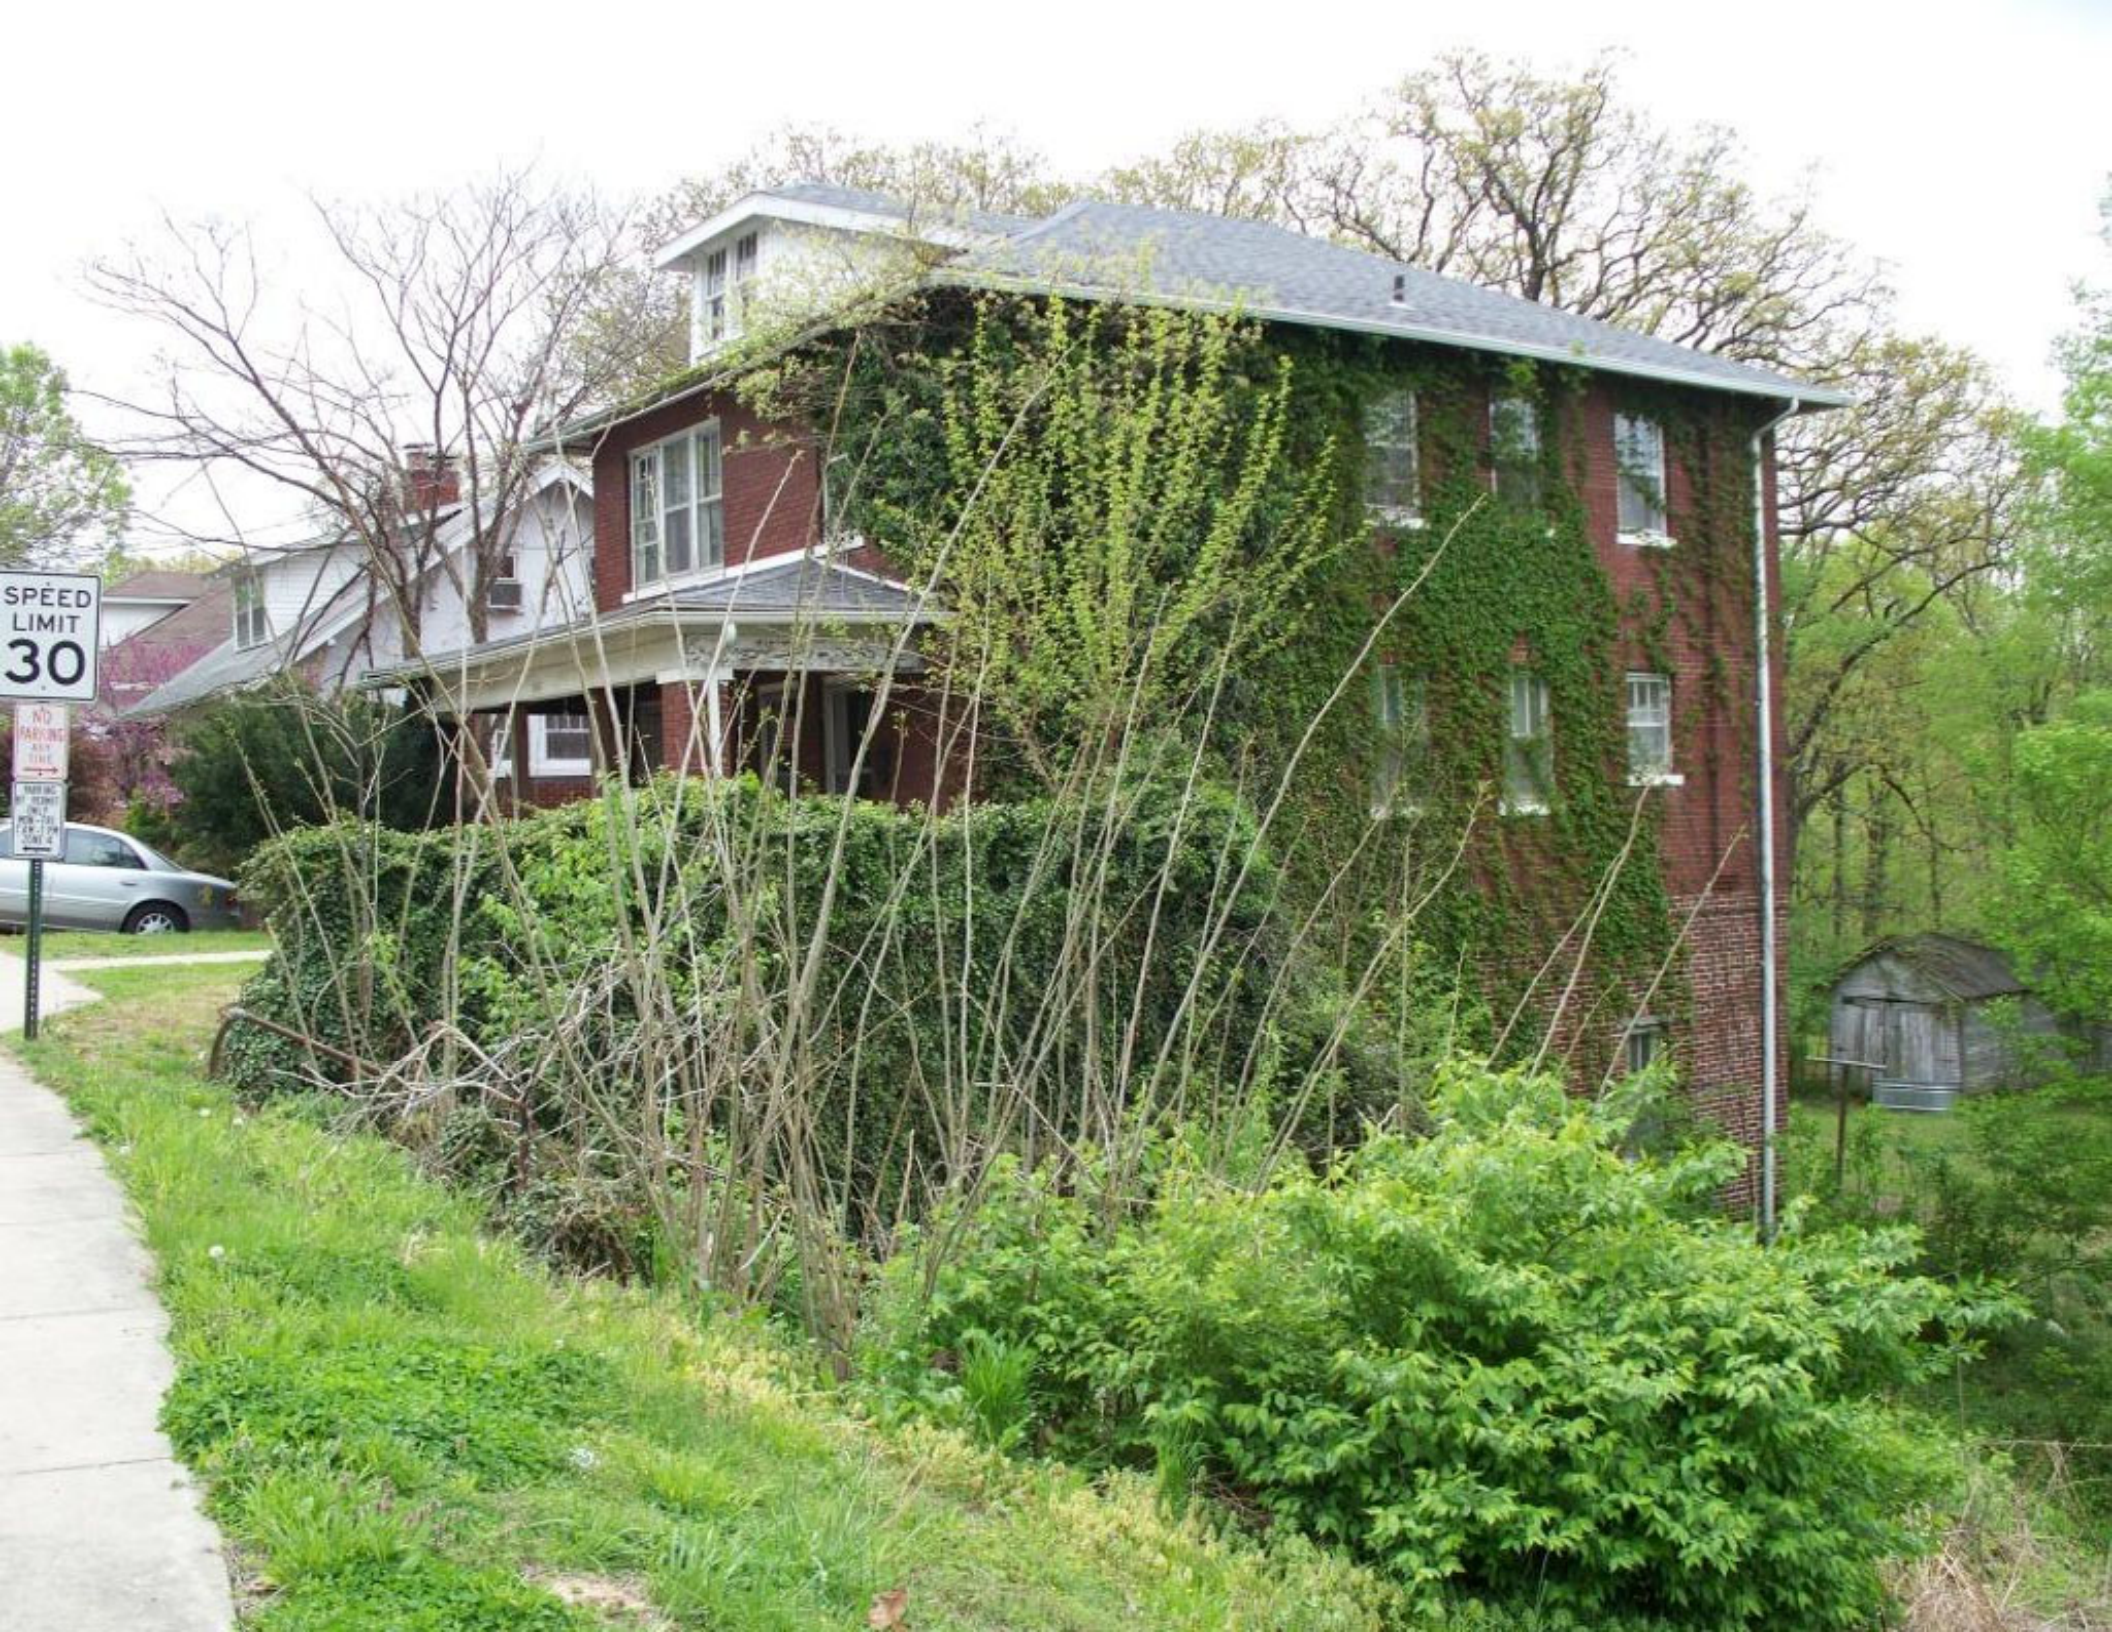
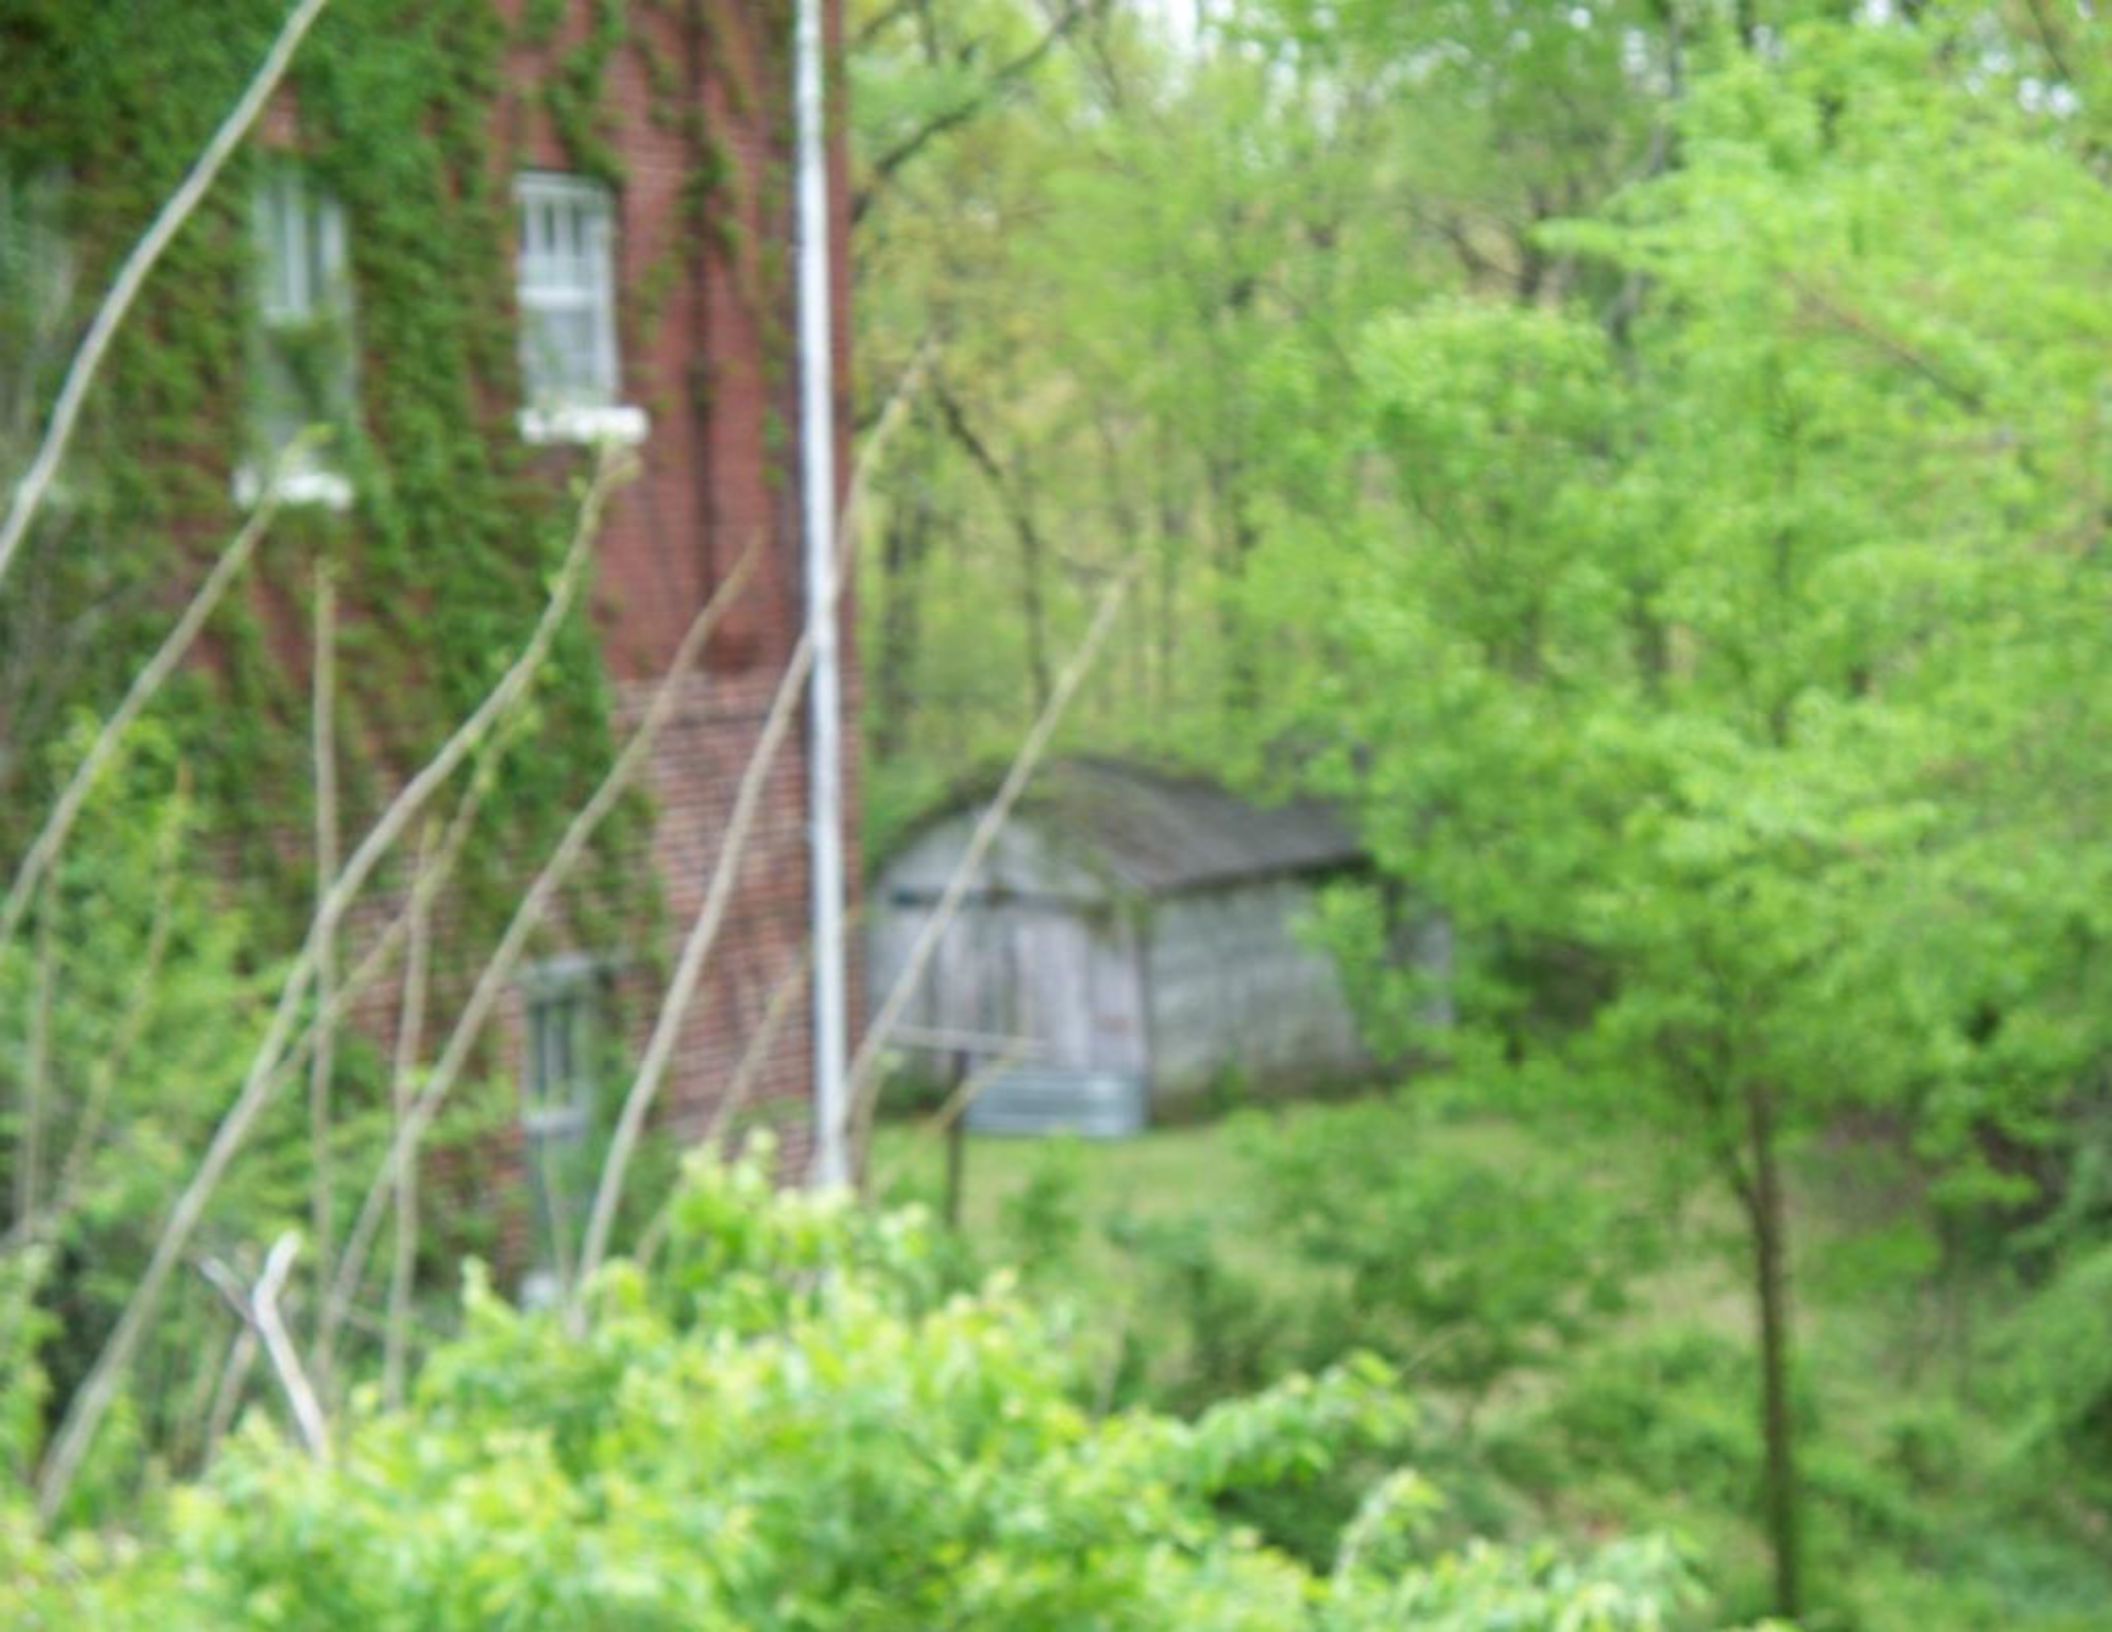
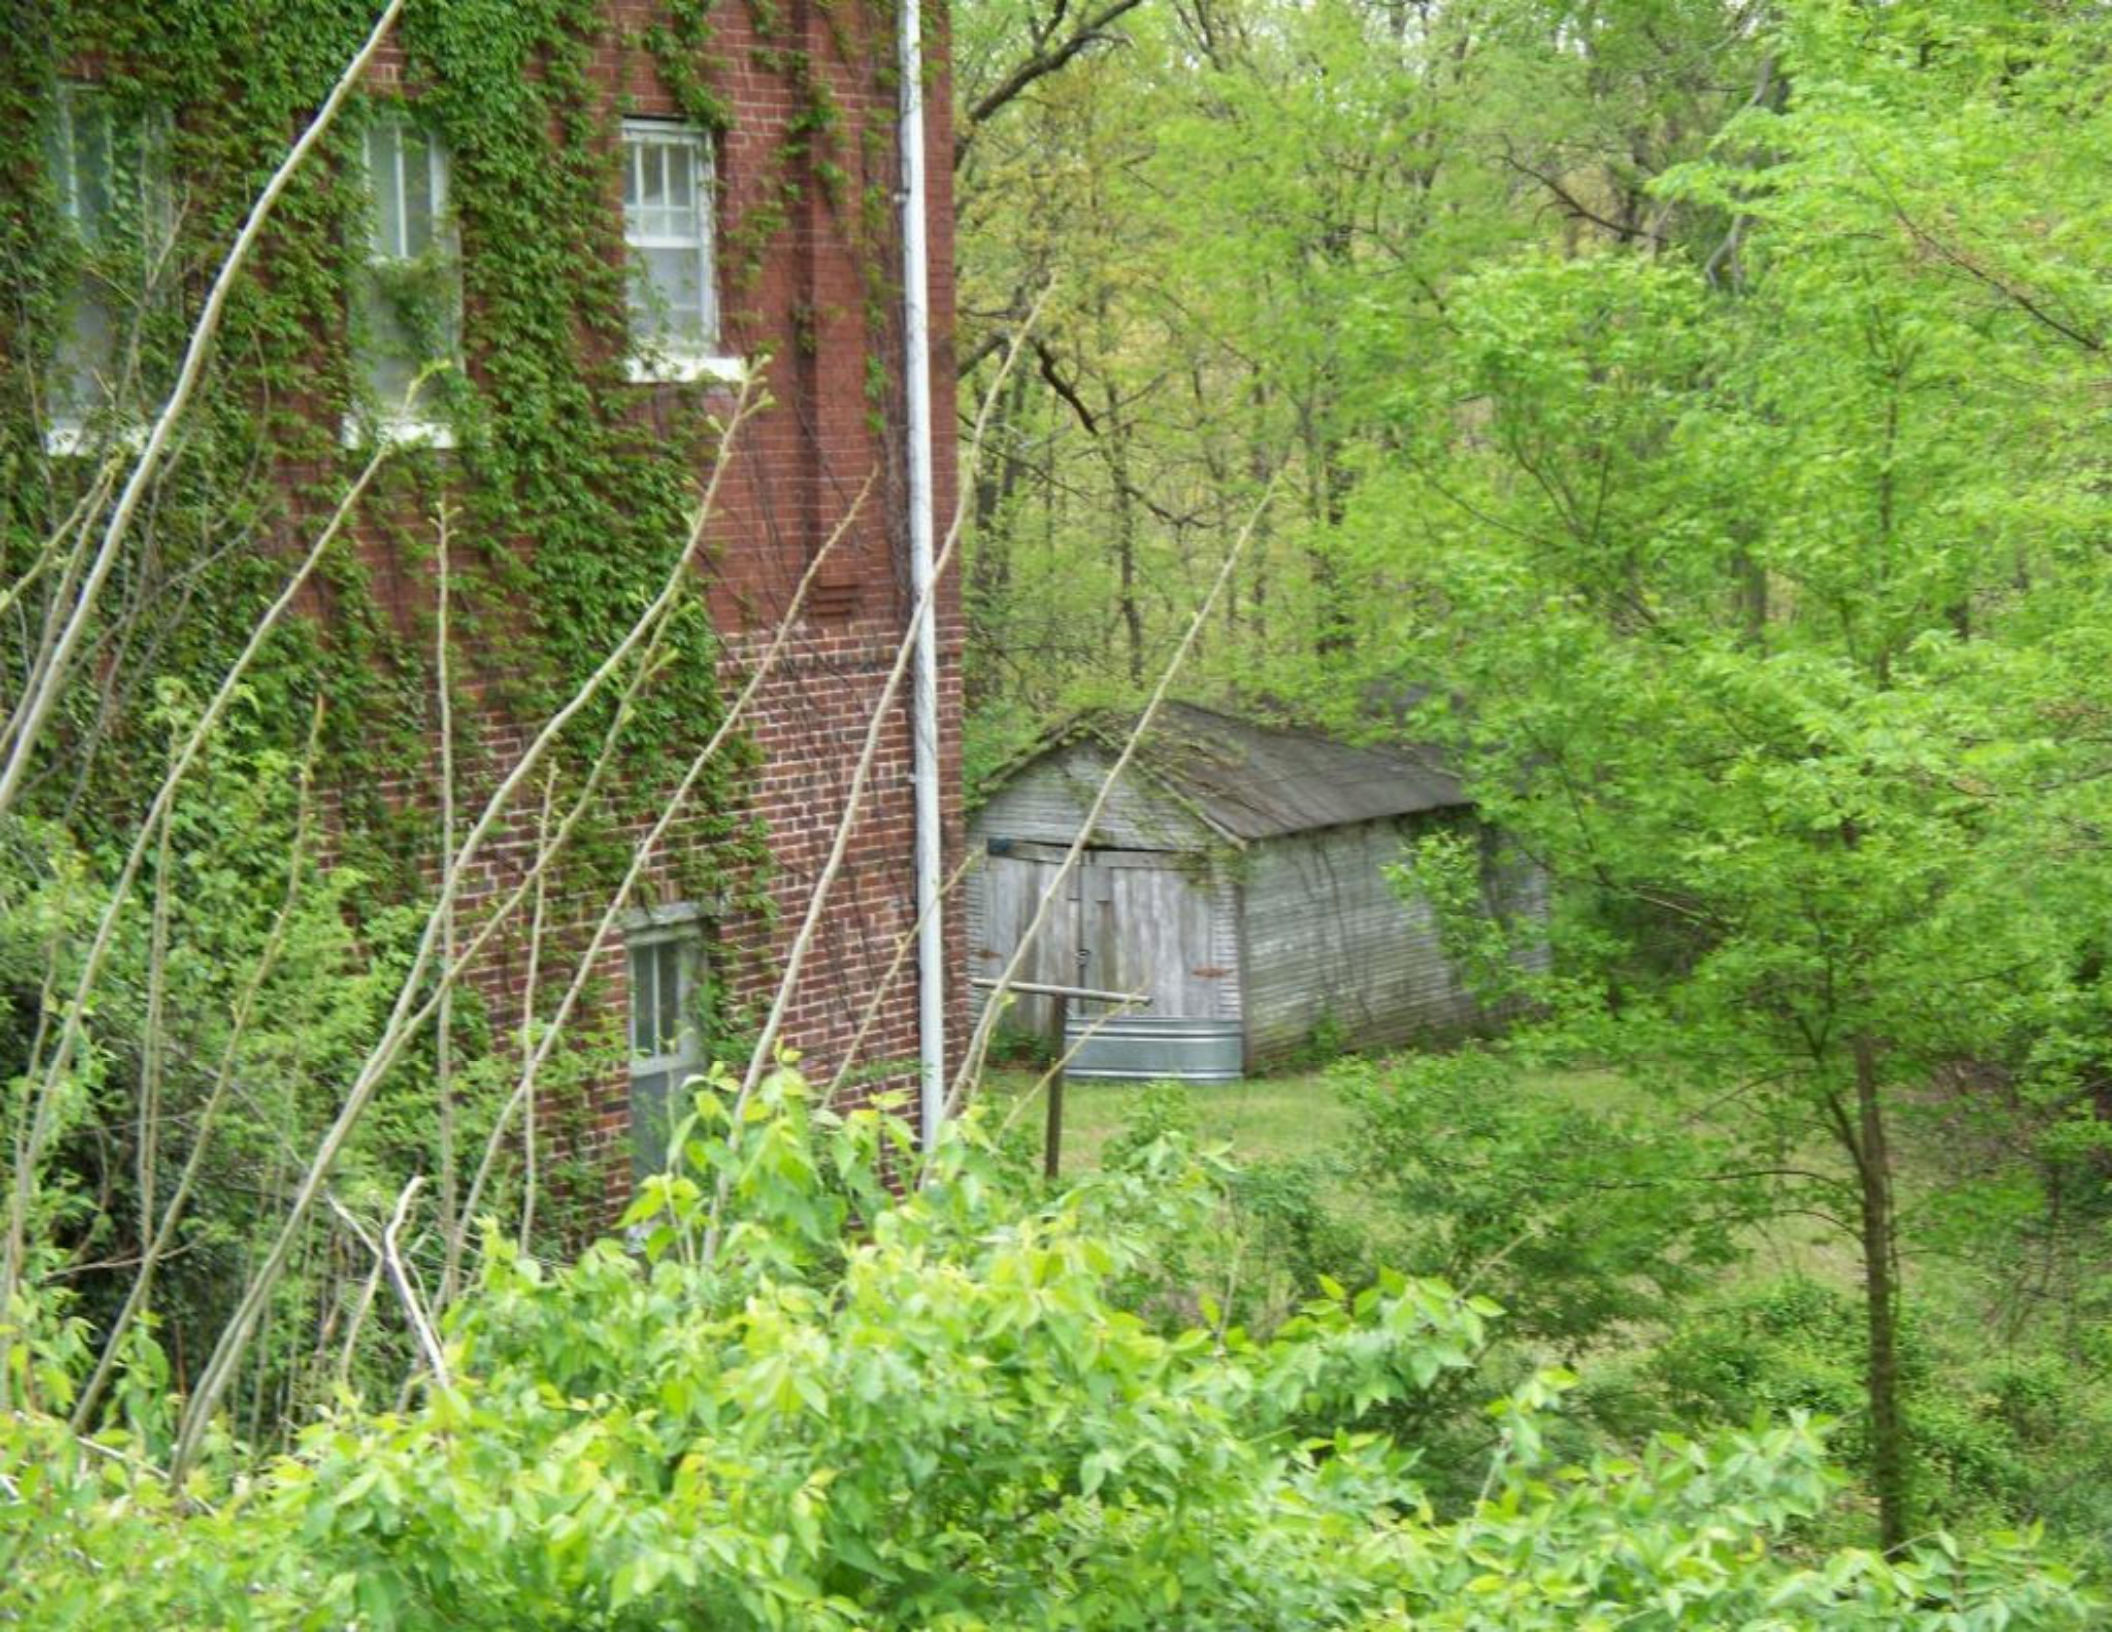
40. (cont.) Description of environment and outbuildings. Expand box as necessary, or add continuation pages.
There is a historic wooden shed in poor condition behind the property with a gable roof and double doors. It is contributing to the district.
