ARCHITECTURAL/HISTORIC INVENTORY FORM

1. Survey No. CO-AS-005-001		2. Survey name: Moreau Drive Neighborhood Survey	
3. County: Cole		4. Address: 1202 Elmerine Ave.	
5. City: Jefferson City	Vicinity: <input type="checkbox"/>	6. UTM: / /	7. Township/Range/Section: T: R: S:
8. Historic name (if known):		9. Present/other name (if known):	
10. Ownership: <input checked="" type="checkbox"/> Private <input type="checkbox"/> Public		11. Historic use (if known): Residential	11. Current use: Residential

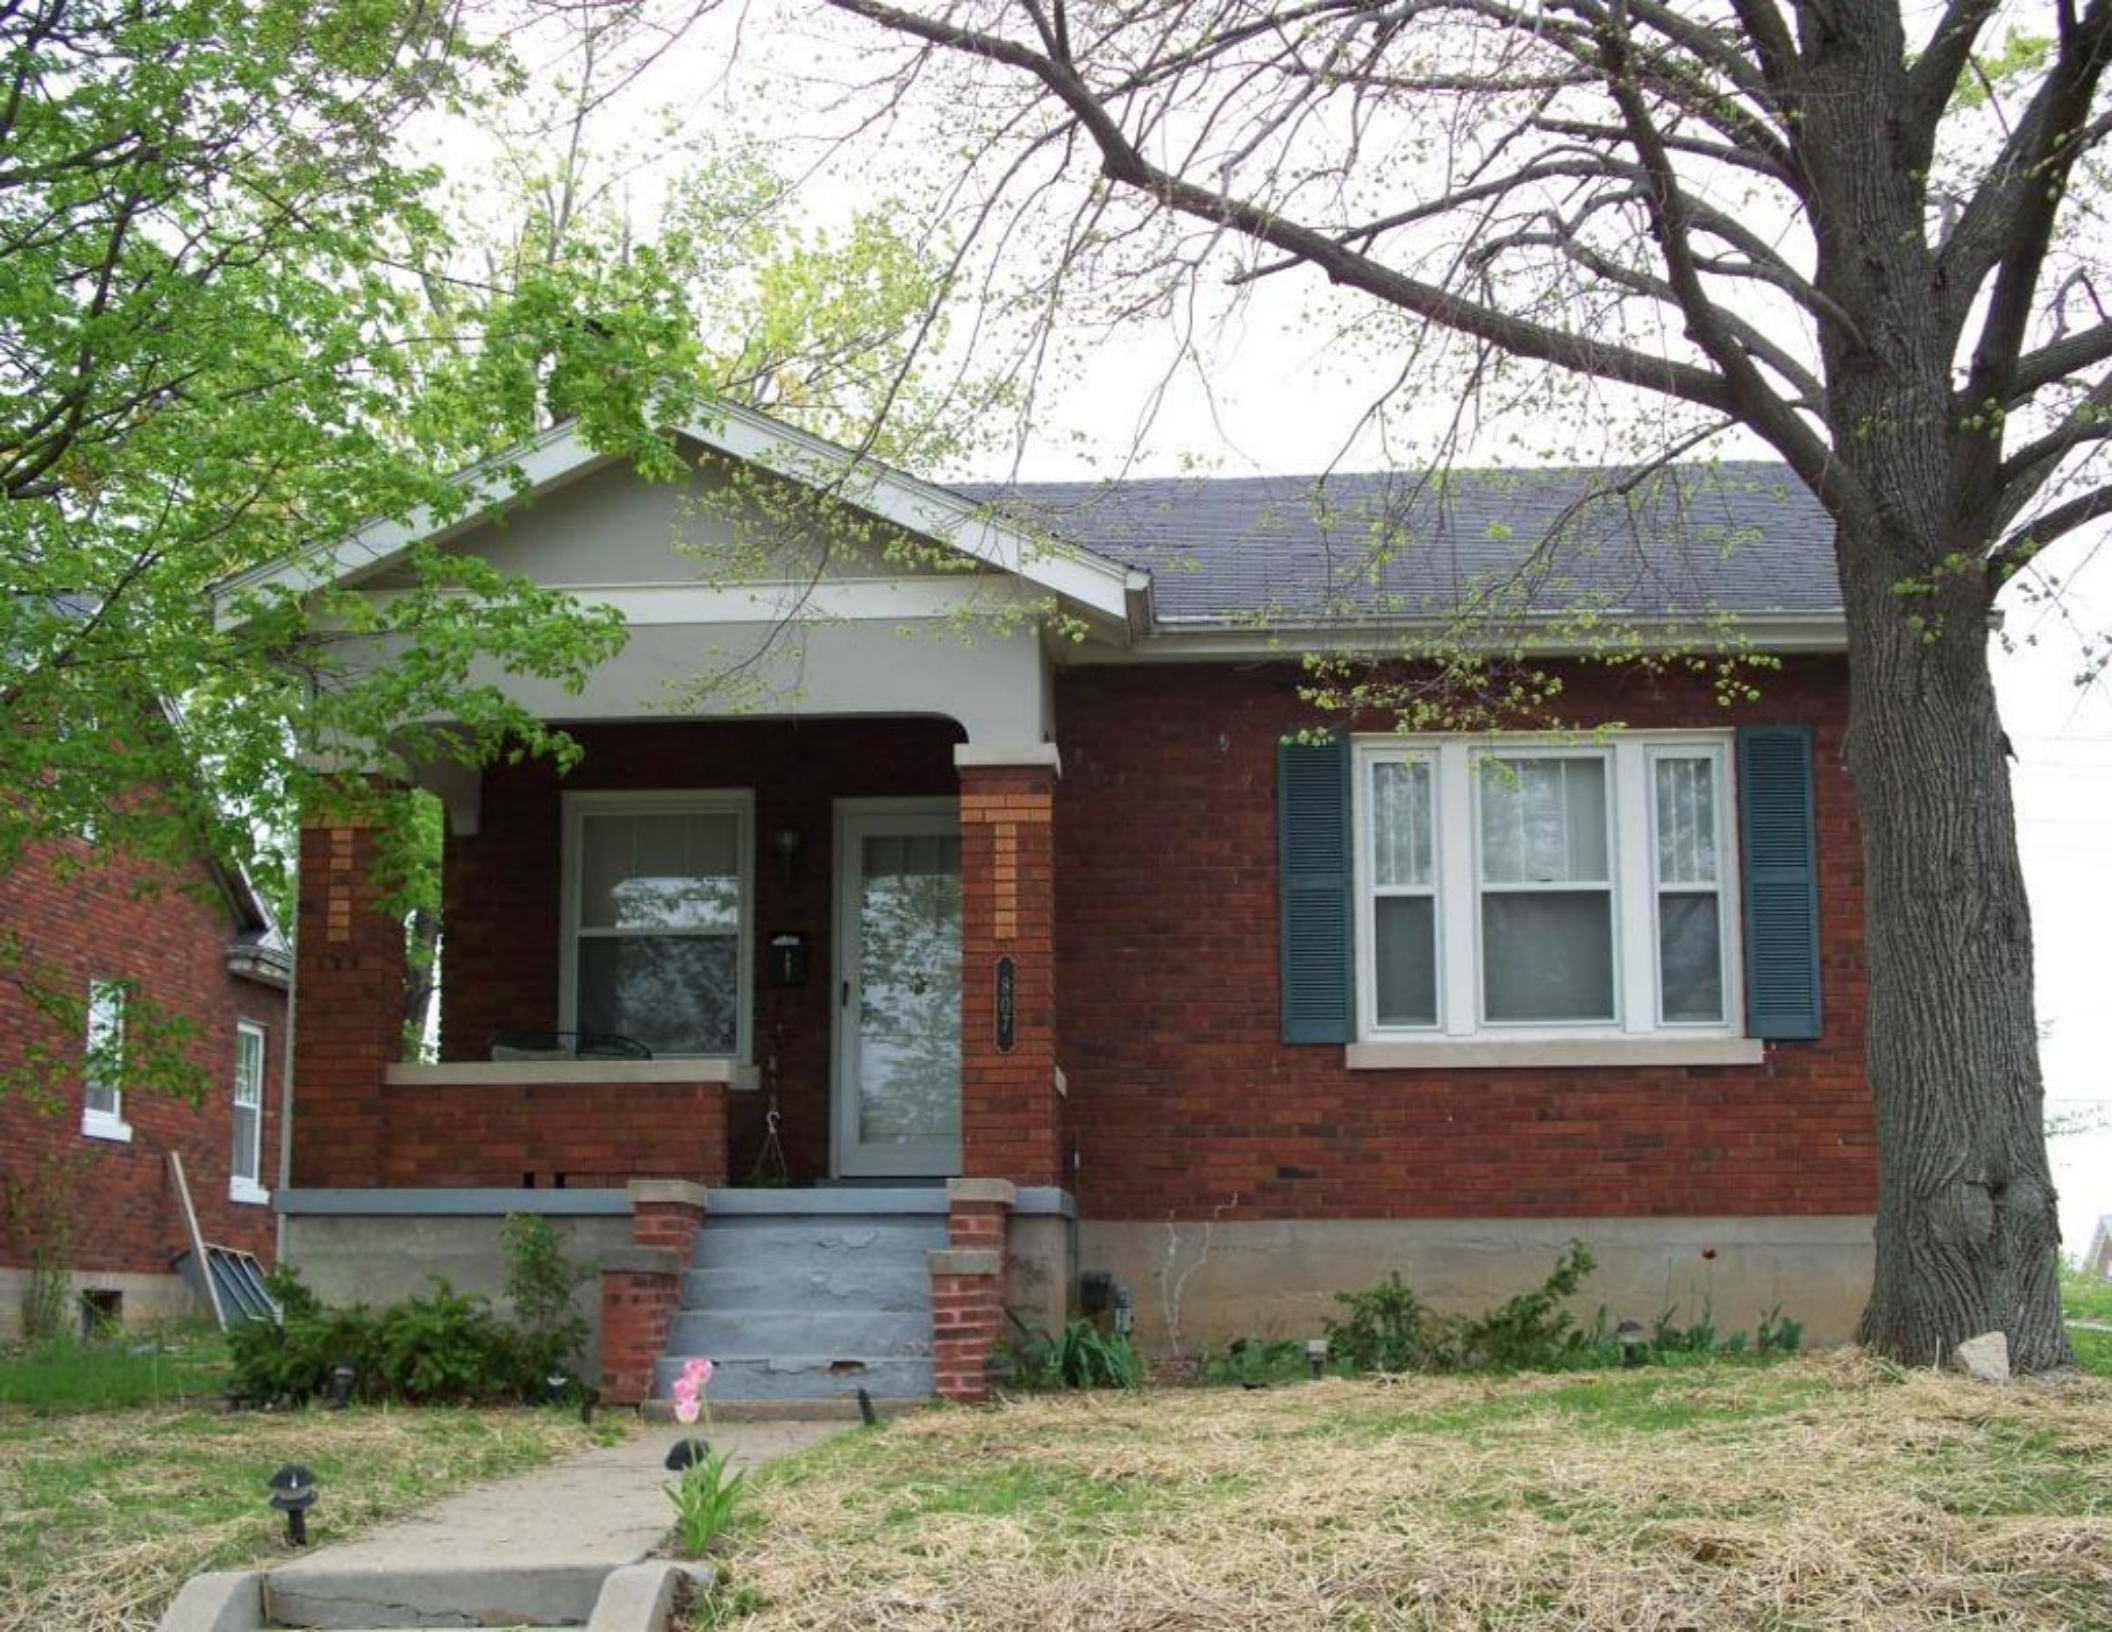
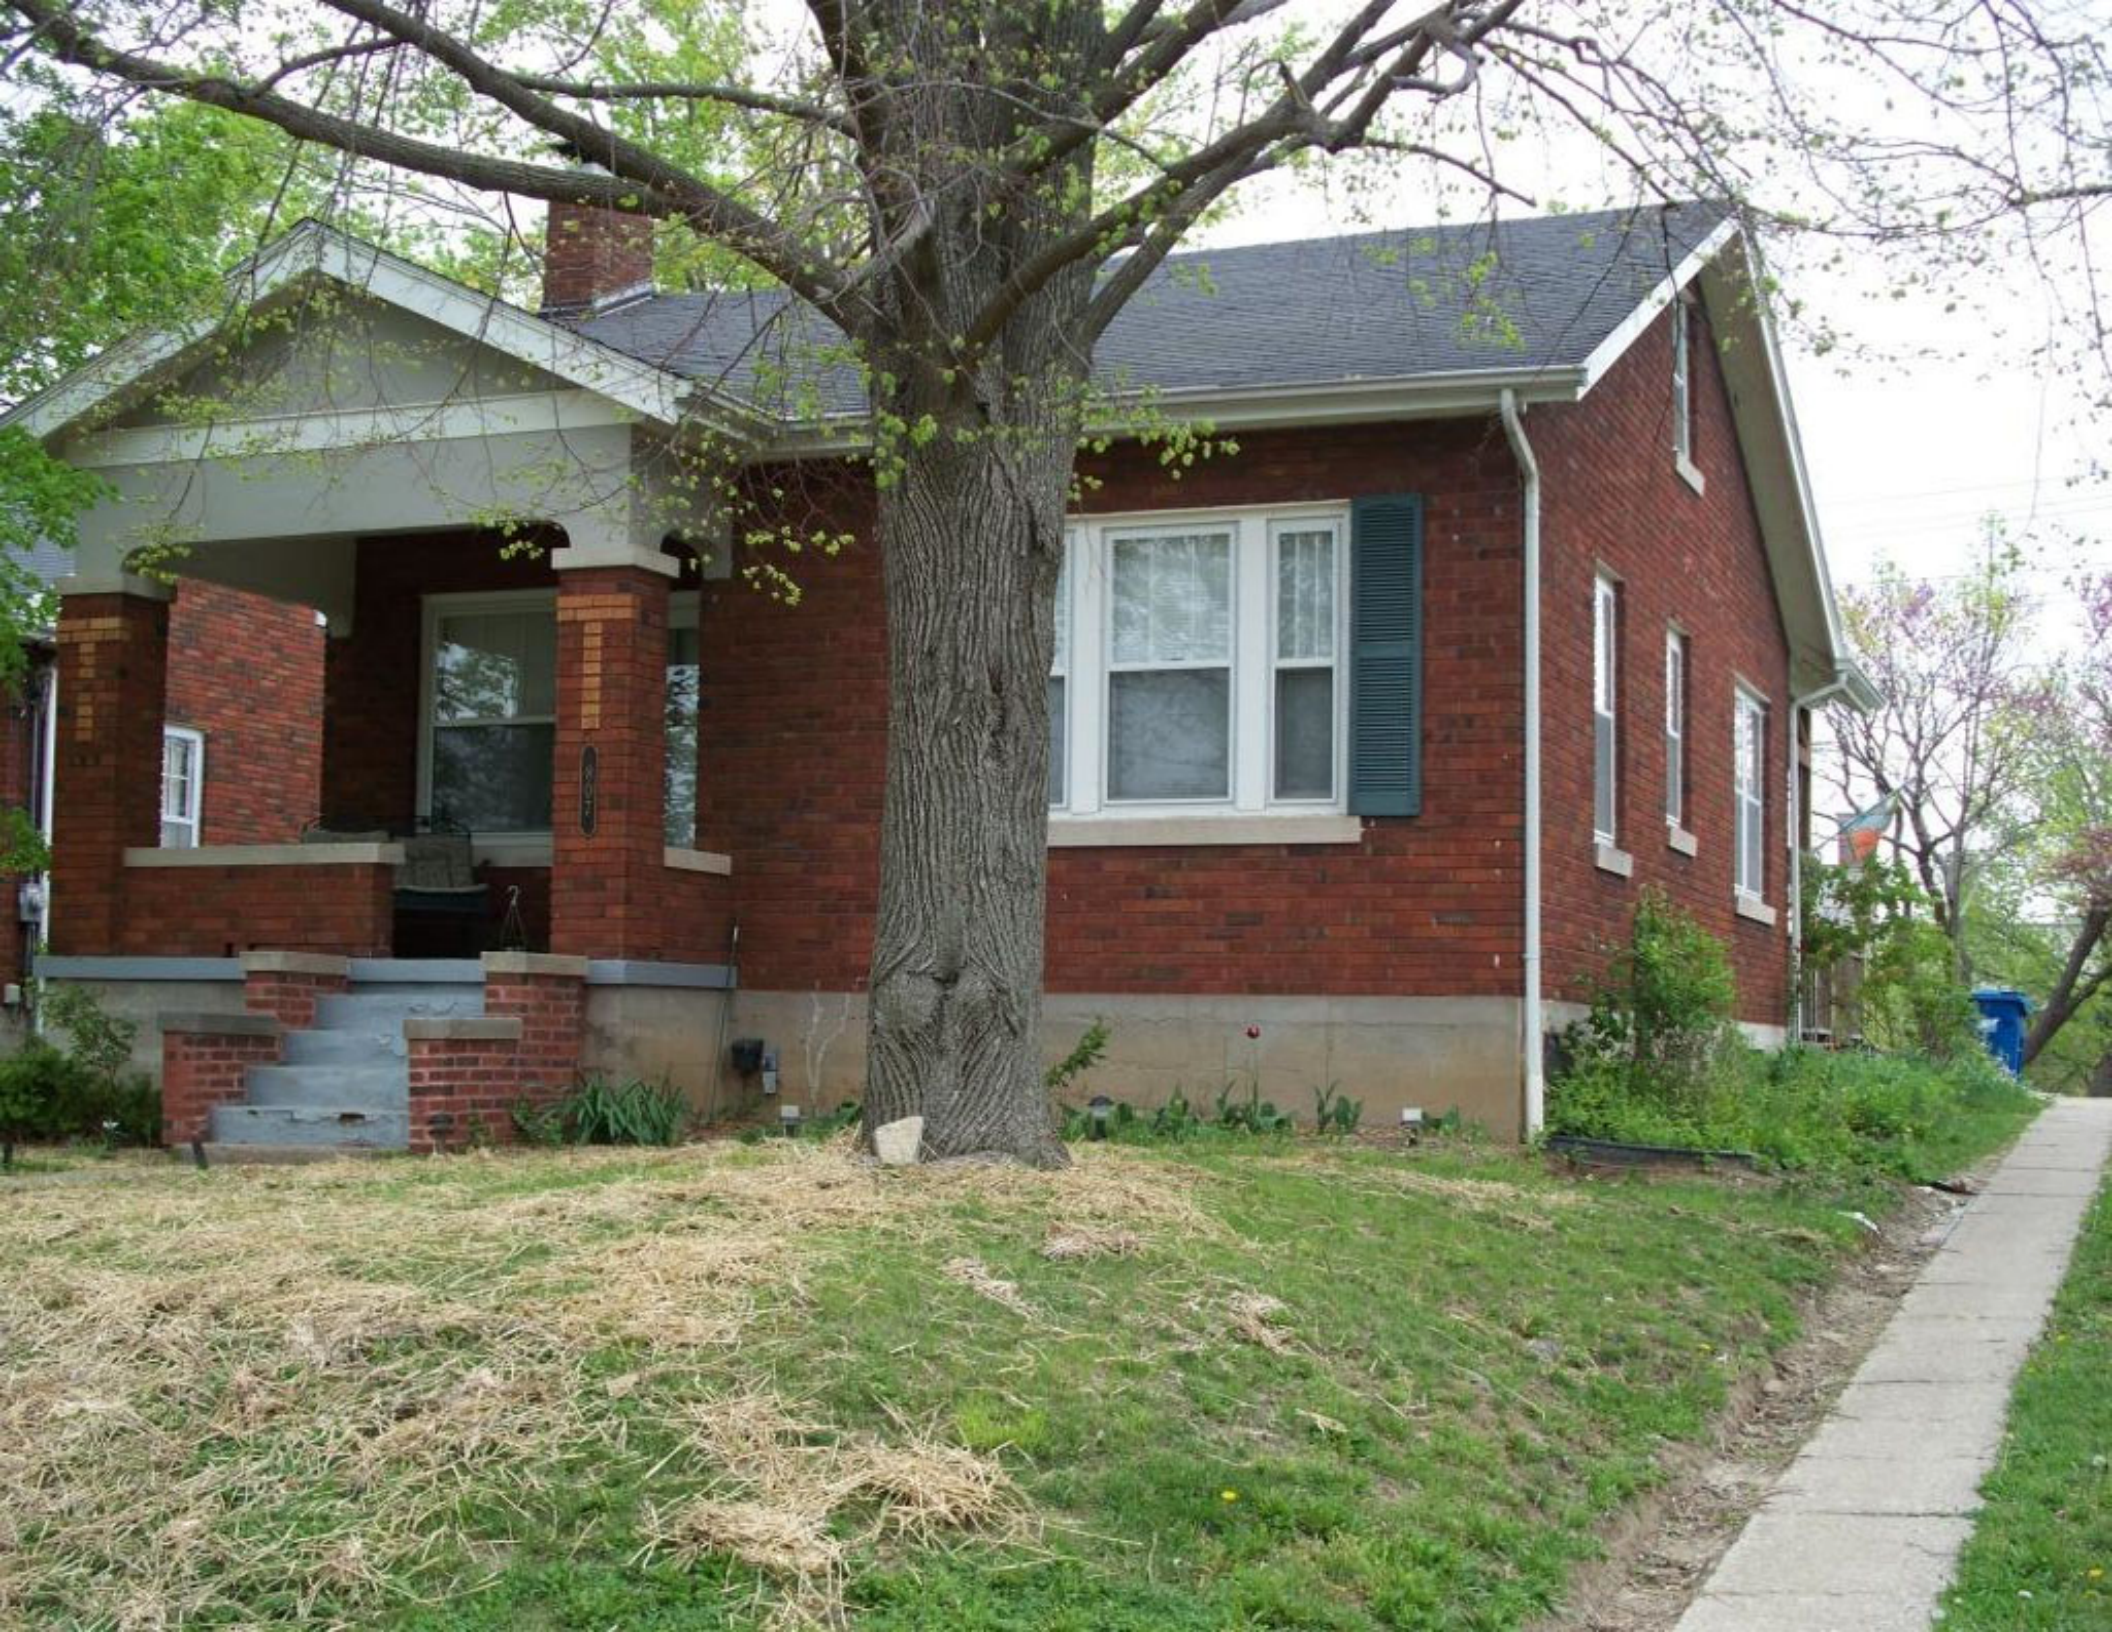
This one-story brick property has a side gable roof with a crossing partial front gable over the porch. The porch is offset to the left and projects slightly from the façade, featuring brick piers, half-walls, and stucco in the pedimented gable. From the left there is a single historic 3/1 window and the entrance. The final bay has a historic tri-part window with narrow 3/1 windows flanking a larger 3/1. The cement foundation is raised and connects to a set of concrete stairs leading to the porch.

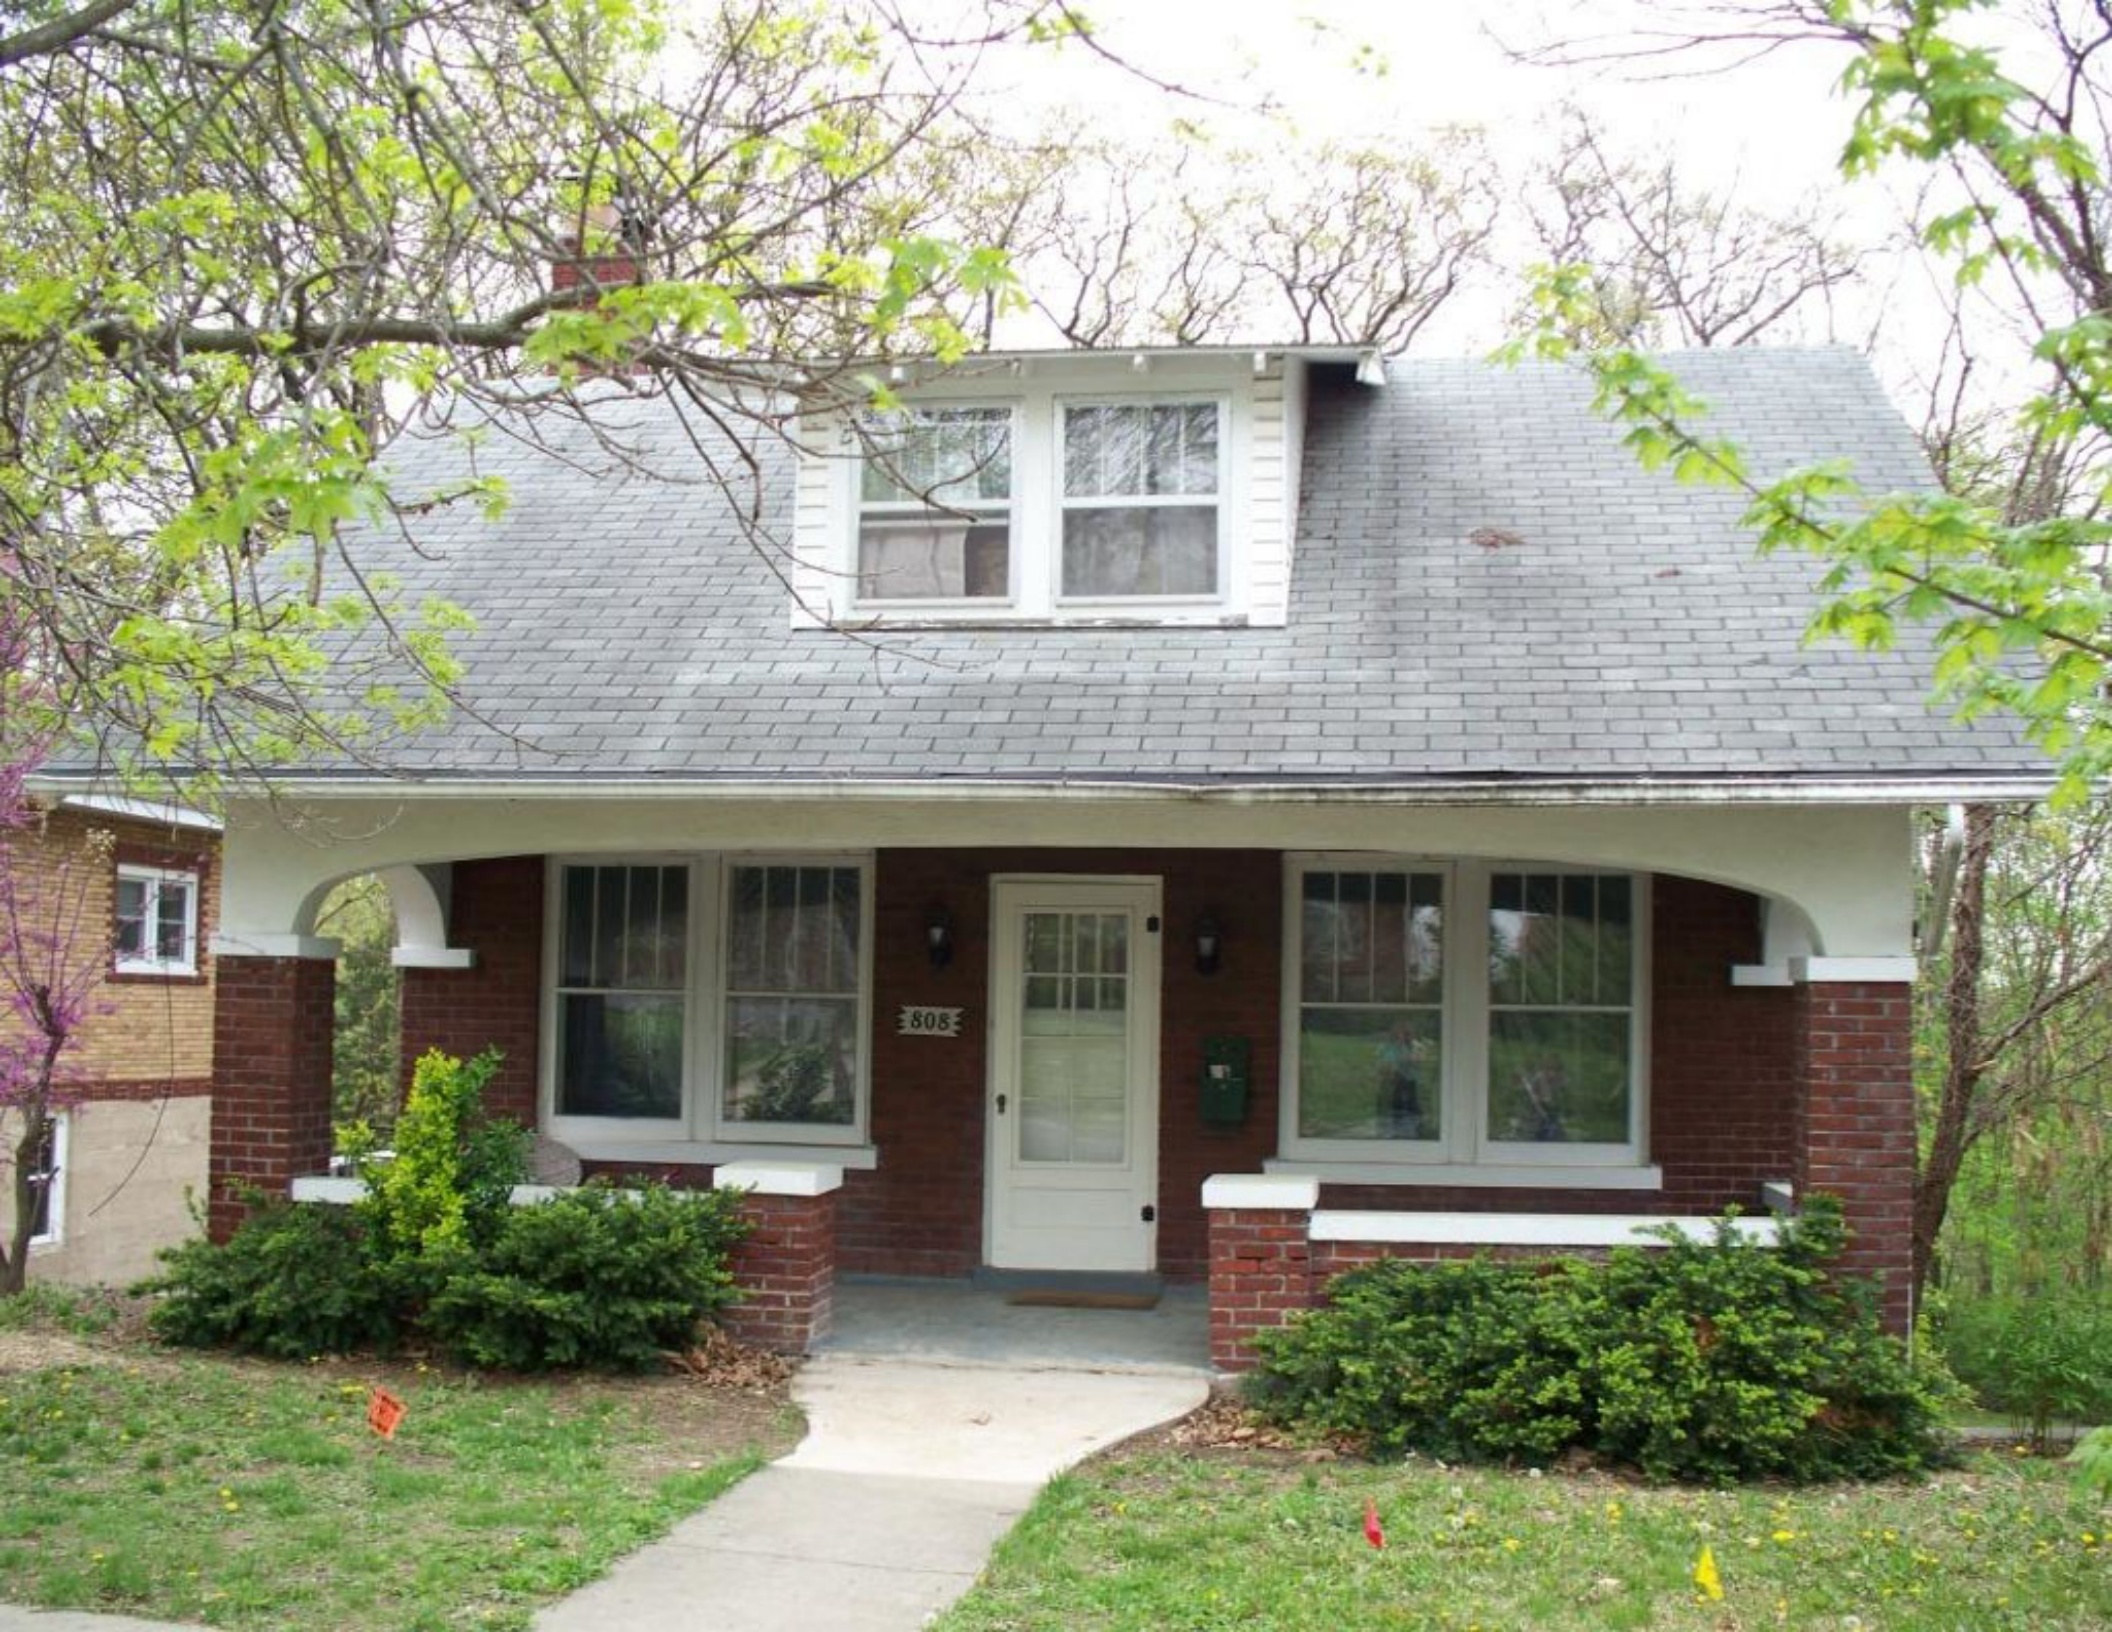
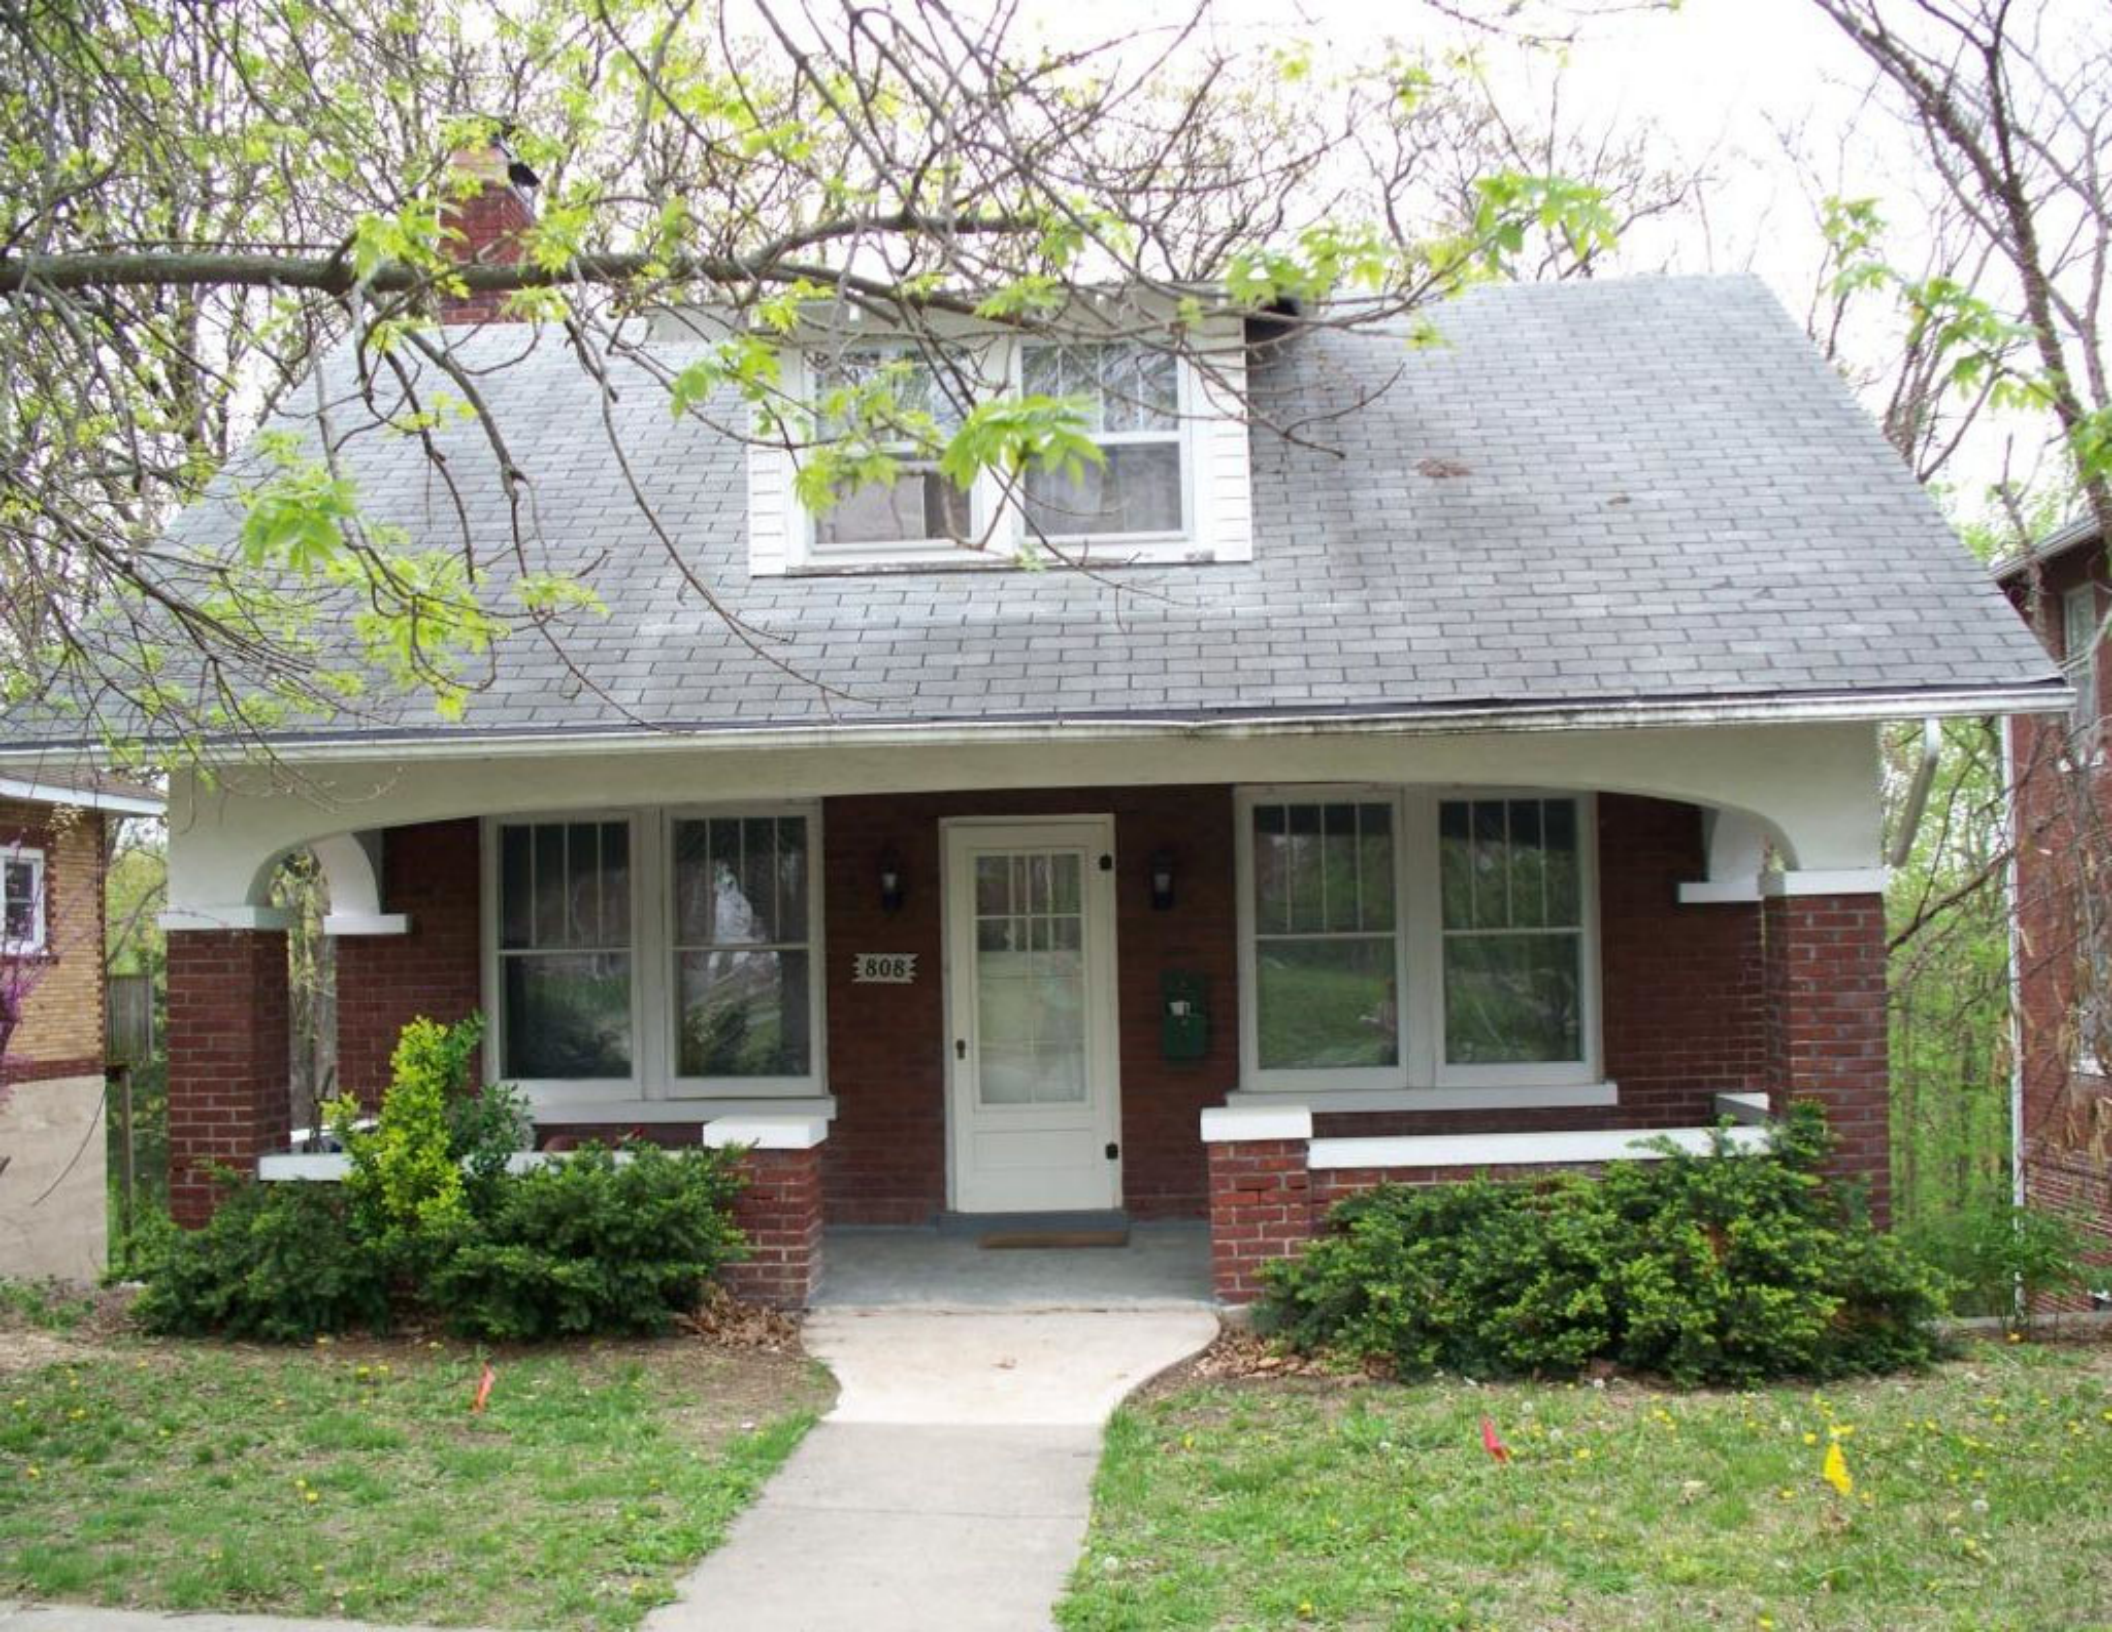
808

This 1 ½ story brick bungalow has a deep slanting side gable roof. There is a central shed dormer with rafter-tails and two 4/1 windows. The ground floor has two symmetrically placed paired 4/1 windows with limestone sills. All of the windows appear historic. The door, centrally located, appears to be historic as well. The porch has brick knee walls and pilasters capped in limestone that meet a wide-arching stucco cornice.

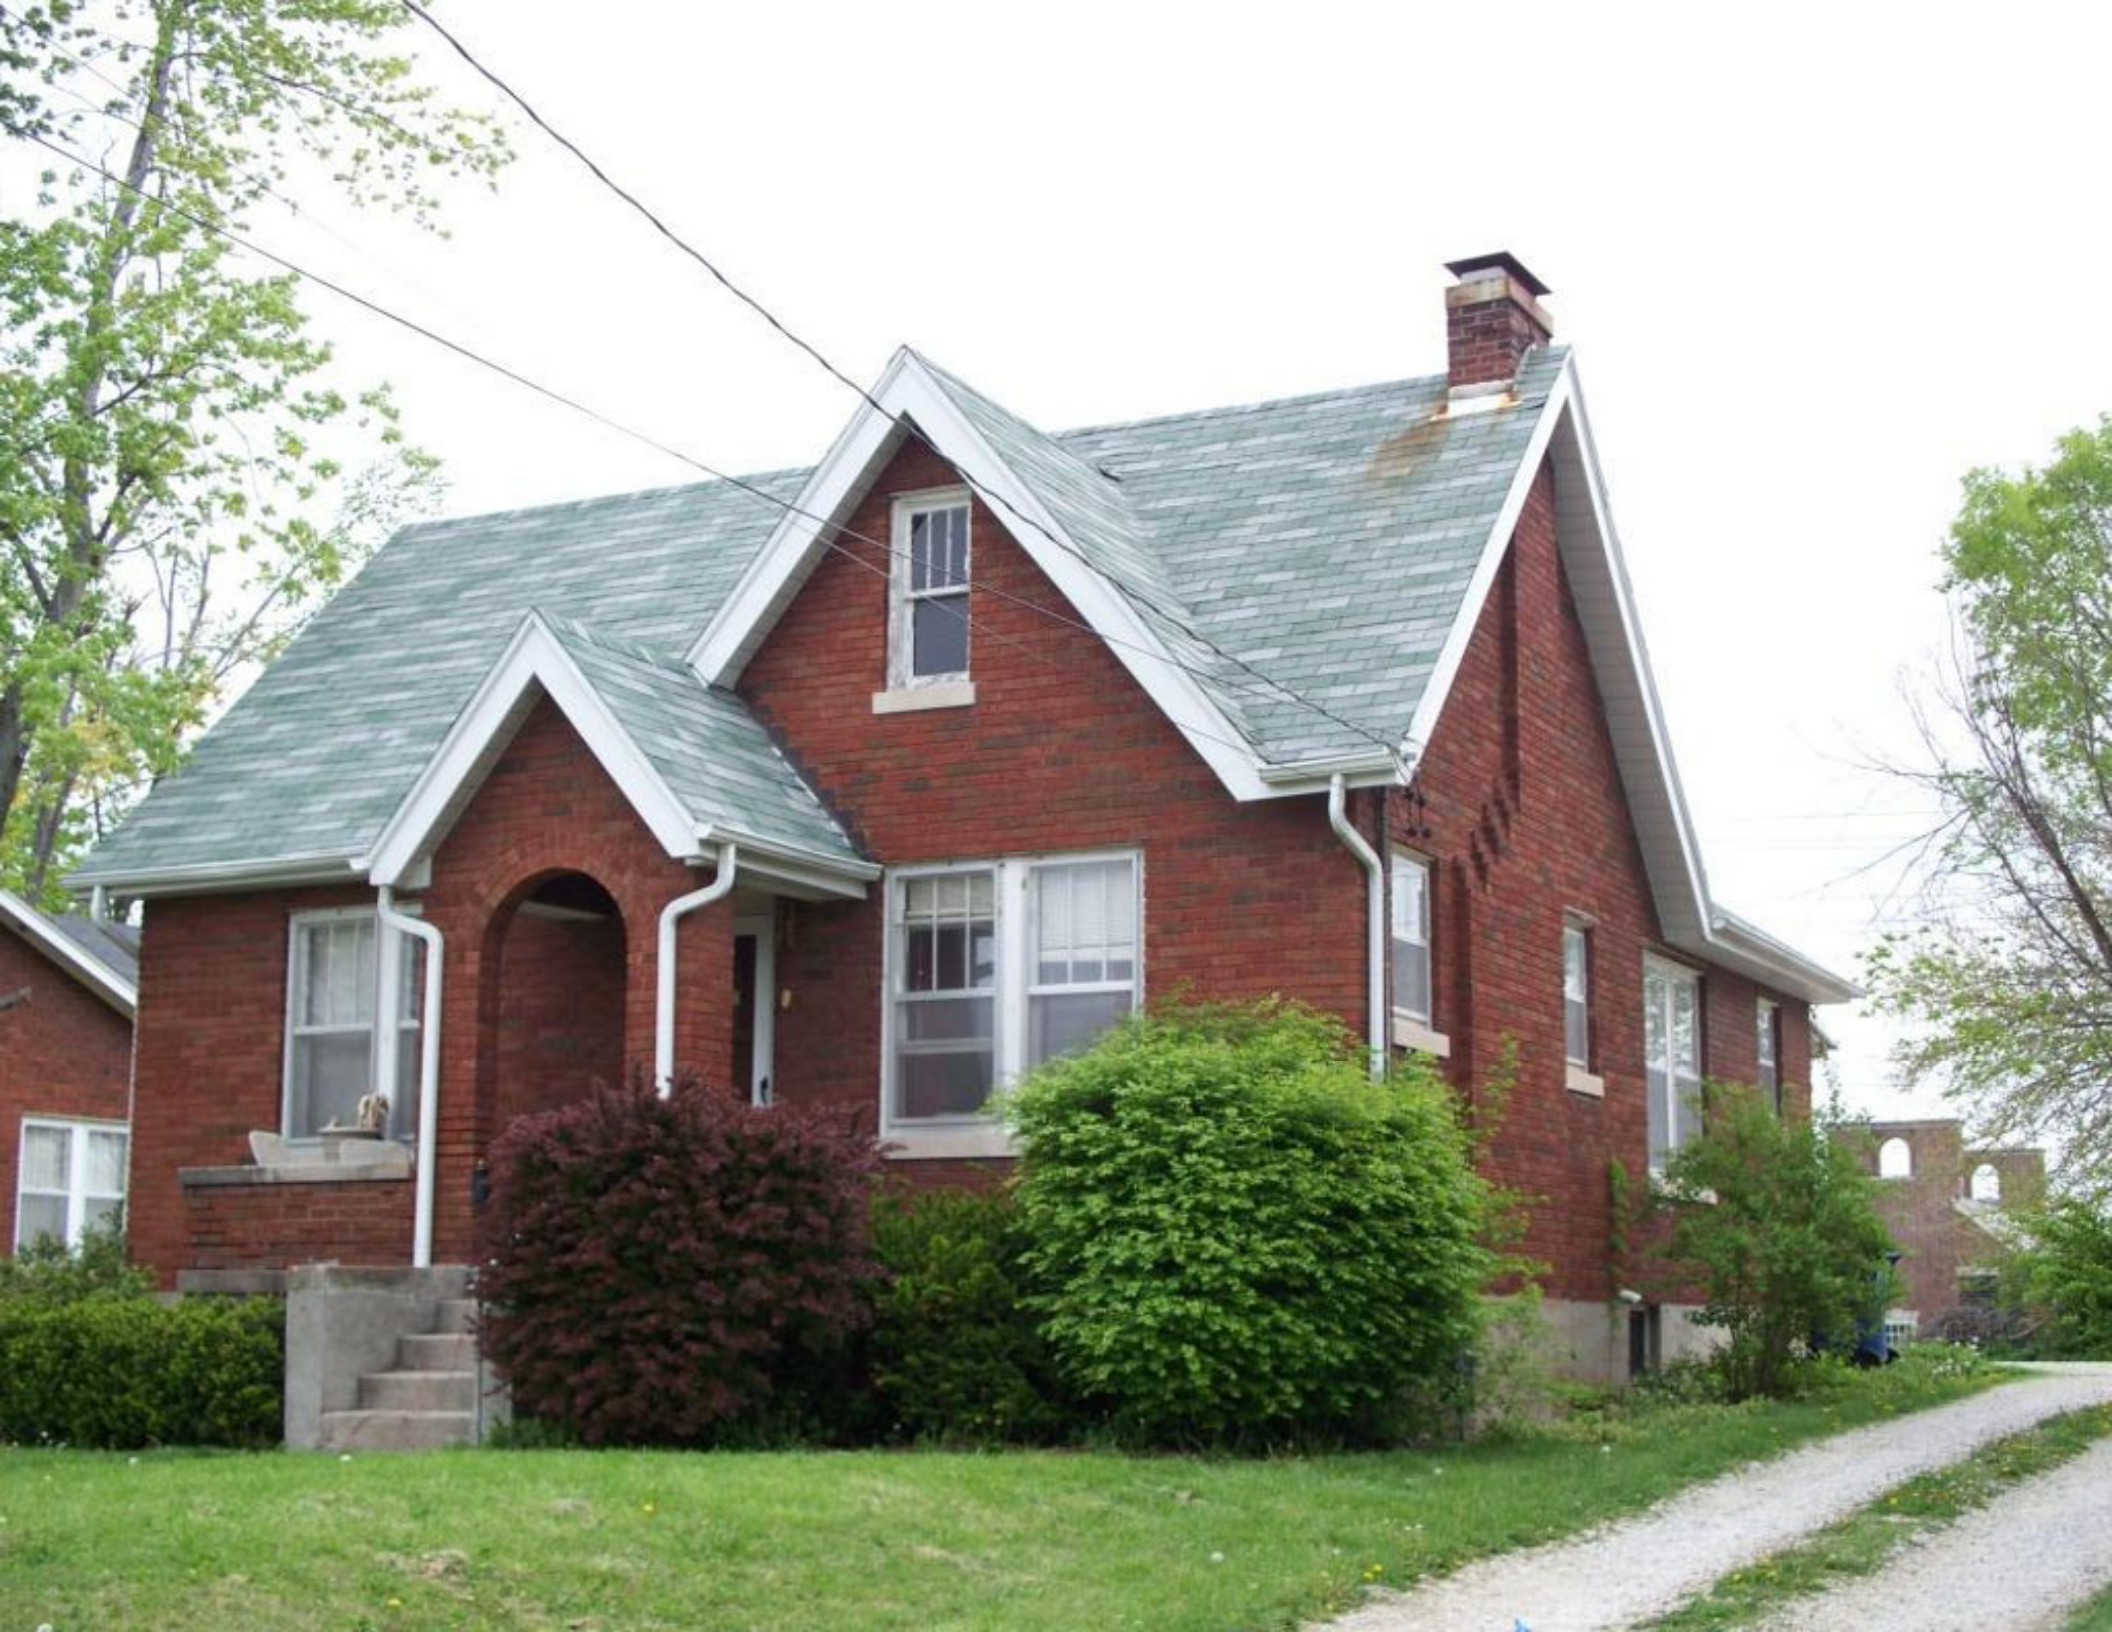
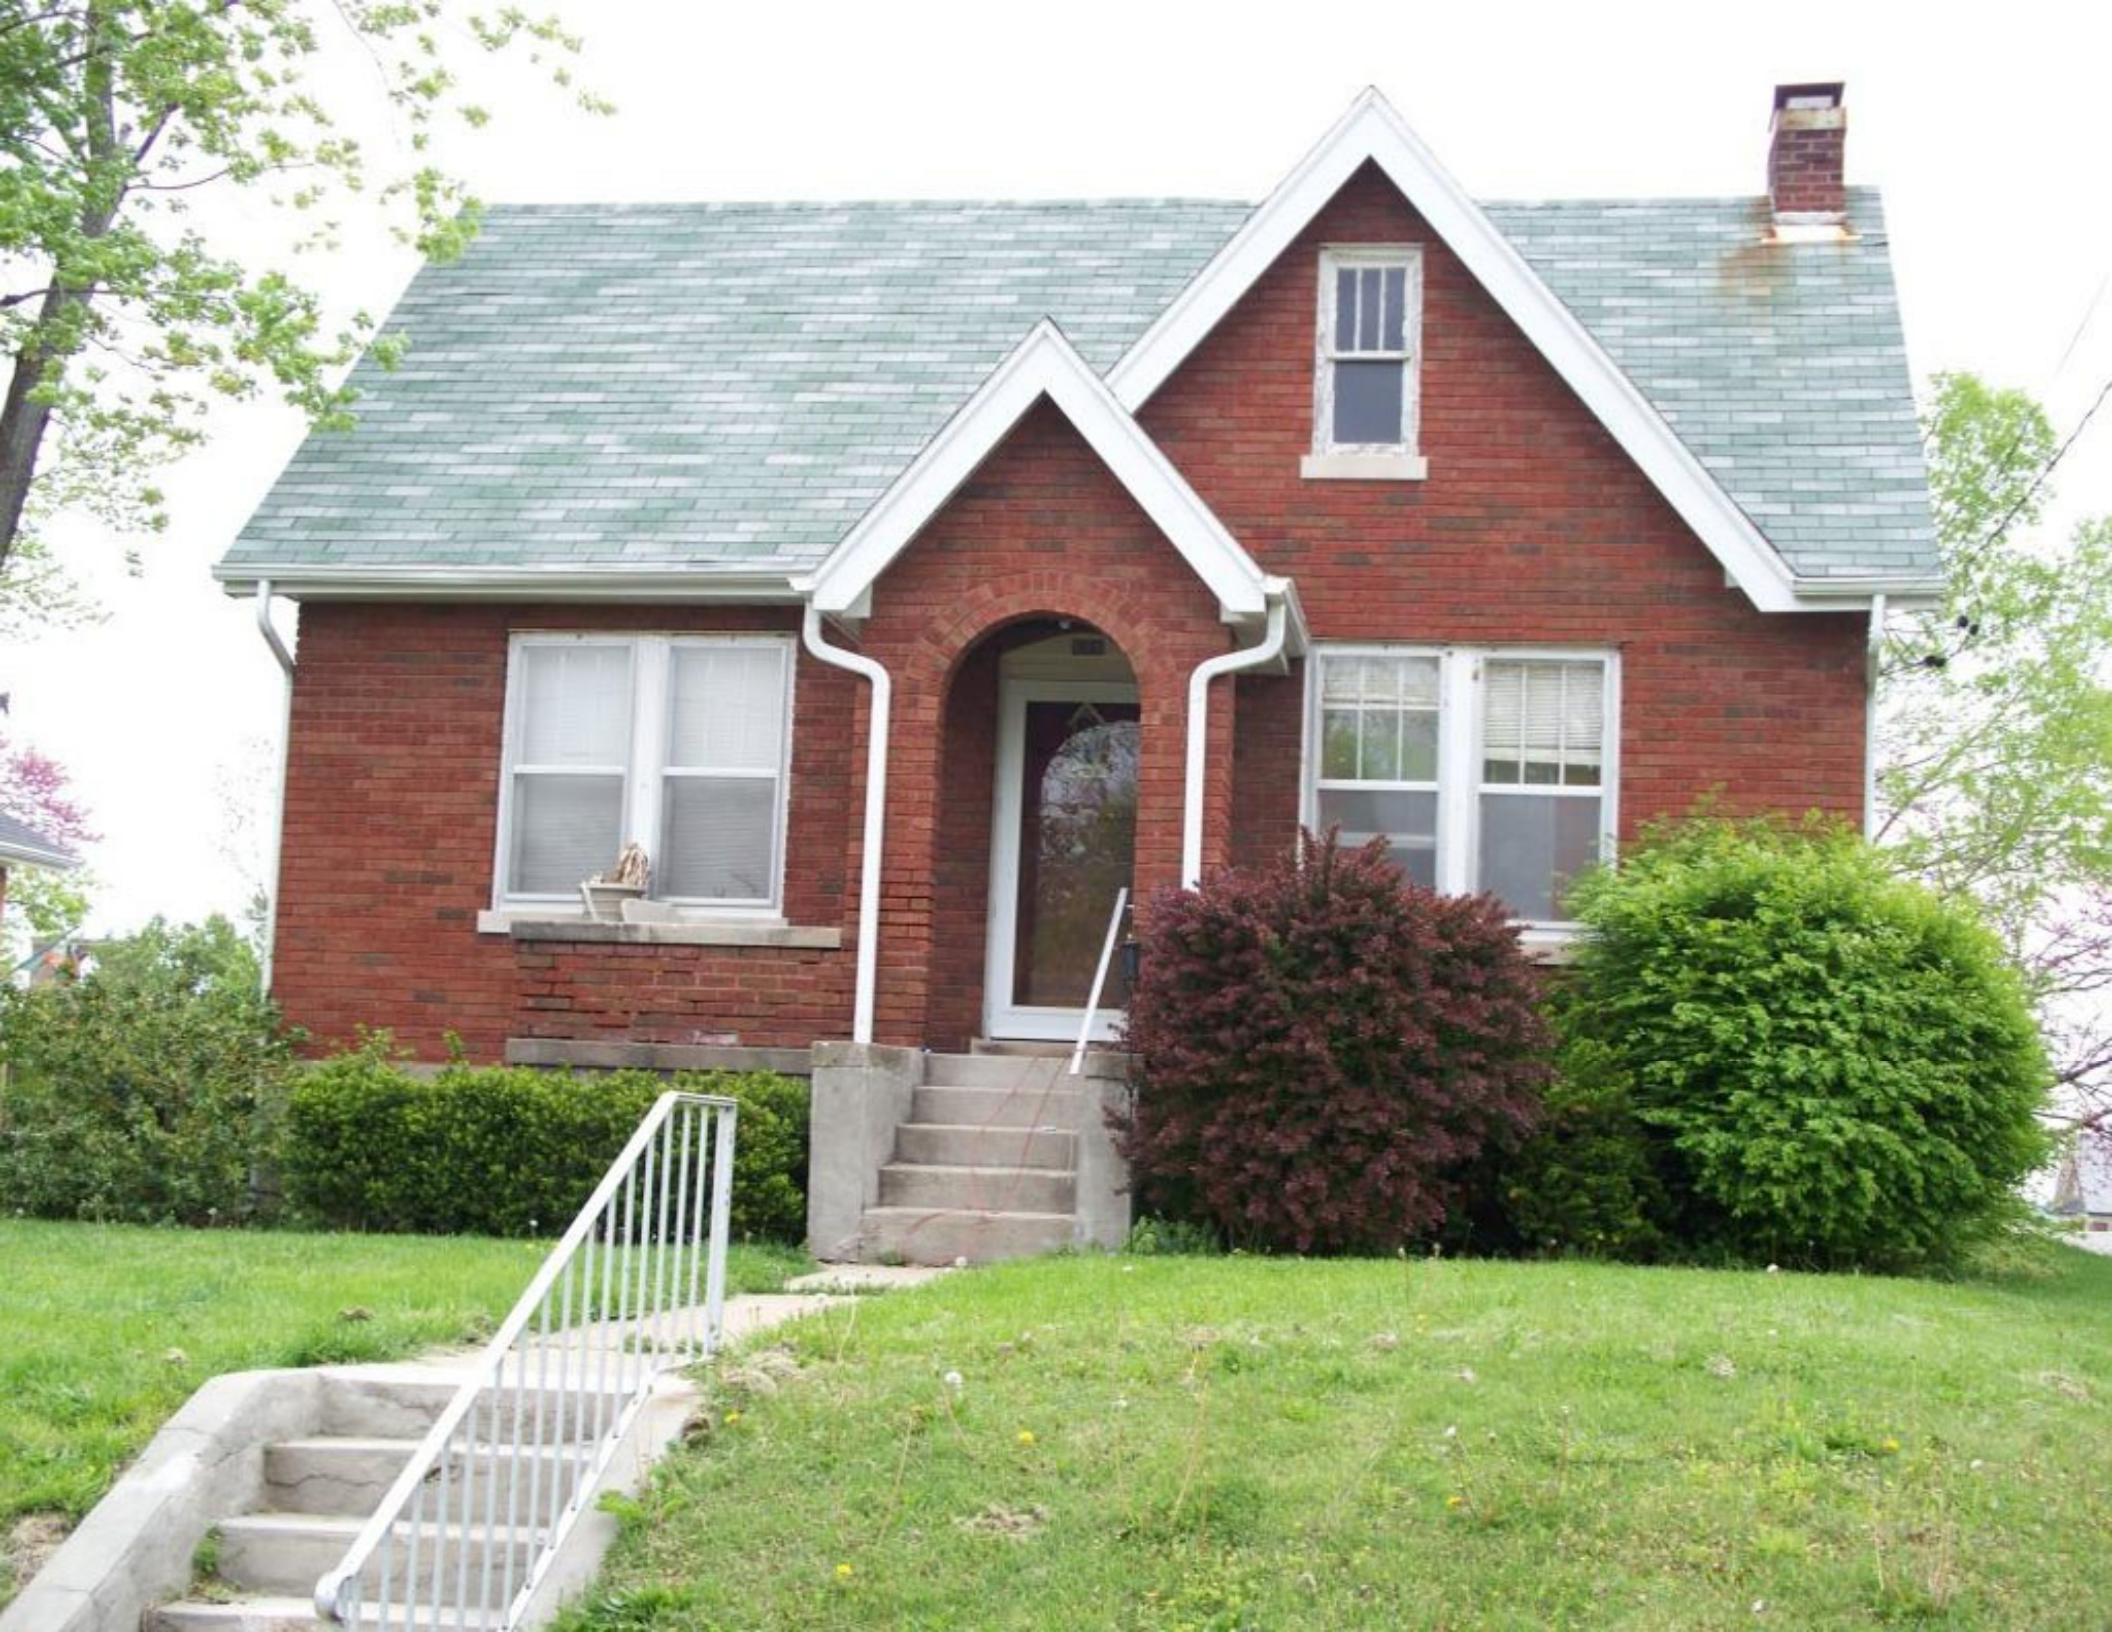
41. (cont.)
This brick Tudor is one-and-a-half-stories tall with a cross gable roof. The intersecting gable has a historic 3/1 window in its peak. From the left, the first bay has paired 3/1 windows. The entrance is centrally located with another pair of 3/1 on the other side. All windows have limestone sills. A portico with partial porch projects from the entrance and extends to the left. The gabled portico has an arched entryway and brick knee-walls capped with limestone that connects to a short concrete stair with concrete knee-walls.
