ARCHITECTURAL/HISTORIC INVENTORY FORM

1. Survey No. CO-AS-005-001		2. Survey name: Moreau Drive Neighborhood Survey	
3. County: Cole		4. Address: 1202 Elmerine Ave.	
5. City: Jefferson City	Vicinity: <input type="checkbox"/>	6. UTM: / /	7. Township/Range/Section: T: R: S:
8. Historic name (if known):		9. Present/other name (if known):	
10. Ownership: <input checked="" type="checkbox"/> Private <input type="checkbox"/> Public		11. Historic use (if known): Residential	11. Current use: Residential

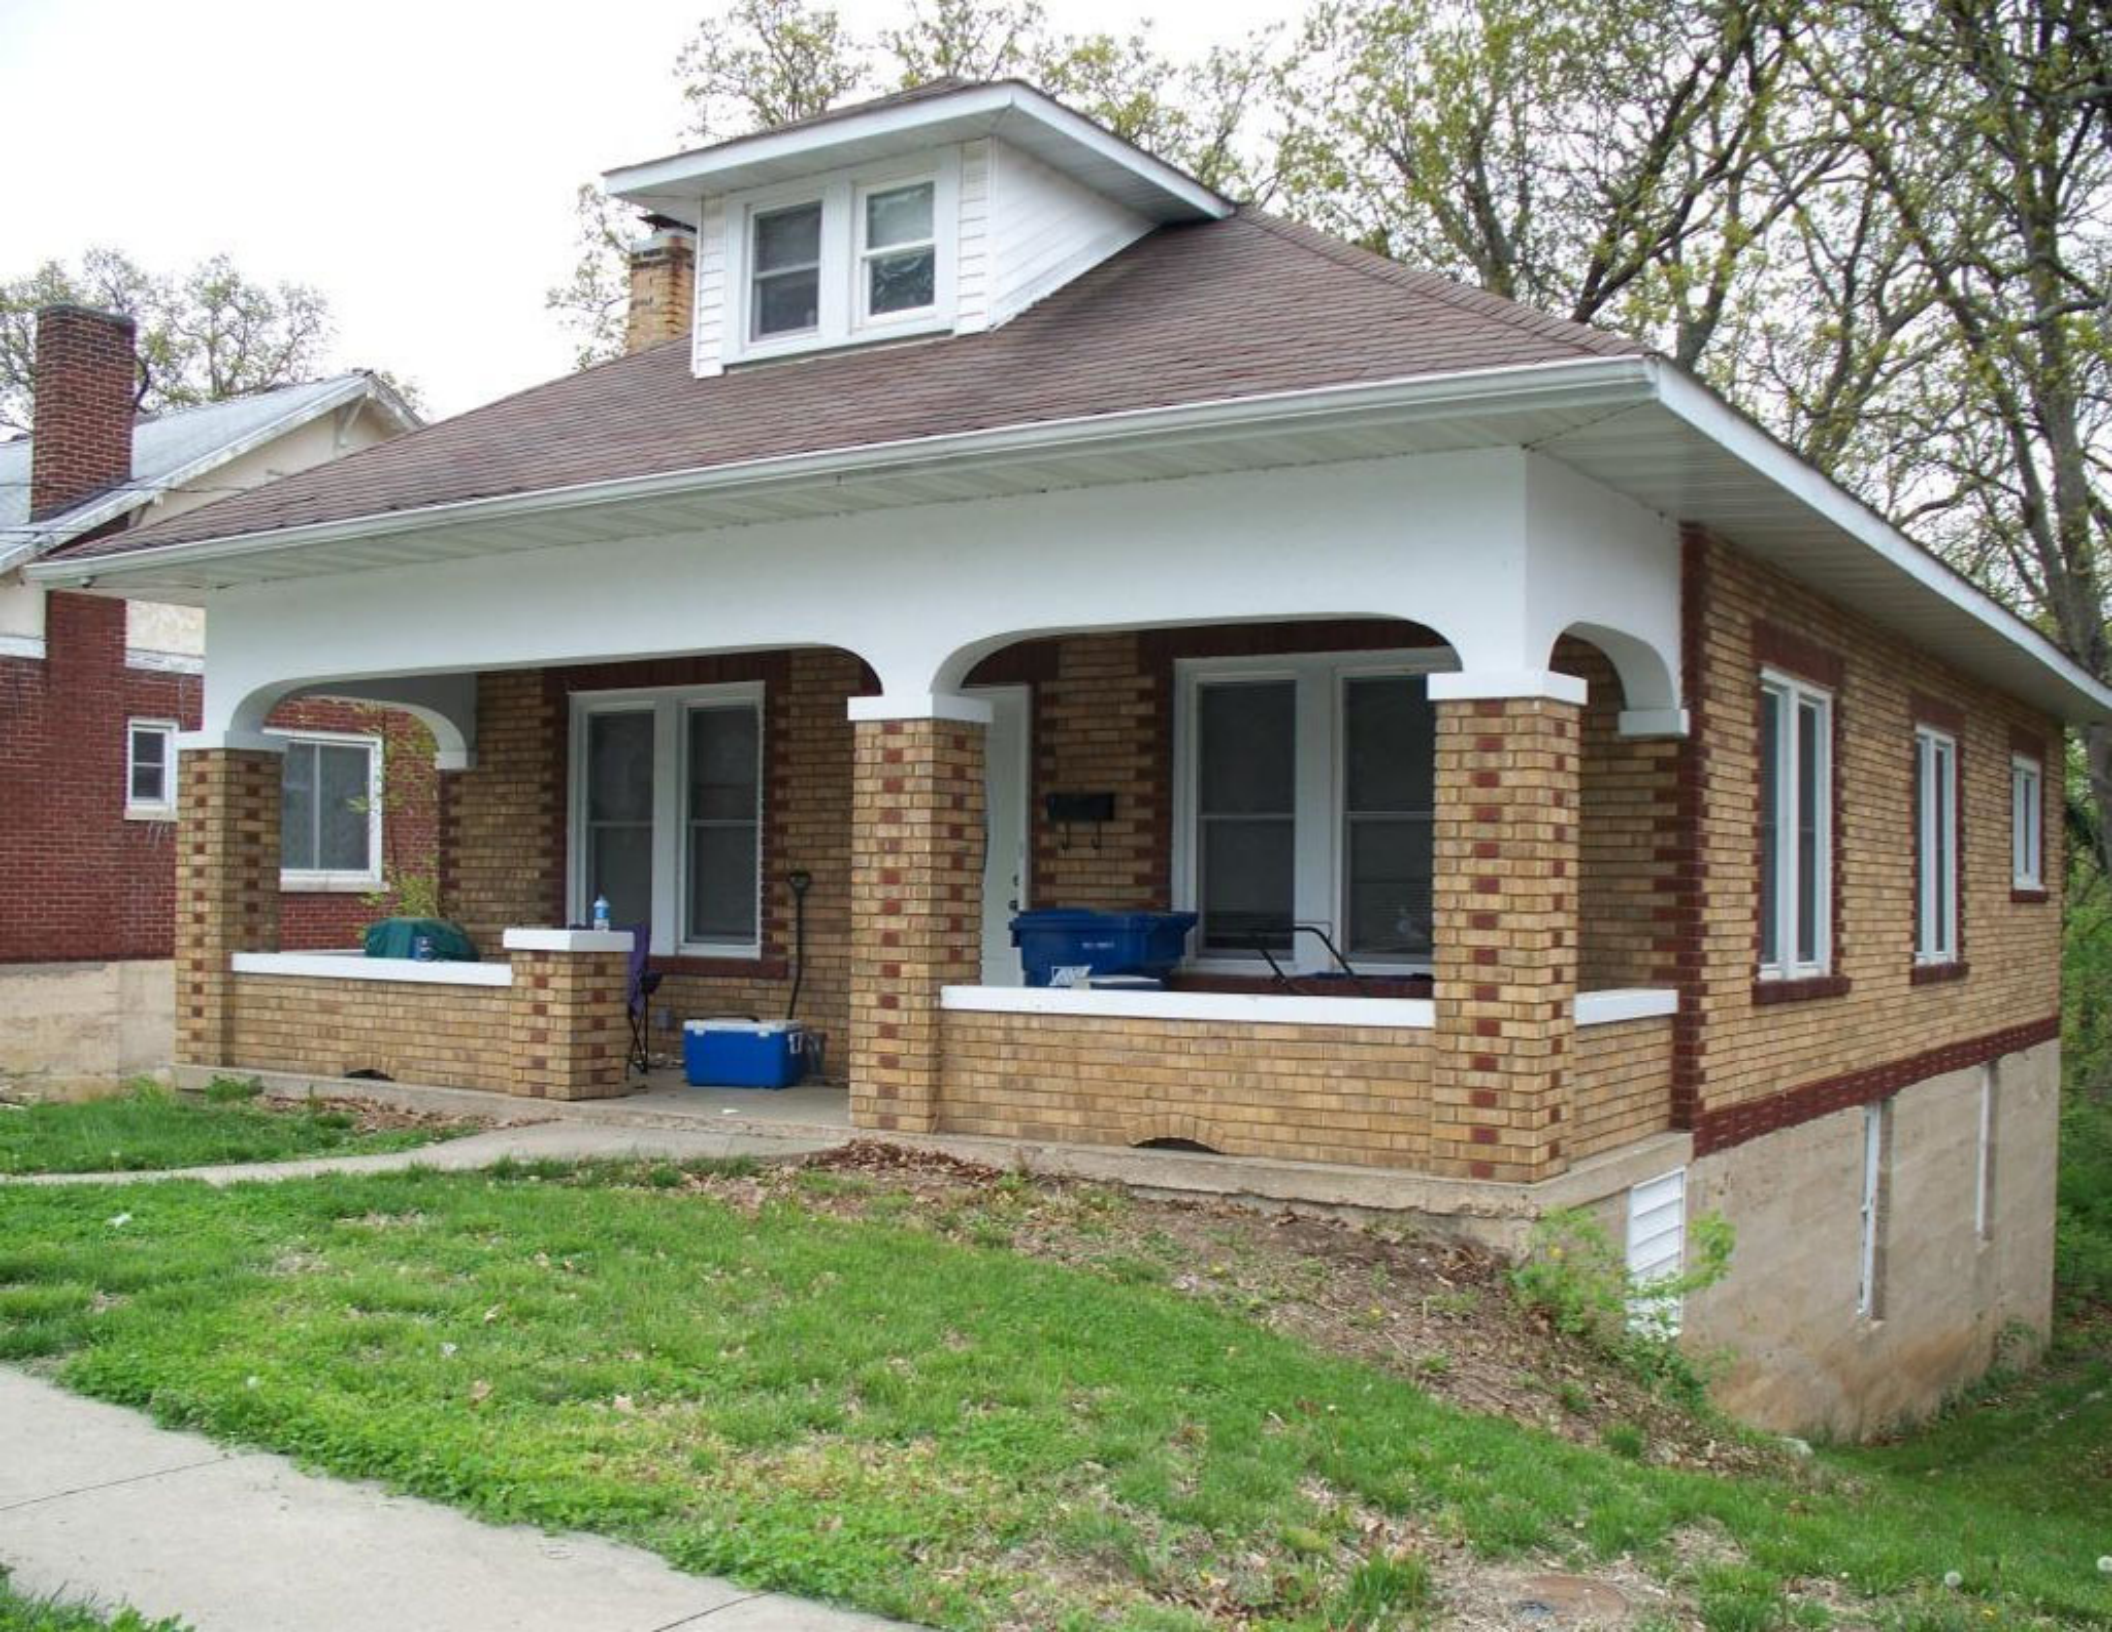
This 1 ½ story brick bungalow has a pyramidal roof with a central pyramidal dormer with two vinyl 1/1 windows. Like 808 Fairmount, full width porch features brick half walls and piers that meet a curving stucco cornice giving somewhat of an arcading appearance. Pairs of replacement 1/1 windows flank the central entrance. The yellow brick is detailed with red brick quoining and red brick headers in the pilasters in the porch. There is a small wide arch at the bottom of each knee wall of the porch, likely for ventilation.

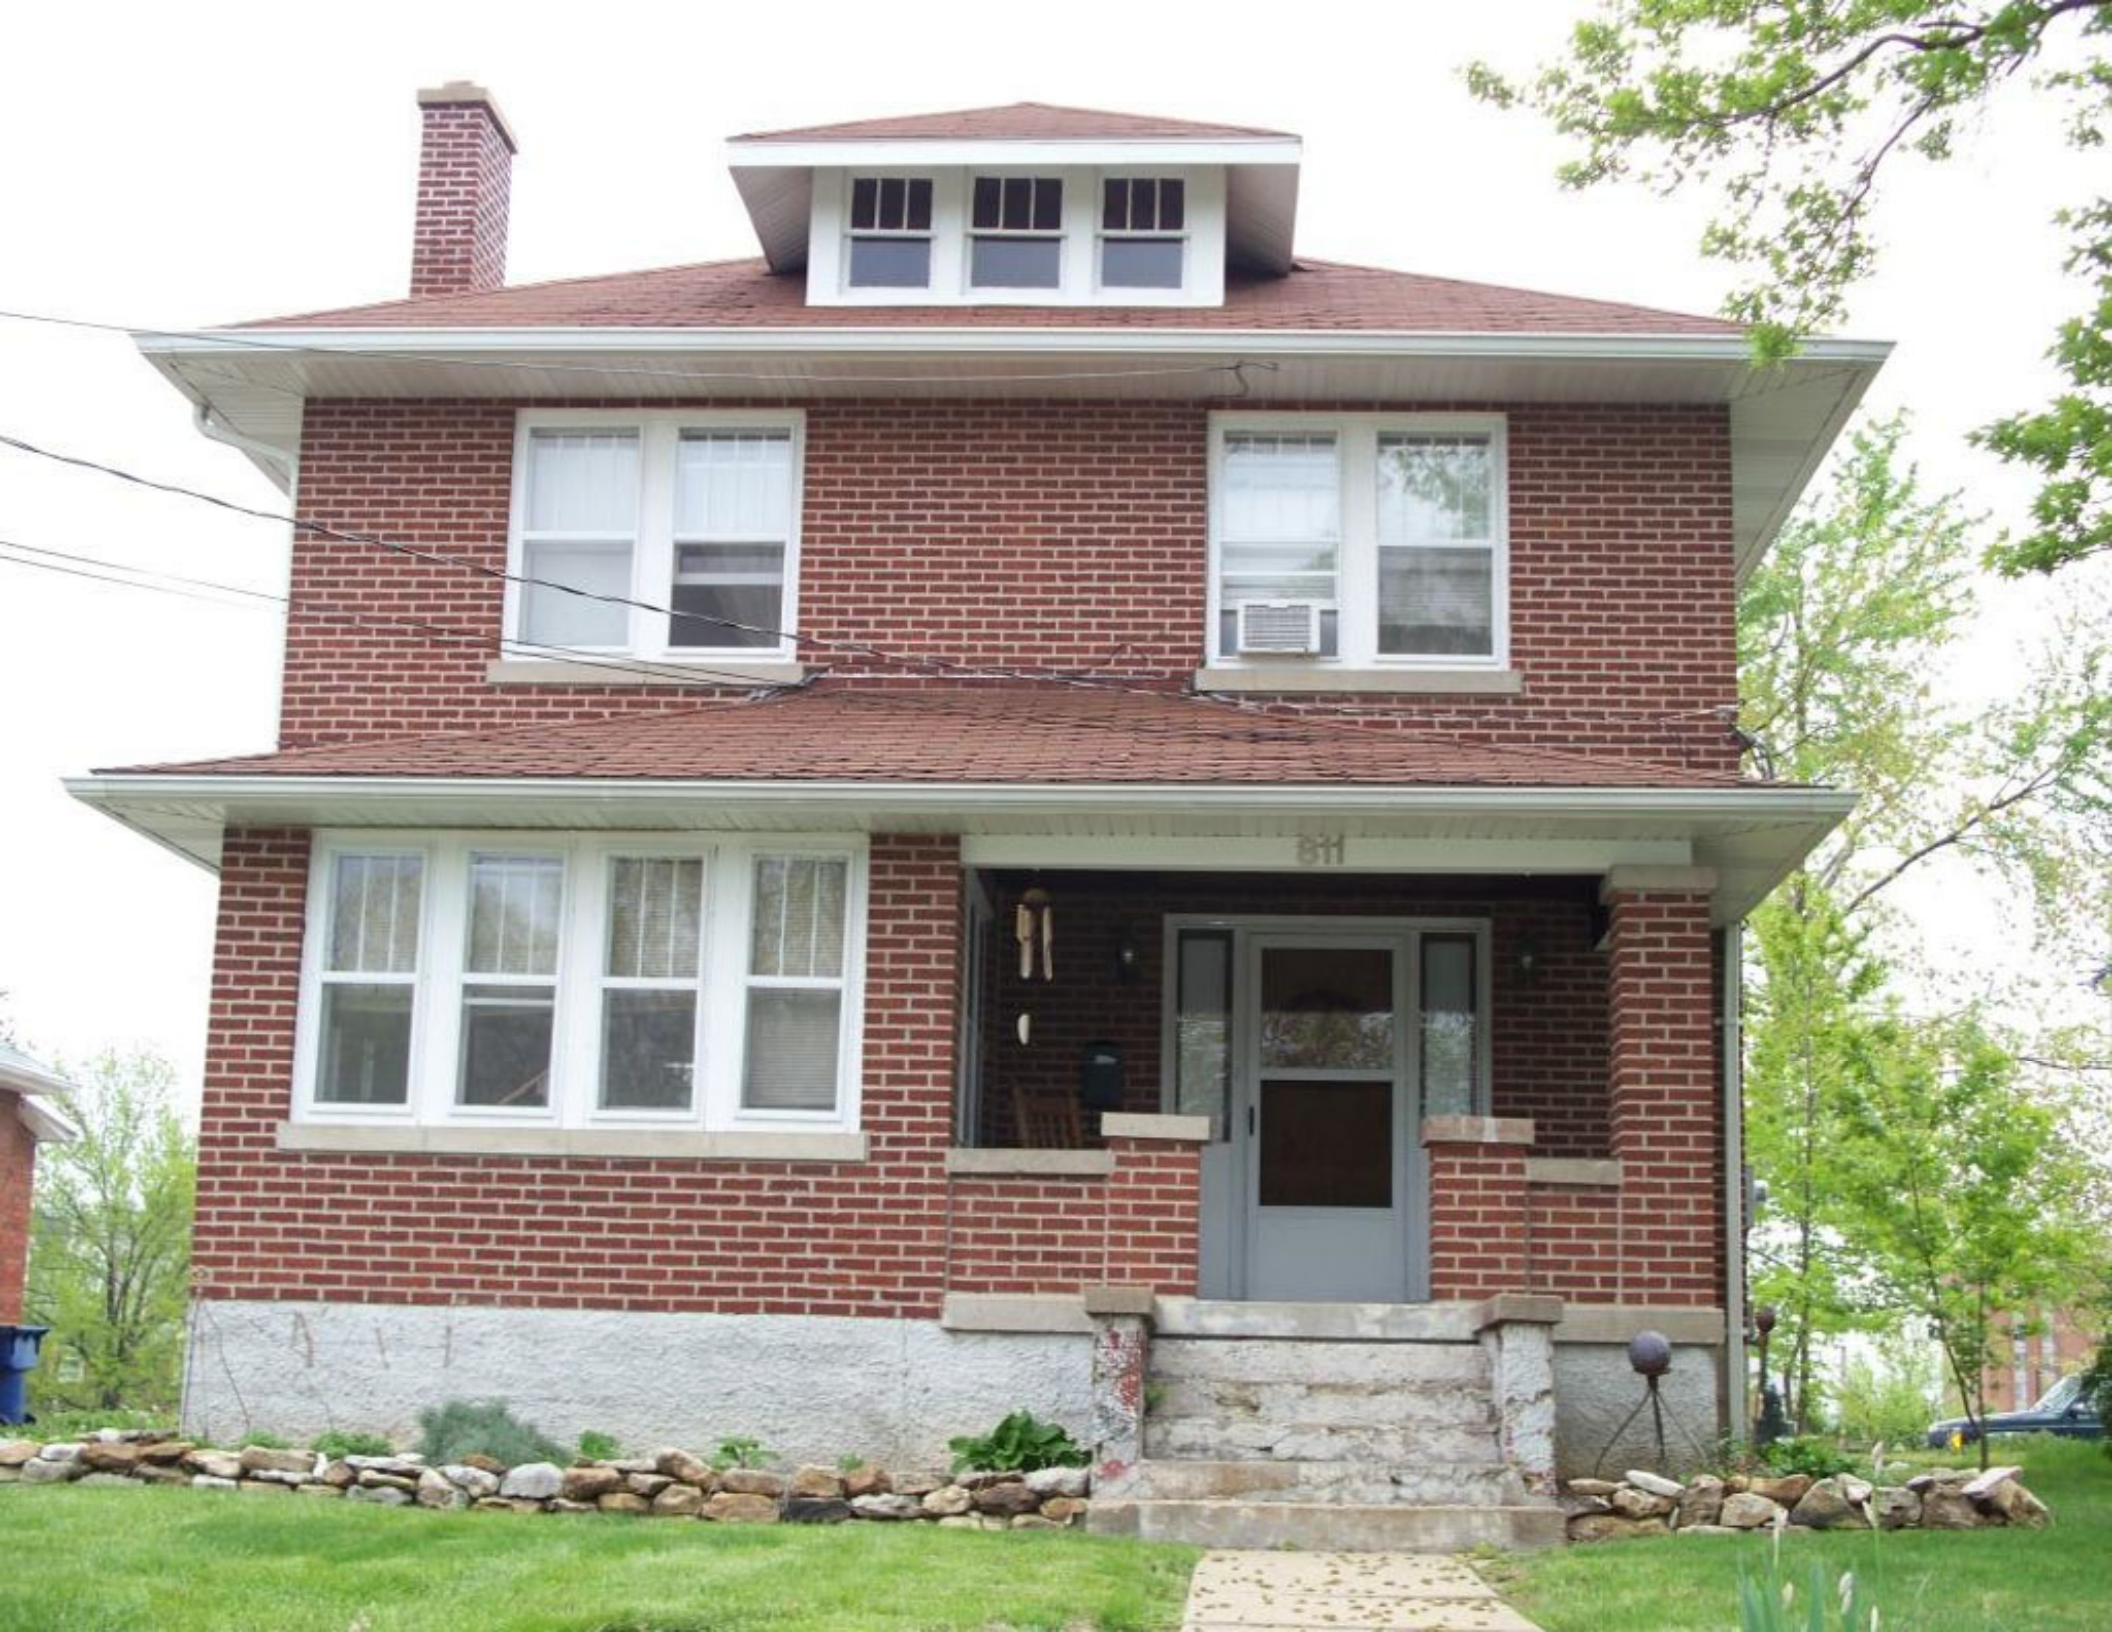
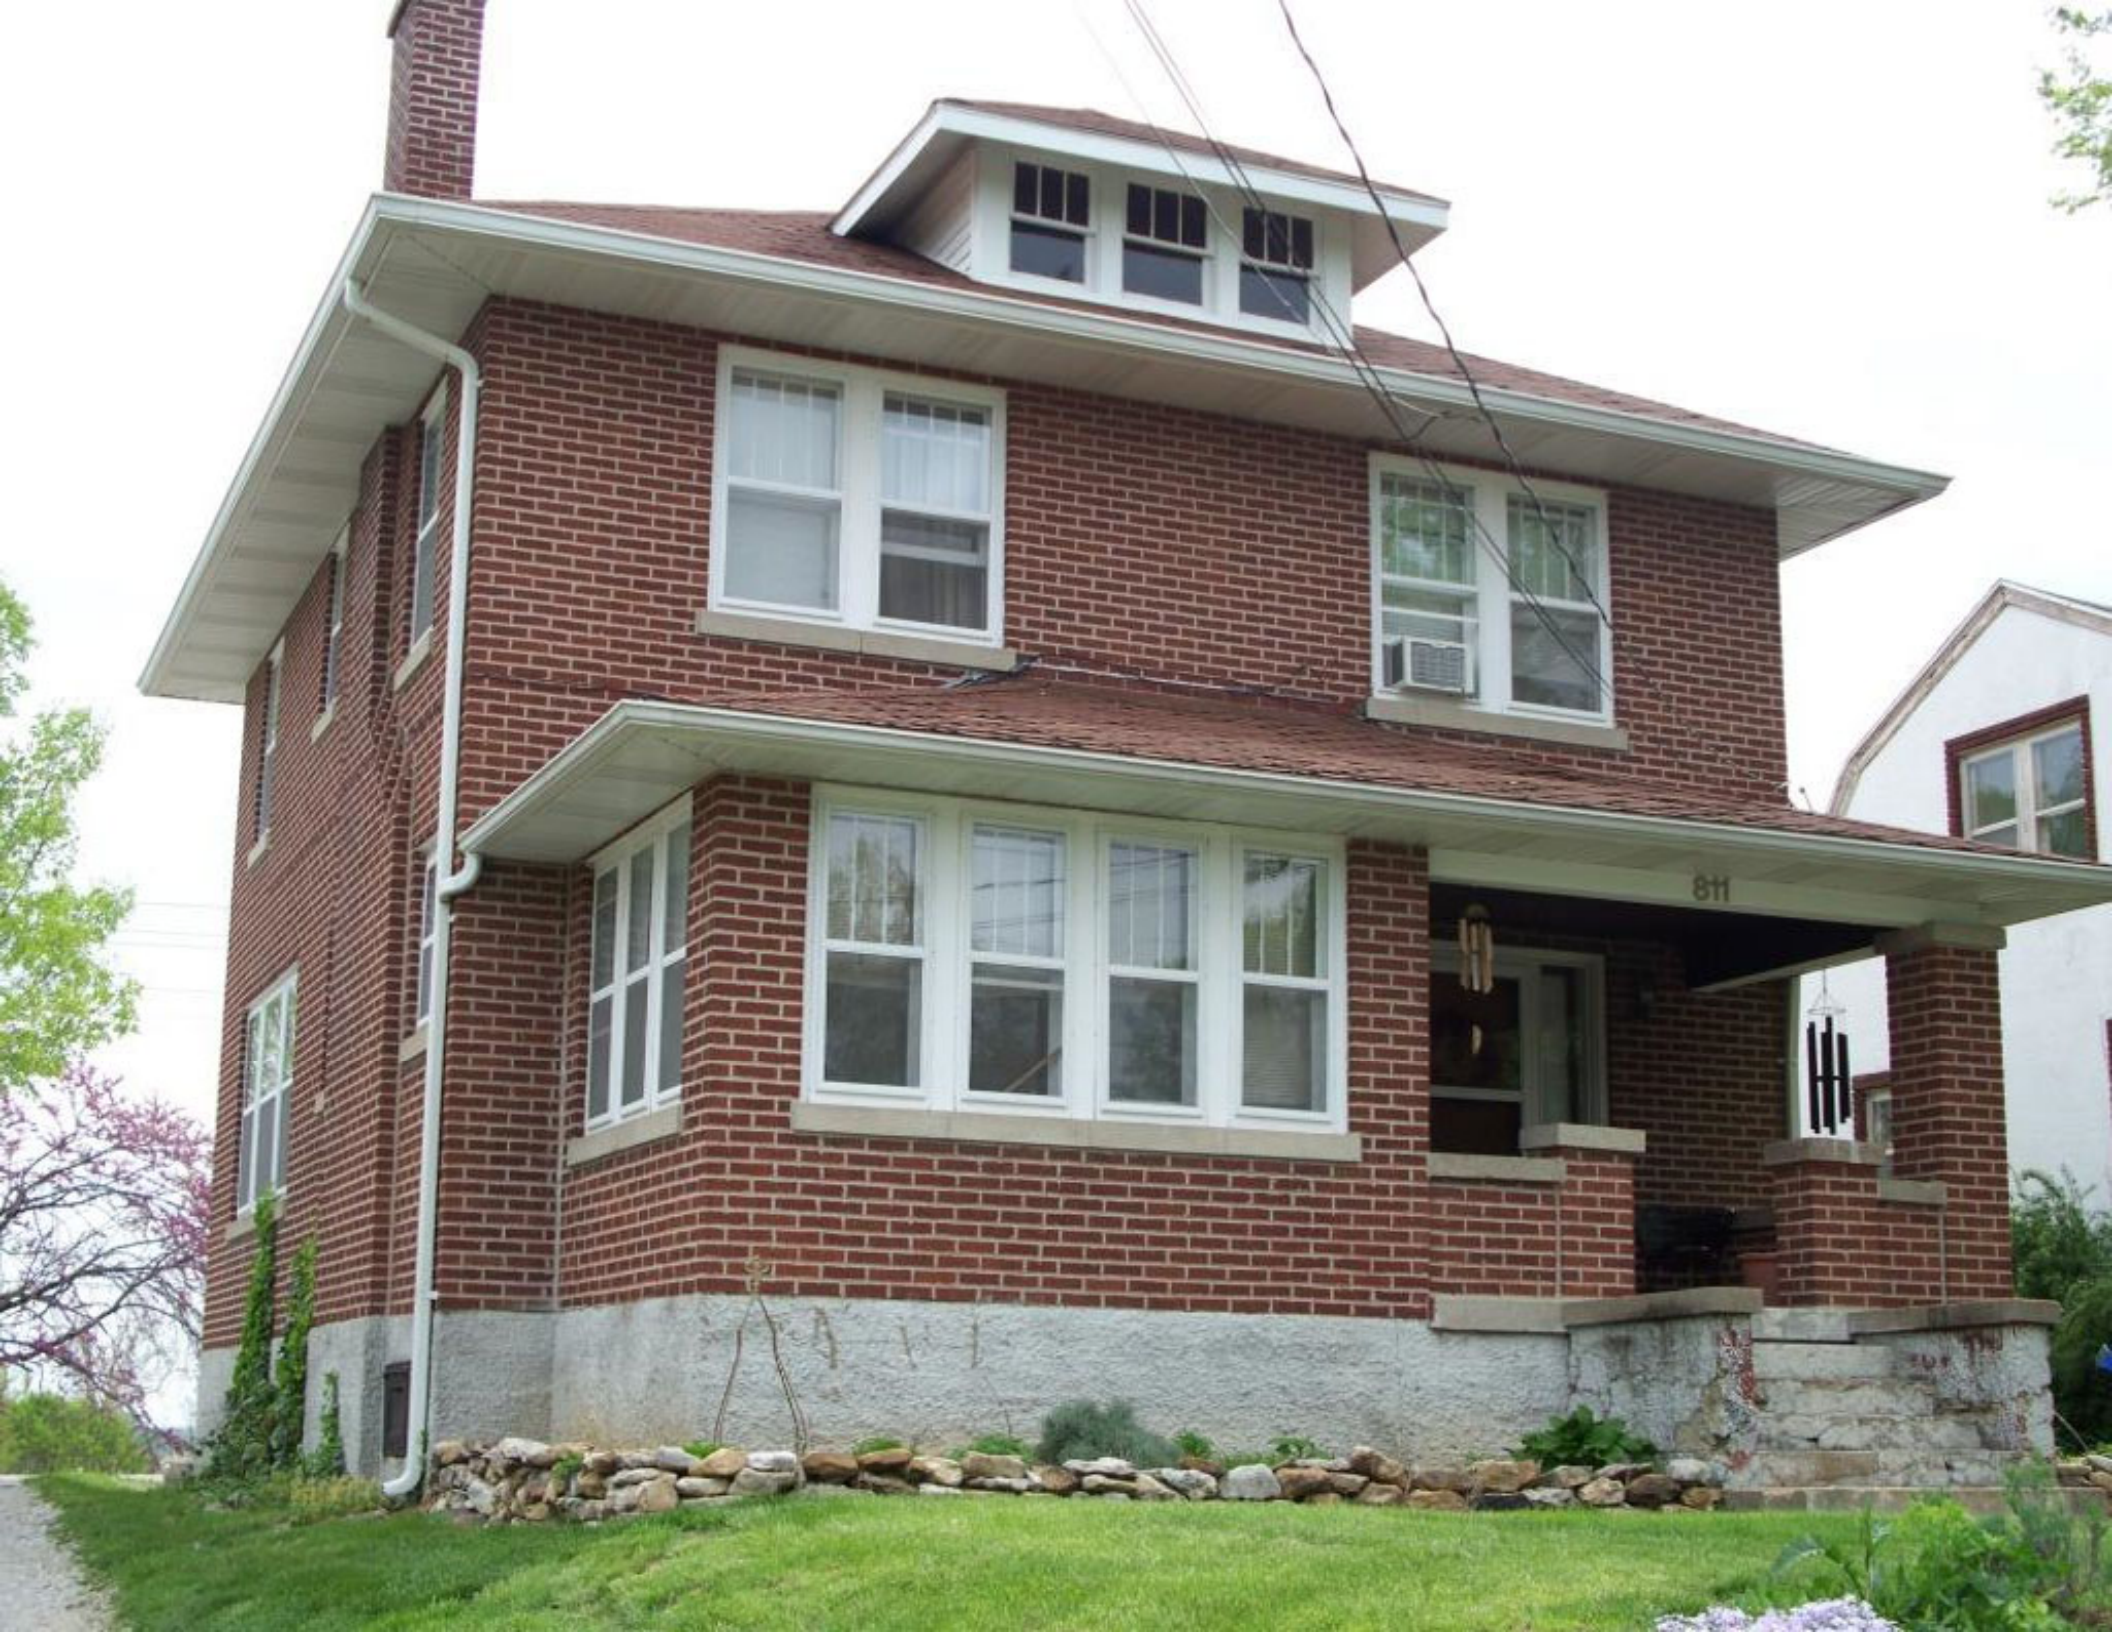
This two-and-a-half story brick four square has a hipped roof with hipped dormer centrally located on the uppermost floor with three 3/1 windows. The second story has two paired 4/1 historic windows with stone sills. The first floor has a row of four 3/1 windows with stone sills in the left bay. The right bay is recessed and contains the door with sidelights. The foundation is raised appears to have been parged. The porch is flush with the façade and features brick half-walls with stone sills. The concrete stairs leading up to the property are also parged. The first floor has a hipped flare roof with wide overhangs. The roof also has a wide overhang.

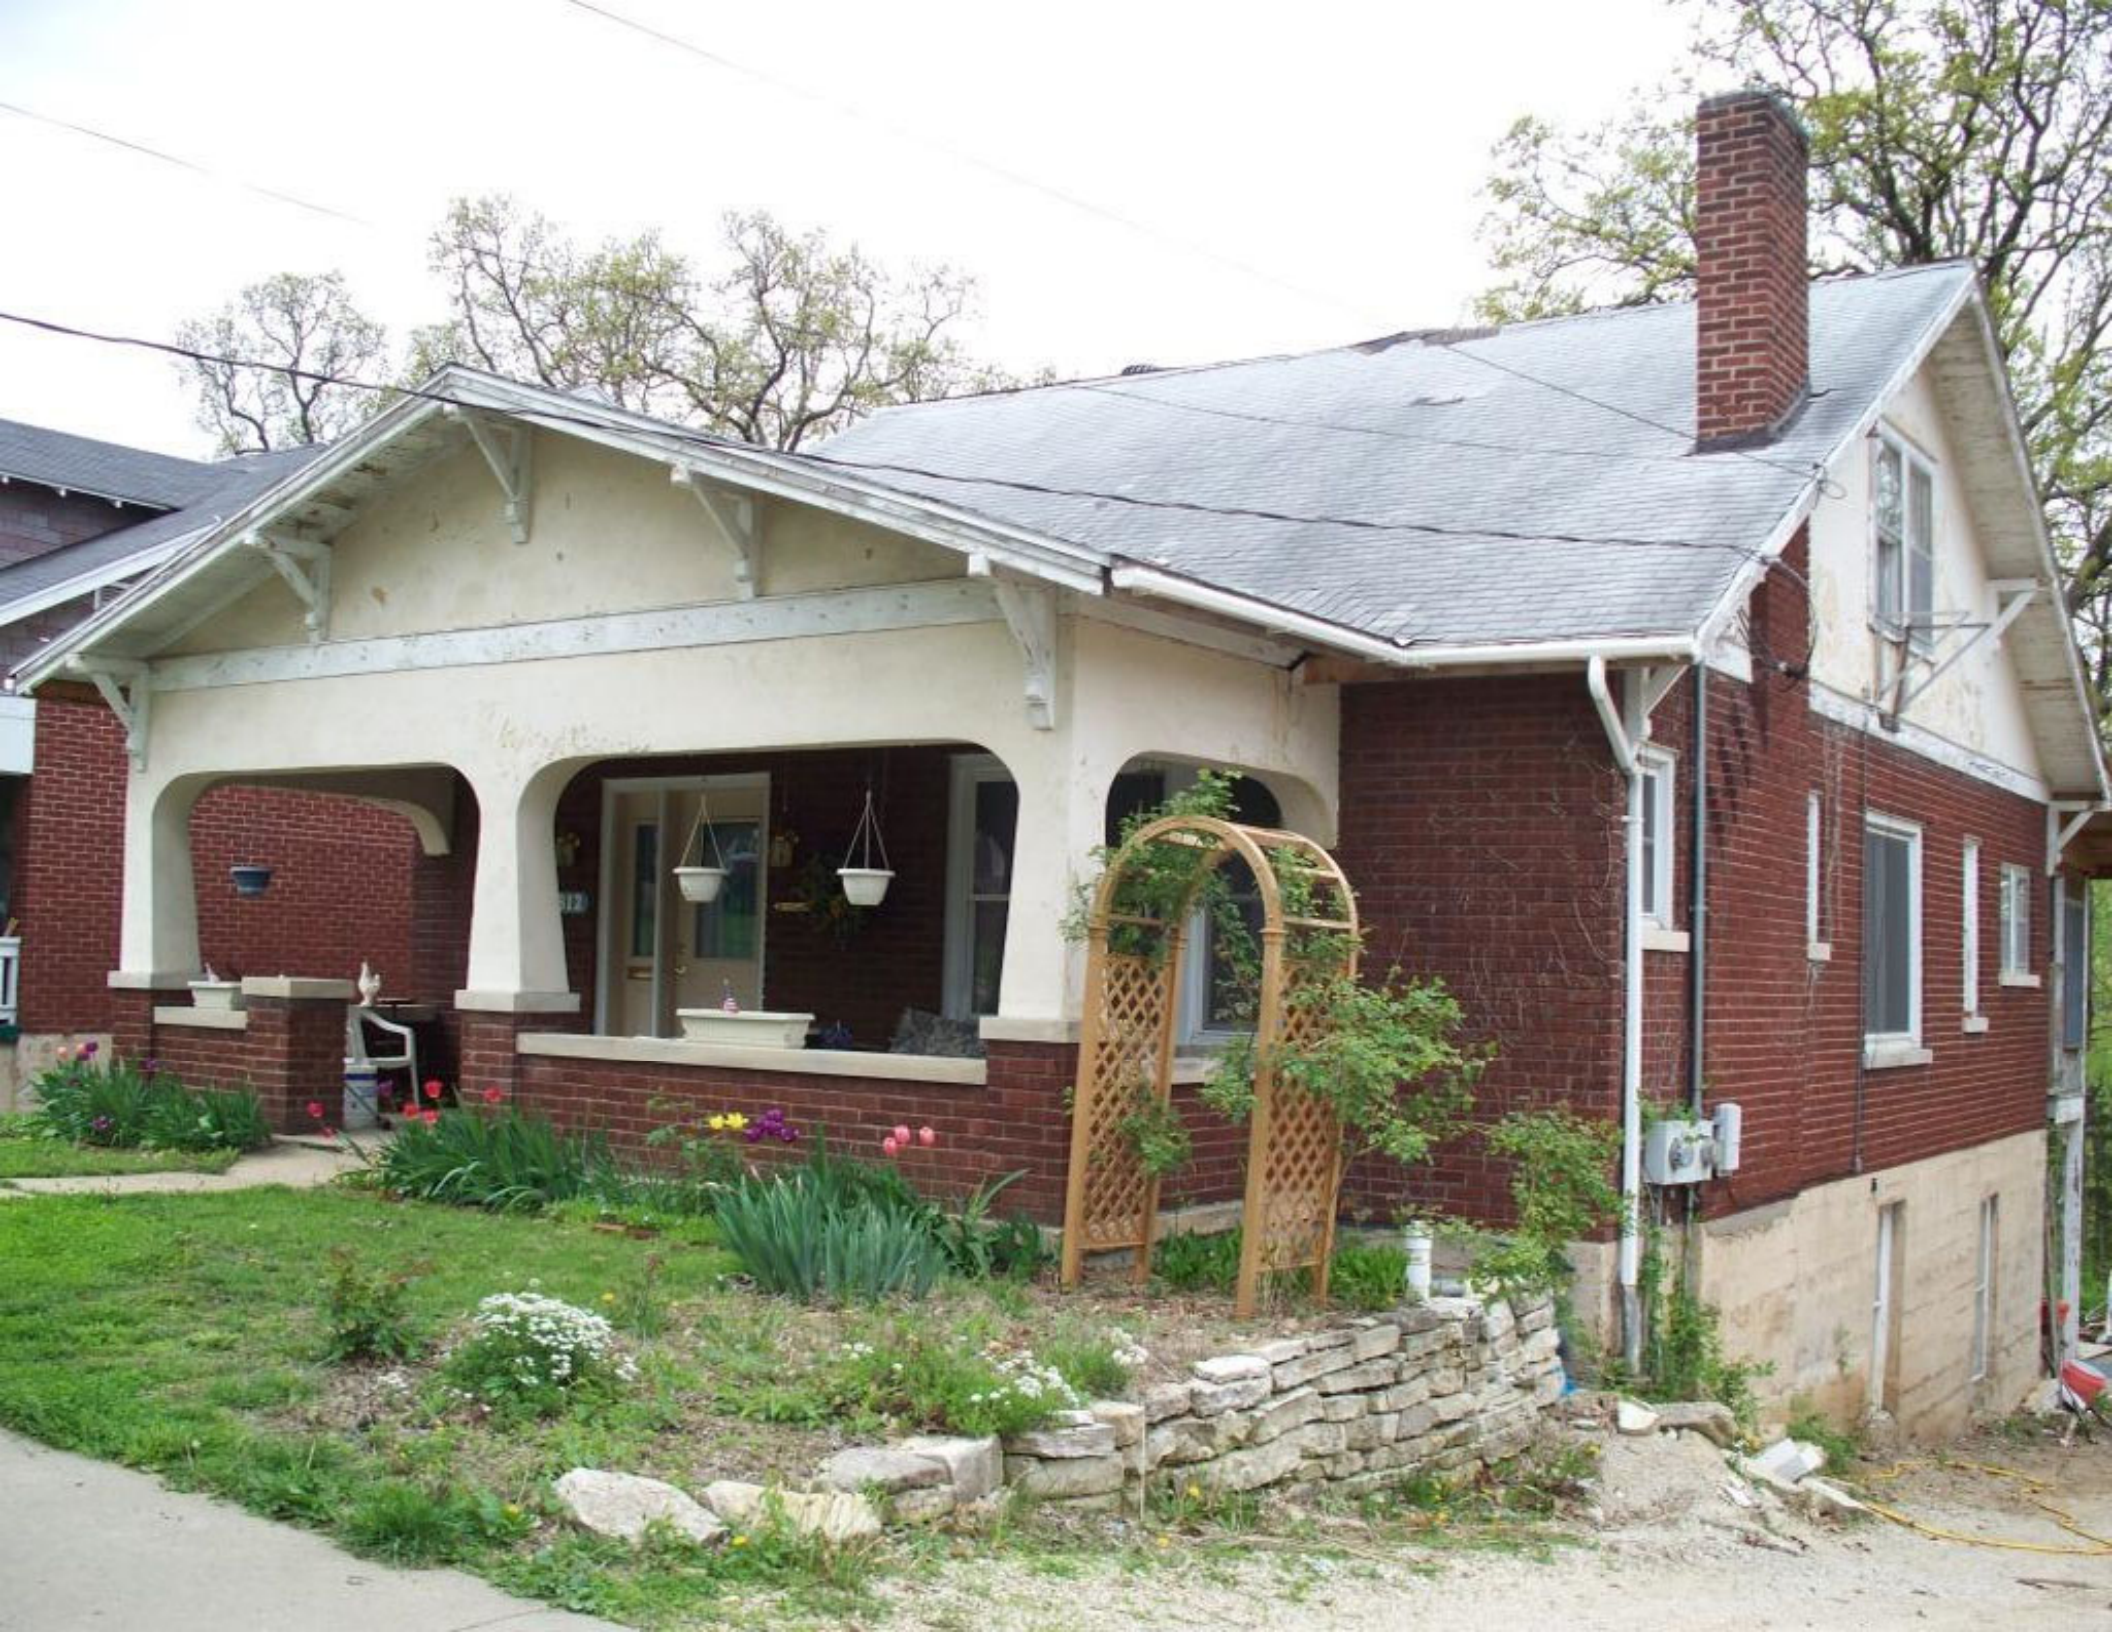
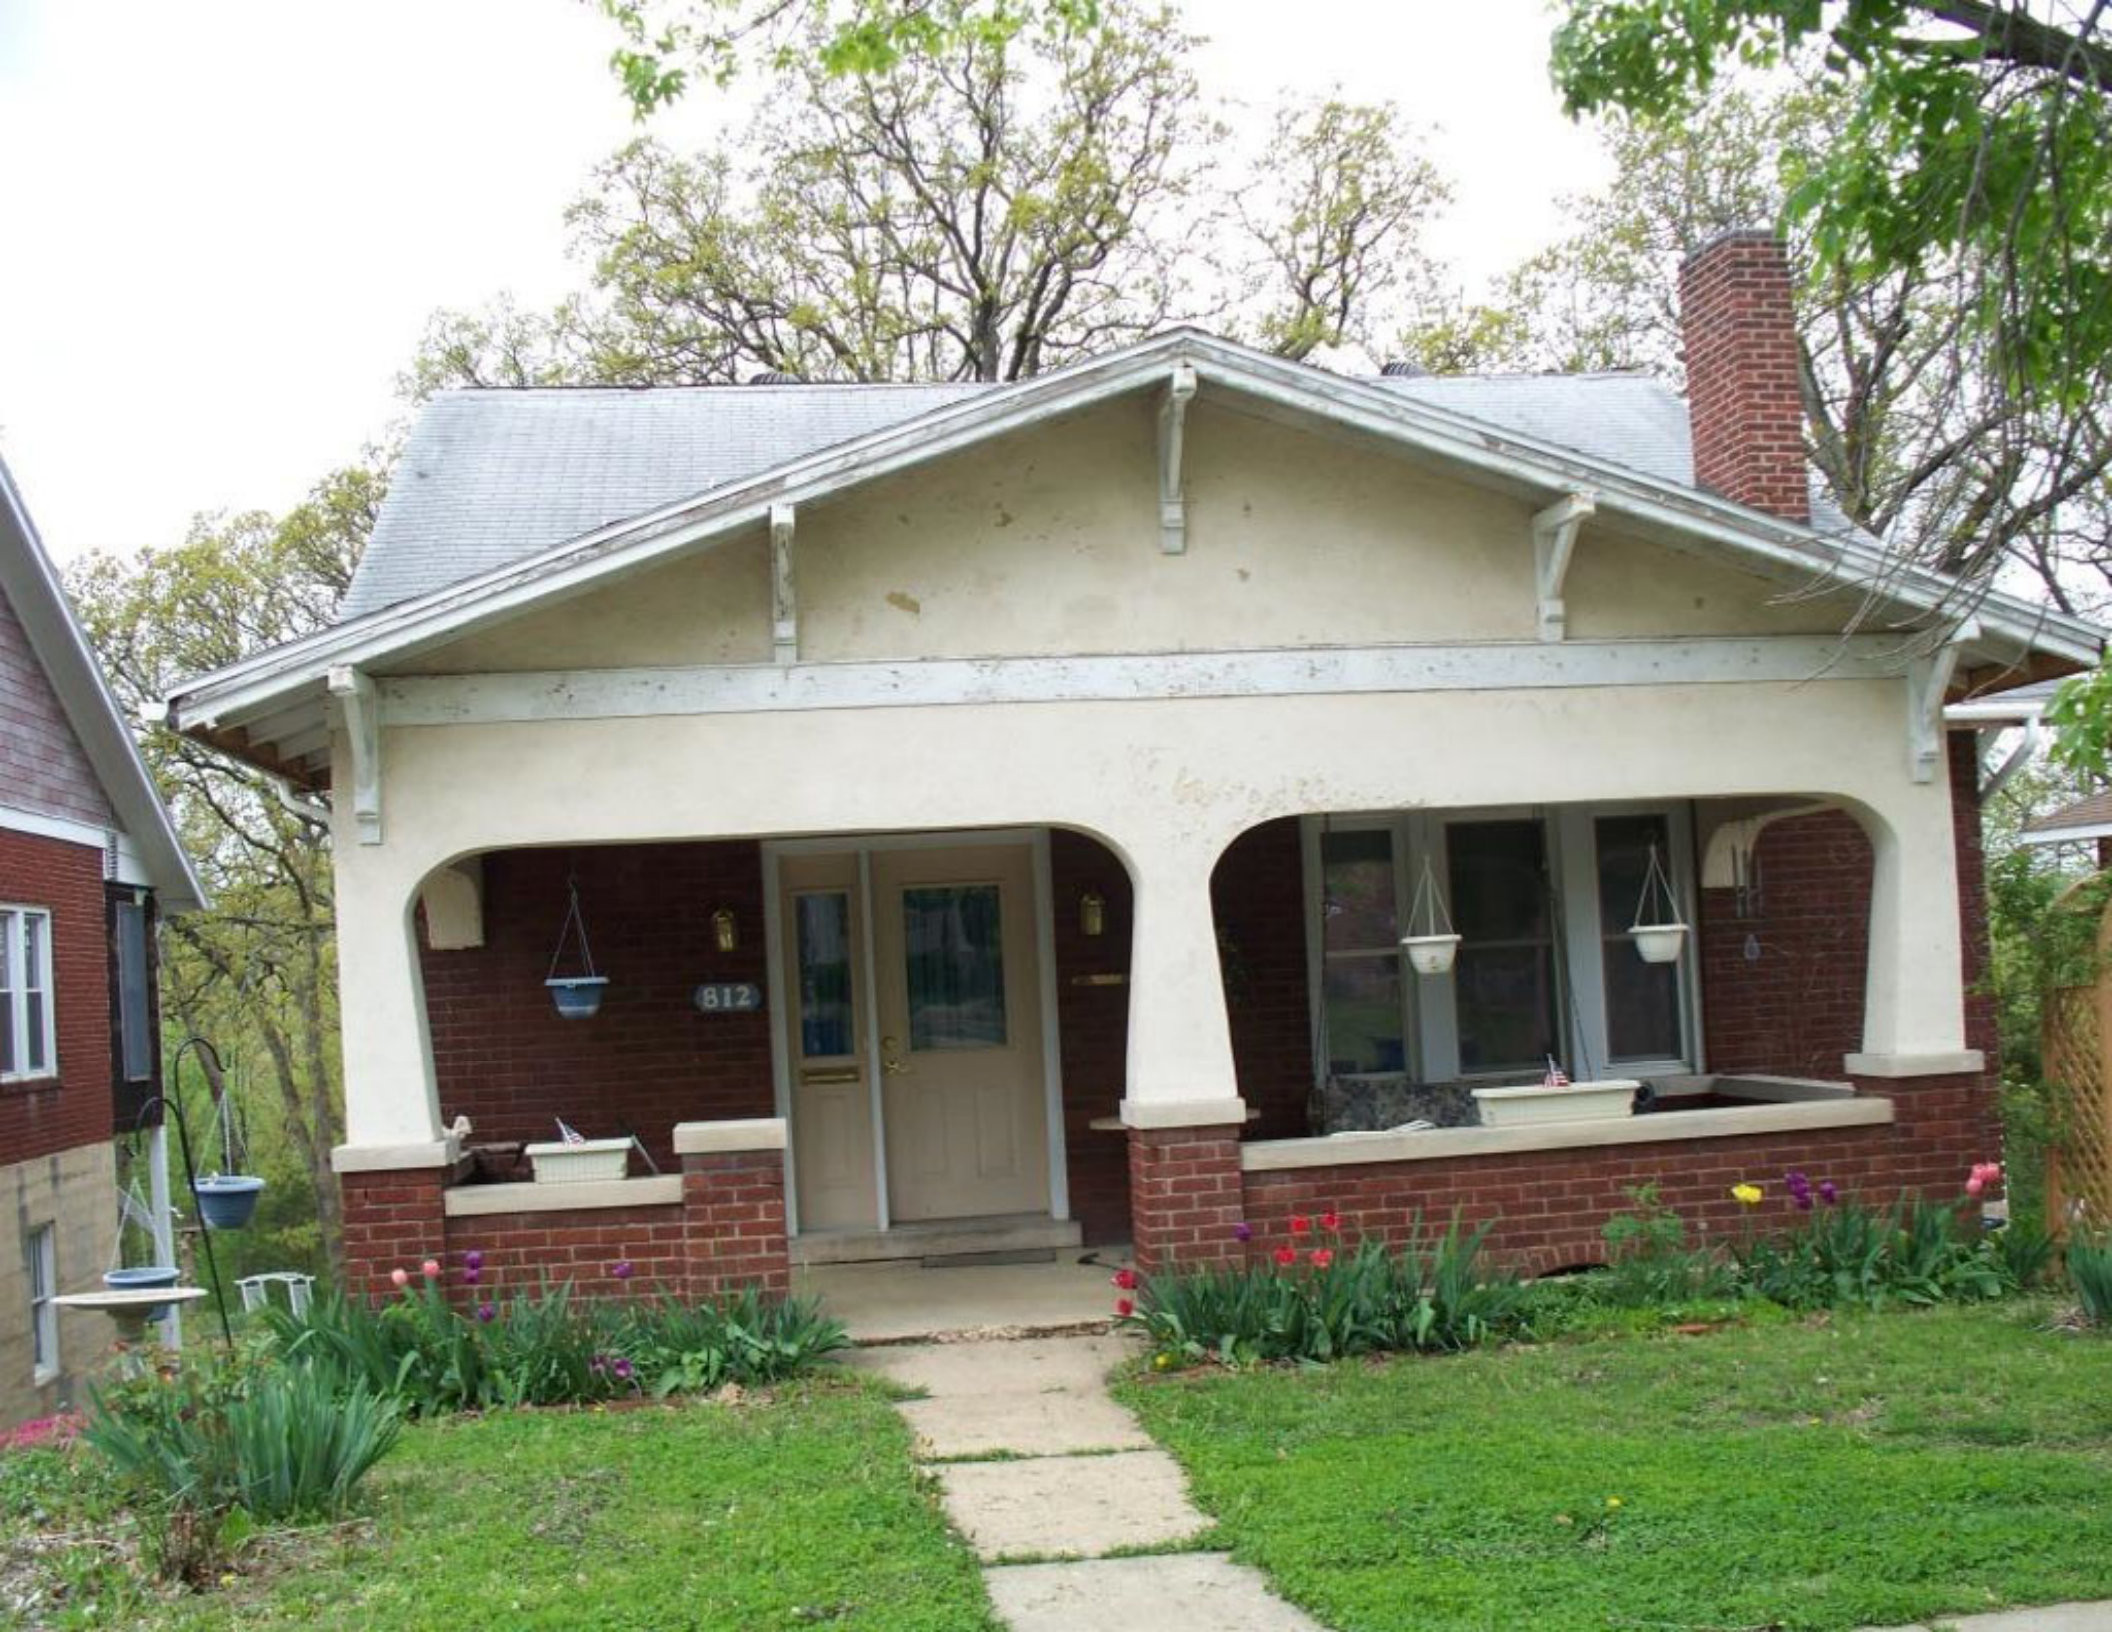
This 1 ½ story brick bungalow has a cross gable roof with brackets, half-timbering (one band) and stucco in the gable-end that seamlessly meets the battered stucco piers of the full width porch. The piers sit atop brick pilasters and knee walls capped in limestone creating a basket handle arch. The tri-part window in the right bay appears to have been replaced with 1/1 windows. The entrance in the left bay has a replacement door and sidelight.
