ARCHITECTURAL/HISTORIC INVENTORY FORM

1. Survey No. CO-AS-005-001		2. Survey name: Moreau Drive Neighborhood Survey	
3. County: Cole		4. Address: 1202 Elmerine Ave.	
5. City: Jefferson City	Vicinity: <input type="checkbox"/>	6. UTM: / /	7. Township/Range/Section: T: R: S:
8. Historic name (if known):		9. Present/other name (if known):	
10. Ownership: <input checked="" type="checkbox"/> Private <input type="checkbox"/> Public		11. Historic use (if known): Residential	11. Current use: Residential

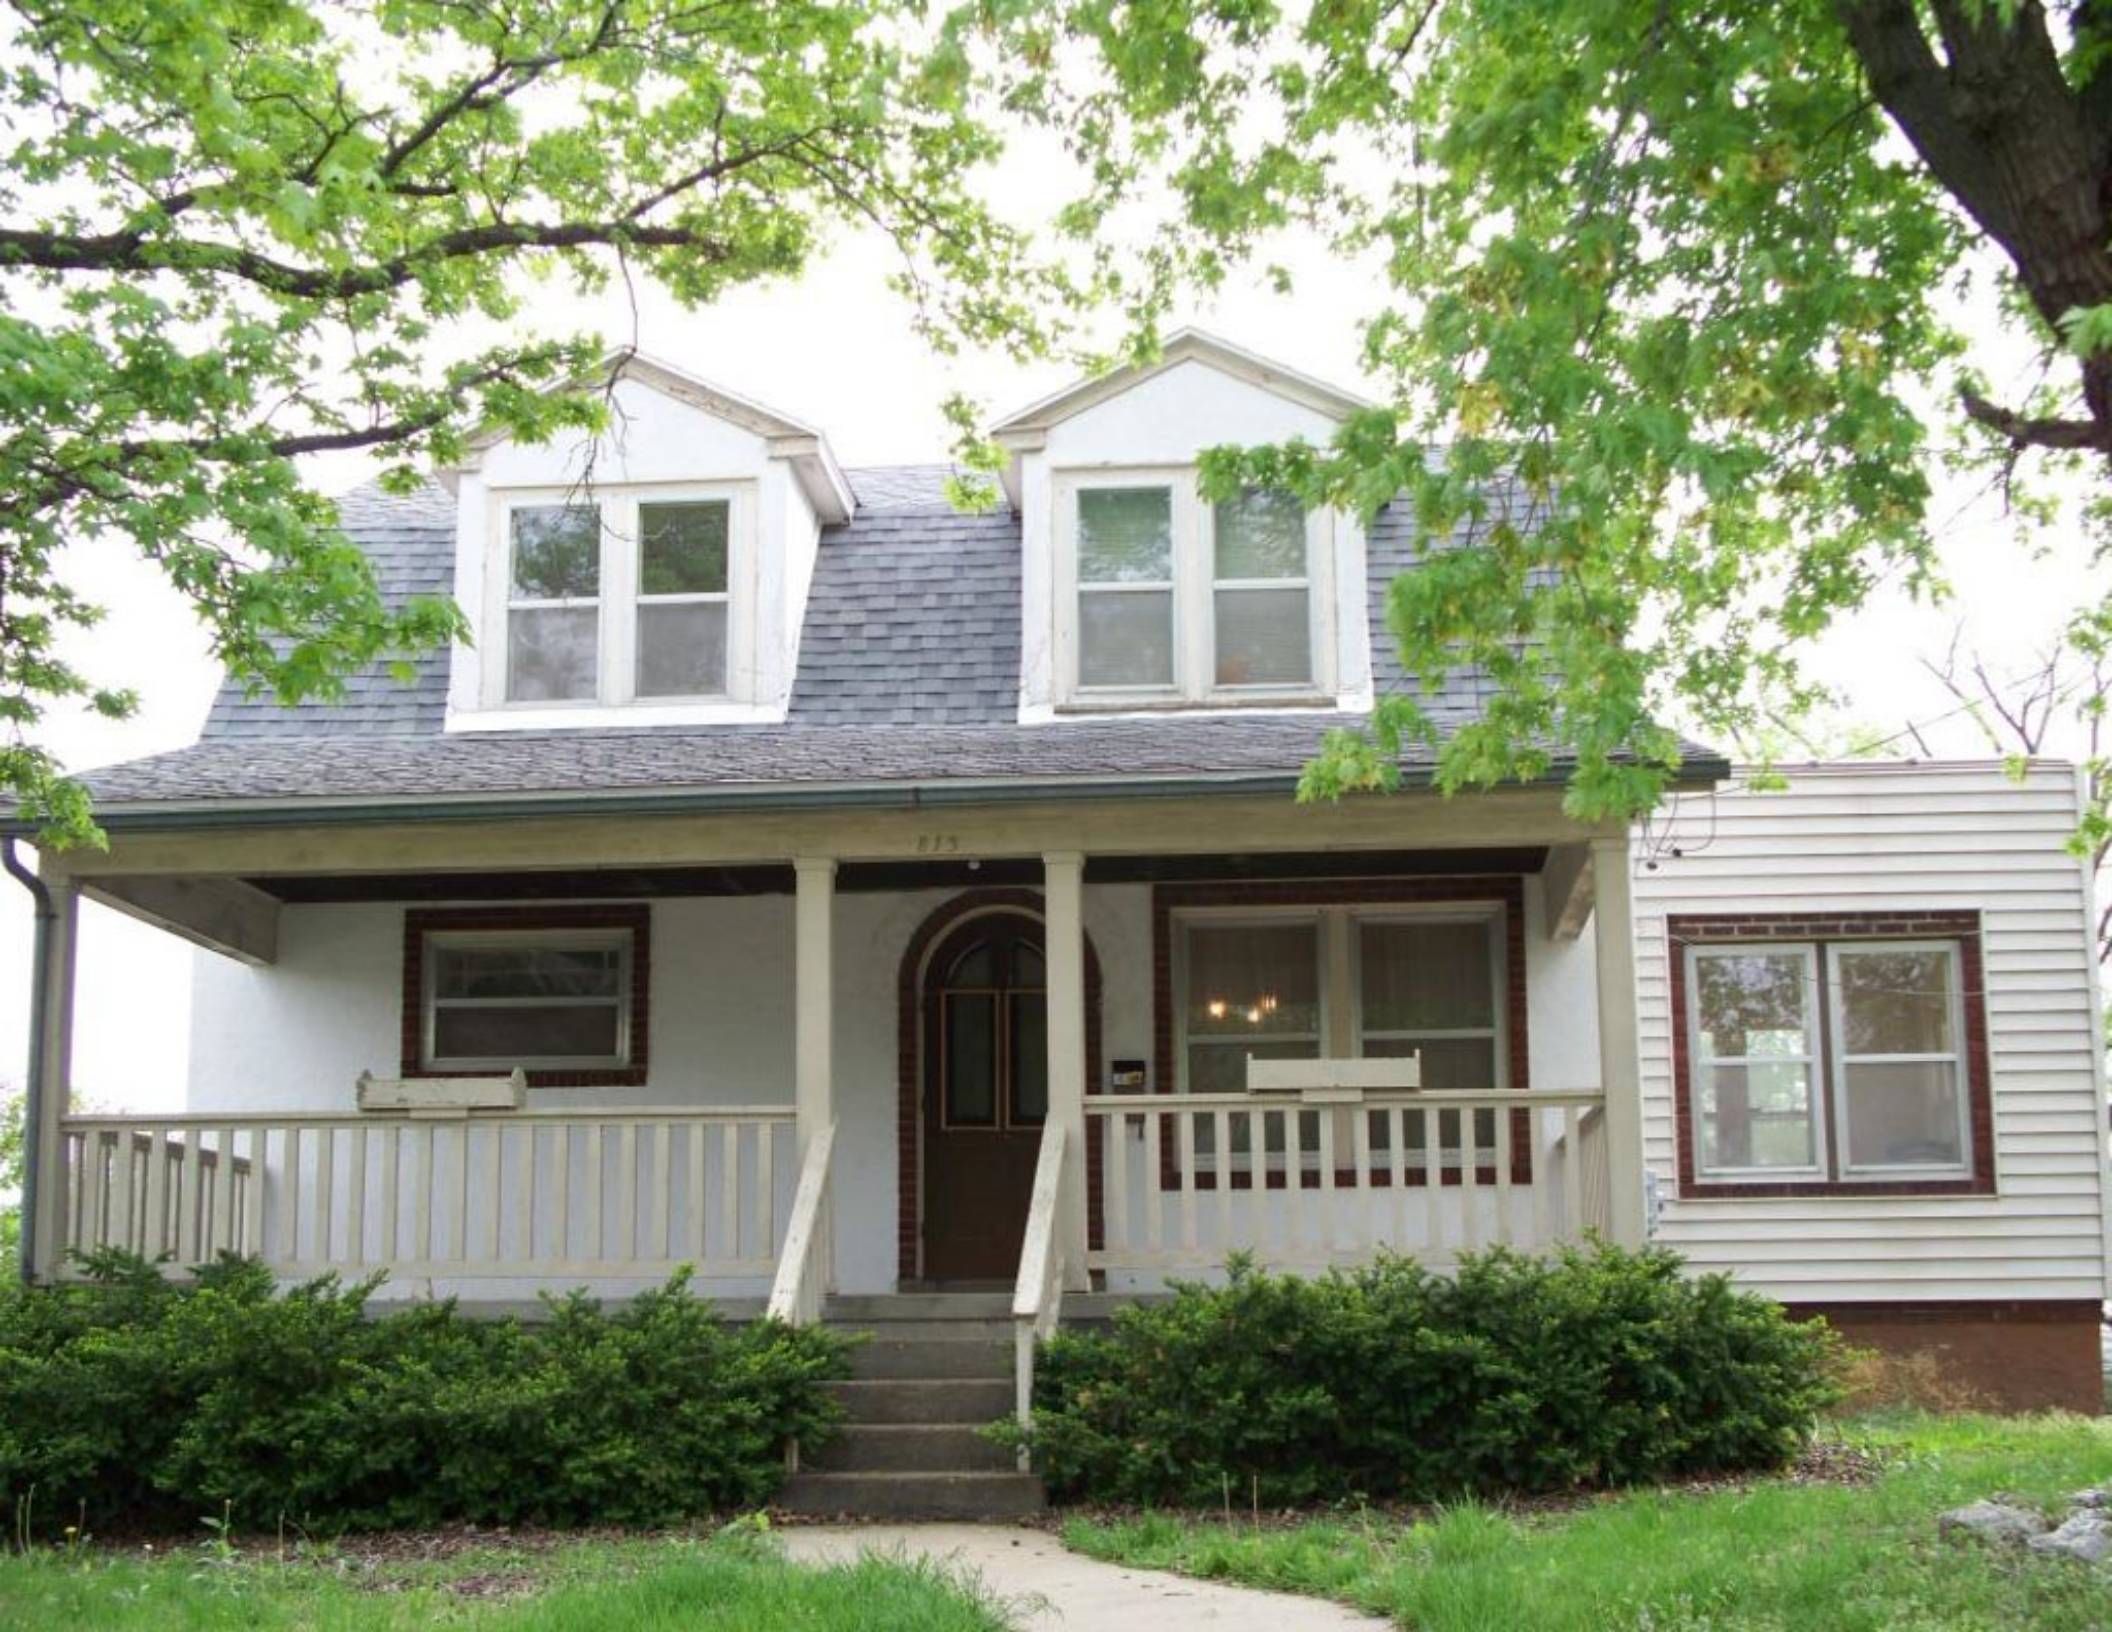
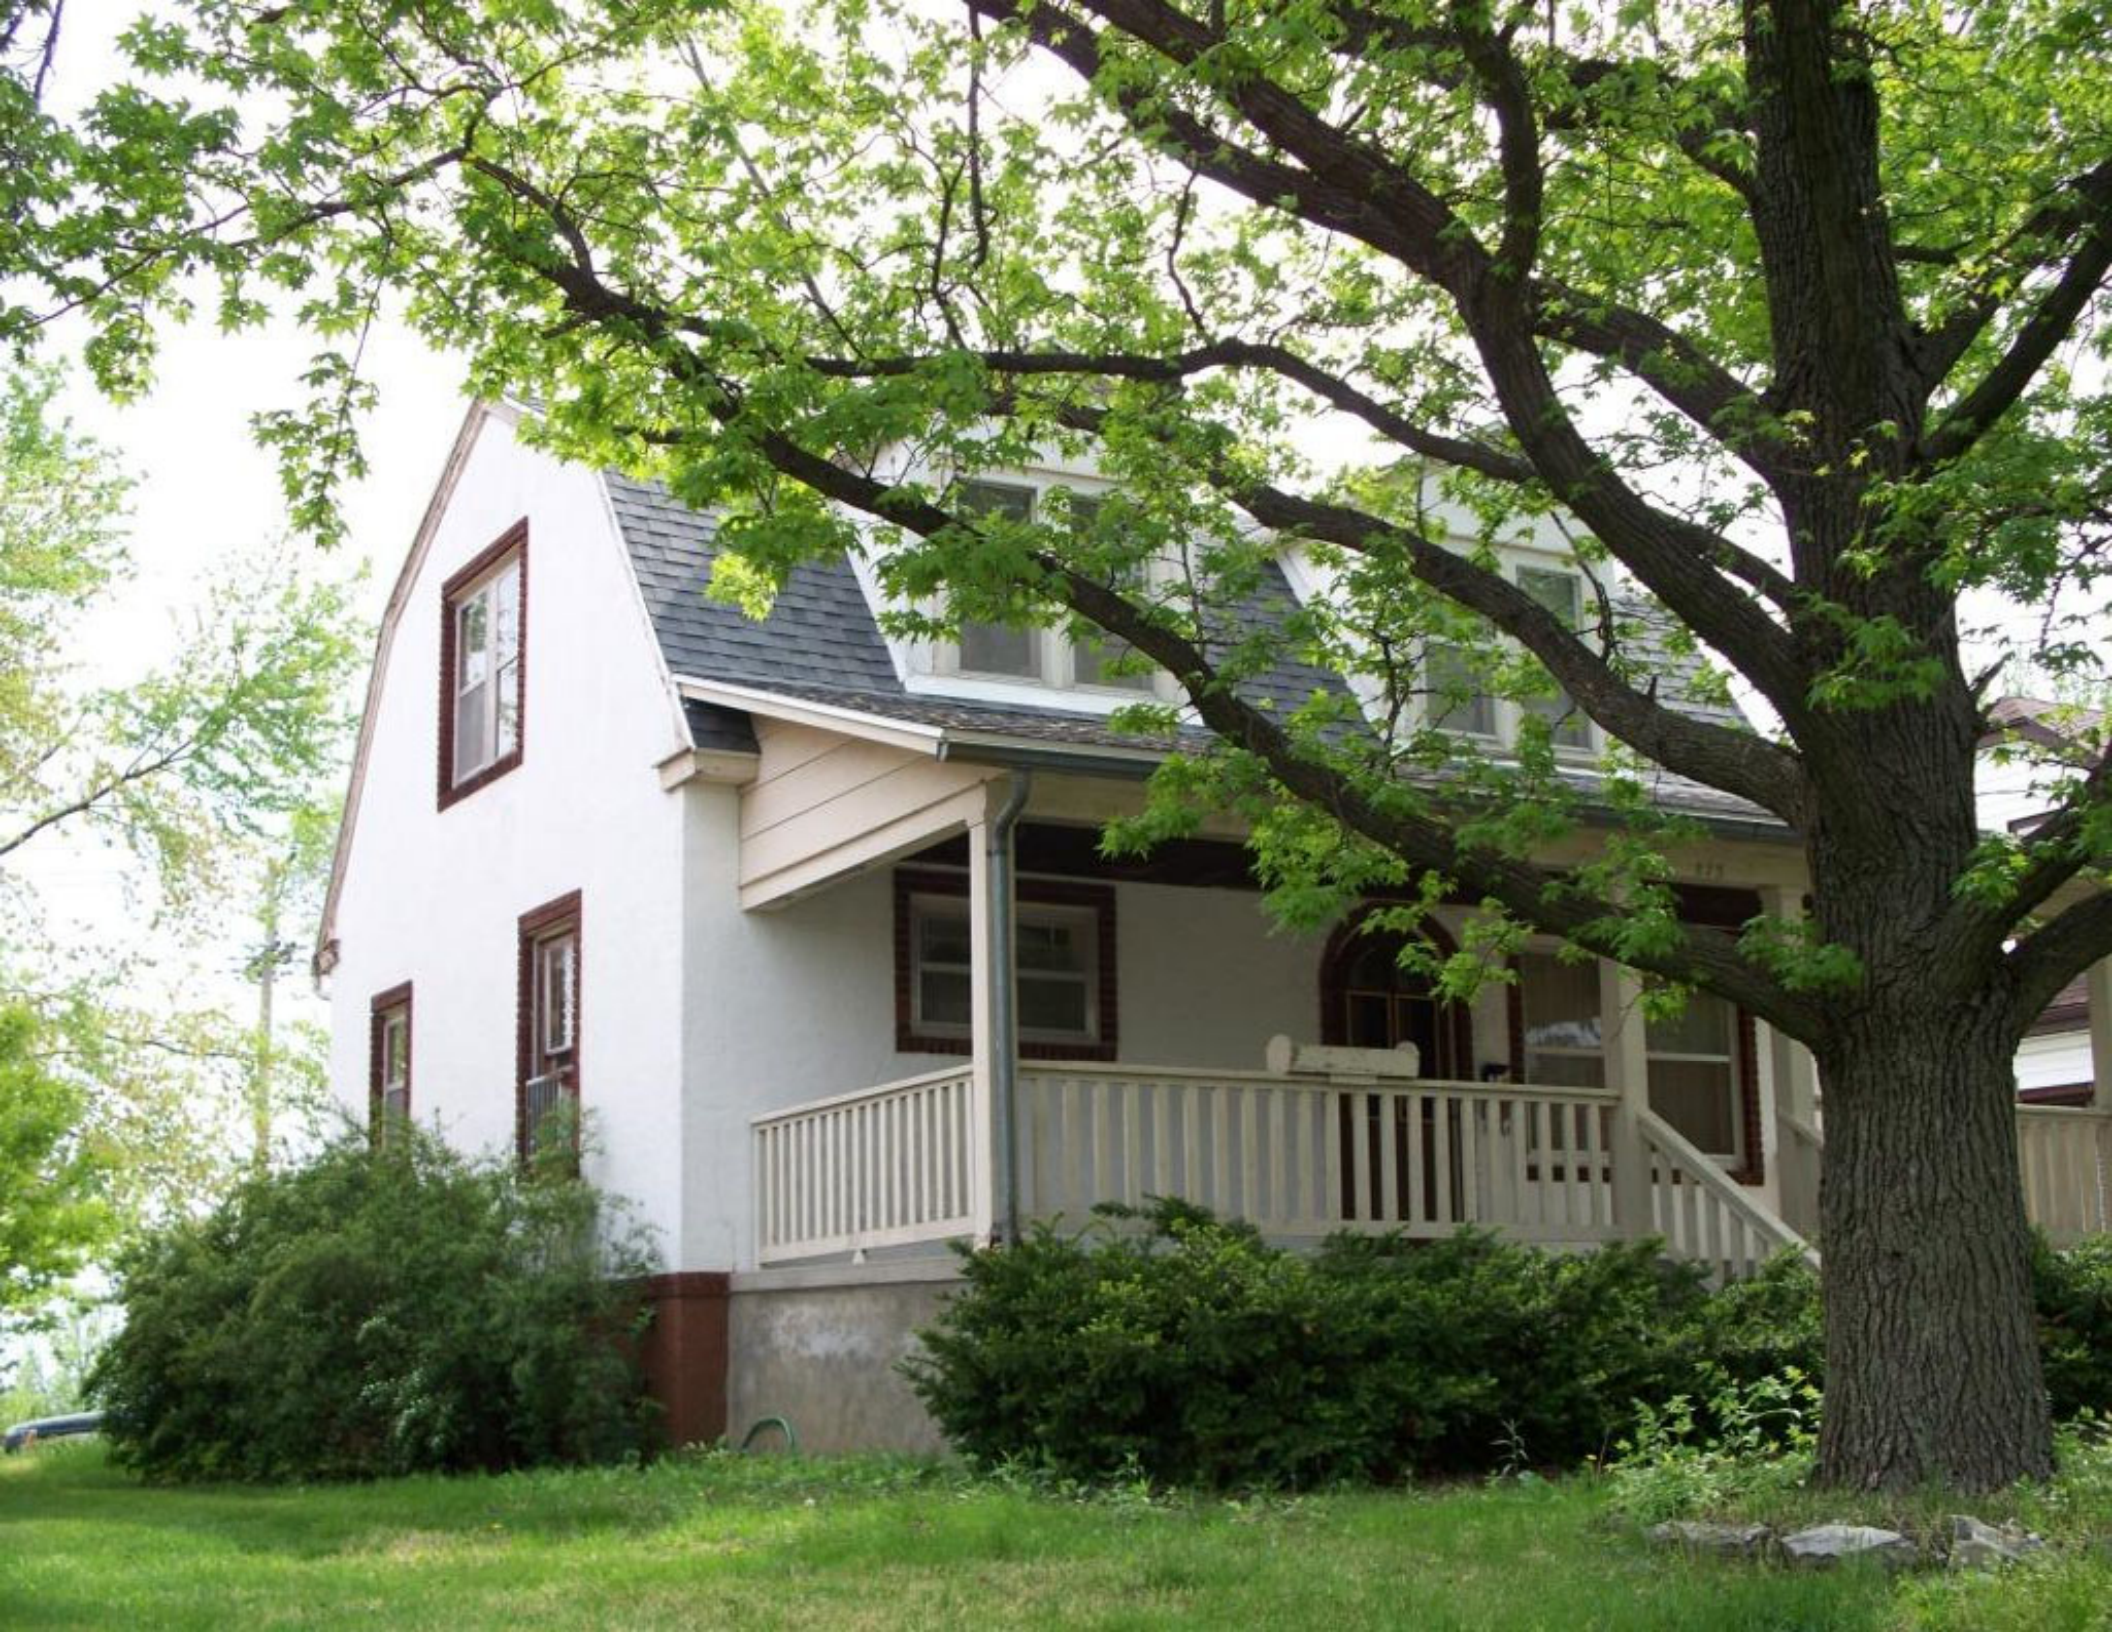
This one-and-a-half-story Dutch Colonial has been sided with stucco leaving brick trim around the fenestration. It's unknown when the stucco was applied but the façade was originally brick. There are two gabled dormers on the upper story, each contain a pair of 1/1 windows. The ground floor has a squat 1/1 window in the left bay and arched entrance and two 1/1 windows in the third bay. There is a one-story attached sunroom with a flat roof on the right side of the property. It was originally in brick but is now clad in vinyl siding. The full-width porch has wood beams and railings. This property is currently considered non-contributing due to the non-original façade coverings. However if future research reveals the stucco was applied more than 50 years ago it could feasibly be contributing.

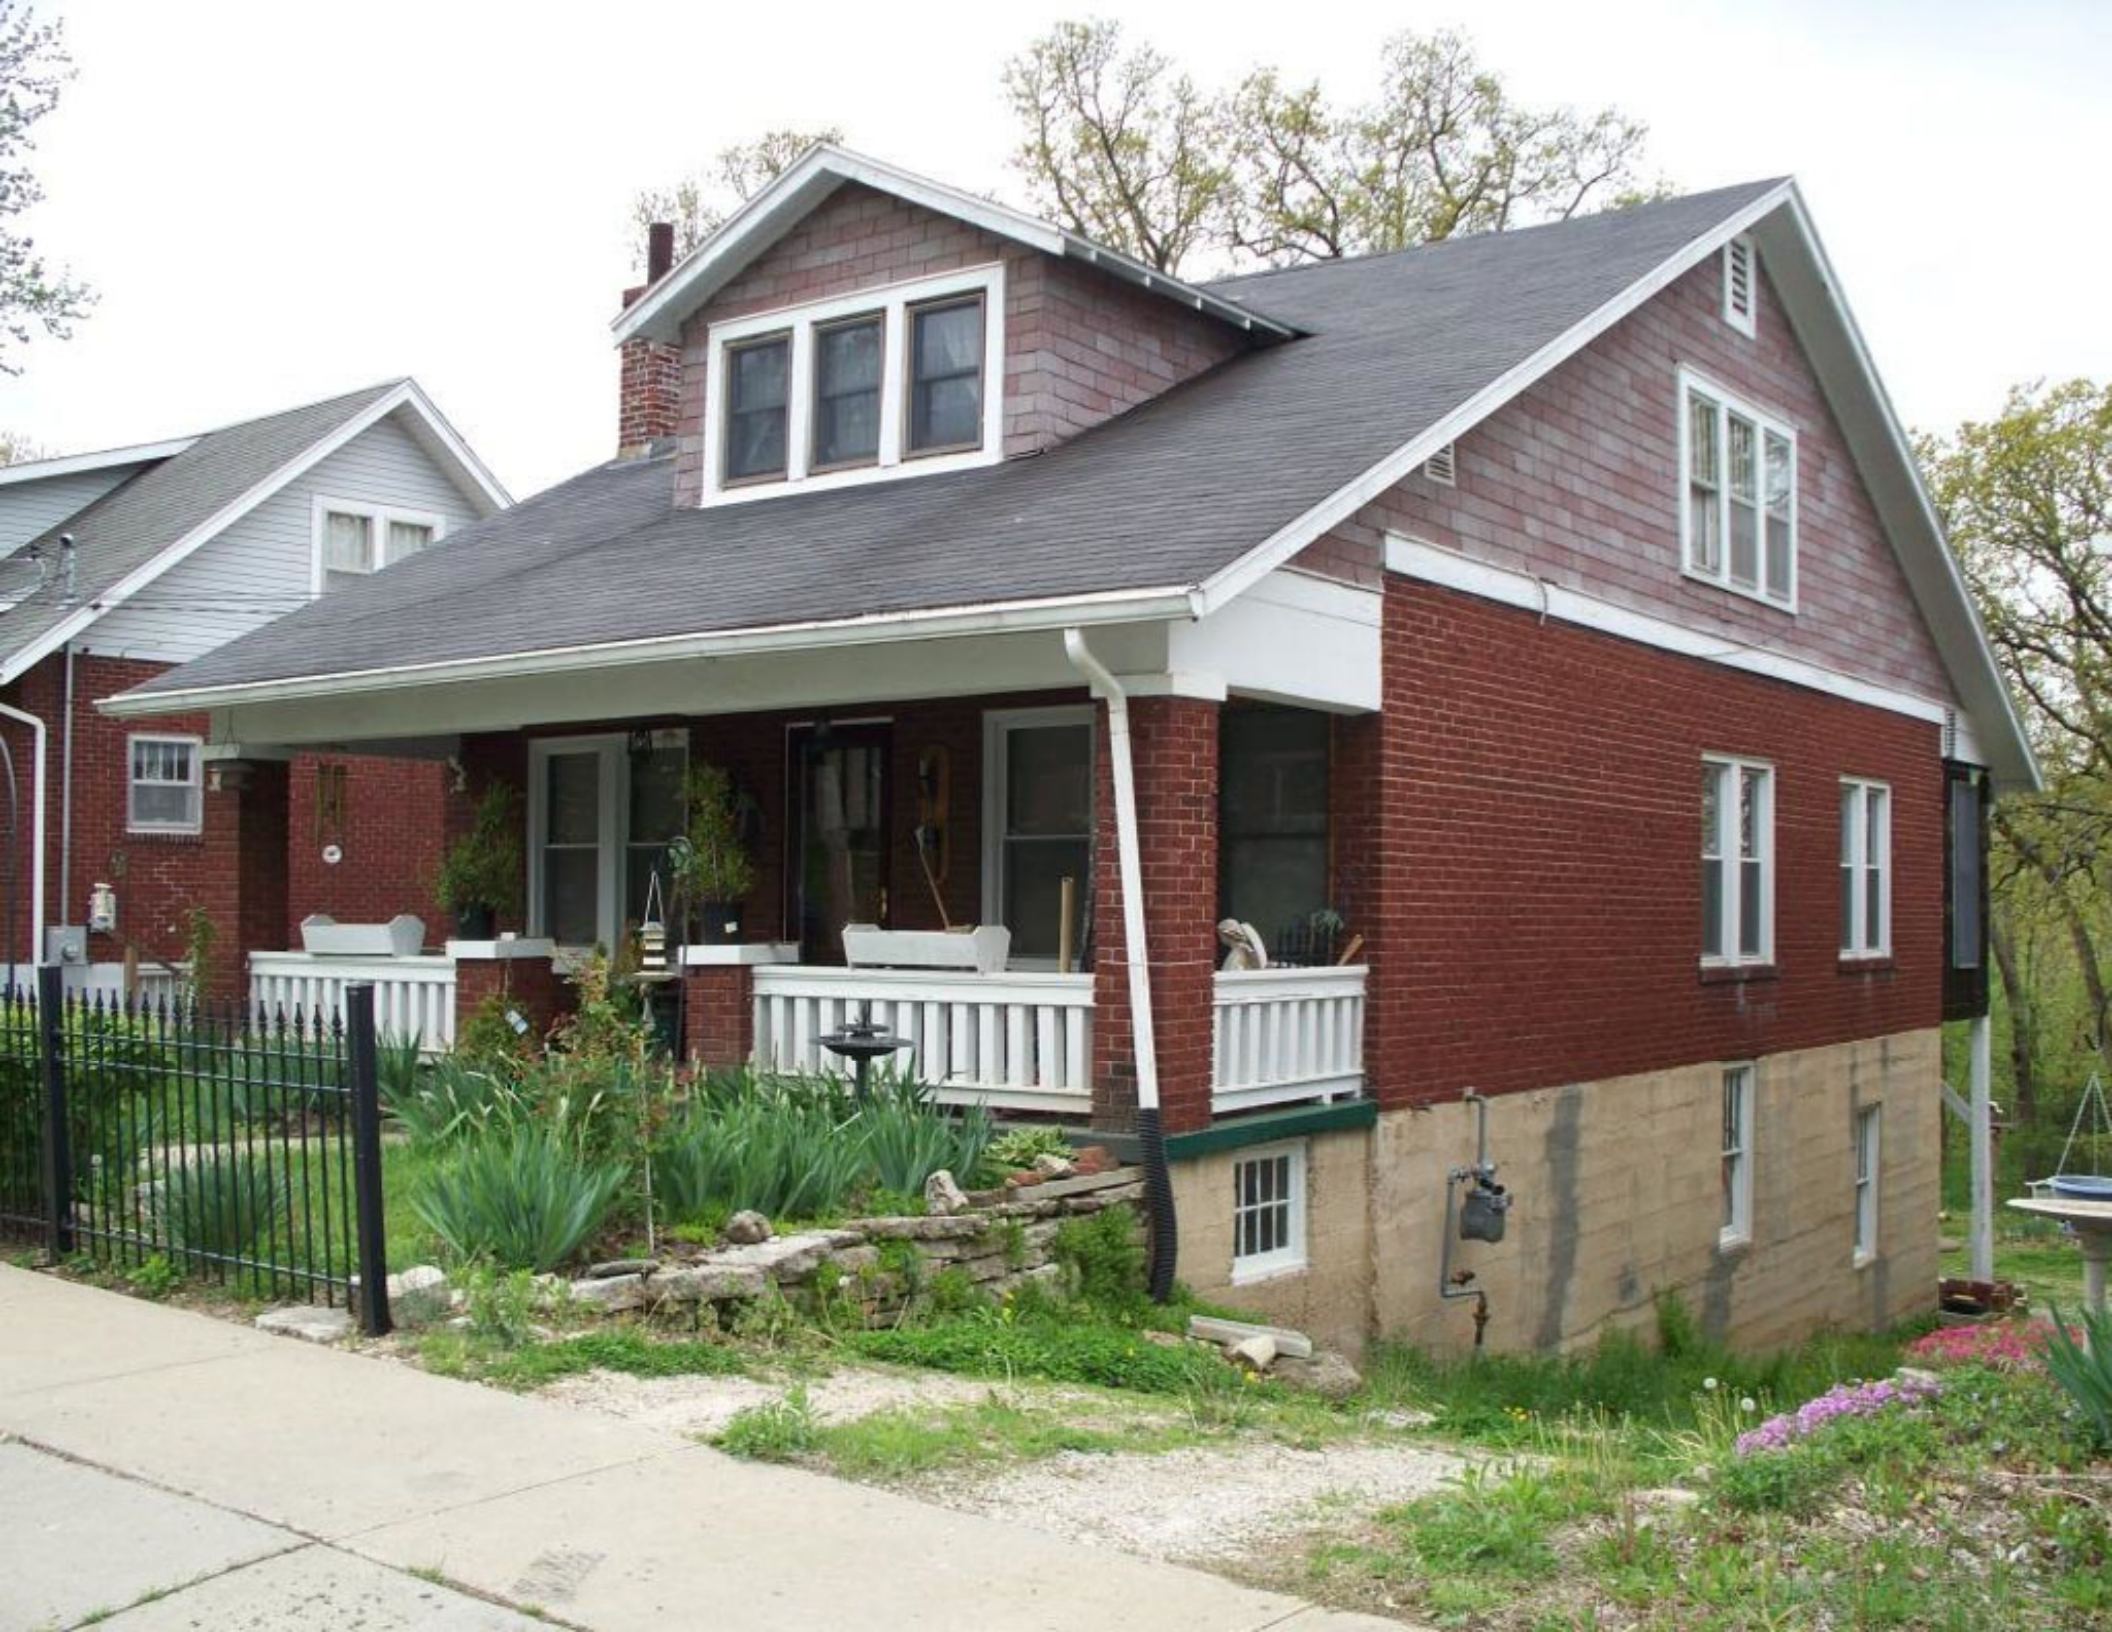
This 1 ½ story brick bungalow has a steeply sloping side gable roof with a central gable dormer with asphalt shingle siding, rafter tails and three replacement 1/1 windows. The ground floor has paired replacement 1/1 windows to the left of the central entrance. To the right are two single replacement 1/1 windows. The full width porch has brick piers with wooden railing. The gable ends of the roof on the sides of the home are clad in asphalt shingle.

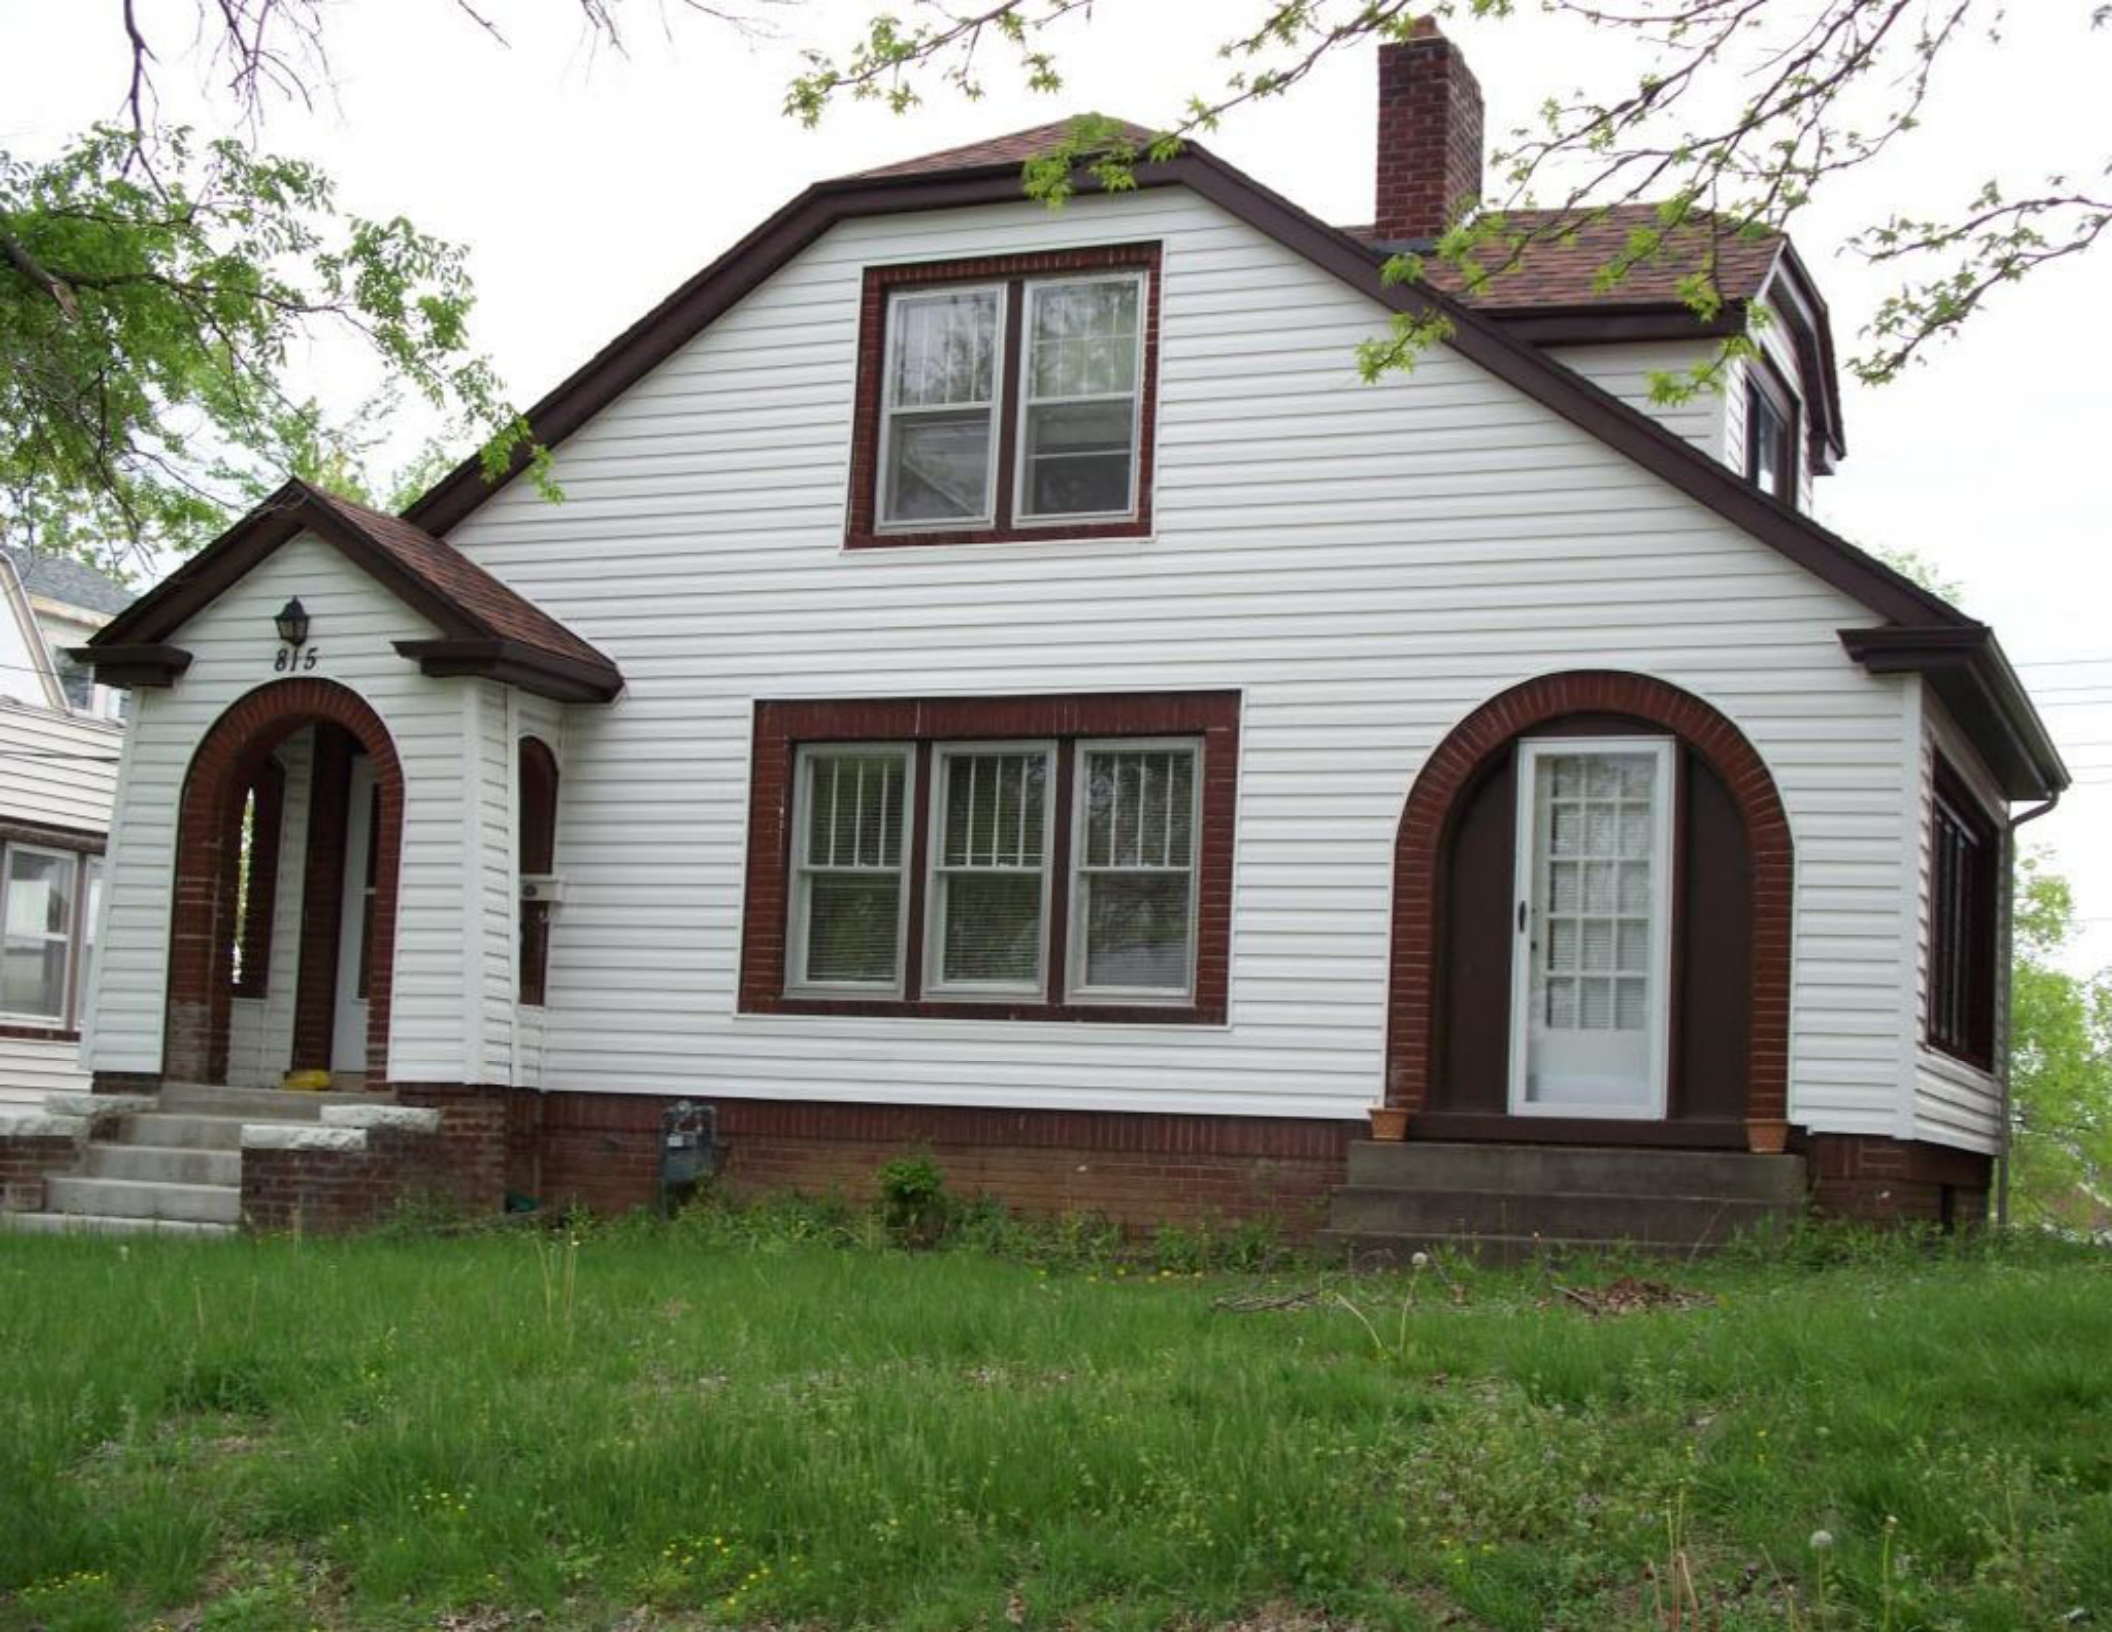
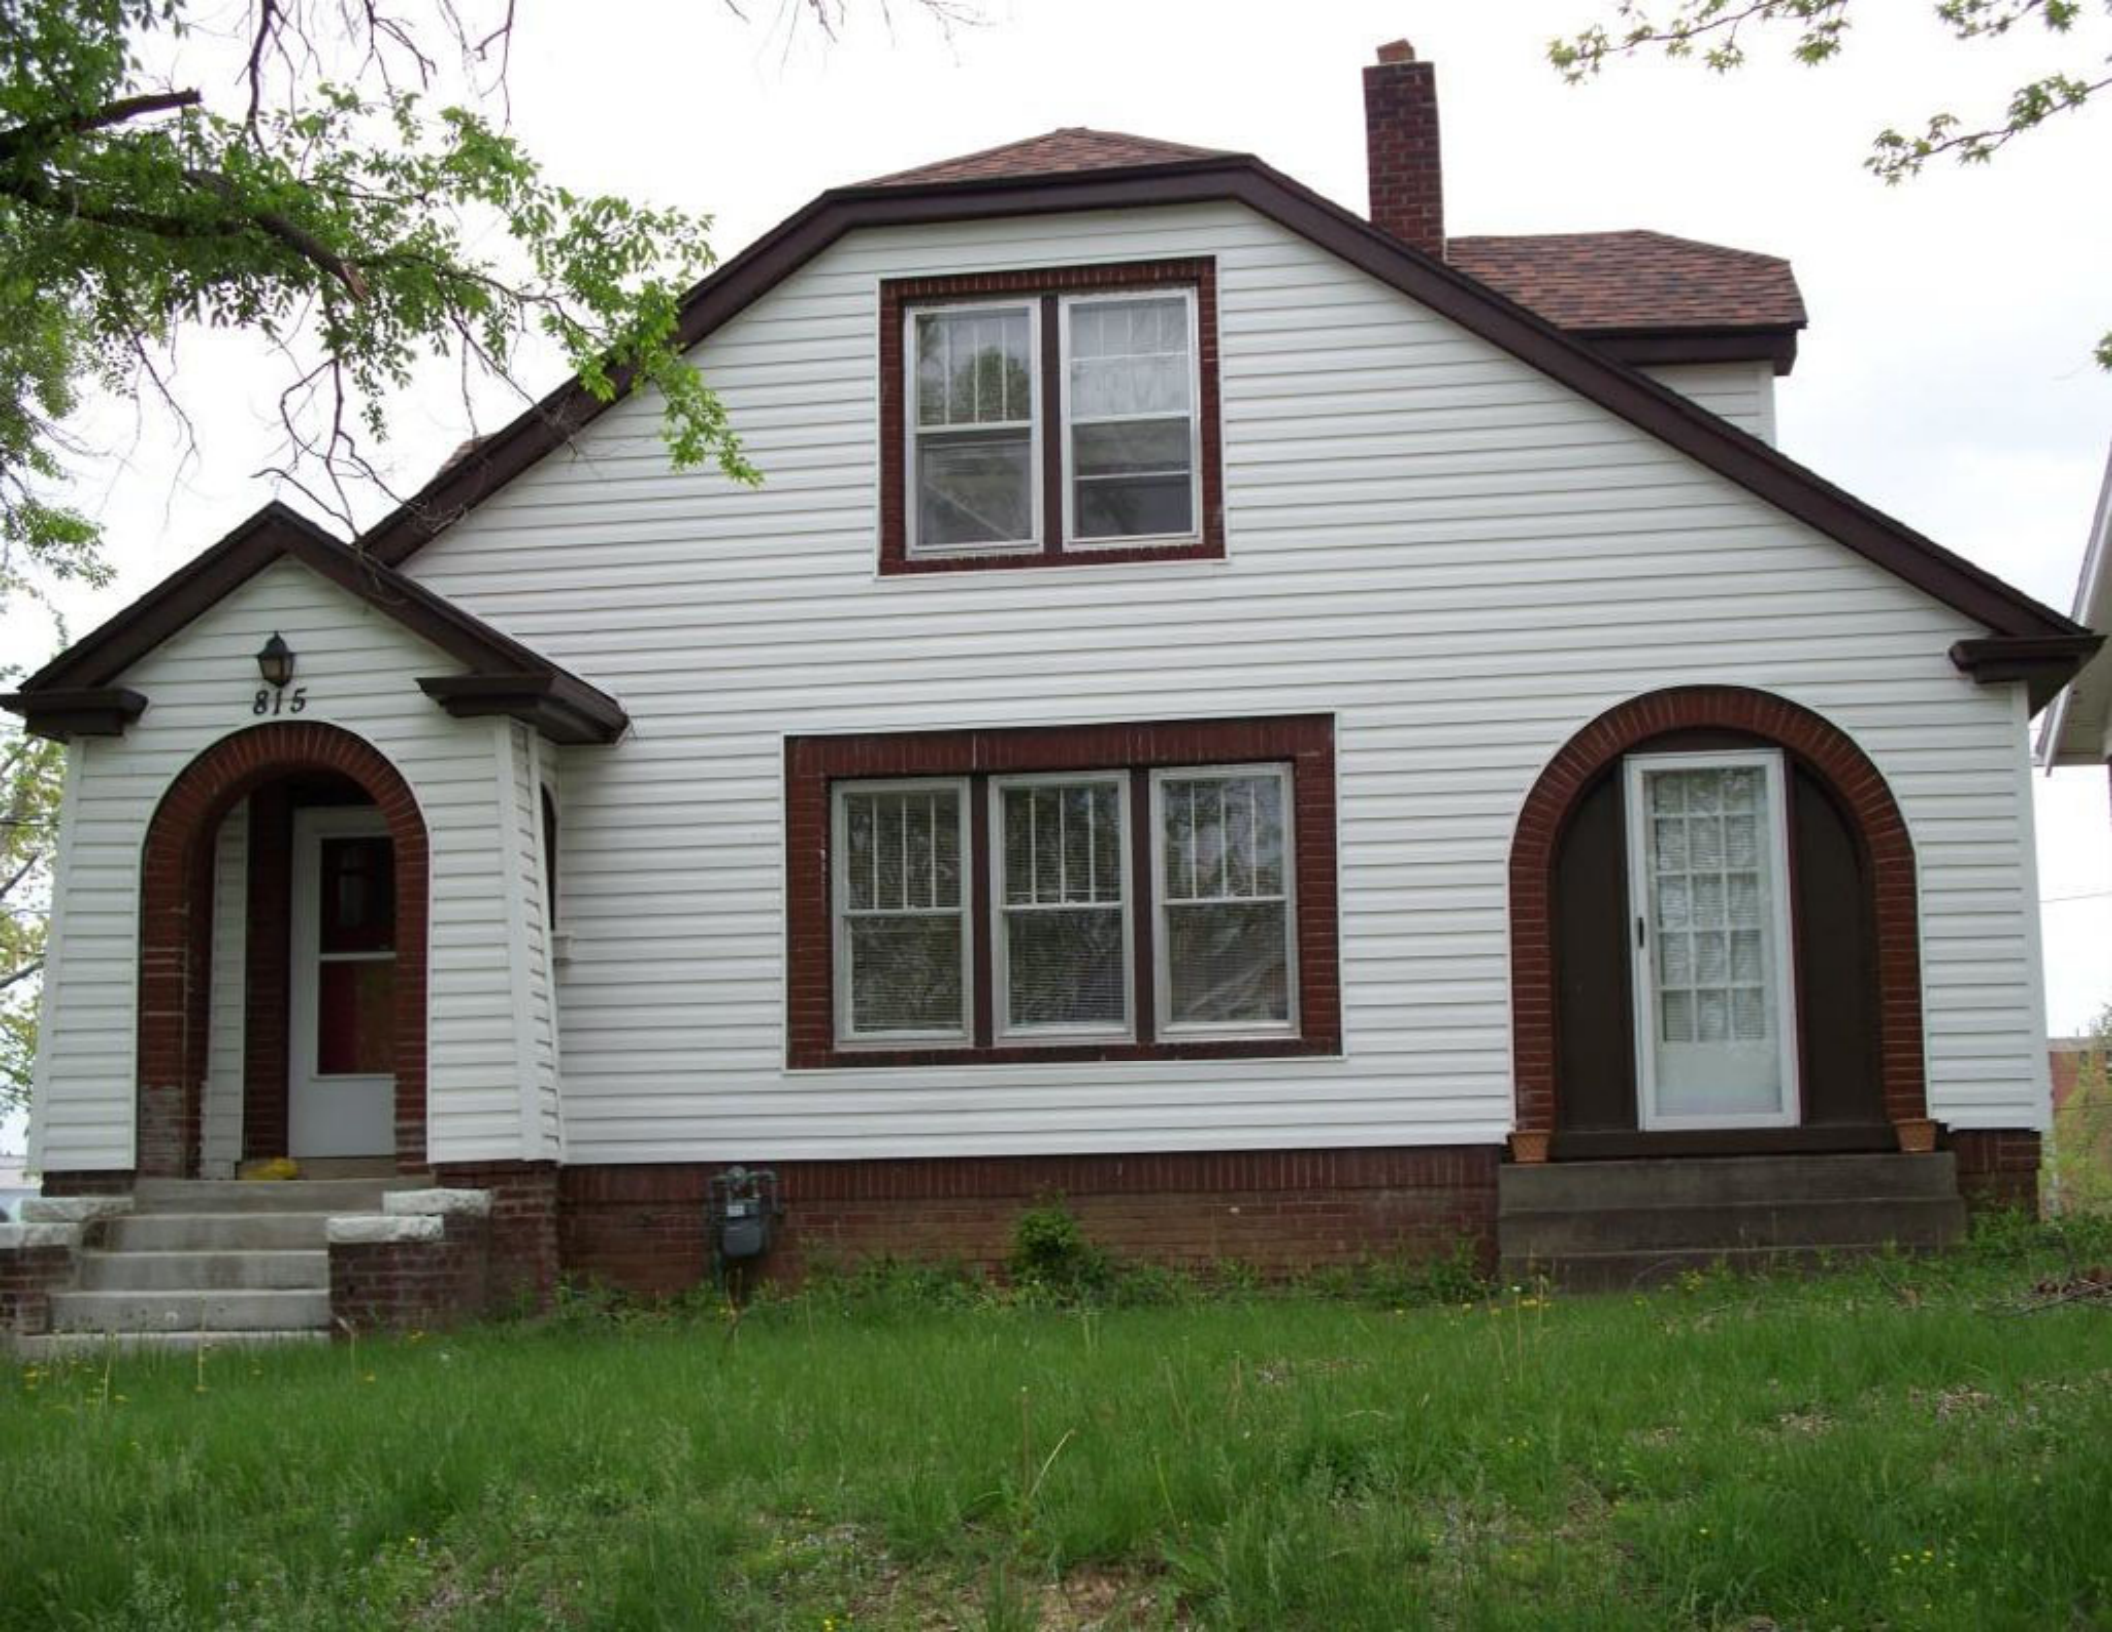
815

This hipped-gabled property was probably built in the Tudor style, however vinyl siding obscures the original brick façade save for trim around the fenestration. A hipped-gabled dormer extends from the center of the building to the right façade. The upper story has paired 4/1 historic windows. The first floor's right bay features a door set in an in-filled arch trimmed with brick that leads into what was probably a sun porch. The central bay consists of a row of three 4/1 windows while the left bay has a vinyl covered a gabled portico that projects from the central façade. The portico features an arched entrance that has a light fixture over it that appears historic. The portico extends to concrete stairs with brick knee-walls capped in stone. The brick foundation was left uncovered and has a decorative row of brick headers. While the windows and shape were retained the vinyl siding significantly detracts from the visual integrity of the property and thus is considered non-contributing. However, if the vinyl was removed it would likely contribute to the potential historic district.
