ARCHITECTURAL/HISTORIC INVENTORY FORM

1. Survey No. CO-AS-005-001		2. Survey name: Moreau Drive Neighborhood Survey	
3. County: Cole		4. Address: 1202 Elmerine Ave.	
5. City: Jefferson City	Vicinity: <input type="checkbox"/>	6. UTM: / /	7. Township/Range/Section: T: R: S:
8. Historic name (if known):		9. Present/other name (if known):	
10. Ownership: <input checked="" type="checkbox"/> Private <input type="checkbox"/> Public		11. Historic use (if known): Residential	11. Current use: Residential

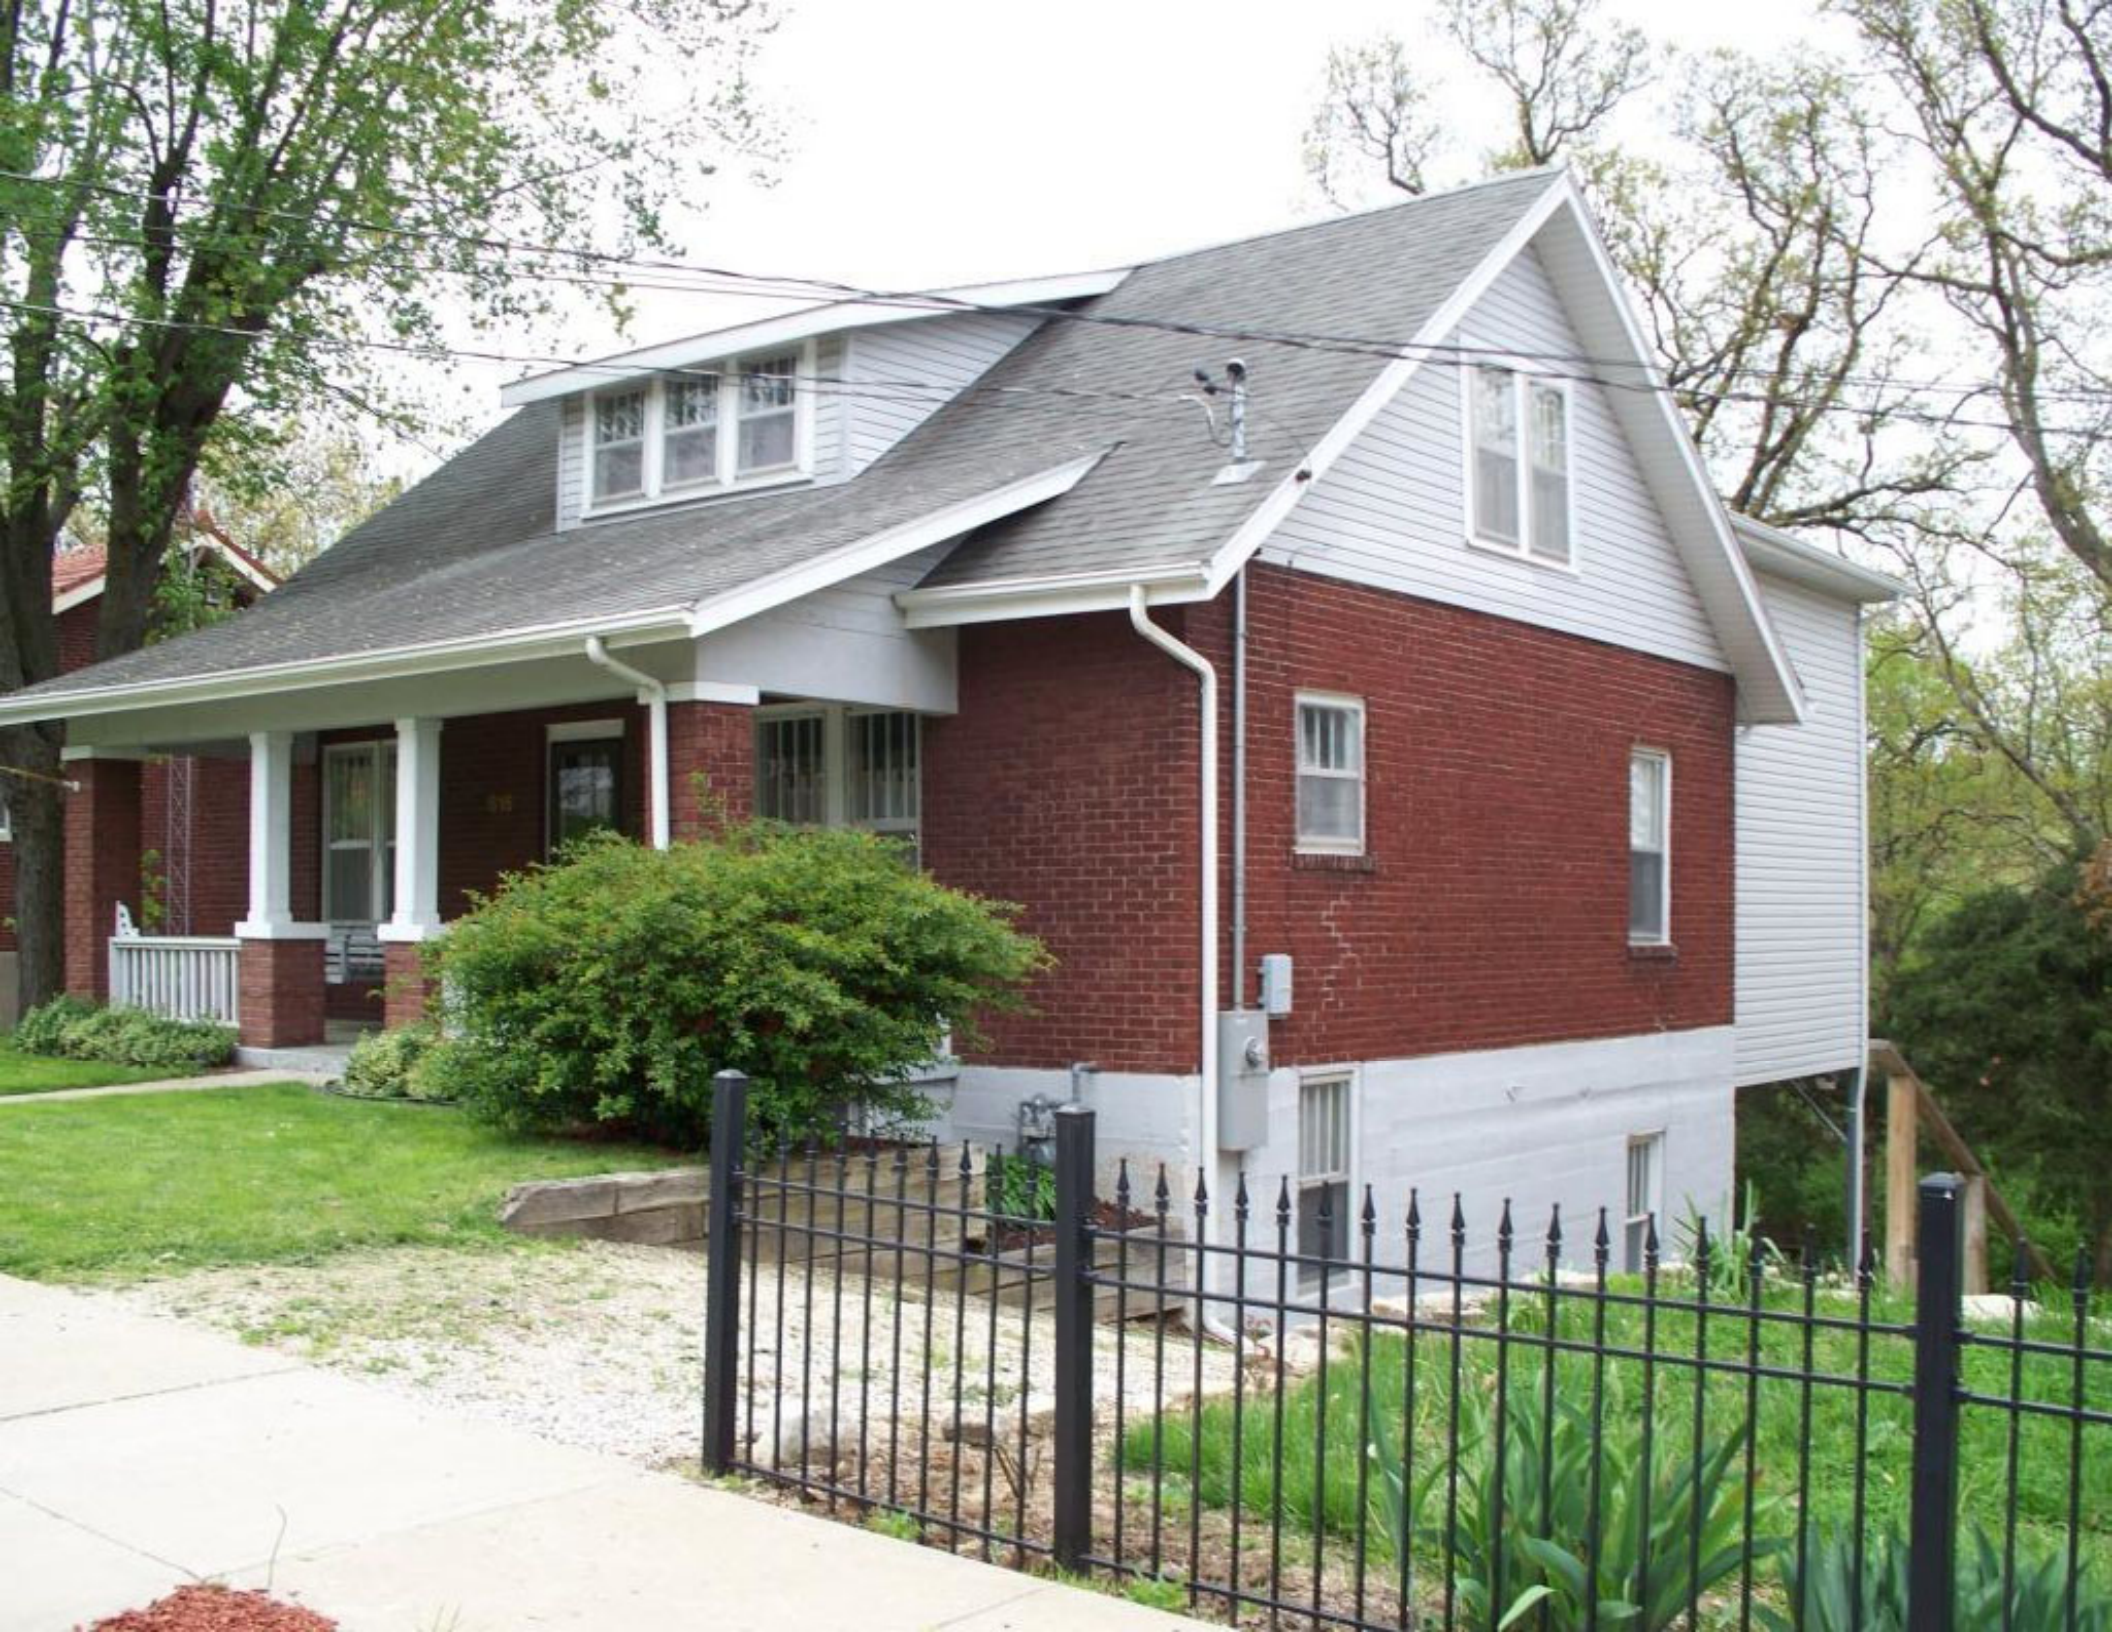
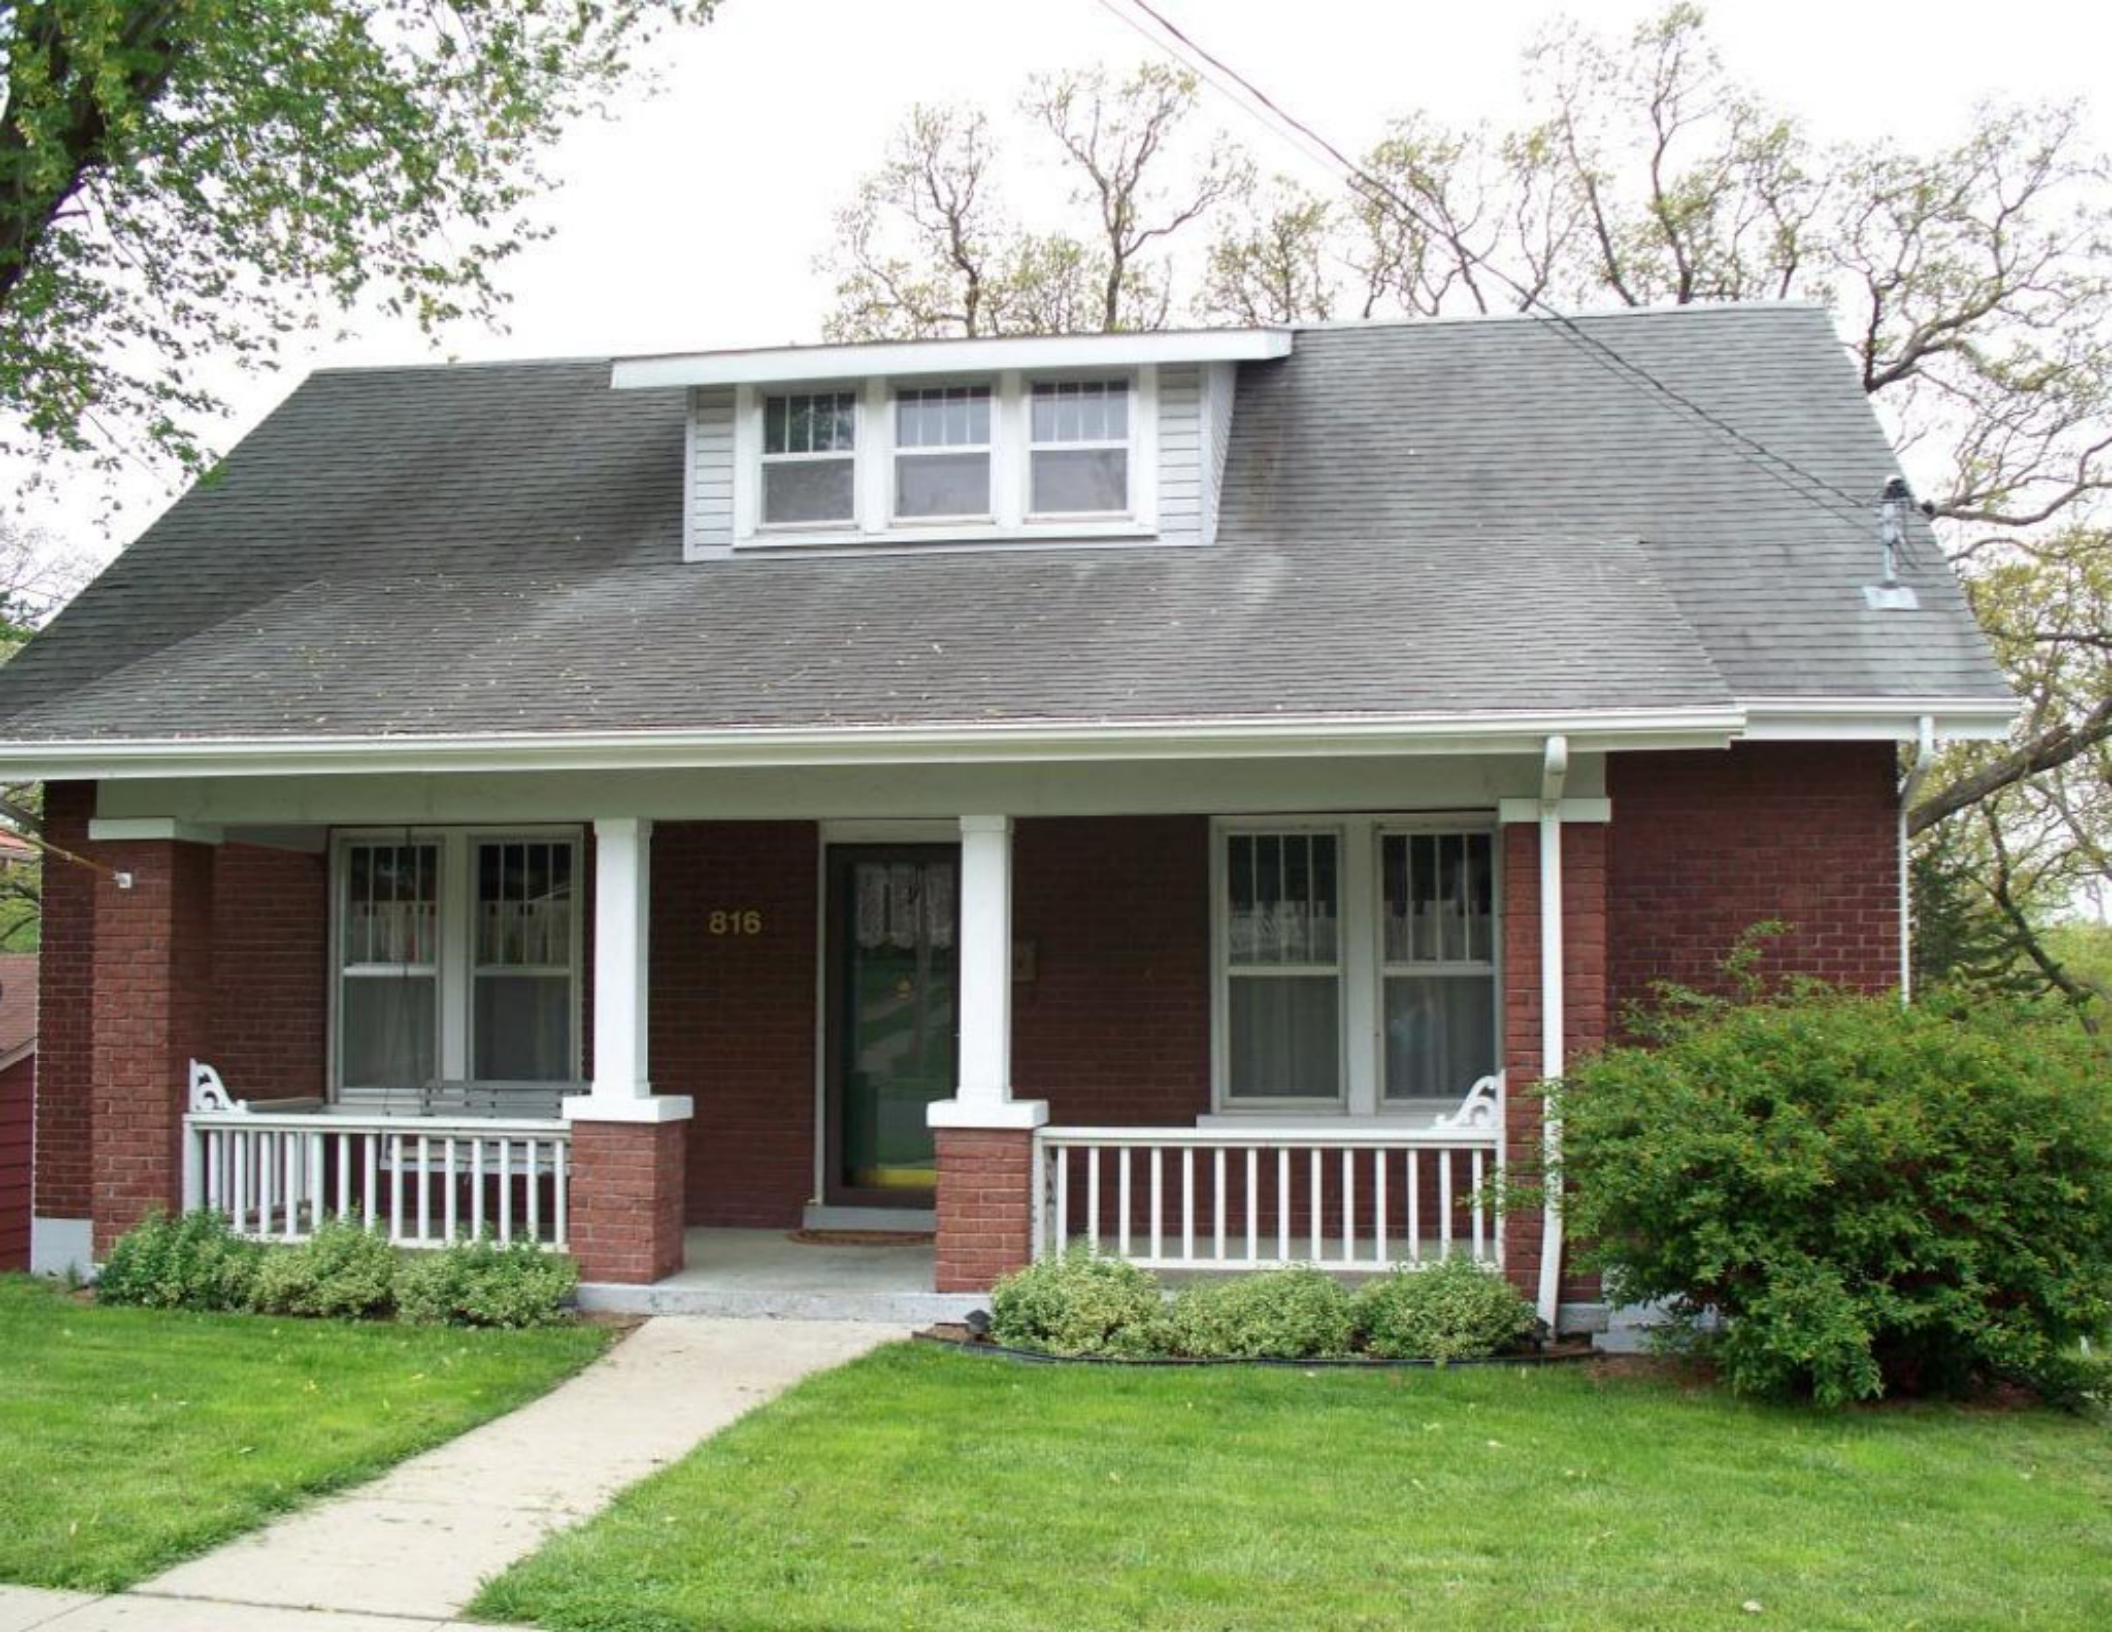
816

This 1 ½ story brick bungalow has a steeply sloping side gable roof with a central shed dormer with three 4/1 historic windows. A secondary shed roof extends over the first floor which has paired 4/1 windows flanking the central entrance. The full width porch features brick piers and pilasters capped in limestone with a wooden railing in-between. Two wooden post support the porch roof in the center of the property.

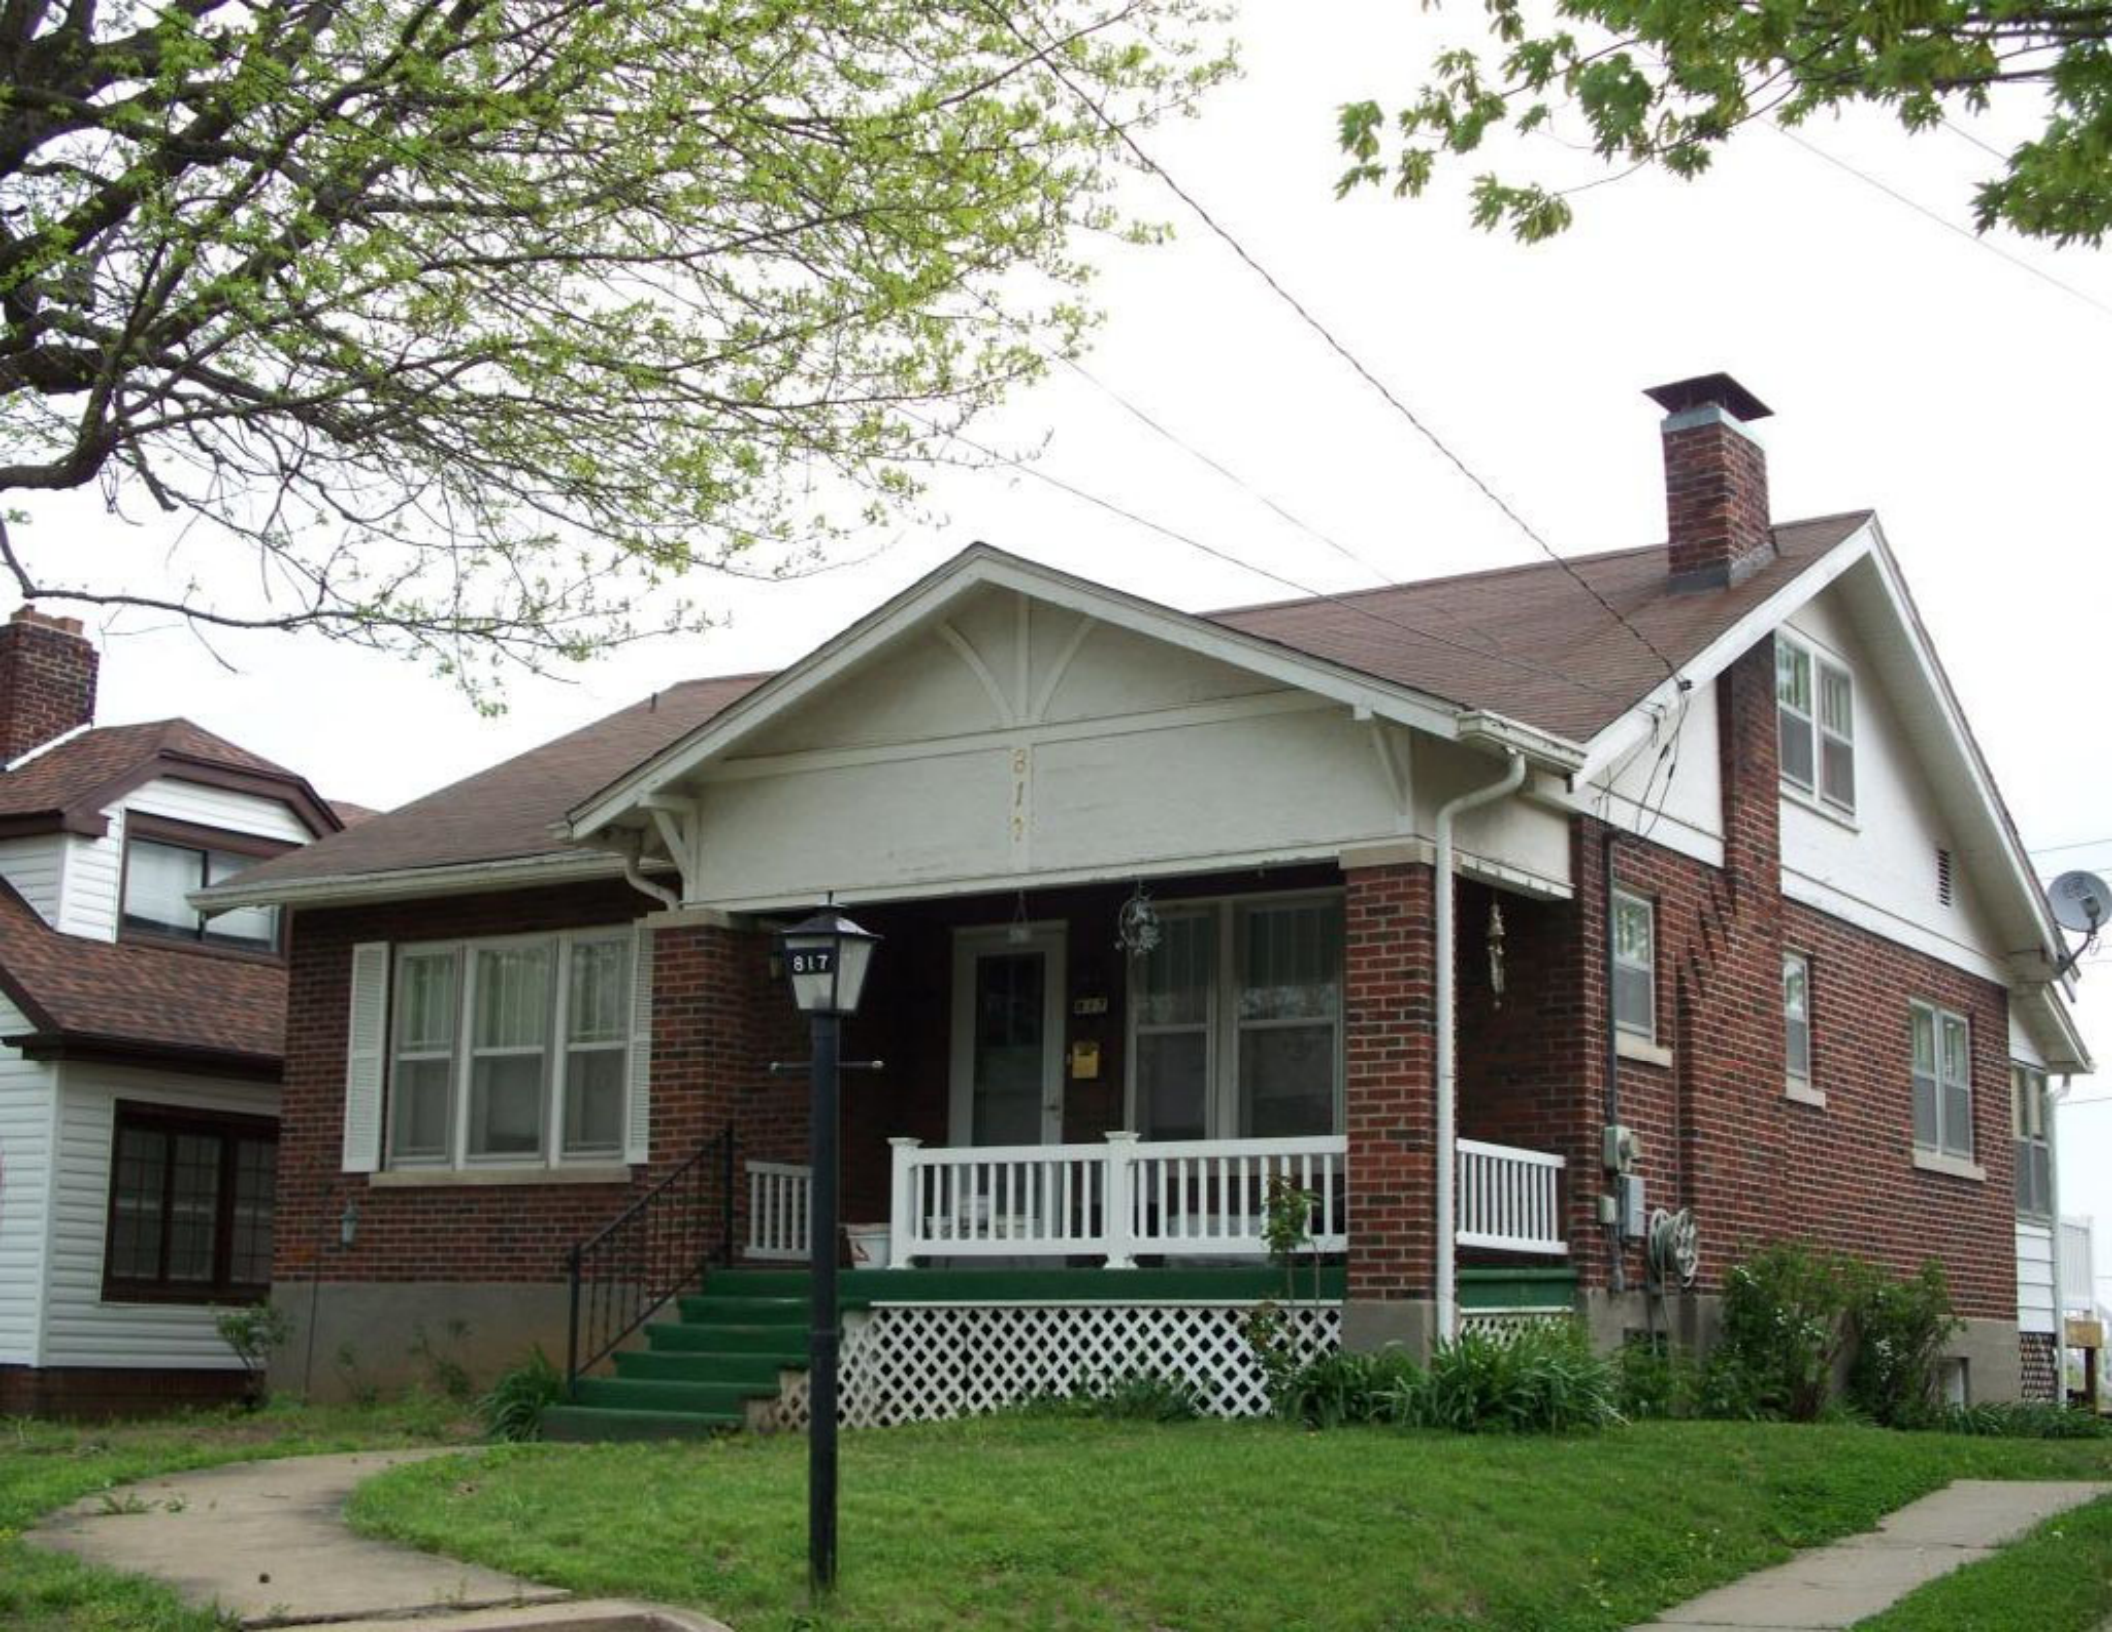
817

This is a brick bungalow with a side gable roof and a large shed-roof central dormer with a row of three 4/1 windows with storms. The windows are flanked by shutters. The first floor has two paired 4/1 historic windows with storms and stone or concrete sills with shutters that flank the central entrance. A small light fixture that could be historic hangs from the porch roof over the door. The full-width brick porch has brick pilasters and two posts centrally located. The brick knee-walls are capped in cement or limestone and feature venting right above the raised stone foundation in the center of each wall.

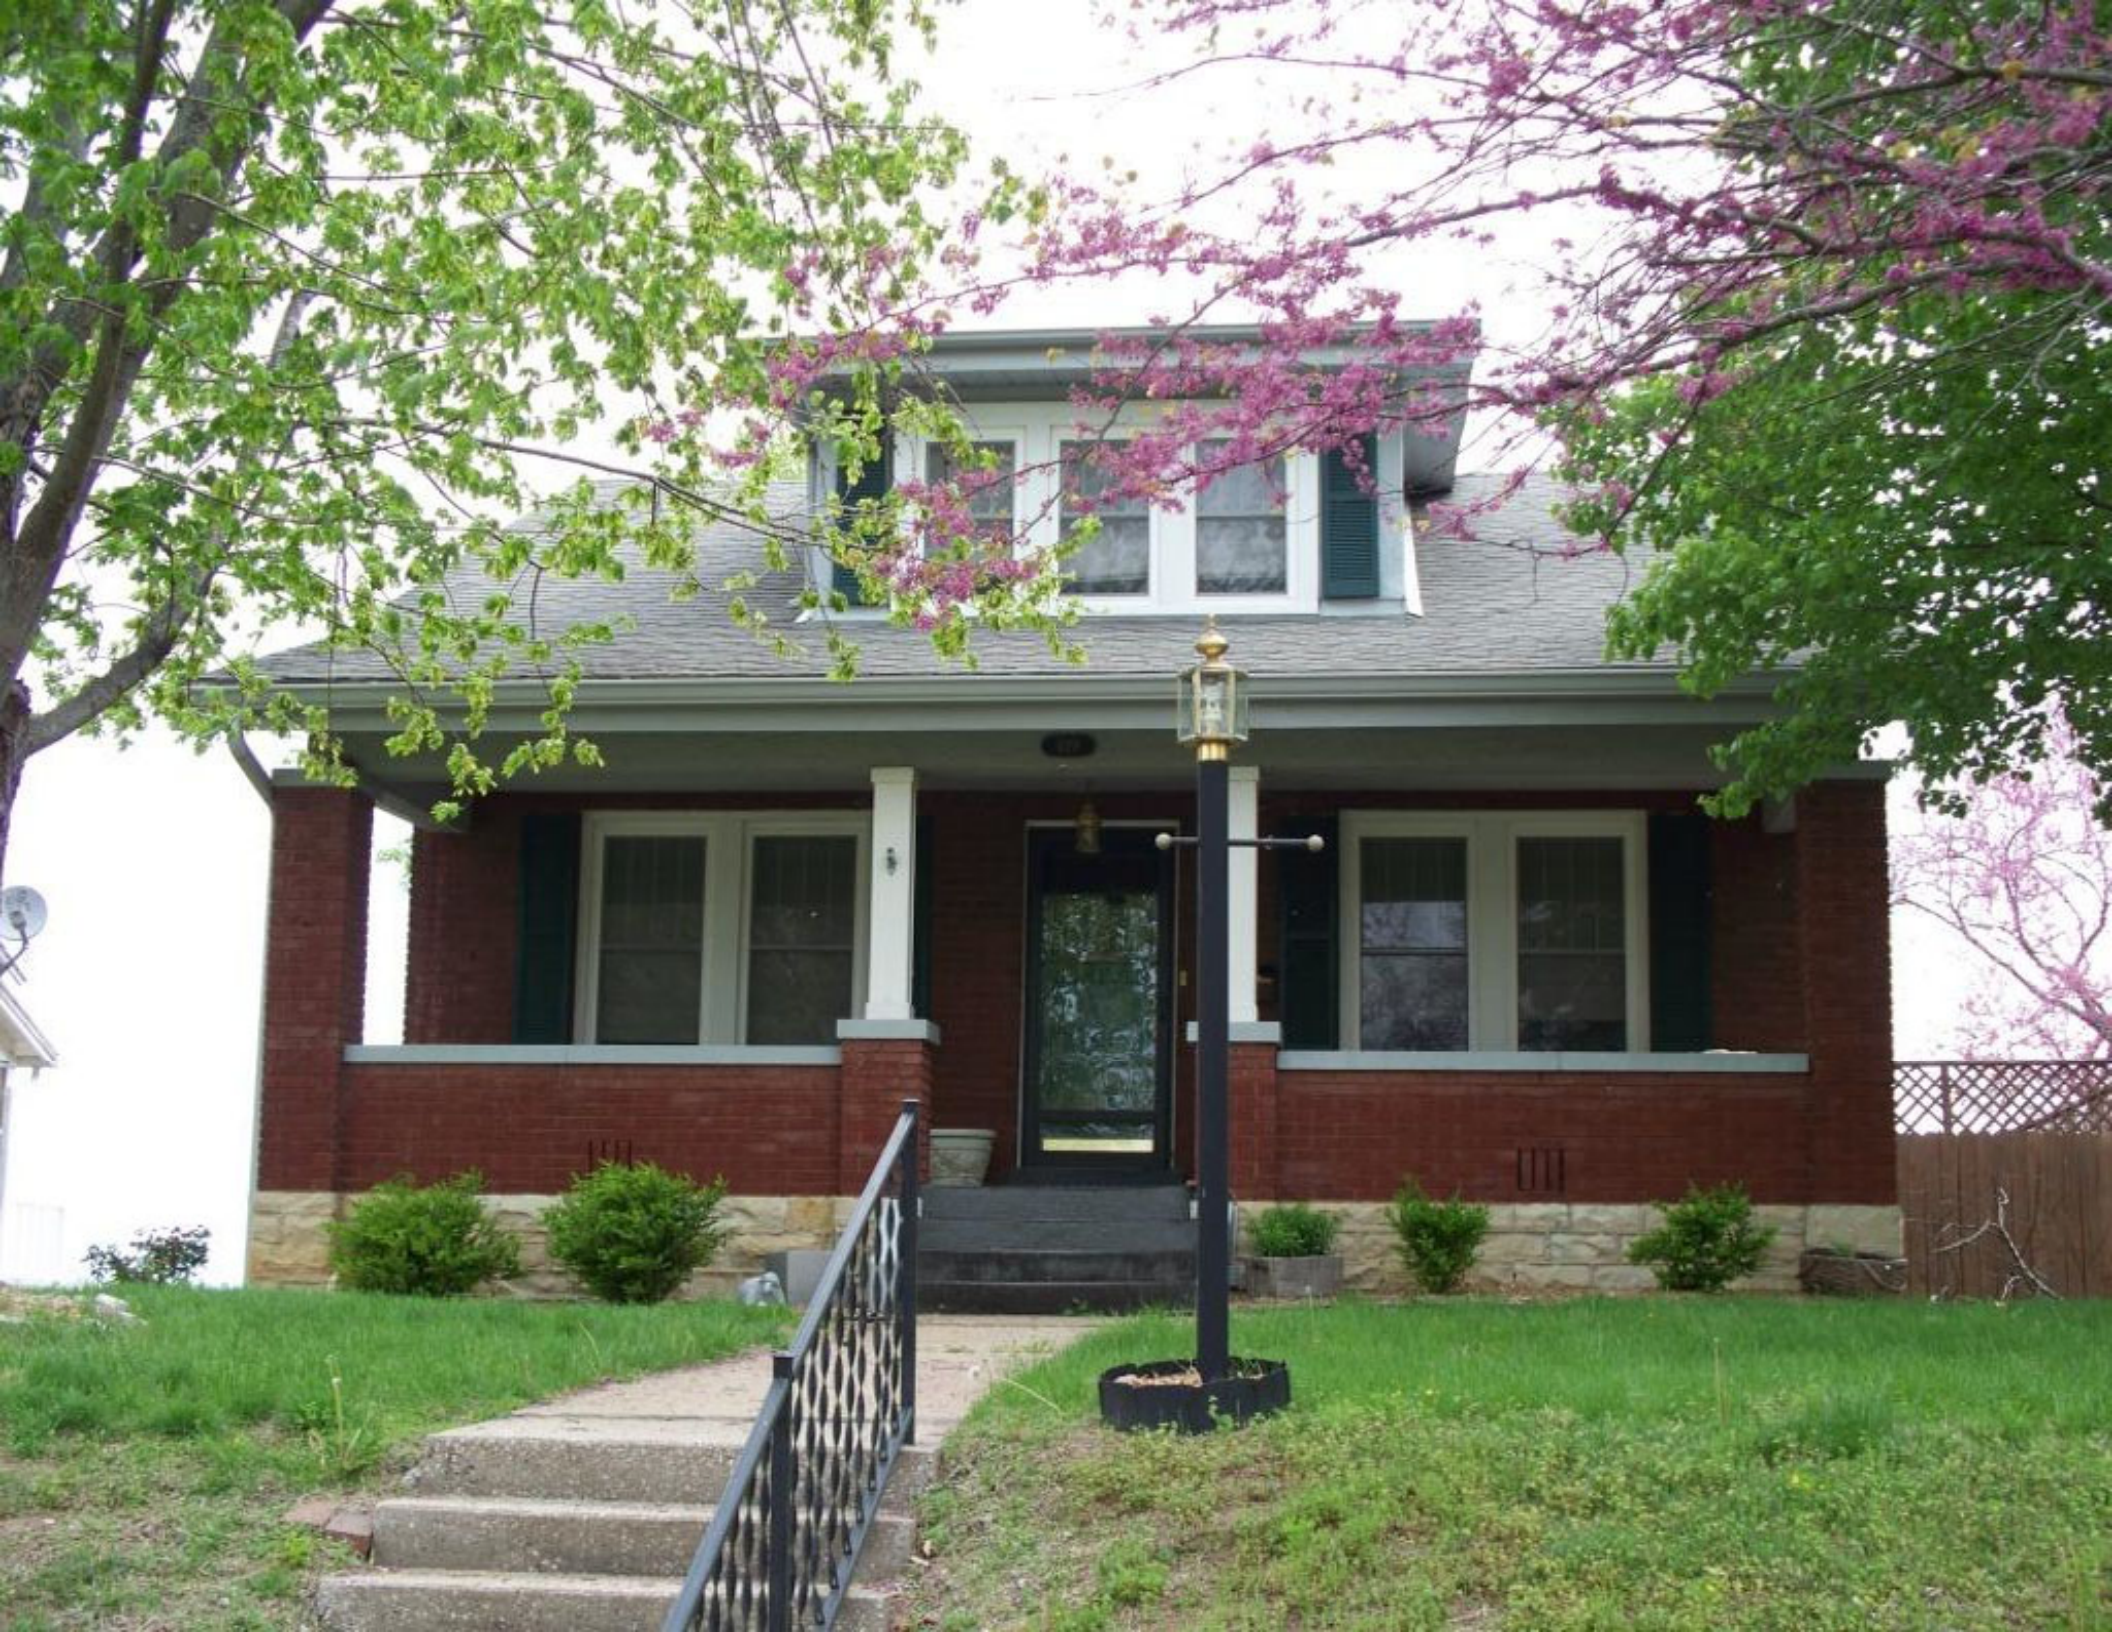
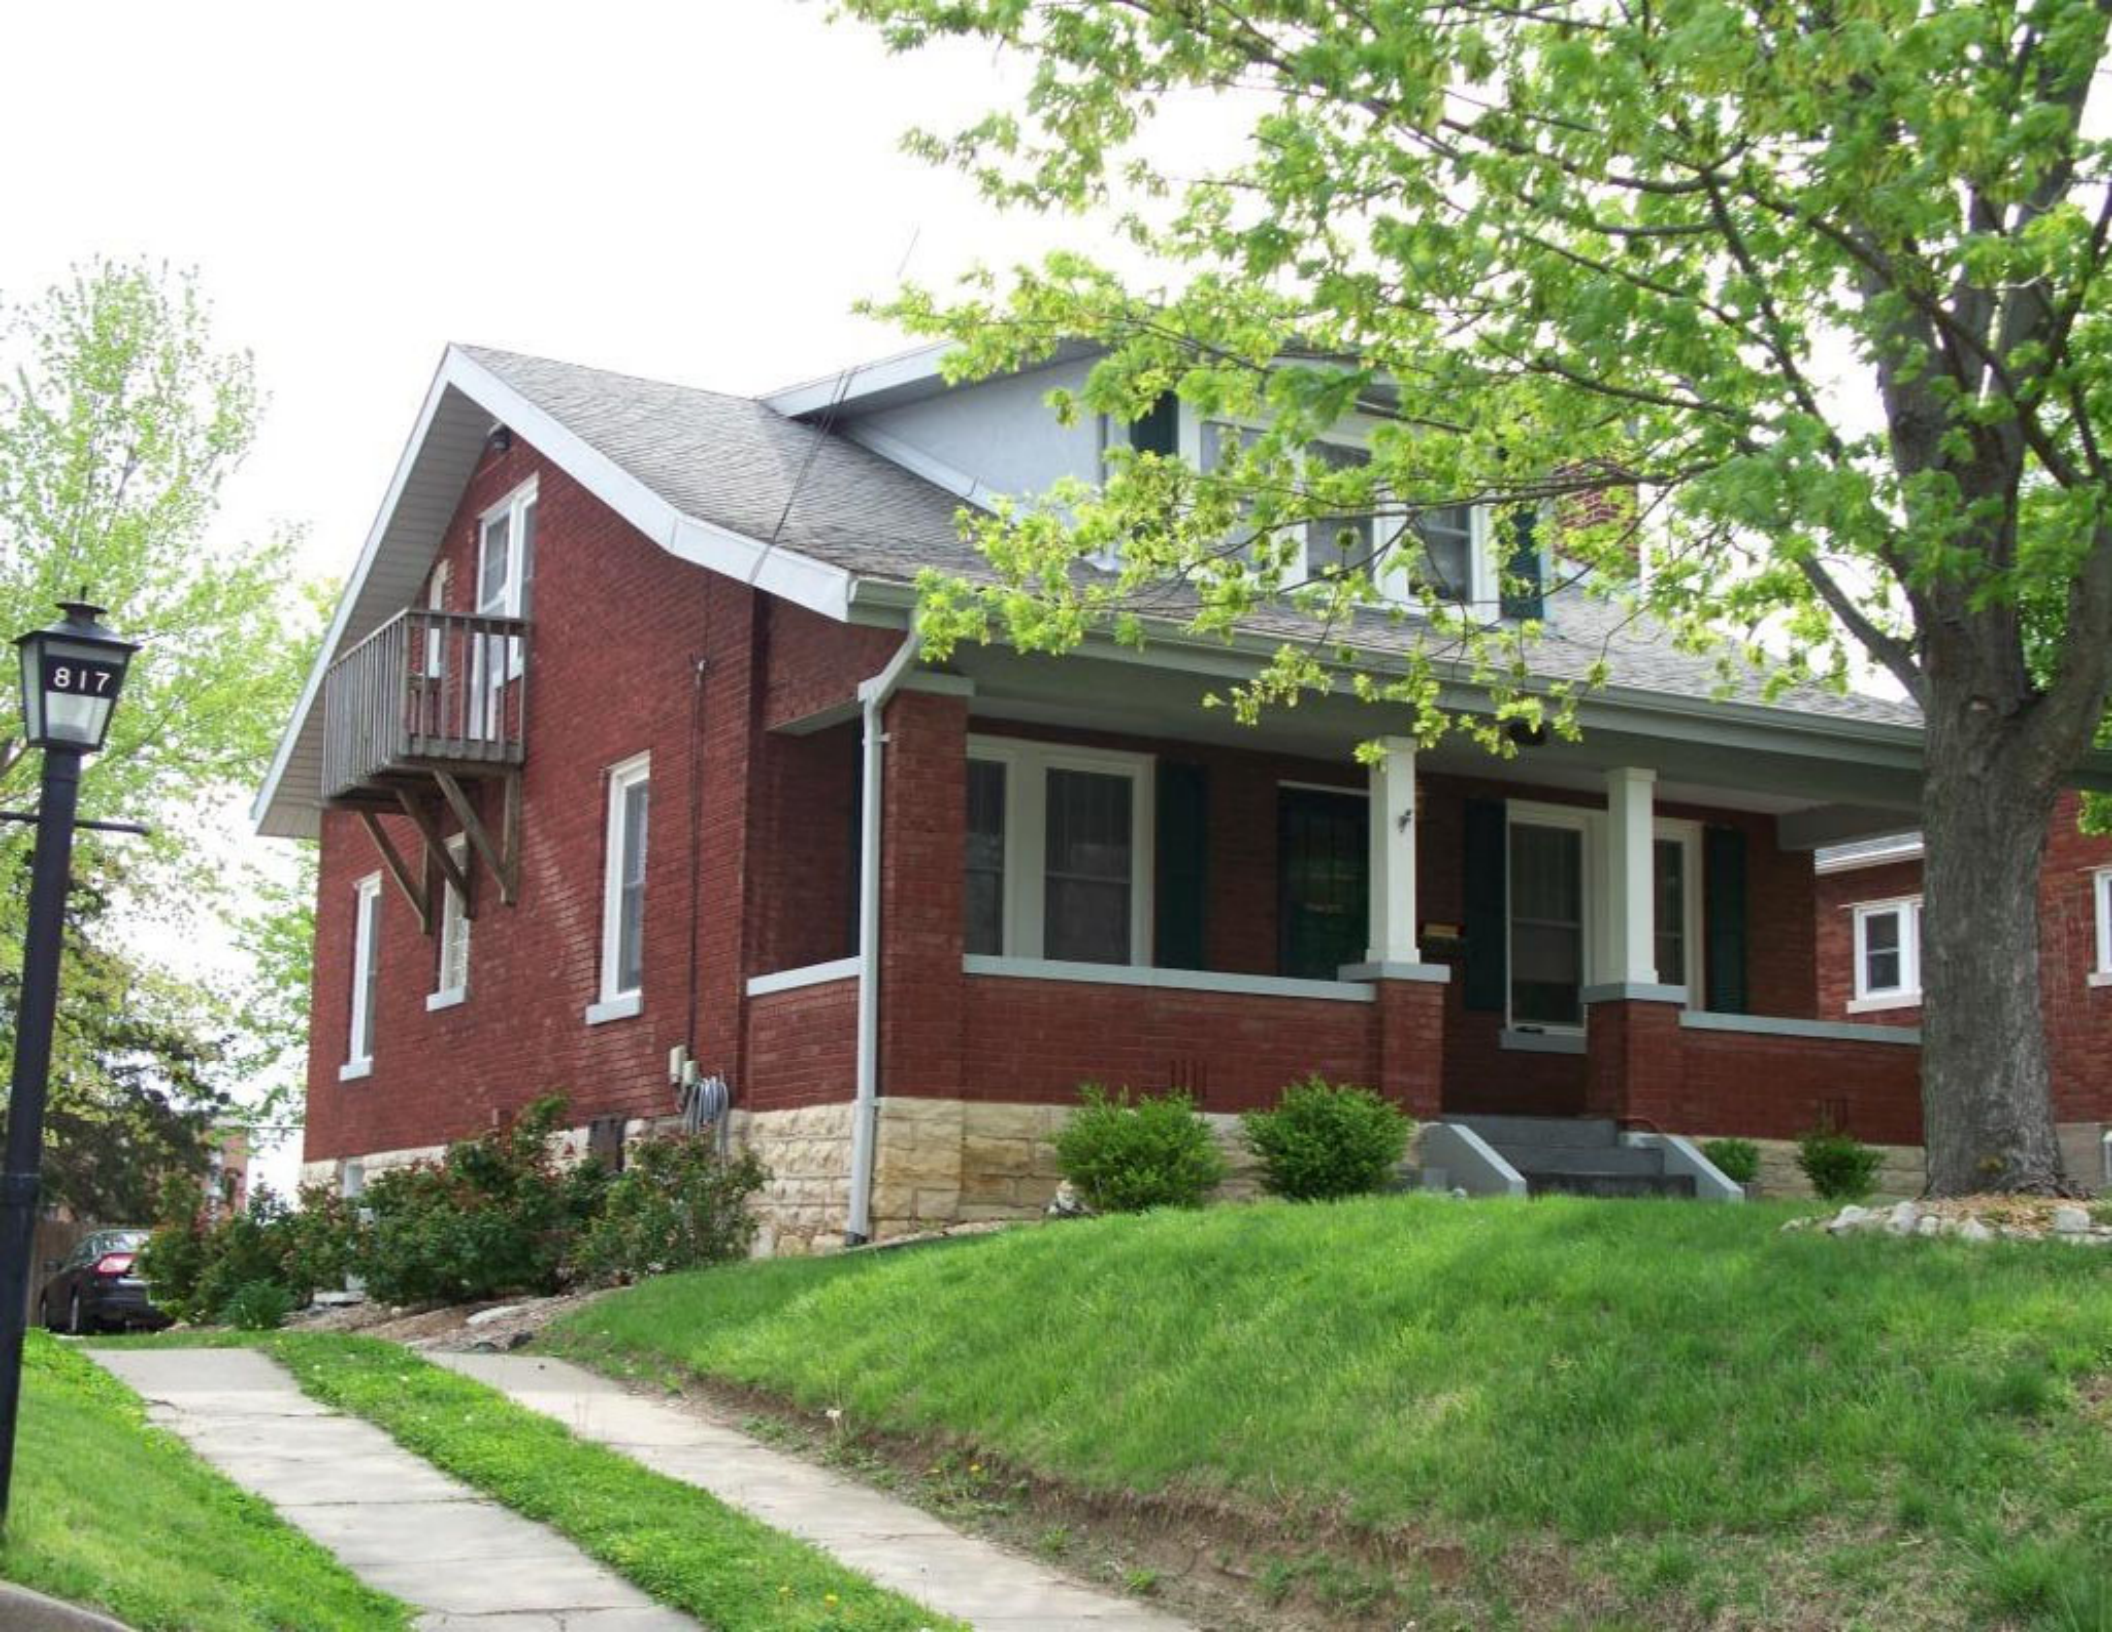
817

This is a brick bungalow with a side gable roof and a large shed-roof central dormer with a row of three 4/1 windows with storms. The windows are flanked by shutters. The first floor has two paired 4/1 historic windows with storms and stone or concrete sills with shutters that flank the central entrance. A small light fixture that could be historic hangs from the porch roof over the door. The full-width brick porch has brick pilasters and two posts centrally located. The brick knee-walls are capped in cement or limestone and feature venting right above the raised stone foundation in the center of each wall.
