ARCHITECTURAL/HISTORIC INVENTORY FORM

1. Survey No. CO-AS-005-001		2. Survey name: Moreau Drive Neighborhood Survey	
3. County: Cole		4. Address: 1202 Elmerine Ave.	
5. City: Jefferson City	Vicinity: <input type="checkbox"/>	6. UTM: / /	7. Township/Range/Section: T: R: S:
8. Historic name (if known):		9. Present/other name (if known):	
10. Ownership: <input checked="" type="checkbox"/> Private <input type="checkbox"/> Public		11. Historic use (if known): Residential	11. Current use: Residential

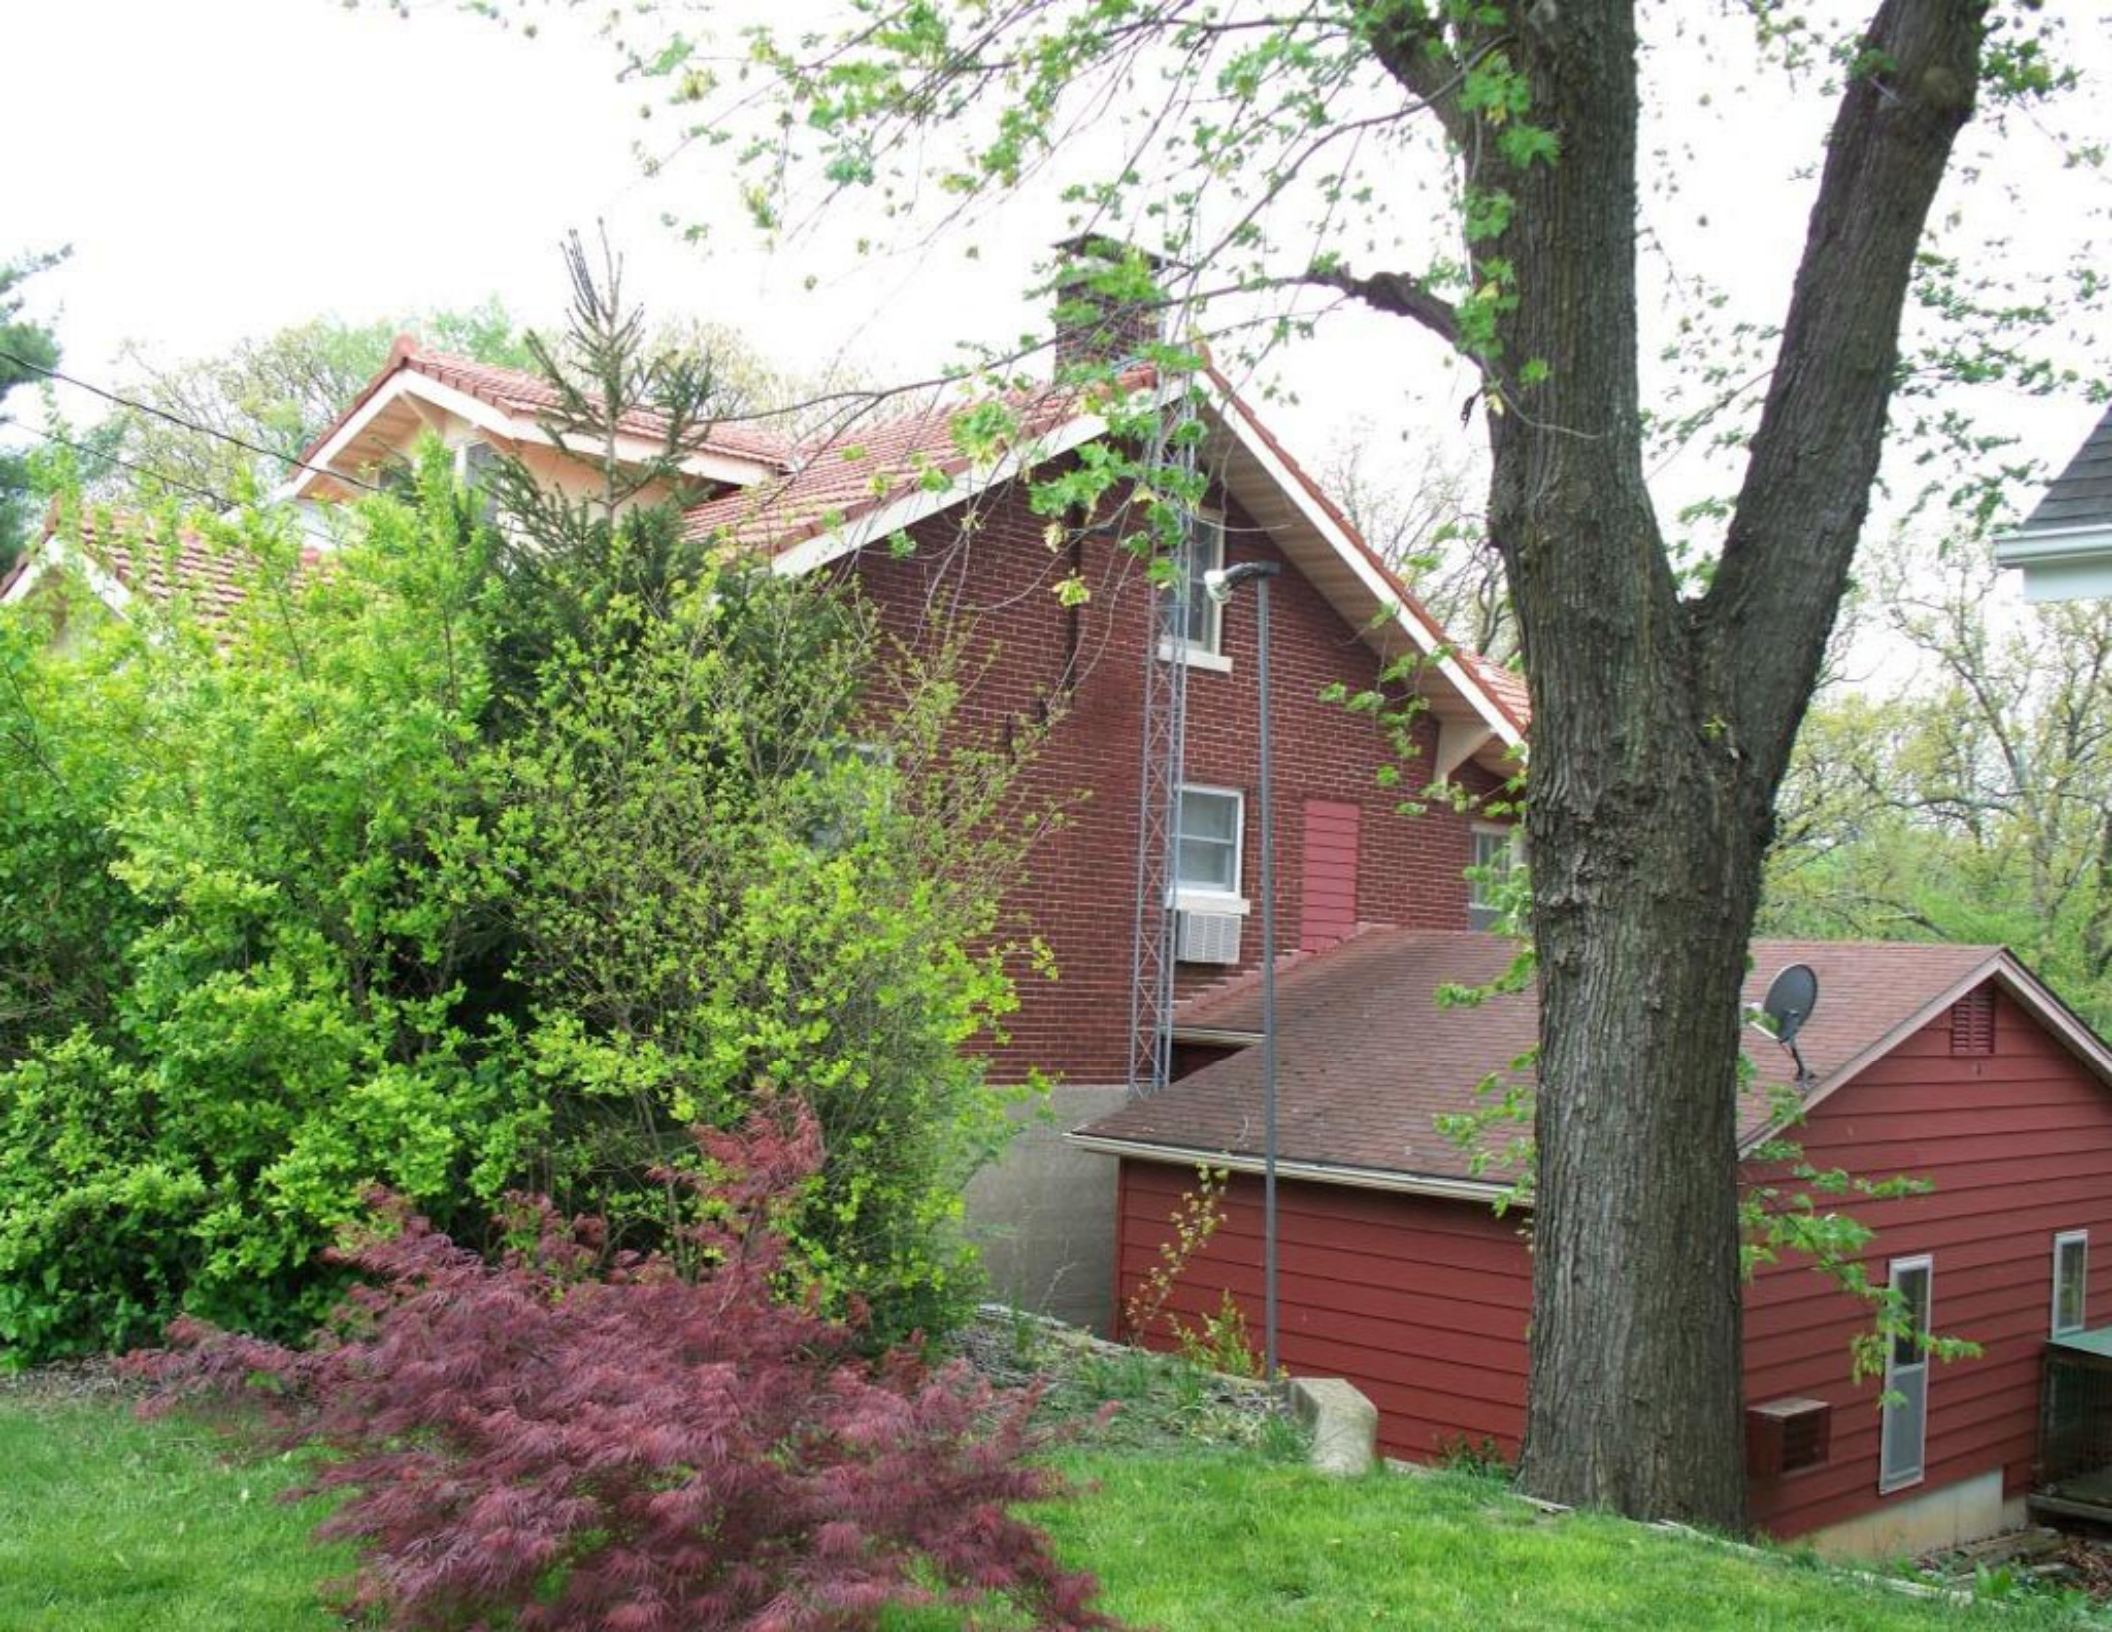
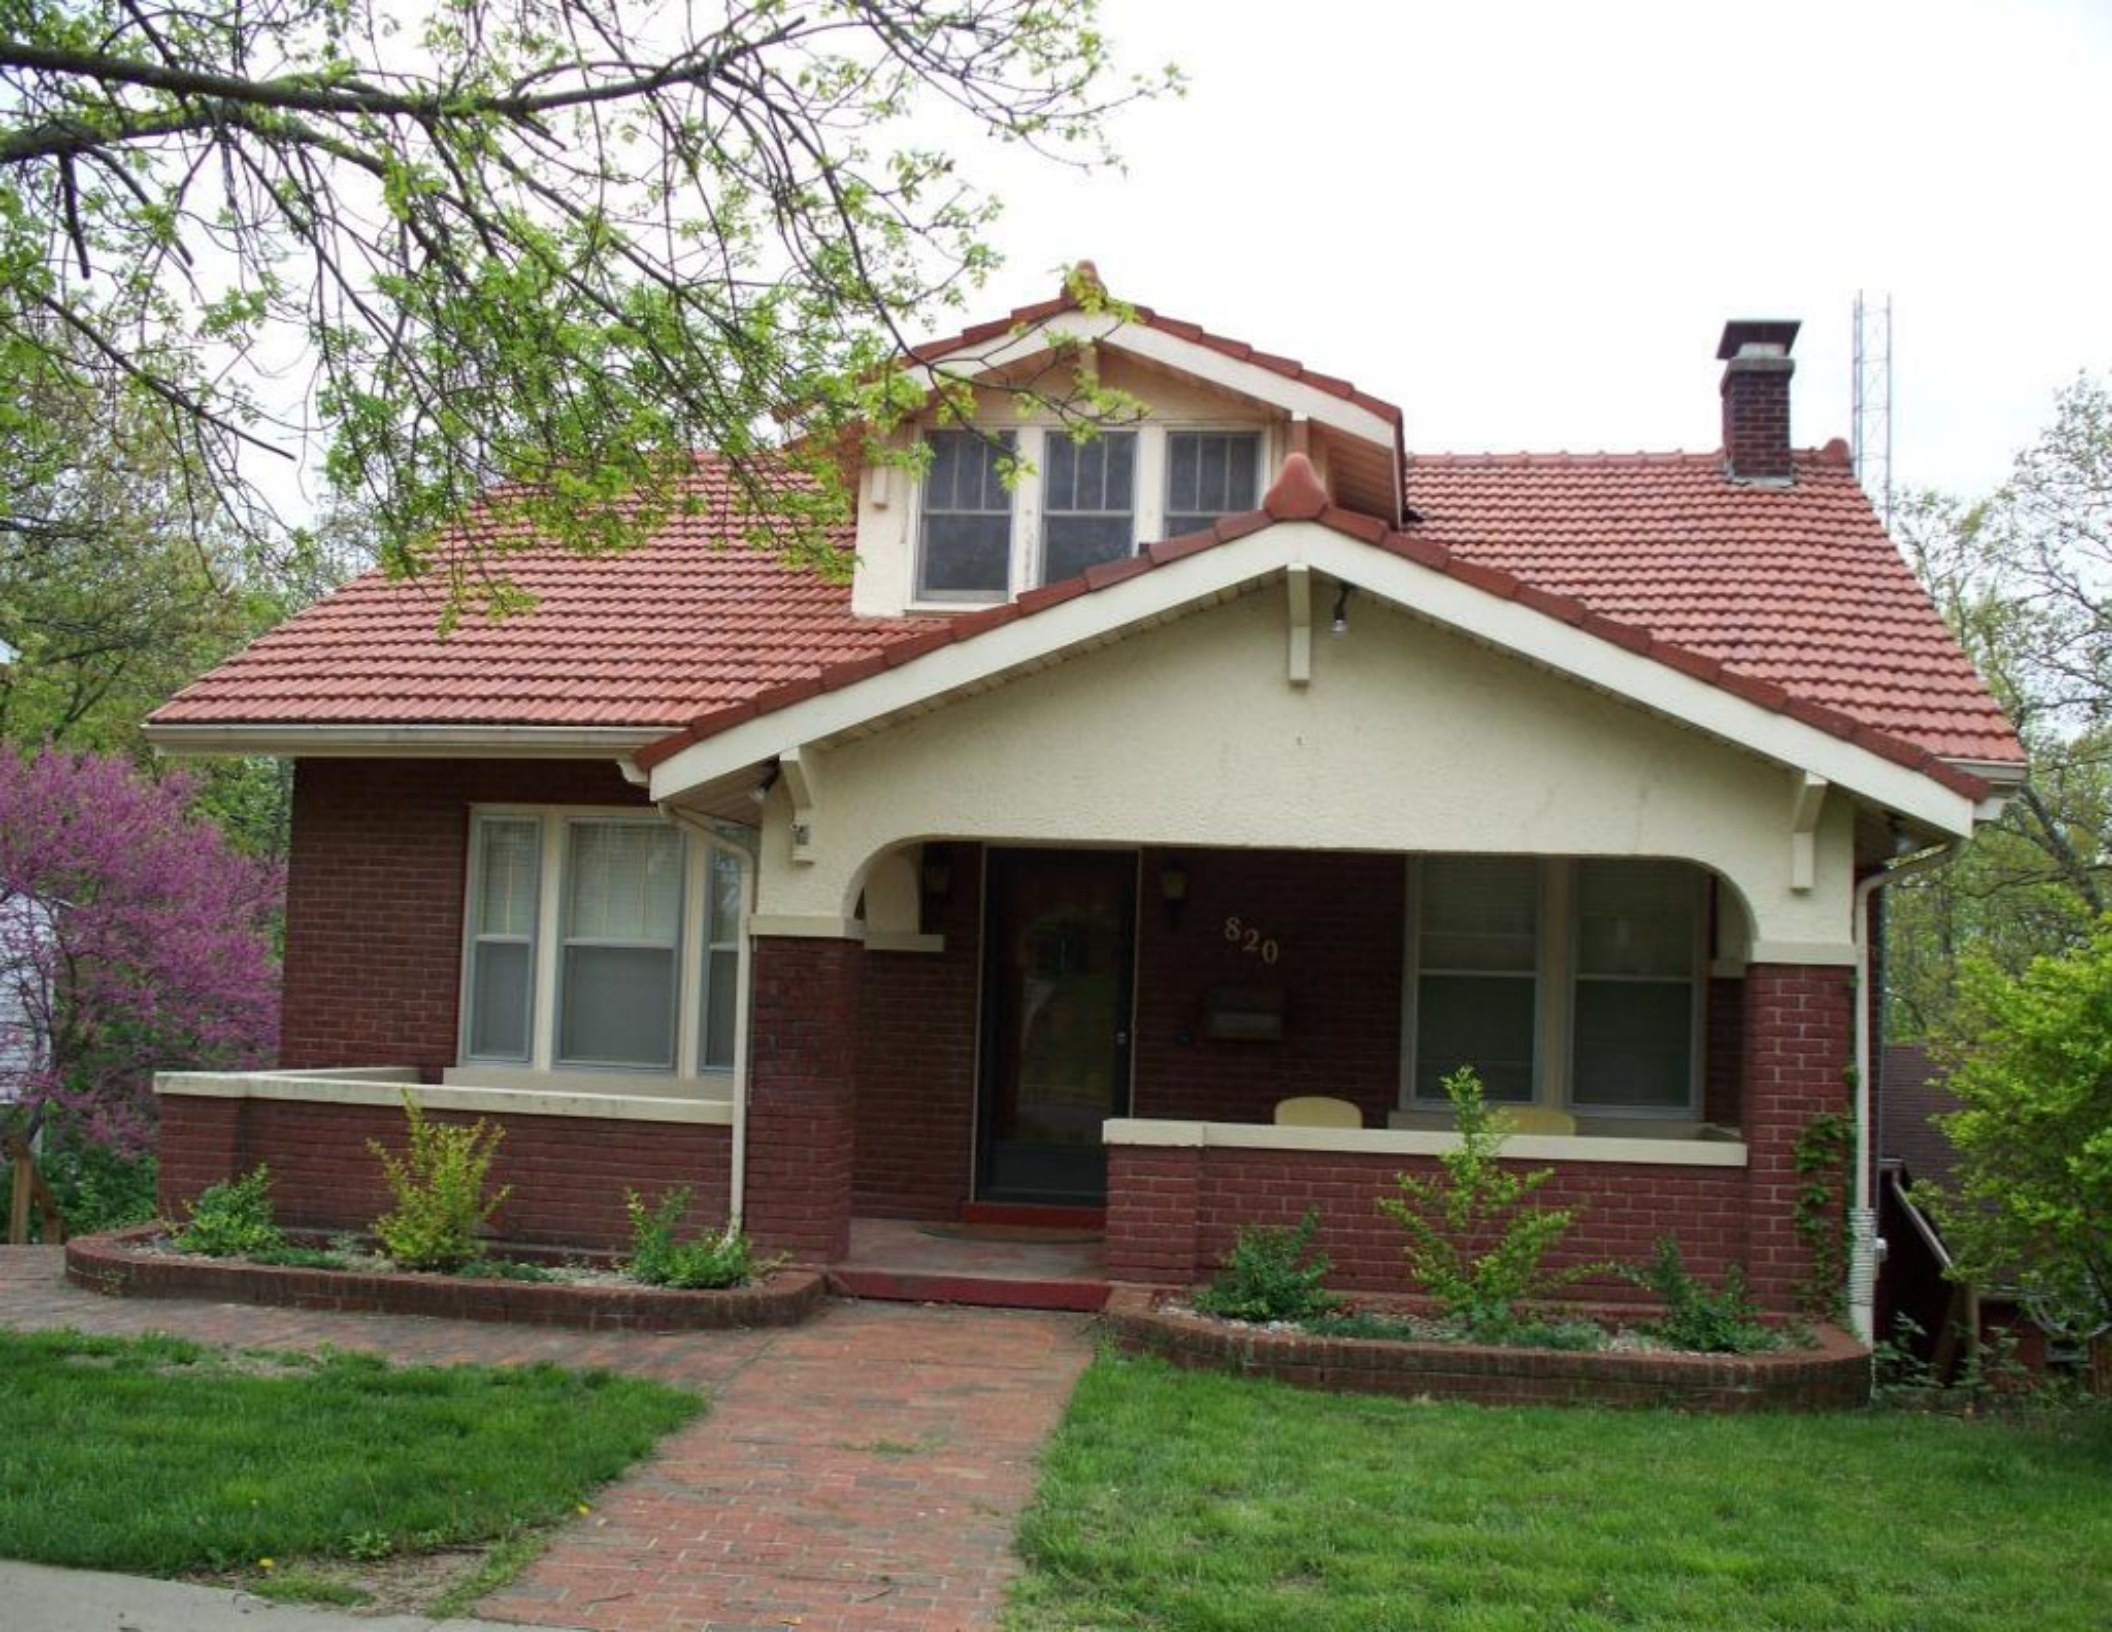
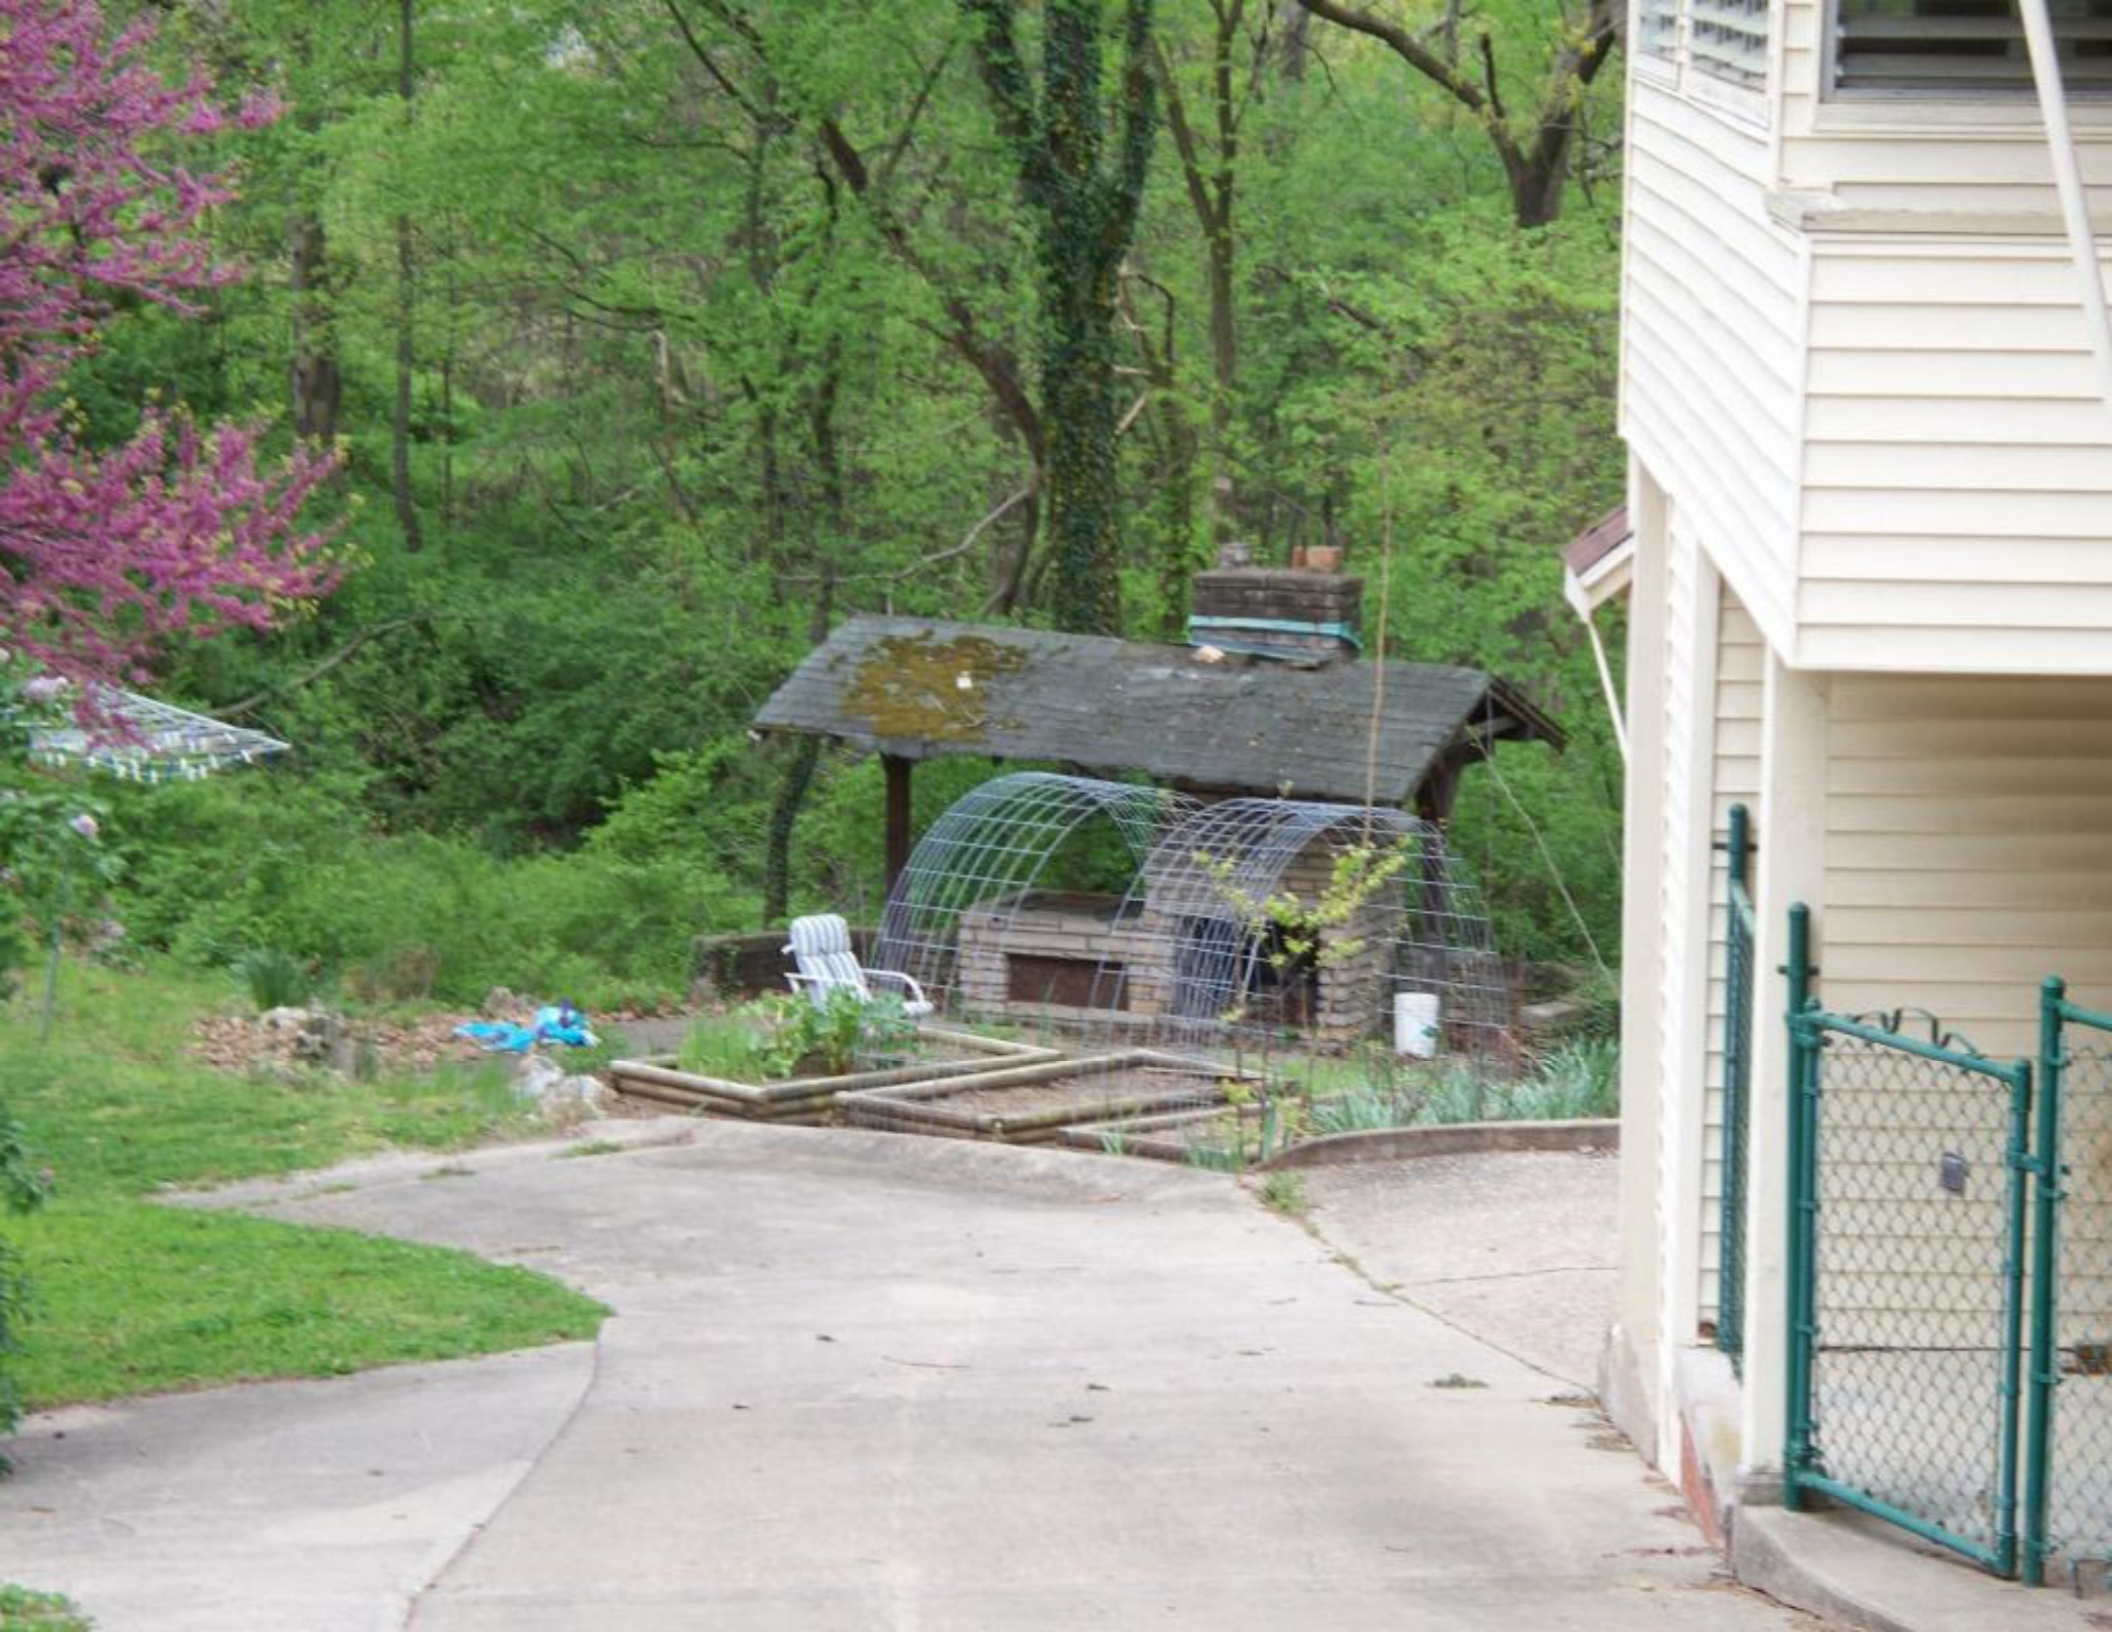
41. (cont.)
This 1 ½ story brick bungalow has a side gable with an intersecting stuccoed front gable with knee braces over the porch. A gabled dormer with brackets protrudes from the tiled roof and has three historic 3/1 windows. The first floor has a tri-part window in the left bay featuring 2/1 flanking a 3/1 window with a limestone sill. The right bay has paired 3/1 historic window and a limestone sill. The door is in the central bay. The full width porch has a brick half wall capped in limestone. The brick pilasters support the gabled roof, which is only over the center and right bay.

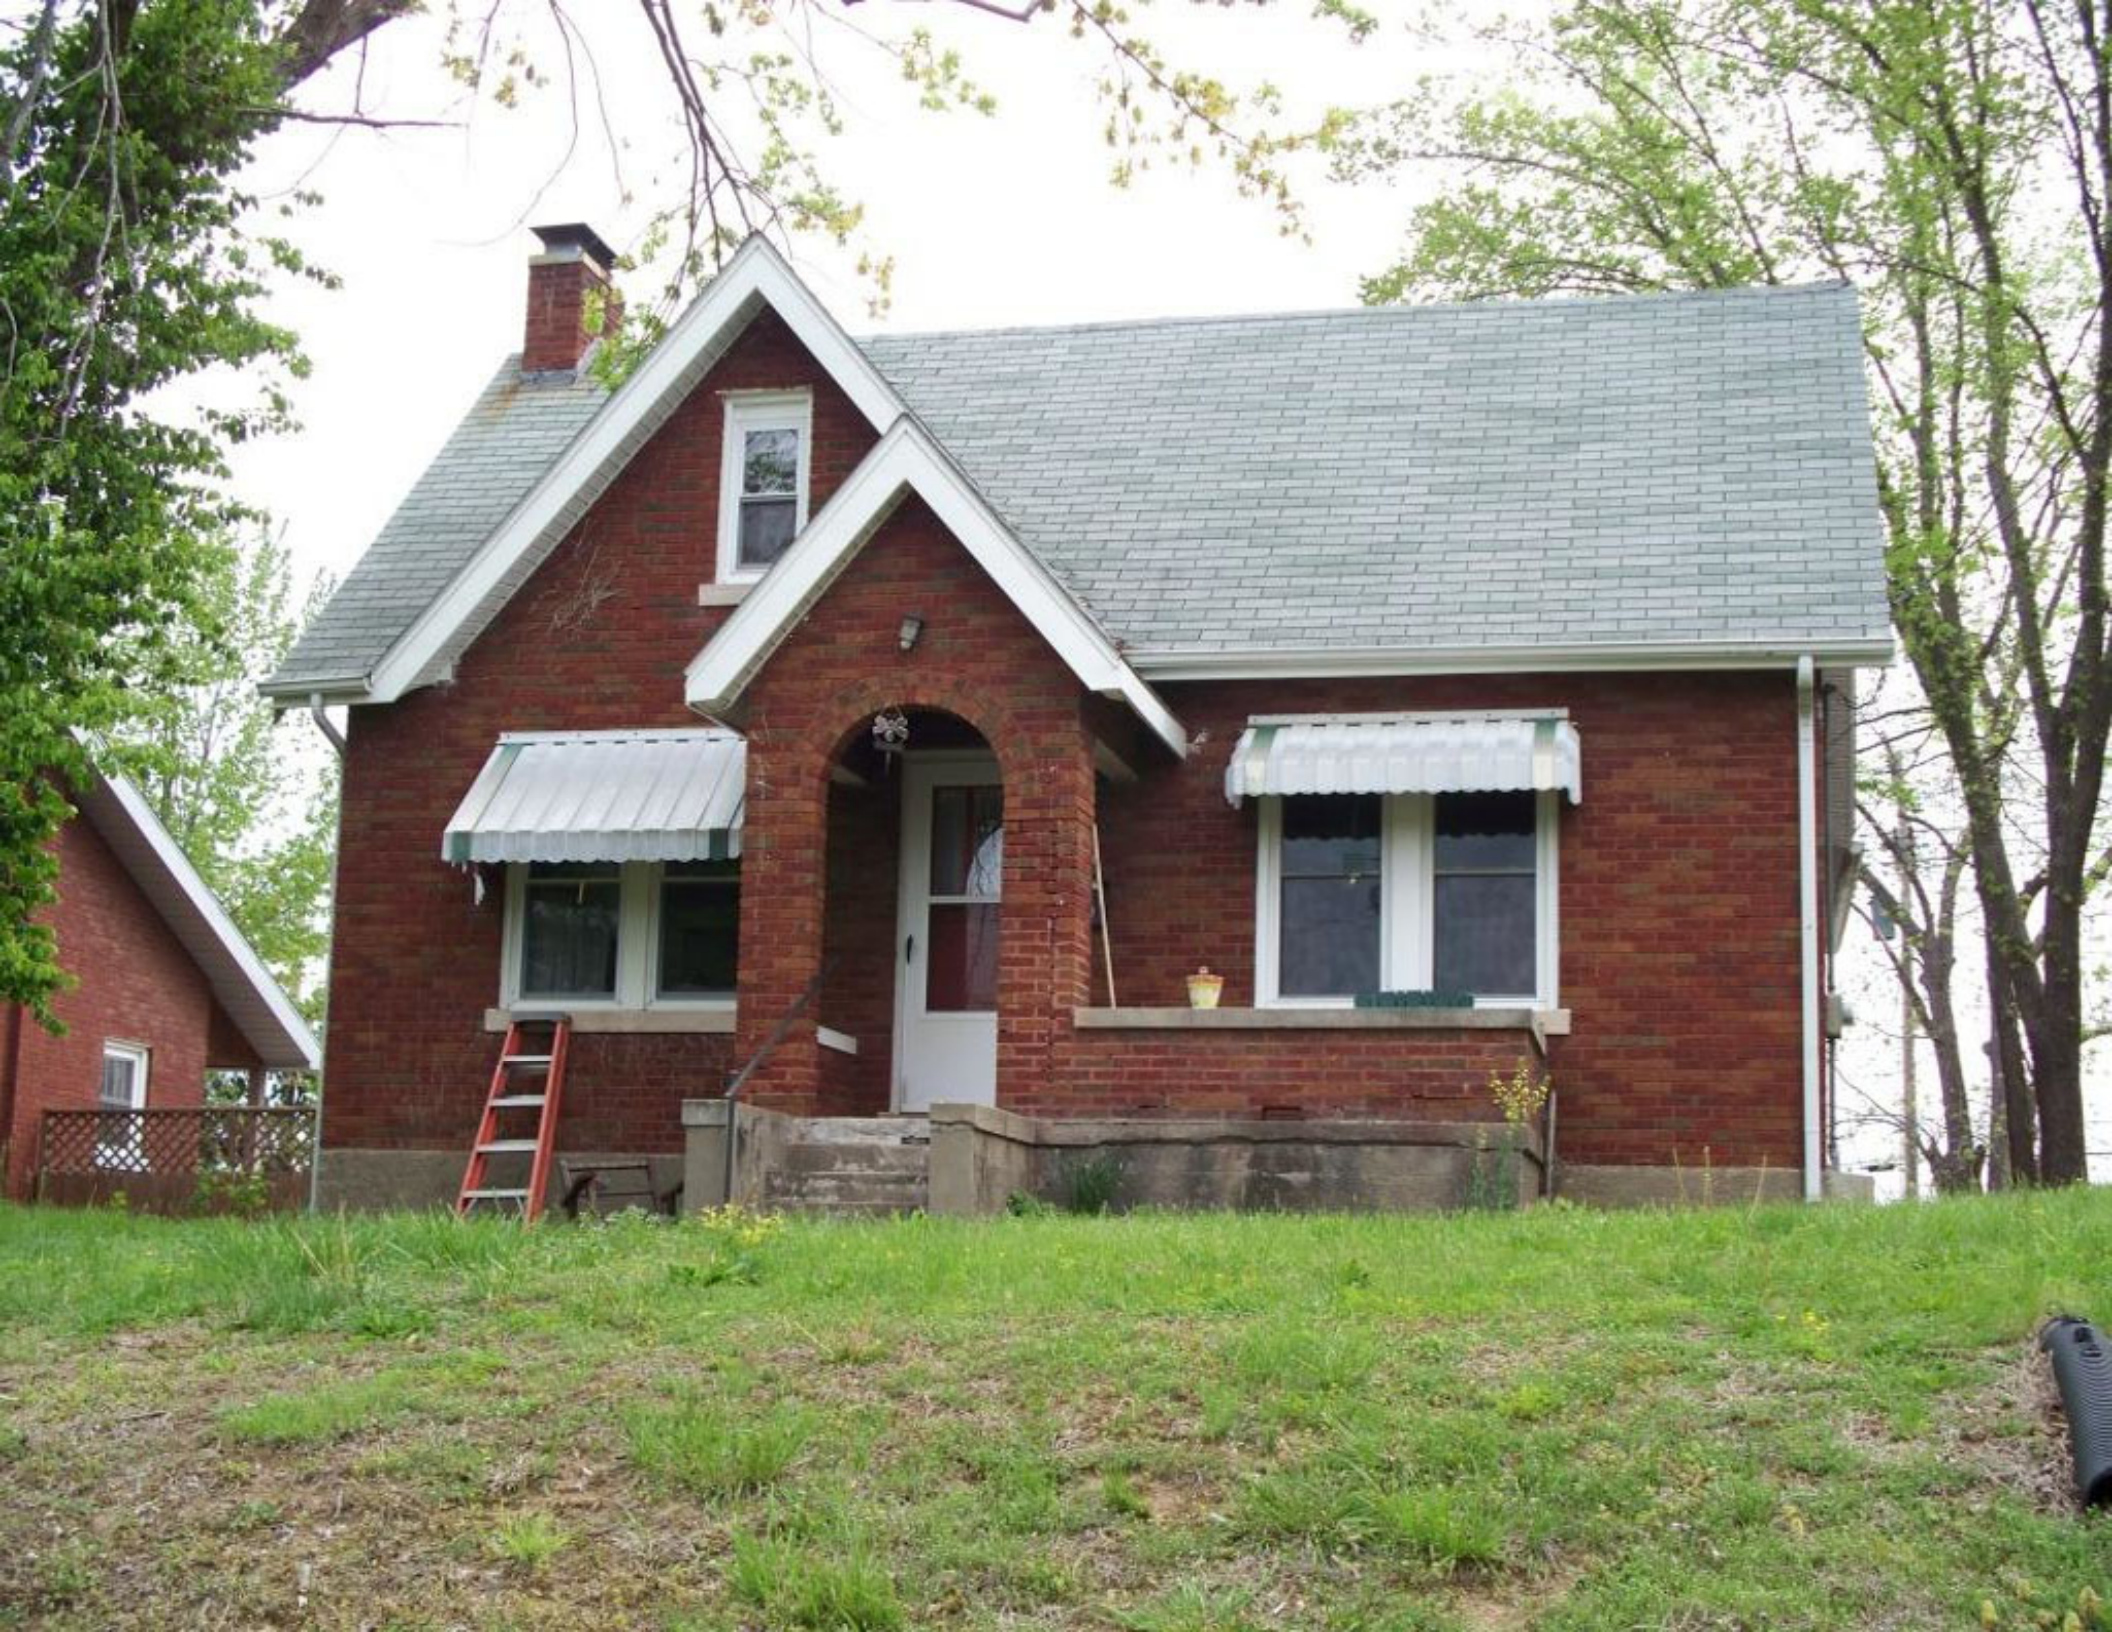
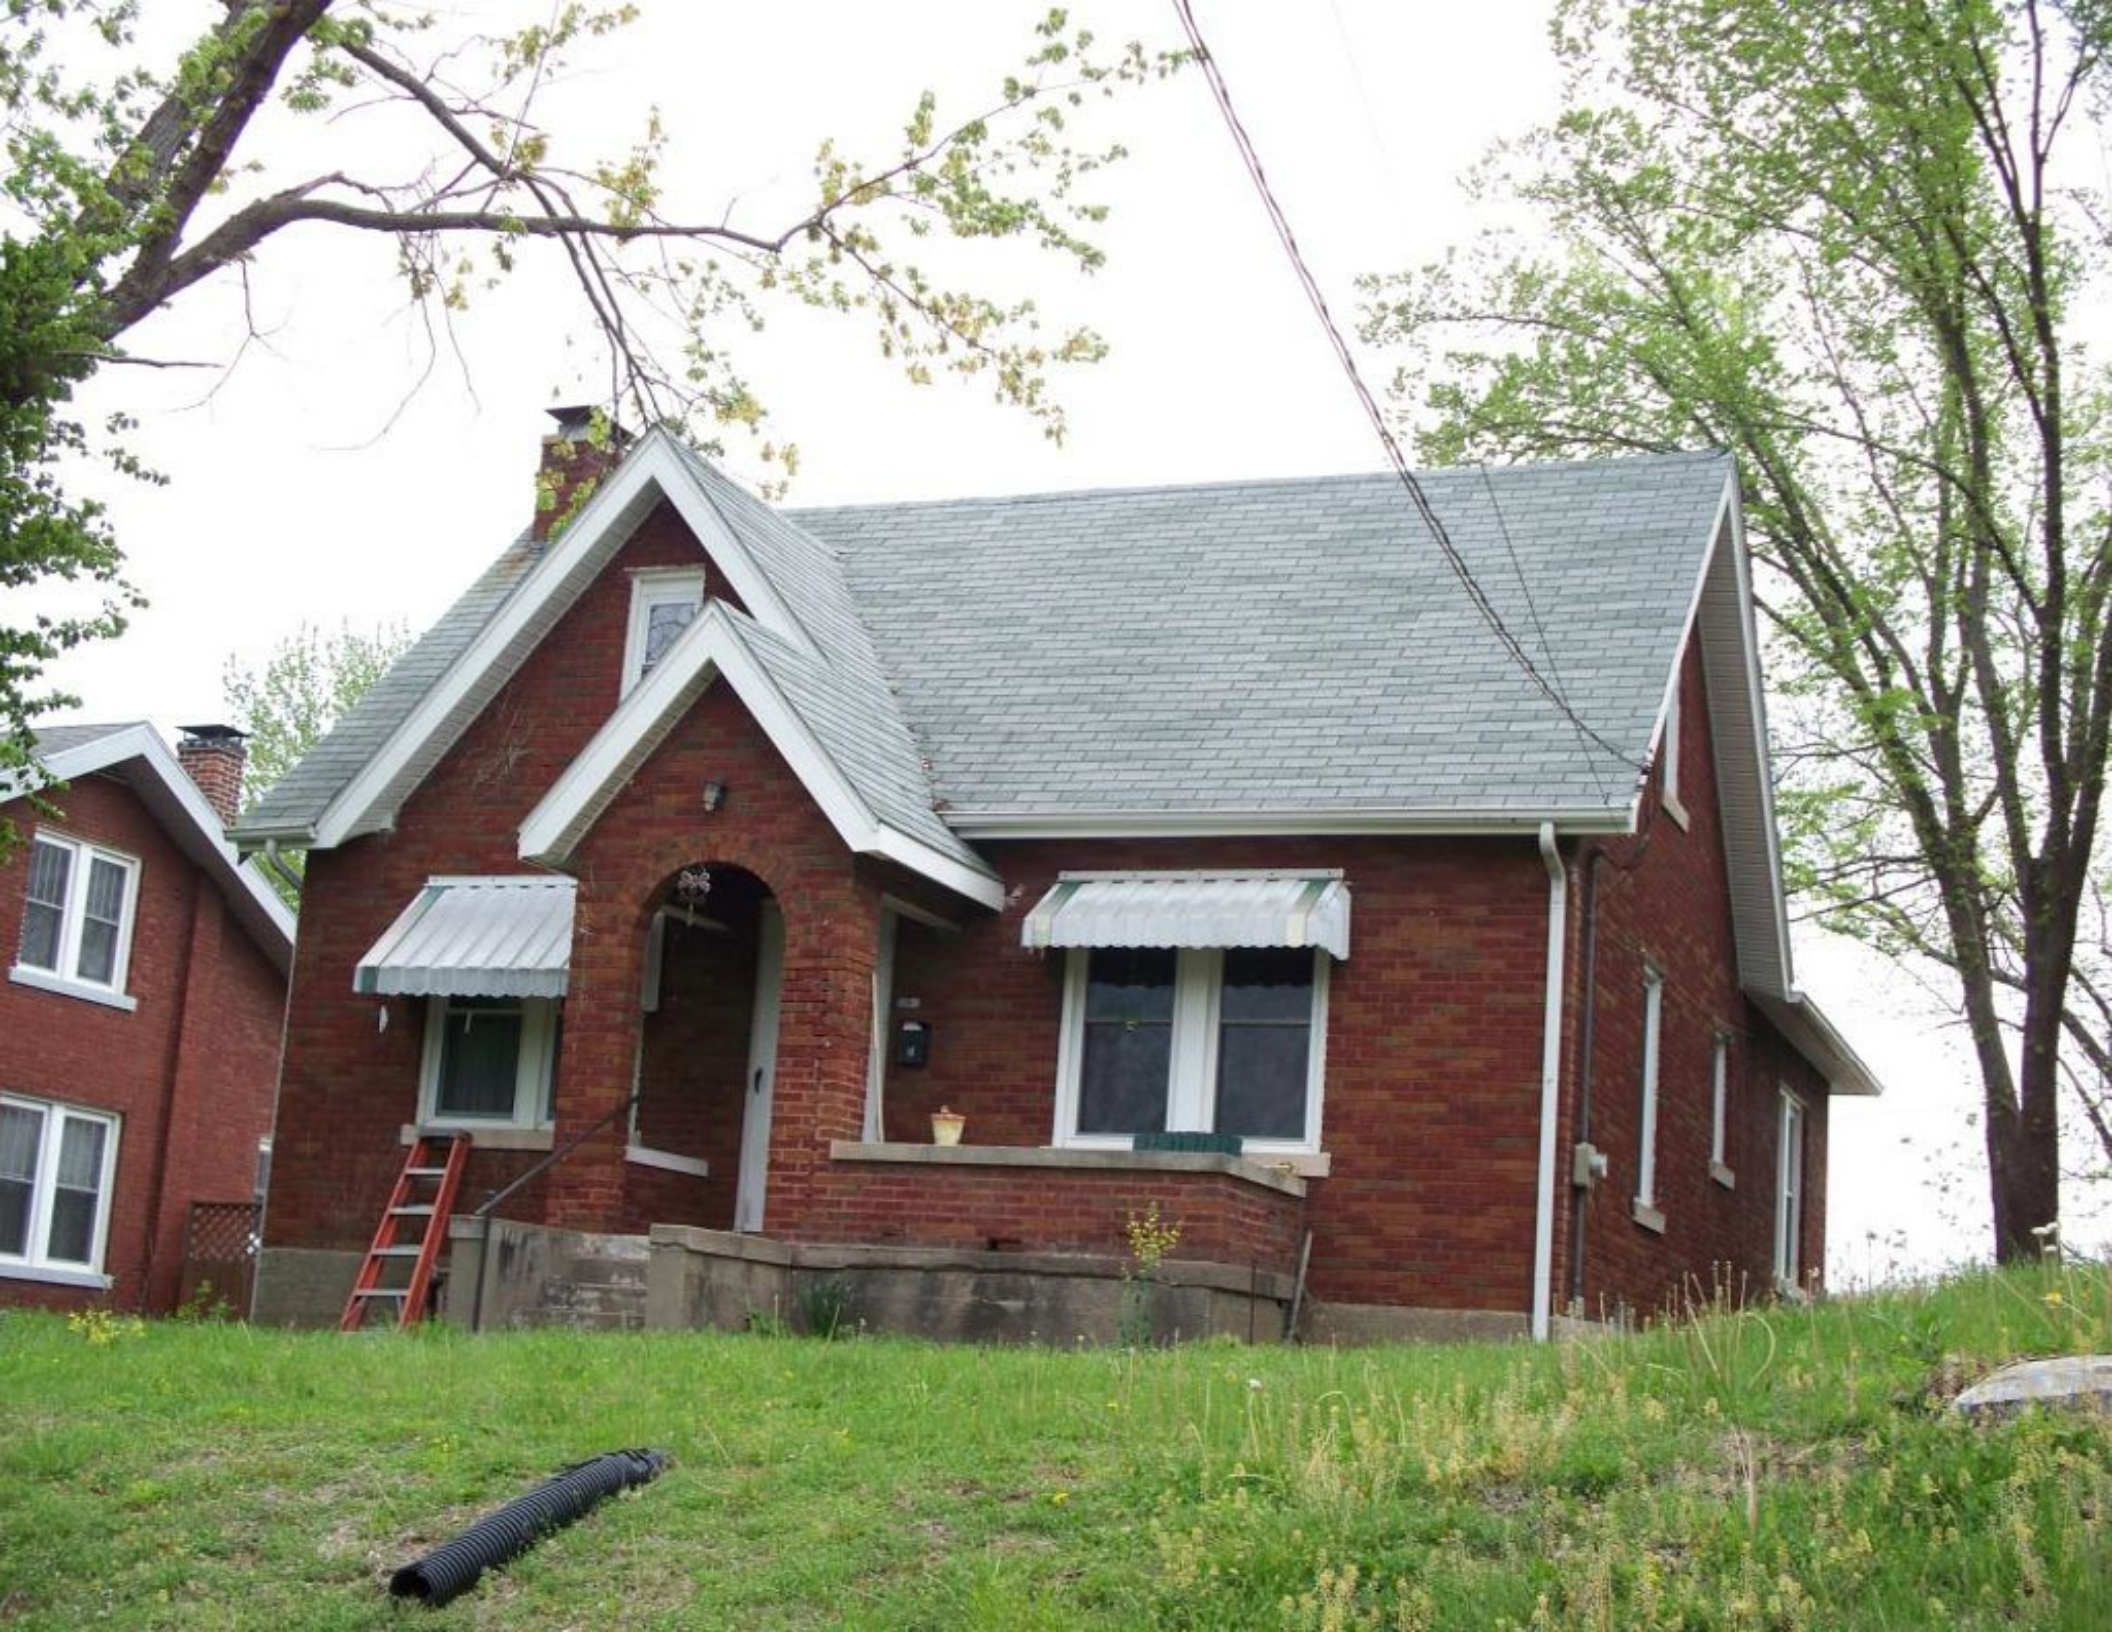
This brick Tudor has a dominate side gabled roof with a partial crossing front gable offset in the front. In the peak is a narrow 1/1 window. The ground story has two paired 1/1 windows with concrete sills and aluminum hoods that flank the entrance. There are storm windows on the property that make it difficult to determine if the windows are historic. The door may or may not be replacement and has a metal screen door. A gabled brick portico and partial porch projects from the façade to the right of the property and features knee walls capped with cement or limestone. The portico has an arched entryway and a light fixture in its peak that appears historic.
